APPENDIX 2

Building Assessment Sheets (Inventory Sheets)

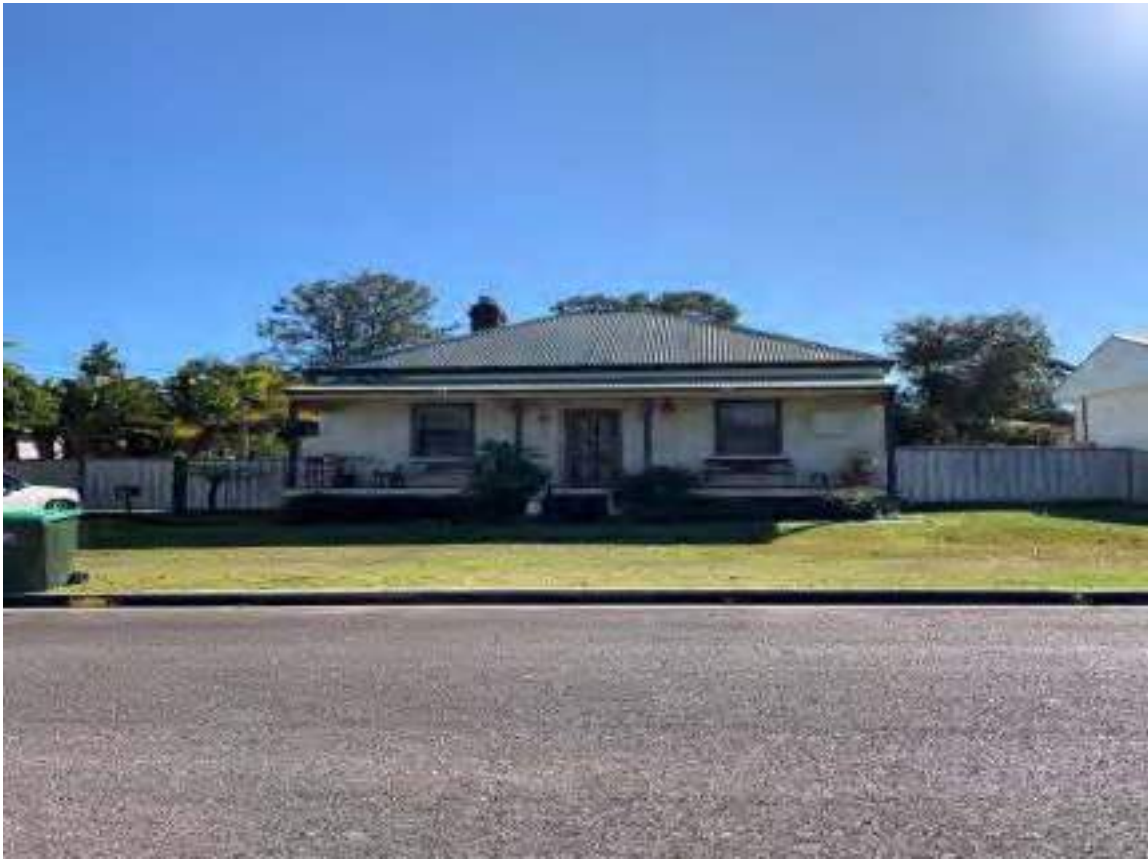
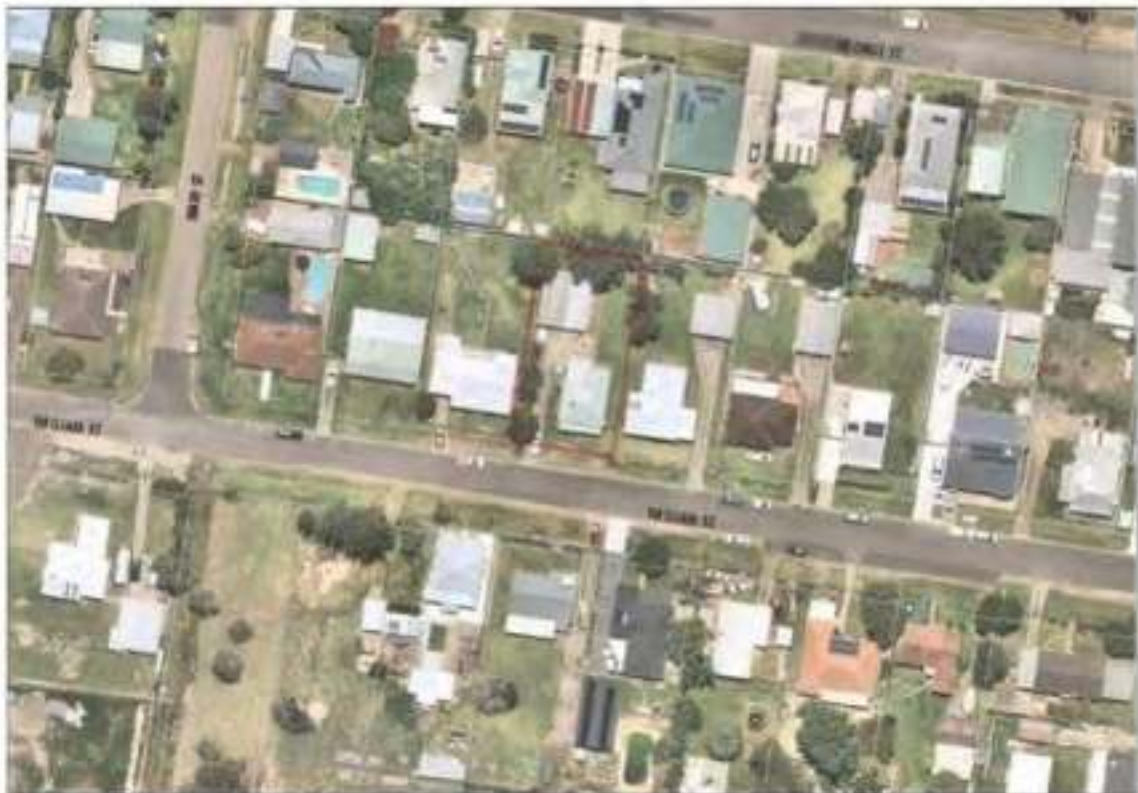
33 WILLIAM STREET, HOLMESVILLE 2286

Conservation Area Contribution Level	Est. Construction Date	Previous studies and/or community input
Contributory 1	1890–1915	No prior heritage investigations and no additional information required
Assessment Text		Observed Modifications
<p>Single storey Vernacular Mining Cottage style dwelling with hipped weatherboard roof and weatherboard cladding. The veranda is open with a Colourbond skillion roof, timber square cut support beams and decorative timber brackets.</p> <p>A set of masonry stairs with associated masonry balustrade leads onto the veranda. No railing encloses the veranda space.</p> <p>The front door is central, being a six panel door design, with double pane sash windows on either side.</p> <p>A simple brick chimney with two terracotta pots is found on the western side of the dwelling.</p> <p>A Colourbond fence runs the width of the property on either side of the dwelling.</p> <p>The dwelling displays architectural features of a heritage style and is representative of the local development of this period, being of historical significance for the HCA.</p>		<p>It is likely that the skillion veranda roof replaced an original bull nose roof, being a common modification for this style of dwelling.</p> <p>A large garage structure is located at the back northern section of the property, however this is not visible from the street and does not impact the contributory value of the dwelling.</p>

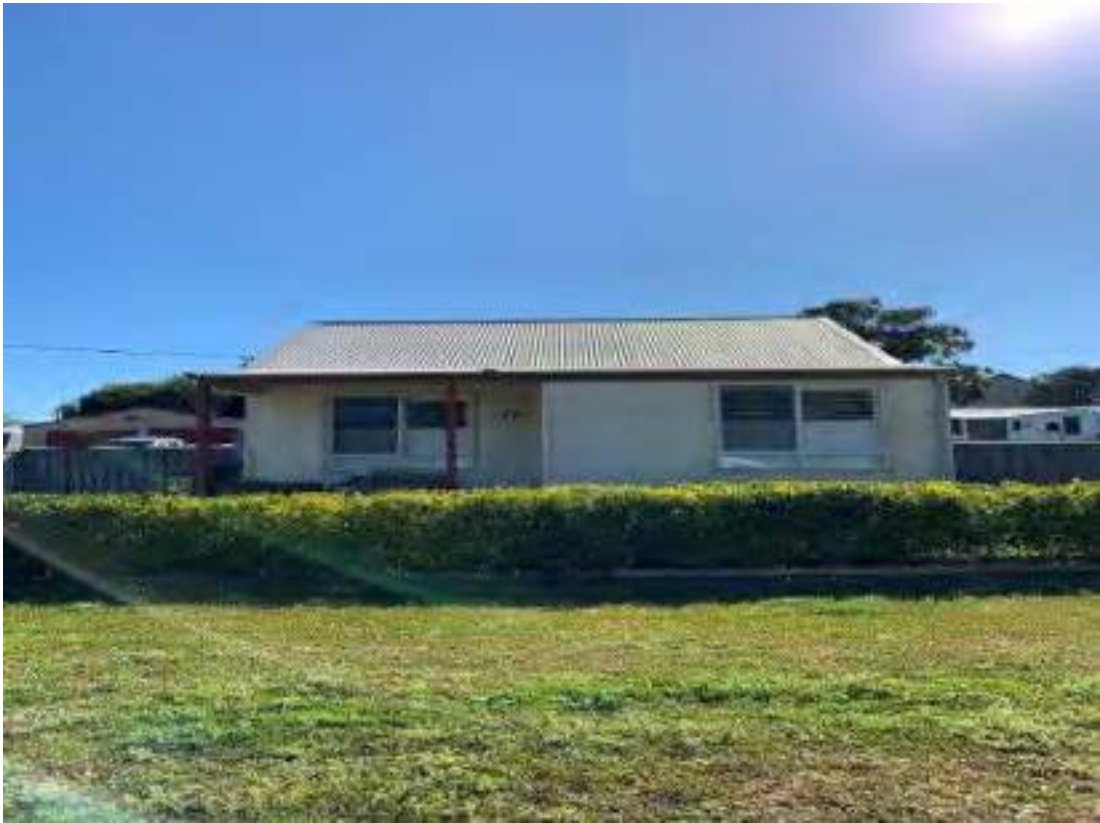
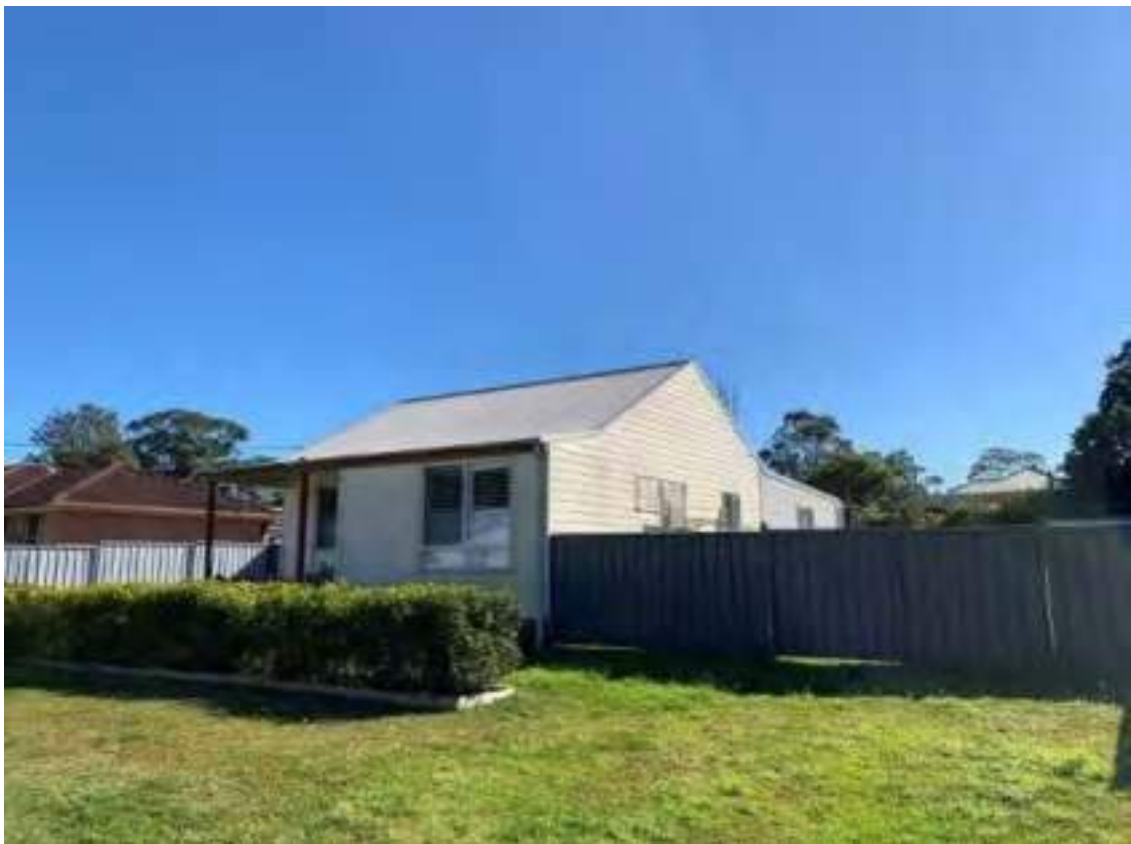
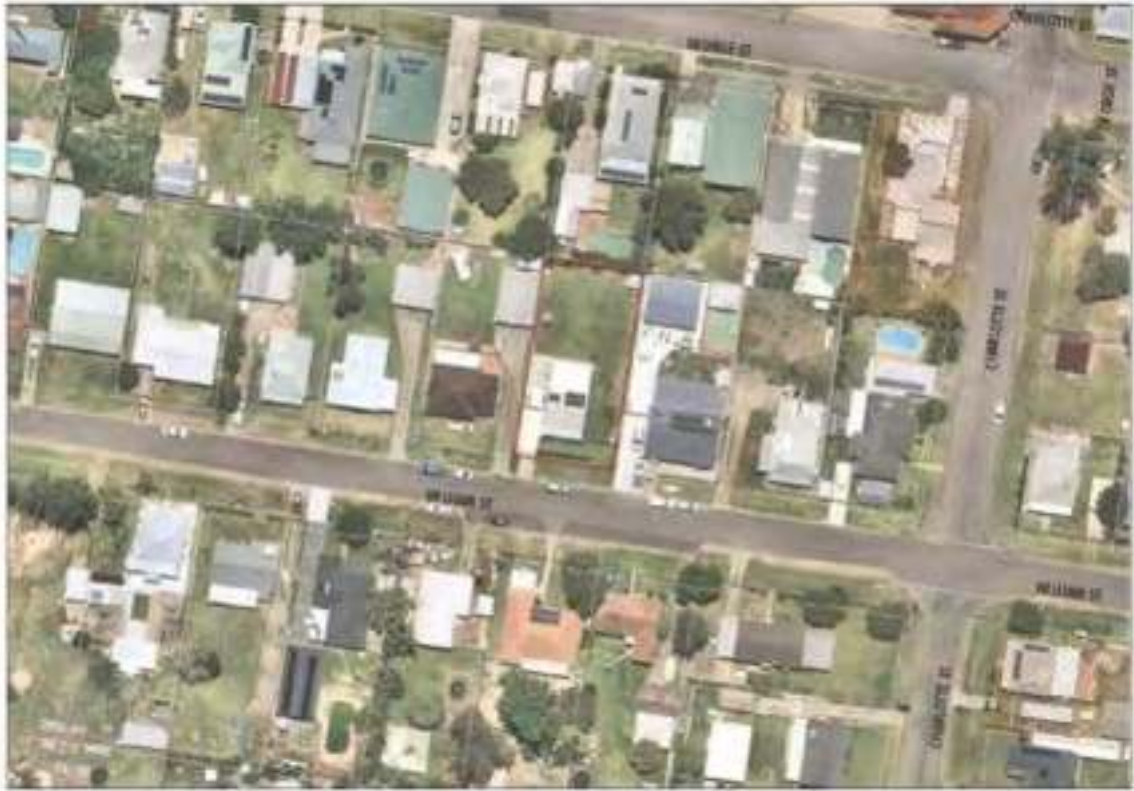
27 WILLIAM STREET, HOLMESVILLE 2286

Conservation Area Contribution Level	Est. Construction Date	Previous studies and/or community input
Contributory 1	1890–1910	No prior heritage investigations and no additional information required
Assessment Text		Observed Modifications
<p>Single storey Vernacular cottage style dwelling with Colourbond gable roof and weatherboard cladding. The veranda is partially enclosed by an additional room on the eastern side. The veranda roof is supported by square cut timber beams.</p> <p>The front door is located on the western side of the additional front constructed room, being timber framed. Double pane sliding windows are located on either side, having metal framing.</p> <p>A high cut hedge is used as a fence line, partially obscuring the dwelling.</p> <p>A Colourbond fence runs the width of the property, from either side of the dwelling.</p> <p>The dwelling displays architectural features of a heritage style and is representative of the local development of this period, being of historical significance for the HCA.</p>		<p>The room constructed at the front of the dwelling is an additional structure, originally the veranda would have consisted of an open space. The front door has been relocated in conjunction with the construction, having been originally located at the centre of the dwelling façade.</p>

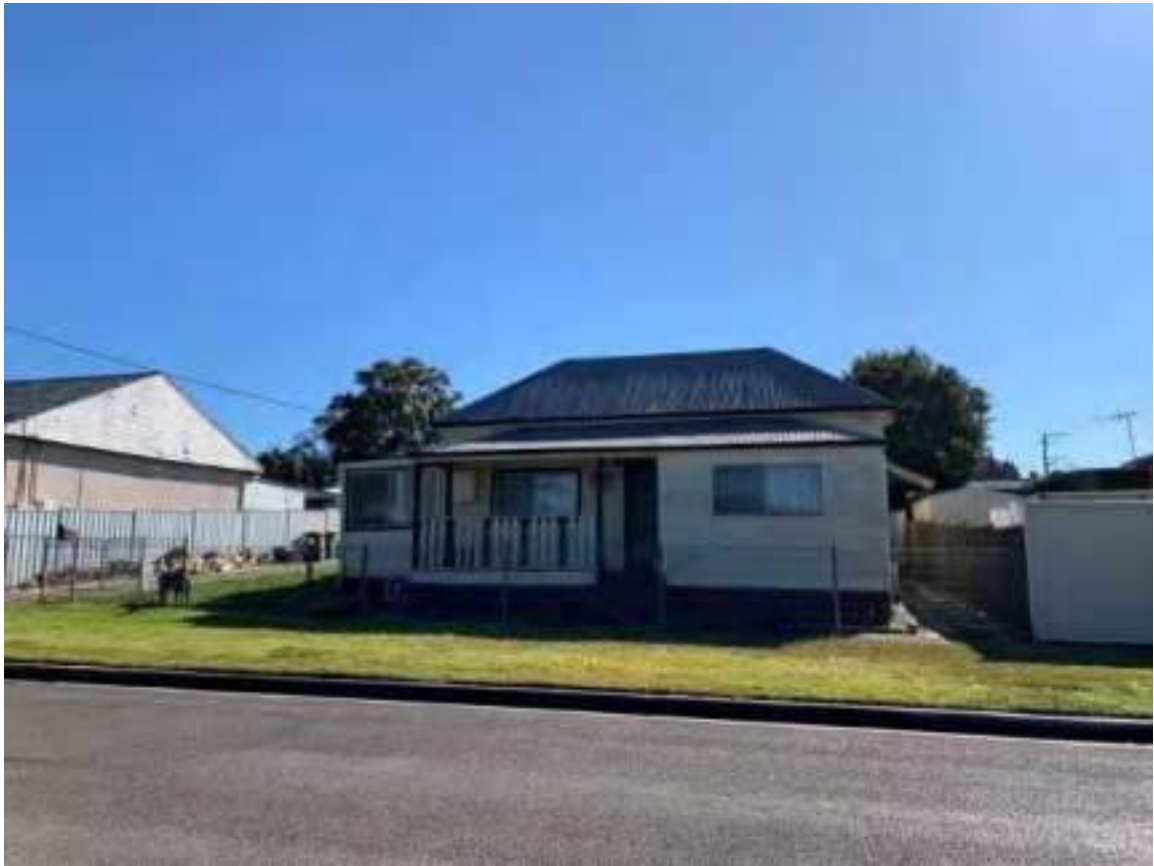
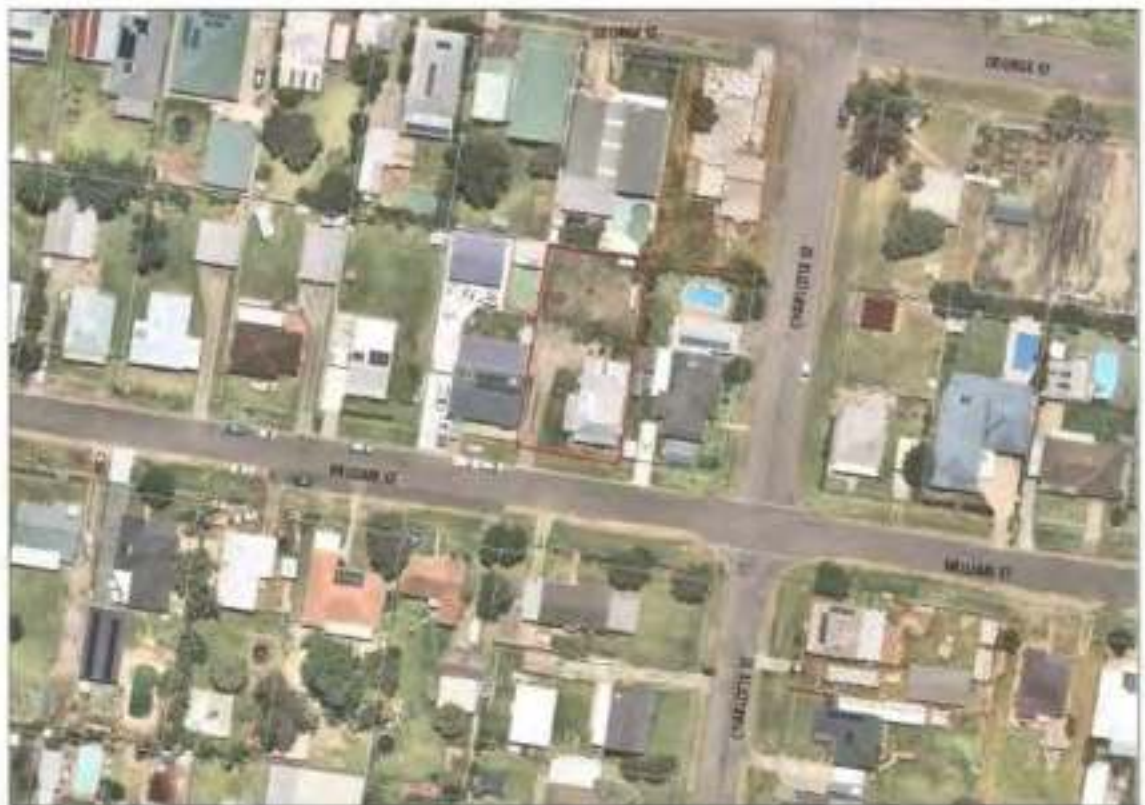
23 WILLIAM STREET, HOLMESVILLE 2286

Conservation Area Contribution Level	Est. Construction Date	Previous studies and/or community input
Contributory 1	1890–1910	No prior heritage investigations and no additional information required
Assessment Text		Observed Modifications
<p>Single storey Vernacular cottage style dwelling with Colourbond gable roof and weatherboard cladding. The veranda is partially enclosed by an additional room on the eastern side, as well as timber balustrades. The veranda roof is supported by square cut timber beams.</p> <p>The front door is centrally located, being timber framed. Double pane sliding windows are located on either side, having metal framing.</p> <p>A set of masonry stairs leads onto the veranda space, with rendered stair balustrade on either side. The dwelling is supported on rendered brick foundations. A concrete path is found either side of the stairs.</p> <p>An additional extension is visible on the western side of the dwelling, impacting the heritage integrity of the dwelling. this is likely a dated modification. Multipaned timber framed windows are found across both the southern and western walls.</p> <p>A simple metal pipe chimney is visible on the western side of the roof.</p> <p>Metal wire fencing runs the width of the property. Colourbond fencing is also evident at the back of the dwelling, with a lattice top.</p> <p>A large garage is located to the north of the dwelling, being a recent construction.</p> <p>The dwelling displays architectural features of a heritage style and is representative of the local development of this period, being of historical significance for the HCA.</p>		<p>The additional structure partially enclosing the veranda space is a modification, however this is likely an aged modification and is commonly found in comparable dwellings in the area.</p> <p>An additional structure on the western side of the dwelling is also a modification, however is again considered to have been constructed in the past. This is highly visible and does impact the contributory value of the dwelling.</p> <p>The timber balustrade found on the veranda is unlikely to be an original feature, as this was not a common feature of vernacular cottage style dwellings.</p> <p>Multiple sections of concreting have been poured, both in the front of the dwelling on either side of the stairs, and leading to the garage acting as a driveway.</p>

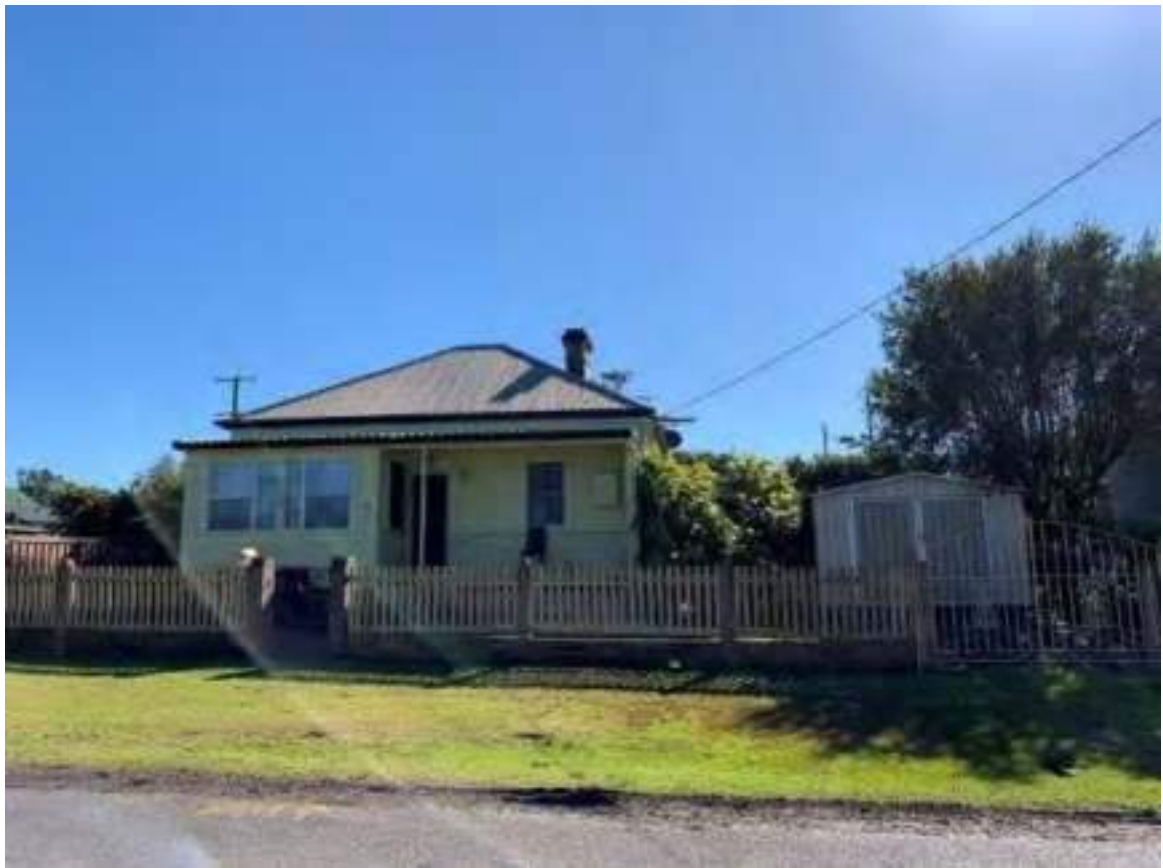
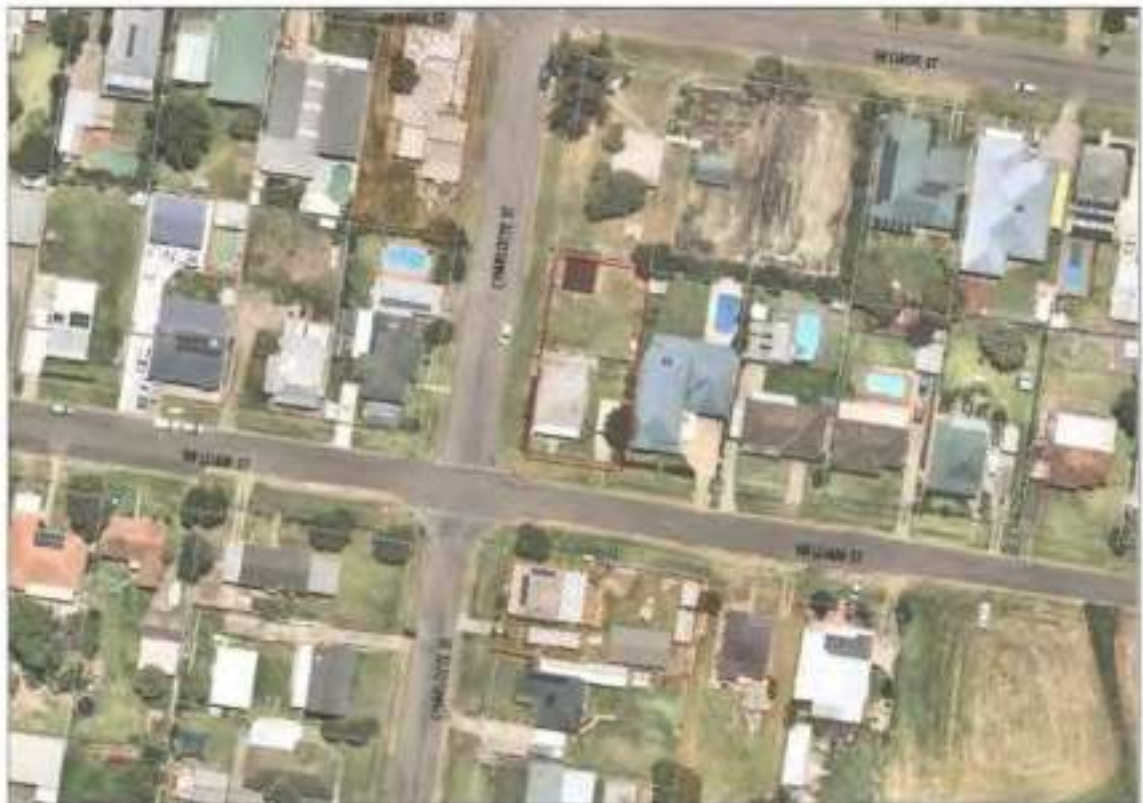
19 WILLIAM STREET, HOLMESVILLE 2286

Conservation Area Contribution Level	Est. Construction Date	Previous studies and/or community input
Contributory 1	1890–1910	No prior heritage investigations and no additional information required
Assessment Text		Observed Modifications
<p>Single storey Vernacular cottage style dwelling with hipped Colourbond roof and weatherboard cladding. The veranda is partially enclosed by an additional constructed room, and ornate metal railing. The veranda has a skillion roof and is supported by square cut timber beams.</p> <p>The front door is centrally located with a fanlight, both with a timber frame. Two double pane sash windows with external timber architraves are visible. One is located on the additional front room, suggesting an early modification. A large multiple window is also found, dominating the façade.</p> <p>Stone or masonry curved entrance stairs lead onto the veranda. A simple brick pillar chimney is visible on the eastern side of the dwelling.</p> <p>A brick and timber picket fence runs the width of the property, with metal entrance gates. Brick pillar foundations have been partially rendered with concrete. A Colourbond sheet garden shed is visible on the eastern side of the dwelling.</p> <p>The dwelling displays architectural features of a heritage style and is representative of the local development of this period, being of historical significance for the HCA.</p>		<p>The additional room at the front veranda portion of the dwelling is a modification, however the continuity of additional heritage styled features, such as the timber sash window, suggests this was a very early modification undertaken following the dwelling's original construction.</p> <p>The metal veranda railing is a modification and does not align with the heritage style of the dwelling.</p> <p>The Colourbond sheet garden shed visible to the easter of the dwelling is not sympathetic to the heritage style of the dwelling.</p>

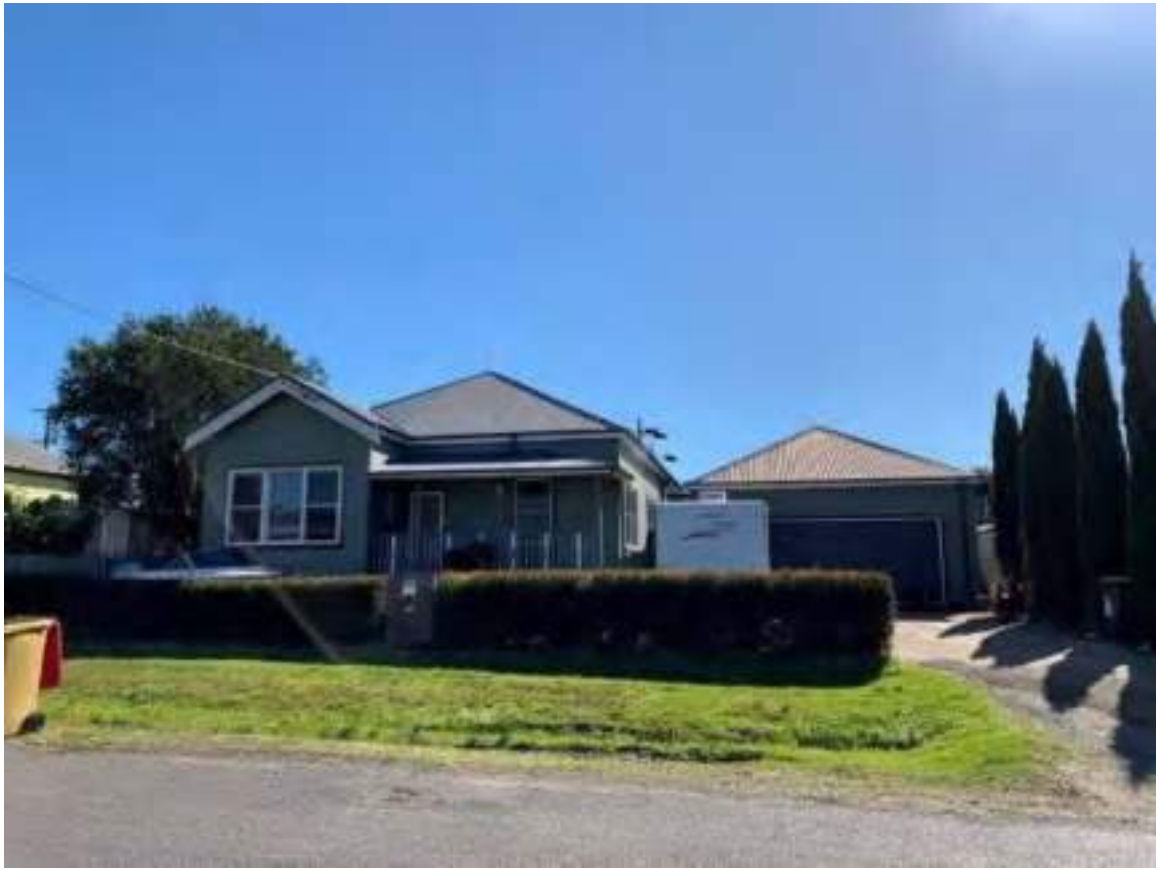
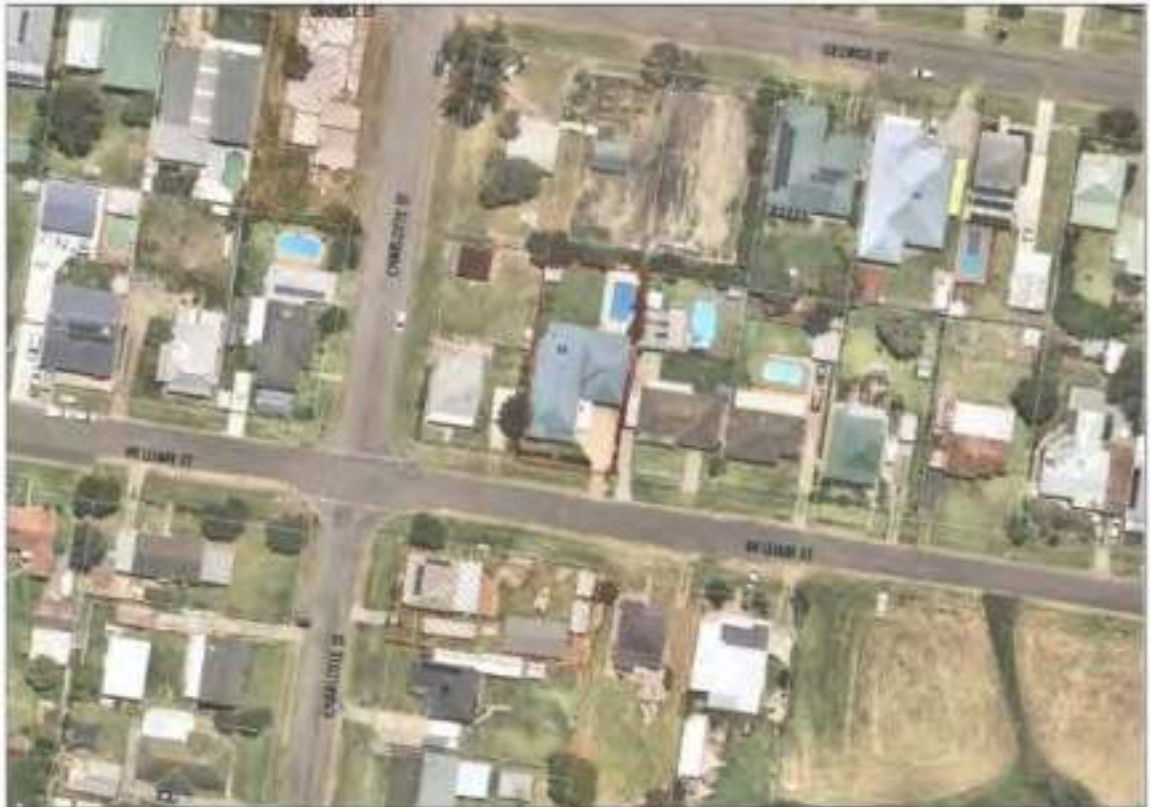
17 WILLIAM STREET, HOLMESVILLE 2286

Conservation Area Contribution Level	Est. Construction Date	Previous studies and/or community input
Contributory 1	1900–1920	No prior heritage investigations and no additional information required
Assessment Text		Observed Modifications
<p>Single storey simple Federation ‘workmen’s cottage’ style dwelling with a double front, weatherboard cladding and Colourbond half hipped and gable roof. The veranda skillion roof is supported by timber columns, with timber balustrade enclosing the space.</p> <p>The front door is centrally located, with timber framing and a metal security screen. Timber framed sash windows are evident at the front and eastern side of the dwelling. A large triple pane timber framed window dominates the façade.</p> <p>The dwelling is supported by brick and concrete foundations, with timber stairs leading onto the veranda.</p> <p>A single door garage has been constructed to the east, in a sympathetic style to the dwelling.</p> <p>The dwelling displays architectural features of a heritage style and is representative of the local development of this period, being of historical significance for the HCA.</p>		<p>The single door garage is a recent addition to the property, however this modification has been constructed in a sympathetic style to the remaining dwelling. as such, it does not detract from the heritage value of the property.</p>

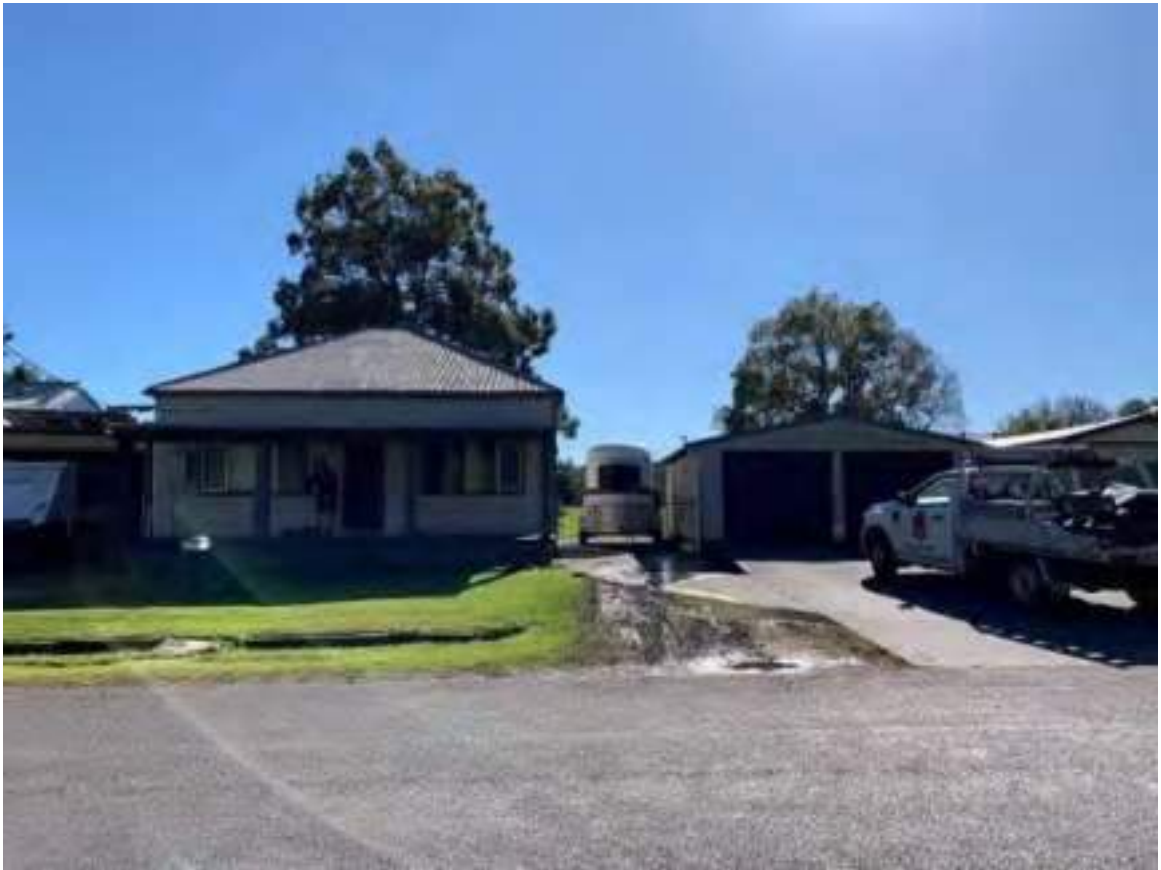
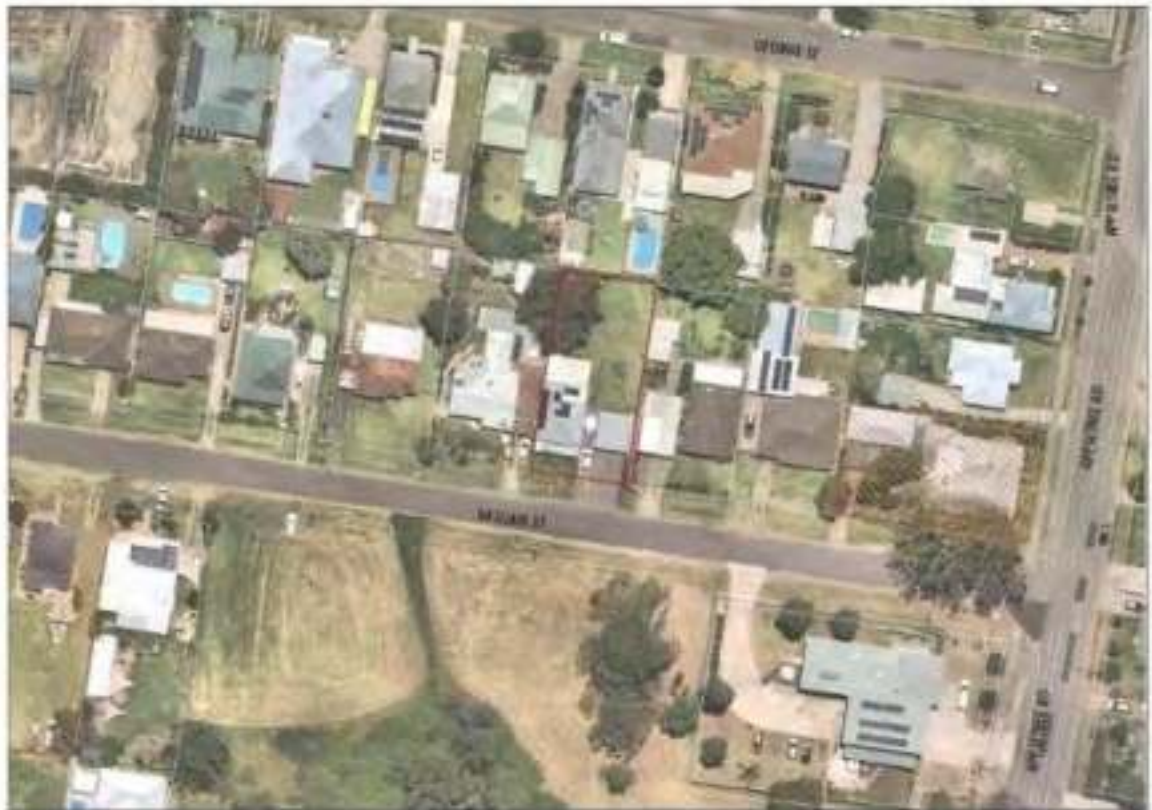
5 WILLIAM STREET, HOLMESVILLE 2286

Conservation Area Contribution Level	Est. Construction Date	Previous studies and/or community input
Contributory 1	1900–1920	No prior heritage investigations and no additional information required
Assessment Text		Observed Modifications
<p>Single storey Vernacular cottage style dwelling with Colourbond hipped roof and weatherboard timber cladding. The veranda has a flat Colourbond roof supported by square brick pillars.</p> <p>The front door is centrally located, being a timber frame with a metal security screen. Triple pane windows are found on either side, also with security screening.</p> <p>The veranda flooring is a masonry styled smooth texture, with brick rendered stairs leading onto the space. The dwelling is supported by rendered brick foundations.</p> <p>A cement driveway is visible from the street, in conjunction with a double door large garage built of weatherboard cladding, and a gabled Colourbond roof.</p> <p>The dwelling displays architectural features of a heritage style and is representative of the local development of this period, being of historical significance for the HCA.</p>		<p>The brick pillars supporting the veranda roof are not sympathetic to the heritage style and are an inappropriate fixture of the dwelling. further the choice of veranda flooring varies from the traditional timber flooring found elsewhere in the area of houses of a similar style.</p> <p>The flat veranda roof would be a replacement of the original bull nose Colourbond roof common to the dwelling style, however this replacement is common.</p> <p>The double door garage located to the east of the dwelling is not consistent with the heritage style of the property, and is highly visible from the street. This negatively impacts the contributory value of the dwelling.</p> <p>The façade windows are of a modern design and are not sympathetic to the heritage style.</p>

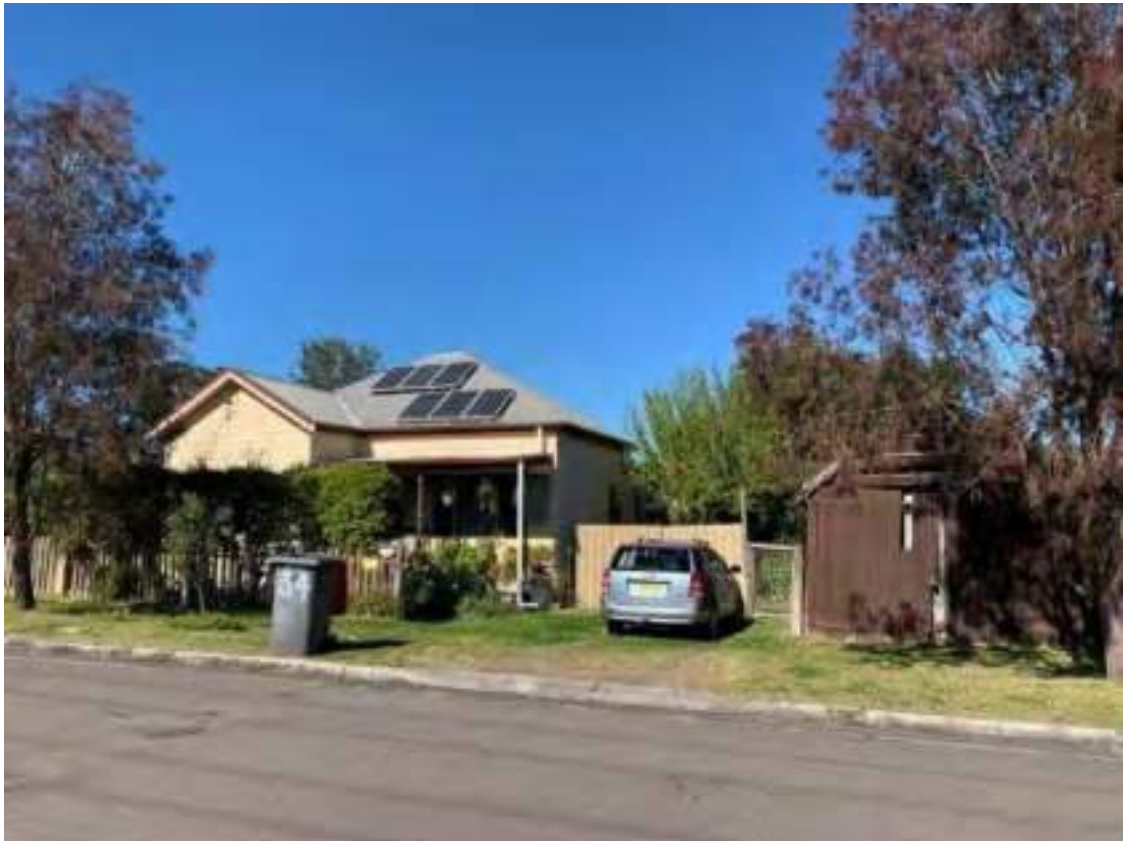
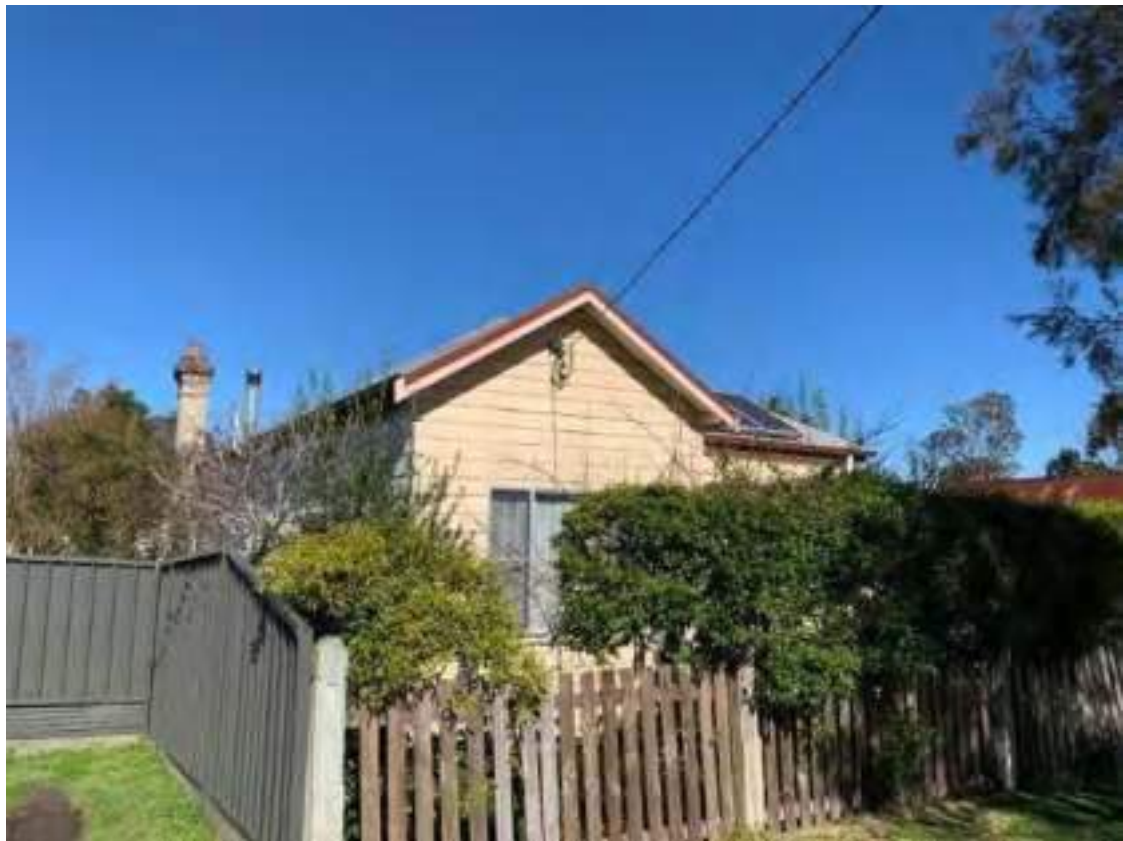
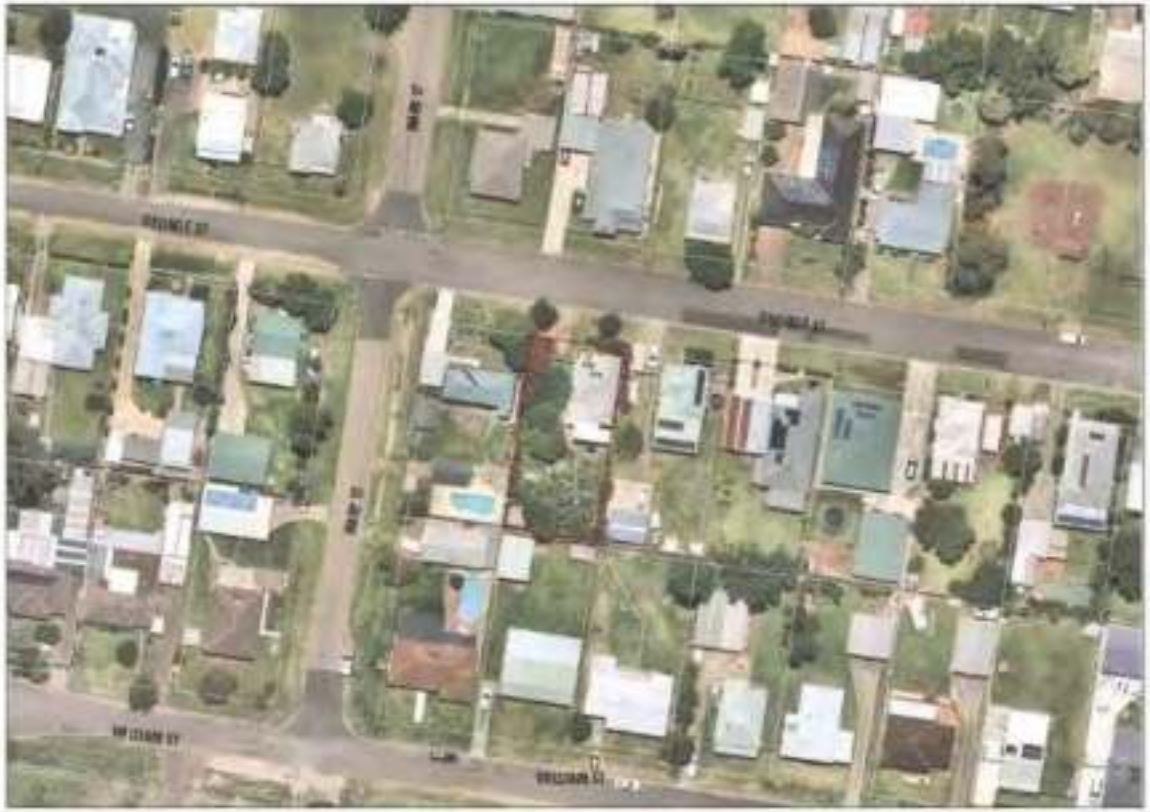
34 GEORGE STREET, HOLMESVILLE 2286

Conservation Area Contribution Level	Est. Construction Date	Previous studies and/or community input
Contributory 1	1900–1915	No prior heritage investigations and no additional information required
Assessment Text		Observed Modifications
<p>Single storey simple Federation ‘workmen’s’ cottage’ style dwelling with half hipped and gable Colourbond roof and timber weatherboard cladding. The hipped portion has visible solar panelling, whilst the gable portion has no visible decorations aside from barge board eaves. The veranda roof is skillion, with timber pillars.</p> <p>The visible northern windows are metal framed and triple panelled picture windows. The front door is centrally located, with a white metal security screen.</p> <p>The veranda has timber flooring, with no balustrades. It is located above ground height, however no stairs are visible.</p> <p>A timber picket fence runs the width of the dwelling, with a dirt driveway.</p> <p>A brickwork chimney is located on the eastern side of the roof, with a terracotta pot and visible corbel.</p> <p>A dark brown garage is located to the west of the dwelling, with timber panelling and gable roof. This is not consistent with the dwellings colour scheme and juxtaposes the heritage style.</p> <p>The dwelling is partially obscured by high vegetation growth.</p> <p>The dwelling displays architectural features of a heritage style and is representative of the local development of this period, being of historical significance for the HCA.</p>		<p>The northern window is a modern style, likely replacing an original timber framed double hung sash design.</p> <p>The solar panels are a modern addition to the dwelling and are highly visible from the street. This is not sympathetic to the heritage style of the property.</p> <p>The garage structure is a modern addition to the dwelling, however the styling suggests it is dated and has likely been a component of the property for decades.</p> <p>A small section of Colourbond fencing stretches from the dwellings western side to the garage, this is a recent modification.</p>

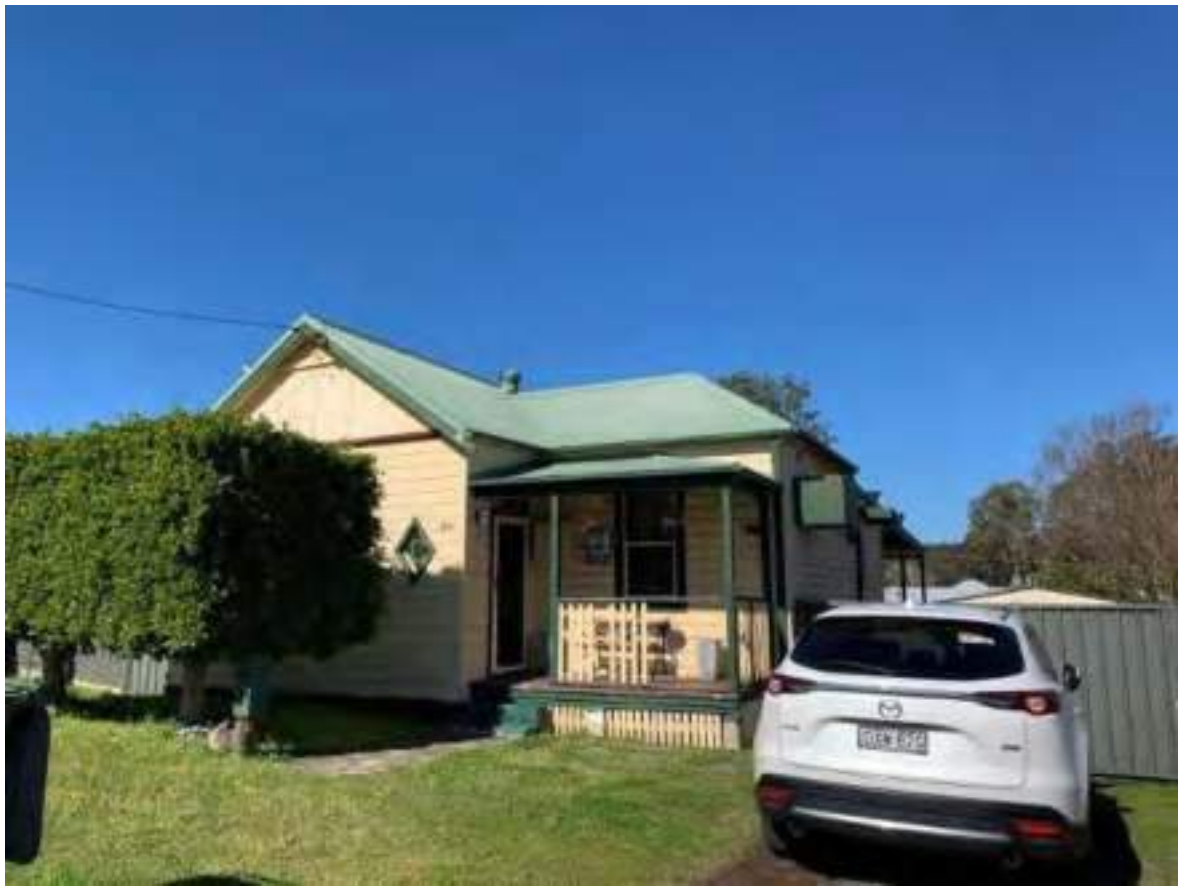
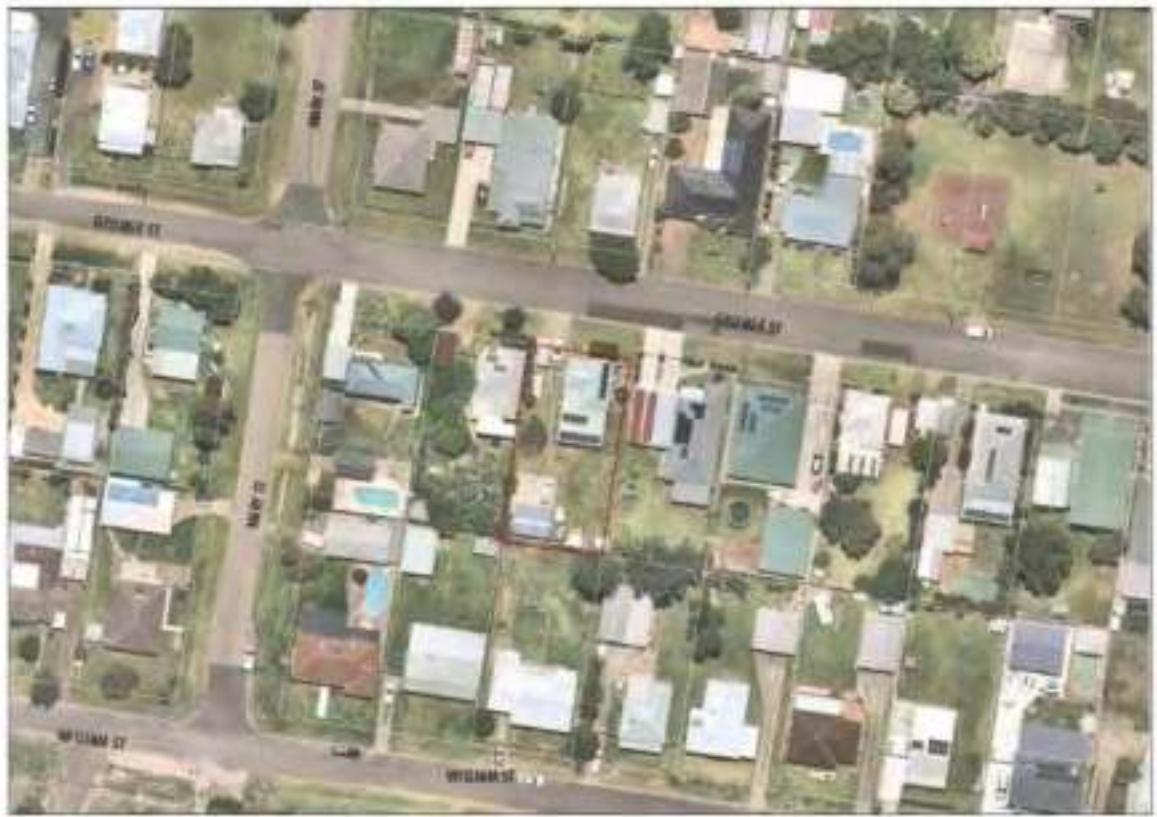
32 GEORGE STREET, HOLMESVILLE 2286

Conservation Area Contribution Level	Est. Construction Date	Previous studies and/or community input
Contributory 1	1900–1915	No prior heritage investigations and no additional information required
Assessment Text		Observed Modifications
<p>Single storey simple Federation ‘workmen’s cottage’ style dwelling with half hipped and gabled Colourbond roof and timber weatherboard cladding. The veranda roof is hipped and supported by square cut timber pillars. Minimal gable battening decoration is visible.</p> <p>The veranda is partially enclosed by timber balustrade, however sections are missing. The flooring is timber. Rendered concrete stairs lead onto the veranda landing, with no railing.</p> <p>The front door is located facing westwards, with a timber frame and metal security screen. A single double hung sash window is located within the veranda alcove. A small diamond shaped window, with stain glass decoration is visible on the front façade.</p> <p>Timber picket panels screen the under house cavity, with visible concrete foundational supports.</p> <p>A double door garage is located to the south of the dwelling, at the back of the property. The structure is built of Colourbond panels and a Colourbond gable roof.</p> <p>The dwelling displays architectural features of a heritage style and is representative of the local development of this period, being of historical significance for the HCA.</p>		<p>The front door is located facing a westward direction, which is uncommon for the dwelling style. Traditionally the front door would be centrally located, facing directly towards the street. This is a potential modification, or design change.</p> <p>The balustrade enclosing the veranda space is likely a later addition, in terms of the timber styling. It is possible a more ornately designed balustrade was built prior.</p>
