APPENDIX 2

Building Assessment Sheets (Inventory Sheets)

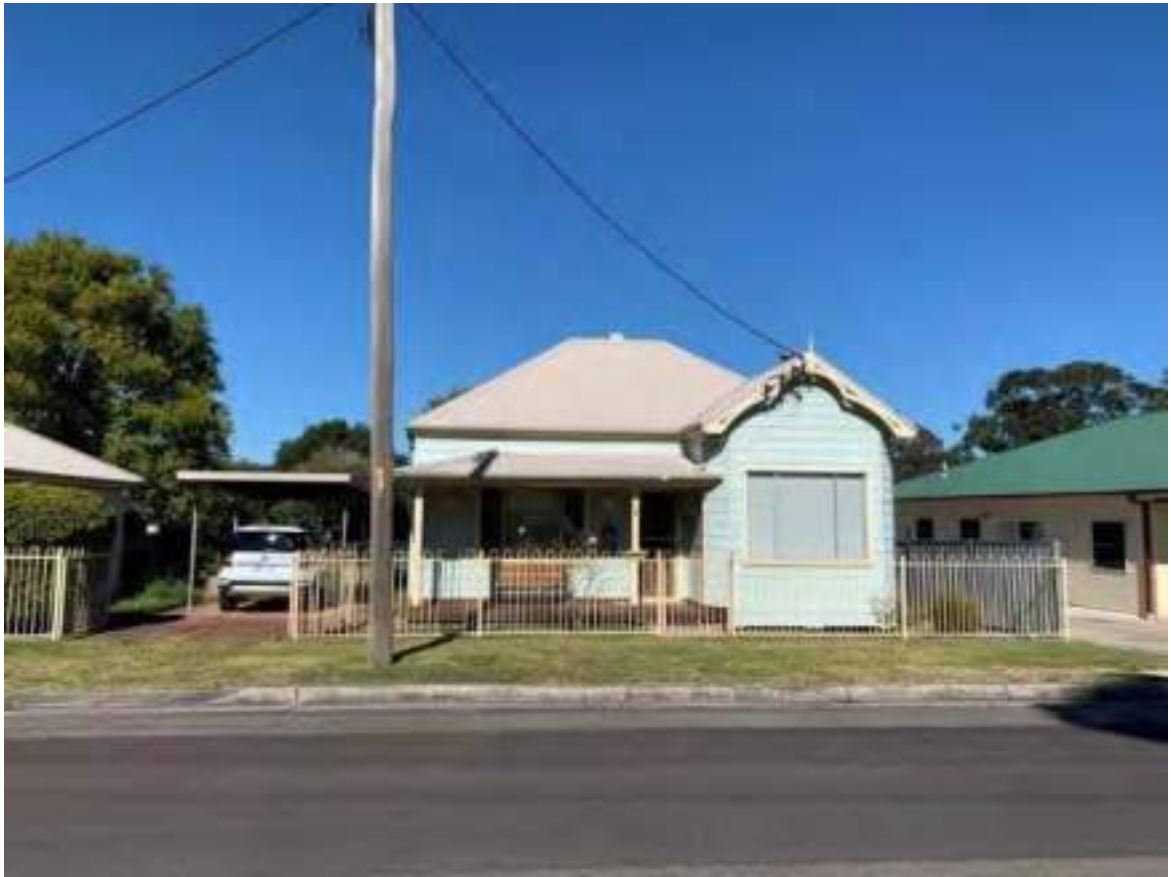
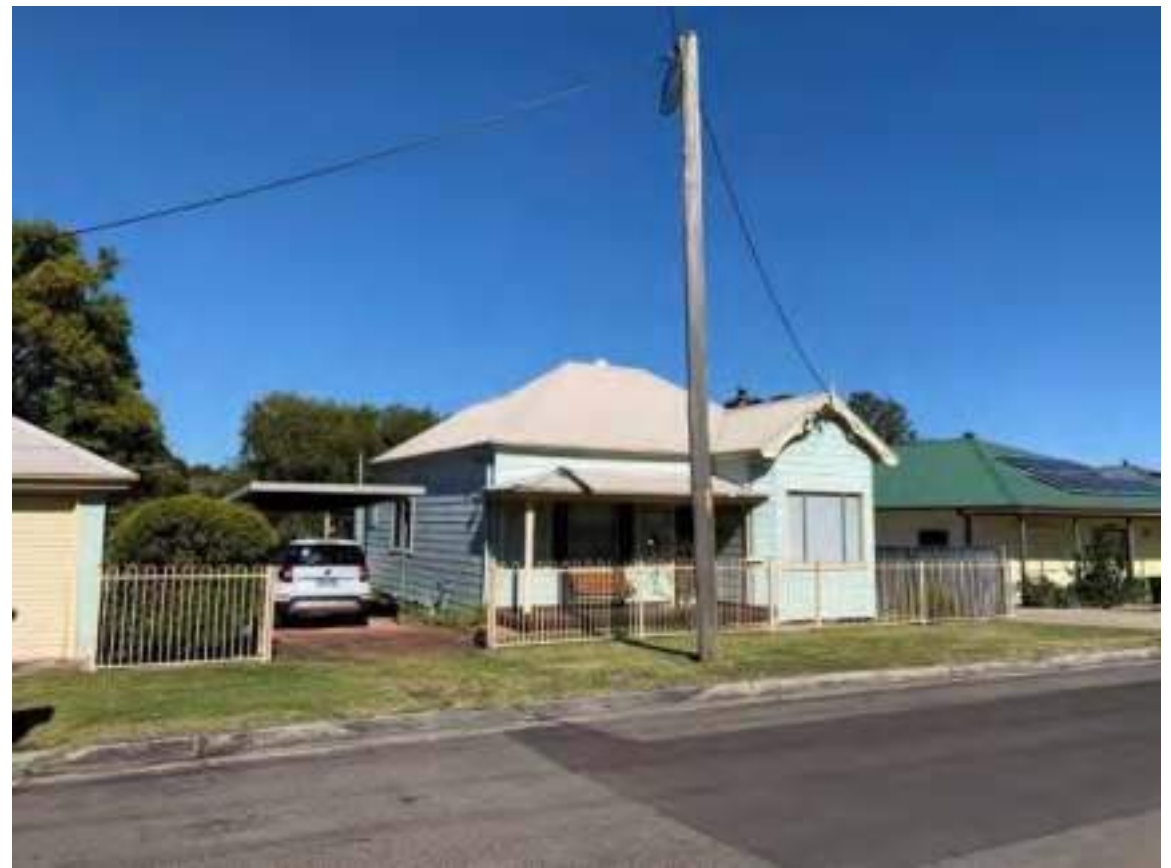
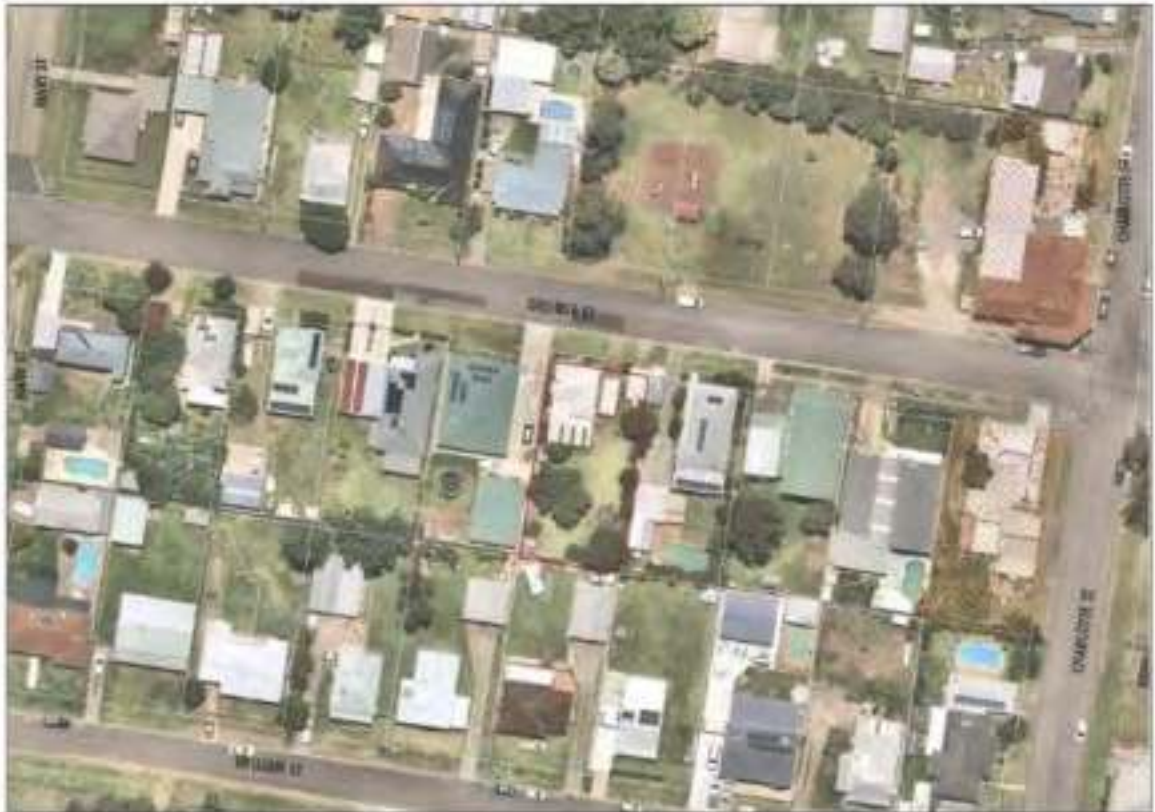
26 GEORGE STREET, HOLMESVILLE 2286

Conservation Area Contribution Level	Est. Construction Date	Previous studies and/or community input
Contributory 1	1900–1920	No prior heritage investigations and no additional information required
Assessment Text		Observed Modifications
<p>Single storey simple Federation ‘workmen’s cottage’ style dwelling with half hipped and gable Colourbond roof and timber weatherboard cladding. The colour scheme is a light aqua, which is otherwise seldomly seen in the area.</p> <p>The veranda roof is hipped with square cut timber support pillars. The veranda is open with timber flooring.</p> <p>The gable roof has visible decorative barge boards and a timber finial.</p> <p>A triple pane picture window dominates the façade, with a small picture window being located within the veranda alcove. The front door is centrally located, facing northwards. The visible door is metal framed with a security screen.</p> <p>A metal modern style fence runs the width of the property, with an entrance gate of the same fence style.</p> <p>The dwelling displays architectural features of a heritage style and is representative of the local development of this period, being of historical significance for the HCA.</p>		<p>The fence fronting the property is a recent addition to the dwelling, being of a modern style. This likely replaced a timber picket fence, or enclosed an otherwise open front yard.</p> <p>The façade picture windows are a recent modification, likely replacing timber framed sash windows. Similarly the addition of a metal security screen overlying the front door has altered to appearance of the dwelling.</p> <p>A car port is located to the east of the dwelling, with a flat roof and support beams.</p>

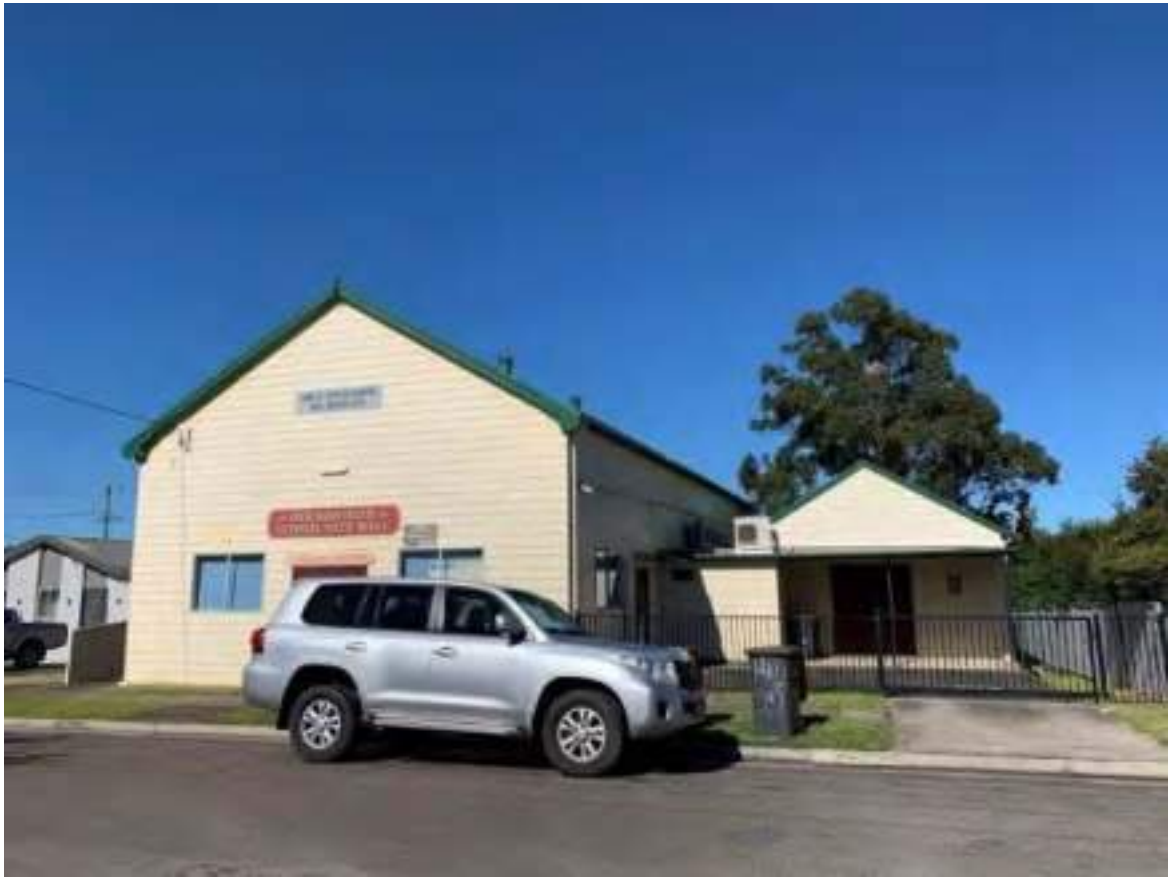
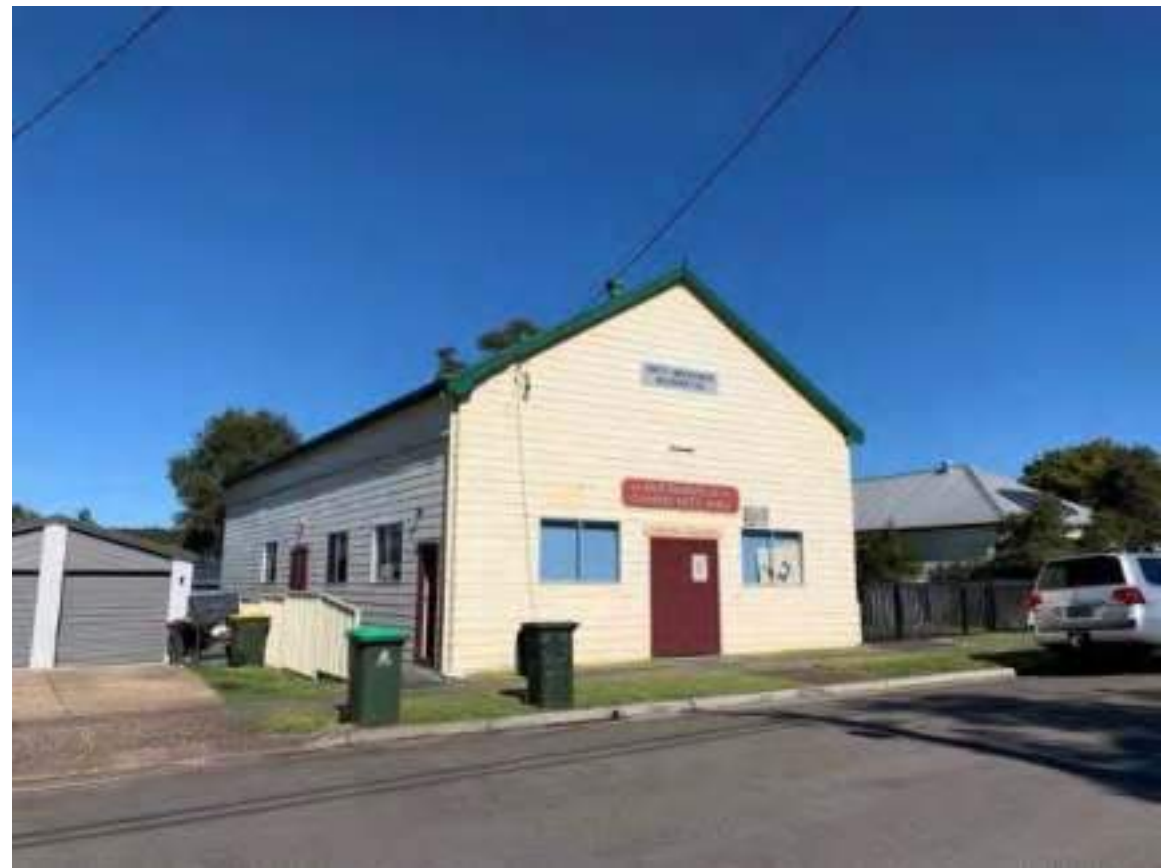
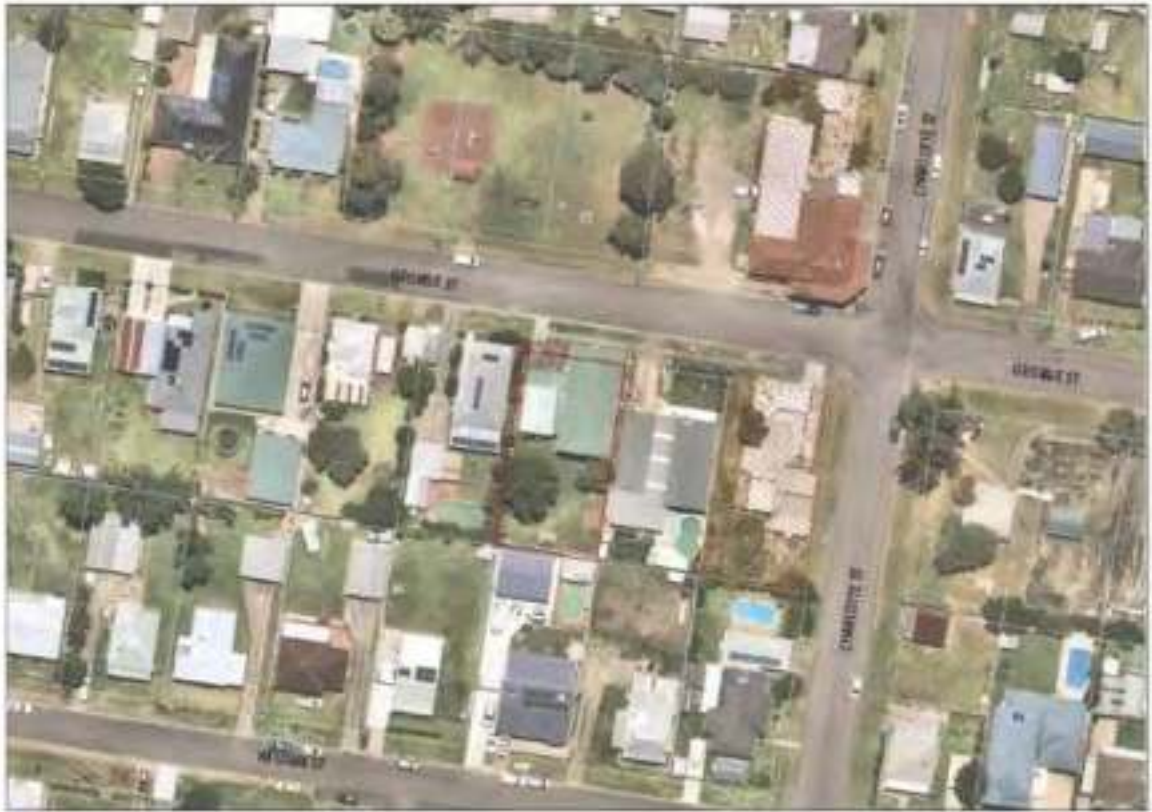
22 GEORGE STREET, HOLMESVILLE 2286

Conservation Area Contribution Level	Est. Construction Date	Previous studies and/or community input
Contributory 1	1901–1925	Holmesville Heritage Assessment Potentially built by William Holmes.
Assessment Text		Observed Modifications
<p>A simple rectangular building with minimal decoration except for a surviving timber finial. The roof is gabled with Colourbond sheets and weatherboard cladding. The gable roof has simple barge board decoration.</p> <p>The visible windows are metal framed and sliding, with the main entrance being timber and double doored.</p> <p>The dwelling displays architectural features of a heritage style and is representative of the local development of this period, being of historical significance for the HCA.</p>		<p>The building has been hardplanked and disproportionate aluminium sliding windows have been installed, likely replacing original timber framed hung/sash windows.</p>

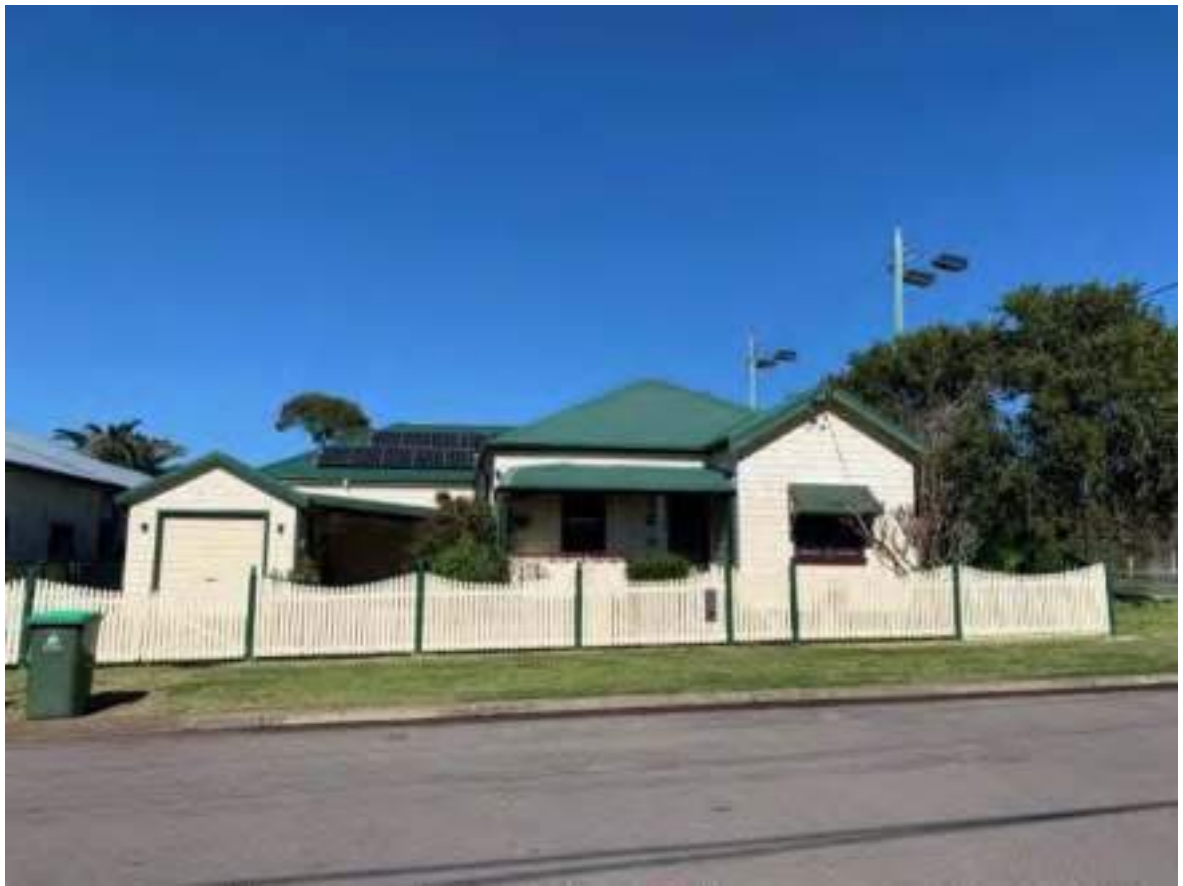
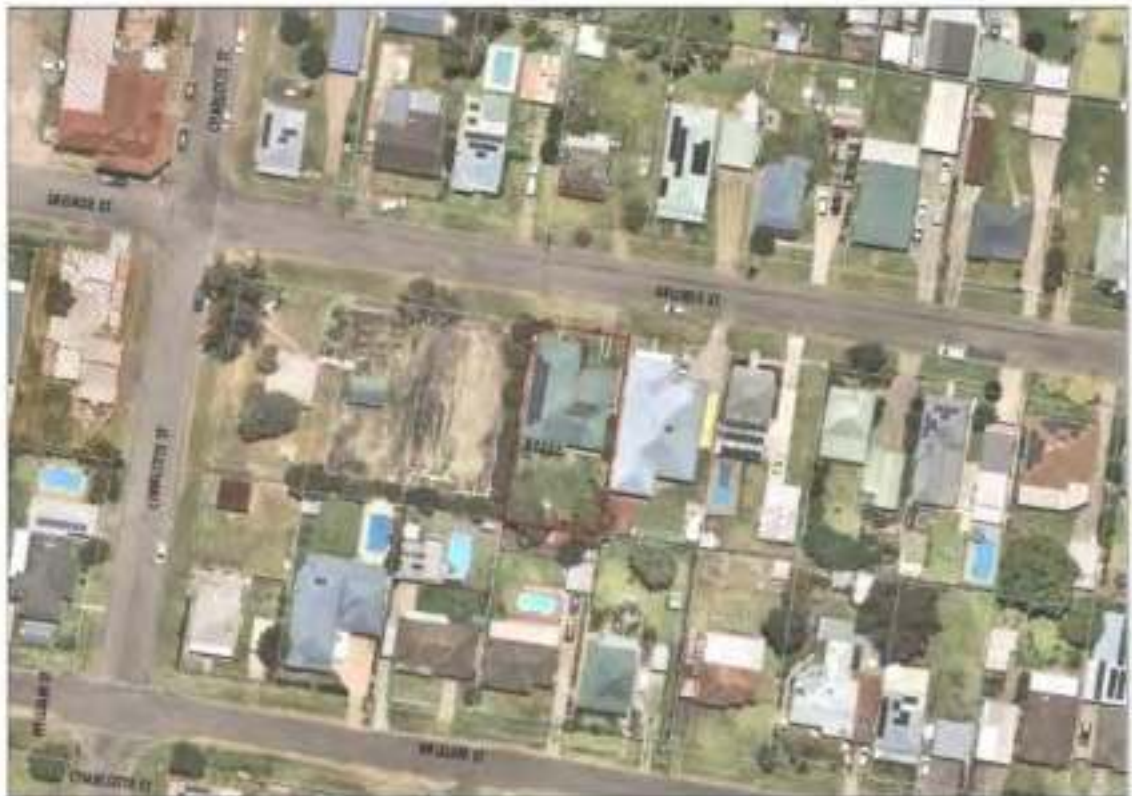
14 GEORGE STREET, HOLMESVILLE 2286

Conservation Area Contribution Level	Est. Construction Date	Previous studies and/or community input
Contributory 1	1900–1915	No prior heritage investigations and no additional information required
Assessment Text		Observed Modifications
<p>Single storey simple Federation ‘workmen’s cottage’ style dwelling with half hipped and gable Colourbond roof and timber weatherboard cladding. The veranda roof is bull nose Colourbond, with square cut timber support pillars.</p> <p>The gable roof has no decoration.</p> <p>The veranda is partially enclosed by ornate metal balustrade, with timber flooring and rendered concrete stairs.</p> <p>The front door is centrally located, with a four-panel design with two panels of glass inlaid. A metal security screen is visible. A single pane hung sash window is located to the east of the door, with a double pane hung sash window to the west. A timber shingle awning overhangs the secondary widow, with timber brackets of minimal decoration.</p> <p>A single door garage is location to the east of the dwelling, with a skillion roofed outdoors area connecting the two. The garage is to a similar style to the dwelling and is sympathetic to the heritage style.</p> <p>A timber picket fence in the same white and green colour scheme as the dwelling encloses the property.</p> <p>The dwelling displays architectural features of a heritage style and is representative of the local development of this period, being of historical significance for the HCA.</p>		<p>Solar panels have been installed on the street facing portion of roof, being highly visible and juxtaposing the historical nature of the property.</p> <p>The metal balustrade enclosing the veranda is a modern addition to the dwelling, and although also in a heritage style is not appropriate for the age of the dwelling.</p> <p>The garage and outdoor area are recent additions to the dwelling, however their sympathetic construction does not detract from the heritage values of the property and does not impact the contributory value of the dwelling.</p>

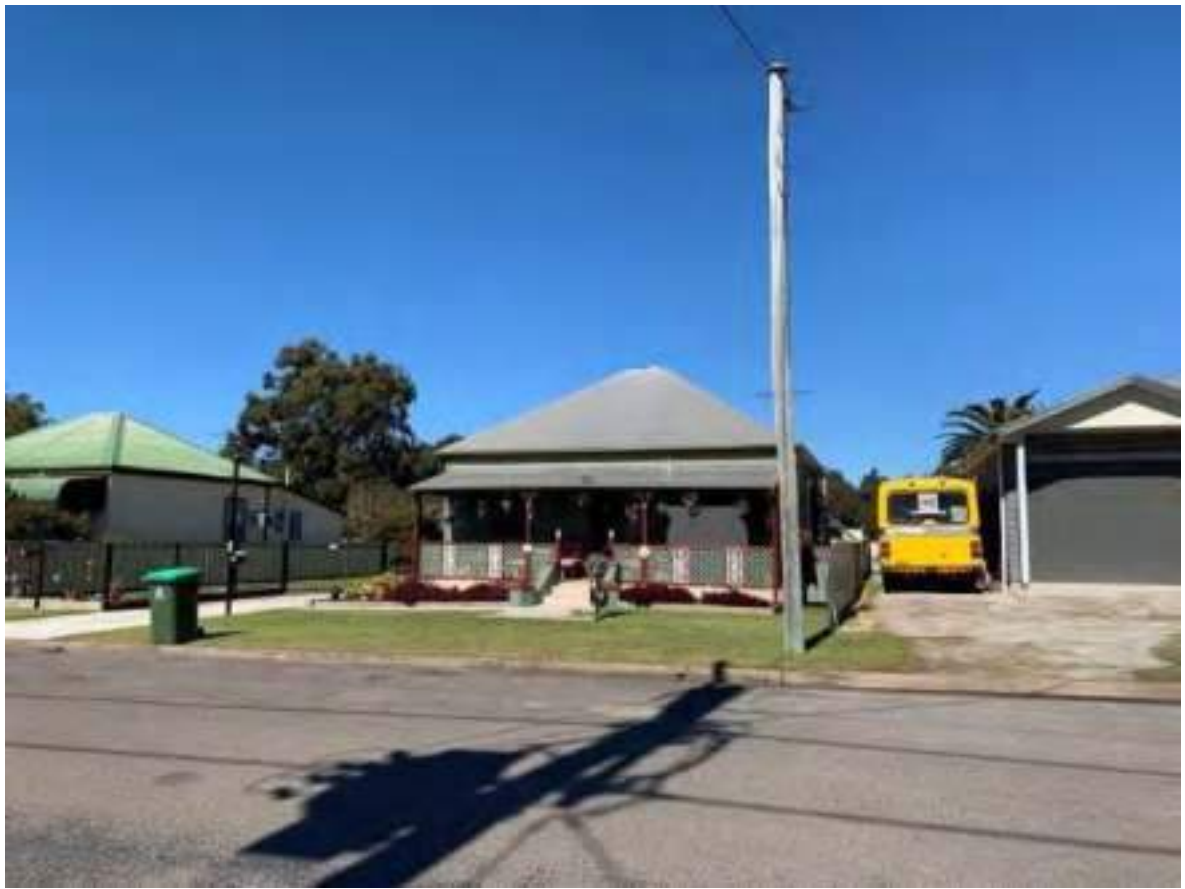
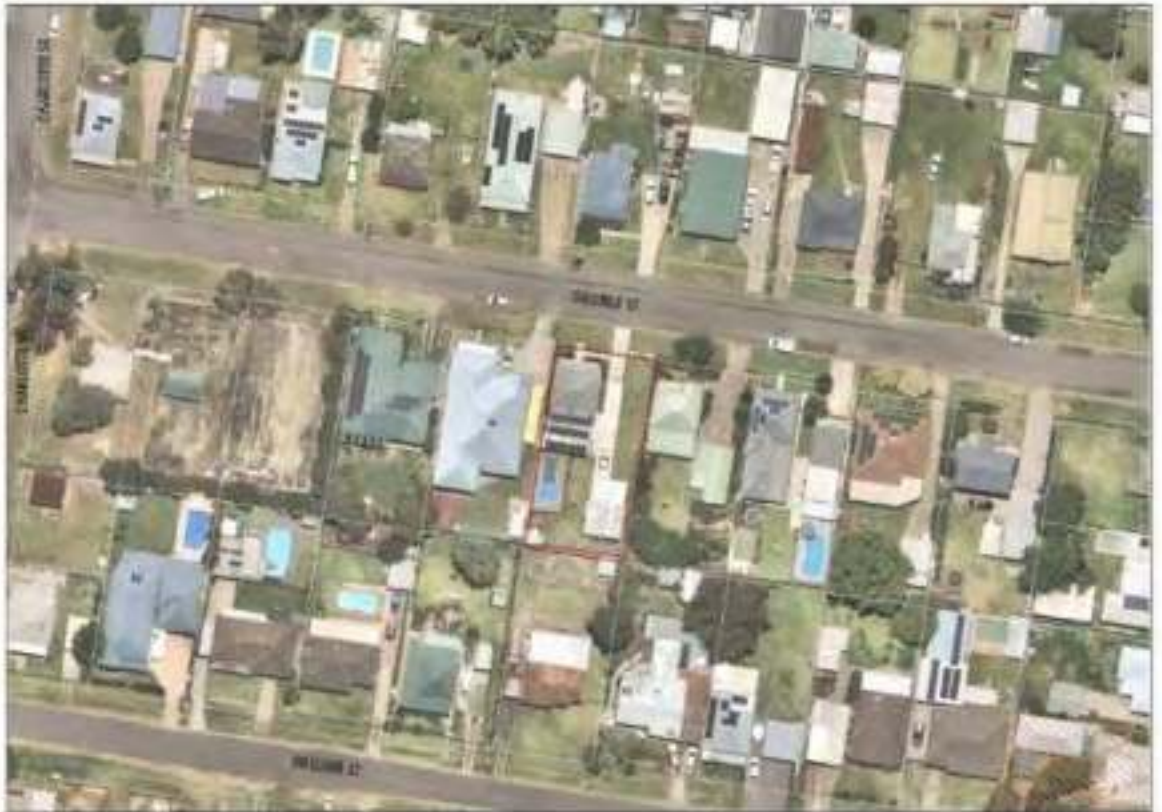
10 GEORGE STREET, HOLMESVILLE 2286

Conservation Area Contribution Level	Est. Construction Date	Previous studies and/or community input
Contributory 1	1890–1915	No prior heritage investigations and no additional information required
Assessment Text		Observed Modifications
<p>Single storey Vernacular ‘Mining Cottage’ style dwelling with hipped Colourbond roof and timber weatherboard cladding. The veranda roof is skillion Colourbond, with square cut timber support pillars. The pillars have metal fretted brackets.</p> <p>The veranda space is enclosed by timber latticing, with intermittent ornate metal panels. The veranda floor is tiled, with rendered stairs, step walls and piers. A single metal support beam is located on the western side of the stairs.</p> <p>The front door is centrally located, with a timber frame and metal security screen. Double panel sliding windows are located on either side, with metal framing.</p> <p>Visible windows on the eastern side of the dwelling are also sliding double panel windows, with metal awnings overhead.</p> <p>A concrete driveway is located on the eastern side of the dwelling, with a further concrete pathway found immediately in front of the veranda space.</p> <p>A gothic styled metal fence encloses the open yard spaces, juxtaposing with the remaining fencing features of the dwelling.</p> <p>The dwelling displays architectural features of a heritage style and is representative of the local development of this period, being of historical significance for the HCA.</p>		<p>The metal support beam adjacent to the entrance stairs is a recent modification to the façade. This is the only silver metal feature visible on the house and is not an appropriate choice of railing.</p> <p>The latticing enclosing the veranda space, as well as the fretted brackets, metal decorative features, tiled veranda floor, tiled stairs and stair walls and piers are likely all modifications. Such decorative ornate features are not common for the style.</p> <p>The metal gothic fencing enclosing the side yard is a modification, and unsympathetic in style.</p> <p>A car port and garage is located at the back southern end of the property, however this is set far back and is constructed in the same colour scheme as the dwelling.</p>

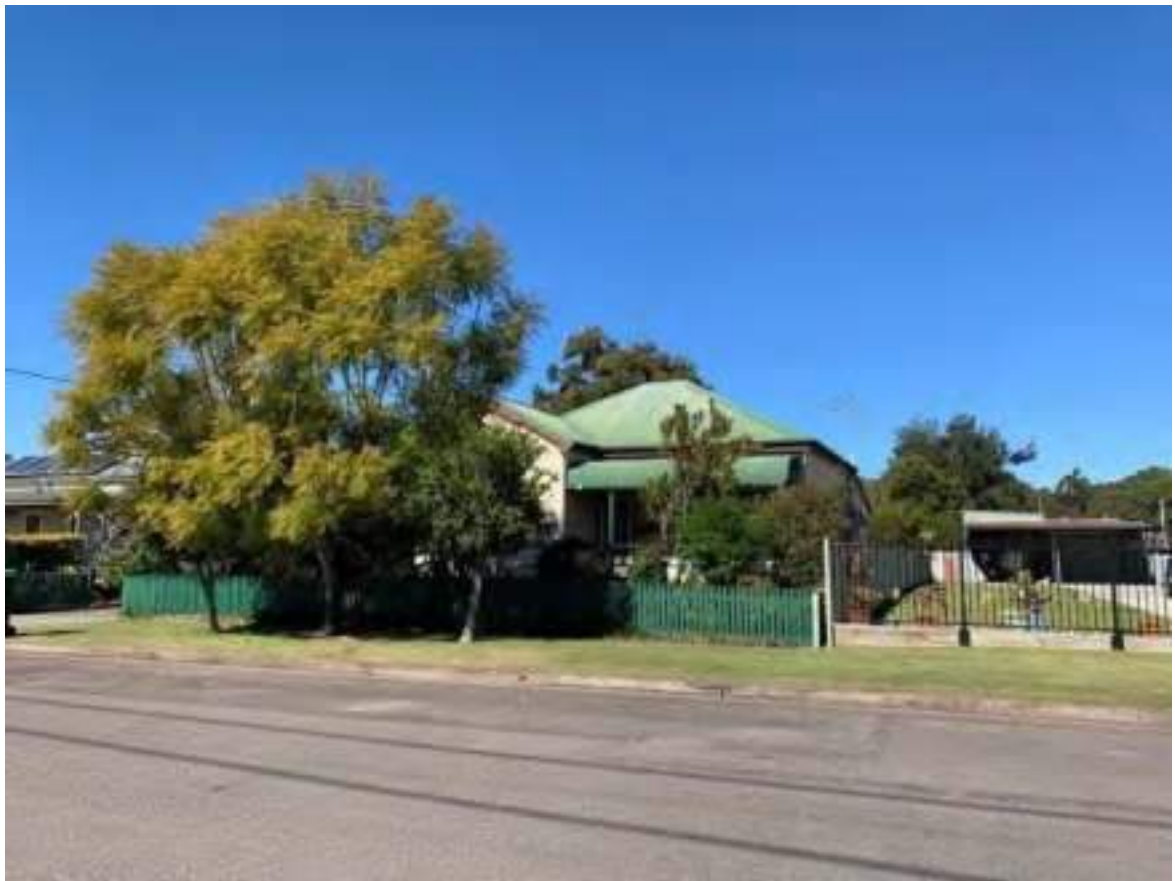
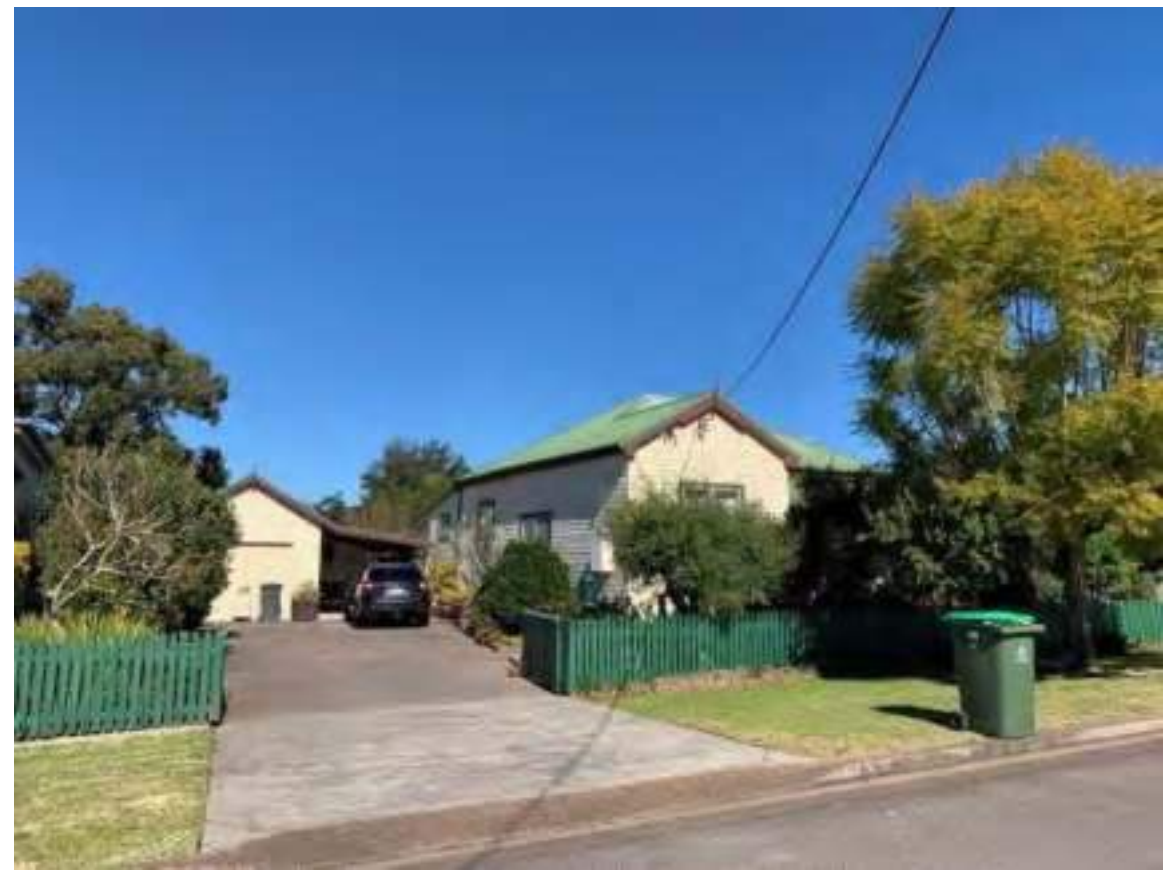
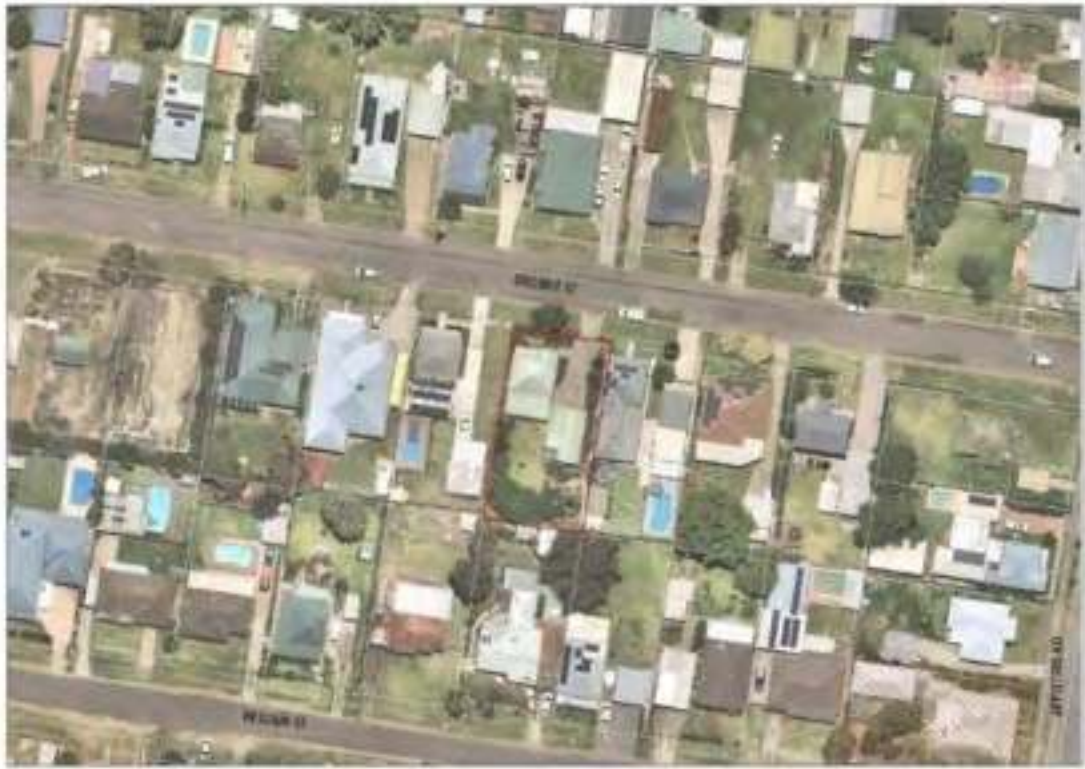
8 GEORGE STREET, HOLMESVILLE 2286

Conservation Area Contribution Level	Est. Construction Date	Previous studies and/or community input
Contributory 1	1900–1915	No prior heritage investigations and no additional information required
Assessment Text		Observed Modifications
<p>Single storey simple Federation ‘workmen’s cottage’ style dwelling with half hipped and gable Colourbond roof and timber weatherboard cladding. The veranda roof is bull nose Colourbond, with timber picket features on the western side.</p> <p>The gable roof has minimal decoration, with a timber finial and barge board detailing.</p> <p>The veranda is partially enclosed by timber railing, with square cut timber posts.</p> <p>The north facing front window is a timber framed sliding design, with half panels of metal security screening. A similar window is visible to the west of the front door, within the veranda alcove. The front door is centrally located, with a metal security screen.</p> <p>A small inlaid name plate is located adjacent to the front door, with the “-8 Bel-” visible.</p> <p>A green timber picket fence runs the width of the property, in a similar colour scheme to the Colourbond roofing.</p> <p>The façade of the dwelling is highly obscured due to extensive vegetation growth.</p> <p>A wide concrete driveway leads to a gable roof secondary residential and garage structure. This has been constructed with similar materials as to the dwelling and has been constructed in a sympathetic style</p> <p>The dwelling displays architectural features of a heritage style and is representative of the local development of this period, being of historical significance for the HCA.</p>		<p>The security screens overlaying the façade windows and front door is visible from the street and contrasts with the timber features otherwise found across the dwelling.</p> <p>The concrete driveway is unsympathetic to the heritage style.</p> <p>The secondary residential/garage structure located to the south east of the dwelling is a recent modification, however is constructed in a similar style.</p>

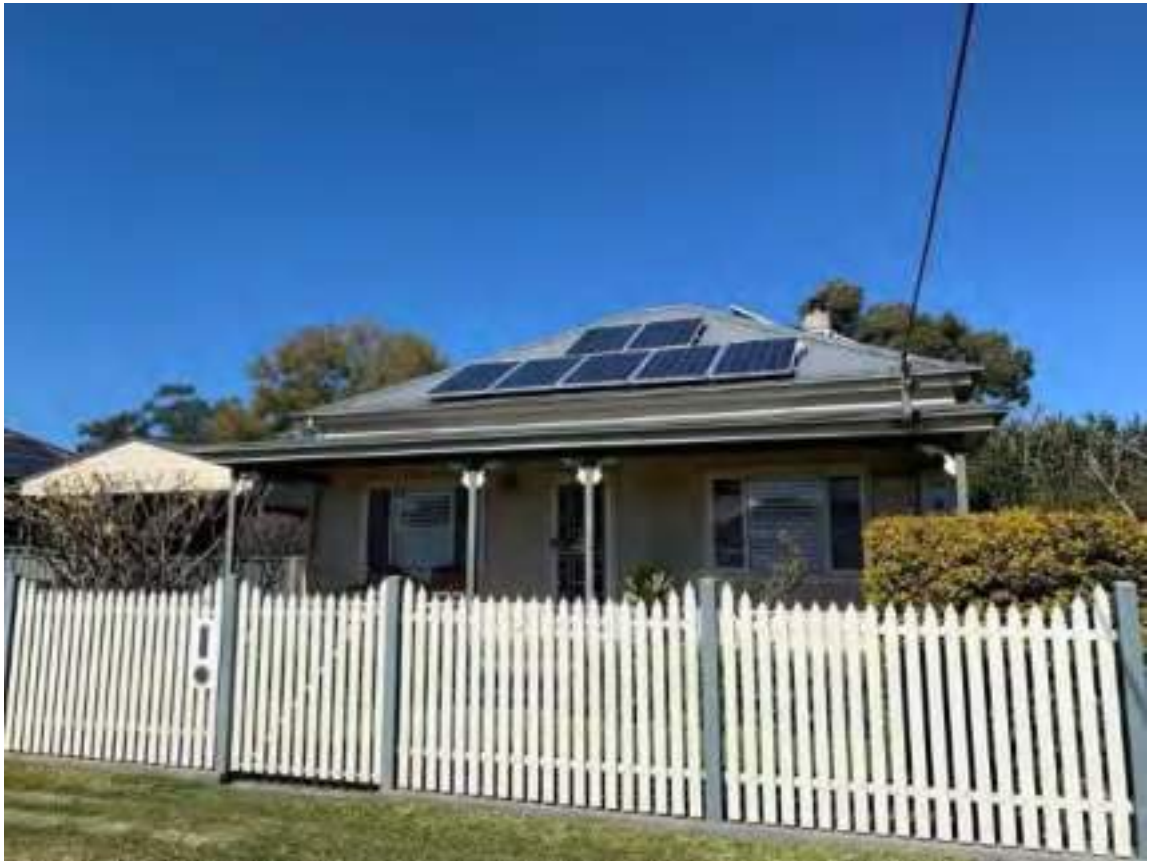
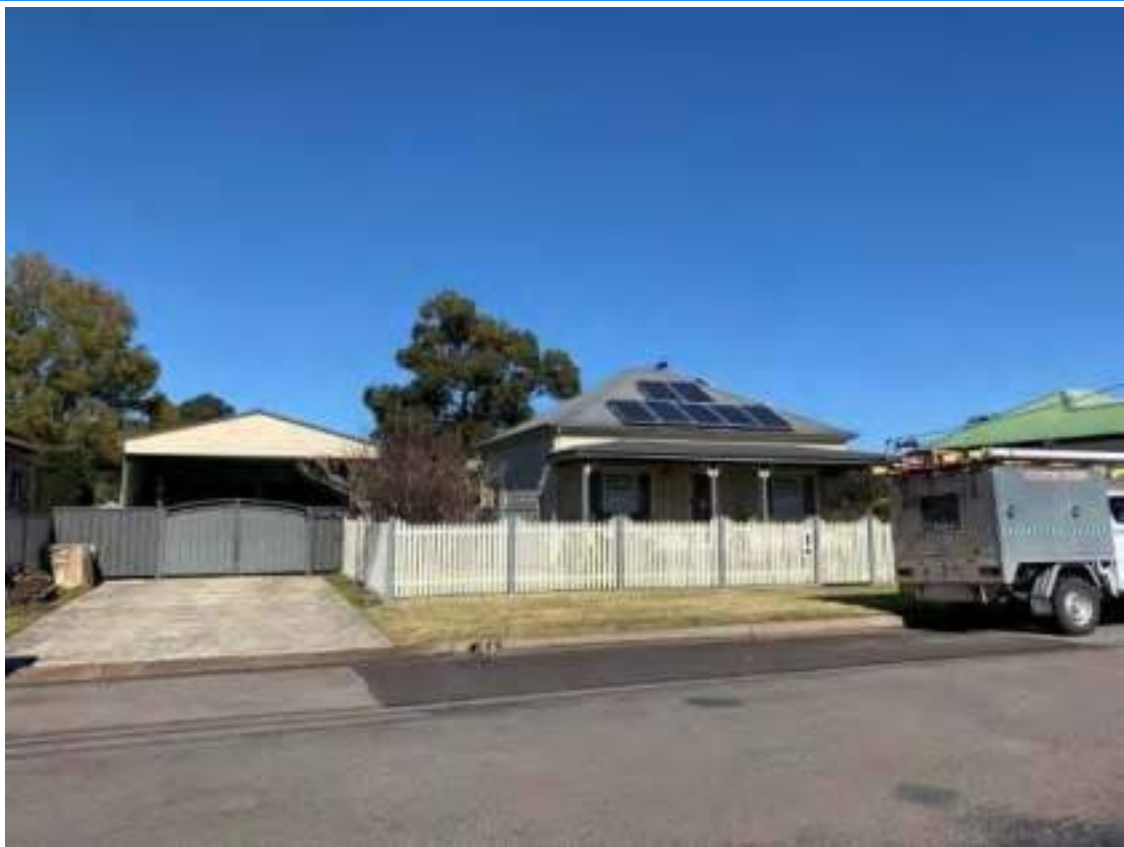
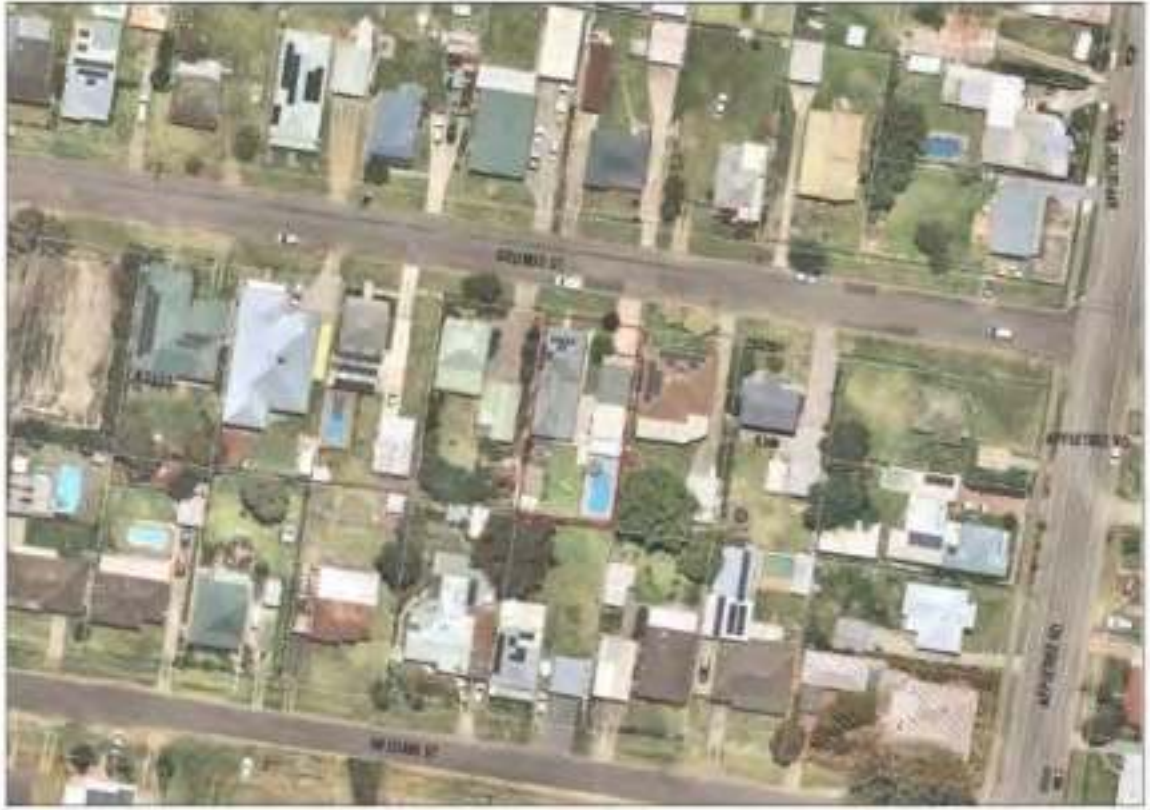
6 GEORGE STREET, HOLMESVILLE 2286

Conservation Area Contribution Level	Est. Construction Date	Previous studies and/or community input
Contributory 1	1910–1940	No prior heritage investigations and no additional information required
Assessment Text		Observed Modifications
<p>Single storey simple vernacular cottage style dwelling with Colourbond hipped roof and weatherboard cladding. The veranda roof is hipped and supported by square cut timber pillars. Simple timber ornate brackets are found either side of the pillars.</p> <p>The front door is centrally located with a timber frame and metal security screen with ornate detailing. Picture style timber windows are located either side of the door, likely sliding.</p> <p>The veranda floor is timber, with no balustrades or railing enclosing the space.</p> <p>A brickwork chimney with double corbel is located on the western portion of the roof, with a pot and lid on top.</p> <p>A white timber picket fence encloses the front yard, with a matching entry gate. A concrete driveway leads to a Colourbond double gate and gable roofed outdoor area and associated garage structure.</p> <p>The dwelling displays architectural features of a heritage style and is representative of the local development of this period, being of historical significance for the HCA.</p>		<p>Solar panels are highly visible, facing the street fronting northern portion of the roof. Further panels are partially visible on the western side of the roof.</p> <p>An extension has been constructed on the back southern portion of the dwelling, however is not visible front he street front.</p> <p>The outdoor space and garage structure are additions to the property, and have been constructed in a sympathetic manner.</p> <p>The façade windows are modern modifications, likely replacing the original timber sash windows common to the style. However due to the later construction date, this may differ.</p>

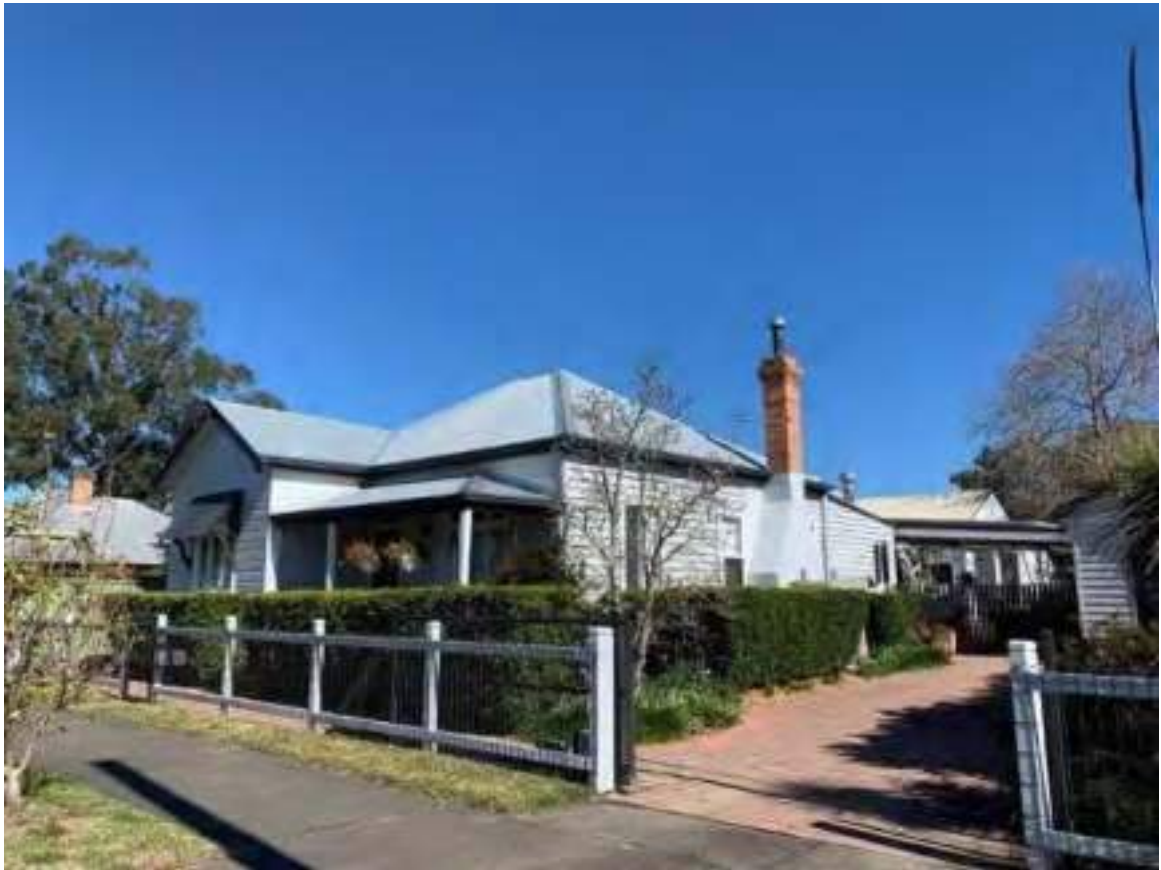
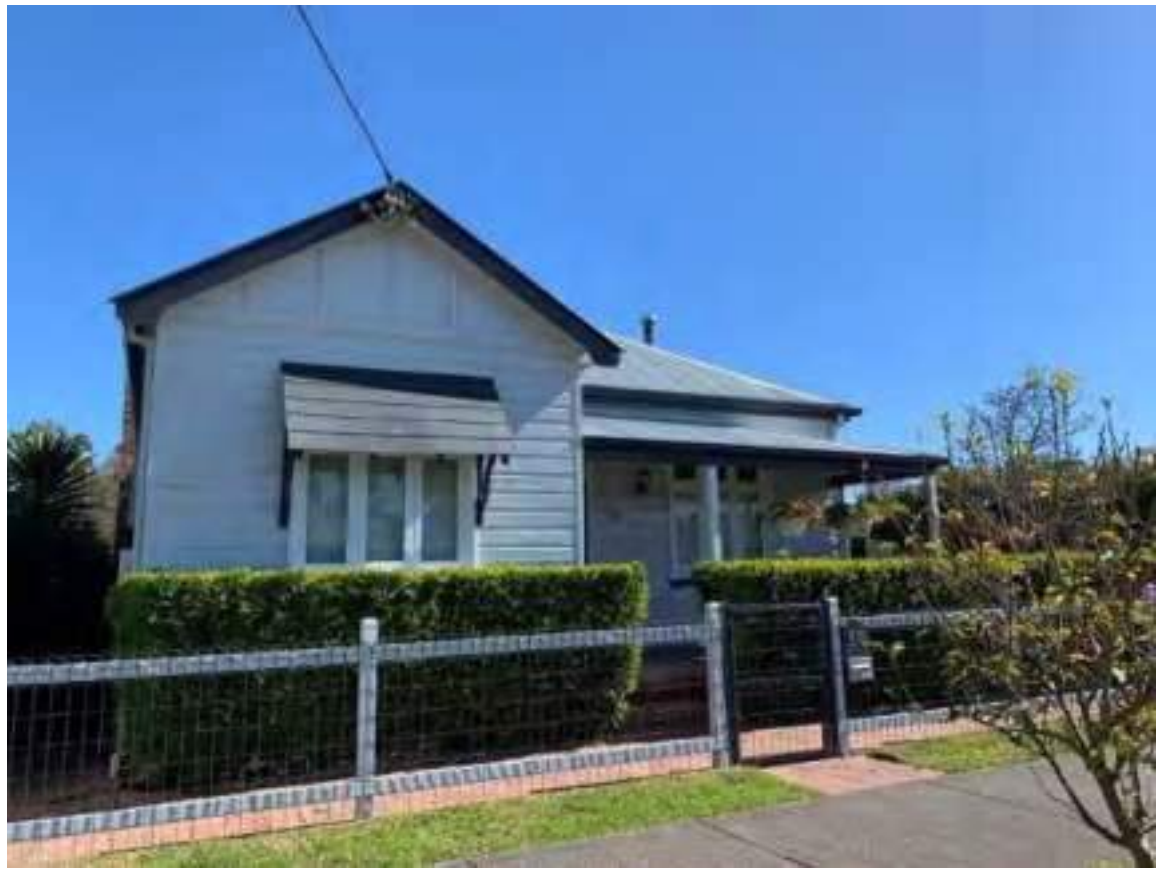
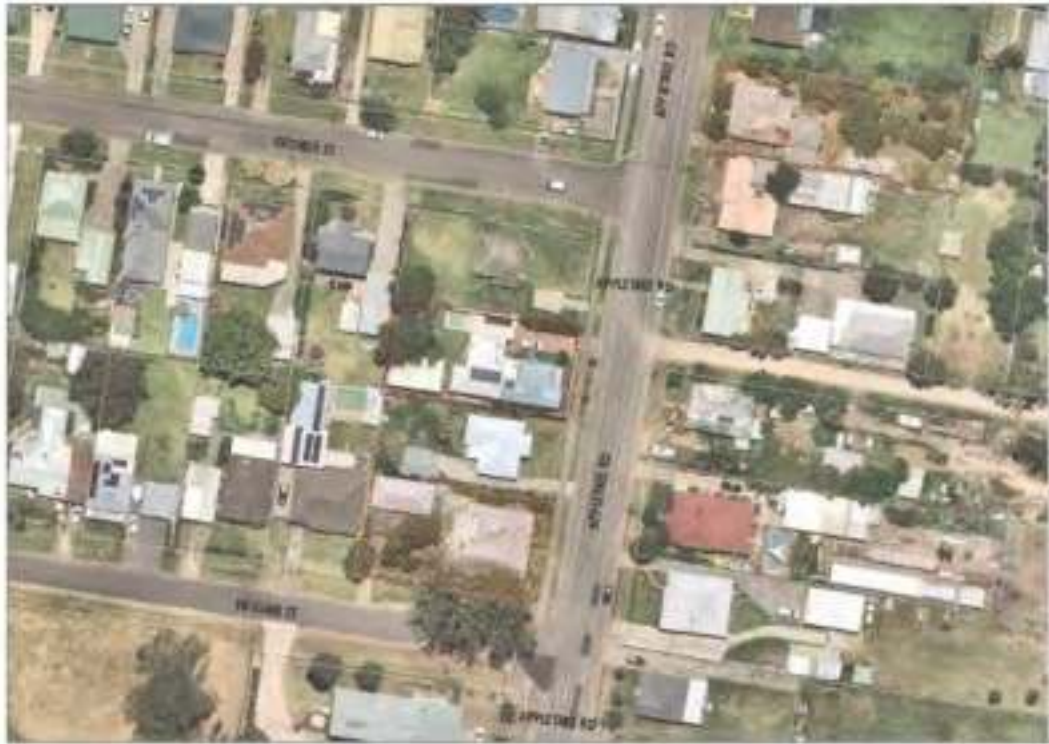
50 APPLETREE ROAD, HOLMESVILLE 2286

Conservation Area Contribution Level	Est. Construction Date	Previous studies and/or community input
Contributory 1	1915–1920	Holmesville Heritage Study 1993. Significant for level of intactness and possible connection to the founding Holmes family.
Assessment Text		Observed Modifications
<p>Single storey simple Federation ‘workmen’s cottage’ style dwelling with a half gable and hipped Colourbond roof and timber weatherboard cladding. The veranda roof is hipped Colourbond and supported by square cut timber posts. The veranda is open with no balustrades, and timber floored.</p> <p>The gable roof has simple battening and barge boards details, however no other decorative features.</p> <p>A large triple pane casement window with timber framing. A timber shingle awning lies overhead, with art nouveau style timber brackets. The same window style is located within the veranda. The front door is centrally located and is a metal framed screen door. A timber framed door is likely behind, however is not currently visible. The windows on the northern side of the dwelling are also timber framed, but single pane sash designs.</p> <p>A brickwork chimney with variegated brick colouration is located on the northern side of the dwelling.</p> <p>A timber and metal fence runs the width of the front yard, enclosing the space. The driveway is located to the north of the dwelling and is comprised of bricks. This carries over to a brick path extending from the driveway to the front portion of the dwelling, to the brick stairs leading upwards to the veranda landing.</p> <p>A single door garage is located to the north west of the dwelling, with a gable Colourbond roof and weatherboard cladding.</p> <p>The dwelling displays architectural features of a heritage style and is representative of the local development of this period, being of historical significance for the HCA.</p>		<p>The garage is an addition to the property, however it has been constructed with the same colour scheme of blue and white, as well as similar materials and design. As such it is sympathetic to the heritage nature of the dwelling.</p> <p>Adjacent to the garage is a skillion roof outdoor area, which would be a modern addition, however similarly this does not detract as it is set far back and is similar in style.</p> <p>A larger additional residential structure has been constructed in the backyard to the west of the dwelling. similarly, this has been constructed in a similar style to the main dwelling and is not visible from the street.</p>
