APPENDIX 2

Building Assessment Sheets (Inventory Sheets)

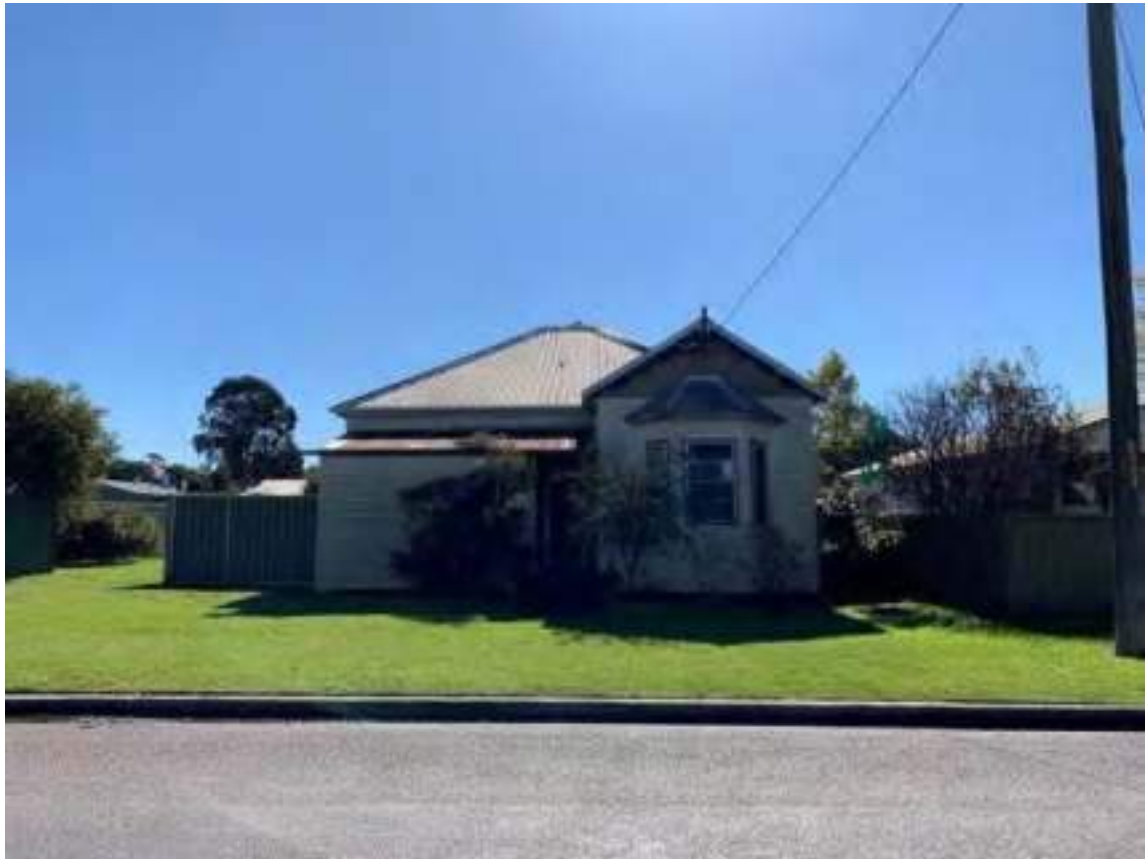
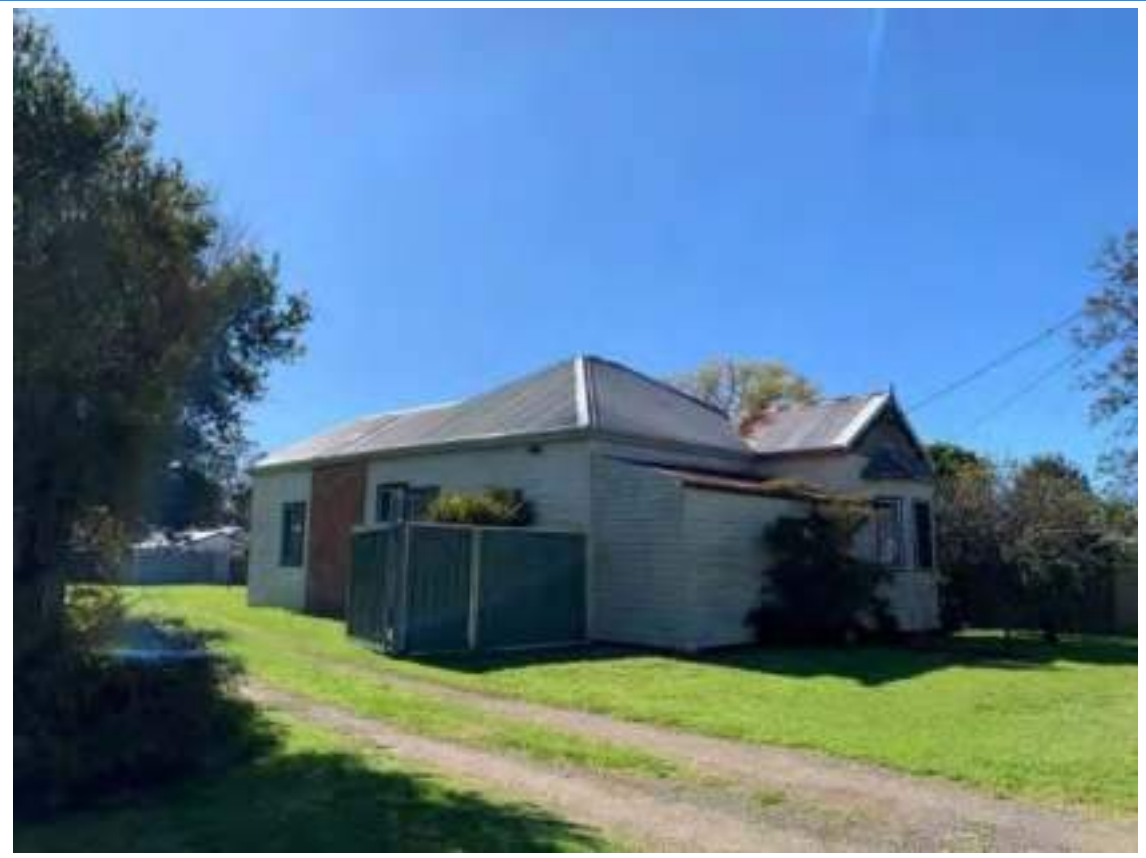
3 GEORGE STREET, HOLMESVILLE 2286

Conservation Area Contribution Level	Est. Construction Date	Previous studies and/or community input
Contributory 1	1900–1920	No prior heritage investigations and no additional information required
Assessment Text		Observed Modifications
<p>Single storey simple Federation ‘workmen’s cottage’ style dwelling with a half gable and hipped Colourbond roof and timber weatherboard cladding. The veranda roof is skillion, with the veranda itself being fully enclosed through the addition of a front extension.</p> <p>The front door is centrally located within an alcove space, with a timber frame and metal security screen. A modern sliding metal framed window is found street facing from the veranda extension. A triple pane timber bay window is located to the east, with a Colourbond sheeted roof.</p> <p>The gable roof has a timber finial and shaped barge boards.</p> <p>The remnants of a brick chimney is evident on the western side of the dwelling, however the chimney shaft has been removed. Additional timber framed sliding windows are evident on the western wall.</p> <p>A green Colourbond fence partially encloses the back yard, with a dirt/gravel driveway.</p> <p>The dwelling displays architectural features of a heritage style and is representative of the local development of this period, being of historical significance for the HCA.</p>		<p>The veranda has been fully enclosed through the construction of an additional room with weatherboard cladding.</p> <p>The Colourbond roof sheeting has been partially replaced and updated, with differential levels of rust evident.</p> <p>The chimney has been modified, with the shaft removed and only the base remaining within the wall structure.</p> <p>Modern sliding windows have been installed on the western side of the dwelling.</p>

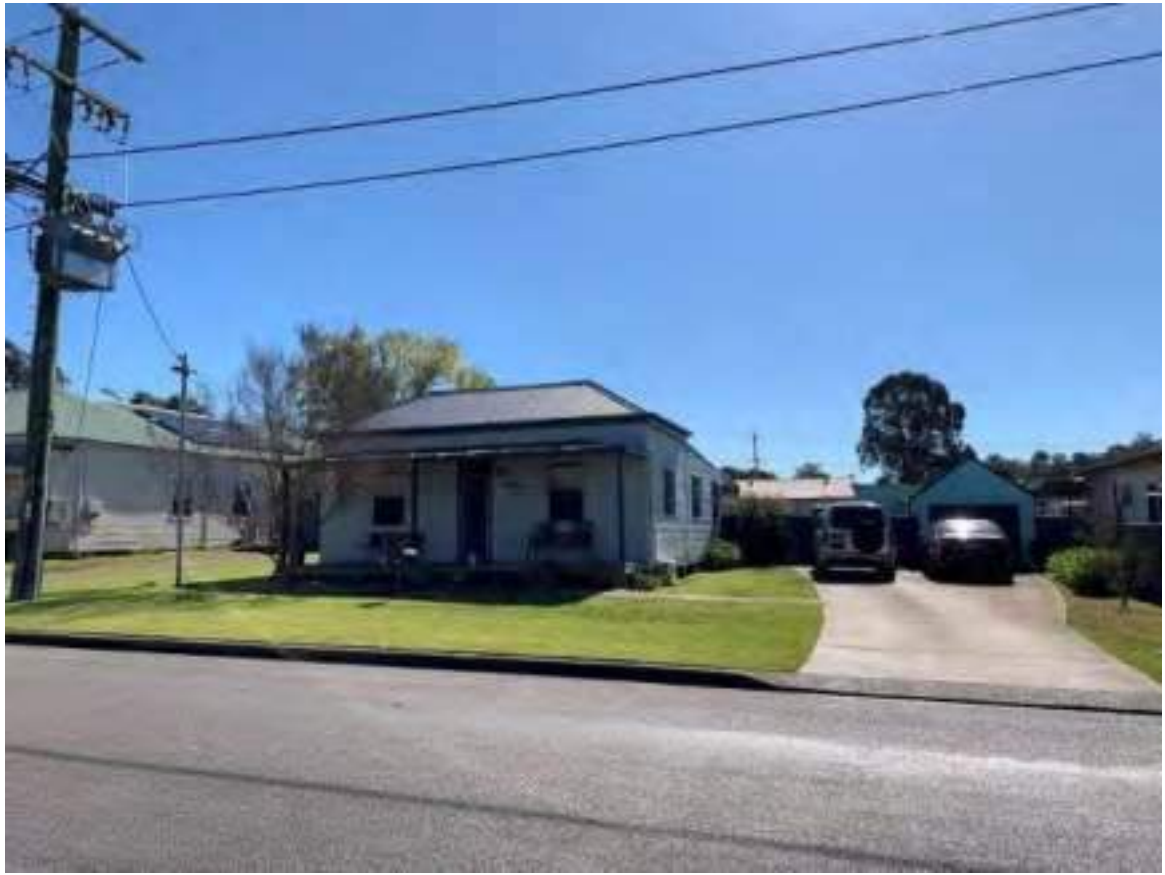
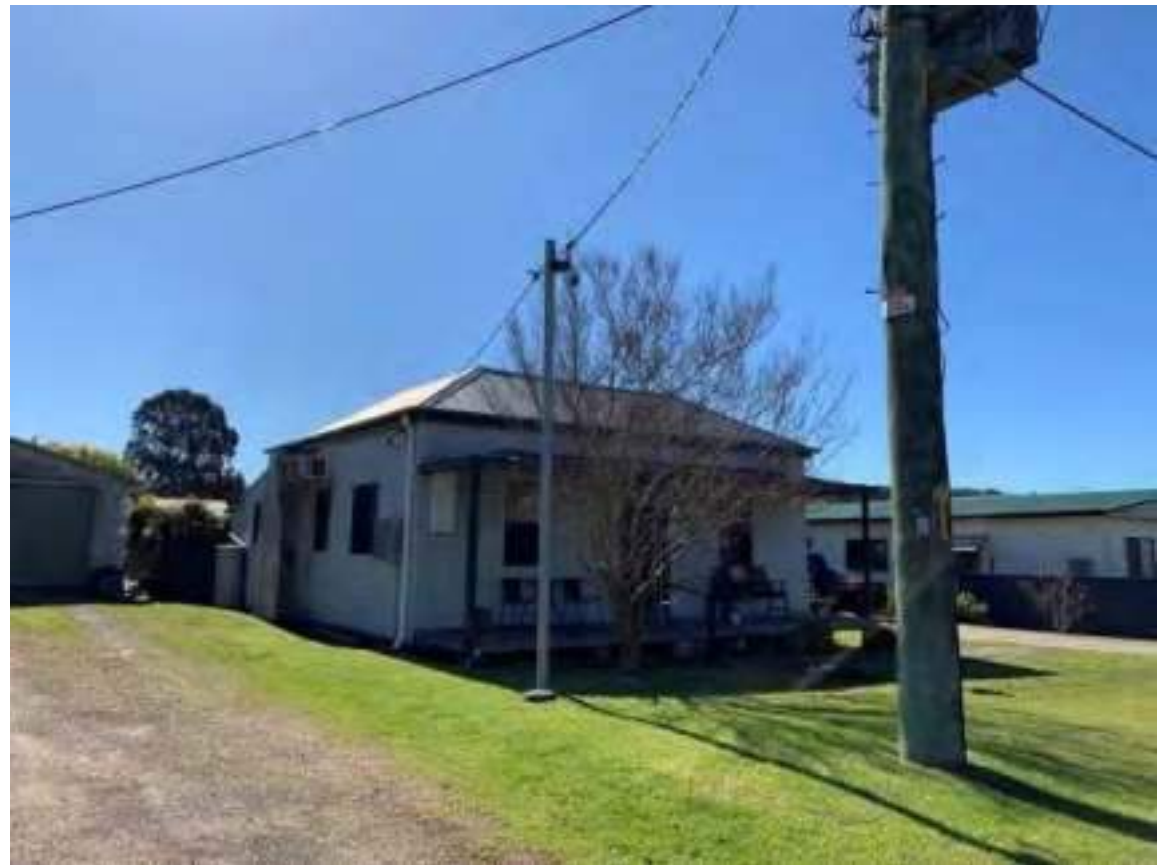
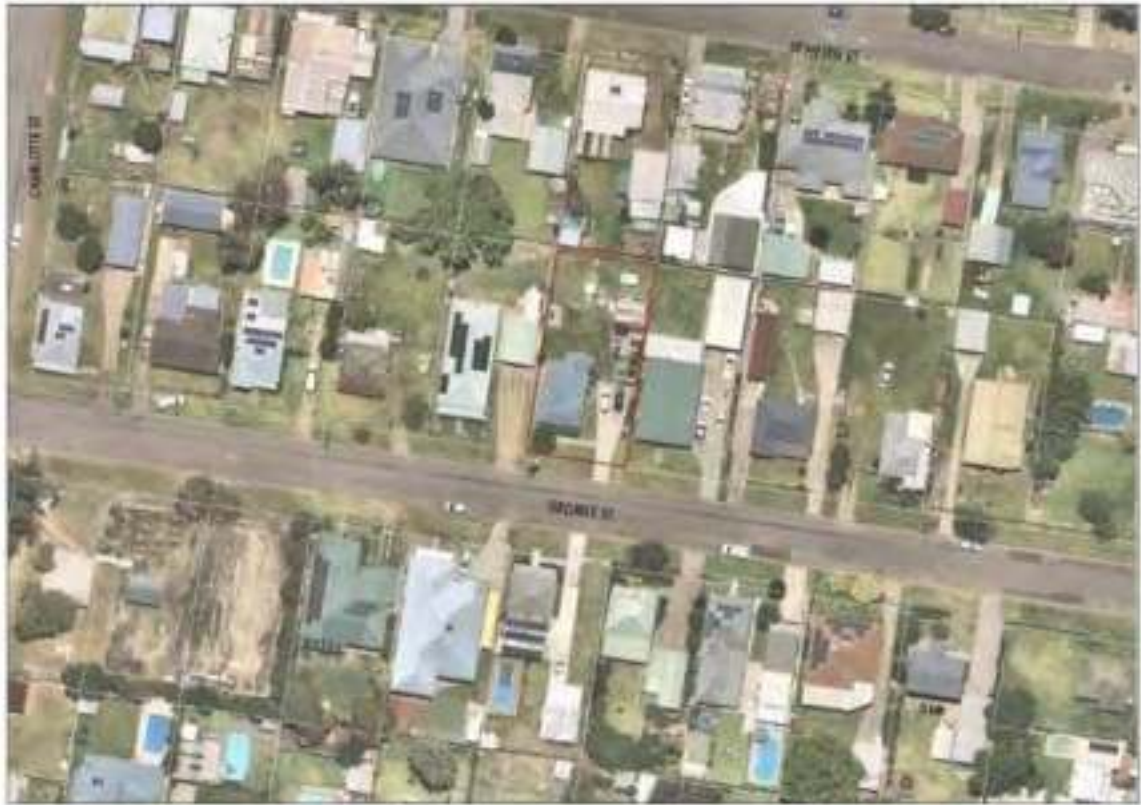
9 GEORGE STREET, HOLMESVILLE 2286

Conservation Area Contribution Level	Est. Construction Date	Previous studies and/or community input
Contributory 1	1890–1920	No prior heritage investigations and no additional information required
Assessment Text		Observed Modifications
<p>Single storey Vernacular ‘Mining Cottage’ style dwelling with Colourbond hipped roof and weatherboard cladding. The veranda roof is hipped and supported by metal pillars.</p> <p>The veranda is an open space, with no balustrades. The floor is timber, with concrete/stone stairs leading onto the veranda landing.</p> <p>The front door is centrally located with a timber framed four panel door, and metal security screen. Double hung windows are located on either side of the door, both metal framed and of modern design.</p> <p>A single door garage is located to the east of the dwelling, with weatherboard cladding and gabled Colourbond roof. This has been constructed in a sympathetic heritage style, however does not match the dwellings design.</p> <p>A secondary presumably residential structure is visible in the back yard, north of the dwelling, with a skillion roof and weatherboard cladding.</p> <p>A blue Colourbond fence runs the width of the back yard, enclosing the space. A concrete driveway leads to this fence, with a concrete path leading to the stairs and veranda entry.</p> <p>The dwelling displays architectural features of a heritage style and is representative of the local development of this period, being of historical significance for the HCA.</p>		<p>The front door security screen is a modern modification, obscuring the traditional four panel timber door behind. The hung windows on either side are similarly recent, with metal framing and a differential design then the traditional timber hung windows of the style.</p> <p>The hipped veranda roof is likely a replacement of the original bull nose Colourbond design. This is a common modification with this style of dwelling.</p> <p>The garage and secondary back structure are visible from the street and juxtapose the heritage style of the dwelling. the garage is less offensive, however both are modifications.</p>

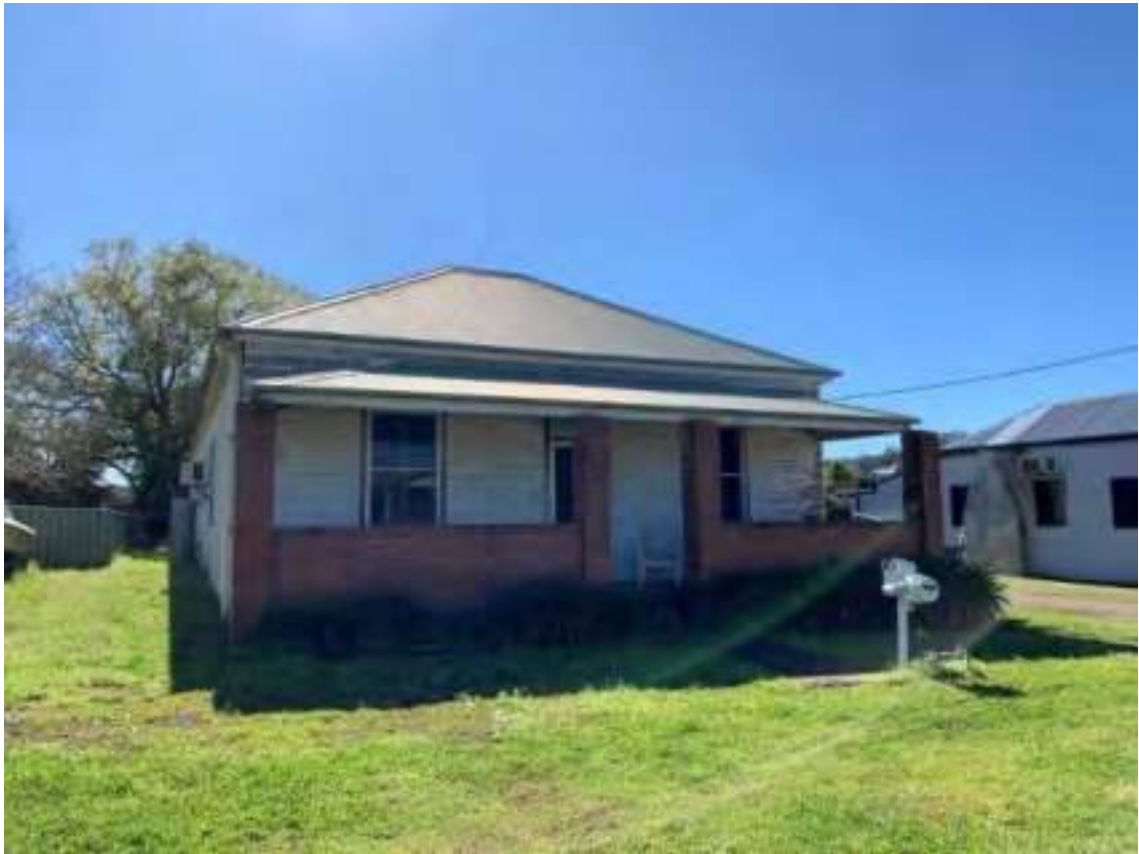
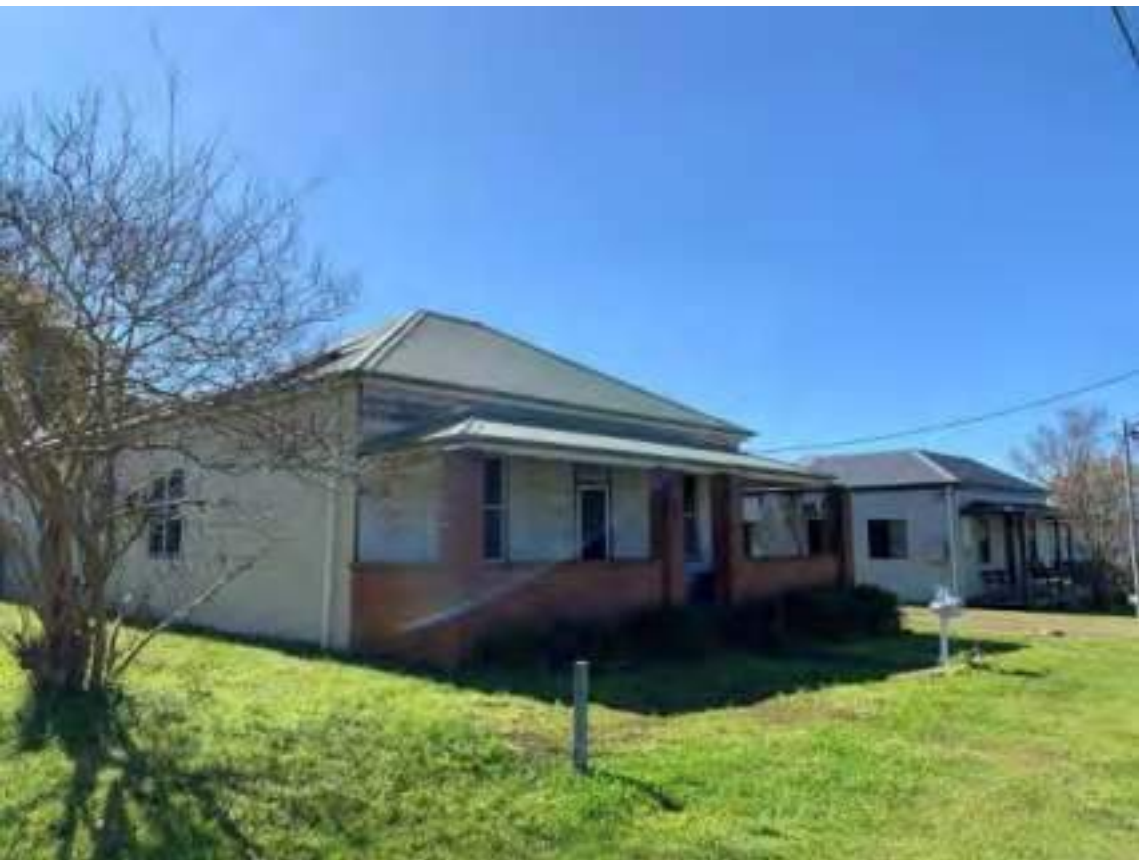
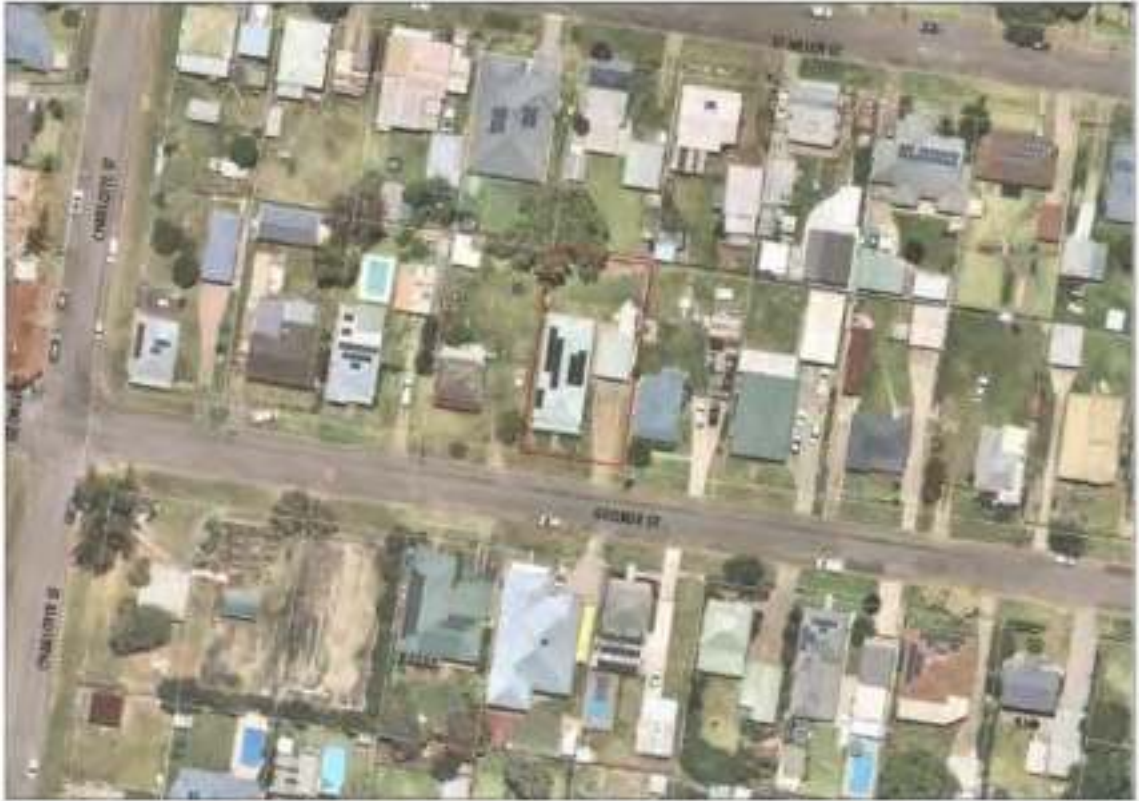
11 GEORGE STREET, HOLMESVILLE 2286

Conservation Area Contribution Level	Est. Construction Date	Previous studies and/or community input
Contributory 1	1890–1920	No prior heritage investigations and no additional information required
Assessment Text		Observed Modifications
<p>Single storey Vernacular ‘Mining’s Cottage’ style dwelling with Colourbond hipped roof and weatherboard cladding. The veranda roof is hipped Colourbond and supported by brick pillars.</p> <p>The veranda is partially enclosed by a red brick wall and brick pillars.</p> <p>The front door is centrally located with a timber frame and security screen. The main door is not visible. Either side are timber framed four pane hung windows. Similar windows are evident on the eastern side of the dwelling.</p> <p>A double door garage is located to the east of the dwelling, with a gable Colourbond roof and weatherboard cladding.</p> <p>The driveway is dirt/gravel, with no fencing or gates.</p> <p>The dwelling displays architectural features of a heritage style and is representative of the local development of this period, being of historical significance for the HCA.</p>		<p>The brick pillars and wall enclosing the veranda are a modification to the dwelling. It is likely that originally no balustrades or walls were present.</p> <p>Solar panels are visible on the eastern and western side of the roof, however this is only partially visible from the street.</p> <p>The double garage is a recent addition and has not been constructed in a sympathetic manner, the colour scheme and design juxtapose the heritage properties of the dwelling.</p> <p>A large back extension has been constructed attached to the northern portion of the dwelling. This is not visible from the street.</p>

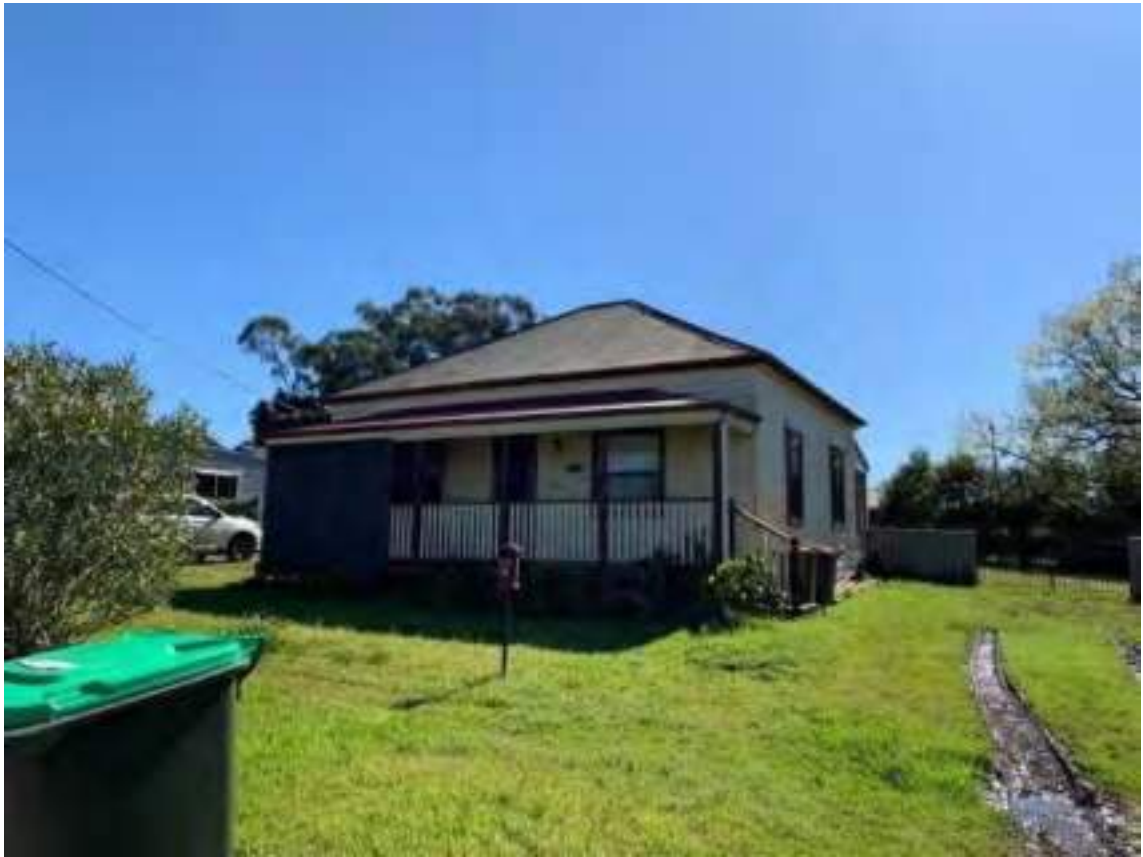
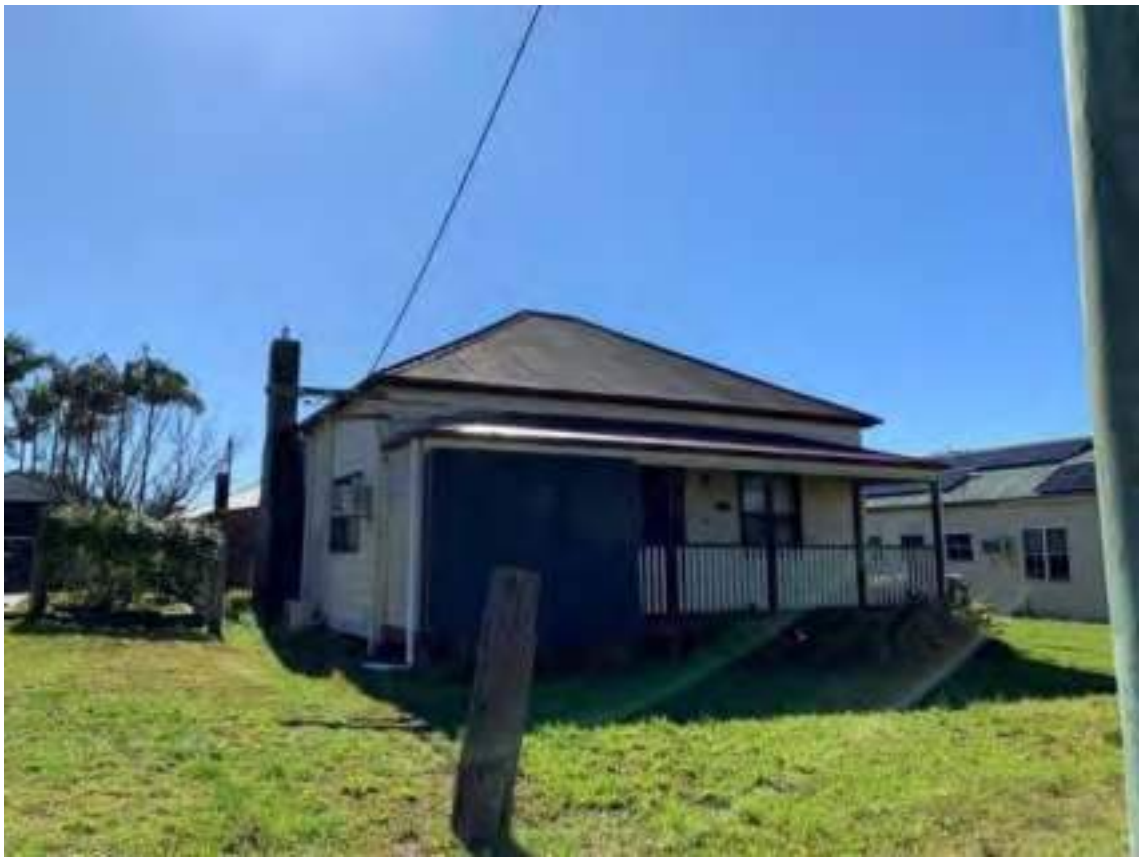
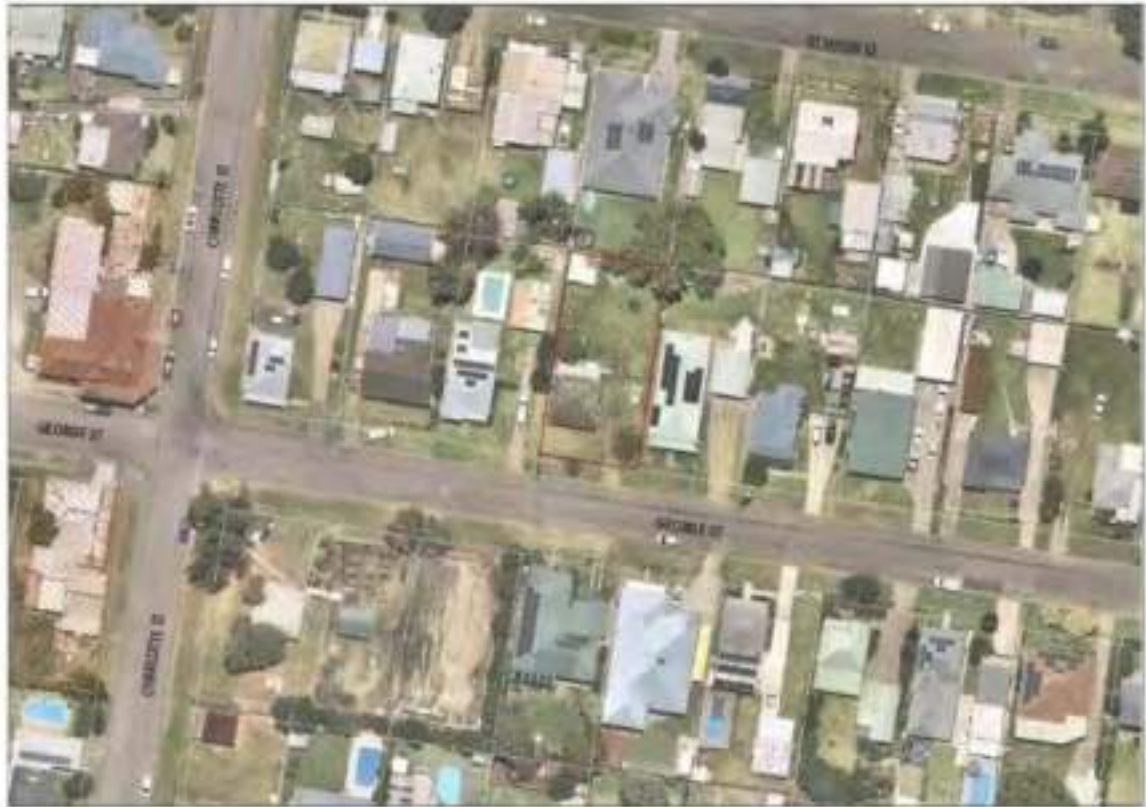
13 GEORGE STREET, HOLMESVILLE 2286

Conservation Area Contribution Level	Est. Construction Date	Previous studies and/or community input
Contributory 1	1890–1920	No prior heritage investigations and no additional information required
Assessment Text		Observed Modifications
<p>Single storey Vernacular ‘Mining Cottage’ style dwelling, with Colourbond hipped roof and weatherboard cladding. The veranda roof is hipped Colourbond and supported by square cut timber pillars. The veranda space is partially enclosed by timber balustrades, with the entrance stairs being located facing the east. The stairs have a similar styled support rail.</p> <p>The front door is centrally located, with a timber framed four panel design with a window arch overhead. A metal framed security screen lies in front. Timber framed awning windows sit either side of the main door.</p> <p>A rendered brick/concrete chimney is visible on the western side of the dwelling.</p> <p>A canvas awnings is located on the western side of the veranda, further enclosing the space for privacy and shade.</p> <p>The driveway is dirt, leading to a green Colourbond fence enclosing the back yard.</p> <p>The dwelling displays architectural features of a heritage style and is representative of the local development of this period, being of historical significance for the HCA.</p>		<p>The security screen addition obscures the traditional timber panel door, which itself is a modern design with the inclusion of the glass arch.</p> <p>The awning windows of the front façade are a modern design, likely replacing original two pane hung windows.</p> <p>The additional canvas awnings found on the western side of the veranda is a recent and modern addition to the dwelling. this is not sympathetic in style.</p>

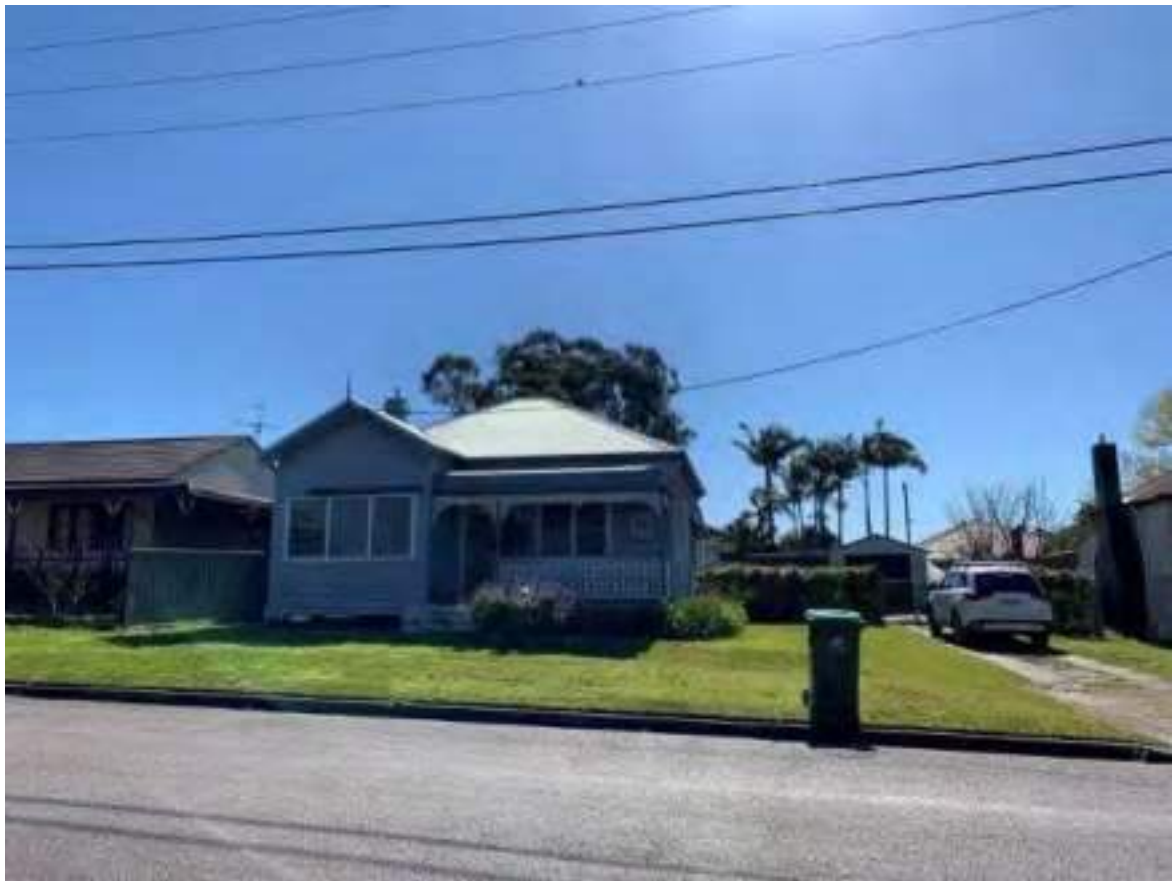
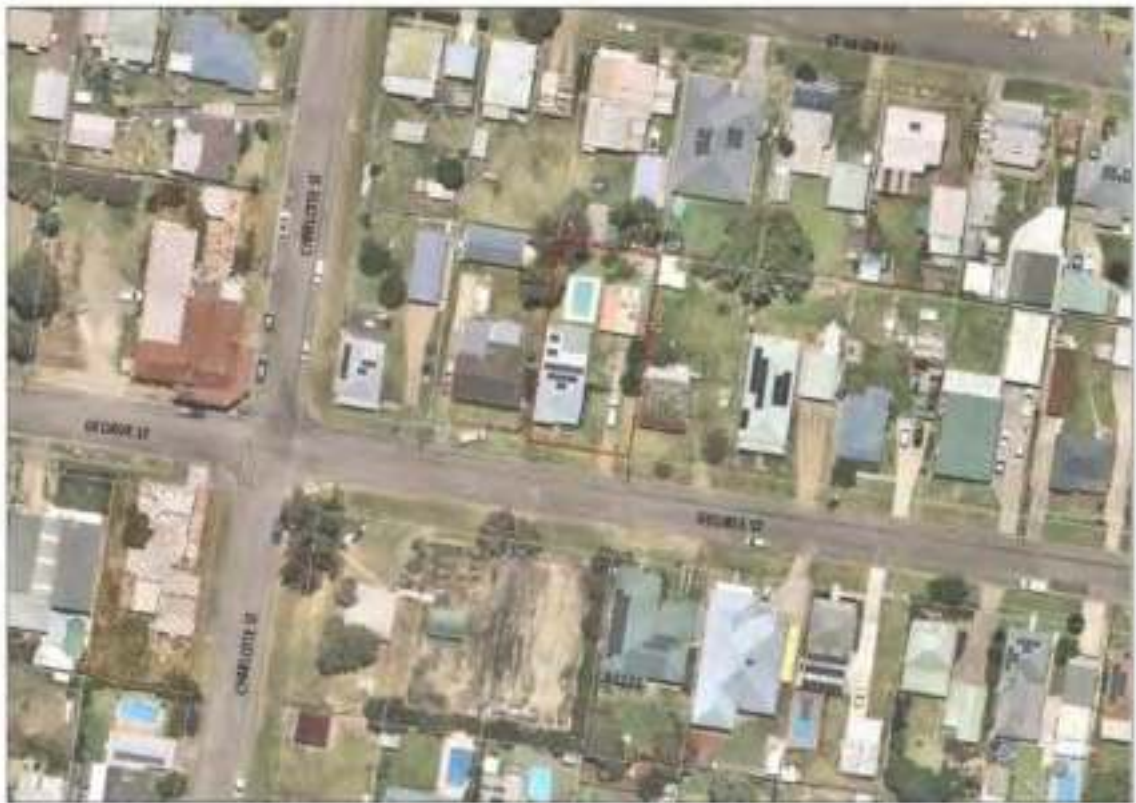
15 GEORGE STREET, HOLMESVILLE 2286

Conservation Area Contribution Level	Est. Construction Date	Previous studies and/or community input
Contributory 1	1900–1920	No prior heritage investigations and no additional information required
Assessment Text		Observed Modifications
<p>Single storey simple Federation ‘workmen’s’ cottage’ style dwelling with a half hipped and gable Colourbond roof and timber weatherboard cladding. The veranda roof is bull nose Colourbond supported by square cut timber posts. Cast iron lace brackets and valance are evident.</p> <p>The veranda space is partially enclosed by cast iron ornate balustrade. Rendered stone/concrete stairs lead to the veranda landing, with the floor being timber. Stone/concrete rendered piers with diamond engravings are found at the foot of the stairs.</p> <p>The gable roof has ornately carved barge boards and a timber finial. The façade is dominated by a three-panel hung window with timber framing.</p> <p>The front door is centrally located, with a metal security screen and four panel timber main door. A double pane hung window with timber frame is located to the east of the door. The eastern windows vary, all being timber framed. A timber awning with bracket overlies a single sliding window.</p> <p>A rendered brick chimney is visible on the western side of the dwelling, with minimal decorations other than corbels.</p> <p>The driveway is concrete, leading to a metal swing gate. A single door garage with gable Colourbond roof and weatherboard cladding is located to the east of the dwelling.</p> <p>The dwelling displays architectural features of a heritage style and is representative of the local development of this period, being of historical significance for the HCA.</p>		<p>The integrity of the façade is impacted by the addition of modern design hung windows. The dwelling likely originally had a multiple double hung windows in this position.</p> <p>The iron lace detailing of the veranda is likely a modern restoration, although the style is appropriate.</p> <p>The single garage is far back, however visible from the street. The construction and colour scheme is unsympathetic to the heritage properties of the dwelling.</p>

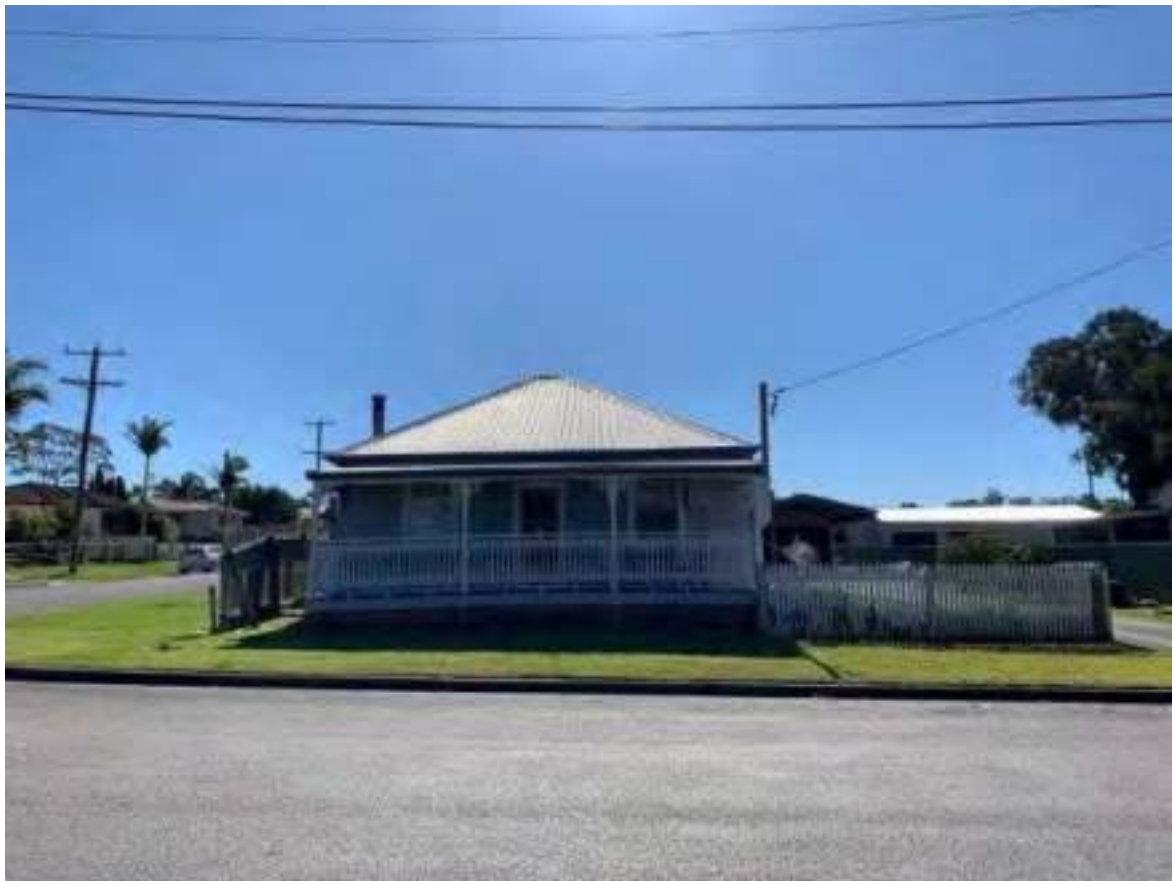
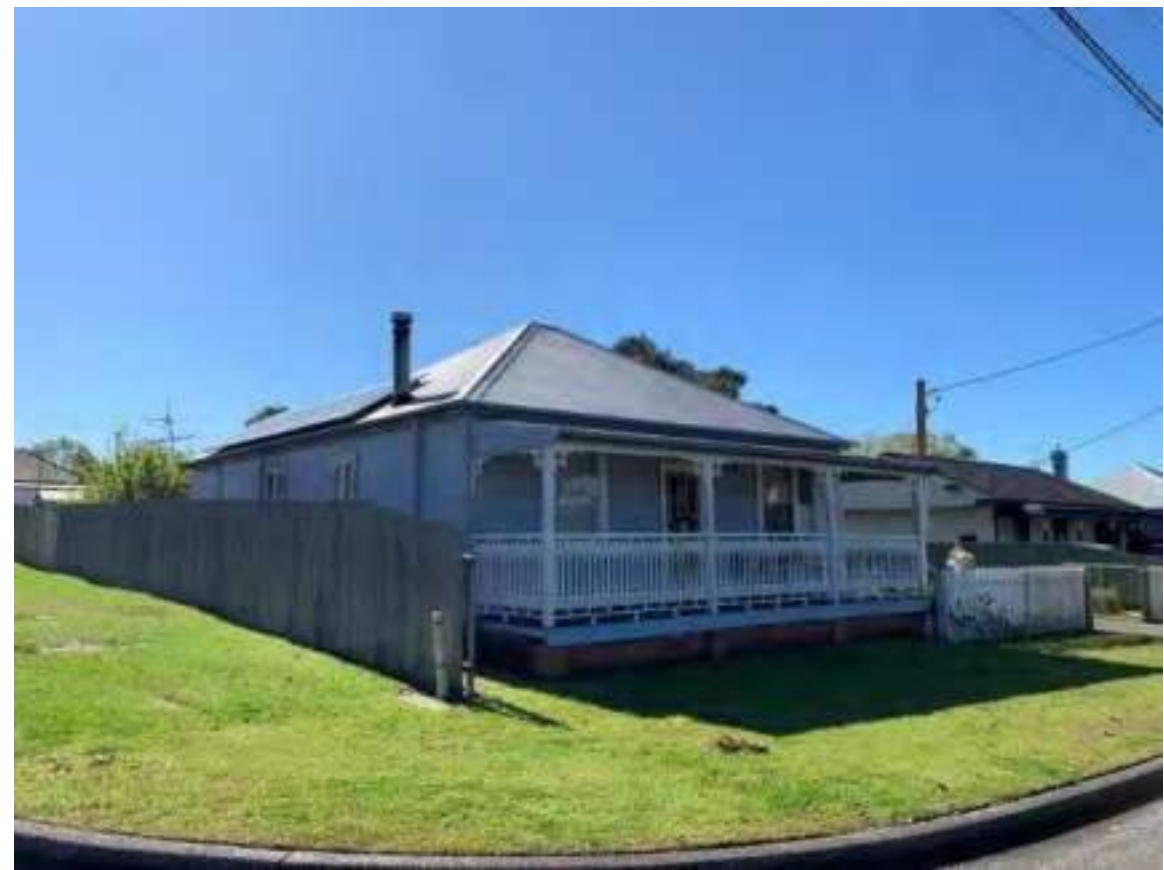
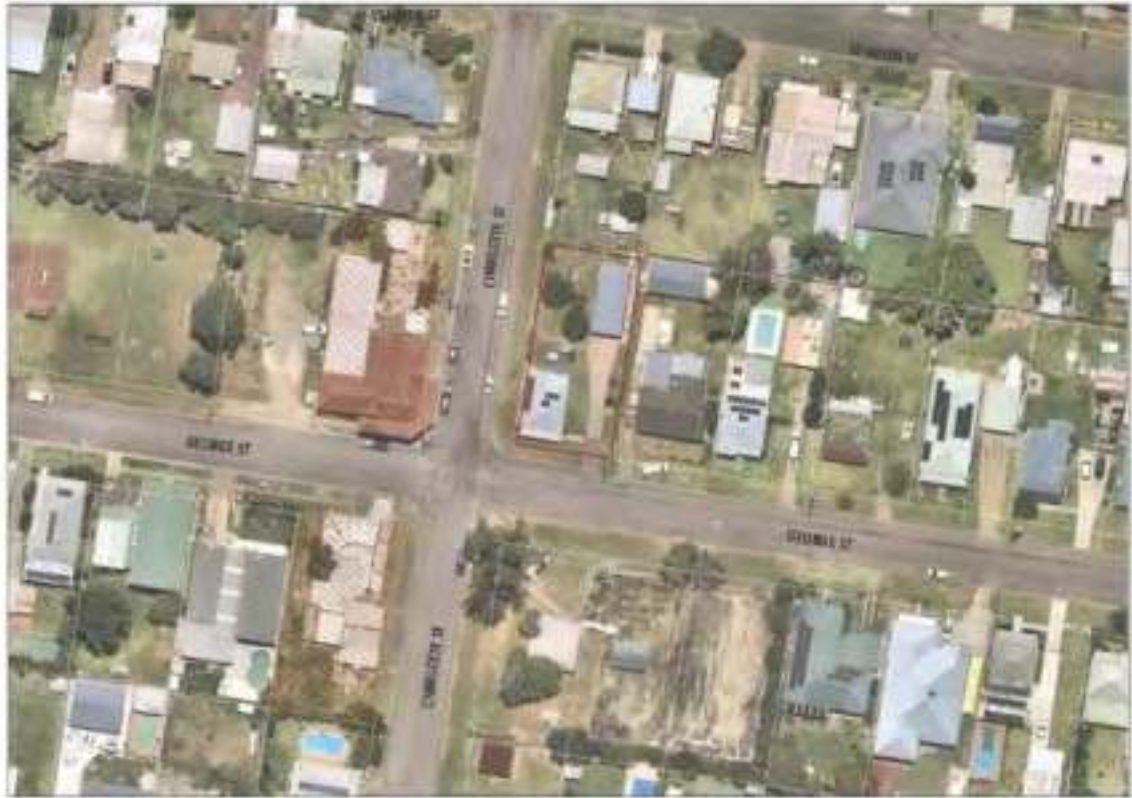
19 GEORGE STREET, HOLMESVILLE 2286

Conservation Area Contribution Level	Est. Construction Date	Previous studies and/or community input
Contributory 1	1890–1920	No prior heritage investigations and no additional information required
Assessment Text		Observed Modifications
<p>Single storey Vernacular ‘Mining Cottage’ style dwelling with hipped Colourbond roof and timber weatherboard cladding. The veranda roof is Colourbond skillion in design, supported by square cut timber posts. The posts have fretted timber brackets.</p> <p>The veranda is partially enclosed by a white iron balustrade. The floor is timber and the entrance stairs are located to the eastern side of the dwelling with a metal support rail.</p> <p>The front door is centrally located with a metal framed ornate screen door. Timber framed twelve pane sash windows are found either side of the main door. The eastern side of the dwelling shows two double hung timber framed windows, and a small rectangular window commonly found in bathrooms.</p> <p>A double door garage is located to the north of the dwelling, with a gable Colourbond roof and Colourbond sheet walls. A concrete driveway leads to the garage from the street.</p> <p>The dwelling is supported by brick and concrete foundations, evident along the front façade. The brick has been rendered.</p> <p>A timber picket fence runs the width of the property.</p> <p>The dwelling displays architectural features of a heritage style and is representative of the local development of this period, being of historical significance for the HCA.</p>		<p>The eastern windows are likely a recent replication of original hung windows common to the style.</p> <p>The garage is a recent addition to the property, being highly visible and of an unsympathetic design to the dwelling.</p> <p>The veranda posts, brackets and iron balustrade are all likely a recent replication of similar historical designs. Likely the dwelling originally had no balustrades or brackets,. Given the demographic the housing style was appealing to. However this has not been undertaken in an unsympathetic manner.</p>

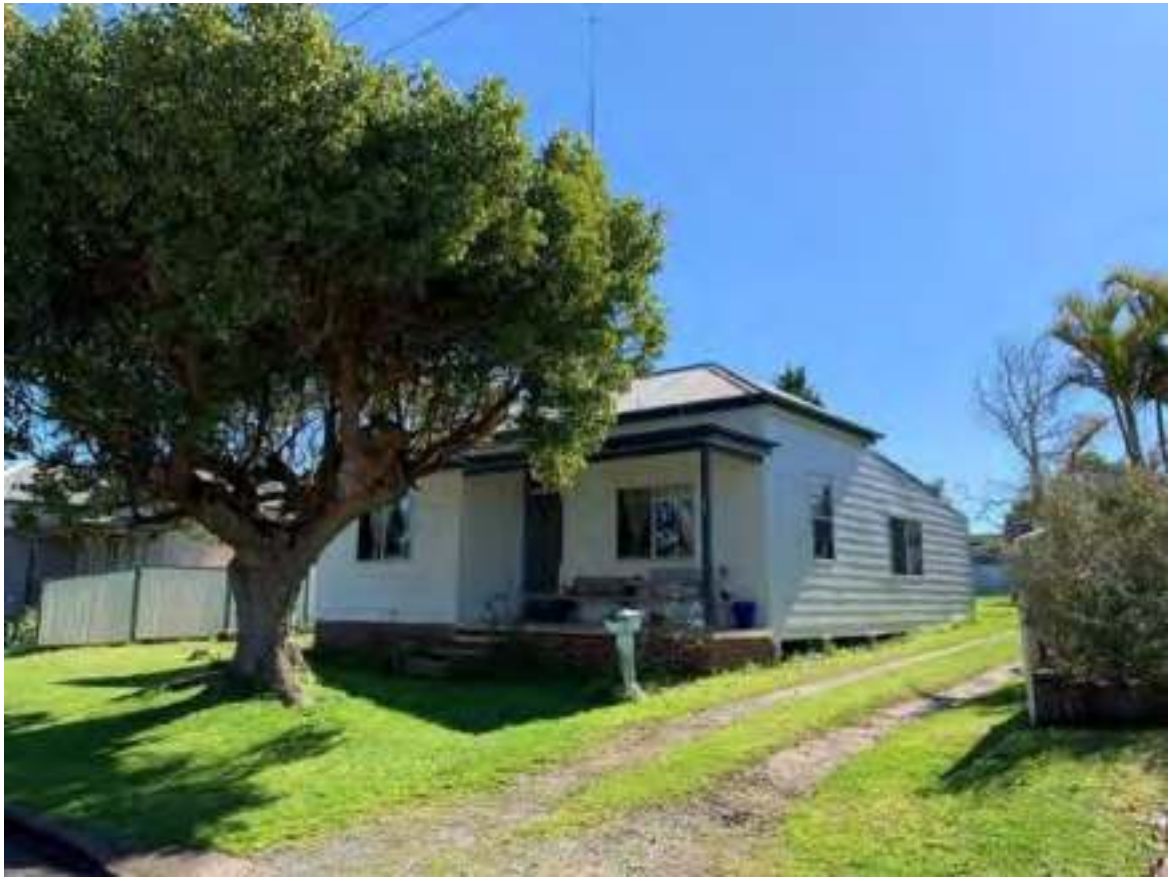
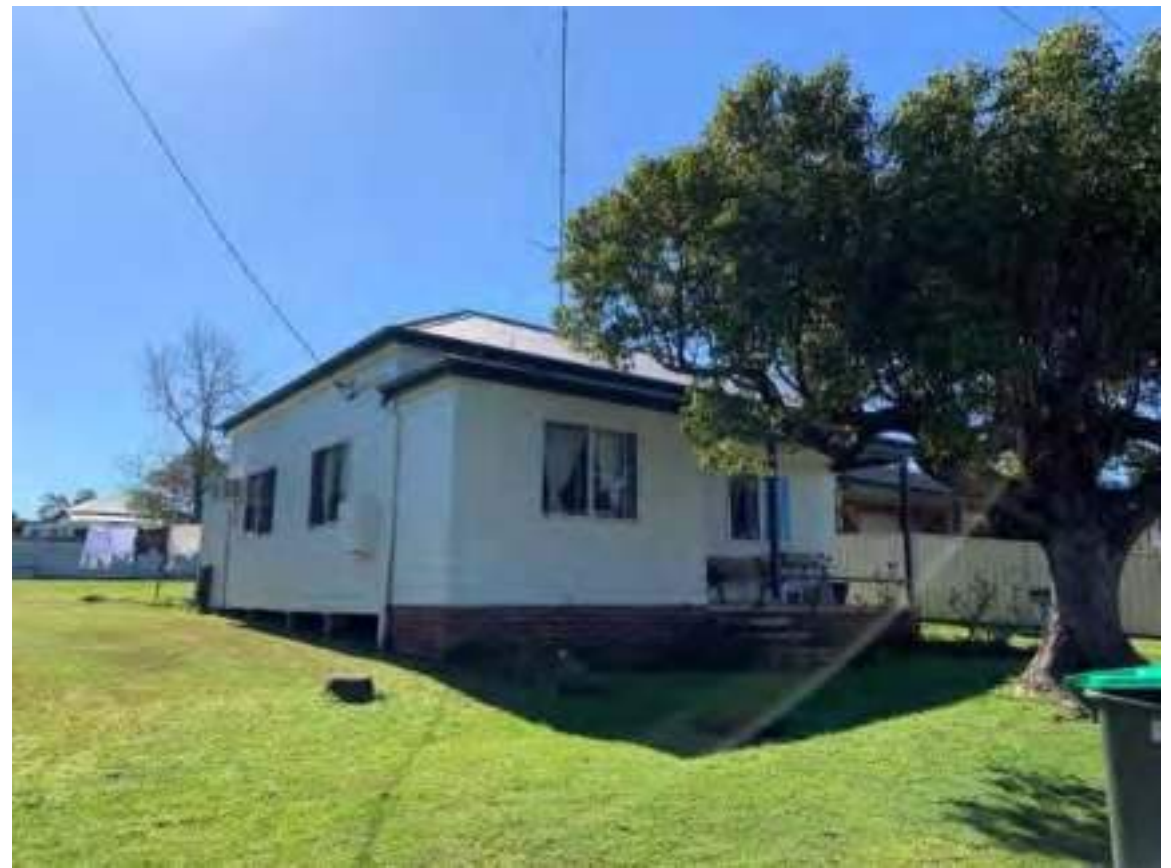
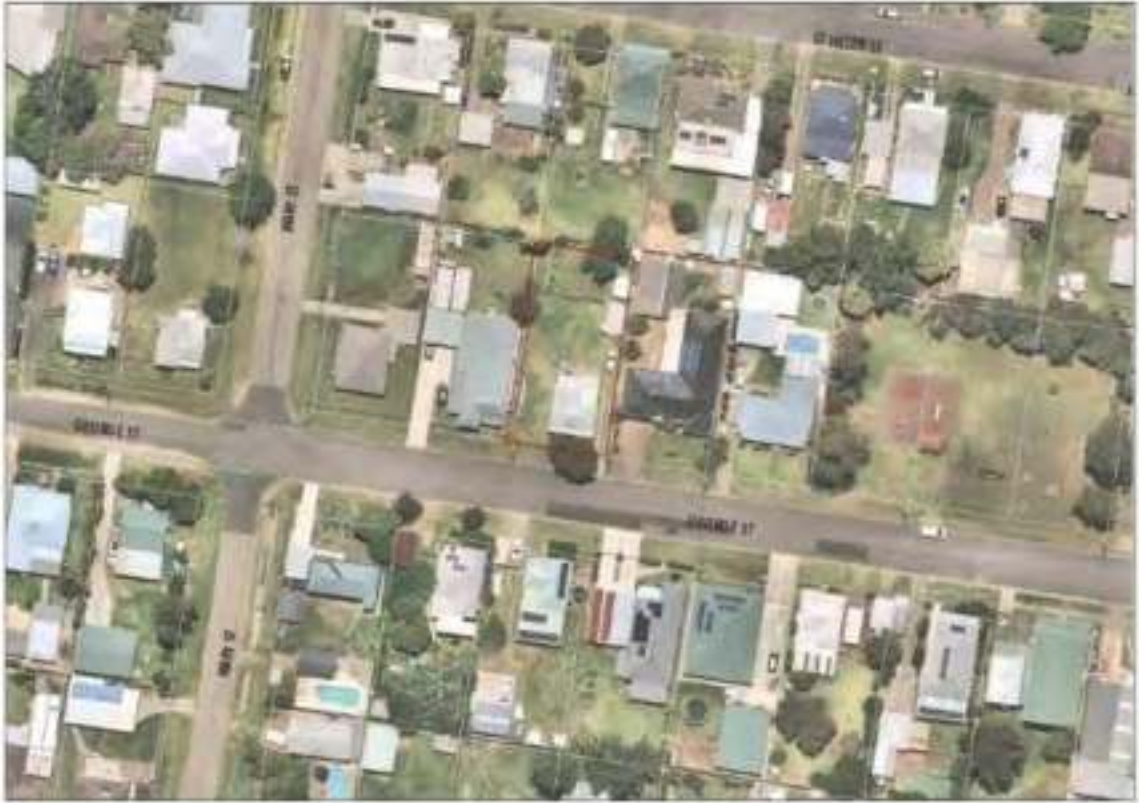
29 GEORGE STREET, HOLMESVILLE 2286

Conservation Area Contribution Level	Est. Construction Date	Previous studies and/or community input
Contributory 1	1890–1920	No prior heritage investigations and no additional information required
Assessment Text		Observed Modifications
<p>Single storey Vernacular cottage style dwelling with Colourbond hipped roof and weatherboard cladding. The veranda roof is hipped and supported by square cut timber posts. The veranda has been shortened through the construction of an additional front room.</p> <p>The veranda has no balustrades or decorative features, it is an open space. The floor is tiled/rendered concrete, being accessed by a central set of brick stairs. The dwelling is supported by brick and concrete foundations.</p> <p>The front door is centrally located, with an ornate iron screen door. Metal framed sliding windows are located on either side of the main door.</p> <p>The eastern side of the dwelling has both sliding and double hung timber framed windows. The western side similarly has sliding windows.</p> <p>The dwelling displays architectural features of a heritage style and is representative of the local development of this period, being of historical significance for the HCA.</p>		<p>The veranda has been shortened to accommodate the front extension, likely being modified from a full length bull nose style to the current hipped.</p> <p>A back lean to extension has been built onto the back northern wall of the dwelling, a common modification in the area. The roof is skillion.</p> <p>The eastern and western walls contain modern sliding windows, with a mix of metal and timber framing, suggesting multiple building phases. Similarly the front façade windows are modern in design and sliding.</p>
