APPENDIX 2

Building Assessment Sheets (Inventory Sheets)

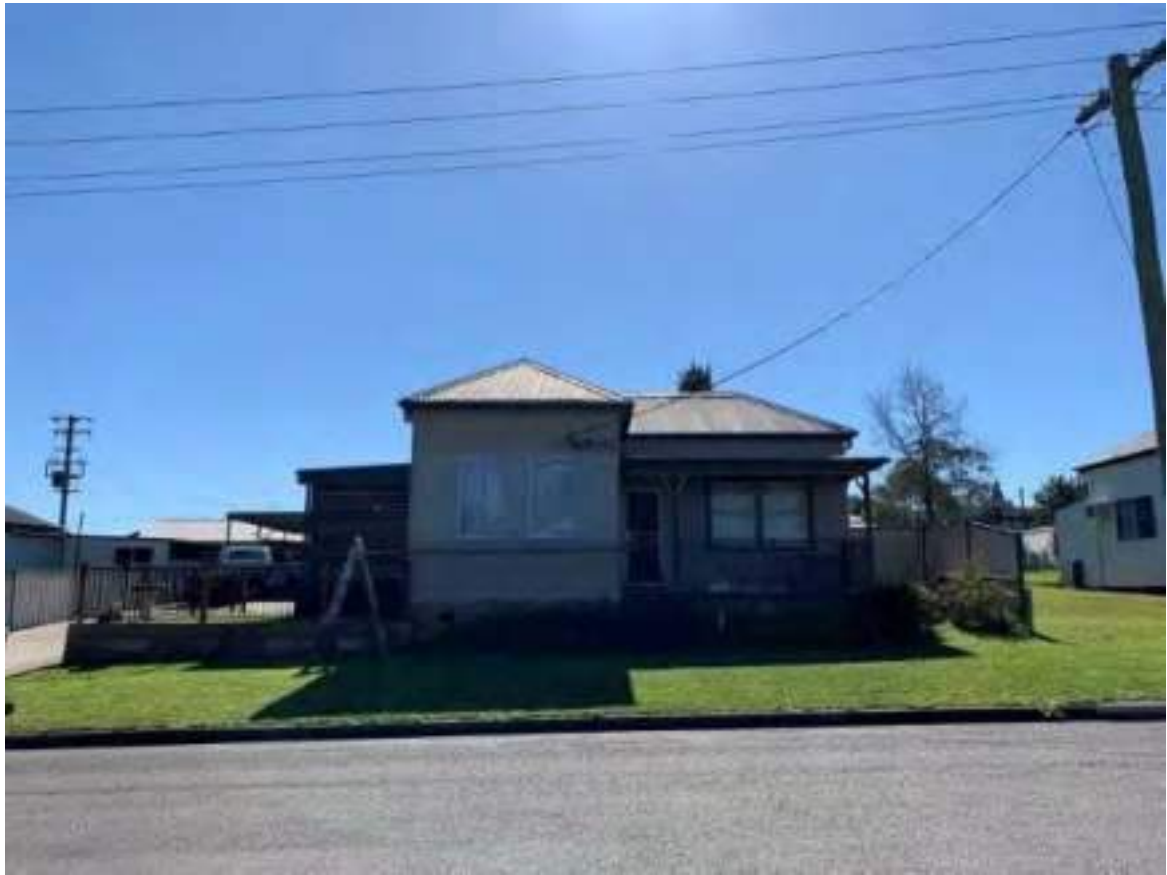
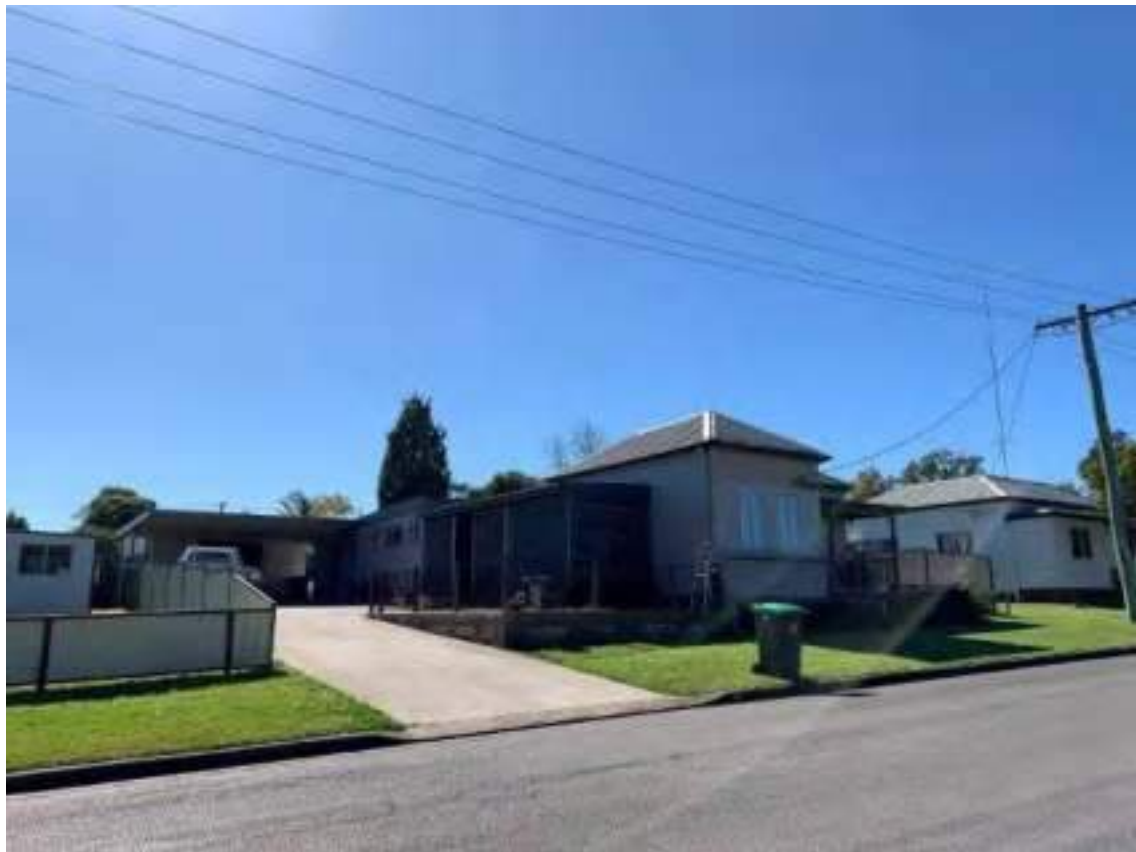
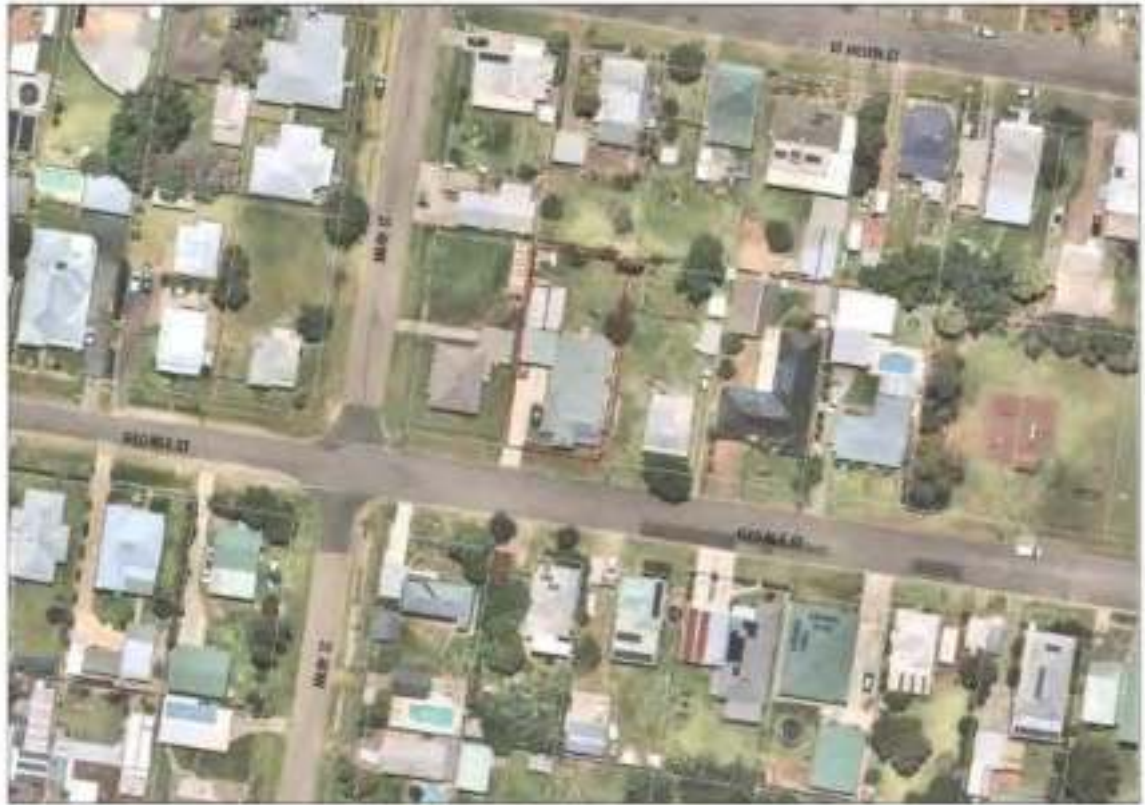
31 GEORGE STREET, HOLMESVILLE 2286

Conservation Area Contribution Level	Est. Construction Date	Previous studies and/or community input
Contributory 1	1890–1920	No prior heritage investigations and no additional information required
Assessment Text		Observed Modifications
<p>Single storey modified Vernacular cottage style dwelling, with Colourbond hipped roof and weatherboard cladding. The veranda roof has been shortened and is hipped, supported by timber posts. The posts have ornate timber brackets.</p> <p>The veranda is partially enclosed by metal balustrade, with the brick stairs leading onto a rendered concrete veranda floor. The dwelling is supported by brick and concrete foundations.</p> <p>The front door is centrally located, with a metal security screen and timber main door. The main door is obscured by the white screen door. Timber framed two pane double hung windows are located to the east of the main door, with modern metal framed sliding windows being to the west.</p> <p>The westwardly extension has a timber façade and skillion corrugated roof. Canvas blinds are used to enclose the space. This is unsympathetic in design to the heritage values of the dwelling.</p> <p>A single door garage and car port are located to the north west of the dwelling, with a gable and flat roof. Neither are sympathetic in style.</p> <p>A low stone wall, with a metal and timber fence atop frames the front yard. This is a stark contrast to the traditional timber picket fencing found elsewhere.</p> <p>A concrete driveway leads to the garage.</p> <p>The dwelling displays architectural features of a heritage style and is representative of the local development of this period, being of historical significance for the HCA.</p>		<p>The front façade has been heavily modified, with an additional room being constructed projecting southward from the dwelling. Similarly, an additional extension has been constructed on the western side of the dwelling. Both are highly visible from the street.</p> <p>The veranda was likely originally timber floored, with the concrete being a recent modification.</p> <p>The stone, timber and metal fencing of the front yard is a modern addition to the property, contrasting with traditional styles.</p>

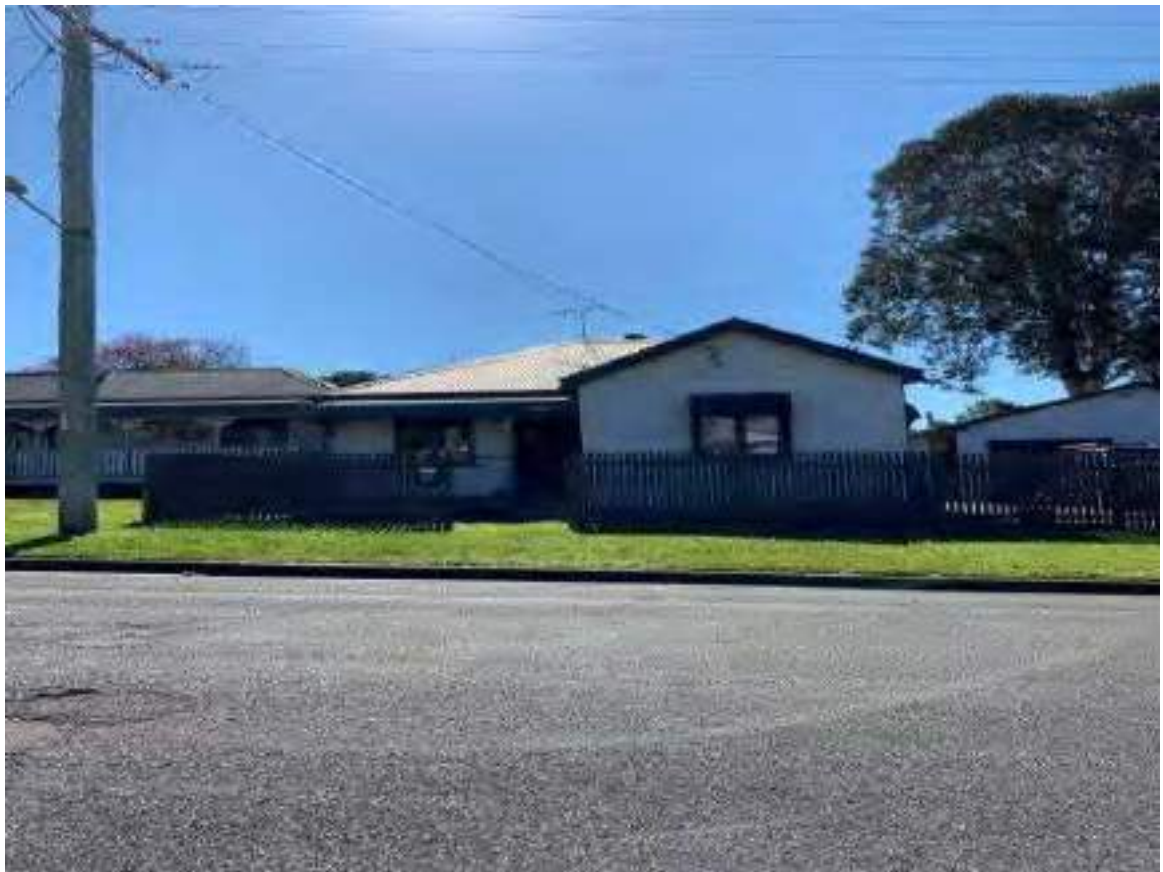
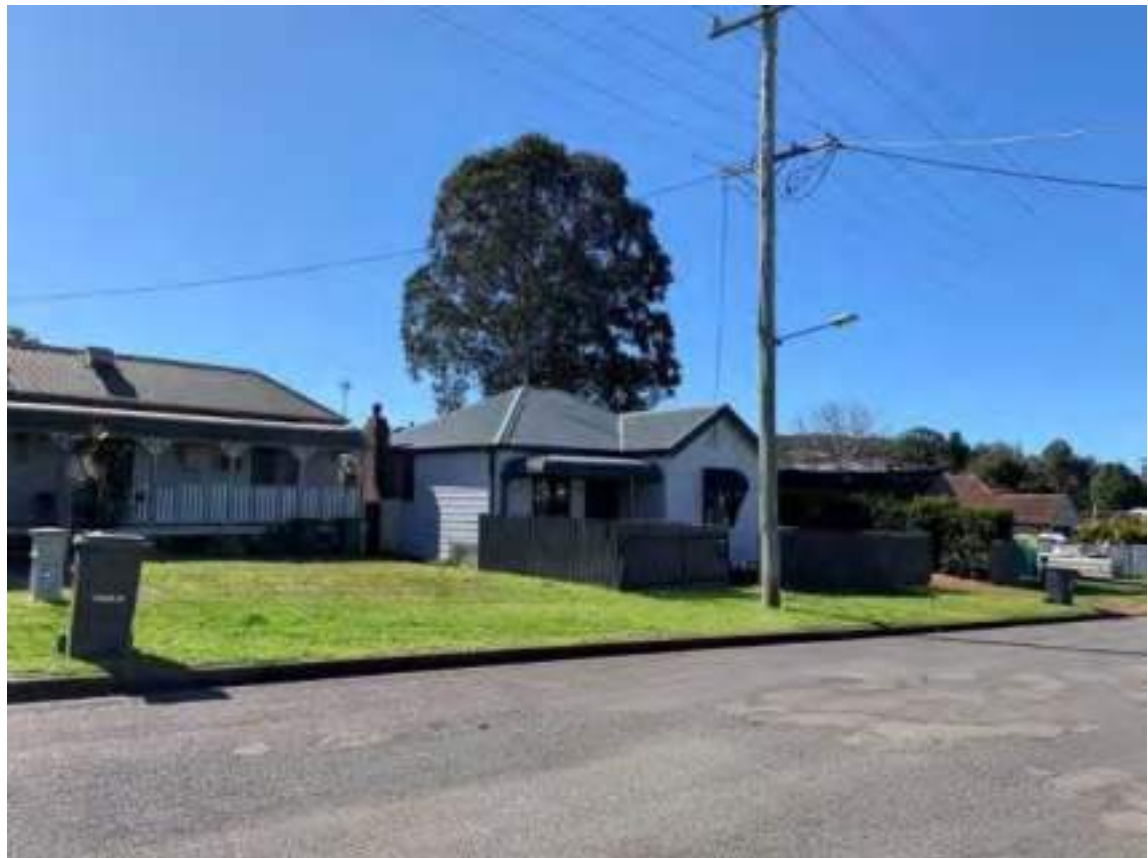
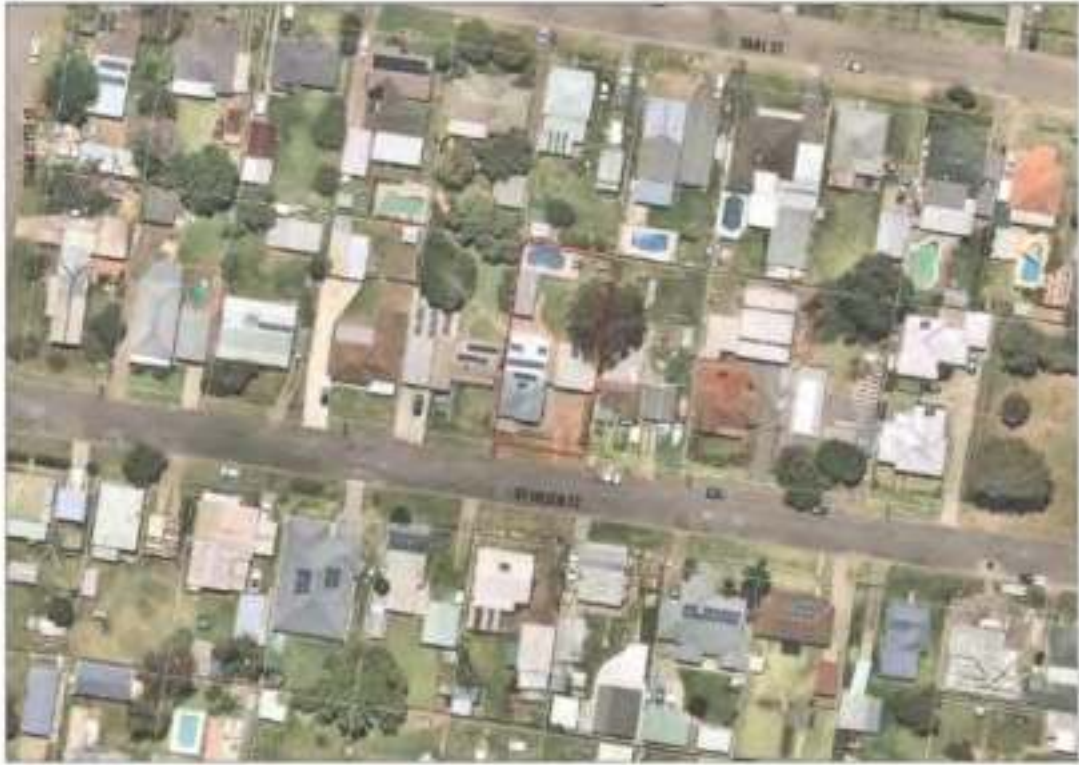
9 ST HELEN STREET, HOLMESVILLE 2286

Conservation Area Contribution Level	Est. Construction Date	Previous studies and/or community input
Contributory 1	1900–1920	No prior heritage investigations and no additional information required
Assessment Text		Observed Modifications
<p>Single storey simple Federation ‘workmen’s cottage’ style dwelling with half hipped and gable Colourbond roof and weatherboard cladding. The veranda has a bull nose roof supported by square cut timber posts.</p> <p>The veranda is partially enclosed with timber and wire balustrade, with no further decoration or details. Concrete stairs lead onto the veranda landing, with timber flooring.</p> <p>The front door is centrally located, with a metal framed screen door obscuring the main door. Double pane casement timber framed windows are found either side of the door. The eastern window has a metal sheet awning, with timber brackets.</p> <p>The gable roof has extended barge boards, however no other decorations are evident.</p> <p>A double door garage is located to the east of the dwelling, with a gable Colourbond roof and weatherboard cladding.</p> <p>The driveway is brick tiles, being brightly orange coloured and starkly contrasting with the remainder of the dwelling.</p> <p>A timber picket fence runs the width of the property, enclosing the front yard.</p> <p>A brickwork chimney is located on the western side of the dwelling. this is partially painted white.</p> <p>The dwelling displays architectural features of a heritage style and is representative of the local development of this period, being of historical significance for the HCA.</p>		<p>The façade windows are likely a modern replication of original styles.</p> <p>The front door has been modified, with the addition of a metal screen door. The main door is not visible.</p> <p>The garage is a recent addition, however has been constructed in a sympathetic manner to the heritage values of the dwelling.</p>

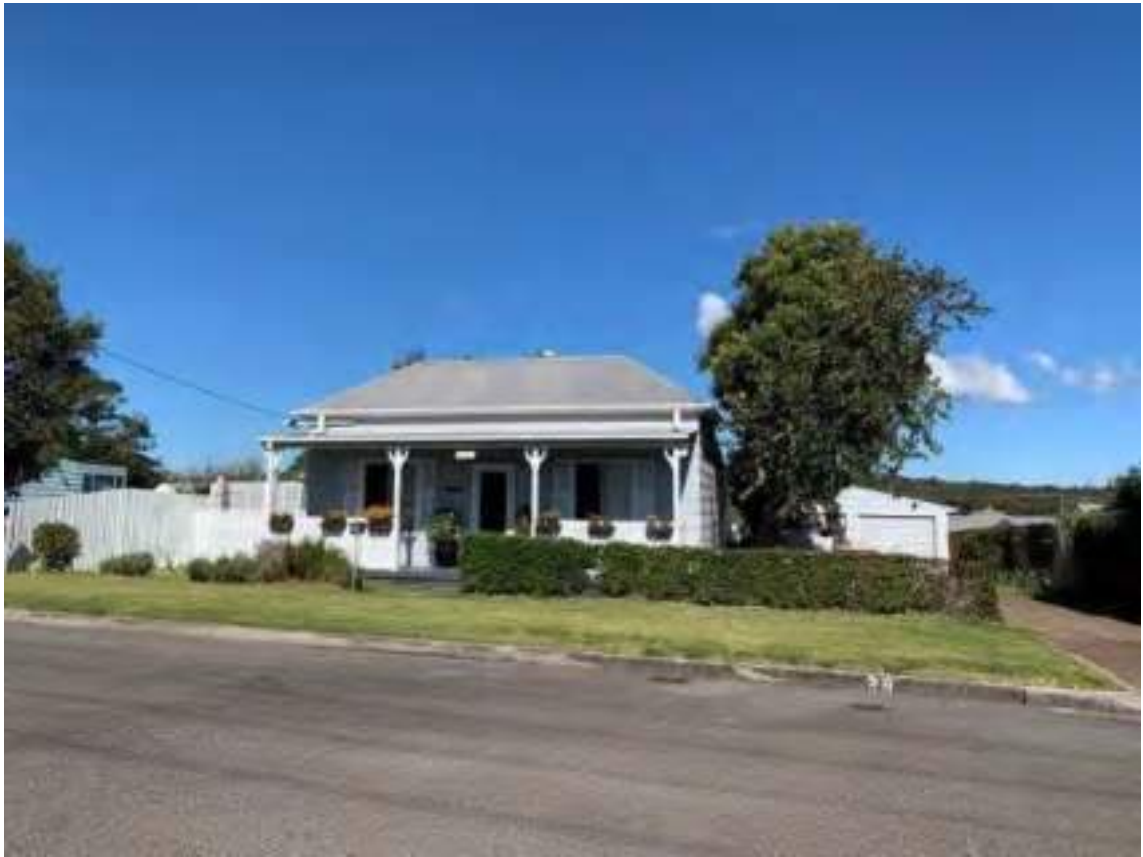
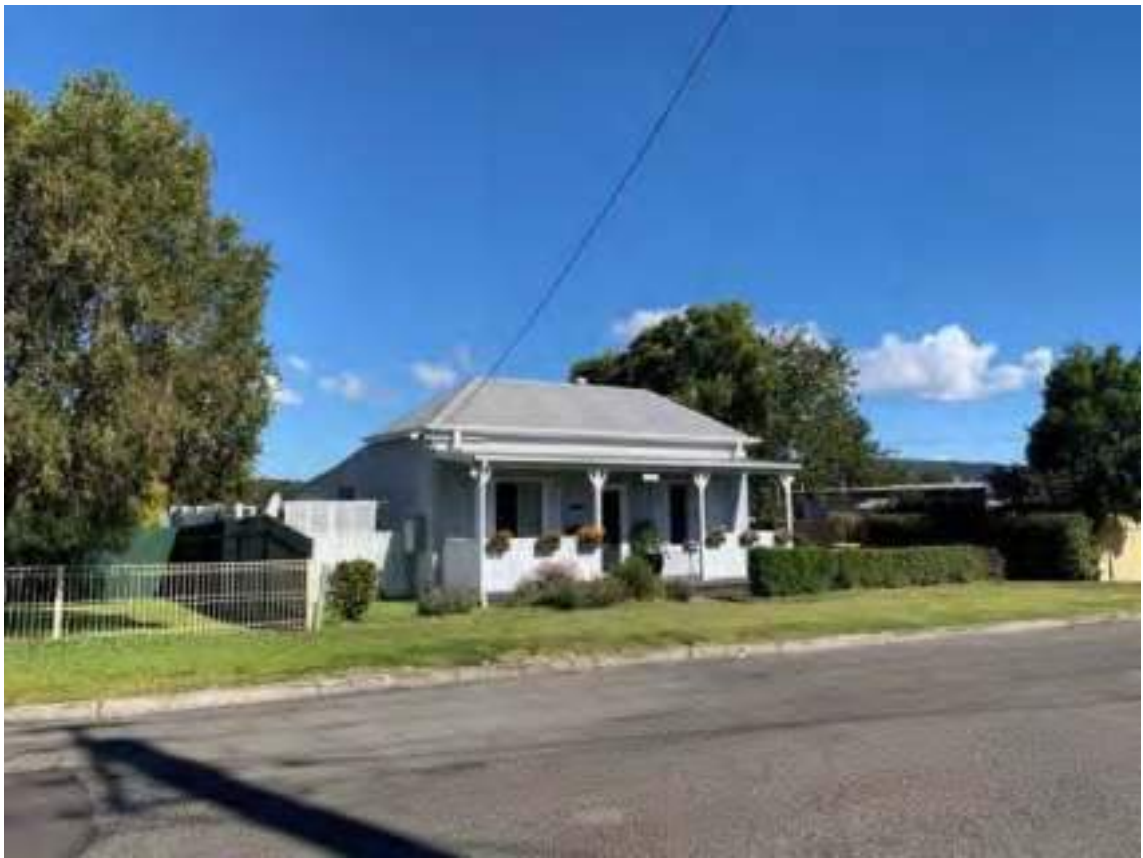
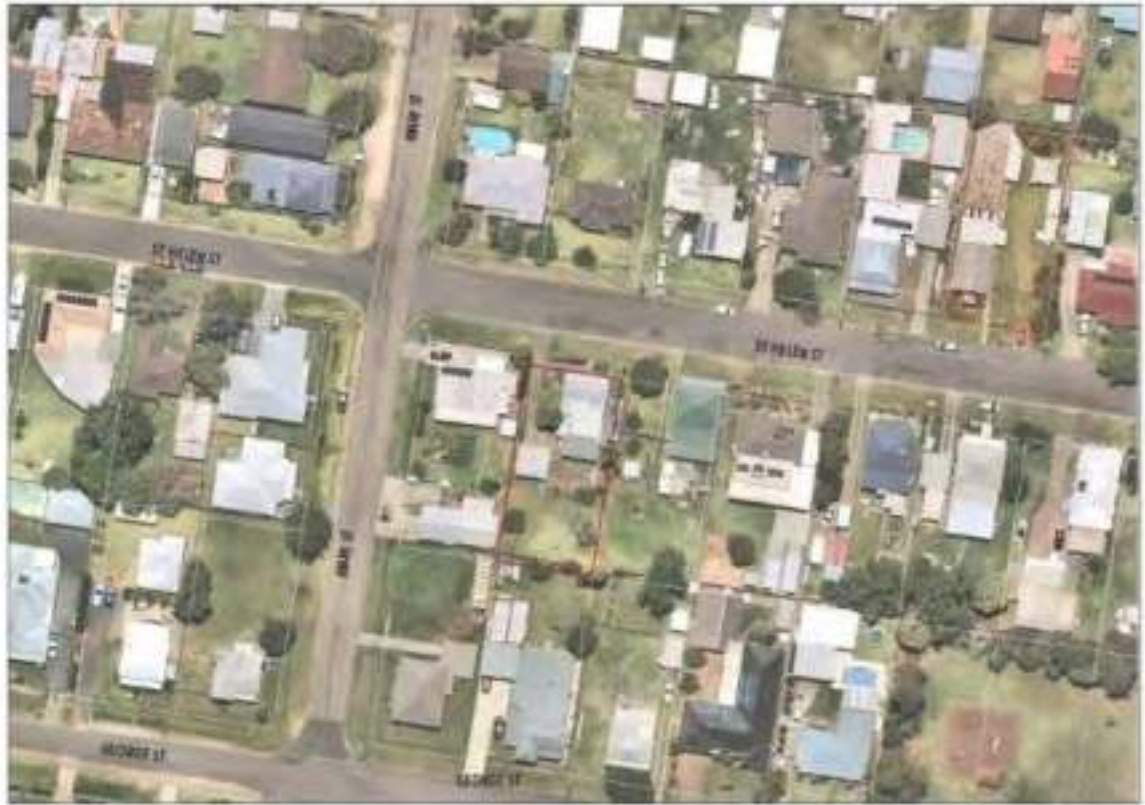
38 ST HELEN STREET, HOLMESVILLE 2286

Conservation Area Contribution Level	Est. Construction Date	Previous studies and/or community input
Contributory 1	1890–1920	No prior heritage investigations and no additional information required
Assessment Text		Observed Modifications
<p>Single storey Vernacular ‘Mining Cottage’ style dwelling with Colourbond hipped roof and weatherboard cladding. The veranda roof is skillion Colourbond, supported by square cut timber posts. The posts have ornate timber brackets.</p> <p>The veranda is partially enclosed by timber balustrade, with a timber floor. A single stair leads onto the veranda landing, with a concrete path in front.</p> <p>The front door is centrally located with a timber frame and a security screen. The main door is obscured. Double pane casement windows with timber shutters are found either side of the door.</p> <p>A concrete driveway runs the length of the property, leading to a double door garage with a hipped Colourbond roof and weatherboard cladding. The garage has been built in a sympathetic style to the dwelling and does not detract from its heritage value.</p> <p>The dwelling displays architectural features of a heritage style and is representative of the local development of this period, being of historical significance for the HCA.</p>		<p>The back of the dwelling has been extended with the addition of an extra room.</p> <p>The double garage is a recent addition, but sympathetic in style.</p>

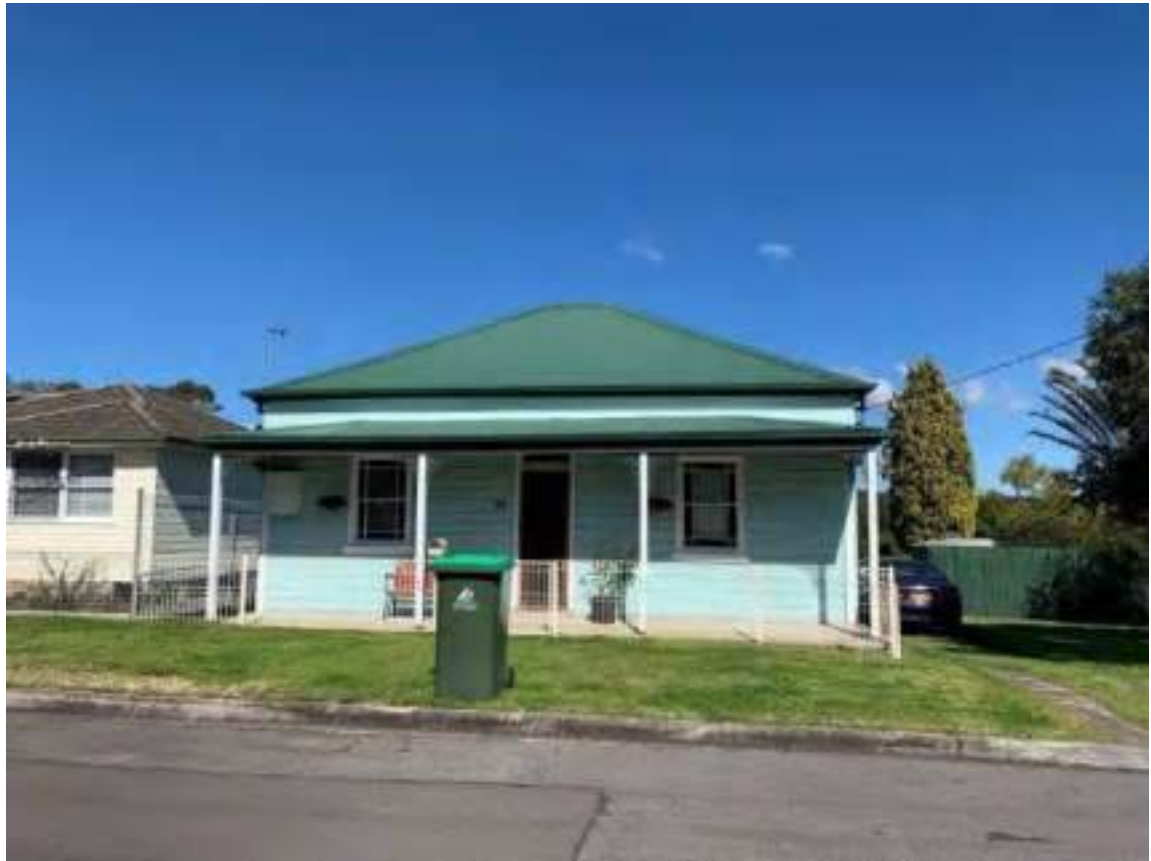
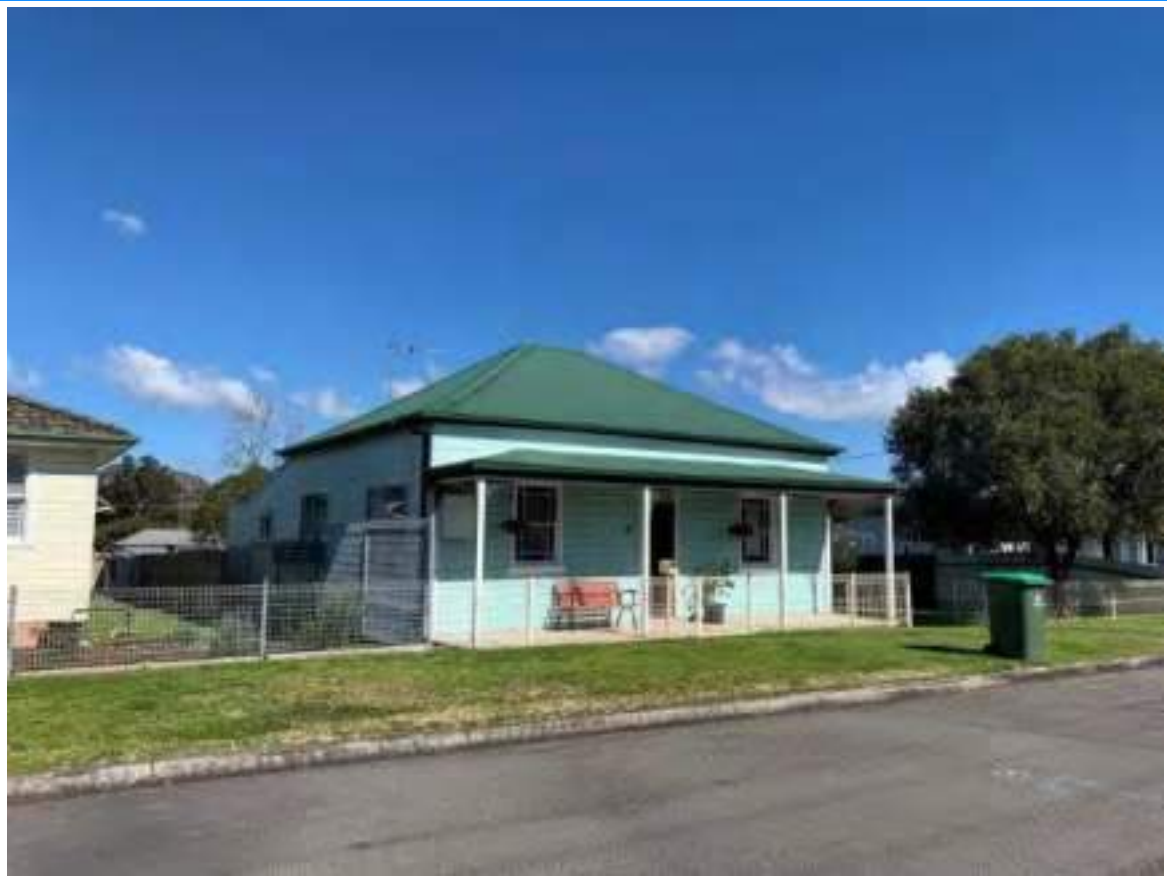
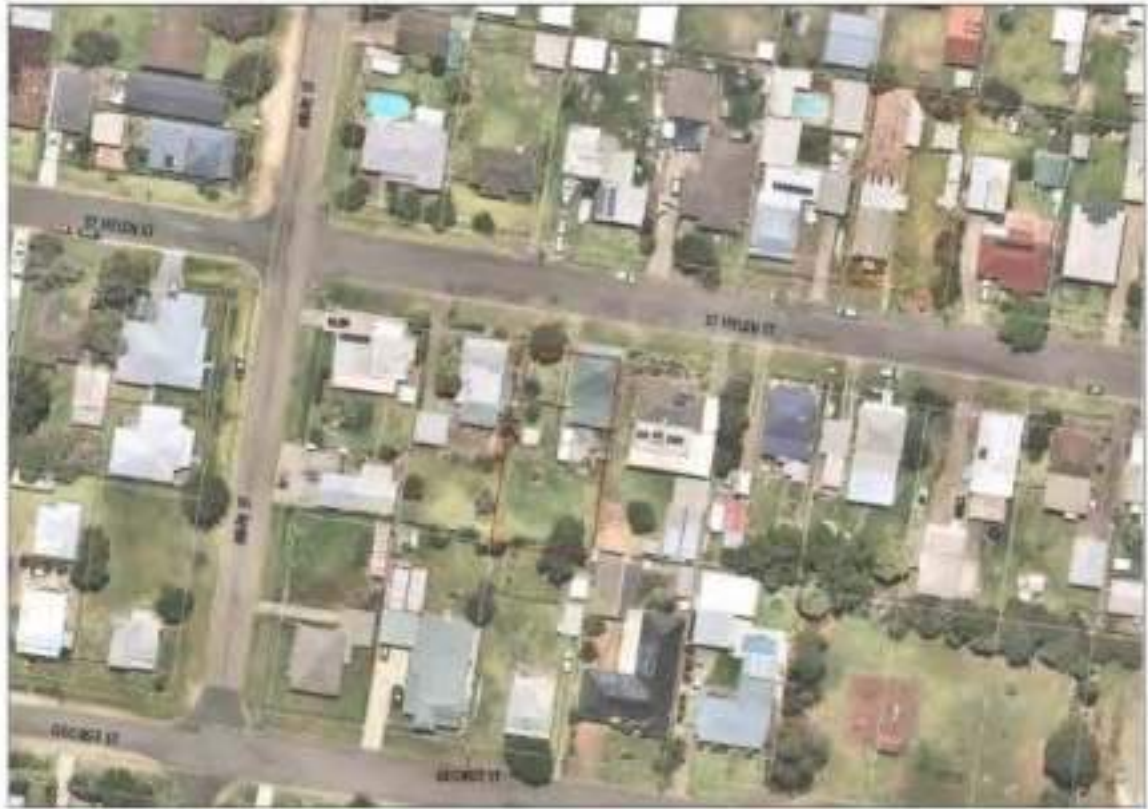
36 ST HELEN STREET, HOLMESVILLE 2286

Conservation Area Contribution Level	Est. Construction Date	Previous studies and/or community input
Contributory 1	1890–1920	No prior heritage investigations and no additional information required
Assessment Text		Observed Modifications
<p>Single storey Vernacular ‘Mining Cottage’ style dwelling with Colourbond hipped roof and timber weatherboard cladding. The veranda roof is hipped Colourbond, supported by square cut timber posts. The posts have iron lace brackets.</p> <p>The veranda is partially enclosed with white metal balustrade, with a gate entrance. The balustrade serves as both a railing/support, as well as the front fence to the property. The floor is concrete, with no stairs necessary.</p> <p>The front door is centrally located, with a timber four panel design, two of which are made of glass. A metal screen door is situated in front. Stained glass double hung timber framed windows are located on either side of the door. Both have a timber sill.</p> <p>The windows on the western side of the dwelling are double pane hung timber framed, however are lacking any stained glass or decorative features. The eastern windows are modern in design, being metal framed and sliding.</p> <p>The driveway is concrete, extended back to a green Colourbond fence enclosing the backyard.</p> <p>The dwelling displays architectural features of a heritage style and is representative of the local development of this period, being of historical significance for the HCA.</p>		<p>The veranda hipped roof is likely a modification to the traditional bull nose roof typical of the style.</p> <p>The eastern windows have been replaced with modern sliding designs, likely replacing the single hung timber windows evident on the western side of the dwelling.</p> <p>An extension has been constructed to the back southern portion of the dwelling. this is a common modification and is not visible from the street.</p>

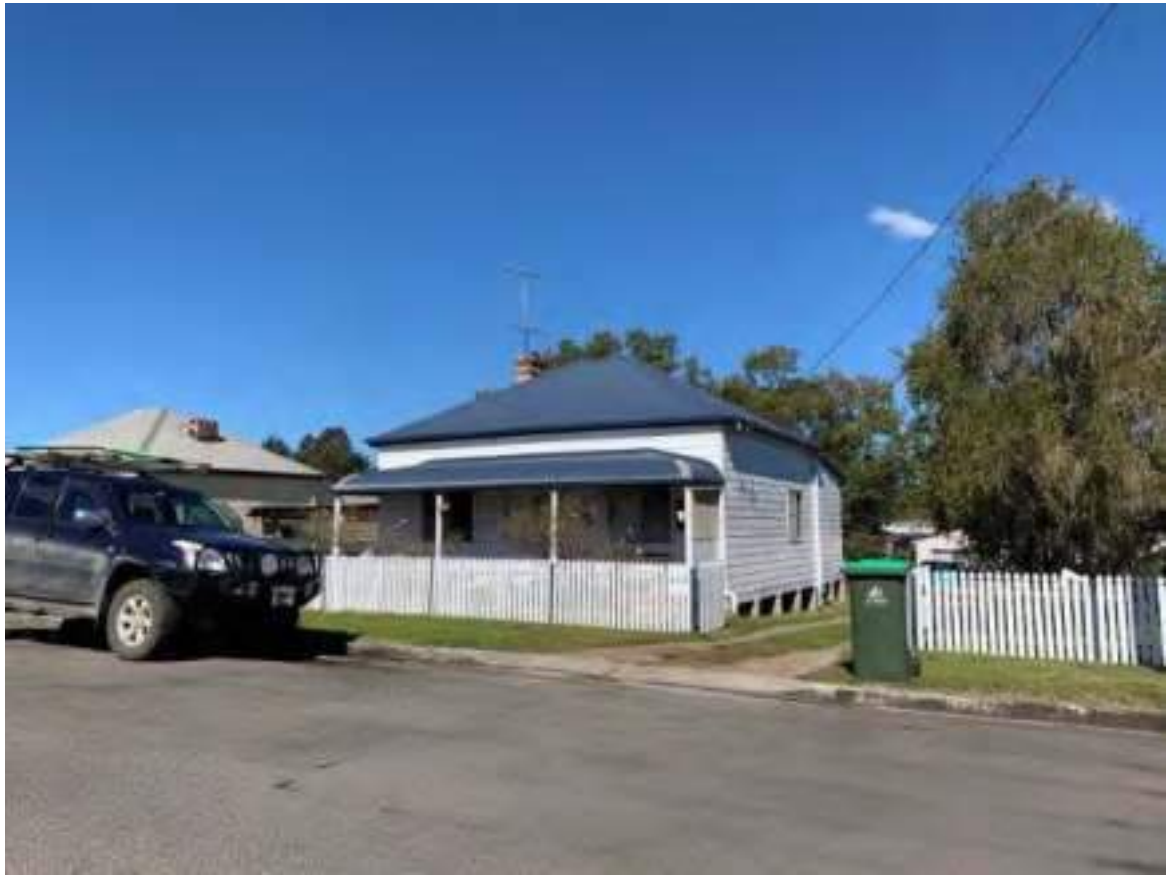
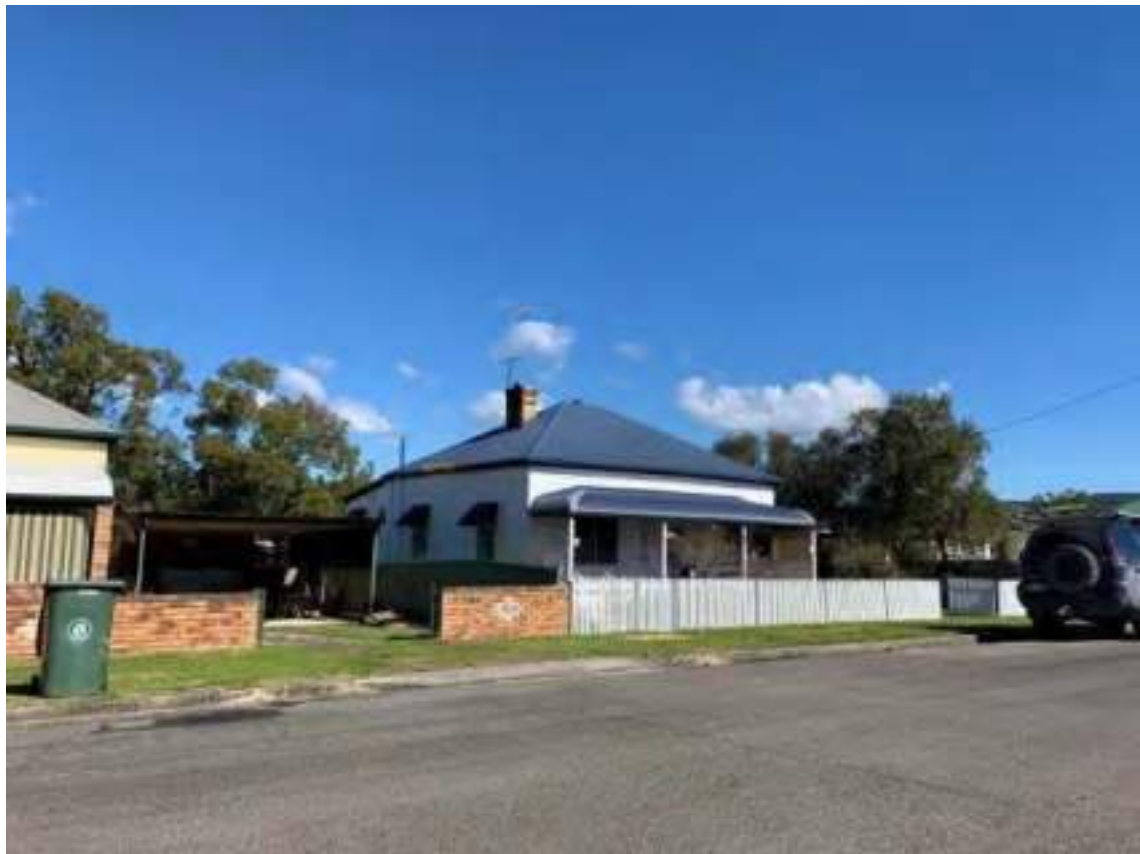
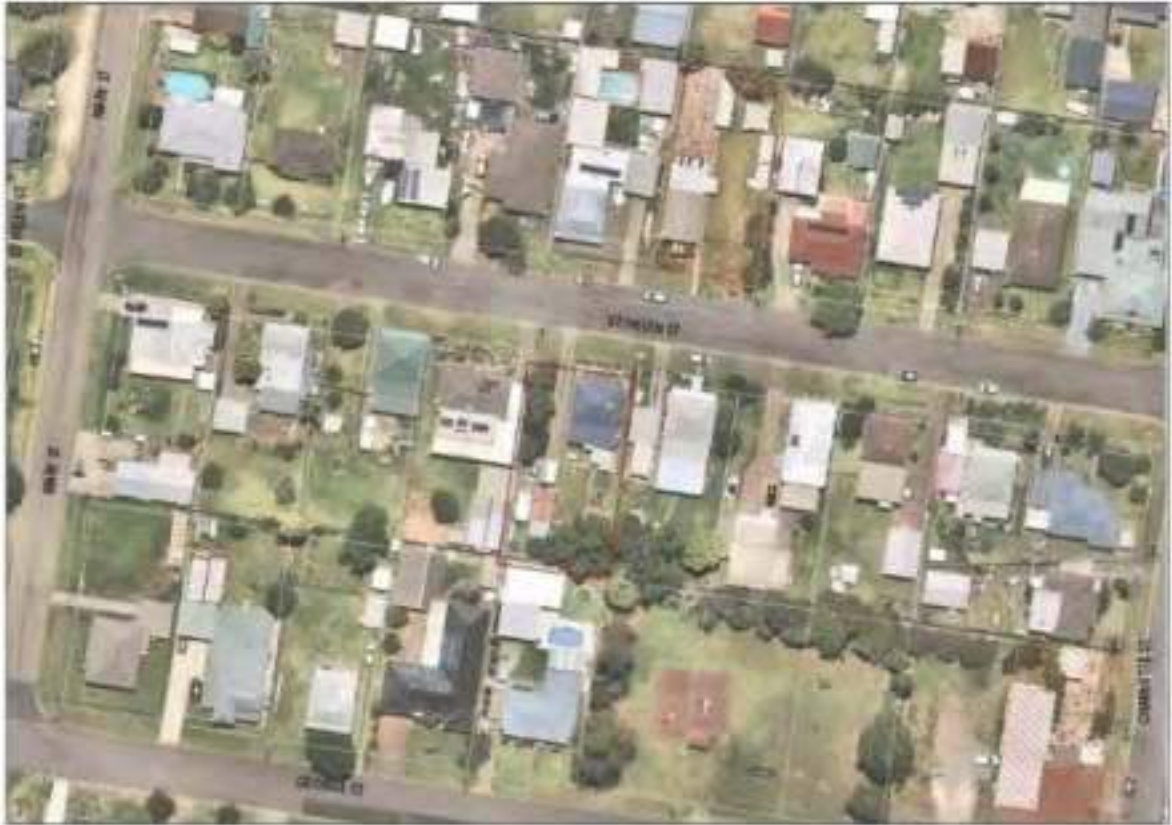
32 ST HELEN STREET, HOLMESVILLE 2286

Conservation Area Contribution Level	Est. Construction Date	Previous studies and/or community input
Contributory 1	1890–1920	No prior heritage investigations and no additional information required
Assessment Text		Observed Modifications
<p>Single storey Vernacular ‘Mining Cottage’ style dwelling with Colourbond hipped roof and weatherboard cladding. The veranda roof is bull nosed and supported by timber square cut posts.</p> <p>The veranda is an open space, with no balustrade. The floor is timber, with the stairs being located to the eastern side of the veranda. The stairs have a double support rail on either side.</p> <p>The front door is off centre, being dominantly to the west. The windows to either side are timbe framed and sliding.</p> <p>A rendered brickwork chimney is visible on the eastern side of the dwelling.</p> <p>The driveway is dirt/gravel and leads to a single door garage. The property is enclosed by a white timber picket fence.</p> <p>The dwelling displays architectural features of a heritage style and is representative of the local development of this period, being of historical significance for the HCA.</p>		<p>The front door being off centre is an unusual feature as the traditional dwelling style has it centrally positioned. This suggests the front façade has been modified. The window either side are modern sliding designs, further suggesting modifications have taken place.</p>

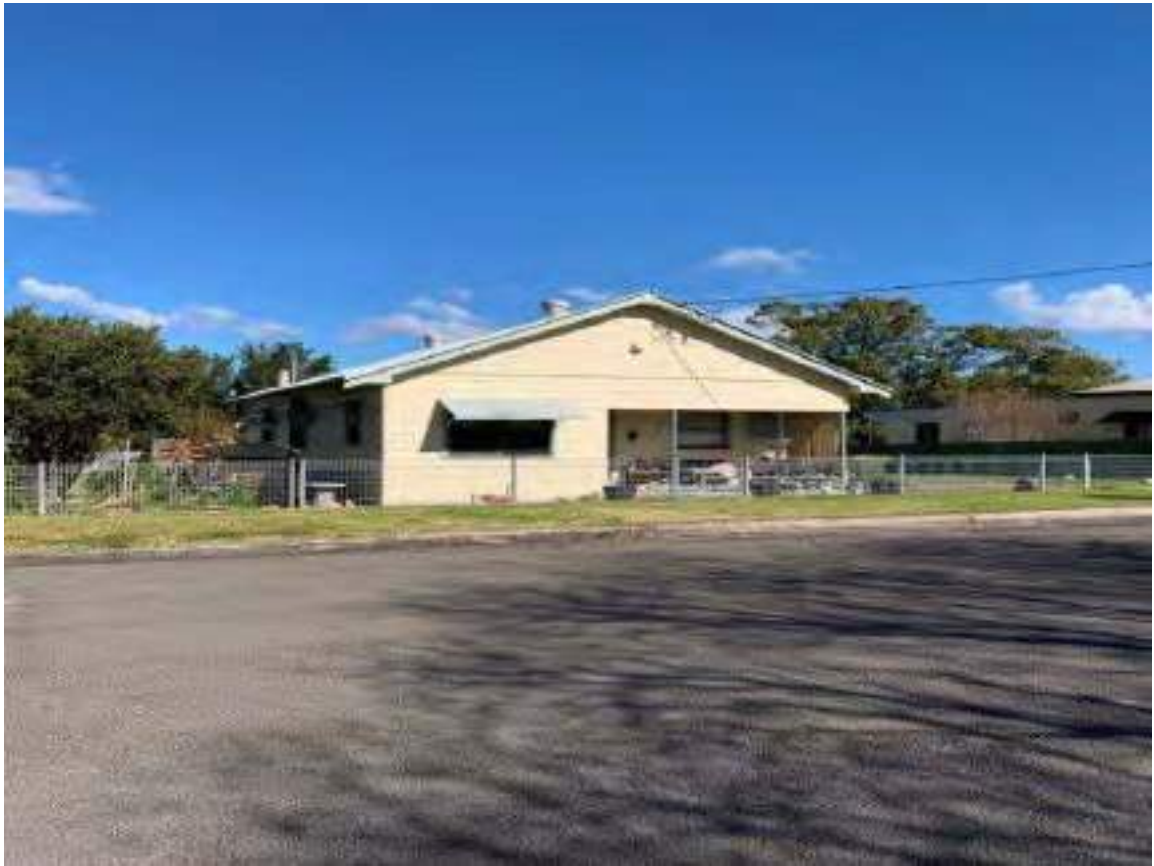
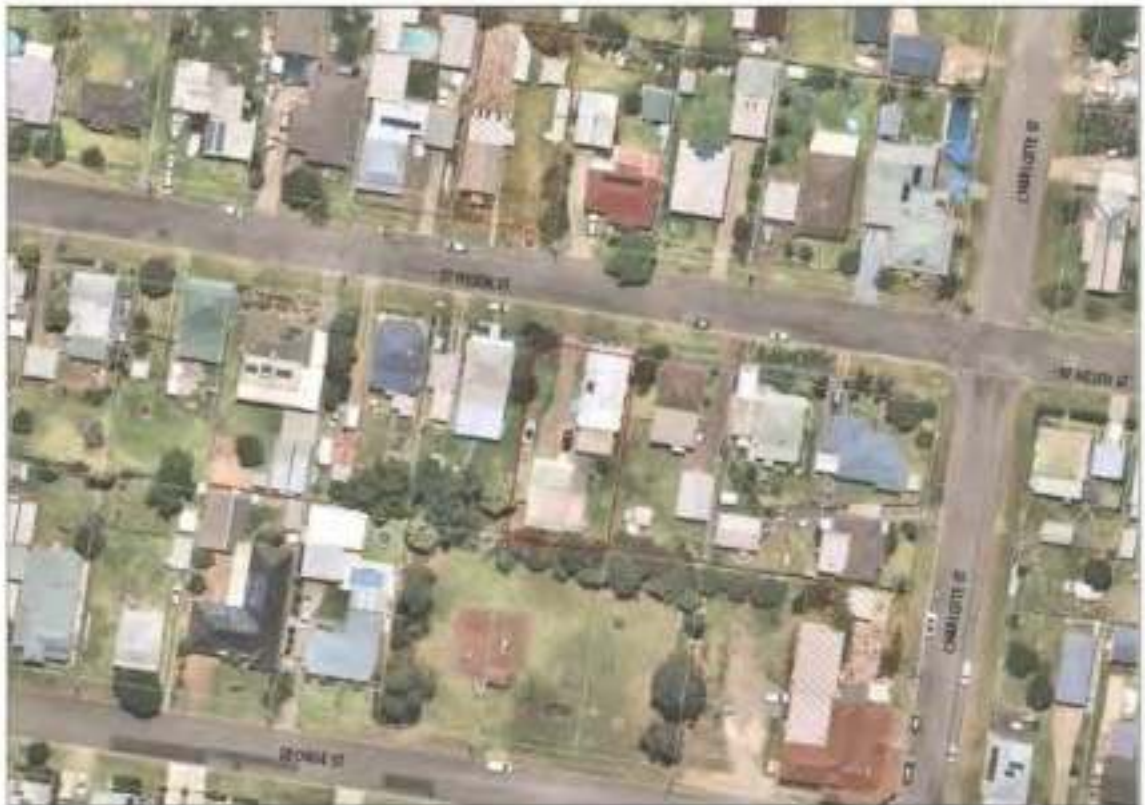
28 ST HELEN STREET, HOLMESVILLE 2286

Conservation Area Contribution Level	Est. Construction Date	Previous studies and/or community input
Contributory 1	1925–1935	No prior heritage investigations and no additional information required
Assessment Text		Observed Modifications
<p>Single storey simple Bungalow style dwelling with Colourbond gable roof and weatherboard cladding. There is no explicit veranda structure, however an alcove is available.</p> <p>The gable roof has no decorative features.</p> <p>The front door is centrally located with a timber frame and metal screen door. The main door is obscured. The window to the west of the door is timber framed and a double hung design, whilst the window to the east is a modern metal sliding design.</p> <p>The northern, western, and eastern walls all have windows with sheet metal awnings, with no decorative bracketing.</p> <p>The driveway is concrete and extends to a back set carport/garage structure at the back southern portion of the property. This is visible from the street and not sympathetic to the style of the dwelling. the concrete is also found as a path leading to the veranda.</p> <p>A metal fence runs the width of the property.</p> <p>The dwelling displays architectural features of a heritage style and is representative of the local development of this period, being of historical significance for the HCA.</p>		<p>The eastern front window has been replaced by a metal sliding design, likely replacing an original casement design.</p> <p>The metal screen main door is an additional to the property, obscuring a likely timber design.</p> <p>The concrete driveway and pathway are modifications to the property.</p>

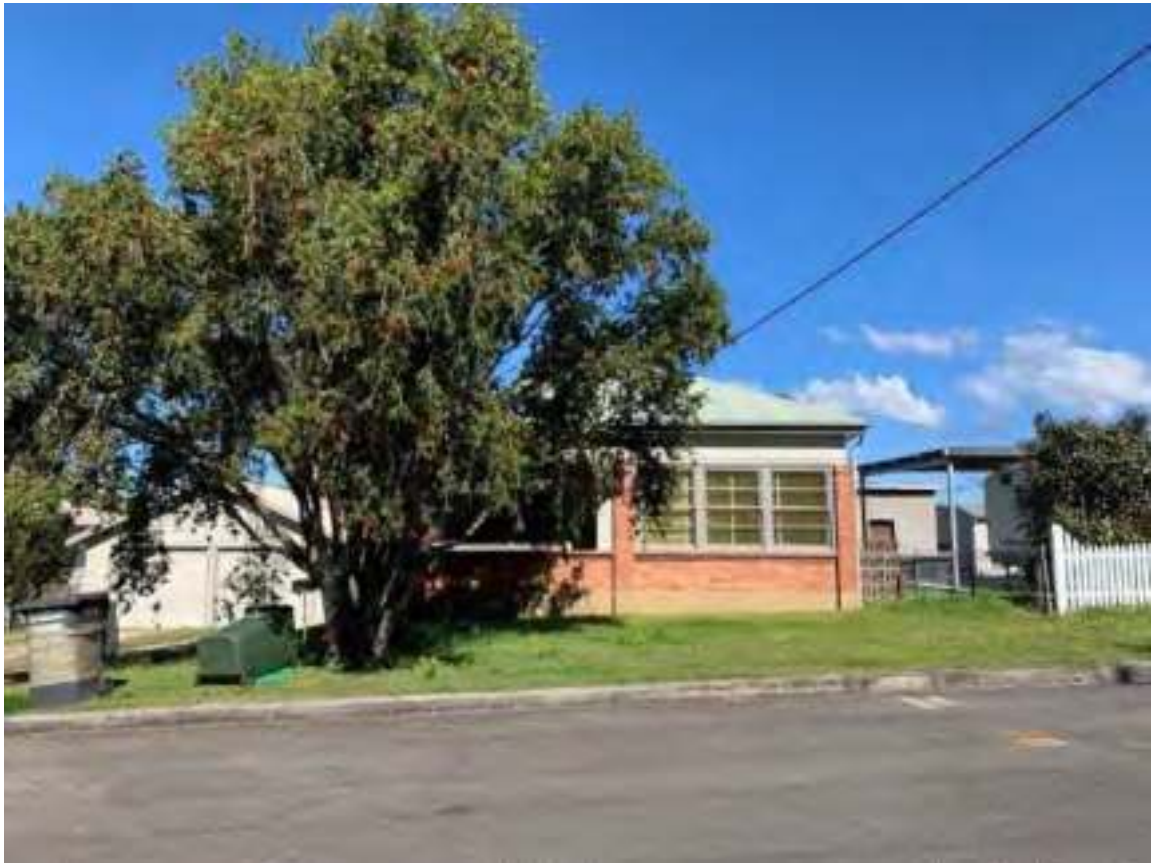
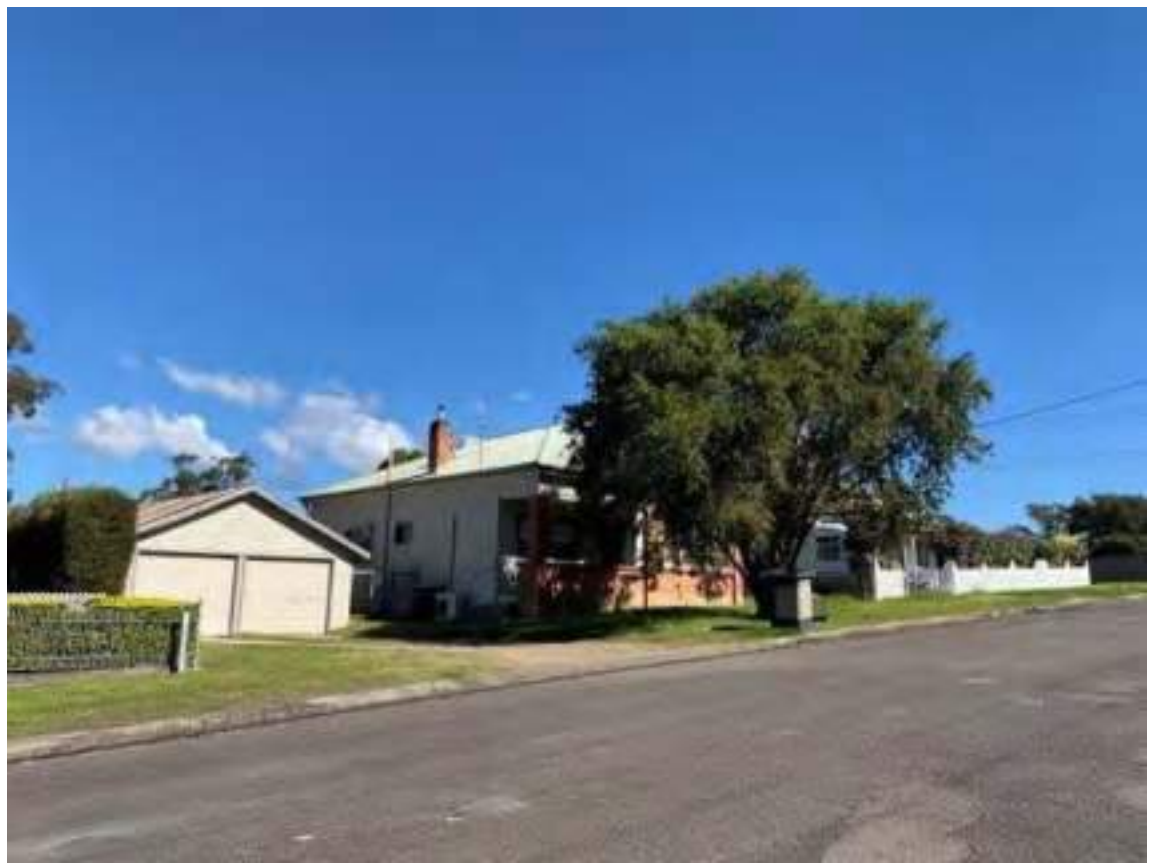
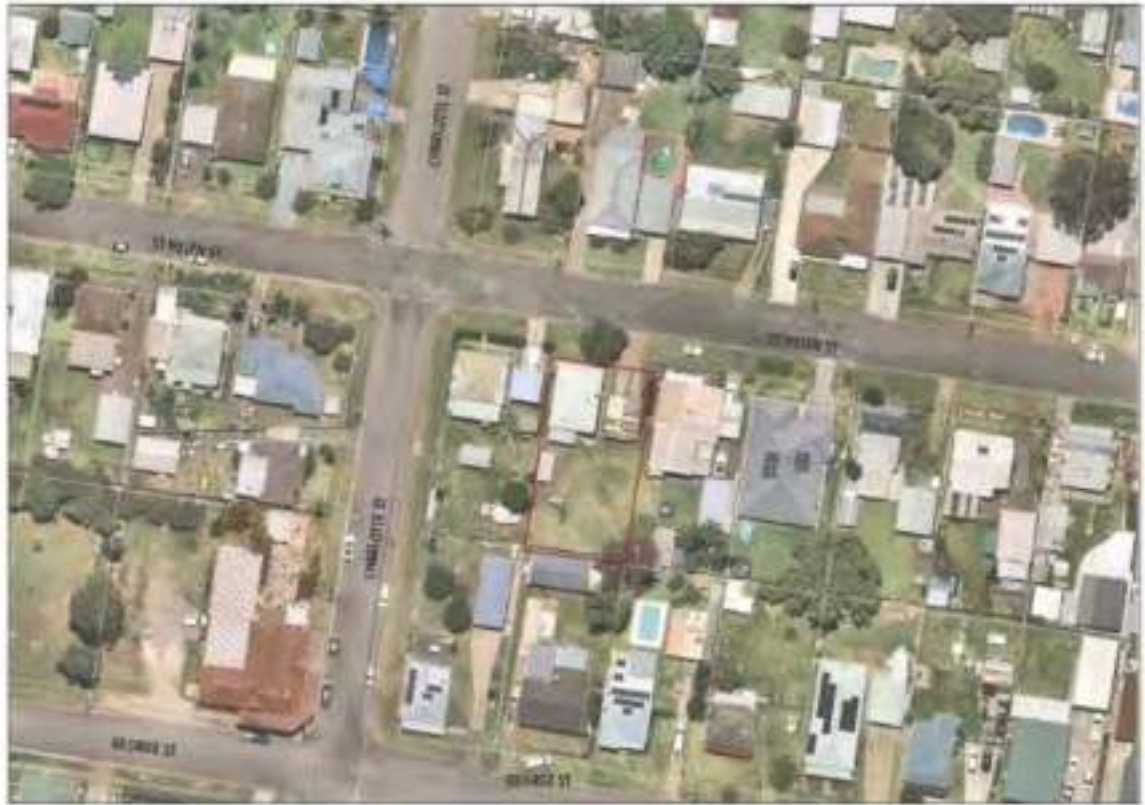
18 ST HELEN STREET, HOLMESVILLE 2286

Conservation Area Contribution Level	Est. Construction Date	Previous studies and/or community input
Contributory 1	1925–1940	No prior heritage investigations and no additional information required
Assessment Text		Observed Modifications
<p>Single storey simple Bungalow styled dwelling with Colourbond hipped roof and weatherboard cladding. The veranda space is enclosed, with red bricking providing a veranda wall as well as piers. The front door is centrally located, however faces to the east. The door is timber framed with a metal security screen. The windows to either side are multi panel eight pane casement designs, with timber framing.</p> <p>A set of concrete stairs lead onto the veranda landing, which has a timber floor. The bottom section of the brick veranda wall has been rendered.</p> <p>A red brickwork chimney is visible on the eastern side of the dwelling. no decorative features are used.</p> <p>A double door garage is located to the east of the dwelling, with a Colourbond gable roof and weatherboard cladding. This has been constructed in a neutral manner and is highly visible from the street.</p> <p>The dwelling displays architectural features of a heritage style and is representative of the local development of this period, being of historical significance for the HCA.</p>		<p>The garage is a recent addition to the property.</p>
