APPENDIX 2

Building Assessment Sheets (Inventory Sheets)

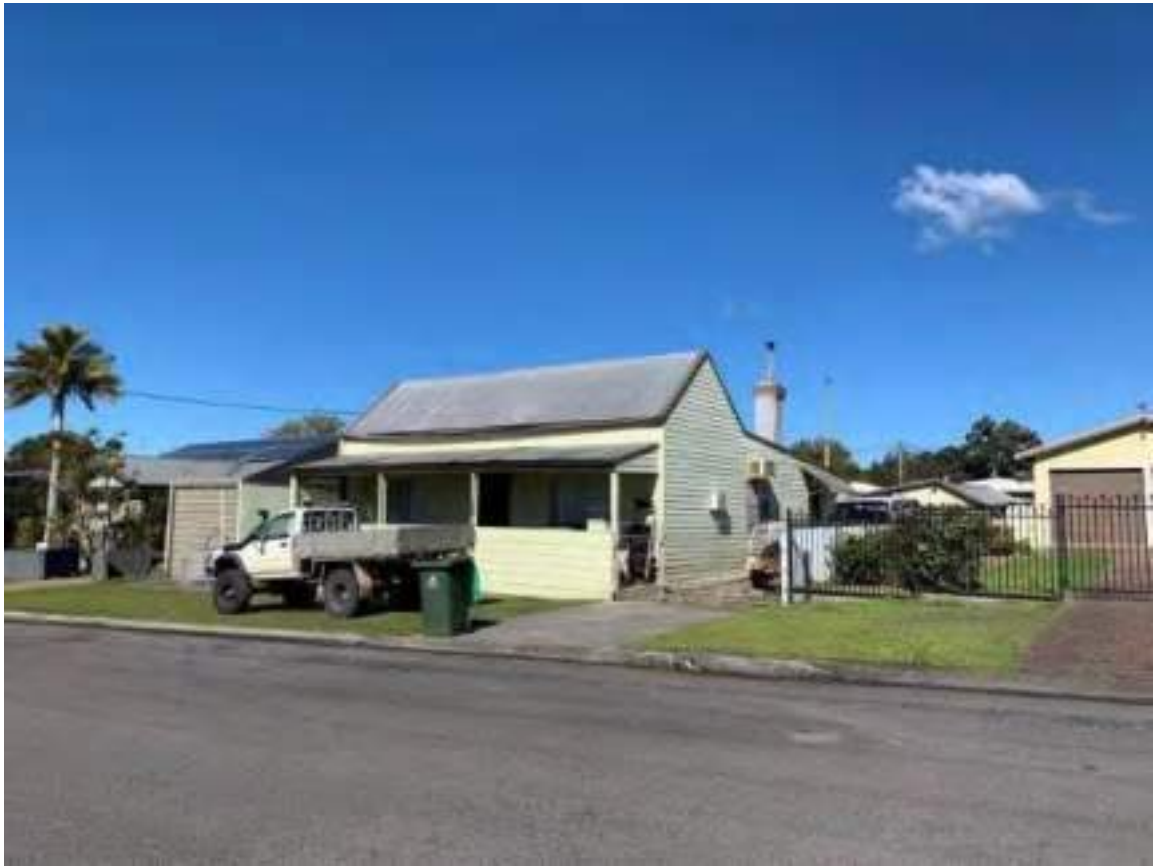
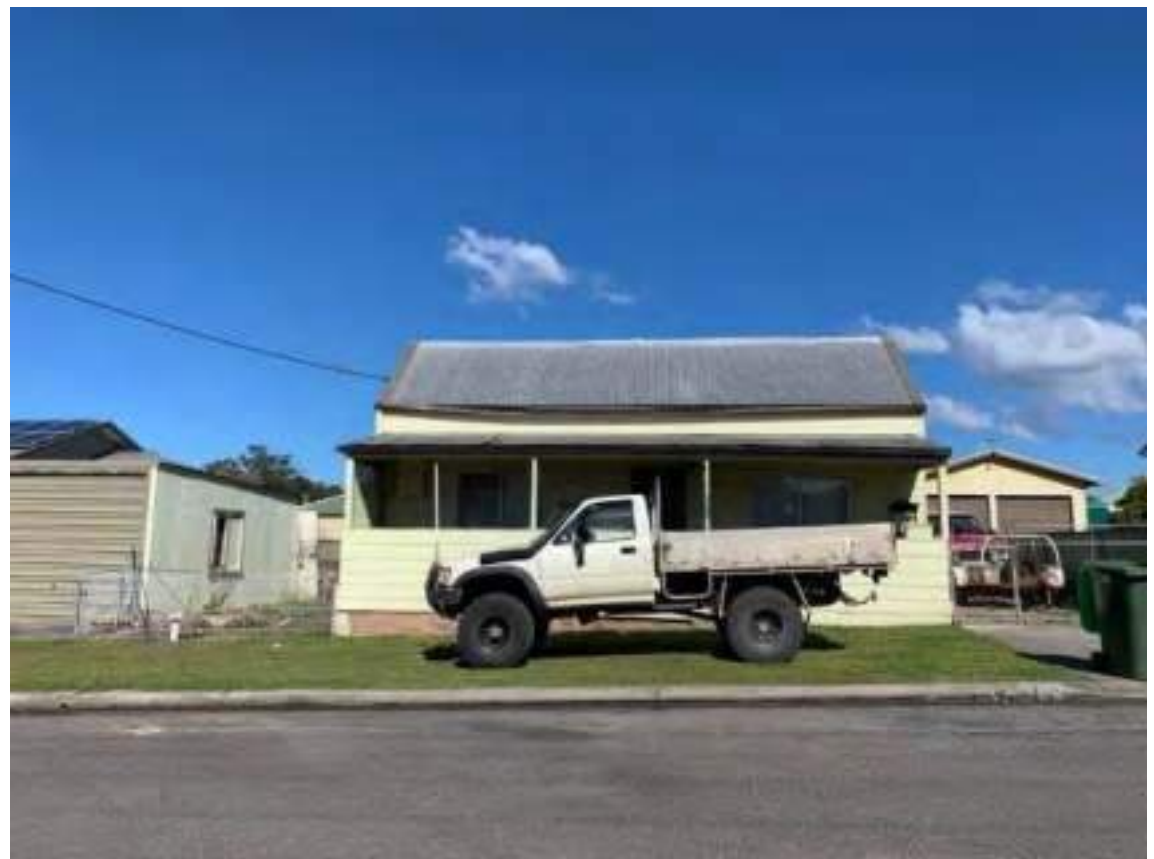
8 ST HELEN STREET, HOLMESVILLE 2286

Conservation Area Contribution Level	Est. Construction Date	Previous studies and/or community input
Contributory 1	1890–1915	No prior heritage investigations and no additional information required
Assessment Text		Observed Modifications
<p>Single storey Vernacular ‘Mining Cottage’ style dwelling with Colourbond gable roof and timber weatherboard cladding. The veranda roof is skillion Colourbond, supported by circular metal poles.</p> <p>The veranda is partially enclosed due to timber panels acting as a veranda wall and a timber lattice panel on the eastern end of the space.</p> <p>The front door is centrally located, with a metal framed security screen obscuring the main door. The windows on either side are metal framed two panel hung/sliding designs.</p> <p>The dwelling is supported by brick piers, as visible at the front façade.</p> <p>A rendered brick chimney is visible on the southern portion of the dwelling.</p> <p>A garage structure is partially visible at the back southern side of the dwelling.</p> <p>The dwelling displays architectural features of a heritage style and is representative of the local development of this period, being of historical significance for the HCA.</p>		<p>The southern portion of the dwelling has been extended, however this is not visible from the street and does not impact the heritage value of the property.</p> <p>The timber panels enclosing the veranda space would be a modification, as typically this style would have no balustrades or veranda walls.</p>

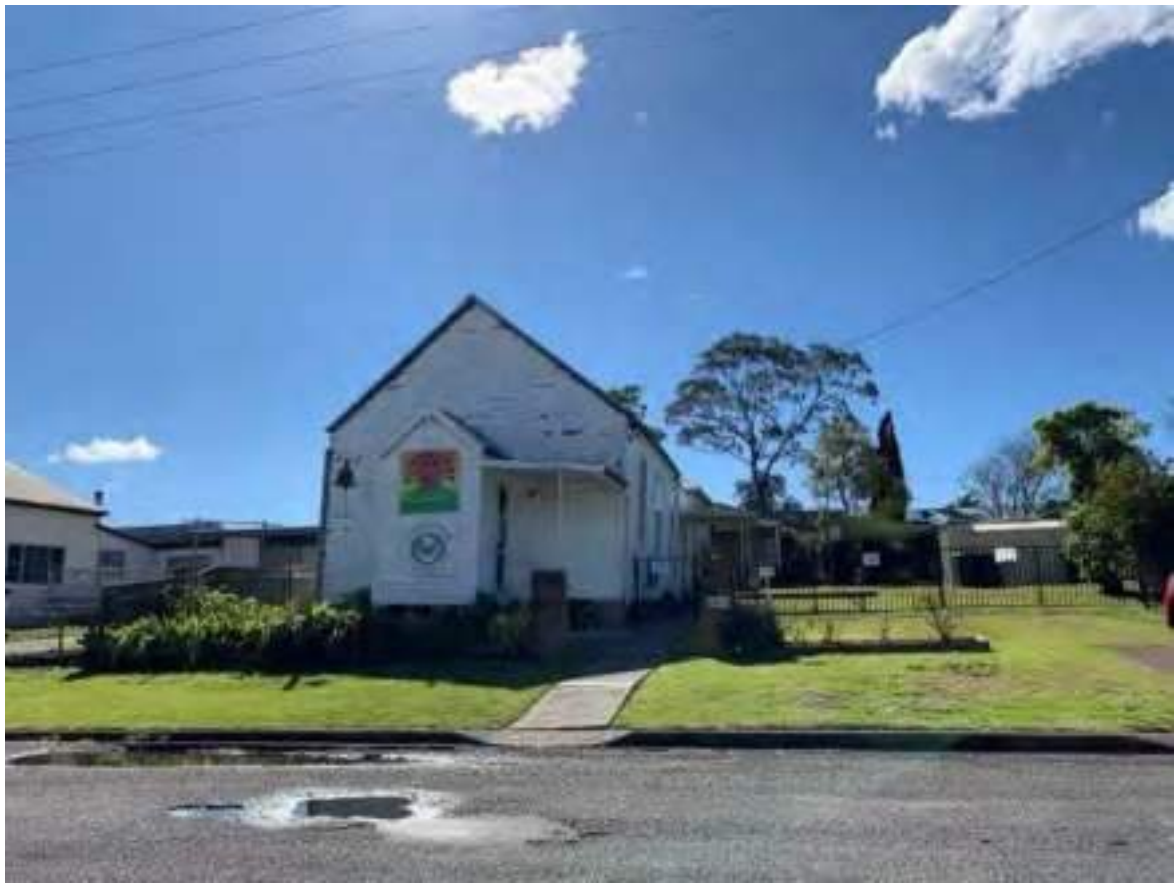
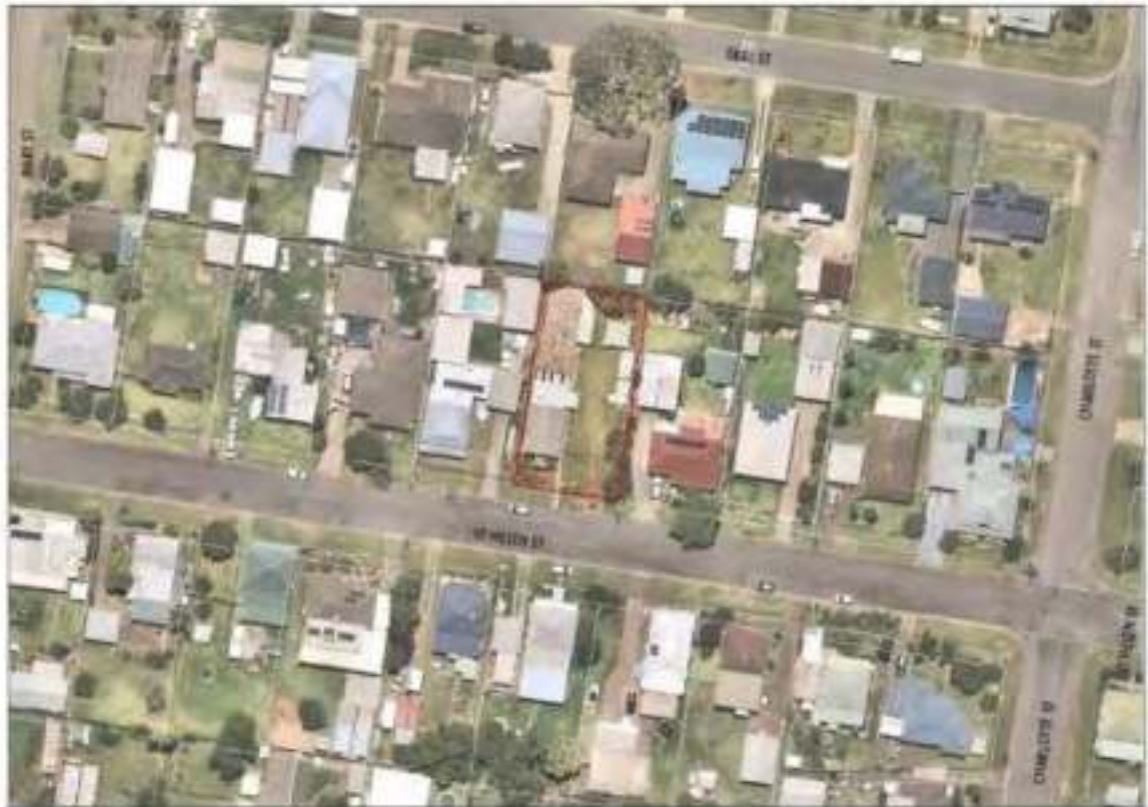
29 ST HELEN STREET, HOLMESVILLE 2286

Conservation Area Contribution Level	Est. Construction Date	Previous studies and/or community input
Contributory 1	1880–1910	No prior heritage investigations and no additional information required
Assessment Text		Observed Modifications
<p>A Simple Victorian to Federation Gothic styled structure with Colourbond gable roof and timber weatherboard cladding. The church is box shaped with steeply pitched gable roof, with no decorative features visible.</p> <p>The western and eastern side windows are single hung double pane windows, with timber frames. The main door is located within the porch, facing eastwards. The porch has a timber finial.</p> <p>A set of timber stairs leads into the porch and to the front door, with support metal rails on either side.</p> <p>The backyard portion of the property is demarcated by a black metal fence, running the width of the property.</p> <p>A secondary structure is located immediately behind the main church building, to the north. This structure has a hipped Colourbond roof and weatherboard cladding.</p> <p>Two red brick pillars frame the entrance, following a concrete path.</p>		<p>The support rails on either side of the entrance stairs are a modern addition of the building.</p> <p>The posters dominating the façade are very recent, stating 'Sugarloaf Community, Uniting Church' and 'Mums Cottage'.</p>

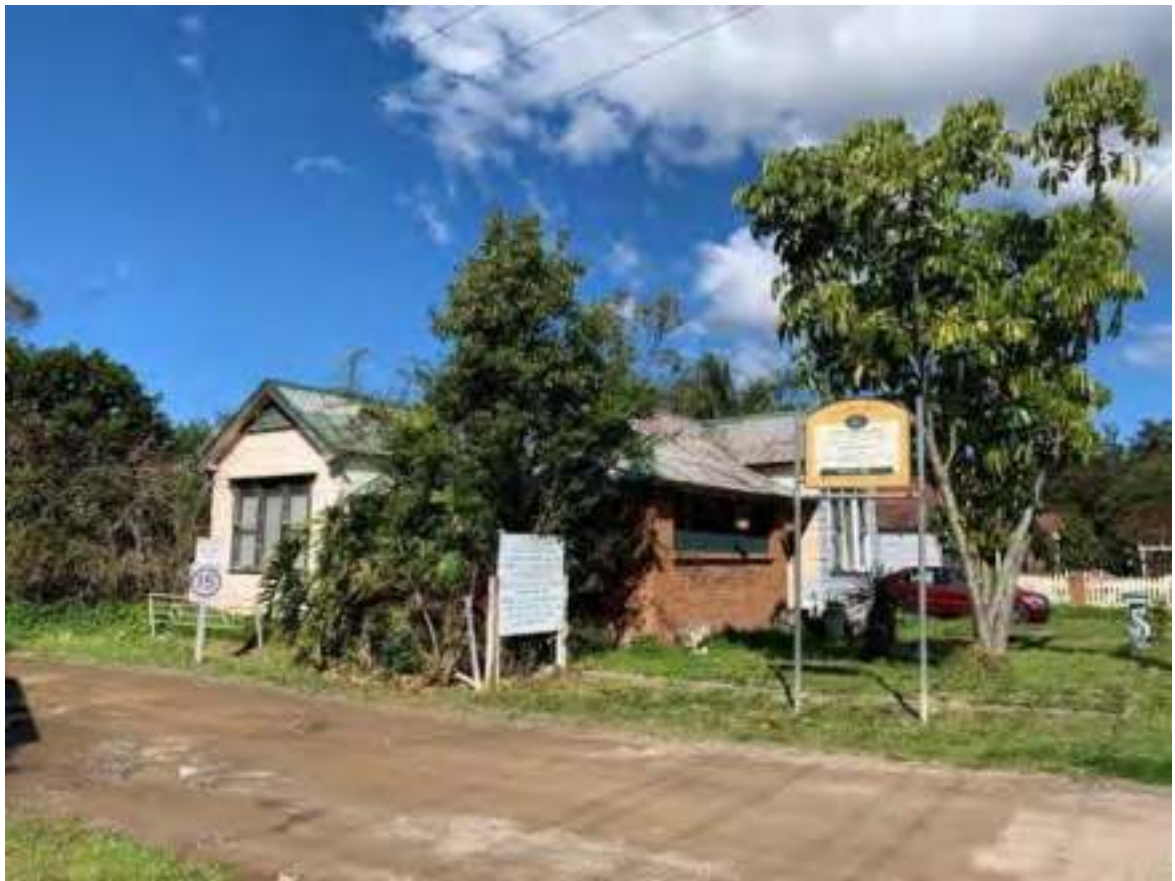
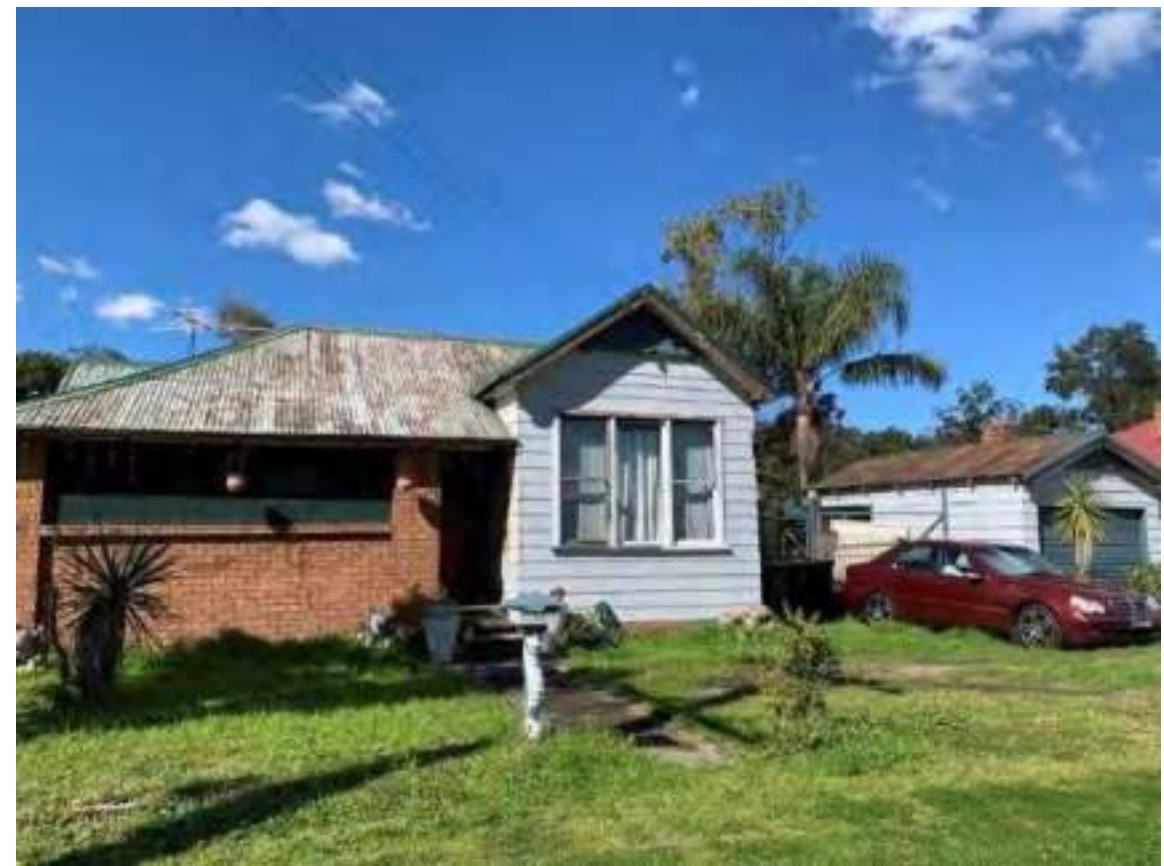
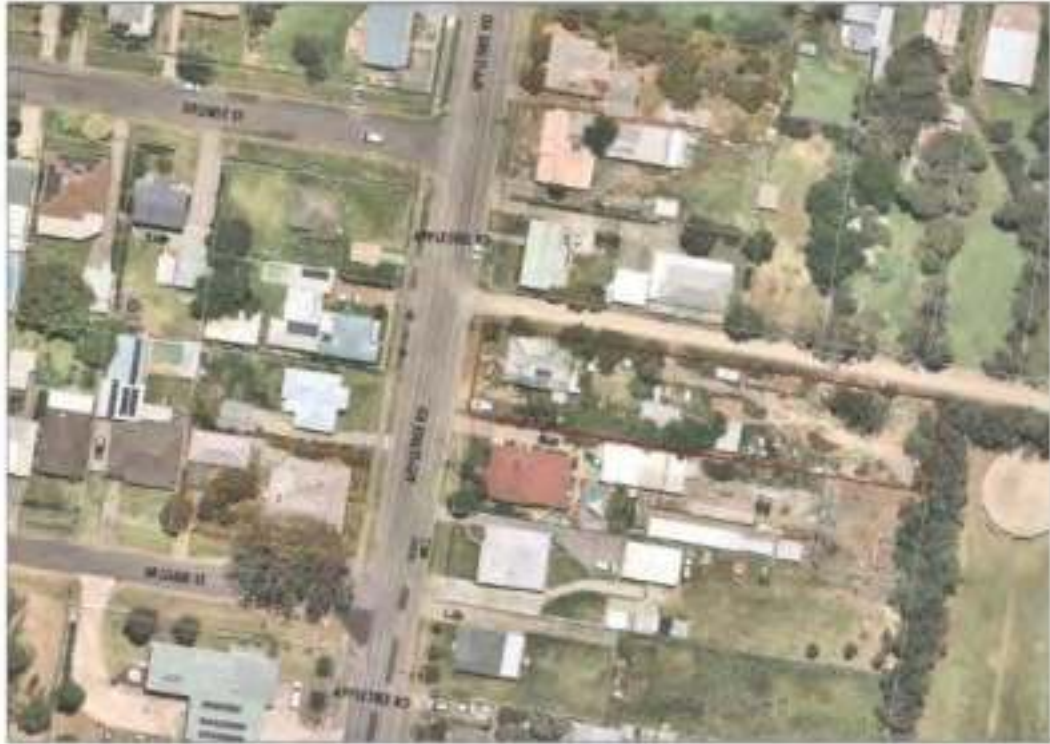
53 APPLETREE ROAD, HOLMESVILLE 2286

Conservation Area Contribution Level	Est. Construction Date	Previous studies and/or community input
Contributory 1	1900–1920	No prior heritage investigations and no additional information required
Assessment Text		Observed Modifications
<p>Single storey simple Federation ‘workmen’s cottage’ style dwelling with extensive modifications to the front façade, and additional period extensions. The roof is a cross gable and hipped Colourbond design, with a timber weatherboard cladding exterior. The veranda roof is an extension of the hipped roof covering the majority of the dwelling and is supported by brick pillars.</p> <p>The veranda is enclosed by a brick veranda wall and brick pillars, with a green canvas/mesh awning provides additional protection. Brick and concrete stairs lead onto the veranda, with no railing.</p> <p>The front door is centrally located, with a timber four panel design. A five pane, three panel timber framed window is located to the south of the main door, dominating the original façade. The window has a simple timber sill. The window is a hung design and is likely original.</p> <p>The gable roof has minimal decoration, with decorative shingles and barge board eaves. The same window and shingle decoration is visible on the gable roof of the northern side of the dwelling.</p> <p>A simple brickwork chimney is visible at the east of the dwelling, with two terracotta pots.</p> <p>A single door garage is located to the south of the dwelling, with a gable Colourbond roof and weatherboard cladding. The garage also has decorative shingles similar to the dwelling. it has been constructed in a sympathetic manner.</p> <p>Extensive vegetation growth along the northern side has obscured the dwelling.</p> <p>The dwelling displays architectural features of a heritage style and is representative of the local development of this period, being of historical significance for the HCA.</p>		<p>The brick veranda features are a later modification to the dwelling, likely replacing timber balustrade and red brick veranda wall.</p> <p>The front door is a modern addition, with the addition of two glass panels.</p> <p>A lean too skillion roofed structure is visible on the southern side of the dwelling.</p>

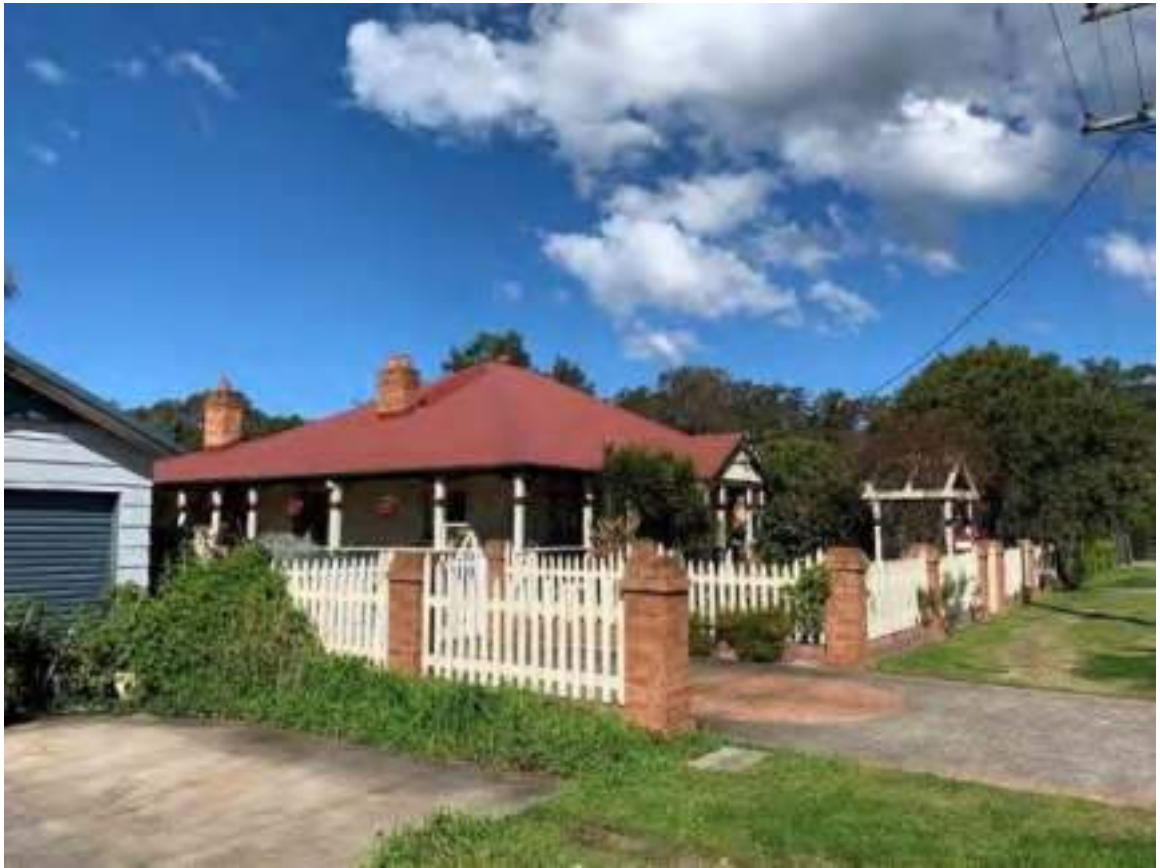
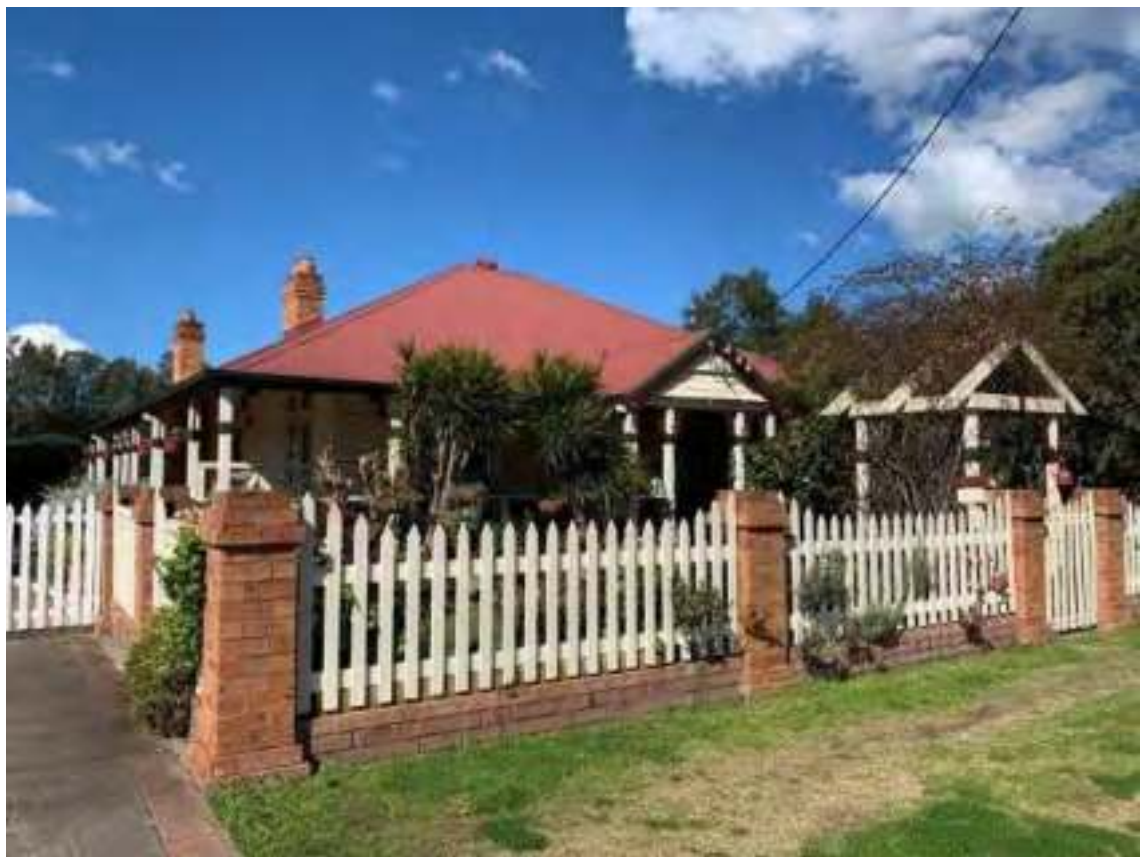
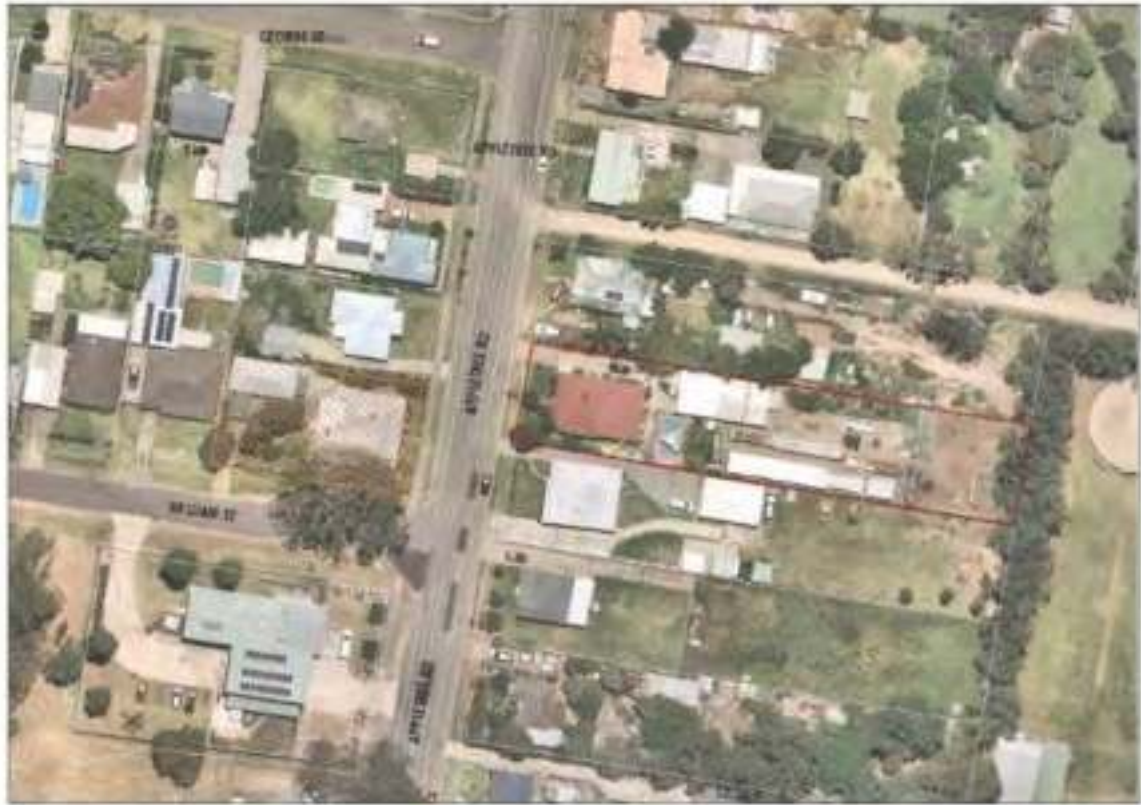
55 APPLETREE ROAD, HOLMESVILLE 2286

Conservation Area Contribution Level	Est. Construction Date	Previous studies and/or community input
Contributory 1	1915–1920	Holmesville Heritage Study 1993
Assessment Text		Observed Modifications
<p>Single storey Federation Bungalow style dwelling with an extended steep hipped Colourbond roof, with western gable feature, and timber weatherboard cladding. The veranda roof is an extension of the main roof, and is supported by square cut timber posts with ornate art nouveau styled brackets.</p> <p>The veranda is partially enclosed by timber balustrades.</p> <p>The gabled roof section has a shingled pediment and lyre shaped timber brackets on the posts.</p> <p>The front is obscured by vegetation, with an additional timber framed door being found on the northern facade. The western and northern visible windows are casement designs, with timber frames, coloured top lights and stained-glass panes on the top and bottom. Timber sills are visible under the windows. Only one of the original northern casement windows remains, the other being removed during renovations.</p> <p>Two mottled pink brickwork chimneys are visible on the northern side, with terracotta pots on top.</p> <p>The property is enclosed by a combined brick and timber picket fence, which although a modification has been constructed in a sympathetic manner. A concrete and brick driveway leads into the dwelling.</p> <p>The dwelling displays architectural features of a heritage style and is representative of the local development of this period, being of historical significance for the HCA.</p>		<p>The dwelling has undergone extensive modifications prior to the 1993 assessment, including the extension of the northern veranda roof and extension of the eastern portion of the dwelling including the incorporation of the secondary eastern chimney.</p> <p>The support posts and associated timber brackets of the northern side of the veranda are all modern replication of the original style present under the gable roofing.</p> <p>The timber balustrade enclosing the veranda space is a modern addition.</p> <p>The timber gabled archway leading into the property is a recent addition.</p> <p>The fencing surrounding the dwelling is a recent addition, having replaced an unsympathetic Colourbond fence.</p>

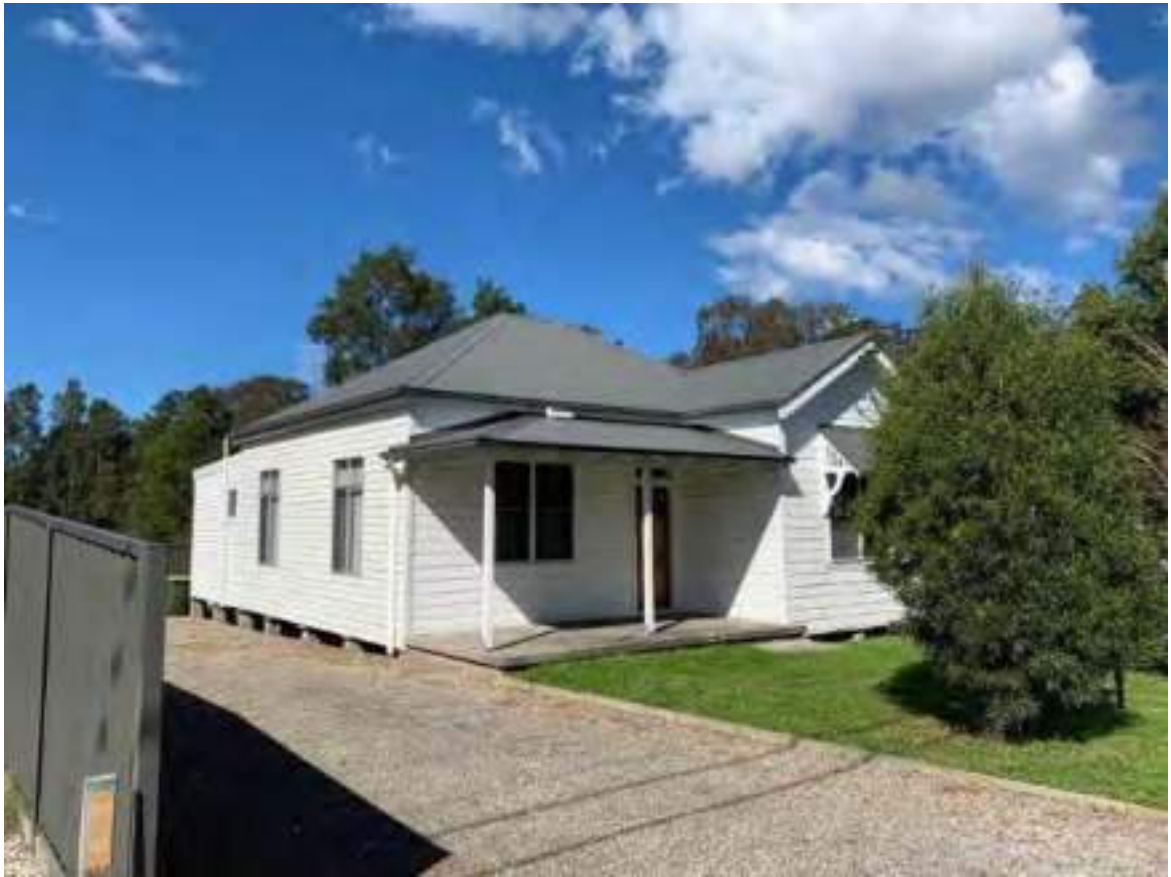
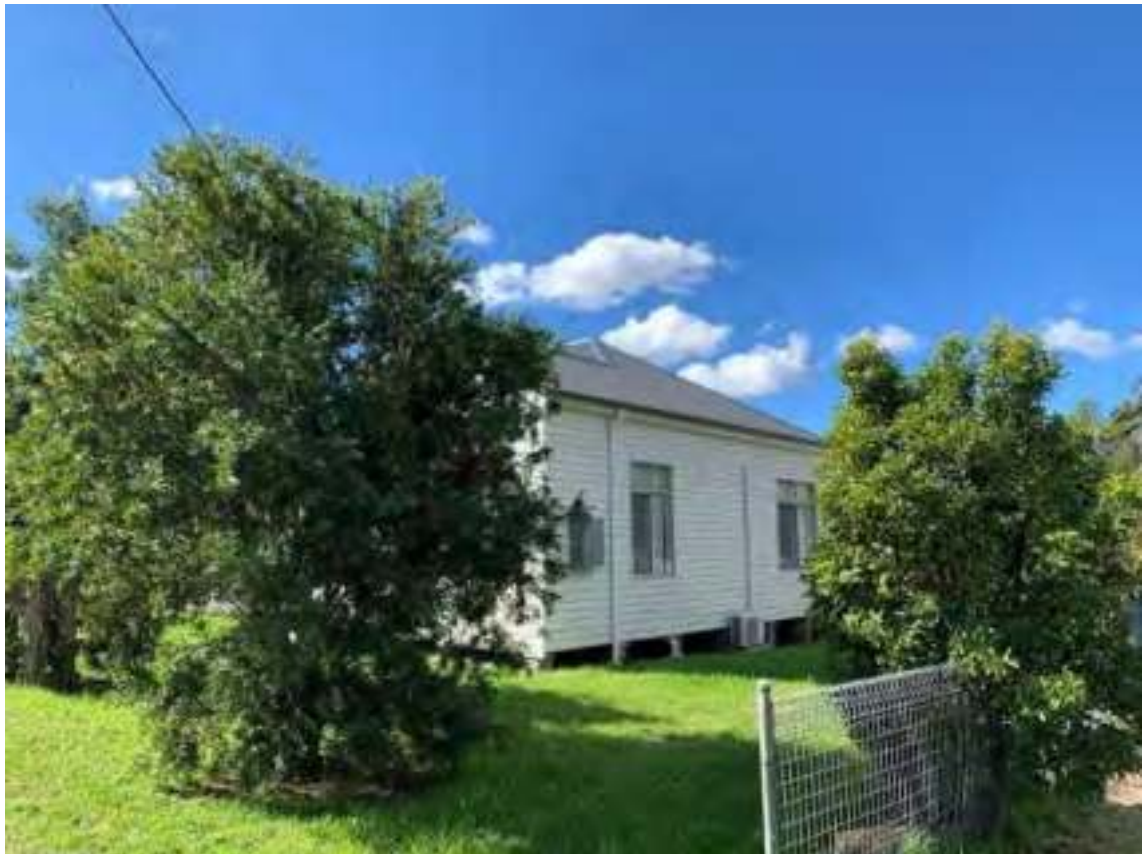
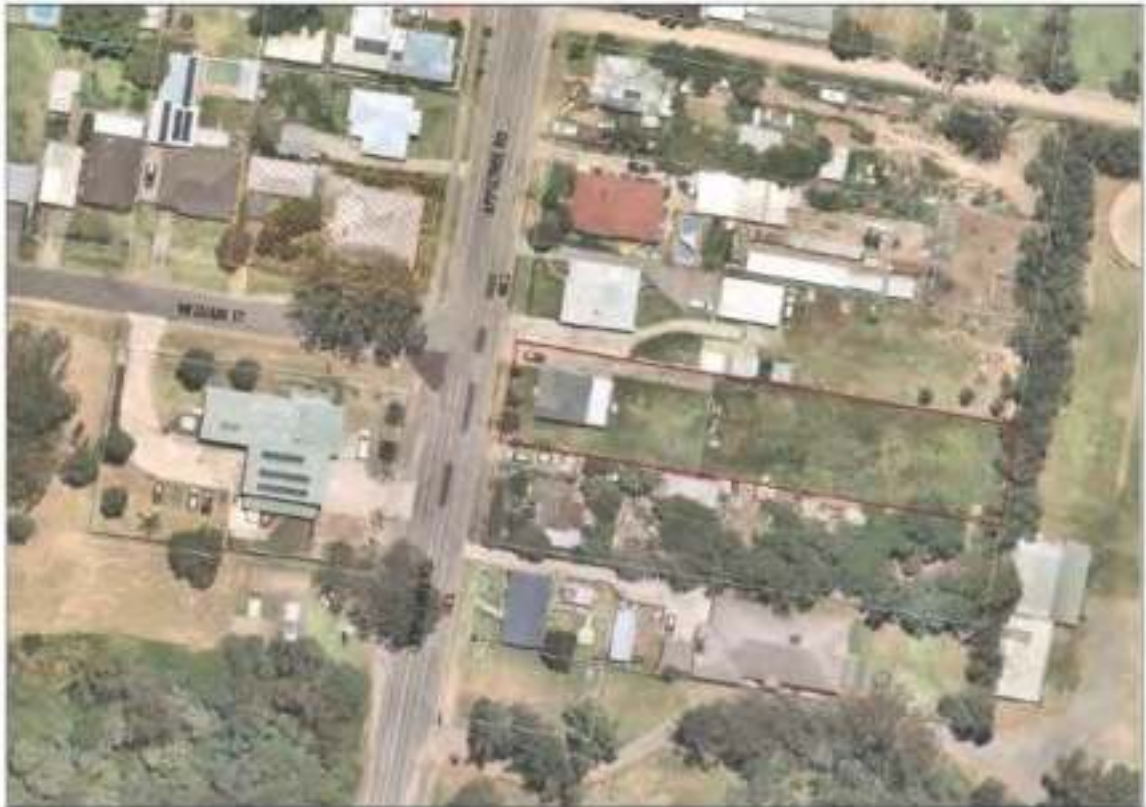
59 APPLETREE ROAD, HOLMESVILLE 2286

Conservation Area Contribution Level	Est. Construction Date	Previous studies and/or community input
Contributory 1	1900–1920	No prior heritage investigations and no additional information required
Assessment Text		Observed Modifications
<p>Single storey simple Federation ‘workmen’s cottage’ style dwelling with half gable and hipped Colourbond roof and timber weatherboard cladding. The veranda is hipped and supported by square cut timber posts, with the underlying support beams being visible.</p> <p>The veranda is open, with no balustrades. The floor is concrete with no stairs.</p> <p>The gable roof has minimal decoration with only barge boards visible. The window is a double pane sash window, with a metal sheet awning and decorative timer bracket.</p> <p>The front door is timber framed and centrally located. It is a four panel design, with a glass arch above. A modern timber framed double pane window is located to the north of the door. The northern facing windows are timber framed sliding designs.</p> <p>The driveway is gravel, with no fencing or gates enclosing the property.</p> <p>The dwelling displays architectural features of a heritage style and is representative of the local development of this period, being of historical significance for the HCA.</p>		<p>The front door and western facing veranda window are recent additions to the dwelling, likely replacing the original features. Similarly the north facing windows are modern additions.</p> <p>An extension has been constructed on the eastern side of the dwelling, and is not visible from the street.</p>

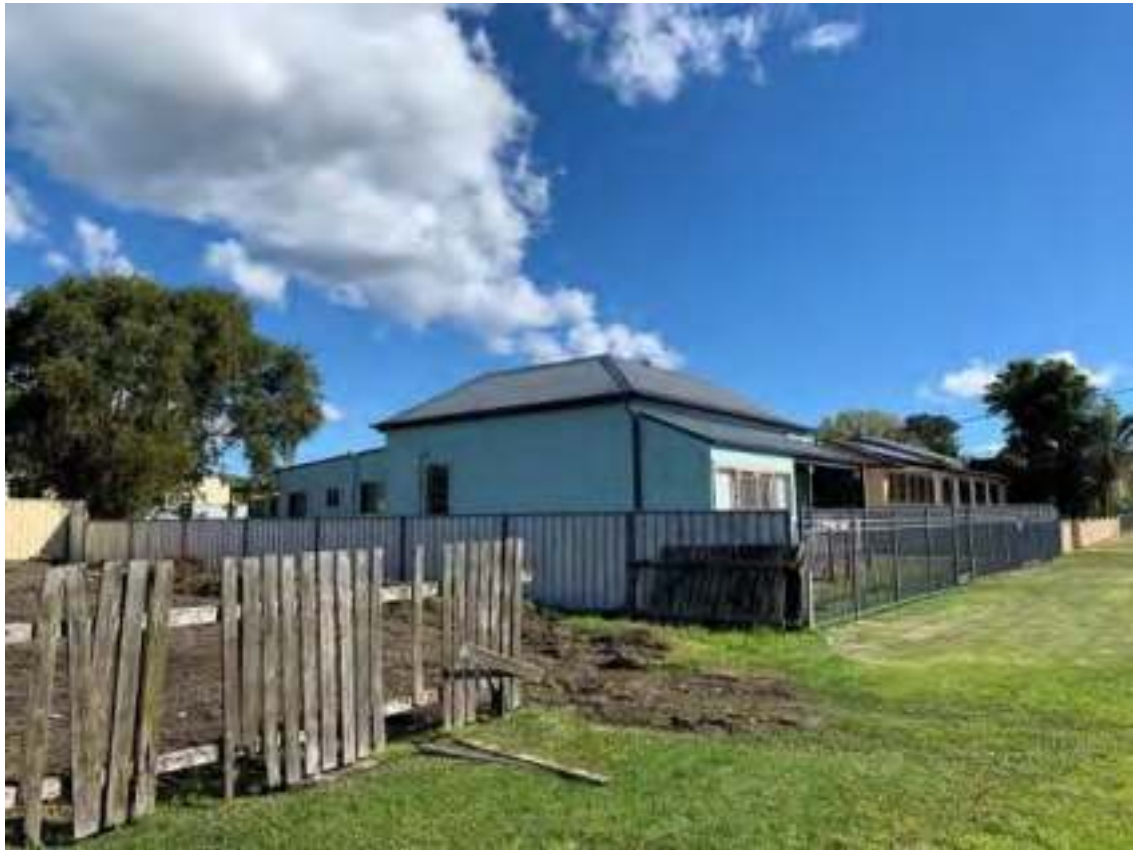
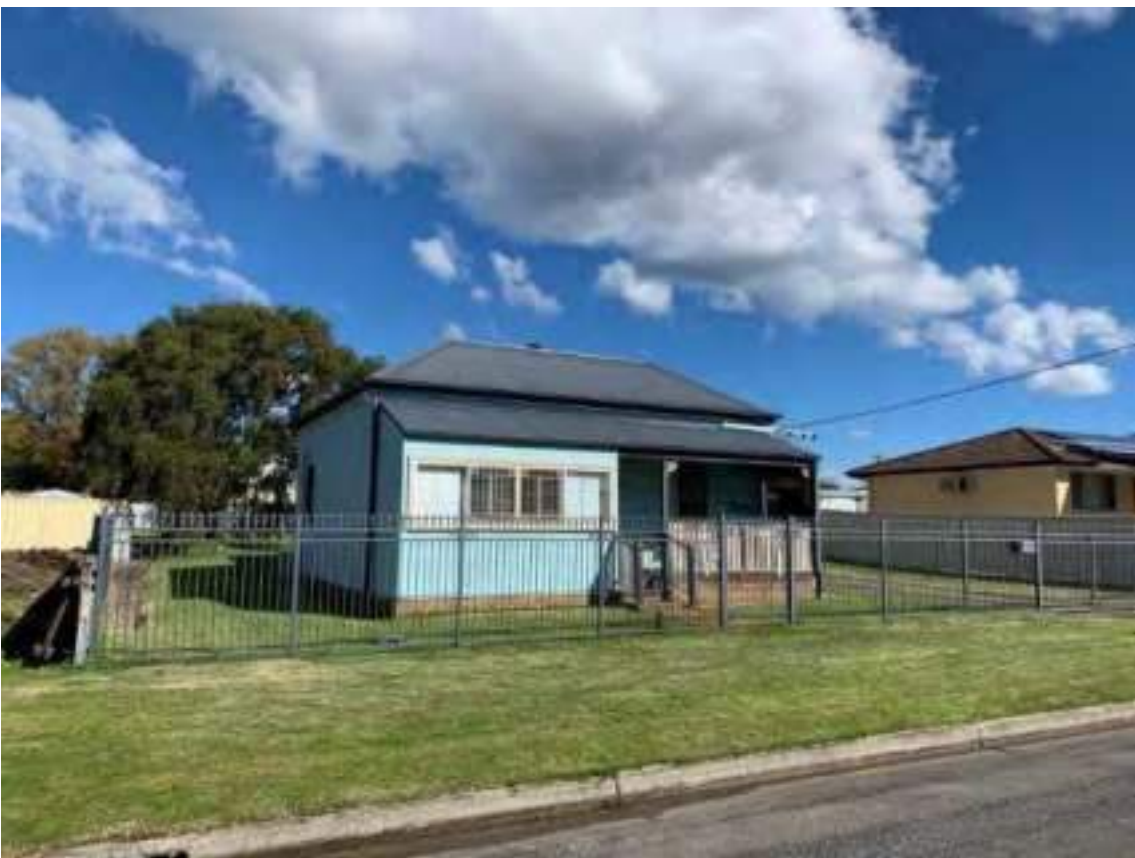
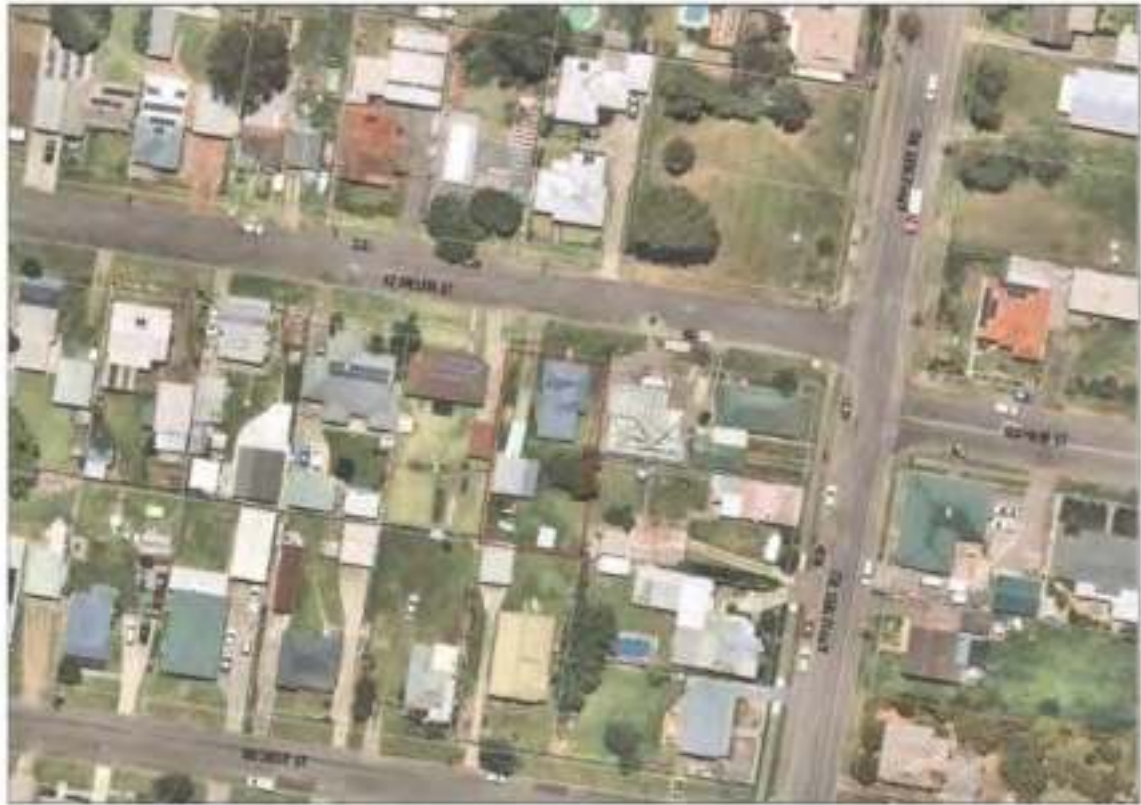
2 ST HELEN STREET, HOLMESVILLE 2286

Conservation Area Contribution Level	Est. Construction Date	Previous studies and/or community input
Contributory 1	1890–1920	No prior heritage investigations and no additional information required
Assessment Text		Observed Modifications
<p>Single storey Vernacular ‘Mining Cottage’ style dwelling with hipped Colourbond roof and timber weatherboard cladding. The veranda roof is skillion and supported by square cut timber posts with ornate timber brackets.</p> <p>The front door is centrally located with a metal framed screen door obscuring the main door. The western window is similarly obscured by metal framing, however appears to be a sash design. The windows facing northwards from the veranda modification are four panes, with metal framing and decorative bars.</p> <p>The veranda is otherwise partially enclosed by timber balustrade, with timber board flooring. A set of concrete stairs leads onto the veranda landing, with timber railing on either side.</p> <p>The dwelling is supported by brick foundations.</p> <p>A concrete driveway is located on the western side of the dwelling, with an iron gothic style fence enclosing the property.</p> <p>A single door garage with gable roof and weatherboard cladding is located to the south of the dwelling. this is set back and does not detract from the heritage values of the dwelling.</p> <p>The dwelling displays architectural features of a heritage style and is representative of the local development of this period, being of historical significance for the HCA.</p>		<p>The veranda has been partially enclosed with the addition of an extra room. This is a common modification to houses of the style.</p> <p>The balustrades enclosing the remaining veranda space is likely a modern addition, as typically this space was left open.</p> <p>A timber frame shelter has been constructed at the back of the dwelling, however is not visible from the street.</p>

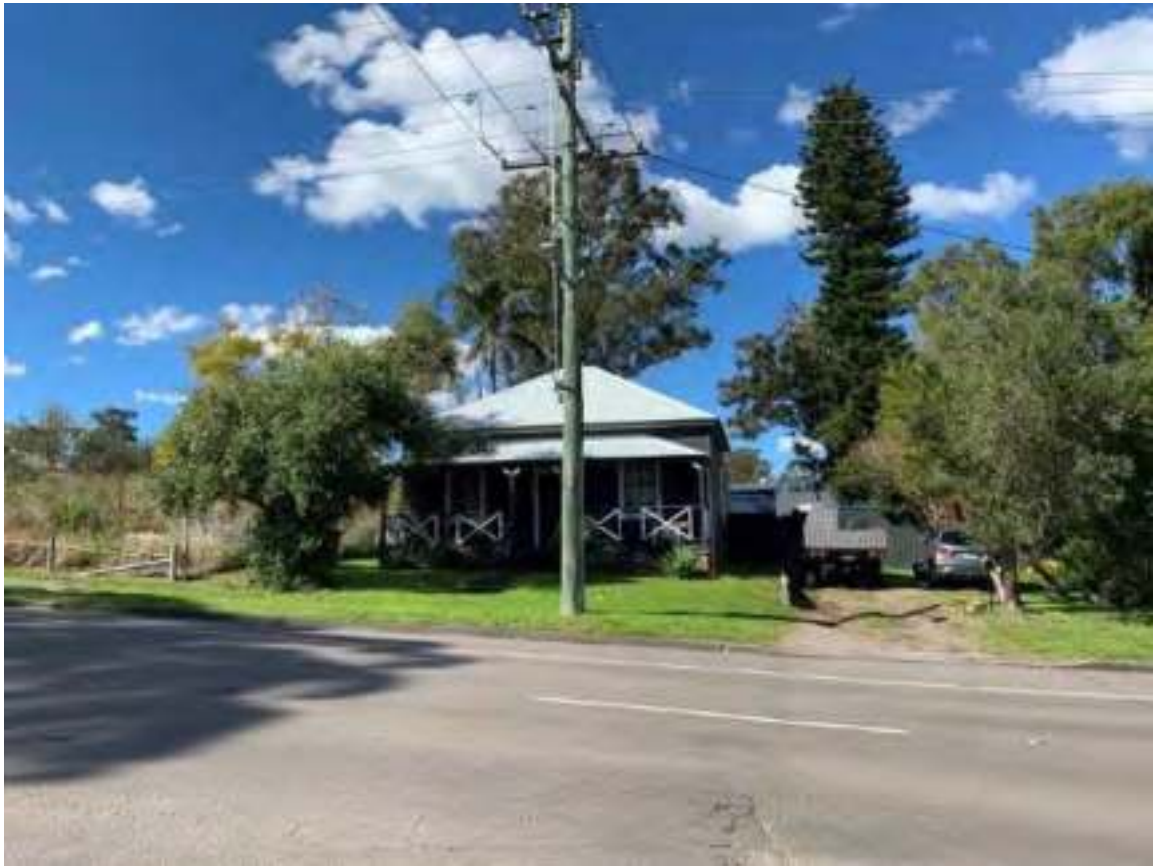
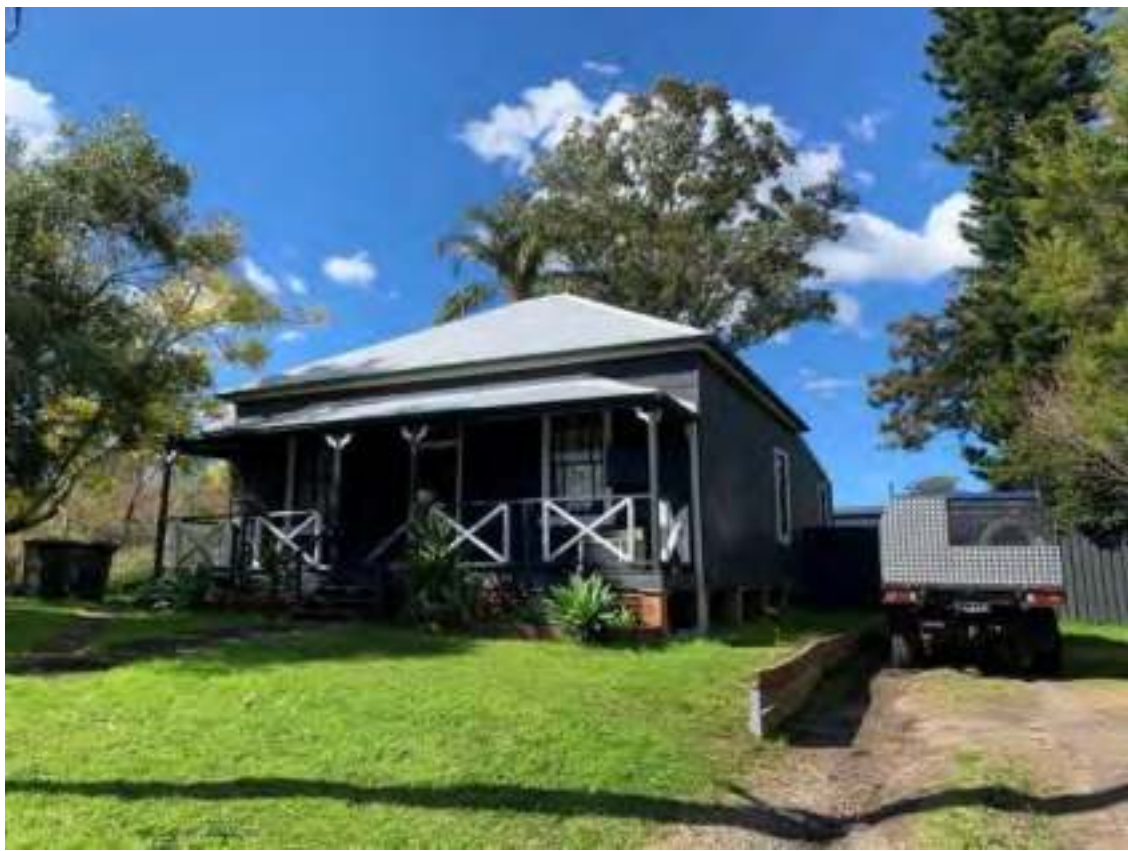
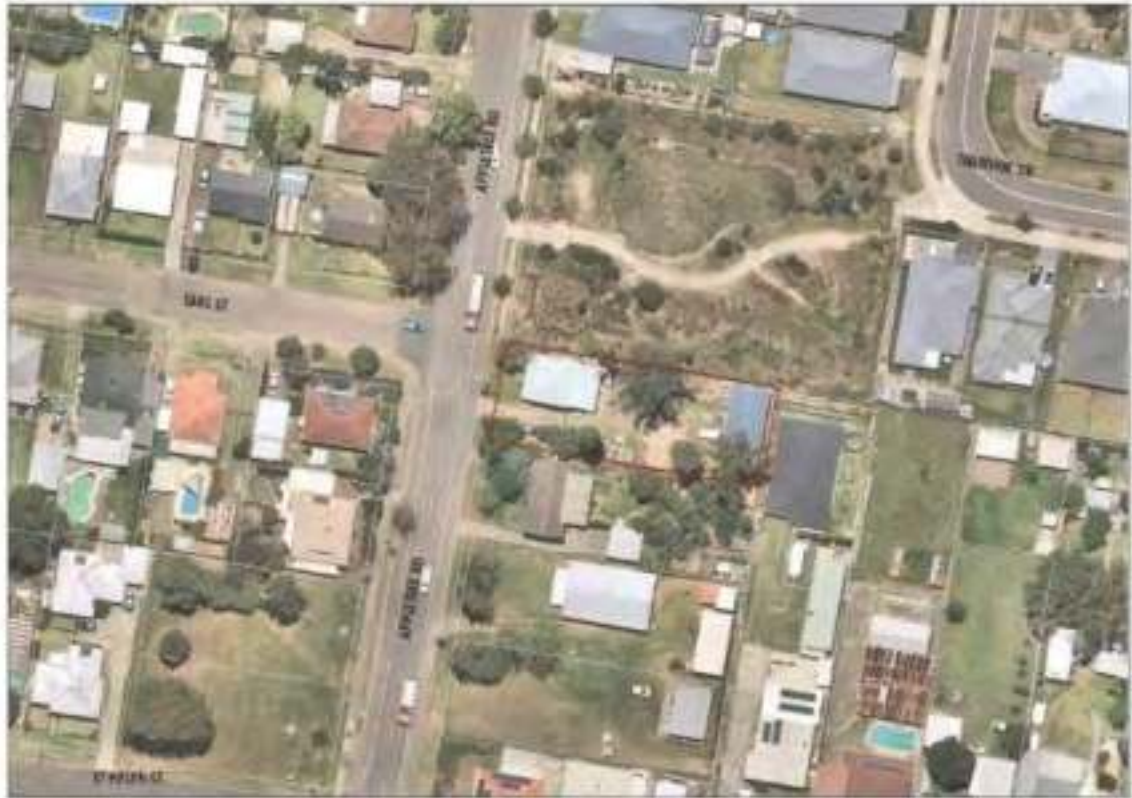
33 APPLETREE ROAD, HOLMESVILLE 2286

Conservation Area Contribution Level	Est. Construction Date	Previous studies and/or community input
Contributory 1	1890–1920	No prior heritage investigations and no additional information required
Assessment Text		Observed Modifications
<p>Single storey Vernacular ‘Mining Cottage’ style dwelling with hipped Colourbond roof and timber weatherboard cladding. The veranda roof is hipped and supported by square cut timber post with ornate brackets.</p> <p>The veranda is partially enclosed by timber balustrade in a crossed design. The floor is timber boarding, with timber stairs leading onto the veranda landing.</p> <p>The dwelling is supported by brick foundational piers, with a decorative timber screen.</p> <p>The front door is centrally located with a timber frame and ornate metal screen/the main door is obscured. A simple fanlight is visible above the door. The windows on either side of the door as timber framed double hung sash designs, with a regency margin inspired construction. The windows are framed by ornate sills. The visible windows on the southern and northern side of the dwelling share the same style.</p> <p>A variegated brickwork chimney is visible on the northern side of the dwelling, with a single terracotta pot a top.</p> <p>A large double door garage is partially visible, with gable roof and Colourbond sheet exterior.</p> <p>The dwelling displays architectural features of a heritage style and is representative of the local development of this period, being of historical significance for the HCA.</p>		<p>The dark blue colour scheme of the dwelling is a modern modification, aligning more with the modern houses in close proximity to the property. However, it is consistent and does not detract from the heritage value of the dwelling.</p> <p>The crossed timber balustrade along the veranda is a recent addition to the dwelling. the style more commonly had an open space with no railing.</p> <p>The timber screens visible at the bottom of the dwellings front western façade is a modern decorative feature.</p> <p>The garage is only partially visible and does not detract from the dwelling’s heritage style. The continuation of the blue colour scheme assists.</p>
