APPENDIX 2

Building Assessment Sheets (Inventory Sheets)

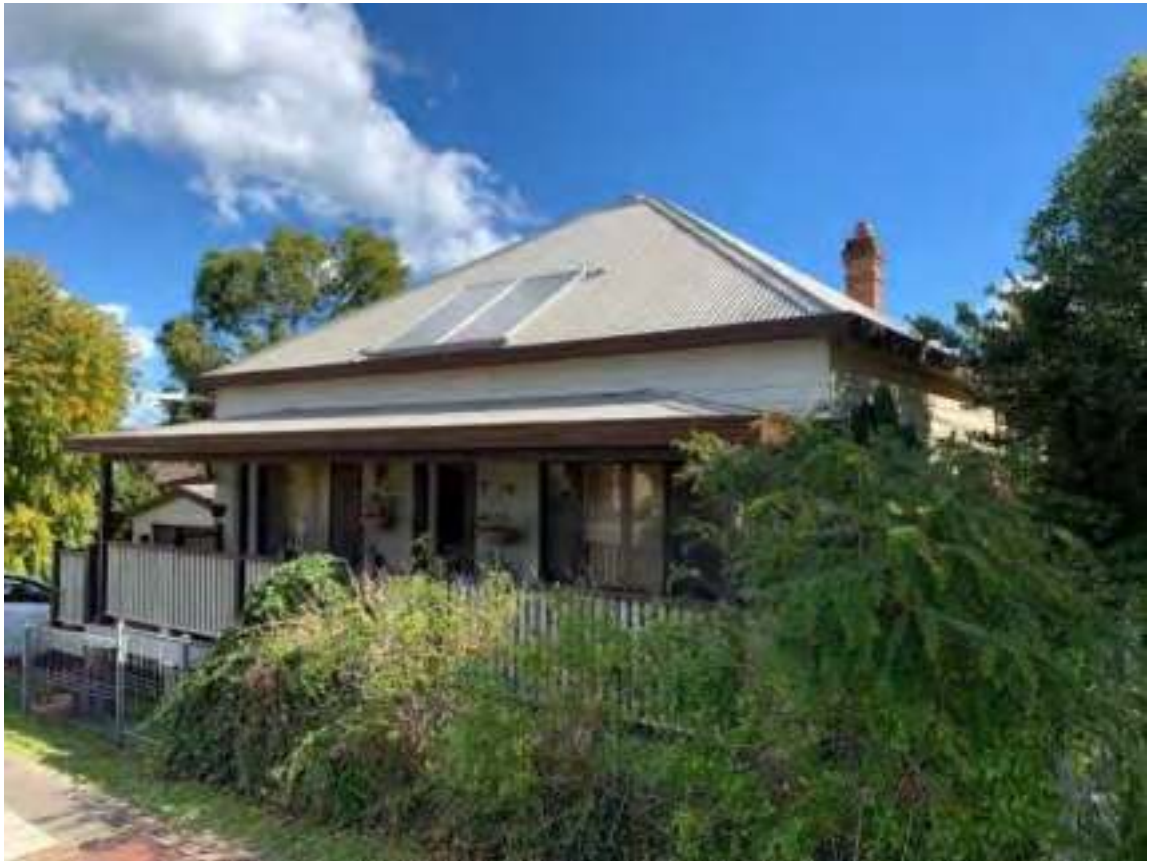
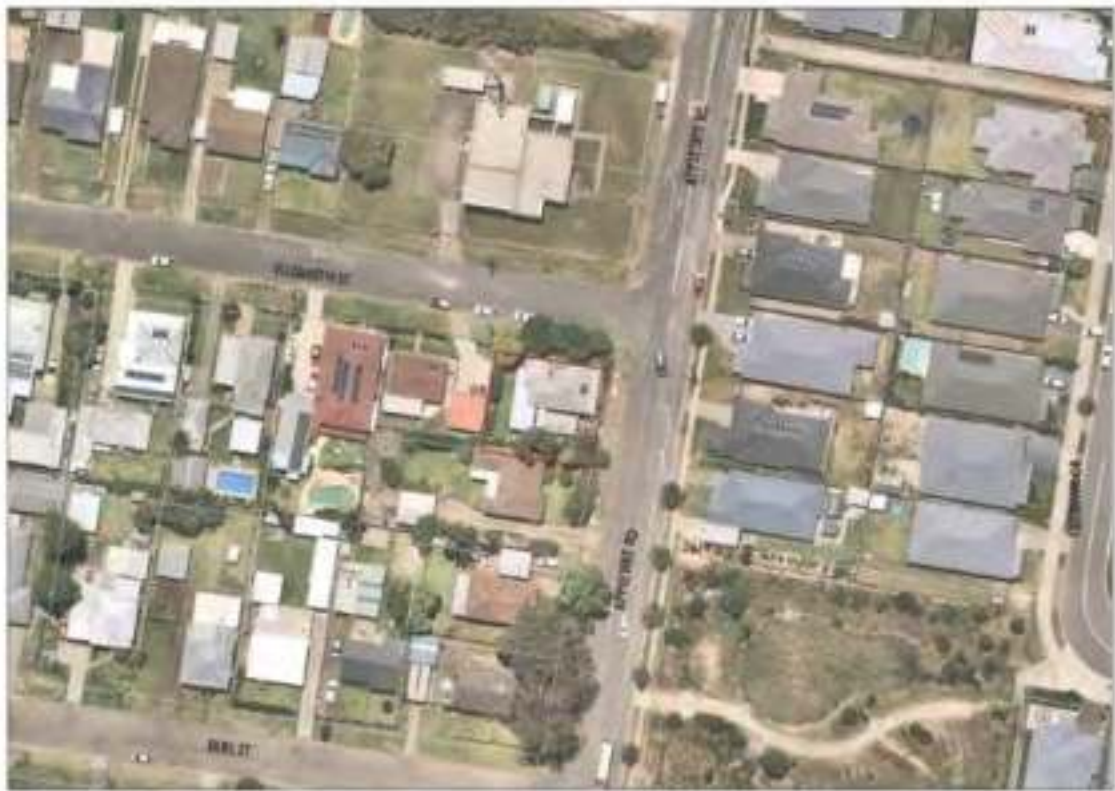
24 APPLETREE ROAD, HOLMESVILLE 2286

Conservation Area Contribution Level	Est. Construction Date	Previous studies and/or community input
Contributory 1	1890–1920	No prior heritage investigations and no additional information required
Assessment Text		Observed Modifications
<p>Single storey Vernacular ‘Mining Cottage’ style dwelling with Colourbond hipped roof and weatherboard cladding. The veranda roof is hipped and supported by square cut timber posts.</p> <p>The veranda is partially enclosed by timber balustrades, with no decorative features. The veranda floor is timber boarding, with a set of timber stairs leading onto the landing. The stairs have no railings or supports. An additional entrance is found on the southern side of the dwelling, with a secondary set of timber stairs with timber balustrades.</p> <p>The front door is centrally located, with a timber frame and four panel design. A metal screen door is in front, obscuring the main door. Triple pane picture windows with metal framing are found on either side of the main door. The visible windows of the southern side are a similar design. The northern side is obscured by thick vegetation growth.</p> <p>A single door garage is located to the south of the dwelling, with gable Colourbond roof and weatherboard cladding. This has been constructed in a sympathetic manner and comparative colour scheme.</p> <p>A brickwork chimney is visible on the northern side of the dwelling, with double corbels and a terracotta pot.</p> <p>A metal fence encloses the property.</p> <p>The dwelling displays architectural features of a heritage style and is representative of the local development of this period, being of historical significance for the HCA.</p>		<p>Solar panels are visible on the front eastern side of the dwellings roof, being highly visible from the street. This juxtaposes with the heritage qualities of the property.</p> <p>The picture windows dominating the front façade are of modern design and would-be recent additions to the dwelling.</p> <p>The screen door obscures the main door, which is of a heritage style. This detracts from the historical aesthetics.</p>

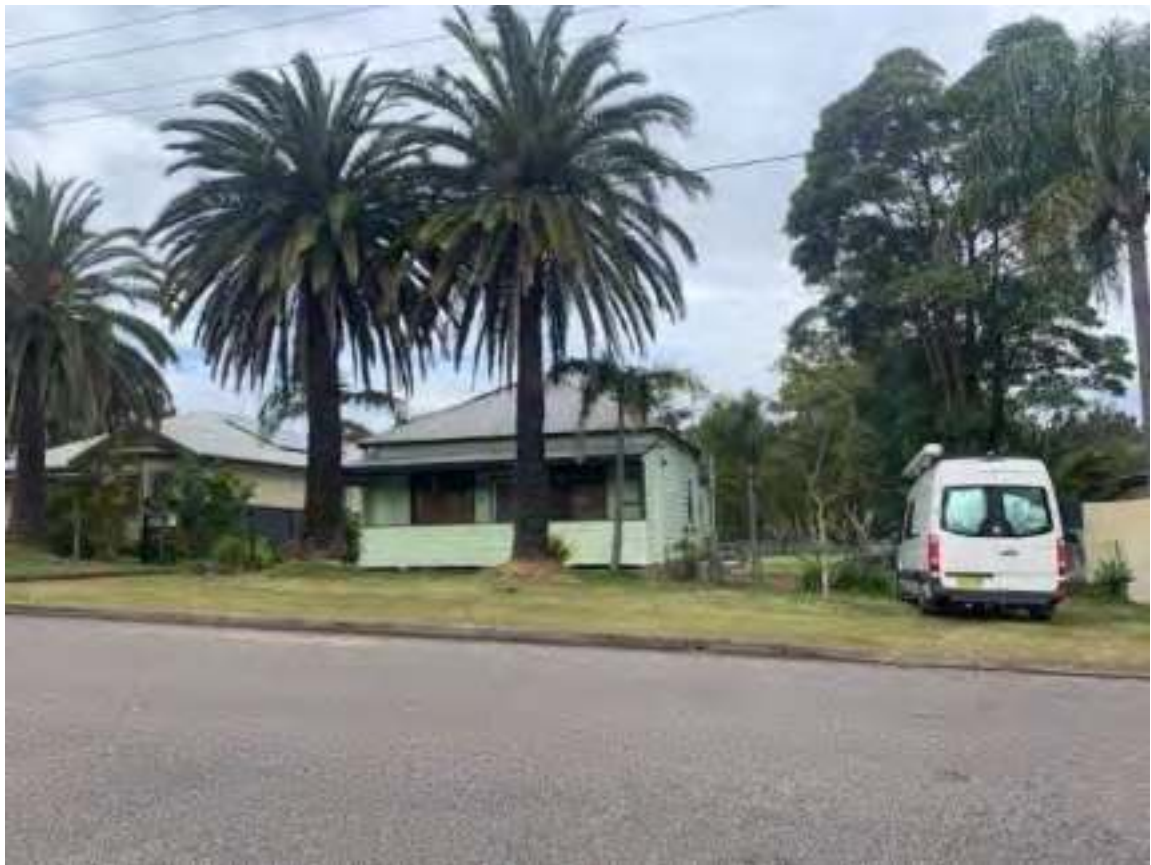
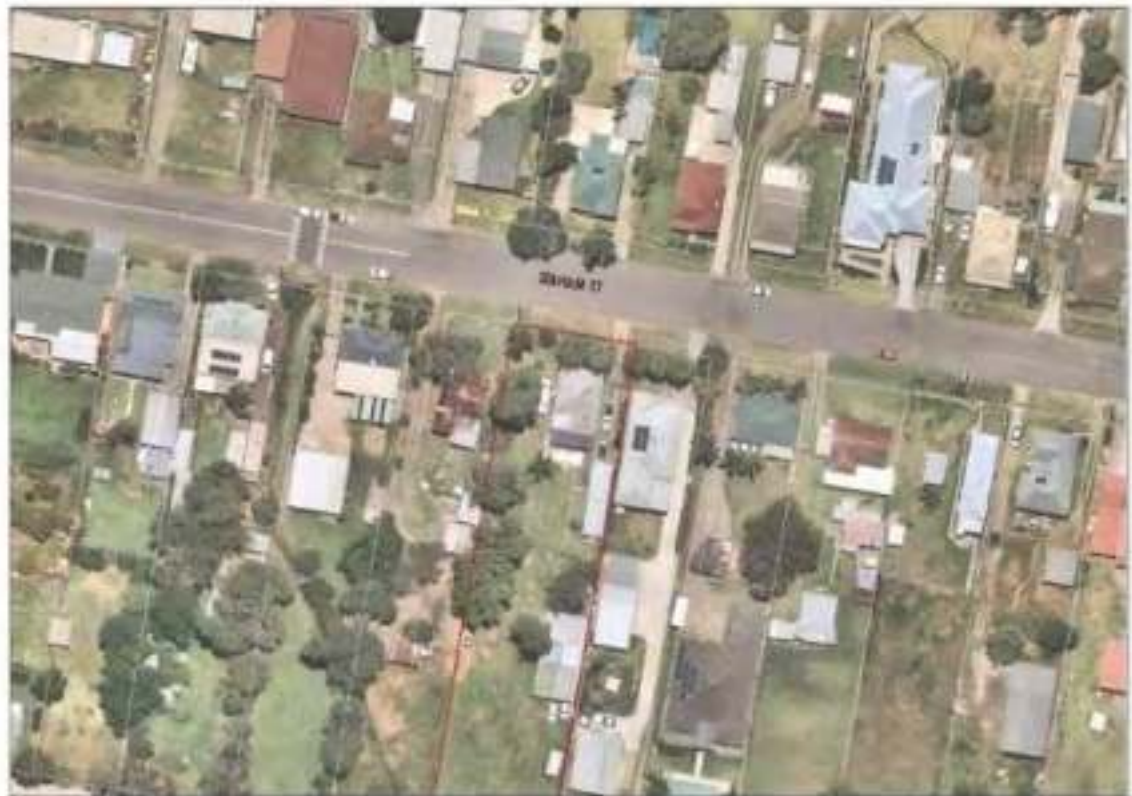
96 SEAHAM STREET, HOLMESVILLE 2286

Conservation Area Contribution Level	Est. Construction Date	Previous studies and/or community input
Contributory 1	1890–1920	Holmesville Heritage Study Canary palms considered magnificent specimens, planted c 1930's. Moderate local significance.
Assessment Text		Observed Modifications
<p>Single storey Vernacular 'Mining Cottage' style dwelling with hipped Colourbond roof and weatherboard cladding. The veranda roof is skillion and supported by timber board panels located at the east and western end of the veranda.</p> <p>The veranda has been enclosed by a timber panel wall, at approximately waist height. A set of concrete stairs leads onto the veranda landing, on the eastern side of the veranda.</p> <p>The front door is centrally located with a timber frame and metal screen door. The main door is obscured. The mulit panel windows on either side of the door are modern in style and metal framed. The windows on the eastern side of the dwelling are similarly modern in style, with one double hung sash timber frame window remaining.</p> <p>A single door garage with a gable Colourbond roof and weatherboard cladding is located at the back of the property, to the south of the dwelling. This is visible from the street, although set back.</p> <p>An ornate metal gate is found on the eastern side of the dwelling, with a simple metal fence enclosing the backyard. The driveway is concrete and brick and to the east of the dwelling.</p> <p>Large introduced palm trees are dispersed across the property. This is an inappropriate choice of flora, however, is found elsewhere in the street.</p> <p>The dwelling displays architectural features of a heritage style and is representative of the local development of this period, being of historical significance for the HCA.</p>		<p>The enclosing of the veranda is a modern addition to the dwelling, with the original structure likely having no walls or balustrades but an open space. Although not original, this modification is likely aged.</p> <p>The screen door juxtaposes the heritage value of the dwelling and is a stark contrast to the other façade features. The windows on either side are further modern additions and are similarly distracting and unsympathetic in style.</p> <p>The aqua green colour scheme is uncommon and is unsympathetic to the heritage aesthetics of the dwelling.</p>

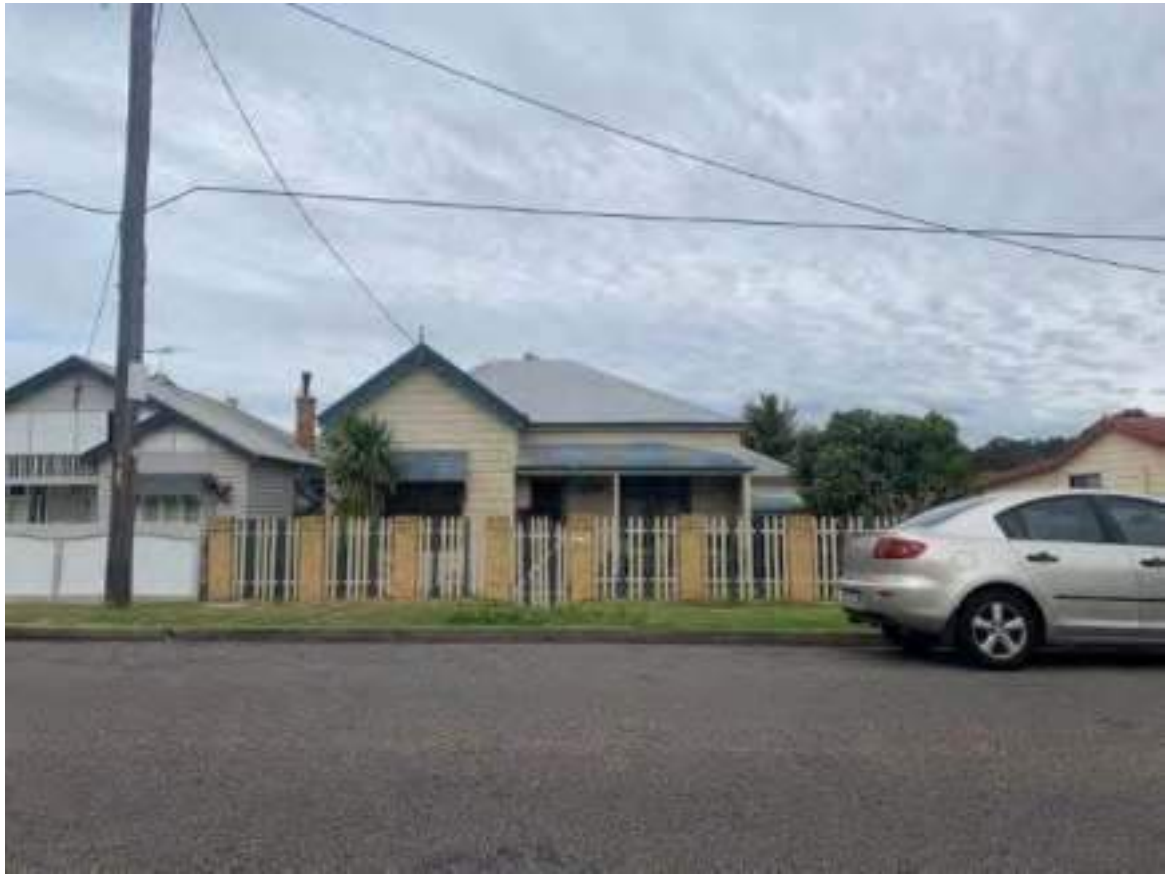
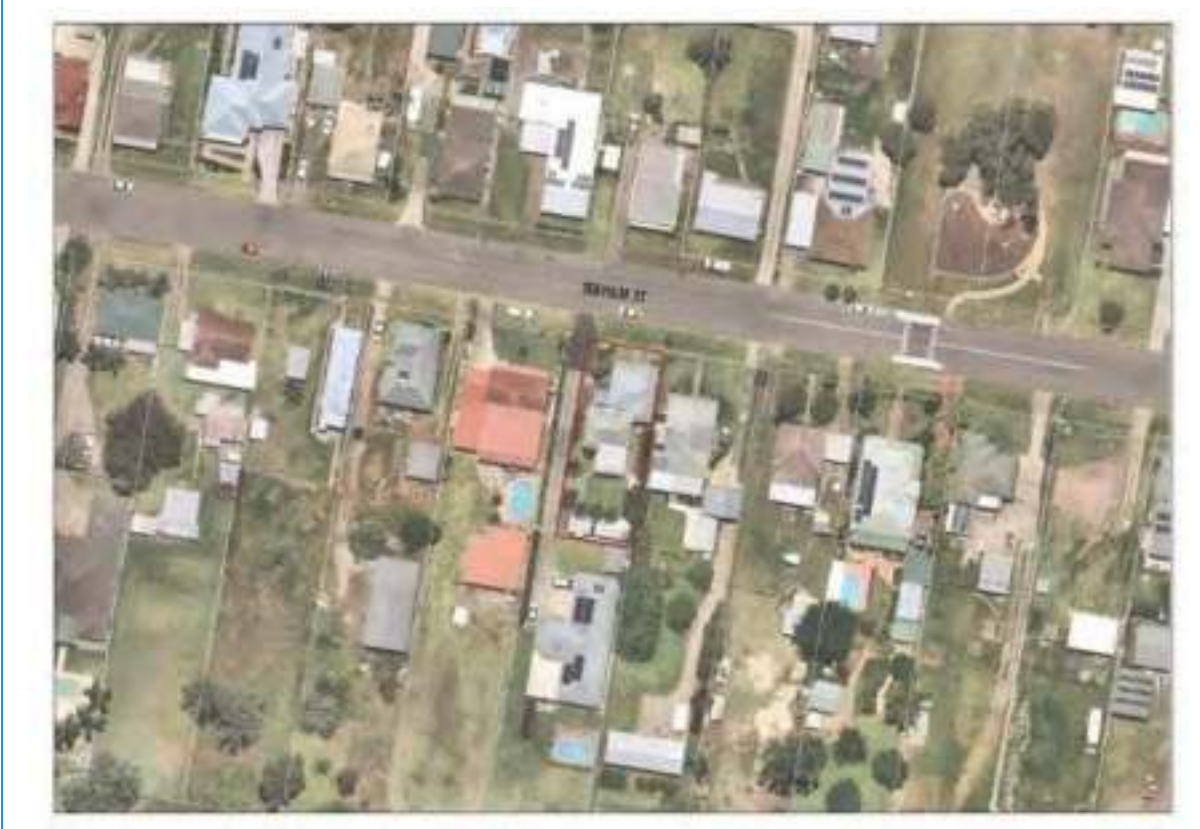
82 SEAHAM STREET, HOLMESVILLE 2286

Conservation Area Contribution Level	Est. Construction Date	Previous studies and/or community input
Contributory 1	1910	Holmesville Heritage Study 1993 Typical of early workers cottages, likely built by the Holmes family.
Assessment Text		Observed Modifications
<p>Single storey simple Federation ‘workmen’s cottage’ style dwelling with half hipped and gable Colourbond roof and timer weatherboard cladding. The veranda roof is bull nosed and supported by timber posts. The veranda roof has a distinct yellow/gold and blue striped painted design.</p> <p>The veranda is open, with no balustrades or decorative features. The floor is timber boarding, with a single timber step leading onto the veranda landing.</p> <p>The gable roof has a timber final and elaborately carved barge boards. The gable underlying window is a timber framed double hung sash design. A timber shingled awning is overhead, with ornately carved timber brackets.</p> <p>The front door is centrally located with a timber framed screen door. The main door is obscured. The window to the west of the main door is timber framed and similarly a double hung sash design.</p> <p>Colourbond fencing is visible along the western property boundary, whilst the front of the property is enclosed by a brick pillar and timber picket fence.</p> <p>The dwelling displays architectural features of a heritage style and is representative of the local development of this period, being of historical significance for the HCA.</p>		<p>It is likely that both façade windows have been replaced and are not original. Although the style is common for the dwelling type, the inconsistency in frame width suggests one or both have been installed following the construction of the dwelling.</p> <p>An extension has been built at the back southern portion of the dwelling, replacing the bull nose veranda roof, weatherboard cladding and hipped Colourbond roof. This is only partially visible and does not detract from the heritage streetscape.</p> <p>The brick pillar and timber picket fence is a recent addition and is unsympathetic to the heritage style.</p> <p>It is likely that the dwelling originally contained additional decorative features such as timber valance, fretted bracketing or more simplistic designs in accordance with the demographic in residence.</p> <p>The 1993 study shows a lattice balustrade enclosing the veranda, having been since removed. Further the finial has been recently added to the gable, likely having been previously removed.</p>

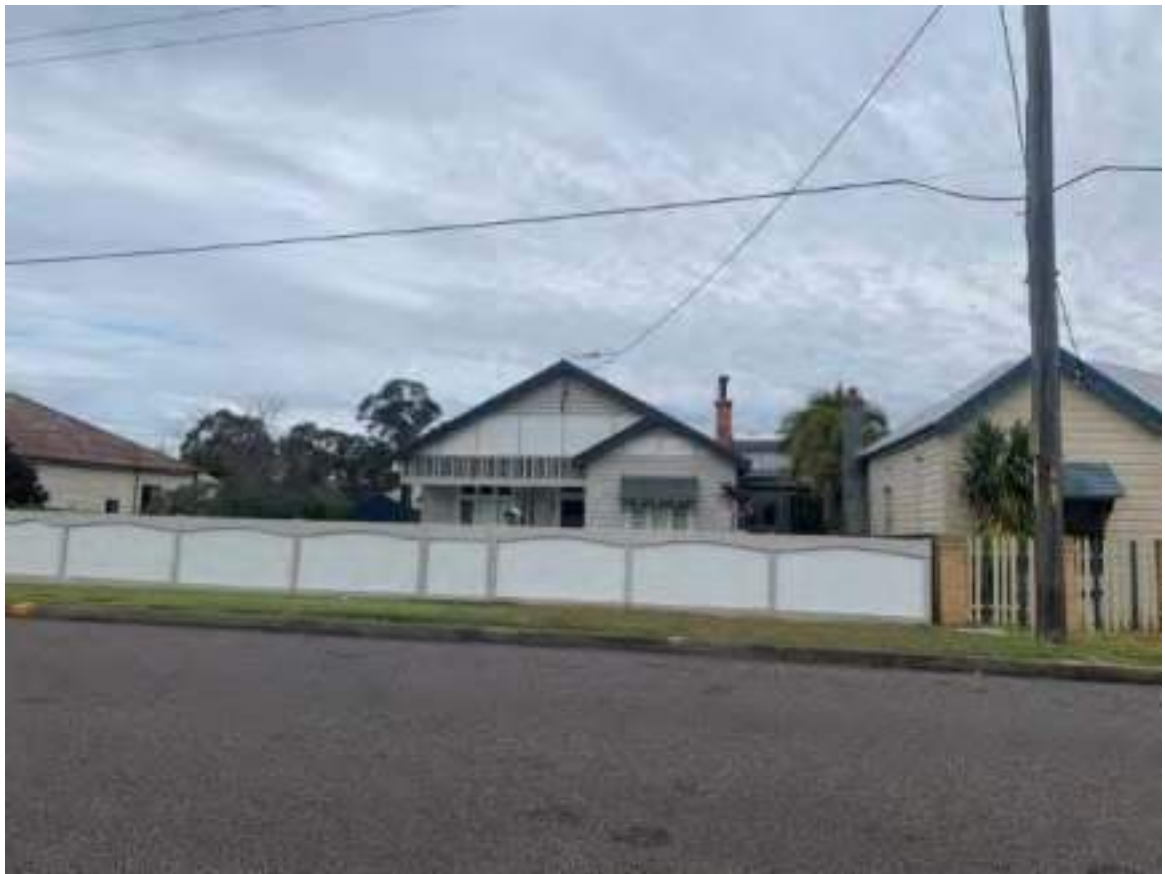
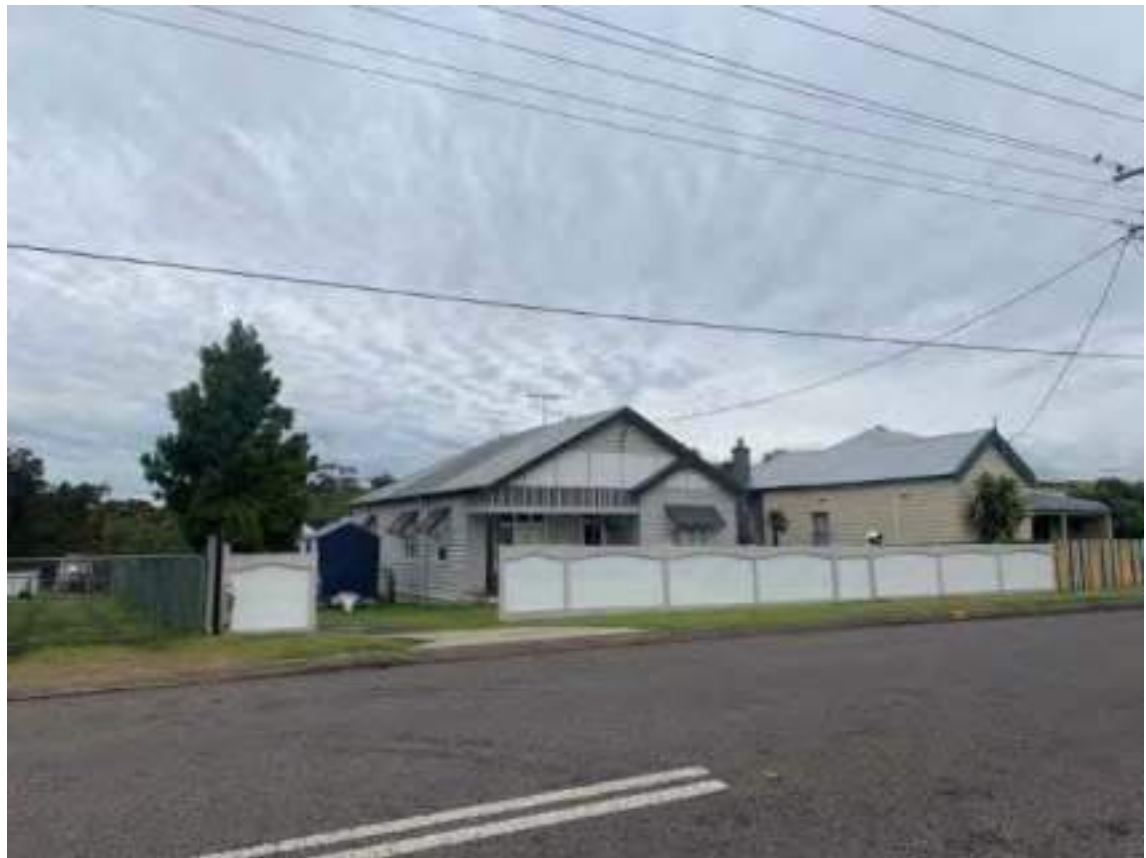
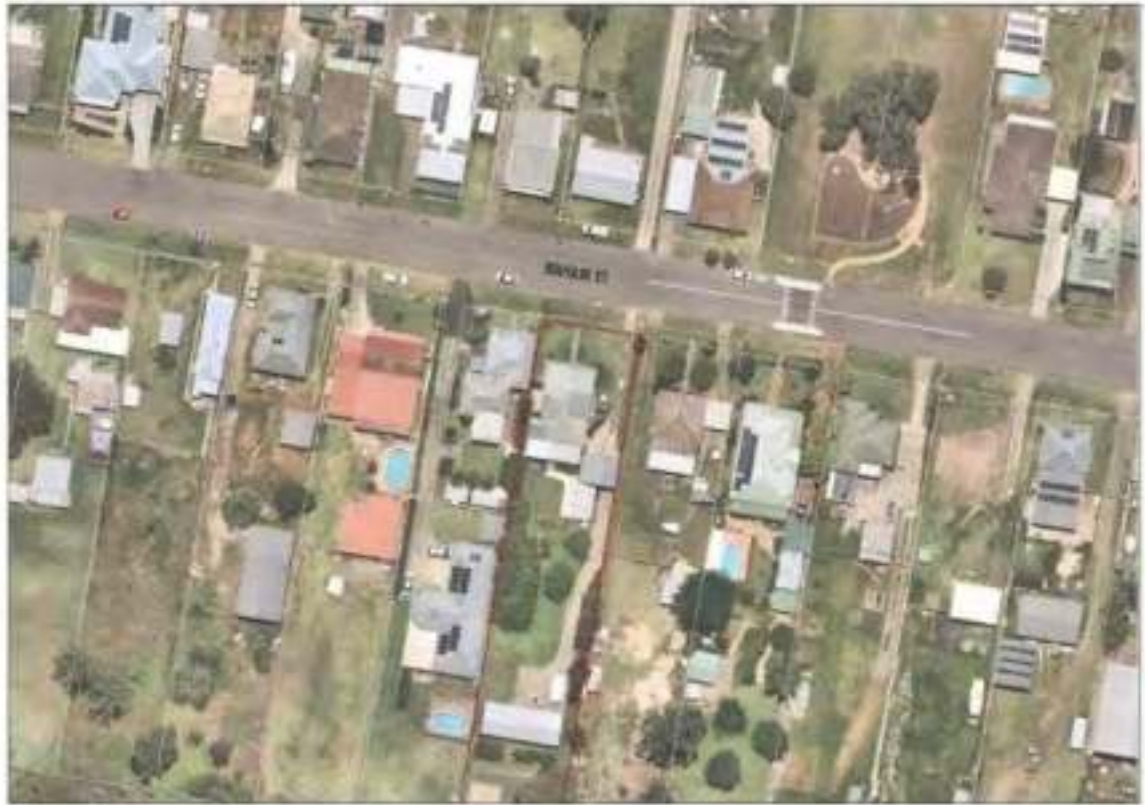
80 SEAHAM STREET, HOLMESVILLE 2286

Conservation Area Contribution Level	Est. Construction Date	Previous studies and/or community input
Contributory 1	1925–1930	Holmesville Heritage Study 1993
Assessment Text		Observed Modifications
<p>Single storey Federation Bungalow style dwelling with gable Colourbond roof and timber weatherboard cladding. The veranda has no individual roof but is covered by the main gable roofing, with timber valance detailing and square cut timber posts.</p> <p>The veranda is open with no balustrades. The floor is timber boarding with a single stair leading onto the veranda landing.</p> <p>The front door is centrally located with a timber frame and screen door. A fanlight is visible above the doorway, with the main door being solid timber with a rectangular glass window. The façade windows either side are casement designs with six panes. The gable window has a timber shingle awning. The eastern side windows are similarly designed, with timber shingle awnings.</p> <p>The gables have both simple battening details and decorative timber panels.</p> <p>A simple red brickwork chimney is visible on the western side of the dwelling.</p> <p>A metal sheet and timber fence encloses the property. A Colourbond fence is visible on the western side of the dwelling, enclosing the backyard.</p> <p>A concrete driveway is located on the eastern side of the dwelling, leading to a gable roofed garage structure.</p> <p>The dwelling displays architectural features of a heritage style and is representative of the local development of this period, being of historical significance for the HCA.</p>		<p>An extension has been built into the back southern portion of the dwelling, however this has been constructed in a sympathetic style and does not detract from the heritage streetscape.</p> <p>The front fence is a recent addition and although not in a heritage appropriate style, does not detract from the heritage aesthetics of the dwelling.</p> <p>It is likely that original veranda balustrades and posts were removed.</p>

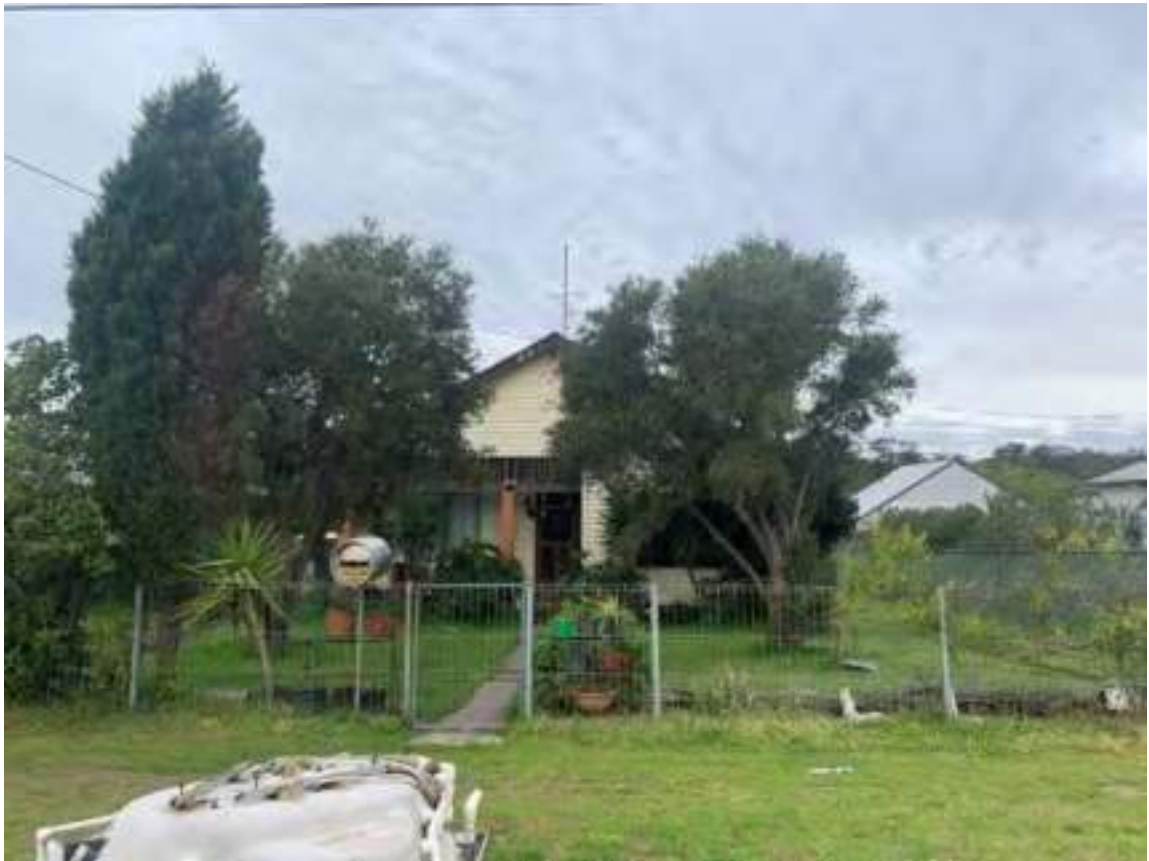
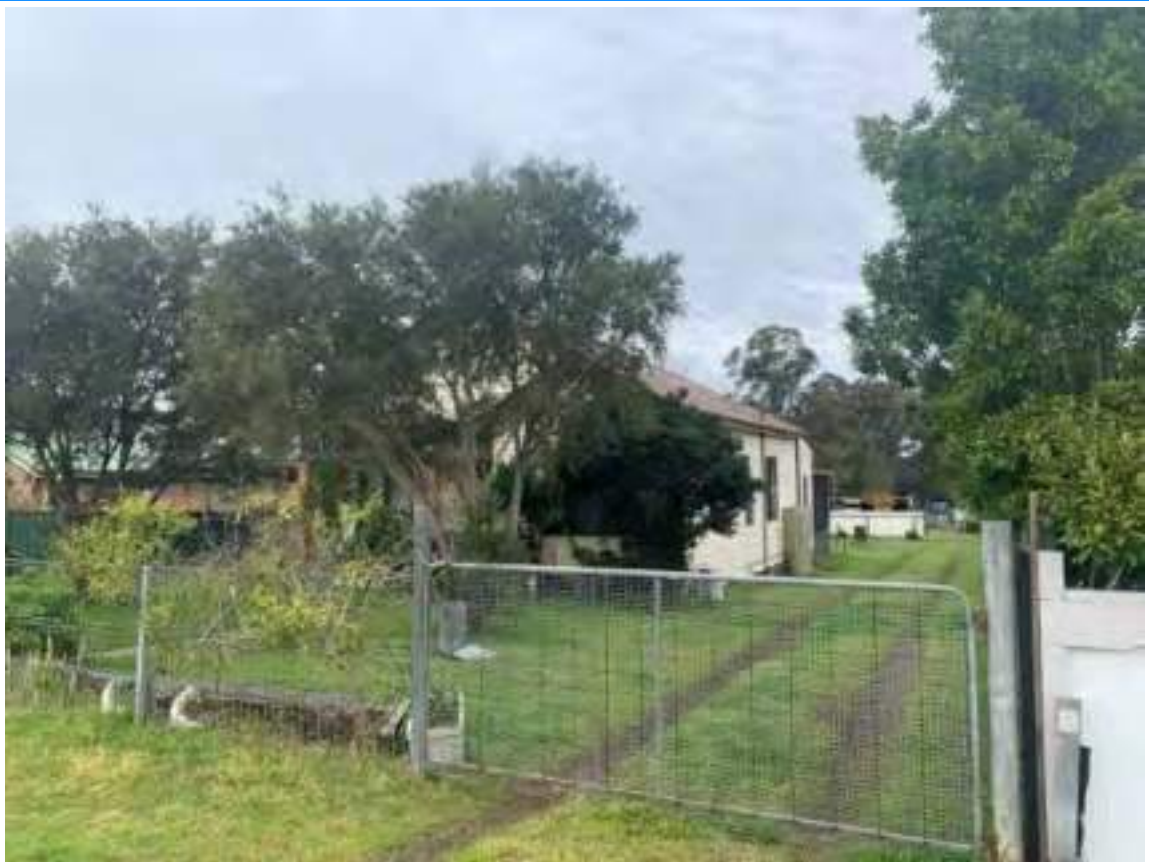
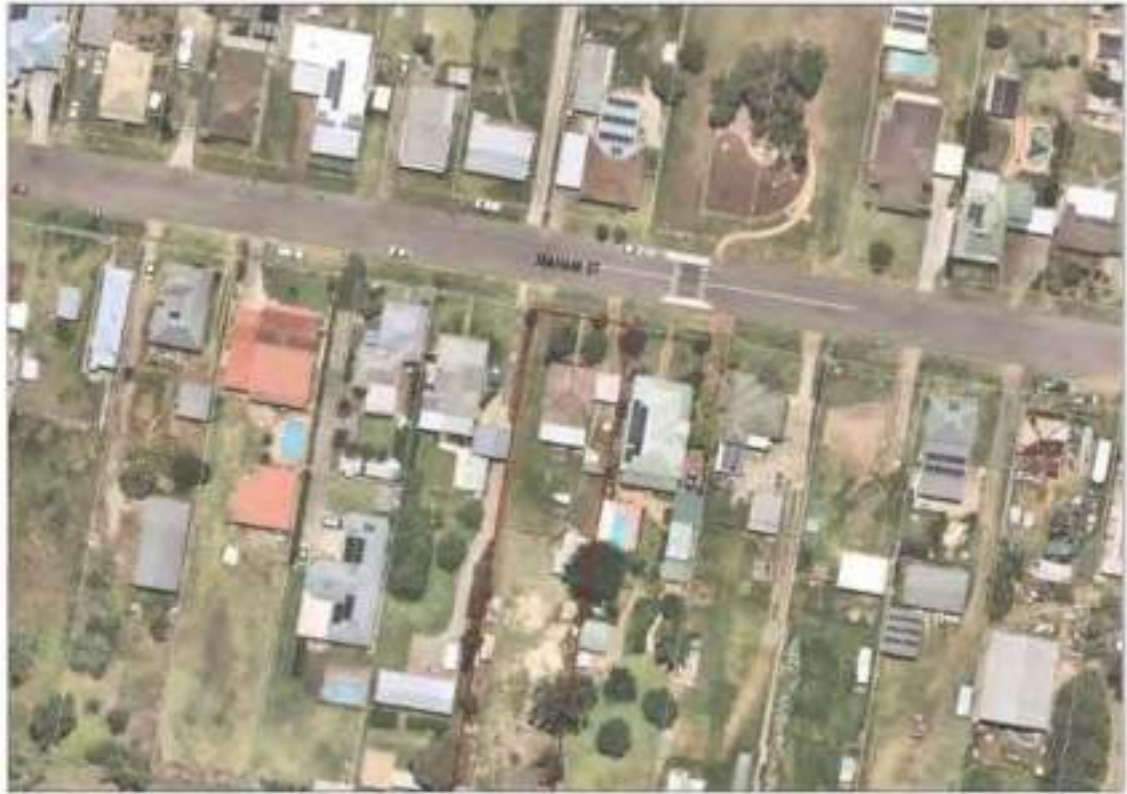
78 SEAHAM STREET, HOLMESVILLE 2286

Conservation Area Contribution Level	Est. Construction Date	Previous studies and/or community input
Contributory 1	1925–1930	Holmesville Heritage Study 1993
Assessment Text		Observed Modifications
<p>Single storey Federation Bungalow style dwelling with gable Colourbond roof and timber weatherboard cladding. The veranda has no individual roof but is covered by the main gable roofing, with timber valance detailing and brick pillars.</p> <p>The veranda is open with no balustrades. The floor is timber boarding with brick stairs leading onto the veranda landing.</p> <p>The front door is centrally located, with a timber framed screen door obscuring the main door.</p> <p>The visible northern and western windows are metal framed sliding modern designs.</p> <p>A metal fence runs the width of the property.</p> <p>Extensive vegetation growth has obscured much of the property.</p> <p>78 and 80 Seaham Street were likely built as a pair due to their similar construction and style.</p> <p>The dwelling displays architectural features of a heritage style and is representative of the local development of this period, being of historical significance for the HCA.</p>		<p>The screen door has likely been custom made due to the ornate design, and is a recent addition to the property.</p> <p>The original veranda balustrades have been removed, as have the support posts.</p> <p>The window awnings have been removed and many of the windows have been replaced with metal framed sliding designs.</p>

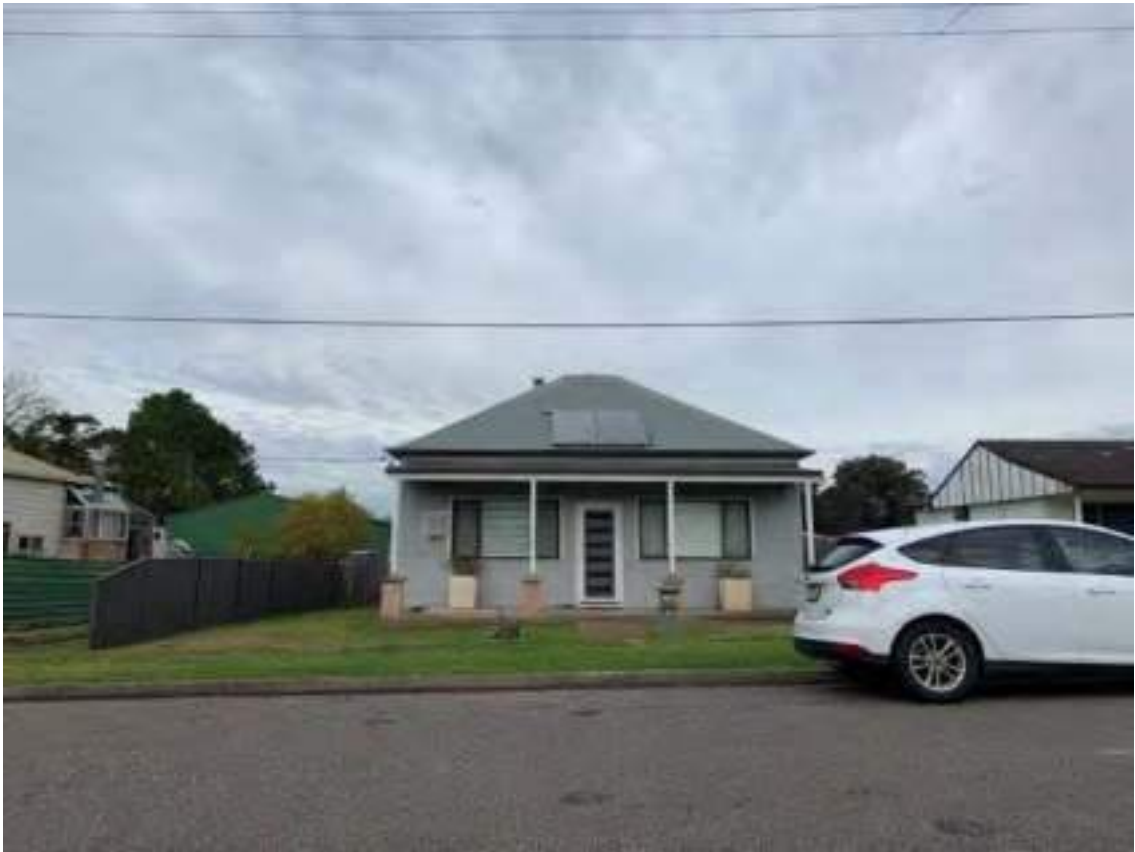
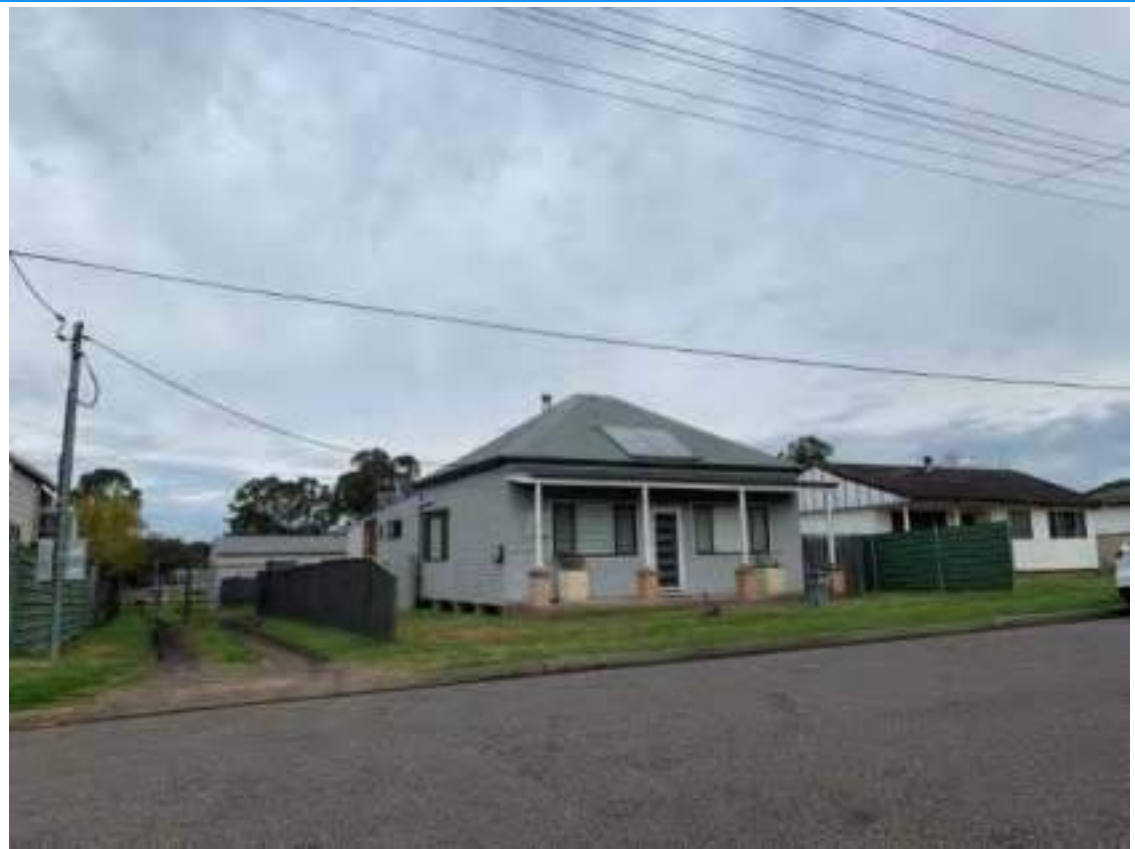
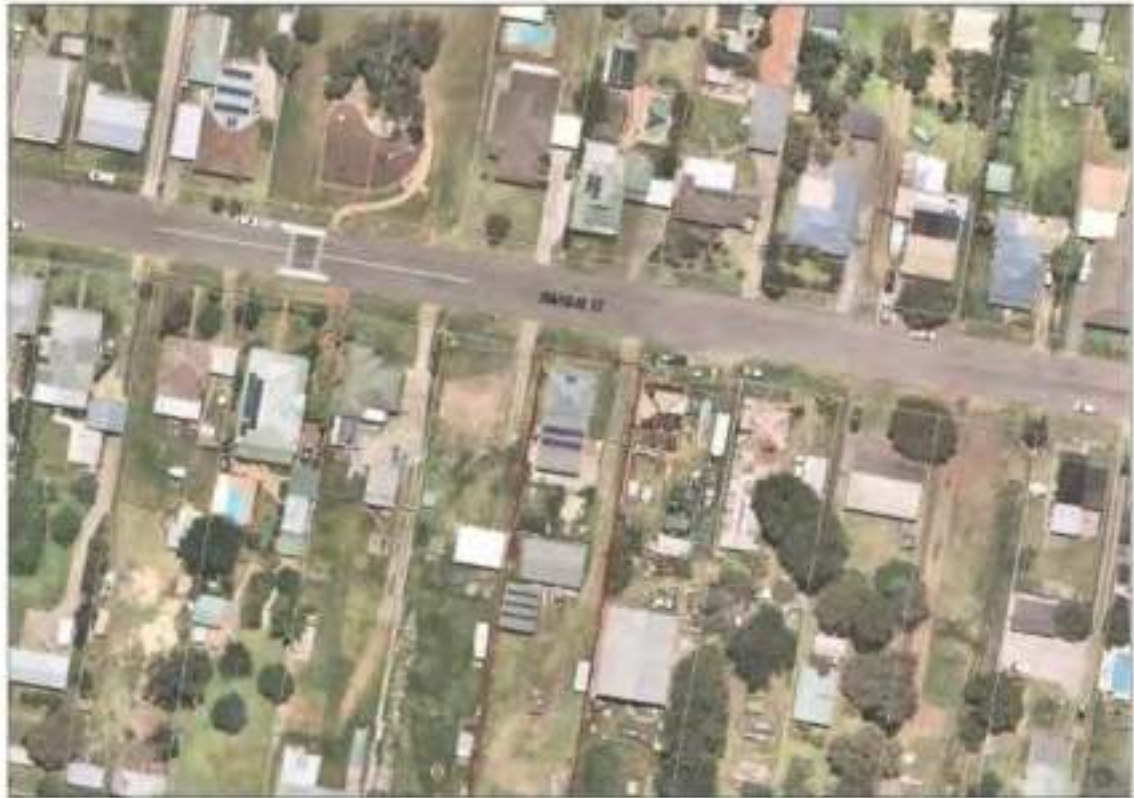
70 SEAHAM STREET, HOLMESVILLE 2286

Conservation Area Contribution Level	Est. Construction Date	Previous studies and/or community input
Contributory 1	1905–1910	Holmesville Heritage Study 1993
Assessment Text		Observed Modifications
<p>Single storey Vernacular cottage style dwelling with hipped Colourbond roof and weatherboard cladding. The veranda roof is skillion and supported with square cut timber posts resting upon brick piers.</p> <p>The veranda is open with no balustrades or decorative features. The veranda floor is concrete with no stairs.</p> <p>The front door is centrally located with a timber frame and screen door, with a modern styled timber and glass panel main door. Large timber framed picture windows are located on either side of the door. The eastern and western facing windows are similarly modern, with metal framing.</p> <p>The dwelling displays architectural features of a heritage style and is representative of the local development of this period, being of historical significance for the HCA.</p>		<p>The main front door is a modern style, with a timber and glass panel design. This is a recent addition to the house and contrast with the heritage features of the dwelling.</p> <p>A hot water panel is visible on the northern street facing side of the dwelling. Further solar panels are found on the back southern side of the dwelling, however this is not visible from the street.</p> <p>An extension has been constructed at the back southern end of the dwelling, however this is keeping with the heritage style and is not visible from the street.</p>

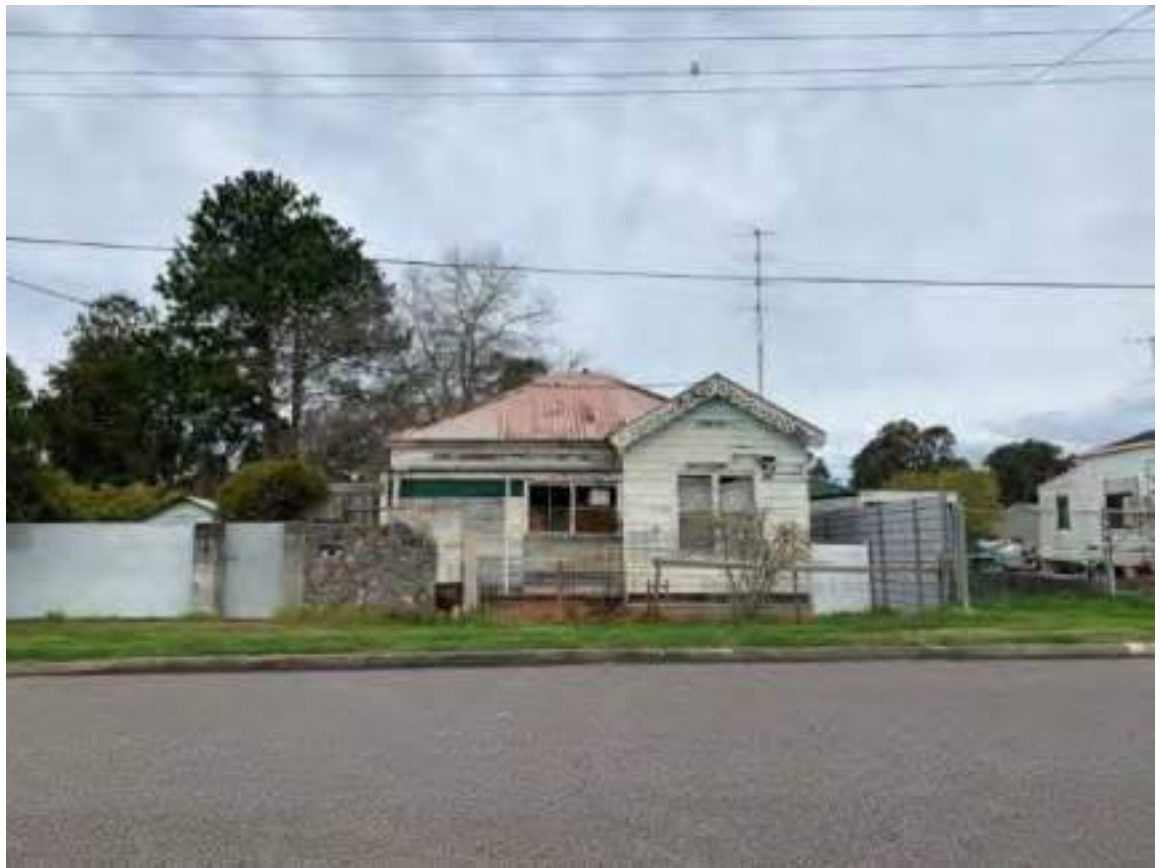
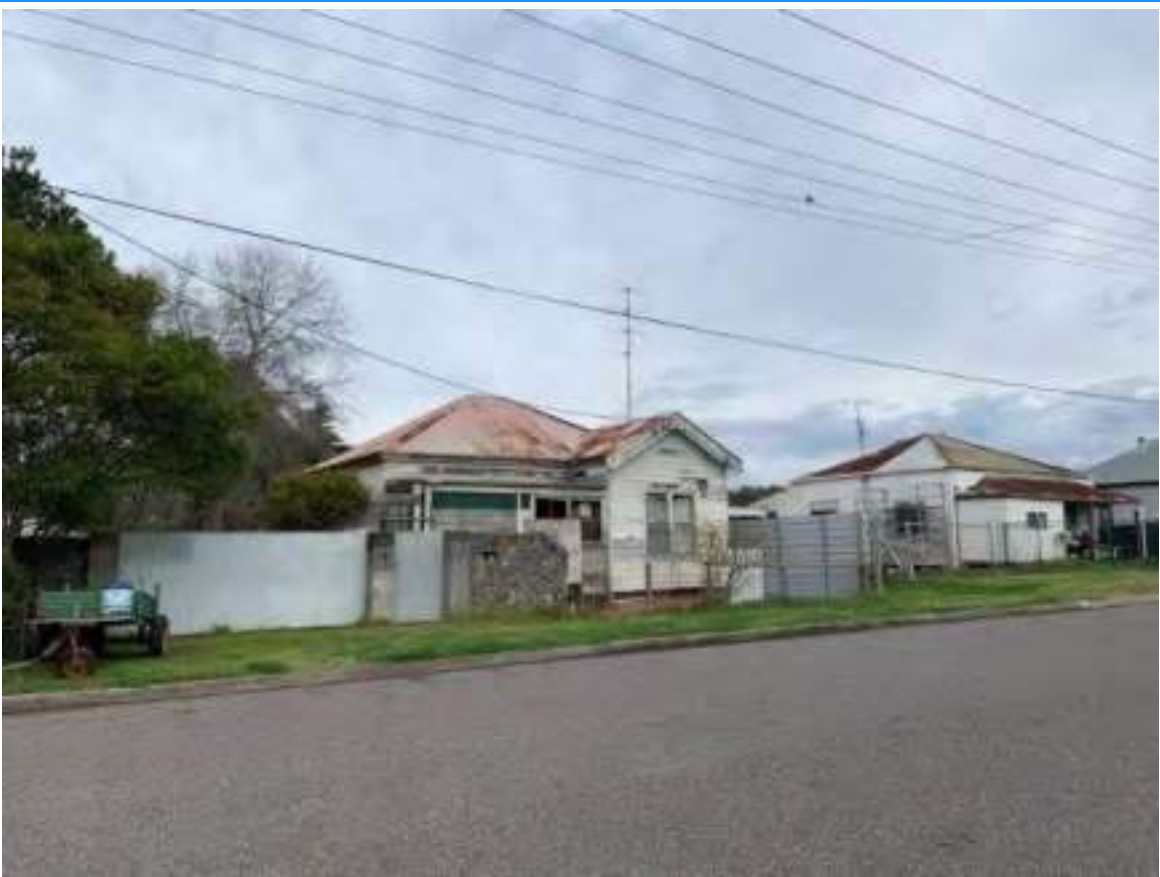
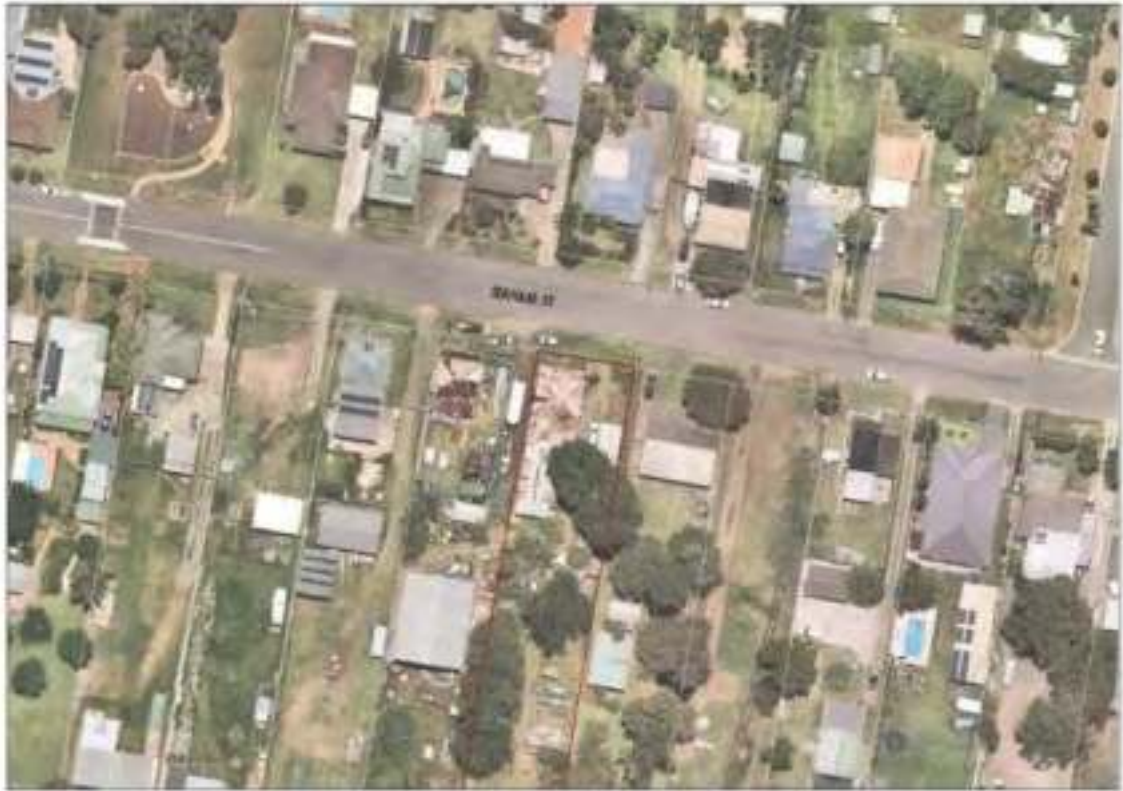
66 SEAHAM STREET, HOLMESVILLE 2286

Conservation Area Contribution Level	Est. Construction Date	Previous studies and/or community input
Contributory 1	1905–1910	Holmesville Heritage Study 1993 In connection with 70 and 68 Seaham Street
Assessment Text		Observed Modifications
<p>Single storey Vernacular Federation style dwelling with a half hipped and gable Colourbond roof and timber weatherboard cladding. The veranda roof is skillion and is supported by external walls.</p> <p>The veranda space has been fully enclosed with timber boarding and square centre bar windows.</p> <p>The gable has ornately carved barge boards, possibly original. No other decorative features are evident. A large double pane sash window dominates the façade.</p> <p>The entrance door is located to the eastern side of the dwelling, however is not visible.</p> <p>The dwelling is supported by red brick foundations.</p> <p>Multiple fencing styles are evident. Including metal wiring, metal sheeting, concrete pillars and masonry. This variation is not consistent with the heritage streetscape.</p> <p>The dwelling displays architectural features of a heritage style and is representative of the local development of this period, being of historical significance for the HCA.</p>		<p>The veranda has been fully enclosed through the construction of timber external walls, potentially undertaken by the residents and not completed to a consistent style.</p> <p>It is likely that additional decorative features have been removed from the dwellings façade.</p> <p>The front door has been relocated to the eastern side of the dwelling.</p> <p>A fence line has been constructed at the front of the property, with various styles. Likely no fence was originally present and this is a very recent modification.</p>
