APPENDIX 2

Building Assessment Sheets (Inventory Sheets)

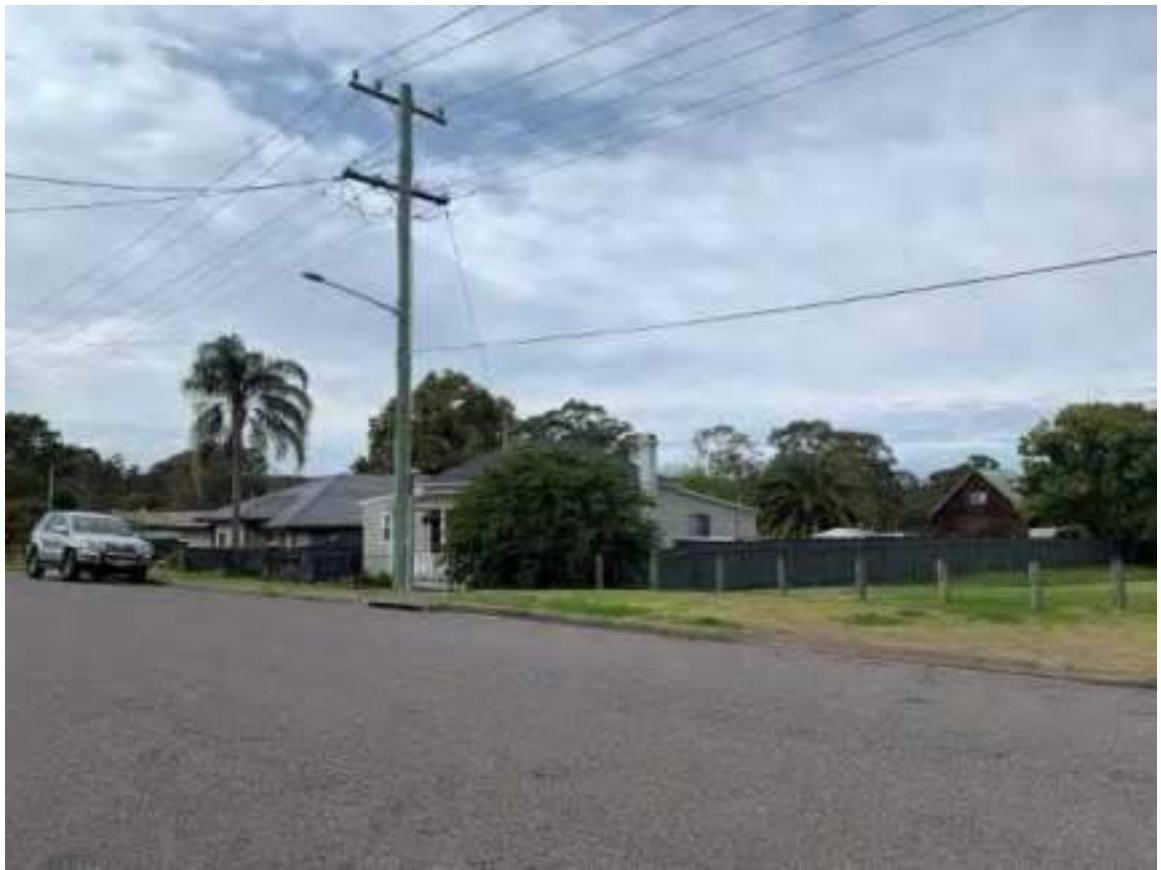
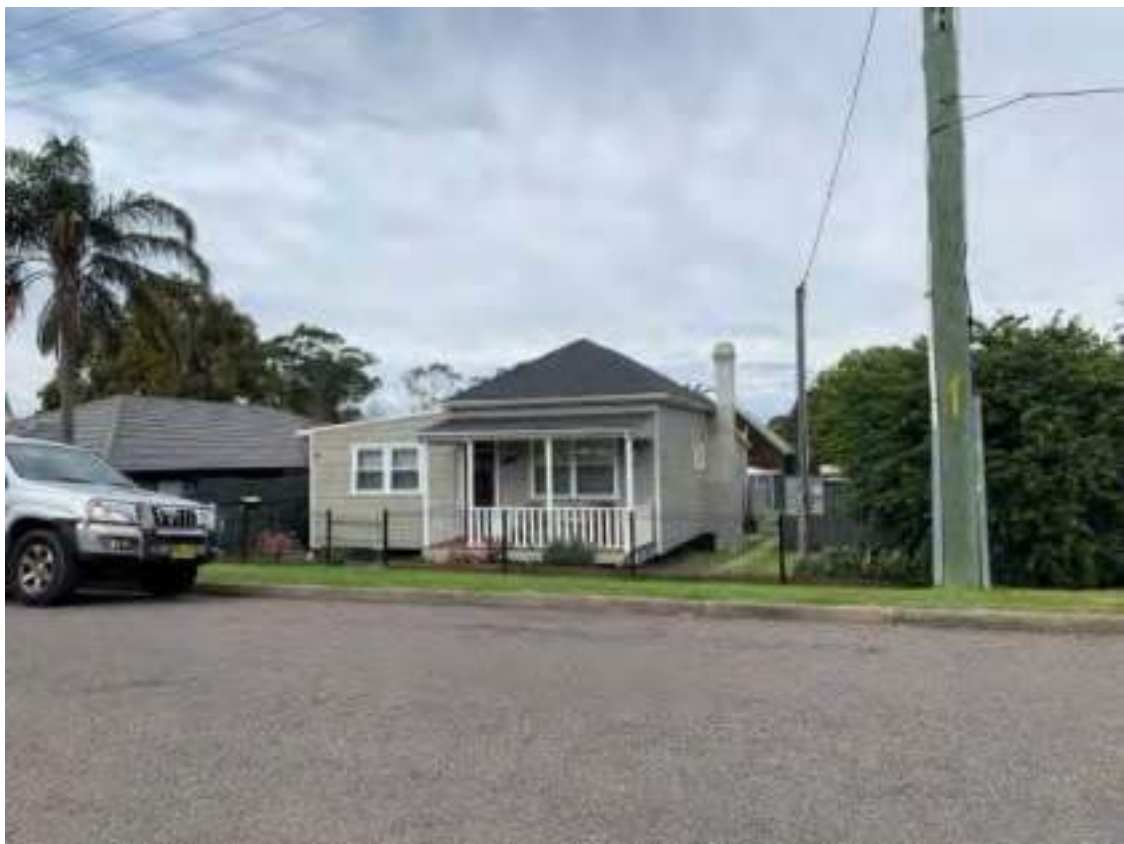
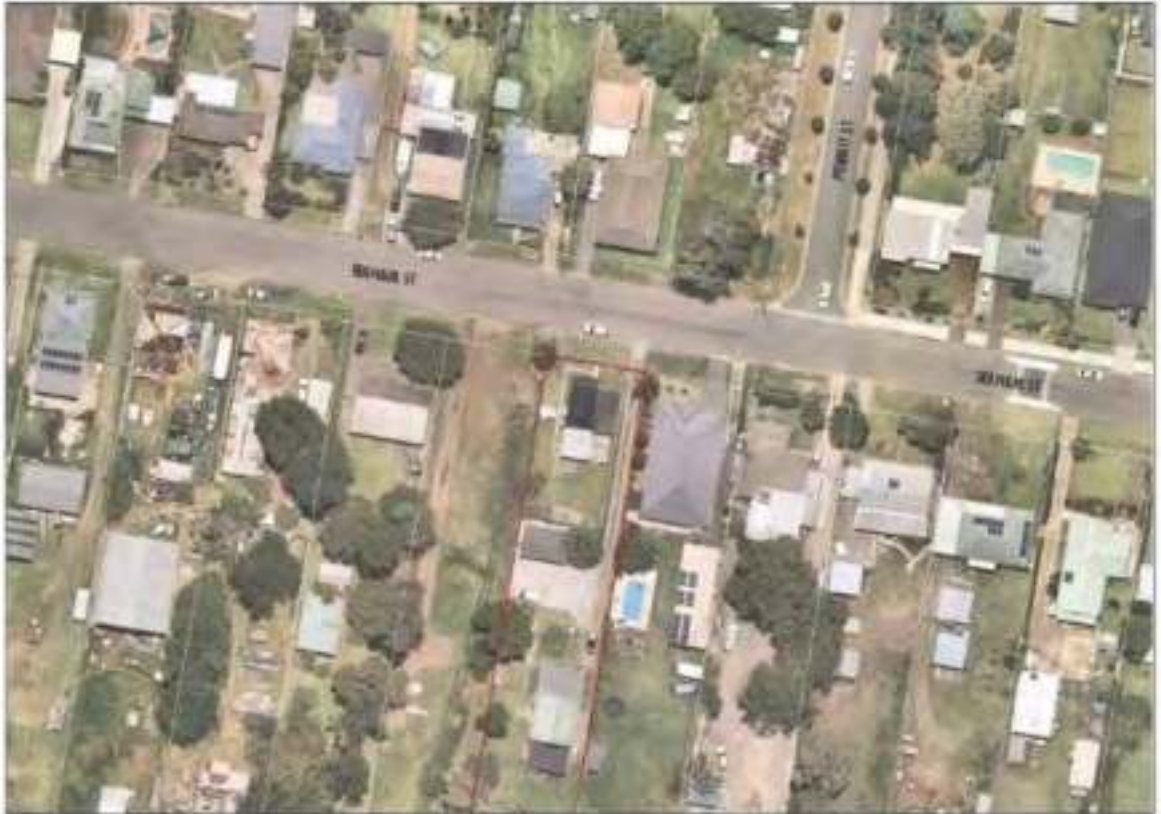
60A SEAHAM STREET, HOLMESVILLE 2286

Conservation Area Contribution Level	Est. Construction Date	Previous studies and/or community input
Contributory 1	1900–1905	Holmesville Heritage Study 1993 Potential built by William Holmes Moderate local significance
Assessment Text		Observed Modifications
<p>A simple Edwardian style dwelling with Colourbond hipped roof and weatherboard cladding. The veranda roof is skillion and supported by square cut timber posts.</p> <p>The veranda is partially enclosed by a low timber balustrade, designed of simple timber pickets and with no decorative features. The veranda floor is timber boarding with a single masonry step leading onto the veranda landing.</p> <p>The front door is located to the eastern side of the veranda, with a timber frame. The main door consists of ten glass panels, with a fanlight above. Double pane sash windows with timber frames are located on either side of the door, both with timber sills.</p> <p>Modern metal framed sliding windows are visible on the western side of the dwelling.</p> <p>A rendered brick chimney is visible on the western side of the dwelling, with prominent corbel. No further decorative features.</p> <p>A simple metal framed fence runs the width of the property, with Colourbond fencing on either side.</p> <p>The dwelling displays architectural features of a heritage style and is representative of the local development of this period, being of historical significance for the HCA.</p>		<p>The balustrade enclosing the veranda is a recent modification, as is the timber board flooring. It is possible that the dwelling original has similar features, and as such this does not impact the heritage style of the dwelling.</p> <p>The visible sash windows are a recent, likely replacing existing windows of a similar design.</p> <p>A skillion roof extension has been constructed to the eastern side of the dwelling, being highly visible from the street. Although constructed in sympathetic materials, this negatively detracts from the contributory value of the dwelling.</p> <p>A back deck with timber balustrade has been constructed at the back southern portion of the dwelling, however this is not visible from the street and does not impact the heritage value of the dwelling.</p>

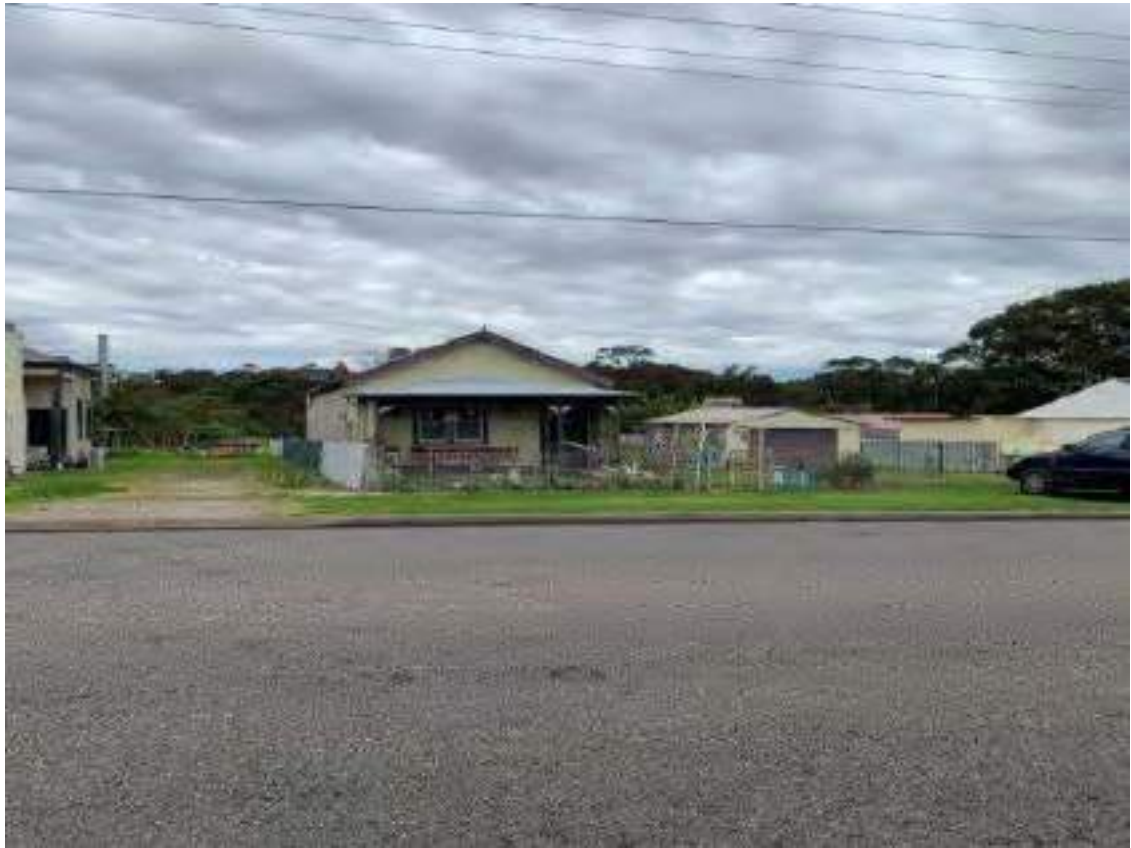
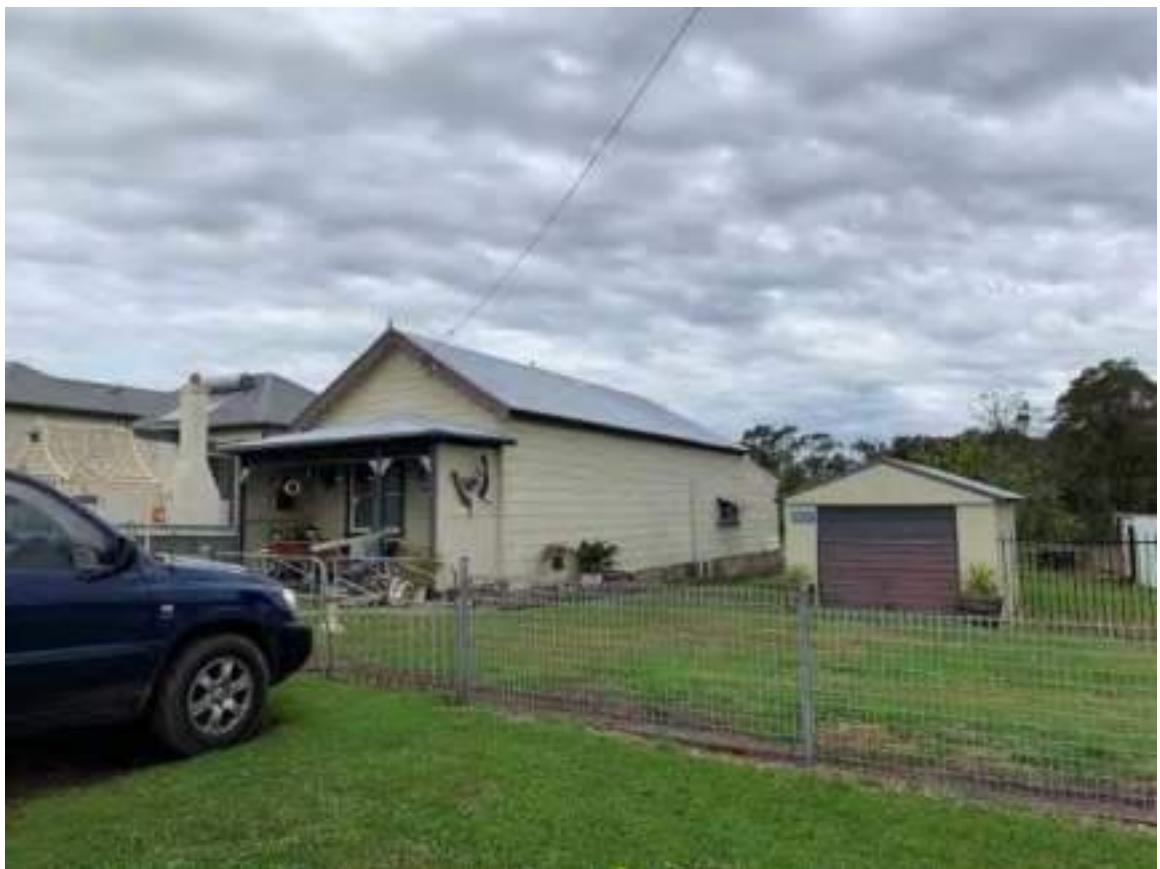
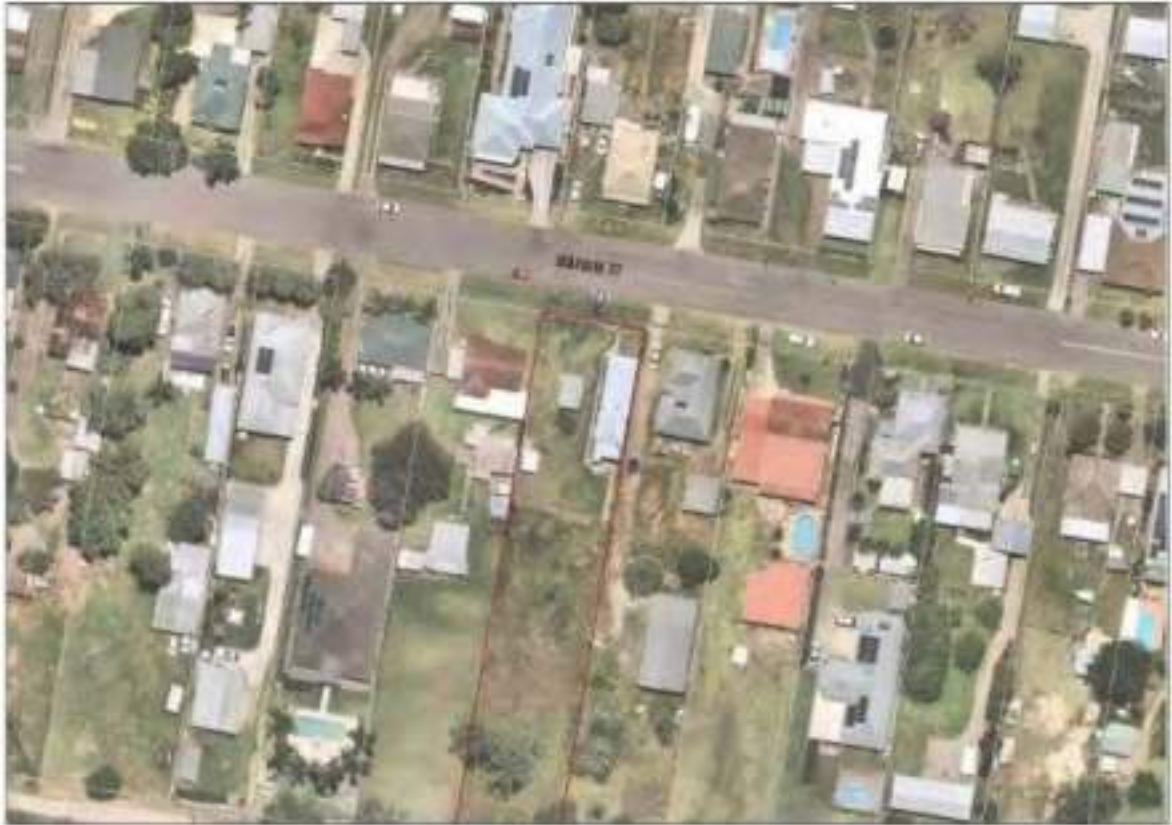
88 SEAHAM STREET, HOLMESVILLE 2286

Conservation Area Contribution Level	Est. Construction Date	Previous studies and/or community input
Contributory 1	1900–1915	West Wallsend Heritage Study 1993
Assessment Text		Observed Modifications
<p>Single storey Federation Vernacular dwelling with weatherboard cladding and Colourbond gable roof. The verandah roof is hipped and supported by timber posts with ornate brackets.</p> <p>Remnant original decorative features include a timber turned pilaster between the window panes and carved barge boards.</p> <p>Two chimneys are visible, potentially made from Friths bricks.</p> <p>The dwelling displays architectural features of a heritage style and is representative of the local development of this period, being of historical significance for the HCA.</p>		<p>A small access ramp and supporting rail has been installed.</p>

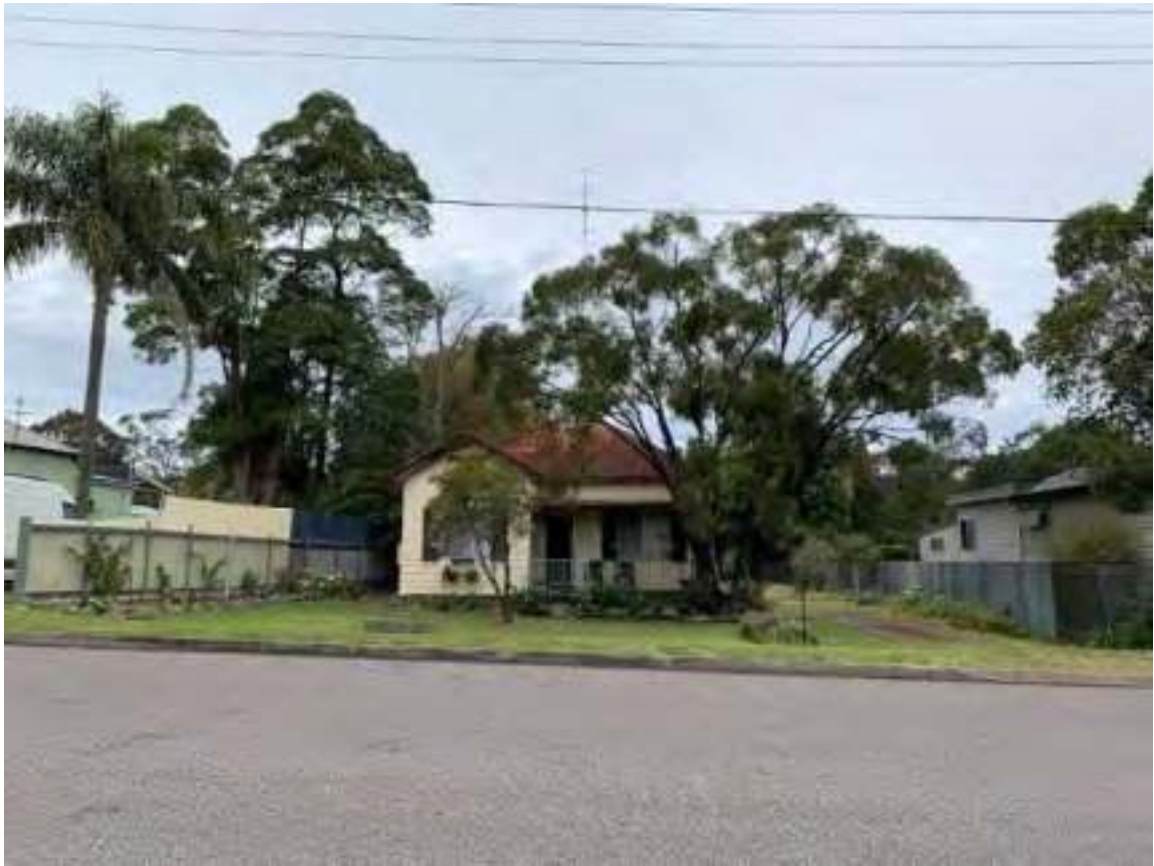
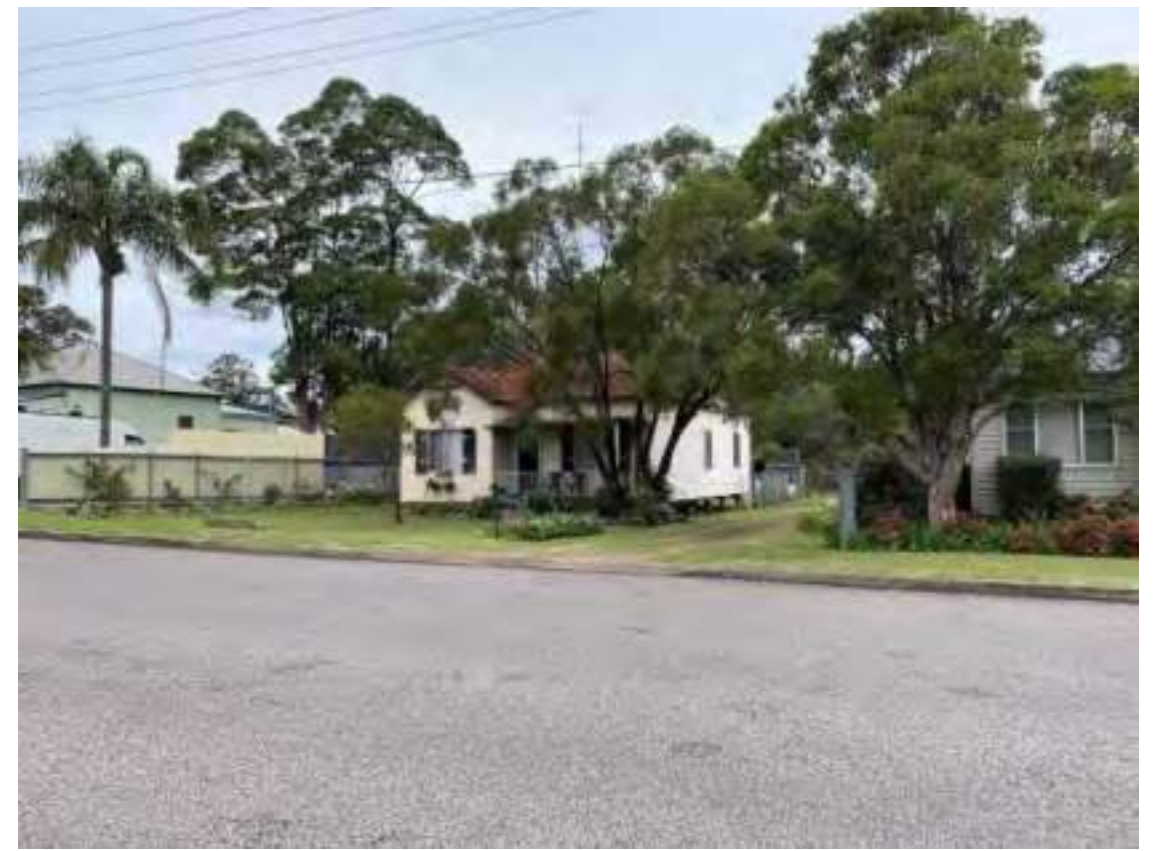
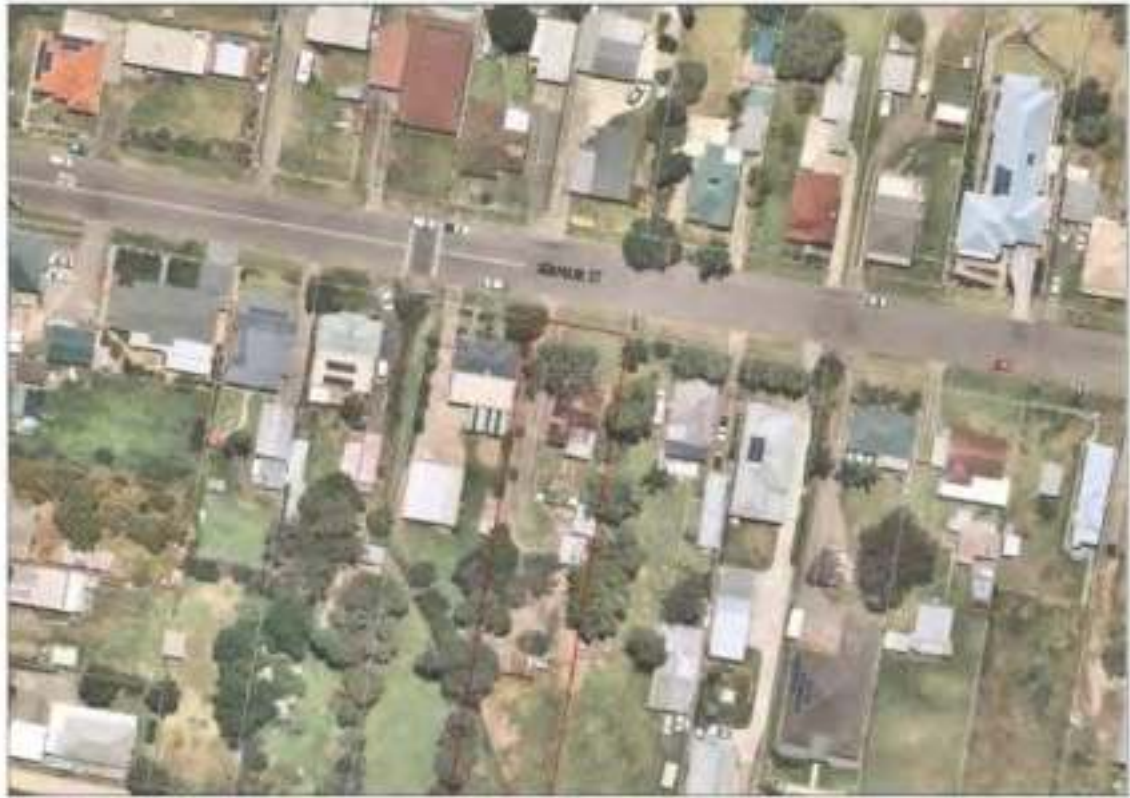
98 SEAHAM STREET, HOLMESVILLE 2286

Conservation Area Contribution Level	Est. Construction Date	Previous studies and/or community input
Contributory 1	1930–1950	No prior heritage investigations and no additional information required
Assessment Text		Observed Modifications
<p>Single storey Vernacular style dwelling with weatherboard cladding and hipped and gable corrugated iron roof. The verandah roof is skillion and supported by timber posts.</p> <p>The verandah is enclosed by a simple metal railing. Concrete stairs lead onto the verandah landing, with the same railing providing support.</p> <p>All visible windows are contemporary in style.</p> <p>The dwelling displays architectural features of a heritage style and is representative of the local development of this period, being of historical significance for the HCA.</p>		<p>The veranda railing and roof are likely more contemporary variations of the original style. If enclosed, the verandah likely had a timber balustrade and a hipped or bull nosed roof.</p> <p>All of the windows have been replaced with metal frames, replacing the original timber designs.</p>

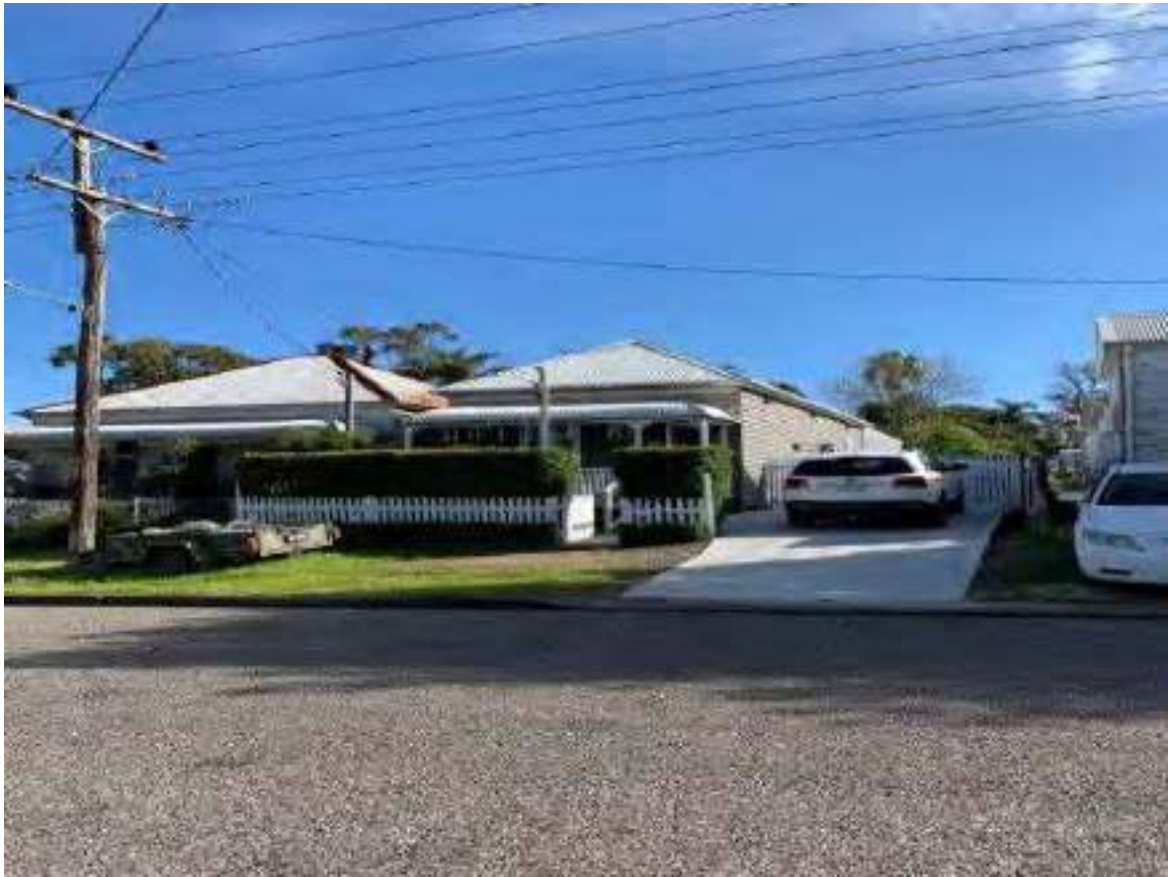
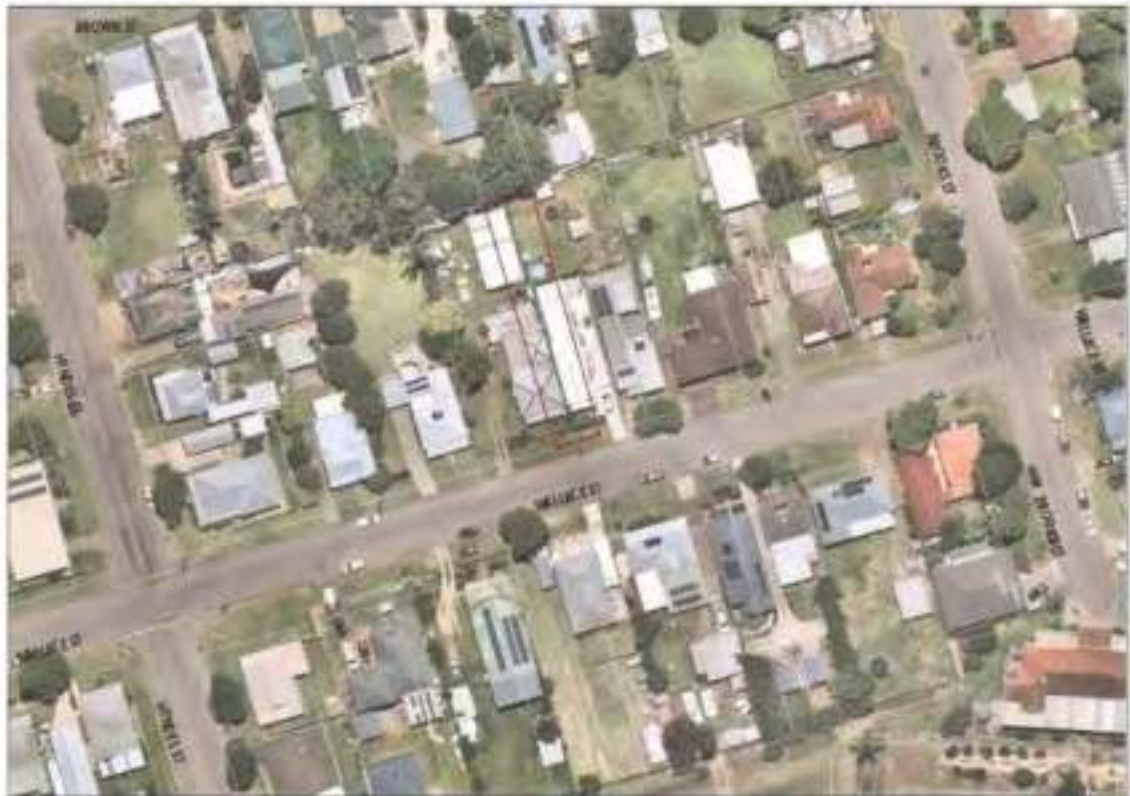
27 WALLACE STREET, WEST WALLSEND 2286

Conservation Area Contribution Level	Est. Construction Date	Previous studies and/or community input
Contributory 1	1890–1915	West Wallsend Heritage Study 1993 In connection with 29 and 21 Wallace Street
Assessment Text		Observed Modifications
<p>Single story simple Edwardian cottage style dwelling with Colourbond hipped roof and timber weatherboard cladding. The veranda roof is bull nosed and supported by ornately carved timber posts.</p> <p>The veranda is enclosed by timber balustrade with timber flooring.</p> <p>Visible windows are double hung sash designs, with a timber framed main door.</p> <p>A timber picket fence encloses the property, with concrete driveway to the east.</p> <p>The dwelling displays architectural features of a heritage style and is representative of the local development of this period, being of historical significance for the HCA.</p>		<p>A back extension has been constructed in a sympathetic manner and is not visible from the street.</p> <p>The balustrade and timber support posts are recent additions, but keep with the heritage style.</p>

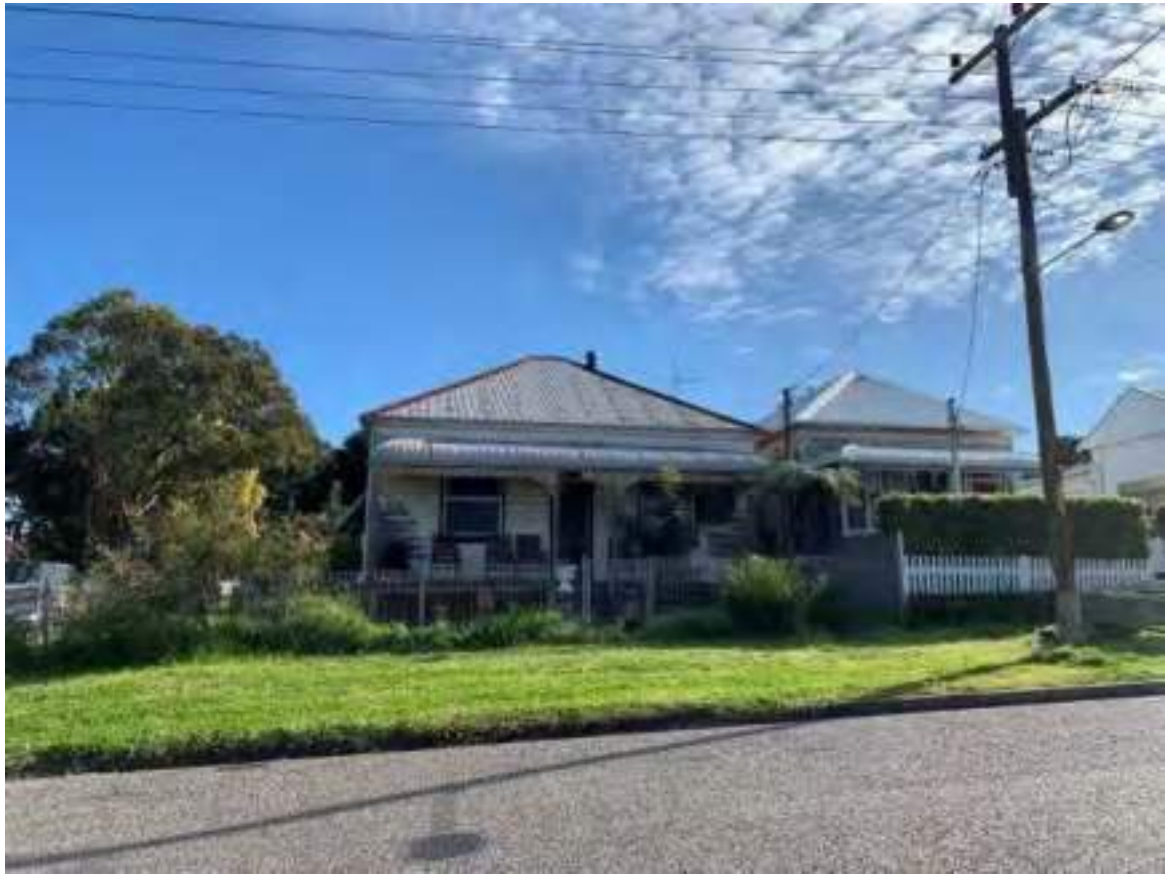
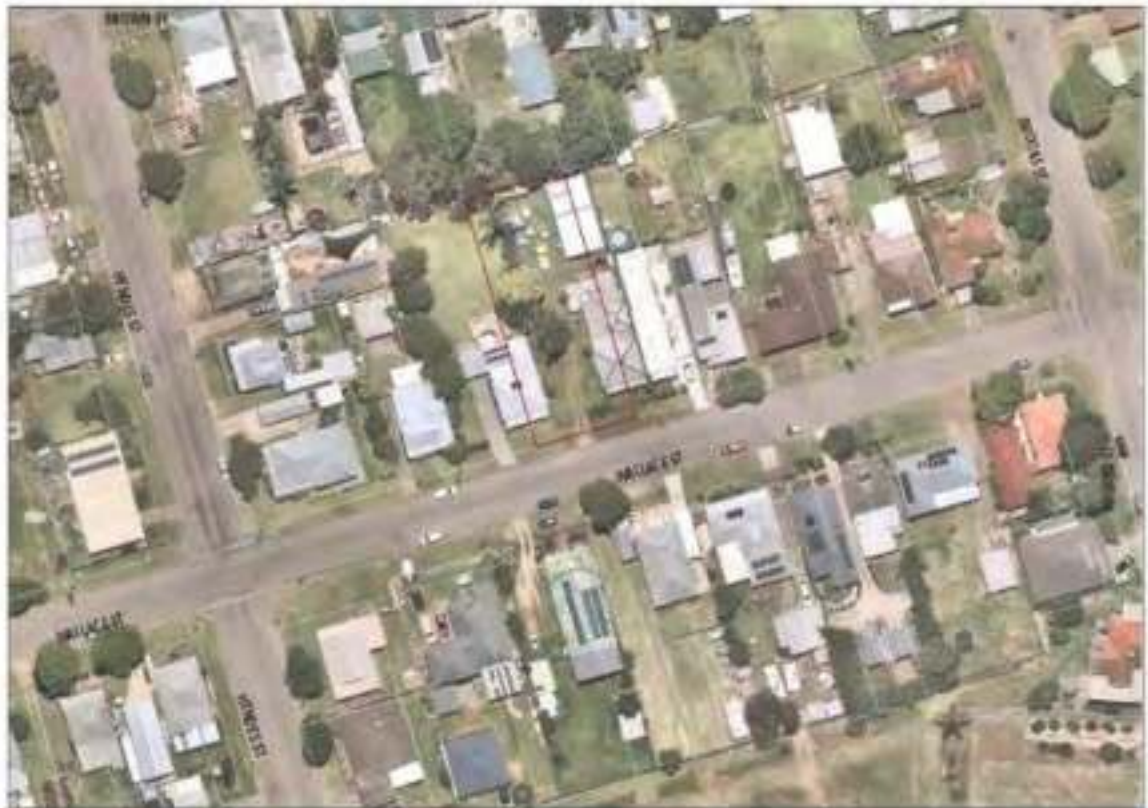
29 WALLACE STREET, WEST WALLSEND 2286

Conservation Area Contribution Level	Est. Construction Date	Previous studies and/or community input
Contributory 1	1890–1915	West Wallsend Heritage Study 1993 In connection with 27 and 31 Wallace Street
Assessment Text		Observed Modifications
<p>Single story vernacular cottage style dwelling with corrugated hipped roof and timber weatherboard cladding. The veranda roof is bull nosed and supported by timber posts with cast iron lace vallance.</p> <p>The veranda is open with no balustrades, timber board flooring and timber stairs leading to the landing. Masonry stair walls and piers are found either side.</p> <p>Visible windows are contemporary sash designs, with aluminium frames. The front door is timber framed, four panel design with a metal security screen. The western window has a metal sheet awning.</p> <p>Multiple structures are built at the back northern side of the property, however this is not visible from the street.</p> <p>The dwelling displays architectural features of a heritage style and is representative of the local development of this period, being of historical significance for the HCA.</p>		<p>Original timber framed sash windows have been replaced with contemporary metal framed designs.</p>

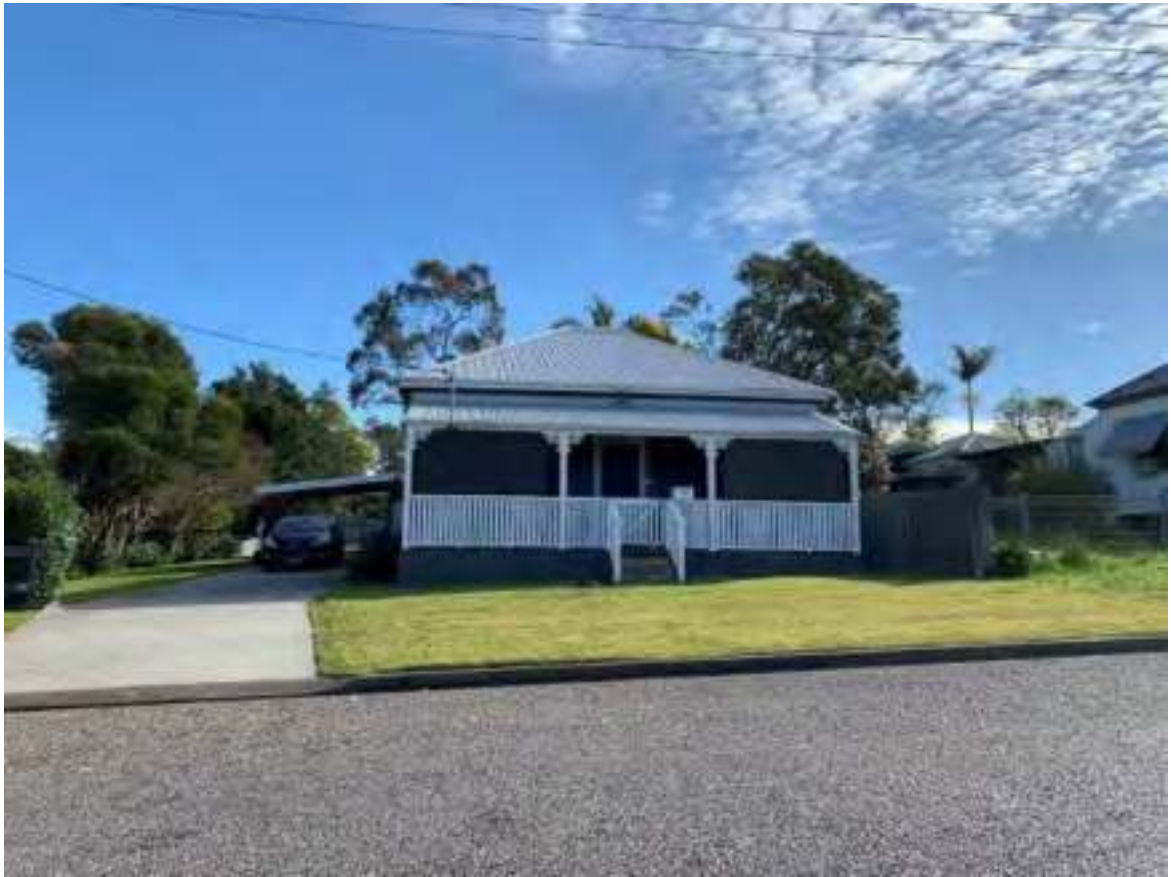
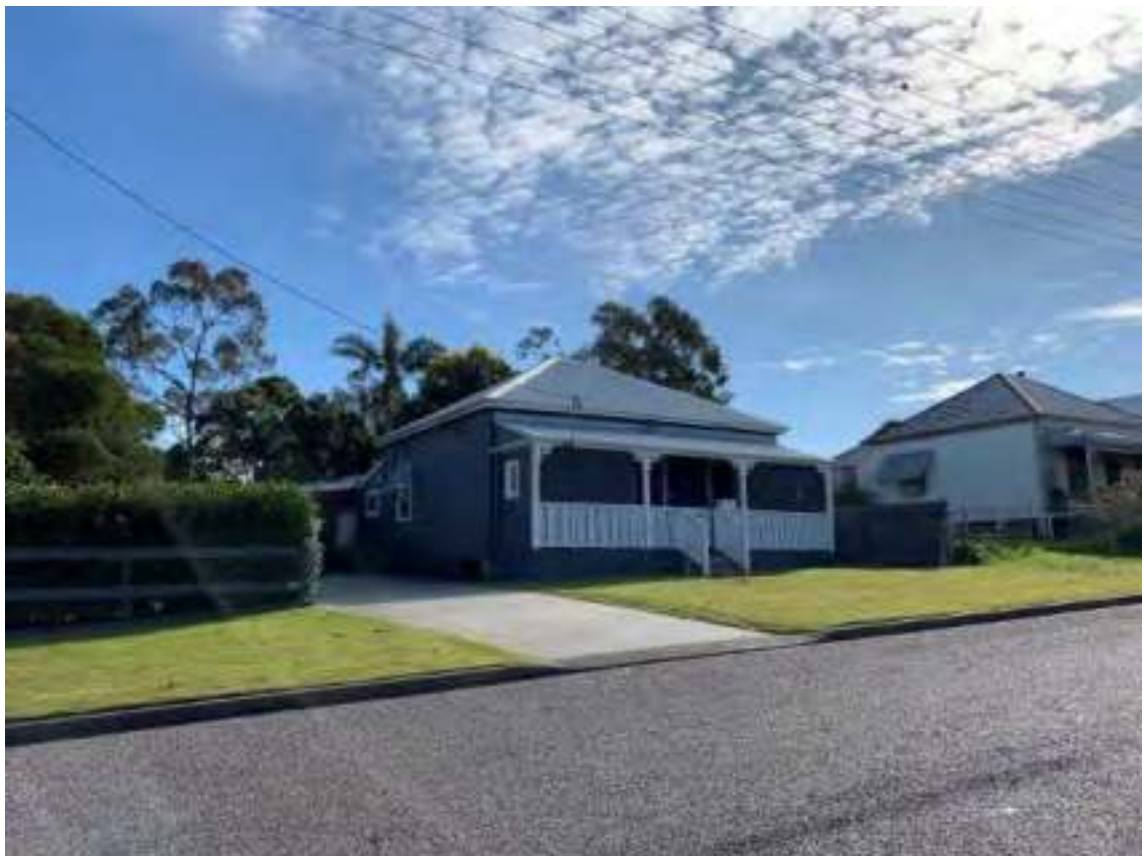
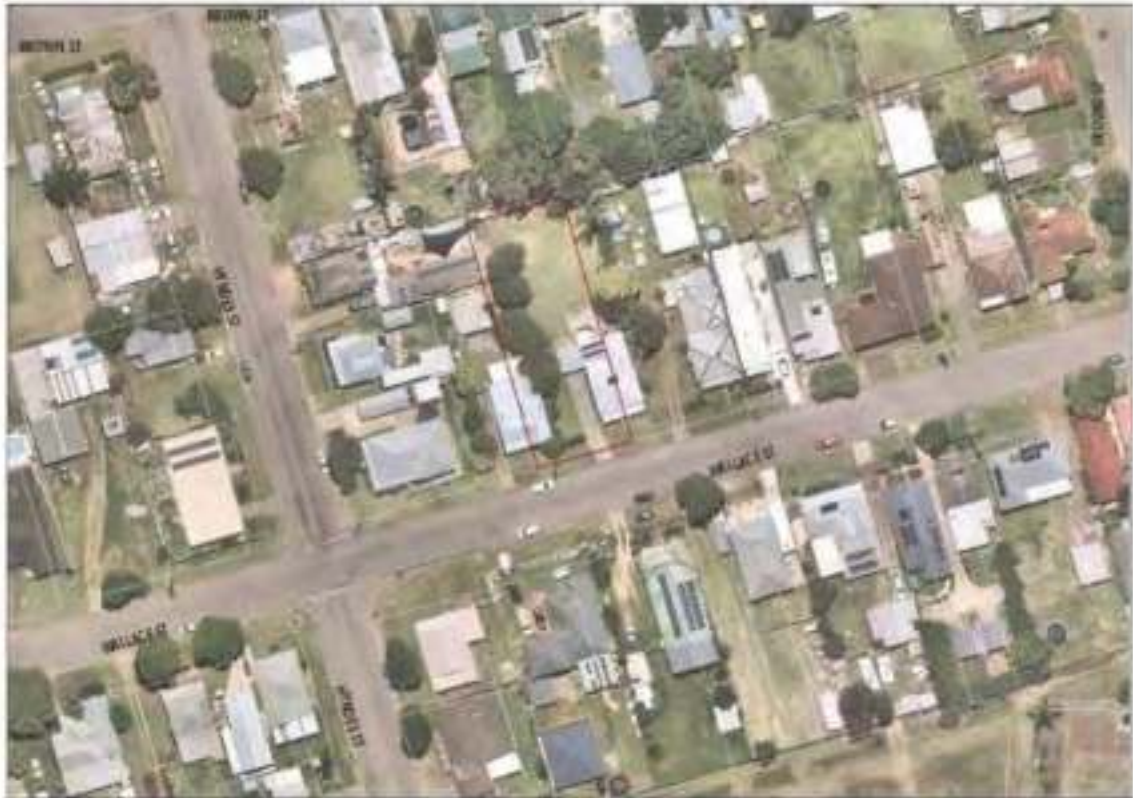
31 WALLACE STREET, WEST WALLSEND 2286

Conservation Area Contribution Level	Est. Construction Date	Previous studies and/or community input
Contributory 1	1890–1915	West Wallsend Heritage Study 1993 In connection with 27 and 29 Wallace Street
Assessment Text		Observed Modifications
<p>Single story vernacular cottage style dwelling with Colourbond hipped roof and weatherboard cladding. The veranda roof is skillion and supported by ornately carved timber posts.</p> <p>The veranda is enclosed by timber balustrade, in a simple dowelled design. A set of concrete stairs leads to the landing, with corresponding timber balustrades and entrance gate.</p> <p>Features of the façade are obscured due to contemporary canvas blinds. The door is central with timber framed windows to either side. western window has evident timber shingle awning with simple bracketing.</p> <p>A skillion roof timber carport is located to the west of the dwelling.</p> <p>The dwelling displays architectural features of a heritage style and is representative of the local development of this period, being of historical significance for the HCA.</p>		<p>The balustrade and posts supporting the veranda are a recent adaptation of original features and have been constructed in a sympathetic manner.</p> <p>The western veranda has been enclosed by a structural wall with small stain glass window.</p> <p>Timber boarding has been added to the façade.</p>

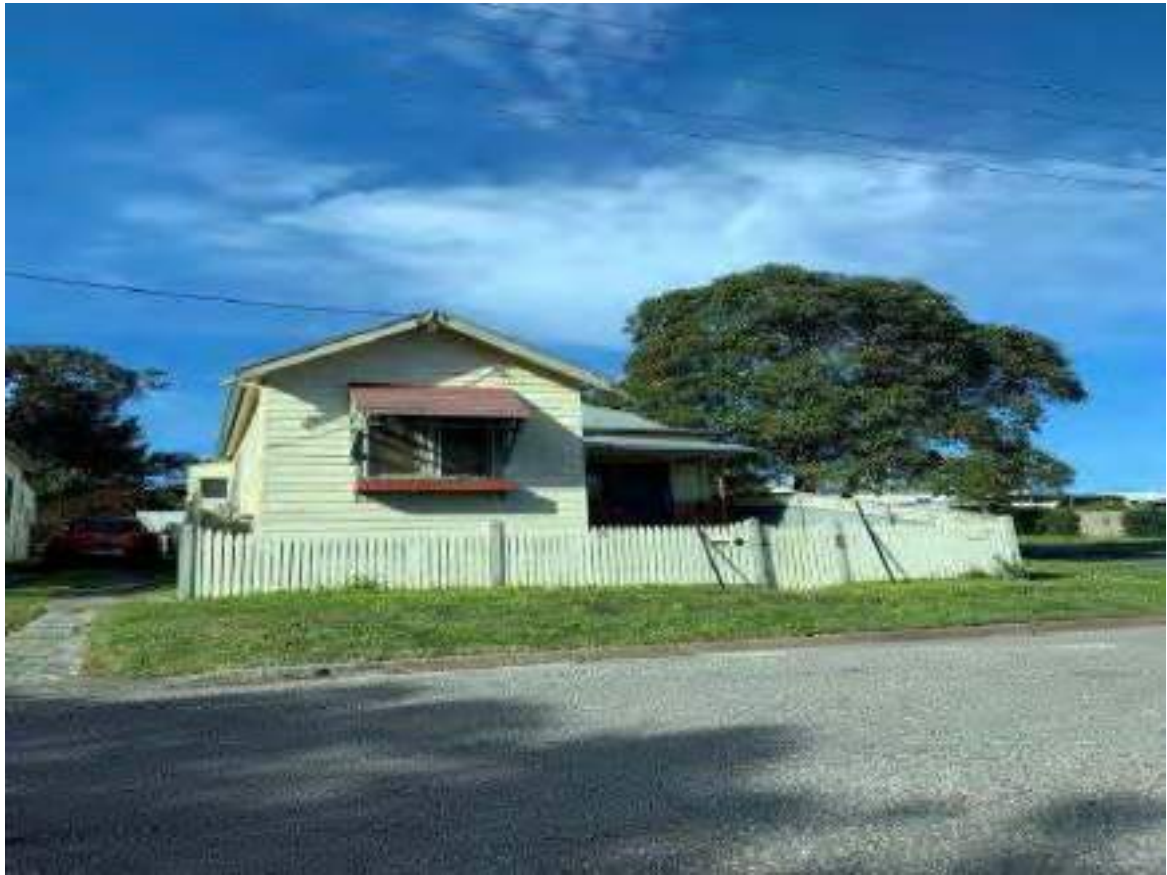
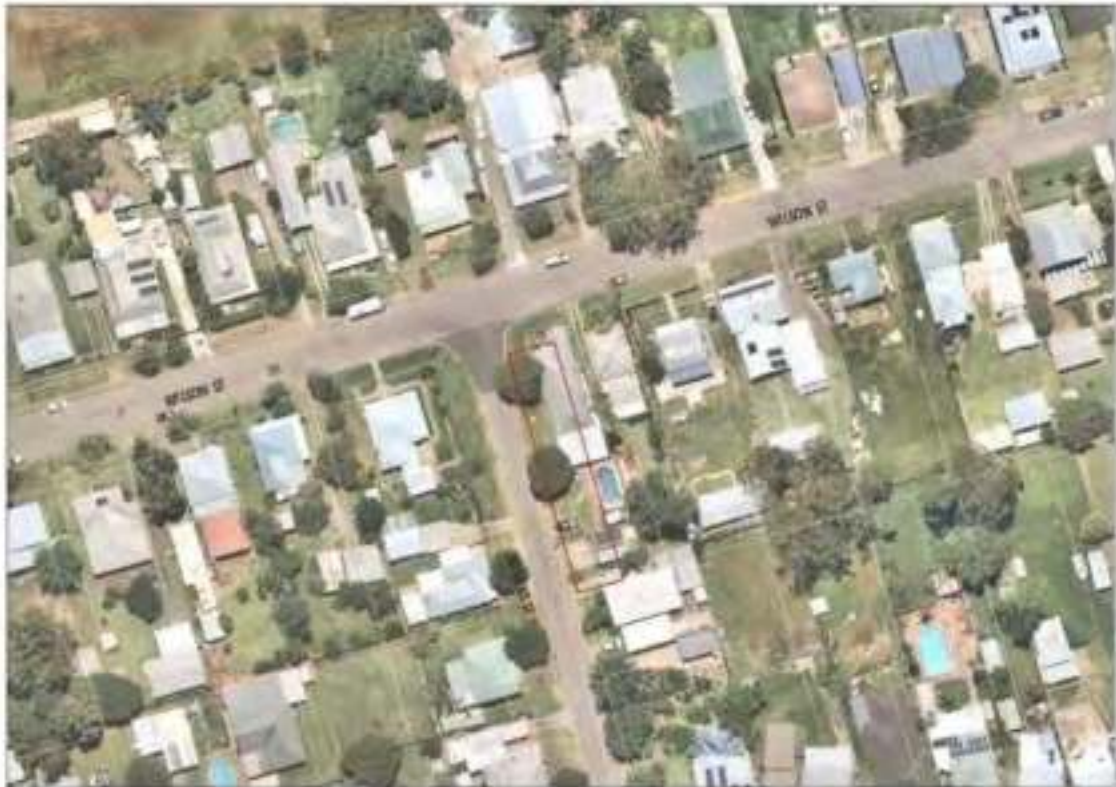
20 WILSON STREET, WEST WALLSEND 2286

Conservation Area Contribution Level	Est. Construction Date	Previous studies and/or community input
Contributory 1	1900–1915	No prior heritage investigations and no additional information required
Assessment Text		Observed Modifications
<p>Single story simple Federation ‘workmen's cottage’ dwelling with half hipped and gable Colourbond roof and timber weatherboard cladding. The veranda roof is hipped and supported by metal posts.</p> <p>The veranda is enclosed by metal balustrade, with rendered concrete and tiled stairs leading to rh landing. The stair balustrade is in the same style.</p> <p>The gable has extended barge boards and no other decorations. The gable window is timber framed and sash designed, with prominent timber sill, shingled awnings, and decorative brackets.</p> <p>A secondary front door is located on the inner eastern side of the dwelling, with metal frame and a security screen.</p> <p>Property is enclosed by a combination of Colourbond and timber picket fencing.</p> <p>The dwelling displays architectural features of a heritage style and is representative of the local development of this period, being of historical significance for the HCA.</p>		<p>The front door has been replaced by a contemporary metal framed sliding design. The secondary door has similarly been replaced with modern metal styles. This juxtaposes the heritage features of the dwelling.</p> <p>The veranda and stair balustrades contrast with the traditionally timber features of the dwelling, impacting the contributory value of the dwelling.</p> <p>A back extension has been constructed in a sympathetic manner, however sliding windows have been installed.</p>

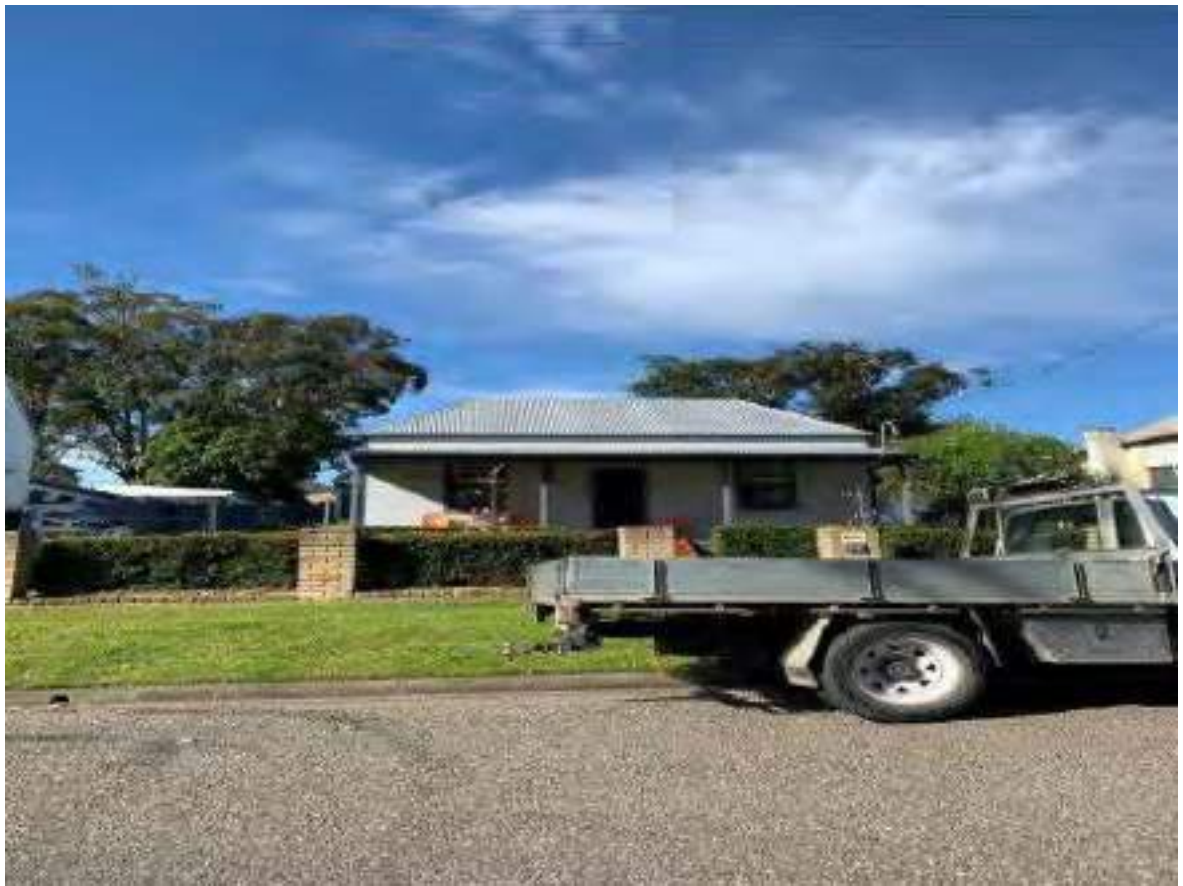
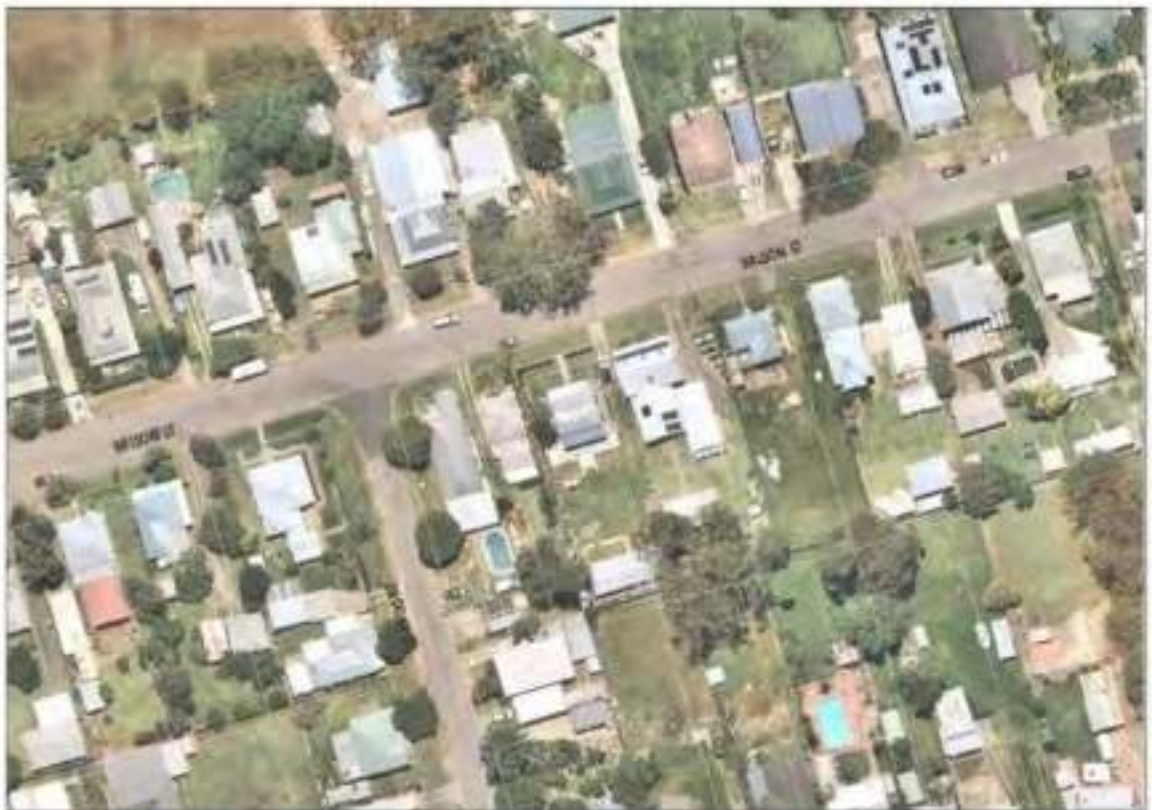
16 WILSON STREET, WEST WALLSEND 2286

Conservation Area Contribution Level	Est. Construction Date	Previous studies and/or community input
Contributory 1	1890–1915	No prior heritage investigations and no additional information required
Assessment Text		Observed Modifications
<p>Single story vernacular cottage style dwelling with Colourbond hipped roof and weatherboard cladding. The veranda roof is skillion and supported by timber posts.</p> <p>The veranda is open with no balustrades, the floor is timber and timber stairs lead onto the landing. The stairs similarly have no balustrades.</p> <p>The central front door is timber framed with a metal security screen. Double hung sash windows are found either side. The eastern and western windows are similar, with additional timber awnings.</p> <p>Brick pillar fencing encloses the dwelling.</p> <p>The dwelling displays architectural features of a heritage style and is representative of the local development of this period, being of historical significance for the HCA.</p>		<p>The timber stairs are a recent modification likely replacing similar original styles. The timber choice contrasts with the dwellings remaining features.</p> <p>A back extension has been constructed, however is not visible and does not detract.</p> <p>A large multi door garage has been constructed at the back southern end of the property.</p>
