APPENDIX 2

Building Assessment Sheets (Inventory Sheets)

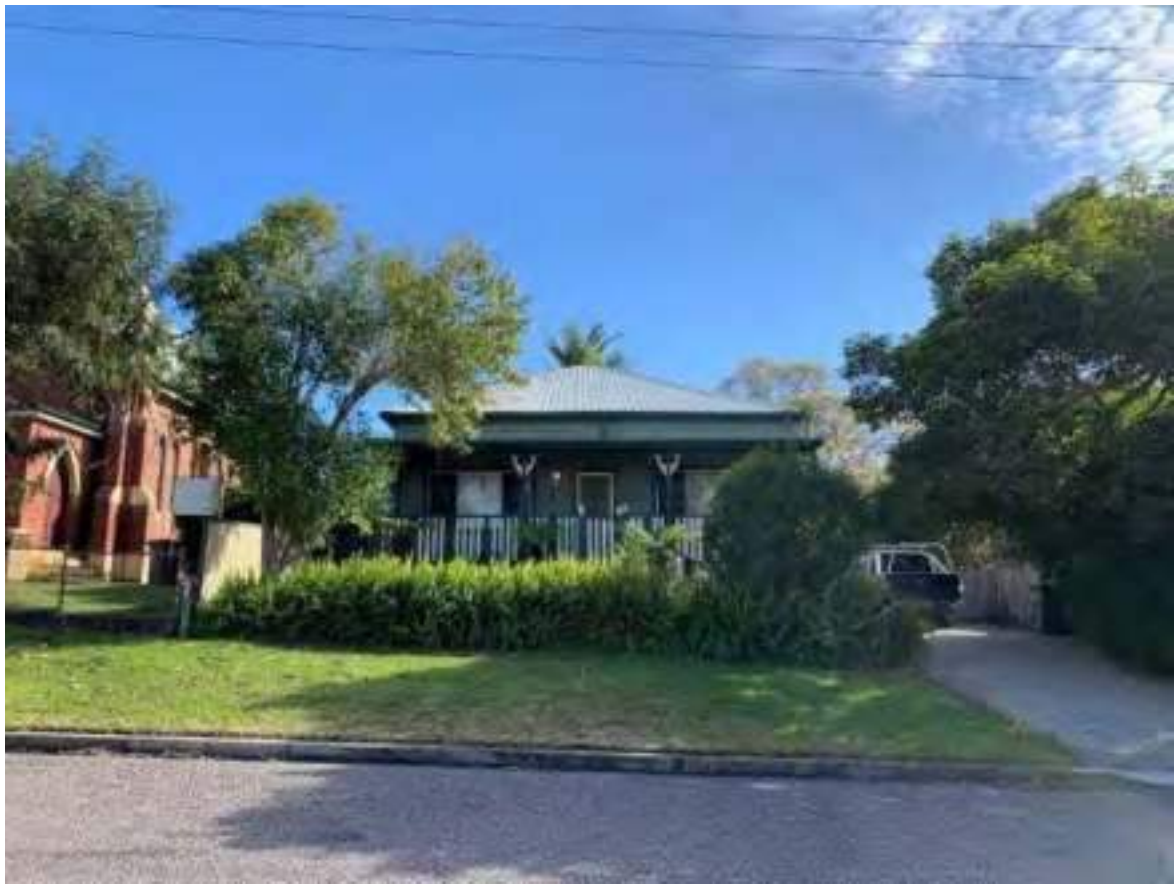
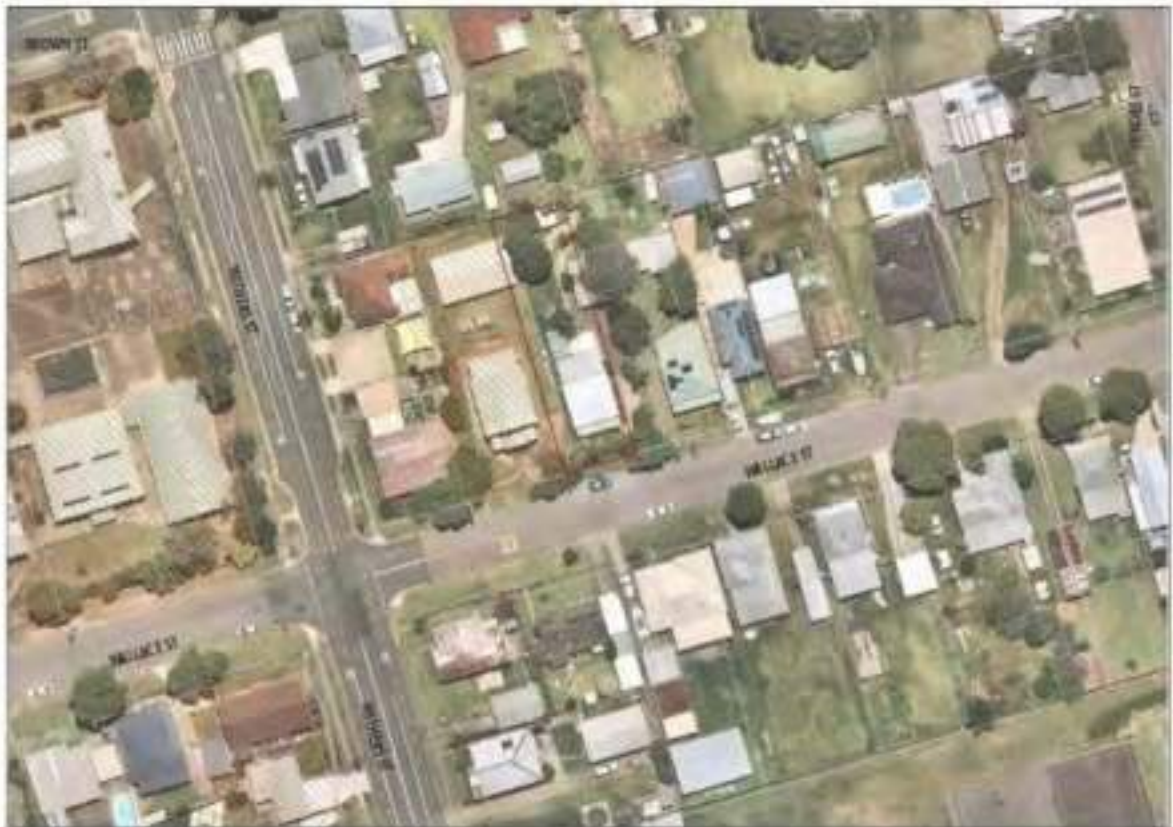
47 WALLACE STREET, WEST WALLSEND 2286

Conservation Area Contribution Level	Est. Construction Date	Previous studies and/or community input
Contributory 1	1890–1915	No prior heritage investigations and no additional information required
Assessment Text		Observed Modifications
<p>Single story vernacular cottage style dwelling with hipped Colourbond roof and weatherboard cladding. The veranda roof is skillion and supported by timber posts with art nouveau brackets. The veranda is enclosed by timber dowelled balustrade with newel posts. Timber stairs with corresponding balustrades lead onto the landing.</p> <p>The front door is timber framed with a metal security screen. Metal framed large picture windows are found either side.</p> <p>The dwelling displays architectural features of a heritage style and is representative of the local development of this period, being of historical significance for the HCA.</p>		<p>The façade windows have been replaced with contemporary metal frames, contrasting with the heritage timber features of the dwelling.</p> <p>The veranda and stair balustrade has likely been updated, based on an original timber design. The orientation of the stairs has possibly been altered, now facing eastwards.</p>

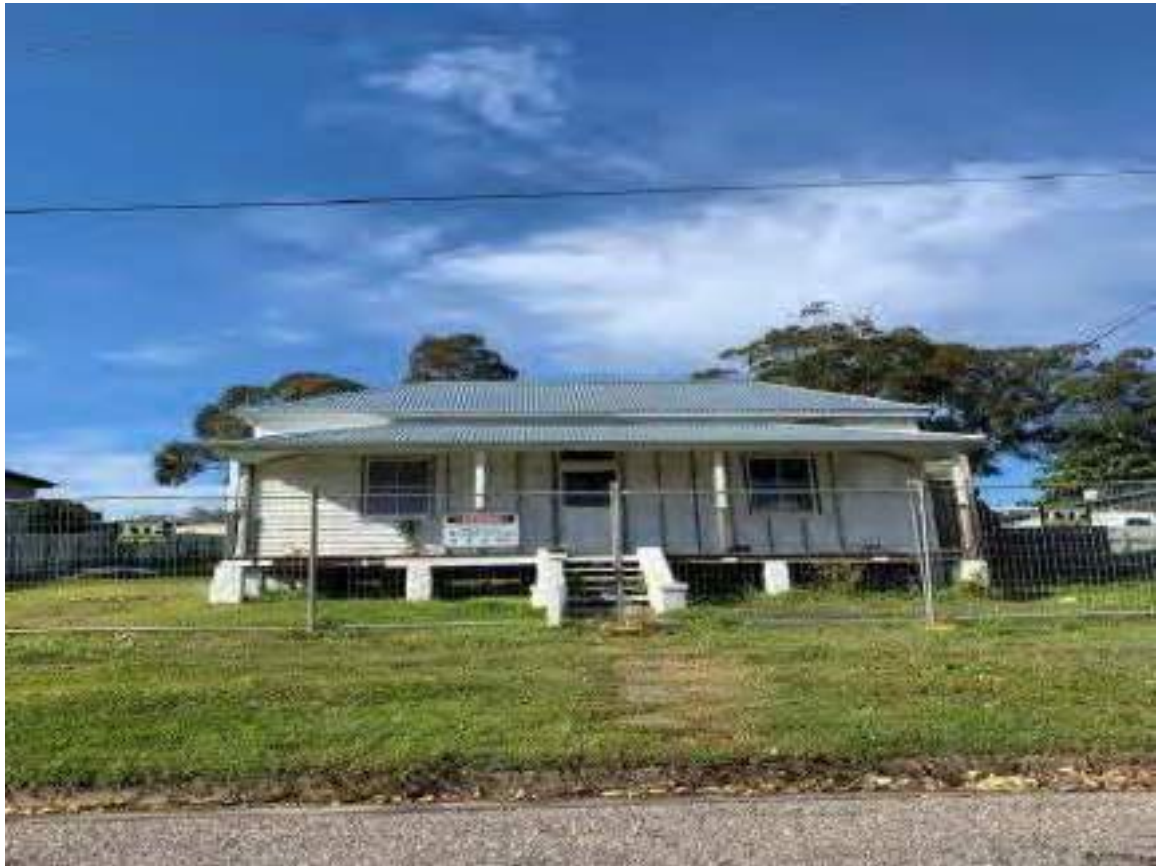
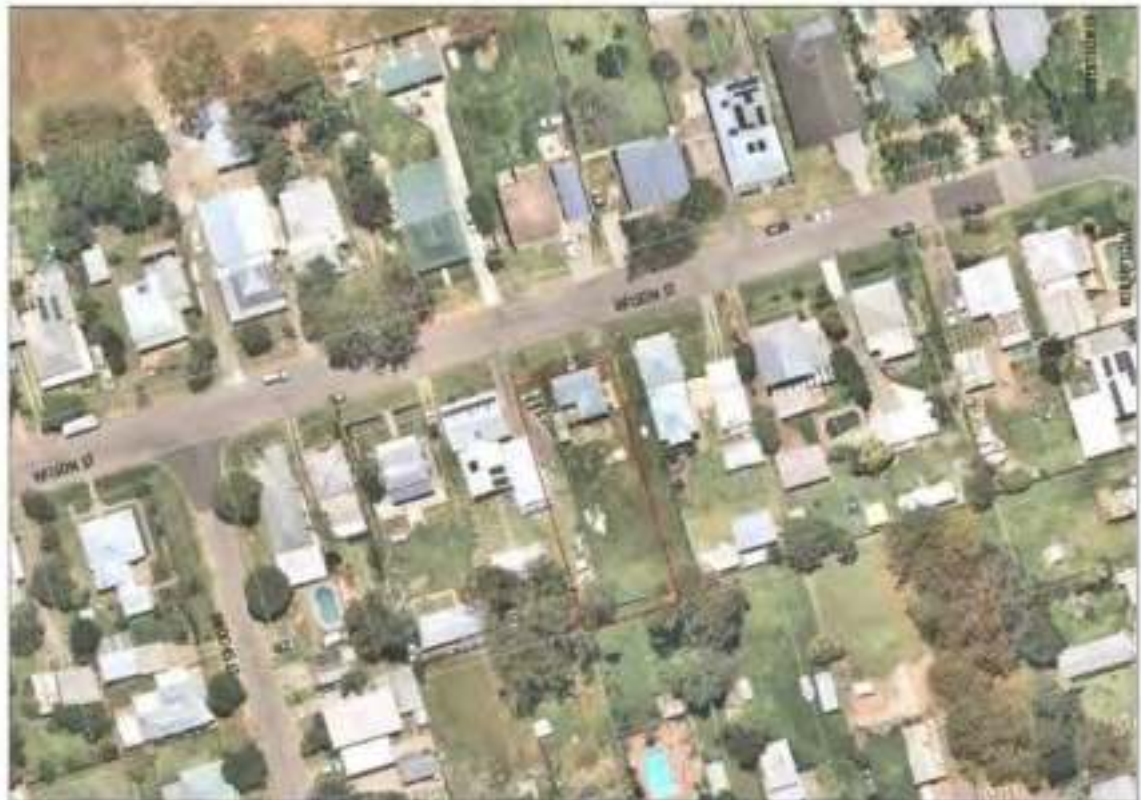
12 WILSON STREET, WEST WALLSEND 2286

Conservation Area Contribution Level	Est. Construction Date	Previous studies and/or community input
Contributory 1	1890–1915	No prior heritage investigations and no additional information required
Assessment Text		Observed Modifications
<p>Single story vernacular 'Mining Cottage' style dwelling with Colourbond hipped roof and timber weatherboard cladding. The veranda roof is hipped and supported by timber posts.</p> <p>The veranda is open with no balustrade, the floor is timber and a set of rendered concrete stairs, with rendered balustrade and piers leads onto the landing.</p> <p>The front door is timber framed with timber sash windows either side.</p> <p>A rendered brick chimney is visible on the eastern side of the dwelling. the chimney stack is missing.</p> <p>The dwelling displays architectural features of a heritage style and is representative of the local development of this period, being of historical significance for the HCA.</p>		<p>Dwelling is currently undergoing a demolition works.</p>

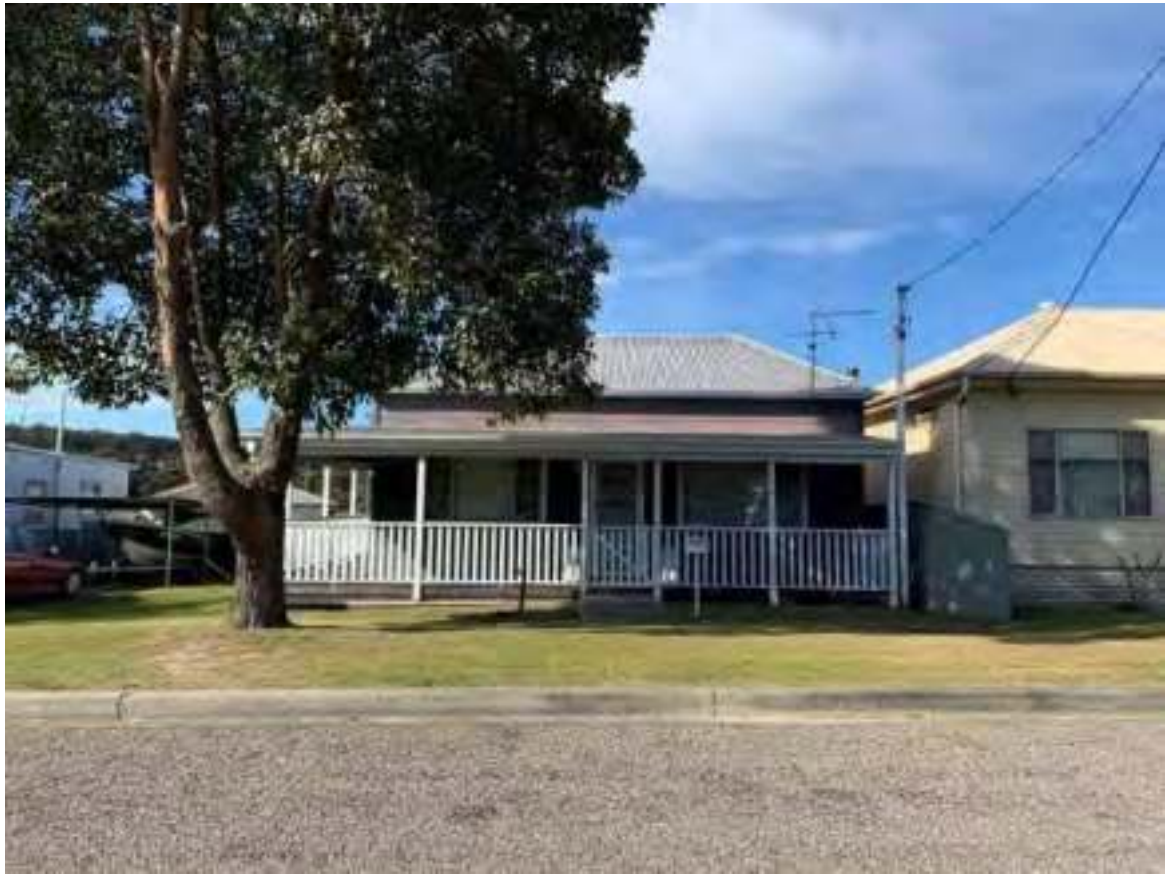
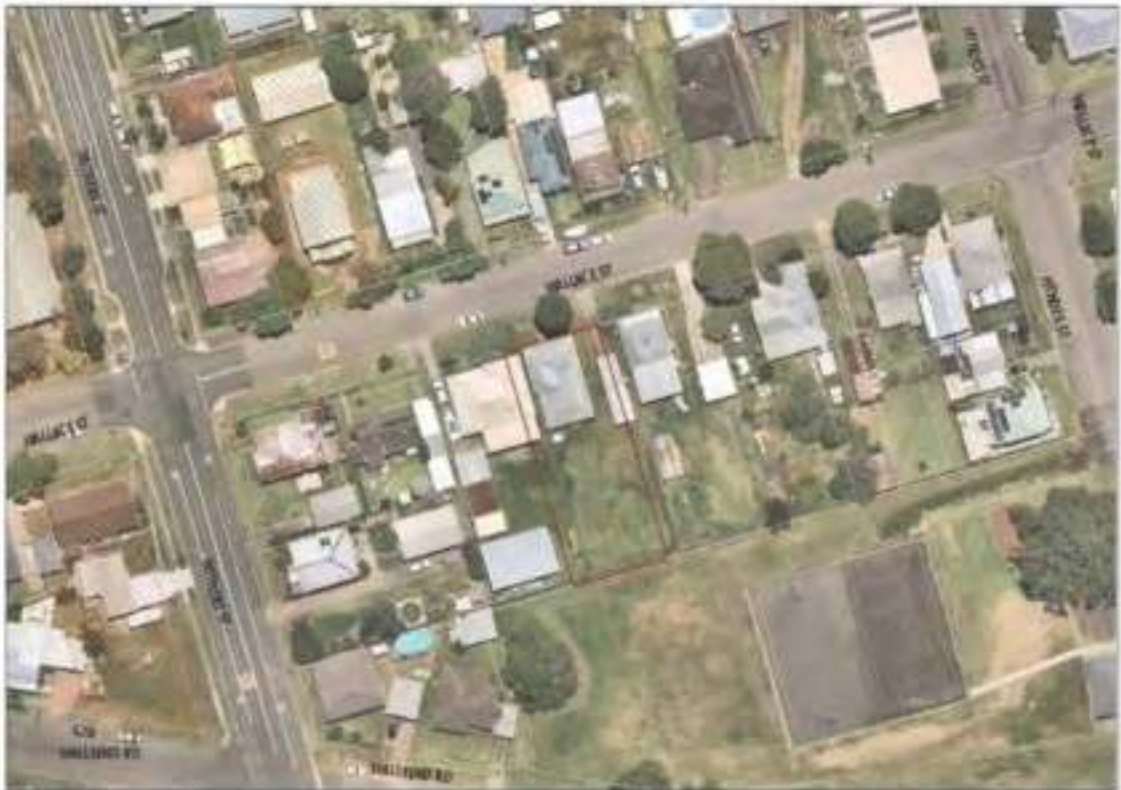
44 WALLACE STREET, WEST WALLSEND 2286

Conservation Area Contribution Level	Est. Construction Date	Previous studies and/or community input
Contributory 1	1890–1915	No prior heritage investigations and no additional information required
Assessment Text		Observed Modifications
<p>Single story vernacular 'Mining Cottage' style dwelling with Colourbond hipped roof and weatherboard cladding. The veranda roof is skillion and supported by timber posts.</p> <p>The veranda is enclosed by timber dowelled balustrade, with timber flooring and no stairs. A concrete ramp leads onto the landing.</p> <p>The front door is central, and timber framed, with large picture style windows either side.</p> <p>A small garage and carport are located to the east of the dwelling.</p> <p>The dwelling displays architectural features of a heritage style and is representative of the local development of this period, being of historical significance for the HCA.</p>		<p>The front door has been replaced by a contemporary style, with horizontal glass panels. The adjacent picture windows are further additions, likely replacing original sash designs.</p> <p>The timber balustrade is sympathetic in style, however, is a modern addition.</p> <p>The veranda wraps around the northern, eastern and southern sides of the dwelling, this is a recent addition and not original. The style is consistent however and does not detract.</p>

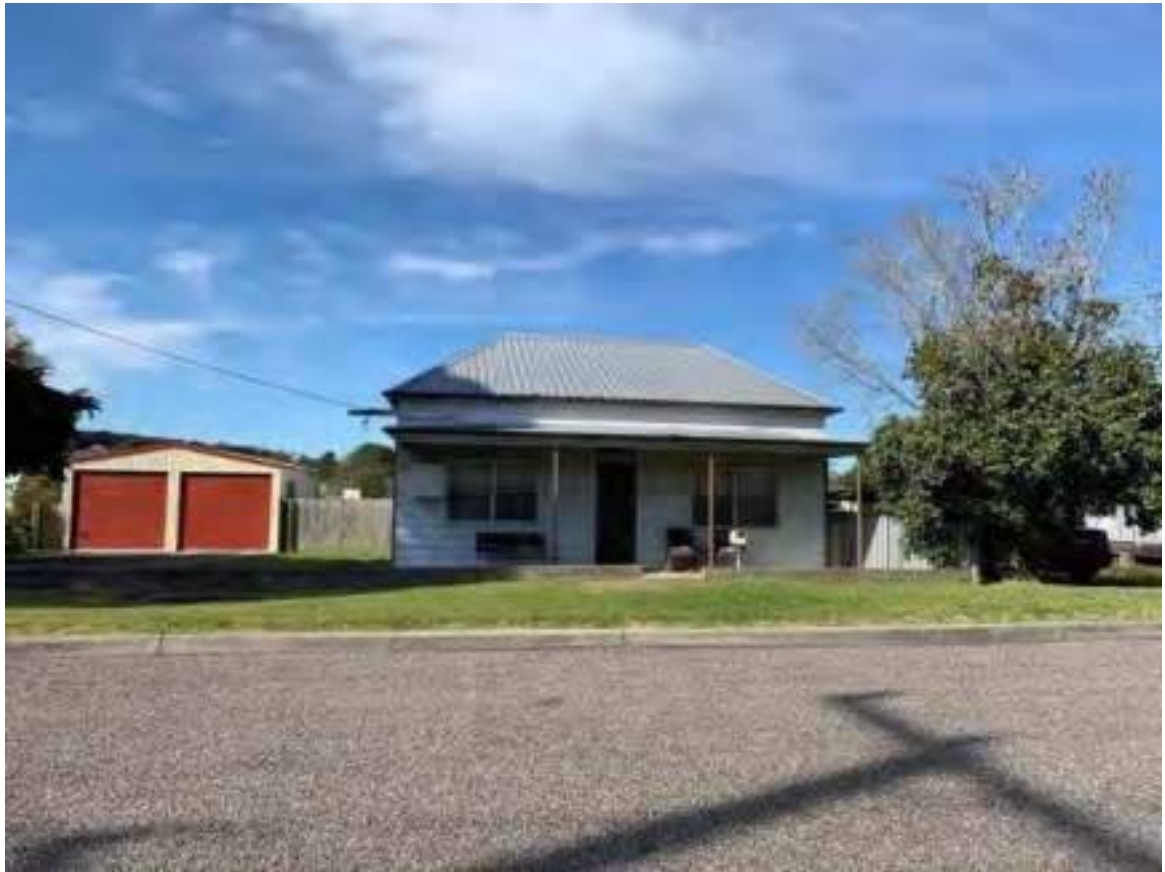
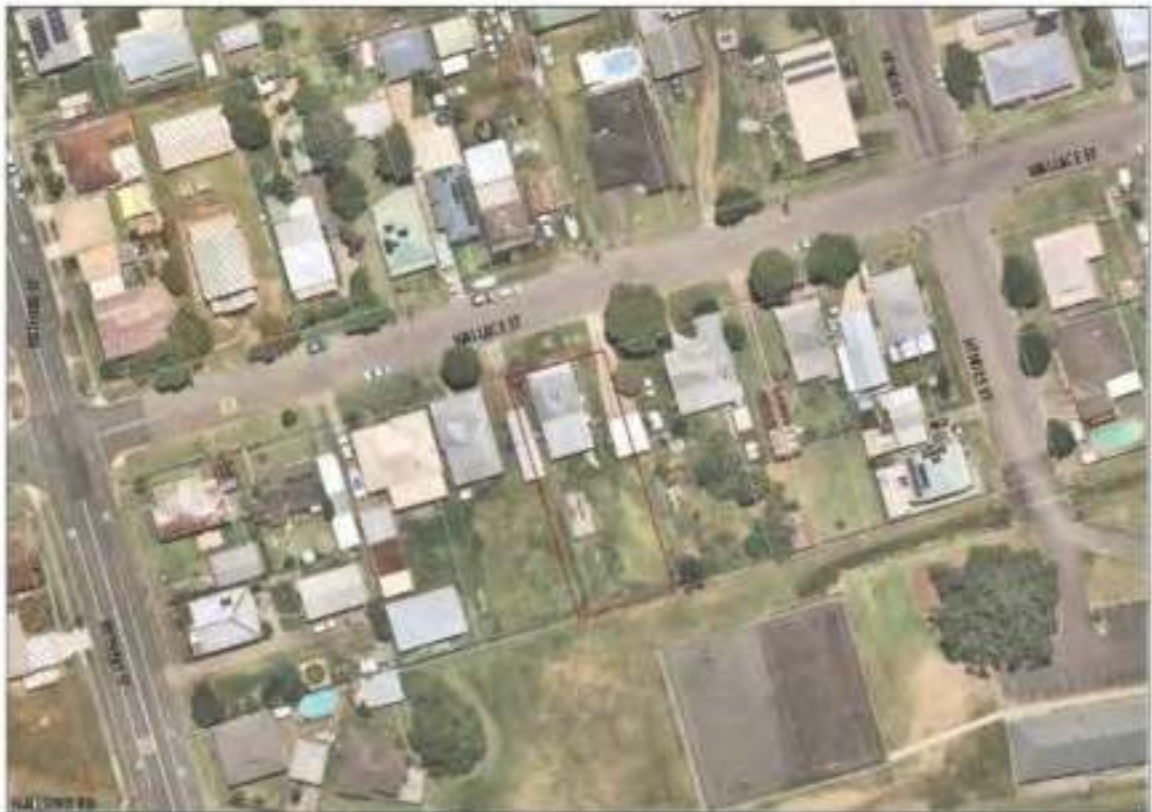
42 WALLACE STREET, WEST WALLSEND 2286

Conservation Area Contribution Level	Est. Construction Date	Previous studies and/or community input
Contributory 1	1890–1915	No prior heritage investigations and no additional information required
Assessment Text		Observed Modifications
<p>Single story Vernacular ‘Mining Cottage’ style dwelling with Colourbond hipped roof and weatherboard cladding. The veranda roof is skillion and supported by metal posts.</p> <p>The veranda is open with no balustrade, the floor is concrete and no stairs are necessary.</p> <p>A low lying brick fence frames the property boundary.</p> <p>The front door is central and timber framed, with a metal security screen. Double hung timber sash windows are either side. The eastern windows have additional metal awnings.</p> <p>A gable roof double garage is located to the east of the dwelling. This is highly visible and detracts.</p> <p>The dwelling displays architectural features of a heritage style and is representative of the local development of this period, being of historical significance for the HCA.</p>		<p>The front door and adjacent windows have been replaced with contemporary styles, contrasting the heritage streetscape.</p> <p>The metal support posts are not original features, likely replacing original timber styles.</p>

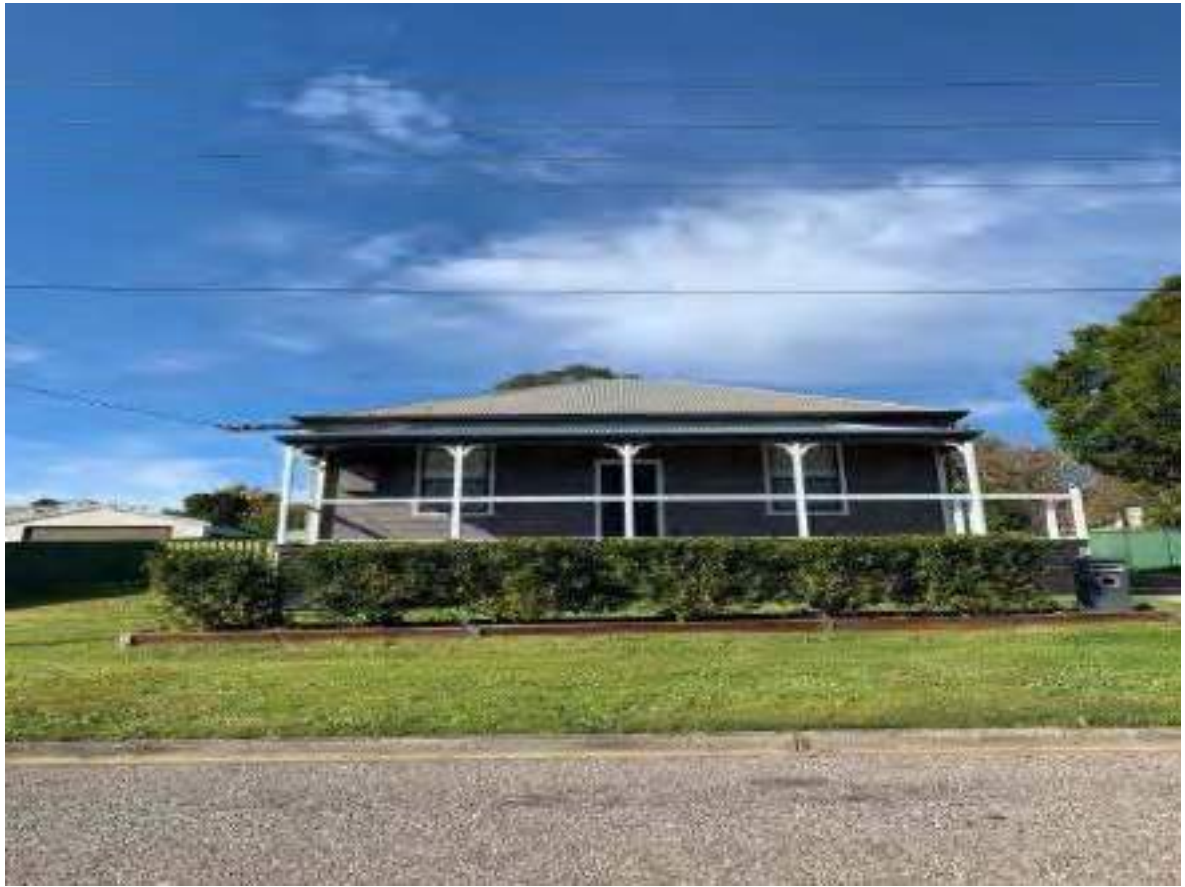
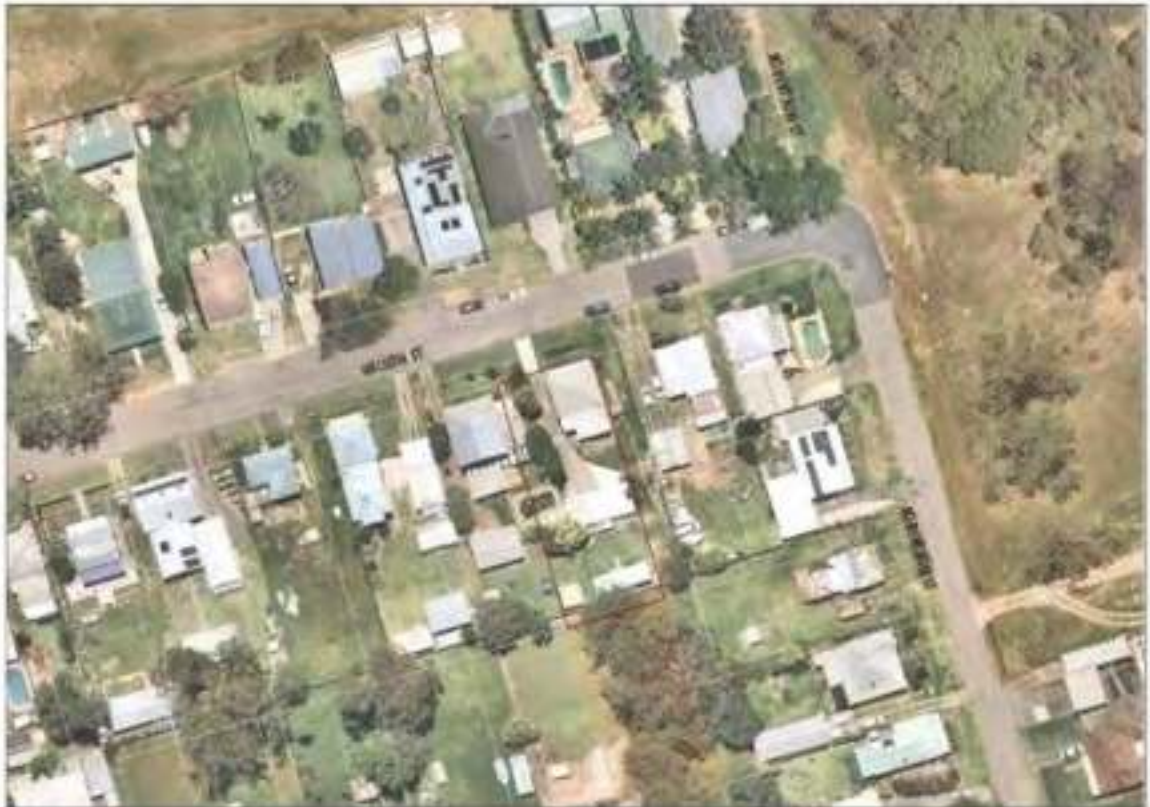
6 WILSON STREET, WEST WALLSEND 2286

Conservation Area Contribution Level	Est. Construction Date	Previous studies and/or community input
Contributory 1	1890–1915	No prior heritage investigations and no additional information required
Assessment Text		Observed Modifications
<p>Single story Vernacular ‘Mining Cottage’ style dwelling with Colourbond hipped roof and timber weatherboard cladding. The veranda roof is hipped and supported by timber posts with art nouveau bracketing.</p> <p>The veranda is enclosed by metal wire fencing, with timber floor and timber stairs leading to the landing. Colourbond sheeting has been added to the façade.</p> <p>The front door is timber framed, with timber sash windows to either side. the eastern and western windows are of a similar style.</p> <p>The dwelling displays architectural features of a heritage style and is representative of the local development of this period, being of historical significance for the HCA.</p>		<p>The wire fencing enclosing the veranda is a very modern addition, contrasting with the heritage streetscape.</p> <p>The stairs have been relocated to the western side of the dwelling.</p> <p>The front door and sash windows are contemporary replications of the original style. Both have been constructed in a sympathetic manner and do not detract.</p> <p>A back extension and attached car port have been constructed, however is not visible from the street.</p>

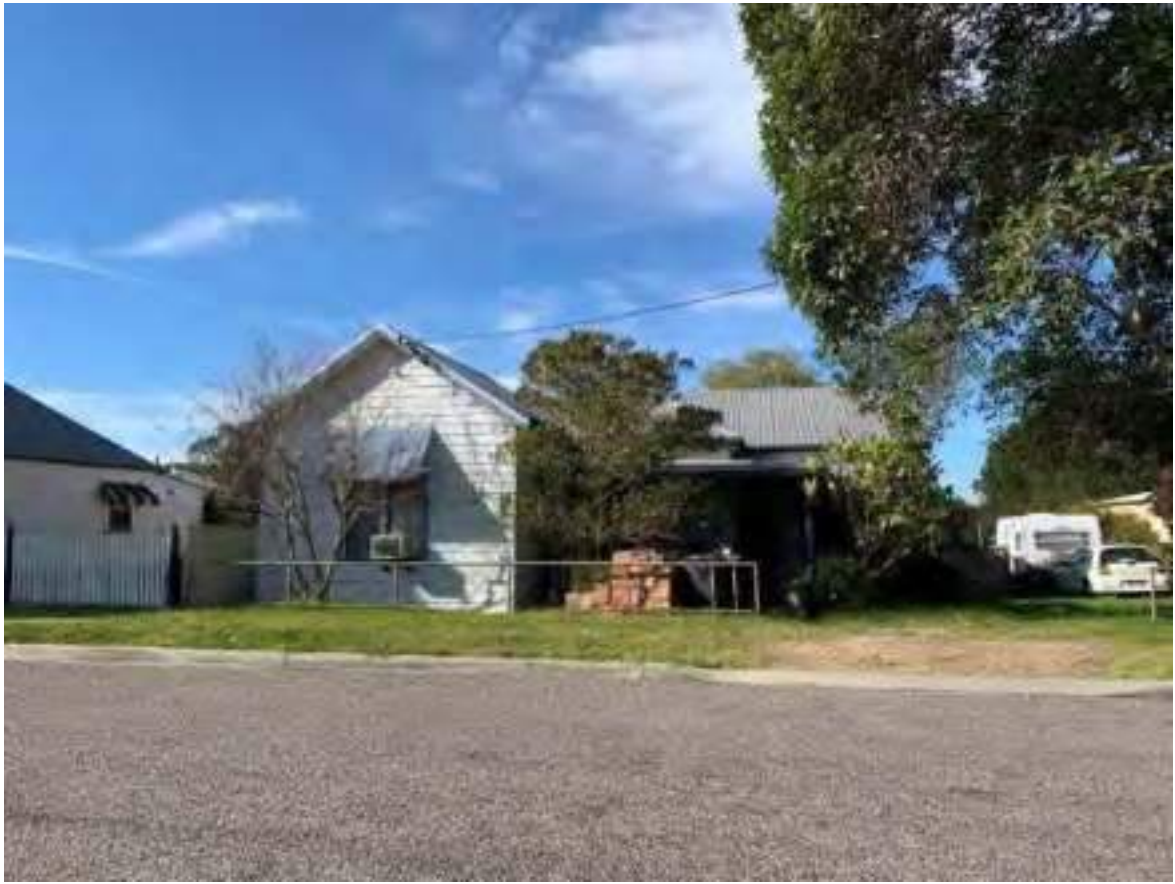
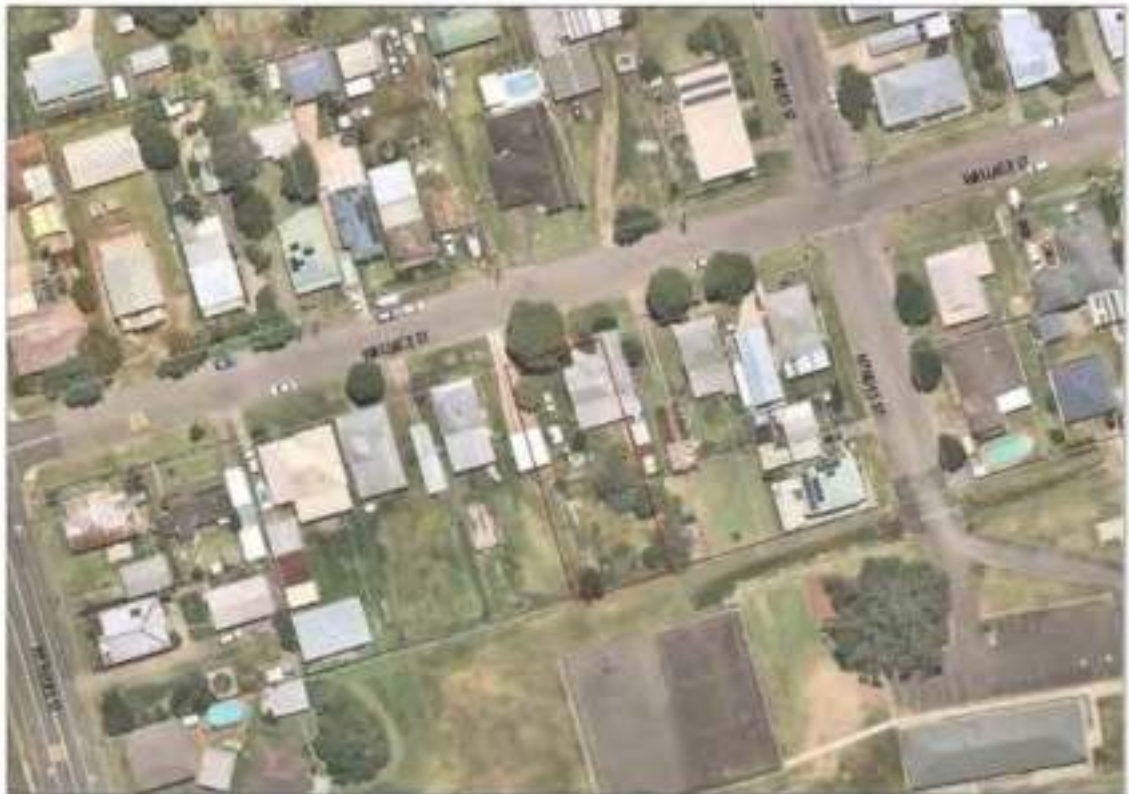
40 WALLACE STREET, WEST WALLSEND 2286

Conservation Area Contribution Level	Est. Construction Date	Previous studies and/or community input
Contributory 1	1900–1915	No prior heritage investigations and no additional information required
Assessment Text		Observed Modifications
<p>Single story simple Federation ‘workmen's cottage’ style dwelling with half gable and hipped Colourbond roof and weatherboard cladding. The veranda is L shaped, half skillion and hipped, and supported by timber posts.</p> <p>The veranda is partially enclosed with timber dowelled balustrade, concrete flooring, and no stairs.</p> <p>The front door is timber framed, with a four-panel design.</p> <p>The visible front façade windows are timber framed sash designs, with the gable window having a timber awning with ornate bracketing.</p> <p>The gable has no decorative features.</p> <p>The dwelling displays architectural features of a heritage style and is representative of the local development of this period, being of historical significance for the HCA.</p>		<p>The general layout of the dwelling is potentially modified, with the style typically being L shaped.</p>

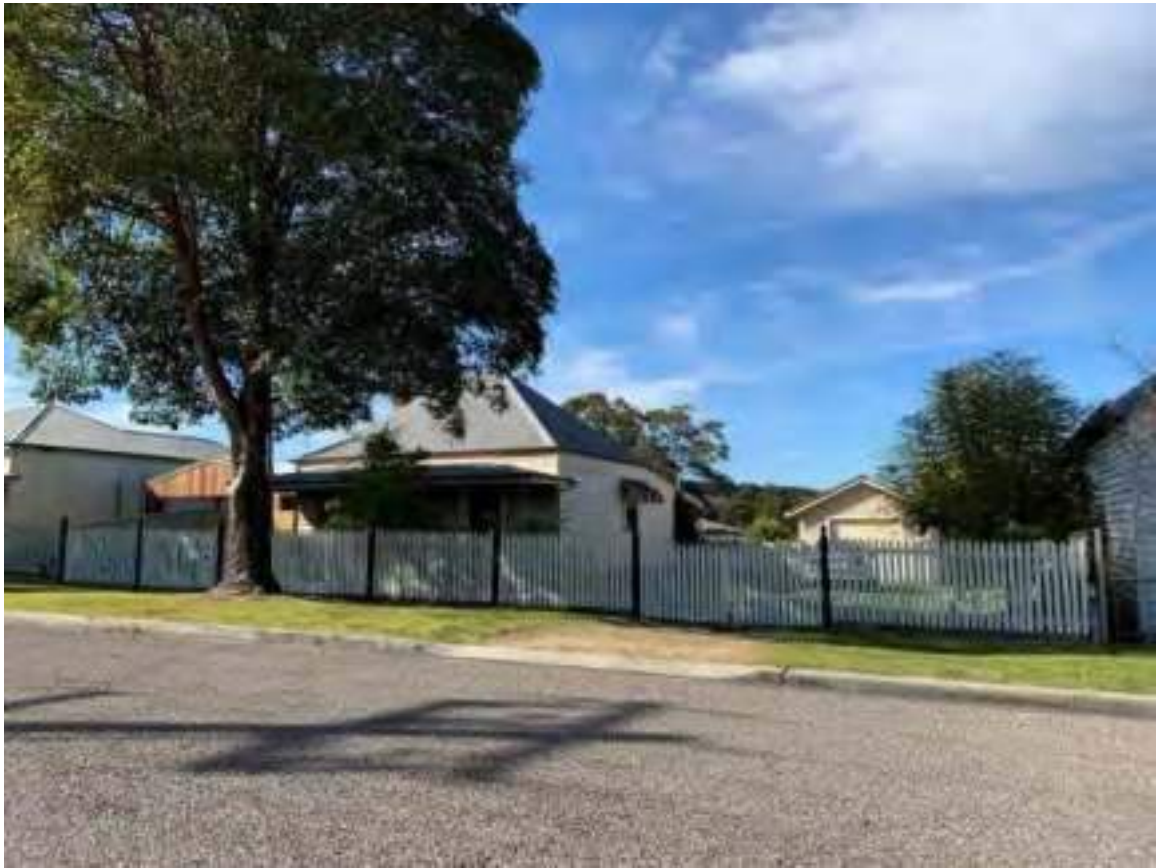
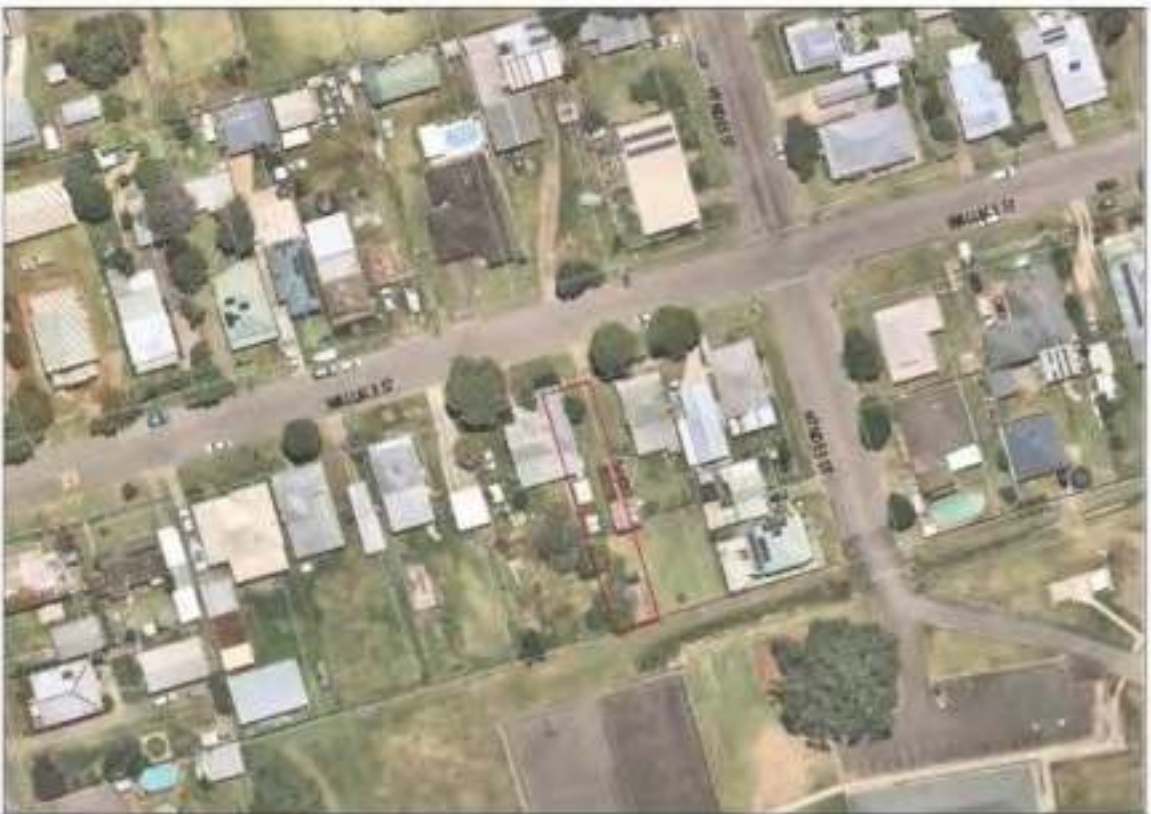
38 WALLACE STREET, WEST WALLSEND 2286

Conservation Area Contribution Level	Est. Construction Date	Previous studies and/or community input
Contributory 1	1890–1915	No prior heritage investigations and no additional information required
Assessment Text		Observed Modifications
<p>Single story Vernacular ‘Mining Cottage’ style dwelling with Colourbond hipped roof and weatherboard cladding. The veranda roof is hipped and supported by ornate metal posts.</p> <p>The veranda is enclosed by an ornate metal balustrade with rendered brick stairs leading onto the landing.</p> <p>The front door is timber framed with a ten panel design, and metal security screen. The adjacent windows are sash designs with prominent frames and simple timber sill. A single metal striped awning is visible on the western side.</p> <p>A red brick chimney is visible on the eastern side of the dwelling,</p> <p>A gable roof garage is visible to the west of the dwelling.</p> <p>White picket timber fencing encloses the property.</p> <p>The dwelling displays architectural features of a heritage style and is representative of the local development of this period, being of historical significance for the HCA.</p>		<p>The façade windows are contemporary examples of traditional sash windows, with modified glass and additional security screens installed.</p> <p>The metal support posts and balustrade is a contemporary addition to the dwelling, likely replacing original timber designs.</p>

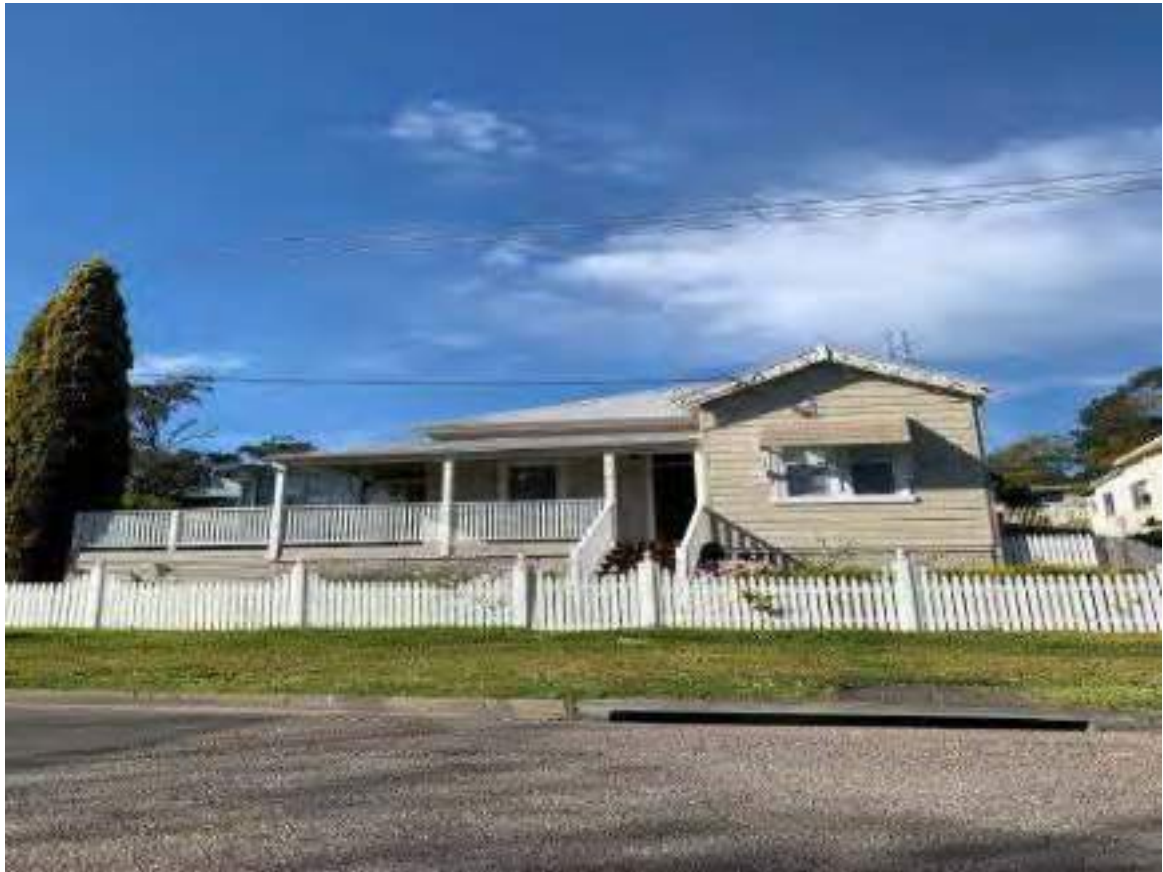
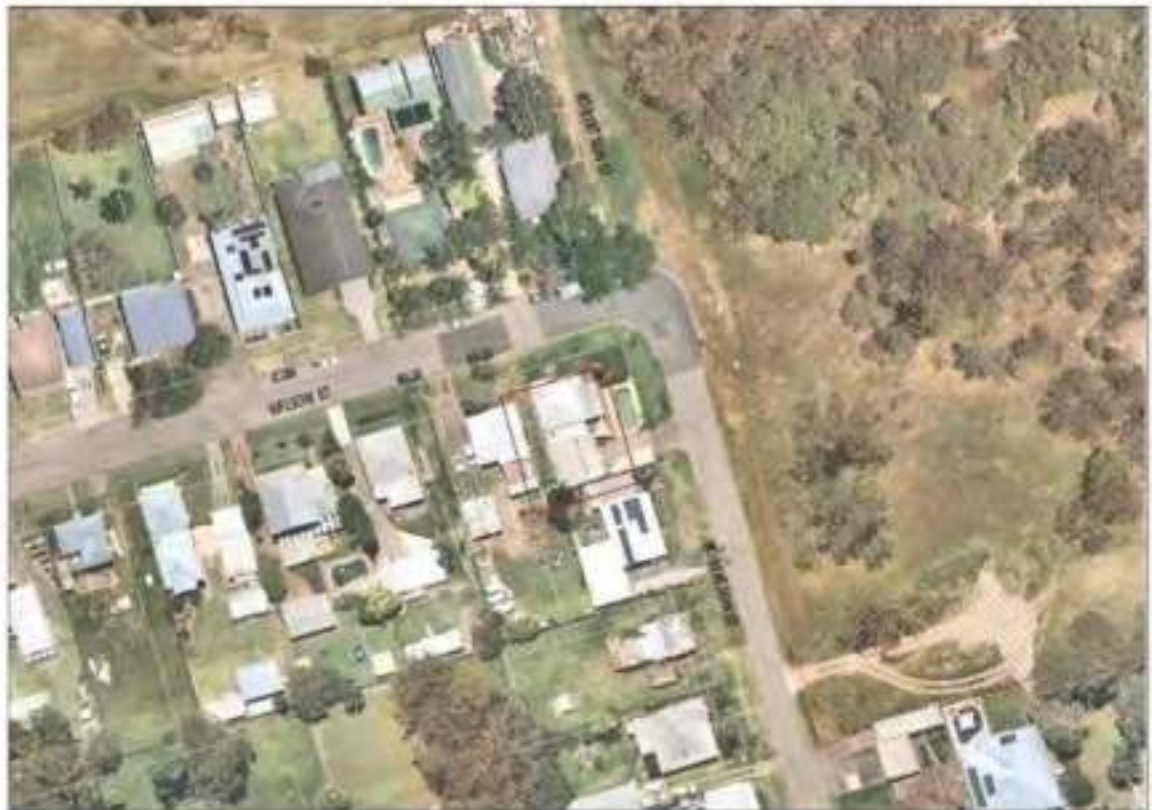
2 WILSON STREET, WEST WALLSEND 2286

Conservation Area Contribution Level	Est. Construction Date	Previous studies and/or community input
Contributory 1	1900–1915	No prior heritage investigations and no additional information required
Assessment Text		Observed Modifications
<p>Single story simple Federation ‘workmen's cottage’ style dwelling with half hipped and gable Colourbond roof and timber weatherboard cladding. The veranda roof is hipped and wraps around from the northern to eastern side of the dwelling, supported by timber posts.</p> <p>The veranda is enclosed by timber dowelled balustrade, with timber flooring and timber stairs leading to the landing. Corresponding balustrade is found on the stairs.</p> <p>The front door is timber framed with a metal security screen. The adjacent windows are timber framed sash designs.</p> <p>The gable has an ornately carved barge board with simplistic finial. The gable window has a timber shingle awning.</p> <p>A white timber picket fence encloses the property.</p> <p>The dwelling displays architectural features of a heritage style and is representative of the local development of this period, being of historical significance for the HCA.</p>		<p>The extension of the veranda to the eastern side of the dwelling is a contemporary modification, not uncommon for the area. This does not detract from the heritage streetscape.</p> <p>An eastern outdoor extension is visible, with timber boarding differentiating between from the original dwelling structure.</p> <p>The veranda balustrade is a contemporary addition, likely replacing an original timber design. This is similarly found with the property fence line.</p> <p>Multiple structures are visible along the east of the dwelling, all of recent construction.</p>

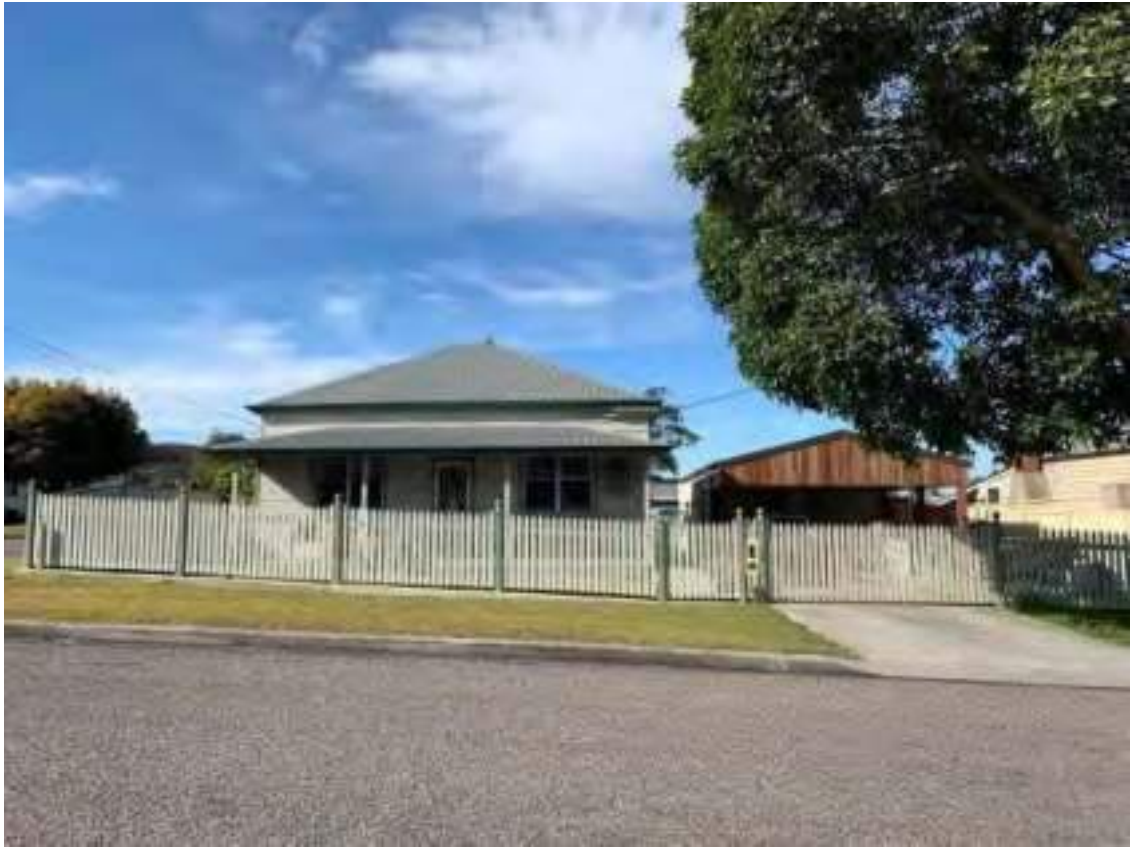
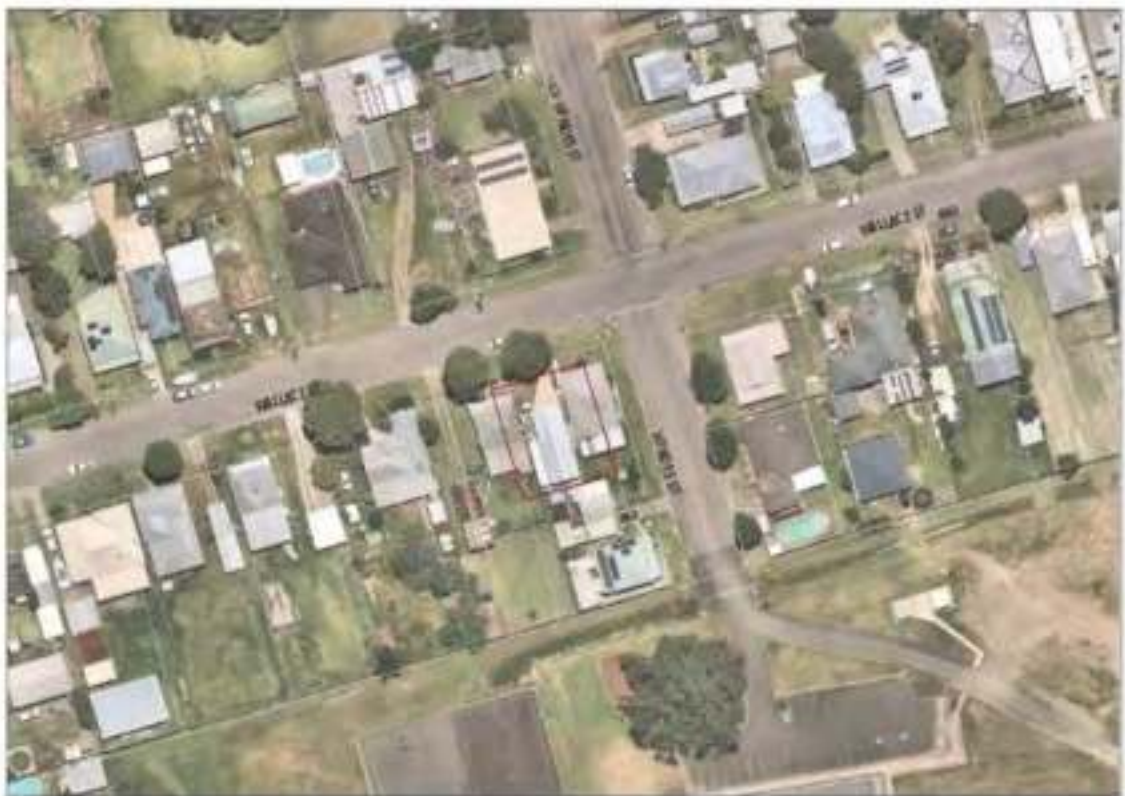
36 WALLACE STREET, WEST WALLSEND 2286

Conservation Area Contribution Level	Est. Construction Date	Previous studies and/or community input
Contributory 1	1890–1915	No prior heritage investigations and no additional information required
Assessment Text		Observed Modifications
<p>Single story Vernacular ‘Mining Cottage’ style dwelling with Colourbond hipped roof and weatherboard cladding. The veranda roof is hipped and supported by timber posts.</p> <p>The veranda is open with no balustrade.</p> <p>The front door is timber framed with ornate metal screen. The adjacent windows are timber sash designs, with ornate sills.</p> <p>A white timber picket fence encloses the property.</p> <p>The dwelling displays architectural features of a heritage style and is representative of the local development of this period, being of historical significance for the HCA.</p>		<p>A contemporary gable roof timber car port and garage structure is located immediately to the west of the dwelling, juxtaposing the heritage streetscape. A structure with the same timber frame is located at the back of the dwelling, and is visible from the eastern side.</p>
