APPENDIX 2

Building Assessment Sheets (Inventory Sheets)

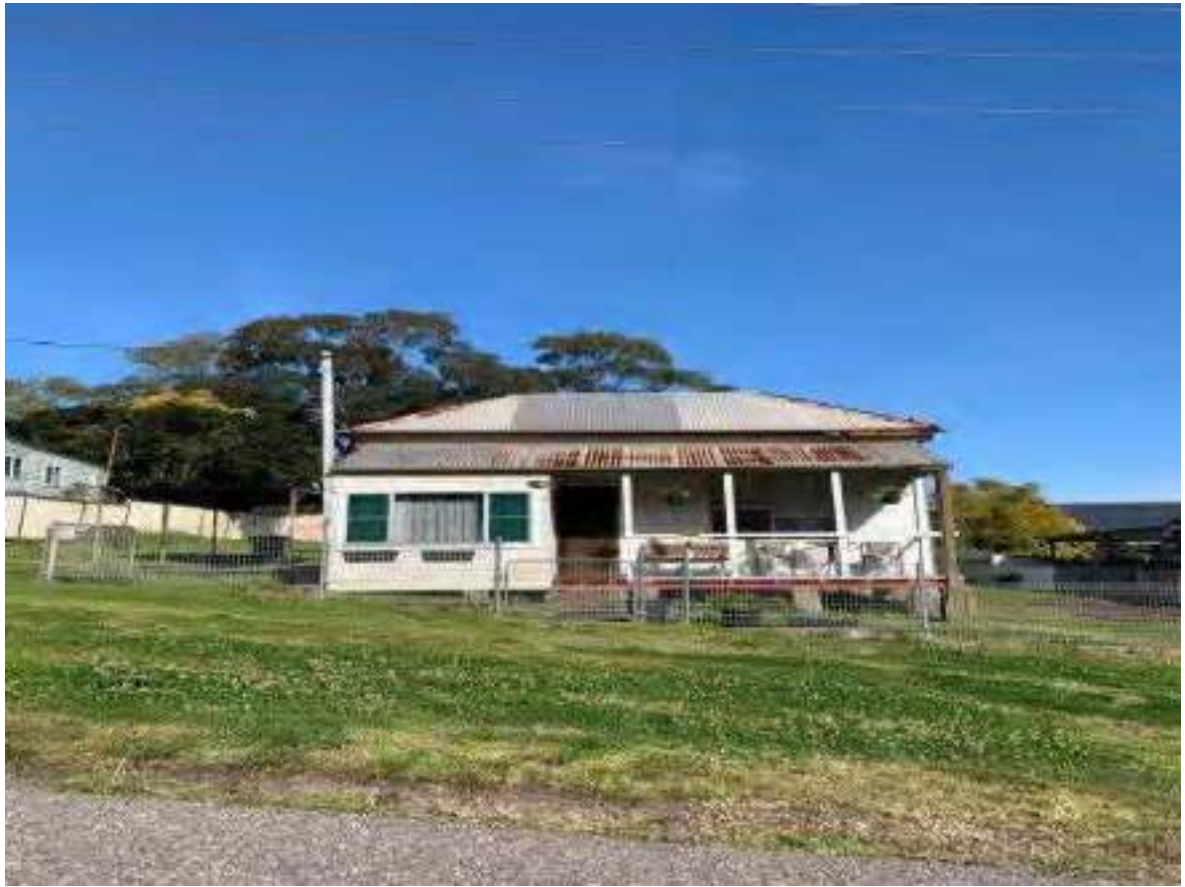
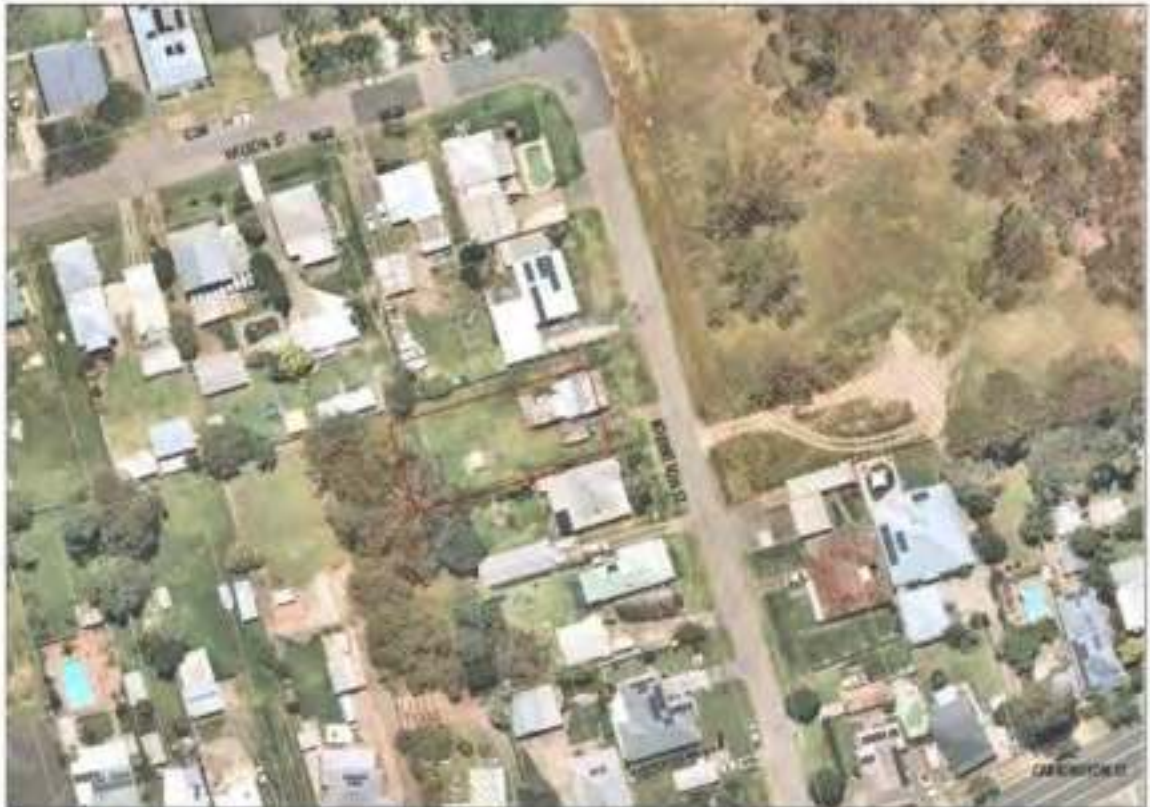
2 ROBERTSON STREET, WEST WALLSEND 2286

Conservation Area Contribution Level	Est. Construction Date	Previous studies and/or community input
Contributory 1	1890–1915	No prior heritage investigations and no additional information required
Assessment Text		Observed Modifications
<p>Single story Vernacular ‘Mining Cottage’ style dwelling with Colourbond hipped roof and weatherboard cladding. The veranda roof is skillion and supported by timber posts.</p> <p>The veranda has been partially built in, with only the northern portion remaining open. Simple timber balustrade enclose the space, the floor is timber and a set of concrete stairs lead to the landing.</p> <p>The front door is timber framed, with timber sash and metal framed picture windows on either side.</p> <p>A rendered brick chimney is visible on the southern side, however the stack is missing.</p> <p>A car port is located to the south of the dwelling.</p> <p>The dwelling displays architectural features of a heritage style and is representative of the local development of this period, being of historical significance for the HCA.</p>		<p>The southern portion of the veranda has been built in to form an additional room. This is constructed under the same skillion roof and is likely an aged modification and common to this style.</p> <p>The façade windows have been replaced with metal and/or timber framed contemporary designs.</p> <p>An additional hipped roof structure is located at the back of the dwelling, sympathetic in style.</p>

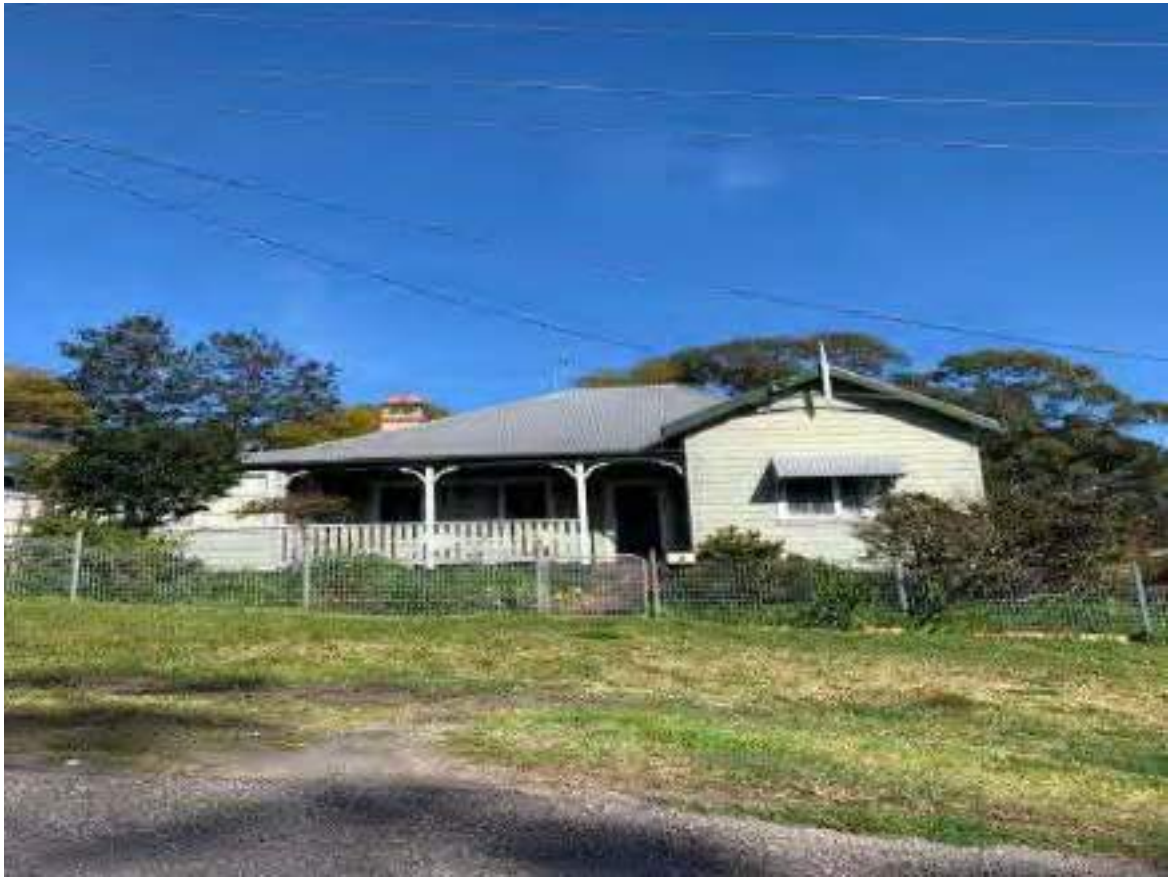
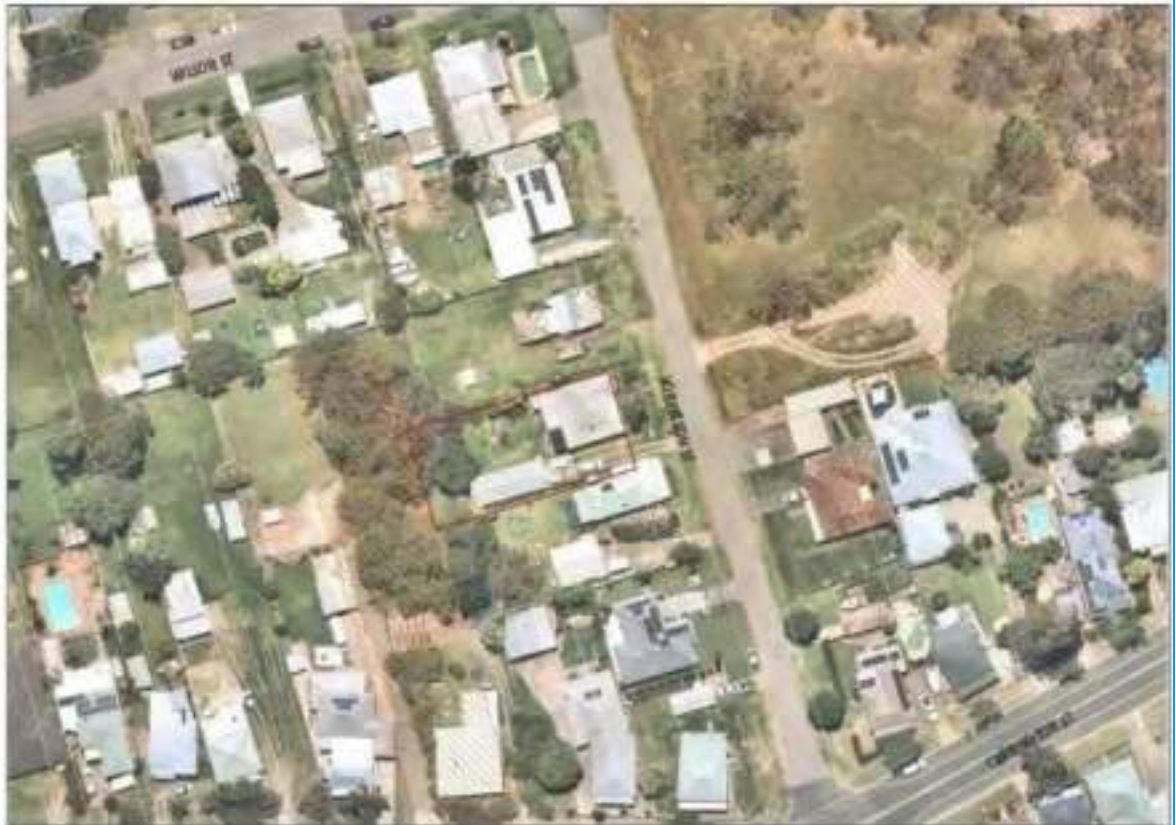
4 ROBERTSON STREET, WEST WALLSEND 2286

Conservation Area Contribution Level	Est. Construction Date	Previous studies and/or community input
Contributory 1	1900–1920	No prior heritage investigations and no additional information required
Assessment Text		Observed Modifications
<p>A single story simple Federation ‘workmen's cottage’ style dwelling with half hipped and gable Colourbond roof and weatherboard cladding. The veranda roof is an encircling skillion design, connecting with the main roof structure. It is supported by timber posts with simple brackets.</p> <p>The veranda is enclosed by a timber dowelled balustrade, with rendered concrete floor and concrete stairs leading to the landing.</p> <p>The front door is timber framed with a large mulit pane picture window located to the south. The northern windows have metal sheet awnings. The gable window is a timber casement design, with metal sheet awning. The gable has extended barge boards and prominent finial.</p> <p>A beige brick chimney is visible on the southern side of the dwelling, with two terracotta pots.</p> <p>A gable roof garage is located to the south, sympathetic in style.</p> <p>The dwelling displays architectural features of a heritage style and is representative of the local development of this period, being of historical significance for the HCA.</p>		<p>The veranda has been partially built in, with the southern portion modified into an additional room. Casement windows have been installed, sympathetic to the remaining dwelling.</p> <p>Dwelling is a possible contemporary or mid 20th century reproduction of a Federation style, as seen through the consistent window style, chimney design and lack of overly ornate decorative features. No DA found, if so this has occurred prior to developmental approvals.</p>

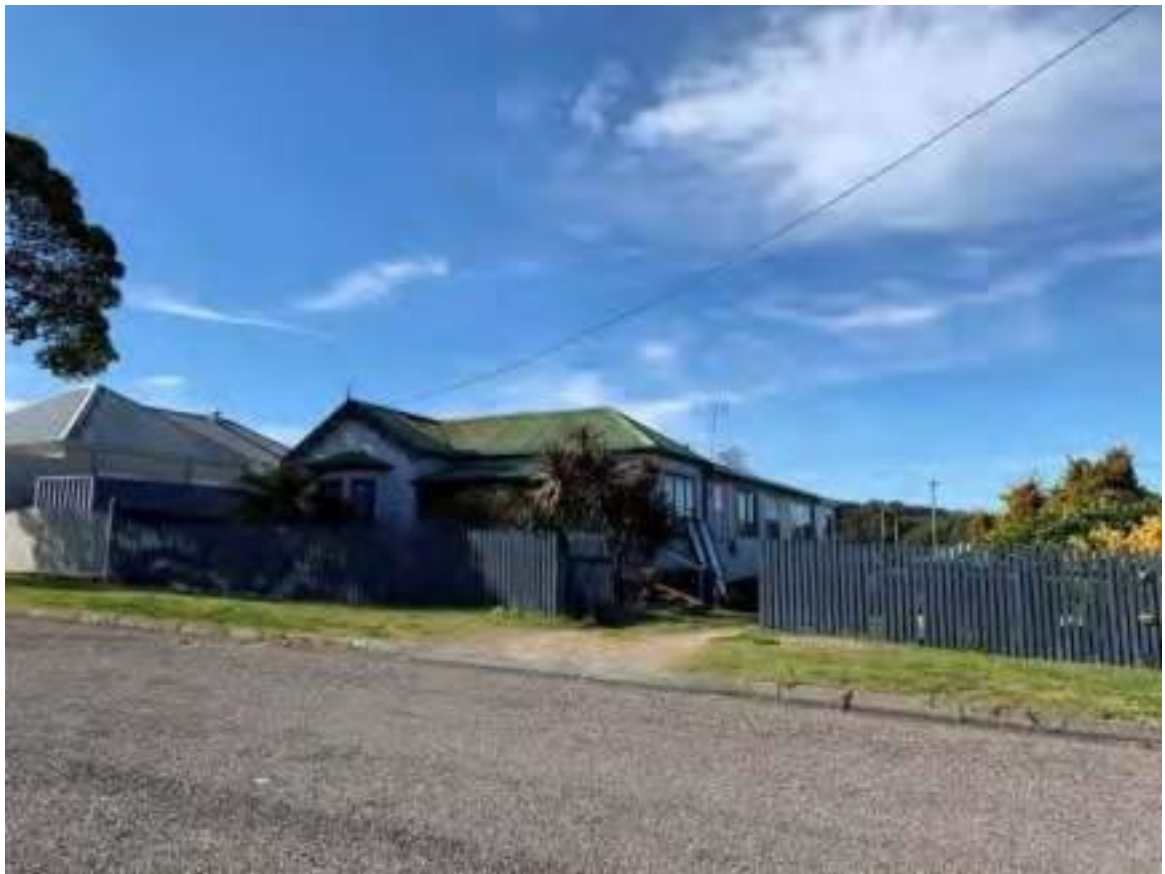
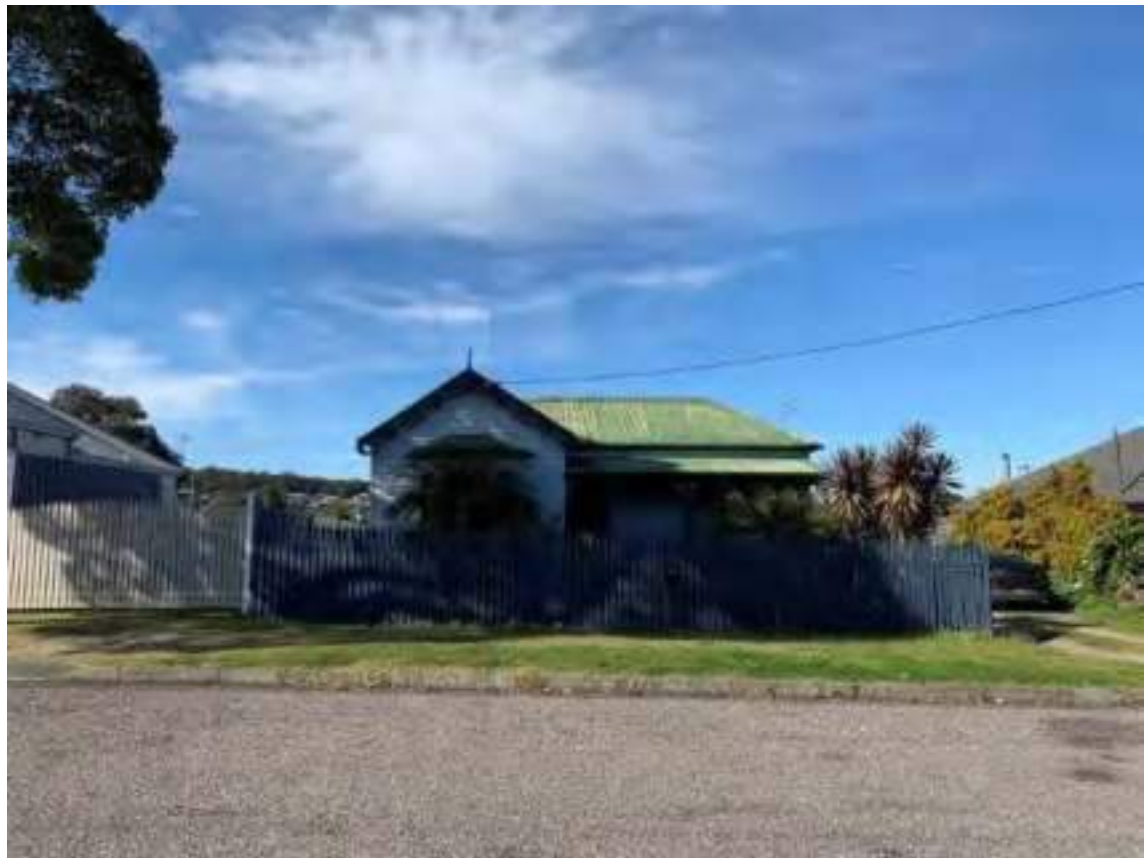
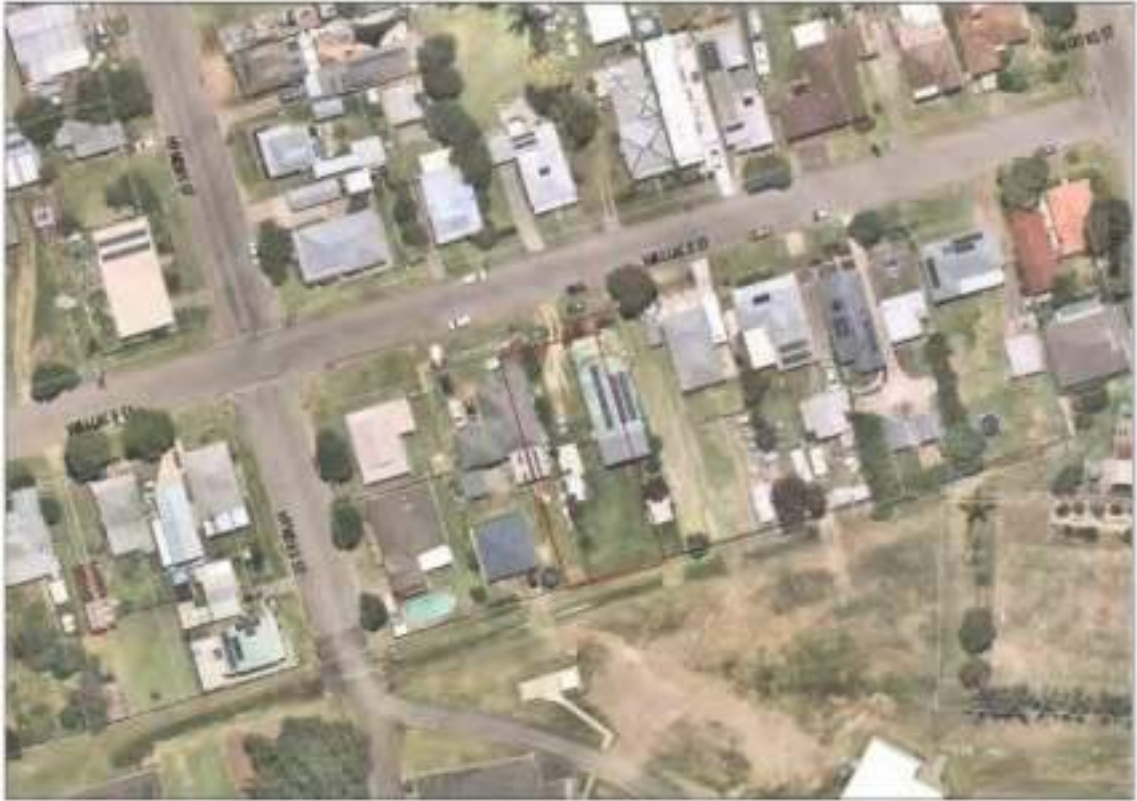
32 WALLACE STREET, WEST WALLSEND 2286

Conservation Area Contribution Level	Est. Construction Date	Previous studies and/or community input
Contributory 1	1900–1920	No prior heritage investigations and no additional information required
Assessment Text		Observed Modifications
<p>Single story simple Federation ‘workmen's cottage’ style dwelling with half gable and hipped Colourbond roof and weatherboard cladding. The veranda roof is skillion and supported by timber posts with ornate brackets.</p> <p>The veranda is open with no balustrade, rendered concrete floor and concrete stairs leading to the landing.</p> <p>The front door is timber framed with sash windows to either side.</p> <p>The gable roof has ornately carved barge boards and timber finial. The oriel style window has a metal sheet roof and simple sill.</p> <p>A timber picket fence encloses the property.</p> <p>The dwelling displays architectural features of a heritage style and is representative of the local development of this period, being of historical significance for the HCA.</p>		<p>An extensive back addition has been constructed, possibly during two construction phases.</p> <p>All western and eastern windows have been replaced with contemporary sliding or sash designs.</p> <p>Solar panels are visible on the roof.</p>

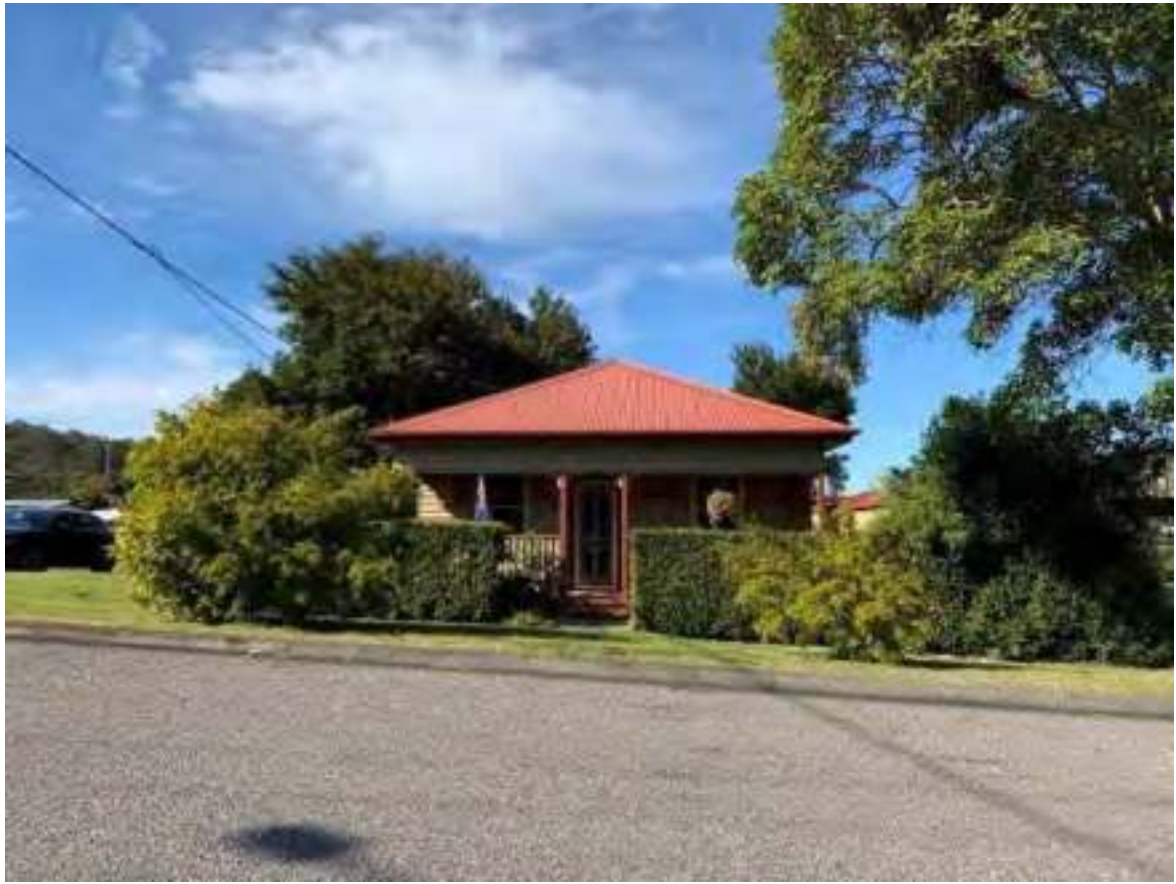
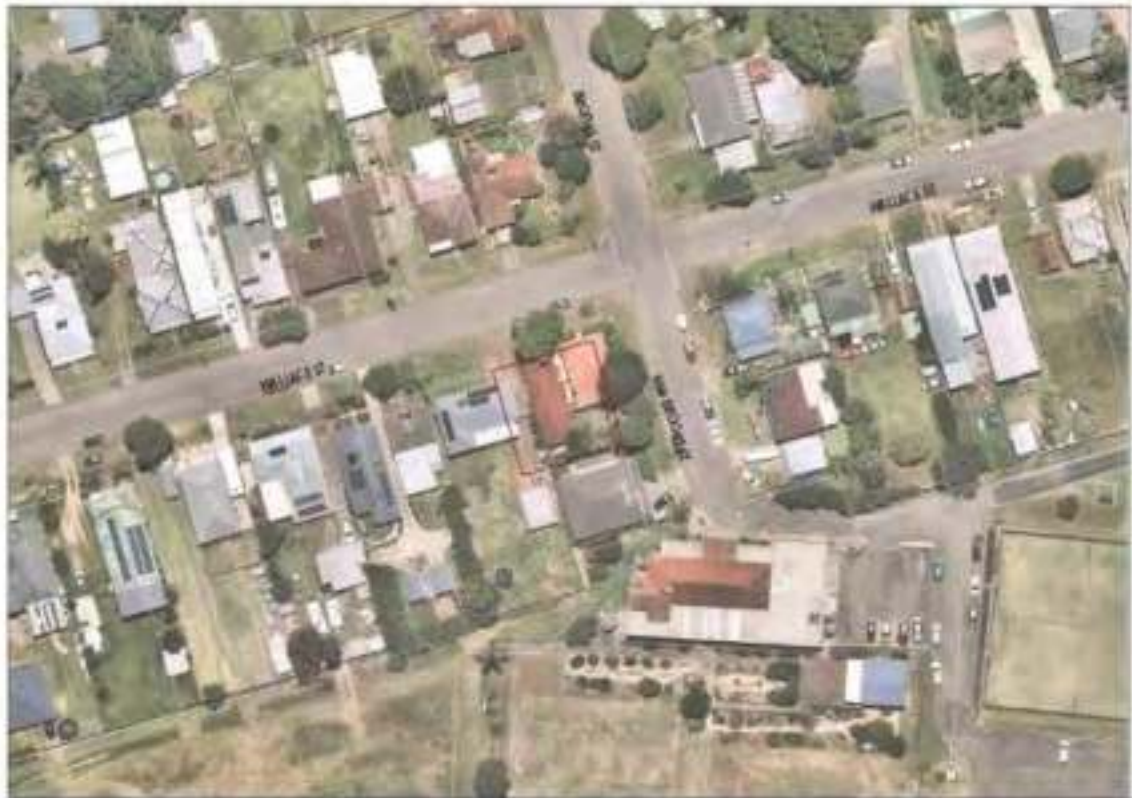
22 WALLACE STREET, WEST WALLSEND 2286

Conservation Area Contribution Level	Est. Construction Date	Previous studies and/or community input
Contributory 1	1890–1920	No prior heritage investigations and no additional information required
Assessment Text		Observed Modifications
<p>Single story Vernacular style dwelling with hipped Colourbond roof and weatherboard cladding. The veranda roof is incorporated into the main roof structure and supported by timber posts with art nouveau brackets.</p> <p>The veranda is partially enclosed by timber dowelled balustrade, with timber flooring and rendered step leading to the landing. Decorative tiles prelude the veranda.</p> <p>The front door is timber framed with an ornate metal screen door. Sash windows are found either side.</p> <p>A large gable roof car port/garage structure is located to the west of the dwelling.</p> <p>The dwelling displays architectural features of a heritage style and is representative of the local development of this period, being of historical significance for the HCA.</p>		<p>The veranda roof has been incorporated into the main hipped roof, whilst originally consisting of an independent structure, likely bull nosed in design.</p> <p>The timber boarding underneath the roof is a contemporary addition, likely in response to incorporating the veranda.</p> <p>The veranda balustrade and support posts are likely a contemporary reproduction of an original timber design. This does not detract from the heritage streetscape.</p>

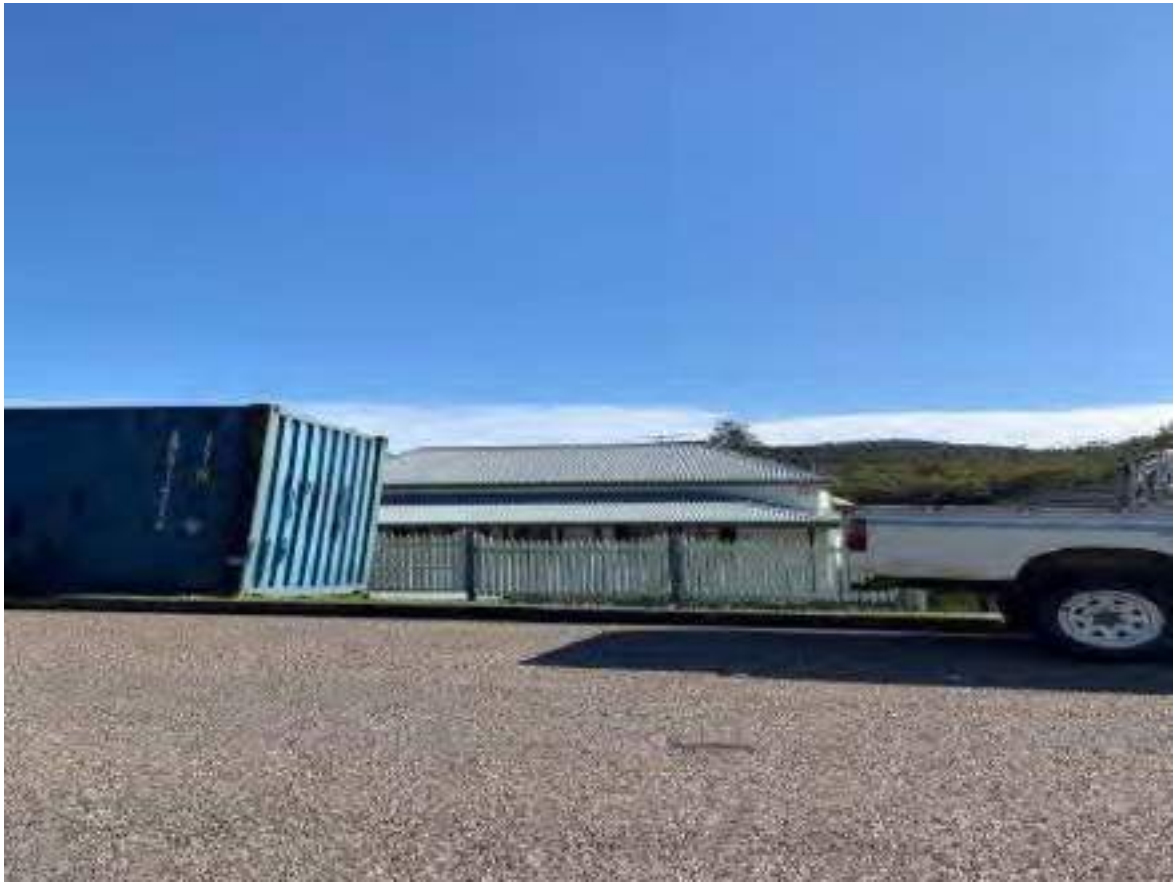
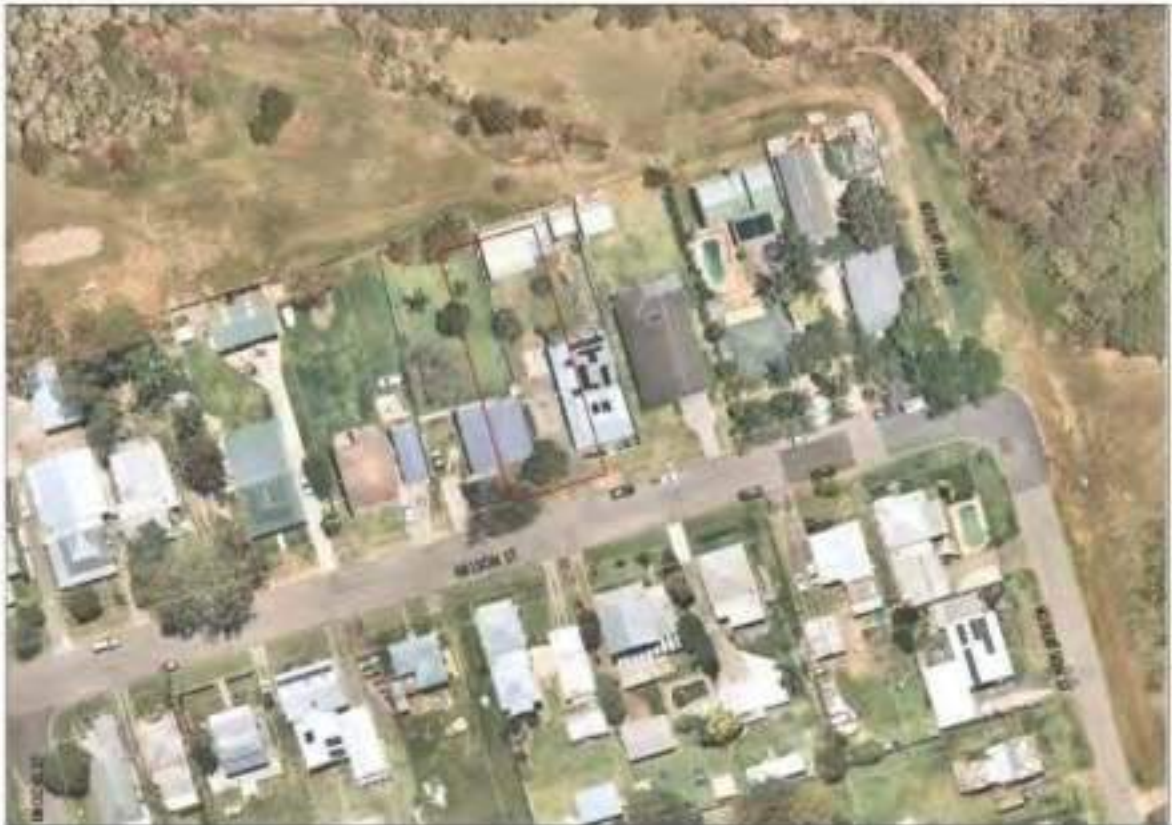
7 WILSON STREET, WEST WALLSEND 2286

Conservation Area Contribution Level	Est. Construction Date	Previous studies and/or community input
Contributory 1	1890–1920	No prior heritage investigations and no additional information required
Assessment Text		Observed Modifications
<p>Single story Vernacular style dwelling with hipped Colourbond roof and weatherboard cladding. The veranda roof is hipped, wrapping around the southern and western sides of the dwelling. the roof is supported by timber posts.</p> <p>The veranda is enclosed by timber dowelled balustrade and with timber flooring.</p> <p>The front door is timber framed with a metal security screen. The adjacent French style doors dominate the façade. The western and eastern windows are sliding in design.</p> <p>Timber picket fencing encloses the property.</p> <p>The dwelling displays architectural features of a heritage style and is representative of the local development of this period, being of historical significance for the HCA.</p>		<p>The French styled doors of the façade are a contemporary addition, likely replacing timber sash window styles. Similarly the western and eastern windows have been replaced with sliding designs.</p> <p>An extensive back extensive has been constructed in a sympathetic style and does not detract.</p> <p>Solar panels are visible on the eastern side of the roof.</p>

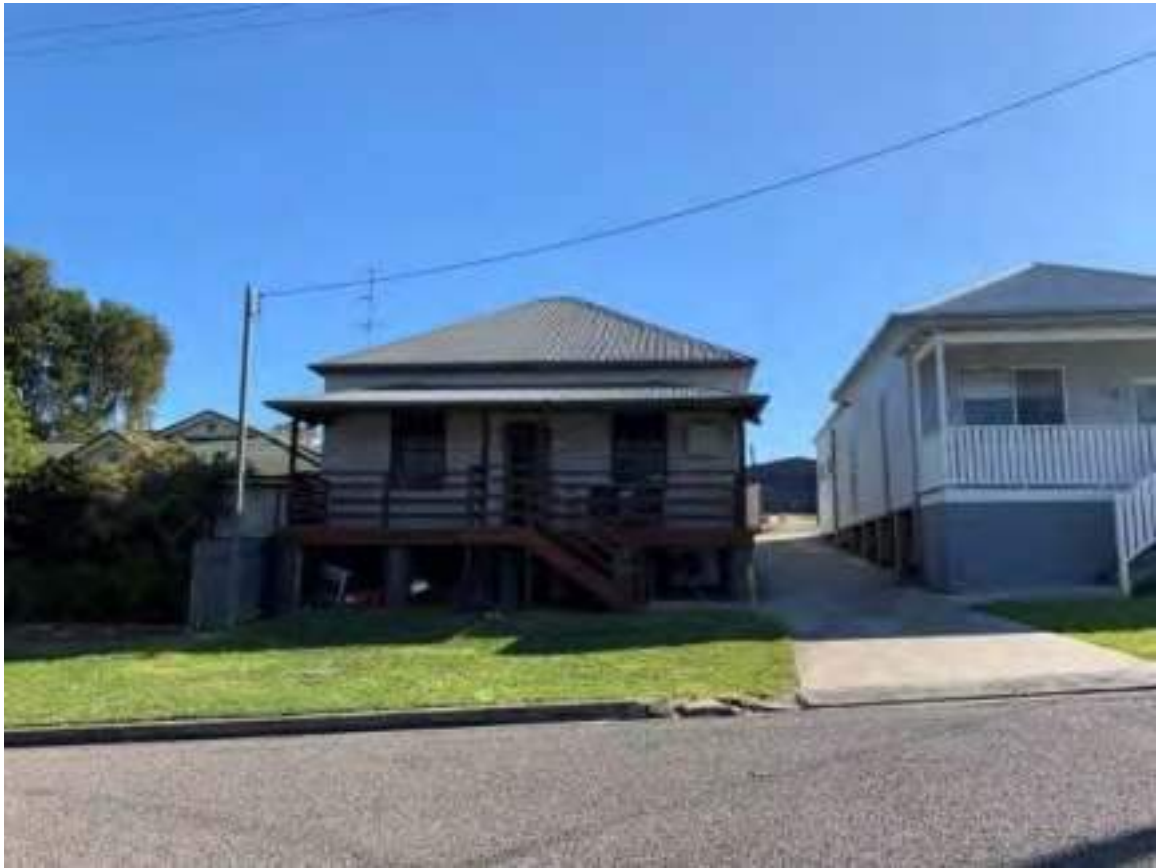
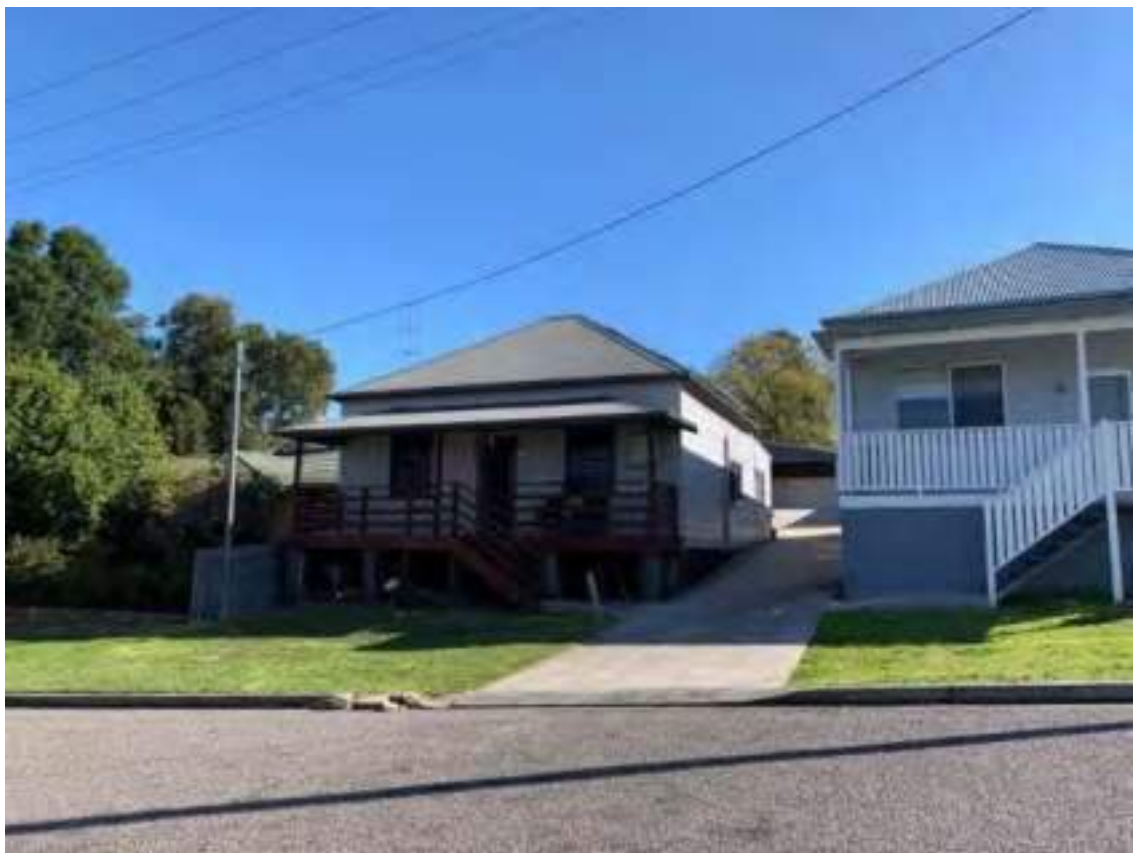
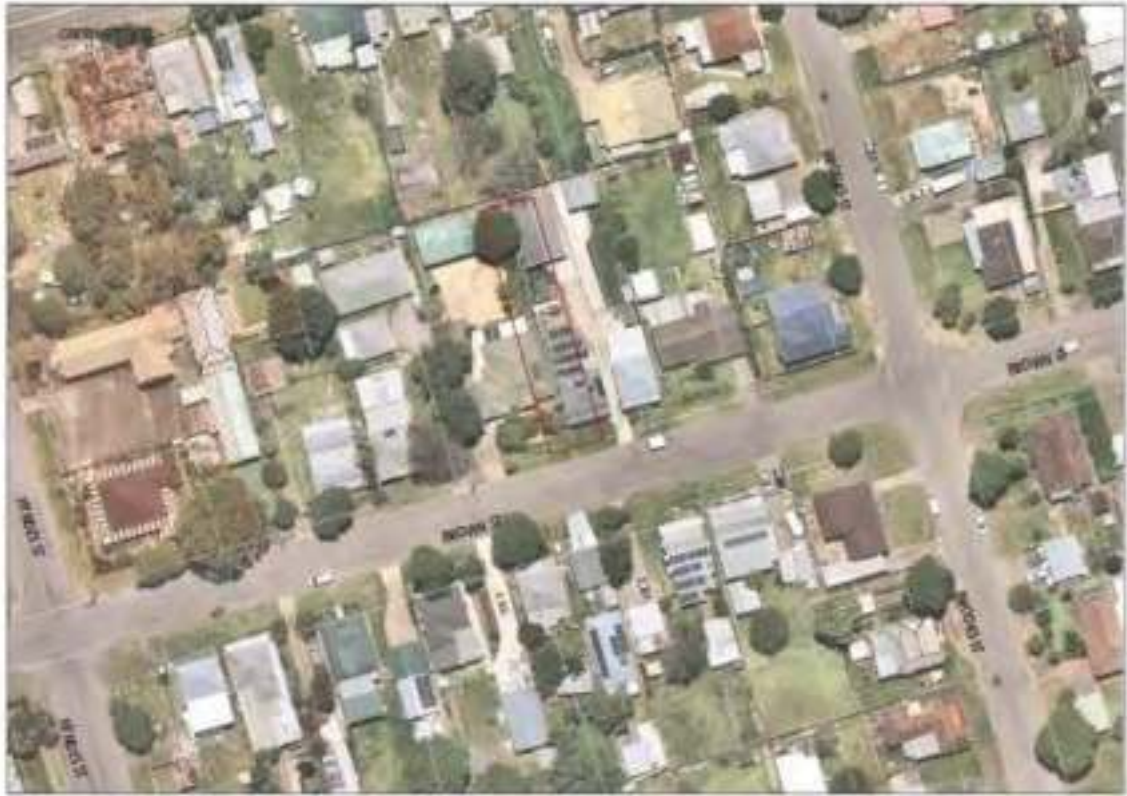
21 BROWN STREET, WEST WALLSEND 2286

Conservation Area Contribution Level	Est. Construction Date	Previous studies and/or community input
Contributory 1	1890–1915	No prior heritage investigations and no additional information required
Assessment Text		Observed Modifications
<p>A single story Vernacular ‘Mining Cottage’ style dwelling with hipped Colourbond roof and weatherboard cladding. The veranda roof is hipped and supported by timber posts.</p> <p>The veranda is enclosed by timber balustrade, with timber flooring and eastern facing stairs. Timber balustrade similarly support the stairs.</p> <p>The dwelling is upon extended concrete foundational pillars.</p> <p>The front door is timber framed with sash windows located on either side.</p> <p>The dwelling displays architectural features of a heritage style and is representative of the local development of this period, being of historical significance for the HCA.</p>		<p>The timber balustrade and stair structures of the front façade are all contemporary modifications. The stair case would have originally been positioned centrally, aligned with the front door.</p> <p>Solar panels are visible on the eastern side of the dwelling.</p> <p>A back extension has been constructed, however is not visible from the street and does not detract.</p>

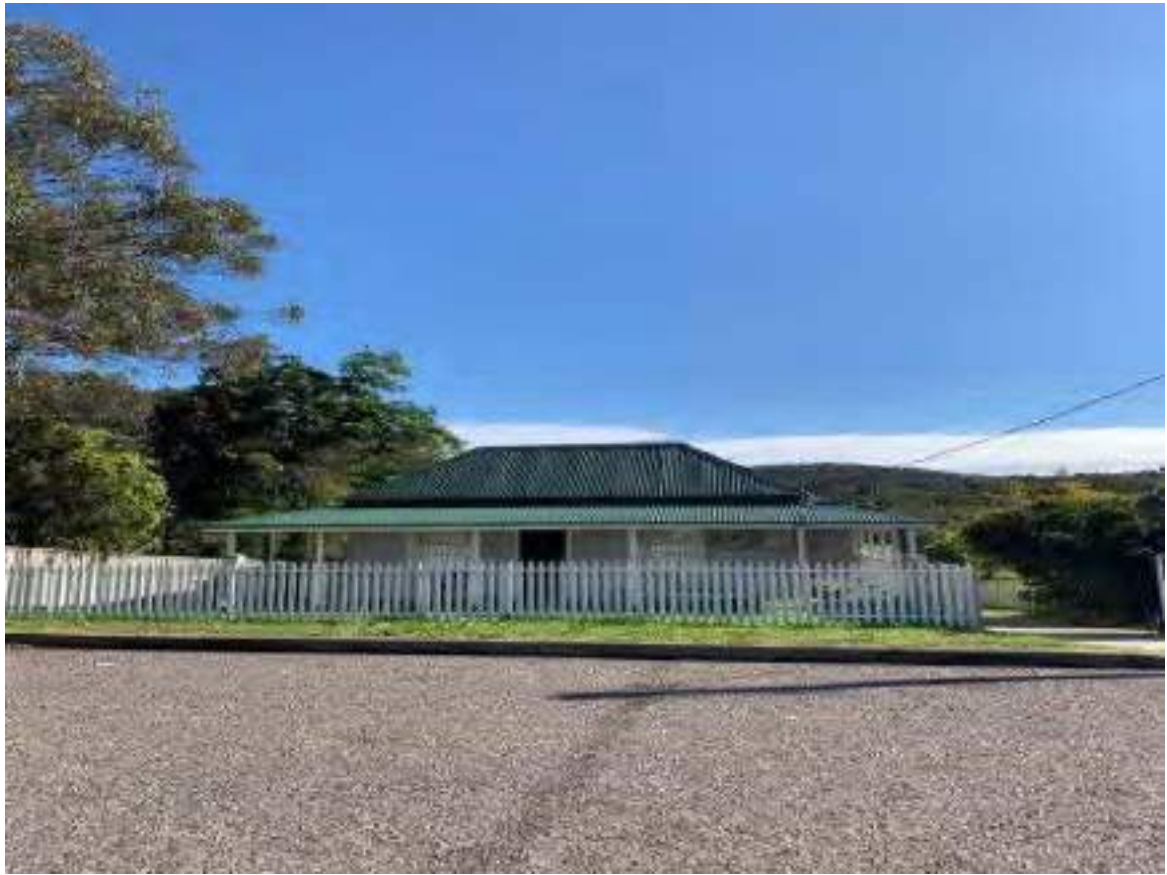
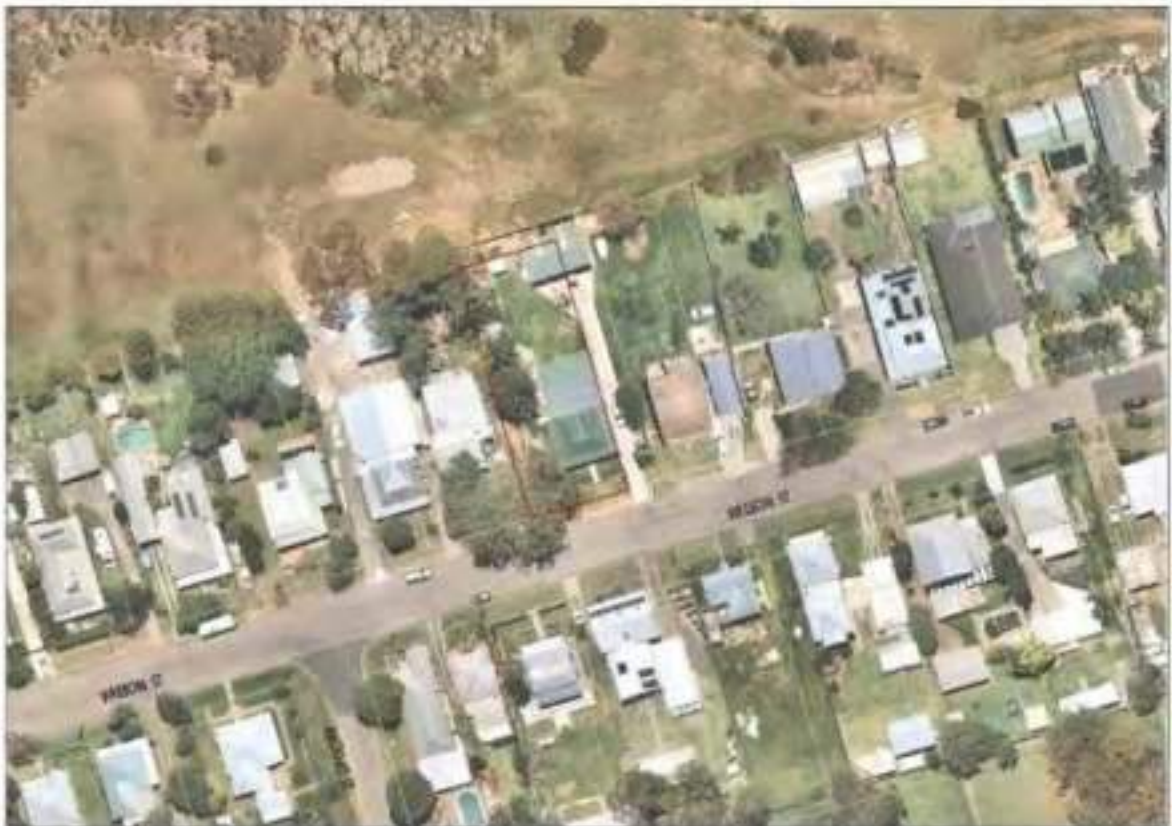
13 WILSON STREET, WEST WALLSEND 2286

Conservation Area Contribution Level	Est. Construction Date	Previous studies and/or community input
Contributory 1	1890–1920	No prior heritage investigations and no additional information required
Assessment Text		Observed Modifications
<p>Single story Vernacular style dwelling with hipped Colourbond roof and weatherboard cladding. The veranda roof wraps around the eastern, southern and western sides of the dwelling, supported by timber posts.</p> <p>The eastern and western side of the veranda is enclosed by timber dowelled balustrade, with timber flooring and no stairs.</p> <p>The front door is timber framed, with original sash windows on either side.</p> <p>A large garage is located to the north of the dwelling.</p> <p>A white timber picket fence encloses the property.</p> <p>The dwelling displays architectural features of a heritage style and is representative of the local development of this period, being of historical significance for the HCA.</p>		<p>The veranda roof has been extended to encircle the dwelling, likely replacing the original bull nosed or skillion roof.</p> <p>A large back extension has been constructed, however is not visible from the street and does not detract from the heritage values.</p>

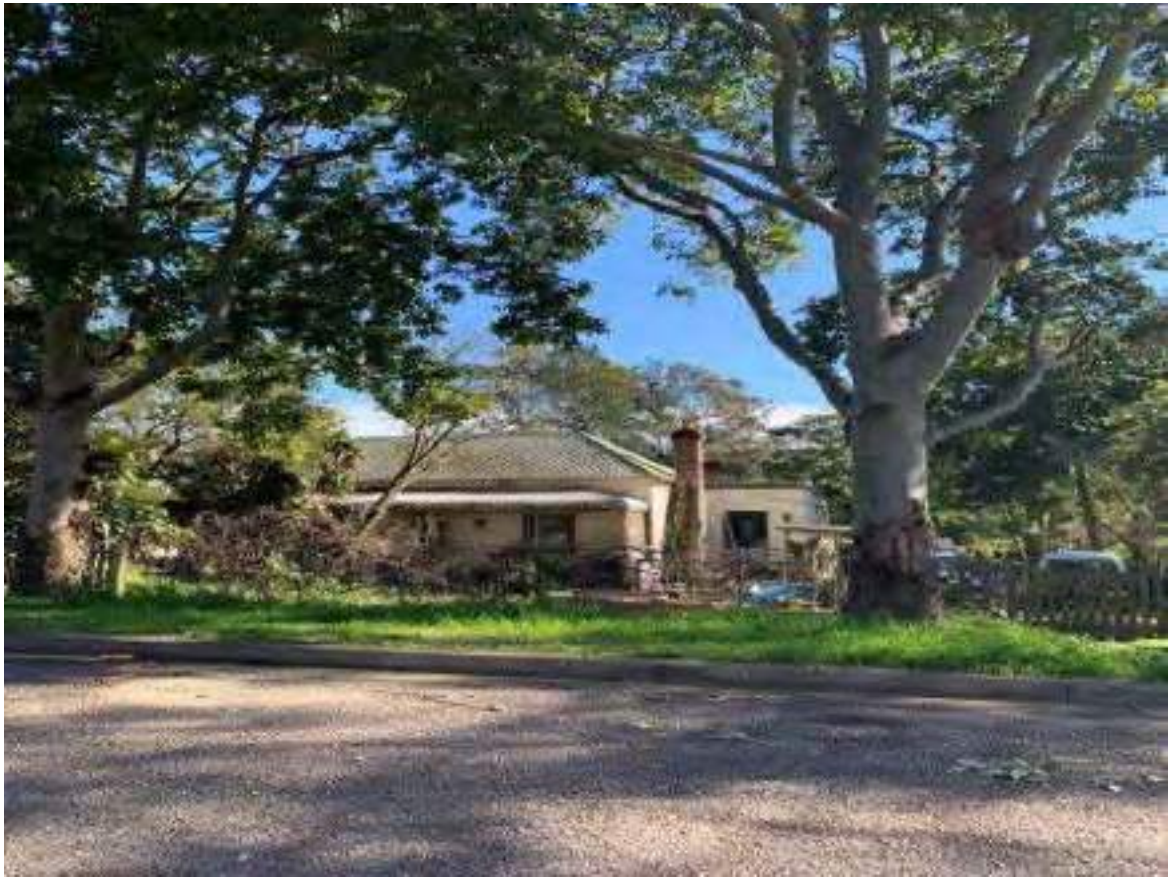
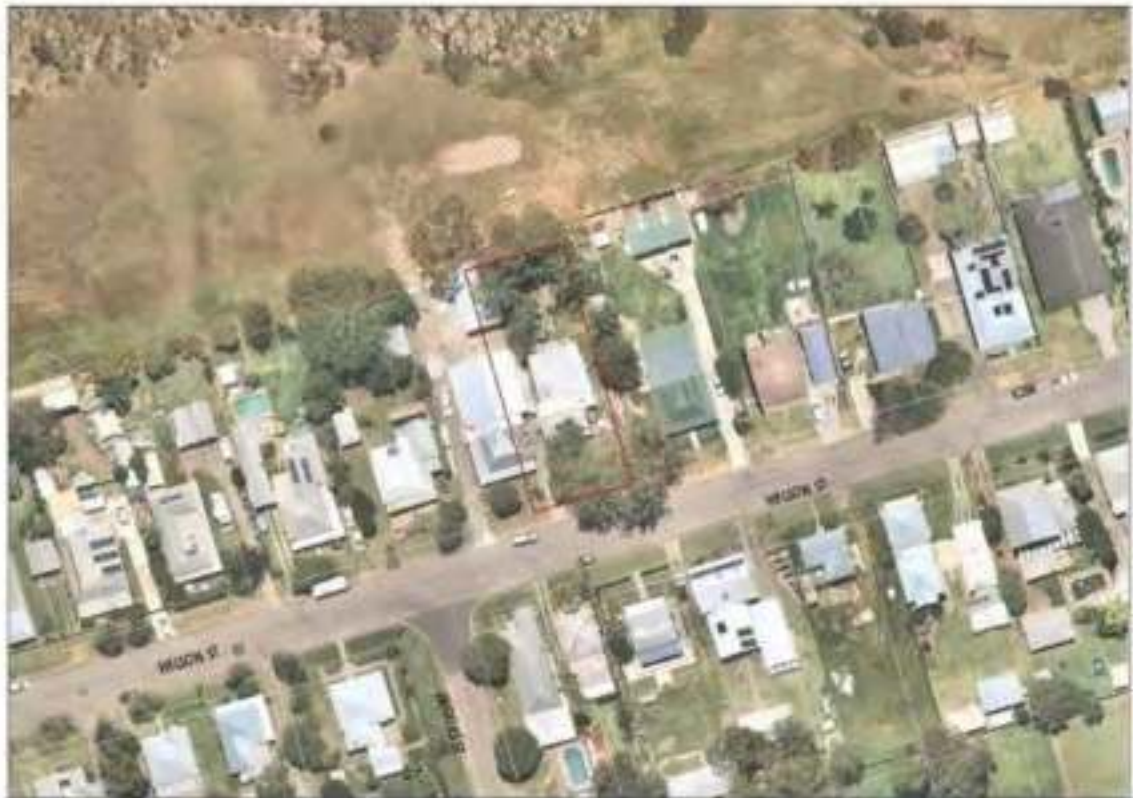
15 WILSON STREET, WEST WALLSEND 2286

Conservation Area Contribution Level	Est. Construction Date	Previous studies and/or community input
Contributory 1	1890–1915	No prior heritage investigations and no additional information required
Assessment Text		Observed Modifications
<p>Single story Vernacular ‘Mining Cottage’ style dwelling with Colourbond hipped roof and timber weatherboard cladding. The veranda roof is bull nosed and supported by timber posts.</p> <p>The veranda is open with no balustrade, timber flooring and obscured stairs.</p> <p>The front door is timber framed four panel design, with adjacent sash windows.</p> <p>A redbrick chimney is located to the eastern side of the dwelling, with a singular terracotta pot.</p> <p>The dwelling displays architectural features of a heritage style and is representative of the local development of this period, being of historical significance for the HCA.</p>		<p>An eastern extension is visible, with a skillion roof, timber framed sash windows with ornate sills and weatherboard cladding. This is potentially an aged modification and has been constructed in a sympathetic manner.</p>
