APPENDIX 2

Building Assessment Sheets (Inventory Sheets)

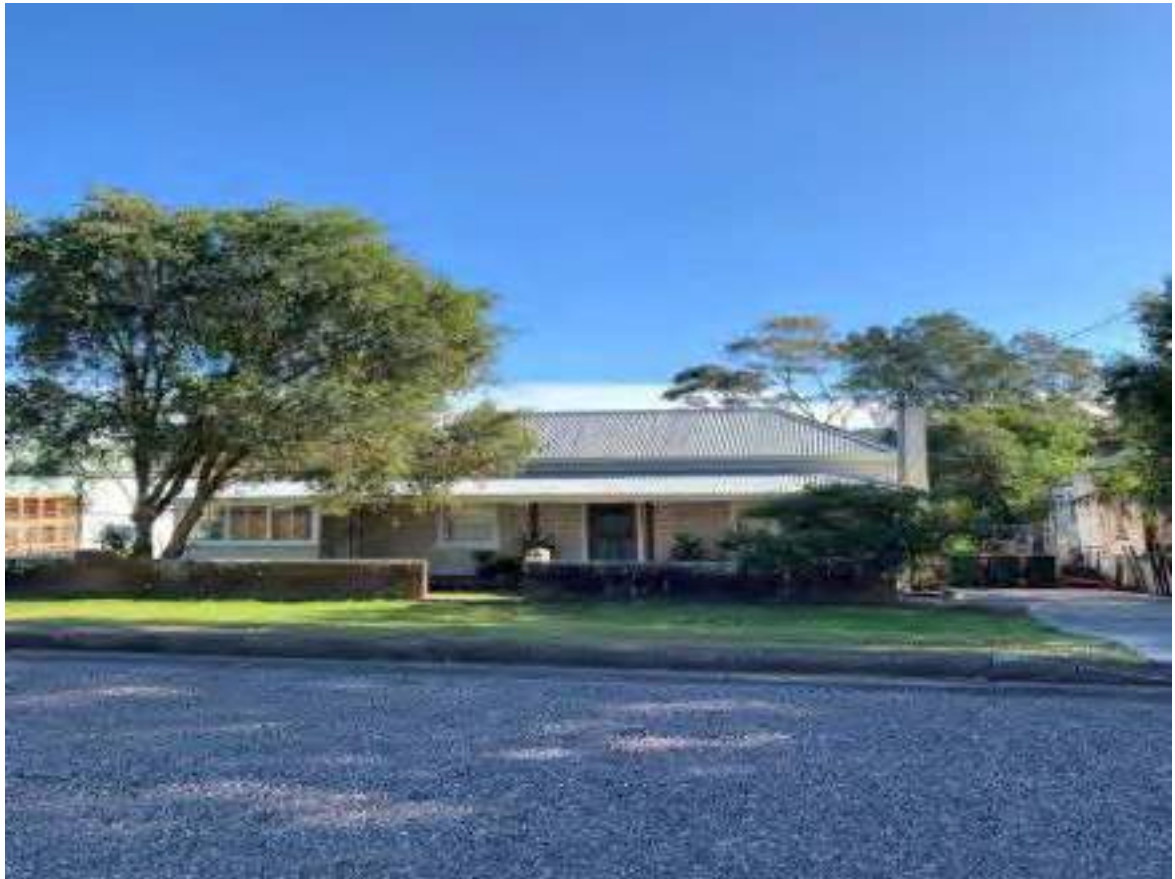
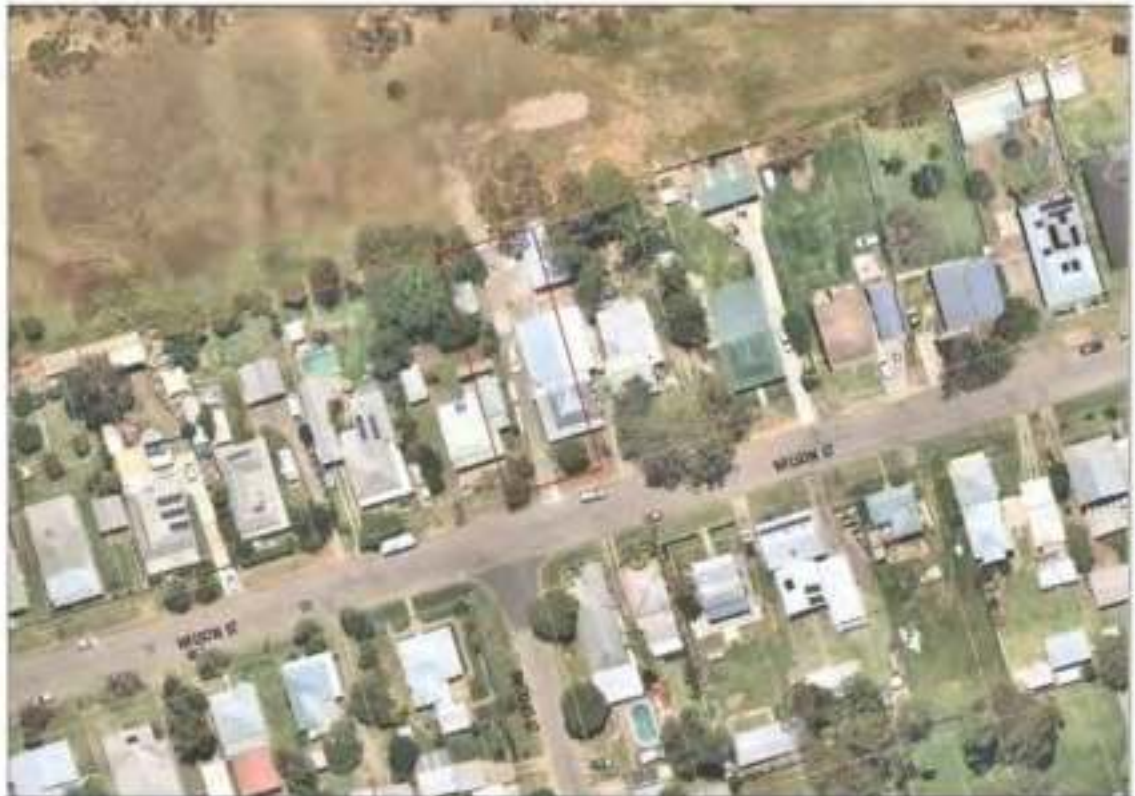
17 WILSON STREET, WEST WALLSEND 2286

Conservation Area Contribution Level	Est. Construction Date	Previous studies and/or community input
Contributory 1	1890–1920	No prior heritage investigations and no additional information required
Assessment Text		Observed Modifications
<p>Single story Vernacular ‘Mining Cottage’ style dwelling with Colourbond hipped roof and weatherboard cladding. The veranda roof is hipped and supported by timber posts with art nouveau style brackets.</p> <p>The front door is timber framed with sash windows on either side. the eastern windows are similarly styled, with the addition of timber awnings.</p> <p>A rendered brick chimney is visible on the eastern side of the dwelling.</p> <p>A large sheet metal garage is located to the north of the dwelling.</p> <p>A low brick fence frames the front of the property.</p> <p>The dwelling displays architectural features of a heritage style and is representative of the local development of this period, being of historical significance for the HCA.</p>		<p>The western portion of the veranda has been built in to create an additional room, wrapping around the western side of the dwelling. This is a common modification for the area.</p> <p>Timber centre bar sliding windows have been installed along the length of the extension.</p> <p>The front screen door and veranda support posts are contemporary additions to the dwelling, contrasting the heritage features of the dwelling.</p>

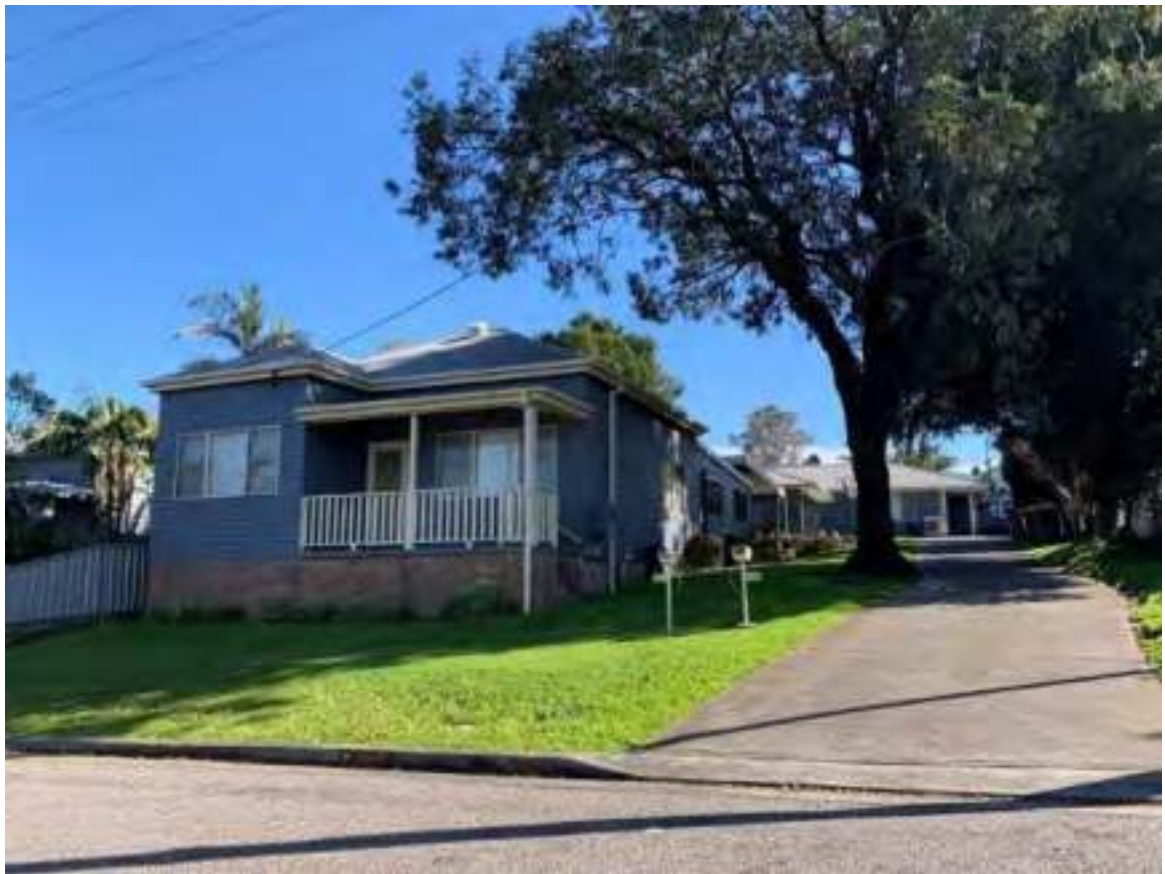
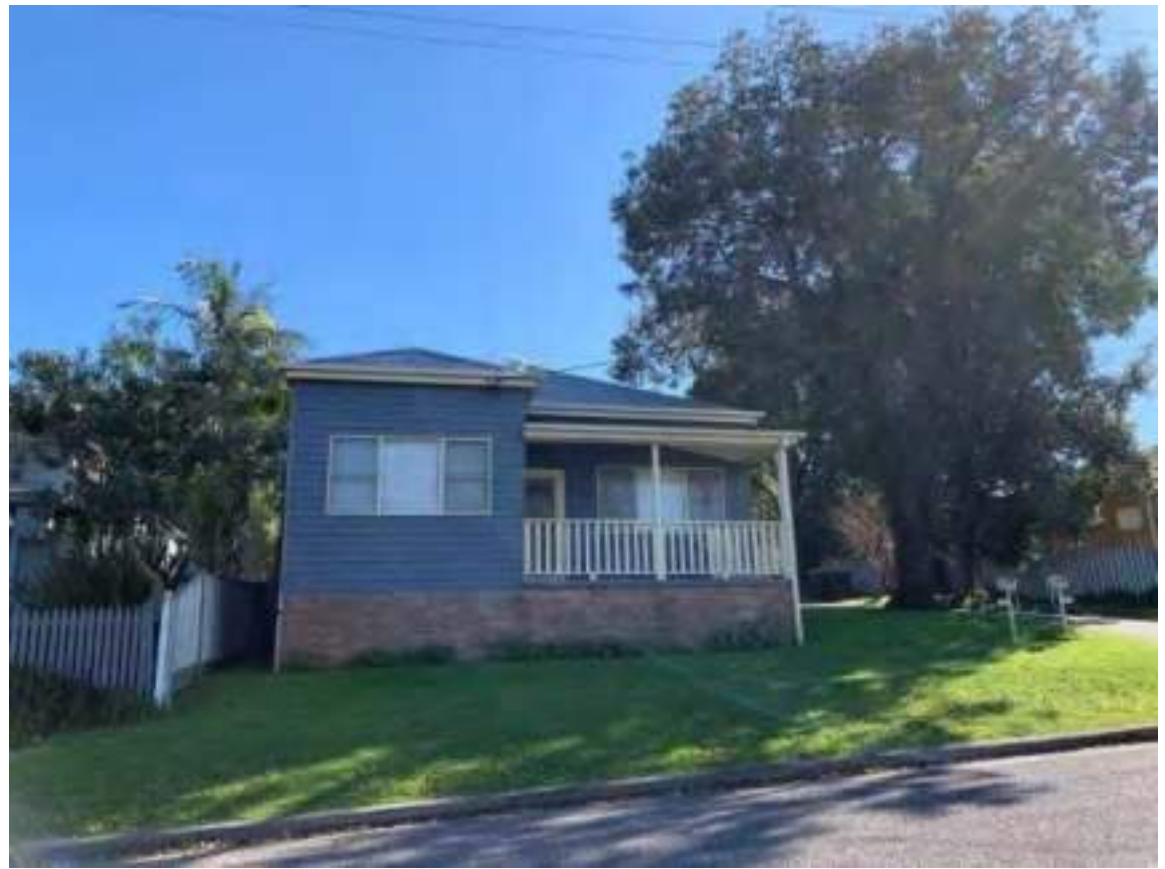
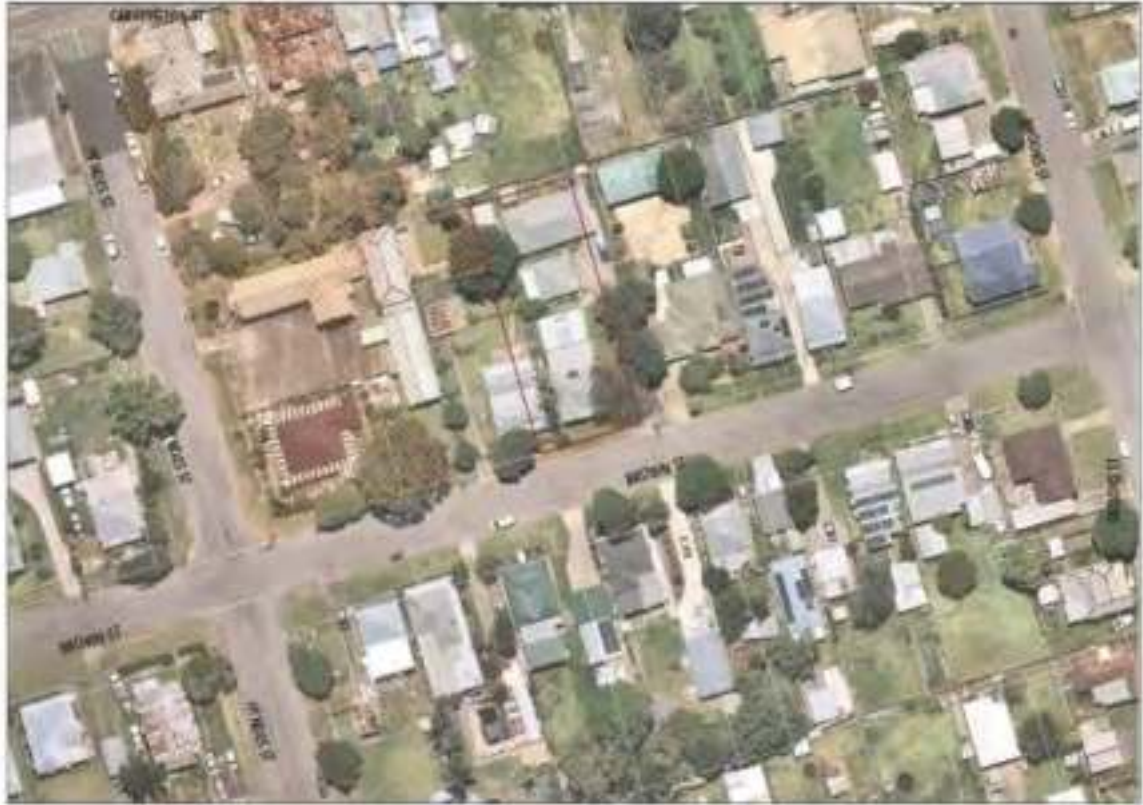
27 BROWN STREET, WEST WALLSEND 2286

Conservation Area Contribution Level	Est. Construction Date	Previous studies and/or community input
Contributory 1	1890–1920	No prior heritage investigations and no additional information required
Assessment Text		Observed Modifications
<p>Single story extensively modified Vernacular style dwelling with hipped Colourbond roof and weatherboard cladding. The veranda roof is hipped and supported by metal posts.</p> <p>The veranda is enclosed by timber dowelled balustrade, with concrete flooring and eastern facing brick stairs. The dwelling is supported by red brick foundations.</p> <p>The front door is timber framed with metal framed picture windows on either side. The visible eastern windows are sliding.</p> <p>The dwelling displays architectural features of a heritage style and is representative of the local development of this period, being of historical significance for the HCA.</p>		<p>The veranda has been heavily modified, with the western portion being enclosed into an additional room, with corresponding modifications to the roof structure.</p> <p>The veranda balustrade is a contemporary addition, likely replacing a similar timber design.</p> <p>An extensive back addition has been constructed, however is not visible from the street.</p> <p>An independent secondary residential structure has been constructed to the north of the dwelling.</p>

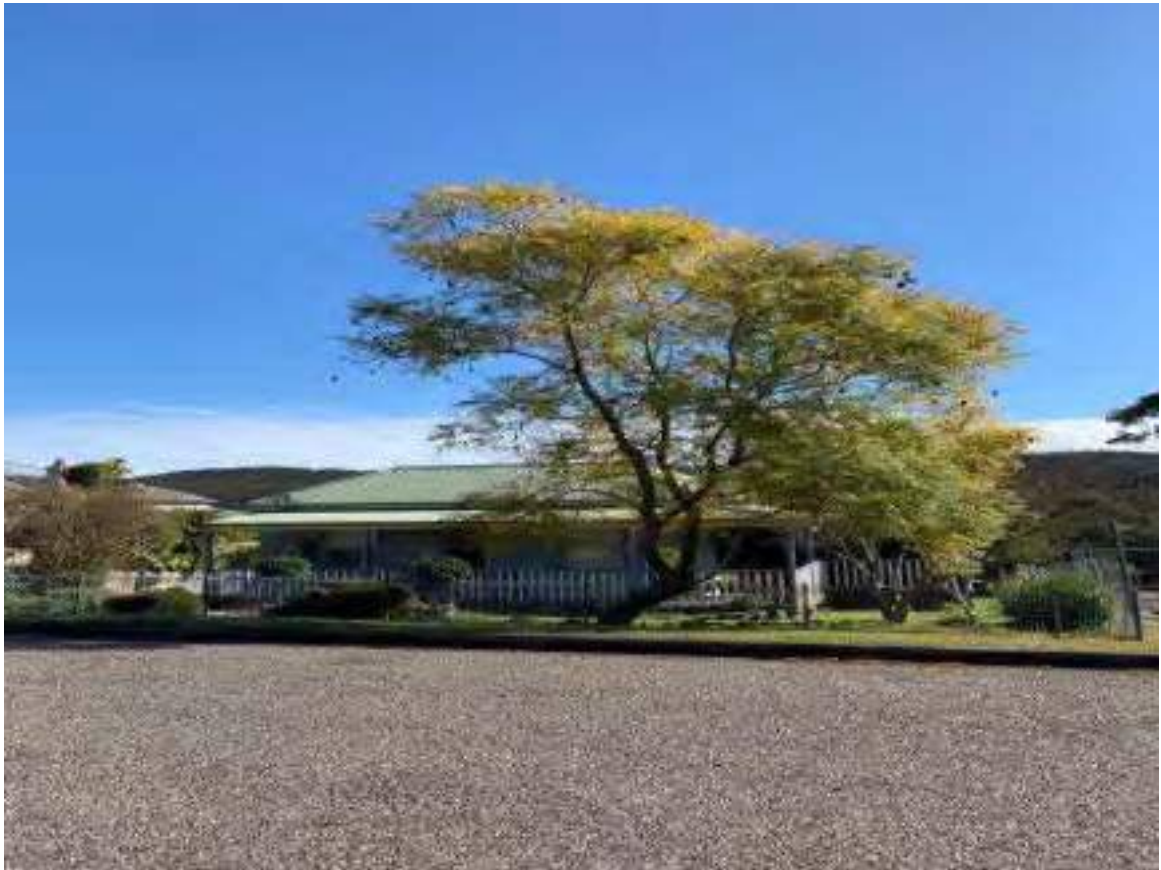
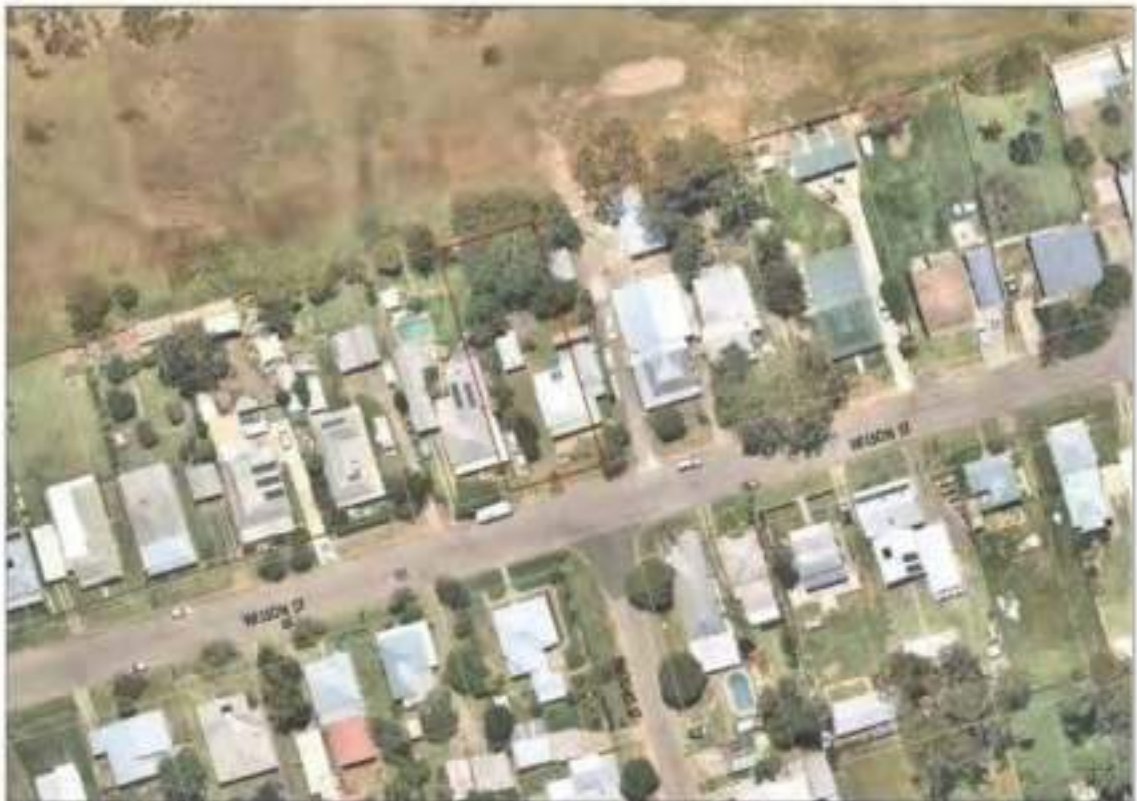
19 WILSON STREET, WEST WALLSEND 2286

Conservation Area Contribution Level	Est. Construction Date	Previous studies and/or community input
Contributory 1	1890–1920	No prior heritage investigations and no additional information required
Assessment Text		Observed Modifications
<p>A single story Vernacular ‘Mining Cottage’ style dwelling with hipped Colourbond roof and weatherboard cladding. The veranda roof is half skillion and hipped, wrapping around the eastern side of the dwelling.</p> <p>The veranda is enclosed by timber dowelled balustrade and timber flooring.</p> <p>The front door is timber framed with sash windows on either side. The western windows are of the same sash design.</p> <p>The dwelling is supported by brick foundations.</p> <p>A small hipped roof garage is located to the north west of the dwelling.</p> <p>The dwelling displays architectural features of a heritage style and is representative of the local development of this period, being of historical significance for the HCA.</p>		<p>The façade sash windows are a contemporary replacement of the original window designs, likely also sash.</p> <p>The veranda balustrade is a modern addition.</p> <p>An eastern addition has been constructed, connecting to the main dwelling via the extended veranda. Although constructed in a sympathetic manner, this modification detracts from the heritage value of the dwelling.</p>

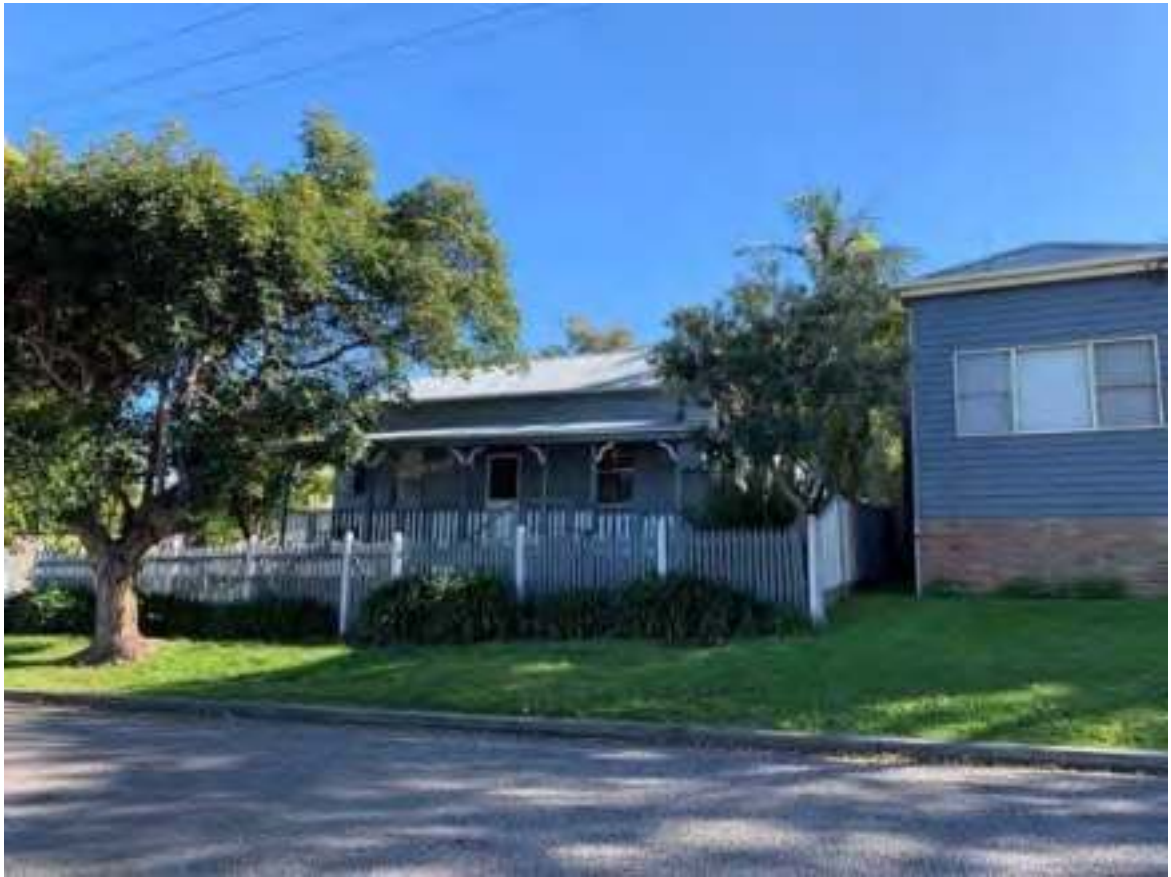
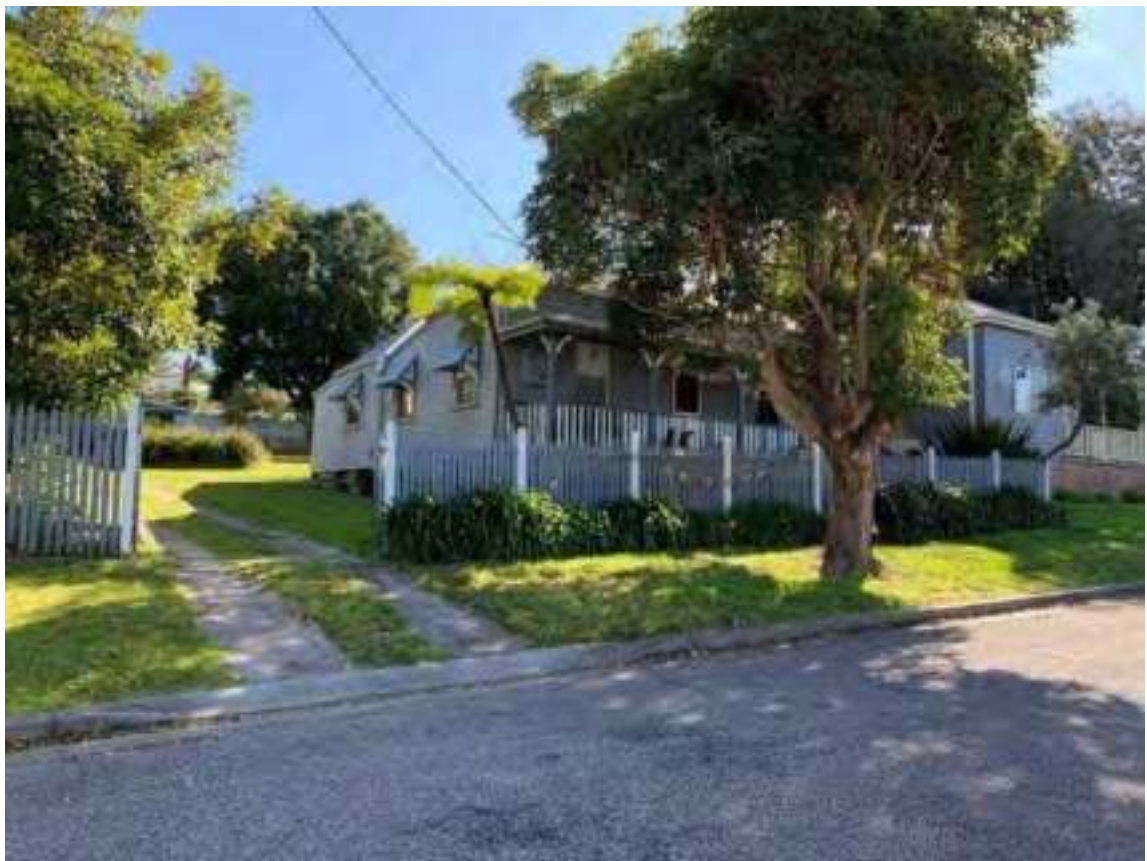
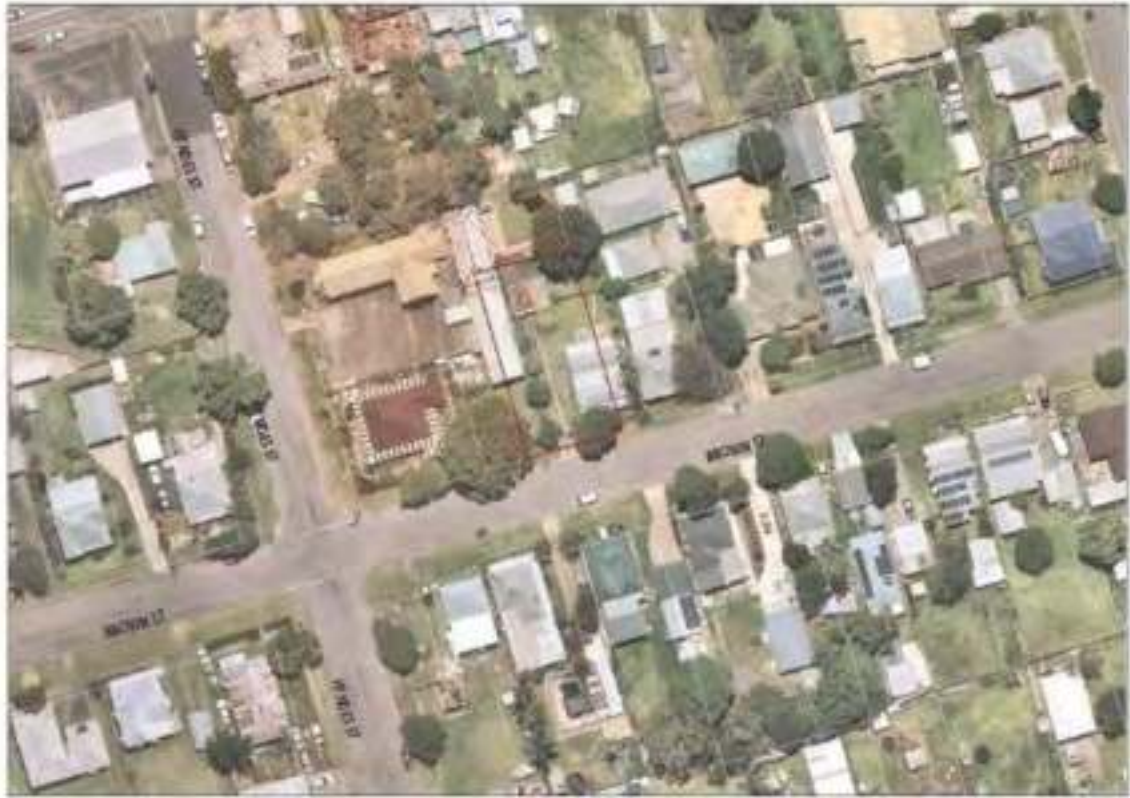
29 BROWN STREET, WEST WALLSEND 2286

Conservation Area Contribution Level	Est. Construction Date	Previous studies and/or community input
Contributory 1	1890–1915	No prior heritage investigations and no additional information required
Assessment Text		Observed Modifications
<p>Single story Vernacular ‘Mining Cottage’ style dwelling with Colourbond hipped roof and weatherboard cladding. The veranda roof is hipped and supported by timber posts with simple bracketing.</p> <p>The veranda is enclosed by timber dowelled balustrade, with an obscured set of stairs. Metal support railing is visible, situated on either side of the stairs.</p> <p>The front door is timber framed with sash windows on either side. The visible western windows are sash, with timber awnings and simplistic bracketing.</p> <p>A timber picket fence fronts the property.</p> <p>A gable roof garage is located to the north of the dwelling.</p> <p>The dwelling displays architectural features of a heritage style and is representative of the local development of this period, being of historical significance for the HCA.</p>		<p>The front door and sash windows of the façade are both contemporary replications of heritage designs. This does not detract from the heritage streetscape.</p> <p>The veranda balustrade is a contemporary replication of a heritage style, and does not impact on the heritage value.</p>

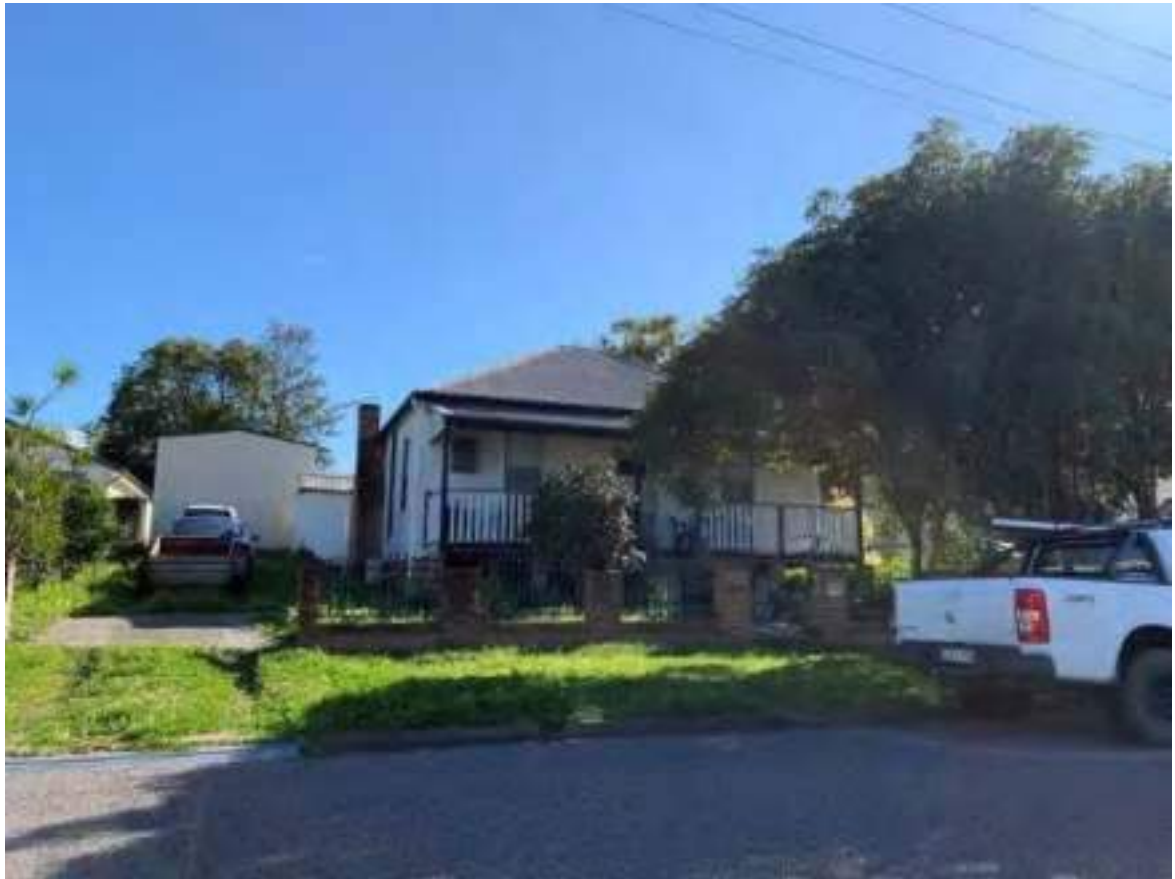
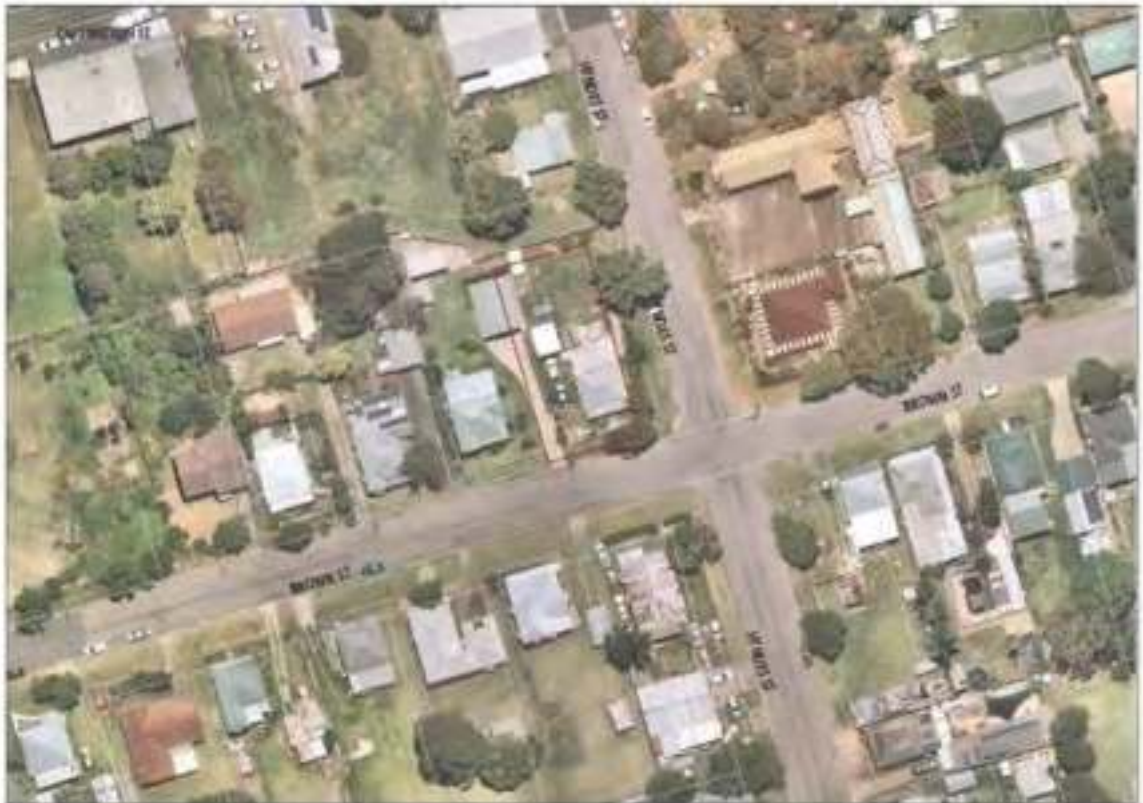
31 BROWN STREET, WEST WALLSEND 2286

Conservation Area Contribution Level	Est. Construction Date	Previous studies and/or community input
Contributory 1	1890–1915	No prior heritage investigations and no additional information required
Assessment Text		Observed Modifications
<p>Single story Vernacular ‘Mining Cottage’ style dwelling with Colourbond hipped roof and weatherboard cladding. The veranda roof is skillion and supported by timber posts.</p> <p>The veranda is enclosed by timber dowelled balustrade with timber flooring and rendered masonry stairs with piers.</p> <p>The front door is timber framed with metal framed sash windows on either side. the visible remaining windows are a combination of modern and original sash designs.</p> <p>A red brick chimney is located to the west of the dwelling.</p> <p>A gable roof garage is located t the west of the dwelling.</p> <p>A brick pillar and metal fence encloses the property.</p> <p>The dwelling displays architectural features of a heritage style and is representative of the local development of this period, being of historical significance for the HCA.</p>		<p>The façade sash windows are a contemporary replacement for the likely original timber windows of the same style. This contrast with the other heritage characteristics of the dwelling.</p> <p>The veranda balustrade is a recent addition, likely replacing an original simplified design.</p> <p>An additional structure is located to the north west of the dwelling, built in a sympathetic style.</p>

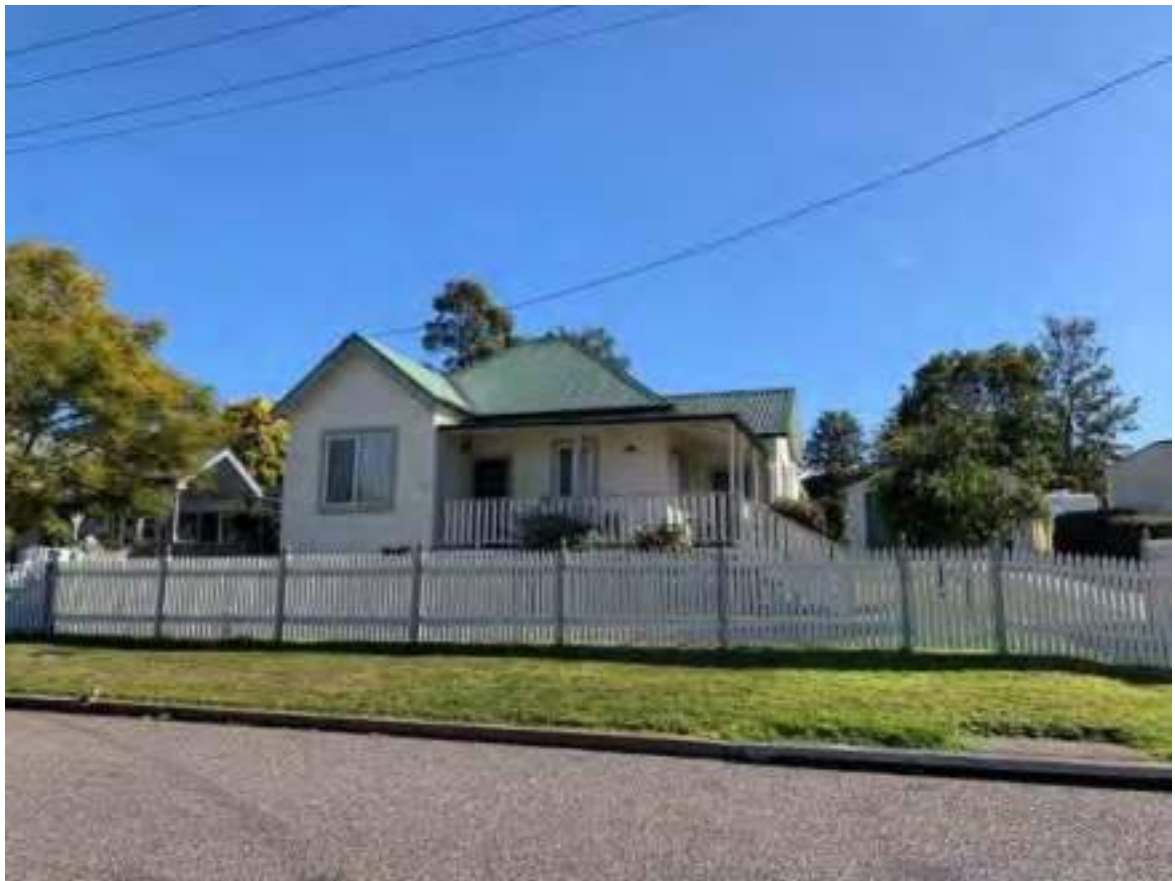
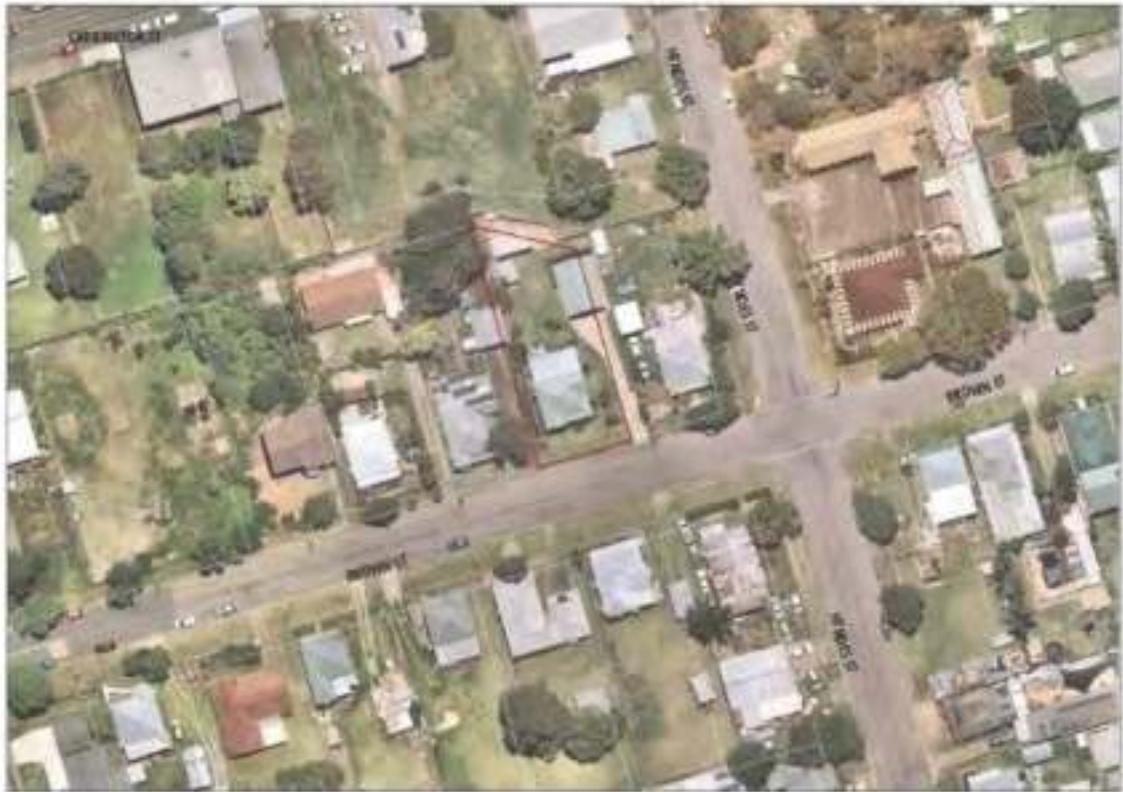
33 BROWN STREET, WEST WALLSEND 2286

Conservation Area Contribution Level	Est. Construction Date	Previous studies and/or community input
Contributory 1	1900–1930	No prior heritage investigations and no additional information required
Assessment Text		Observed Modifications
<p>A single story dwelling with half hipped and gable Colourbond roof and weatherboard cladding. The veranda roof is hipped and supported by timber posts.</p> <p>The veranda is enclosed by timber dowelled balustrade, with timber flooring and eastern facing timber stairs. The stairs have the same timber balustrade.</p> <p>The front door is timber framed with sliding windows to either side. the windows have prominent frames.</p> <p>The gable has ornate decorative barge boards.</p> <p>A gable roof garage is located to the north of the dwelling.</p> <p>A white timber picket fence encloses the property.</p> <p>The dwelling displays architectural features of a heritage style and is representative of the local development of this period, being of historical significance for the HCA.</p>		<p>A back extension has been constructed, however this is not visible from the street and does not detract.</p> <p>The general layout of the dwelling is suggestive of heavy modification or contemporary construction. Traditionally dwellings of the era are L shaped or box shaped.</p> <p>The veranda balustrade is a recent addition to the dwelling, likely replicating an earlier style. This has been constructed in a sympathetic style and does not detract.</p>

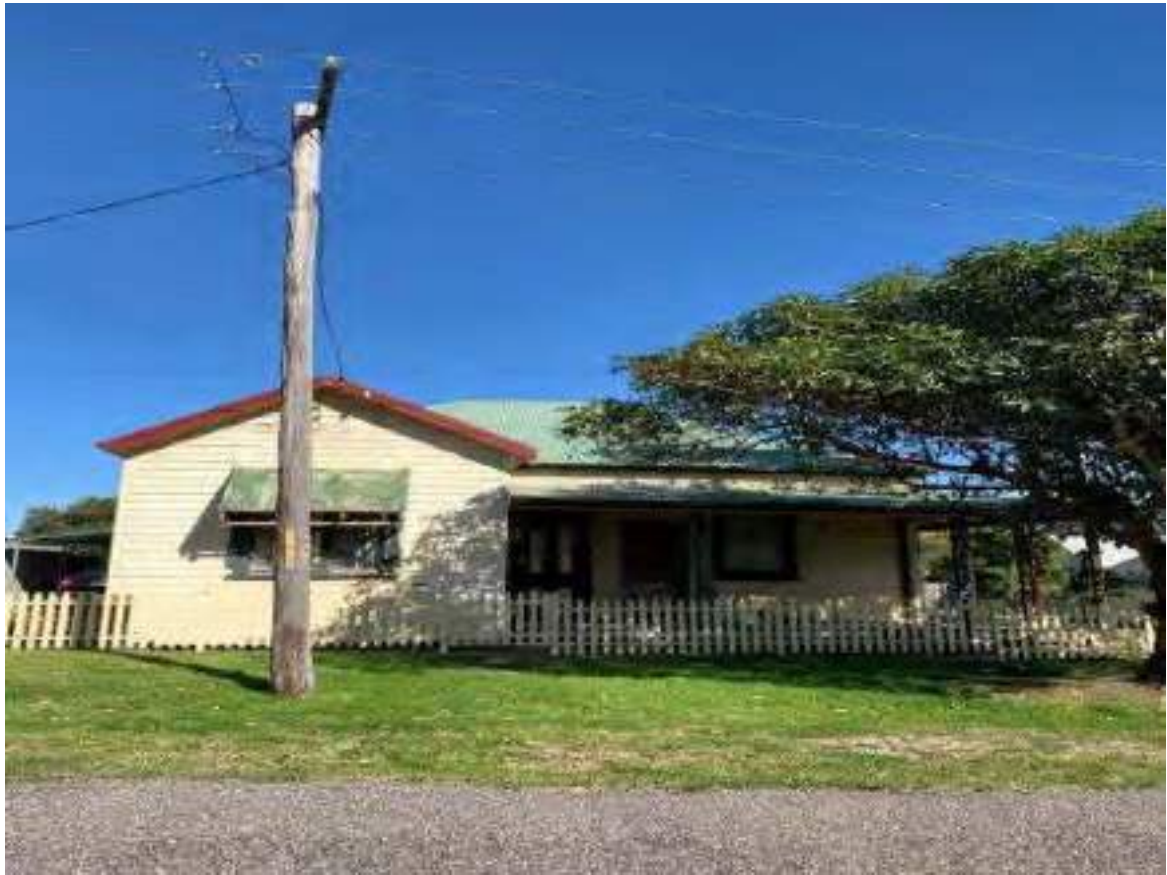
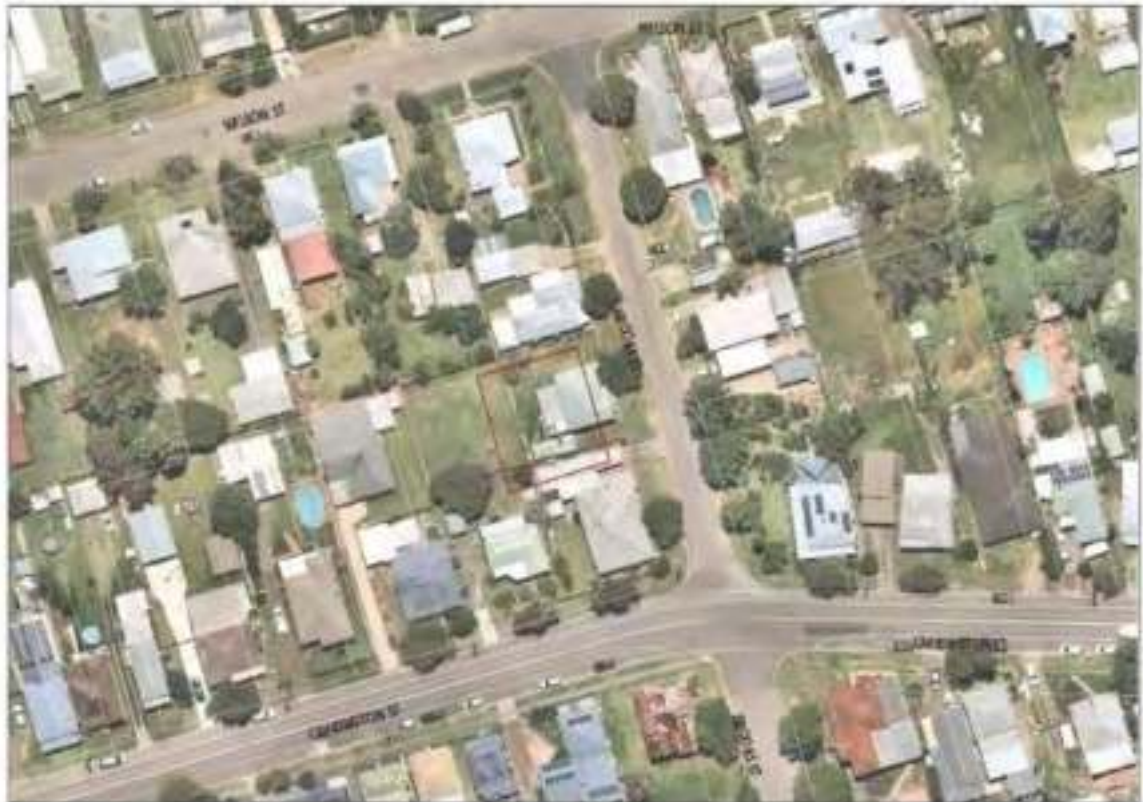
4 BROOKS STREET, WEST WALLSEND 2286

Conservation Area Contribution Level	Est. Construction Date	Previous studies and/or community input
Contributory 1	1900–1920	No prior heritage investigations and no additional information required
Assessment Text		Observed Modifications
<p>Single story simple Federation style dwelling with half hipped and gable Colourbond roof and weatherboard cladding. The veranda roof is hipped and wraps around the eastern and northern side of the dwelling.</p> <p>The veranda is open with no balustrades, supported by timber posts and timber flooring. The veranda is found at the eastern and northern side of the dwelling.</p> <p>The front door is central and timber framed, with a four panel design/ a secondary door with security screen is located to the northern side of the front façade. Visible windows are double hung sash designs with timber frames.</p> <p>The gable window has a metal awnings, with simple brackets.</p> <p>A gable roof car port and garage is located to the south of the dwelling.</p> <p>A timber picket fence encloses the property.</p> <p>The dwelling displays architectural features of a heritage style and is representative of the local development of this period, being of historical significance for the HCA.</p>		<p>Potential for the northern side of the veranda to be a modification and later extension.</p> <p>Windows on the northern side of the veranda are modern sliding designs.</p> <p>Secondary door is a recent addition.</p>

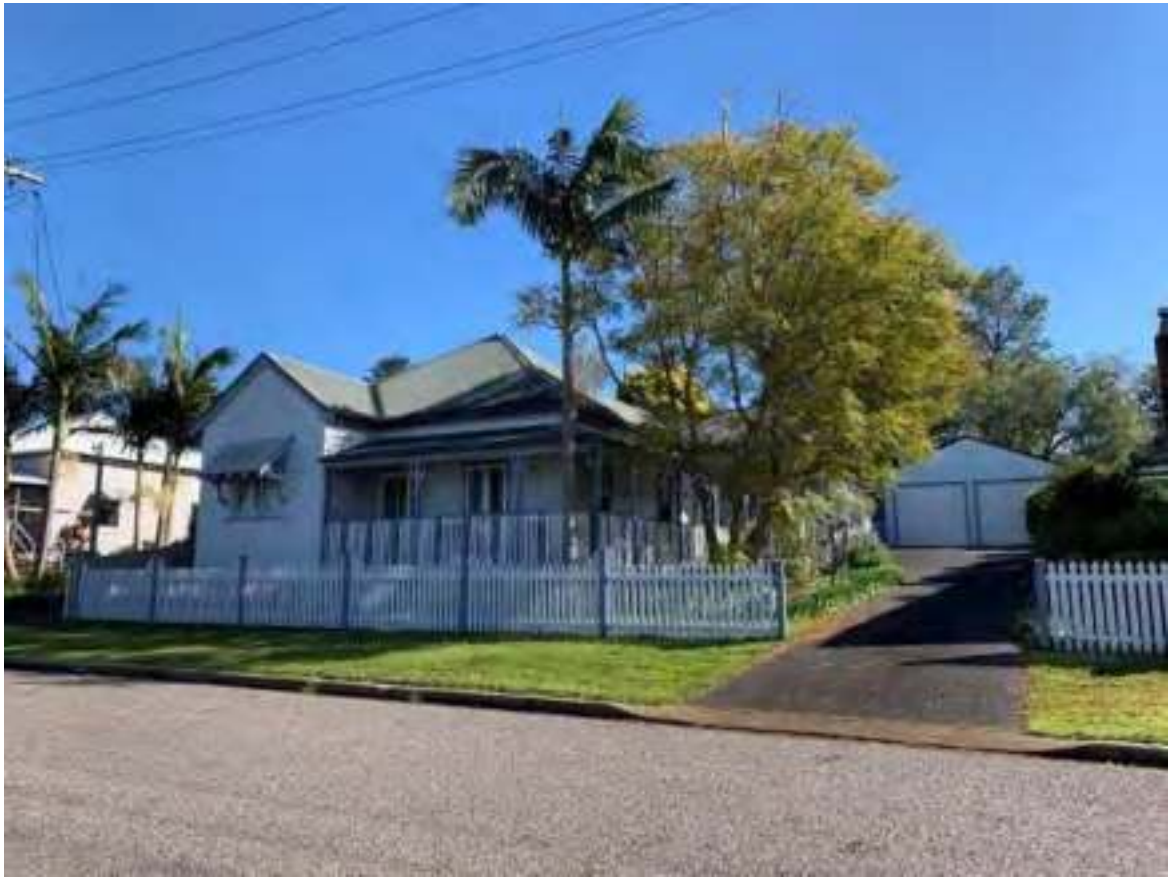
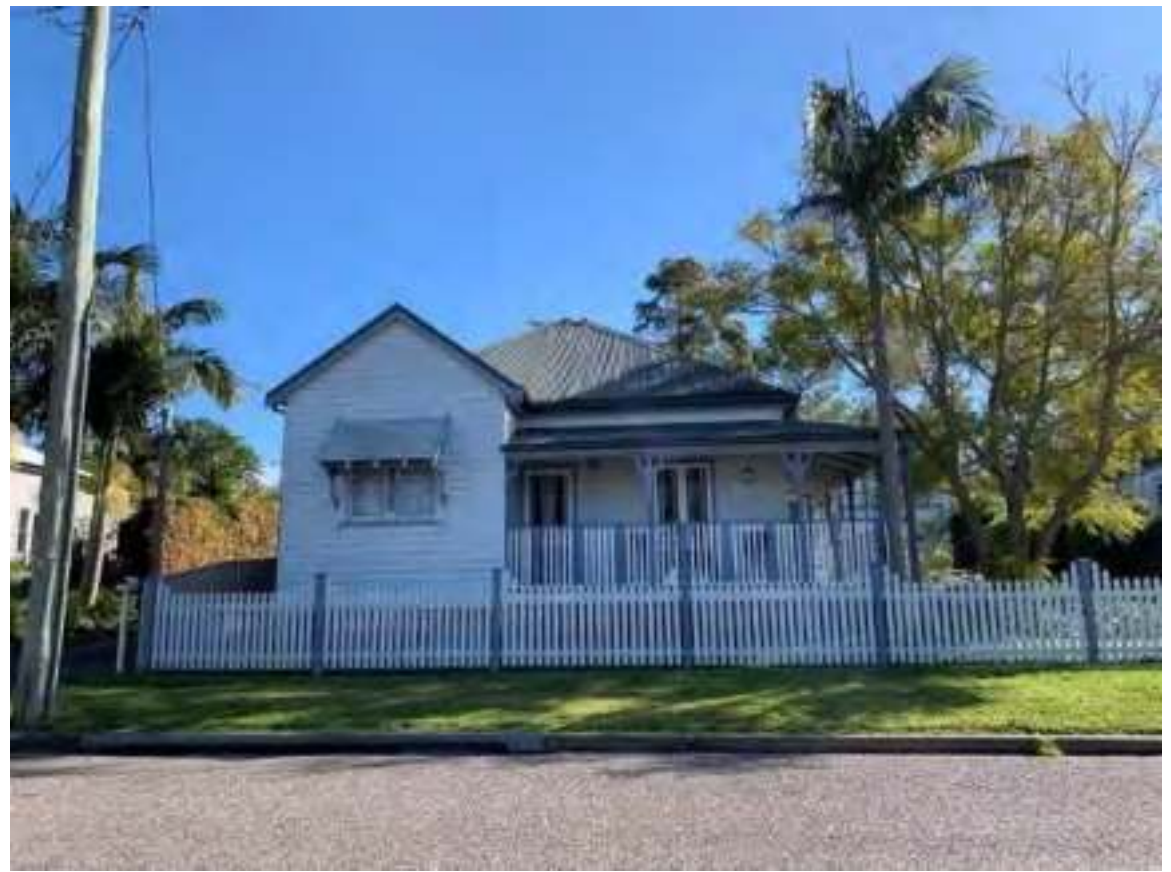
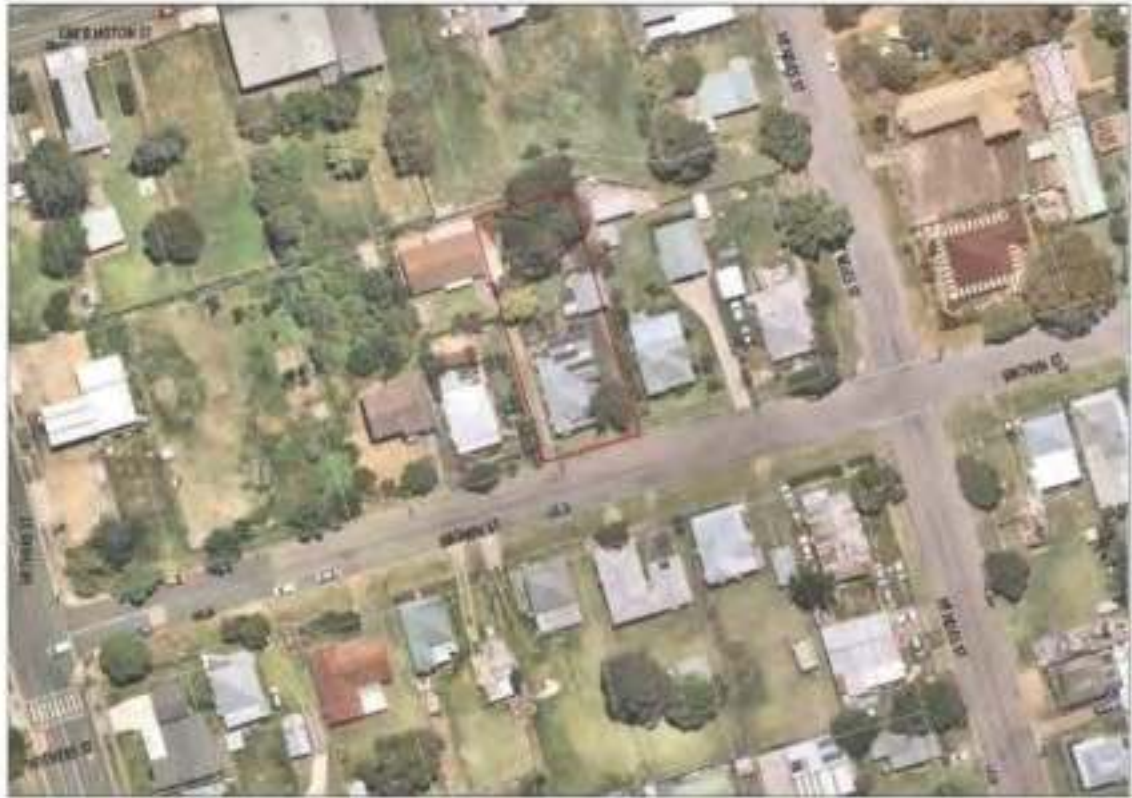
35 BROWN STREET, WEST WALLSEND 2286

Conservation Area Contribution Level	Est. Construction Date	Previous studies and/or community input
Contributory 1	1900–1915	No prior heritage investigations. Dwelling has been owned by three owners since construction: Hunters, Coult and Olgilvie.
Assessment Text		Observed Modifications
<p>Single story simple Federation style dwelling with half hipped and gable Colourbond roof and weatherboard cladding. The veranda roof is hipped and wraps around the southern and eastern side of the dwelling.</p> <p>The veranda is enclosed with timber balustrades and supported by timber posts with art nouveau style brackets. Flower motifs are carved into the timber balustrade. The floor is timber. Timber stairs with balustrade leads onto the veranda landing.</p> <p>A front door is central and timber framed, with a metal security screen. A secondary door is visible and similarly designed.</p> <p>The windows are double hung sash designs and timber framed. The gable window has a timber awning with shingle roof and ornate brackets.</p> <p>A double door gable roof garage is located to the north of the dwelling and is constructed in a sympathetic style.</p> <p>Timber picket fencing encloses the property.</p> <p>The dwelling displays architectural features of a heritage style and is representative of the local development of this period, being of historical significance for the HCA.</p>		<p>The larger secondary door is a recent modification, and is noted in other similarly designed dwellings.</p> <p>The front entrance door has been relocated to the eastern side of the dwelling and is not street facing. A secondary gable roof has been constructed, in association with a back extension on the northern side of the dwelling. this is partially visible from the street, but is constructed in a sympathetic style.</p> <p>The veranda balustrade is a recent addition to the dwelling, likely replicating an earlier style. This has been constructed in a sympathetic style and does not detract.</p>
