APPENDIX 2

Building Assessment Sheets (Inventory Sheets)

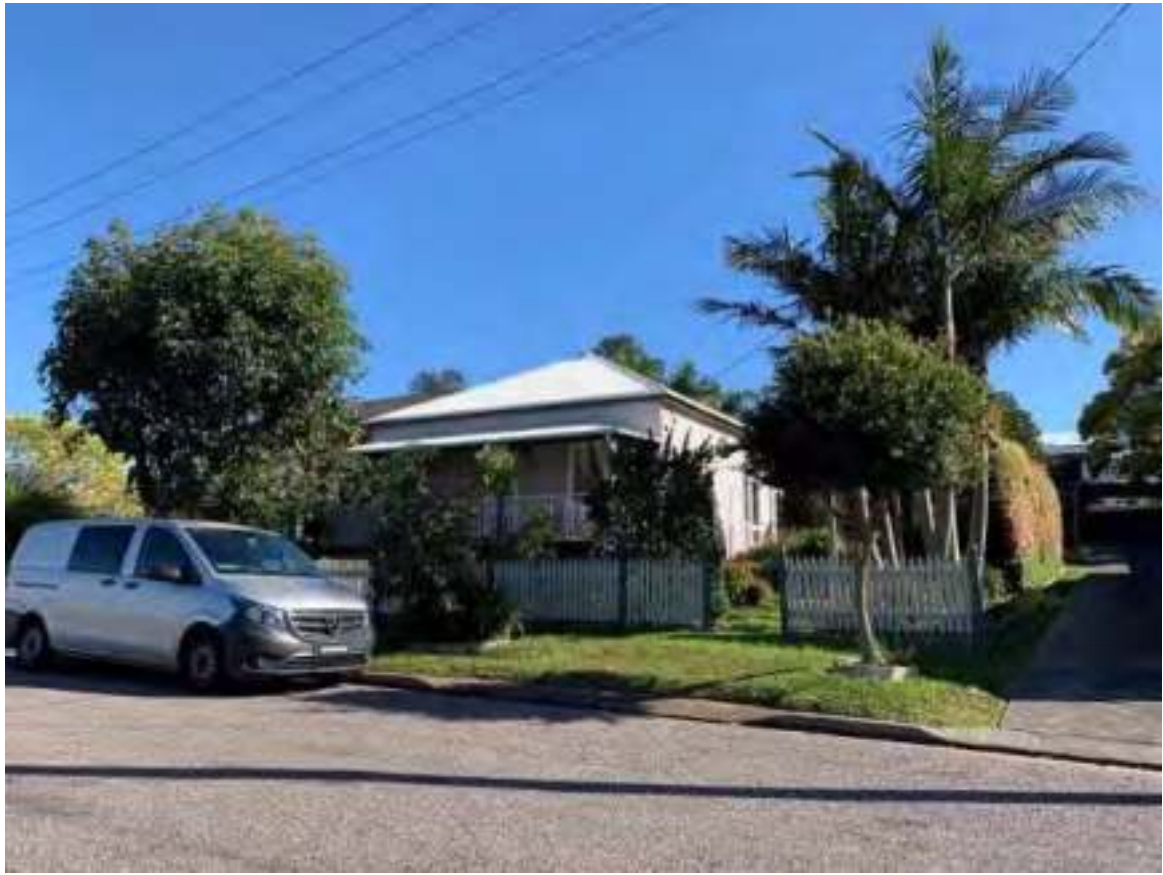
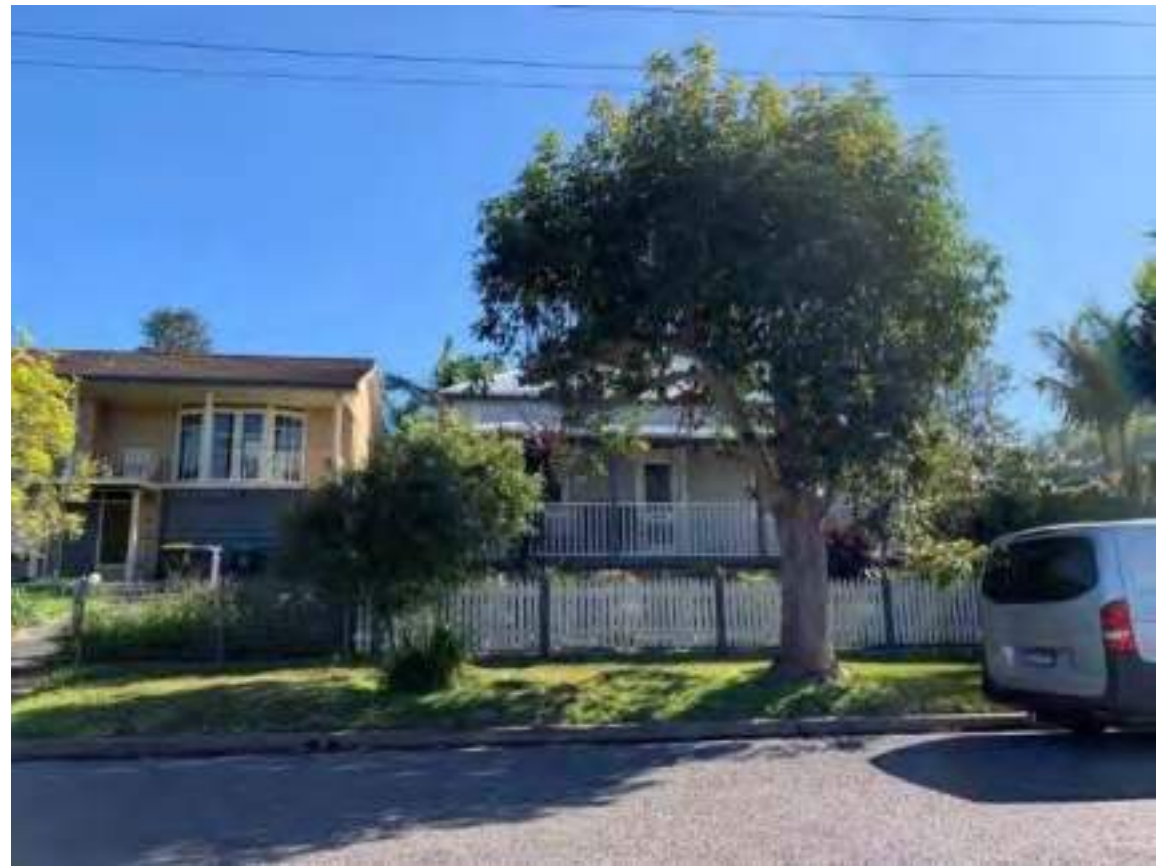
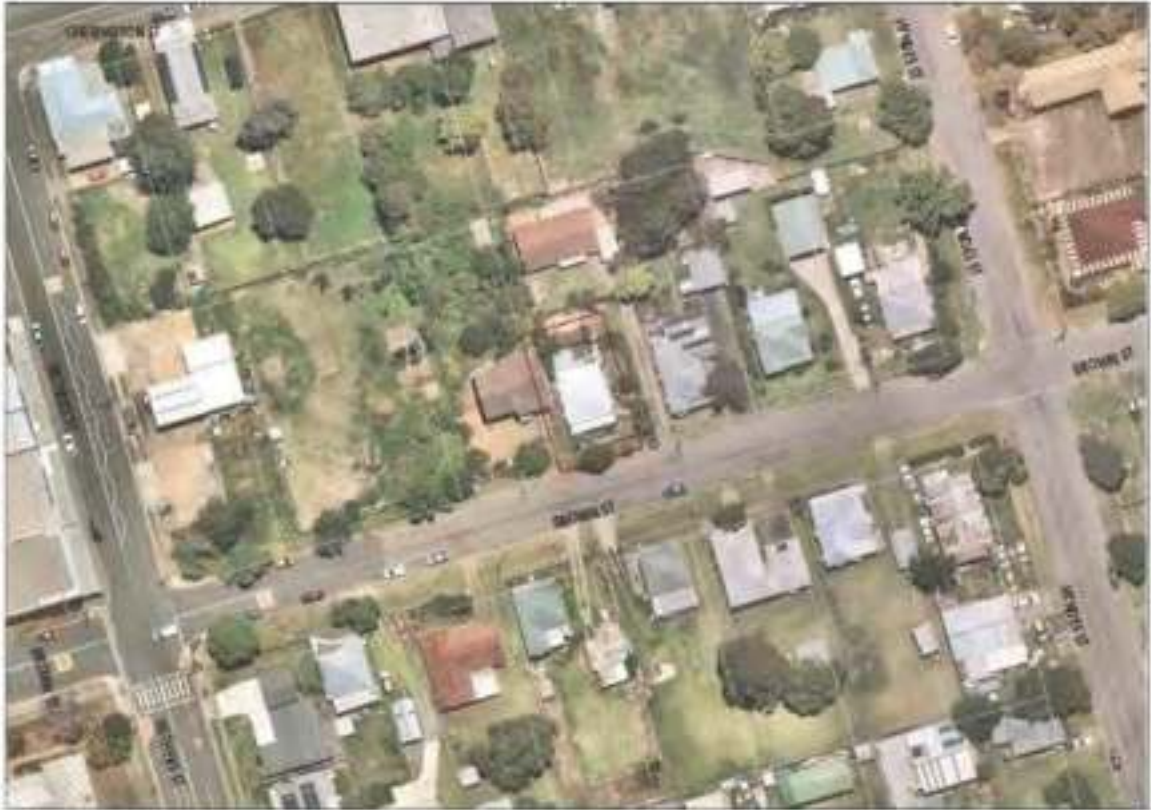
37 BROWN STREET, WEST WALLSEND 2286

Conservation Area Contribution Level	Est. Construction Date	Previous studies and/or community input
Contributory 1	1890–1915	No prior heritage investigations and no additional information required
Assessment Text		Observed Modifications
<p>A single story Vernacular ‘Mining Cottage’ style dwelling with hipped Colourbond roof and weatherboard cladding. The veranda roof is hipped and supported by timber posts.</p> <p>The veranda is enclosed by timber balustrade, with timber flooring.</p> <p>The front door is centrally located and timber framed, with double pane sash windows on either side. the eastern and western windows are a similar style, with four panes and metal awnings.</p> <p>The dwelling is supported by sandstone foundations.</p> <p>A timber picket fence encloses the property.</p> <p>The dwelling displays architectural features of a heritage style and is representative of the local development of this period, being of historical significance for the HCA.</p>		<p>The veranda balustrade is a recent addition to the dwelling, likely replicating an earlier style. This has been constructed in a sympathetic style and does not detract.</p>

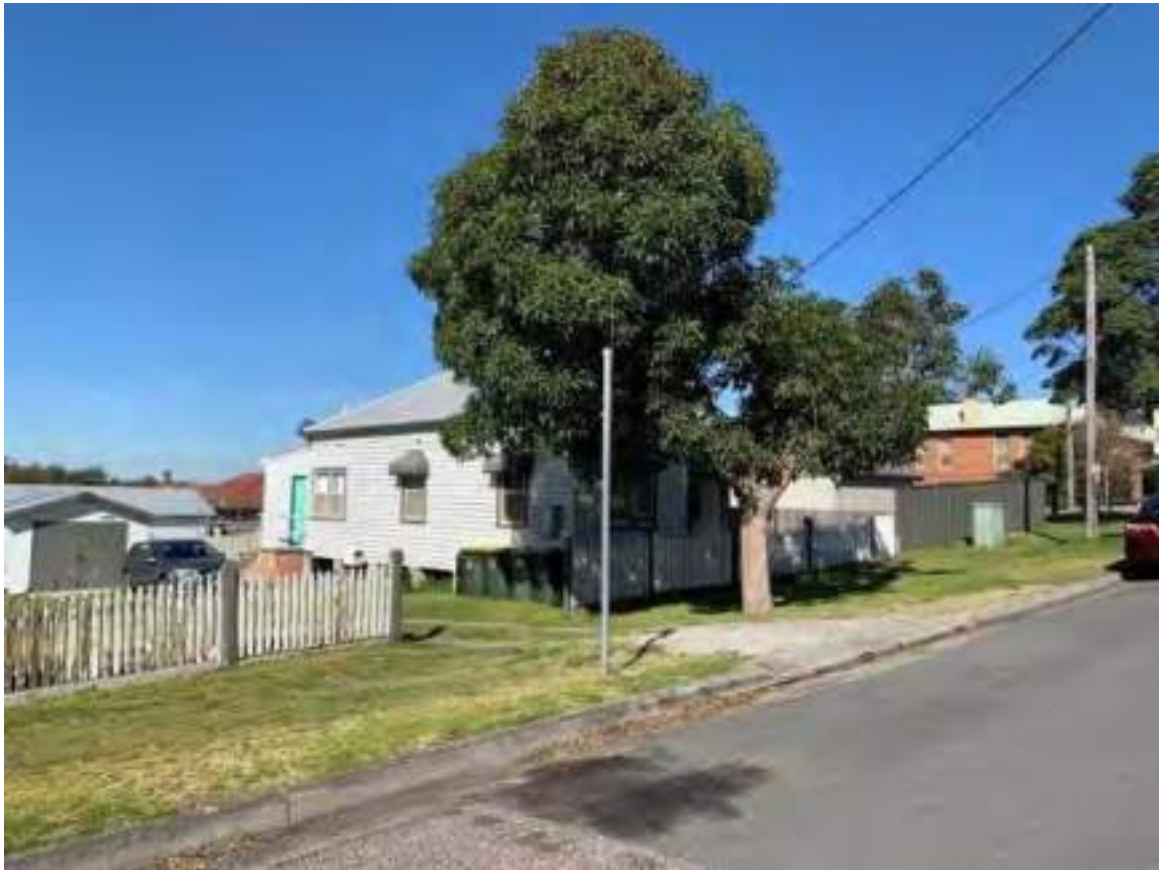
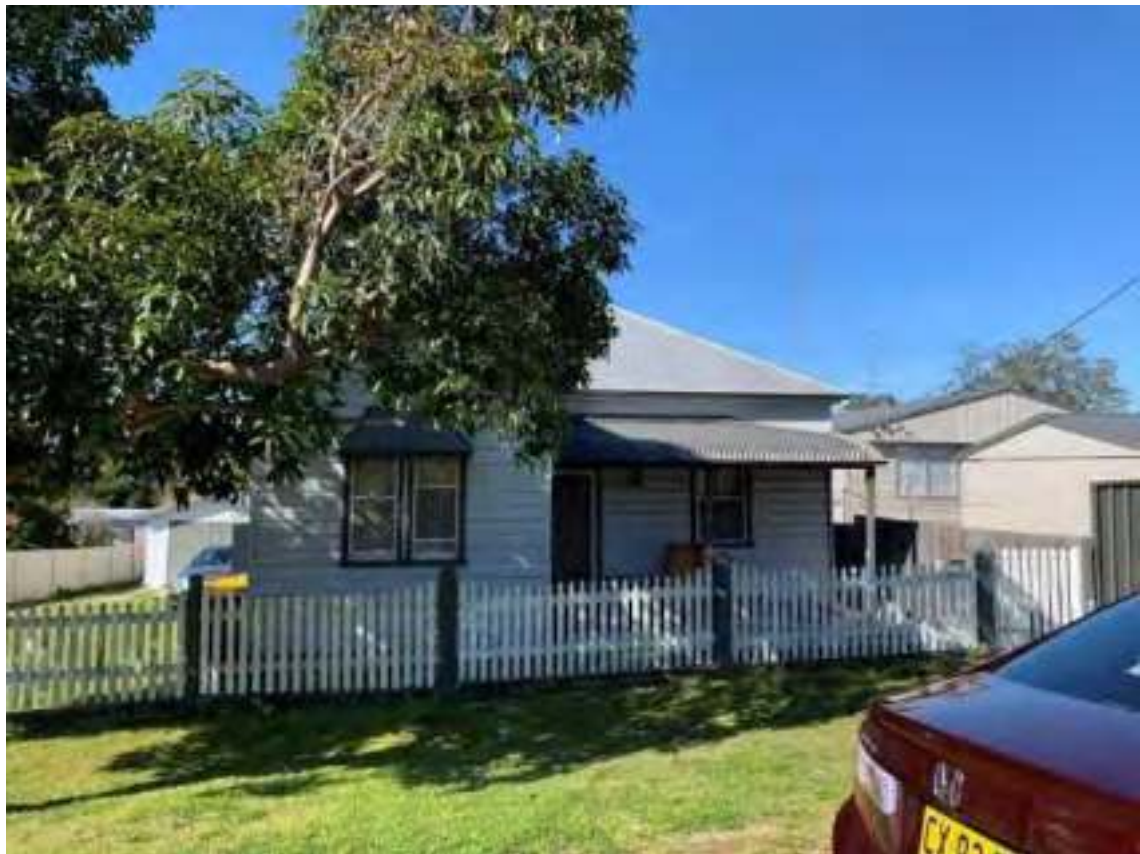
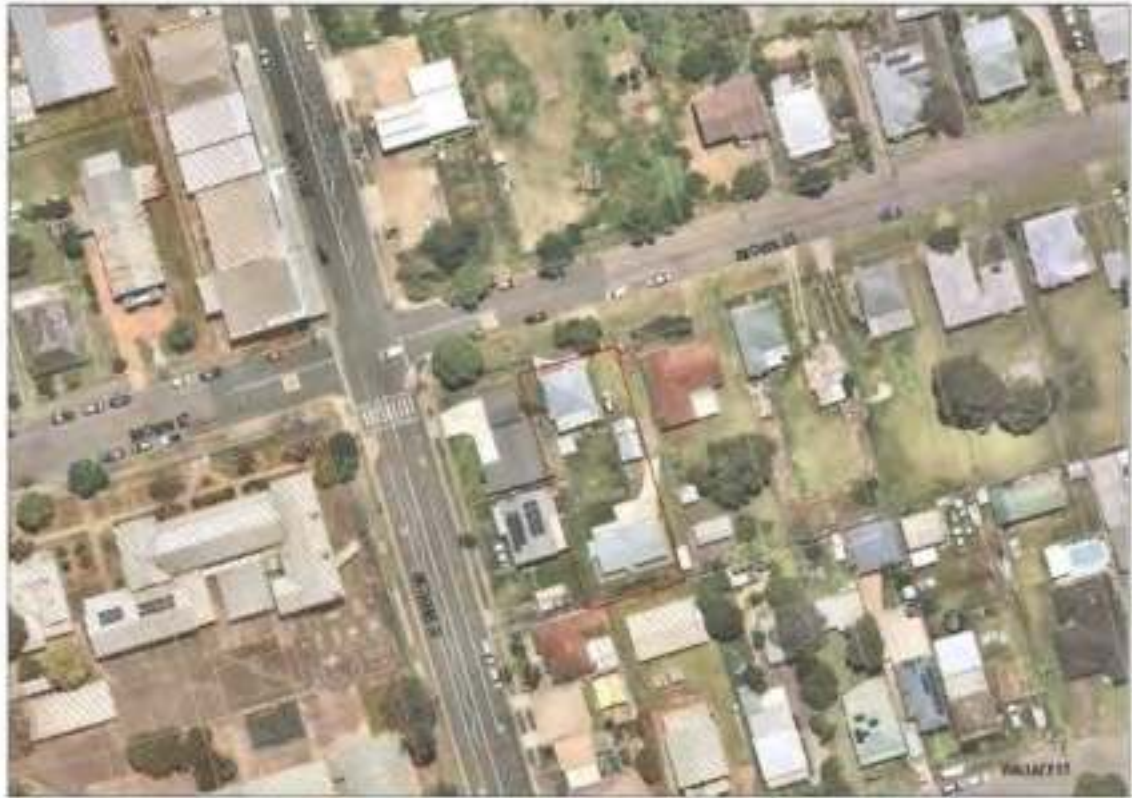
56 BROWN STREET, WEST WALLSEND 2286

Conservation Area Contribution Level	Est. Construction Date	Previous studies and/or community input
Contributory 1	1895–1900	West Wallsend Heritage Study 1993 Moderate local significance
Assessment Text		Observed Modifications
<p>A single story ‘workmen’s’ cottage style dwelling with projecting gable roof and timber weatherboard cladding. The remaining structure has a hipped roof, all Colourbond. The veranda roof is bull nosed and supported by timber posts.</p> <p>The veranda is open with timber flooring.</p> <p>The gable window has a frilled sheet metal window hood, ornately carved barged board, and timber finial. An elaborately carved timber pilaster is situated between the two sash windows. The frilled metal hood is similarly found on the western side. the front door is centrally located and timber framed.</p> <p>A timber picket fence encloses the property.</p> <p>A single door gable roof garage is located to the south of the dwelling.</p> <p>The dwelling displays architectural features of a heritage style and is representative of the local development of this period, being of historical significance for the HCA.</p>		<p>All visible windows and doors have contemporary metal screening, which juxtaposes the heritage style of the dwelling.</p>

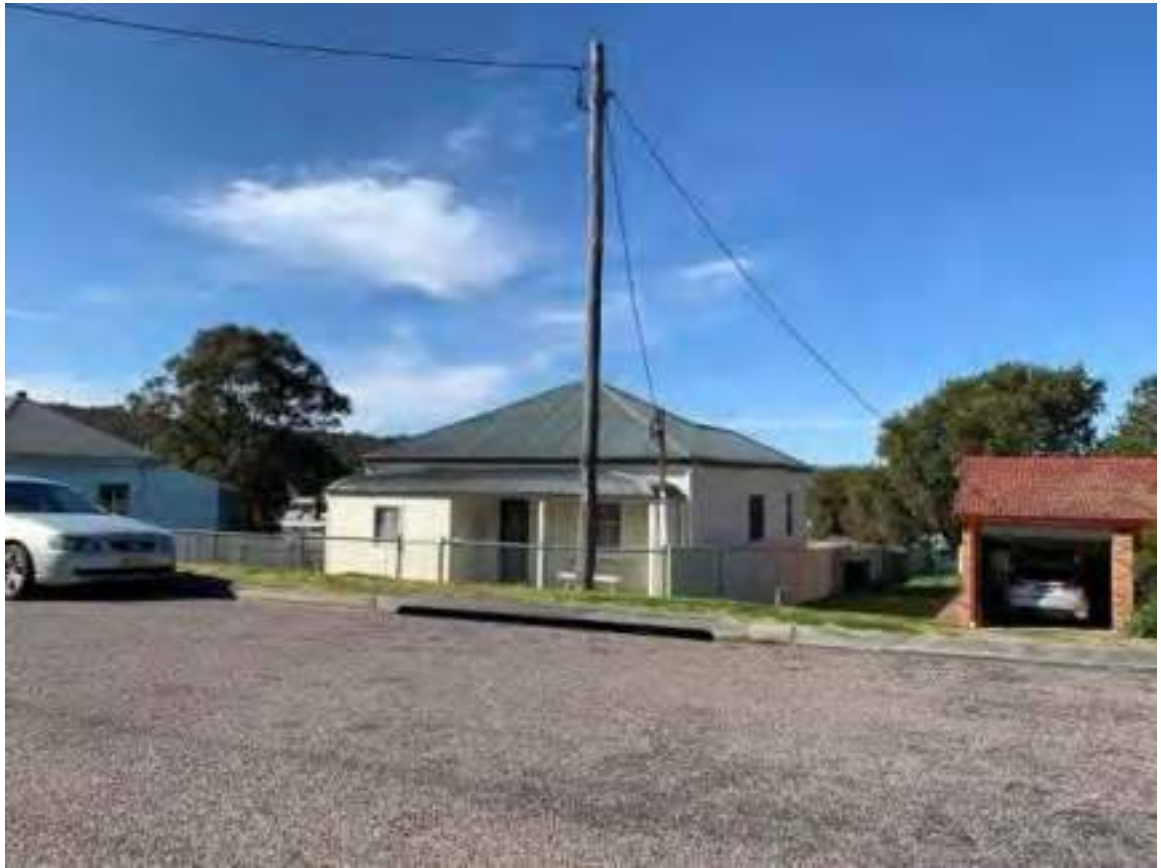
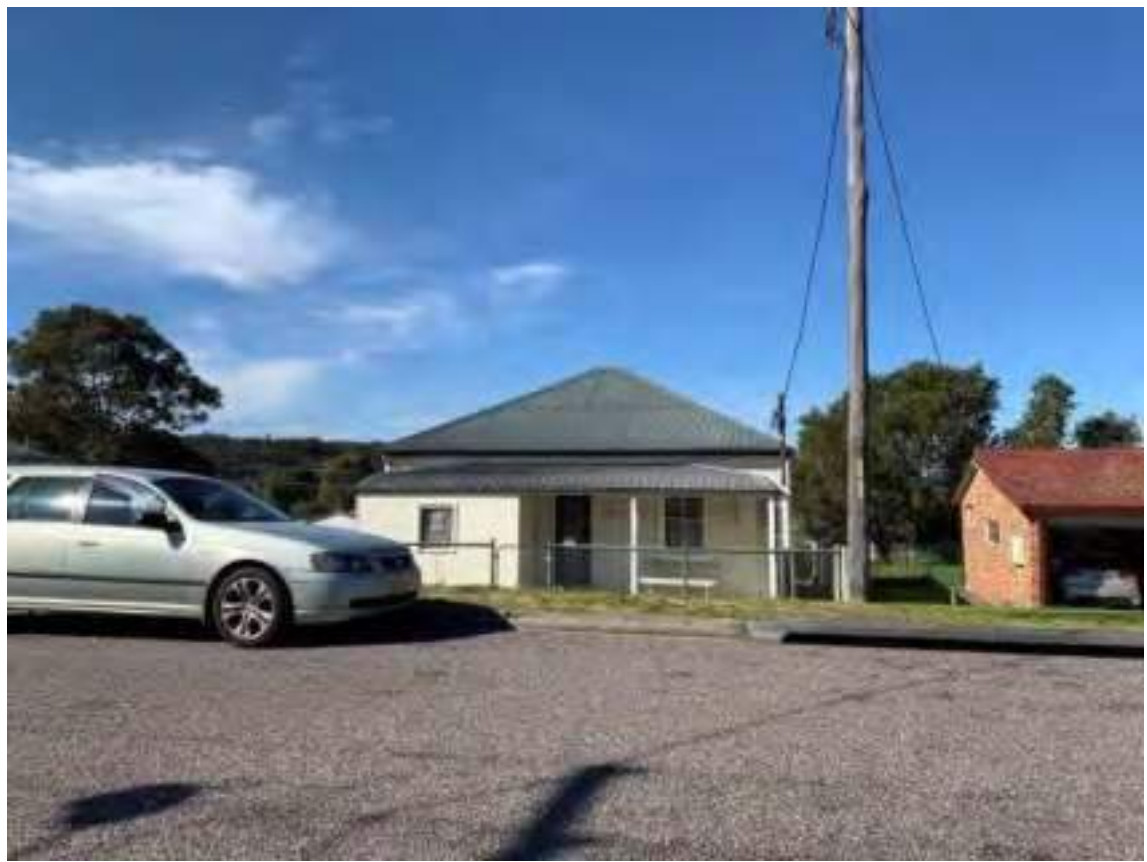
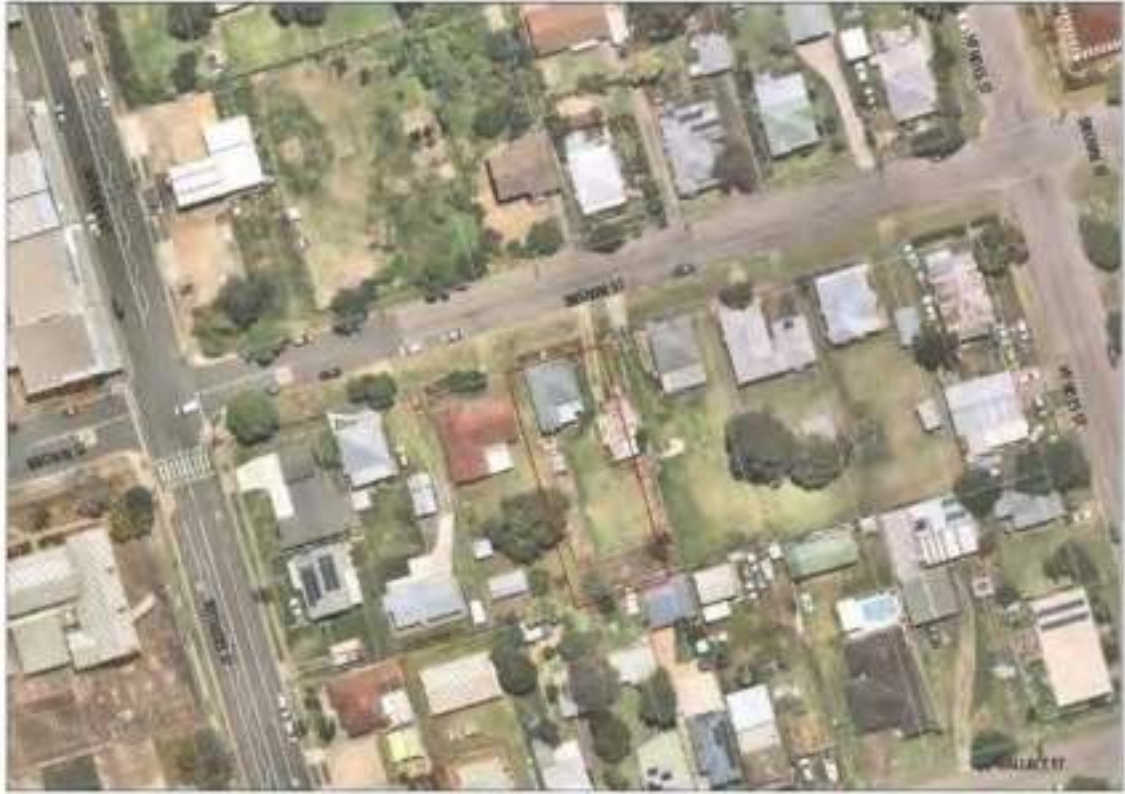
52 BROWN STREET, WEST WALLSEND 2286

Conservation Area Contribution Level	Est. Construction Date	Previous studies and/or community input
Contributory 1	1890=1910	No prior heritage investigations and no additional information required
Assessment Text		Observed Modifications
<p>A single story Vernacular 'Mining Cottage' style dwelling with hipped Colourbond roof and weatherboard cladding. The veranda roof is bull nosed and supported by timber posts.</p> <p>The veranda is open with no balustrades, and timber flooring. Timber latticing is visible on the western side.</p> <p>The front door is centrally located with timber framing and a metal security screen/a four pane sash window is located to the west, with the built in section to the east having a contemporary jalousie window design. The remaining visible windows are a mix of sash and sliding designs.</p> <p>The dwelling displays architectural features of a heritage style and is representative of the local development of this period, being of historical significance for the HCA.</p>		<p>The veranda has been partially enclosed and built in by a fibro-clad timber frame, on the eastern side. This is a common modification amongst similar dwellings and is reflective of the demographic.</p> <p>Some windows have been replaced with contemporary sliding styles.</p> <p>A back extension has been built on the southern end of the dwelling, however is not visible from the street and does not detract.</p>

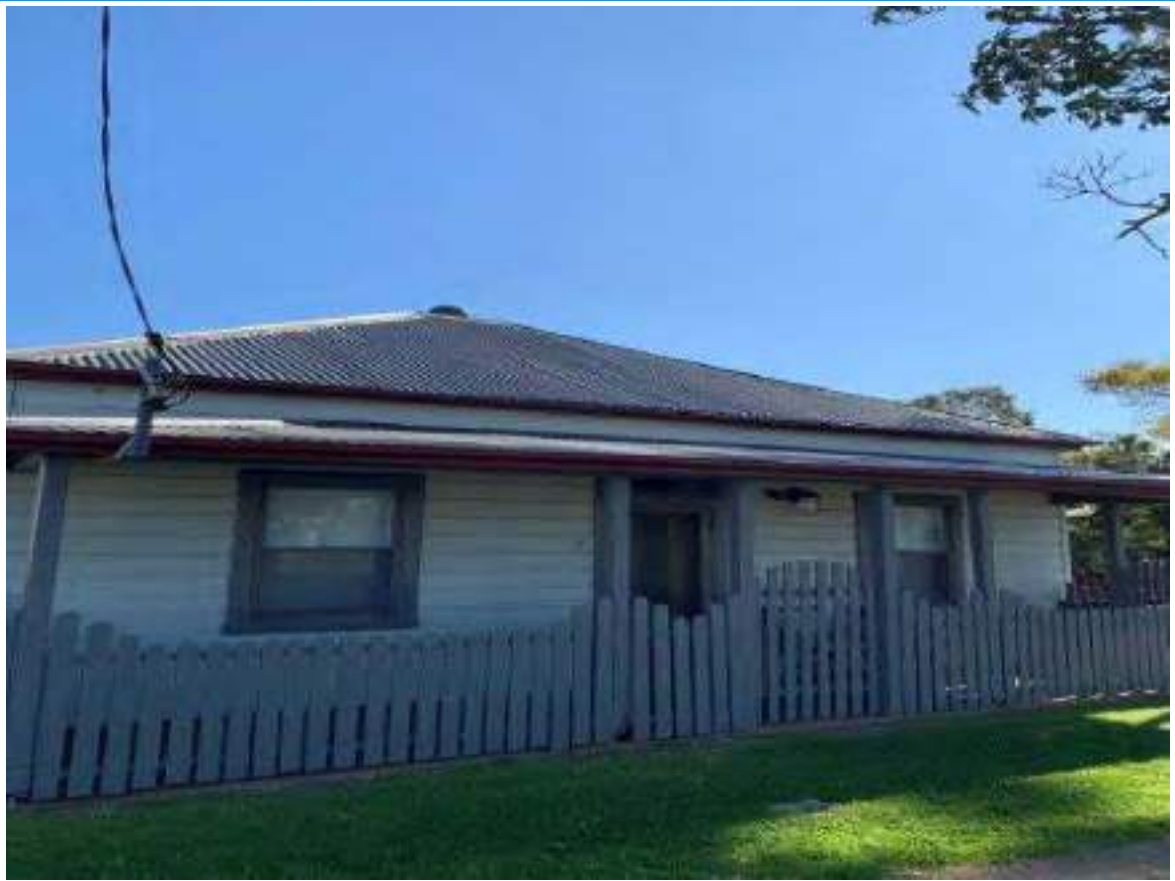
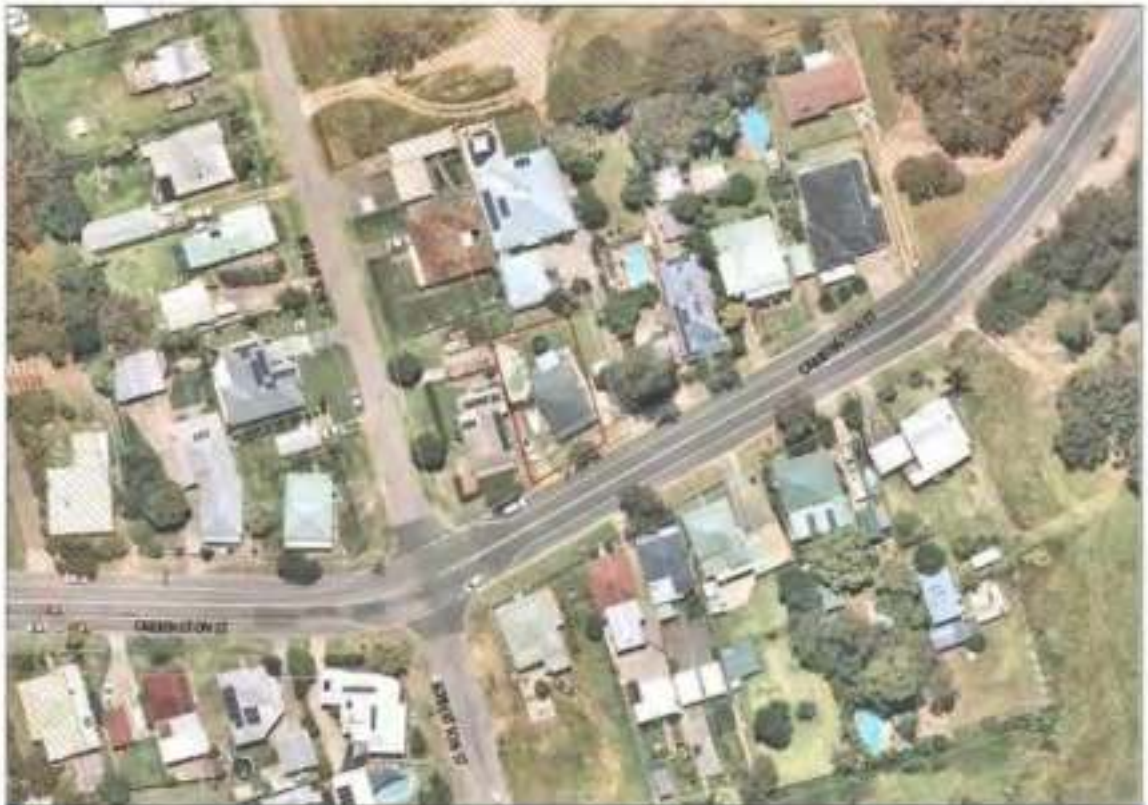
Conservation Area Contribution Level	Est. Construction Date	Previous studies and/or community input
Contributory 1	1890–1900	West Wallsend Heritage Study 1993 Moderate local significance.
Assessment Text		Observed Modifications
<p>Single story Vernacular ‘Mining Cottage’ style dwelling with hipped Colourbond roof and weatherboard cladding. The veranda is hipped and supported by timber posts.</p> <p>The veranda is enclosed by timber fencing, with a central entrance gate.</p> <p>The front door is centrally located with a timber frame, with timber framed sash windows on either side. They are likely original.</p> <p>A rendered brickwork chimney is located on the eastern side of the dwelling.</p> <p>The dwelling displays architectural features of a heritage style and is representative of the local development of this period, being of historical significance for the HCA.</p>		<p>When referencing the original heritage listing, the dwelling has undergone extensive modifications with the corrugated iron sheeting being replaced with Colourbond and redwood rebated weatherboarding replaced with more contemporary cladding.</p> <p>The chimney shaft has been removed.</p> <p>The veranda fencing is a contemporary modification.</p>

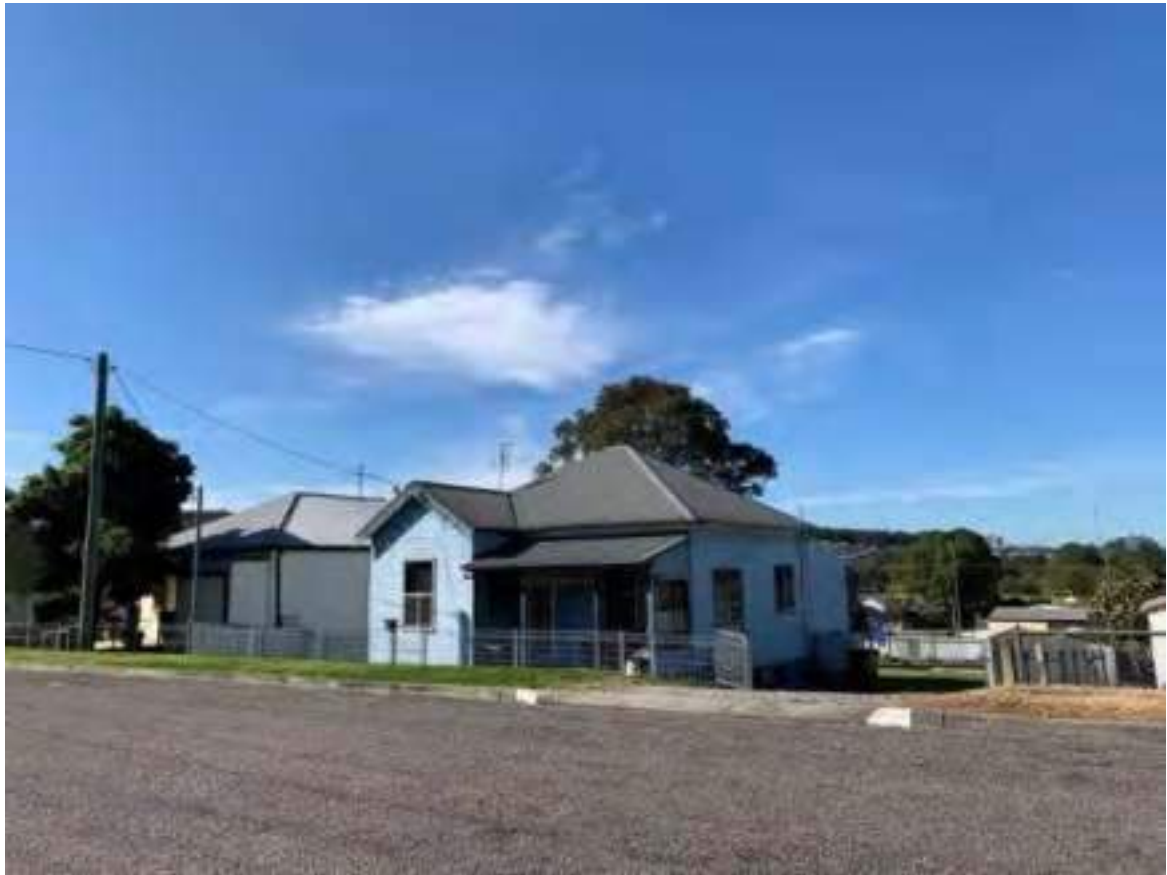
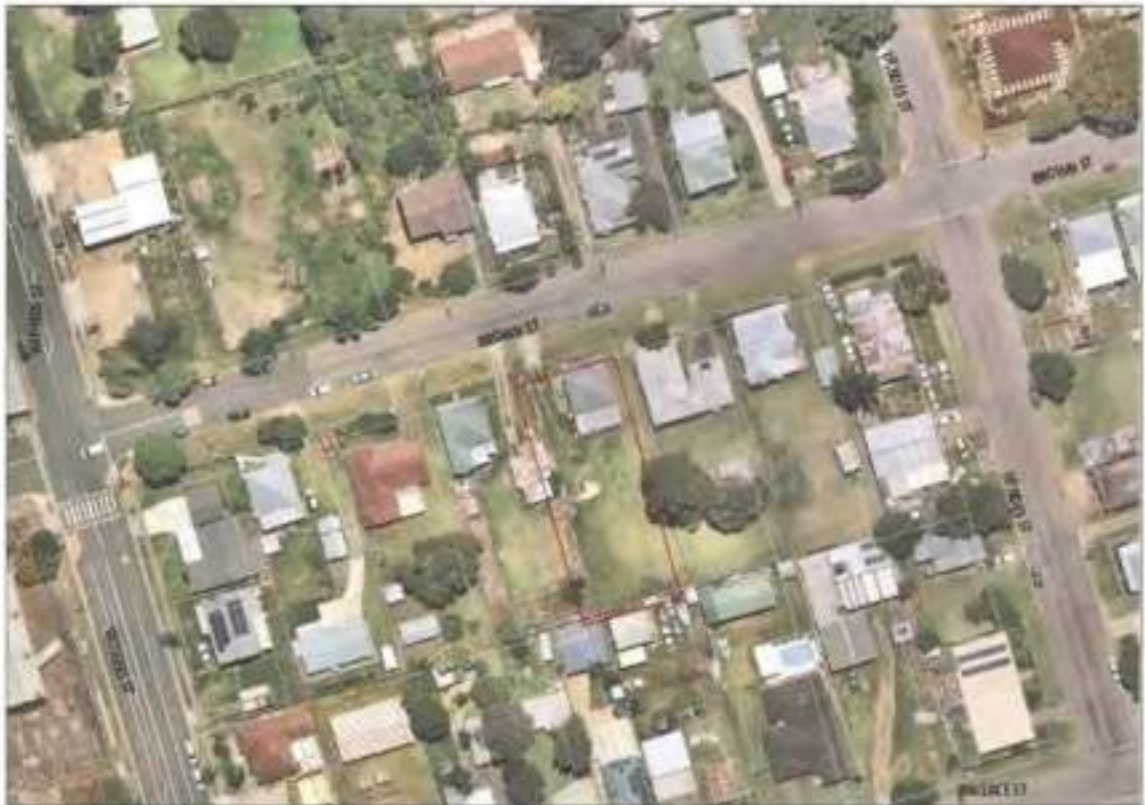
50 BROWN STREET, WEST WALLSEND 2286

Conservation Area Contribution Level	Est. Construction Date	Previous studies and/or community input
Contributory 1	1890–1900	No prior heritage investigations and no additional information required.
Assessment Text		Observed Modifications
<p>A single story ‘workmen’s’ cottage style dwelling with projecting gable roof and timber weatherboard cladding. The remaining structure has a hipped roof, all Colourbond. The veranda roof is skillion and supported by timber posts.</p> <p>The veranda is open with no balustrades, timber flooring and a singular timber stair leading onto the landing. Red and yellow canvas blind is visible.</p> <p>The front door is centrally located with a decorative metal screen. The windows of the front facade are contemporary sash designs. The remaining visible windows are sliding designs.</p> <p>The gable has ornately decorated barge boards.</p> <p>A metal fence encloses the property.</p> <p>The dwelling displays architectural features of a heritage style and is representative of the local development of this period, being of historical significance for the HCA.</p>		<p>The canvas blind is a contemporary modification.</p> <p>The bright blue colour scheme is unsympathetic to the heritage streetscape.</p> <p>The vast majority of the windows have been replaced with contemporary sliding designs, juxtaposing the heritage style of the dwelling.</p>

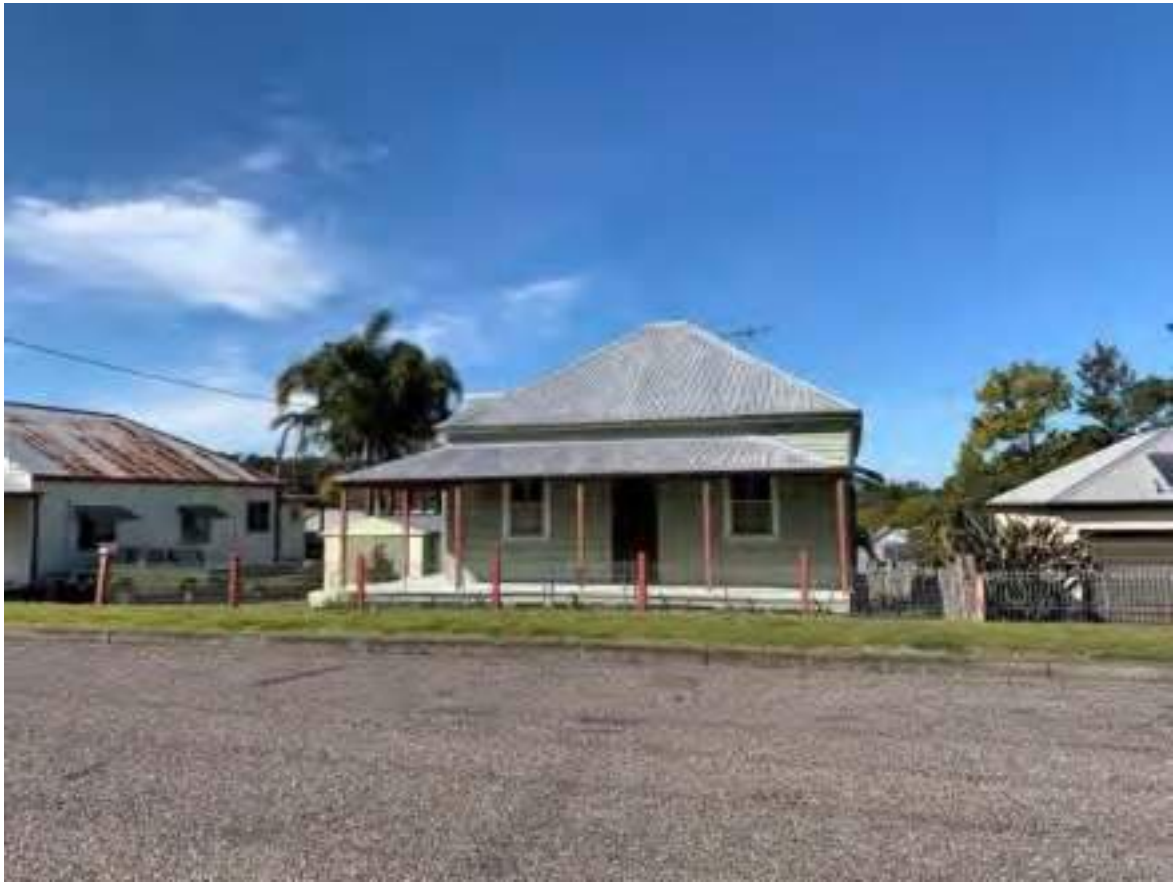
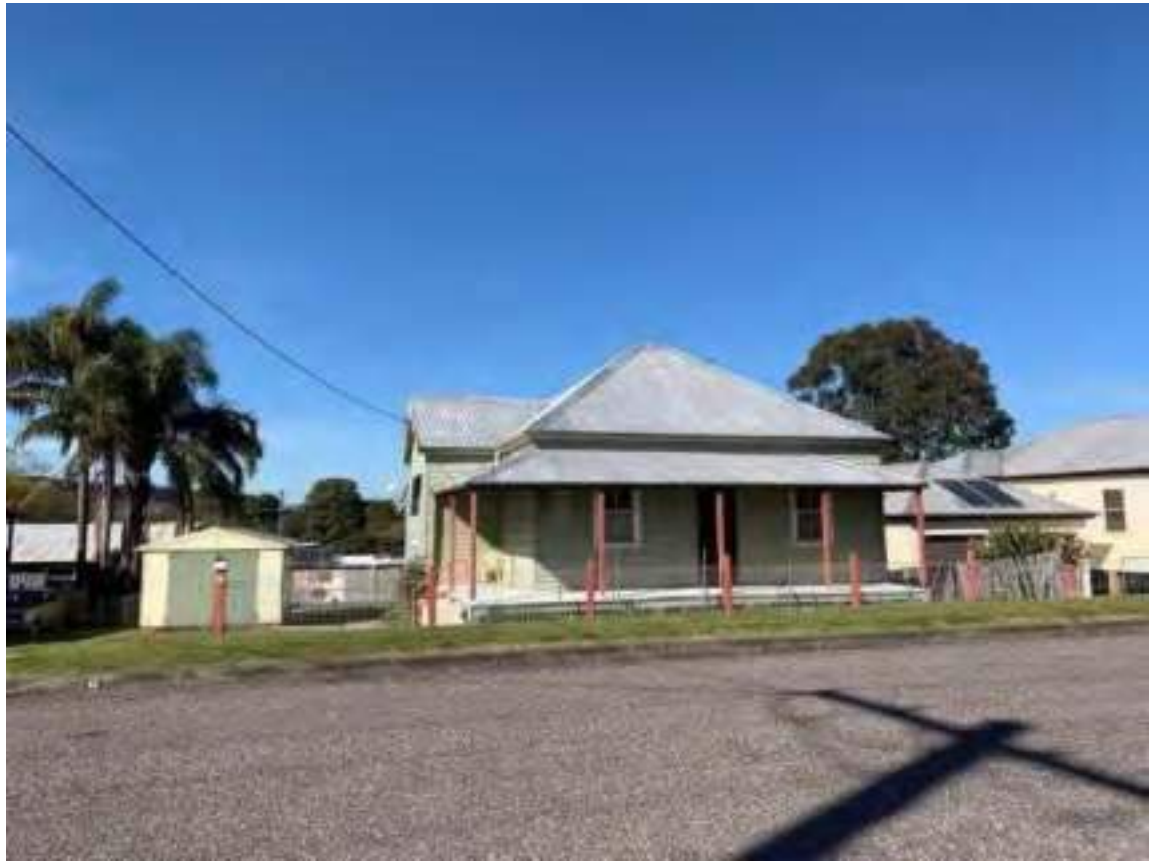
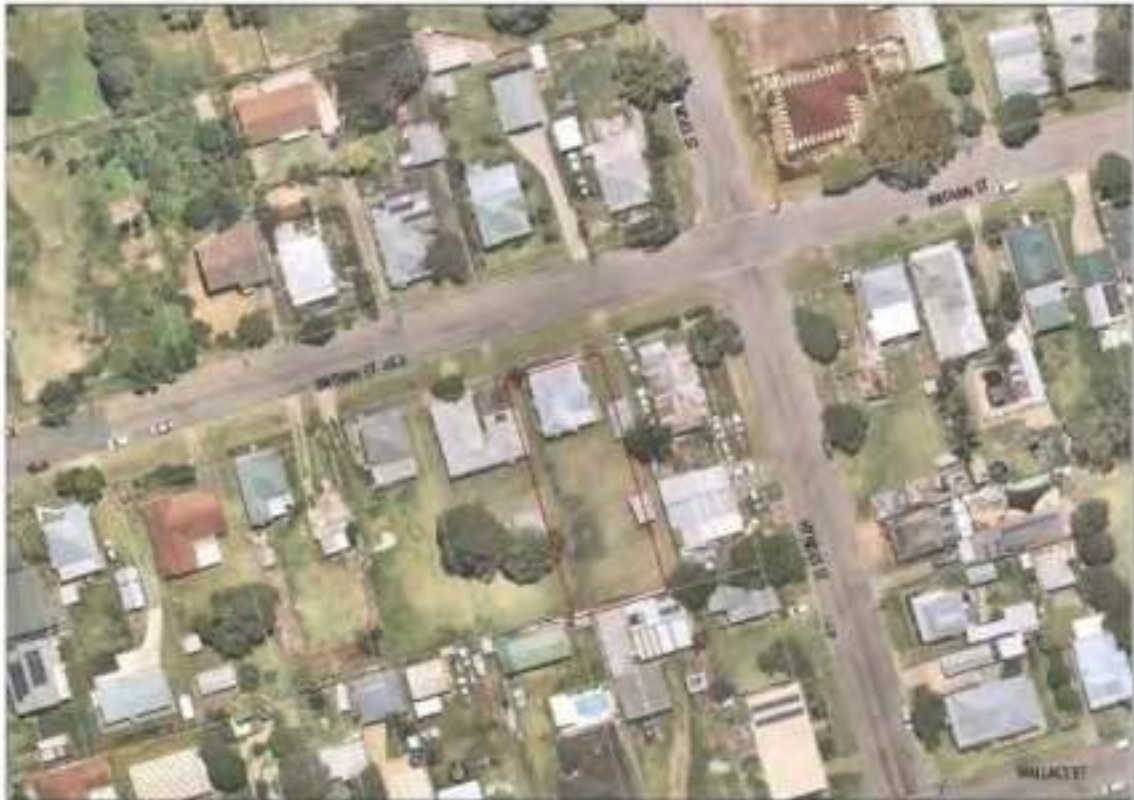
46 BROWN STREET, WEST WALLSEND 2286

Conservation Area Contribution Level	Est. Construction Date	Previous studies and/or community input
Contributory 1	1890–1915	No prior heritage investigations and no additional information required.
Assessment Text		Observed Modifications
<p>Single story Vernacular ‘Mining Cottage’ style dwelling with steeply hipped and half gable Colourbond roof and weatherboard cladding. The veranda roof is hipped and supported by timber posts.</p> <p>The veranda is open with no balustrade and partially wraps around to the eastern side of the dwelling. entrance stairs are located on the eastern portion of the veranda, with metal support railing and masonry balustrade.</p> <p>The gable roof has an ornately carved barge board, with a metal awning over the gable window.</p> <p>The front door is centrally located with a metal screen door. Timber framed sash windows are located on either side.</p> <p>A gable roof single door garage is located to the east of the dwelling.</p> <p>A metal frame and timber post fence encloses the property.</p> <p>The dwelling displays architectural features of a heritage style and is representative of the local development of this period, being of historical significance for the HCA.</p>		<p>The eastern extension of the veranda is likely a contemporary modification.</p> <p>The gable roof section of the dwelling is potentially a contemporary extension constructed in a sympathetic manner. The positioning of the gable to the eastern side of the dwelling as opposed to street facing is uncommon.</p>

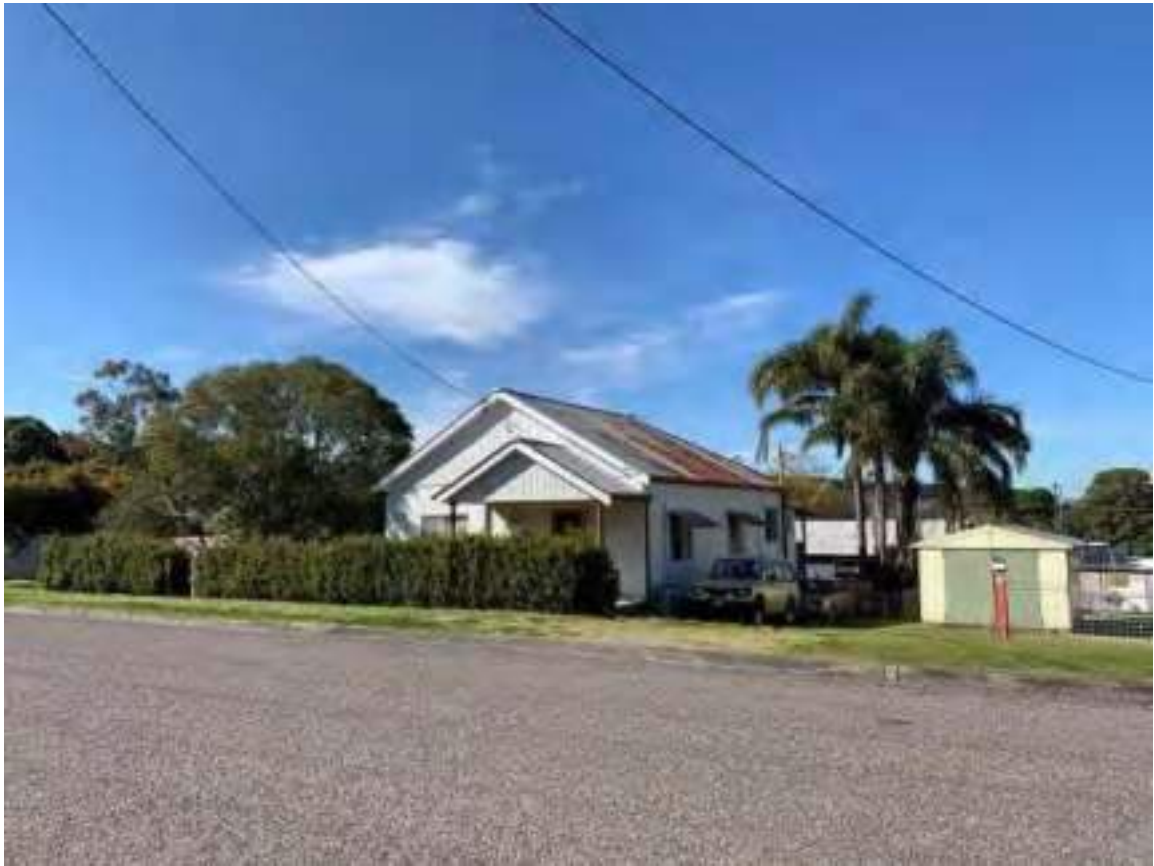
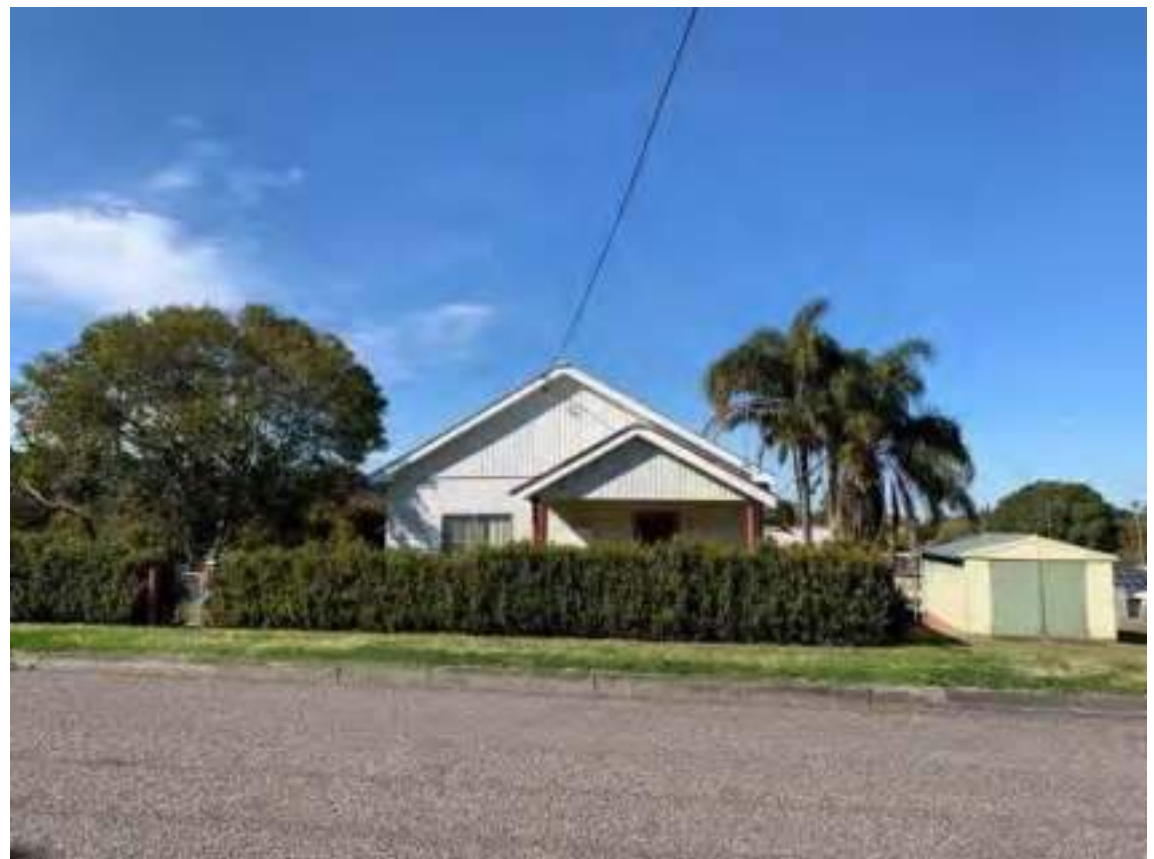
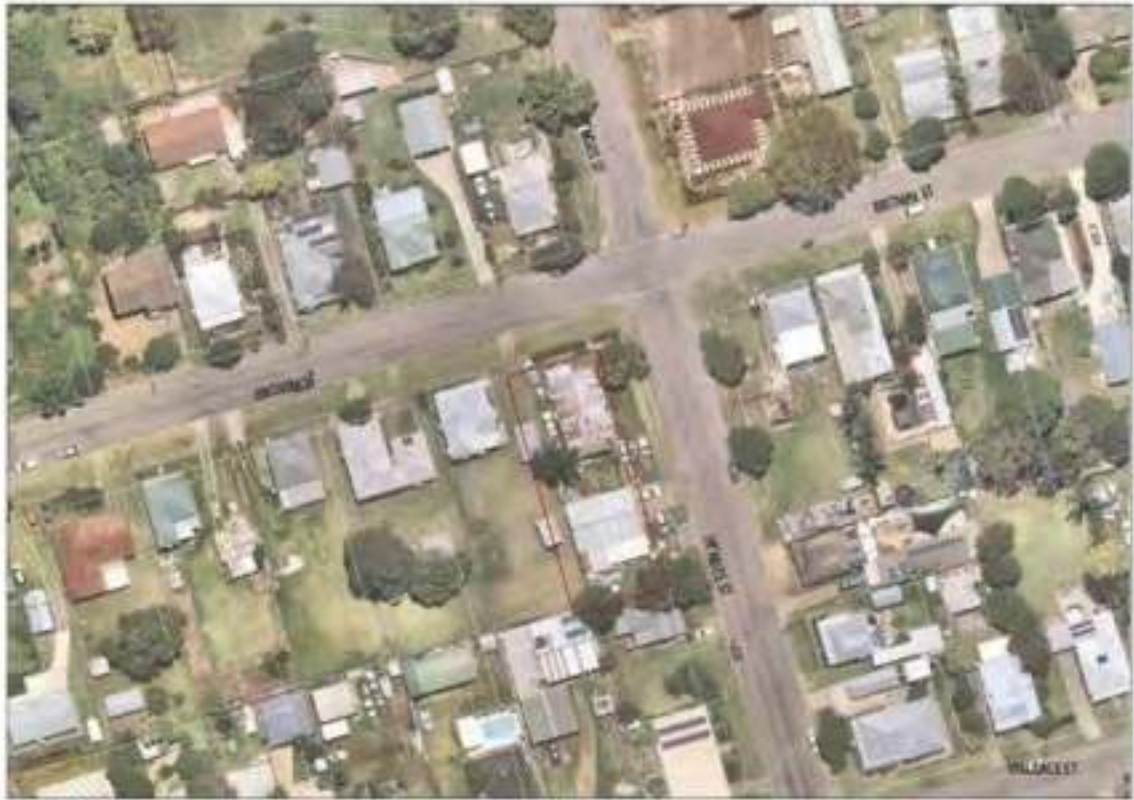
44 BROWN STREET, WEST WALLSEND 2286

Conservation Area Contribution Level	Est. Construction Date	Previous studies and/or community input
Contributory 1	1925–1940	No prior heritage investigations and no additional information required.
Assessment Text		Observed Modifications
<p>A Bungalow style dwelling with double gable Colourbond roof and weatherboard cladding. The gables have extended barge boards, but no further decorations.</p> <p>The veranda is located under the smaller gable, being supported by faux Corinthian style pillars.</p> <p>The front door is timber framed with a metal security screen door. All visible windows are contemporary sliding designs, with metal awnings atop the western and eastern sides.</p> <p>The dwelling is supported by red brick foundations.</p> <p>The dwelling displays architectural features of a heritage style and is representative of the local development of this period, being of historical significance for the HCA.</p>		<p>The visible windows have been replaced with contemporary designs.</p> <p>The metal screening of the front door juxtaposes the heritage style.</p> <p>A back extension and veranda is located at the southern end of the dwelling and is not visible from the street.</p>
