APPENDIX 2

Building Assessment Sheets (Inventory Sheets)

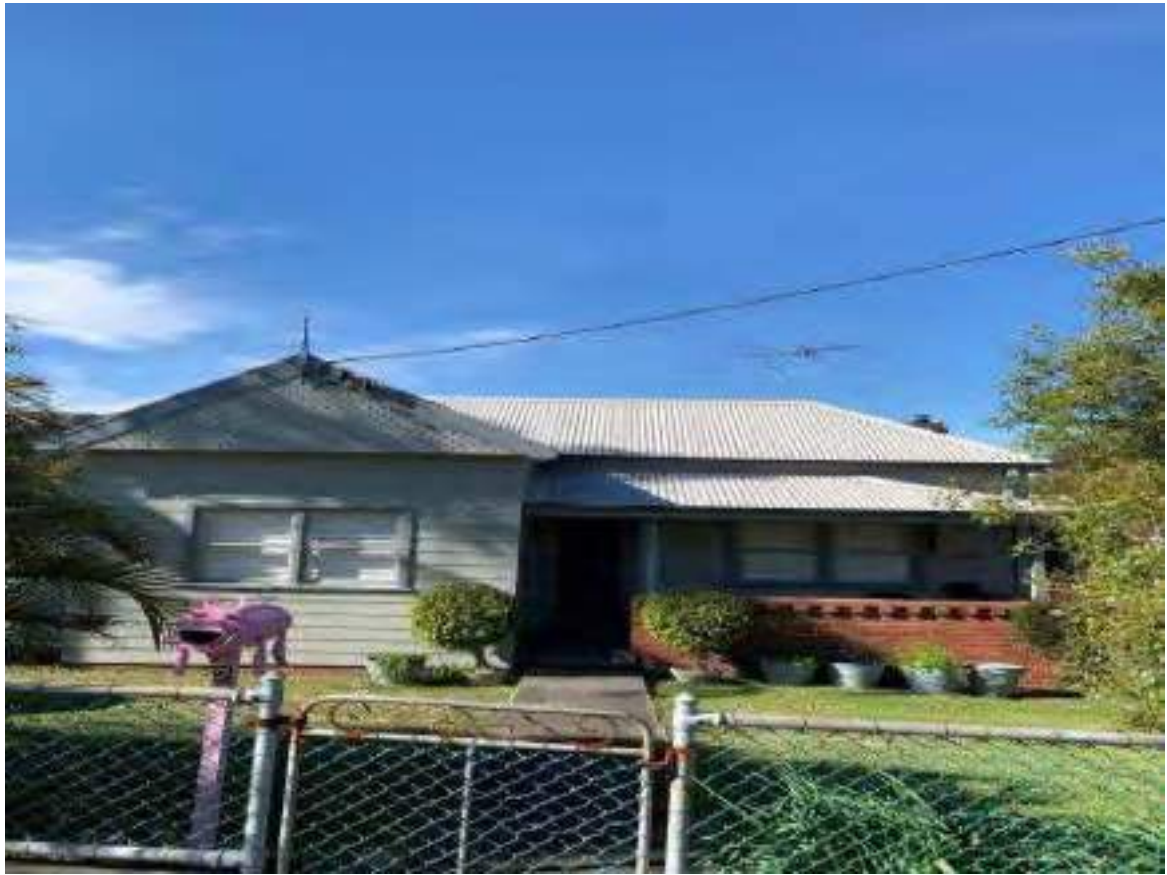
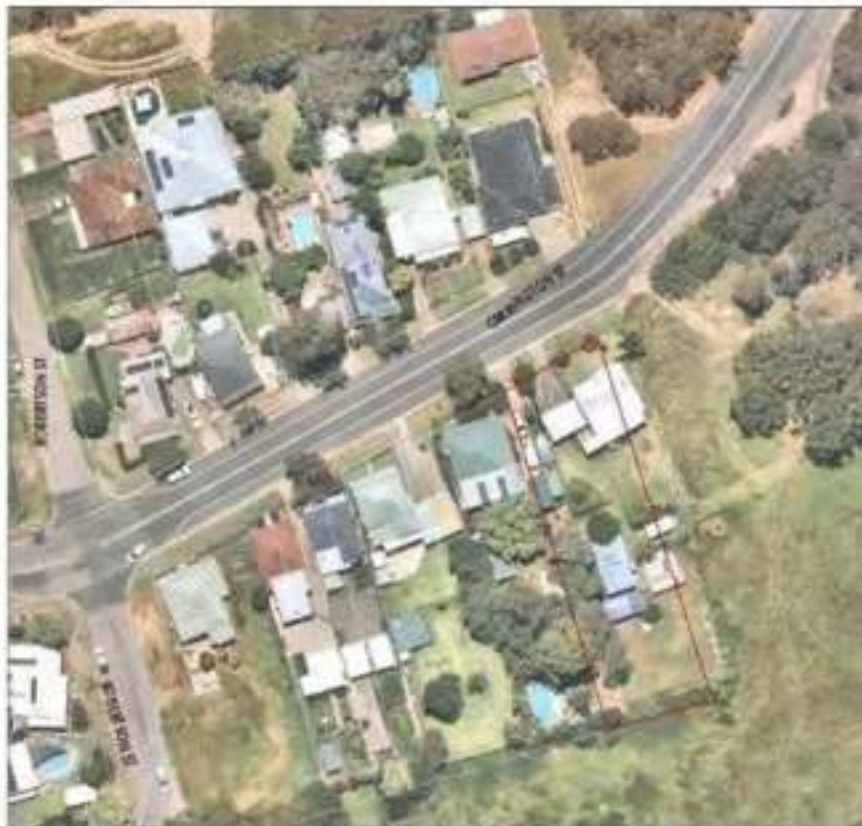
2 CARRINGTON STREET, WEST WALLSEND 2286

Conservation Area Contribution Level	Est. Construction Date	Previous studies and/or community input
Contributory 1	1900–1920	No prior heritage investigations and no additional information required.
Assessment Text		Observed Modifications
<p>Single story dwelling with half hipped and gable Colourbond roof and weatherboard cladding. The veranda is skillion and supported by timber posts and a red brick veranda wall. The veranda wall has dental brickwork features.</p> <p>The front door is centrally located with timber framed sash windows on either side.</p> <p>The gable has extended barge boards, lattice panelling and timber finial.</p> <p>A brickwork chimney is visible on the western side of the dwelling.</p> <p>A double door gable roof garage is located to the west of the dwelling.</p> <p>Metal wire fencing encloses the property.</p> <p>The dwelling displays architectural features of a heritage style and is representative of the local development of this period, being of historical significance for the HCA.</p>		<p>The brickwork veranda wall is potentially a contemporary modification, with the veranda originally being open or containing a timber balustrade.</p> <p>A back extension is located to the southern end of the dwelling, however is not visible from the street and does not detract.</p> <p>The eastern side of the dwelling has a visible veranda extension, stretching the length of the dwelling. the roof is skillion, with lattice panelling and canvas blinds.</p>

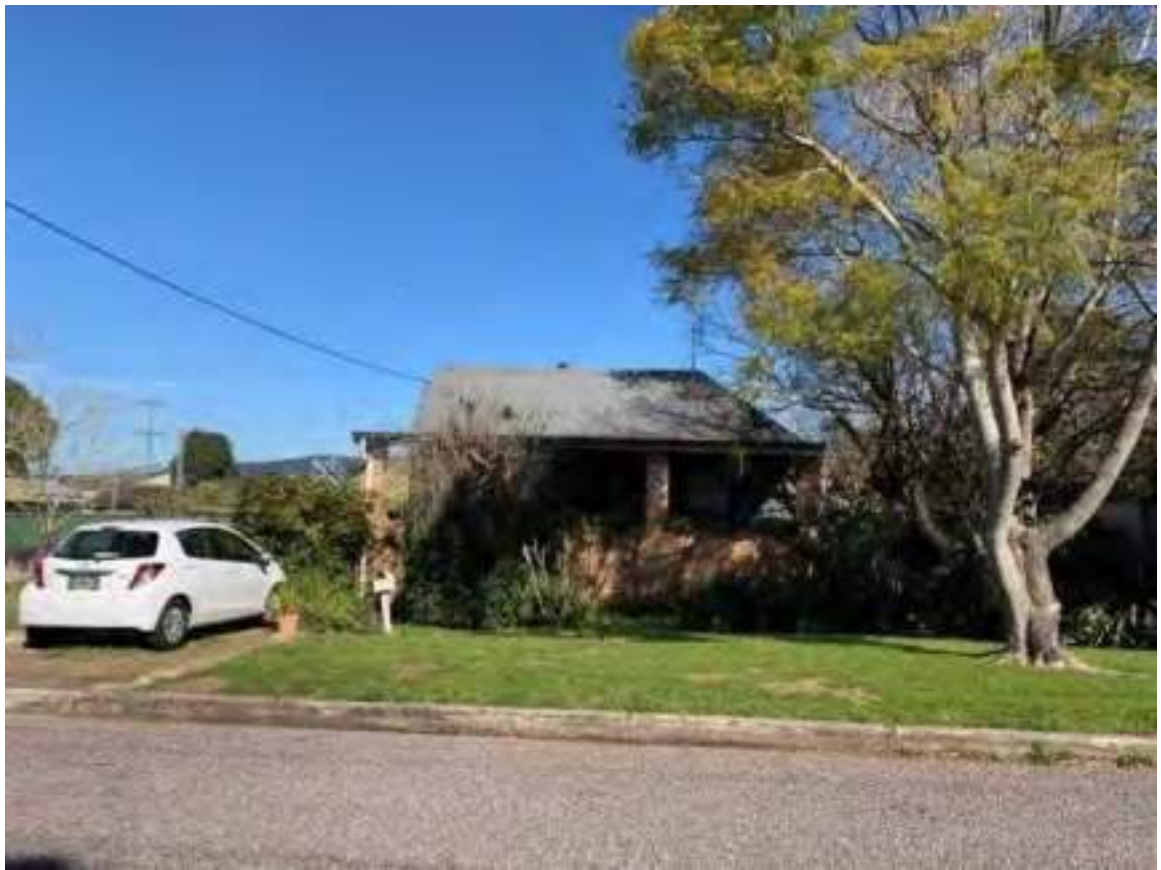
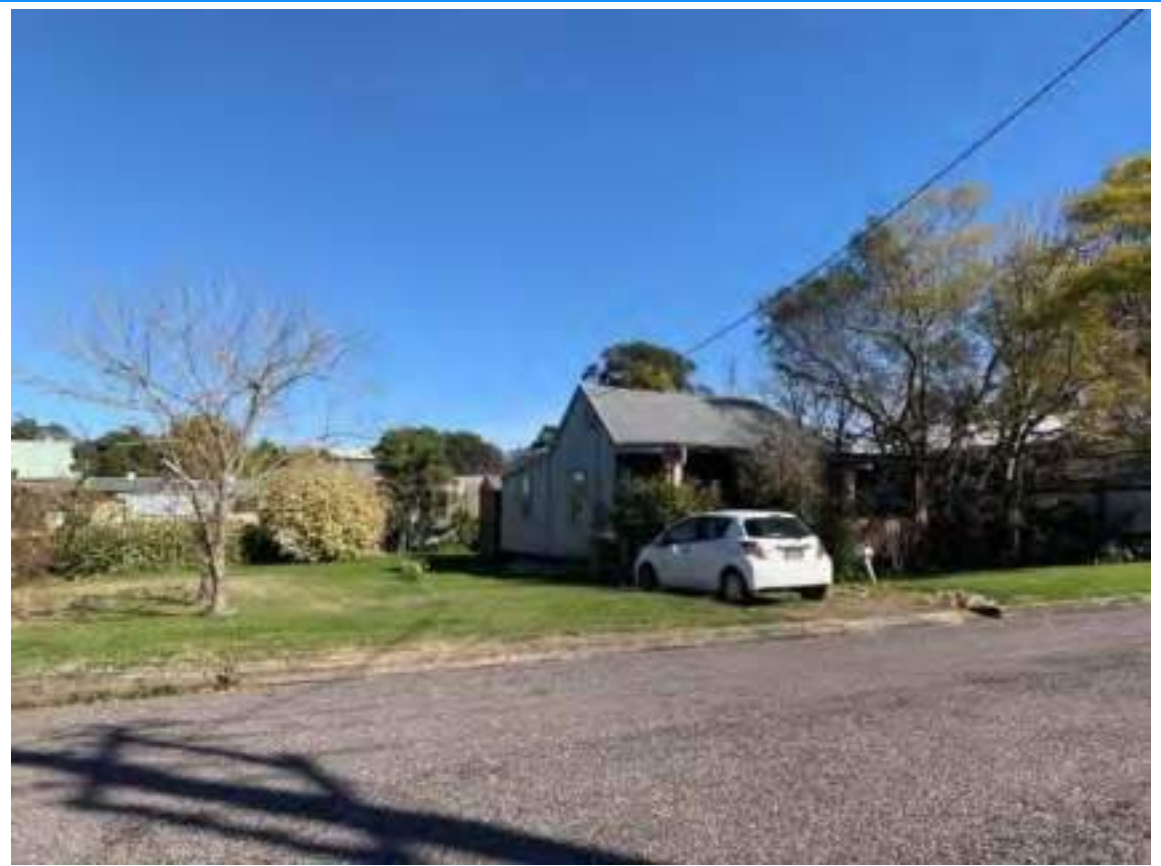
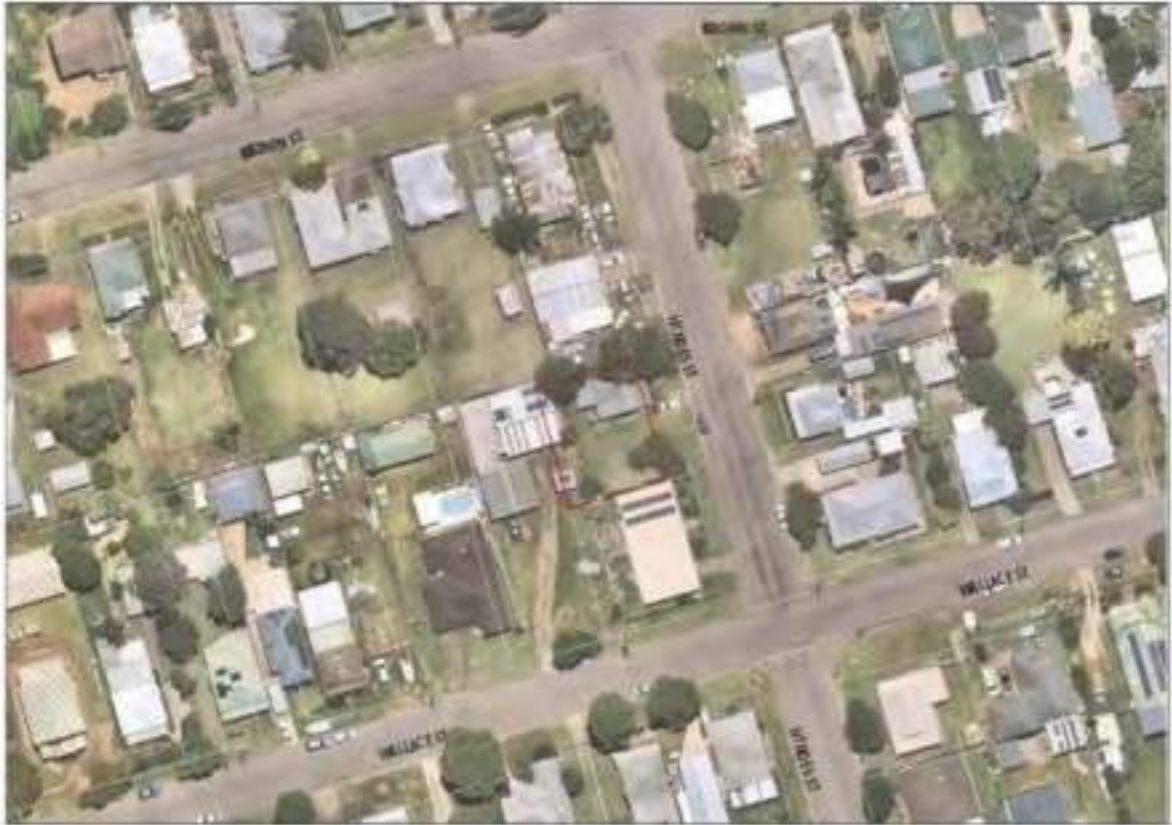
8 HYNDES STREET, WEST WALLSEND 2286

Conservation Area Contribution Level	Est. Construction Date	Previous studies and/or community input
Contributory 1	1890–1910	No prior heritage investigations and no additional information required.
Assessment Text		Observed Modifications
<p>Single story Vernacular style dwelling with gable Colourbond roof and weatherboard cladding. The veranda roof is skillion and supported by brick pillars.</p> <p>The veranda is partially enclosed by brown brick veranda wall and pillars, with timber flooring and a single step leading to the landing.</p> <p>The front door is obscure by vegetation growth, with the visible windows being sash timber framed designs.</p> <p>A gable roof timber structure is visible to the west of the dwelling, potentially the original outhouse.</p> <p>The dwelling displays architectural features of a heritage style and is representative of the local development of this period, being of historical significance for the HCA.</p>		<p>The brickwork pillars and veranda walls are contemporary modifications, juxtaposing the heritage style of the dwelling.</p>

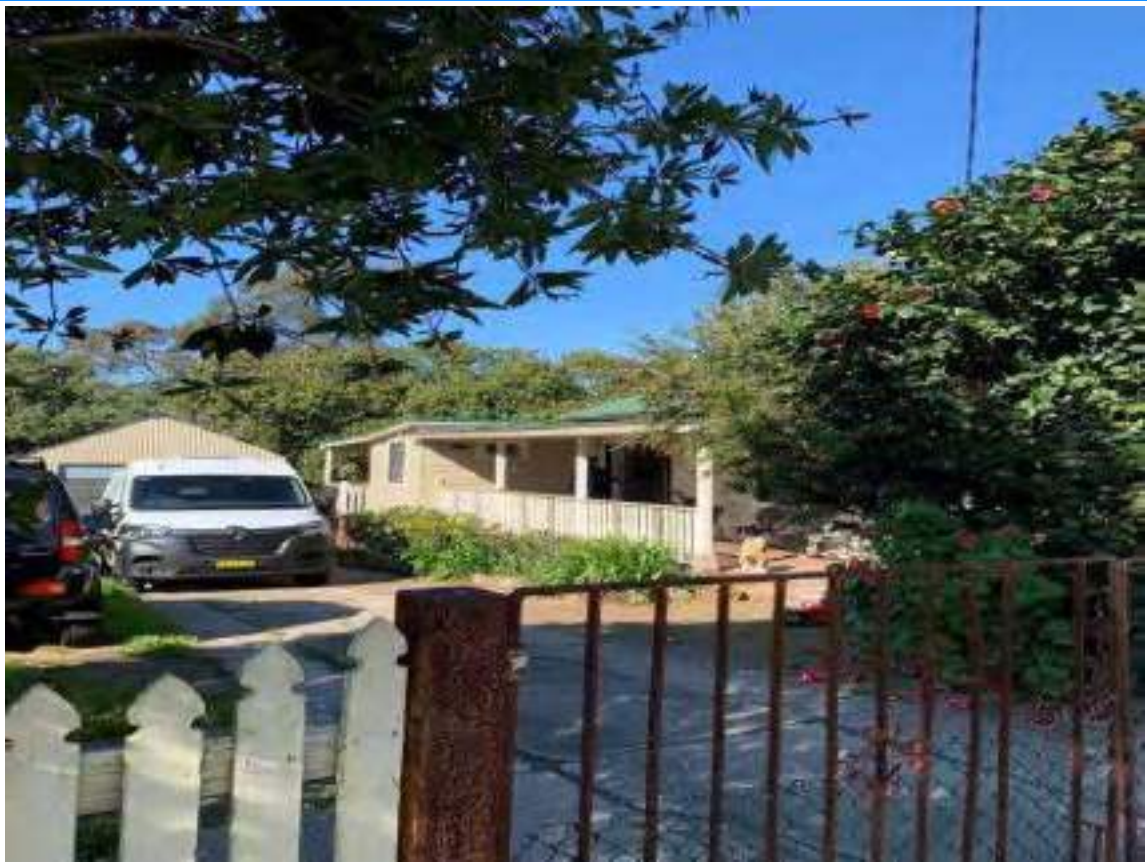
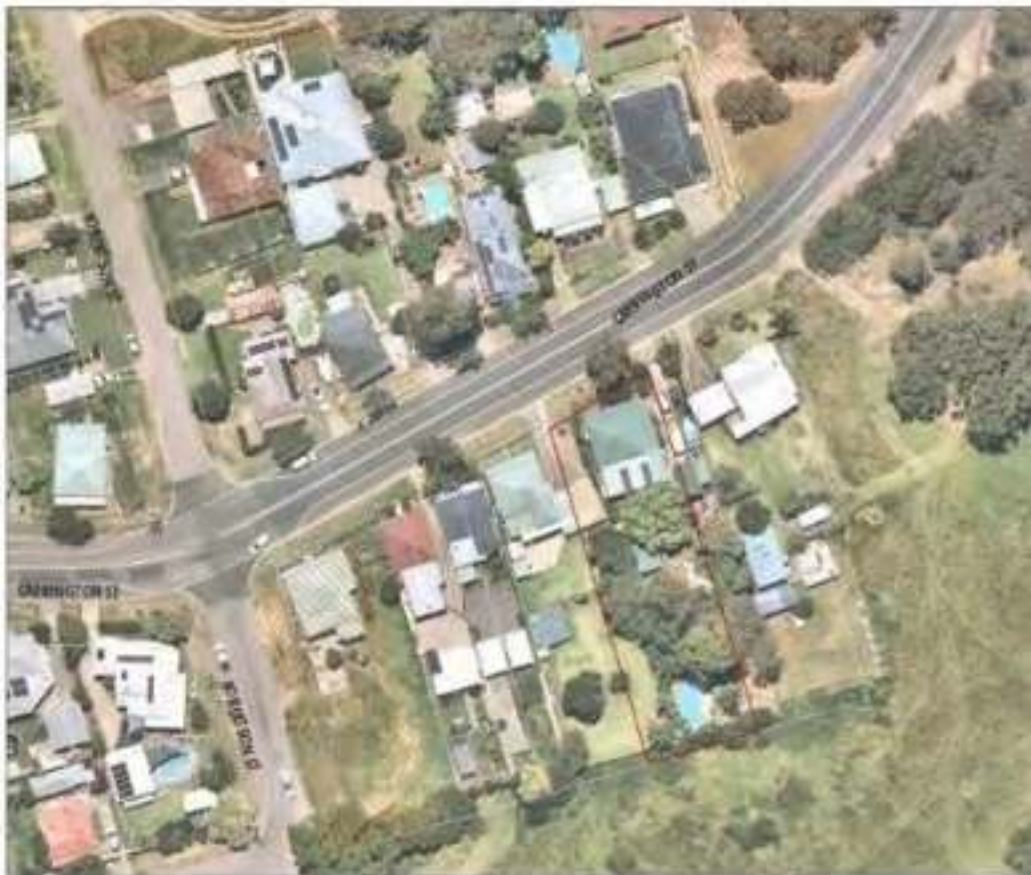
Conservation Area Contribution Level	Est. Construction Date	Previous studies and/or community input
Contributory 1	1890–1920	No prior heritage investigations and no additional information required.
Assessment Text		Observed Modifications
<p>Single story Vernacular ‘Mining Cottage’ style dwelling with steeply hipped Colourbond roof and weatherboard cladding. The veranda roof is hipped and supported by timber posts.</p> <p>The western portion of the veranda has been built in, with the façade being dominated by timber framed sliding and awning windows. below the wall is rendered brick, with dental coursework features. The eastern veranda is timber floored with timber balustrades.</p> <p>The front door is centrally located, but obscured, with contemporary sliding window to the east. The visible windows are a combination of timber framed sash and sliding designs.</p> <p>A single door gable roof garage is located to the east of the dwelling.</p> <p>The dwelling displays architectural features of a heritage style and is representative of the local development of this period, being of historical significance for the HCA.</p>		<p>The veranda has been partially built in, with the western portion being converted into an additional living area.</p> <p>The veranda has been extended to the eastern side of the dwelling, with timber balustrades being constructed in a sympathetic style.</p> <p>A back extension is located to the southern end of the dwelling and is partially visible from the street.</p>

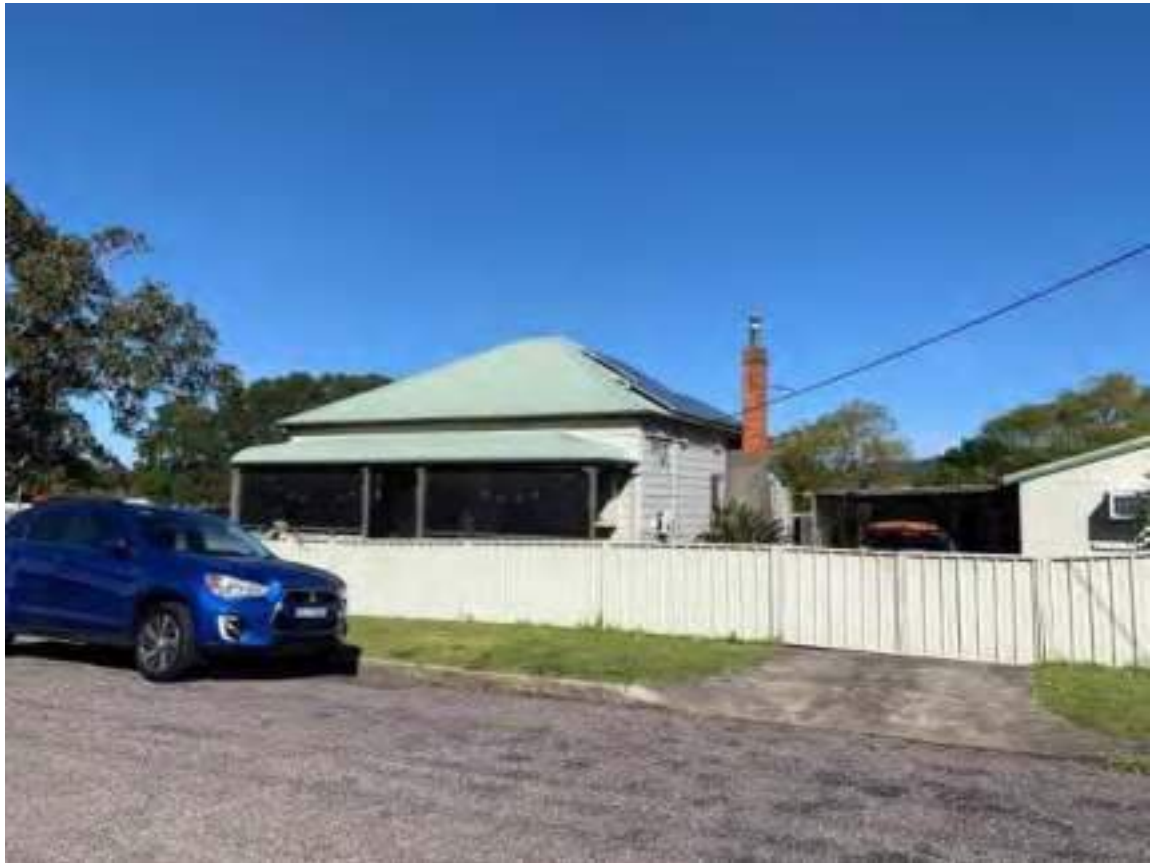
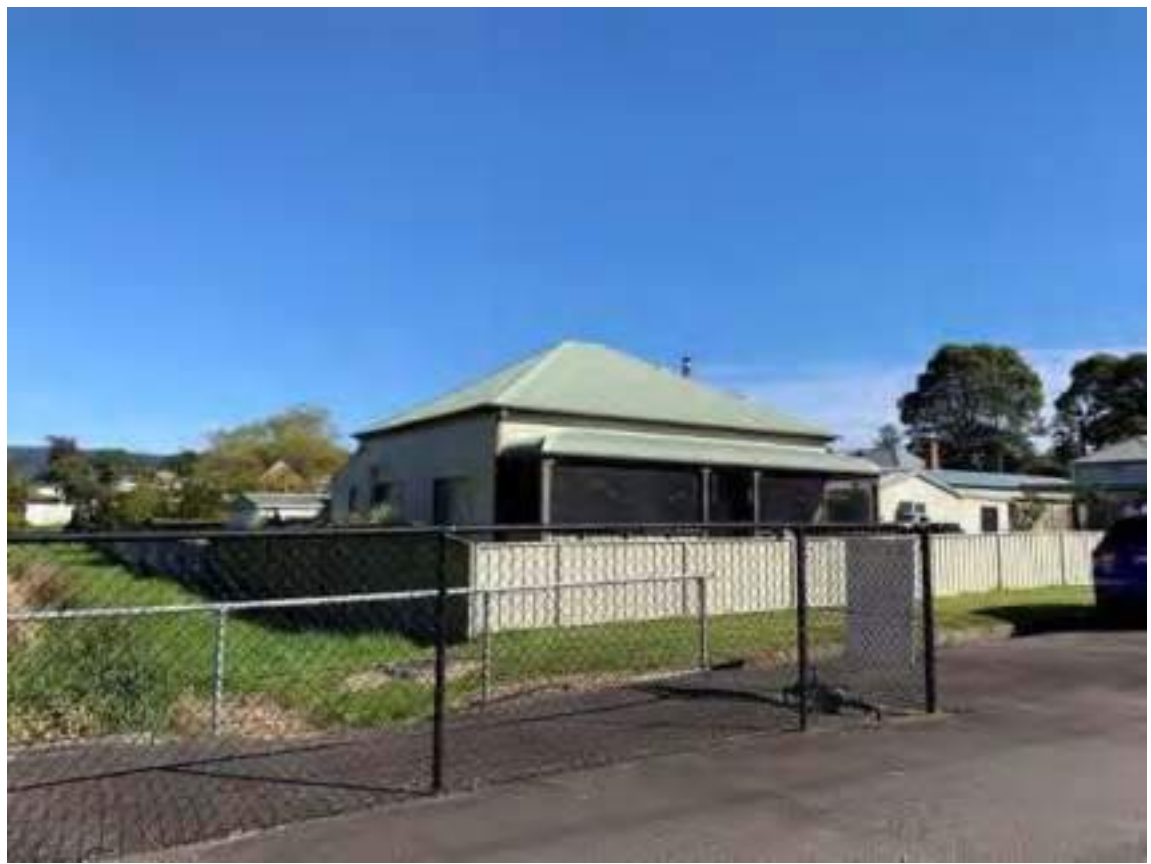
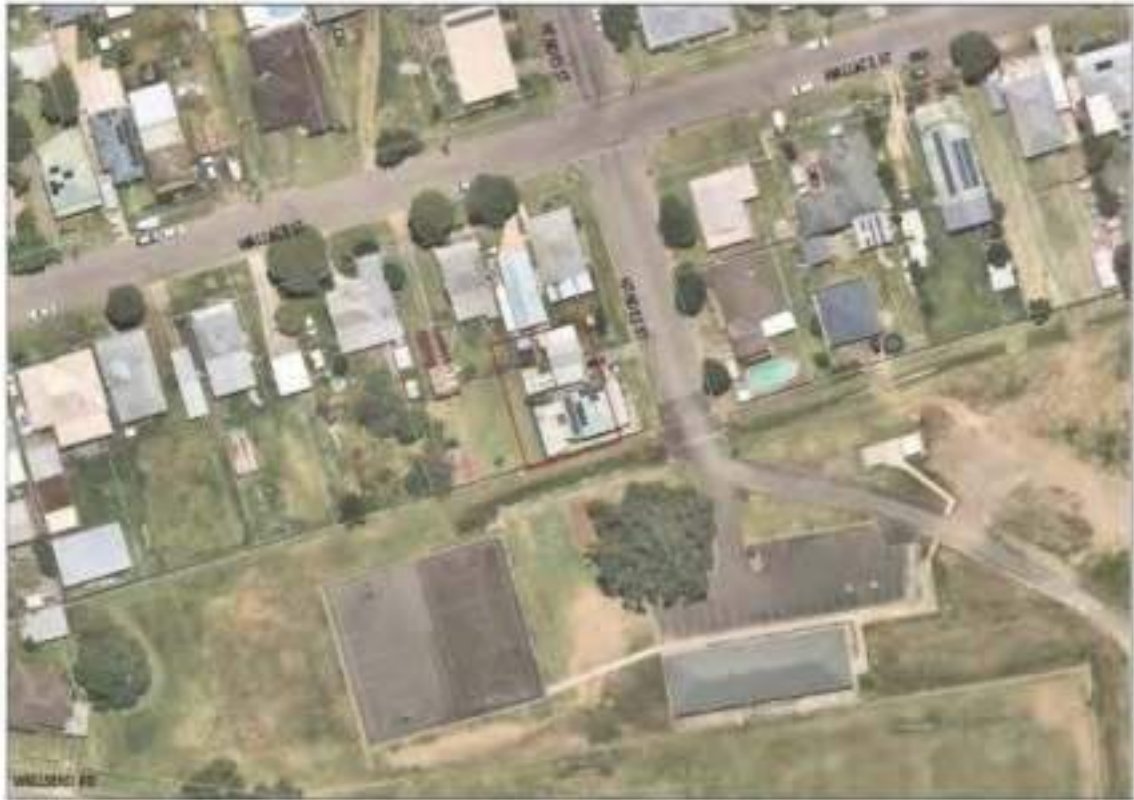
10 HYNDES STREET, WEST WALLSEND 2286

Conservation Area Contribution Level	Est. Construction Date	Previous studies and/or community input
Contributory 1	1890–1920	No prior heritage investigations and no additional information required.
Assessment Text		Observed Modifications
<p>Single story Vernacular ‘Mining Cottage’ style dwelling with hipped Colourbond roof and weatherboard cladding. The veranda roof is bull nosed and supported by timber posts.</p> <p>The veranda is partially enclosed by timber lattice panels and mesh blinds.</p> <p>The front door is centrally located, with metal framed sliding windows on either side. All visible windows are sliding designs.</p> <p>A half rendered red brick chimney is visible on the northern side of the dwelling, with no decorative features and metal chimney pot.</p> <p>A garage and car port structure is located to the north of the dwelling, with gable roof and fibro-clad timber frame.</p> <p>A Colourbond fence encloses the property.</p> <p>The dwelling displays architectural features of a heritage style and is representative of the local development of this period, being of historical significance for the HCA.</p>		<p>The façade windows have been replaced with contemporary sliding designs.</p> <p>The veranda latticing and the addition of mesh blinds are a recent modification, likely with no fencing or balustrade being present.</p> <p>Solar panels are visible on the northern side of the roof.</p>

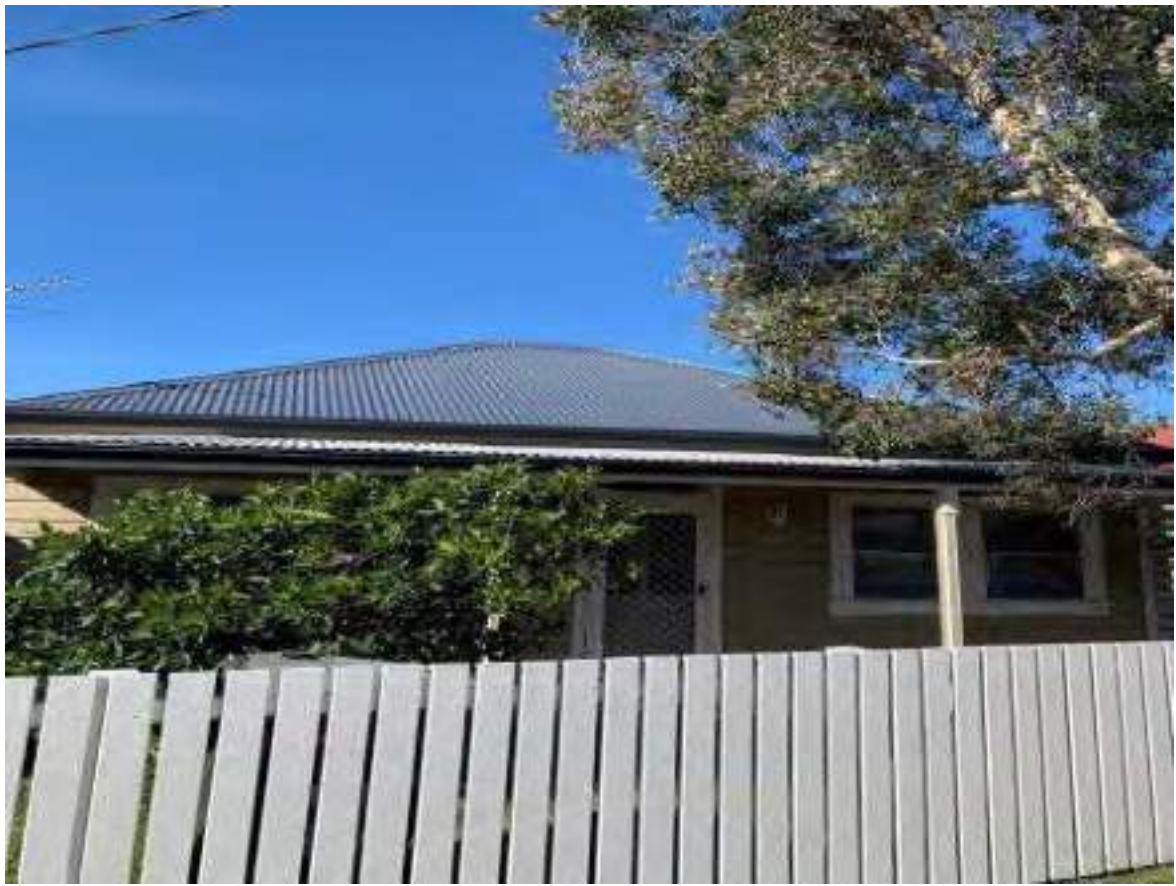
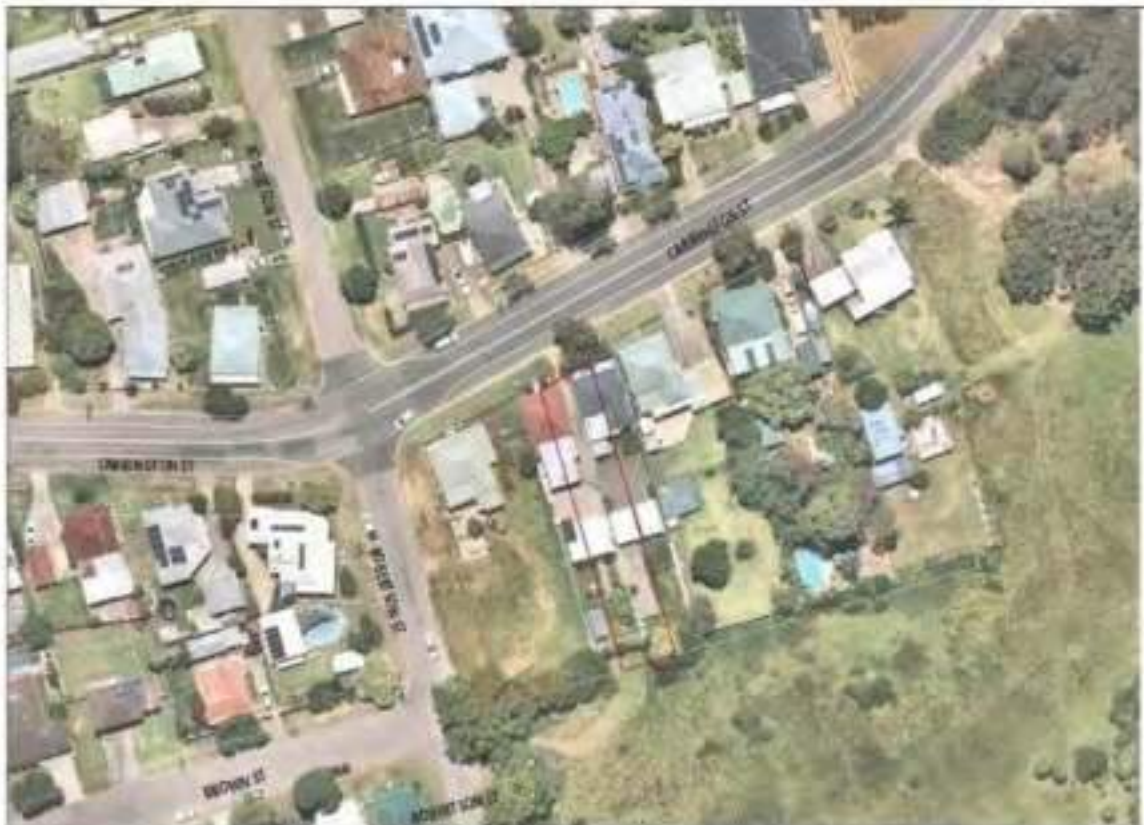
8 CARRINGTON STREET, WEST WALLSEND 2286

Conservation Area Contribution Level	Est. Construction Date	Previous studies and/or community input
Contributory 1	1890–1900	West Wallsend Heritage Study 1993 Moderate local significance.
Assessment Text		Observed Modifications
<p>Single story Vernacular ‘Workers Cottage’ style dwelling with hipped Colourbond roof and weatherboard cladding. The veranda roof is hipped and supported by timber posts.</p> <p>The veranda is open with no balustrade, with timber flooring and a single step onto the landing.</p> <p>The front door is central and timber framed with a double panel design and a metal security screen. Original timber framed double hung double pane sash windows are either side.</p> <p>A timber fence encloses the property.</p> <p>The driveway is shared with the adjoining property, number 10.</p> <p>The dwelling displays architectural features of a heritage style and is representative of the local development of this period, being of historical significance for the HCA.</p>		<p>Timber boards enclose the western end of the veranda.</p> <p>An extension has been built on the southern end of the dwelling, however is not visible from the street.</p> <p>A multi door garage structure extending the width of the property is located at the southern back end of the dwelling, subdividing the backyard.</p>

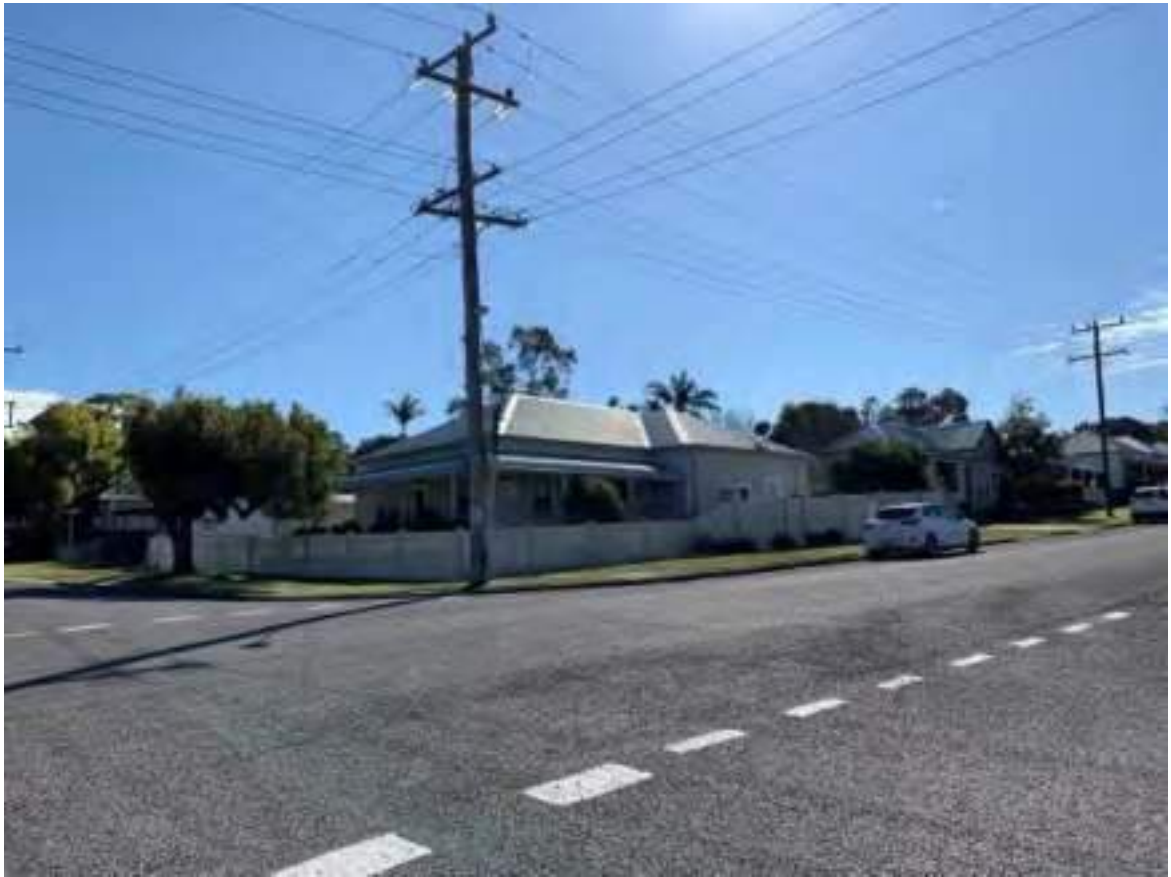
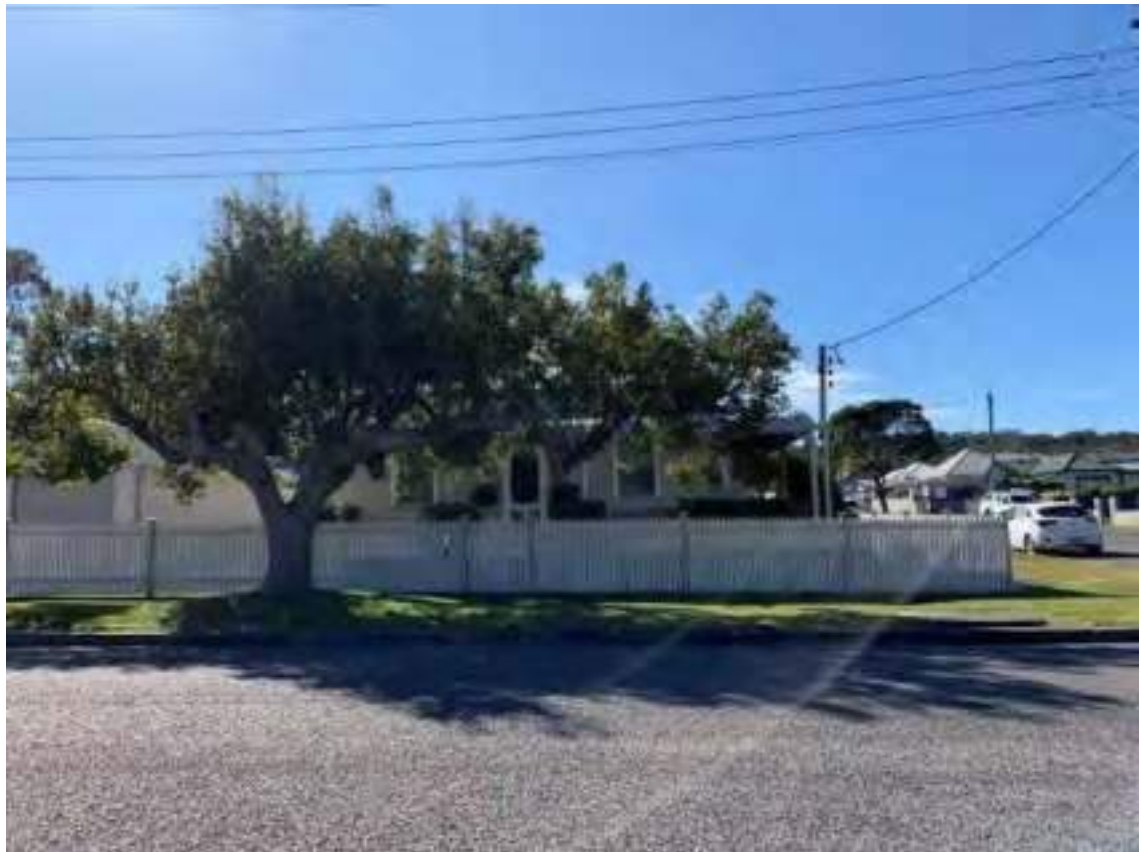
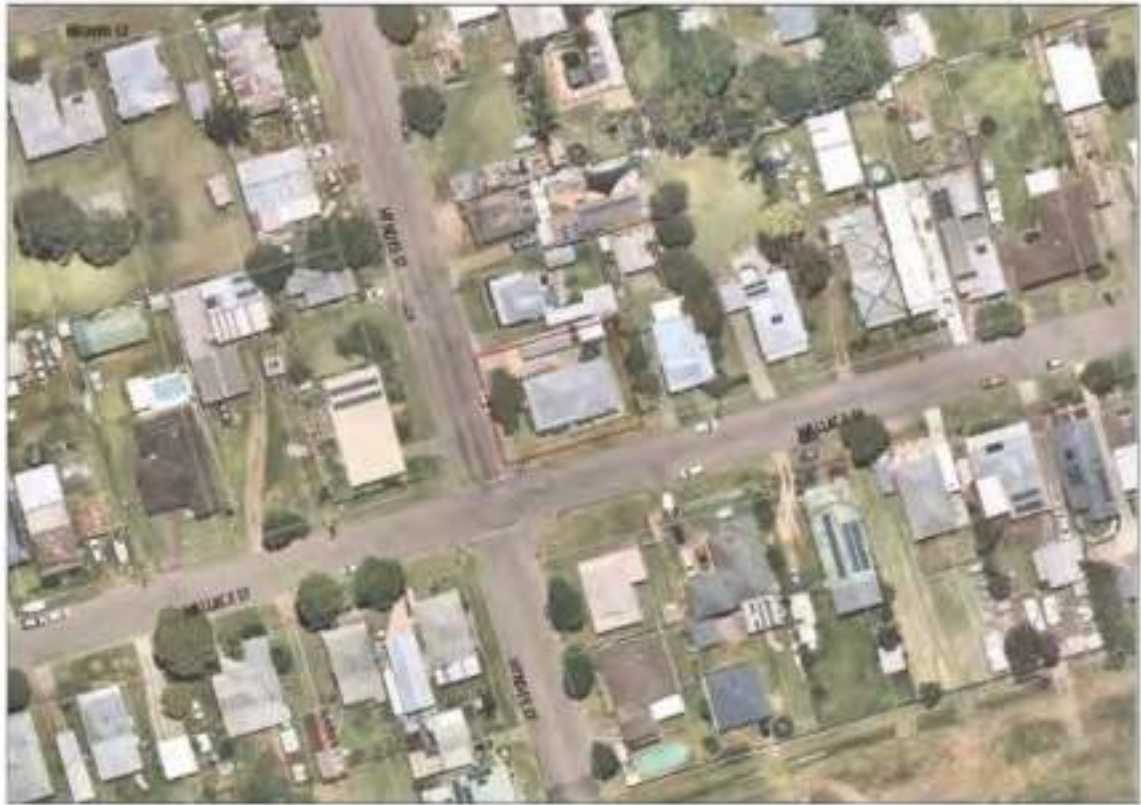
13 HYNDES STREET, WEST WALLSEND 2286

Conservation Area Contribution Level	Est. Construction Date	Previous studies and/or community input
Contributory 1	1890–1910	No prior heritage investigations and no additional information required.
Assessment Text		Observed Modifications
<p>Single story Vernacular ‘Mining Cottage’ style dwelling with hipped Colourbond roof and weatherboard cladding. The veranda roof is bull nosed and supported by timber posts with art nouveau style bracketing.</p> <p>The veranda is open with no balustrades and partially wraps around the southern side of the dwelling as well as the western façade. The floor is timber.</p> <p>The front door is centrally located with timber framing and timber framed sash windows on either side. All visible windows are likely original sash designs.</p> <p>A single door gable roof garage is located to the north of the dwelling, constructed in a sympathetic style.</p> <p>A timber picket fence encloses the property.</p> <p>The dwelling displays architectural features of a heritage style and is representative of the local development of this period, being of historical significance for the HCA.</p>		<p>An extension has been built onto the eastern side of the dwelling, being visible from the southern and eastern sides of the dwelling. this has been constructed in a sympathetic manner and does not detract.</p> <p>The veranda wraps around the southern side of the dwelling, likely a contemporary modification and extension.</p>

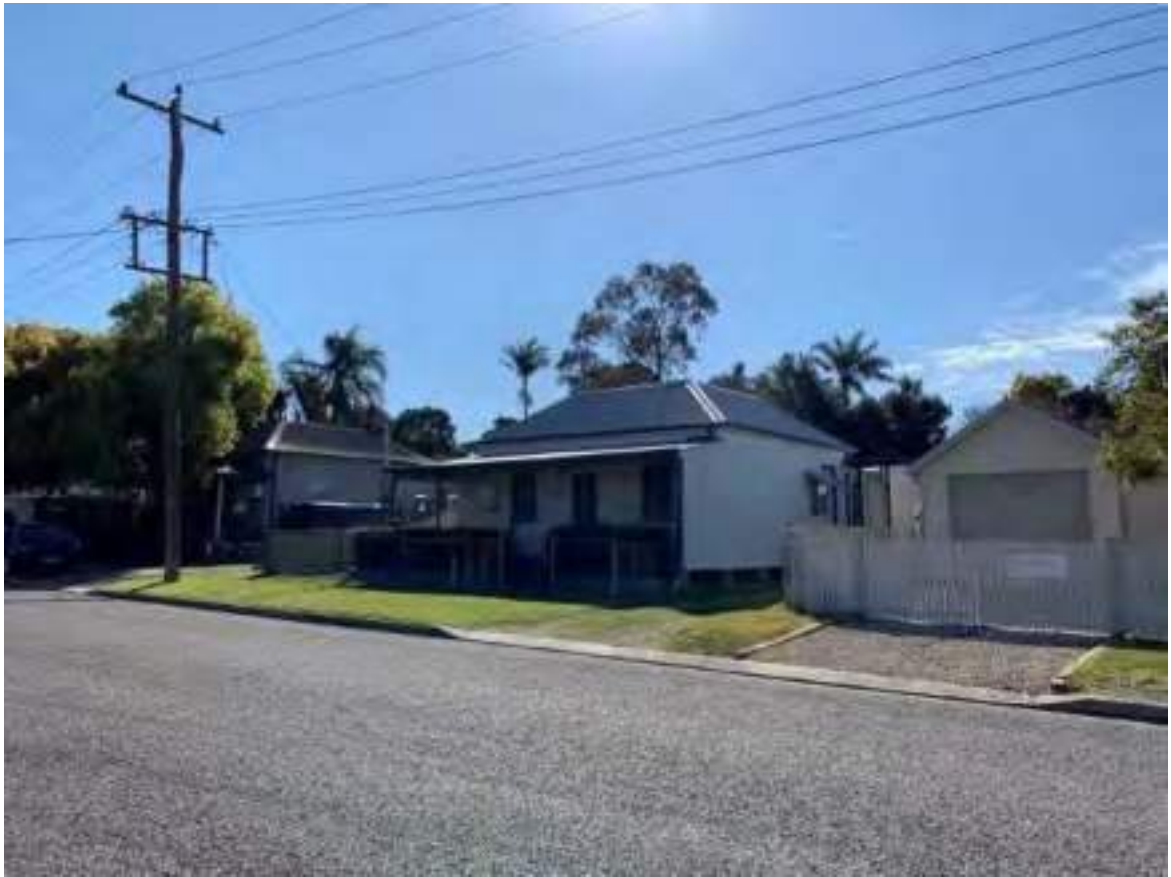
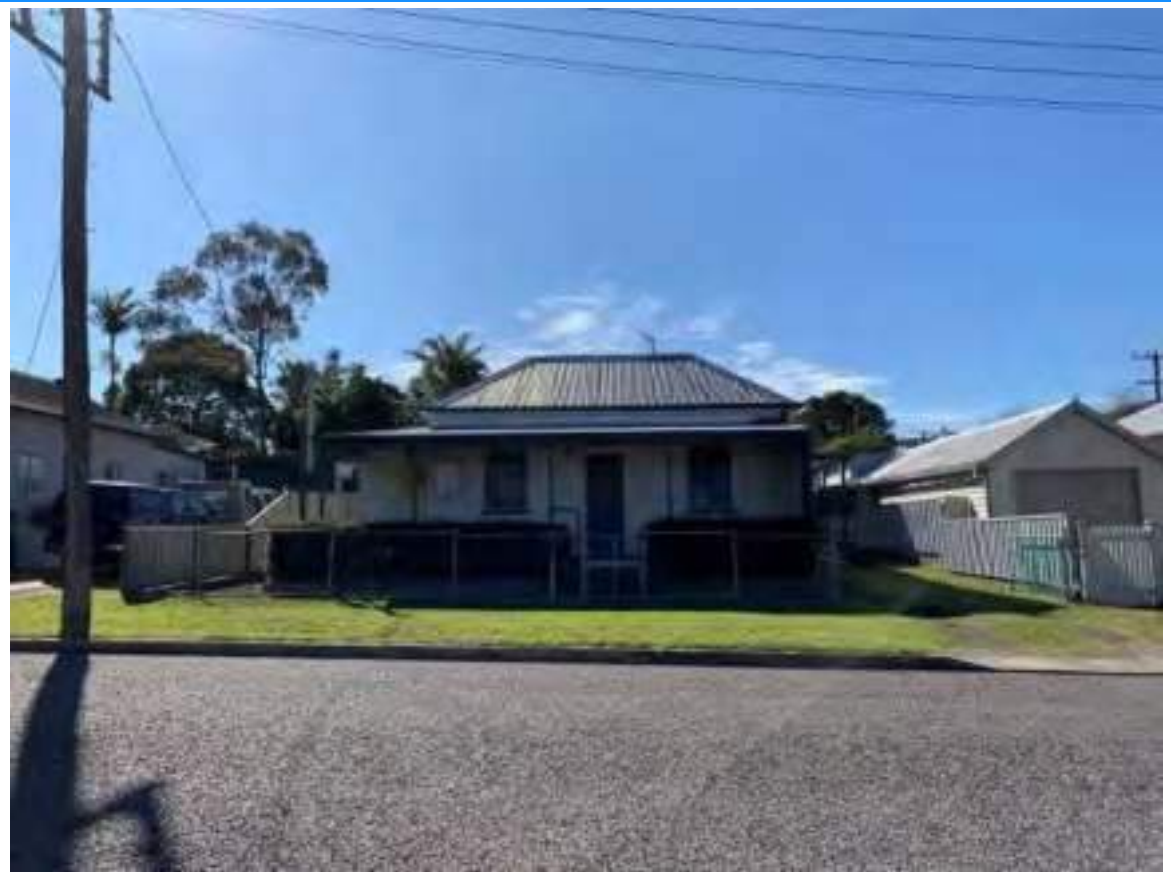
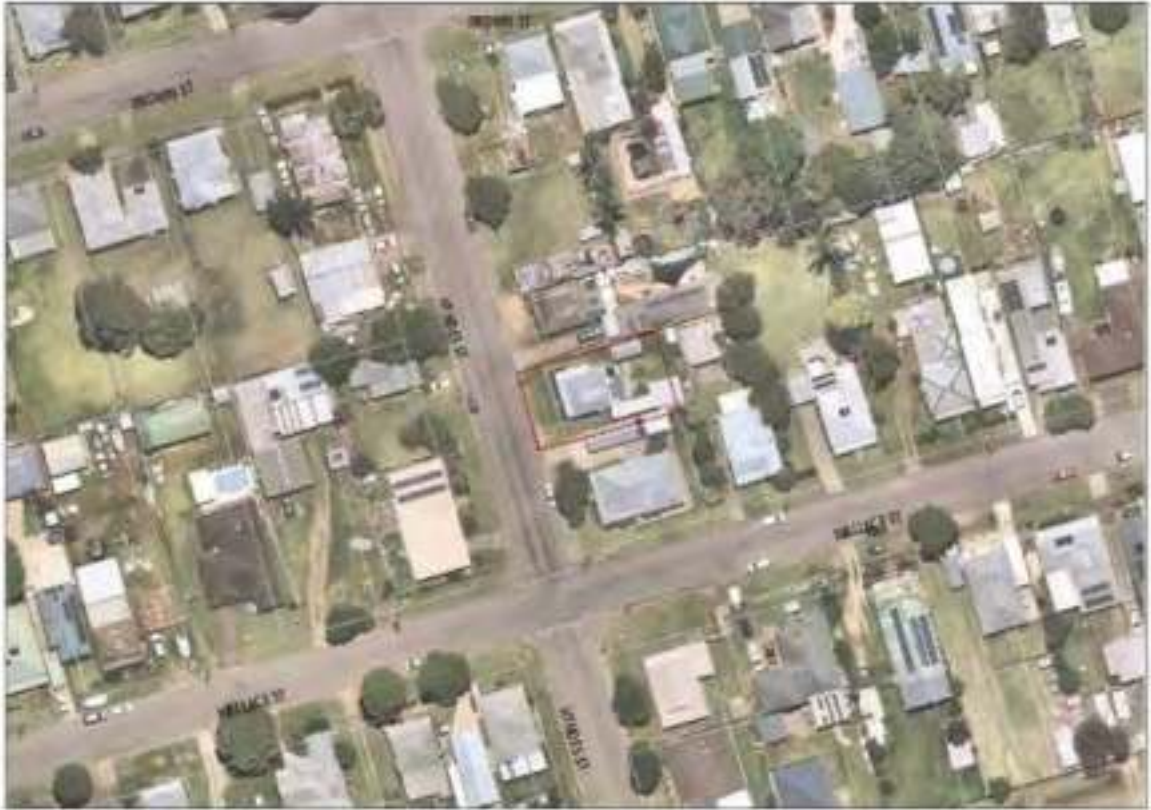
11 HYNDES STREET, WEST WALLSEND 2286

Conservation Area Contribution Level	Est. Construction Date	Previous studies and/or community input
Contributory 1	1890–1910	No prior heritage investigations and no additional information required.
Assessment Text		Observed Modifications
<p>Single story Vernacular ‘Mining Cottage’ style dwelling with shallow hipped corrugated zincalume roof and weatherboard cladding. The veranda roof is skillion and supported by steel posts.</p> <p>The veranda is open with no balustrades, timber flooring and a set of masonry stairs with masonry balustrades and metal support railing leading to the landing. The veranda partially wraps around the northern side of the dwelling, with a built-in additional living area.</p> <p>The front door is centrally located with a decorative metal screen door and timber framed sash windows on either side. windows are potentially original.</p> <p>A metal wire fence encloses the property.</p> <p>A car port and garage is located to the east of the dwelling.</p> <p>The dwelling displays architectural features of a heritage style and is representative of the local development of this period, being of historical significance for the HCA.</p>		<p>The northern and southern windows are contemporary sliding styles, likely replacing the original sash designs.</p> <p>The additional built in section of the north facing veranda side is a contemporary modification constructed in a sympathetic manner. The wrapping around of the veranda is further likely contemporary.</p>
