APPENDIX 2

Building Assessment Sheets (Inventory Sheets)

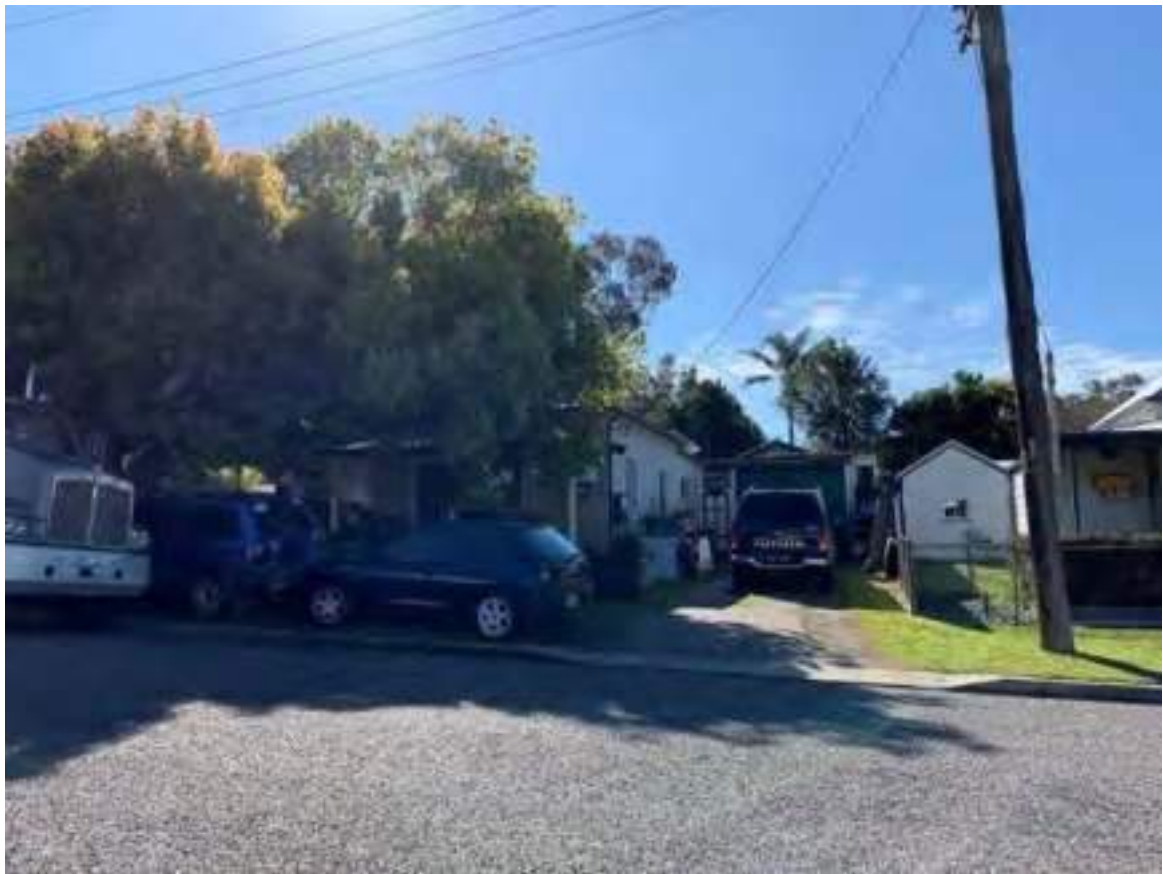
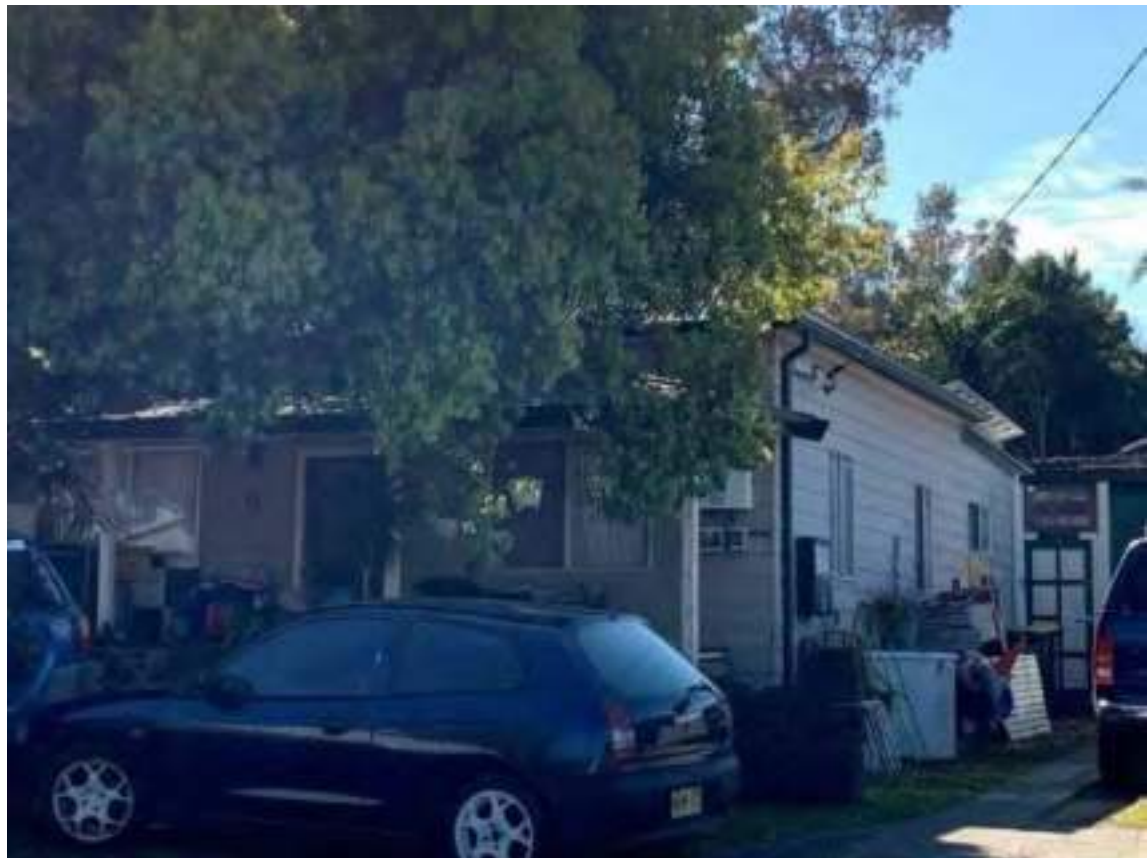
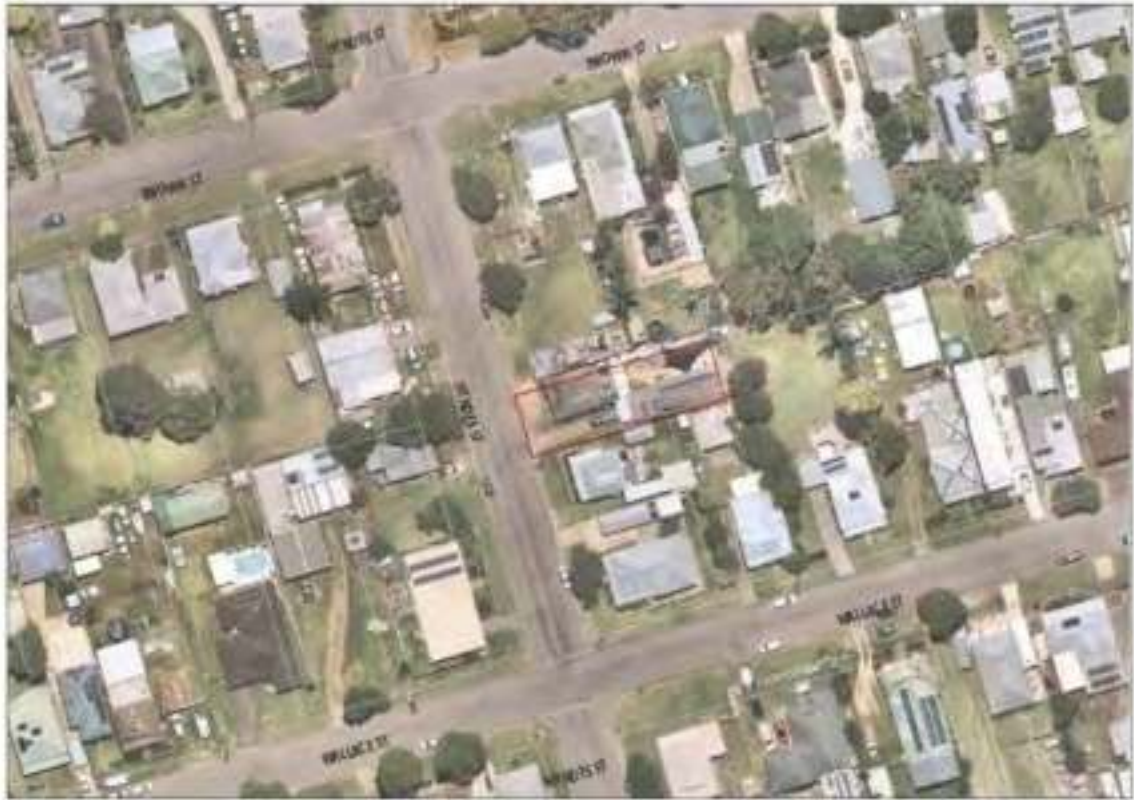
9 HYNDES STREET, WEST WALLSEND 2286

Conservation Area Contribution Level	Est. Construction Date	Previous studies and/or community input
Contributory 1	1890–1910	No prior heritage investigations and no additional information required.
Assessment Text		Observed Modifications
<p>Single story Vernacular ‘Mining Cottage’ style dwelling with Colourbond roof and weatherboard cladding. The veranda roof is hipped and supported by timber posts.</p> <p>The veranda is open with no balustrades and timber floored.</p> <p>All visible windows are contemporary, with sliding designs. The front door is centrally located but obscured.</p> <p>A low brick wall encloses the front portion of the property.</p> <p>A skillion roof single door garage is located to the east of the dwelling, constructed in an unsympathetic manner.</p> <p>The dwelling could not be assessed thoroughly due to extensive mature vegetation growth.</p> <p>The dwelling displays architectural features of a heritage style and is representative of the local development of this period, being of historical significance for the HCA.</p>		<p>All windows have been replaced with contemporary sliding designs, likely replacing original timber framed sash styled.</p>

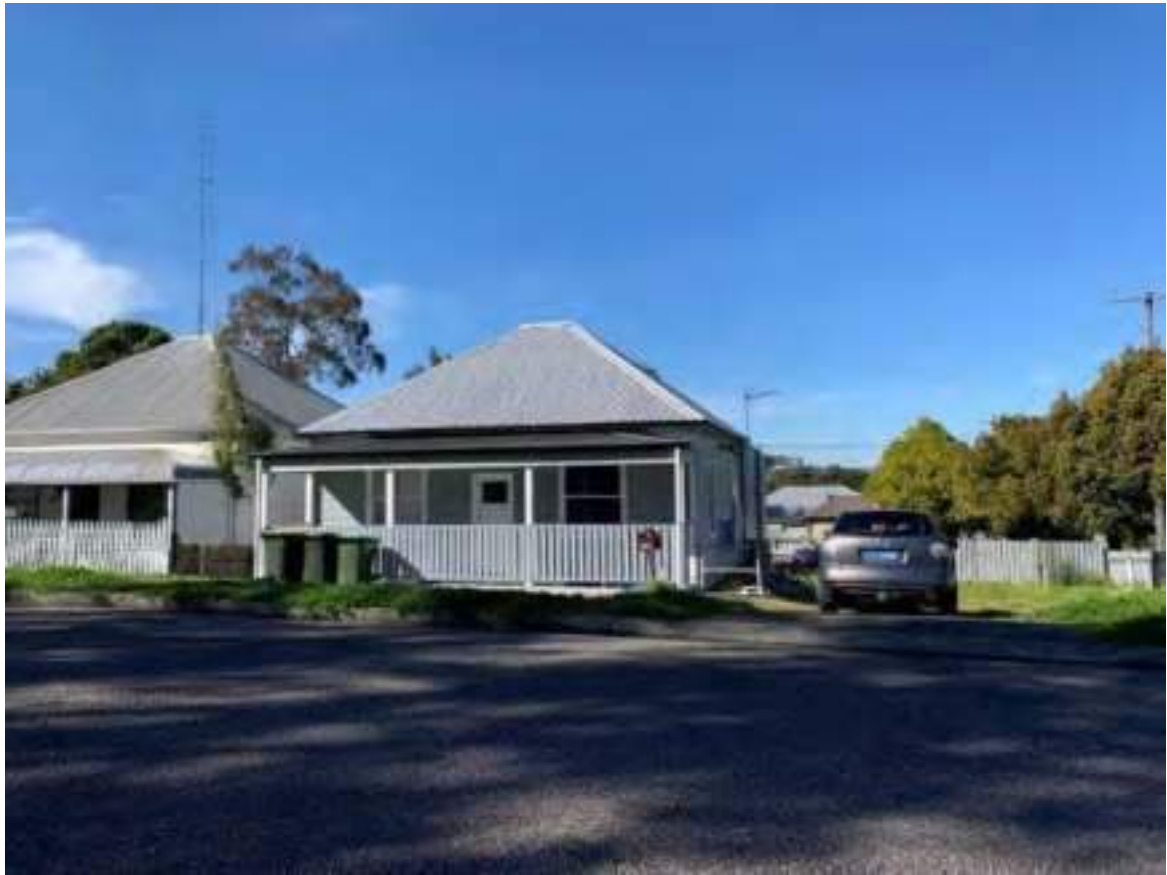
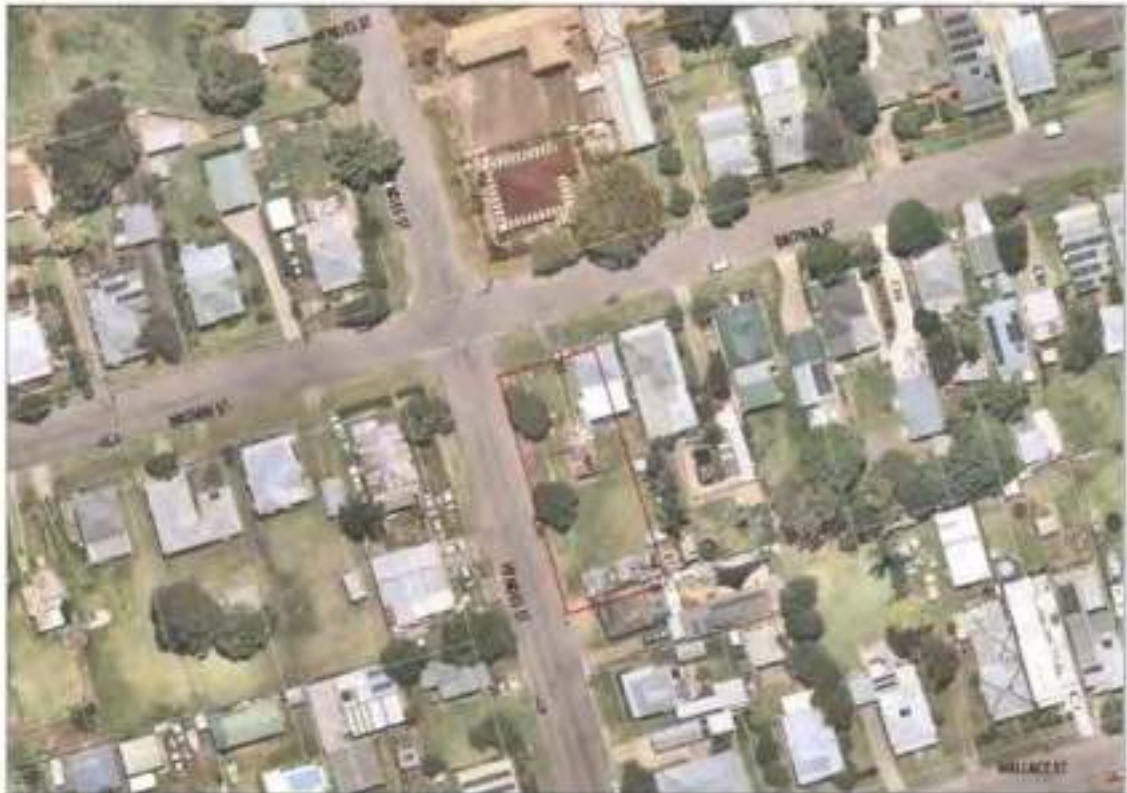
42 BROWN STREET, WEST WALLSEND 2286

Conservation Area Contribution Level	Est. Construction Date	Previous studies and/or community input
Contributory 1	1890–1915	No prior heritage investigations and no additional information required.
Assessment Text		Observed Modifications
<p>Single story Vernacular ‘Mining Cottage’ style dwelling with hipped Colourbond roof and weatherboard cladding. The veranda roof is hipped and supported by timber posts.</p> <p>The veranda is enclosed by timber balustrade, with concrete flooring.</p> <p>The front door is centrally located and timber framed, with a single glass pane. Double hung timber framed sash windows are either side, likely original. The western and eastern windows are timber framed sash designs.</p> <p>A single door gable roof garage is located to the west of the dwelling.</p> <p>The dwelling displays architectural features of a heritage style and is representative of the local development of this period, being of historical significance for the HCA.</p>		<p>The veranda balustrade is a contemporary replication of a heritage style.</p> <p>The veranda roof was likely originally bull nosed.</p>

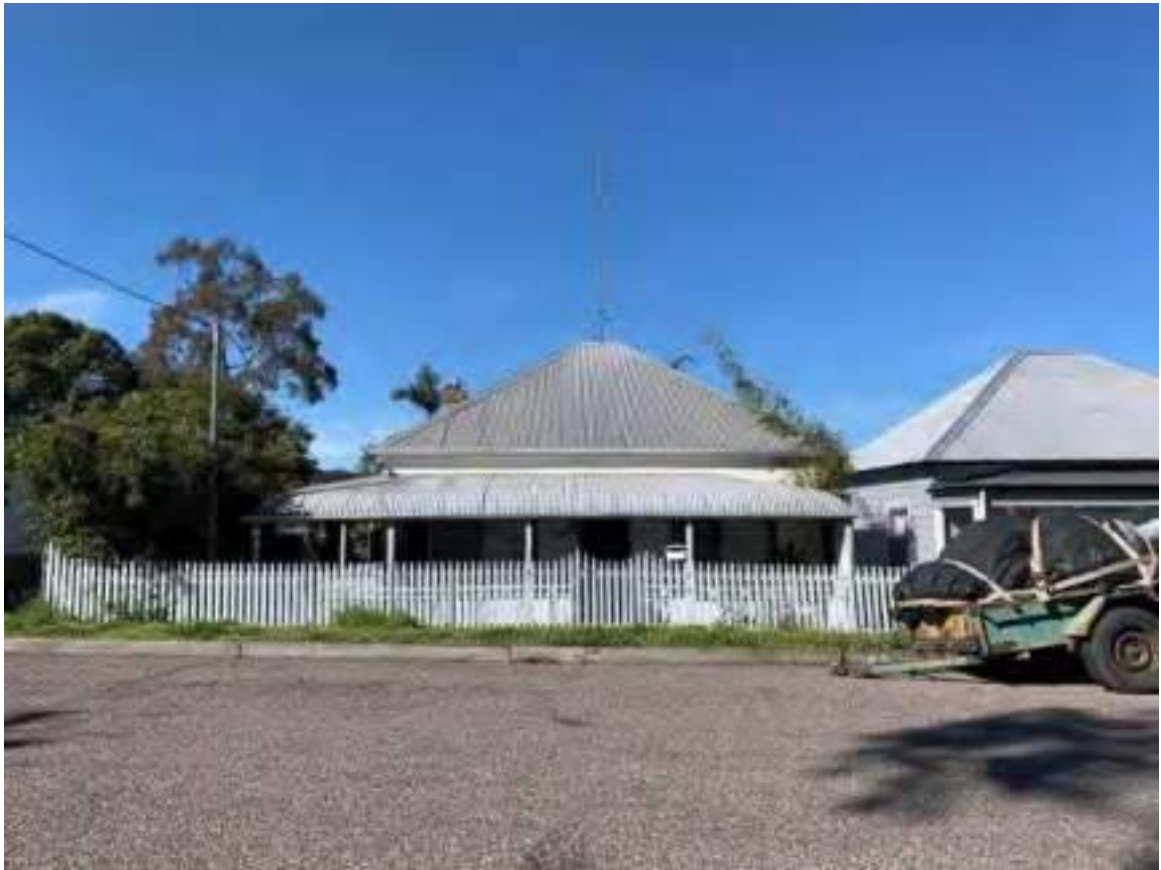
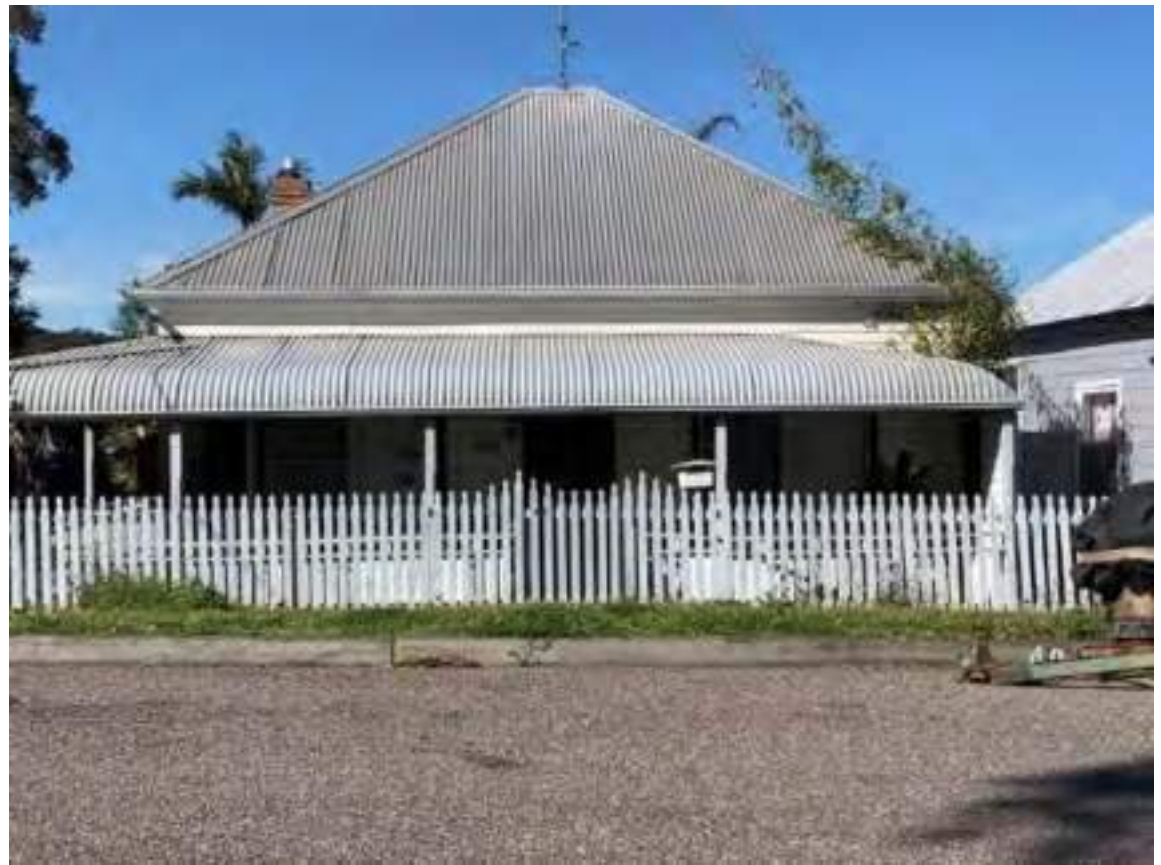
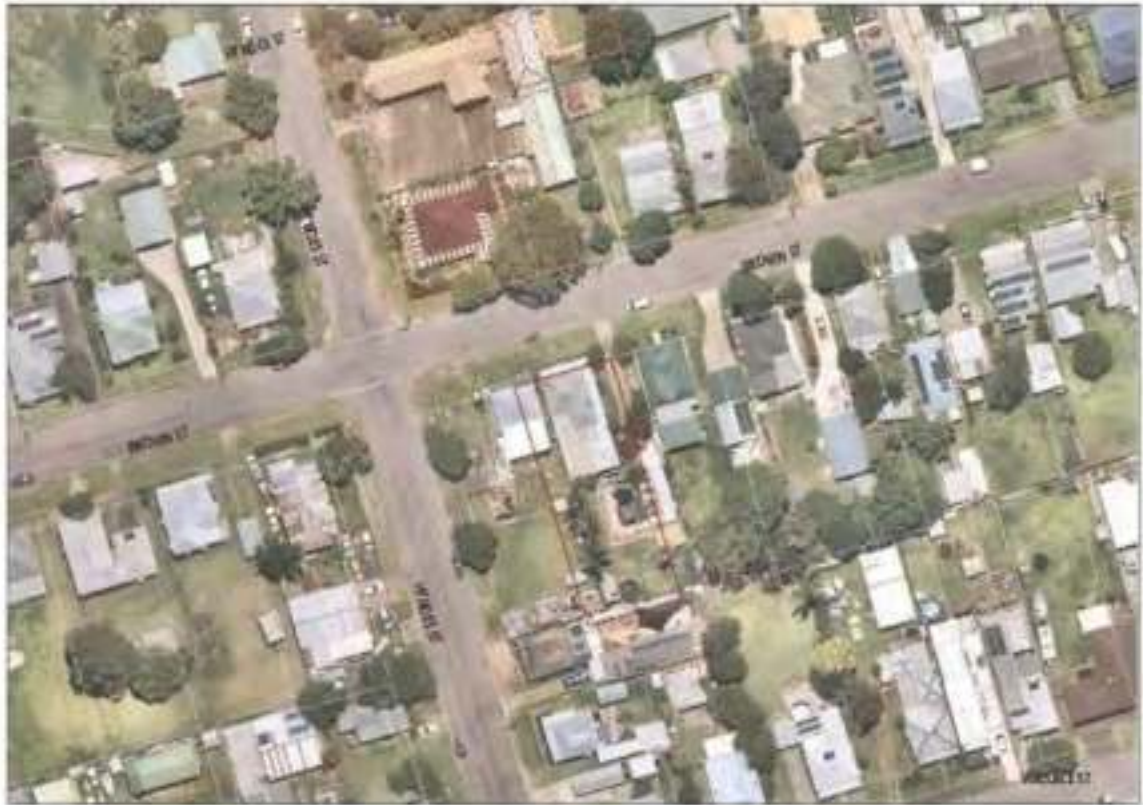
40 BROWN STREET, WEST WALLSEND 2286

Conservation Area Contribution Level	Est. Construction Date	Previous studies and/or community input
Contributory 1	1890–1910	No prior heritage investigations and no additional information required.
Assessment Text		Observed Modifications
<p>Single story Vernacular ‘Mining Cottage’ style dwelling with steep hipped Colourbond roof and weatherboard cladding. The veranda roof is bull nosed and supported by timber posts.</p> <p>The veranda wraps around the northern and eastern sides of the dwelling, with timber balustrades along the eastern side. the floor is timber.</p> <p>The front door is centrally located with a decorative metal screen door and sliding windows either side.</p> <p>A red brickwork chimney is visible on the eastern side of the dwelling.</p> <p>A timber picket fence encloses the property.</p> <p>The dwelling displays architectural features of a heritage style and is representative of the local development of this period, being of historical significance for the HCA.</p>		<p>The visible windows are contemporary sliding designs, likely replacing original sash designs.</p> <p>The extension of the veranda along the eastern side of the dwelling is a recent modification, with the chimney being absorbed into the extended roofing.</p> <p>An extension has been built onto the back southern portion of the dwelling, however this is not visible from the street and does not detract.</p>

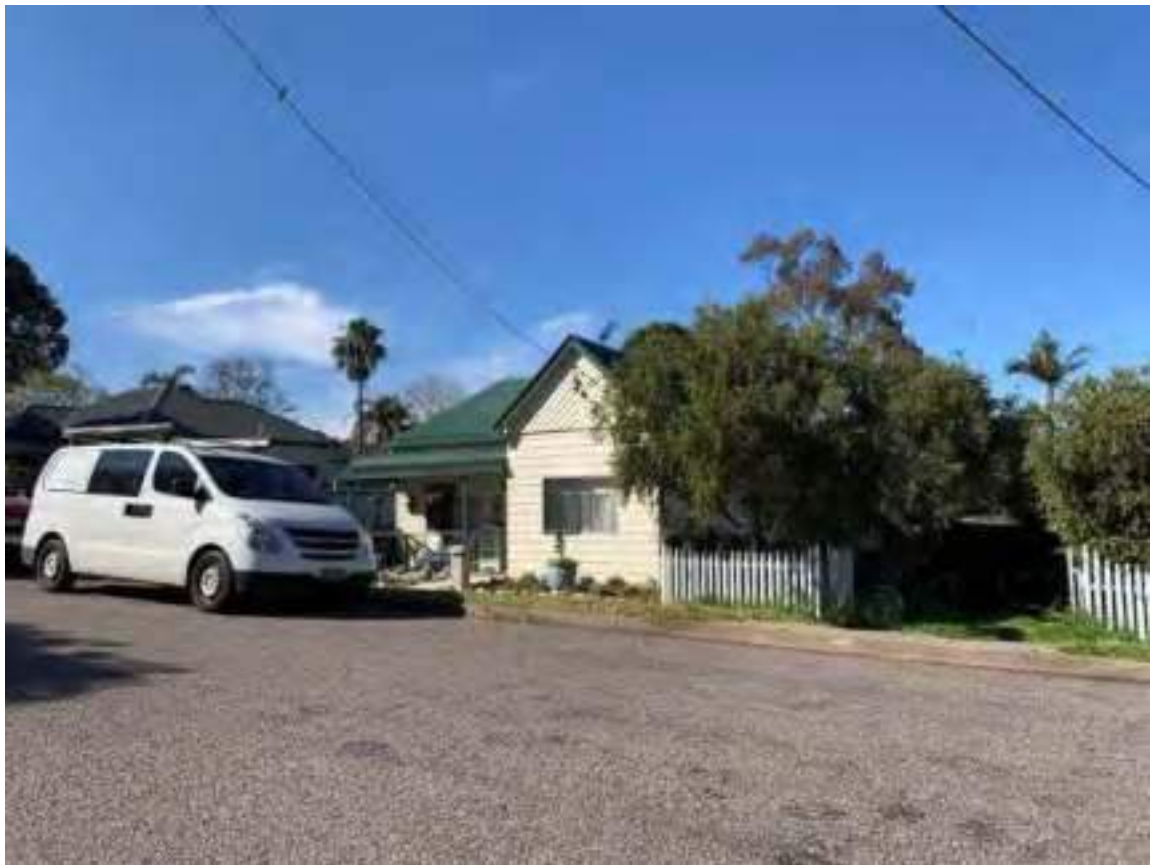
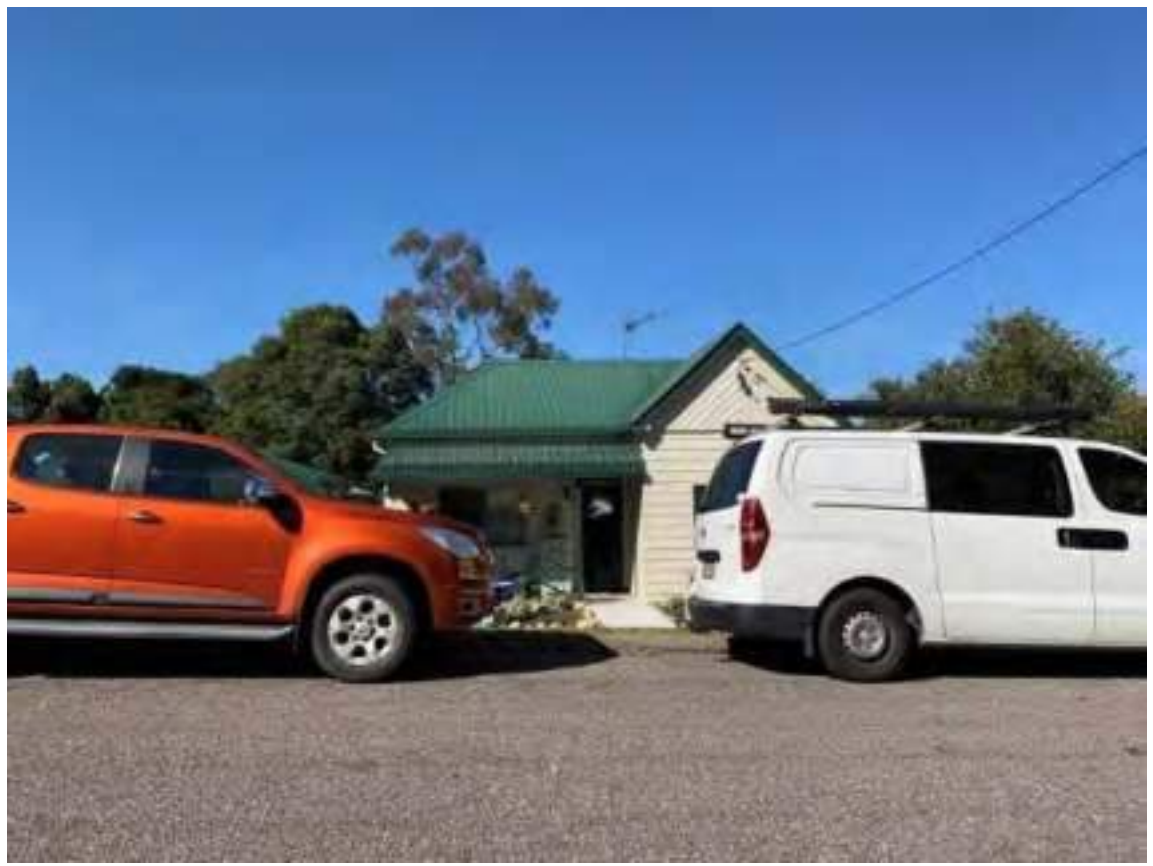
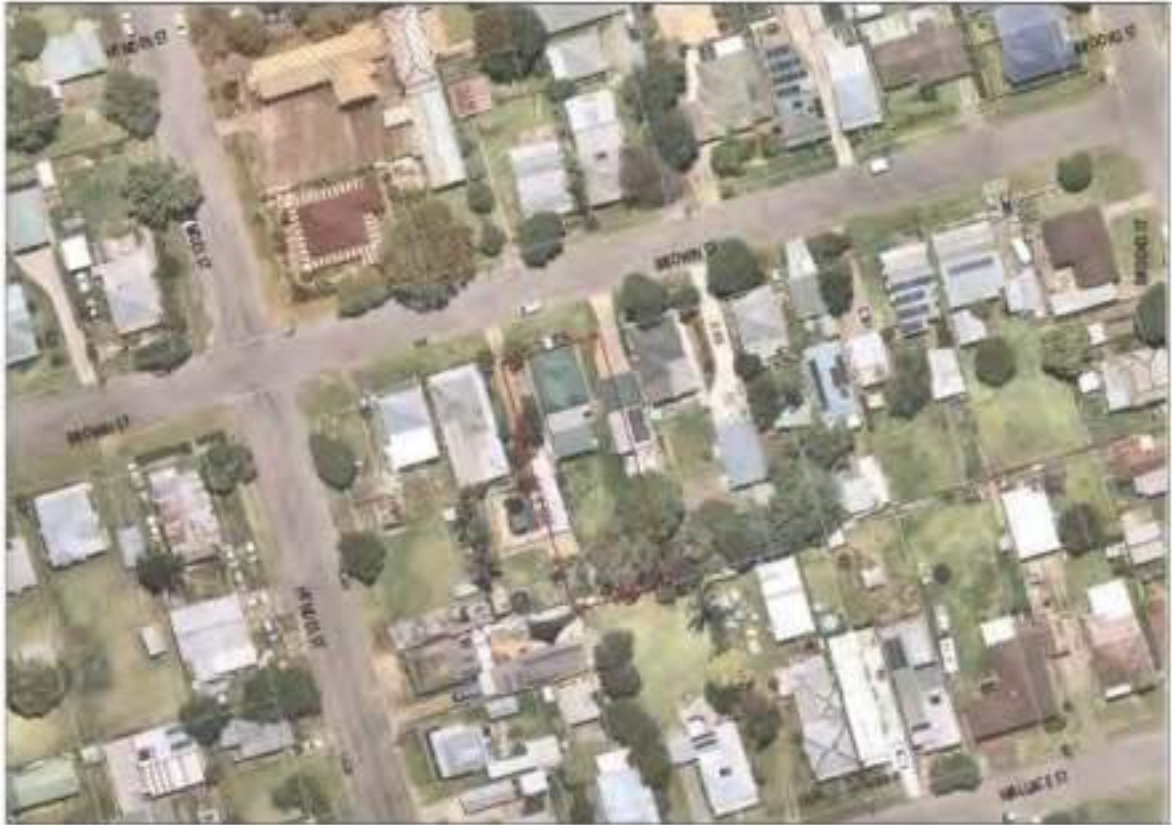
38 BROWN STREET, WEST WALLSEND 2286

Conservation Area Contribution Level	Est. Construction Date	Previous studies and/or community input
Contributory 1	1895–1910	No prior heritage investigations and no additional information required.
Assessment Text		Observed Modifications
<p>A single story Vernacular ‘workmen’s’ cottage style dwelling with projecting gable roof and timber weatherboard cladding. The remaining structure has a hipped roof, all Colourbond. The veranda roof is bull nosed and supported by timber posts.</p> <p>The veranda is partially enclosed by cross beam timber balustrade, with concrete flooring.</p> <p>The front door is centrally located with a double glass pane design and metal security screen. Sliding windows are located on either side, similarly with security screens.</p> <p>The gable roof has extended barge boards and no further decoration.</p> <p>A gable roof carport and double door garage is located to the east of the dwelling.</p> <p>The dwelling displays architectural features of a heritage style and is representative of the local development of this period, being of historical significance for the HCA.</p>		<p>All visible windows have been replaced with contemporary sliding designs.</p> <p>An extension has been built onto the back southern portion of the dwelling, however is not visible from the street and does not detract.</p>

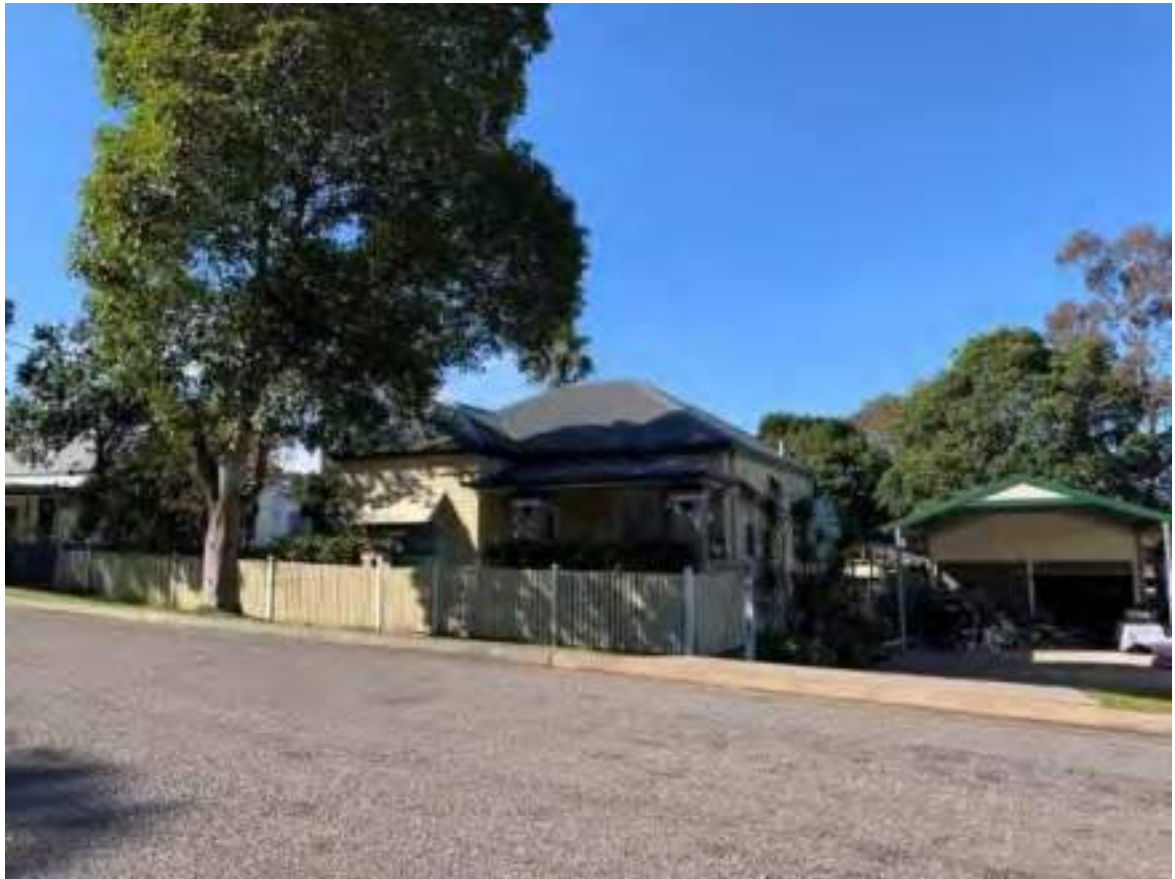
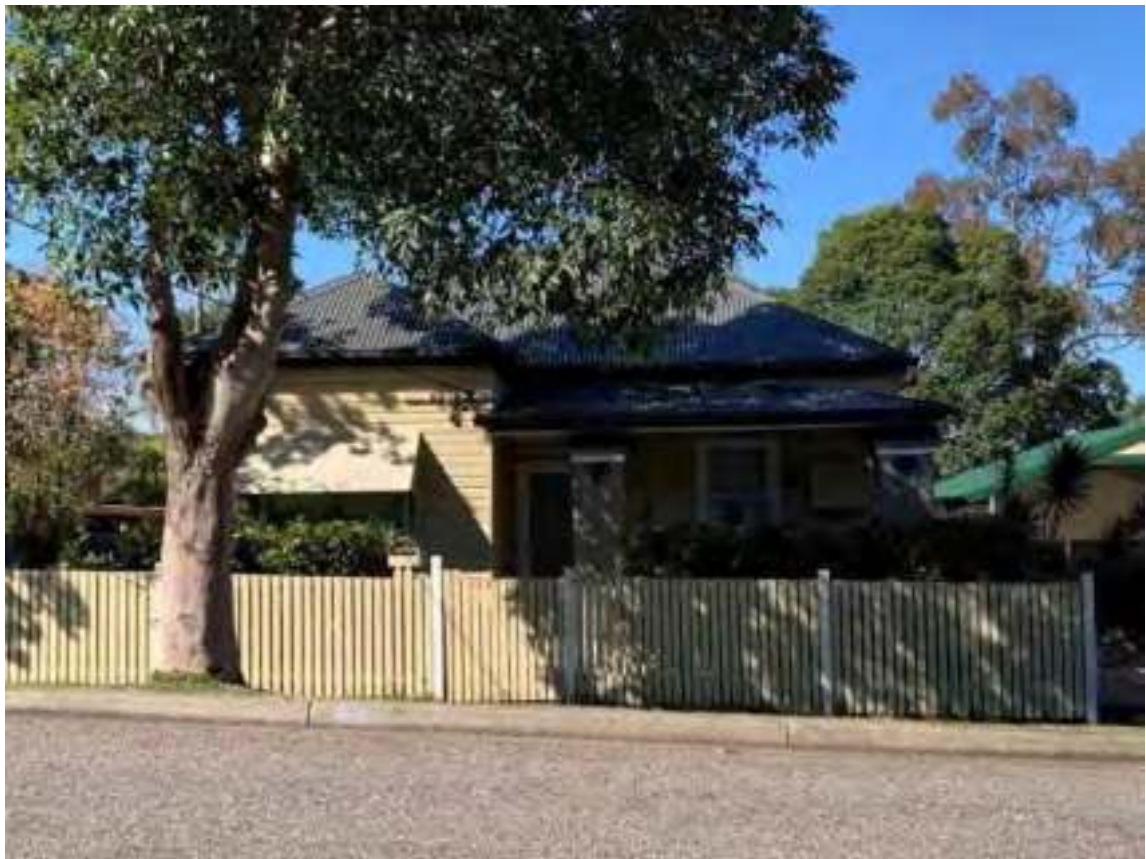
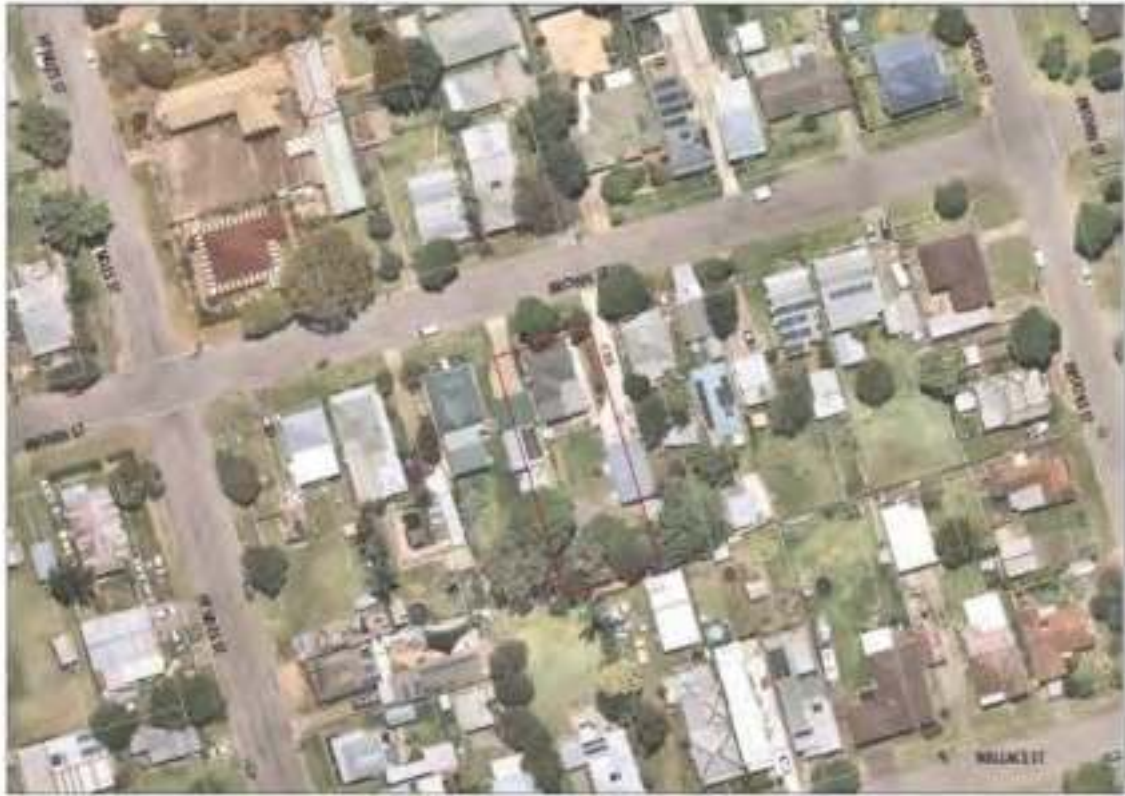
36 BROWN STREET, WEST WALLSEND 2286

Conservation Area Contribution Level	Est. Construction Date	Previous studies and/or community input
Contributory 1	1890–1915	No prior heritage investigations and no additional information required.
Assessment Text		Observed Modifications
<p>Singles tory Vernacular ‘workmen’s cottage’ style dwelling with hipped Colourbond roof and weatherboard cladding. The veranda roof is hipped and supported by brick pillars.</p> <p>The front door is centrally located with a metal security screen. The western façade window is likely an original timber framed sash design. The northern and western windows have metal awnings.</p> <p>A gable roof car port and garage is located to the west of the dwelling.</p> <p>A timber fence encloses the property.</p> <p>The dwelling displays architectural features of a heritage style and is representative of the local development of this period, being of historical significance for the HCA.</p>		<p>The brick pillars are a contemporary modification, likely replacing timber posts. This juxtaposes the remaining heritage features of the dwelling.</p> <p>Many windows have been replaced with contemporary sliding designs.</p>

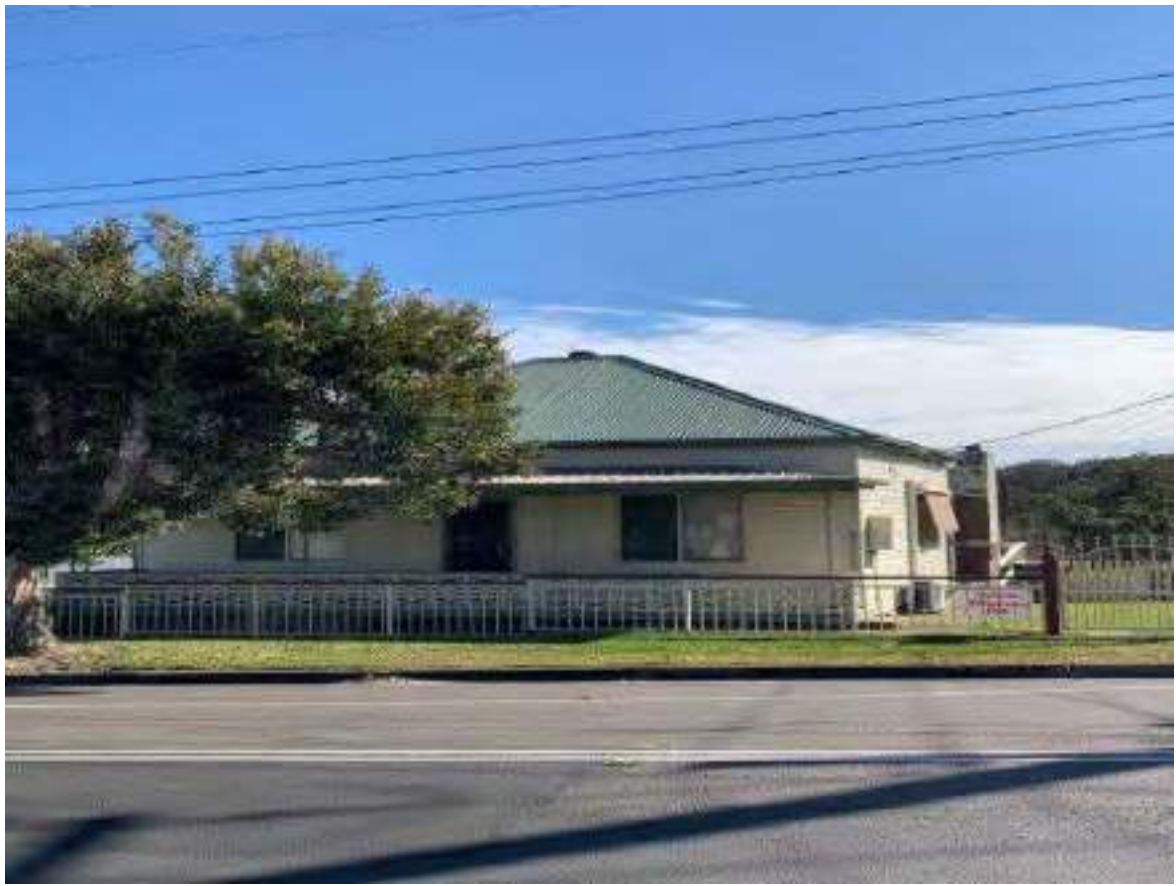
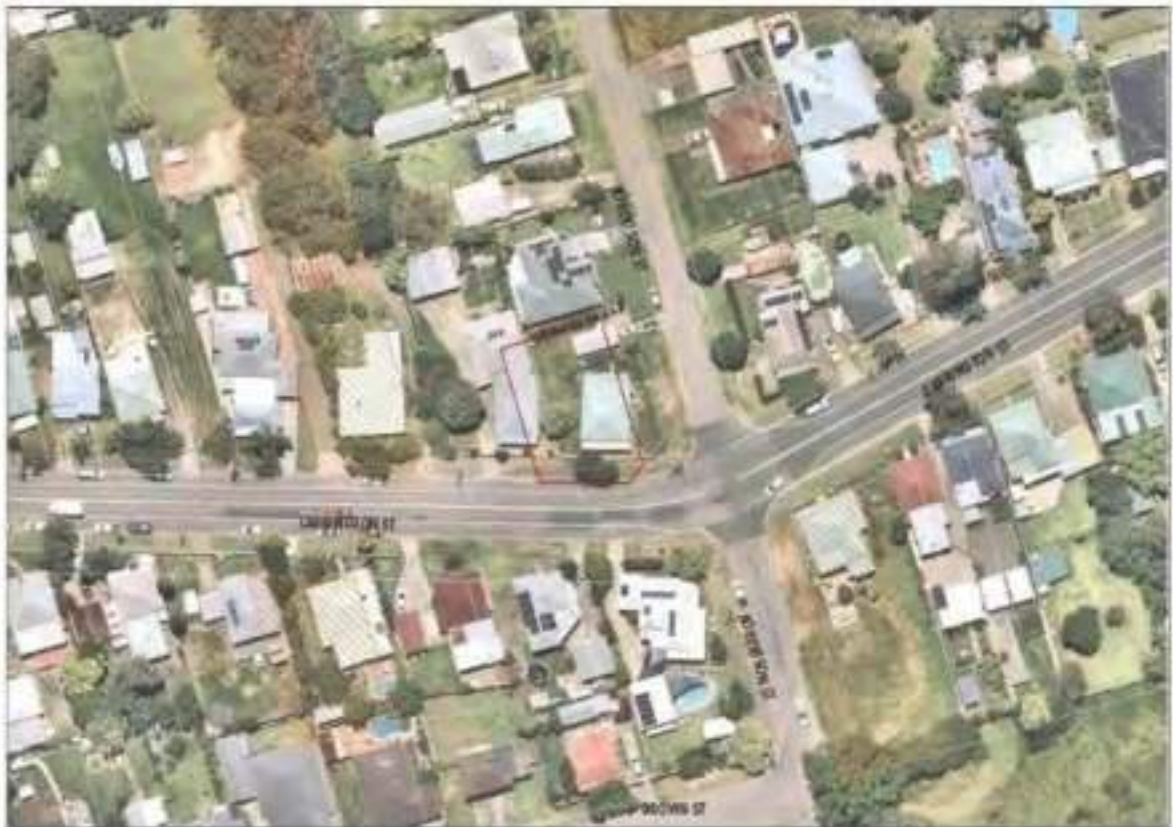
11 CARRINGTON STREET, WEST WALLSEND 2286

Conservation Area Contribution Level	Est. Construction Date	Previous studies and/or community input
Contributory 1	1890–1910	No prior heritage investigations and no additional information required.
Assessment Text		Observed Modifications
<p>Single story Vernacular ‘Mining Cottage’ style dwelling with hipped Colourbond roof and weatherboard cladding. The veranda roof is hipped and supported by metal posts.</p> <p>The veranda is partially enclosed by a concrete block wall, with concrete flooring.</p> <p>The front door is centrally located with a security screen and sliding windows are either side. a secondary door is located on the eastern side of the dwelling, with a concrete ramp and timber balustrade.</p> <p>A rendered brickwork chimney is visible on the eastern side of the dwelling.</p> <p>A timber picket fence encloses the property.</p> <p>The dwelling displays architectural features of a heritage style and is representative of the local development of this period, being of historical significance for the HCA.</p>		<p>All visible windows are contemporary sliding designs, replacing original timber sash styles.</p> <p>The eastern door and associative ramp are recent modifications.</p> <p>The chimney shaft has been removed.</p>

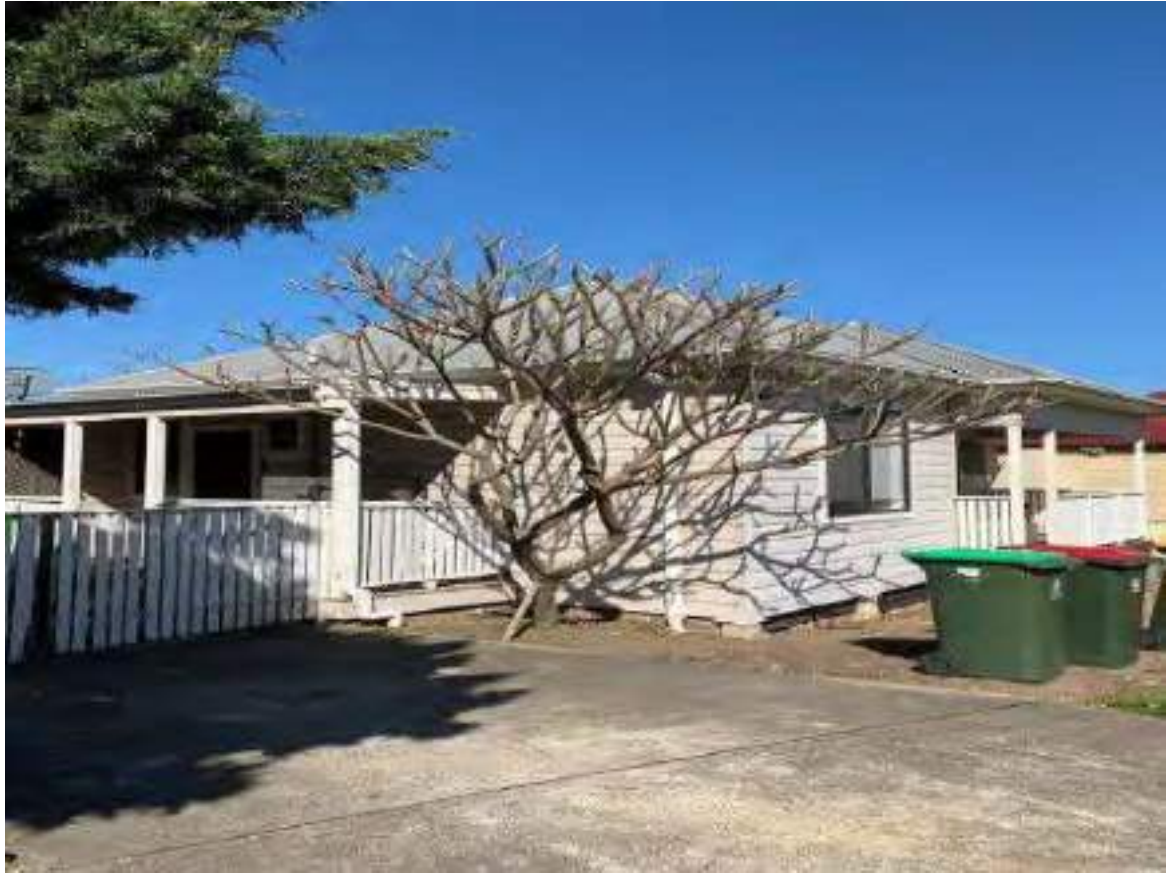
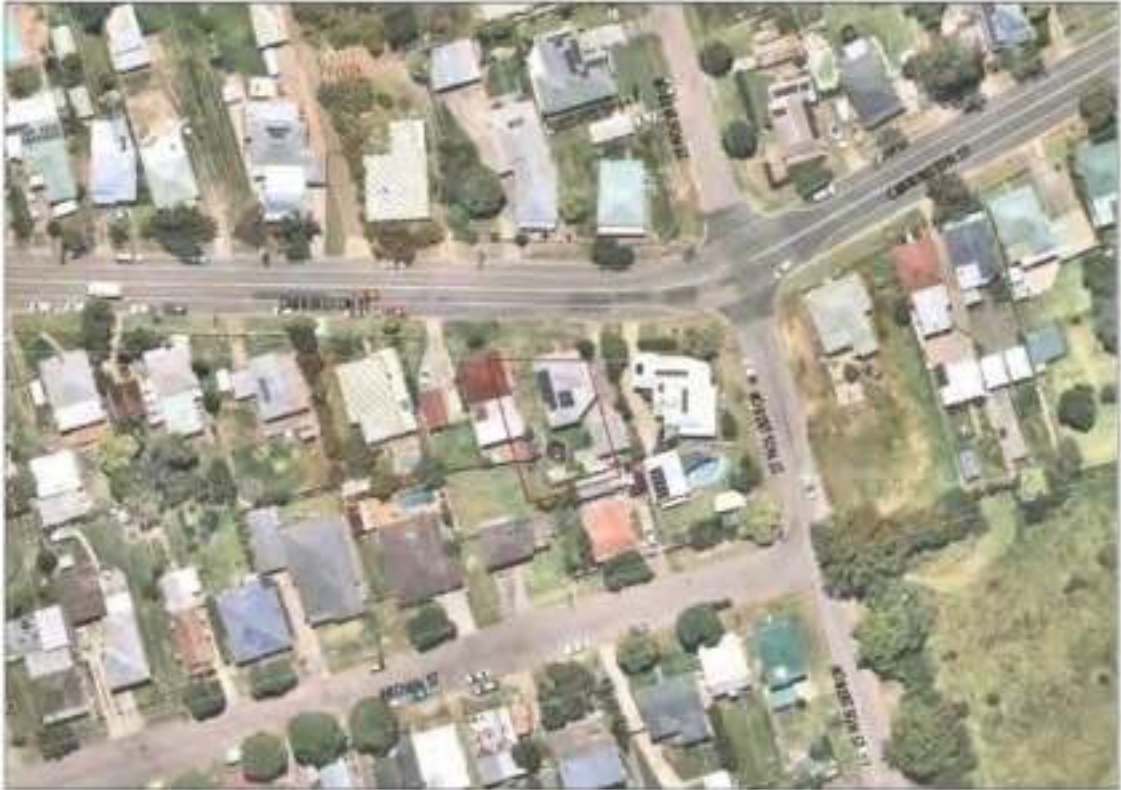
Conservation Area Contribution Level	Est. Construction Date	Previous studies and/or community input
Contributory 1	1935–1945	West Wallsend Heritage Study 1993
Assessment Text		Observed Modifications
<p>Single story Inter-War Workers Cottage style dwelling with Colourbond double hipped roof and weatherboard cladding. The veranda roof is incorporated into the main hipped roof and is supported by timber posts.</p> <p>The veranda is partially enclosed by timber balustrade, with timber flooring and concrete steps leading to the landing.</p> <p>The front door is centrally located with a timber frame and sliding windows on either side.</p> <p>A gable roof double door garage is located to the south of the dwelling.</p> <p>Timber fencing encloses the backyard portion of the dwelling.</p> <p>The dwelling displays architectural features of a heritage style and is representative of the local development of this period, being of historical significance for the HCA.</p>		<p>All visible windows are contemporary sliding designs, replacing the original timber framed double hung sash designs.</p> <p>The timber balustrade is a recent modification, likely replacing an earlier balustrade style.</p> <p>An eastern veranda extension has been constructed, however in a sympathetic style to the remaining structure.</p>

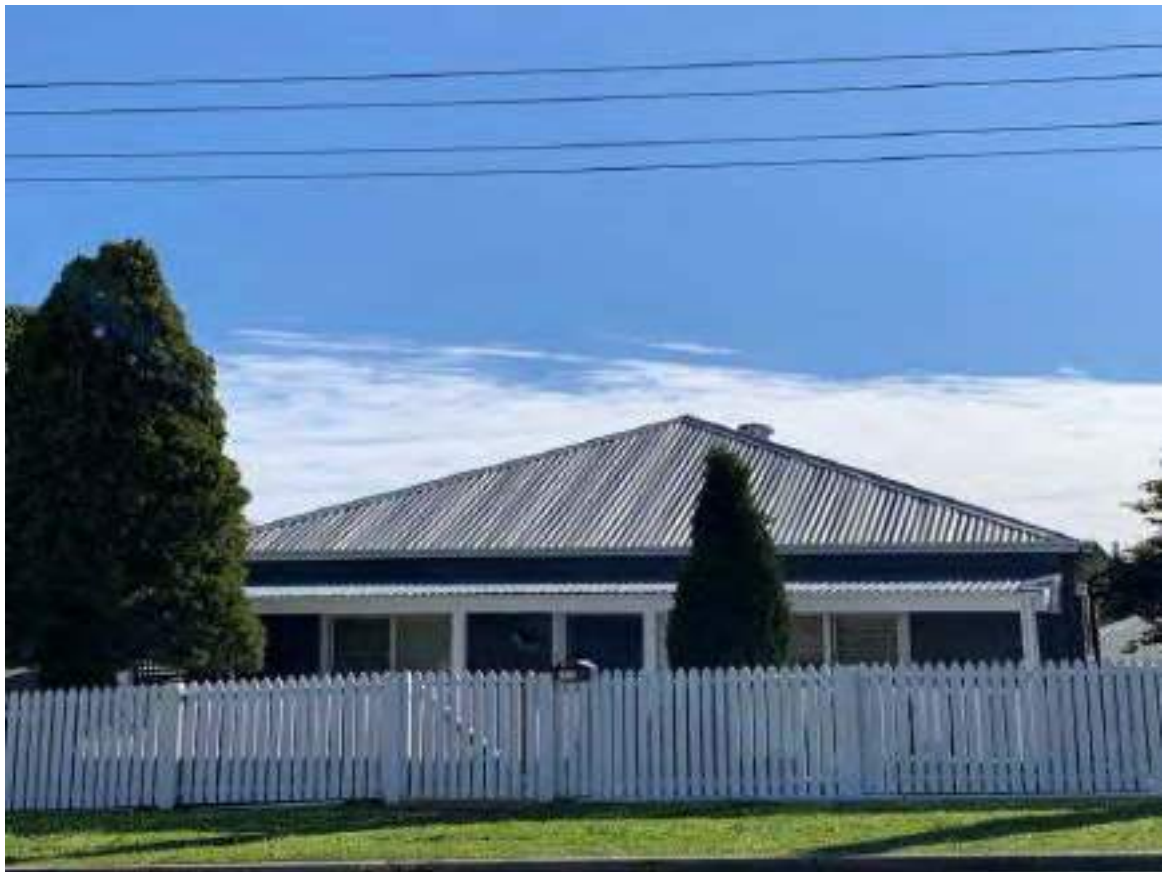
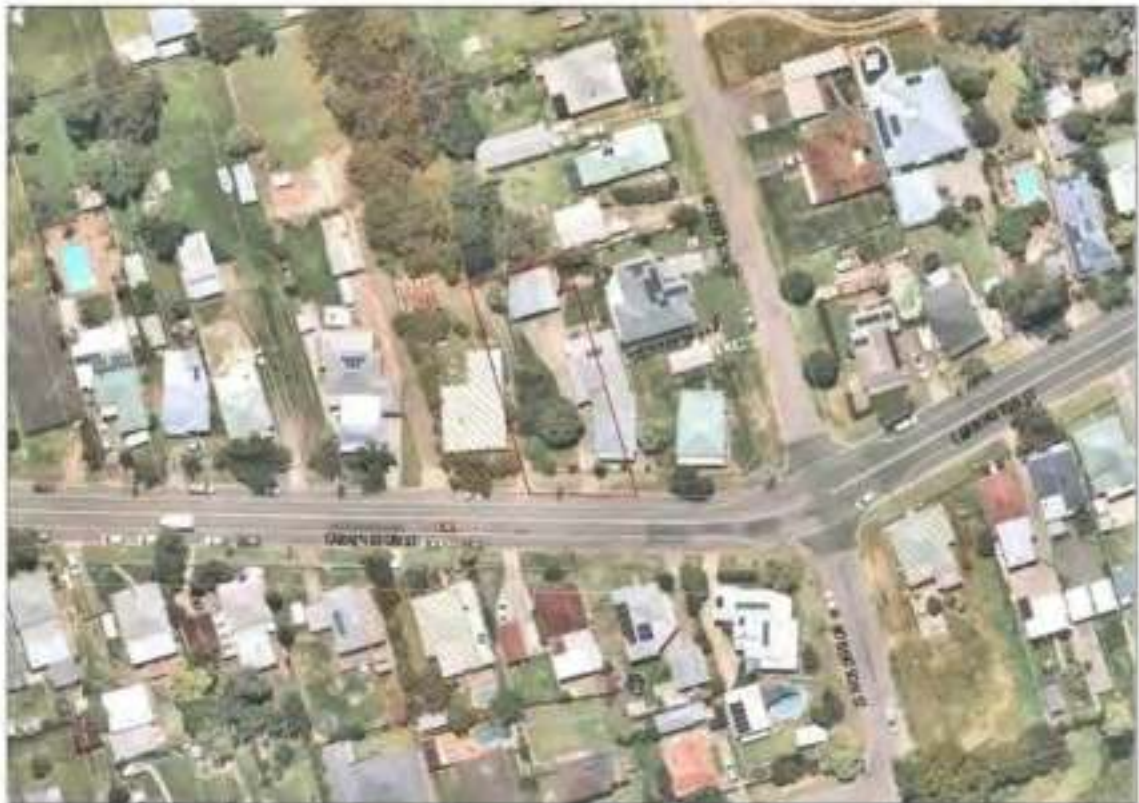
13 CARRINGTON STREET, WEST WALLSEND 2286

Conservation Area Contribution Level	Est. Construction Date	Previous studies and/or community input
Contributory 1	1890–1915	No prior heritage investigations and no additional information required.
Assessment Text		Observed Modifications
<p>Single story Vernacular ‘Mining Cottage’ style dwelling with hipped Colourbond roof and weatherboard cladding. The veranda roof is skillion and supported by timber posts.</p> <p>The veranda is partially enclosed with timber balustrade. Lattice boards are found at either end of the veranda.</p> <p>The front door is centrally located with an ornate metal screen door. Timber framed sliding windows are located on either side.</p> <p>A timber picket fence encloses the property.</p> <p>The dwelling displays architectural features of a heritage style and is representative of the local development of this period, being of historical significance for the HCA.</p>		<p>The dark blue and white colour scheme is a contemporary colour choice, and contrast with the surrounding heritage streetscape.</p> <p>The veranda roof was likely originally bull nosed, however a modified veranda roof is a common feature.</p> <p>All visible windows have been replaced with contemporary sliding designs.</p> <p>A large back extension is located to the southern end of the dwelling, however this has been constructed in a sympathetic style and does not detract.</p>
