APPENDIX 2

Building Assessment Sheets (Inventory Sheets)

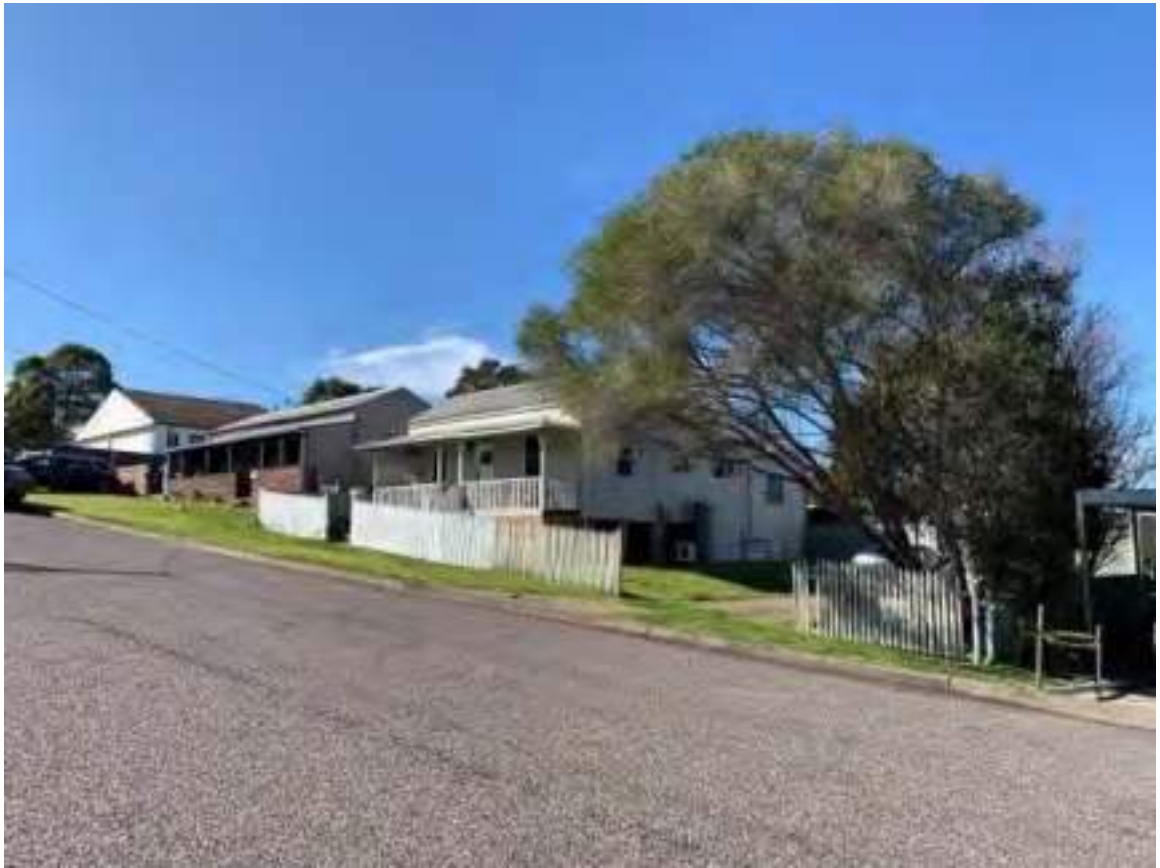
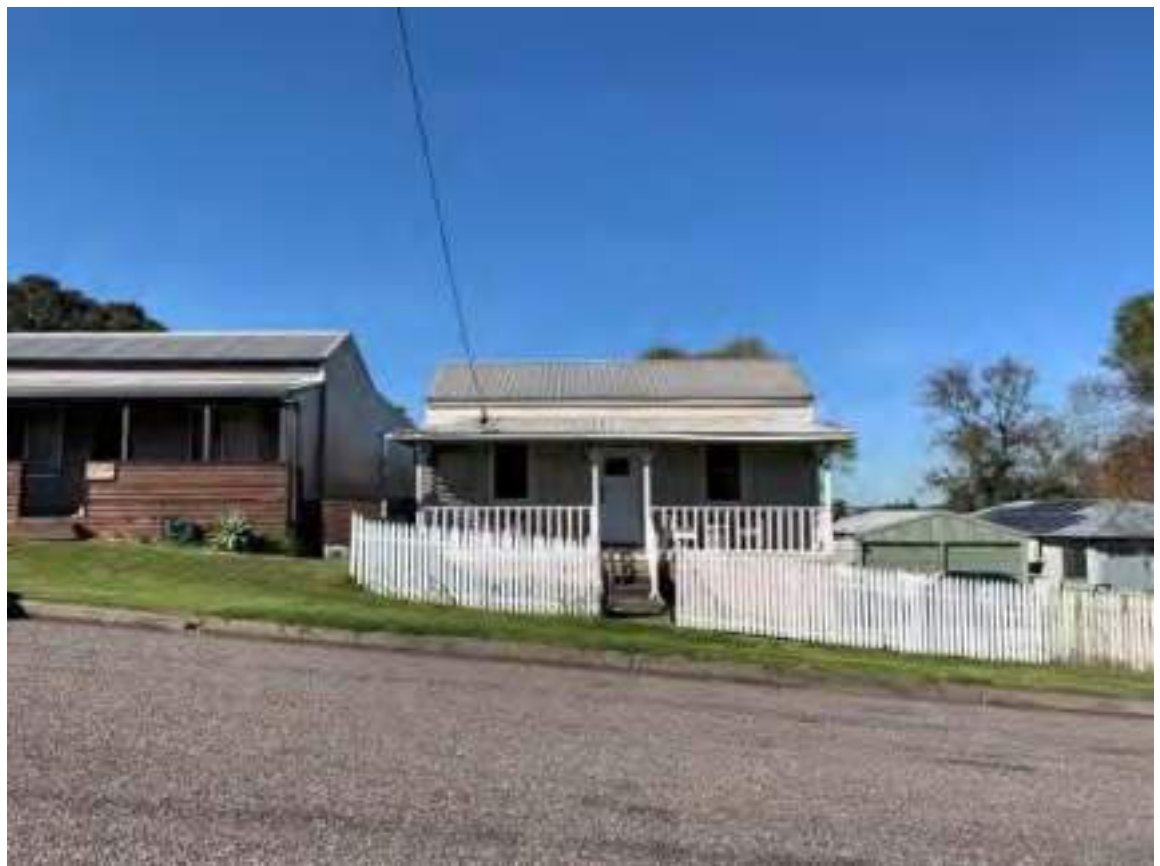
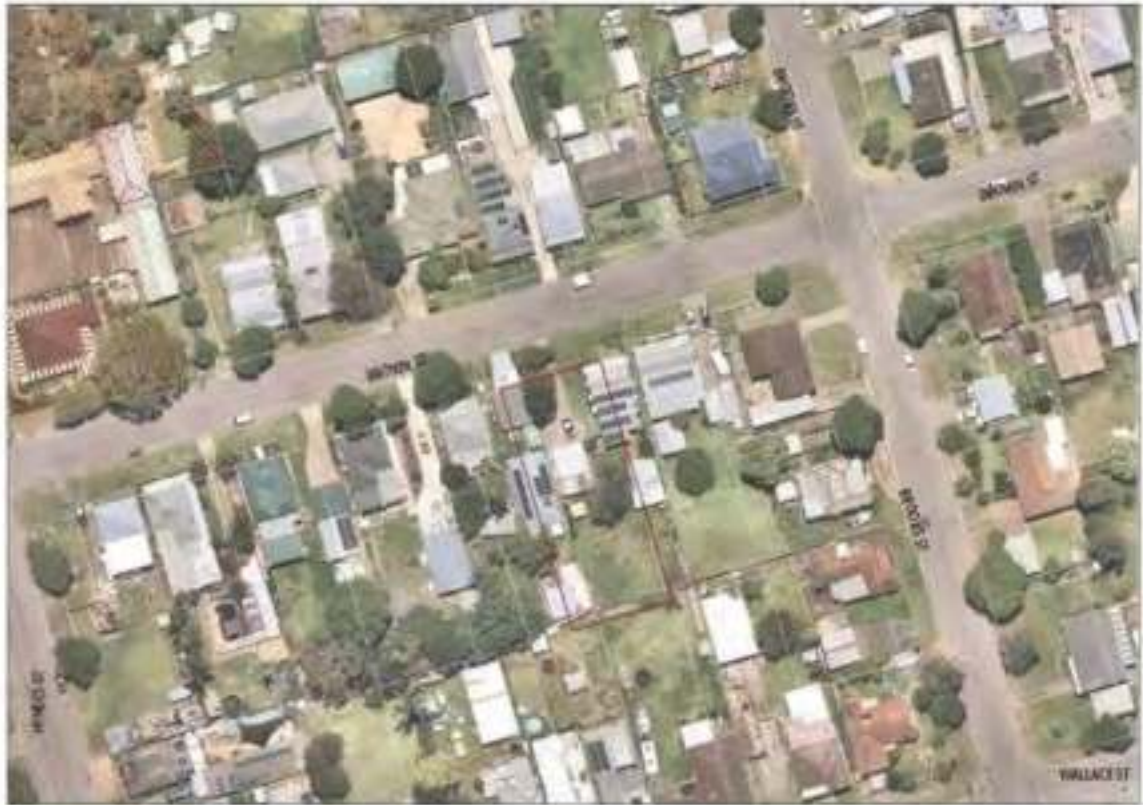
30 BROWN STREET, WEST WALLSEND 2286

Conservation Area Contribution Level	Est. Construction Date	Previous studies and/or community input
Contributory 1	1890–1915	No prior heritage investigations and no additional information required.
Assessment Text		Observed Modifications
<p>Single story Vernacular ‘Mining Cottage’ style dwelling with half skillion and gable Colourbond roof and weatherboard cladding. The veranda roof is hipped and supported by timber posts with ornate brackets.</p> <p>The veranda is enclosed by timber balustrade, has timber flooring and a set of concrete stairs with timber balustrade leading onto the landing.</p> <p>The dwelling is supported by red brick foundations.</p> <p>The front door is centrally located with timber frame and security screen. Sash windows are located either side. the western windows are all sash with timber awnings with ornate brackets.</p> <p>Timber fencing encloses the property.</p> <p>The dwelling displays architectural features of a heritage style and is representative of the local development of this period, being of historical significance for the HCA.</p>		<p>The timber balustrade and support post brackets are recent modifications and replications of heritage styles. The brackets are not consistent with this housing style.</p> <p>Solar panels are visible at the back southern portion of the roof.</p> <p>A back extension is located at the southern end of the dwelling, however is not visible from the street.</p>

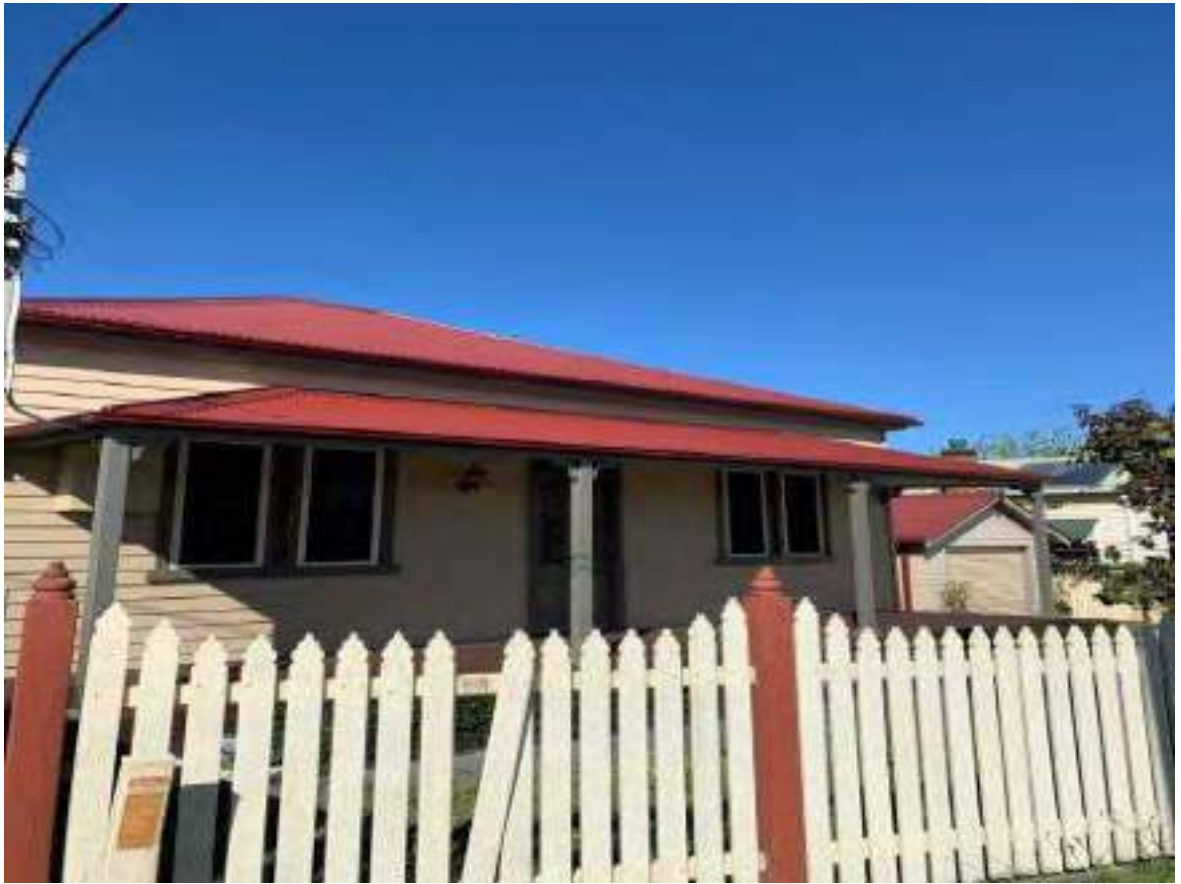
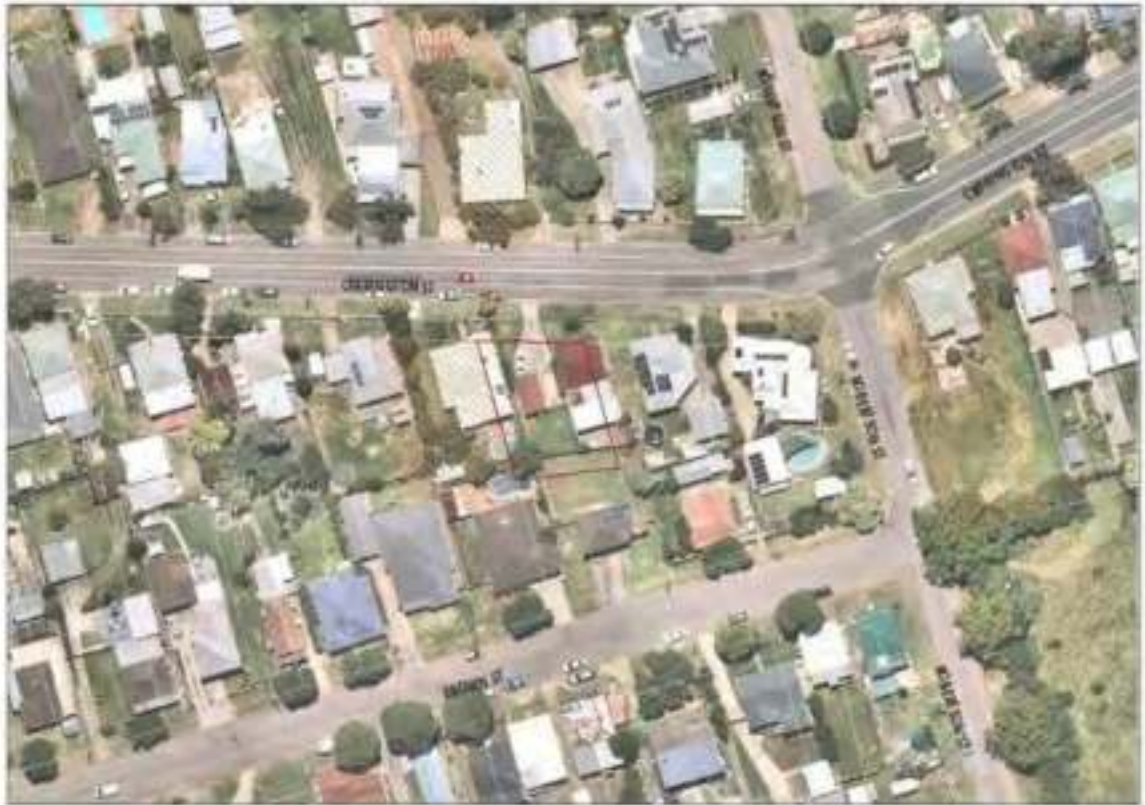
18 CARRINGTON STREET, WEST WALLSEND 2286

Conservation Area Contribution Level	Est. Construction Date	Previous studies and/or community input
Contributory 1	1890–1915	No prior heritage investigations and no additional information required.
Assessment Text		Observed Modifications
<p>Single story Vernacular ‘Mining Cottage’ style dwelling with hipped Colourbond roof and weatherboard cladding. The veranda roof is hipped and supported by timber posts with ornate brackets. The veranda is open with no balustrade and timber flooring. The front door is timber framed with a four panel design and security screen. Timber framed sash windows are either side. The visible western windows have timber awnings with ornate wrought iron brackets.</p> <p>A rendered brick chimney is located on the eastern side of the dwelling.</p> <p>Timber picket fencing encloses the property.</p> <p>A single door gable roof garage is located to the west of the dwelling.</p> <p>The dwelling displays architectural features of a heritage style and is representative of the local development of this period, being of historical significance for the HCA.</p>		<p>An extension has been constructed at the southern back end of the dwelling, however this is not visible from the street and does not detract.</p> <p>The shaft of the chimney has been removed.</p> <p>The hipped veranda roof is a contemporary replacement of the original bull nose roof.</p>

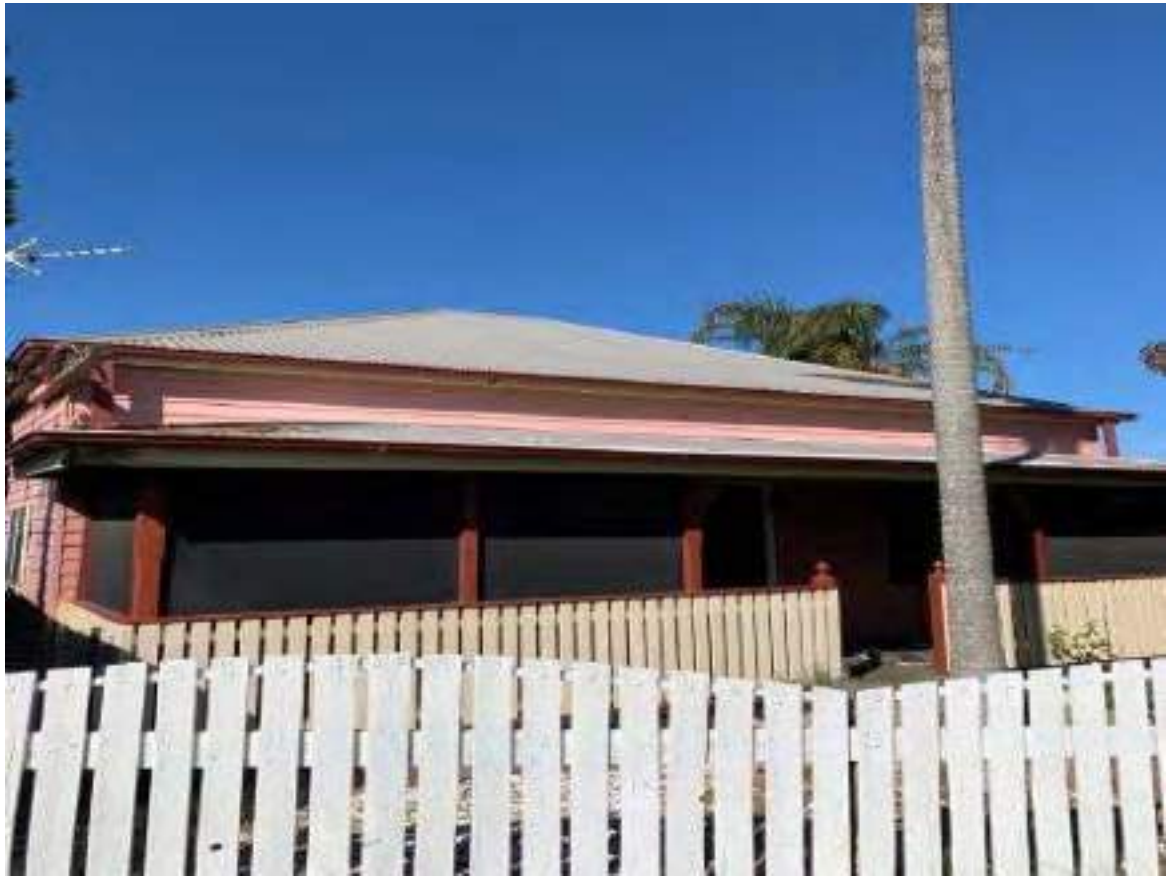
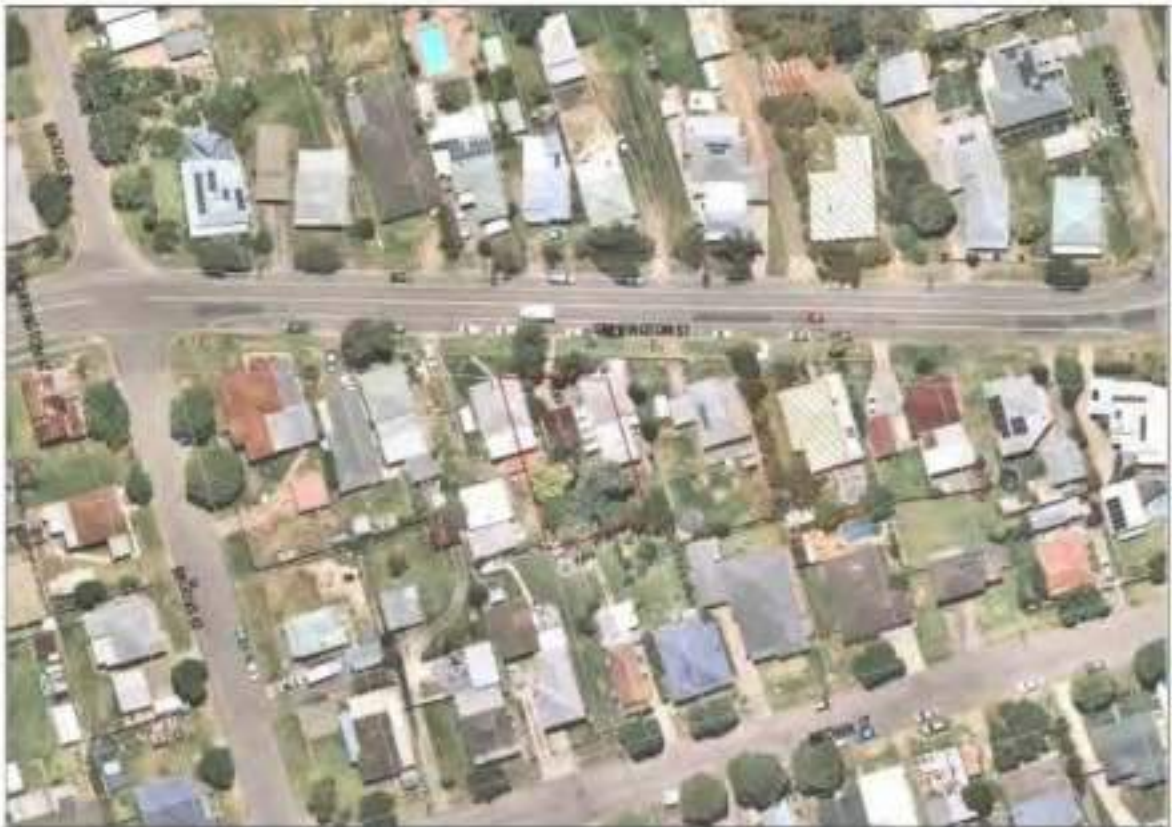
24 CARRINGTON STREET, WEST WALLSEND 2286

Conservation Area Contribution Level	Est. Construction Date	Previous studies and/or community input
Contributory 1	1890–1915	No prior heritage investigations and no additional information required.
Assessment Text		Observed Modifications
<p>Single story Vernacular ‘Mining Cottage’ style dwelling with hipped Colourbond roof and weatherboard cladding. The veranda roof is hipped and supported by timber posts with some wrought iron lace brackets.</p> <p>The veranda is enclosed by timber balustrade and mesh screening.</p> <p>The front door is centrally located with sliding windows on either side.</p> <p>A gable arch frames the entrance to the property, with a timber finial.</p> <p>Timber fencing encloses the property.</p> <p>The dwelling displays architectural features of a heritage style and is representative of the local development of this period, being of historical significance for the HCA.</p>		<p>The visible windows are contemporary sliding designs, likely replacing the original sash styles.</p> <p>The pink colour scheme is inappropriate and is not sympathetic to the heritage streetscape.</p> <p>The veranda balustrade and mesh screening are recent modifications.</p>

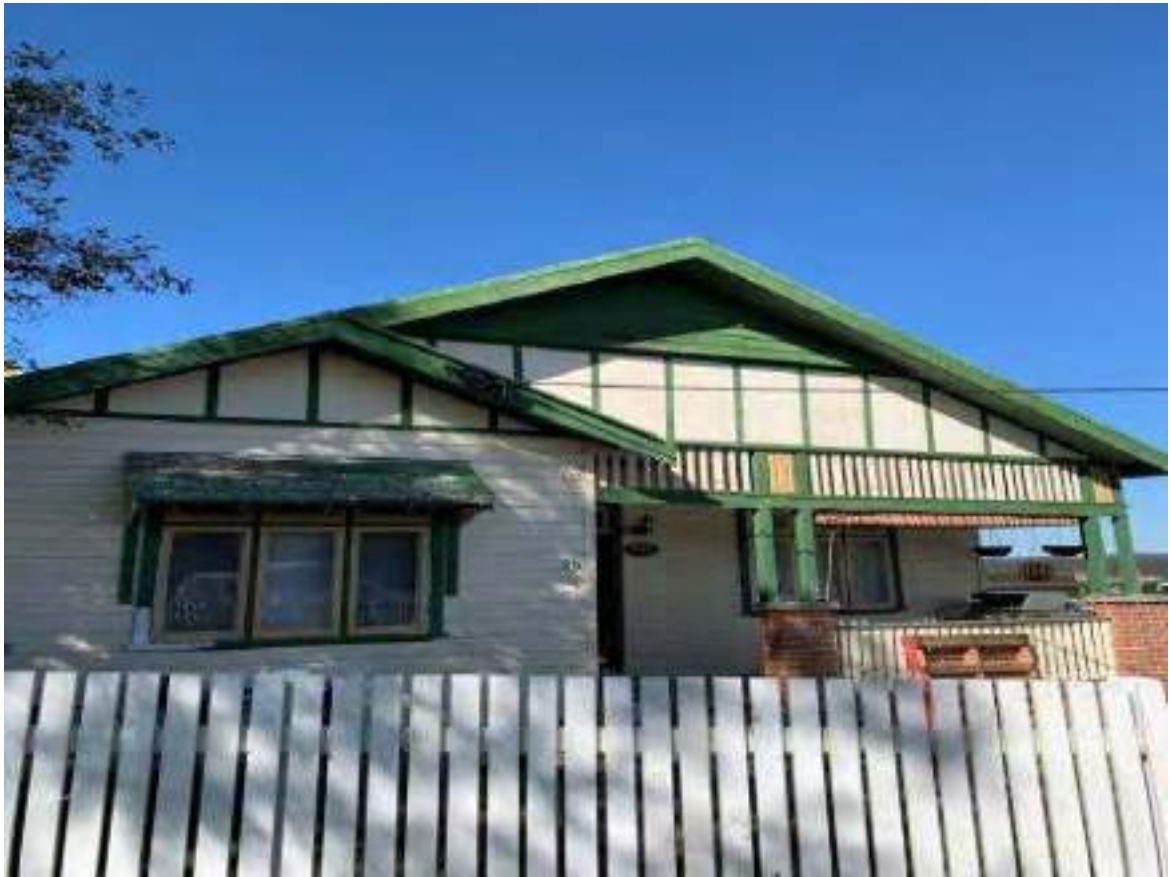
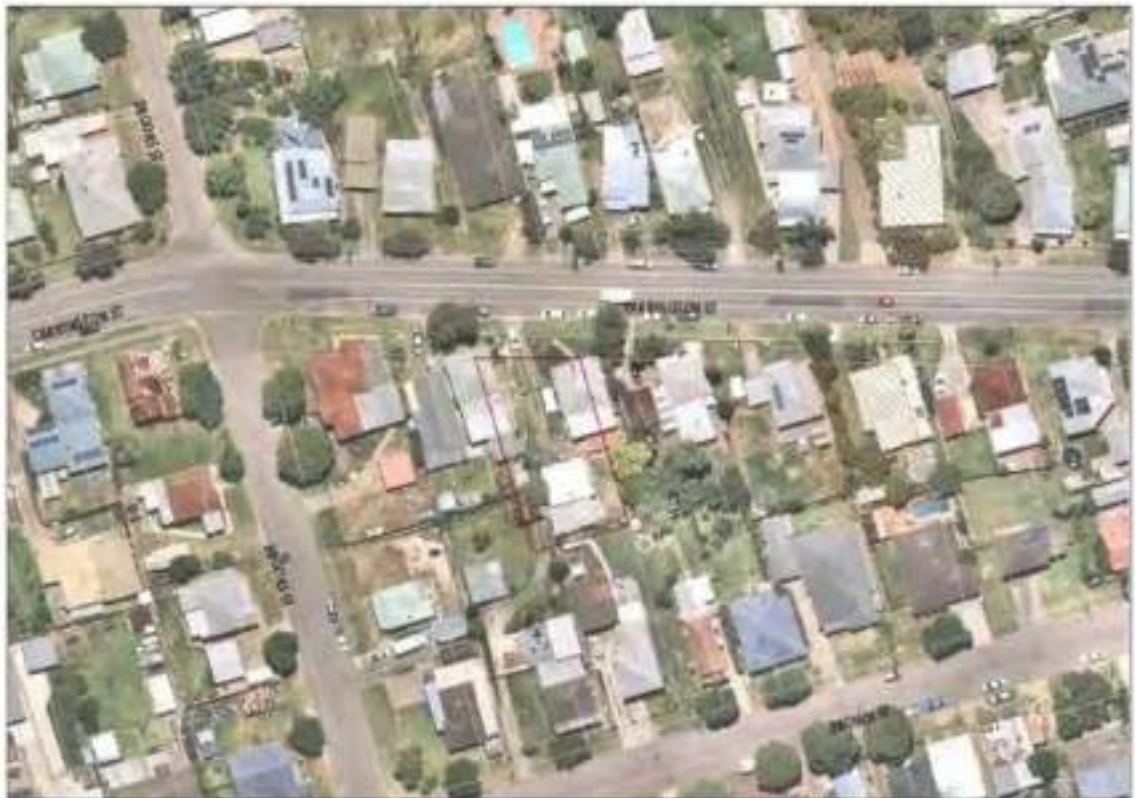
26 CARRINGTON STREET, WEST WALLSEND 2286

Conservation Area Contribution Level	Est. Construction Date	Previous studies and/or community input
Contributory 1	1920–1930	West Wallsend Heritage Study 1993 Moderate local significance
Assessment Text		Observed Modifications
<p>Single story Bungalow style dwelling with double gable Colourbond roof and weatherboard cladding. Brick pillars and timber posts support the veranda portion of the roof.</p> <p>The veranda is partially enclosed by timber balustrade. A decorative timber frieze is atop of the veranda.</p> <p>The front door is centrally located, with triple pane casement windows on either side. the gable window has a shingled timber awning. Battening and decorative shingles are visible.</p> <p>A timber fence encloses the property.</p> <p>The dwelling displays architectural features of a heritage style and is representative of the local development of this period, being of historical significance for the HCA.</p>		<p>The front door is a modern style and an inappropriate choice given the heritage nature of the dwelling.</p> <p>The brick pillars are potentially not original.</p> <p>A canvas blind is visible over the veranda.</p>

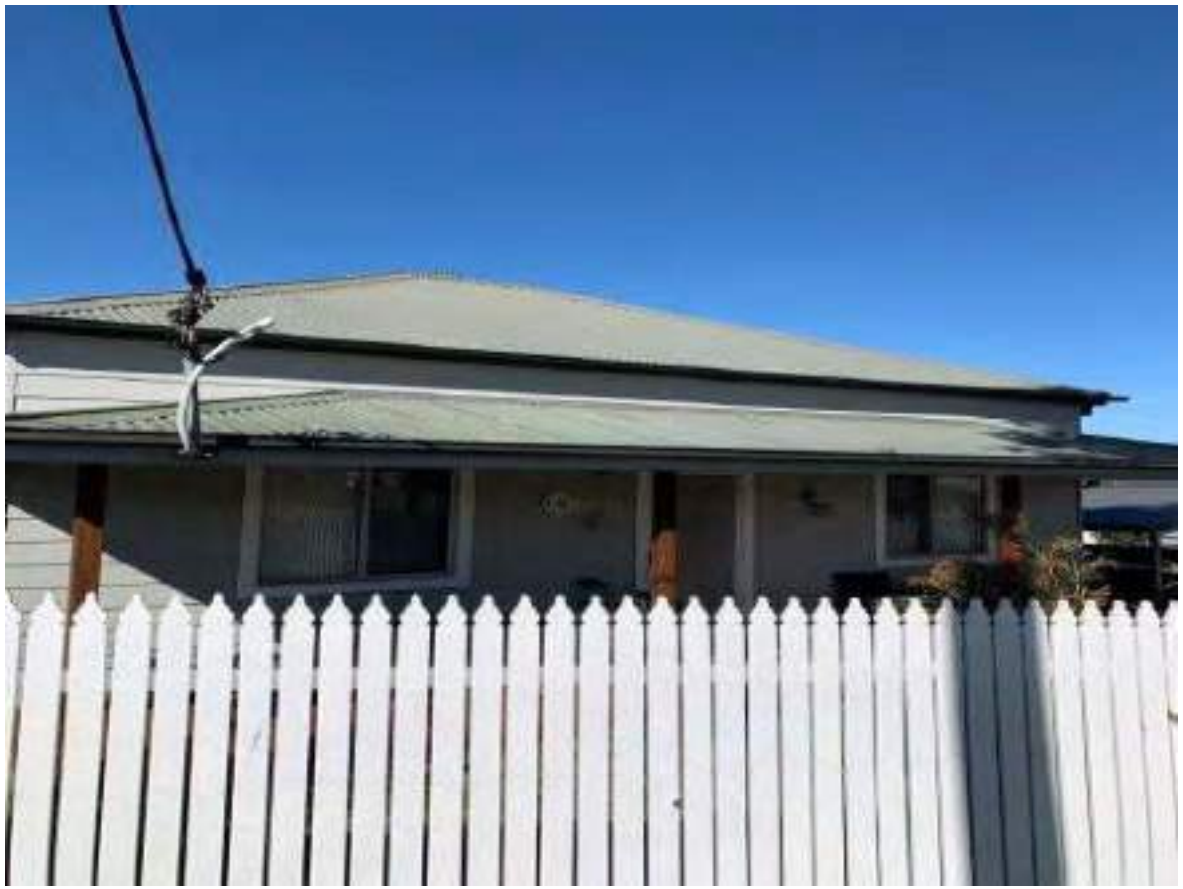
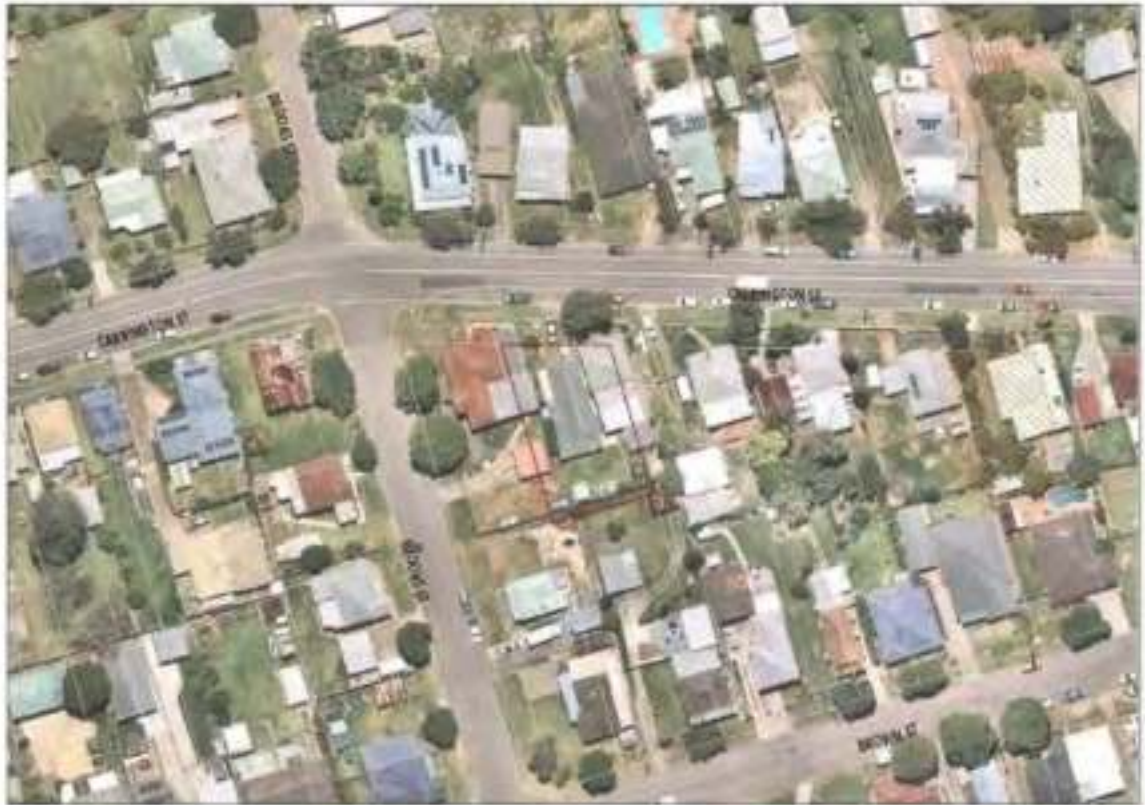
28 CARRINGTON STREET, WEST WALLSEND 2286

Conservation Area Contribution Level	Est. Construction Date	Previous studies and/or community input
Contributory 1	1890–1915	No prior heritage investigations and no additional information required.
Assessment Text		Observed Modifications
<p>Single story Vernacular ‘Mining Cottage’ style dwelling with Colourbond hipped roof and weatherboard cladding. The veranda roof is hipped and supported by timber posts.</p> <p>The veranda is open with no balustrade, with timber flooring.</p> <p>The front door is centrally located with a metal security screen, with sliding windows either side.</p> <p>A gable roof car port and garage is located to the west of the dwelling.</p> <p>A timber picket fence encloses the property.</p> <p>The dwelling displays architectural features of a heritage style and is representative of the local development of this period, being of historical significance for the HCA.</p>		<p>The front door and corresponding façade windows are contemporary styles.</p> <p>All visible windows are modern sliding designs, likely replacing original sash designs.</p>

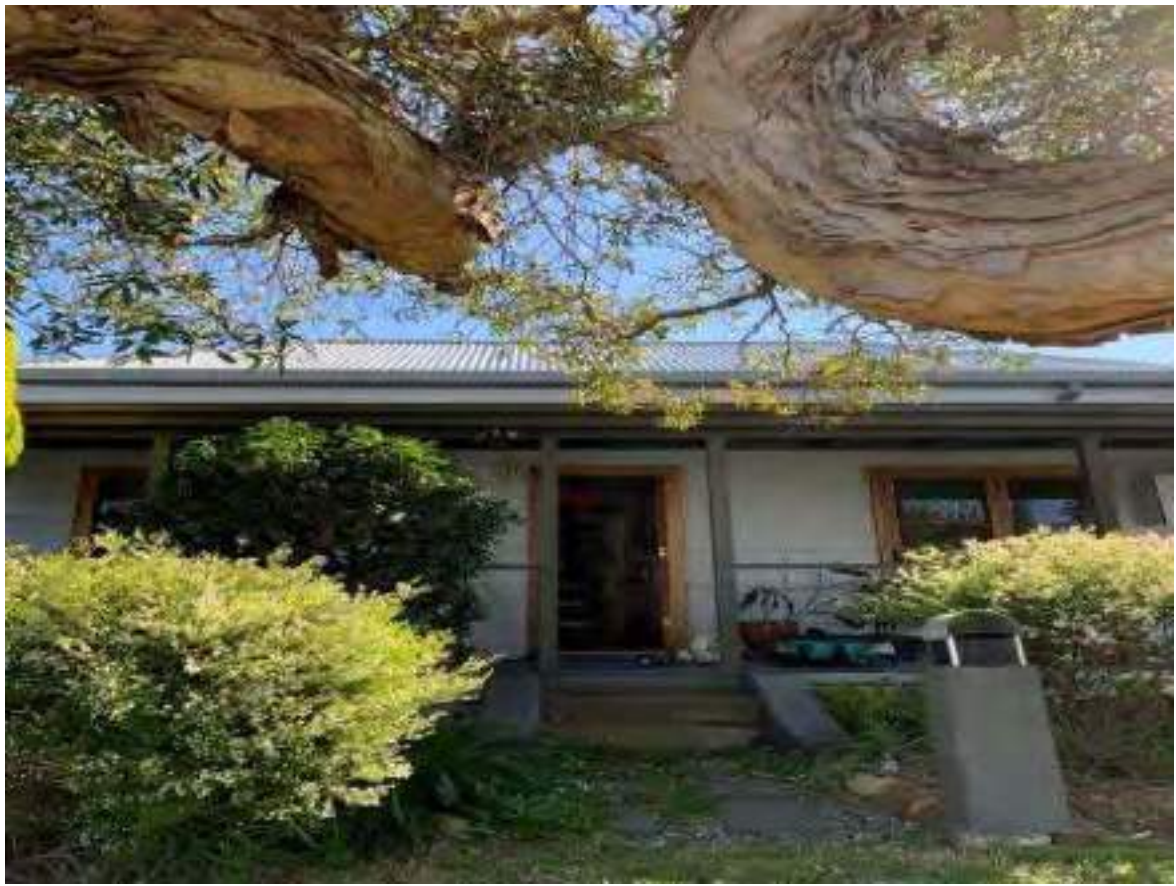
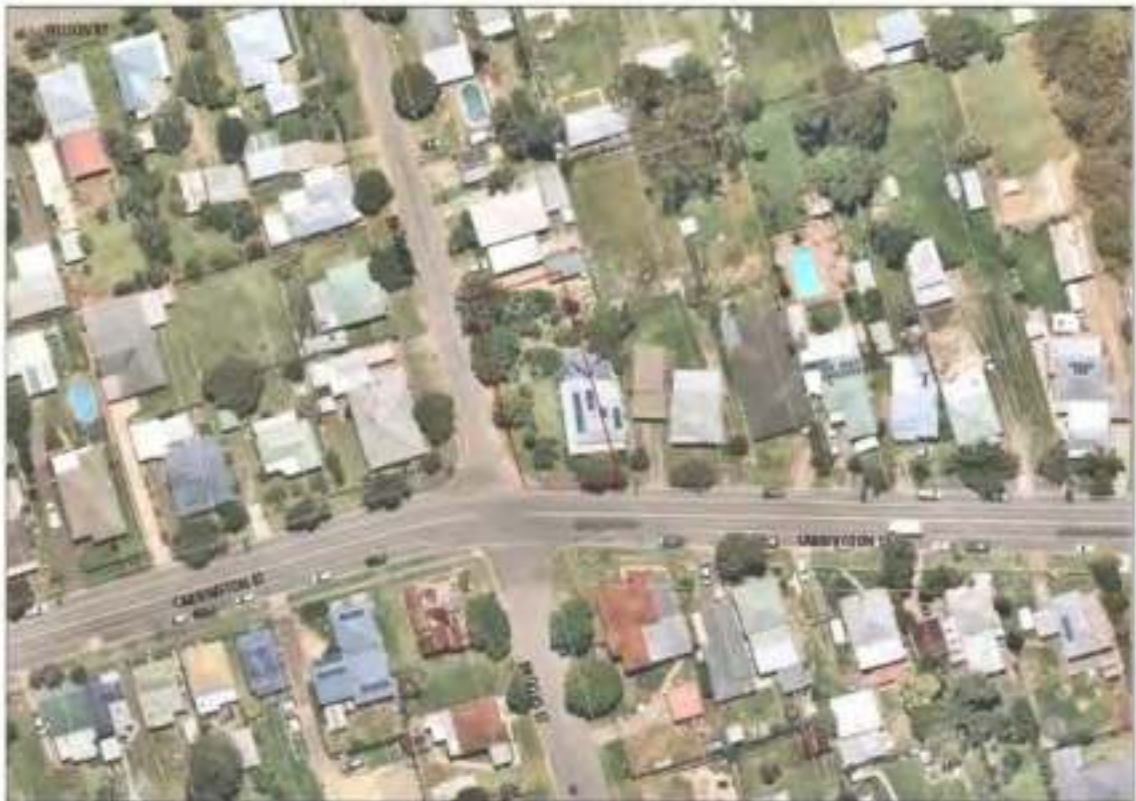
29 CARRINGTON STREET, WEST WALLSEND 2286

Conservation Area Contribution Level	Est. Construction Date	Previous studies and/or community input
Contributory 1	1890–1915	No prior heritage investigations and no additional information required.
Assessment Text		Observed Modifications
<p>Single story Vernacular 'Mining Cottage' style dwelling with Colourbond hipped roof and weatherboard cladding. The veranda roof is skillion and supported by timber posts.</p> <p>The veranda is partially enclosed by simple timber and wire balustrade, with timber flooring.</p> <p>The front door is centrally located with timber frame, with timber framed sash windows either side.</p> <p>The dwelling is partially obscured by mature vegetation growth.</p> <p>The dwelling displays architectural features of a heritage style and is representative of the local development of this period, being of historical significance for the HCA.</p>		<p>The veranda balustrade is a contemporary design and a recent modification.</p> <p>The front door and façade windows are recent modifications, however have been installed in a sympathetic style and do not detract.</p>

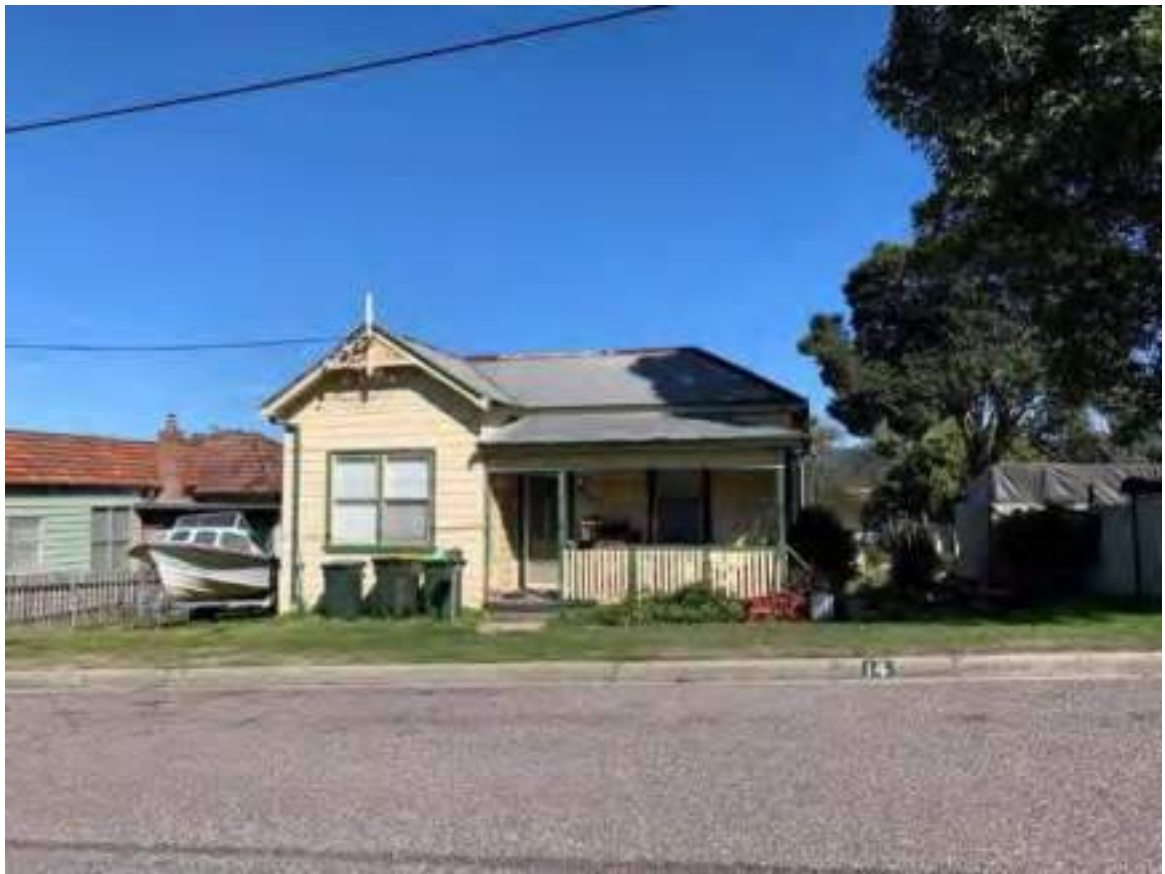
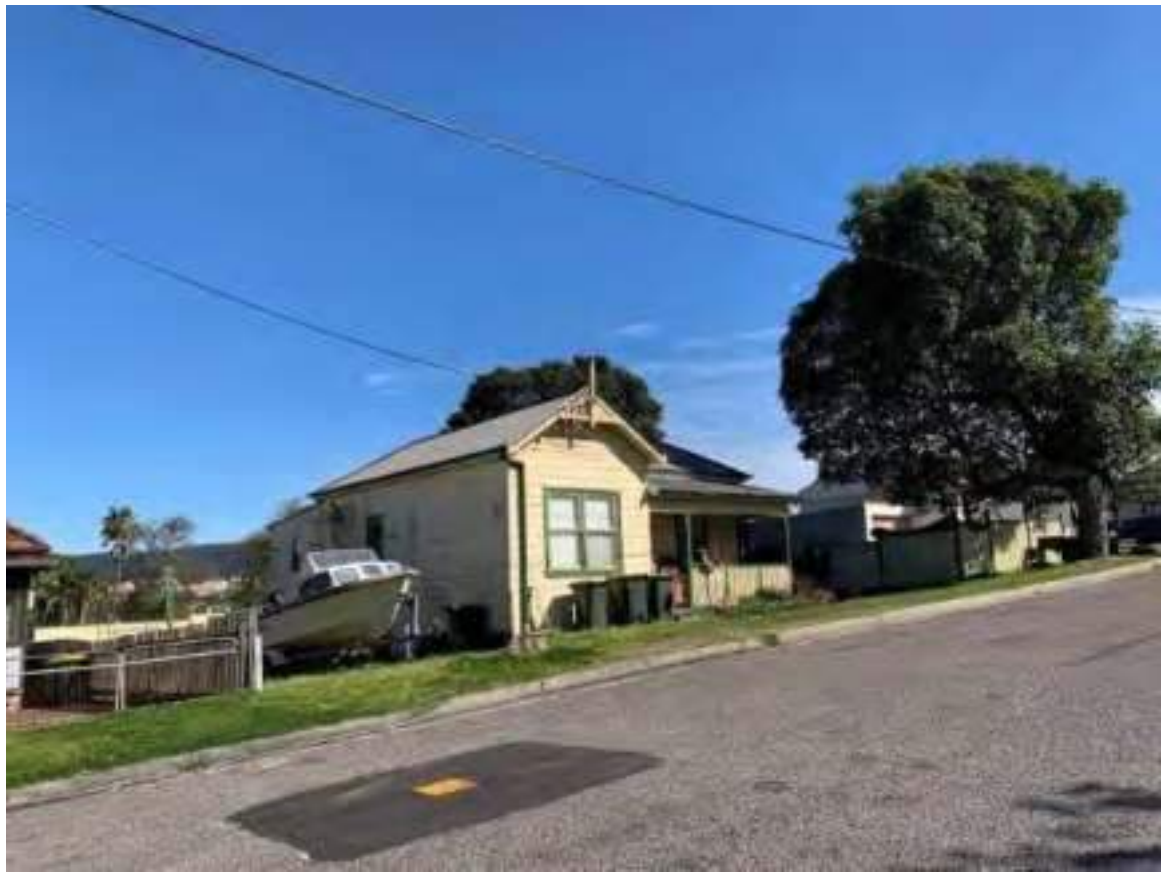
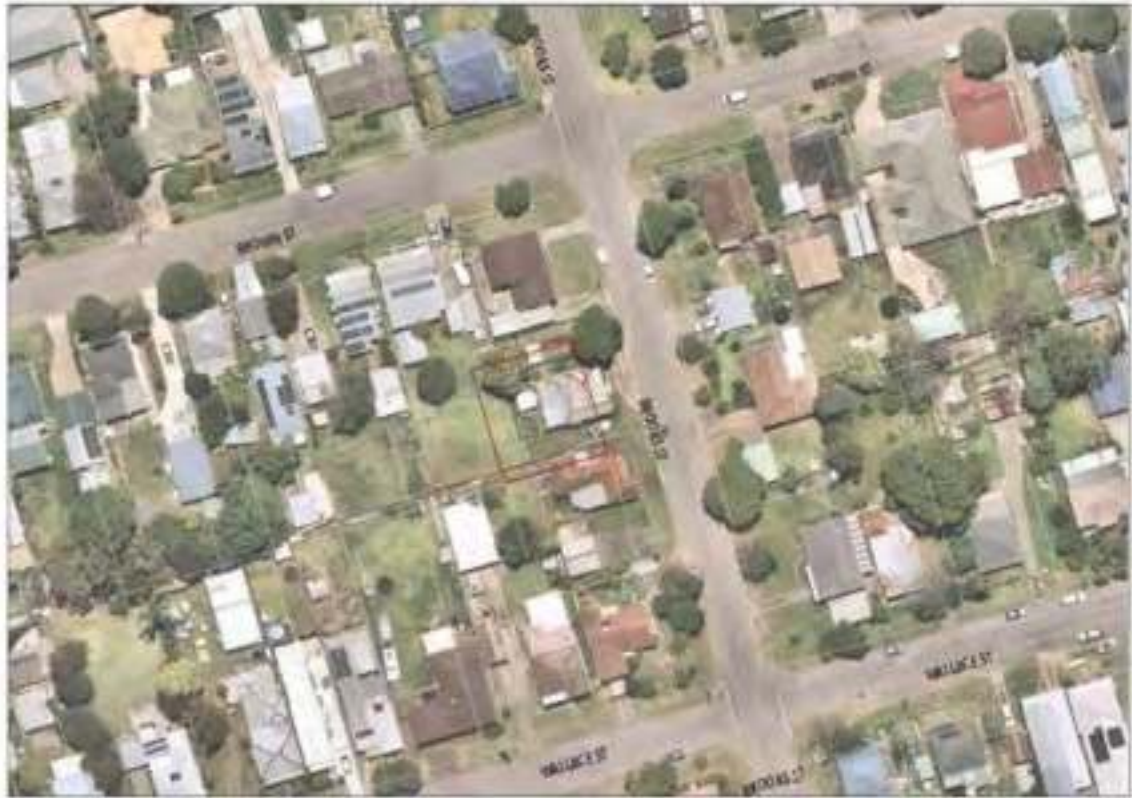
14 BROOKS STREET, WEST WALLSEND 2286

Conservation Area Contribution Level	Est. Construction Date	Previous studies and/or community input
Contributory 1	1900–1930	No prior heritage investigations and no additional information required
Assessment Text		Observed Modifications
<p>A single story ‘workmen’s’ cottage style dwelling with projecting gable roof and timber weatherboard cladding. The remaining structure has a hipped roof, all Colourbond. The veranda roof is hipped and supported by timber posts.</p> <p>The veranda is partially enclosed by timber balustrade, with timber flooring and a single concrete step leading to the landing.</p> <p>The front door is centrally located with security screen. Timber framed sash windows are either side.</p> <p>The gable has decorative shingles, timber finial and fretwork.</p> <p>A rendered brick chimney is visible on the southern side of the dwelling.</p> <p>The dwelling displays architectural features of a heritage style and is representative of the local development of this period, being of historical significance for the HCA.</p>		<p>The veranda balustrade is likely a contemporary addition, replacing an original timber design.</p> <p>The white security screen of the front door juxtaposes the heritage features of the dwelling.</p> <p>The chimney shaft has been removed.</p>

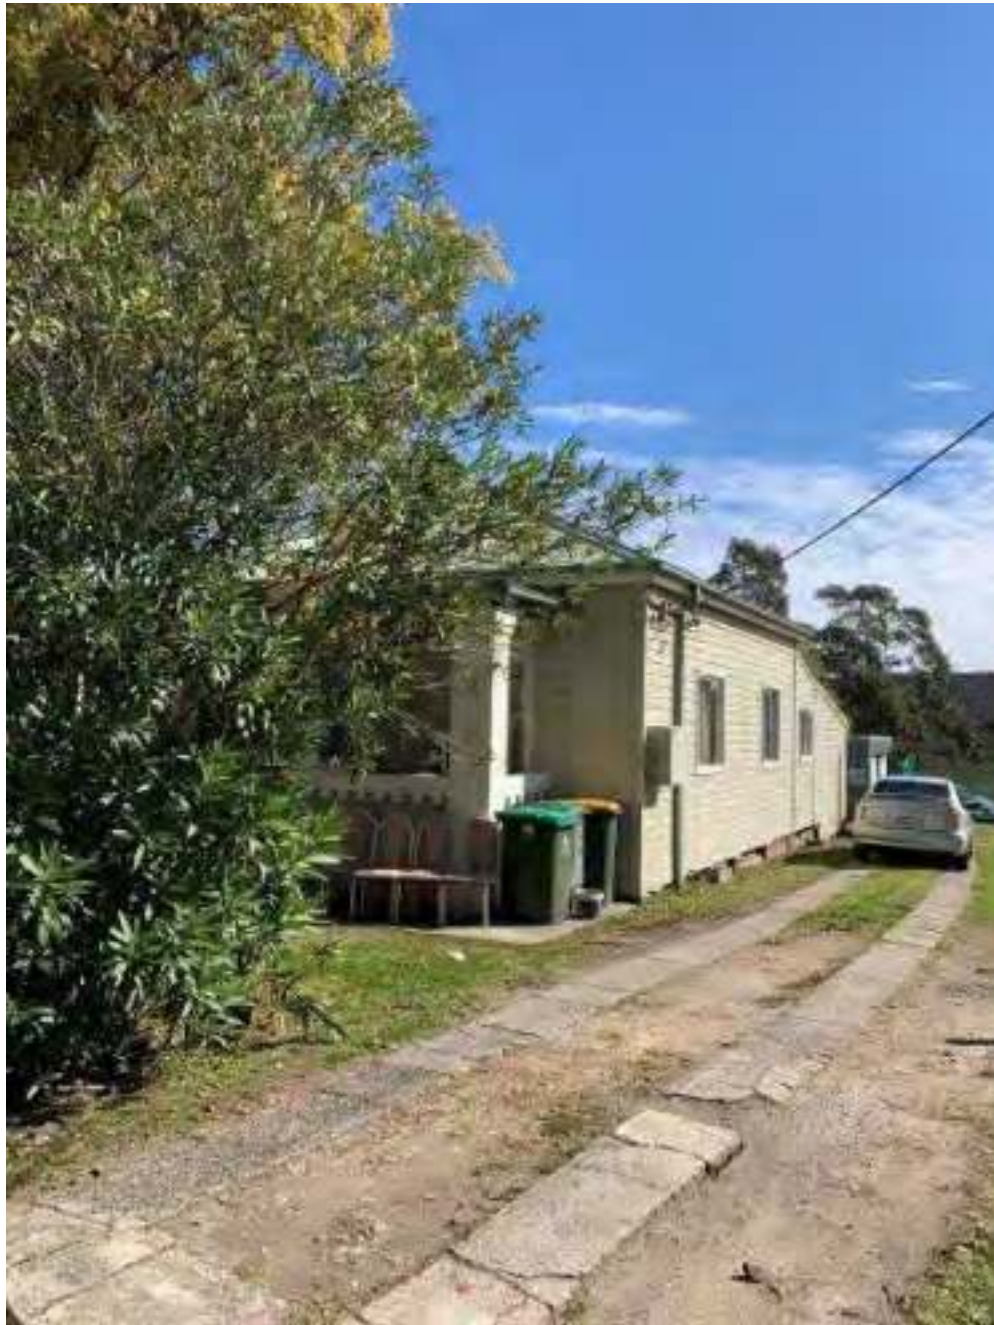
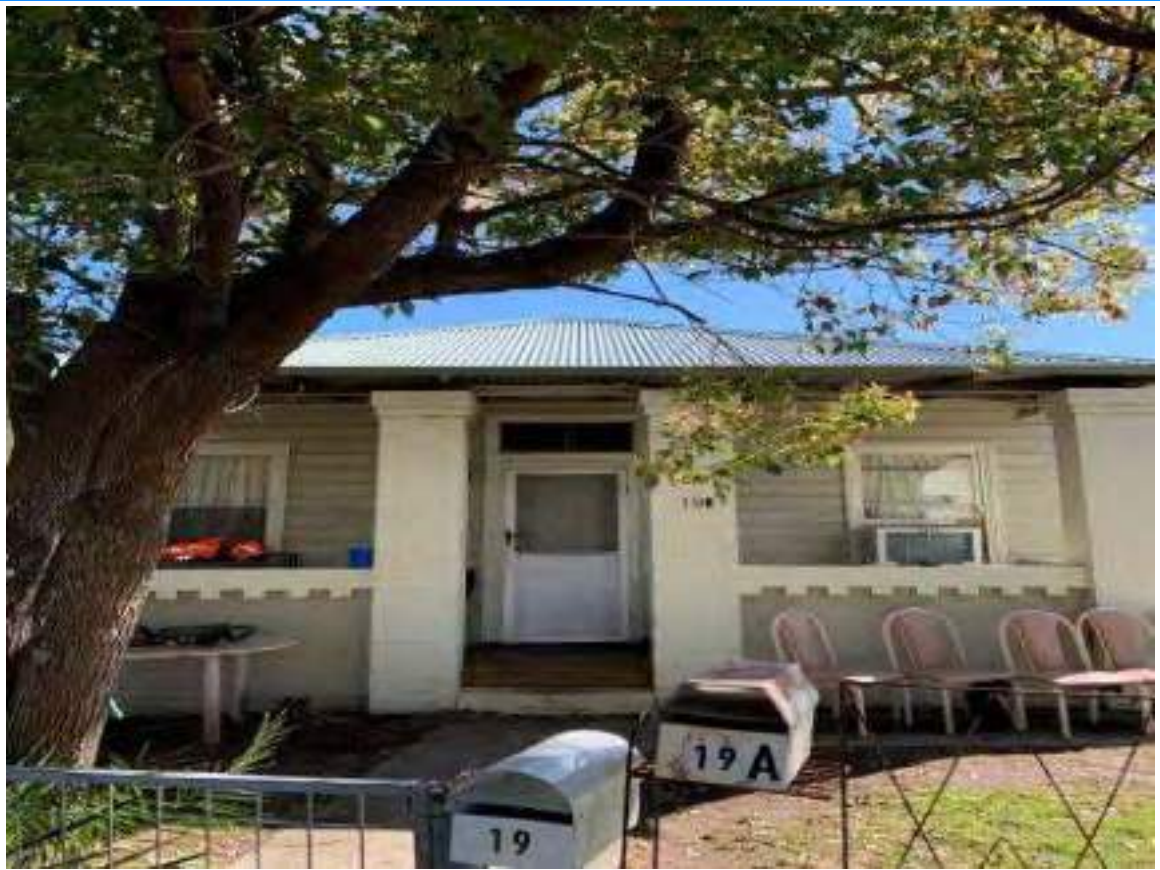
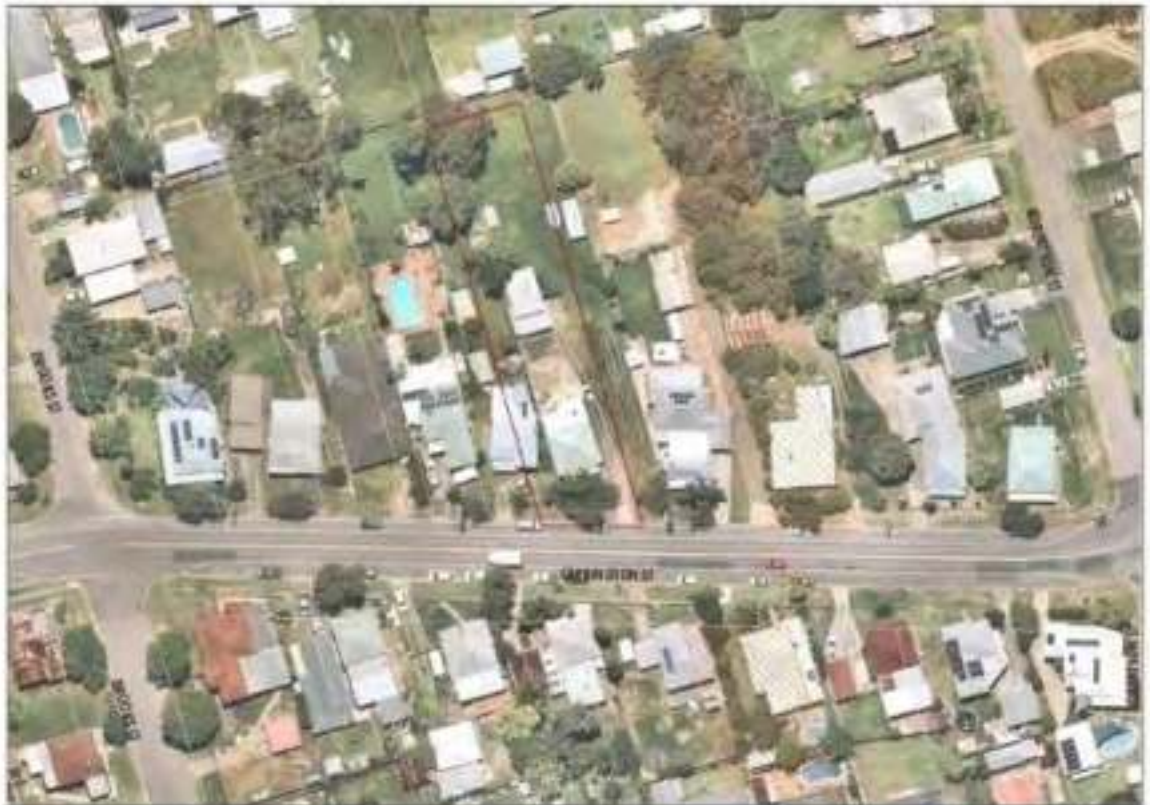
19 CARRINGTON STREET, WEST WALLSEND 2286

Conservation Area Contribution Level	Est. Construction Date	Previous studies and/or community input
Contributory 1	1920–1945	No prior heritage investigations and no additional information required
Assessment Text		Observed Modifications
<p>Single story Inter-War cottage style dwelling with hipped Colourbond roof and weatherboard cladding. The veranda is skillion and support by brick pillars.</p> <p>The veranda is partially enclosed by brick veranda wall with dental coursework features, with timber flooring and a single masonry step leading to the landing.</p> <p>The front door is centrally located with timber frame and fanlight. Sash windows are found on either side.</p> <p>A brickwork chimney is located at the northern end of the dwelling.</p> <p>The dwelling was partially obscured by mature vegetation.</p> <p>The dwelling displays architectural features of a heritage style and is representative of the local development of this period, being of historical significance for the HCA.</p>		<p>No prior heritage investigations and no additional information required.</p>
