APPENDIX 2

Building Assessment Sheets (Inventory Sheets)

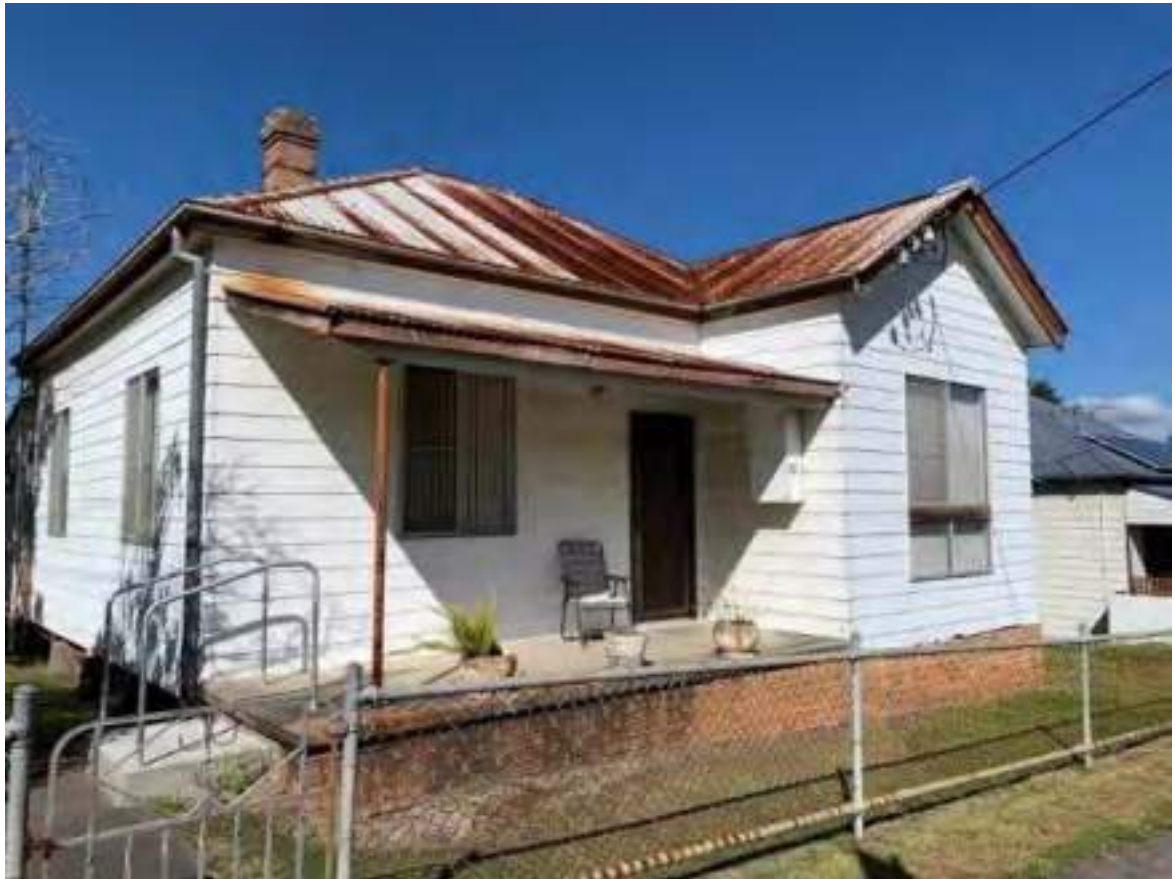
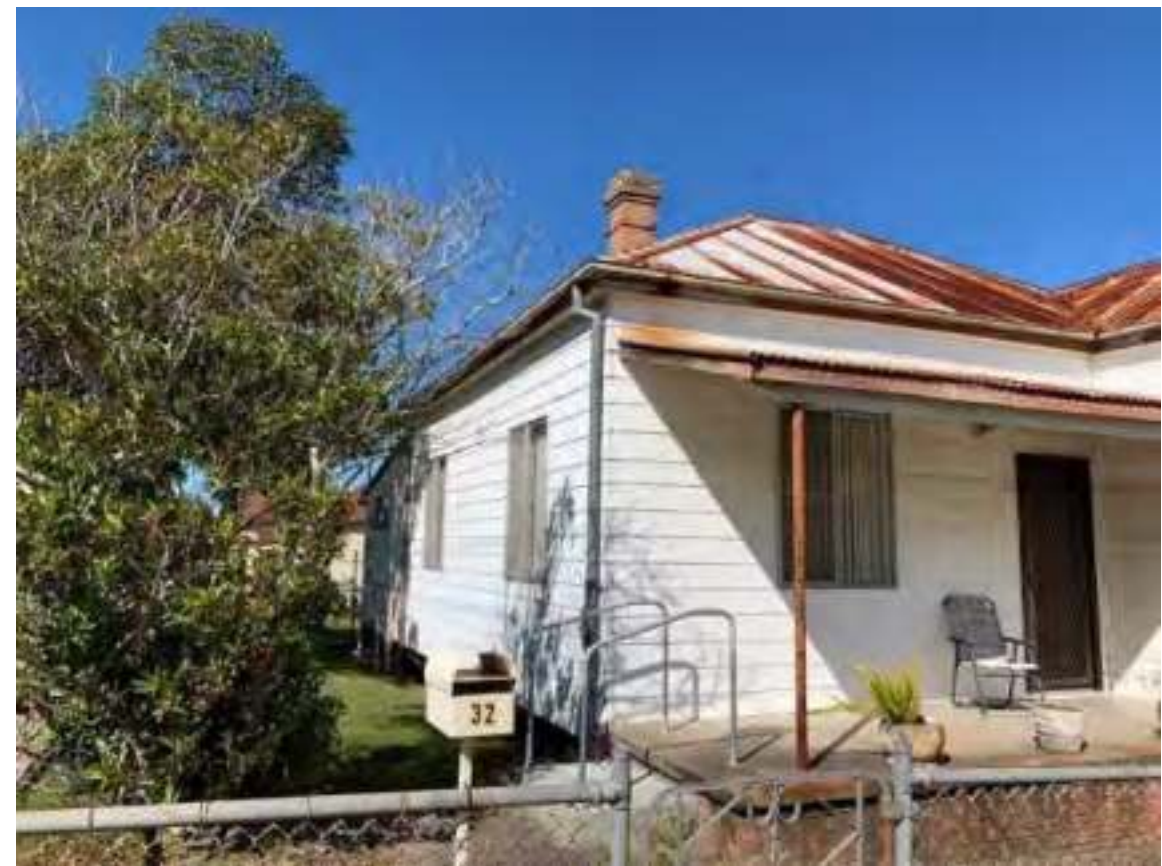
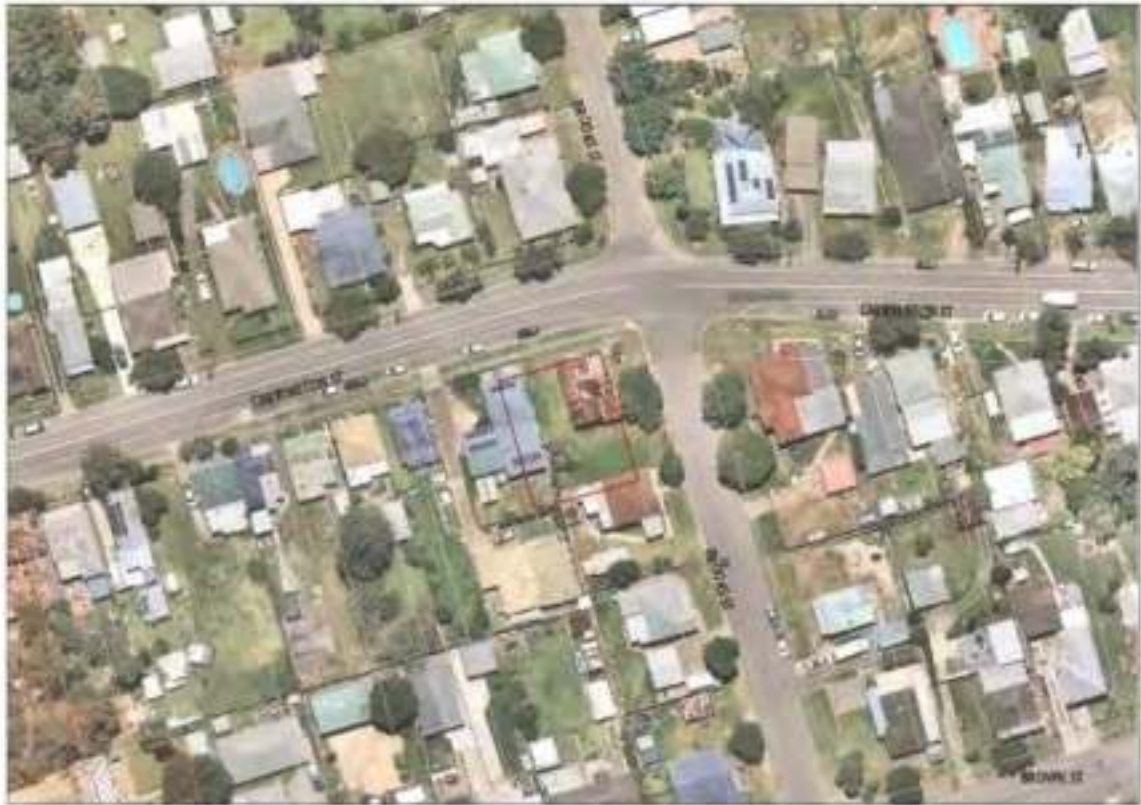
32 CARRINGTON STREET, WEST WALLSEND 2286

Conservation Area Contribution Level	Est. Construction Date	Previous studies and/or community input
Contributory 1	1900–1920	No prior heritage investigations and no additional information required
Assessment Text		Observed Modifications
<p>Single storey simple Federation ‘workmen’s cottage’ style dwelling with hipped Colourbond roof with gable projection and weatherboard cladding. The veranda roof is skillion.</p> <p>A brickwork chimney is visible on the eastern side of the dwelling, with double corbel decorations.</p> <p>The gable has extended eaves but no other decorative features.</p> <p>The dwelling displays architectural features of a heritage style and is representative of the local development of this period, being of historical significance for the HCA.</p>		<p>All visible windows have been replaced with contemporary sliding designs.</p> <p>A cement step has been installed on the eastern side of the dwelling, with support railing.</p>

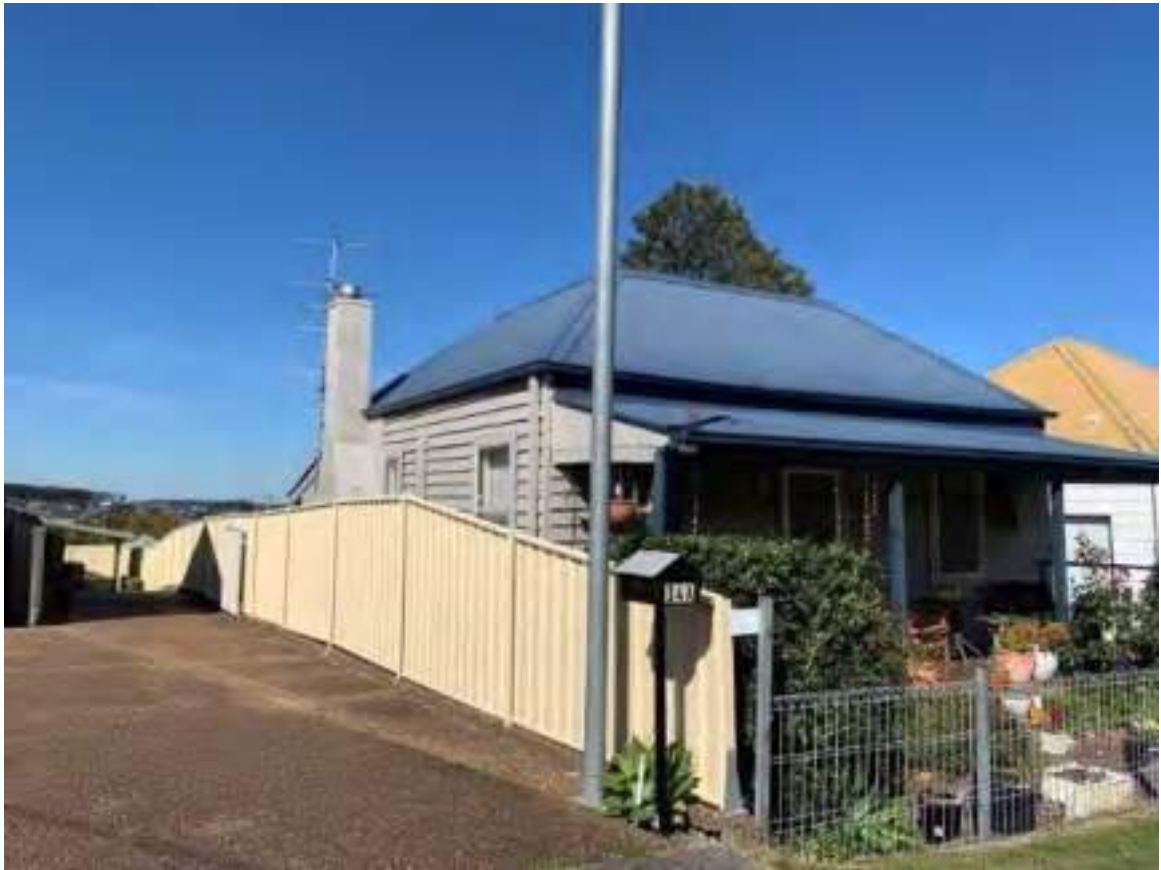
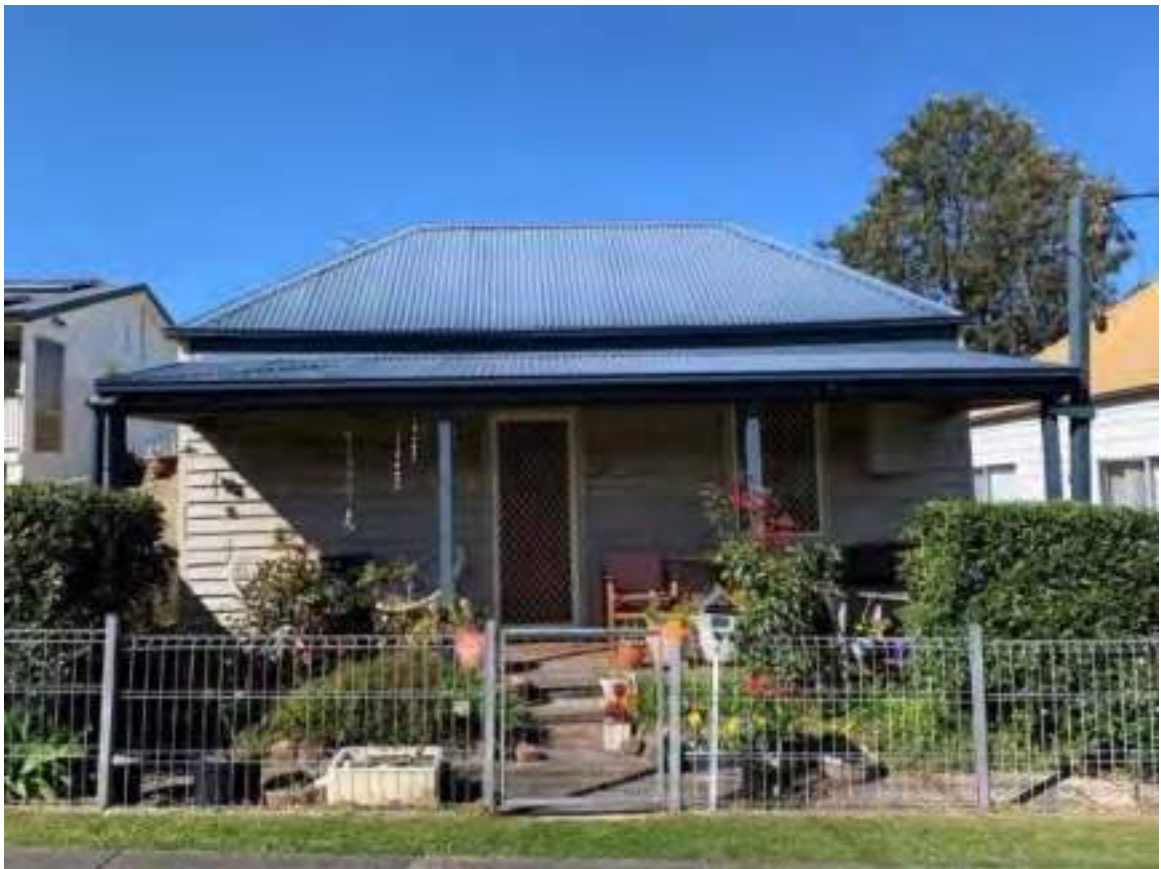
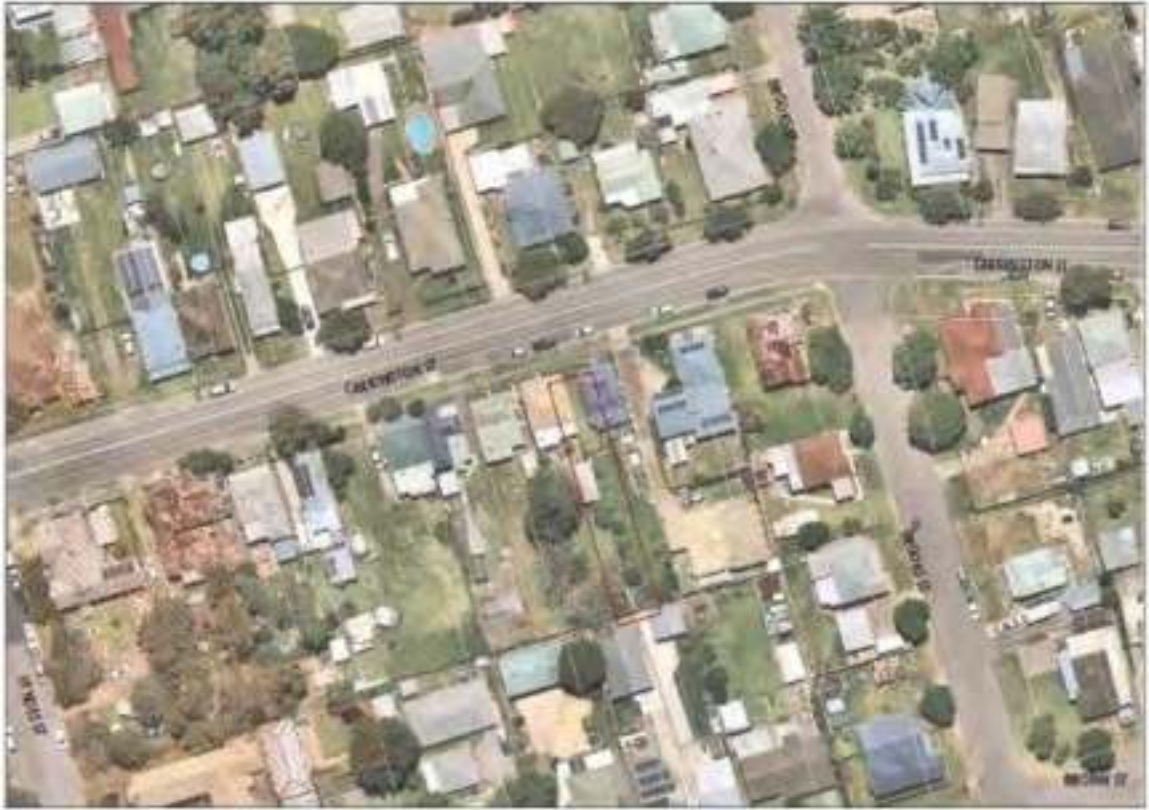
36 CARRINGTON STREET, WEST WALLSEND 2286

Conservation Area Contribution Level	Est. Construction Date	Previous studies and/or community input
Contributory 1	1890–1910	No prior heritage investigations and no additional information required
Assessment Text		Observed Modifications
<p>Single story Vernacular ‘Mining Cottage’ style dwelling with Colourbond hipped roof and weatherboard cladding. The veranda roof is skillion and supported by timber posts.</p> <p>The veranda is open with no balustrade and timber flooring.</p> <p>The front door is centrally located with a metal security screen and sash window on the western side.</p> <p>A rendered brick chimney is visible on the eastern side of the dwelling.</p> <p>A metal fence encloses the property.</p> <p>The dwelling displays architectural features of a heritage style and is representative of the local development of this period, being of historical significance for the HCA.</p>		<p>The eastern front façade window has been removed, creating a solid wall.</p> <p>The security screens of the front door and western front façade window are contemporary additions and juxtapose the heritage style of the dwelling.</p>

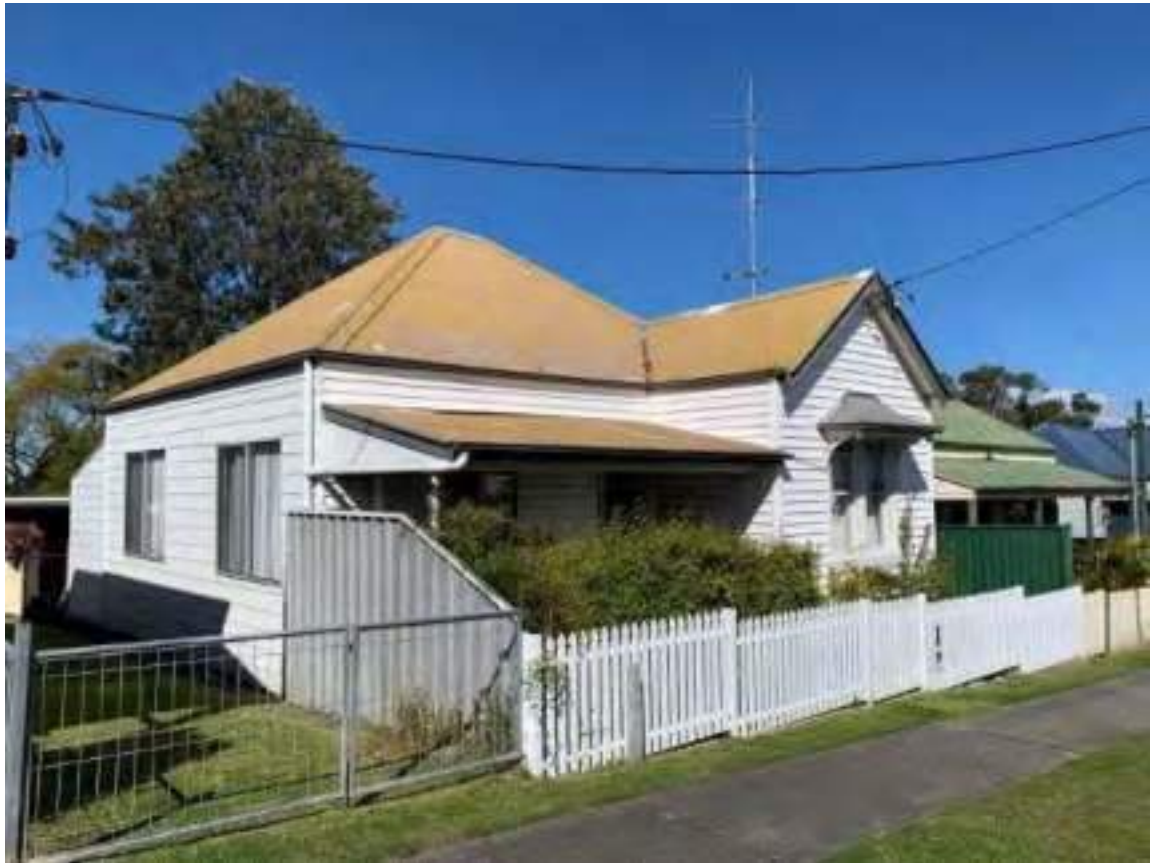
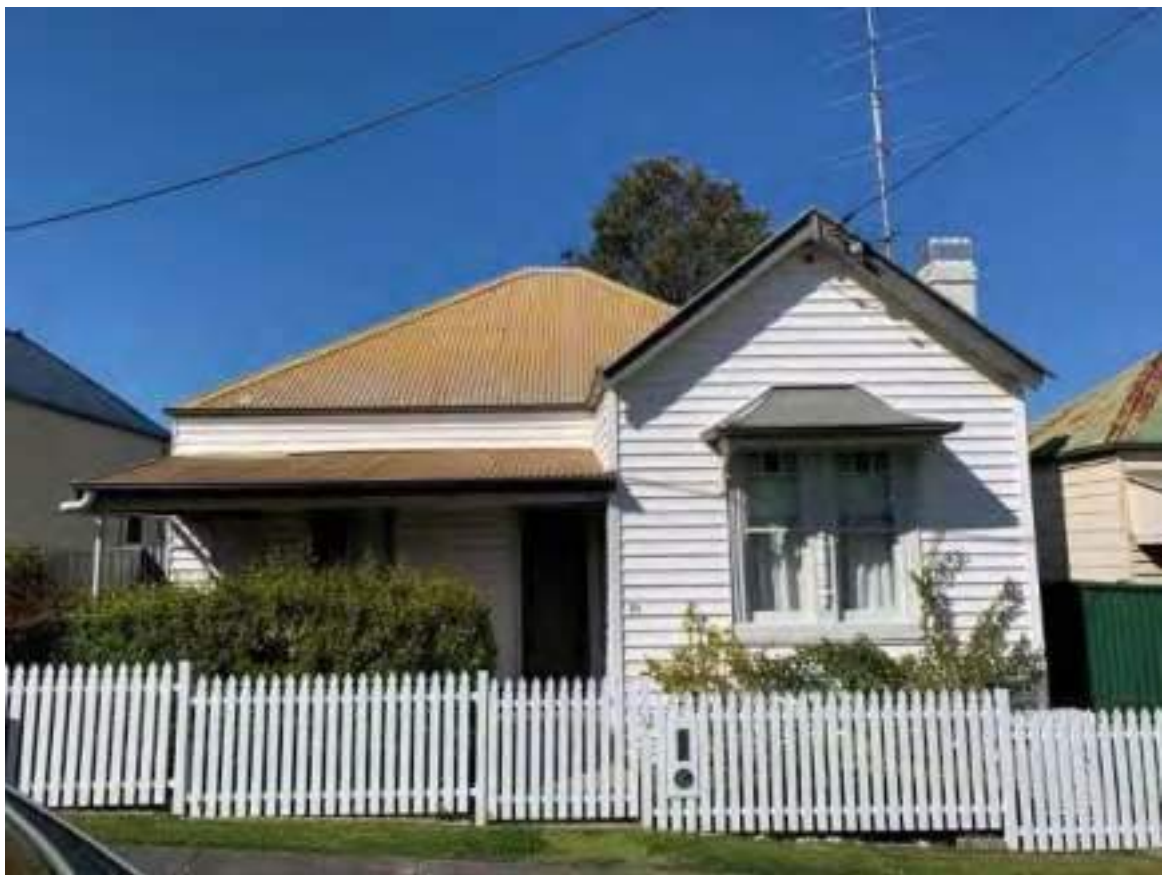
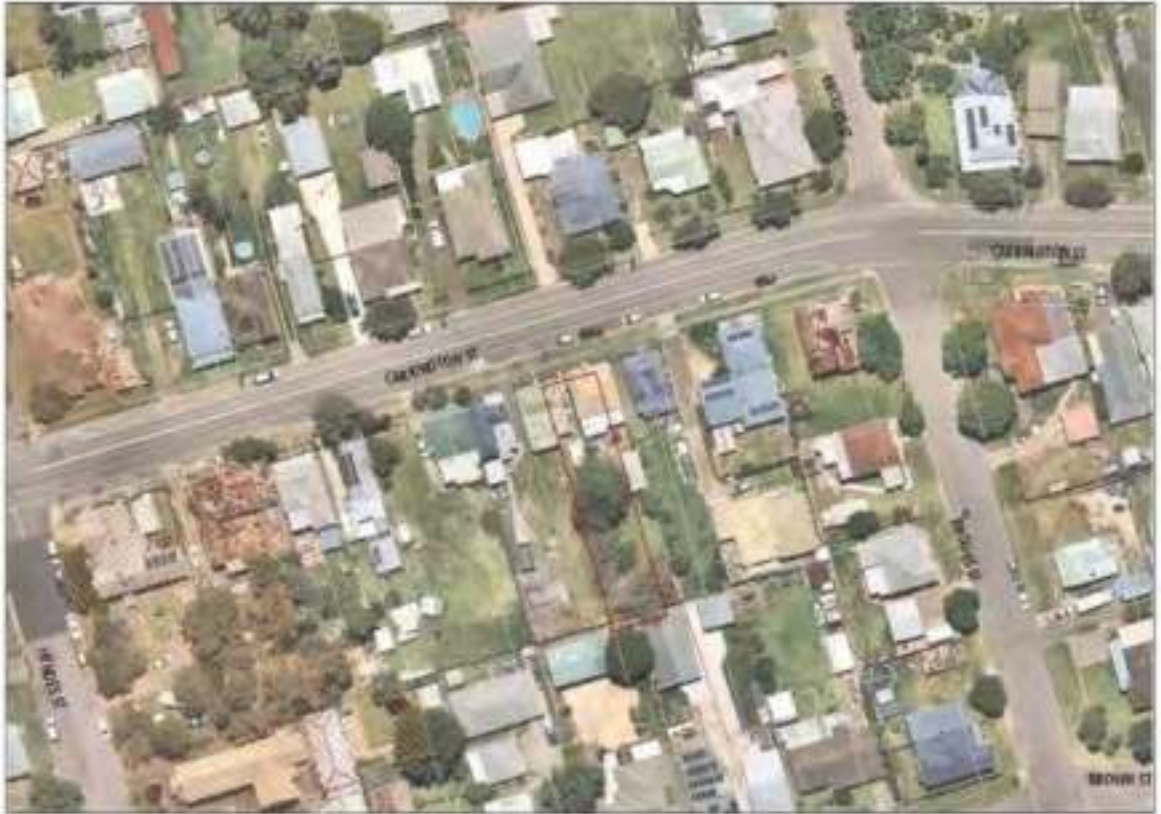
38 CARRINGTON STREET, WEST WALLSEND 2286

Conservation Area Contribution Level	Est. Construction Date	Previous studies and/or community input
Contributory 1	1900–1915	No prior heritage investigations and no additional information required
Assessment Text		Observed Modifications
<p>A single story ‘workmen’s’ cottage style dwelling with projecting gable roof and timber weatherboard cladding. The remaining structure has a hipped roof, all Colourbond. The veranda roof is skillion and supported by timber posts.</p> <p>The veranda is open with no balustrade.</p> <p>The front door is centrally located with a metal security screen and sliding window to the east.</p> <p>The gable has extended barge boards and frilled metal hood, with coloured pane sash windows and an elaborately carved timber pilaster is situated between the two sash windows.</p> <p>A timber picket fence encloses the property.</p> <p>The dwelling displays architectural features of a heritage style and is representative of the local development of this period, being of historical significance for the HCA.</p>		<p>Some windows have been replaced with contemporary sliding designs.</p>

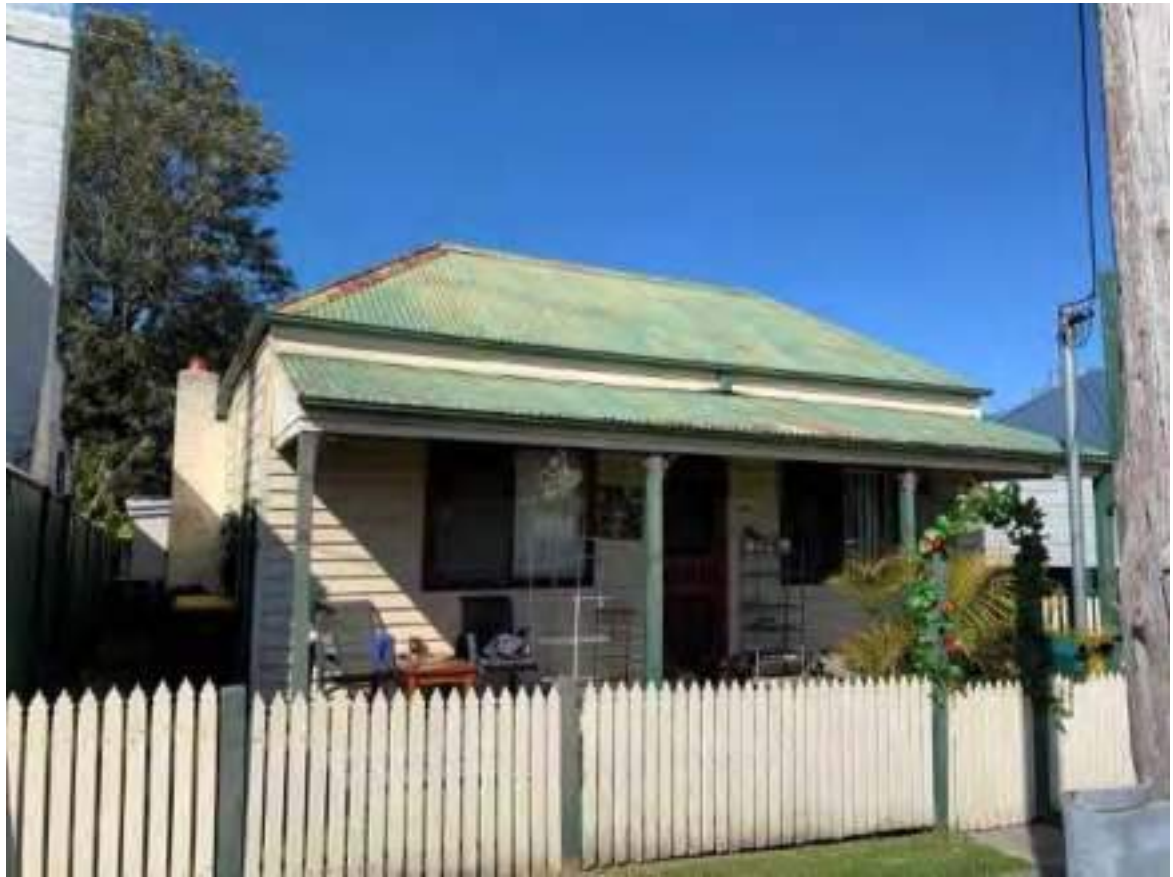
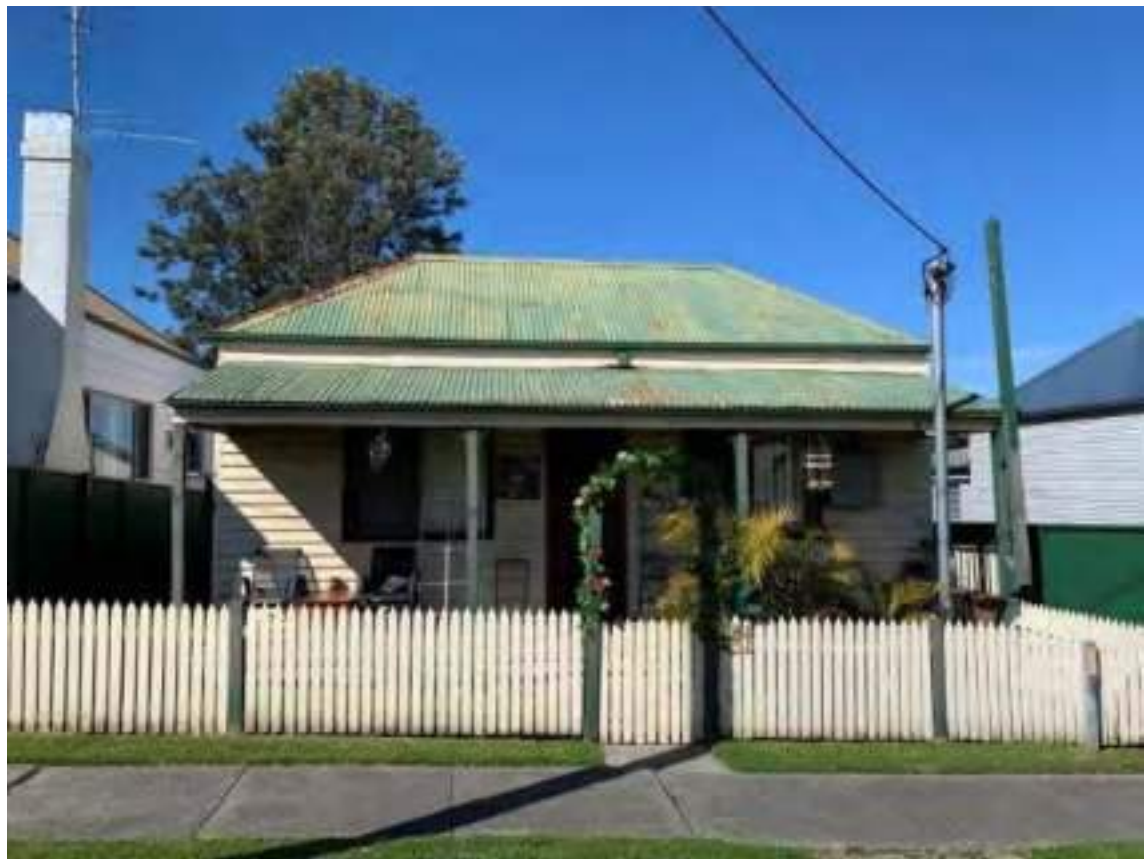
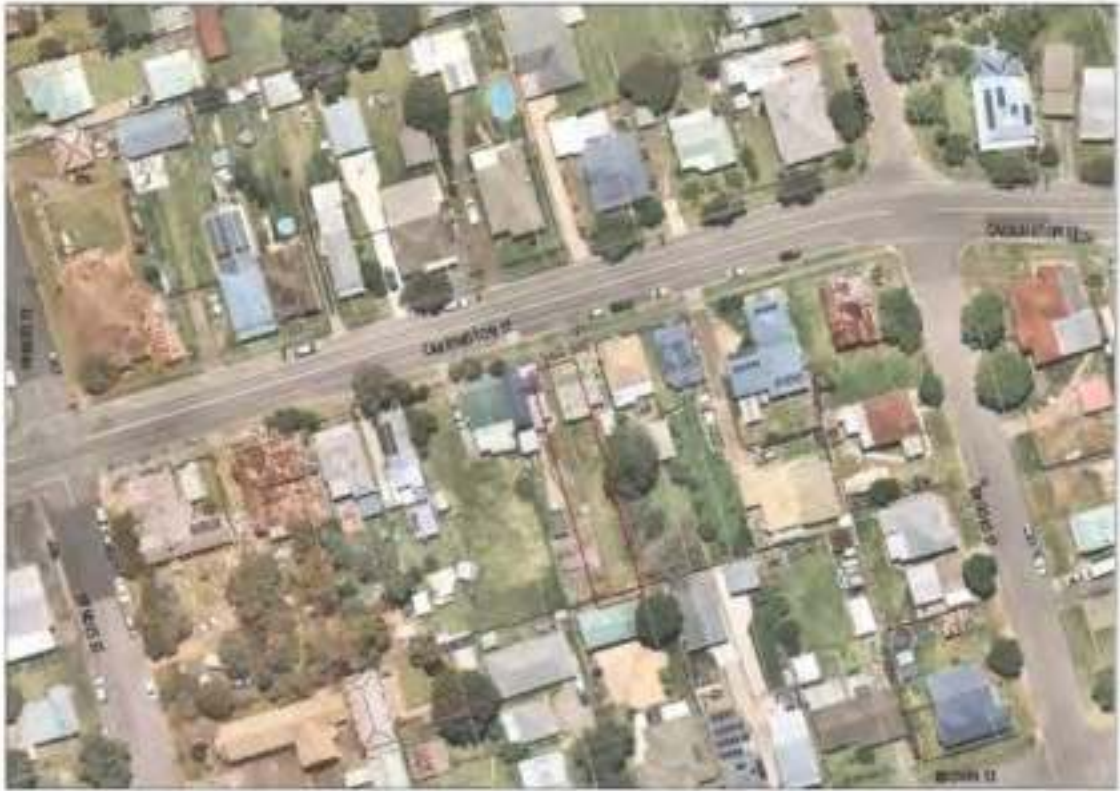
40 CARRINGTON STREET, WEST WALLSEND 2286

Conservation Area Contribution Level	Est. Construction Date	Previous studies and/or community input
Contributory 1	1890–1915	No prior heritage investigations and no additional information required
Assessment Text		Observed Modifications
<p>Single story Vernacular ‘Mining Cottage’ style dwelling with hipped Colourbond roof and weatherboard cladding. The veranda roof is skillion and supported by timber post with ornately carved brackets.</p> <p>The veranda is open with no balustrade.</p> <p>The front door is centrally located with decorative metal screen door and sliding windows either side.</p> <p>A timber picket fence encloses the property.</p> <p>The dwelling displays architectural features of a heritage style and is representative of the local development of this period, being of historical significance for the HCA.</p>		<p>Visible windows are contemporary sliding designs, juxtaposing the heritage style of the dwelling.</p>

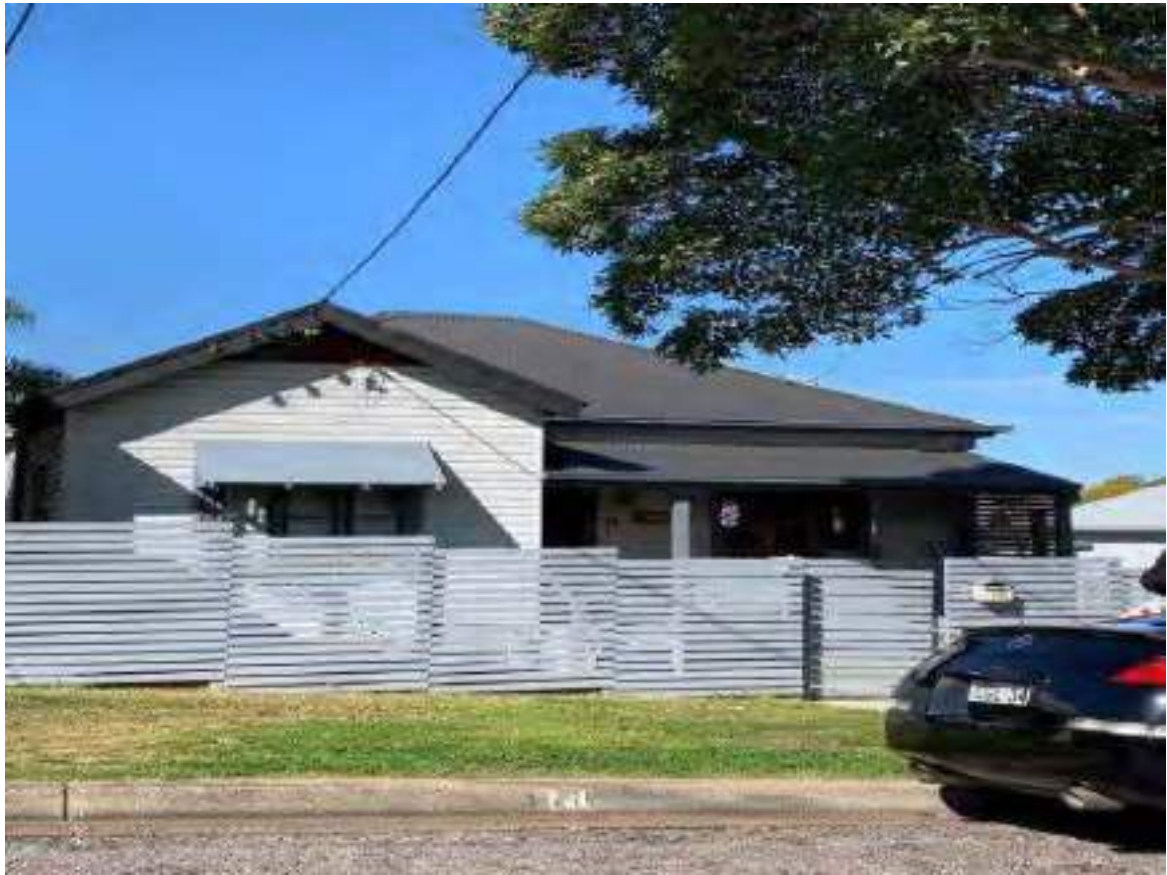
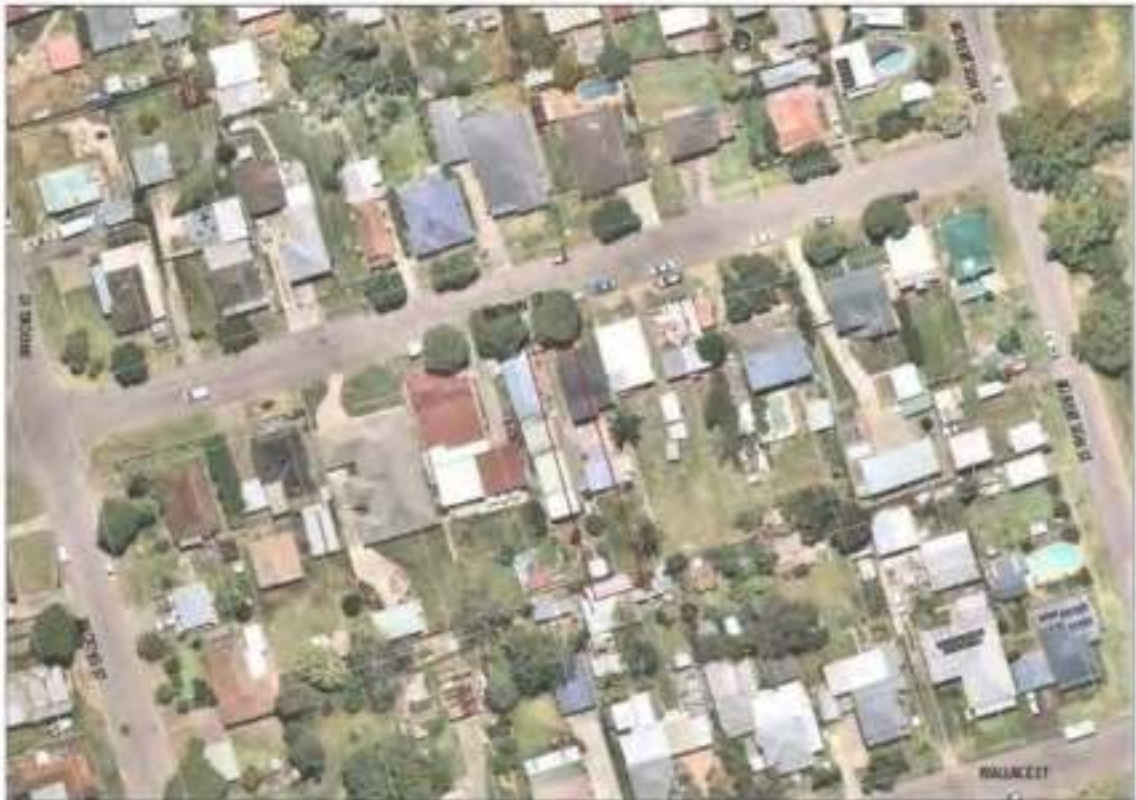
14 BROWN STREET, WEST WALLSEND 2286

Conservation Area Contribution Level	Est. Construction Date	Previous studies and/or community input
Contributory 1	1890–1910	No prior heritage investigations and no additional information required
Assessment Text		Observed Modifications
<p>A single story ‘workmen’s’ cottage style dwelling with projecting gable roof and timber weatherboard cladding. The remaining structure has a hipped roof, all Colourbond. The veranda roof is skillion and supported by timber posts.</p> <p>The veranda is partially enclosed by a timber balustrade. A timber board panel encloses the western end of the veranda.</p> <p>The front door is timber framed with a metal security screen, and triple pane sash windows with colourful decorative panels on either side. the gable window has a decorative timber sill.</p> <p>Timber beam fencing encloses the property and obscures some features.</p> <p>The dwelling displays architectural features of a heritage style and is representative of the local development of this period, being of historical significance for the HCA.</p>		<p>The timber balustrade is a contemporary modification, in association with the property boundary fence.</p>

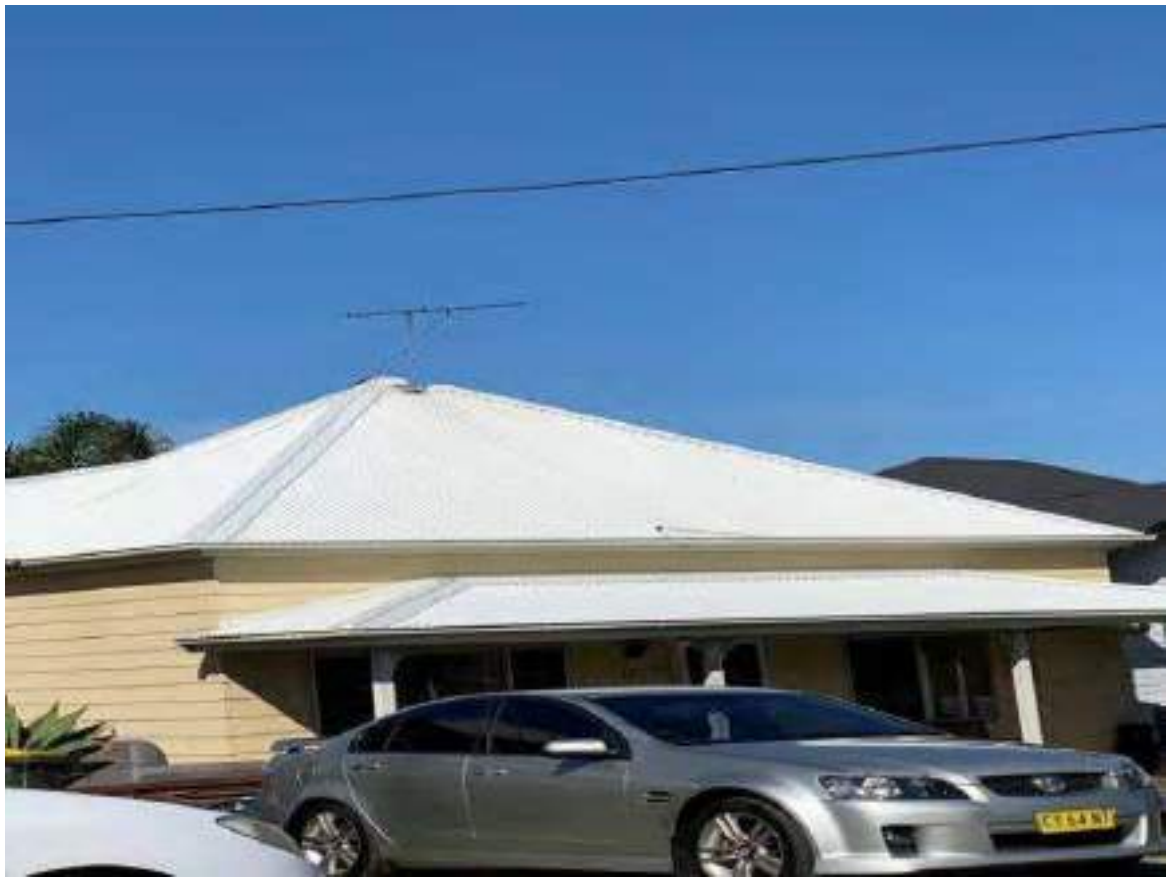
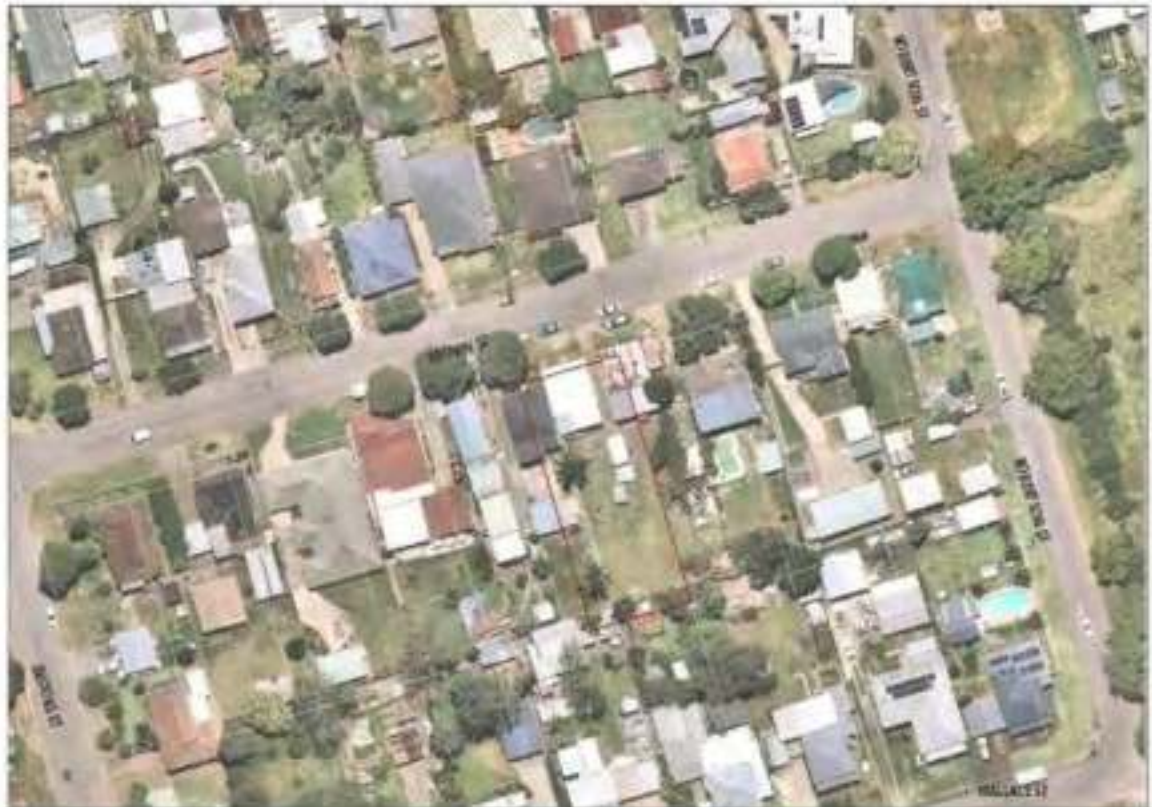
12 BROWN STREET, WEST WALLSEND 2286

Conservation Area Contribution Level	Est. Construction Date	Previous studies and/or community input
Contributory 1	1890–1915	No prior heritage investigations and no additional information required
Assessment Text		Observed Modifications
<p>Single story Vernacular ‘Mining Cottage’ style dwelling with hipped Colourbond roof and weatherboard cladding. The veranda roof is hipped and supported by timber posts with ornately carved brackets.</p> <p>The veranda is open with timber flooring.</p> <p>The front door is timber framed with a metal security screen and sliding windows either side.</p> <p>The dwelling displays architectural features of a heritage style and is representative of the local development of this period, being of historical significance for the HCA.</p>		<p>The visible windows are contemporary sliding styles, likely replacing original sash designs.</p>

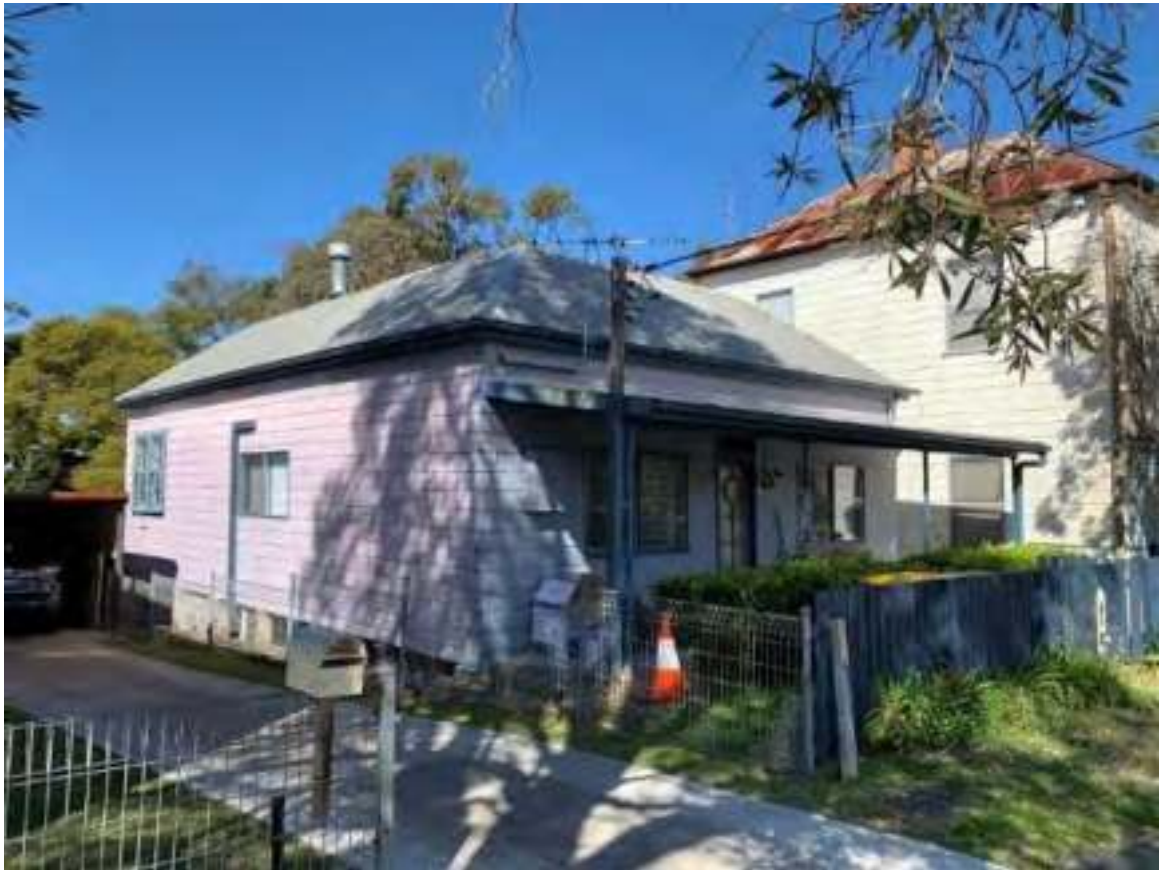
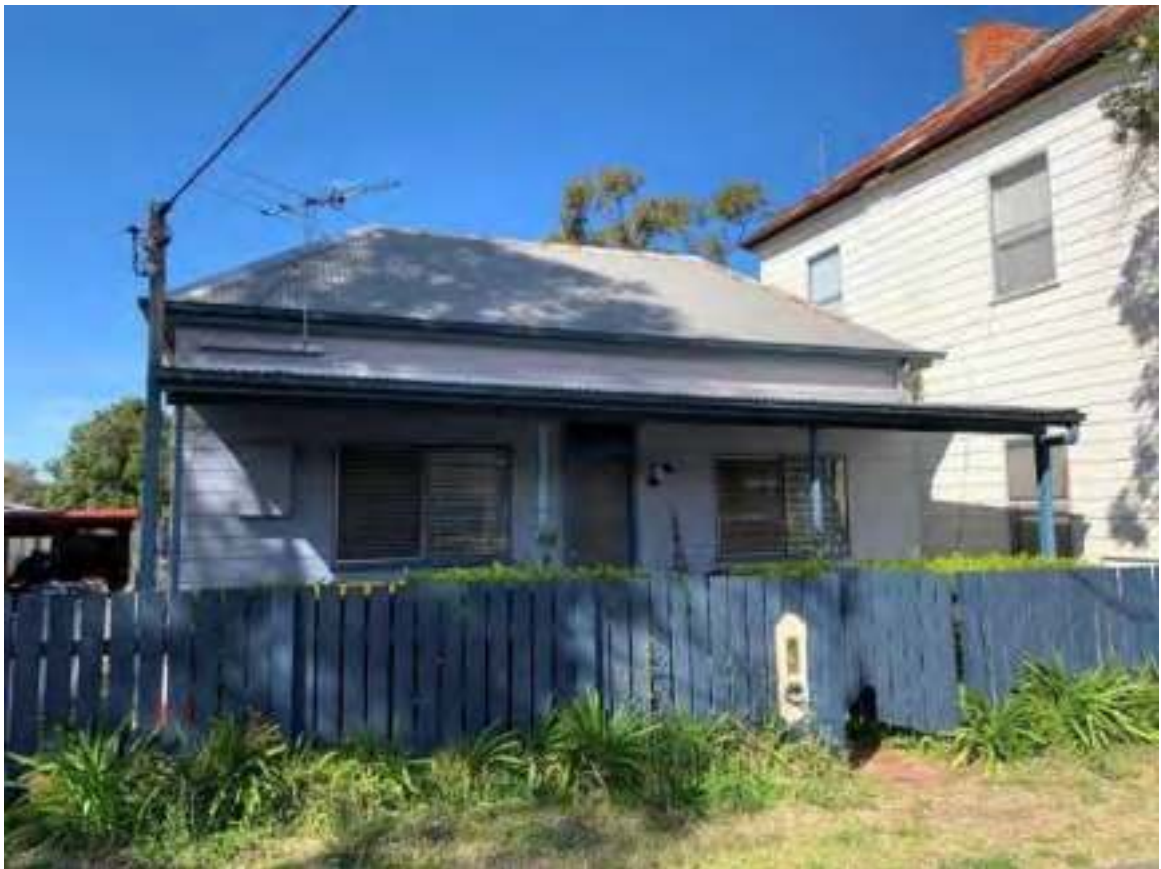
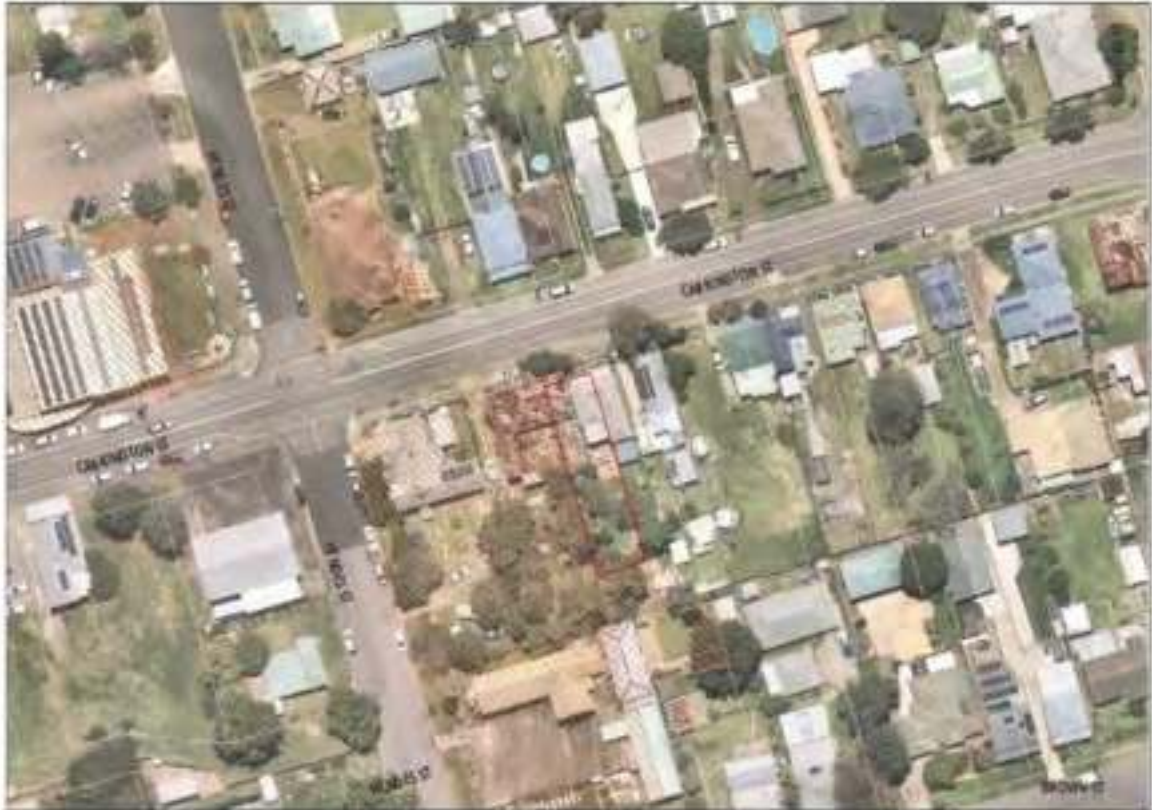
50 CARRINGTON STREET, WEST WALLSEND 2286

Conservation Area Contribution Level	Est. Construction Date	Previous studies and/or community input
Contributory 1	1890–1915	No prior heritage investigations and no additional information required
Assessment Text		Observed Modifications
<p>Single story Vernacular ‘Mining Cottage’ style dwelling with hipped corrugated roof and weatherboard cladding. The veranda roof is skillion and supported by timber posts.</p> <p>The front door is timber framed with a metal security screen and sliding windows on either side.</p> <p>A timber fence encloses the property.</p> <p>The dwelling displays architectural features of a heritage style and is representative of the local development of this period, being of historical significance for the HCA.</p>		<p>All visible windows are contemporary sliding designs, likely replacing original sash designs.</p>
