APPENDIX 2

Building Assessment Sheets (Inventory Sheets)

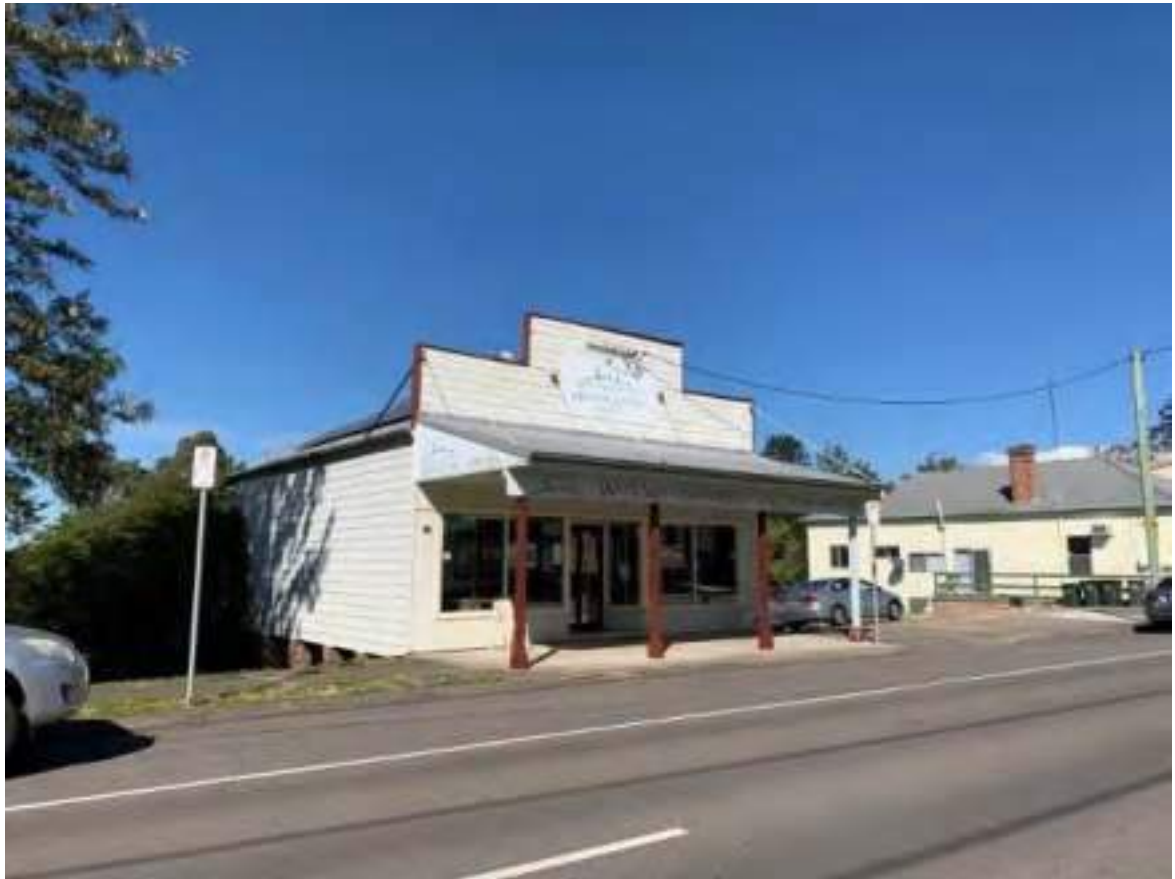
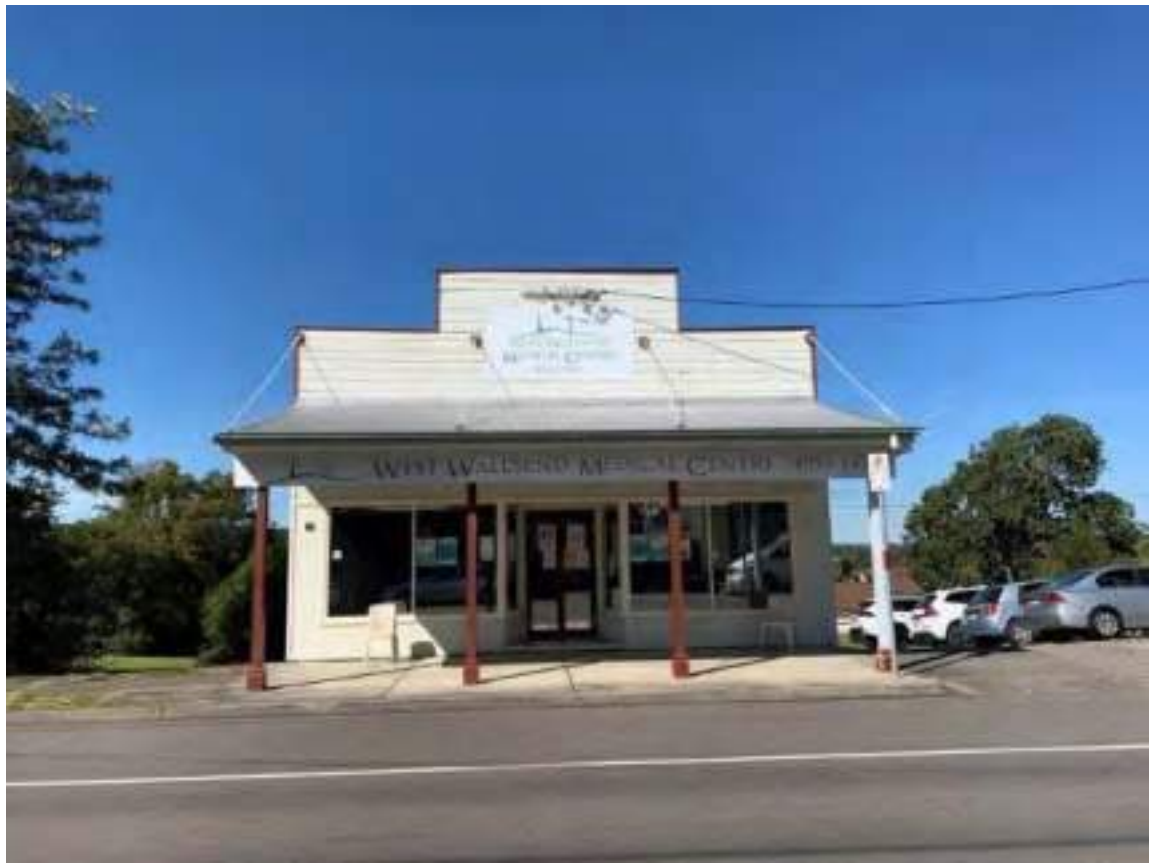
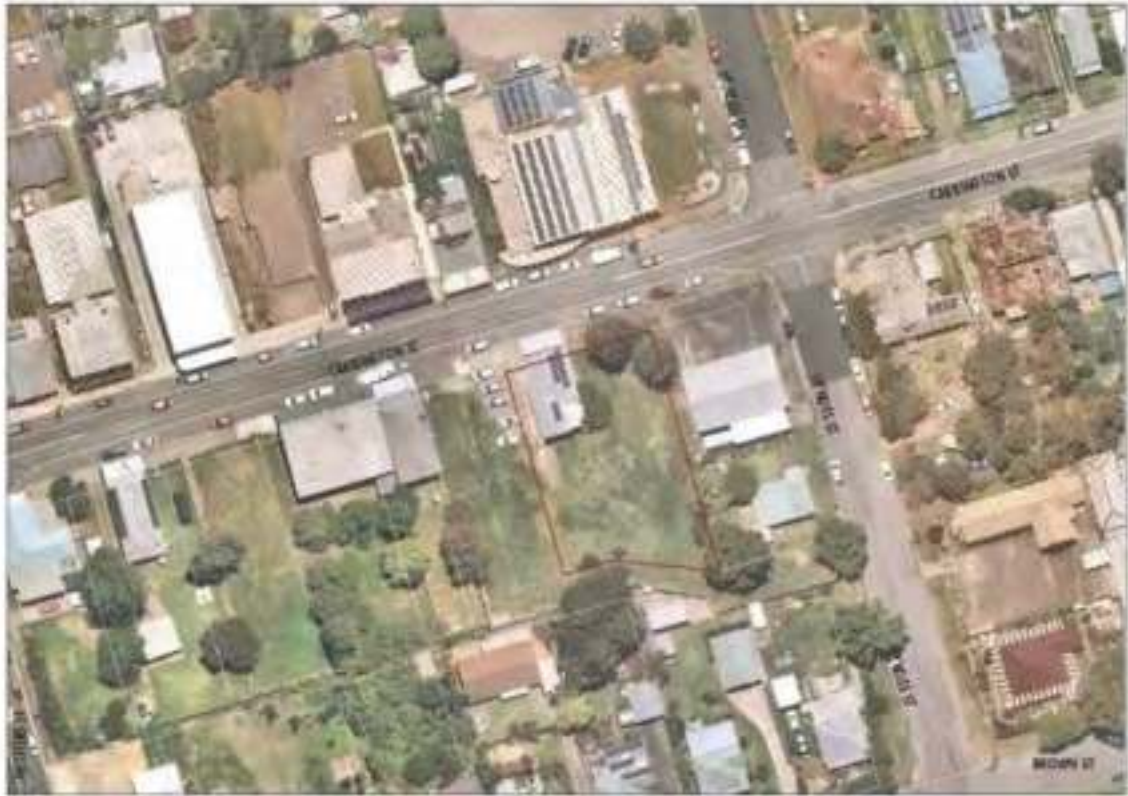
60 CARRINGTON STREET, WEST WALLSEND 2286

Conservation Area Contribution Level	Est. Construction Date	Previous studies and/or community input
Contributory 1	1900–1930	No prior heritage investigations and no additional information required
Assessment Text		Observed Modifications
<p>Single story structure with gable Colourbond roof and weatherboard cladding. The veranda roof is skillion and supported by timber posts. A brick pediment is found above the veranda.</p> <p>The structure is used as a doctors office, with commercial size windows dominating the front façade. The front door is timber framed and composed of glass.</p> <p>The western windows are timber framed sash windows.</p> <p>The dwelling displays architectural features of a heritage style and is representative of the local development of this period, being of historical significance for the HCA.</p>		Signage relating to the medical practice.

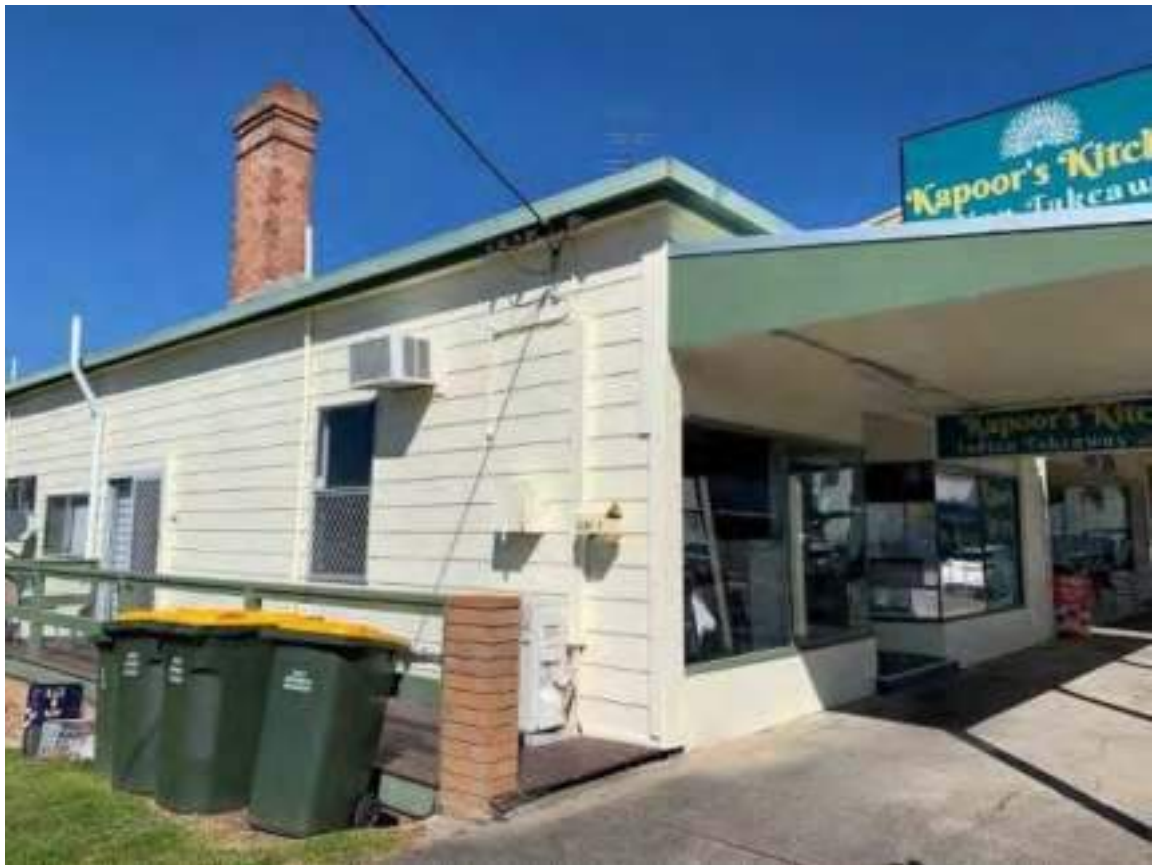
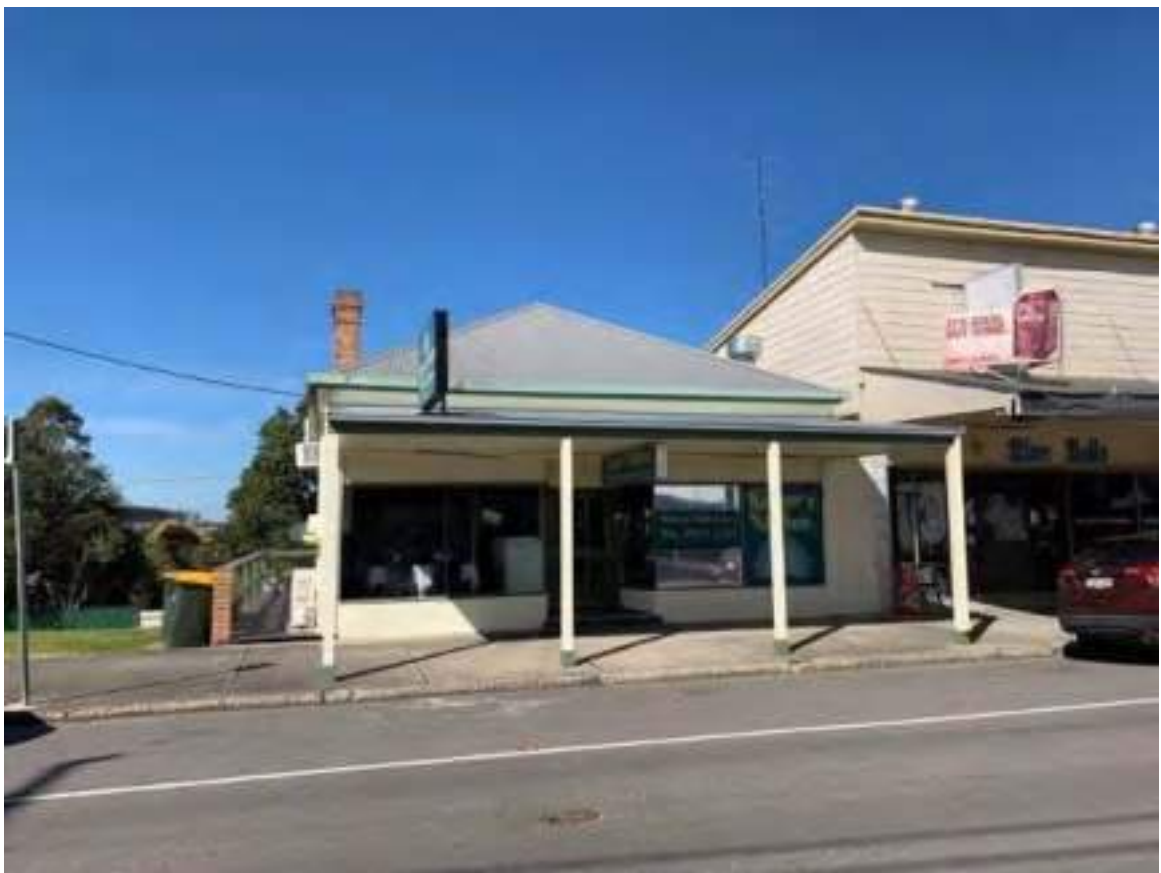
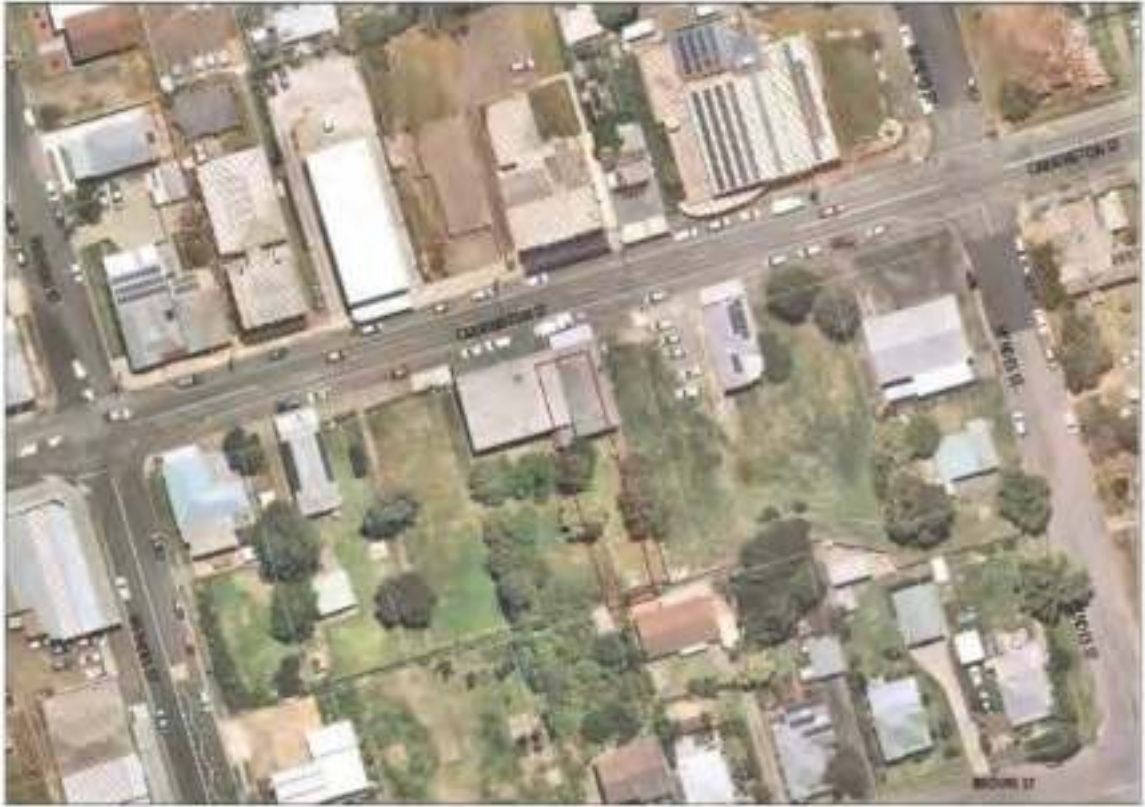
66 CARRINGTON STREET, WEST WALLSEND 2286

Conservation Area Contribution Level	Est. Construction Date	Previous studies and/or community input
Contributory 1	1900–1930	No prior heritage investigations and no additional information required
Assessment Text		Observed Modifications
<p>Single story structure with hipped Colourbond roof and weatherboard cladding. The veranda is skillion and supported by timber posts.</p> <p>The structure is used for commercial purposes, with large windows dominating the front façade. The front door is timber framed and sliding. An additional entrance is visible on the eastern side of the structure, with an associative timber ramp.</p> <p>A brickwork chimney is visible on the eastern side of the dwelling.</p> <p>The dwelling displays architectural features of a heritage style and is representative of the local development of this period, being of historical significance for the HCA.</p>		No modifications observed.

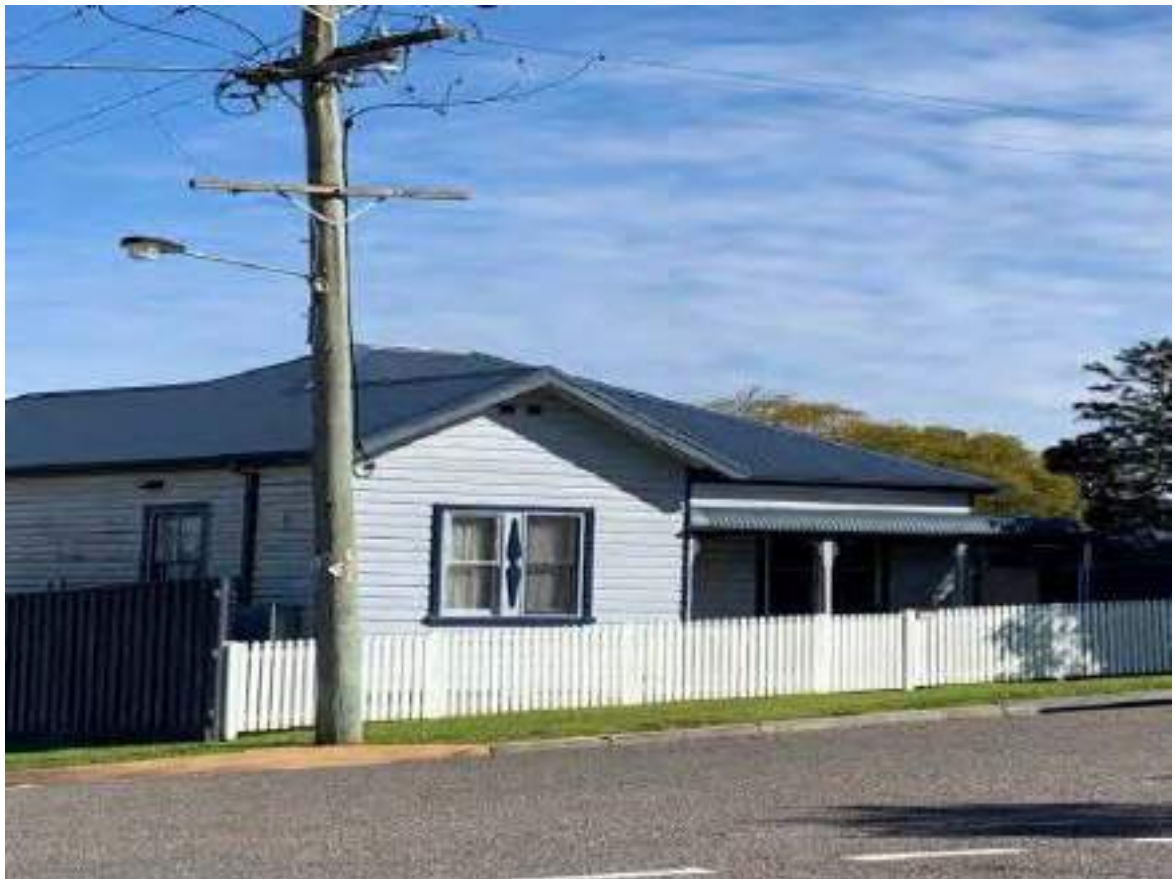
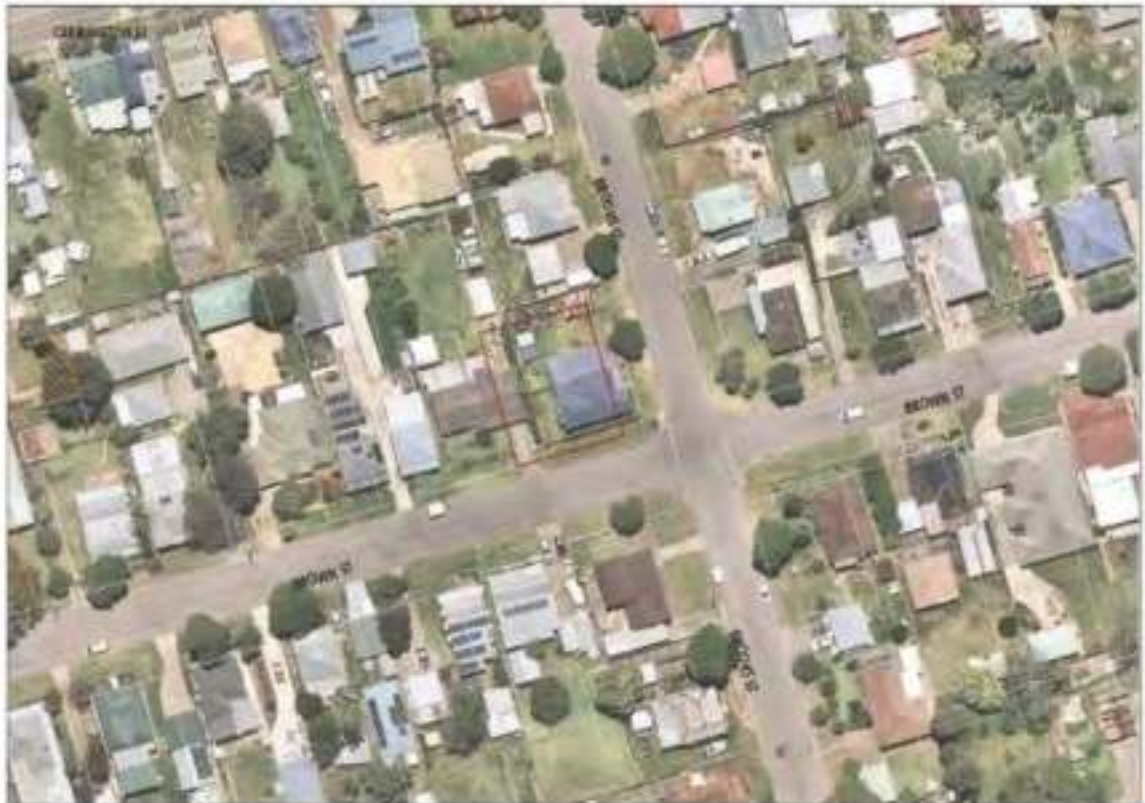
10 BROOKS STREET, WEST WALLSEND 2286

Conservation Area Contribution Level	Est. Construction Date	Previous studies and/or community input
Contributory 1	1900–1915	No prior heritage investigations and no additional information required
Assessment Text		Observed Modifications
<p>A single story ‘workmen’s’ cottage style dwelling with projecting gable roof and timber weatherboard cladding. The remaining structure has a hipped roof, all Colourbond. The veranda roof is bull nosed and supported by timber posts with ornately carved brackets.</p> <p>The front door is timber framed with sash windows on either side. An elaborately carved timber pilaster is situated between the two sash windows. all visible windows appear original with carved timber sills.</p> <p>Timber picket fencing encloses the property.</p> <p>The dwelling displays architectural features of a heritage style and is representative of the local development of this period, being of historical significance for the HCA.</p>		No modifications observed.

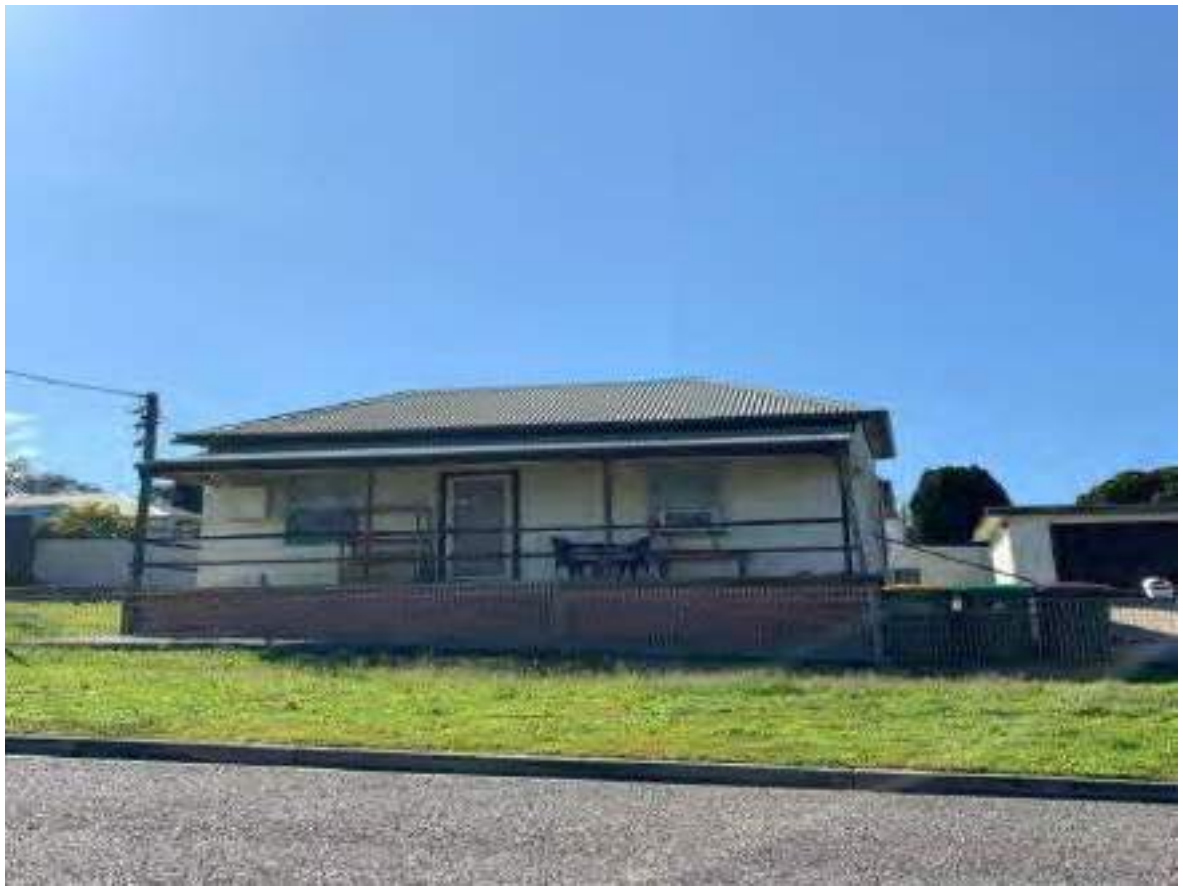
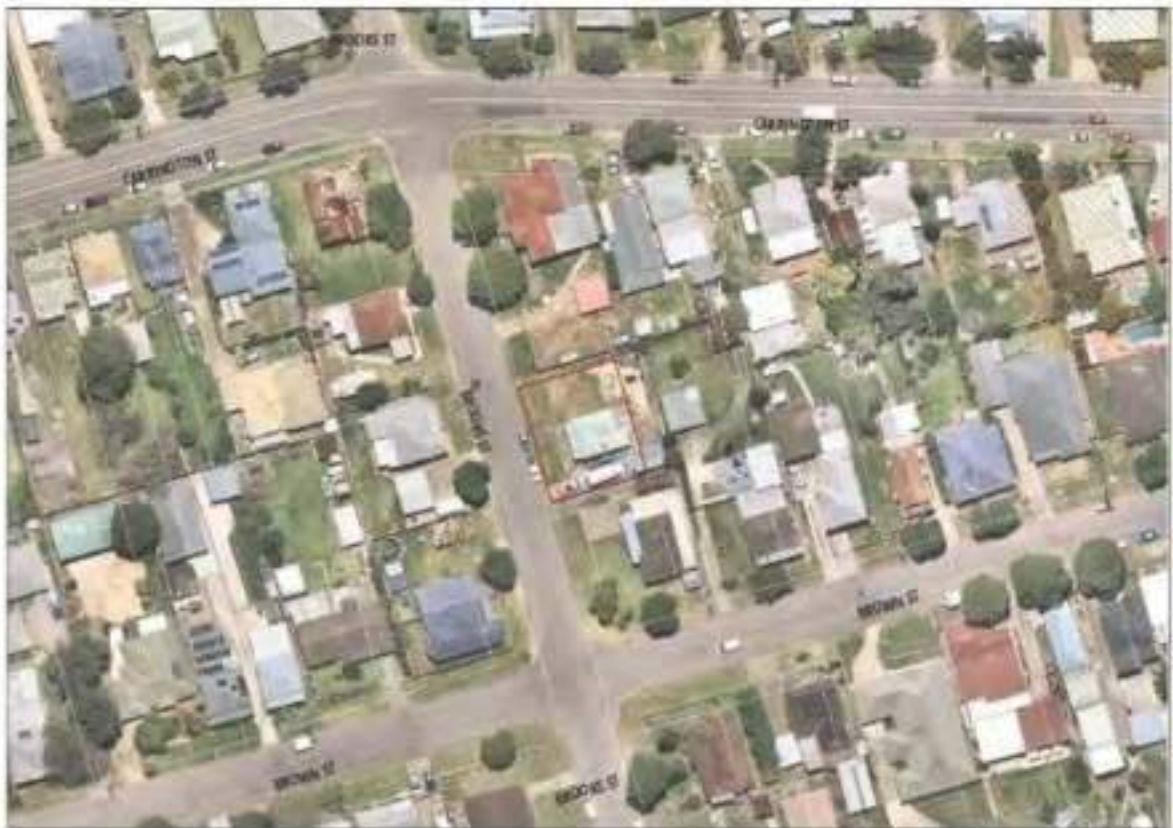
3 BROOKS STREET, WEST WALLSEND 2286

Conservation Area Contribution Level	Est. Construction Date	Previous studies and/or community input
Contributory 1	1890–1915	No prior heritage investigations and no additional information required
Assessment Text		Observed Modifications
<p>Single story Vernacular ‘Mining Cottage’ style dwelling with hipped Colourbond roof and weatherboard cladding. The veranda roof is skillion and supported by metal poles.</p> <p>The veranda is partially enclosed by metal balustrade, with concrete flooring.</p> <p>The front door is timber framed with metal security screening and sash windows either side.</p> <p>The dwelling is supported by red brick foundations.</p> <p>A metal wire fence encloses the property.</p> <p>A single door flat roof garage is located to the east of the dwelling.</p> <p>The dwelling displays architectural features of a heritage style and is representative of the local development of this period, being of historical significance for the HCA.</p>		<p>The metal poles supporting the veranda roof are likely replacement for original timber posts.</p> <p>The concrete flooring and metal balustrade of the veranda are contemporary modifications, replacing timber designs.</p> <p>All visible windows are contemporary replications of the original timber sash windows.</p>

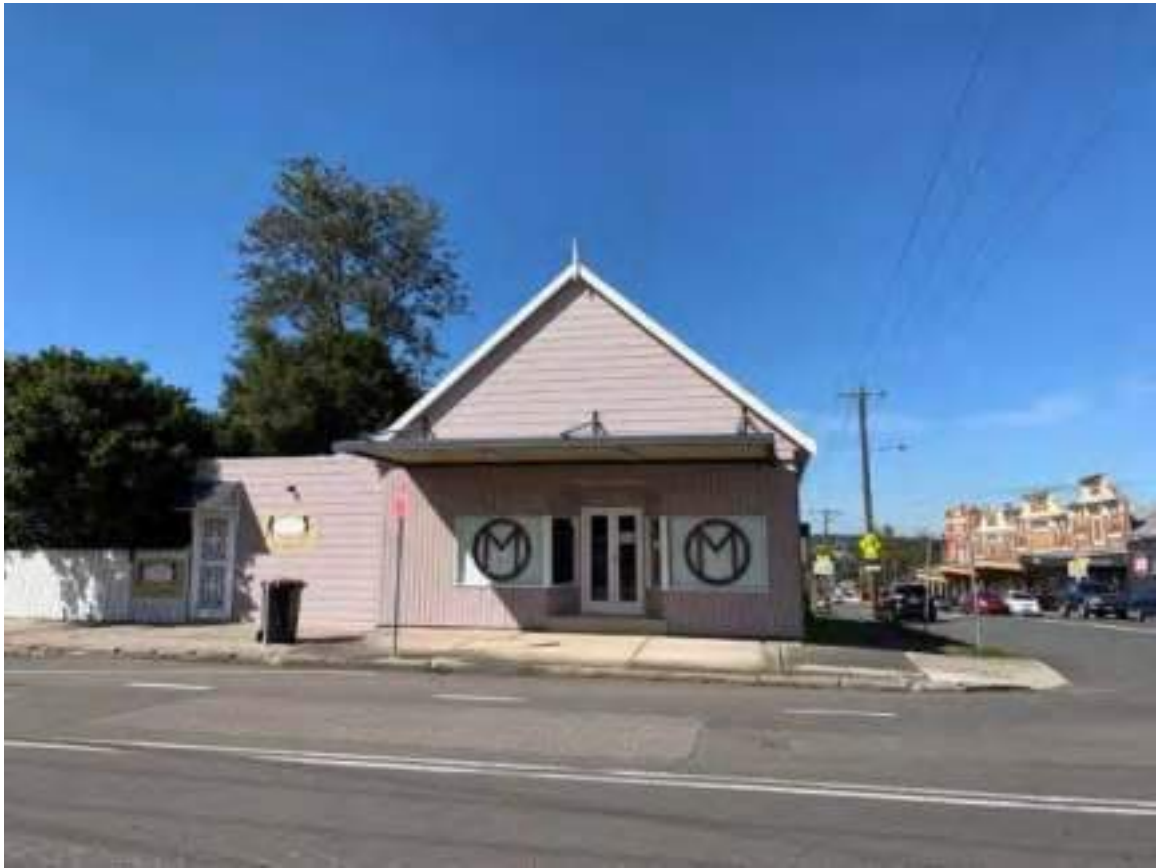
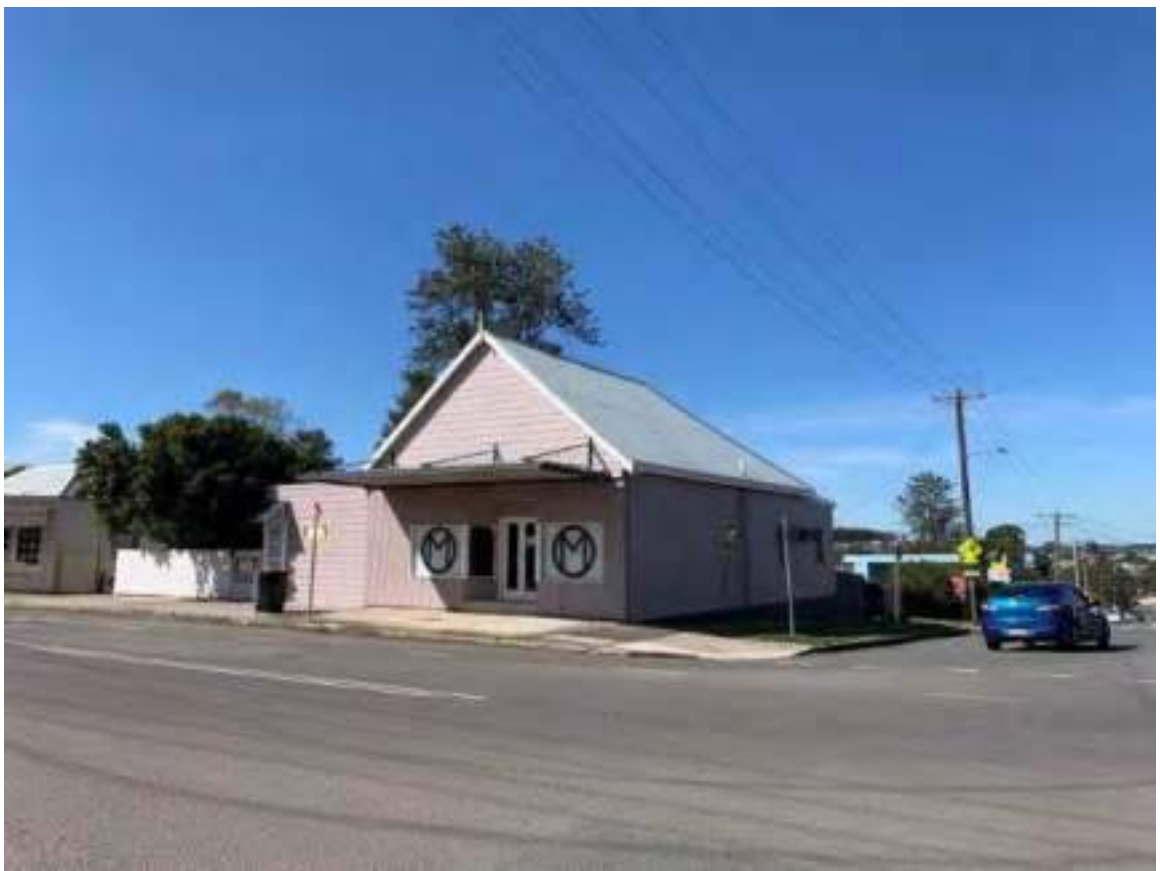
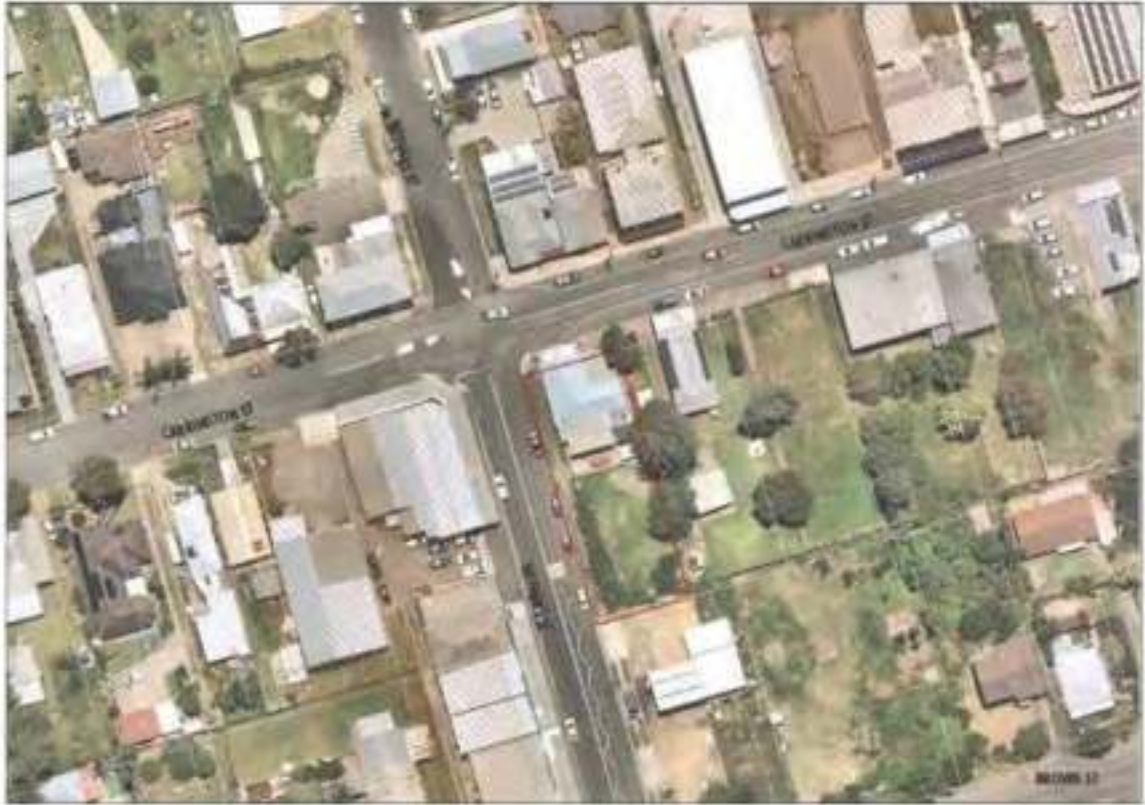
74 CARRINGTON STREET, WEST WALLSEND 2286

Conservation Area Contribution Level	Est. Construction Date	Previous studies and/or community input
Contributory 1	1900–1920	No prior heritage investigations and no additional information required
Assessment Text		Observed Modifications
<p>Singles tory structure used for commercial purposes, with a high gable Colourbond roof and weatherboard cladding. The veranda roof is flat and is supported by metal brackets located above the roofing.</p> <p>The front façade has vertical timber boards and contains two large timber framed windows, with the front door centre. A tiled single step leads into the premises.</p> <p>All visible windows are sash, with some being covered by metal security screens.</p> <p>A potentially residential extension is located to the eastern side.</p> <p>Timber picket fencing encloses the yard.</p> <p>The dwelling displays architectural features of a heritage style and is representative of the local development of this period, being of historical significance for the HCA.</p>		<p>The light purple colour scheme is a contemporary modification, likely in relation to the commercial use of the building.</p>

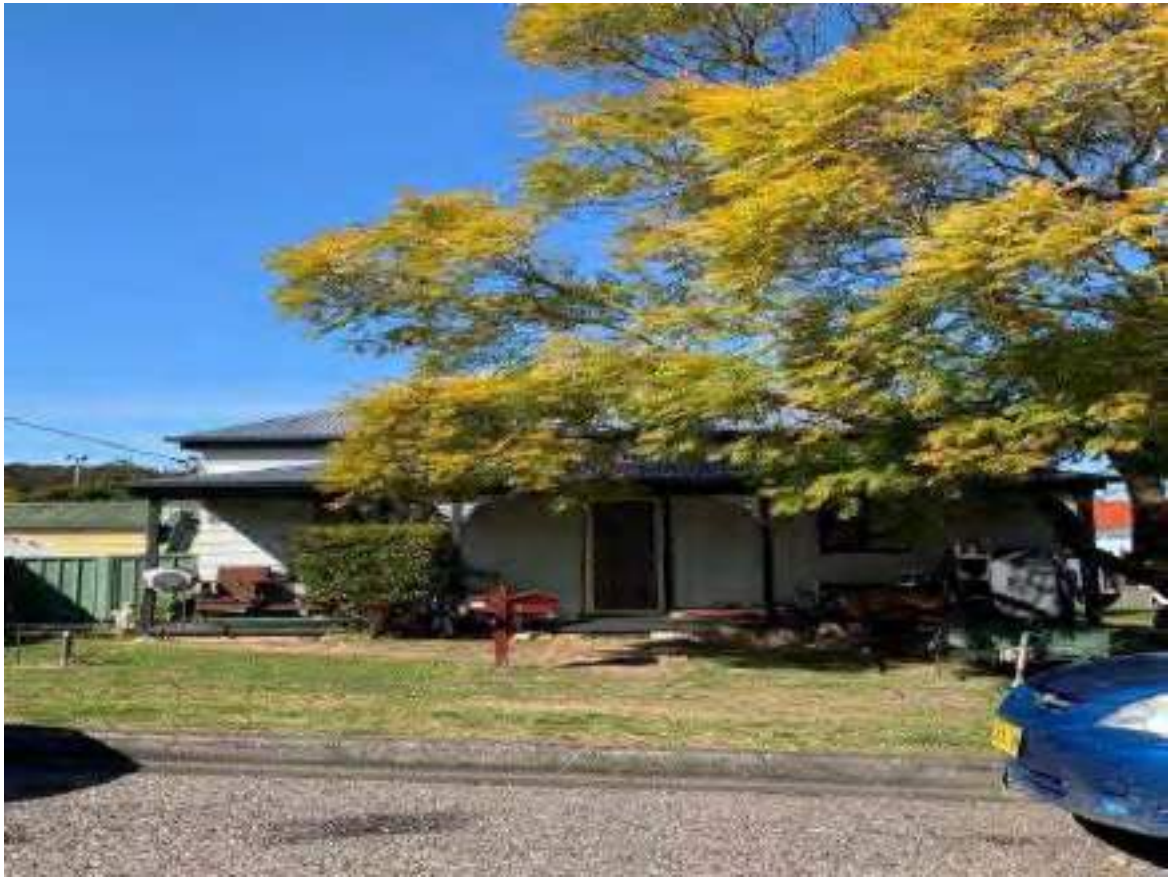
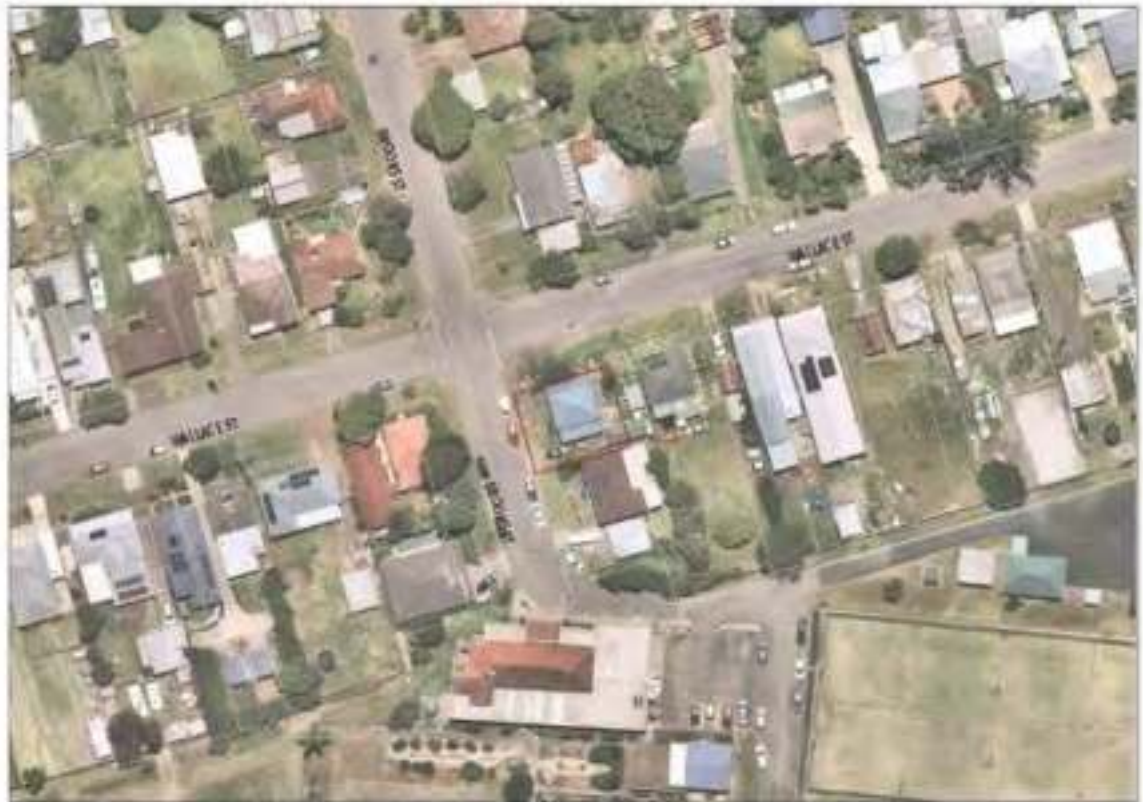
20 WALLACE STREET, WEST WALLSEND 2286

Conservation Area Contribution Level	Est. Construction Date	Previous studies and/or community input
Contributory 1	1890–1915	No prior heritage investigations and no additional information required
Assessment Text		Observed Modifications
<p>Single storey Vernacular 'Mining Cottage' style dwelling with hipped Colourbond roof and weatherboard cladding. The veranda roof is hipped and supported by timber posts with ornate cast iron lace brackets.</p> <p>The veranda is open with no balustrades and the floor is timber.</p> <p>The front door is timber framed with a metal security screen, with sliding windows to either side.</p> <p>A gable roof single door garage is located to the south east of the dwelling.</p> <p>A green Colourbond fence encloses the yard.</p> <p>The dwelling displays architectural features of a heritage style and is representative of the local development of this period, being of historical significance for the HCA.</p>		<p>Visible windows are contemporary sliding designs, replacing the original timber framed sash styles.</p> <p>The veranda roof has been replaced, originally being bull nosed.</p>

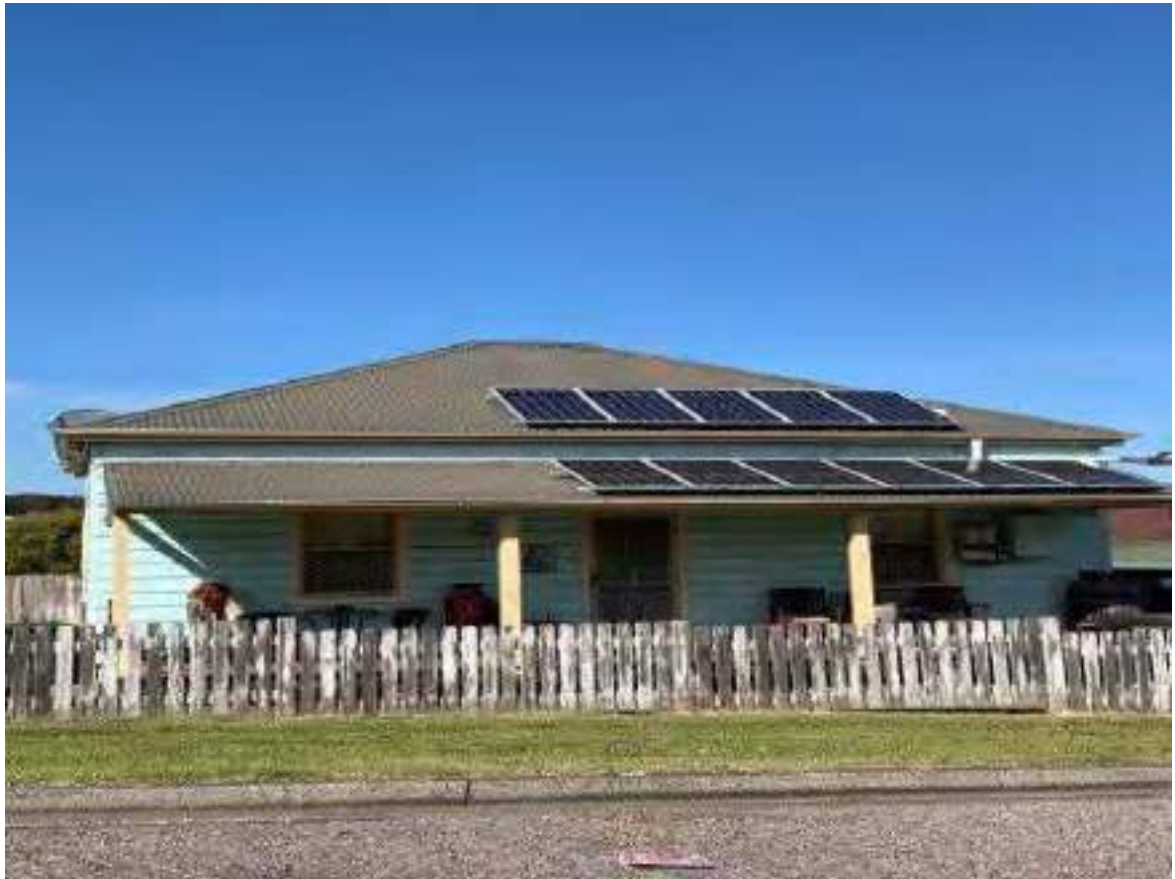
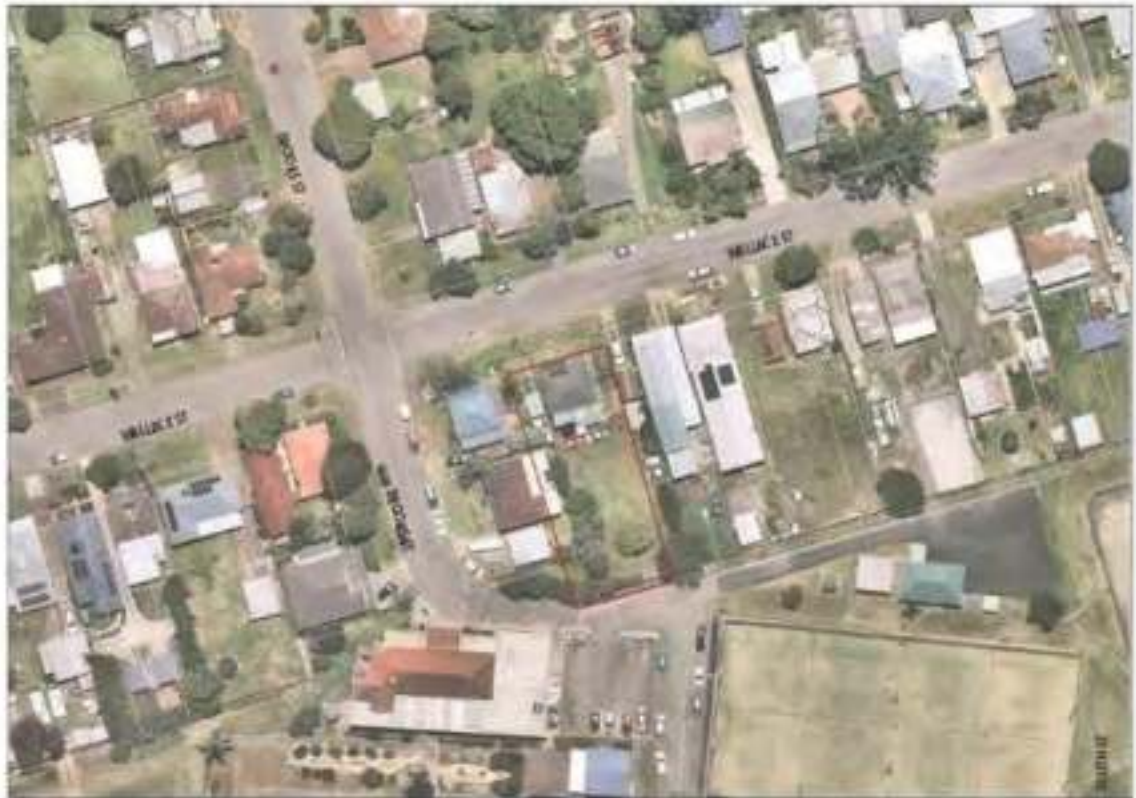
18 WALLACE STREET, WEST WALLSEND 2286

Conservation Area Contribution Level	Est. Construction Date	Previous studies and/or community input
Contributory 1	1890–1915	No prior heritage investigations and no additional information required
Assessment Text		Observed Modifications
<p>Single story Vernacular ‘Mining Cottage’ style dwelling with hipped Colourbond roof and timber weatherboard cladding. The veranda roof is skillion and supported by timber posts.</p> <p>The veranda is open with no balustrade and timber flooring.</p> <p>The front door is timber framed with a decorative metal screen, with sash windows to either side. The windows similarly have metal security screens, however are likely original frames.</p> <p>Timber fencing encloses the property.</p> <p>A single door gable roof garage is located to the west of the dwelling.</p> <p>The dwelling displays architectural features of a heritage style and is representative of the local development of this period, being of historical significance for the HCA.</p>		<p>The metal screen doors and security screens on the visible windows are recent additions, detracting from the heritage aesthetics of the dwelling.</p> <p>Solar panels are highly visible on the northern façade of the dwelling.</p> <p>The light blue colour scheme is inappropriate for the heritage streetscape.</p> <p>A small back extension is located at the southern end of the dwelling, however is not visible from the street and does not detract.</p>

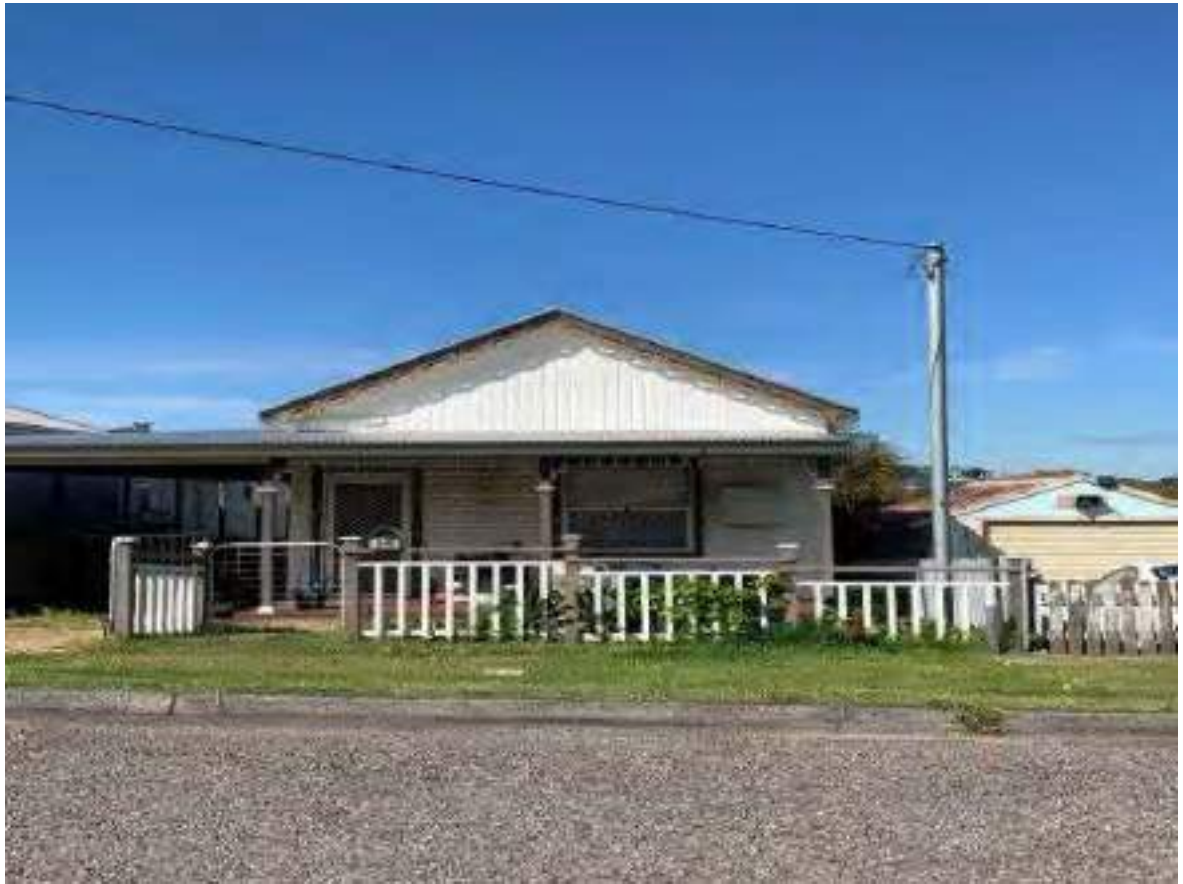
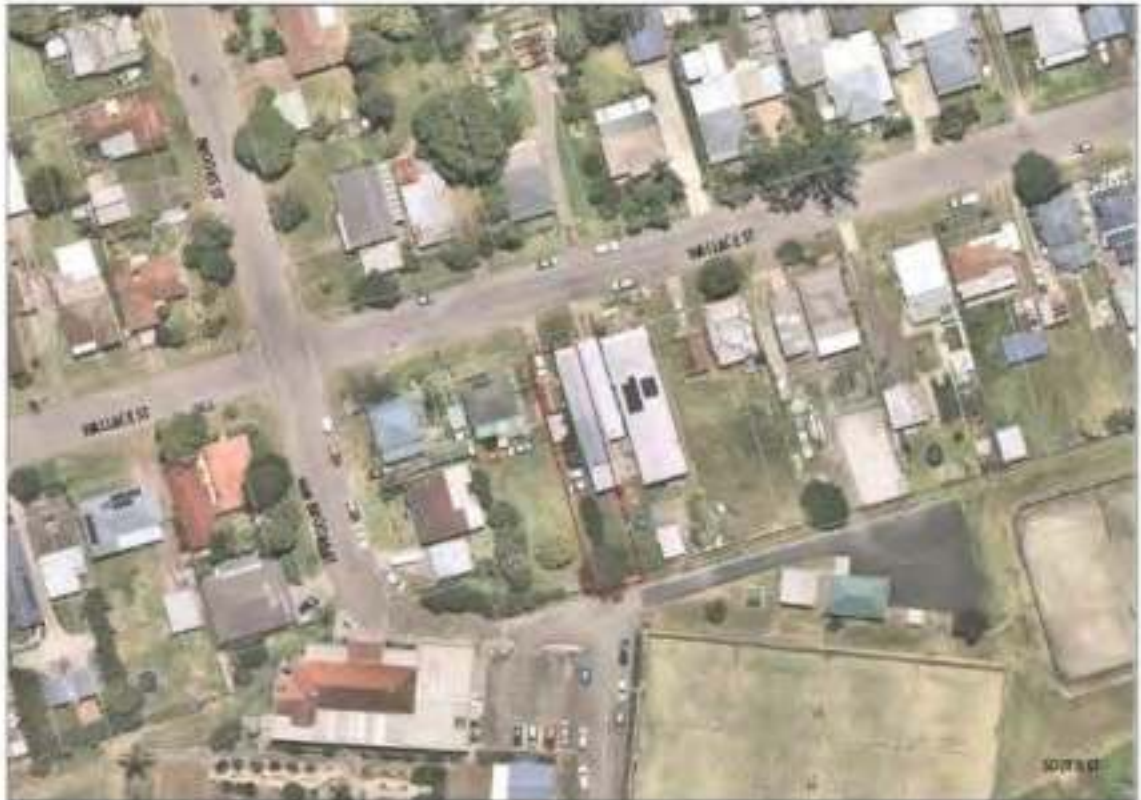
16 WALLACE STREET, WEST WALLSEND 2286

Conservation Area Contribution Level	Est. Construction Date	Previous studies and/or community input
Contributory 1	1890–1910	No prior heritage investigations and no additional information required
Assessment Text		Observed Modifications
<p>Single story simplified Victorian Regency style dwelling with gable Colourbond roof and weatherboard cladding. The veranda roof is hipped and supported by timber posts. A timber valance frames the veranda roof.</p> <p>The veranda is open with no balustrade and timber flooring. The veranda roof wraps around the northern and eastern side of the dwelling, projecting to create a carport.</p> <p>The front door is timber framed with a metal security screen. Visible windows are sash with security screens.</p> <p>The gable has an ornately carved barge board and vertical timber boards.</p> <p>Timber fencing encloses the property.</p> <p>The dwelling displays architectural features of a heritage style and is representative of the local development of this period, being of historical significance for the HCA.</p>		<p>The veranda roof is a contemporary modification construction to accommodate vehicle parking and detracts from the heritage style of the dwelling.</p> <p>All visible windows have been replaced with contemporary sash designs, with security screens with further detract.</p>
