APPENDIX 2

Building Assessment Sheets (Inventory Sheets)

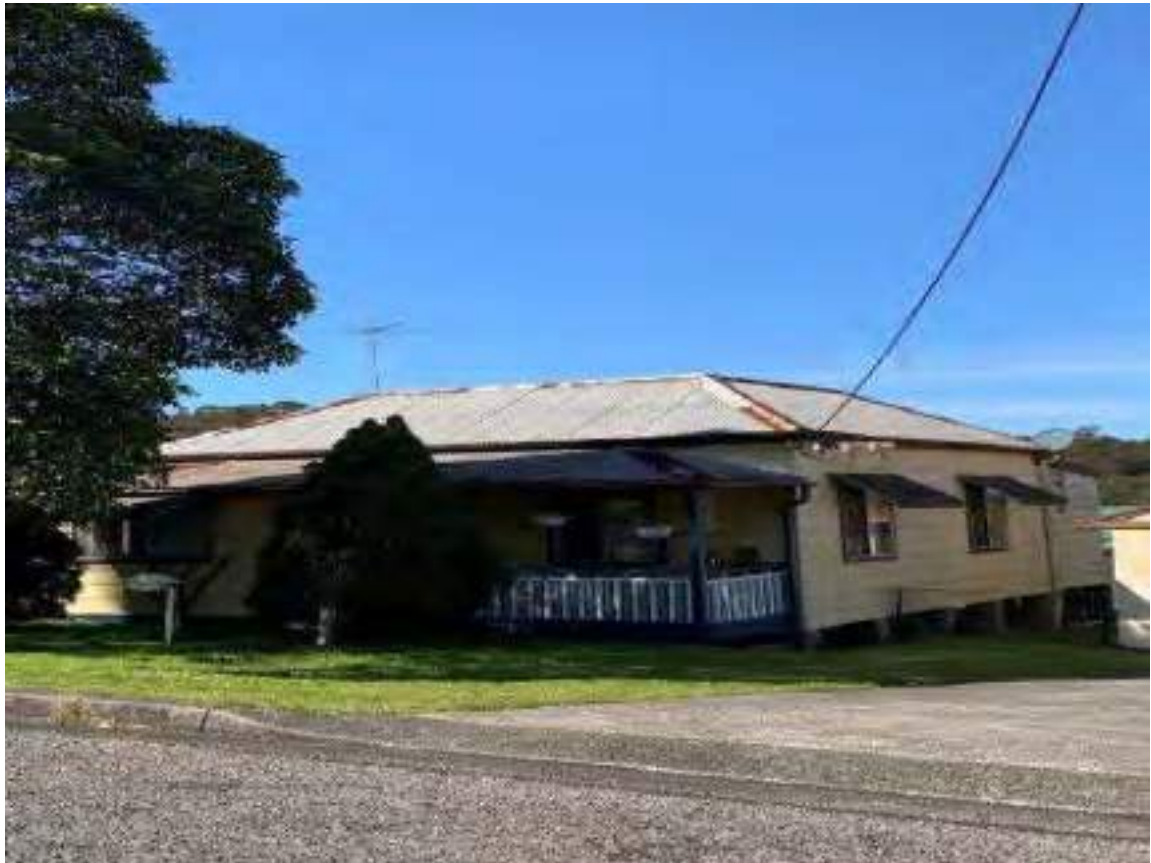
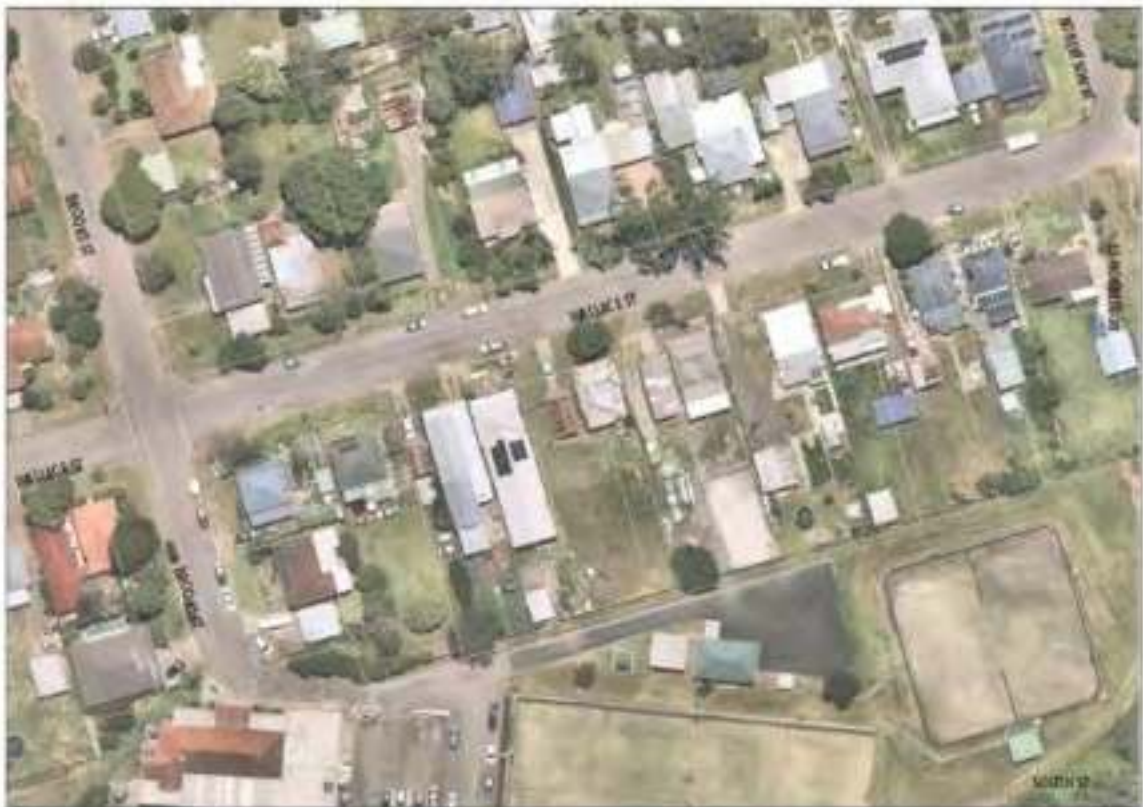
14 WALLACE STREET, WEST WALLSEND 2286

Conservation Area Contribution Level	Est. Construction Date	Previous studies and/or community input
Contributory 1	1890–1915	No prior heritage investigations and no additional information required
Assessment Text		Observed Modifications
<p>Single story Vernacular ‘mining Cottage’ style dwelling with hipped Colourbond roof. The veranda roof is hipped and supported by timber posts.</p> <p>The veranda is enclosed by timber balustrade, with timber flooring and timber gate.</p> <p>The front door is timber framed with sliding windows to either side. the eastern and western windows have metal awnings a top.</p> <p>A brickwork chimney is visible on the eastern side of the dwelling.</p> <p>A single door gable roof garage is located to the west of the dwelling.</p> <p>The dwelling displays architectural features of a heritage style and is representative of the local development of this period, being of historical significance for the HCA.</p>		<p>The eastern end of the veranda has been built in to provide an additional living room. This is a common modification for the housing style.</p> <p>All visible windows are contemporary sliding designs, replacing the original sash designs.</p> <p>The veranda roof was likely originally bull nosed.</p> <p>The veranda balustrade is a contemporary additional.</p>

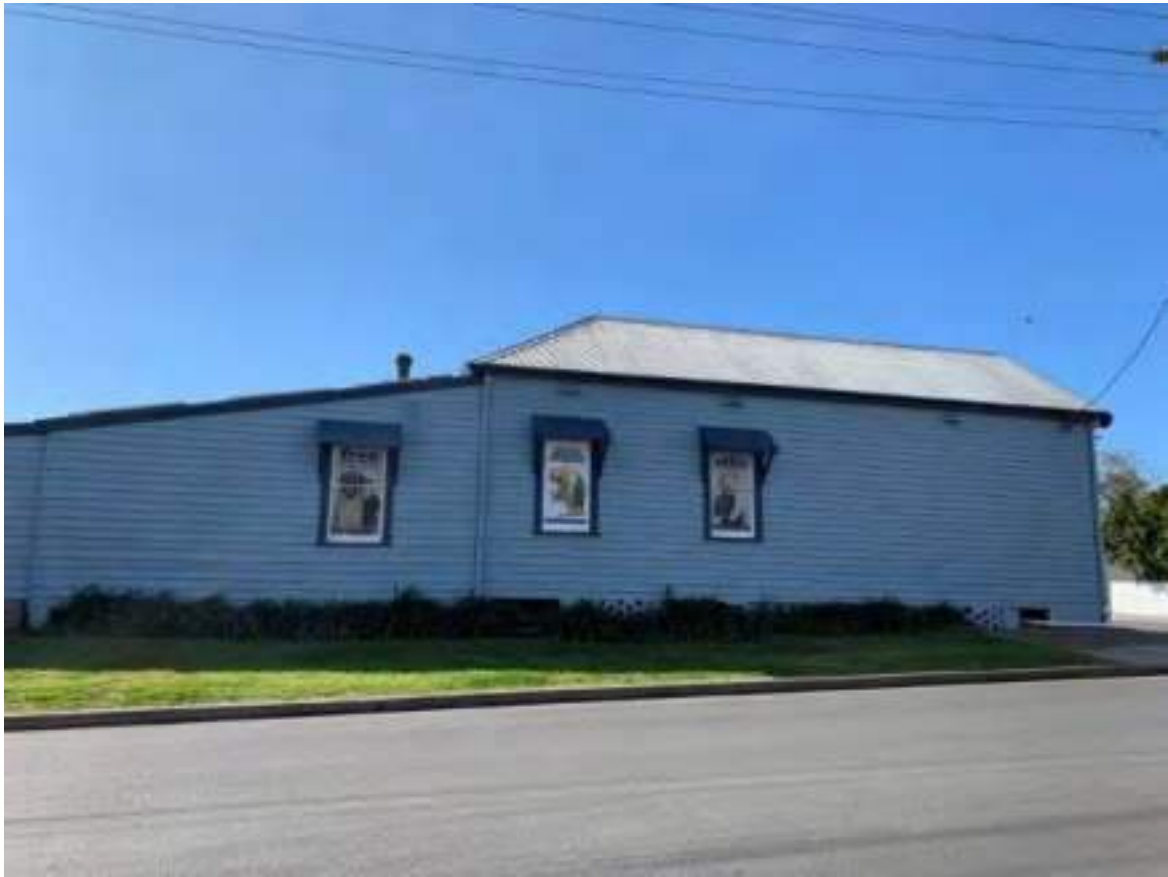
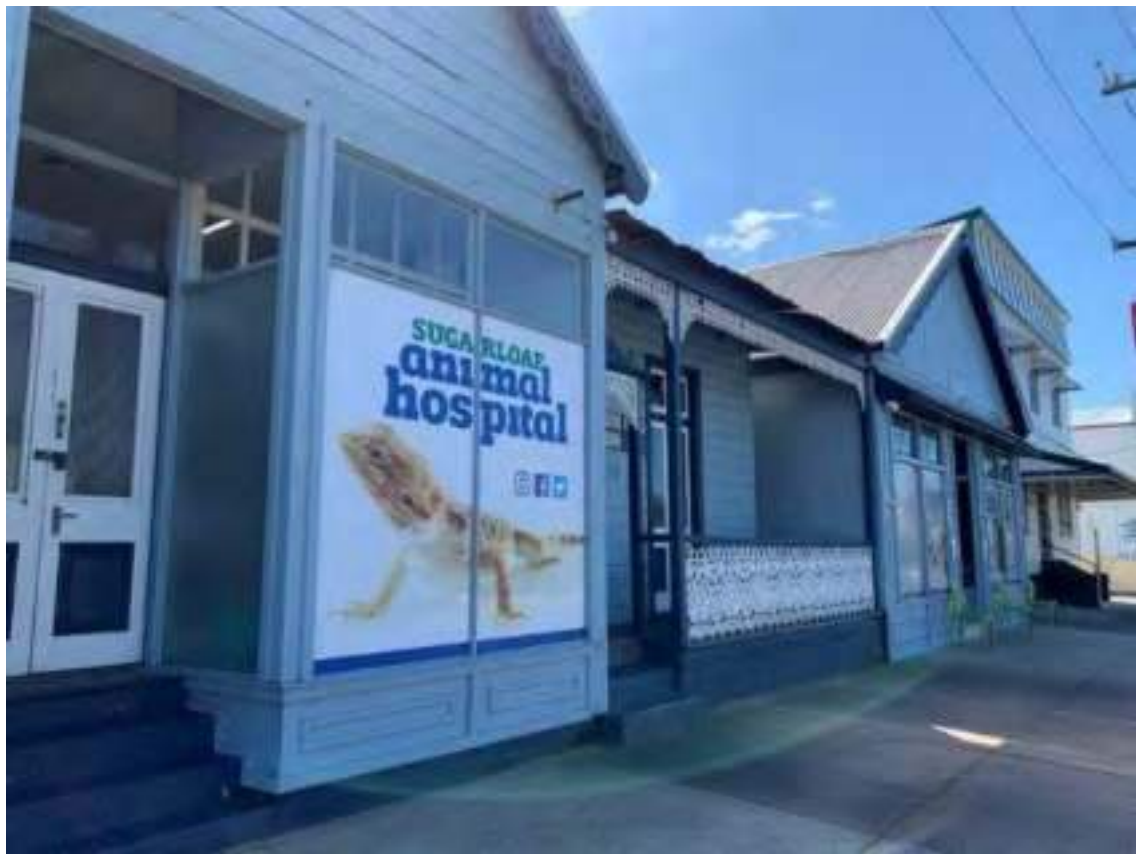
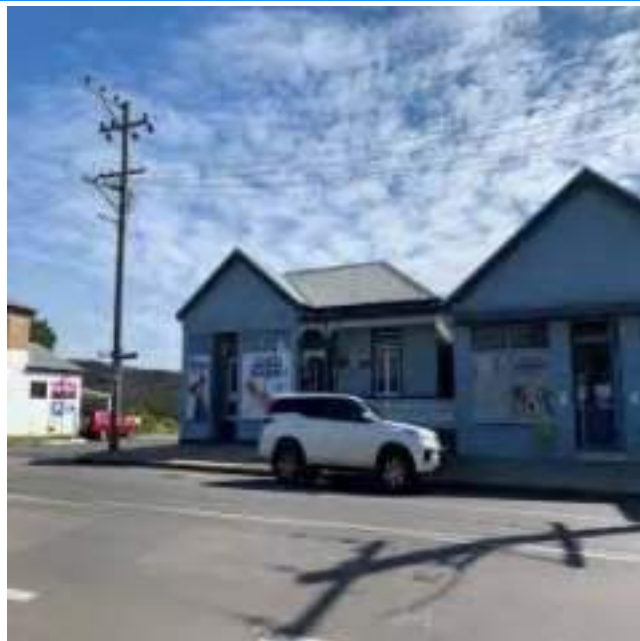
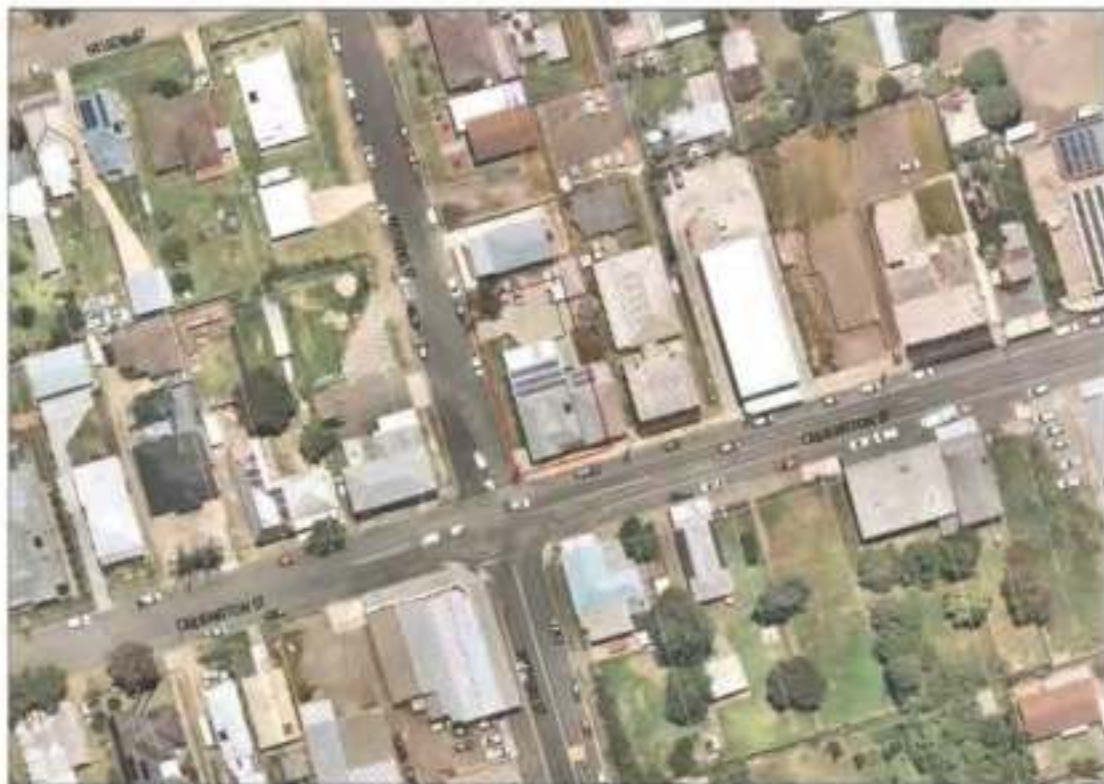
67A CARRINGTON STREET, WEST WALLSEND 2286

Conservation Area Contribution Level	Est. Construction Date	Previous studies and/or community input
Contributory 1	1890–1900	West Wallsend Heritage Study 1993 Moderate local significance
Assessment Text		Observed Modifications
<p>Single story Vernacular ‘workmen’s cottage’ style dwelling with projecting gable roof. The remaining roof is hipped, all Colourbond, with timber weatherboard cladding. The veranda roof is flat and supported by timber posts with ornate cast iron lace brackets. A cast iron lace valance frames the veranda roof.</p> <p>The veranda is partially enclosed by cast iron ornate balustrade, with timber flooring and timber stairs leading onto the landing.</p> <p>Three front doors are visible, all timber framed with glass panels and fanlights above. The entranceway is framed by an additional decorative timber archway with cast iron detailing. All visible western windows are original sash designs with timber awnings.</p> <p>The gable roof has an ornately carved barge board, with the façade being dominated by large windows.</p> <p>The dwelling displays architectural features of a heritage style and is representative of the local development of this period, being of historical significance for the HCA.</p>		<p>A back extension is visible at the northern end of the building.</p> <p>The windows have advertisements for the vets practiced inlaid into the glass.</p>

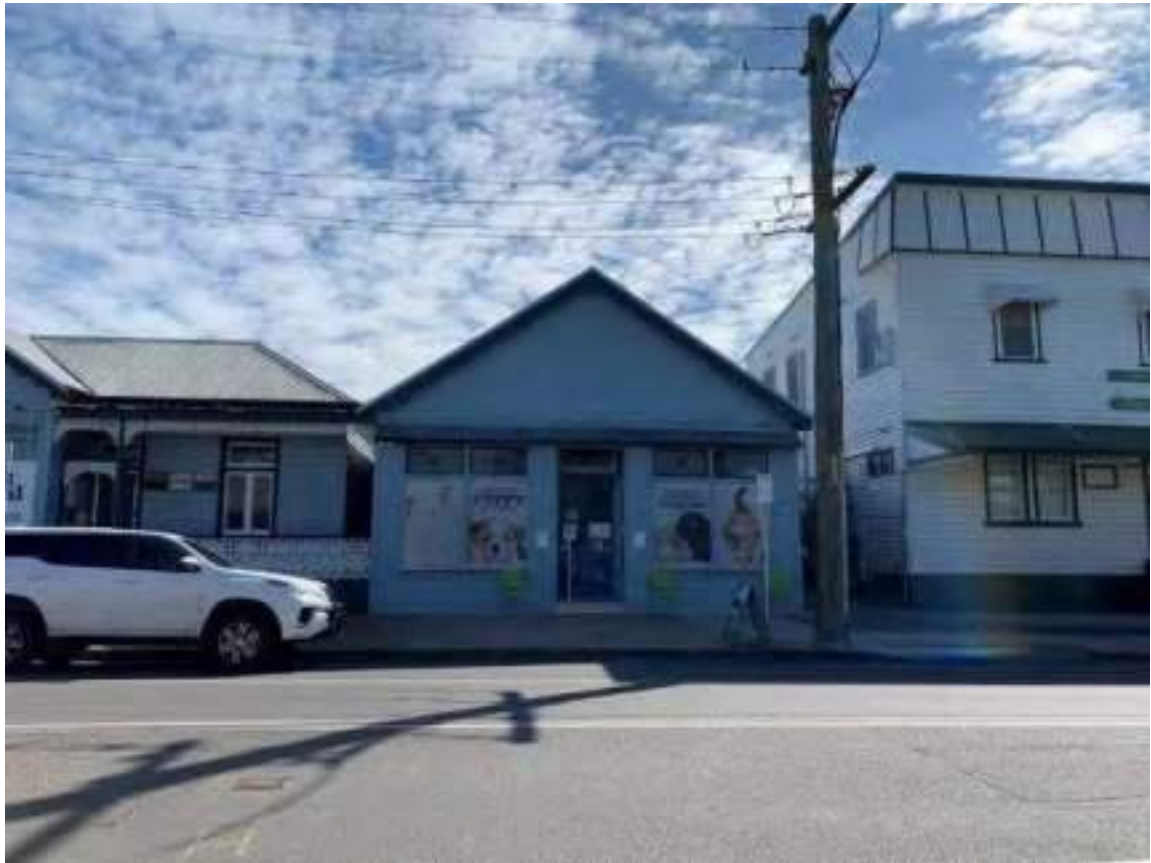
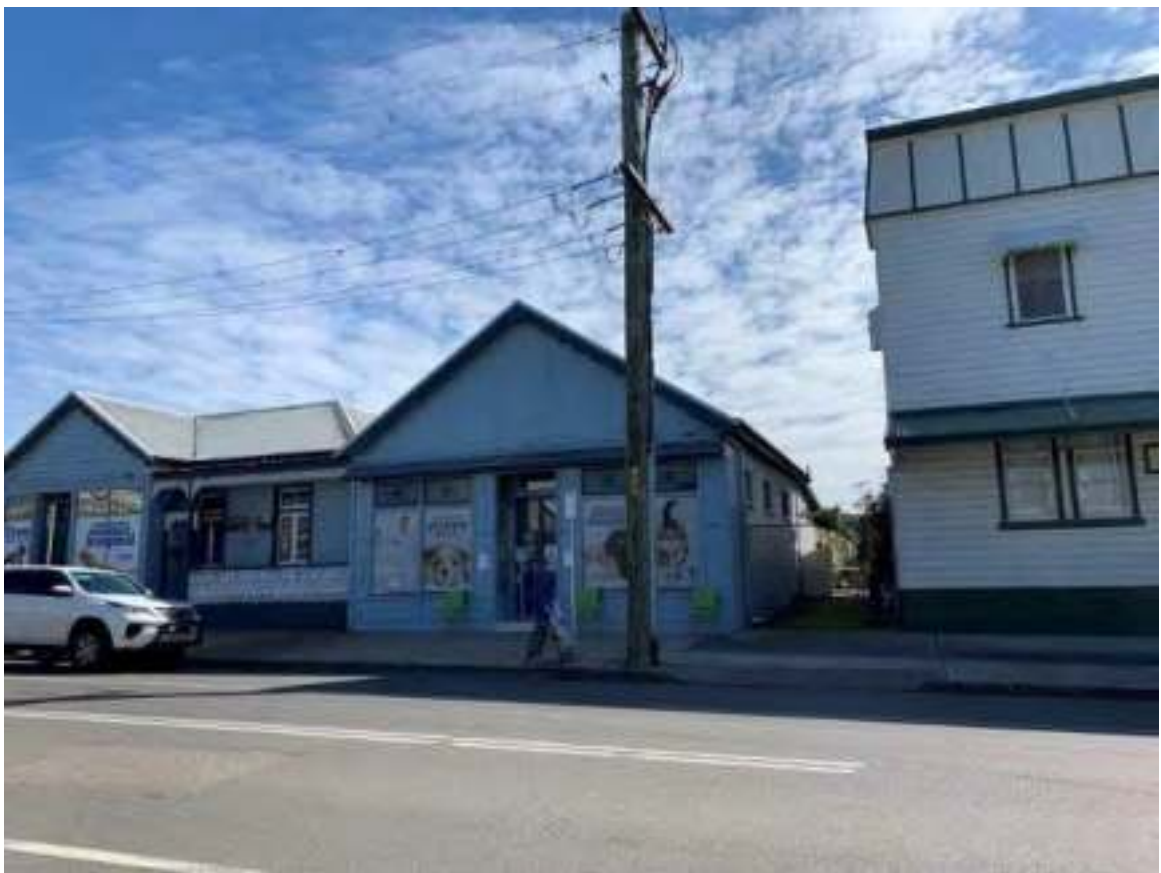
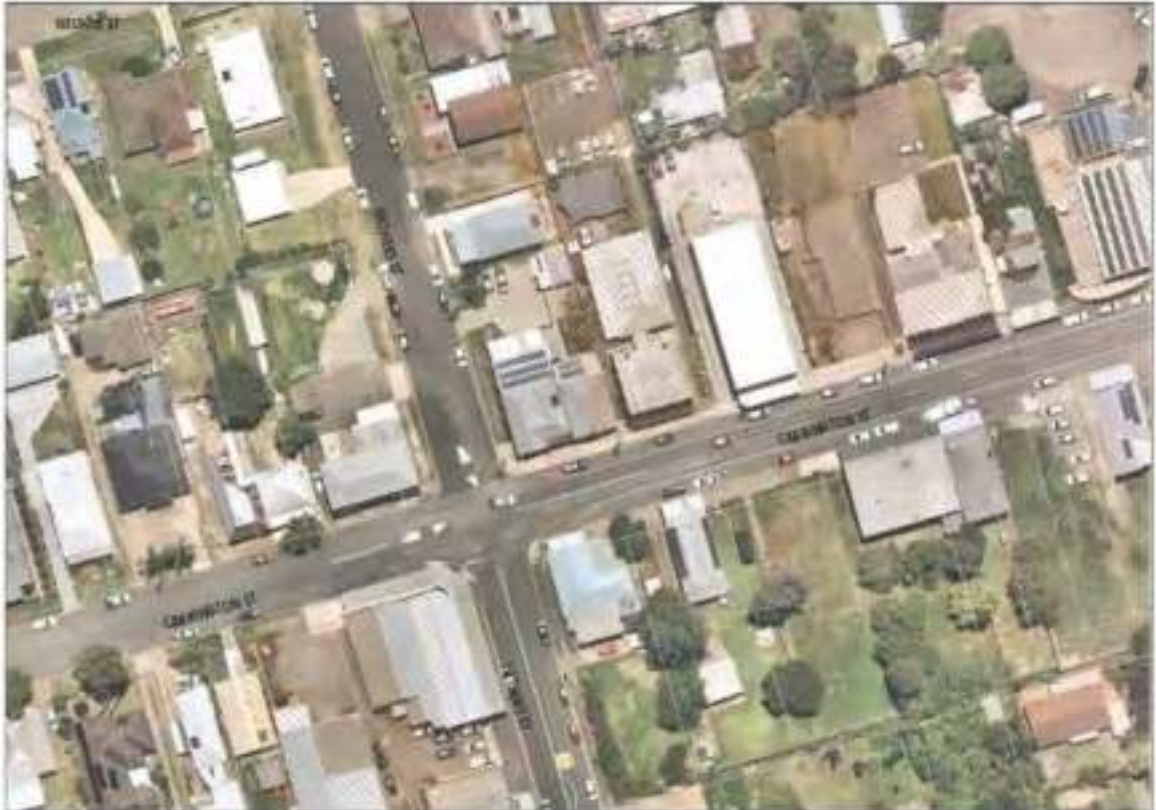
67A CARRINGTON STREET, WEST WALLSEND 2286

Conservation Area Contribution Level	Est. Construction Date	Previous studies and/or community input
Contributory 1	1920–1930	West Wallsend Heritage Study 1993 Moderate local significance
Assessment Text		Observed Modifications
<p>Single story box shaped building with steep gable Colourbond roof and timber façade. A small skillion veranda roof is visible.</p> <p>The front facade is dominated by large windows and carved timber panelling.</p> <p>The front door is timber framed with glass panels and fanlight.</p> <p>Leadlight decorative windows are visible atop of the southern front façade. Black and white tiled stairs lead into the establishment.</p> <p>The gable consists of timber panels and has ornately carved barge boards.</p> <p>The dwelling displays architectural features of a heritage style and is representative of the local development of this period, being of historical significance for the HCA.</p>		<p>Visible windows have inlaid advertisements for the vet practice.</p>

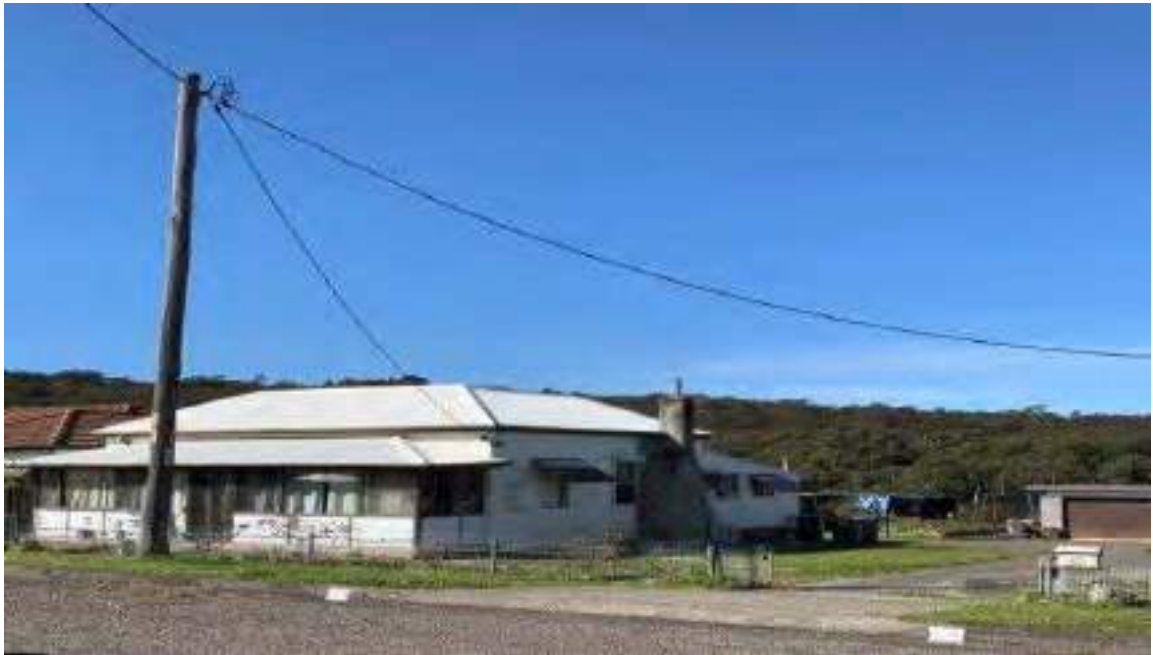
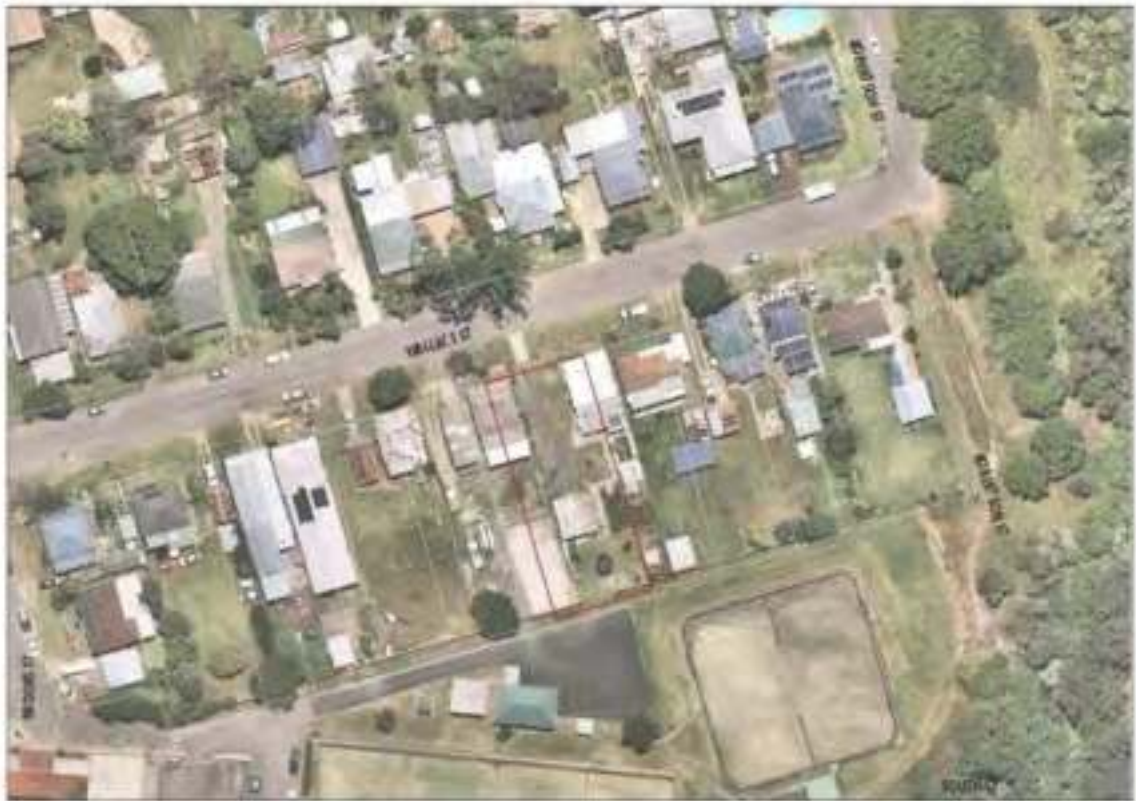
10 WALLACE STREET, WEST WALLSEND 2286

Conservation Area Contribution Level	Est. Construction Date	Previous studies and/or community input
Contributory 1	1890–1915	No prior heritage investigations and no additional information required
Assessment Text		Observed Modifications
<p>Single story Vernacular ‘Mining Cottage’ style dwelling with Colourbond hipped roof and weatherboard cladding. The veranda roof is hipped and has been built in to create additional living rooms.</p> <p>The front door is metal and sliding, with metal framed sliding windows dominating the façade. The western and eastern windows are sash with metal awnings.</p> <p>A rendered brickwork chimney is visible on the western side of the dwelling, with a metal flute.</p> <p>A double door concrete flat roof garage is located to the south of the dwelling.</p> <p>A metal wire fence encloses the property.</p> <p>The dwelling displays architectural features of a heritage style and is representative of the local development of this period, being of historical significance for the HCA.</p>		<p>The veranda space has been fully enclosed and built in, providing room for additional living areas. This is a common modification for this housing style and is reflective of the family-oriented demographic of the area. This modification detracts from the heritage style of the dwelling.</p> <p>The veranda roof likely would have originally been bull nosed in style.</p>

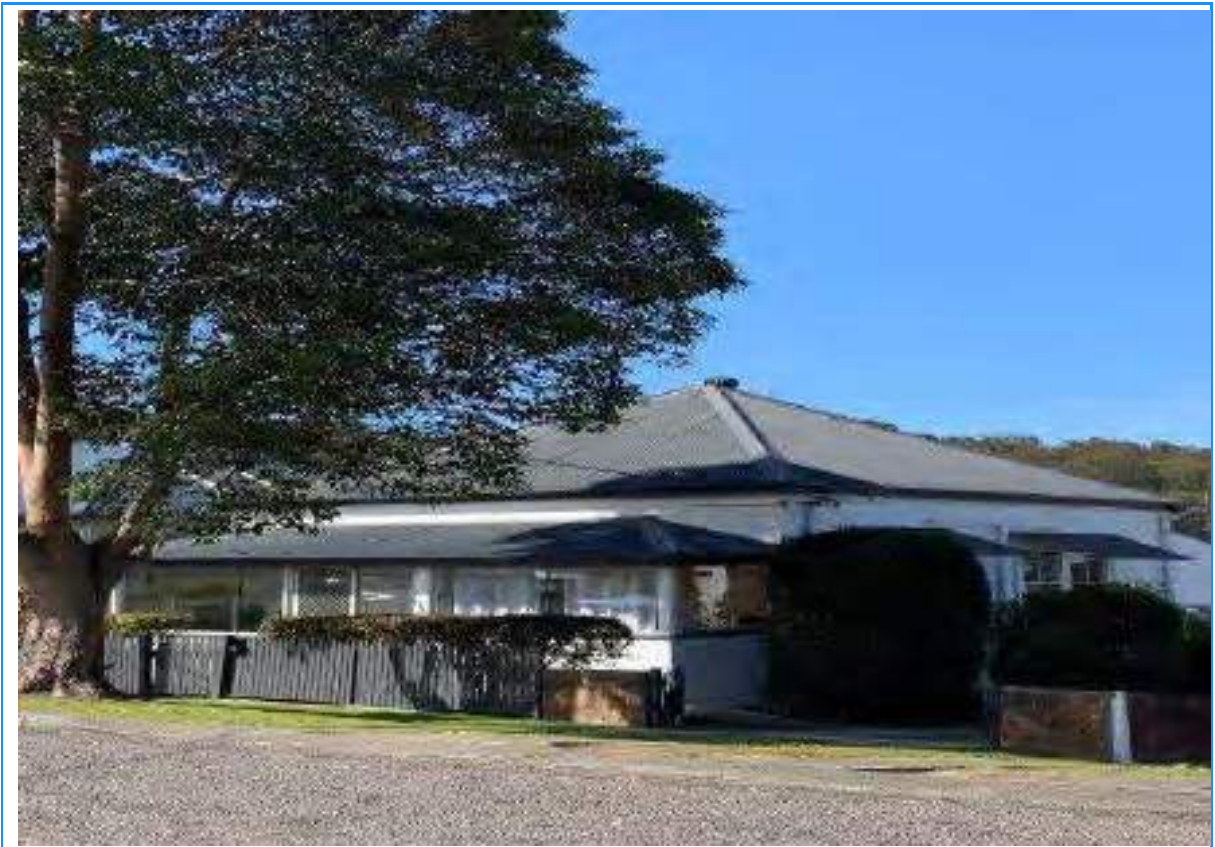
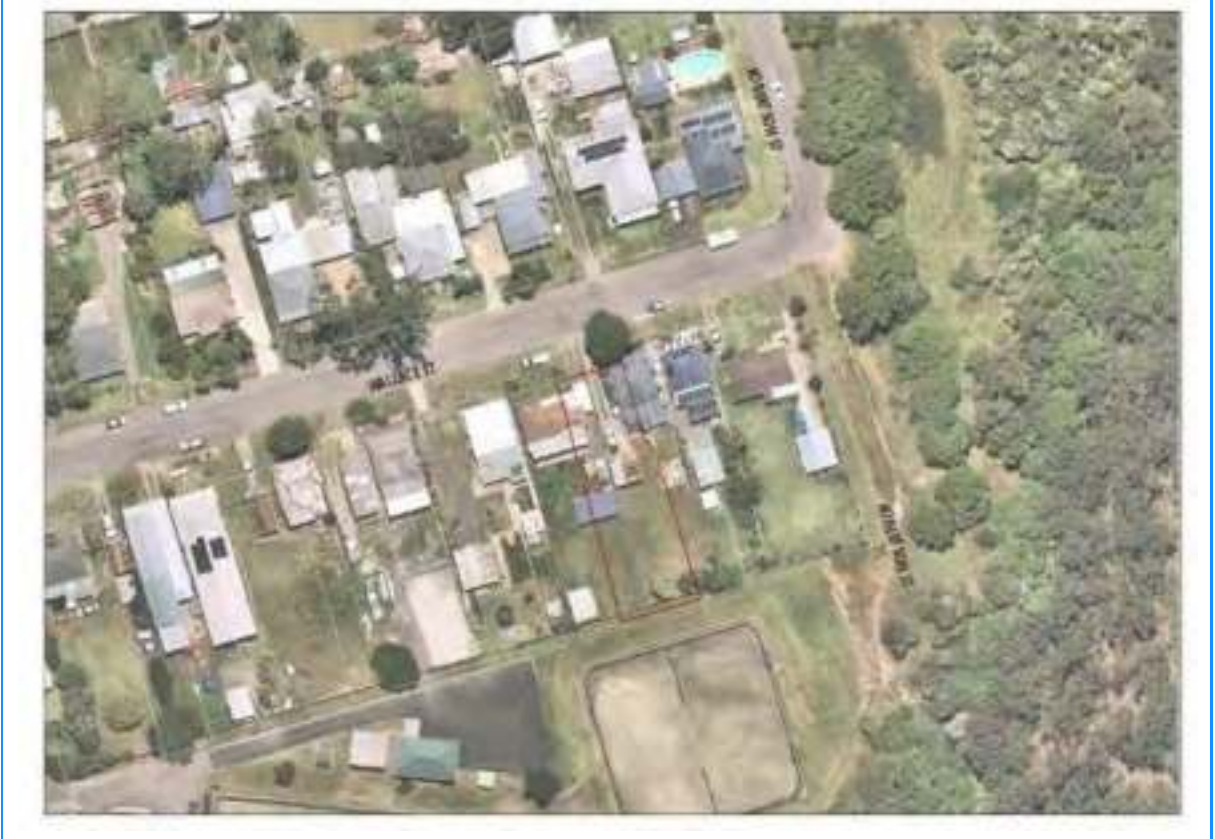
Conservation Area Contribution Level	Est. Construction Date	Previous studies and/or community input
Contributory 1	1890–1915	No prior heritage investigations and no additional information required
Assessment Text		Observed Modifications
<p>Single story Vernacular ‘Mining Cottage’ style dwelling with Colourbond hipped roof and timber weatherboard cladding. The veranda roof is hipped and has been built in to create additional living areas.</p> <p>The front door is metal sliding, with an additional security screen. Frameless sliding windows dominate the front façade.</p> <p>The original front door is visible with a timber frame. The original sash windows are either side. All visible eastern and western windows are original sash designs with heavy timber frame. Timber awnings are visible atop the side windows.</p> <p>A single door gable roof garage is visible to the south of the dwelling.</p> <p>A timber picket fence encloses the property.</p> <p>The dwelling displays architectural features of a heritage style and is representative of the local development of this period, being of historical significance for the HCA.</p>		<p>The veranda has been converted into a sunroom and study, a common modification for this housing style.</p> <p>The veranda roof was originally bull nosed, but converted to hipped. This is equally a common modification.</p> <p>The chimney has been removed.</p>

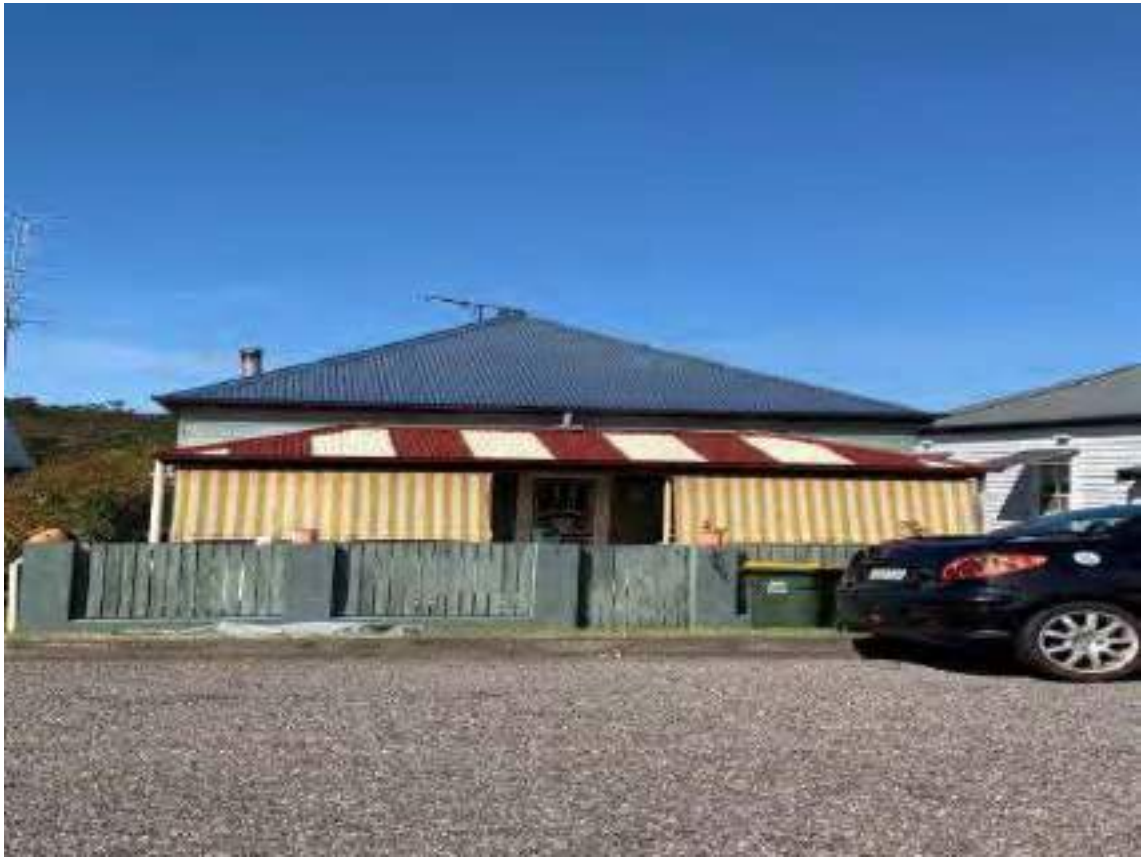
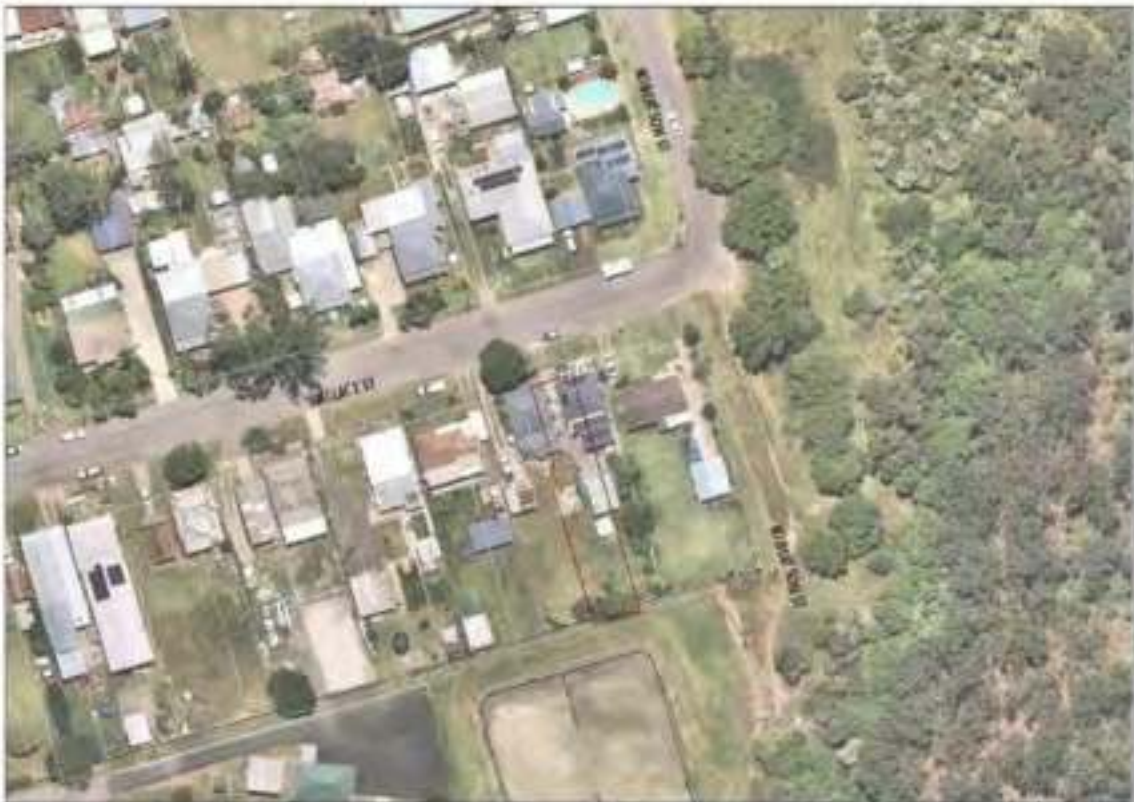
4 WALLACE STREET, WEST WALLSEND 2286

Conservation Area Contribution Level	Est. Construction Date	Previous studies and/or community input
Contributory 1	1890–1915	No prior heritage investigations and no additional information required
Assessment Text		Observed Modifications
<p>Single story Vernacular ‘Mining Cottage’ style dwelling with hipped Colourbond roof and weatherboard cladding. The veranda roof is hipped with red and white painted stripes.</p> <p>The veranda is partially enclosed by a timber board balustrade and yellow and white striped canvas blinds.</p> <p>The front door is timber framed with the original sash windows either side. all visible windows are the original heavy timber frame sash style. The eastern and western windows have shingle timber awnings with ornate brackets.</p> <p>A metal chimney flume is visible on the eastern side of the dwelling.</p> <p>A brick and timber fence encloses the dwelling.</p> <p>The dwelling displays architectural features of a heritage style and is representative of the local development of this period, being of historical significance for the HCA.</p>		<p>The window awnings are a contemporary replication of the original designs, and are sympathetic to the heritage style.</p> <p>The red and white painted veranda hipped roof is a modification to the original bull nosed design. The colour scheme is possibly a replication of the original design and is seen elsewhere in the area. As such this does not detract from the heritage streetscape.</p> <p>The white and yellow canvas blinds are contemporary additions and are not sympathetic to the colour scheme or heritage style of the dwelling.</p> <p>The original brickwork chimney has been removed.</p>

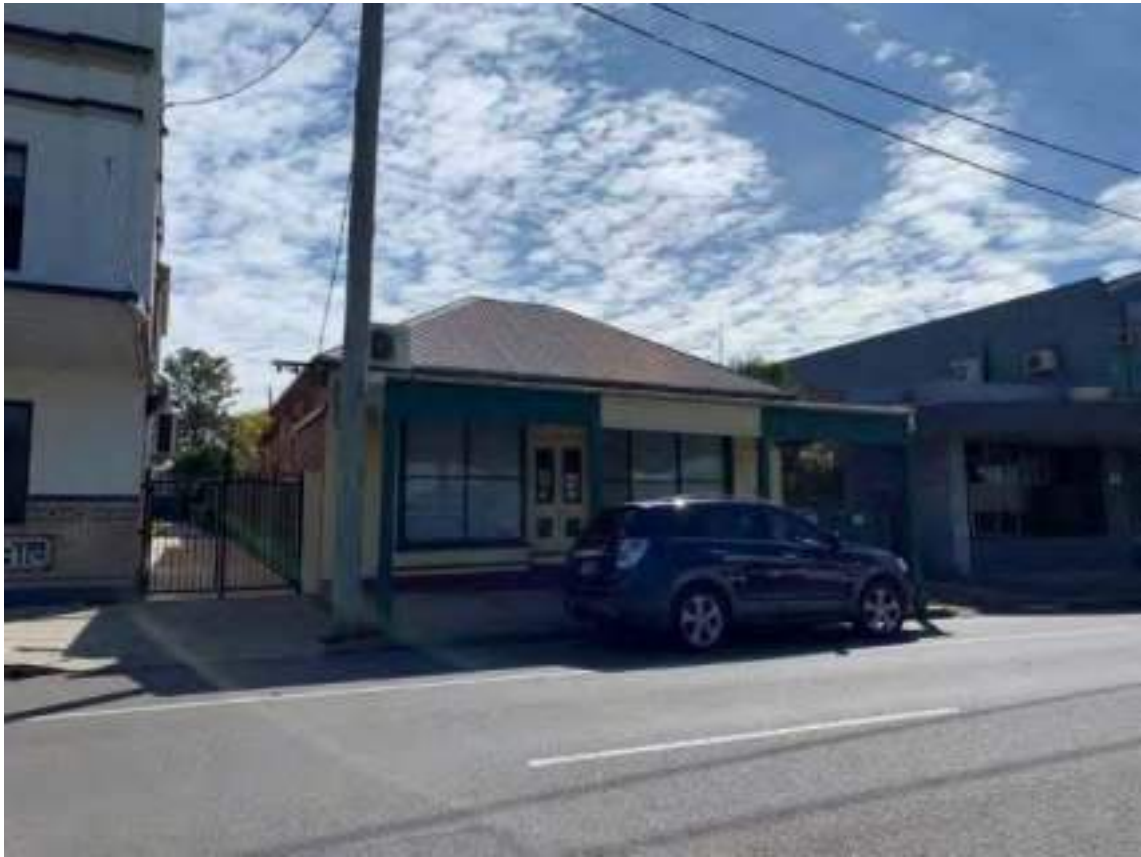
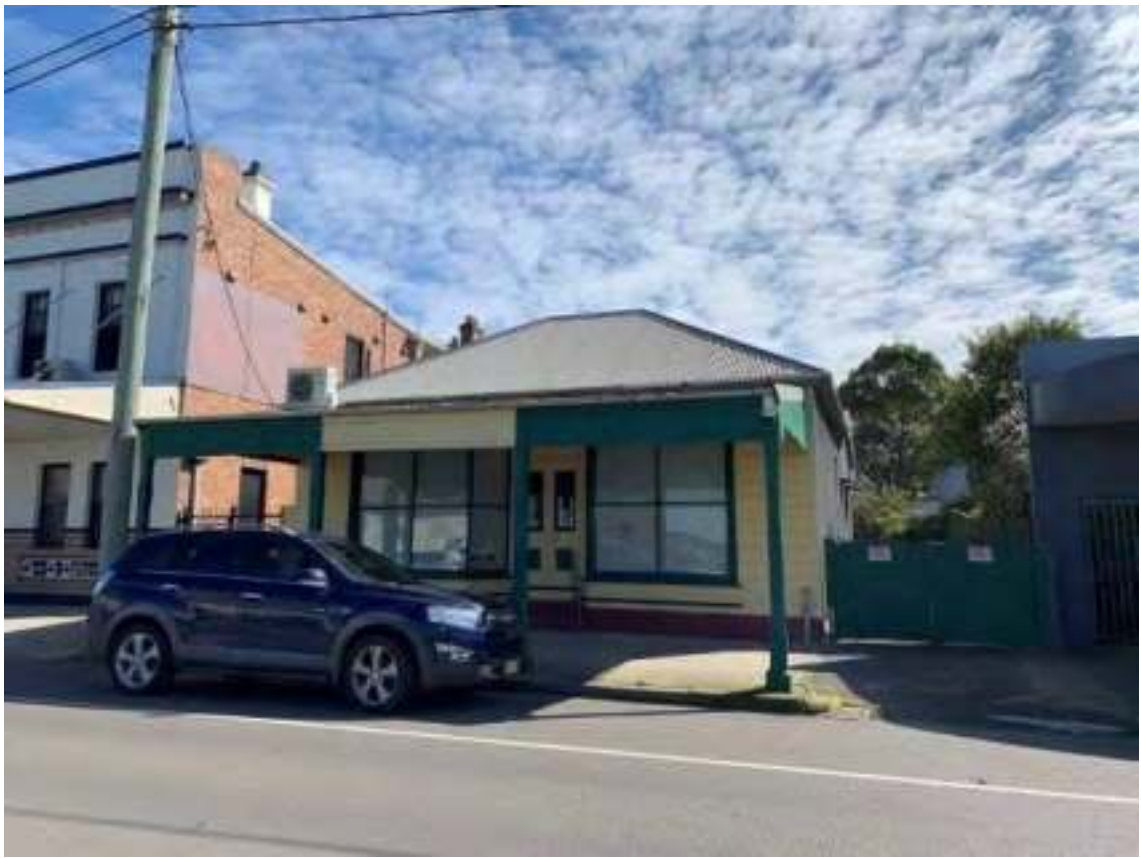
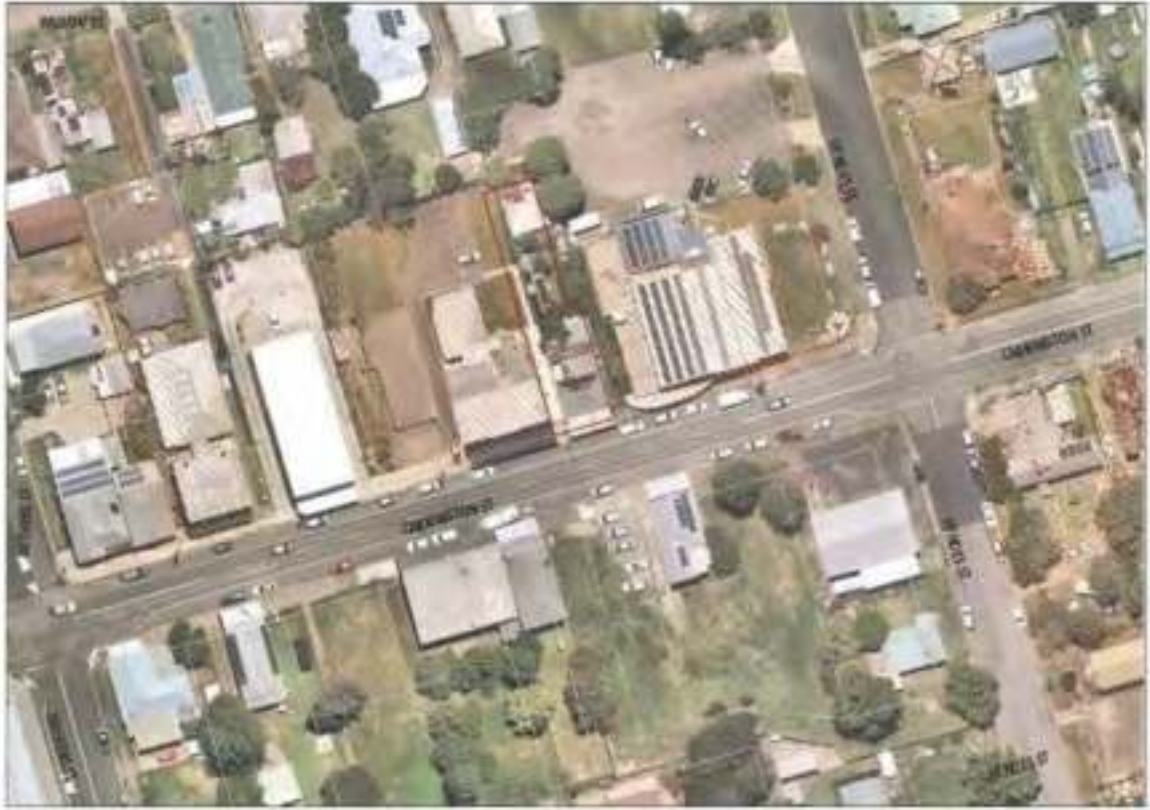
55 CARRINGTON STREET, WEST WALLSEND 2286

Conservation Area Contribution Level	Est. Construction Date	Previous studies and/or community input
Contributory 1	1890	West Wallsend Heritage Study 1993 Moderate local significance
Assessment Text		Observed Modifications
<p>Single story commercial building with hipped Colourbond roof and timber ashlar patterned weatherboard cladding. The veranda roof is skillion with timber support posts.</p> <p>The veranda roof has a timber panel valance.</p> <p>The front door is heavy timber framed with a four panel design. The façade is dominated by large multi pane windows.</p> <p>A set of two tiled stairs leads into the establishment, with a metal support rail.</p> <p>The dwelling displays architectural features of a heritage style and is representative of the local development of this period, being of historical significance for the HCA.</p>		<p>The eastern wall has been replaced with corrugated iron sheeting.</p> <p>An extension has been added to the northern section of the building, with a gable roof. This is likely an early extension and does not detract.</p> <p>The façade of the building has undergone minimal to no modifications.</p>

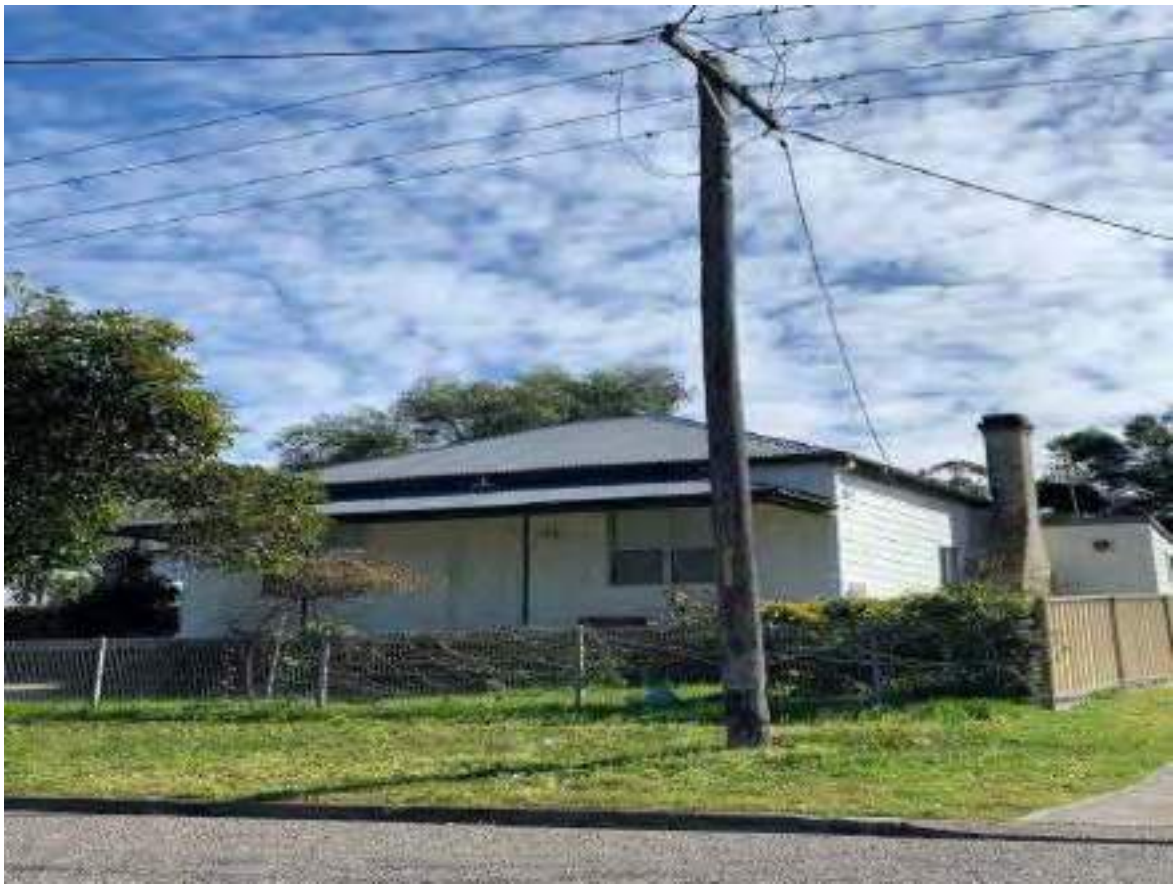
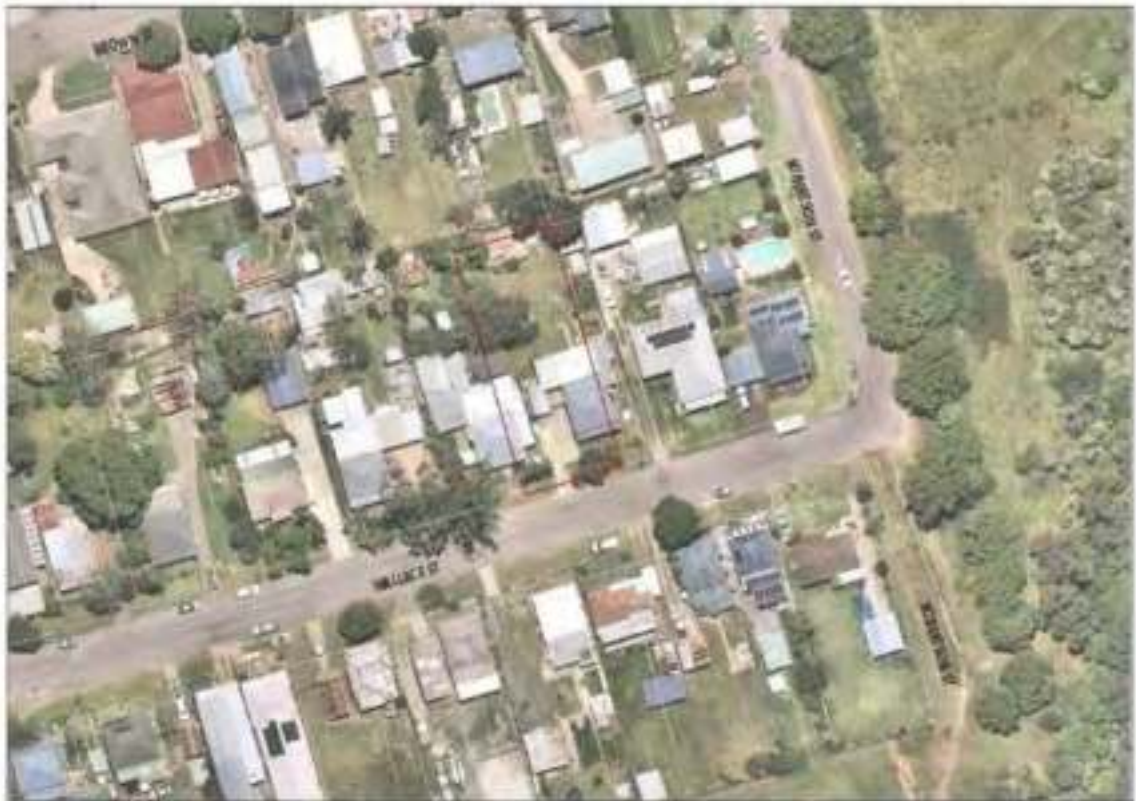
5 WALLACE STREET, WEST WALLSEND 2286

Conservation Area Contribution Level	Est. Construction Date	Previous studies and/or community input
Contributory 1	1890–1915	No prior heritage investigations and no additional information required
Assessment Text		Observed Modifications
<p>Single story Vernacular ‘Mining Cottage’ style dwelling with hipped Colourbond roof and weatherboard cladding. The veranda roof is hipped and supported by metal poles.</p> <p>The veranda is open with concrete floor.</p> <p>The front door is timber framed with sash windows either side.</p> <p>A brickwork chimney is visible on the eastern side of the dwelling, with double corbel.</p> <p>A metal wire fence encloses the property</p> <p>The dwelling displays architectural features of a heritage style and is representative of the local development of this period, being of historical significance for the HCA.</p>		<p>An extension has been constructed on the northern portion of the structure and is partially visible along the eastern side. this has been constructed in a sympathetic manner.</p> <p>The southern front windows are contemporary designs, likely replacing original timber framed sash designs.</p> <p>The veranda roof was likely originally bull nosed.</p>
