APPENDIX 2

Building Assessment Sheets (Inventory Sheets)

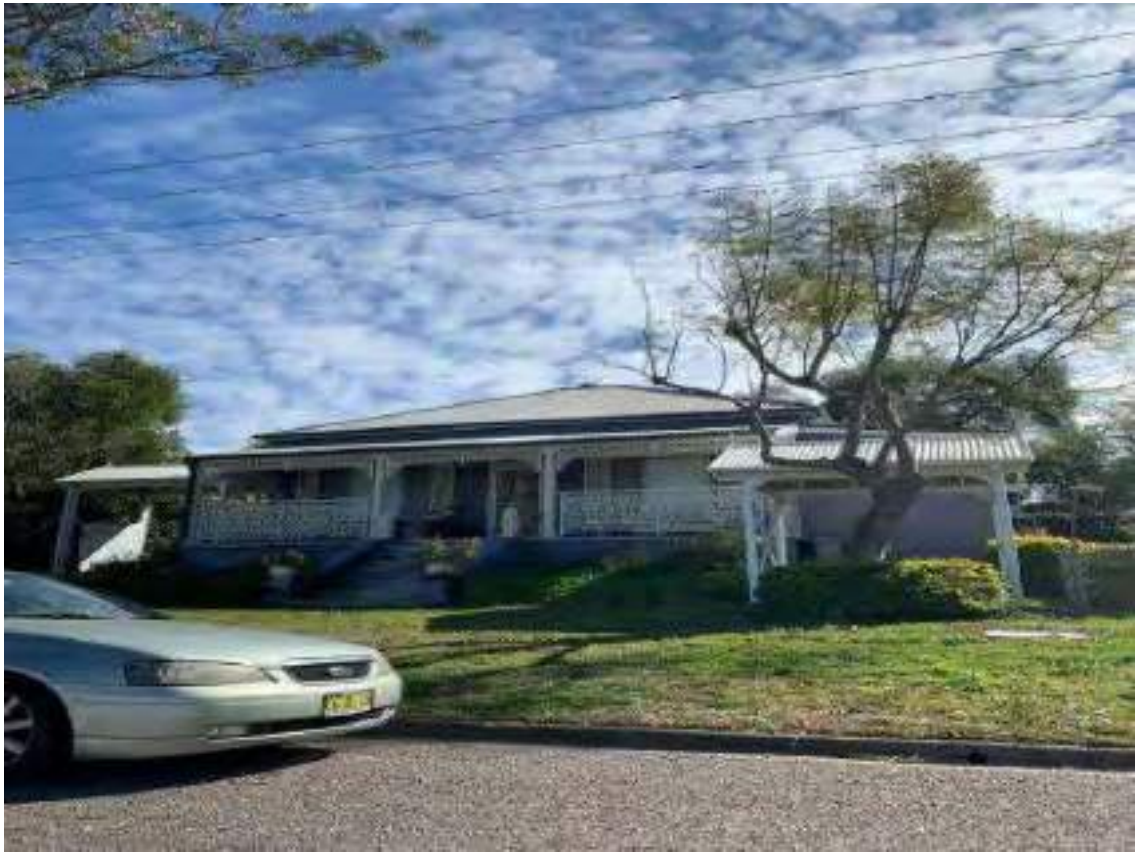
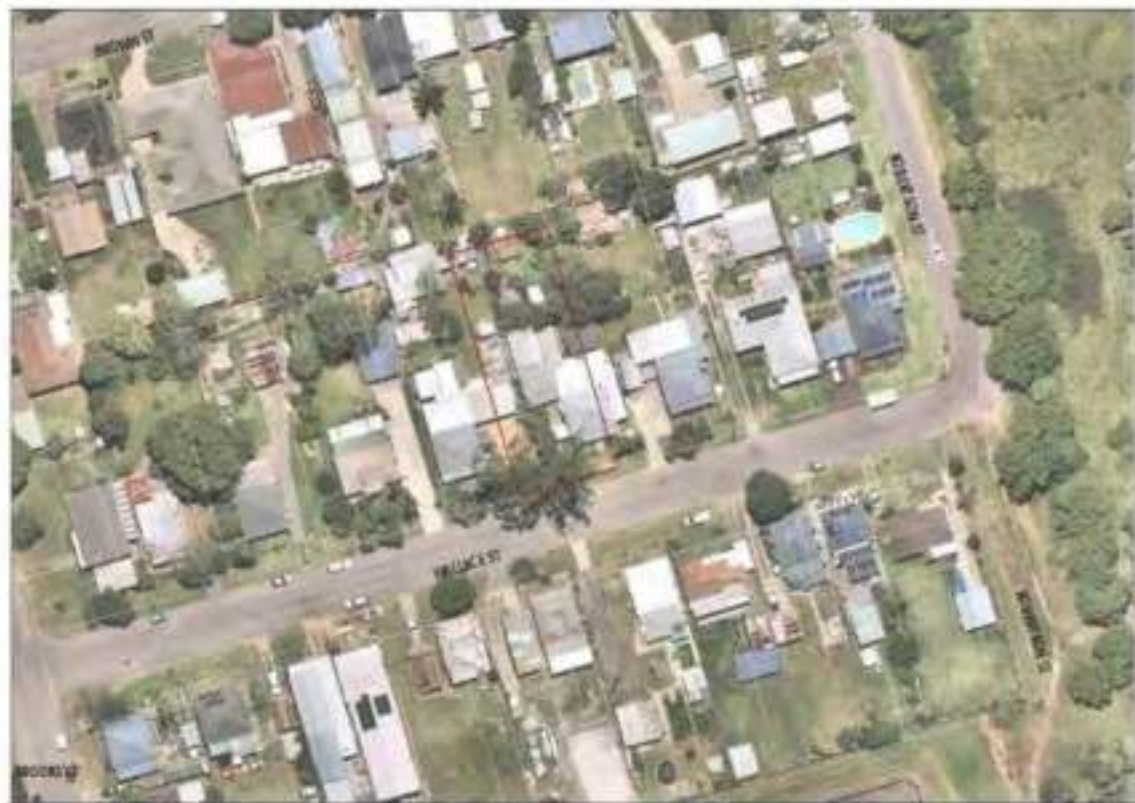
7 WALLACE STREET, WEST WALLSEND 2286

Conservation Area Contribution Level	Est. Construction Date	Previous studies and/or community input
Contributory 1	1890–1915	No prior heritage investigations and no additional information required Potentially former residence of a local doctor.
Assessment Text		Observed Modifications
<p>Single story Vernacular ‘Mining Cottage’ style dwelling with hipped Colourbond roof and weatherboard cladding. The veranda roof is skillion with plaster Corinthian styled support pillars.</p> <p>The veranda is partially enclosed by cast iron ornate balustrade and framed by a cast iron valance. Masonry/concrete stairs lead onto the veranda landing, with masonry balustrade, piers and decorative lion statues.</p> <p>The front door is timber framed with ornate metal screen door, and large sliding windows either side.</p> <p>A timber gable roof structure with finials is visible in the front garden. A gable roof carport and garage is located to the west and north of the dwelling.</p> <p>The dwelling displays architectural features of a heritage style and is representative of the local development of this period, being of historical significance for the HCA.</p>		<p>The cast iron detailing on the veranda is all a contemporary addition constructed in a heritage style. These decorative features are not common or appropriate for the dwelling style.</p> <p>The grand stairs leading to the dwelling are potentially a contemporary addition, as no other examples are present in the area.</p> <p>The southern façade windows are contemporary sliding designs, likely replacing original timber framed sash styles.</p>

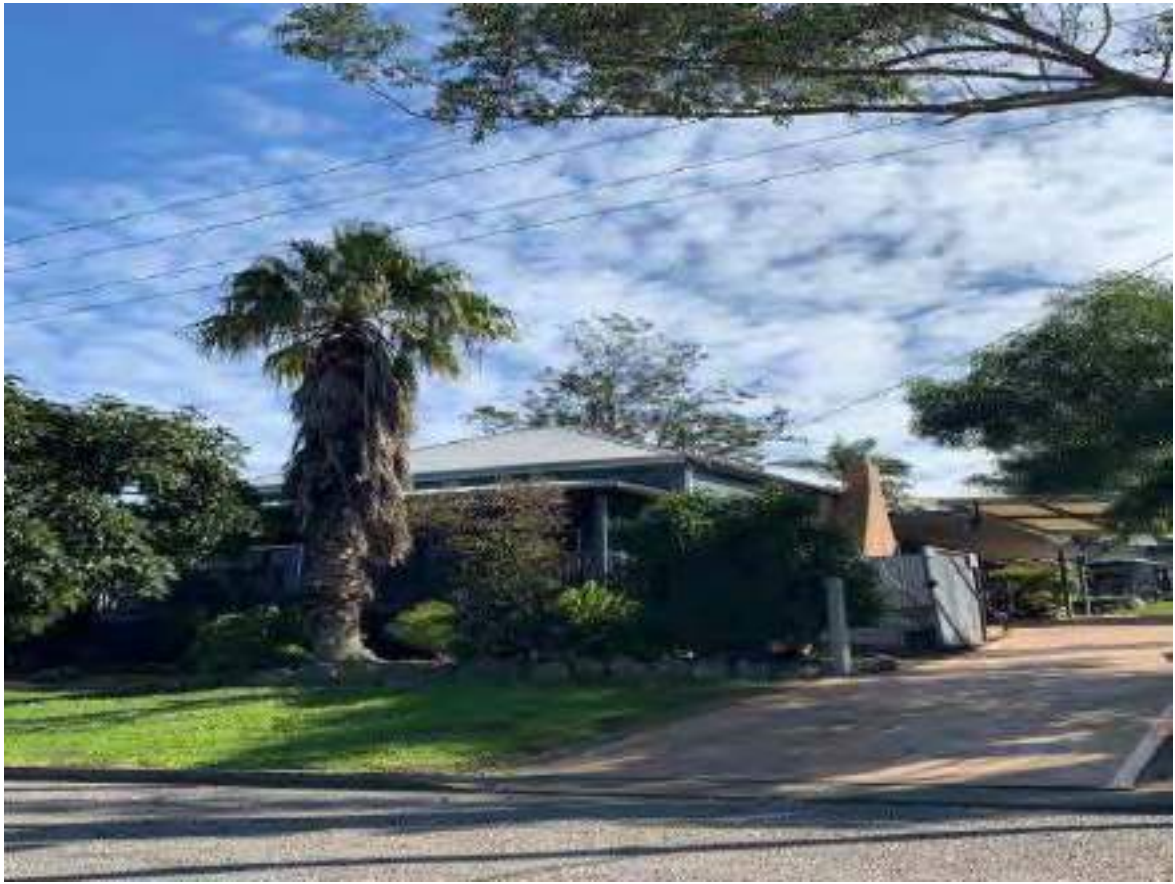
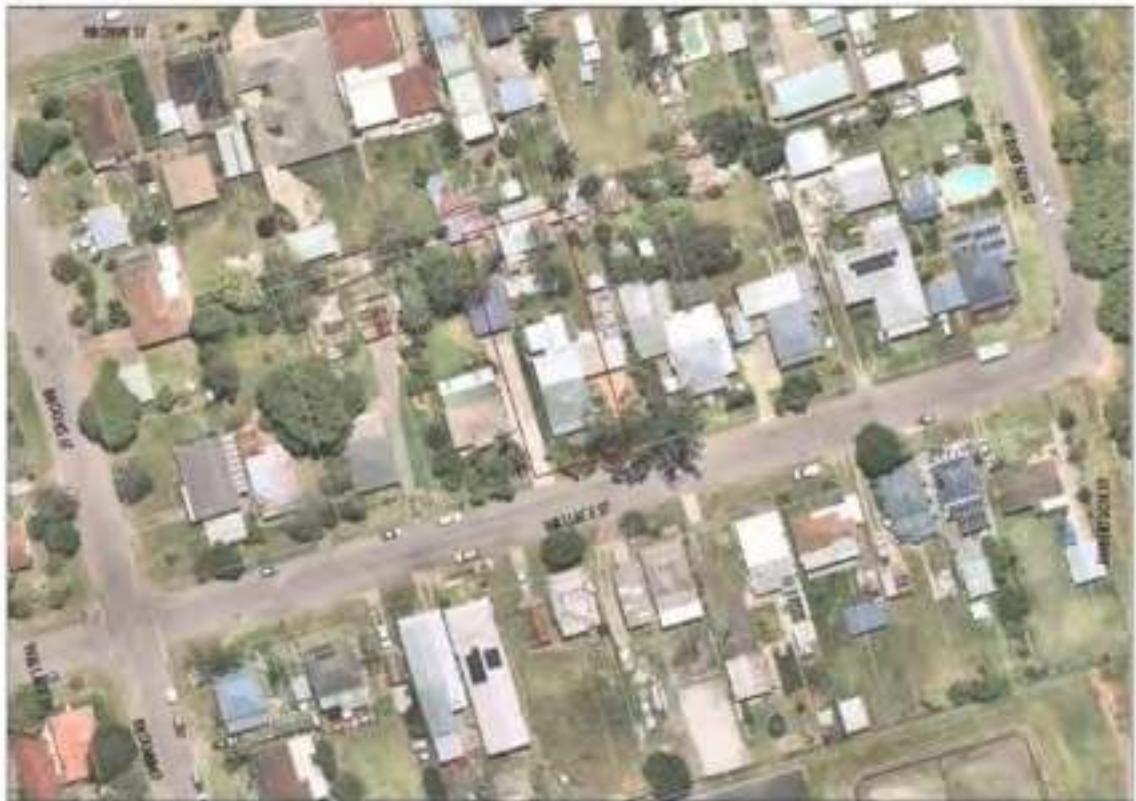
9 WALLACE STREET, WEST WALLSEND 2286

Conservation Area Contribution Level	Est. Construction Date	Previous studies and/or community input
Contributory 1	1890–1915	No prior heritage investigations and no additional information required
Assessment Text		Observed Modifications
<p>Single story Vernacular ‘Mining Cottage’ style dwelling with Colourbond hipped roof and weatherboard cladding. The veranda roof is hipped and supported by timber posts.</p> <p>The veranda is partially enclosed by timber balustrade, with timber flooring. A set of timber stairs leads onto the landing.</p> <p>A brickwork chimney is visible on the eastern side of the dwelling.</p> <p>A car port and garage are located to the north of the dwelling.</p> <p>The dwelling is partially obscured by mature vegetation.</p> <p>The dwelling displays architectural features of a heritage style and is representative of the local development of this period, being of historical significance for the HCA.</p>		<p>The chimney is likely contemporary addition, likely replacing the original brick chimney.</p> <p>The timber balustrade and stairs are recent modifications.</p>

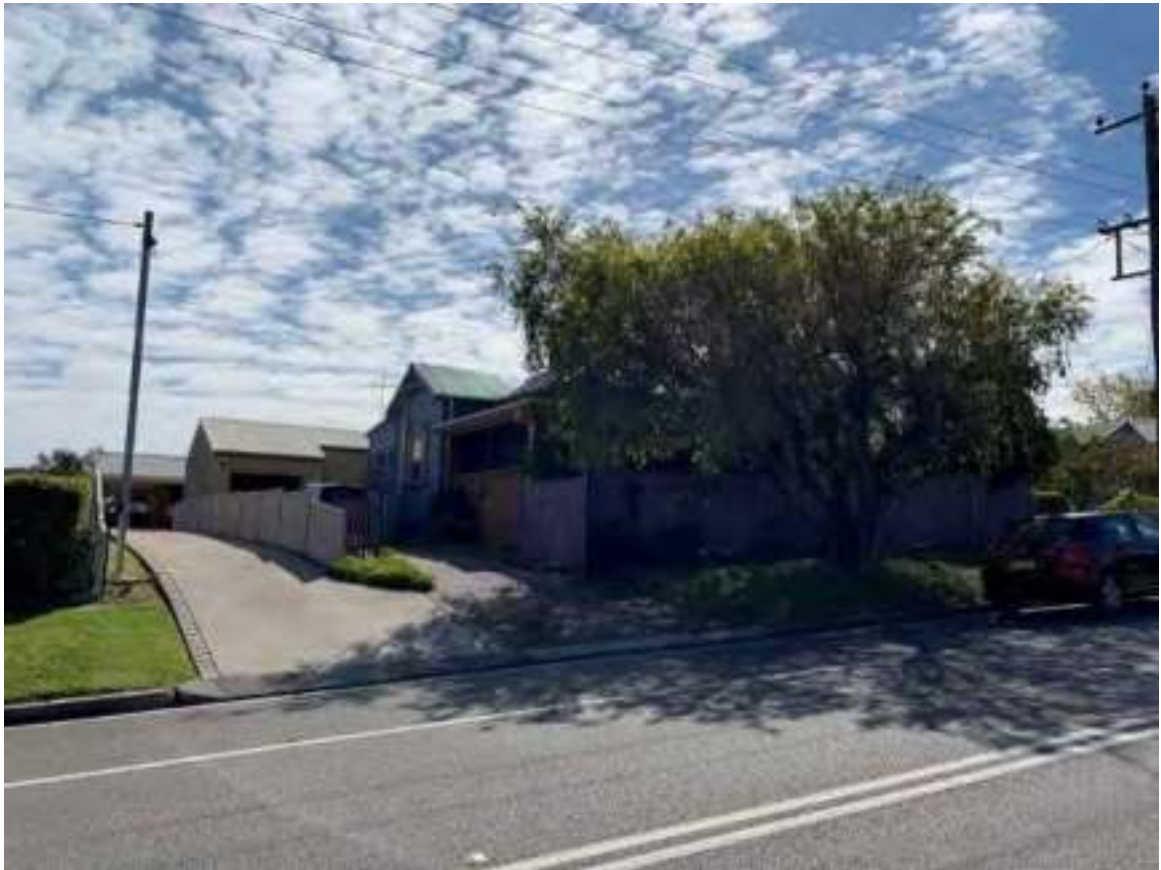
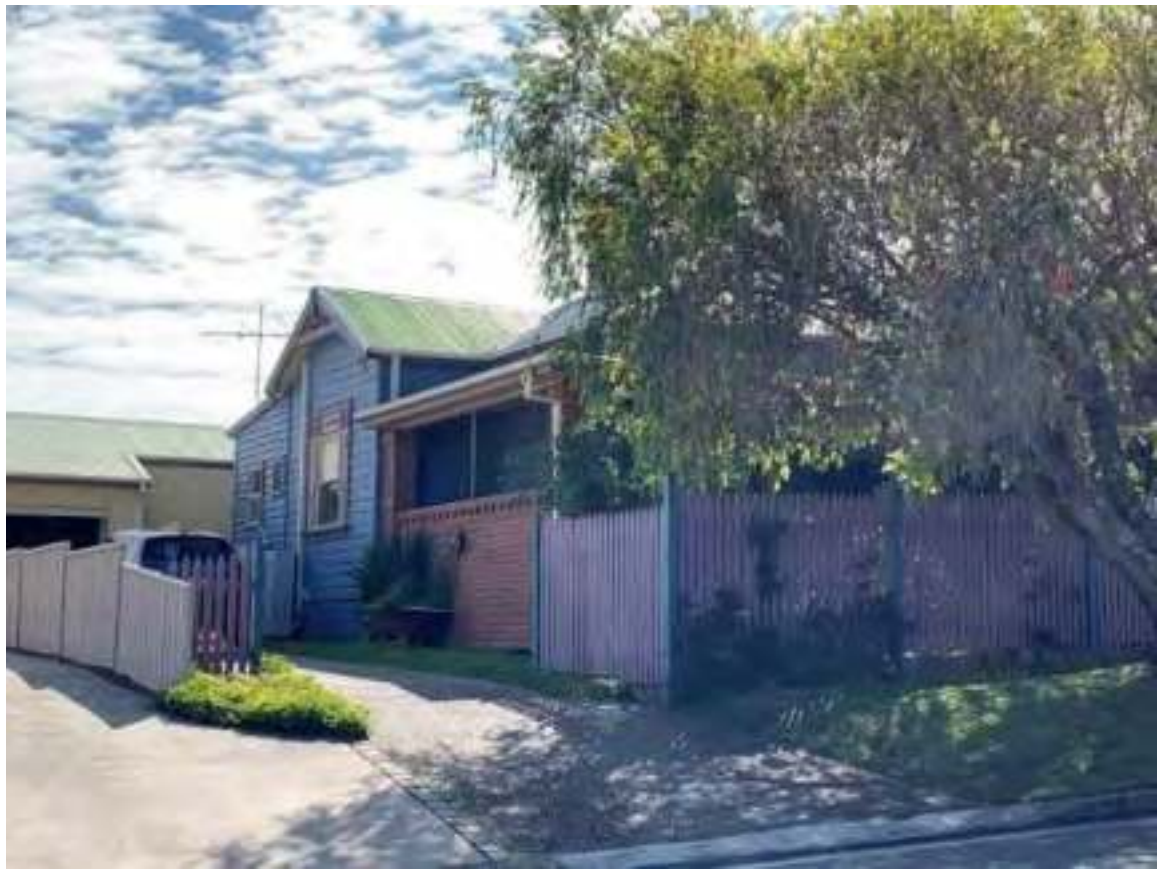
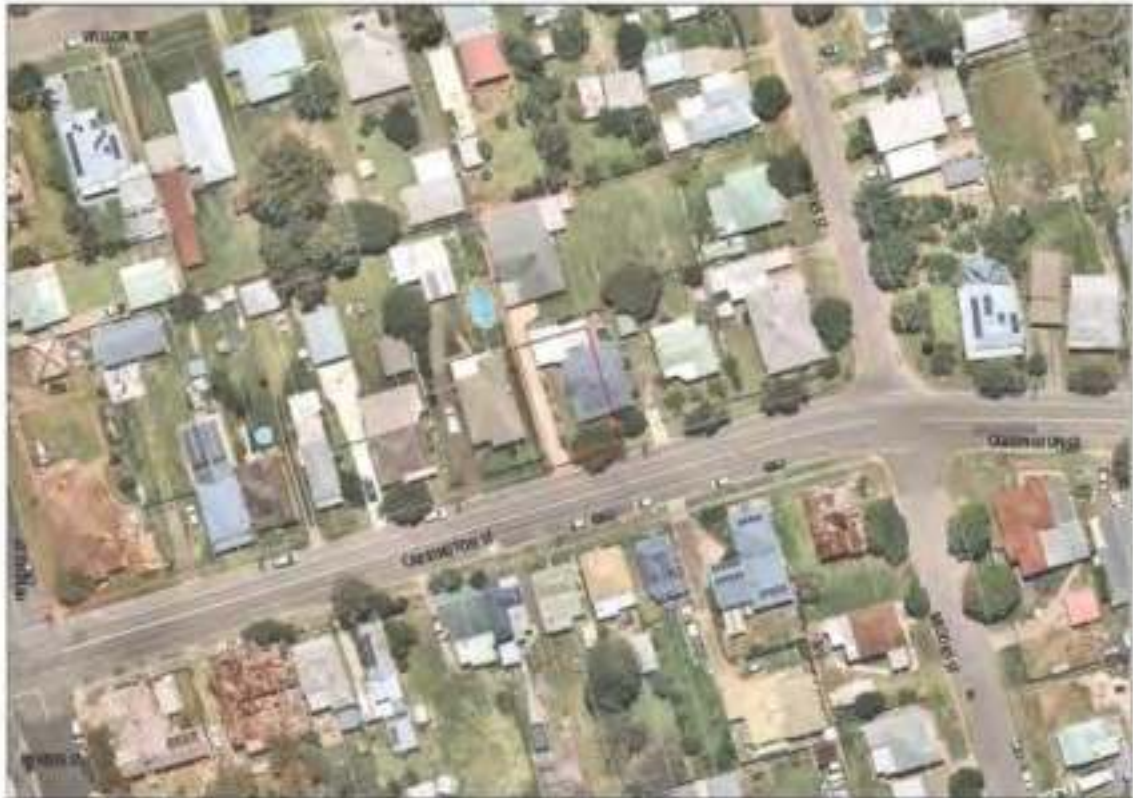
35 CARRINGTON STREET, WEST WALLSEND 2286

Conservation Area Contribution Level	Est. Construction Date	Previous studies and/or community input
Contributory 1	1890–1915	No prior heritage investigations and no additional information required
Assessment Text		Observed Modifications
<p>Single story dwelling with half hipped and gable Colourbond roof and weatherboard cladding. The veranda roof is hipped and supported by brick pillars.</p> <p>The veranda is enclosed by a red brick veranda wall with brick pillars and dental course decorative features.</p> <p>The visible windows are timber framed with ornate panel decorations and sash in design.</p> <p>The western gable has simple ornate barge boards and timber work.</p> <p>A brickwork chimney is visible on the western side.</p> <p>A timber picket fence encloses the property.</p> <p>The dwelling is obscured by mature vegetation.</p> <p>The dwelling displays architectural features of a heritage style and is representative of the local development of this period, being of historical significance for the HCA.</p>		<p>No prior heritage investigations and no additional information required</p>

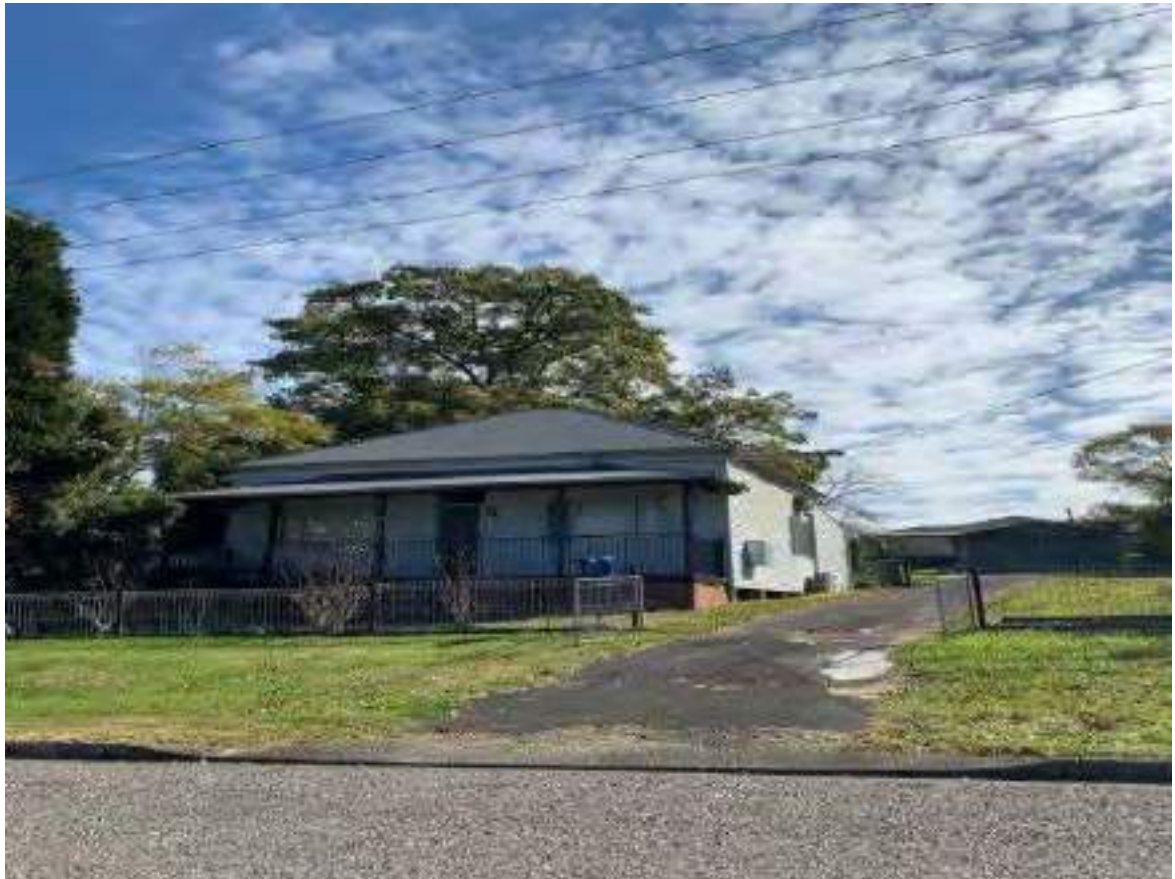
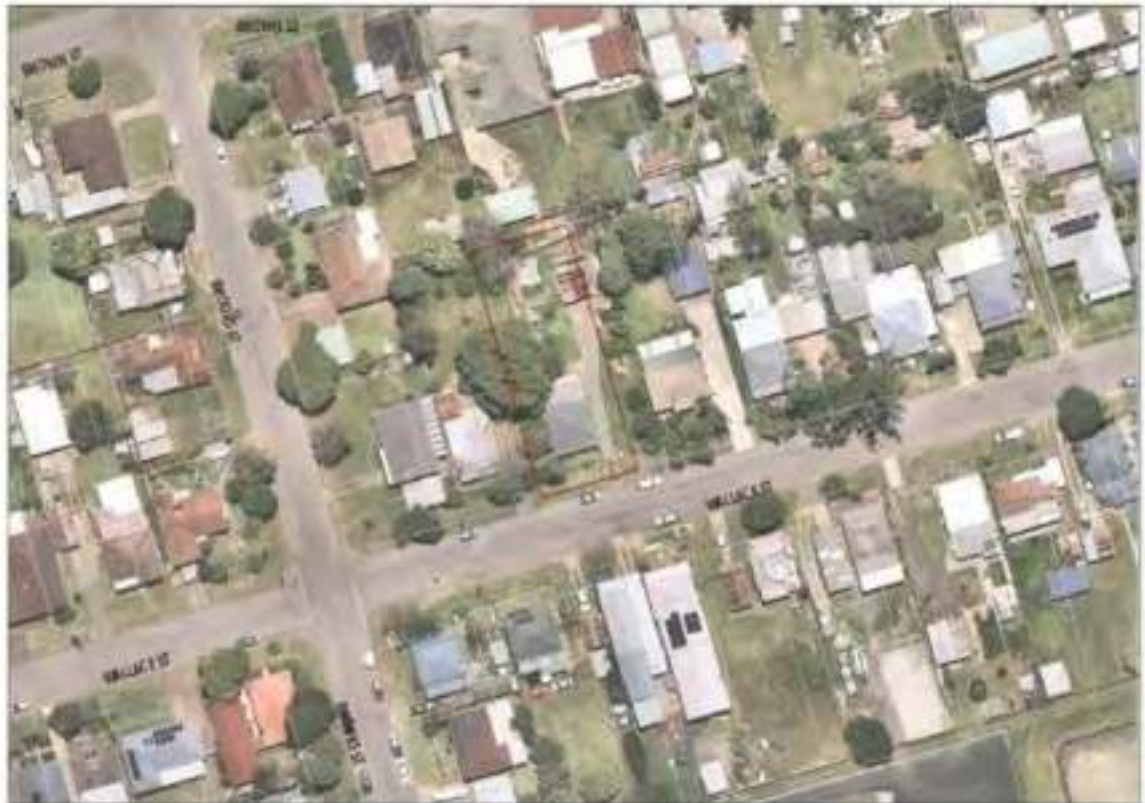
13 WALLACE STREET, WEST WALLSEND 2286

Conservation Area Contribution Level	Est. Construction Date	Previous studies and/or community input
Contributory 1	1890–1915	No prior heritage investigations and no additional information required
Assessment Text		Observed Modifications
<p>Single story Vernacular ‘Mining Cottage’ style dwelling with Colourbond hipped roof and weatherboard cladding. The veranda roof is hipped and supported by timber posts.</p> <p>The veranda is partially enclosed by a simple metal balustrade. A set of concrete stairs leads to the landing</p> <p>The front door is timber framed with a fan light above and metal security screen. Large picture windows are either side.</p> <p>A metal fence encloses the property.</p> <p>A double door gable roof garage is located to the north of the dwelling</p> <p>The dwelling displays architectural features of a heritage style and is representative of the local development of this period, being of historical significance for the HCA.</p>		<p>All visible windows have been replaced with contemporary metal framed designs, likely replacing the original timber framed sash styles.</p> <p>The metal balustrade is a recent addition.</p>

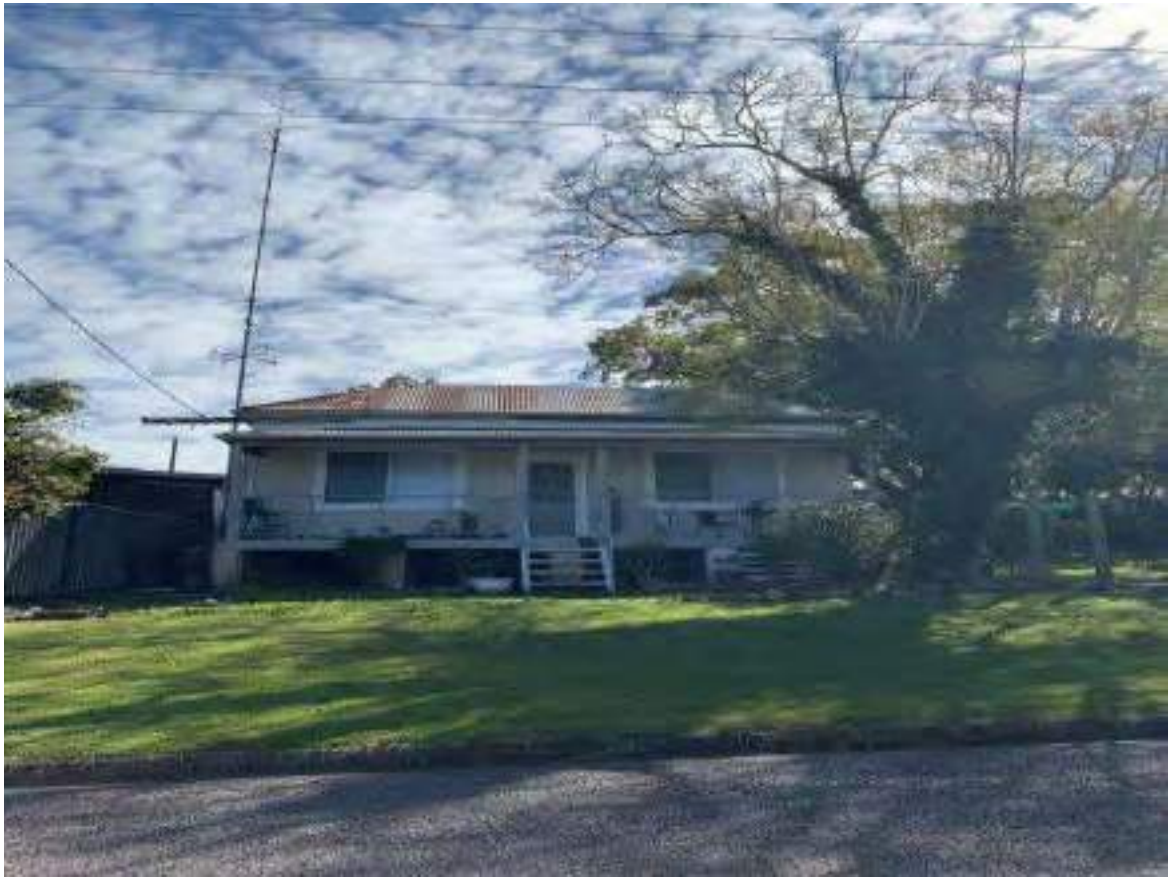
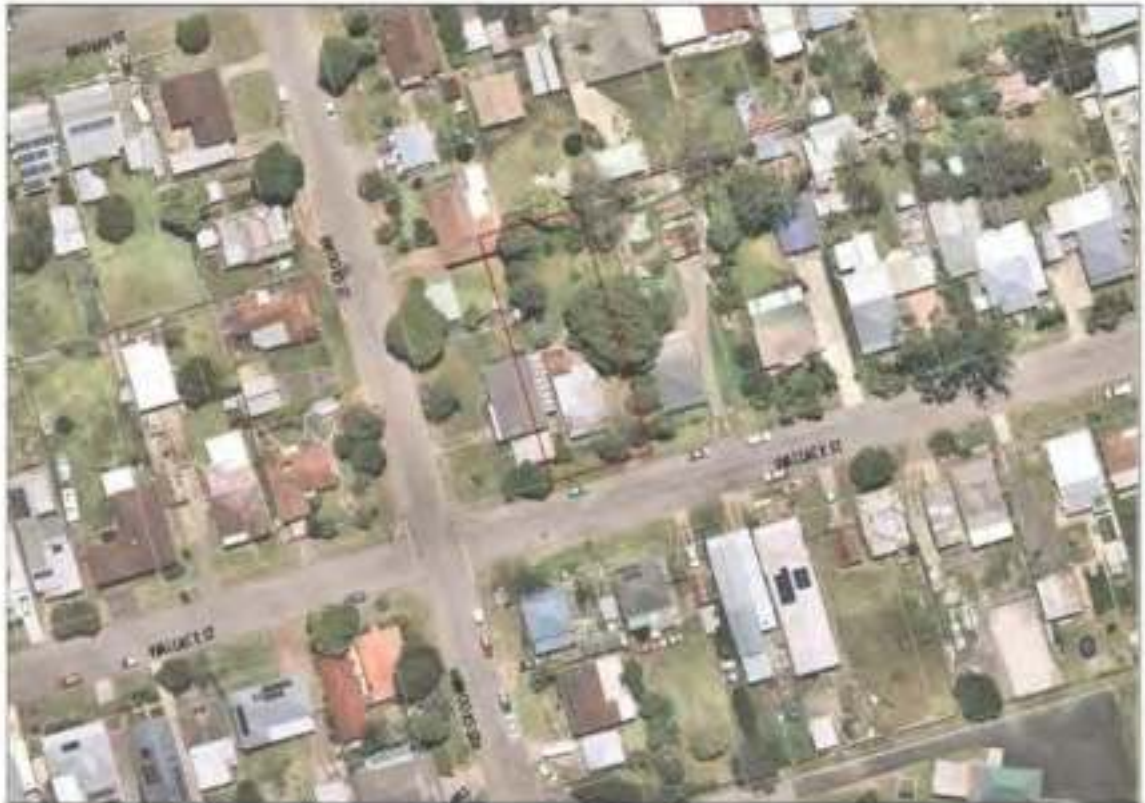
15 WALLACE STREET, WEST WALLSEND 2286

Conservation Area Contribution Level	Est. Construction Date	Previous studies and/or community input
Contributory 1	1890–1915	No prior heritage investigations and no additional information required
Assessment Text		Observed Modifications
<p>Single story Vernacular ‘Mining Cottage’ style dwelling with hipped Colourbond roof and weatherboard cladding. The veranda roof is hipped and supported by timber posts.</p> <p>The veranda is partially enclosed by simple timber balustrade, with timber stairs leading onto the landing with metal support rails.</p> <p>The front door is timber framed with a metal security screen, with sliding windows on either side.</p> <p>The dwelling displays architectural features of a heritage style and is representative of the local development of this period, being of historical significance for the HCA.</p>		<p>All visible windows have been replaced with contemporary timber framed sliding designs, replacing the original sash styles.</p> <p>The timber balustrade and metal support rail are recent additions to the dwelling.</p>

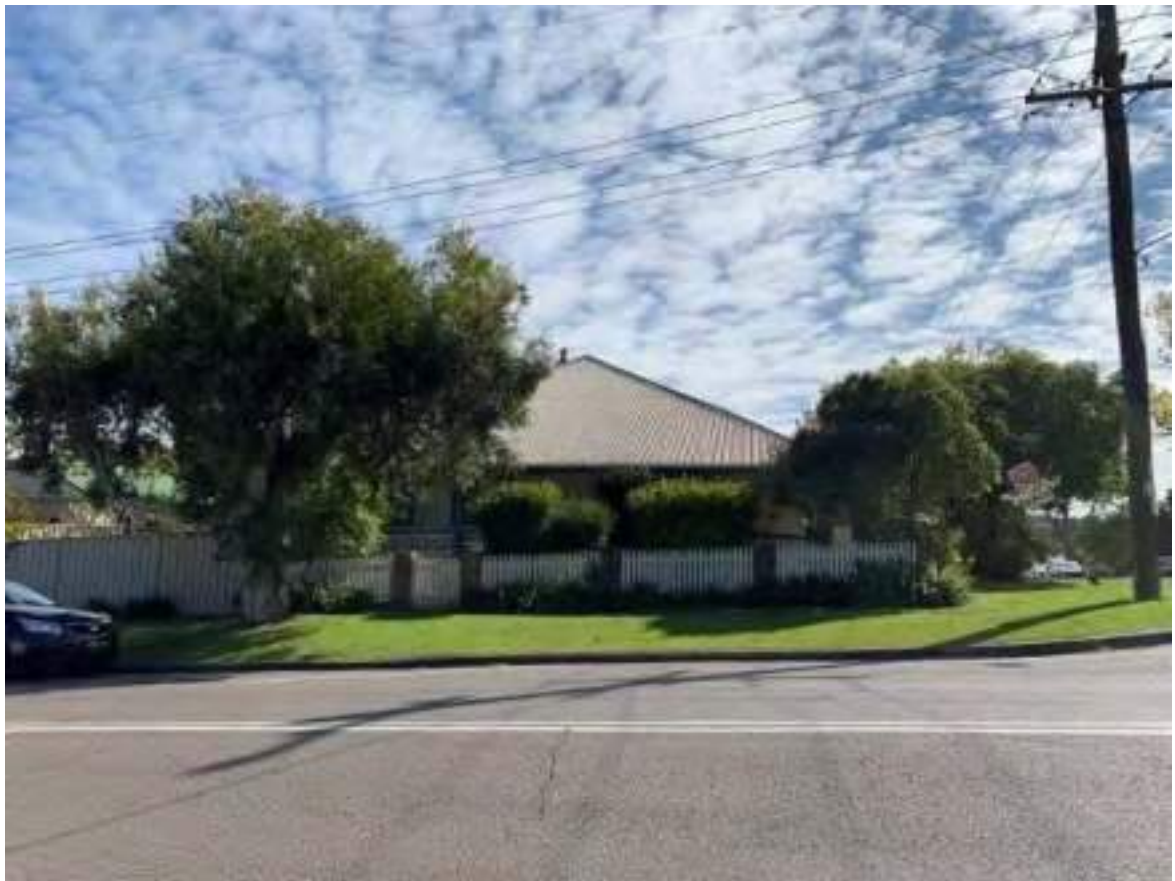
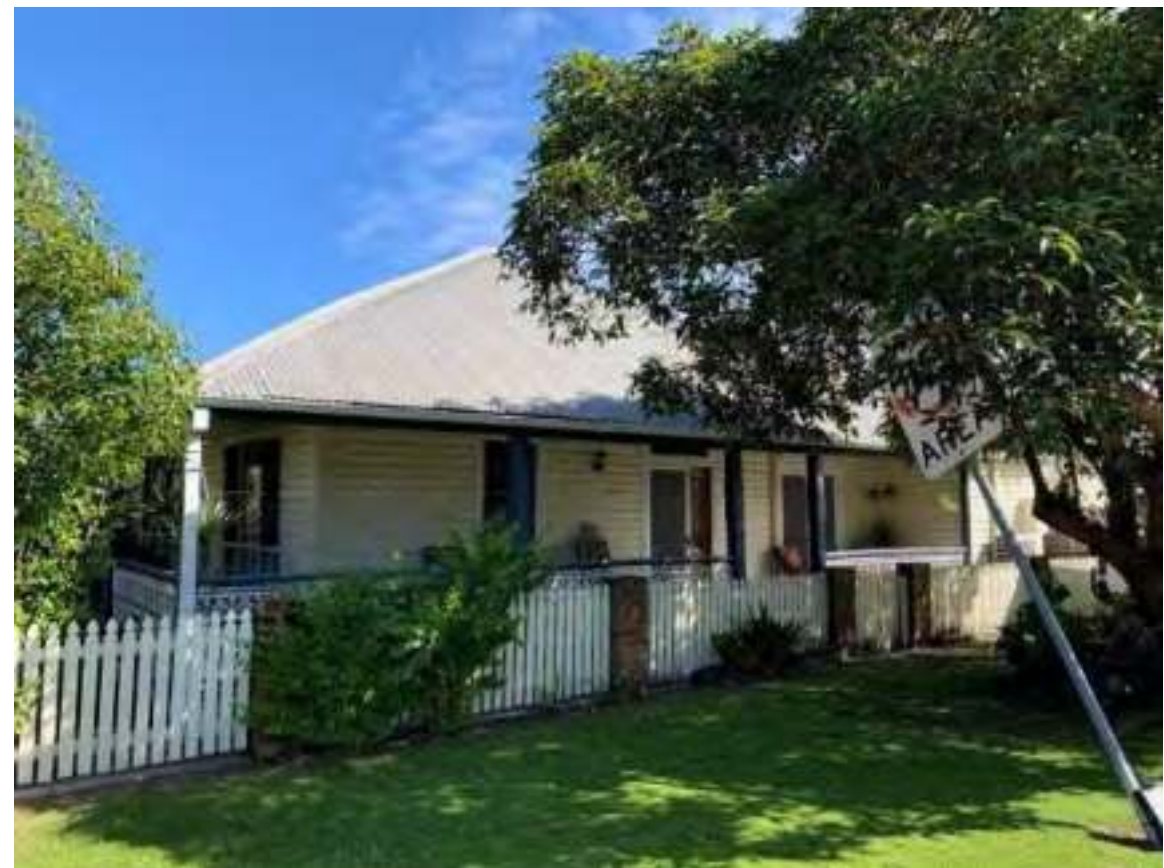
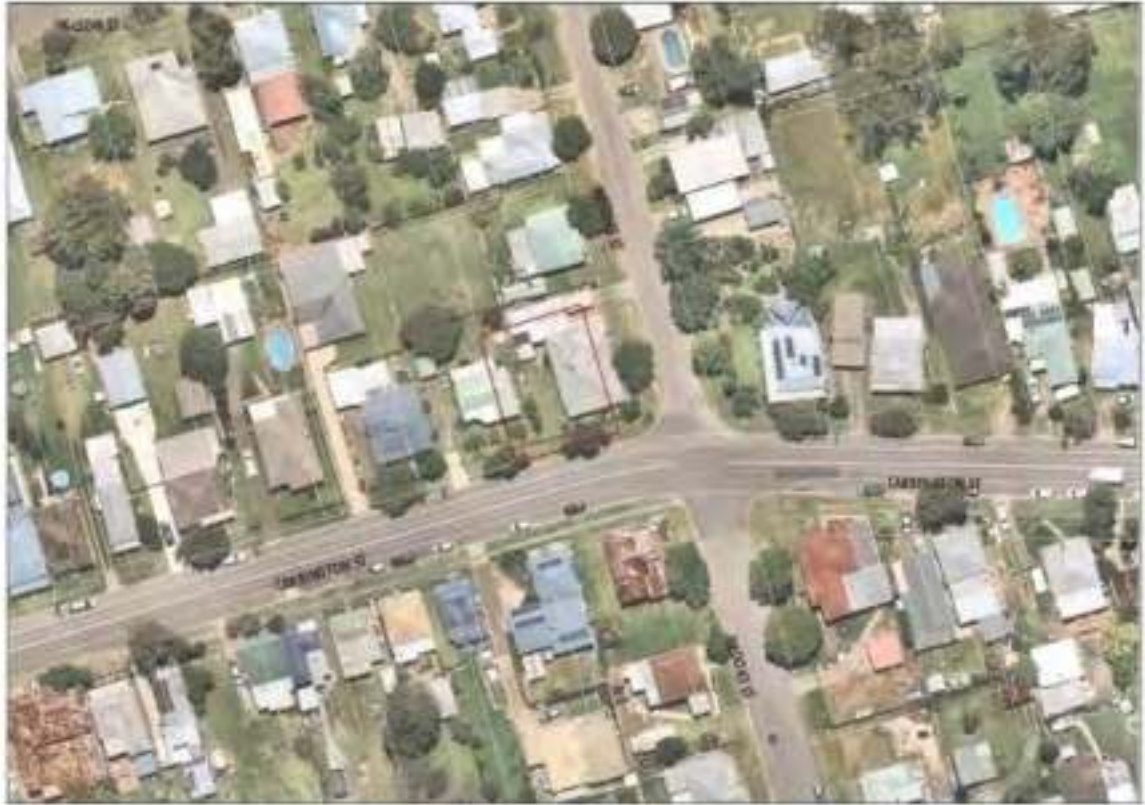
31 CARRINGTON STREET, WEST WALLSEND 2286

Conservation Area Contribution Level	Est. Construction Date	Previous studies and/or community input
Contributory 1	1900–1920	No prior heritage investigations and no additional information required
Assessment Text		Observed Modifications
<p>Single story dwelling with box layout, extended hipped Colourbond roof and weatherboard cladding. The veranda roof is incorporated into the hipped main roof and wraps around the southern and eastern sides of the dwelling.</p> <p>The veranda is partially enclosed by timber and cast iron decorative balustrade. The western wall is enclosed by timber laticing.</p> <p>The front door is timber framed with a fan light and sash windows either side.</p> <p>A brickwork chimney is visible on the northern side of the dwelling.</p> <p>Timber picket fencing encloses the property.</p> <p>The dwelling is obscured by mature vegetation.</p> <p>The dwelling displays architectural features of a heritage style and is representative of the local development of this period, being of historical significance for the HCA.</p>		<p>The veranda balustrade is likely a contemporary replication of a heritage design.</p>

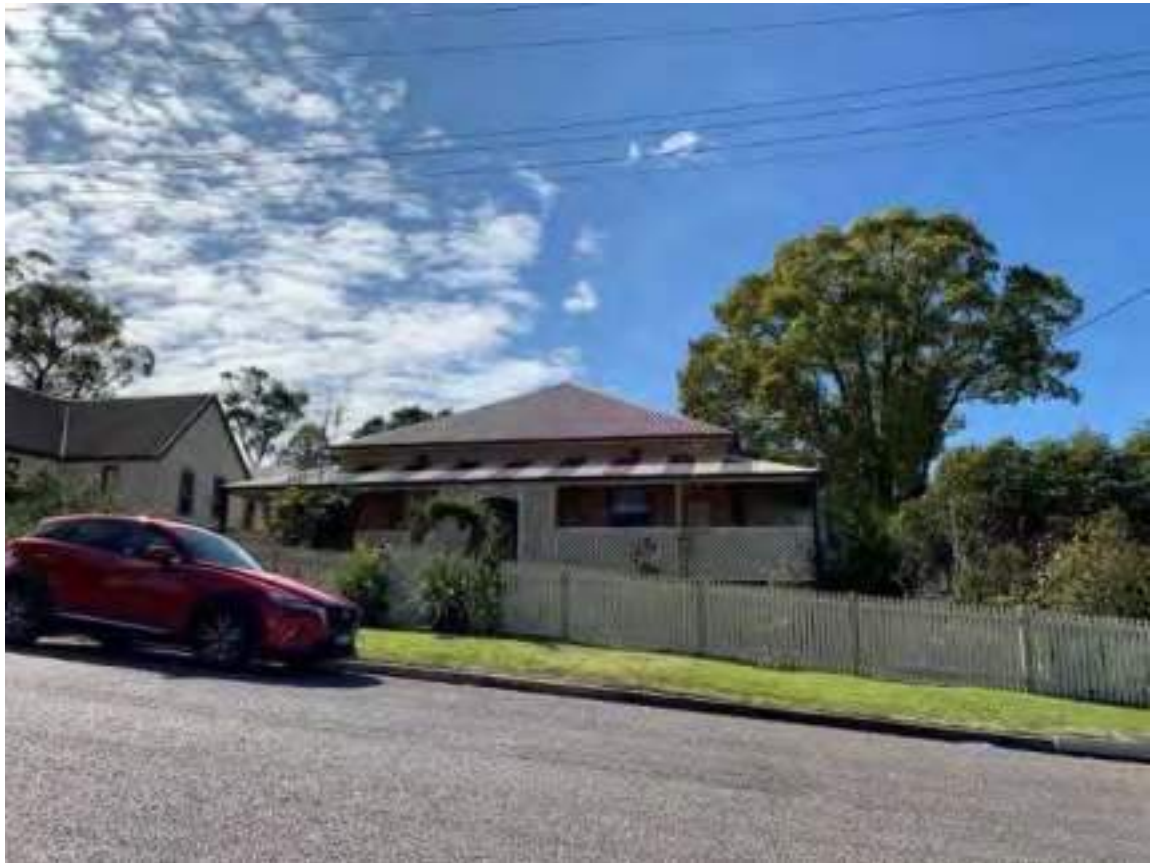
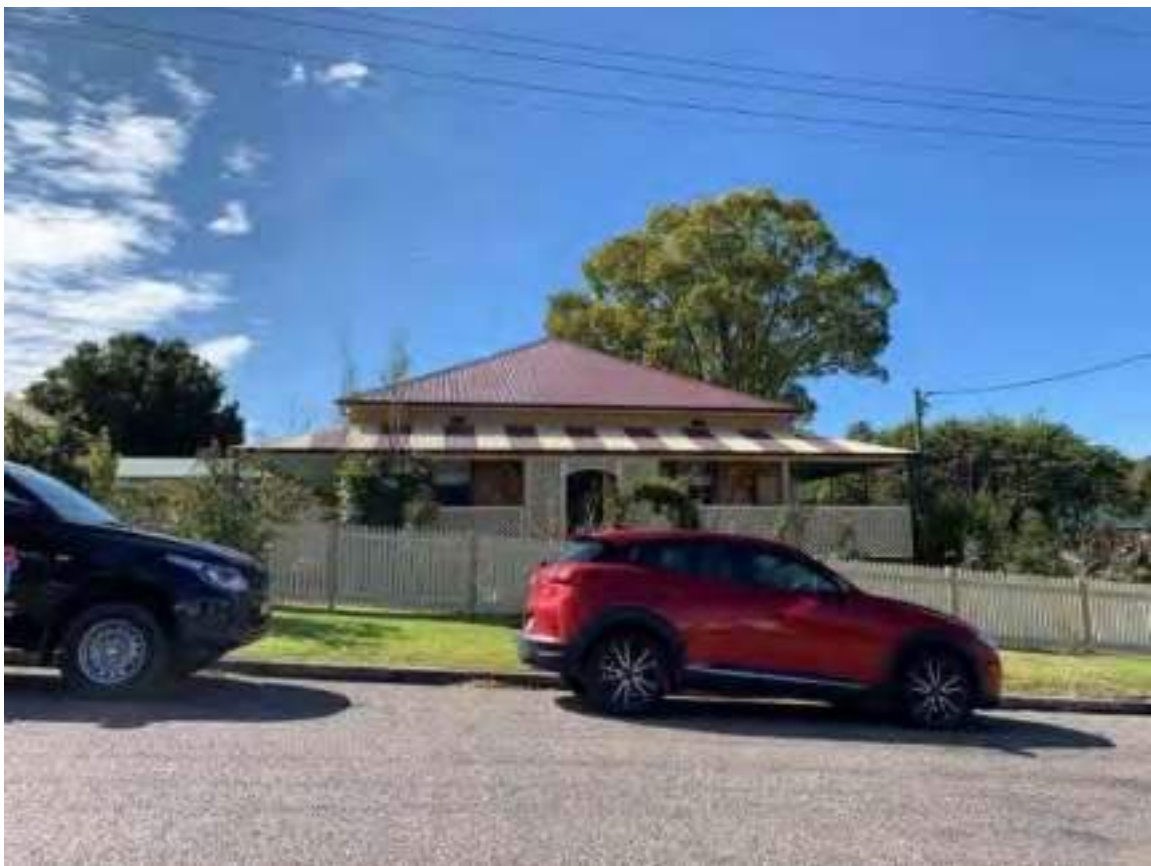
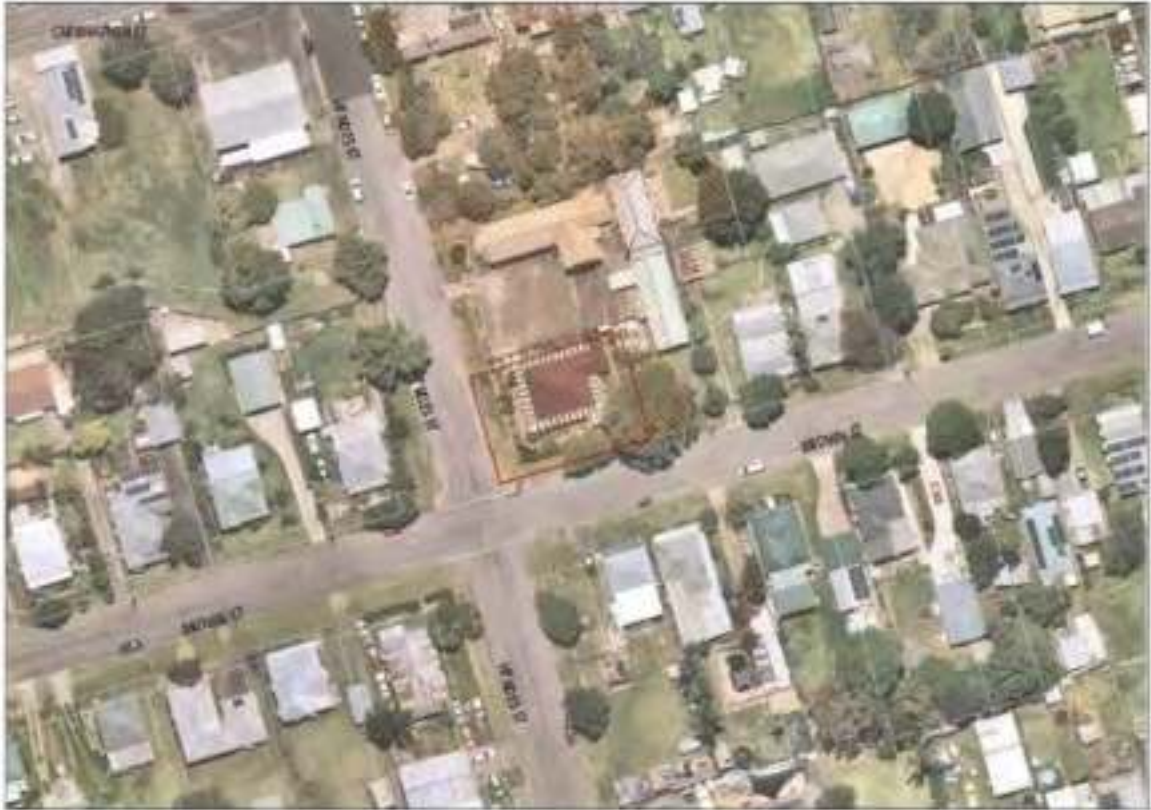
ST JOSEPHS CONVENT, 7 HYNDES STREET, WEST WALLSEND 2286

Conservation Area Contribution Level	Est. Construction Date	Previous studies and/or community input
Contributory 1	1912	West Wallsend Heritage Study 1993
Assessment Text		Observed Modifications
<p>Single story convent style mid Victorian dwelling with hipped Colourbond roof and weatherboard cladding. The veranda roof is hipped and encircles the northern, western and southern side of the building. The veranda roof has yellow and red painted stripe detailing.</p> <p>The veranda is partially enclosed by a timber lattice balustrade, with arched lattice entranceway.</p> <p>The front door is timber framed with original heavy timber sash windows on either side.</p> <p>A timber picket fence encloses the property.</p> <p>The dwelling displays architectural features of a heritage style and is representative of the local development of this period, being of historical significance for the HCA.</p>		<p>In reference to the 1993 study the lattice balustrade is a contemporary addition, whilst a small dormer gable projection and Queensland style trellised balustrade have been removed.</p>

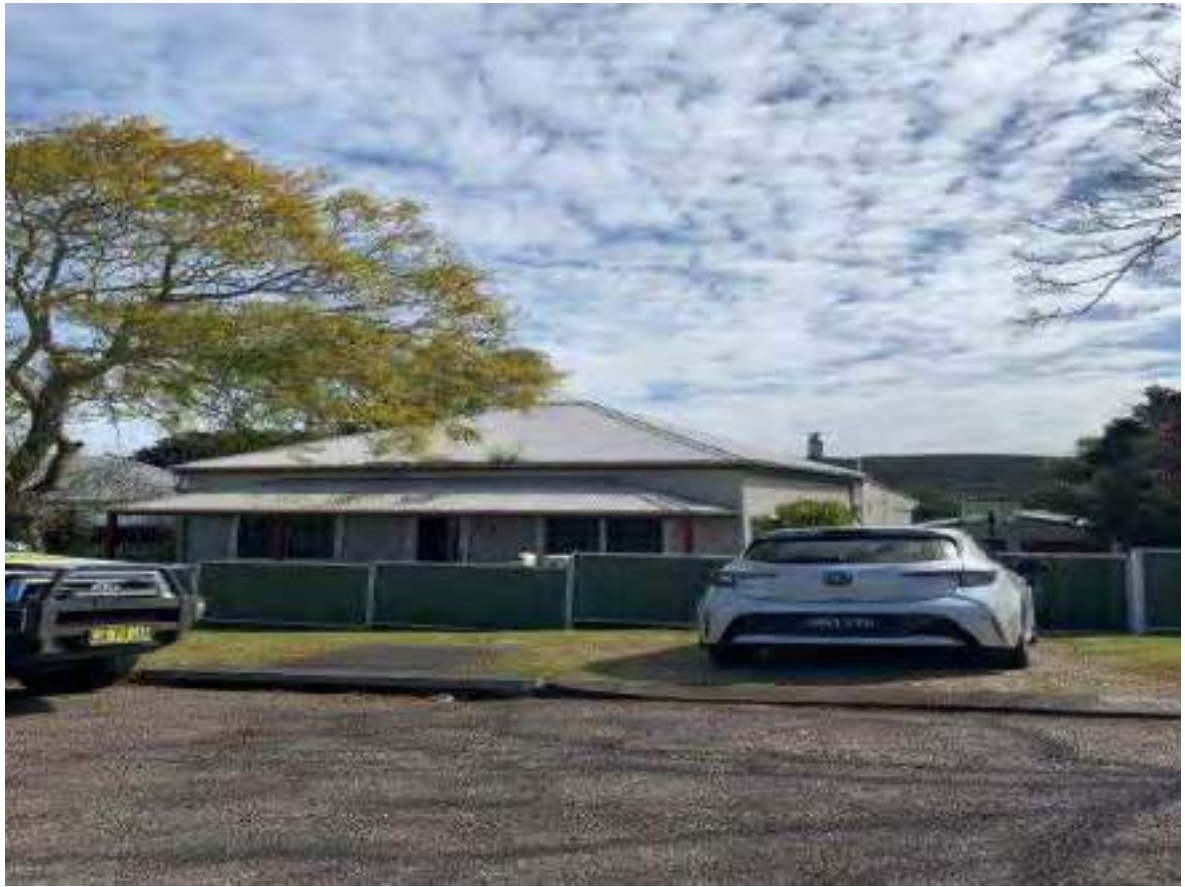
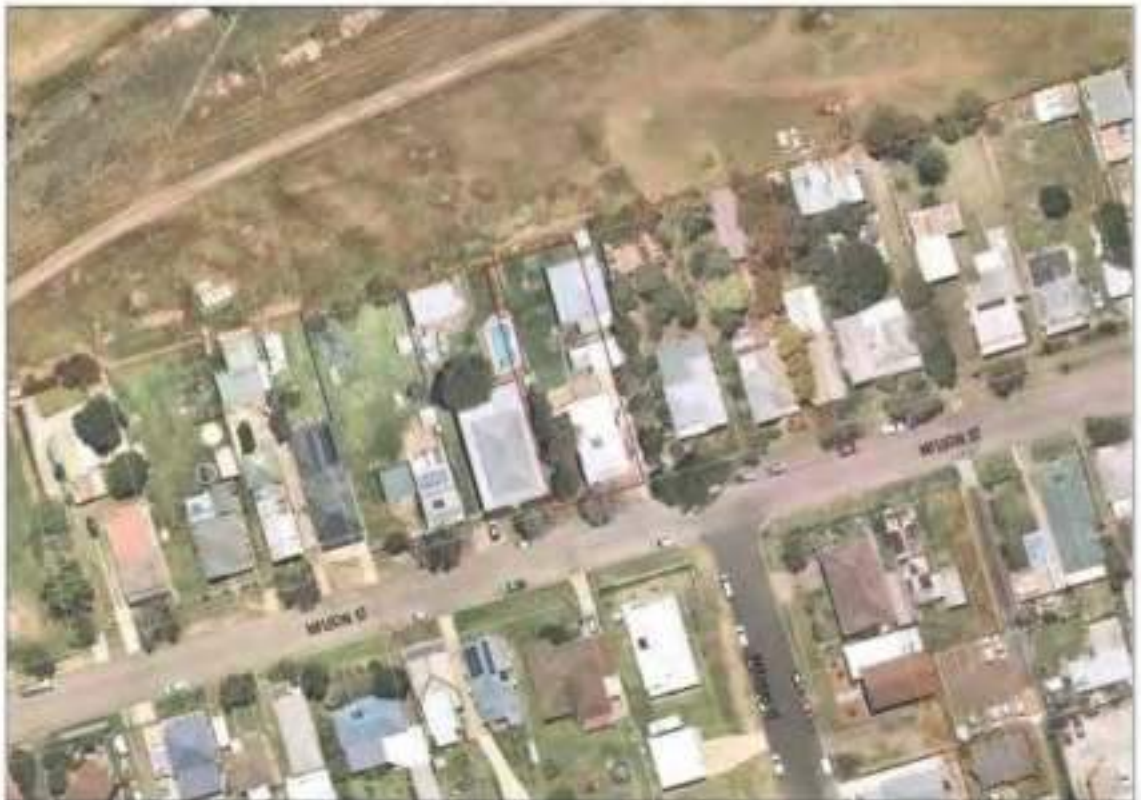
59 WILSON STREET, WEST WALLSEND 2286

Conservation Area Contribution Level	Est. Construction Date	Previous studies and/or community input
Contributory 1	1890–1915	No prior heritage investigations and no additional information required
Assessment Text		Observed Modifications
<p>Single story Vernacular ‘Mining Cottage’ style dwelling with Colourbond hipped roof and weatherboard cladding. The veranda roof is hipped and supported by timber posts.</p> <p>The front door is timber framed with double sash windows on either side.</p> <p>A metal chimney flume is visible on the eastern side of the dwelling.</p> <p>A Colourbond fence encloses the property</p> <p>The dwelling displays architectural features of a heritage style and is representative of the local development of this period, being of historical significance for the HCA.</p>		<p>All visible windows are contemporary variations on the traditional sash window design.</p> <p>The chimney has been removed and replaced with a contemporary metal style.</p> <p>A back extension has been constructed on the northern side of the dwelling, however is not visible from the street.</p>
