APPENDIX 2

Building Assessment Sheets (Inventory Sheets)

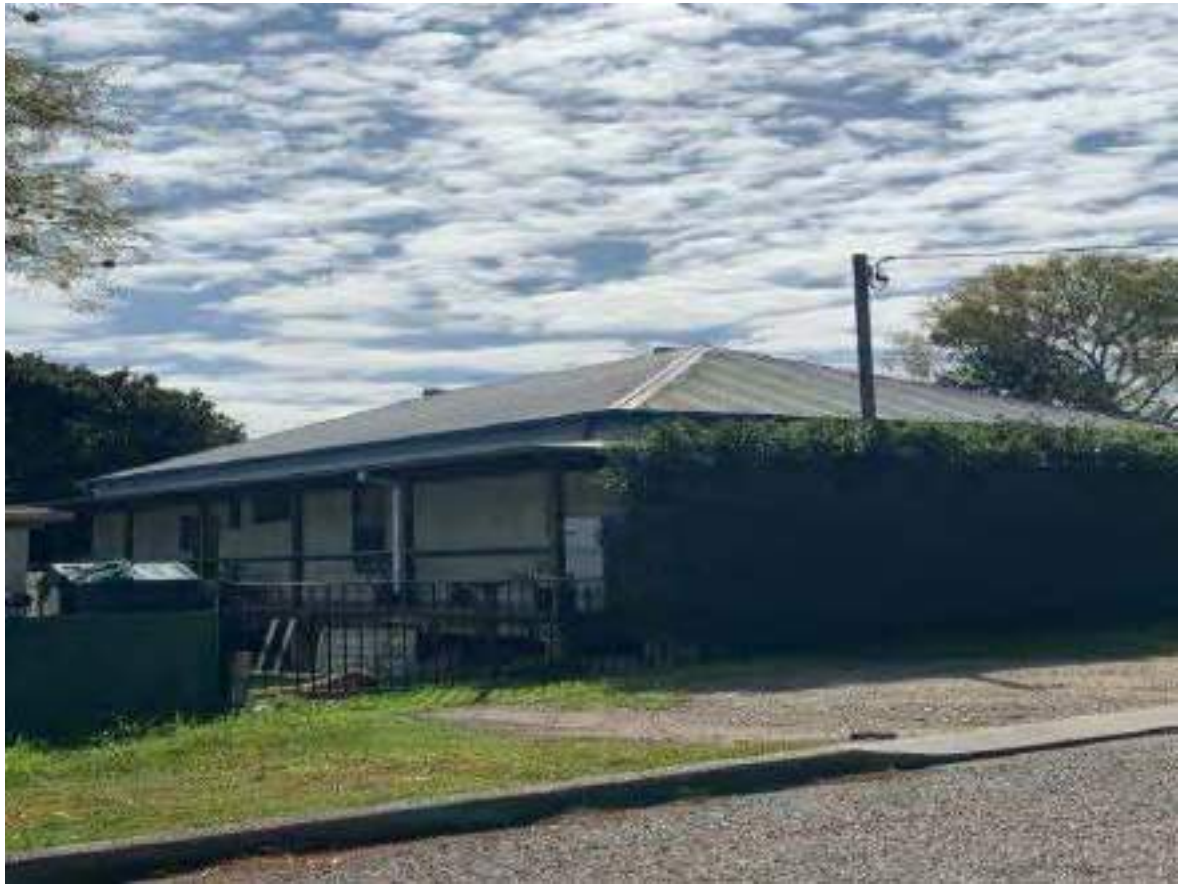
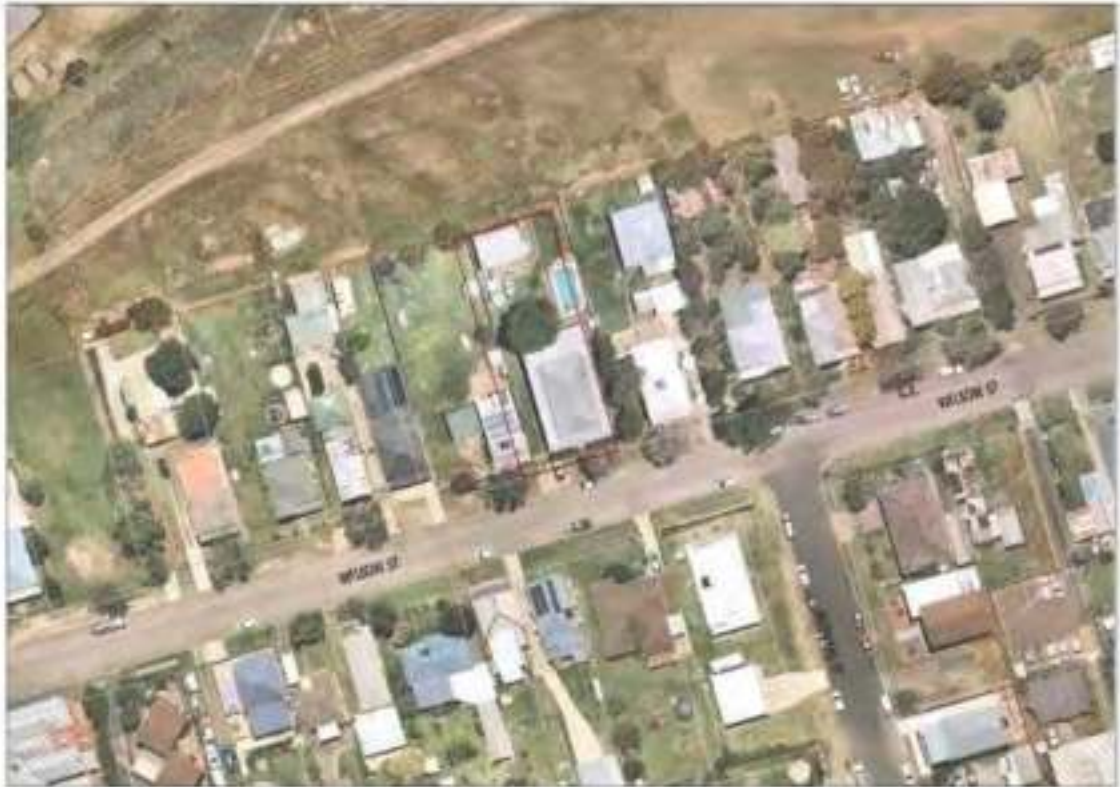
61 WILSON STREET, WEST WALLSEND 2286

Conservation Area Contribution Level	Est. Construction Date	Previous studies and/or community input
Contributory 1	1890–1920	No prior heritage investigations and no additional information required
Assessment Text		Observed Modifications
<p>Single story Vernacular ‘Mining Cottage’ style dwelling with hipped Colourbond roof and weatherboard cladding the veranda roof is hipped and supported by timber posts. The veranda roof encircles the entire dwelling.</p> <p>The veranda is partially enclosed by a simple timber balustrade.</p> <p>The visible windows are sash designs, and potentially original.</p> <p>The dwelling is partially obscured by mature hedge growth.</p> <p>The dwelling displays architectural features of a heritage style and is representative of the local development of this period, being of historical significance for the HCA.</p>		<p>The dwelling has been extended on the northern side, however this has been done in a sympathetic manner and does not detract.</p> <p>The veranda encircles the entire dwelling, likely originally only being present on the front facing southern side.</p> <p>The timber balustrade is a contemporary addition.</p>

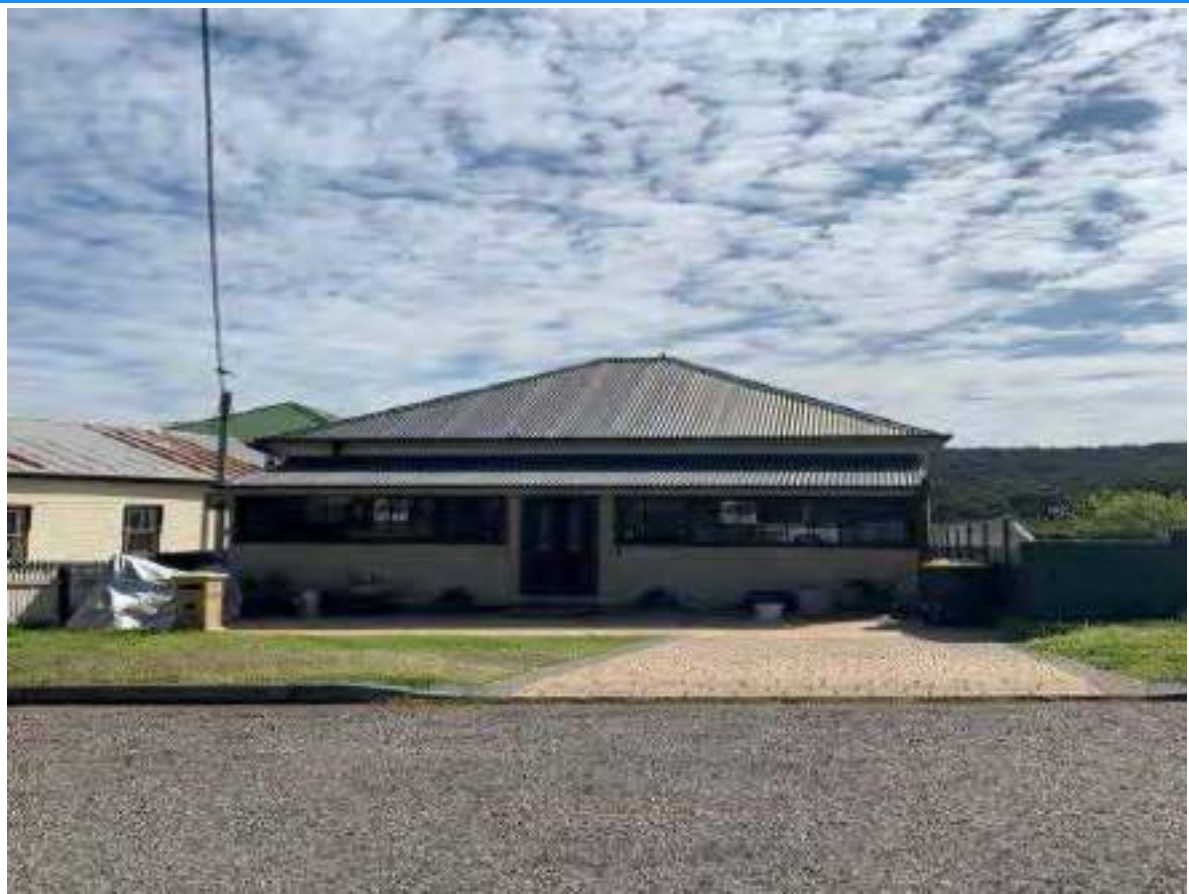
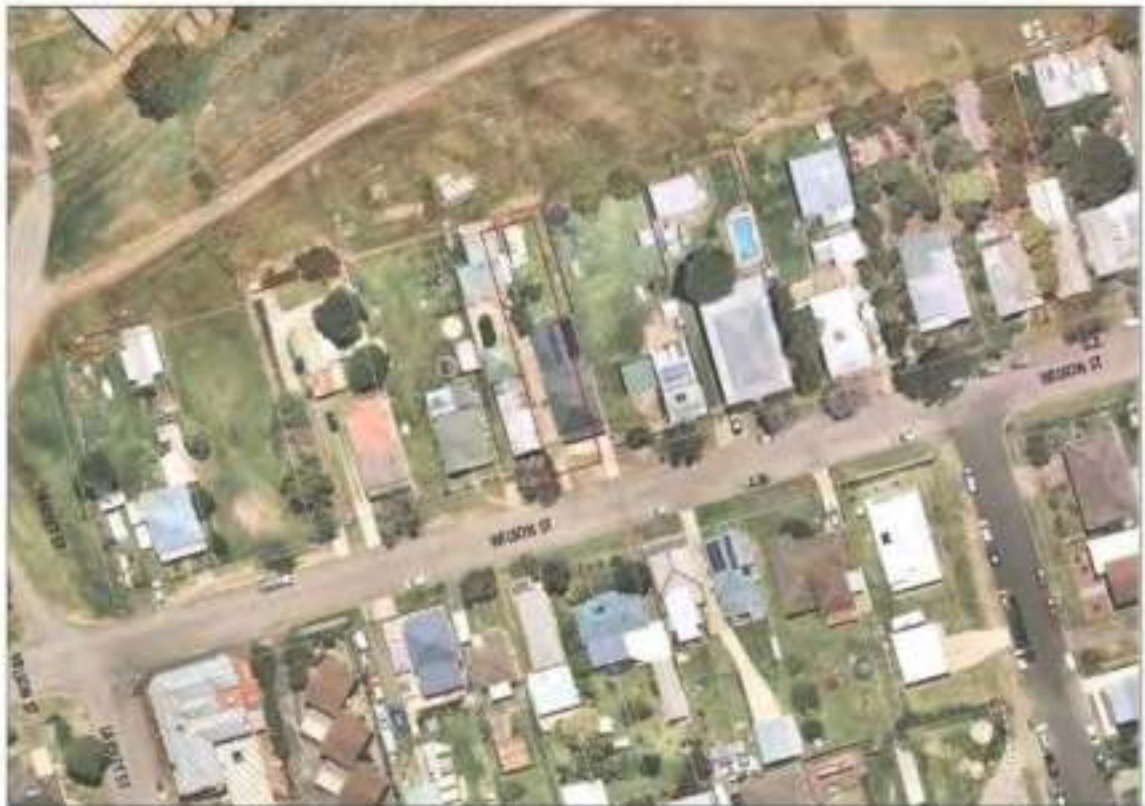
Conservation Area Contribution Level	Est. Construction Date	Previous studies and/or community input
Contributory 1	1890–1915	No prior heritage investigations and no additional information required
Assessment Text		Observed Modifications
<p>Single story Vernacular ‘Mining Cottage’ style dwelling with hipped Colourbond roof and weatherboard cladding. The veranda roof is skillion, with the veranda being fully enclosed and built in to create additional living areas.</p> <p>The front door is timber framed with decorative glass panels. Multipaned windows dominate the entire veranda extension and front façade. The visible western and eastern windows are sliding styles.</p> <p>The dwelling displays architectural features of a heritage style and is representative of the local development of this period, being of historical significance for the HCA.</p>		<p>The veranda has been built in to create an additional living area. This is a common modification for the housing style and can be seen throughout the area.</p> <p>The remaining windows are contemporary sliding styles, likely replacing original heavy timber framed sash designs.</p> <p>An extension has been constructed at the back northern portion of the dwelling, however is not visible from the street.</p>

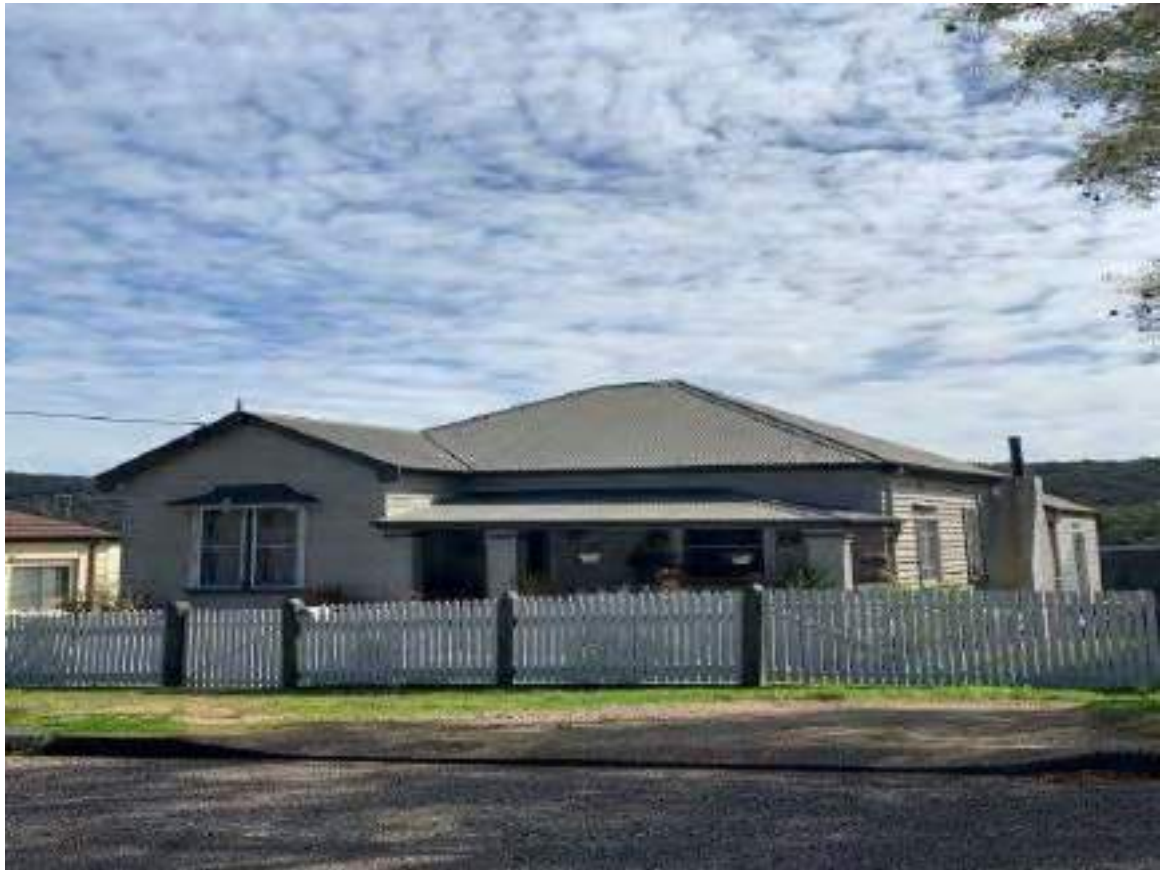
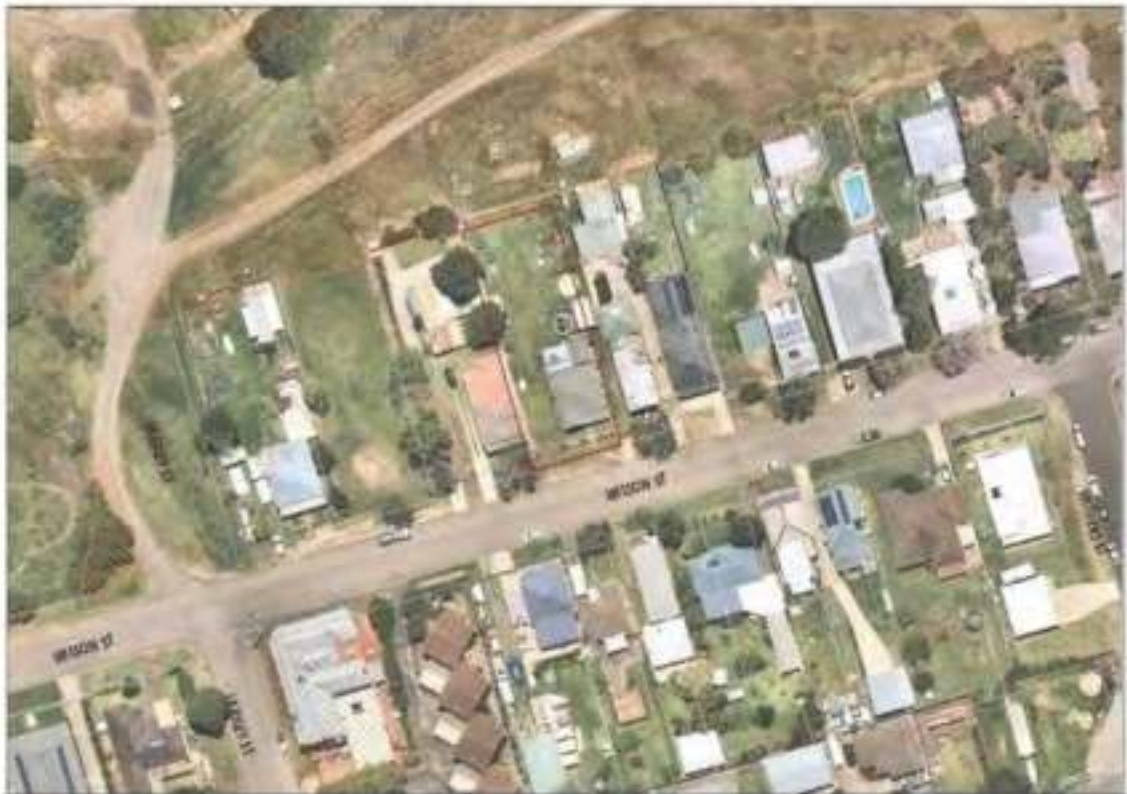
69 WILSON STREET, WEST WALLSEND 2286

Conservation Area Contribution Level	Est. Construction Date	Previous studies and/or community input
Contributory 1	1895–1910	No prior heritage investigations and no additional information required
Assessment Text		Observed Modifications
<p>Single story Vernacular ‘workmen’s cottage’ style dwelling with hipped Colourbond roof with projecting gable section and weatherboard cladding. The veranda roof is hipped and supported by brick pillars.</p> <p>The veranda is partially enclosed by a rendered brick veranda wall with pillars and decorative dental coursework.</p> <p>The front door is timber framed with sash windows on either side. All visible windows appear to be original.</p> <p>The gable has simple decorative barge boards and timber finial. The gable window has a frilled metal hood and an elaborately carved timber pilaster.</p> <p>A rendered brickwork chimney is visible on the eastern side of the dwelling.</p> <p>A timber picket fence encloses the property</p> <p>The dwelling displays architectural features of a heritage style and is representative of the local development of this period, being of historical significance for the HCA.</p>		<p>The brick veranda wall and pillars are likely a contemporary modification to the dwelling. This is a common modification and can be found in various properties of the area.</p> <p>The chimney shaft has been removed.</p> <p>A back extension has been constructed, however is not visible from the street.</p>

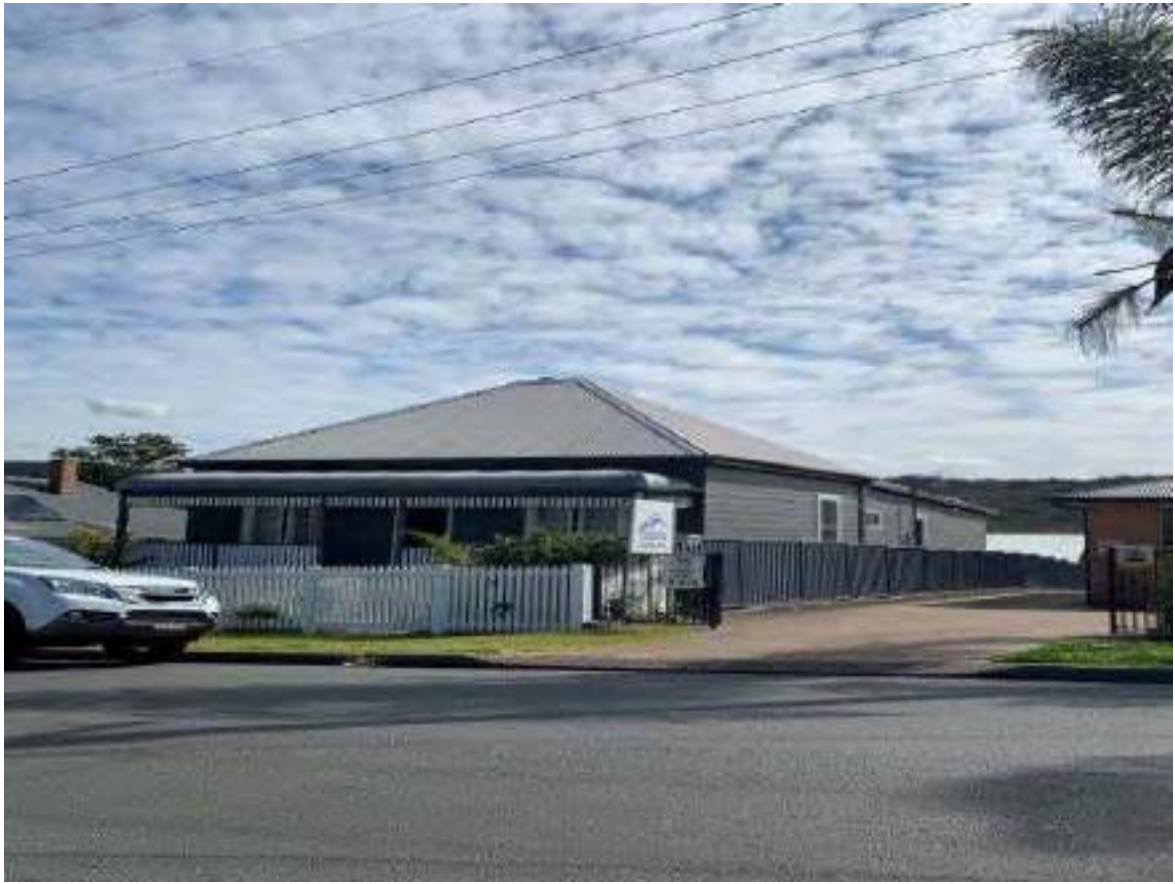
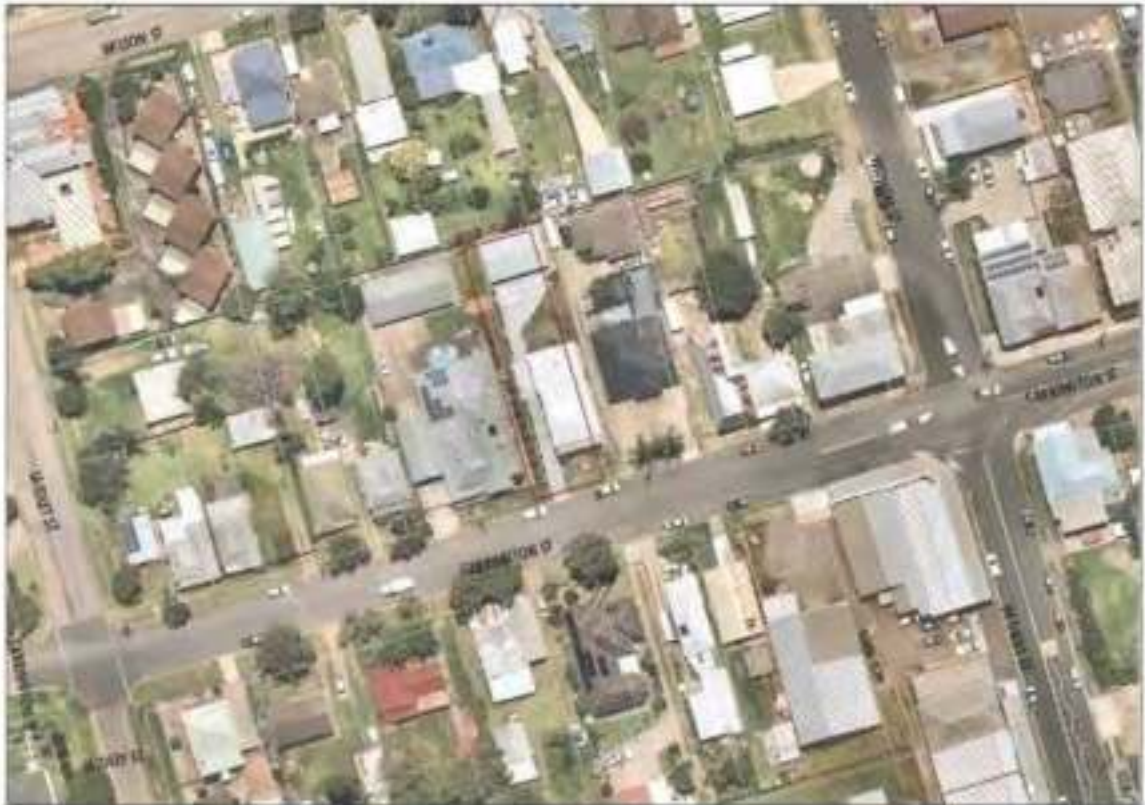
77 CARRINGTON STREET, WEST WALLSEND 2286

Conservation Area Contribution Level	Est. Construction Date	Previous studies and/or community input
Contributory 1	1890–1915	No prior heritage investigations and no additional information required
Assessment Text		Observed Modifications
<p>Single story Vernacular ‘Mining Cottage’ style dwelling with hipped Colourbond roof and weatherboard cladding/ the veranda roof is bull nosed and supported by timber posts. The veranda roof is framed by a timber valance.</p> <p>The veranda is partially enclosed by a simple timber balustrade.</p> <p>The front door is timber framed with double sash windows on either side, likely original. An elaborately carved timber pilaster is situated between the two sash windows.</p> <p>A large multi door garage is located to the north of the dwelling.</p> <p>A timber picket fence encloses the property</p> <p>The dwelling displays architectural features of a heritage style and is representative of the local development of this period, being of historical significance for the HCA.</p>		<p>An extension has been constructed onto the northern back end of the dwelling, however is not visible from the street and does not detract from the heritage style of the dwelling.</p> <p>The timber valance and balustrade are likely a contemporary replication of a heritage style.</p>

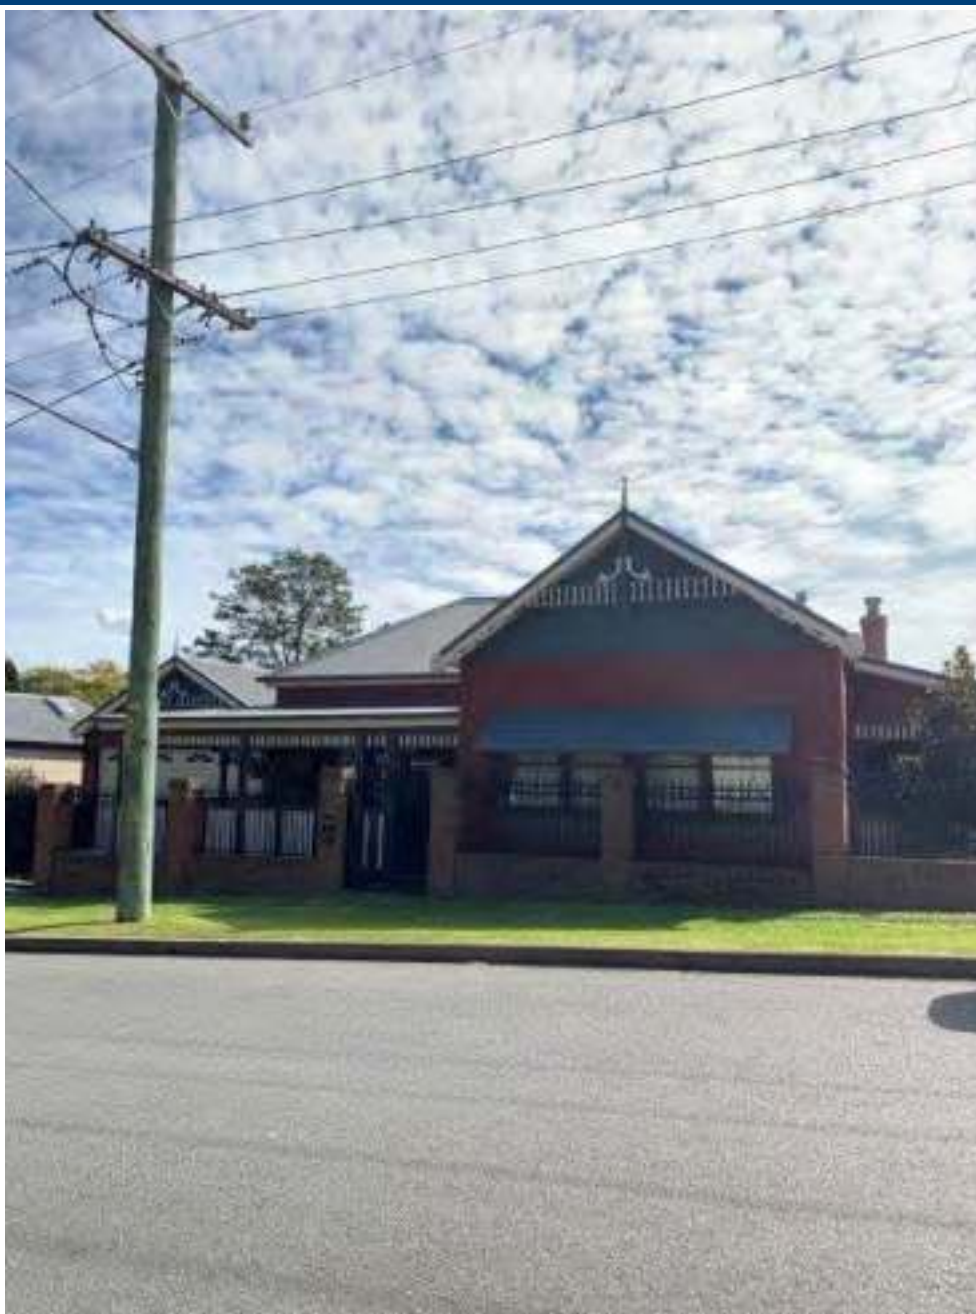
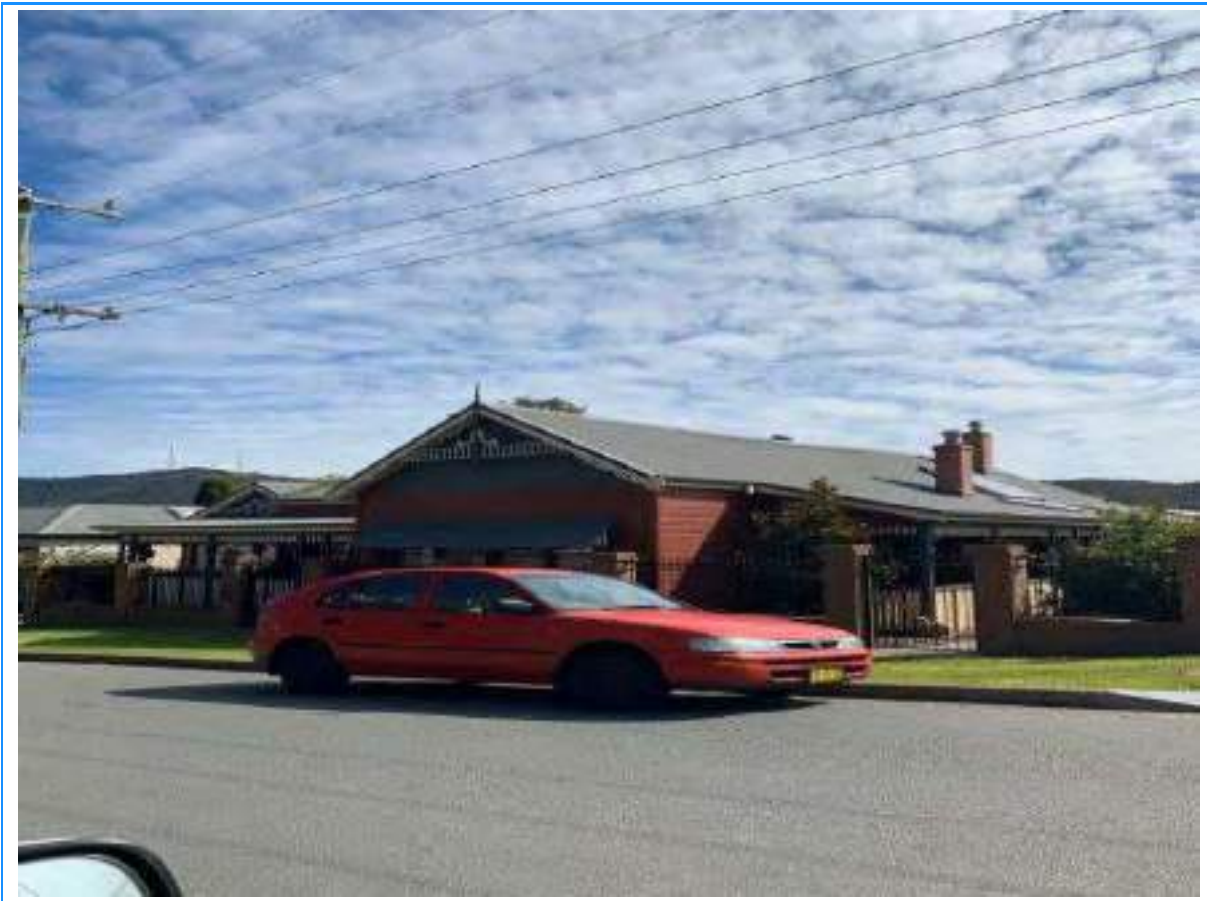
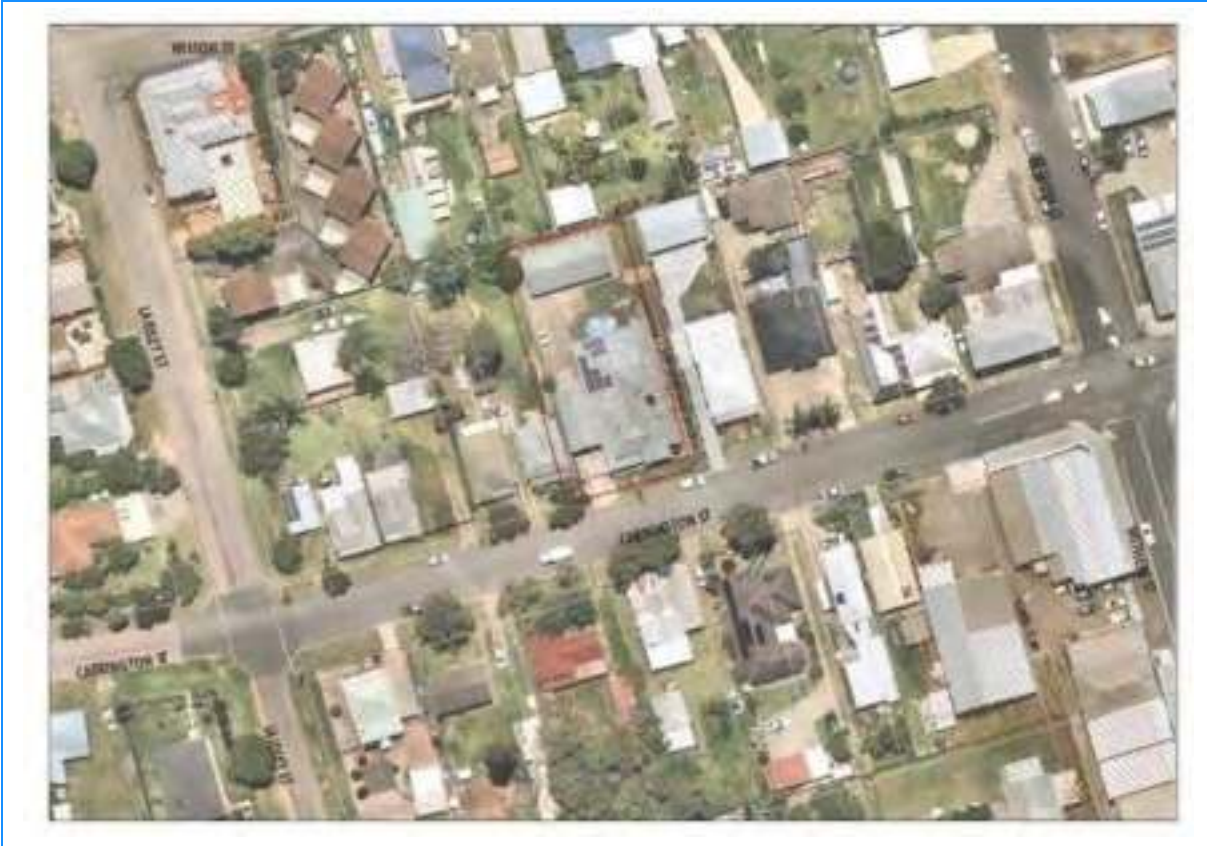
79 CARRINGTON STREET, WEST WALLSEND 2286

Conservation Area Contribution Level	Est. Construction Date	Previous studies and/or community input
Contributory 1	1895–1910	No prior heritage investigations and no additional information required.
Assessment Text		Observed Modifications
<p>Single story elaborate Federation inspired ‘workmen's cottage’ style dwelling with hipped Colourbond roof with projected gable and weatherboard cladding. The veranda roof is hipped and wraps around the southern and western side of the dwelling. A simple timber valance frames the veranda roof, with decorative timber posts supporting the structure.</p> <p>The veranda is partially enclosed by timber balustrade.</p> <p>All visible windows are sash designs, and likely original.</p> <p>The gable has ornately carved barge boards, timber finial, timber fretwork and shingle decoration. A shingle timber awning covers the gable window.</p> <p>A brick and metal fence encloses the property.</p> <p>A single door gable roof garage is located to the west of the dwelling. this is constructed in a sympathetic style and does not detract from the heritage streetscape.</p> <p>The dwelling displays architectural features of a heritage style and is representative of the local development of this period, being of historical significance for the HCA.</p>		<p>Extensions have been constructed on the northern and eastern sides of the dwelling. all have been built in a sympathetic style and do not negatively impact the heritage style of the dwelling.</p> <p>The timber valance and balustrades are likely contemporary replications of a similar heritage style.</p>

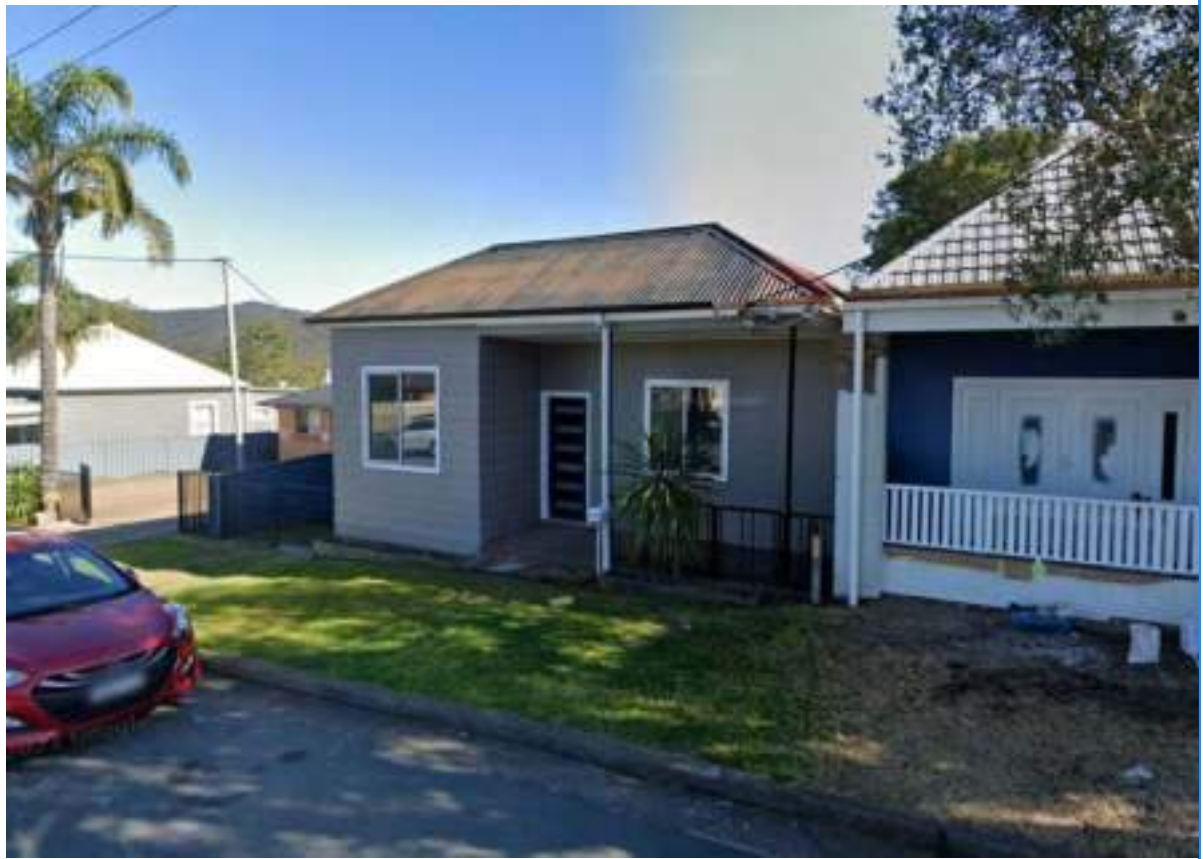
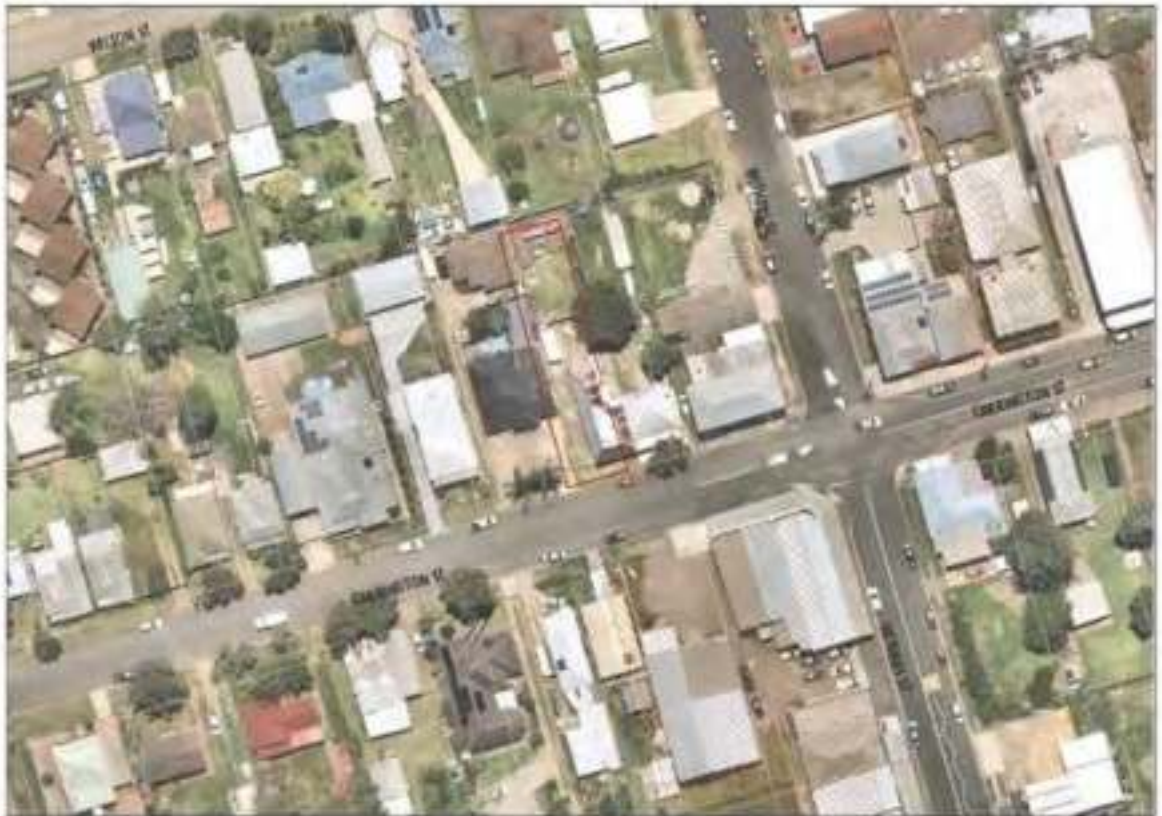
73 CARRINGTON STREET, WEST WALLSEND 2286

Conservation Area Contribution Level	Est. Construction Date	Previous studies and/or community input
Contributory 1	1900–1920	No prior heritage investigations and no additional information required
Assessment Text		Observed Modifications
<p>Single storey Vernacular cottage with weatherboard cladding with hipped Colourbond roof. The veranda roof is absorbed into the main dwelling roof and is supported by timber posts.</p>		<p>An extension has been constructed to the front of the dwelling, creating an additional living area.</p> <p>All the visible windows are contemporary in style.</p> <p>A low level metal balustrade has been installed, likely replacing an original timber design.</p> <p>The front door has been replaced with a contemporary multi glass pane design.</p>

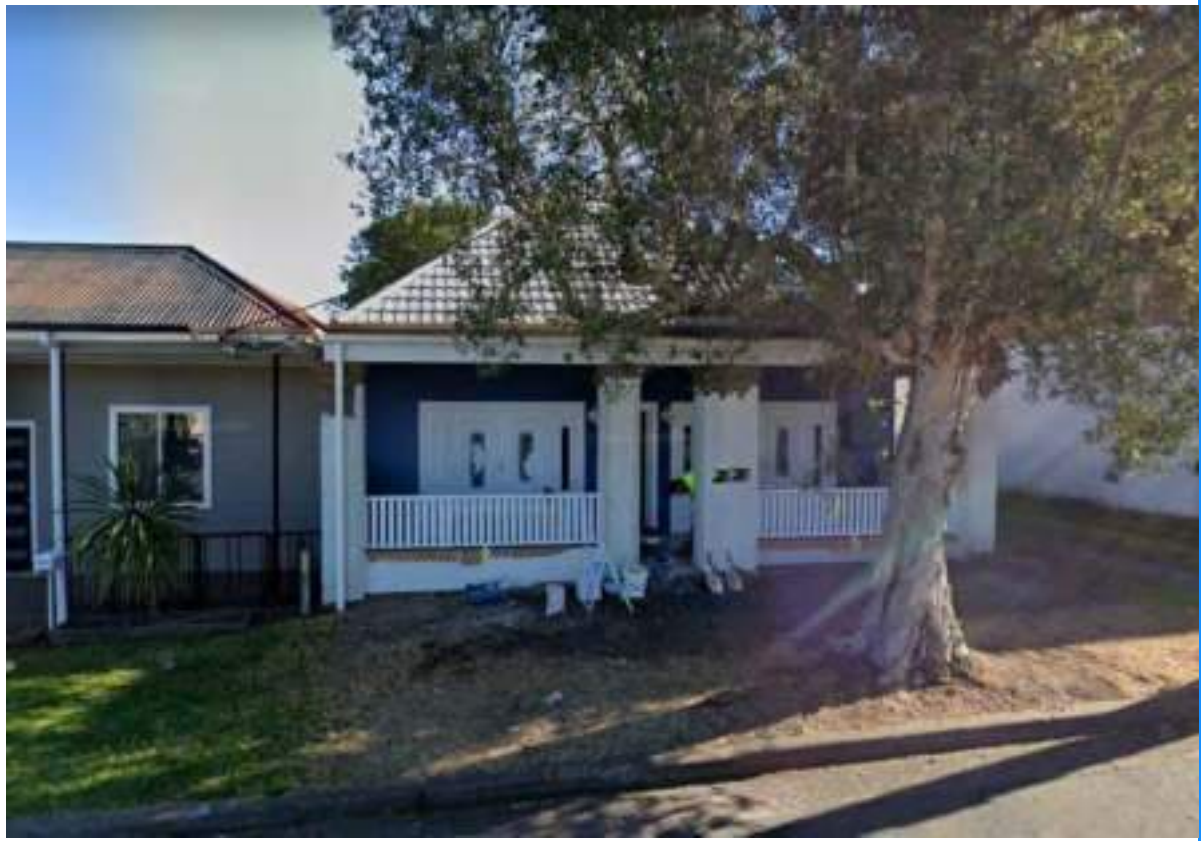
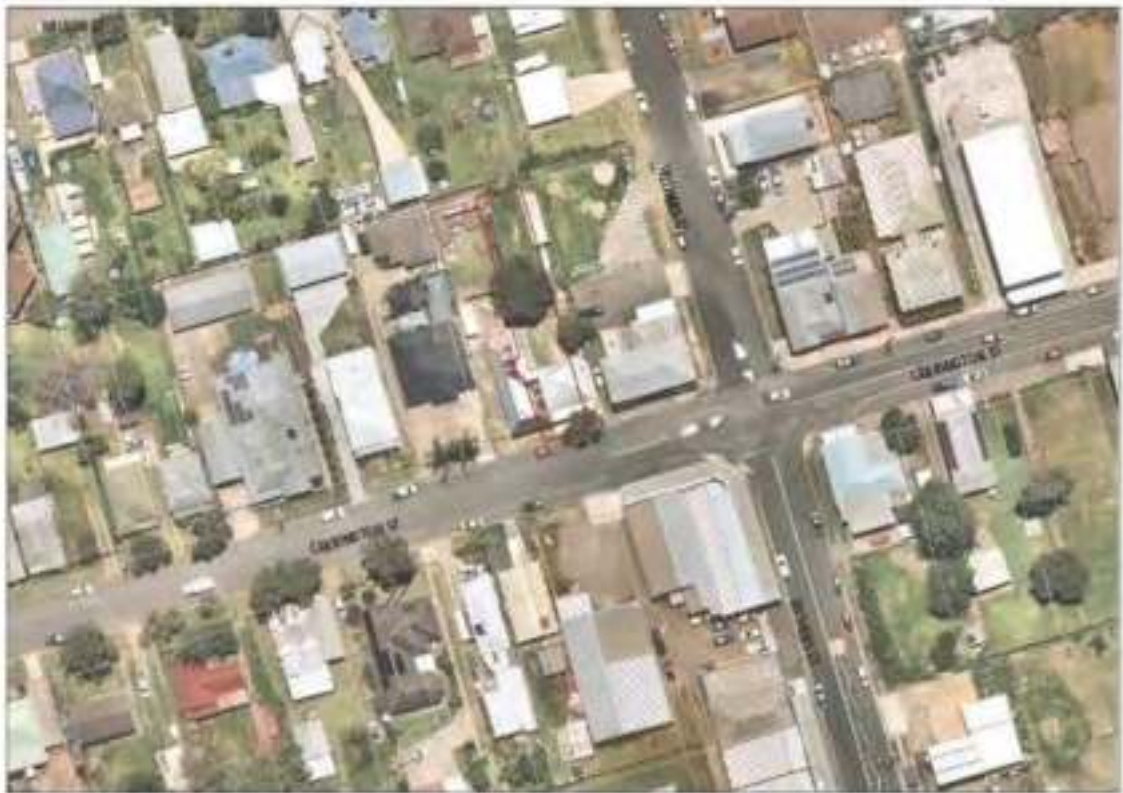
71 CARRINGTON STREET, WEST WALLSEND 2286

Conservation Area Contribution Level	Est. Construction Date	Previous studies and/or community input
Contributory 1	1900–1925	No prior heritage investigations and no additional information required
Assessment Text		Observed Modifications
<p>Single story Inter-War dwelling with steeply hipped tiled roof and rendered brick façade. The veranda roof is incorporated into the main hipped roof and is supported by brick pillars.</p> <p>The veranda is partially enclosed by timber balustrade.</p> <p>The front door is timber framed, with windows either side.</p> <p>At the time of assessment, the dwelling was undergoing renovation works.</p> <p>The dwelling displays architectural features of a heritage style and is representative of the local development of this period, being of historical significance for the HCA.</p>		<p>The timber balustrade is a contemporary replacement for the original, or preceding brick veranda wall previous.</p> <p>The dwelling was undergoing renovation works at the time of assessment.</p>

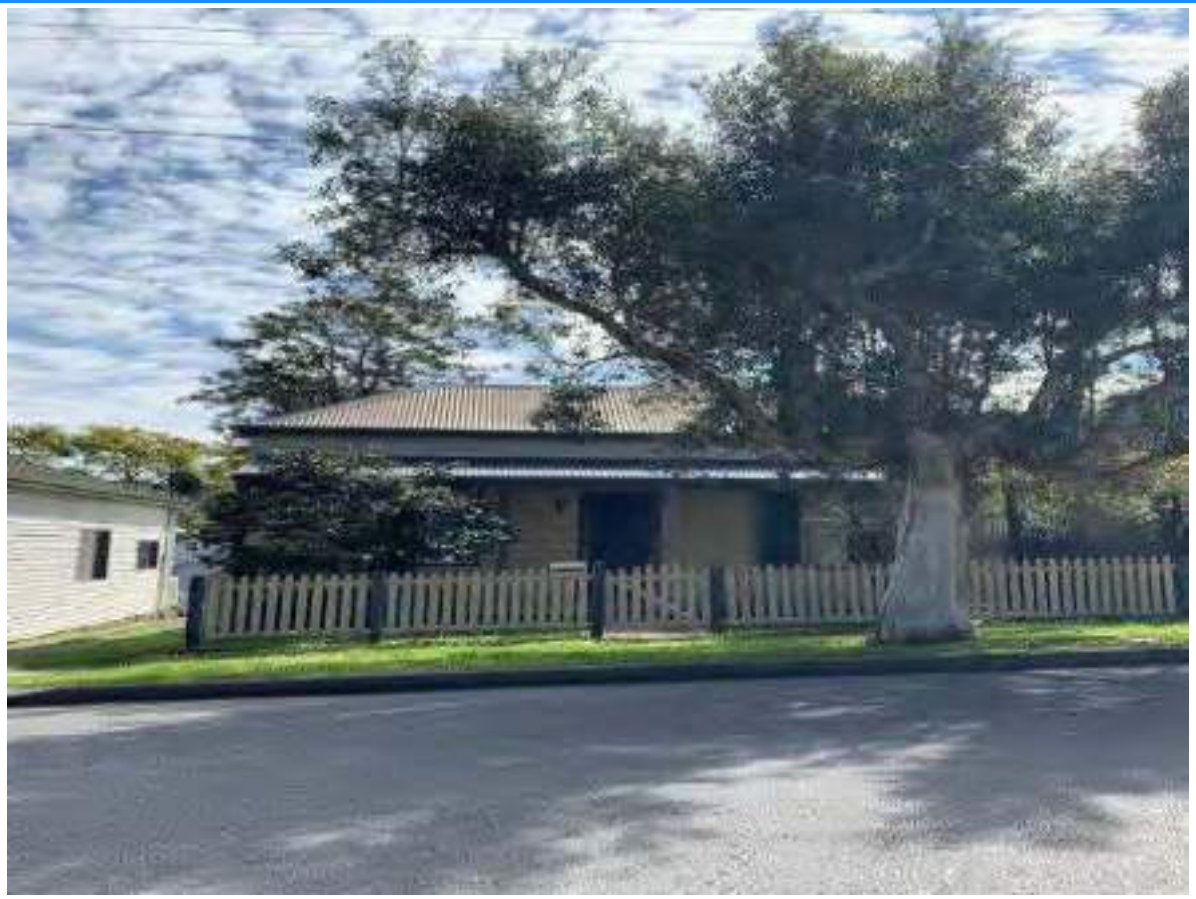
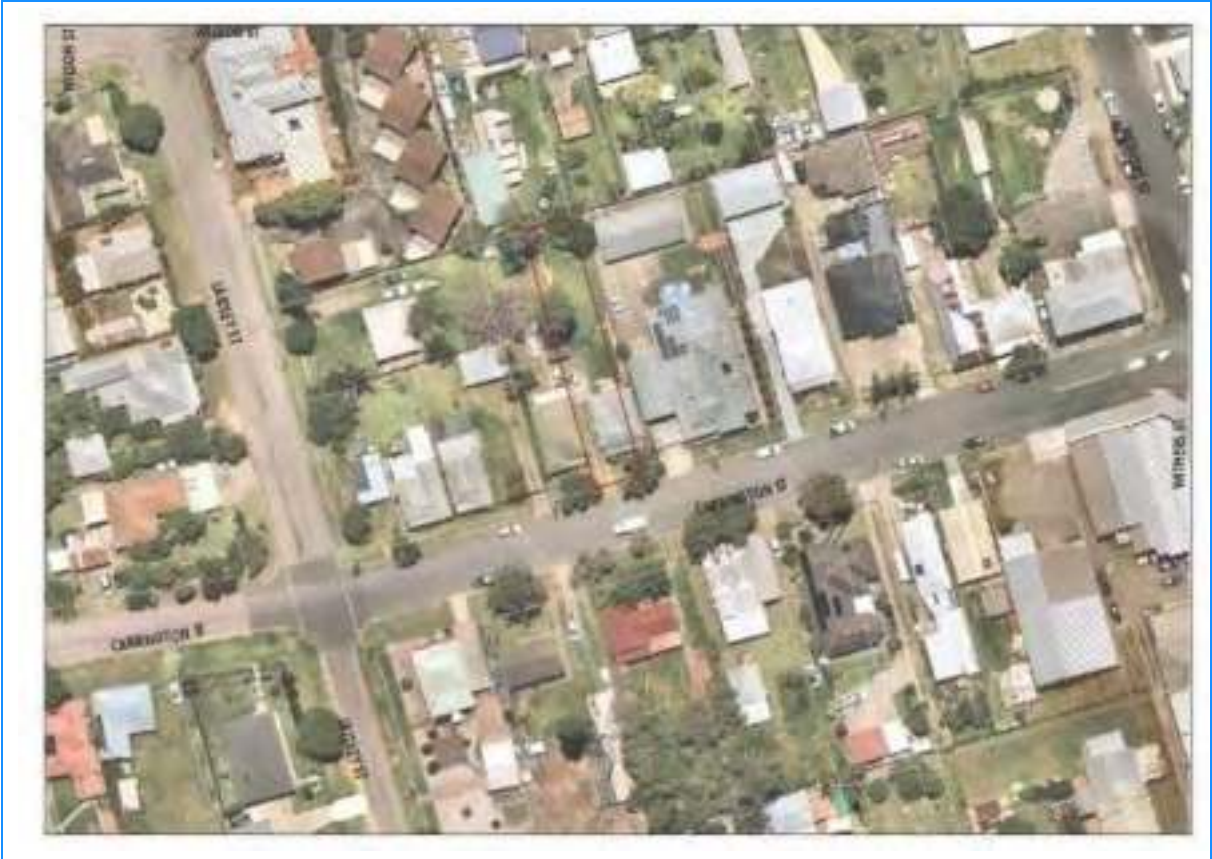
Conservation Area Contribution Level	Est. Construction Date	Previous studies and/or community input
Contributory 1	1890–1915	No prior heritage investigations and no additional information required
Assessment Text		Observed Modifications
<p>Single story Vernacular ‘Mining Cottage’ style dwelling with hipped Colourbond roof and weatherboard cladding. The veranda roof is skillion and supported by timber posts.</p> <p>The veranda is open.</p> <p>The front door is timber framed with sliding windows either side.</p> <p>A timber picket fence encloses the property.</p> <p>The dwelling displays architectural features of a heritage style and is representative of the local development of this period, being of historical significance for the HCA.</p>		<p>The veranda roof is likely a replacement of the original bull nose style.</p> <p>The visible windows have been replaced with contemporary sliding designs, likely replacing original timber framed sash styles.</p>

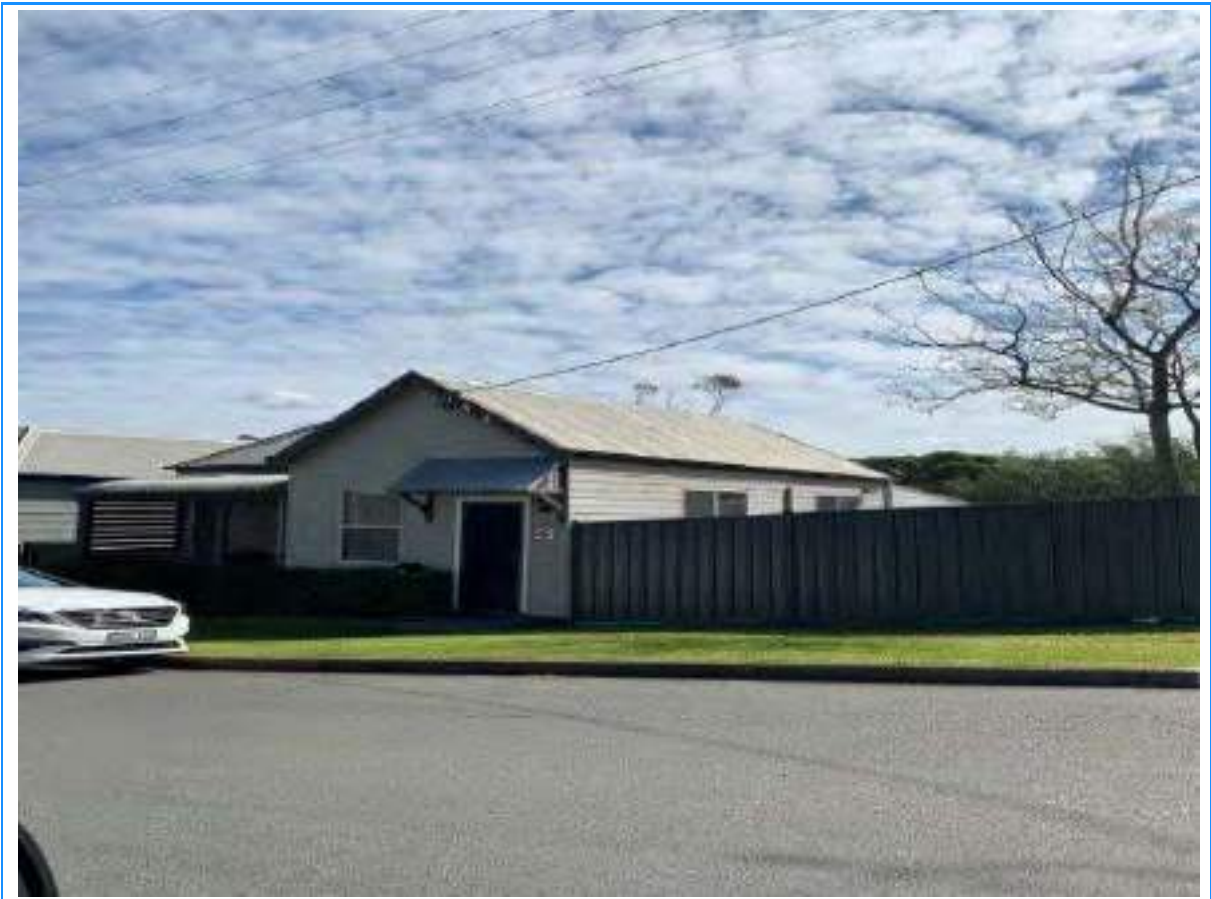
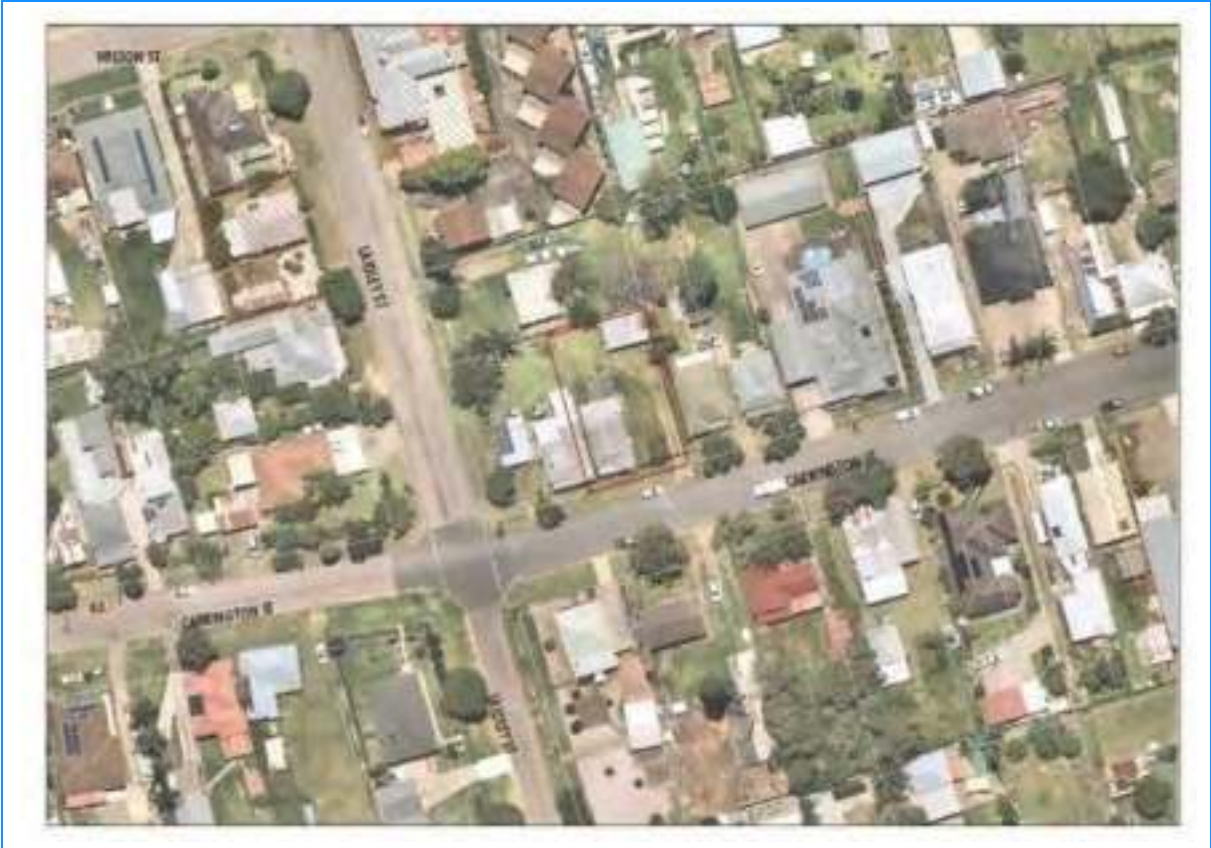
Conservation Area Contribution Level	Est. Construction Date	Previous studies and/or community input
Contributory 1	1895–1910	No prior heritage investigations and no additional information required
Assessment Text		Observed Modifications
<p>Single story ‘workmen's cottage’ style dwelling with hipped Colourbond roof with gable projection and weatherboard cladding. The veranda roof is bull nosed and supported by timber posts.</p> <p>The veranda is partially enclosed by timber boarding on the western side and a metal balustrade.</p> <p>The front door is timber framed with metal security screen. A secondary door is similarly presented. A metal awning is atop of the main door.</p> <p>The gable has extended eaves.</p> <p>A double door garage is located to the north of the dwelling.</p> <p>Colourbond fence encloses the property</p> <p>The dwelling displays architectural features of a heritage style and is representative of the local development of this period, being of historical significance for the HCA.</p>		<p>The front entrance has been moved to the gable projection as opposed to the original door within the veranda alcove. This original door remains, suggesting this is a recent modification.</p> <p>The visible windows are contemporary sliding or sash designs.</p>
