APPENDIX 2

Building Assessment Sheets (Inventory Sheets)

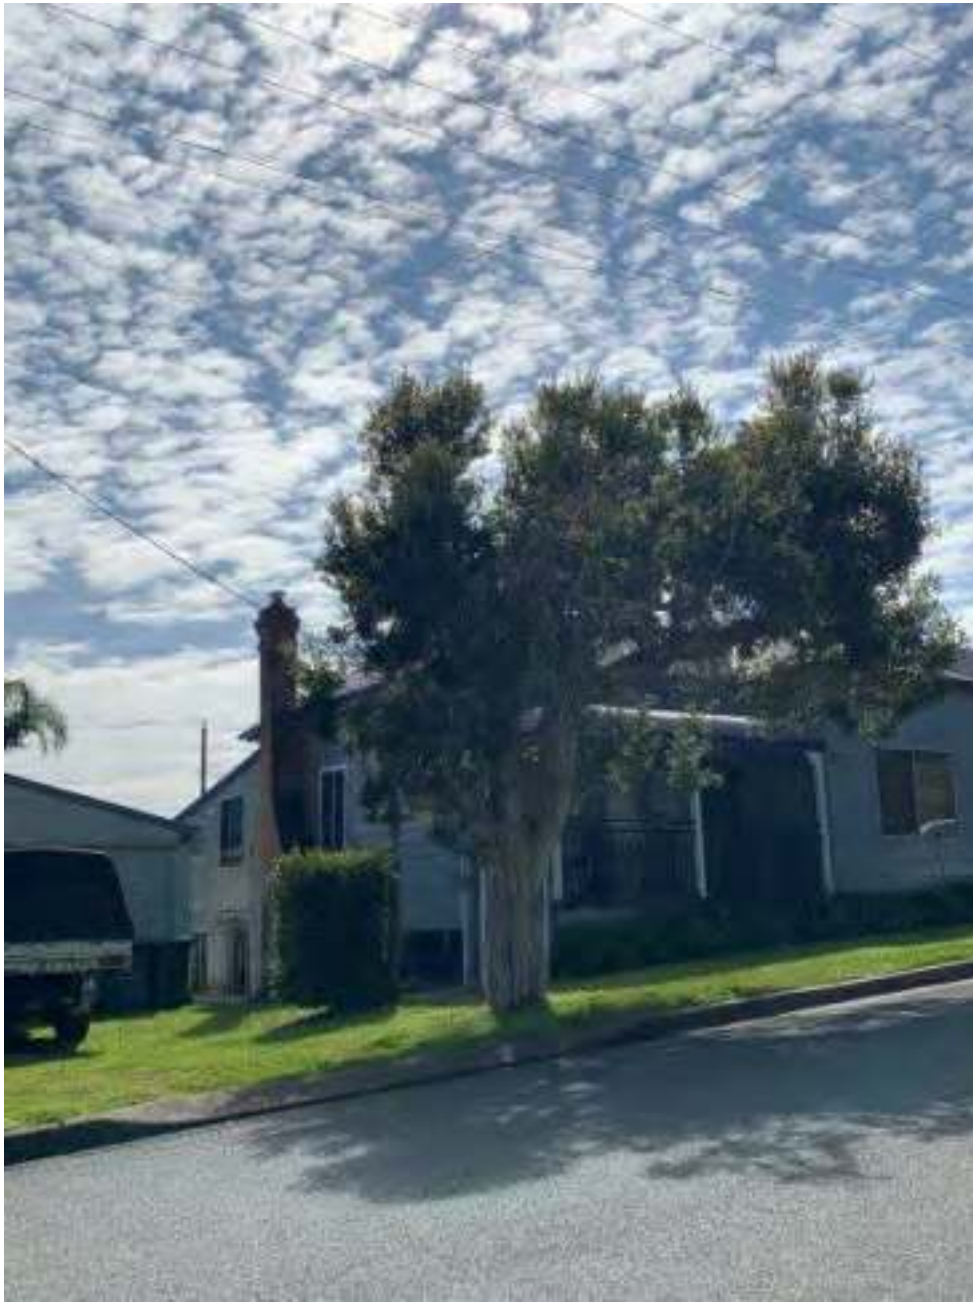
Conservation Area Contribution Level	Est. Construction Date	Previous studies and/or community input
Contributory 1	1895–1910	No prior heritage investigations and no additional information required
Assessment Text		Observed Modifications
<p>Single story ‘workmen's cottage’ style dwelling with hipped Colourbond roof with gable projection and weatherboard cladding. The veranda roof is bull nosed and supported by timber posts.</p> <p>The veranda is partially enclosed by timber boarding on the western side and a metal balustrade.</p> <p>The front door is timber framed with metal security screen. A secondary door is similarly presented. A metal awning is atop of the main door.</p> <p>The gable has extended eaves.</p> <p>A double door garage is located to the north of the dwelling.</p> <p>Colourbond fence encloses the property</p> <p>The dwelling displays architectural features of a heritage style and is representative of the local development of this period, being of historical significance for the HCA.</p>		<p>The front entrance has been moved to the gable projection as opposed to the original door within the veranda alcove. This original door remains, suggesting this is a recent modification.</p> <p>The visible windows are contemporary sliding or sash designs.</p>

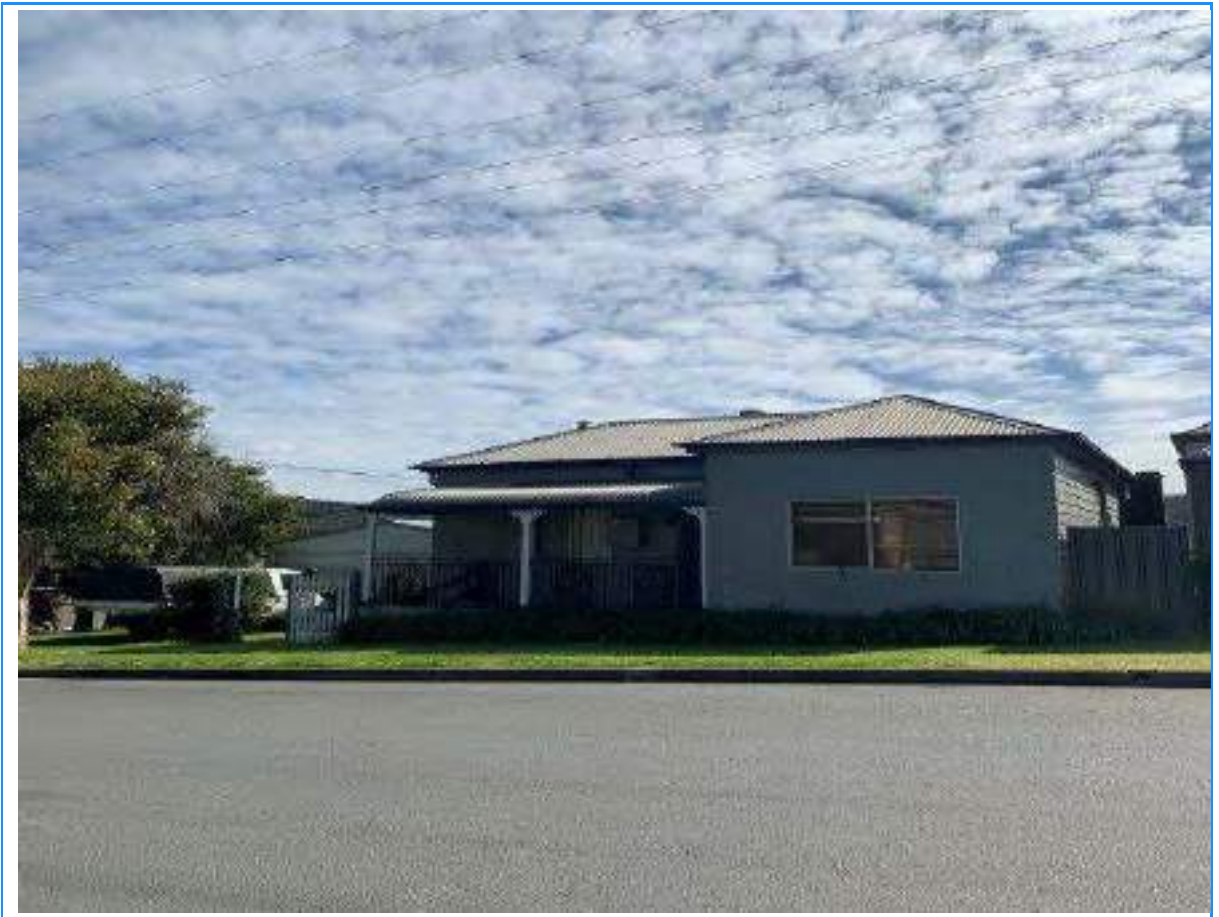
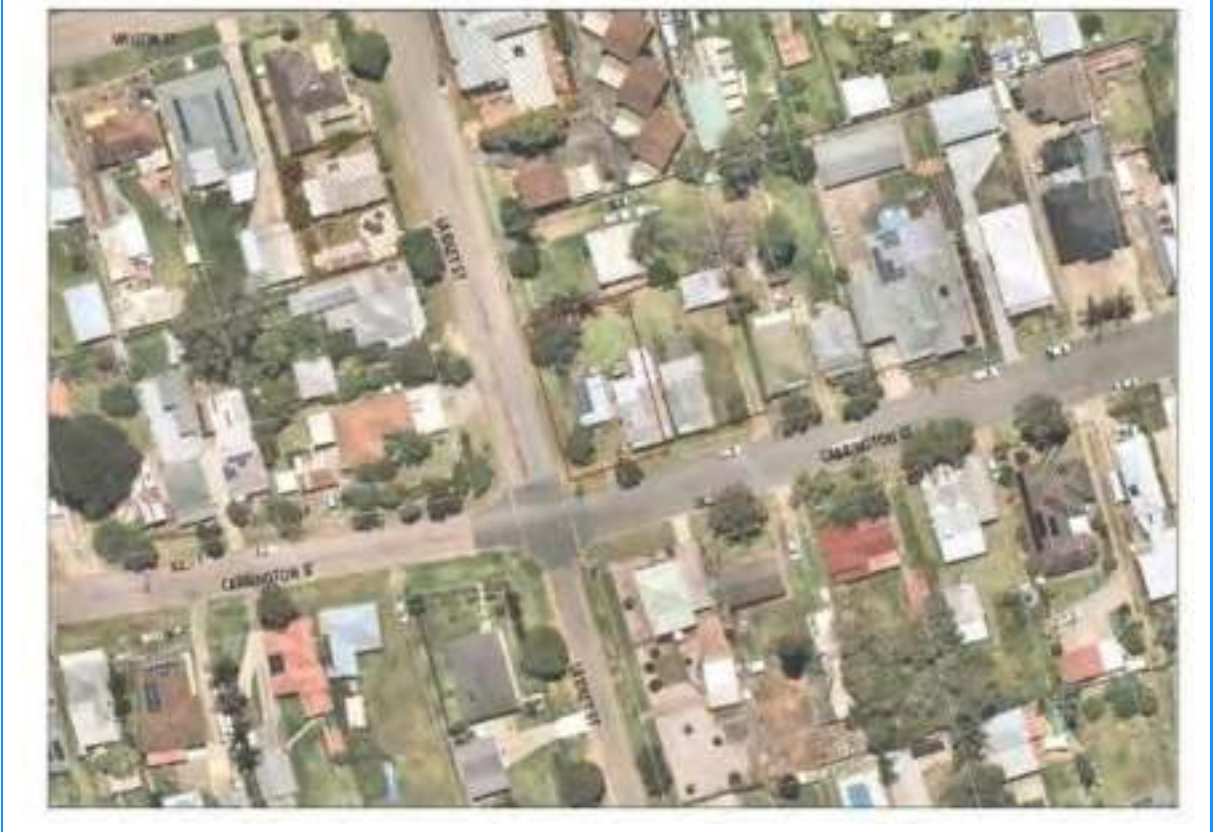
Conservation Area Contribution Level	Est. Construction Date	Previous studies and/or community input
Contributory 1	1895–1910	No prior heritage investigations and no additional information required
Assessment Text		Observed Modifications
<p>Single story 'workmen's cottage' style dwelling with hipped Colourbond roof with gable projection and weatherboard cladding. The veranda roof is bull nosed and supported by timber posts with ornate brackets.</p> <p>The veranda is partially enclosed with metal balustrade.</p> <p>The front door is timber framed with metal security screen, and sliding windows on either side.</p> <p>A brickwork chimney is visible on the western side of the dwelling.</p> <p>A double door garage is located to the west of the dwelling.</p> <p>The dwelling displays architectural features of a heritage style and is representative of the local development of this period, being of historical significance for the HCA.</p>		<p>The metal balustrade is a contemporary addition to the dwelling.</p> <p>All visible windows are contemporary sliding designs.</p>

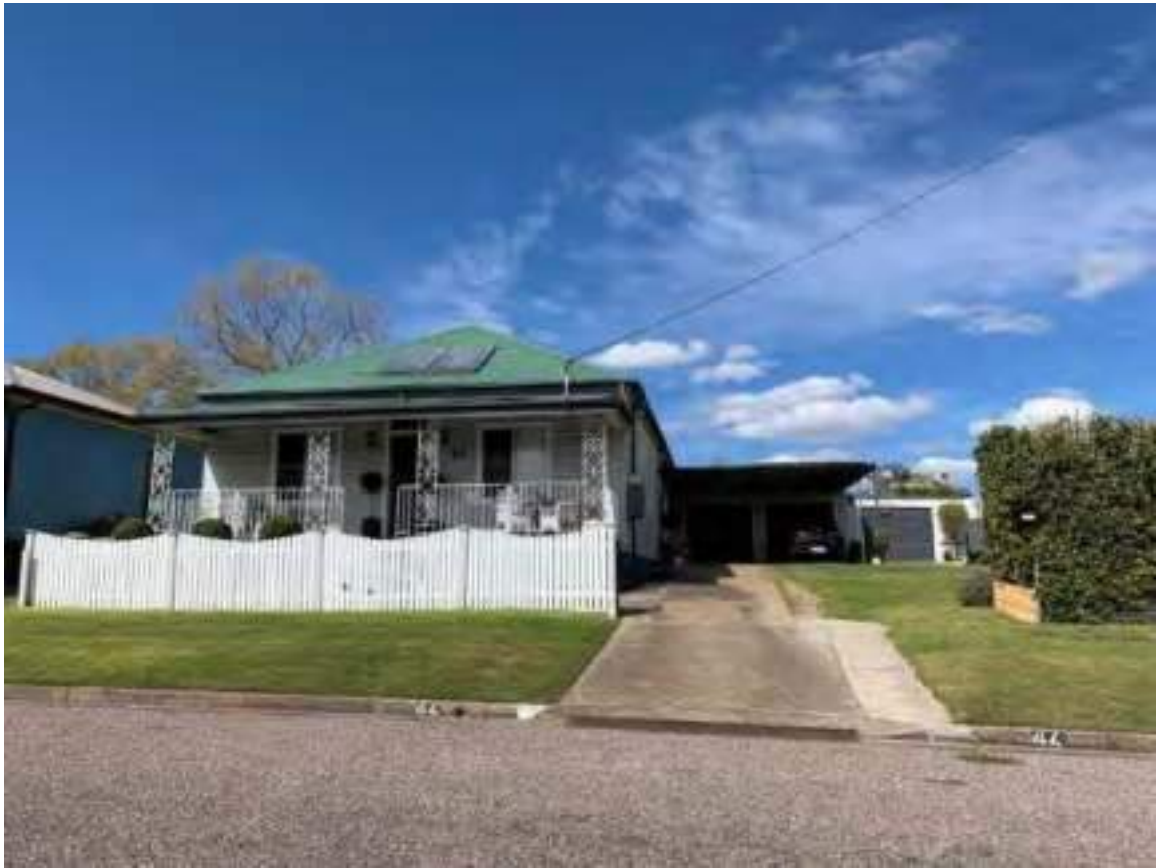
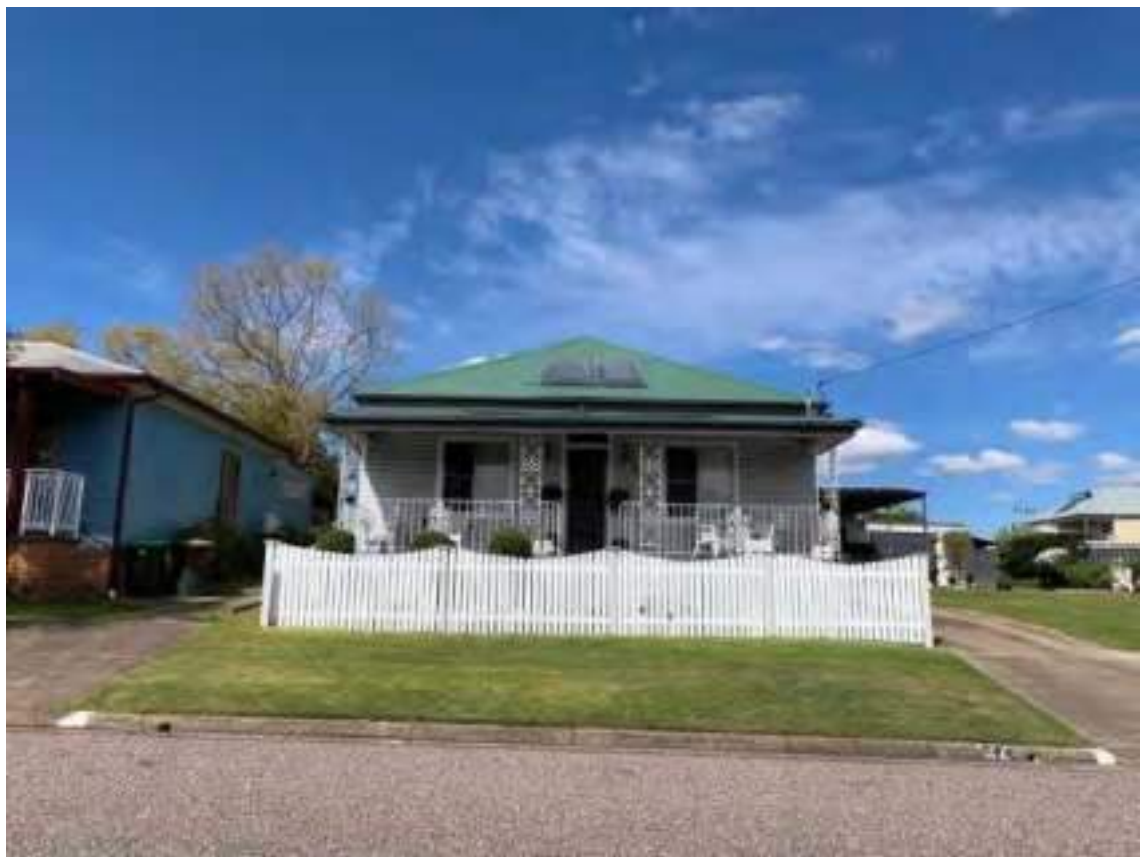
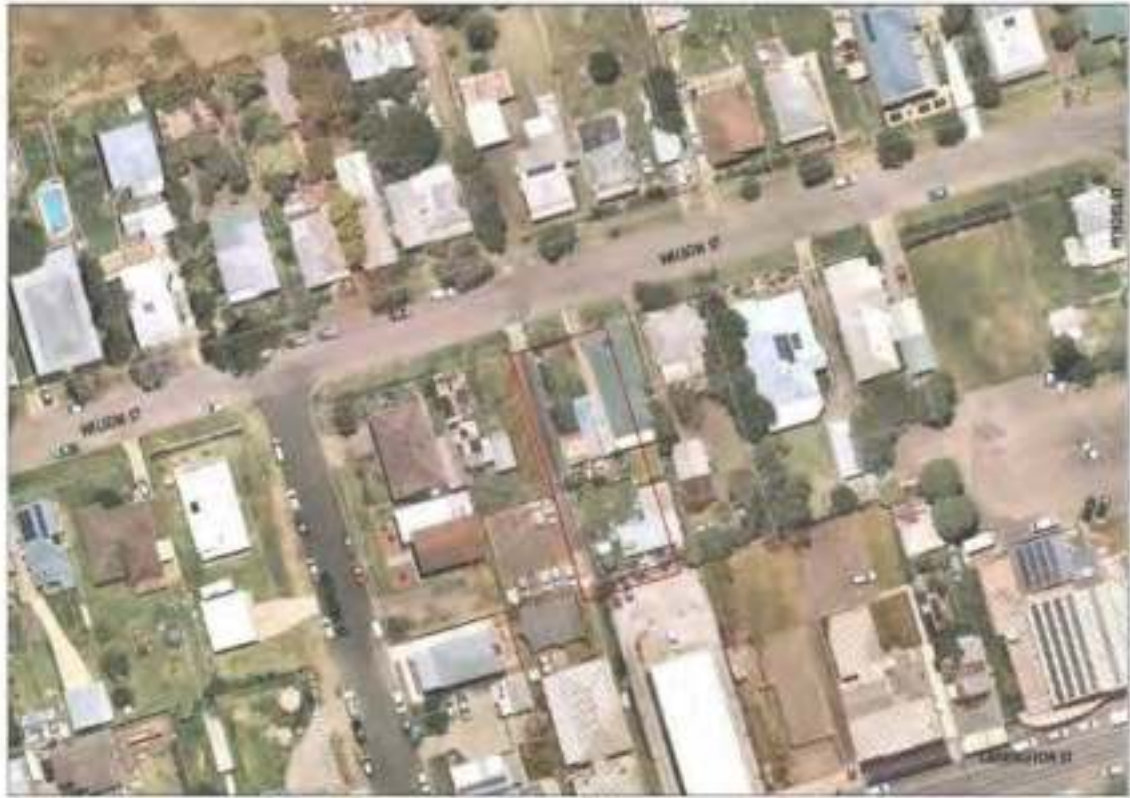
46 WILSON STREET, WEST WALLSEND 2286

Conservation Area Contribution Level	Est. Construction Date	Previous studies and/or community input
Contributory 1	1890–1915	No prior heritage investigations and no additional information required
Assessment Text		Observed Modifications
<p>Single story Vernacular ‘Mining Cottage’ style dwelling with hipped Colourbond roof and weatherboard cladding. The veranda roof is hipped with ornate metal pillars supporting.</p> <p>The veranda is partially enclosed with metal balustrade.</p> <p>The front door is timber framed with ornate metal screen door. Sliding windows are found either side.</p> <p>A car port and garage is located to the west of the dwelling</p> <p>The dwelling displays architectural features of a heritage style and is representative of the local development of this period, being of historical significance for the HCA.</p>		<p>All visible windows are contemporary timber framed sliding designs.</p> <p>The metal balustrade and support pillars are a contemporary addition to the dwelling.</p>

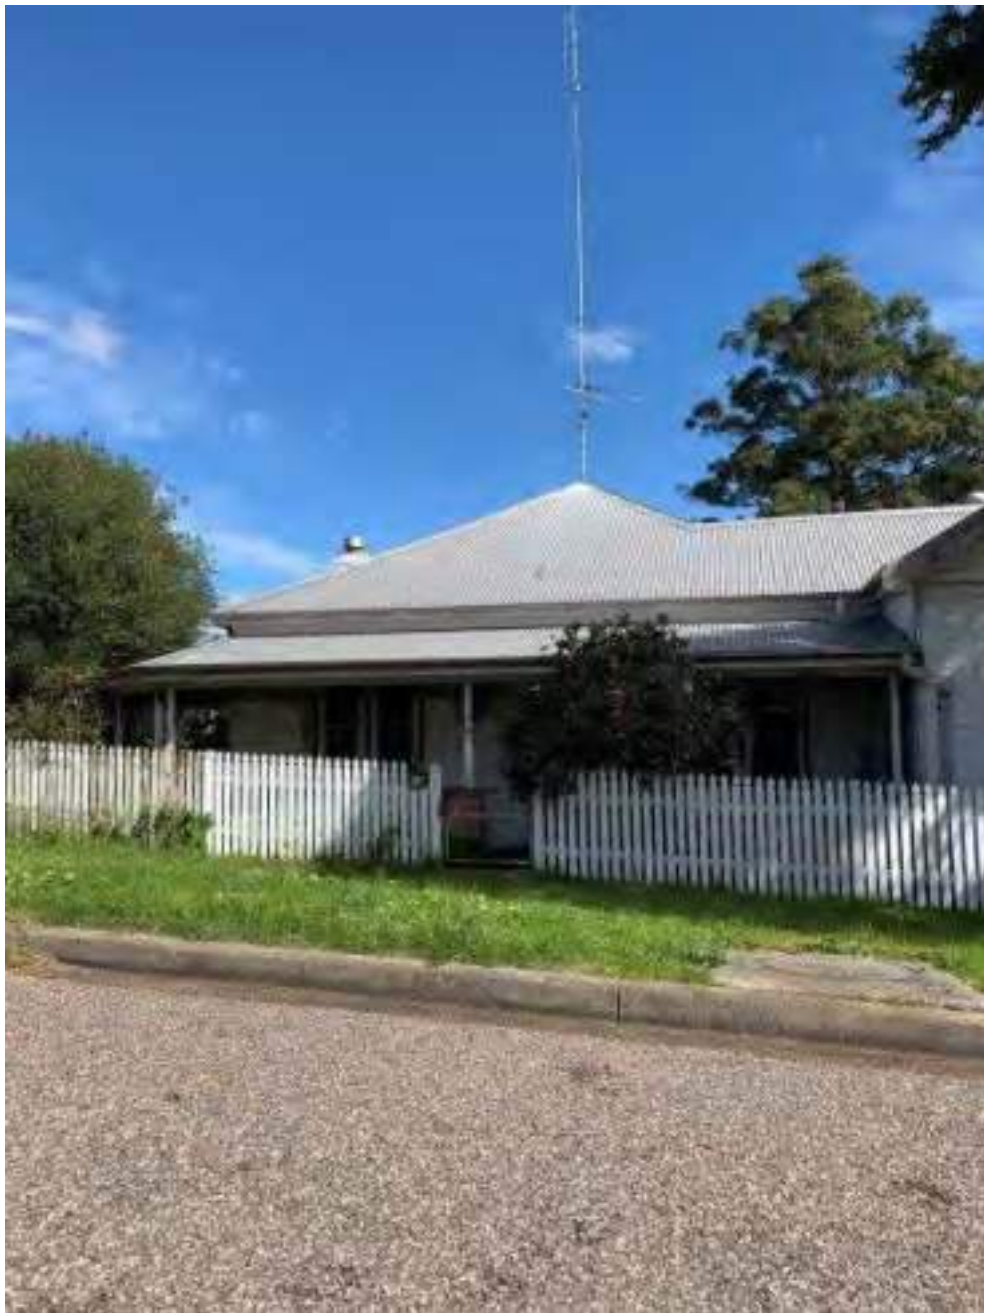
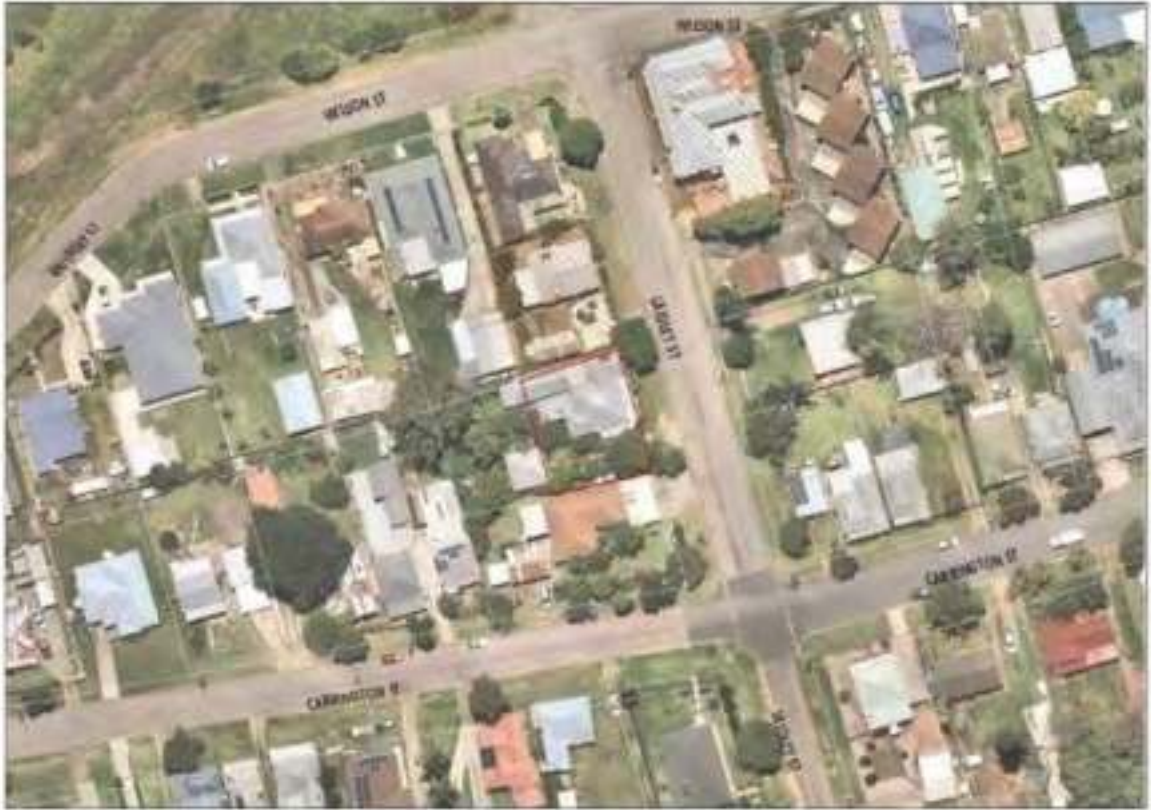
10 LAIDLEY STREET, WEST WALLSEND 2286

Conservation Area Contribution Level	Est. Construction Date	Previous studies and/or community input
Contributory 1	1895–1910	No prior heritage investigations and no additional information required
Assessment Text		Observed Modifications
<p>Single story ‘workmen’s cottage’ style dwelling with hipped Colourbond roof with gable projection, and weatherboard cladding. The veranda roof is both skillion and hipped, and encircles the eastern and southern sides of the dwelling. The veranda is framed by a cast iron lace valance.</p> <p>The front door is timber framed with double sash windows on either side. An elaborately carved timber pilaster is situated between the two sash windows. All the visible windows are original.</p> <p>The gable has simply decorated barge boards and timber finial. The gable window has a timber awning.</p> <p>A timber picket fence encloses the property.</p> <p>The dwelling displays architectural features of a heritage style and is representative of the local development of this period, being of historical significance for the HCA.</p>		<p>The veranda has potentially been extended to wrap around the southern side of the dwelling, however if this is an extension this has been constructed in a sympathetic manner and does not impact the heritage value of the dwelling.</p>

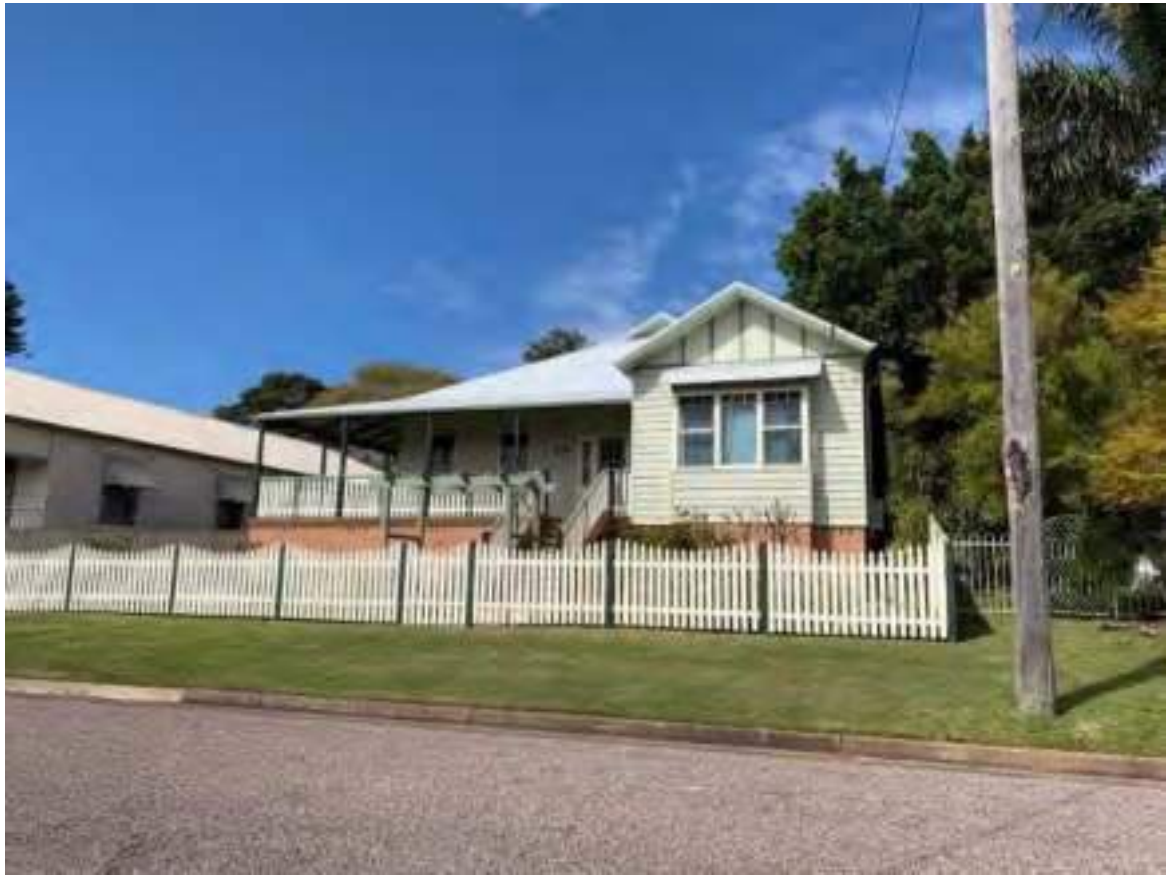
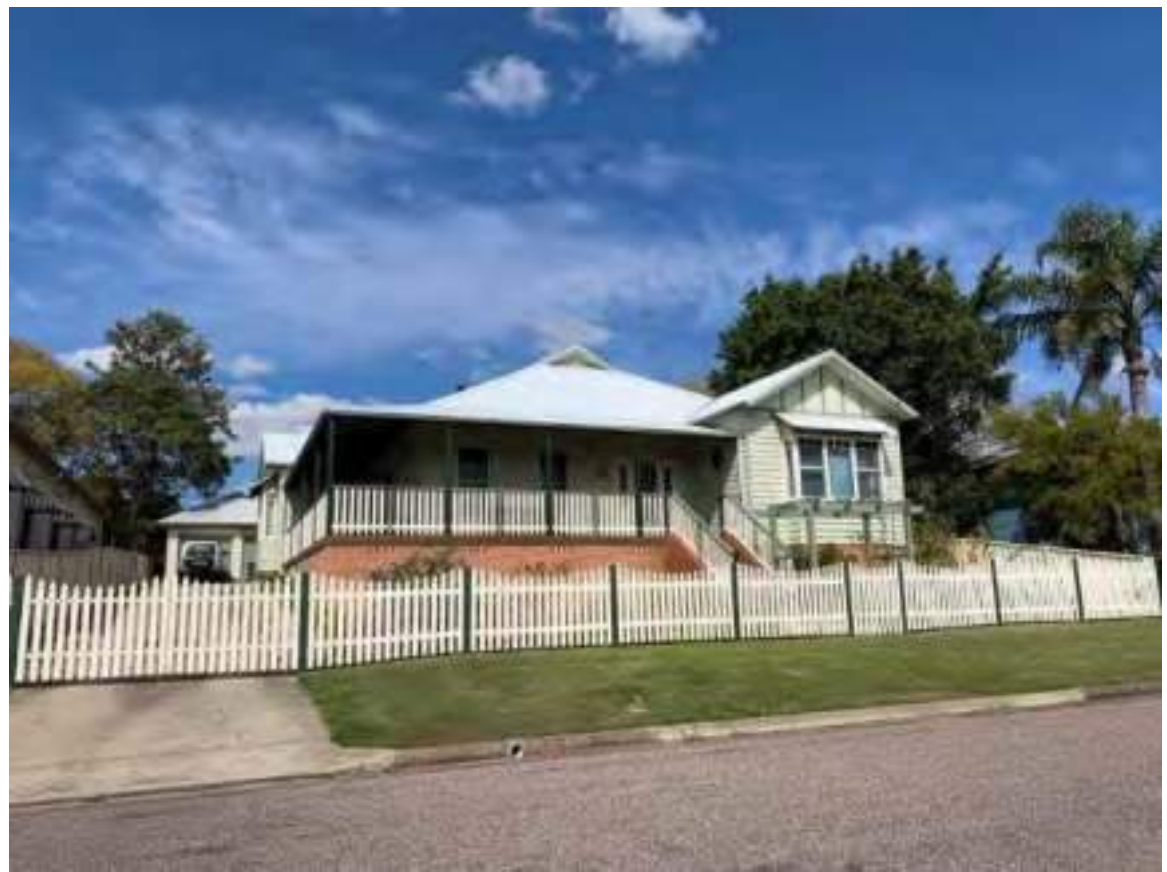
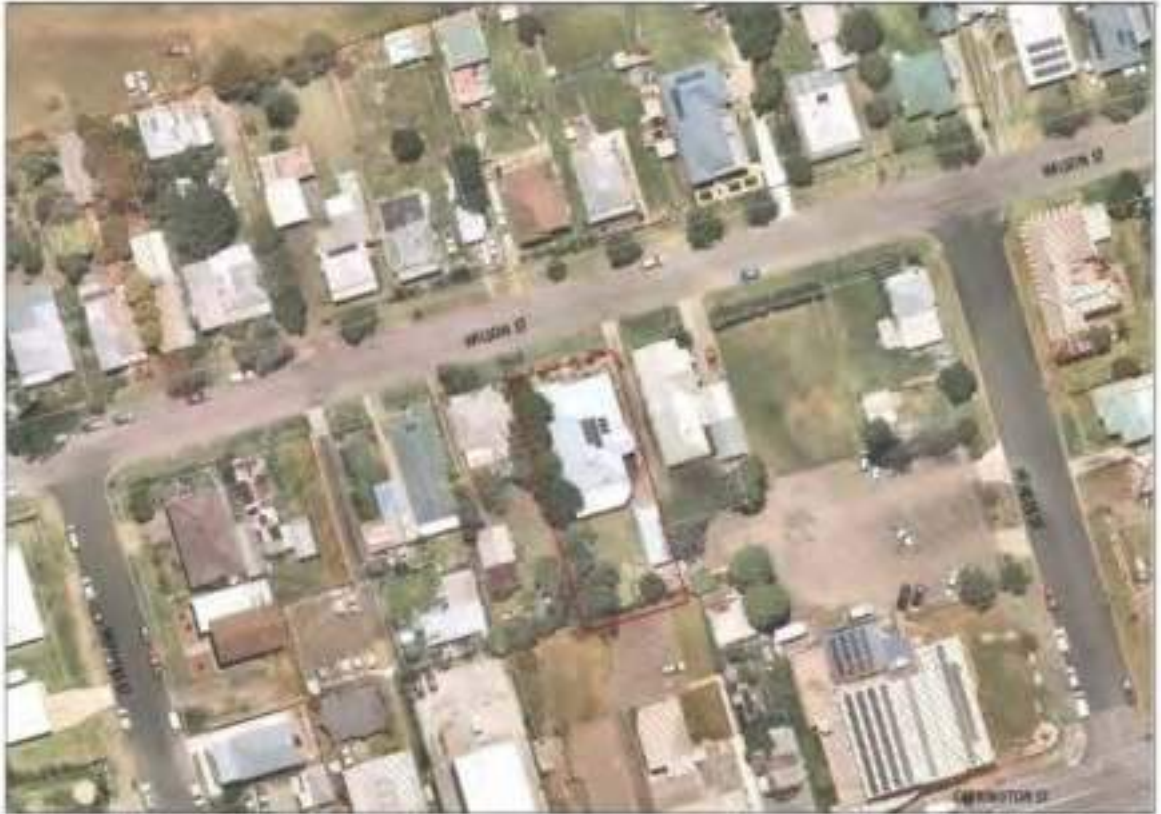
42 WILSON STREET, WEST WALLSEND 2286

Conservation Area Contribution Level	Est. Construction Date	Previous studies and/or community input
Contributory 1	1900–1920	No prior heritage investigations and no additional information required
Assessment Text		Observed Modifications
<p>Single story Vernacular simple Federation style dwelling with half hipped and gable Colourbond roof with dormer detailing and weatherboard cladding. The veranda roof is hipped and incorporation into the main roof structure, with timber supports. The veranda is partially enclosed with simple timber balustrade with brick stairs with corresponding balustrade. The front door is timber framed with ornate metal screen door and adjacent window panels. The gable has battening detailing and a triple pane double hung sash window with small coloured glass panes. A metal awning is over top. A gable roof garage is located to the east of the dwelling. The dwelling displays architectural features of a heritage style and is representative of the local development of this period, being of historical significance for the HCA.</p>		<p>Most windows have been replaced by contemporary sash designs, with only the gable window remaining original. The brick stairs are likely recent additions, due to the differential brick colour to the foundational brick supports. The timber balustrade is a recent addition, however is constructed in a sympathetic manner and does not detract. A back extension has been constructed, however is similarly sympathetic in style. The gable projection is a contemporary addition.</p>

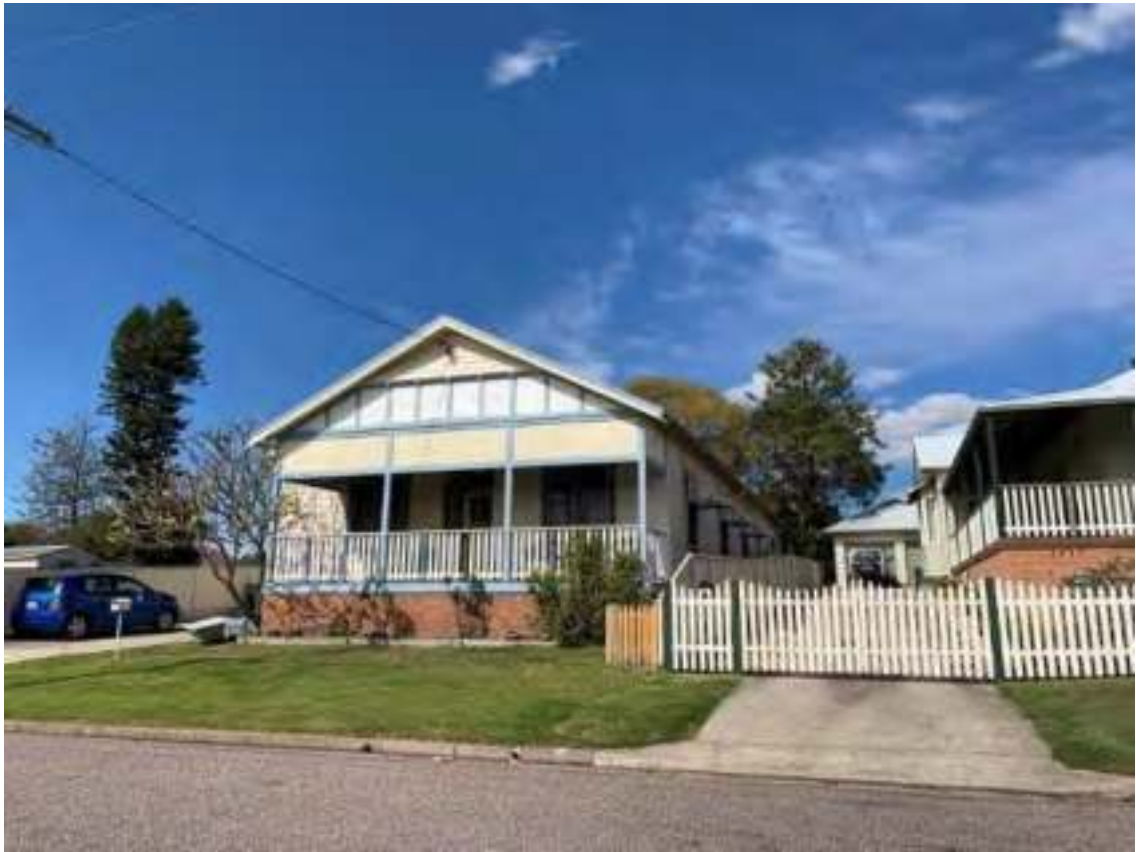
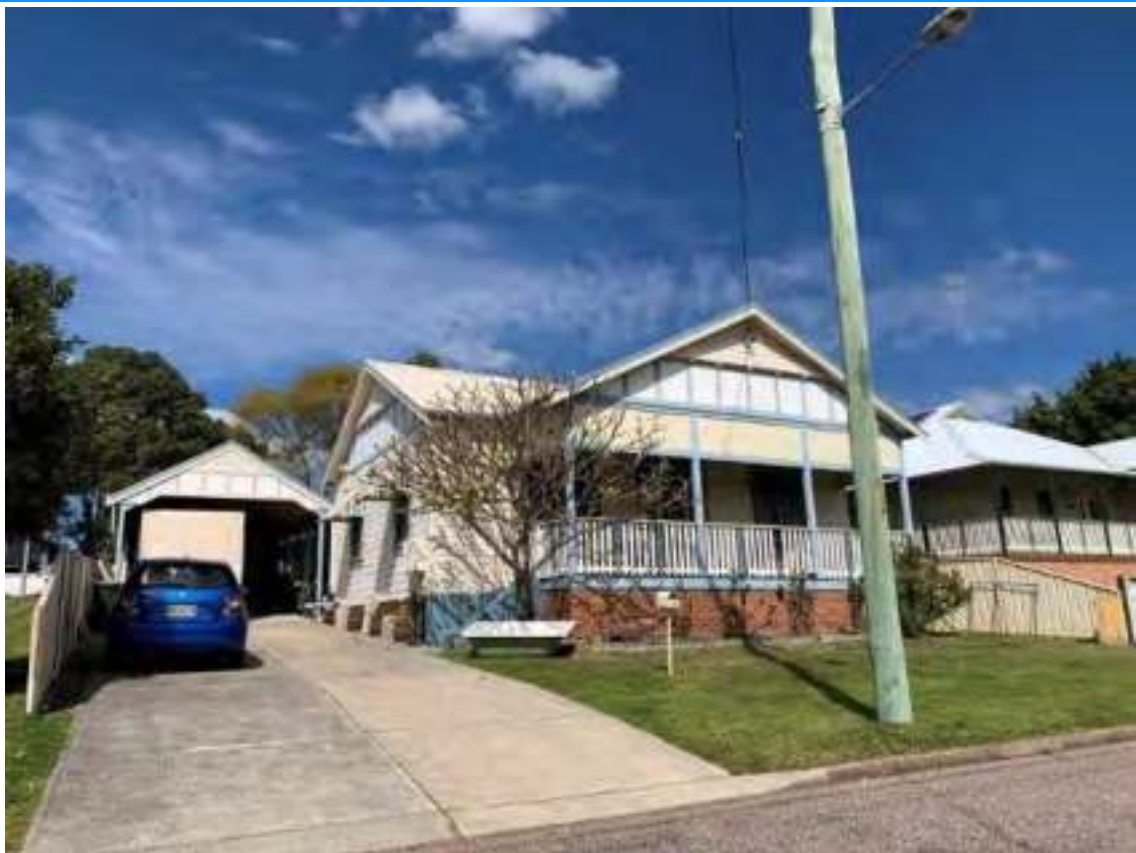
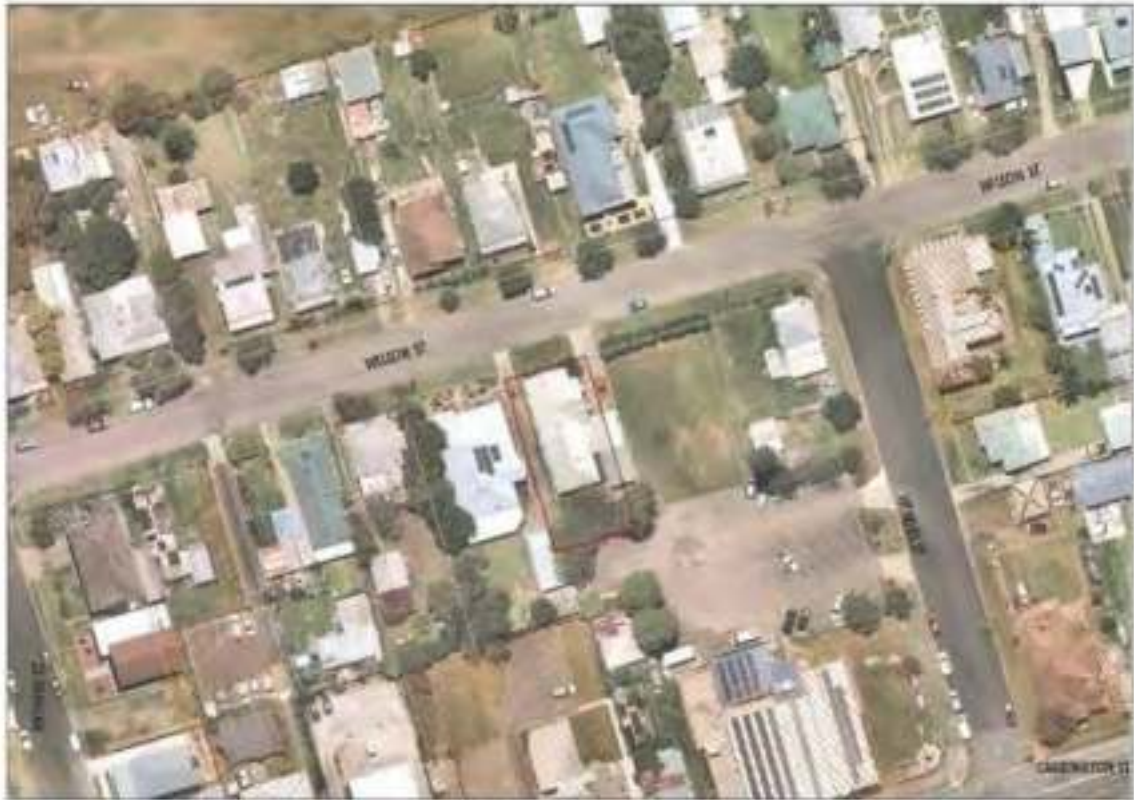
40 WILSON STREET, WEST WALLSEND 2286

Conservation Area Contribution Level	Est. Construction Date	Previous studies and/or community input
Contributory 1	1920–1930	No prior heritage investigations and no additional information required
Assessment Text		Observed Modifications
<p>Single story Federation Bungalow style dwelling with a double gable Colourbond roof and weatherboard cladding.</p> <p>The veranda is partially enclosed by timber balustrade and timber posts. Concrete stairs with masonry balustrades lead onto the landing.</p> <p>The front door is timber framed with metal screen door with adjacent window features and fan light. Double sash windows are either side with the western and eastern windows all having timber sills and hoods. All windows appear to be original.</p> <p>Both gables have battening detailing and extended eaves.</p> <p>A gable roof garage is located to the east of the dwelling.</p> <p>The dwelling displays architectural features of a heritage style and is representative of the local development of this period, being of historical significance for the HCA.</p>		<p>The timber balustrade is potentially a contemporary replication of an original heritage design.</p>

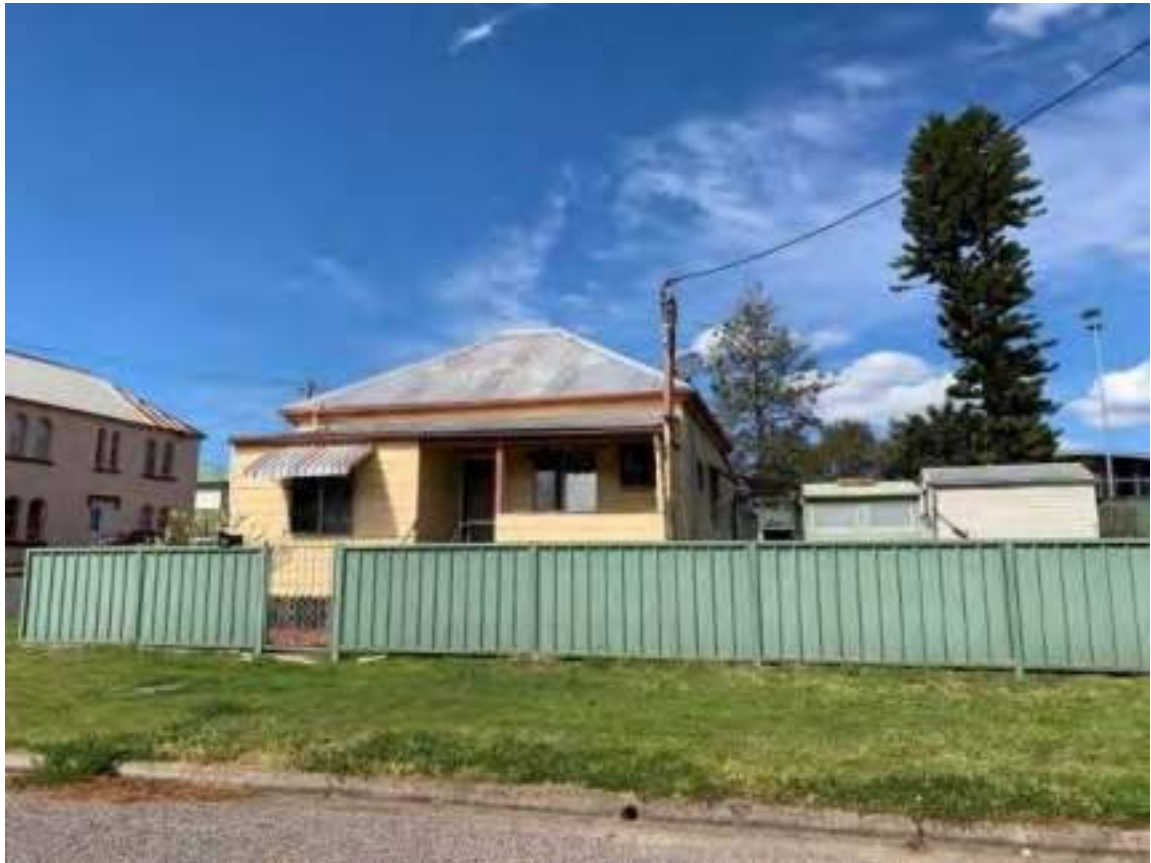
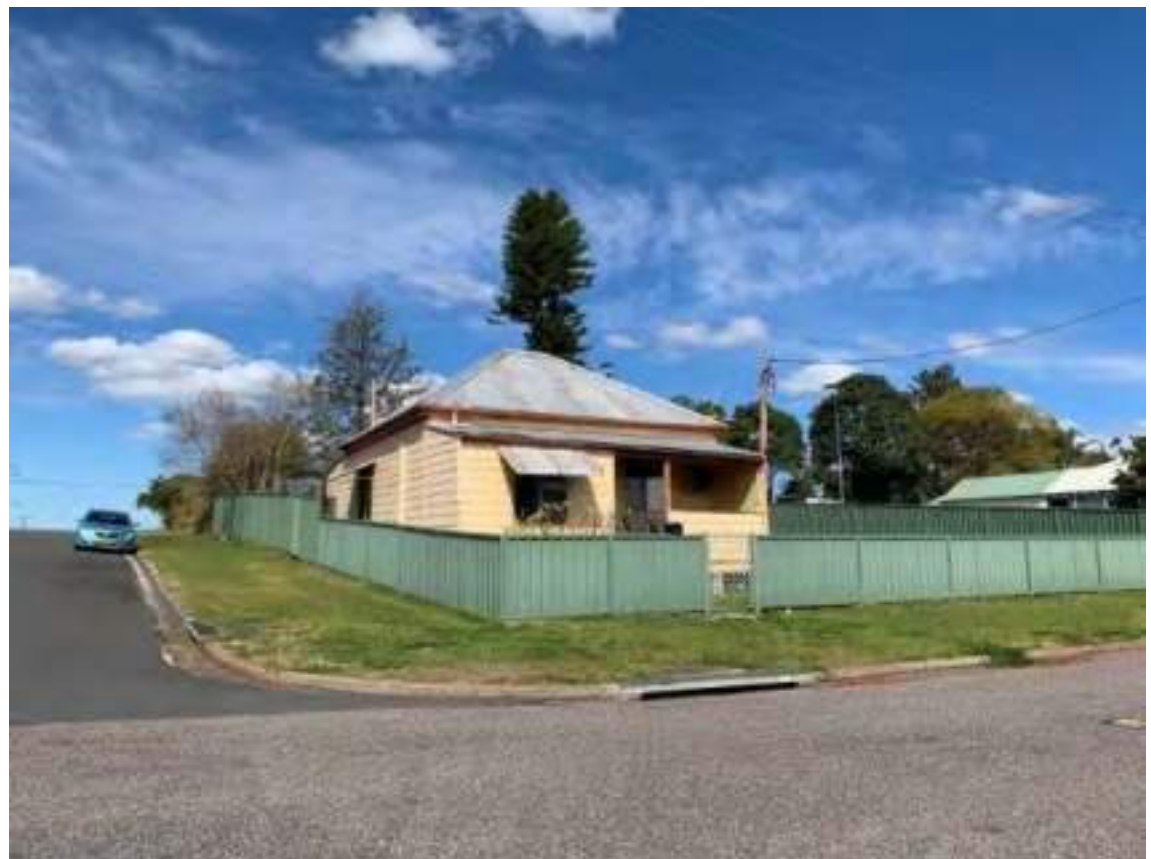
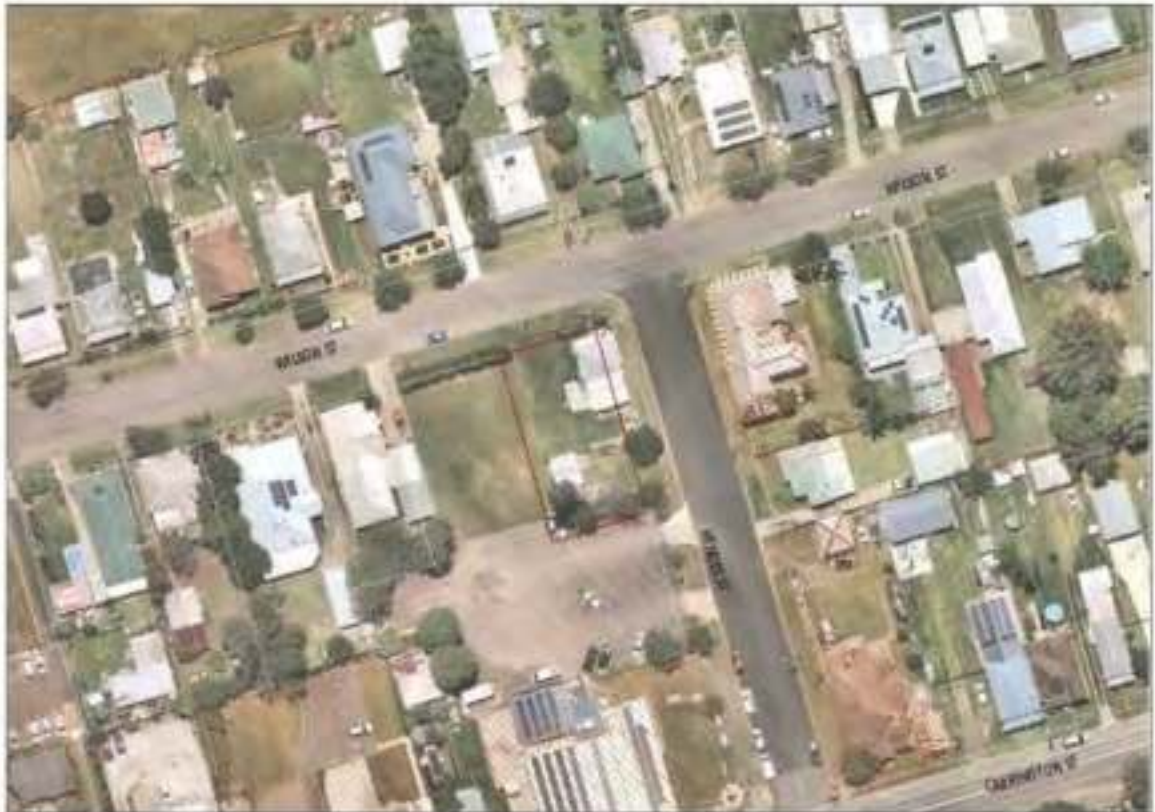
36 WILSON STREET, WEST WALLSEND 2286

Conservation Area Contribution Level	Est. Construction Date	Previous studies and/or community input
Contributory 1	1890–1915	No prior heritage investigations and no additional information required
Assessment Text		Observed Modifications
<p>Single story Vernacular ‘Mining Cottage’ style dwelling with hipped Colourbond roof and weatherboard cladding. The veranda roof is skillion and supported by timber posts.</p> <p>The veranda is partially enclosed by timber boarding, with the eastern side being built in into an additional living area.</p> <p>All visible windows are sliding with metal hoods or awnings.</p> <p>A gable roof garage is located to the south of the dwelling.</p> <p>Colourbond fencing encloses the property.</p> <p>The dwelling displays architectural features of a heritage style and is representative of the local development of this period, being of historical significance for the HCA.</p>		<p>All windows have been replaced by contemporary sliding designs. Similarly the metal awnings and hoods are recent modification, potentially replacing original timber designs.</p> <p>The veranda extension is a common modification for the housing style.</p> <p>Metal support rails are visible leading onto the veranda, a recent addition.</p> <p>The veranda timber boarding partially enclosing the veranda is a contemporary addition.</p>

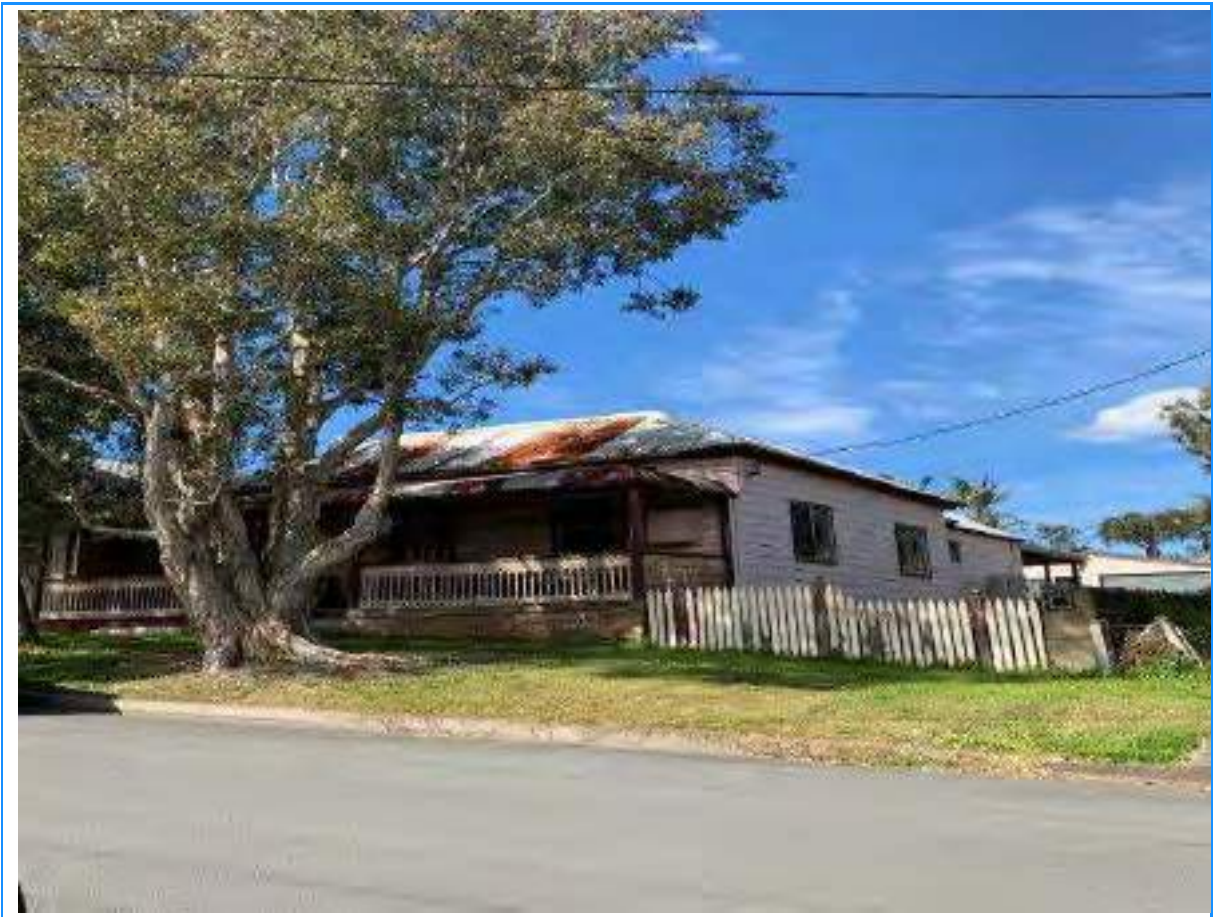
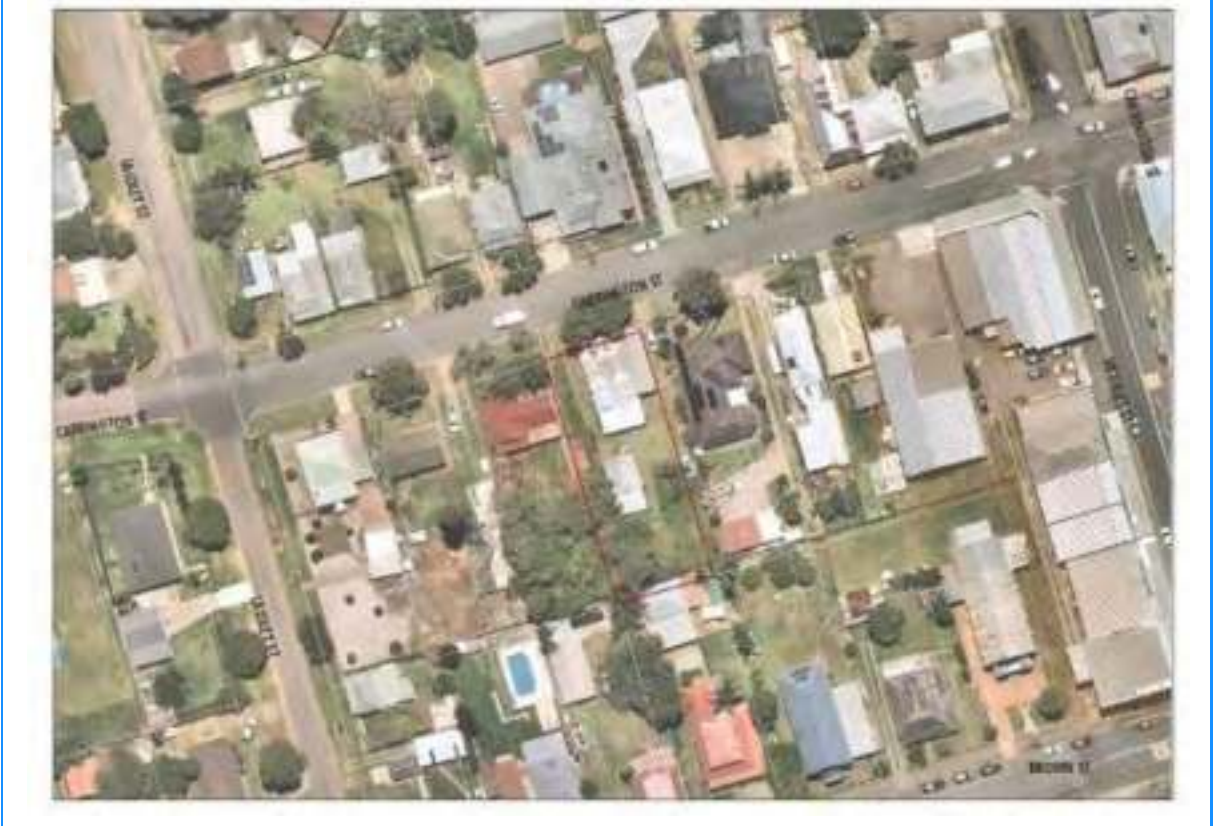
Conservation Area Contribution Level	Est. Construction Date	Previous studies and/or community input
Contributory 1	1895–1910	No prior heritage investigations and no additional information required
Assessment Text		Observed Modifications
<p>Single story 'workmen's cottage' style dwelling with hipped Colourbond roof with gable projection, and timber weatherboard cladding. The veranda roof is bull nosed with white/yellow and red striped detailing and supported by timber posts.</p> <p>The veranda is partially enclosed by ornate metal balustrade.</p> <p>The front door is the original heavy timber framed four panel design, with double hung sash windows either side. All visible windows are original.</p> <p>The gable has no decorative features, but the triple sash bay window has an impressive frilled metal hood above.</p> <p>The dwelling displays architectural features of a heritage style and is representative of the local development of this period, being of historical significance for the HCA.</p>		<p>No prior heritage investigations and no additional information required</p>
