APPENDIX 2

Building Assessment Sheets (Inventory Sheets)

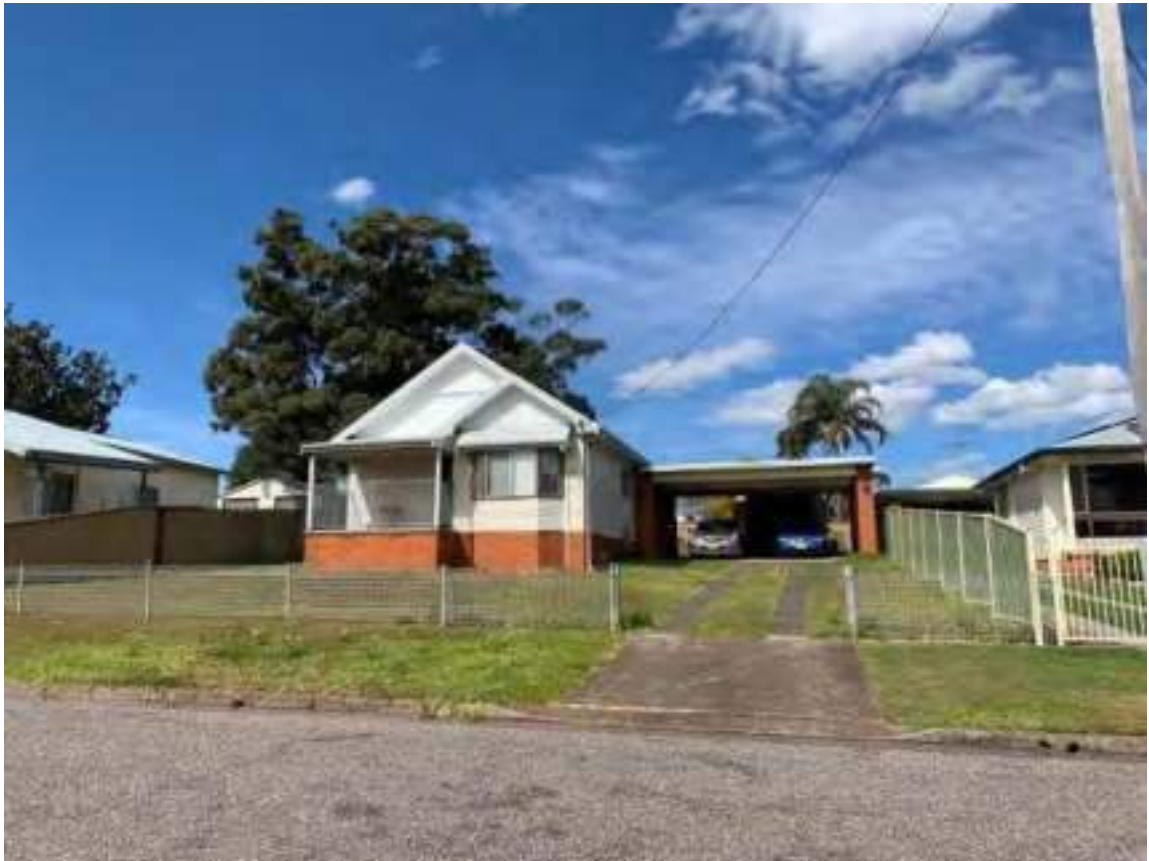
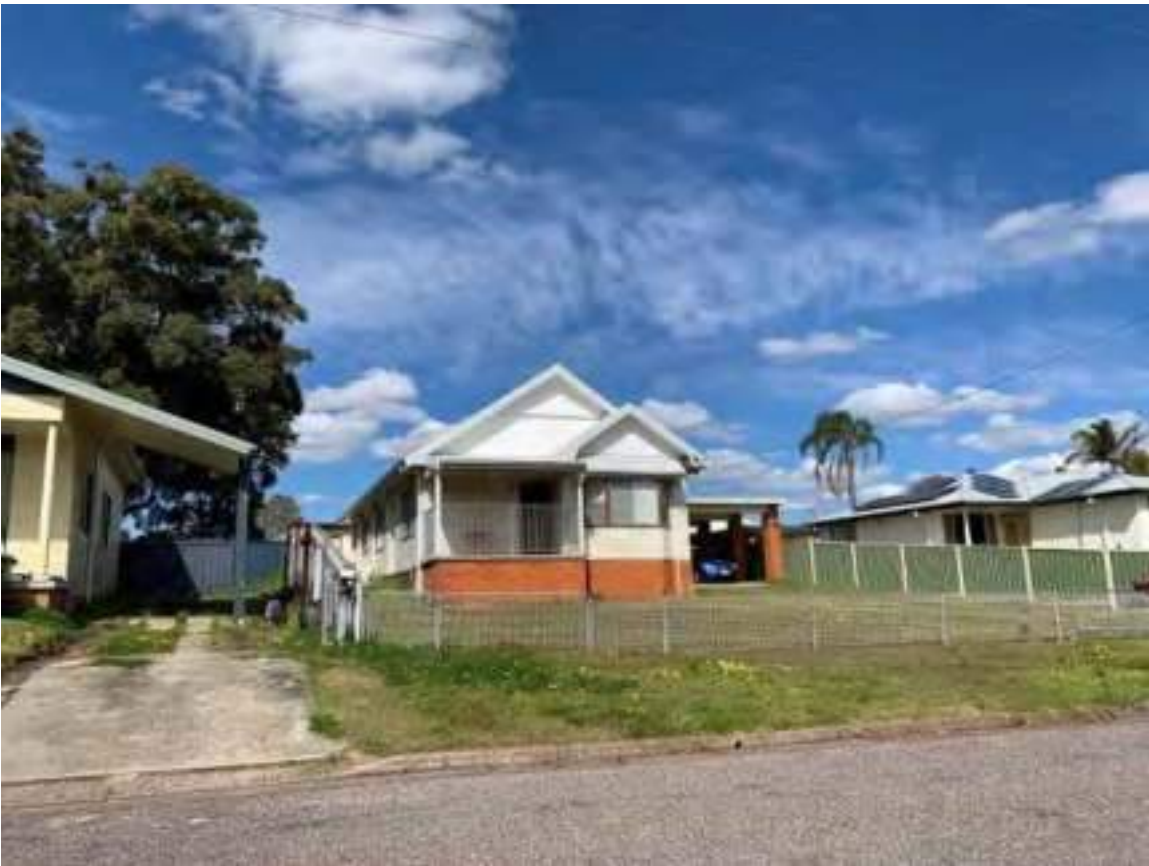
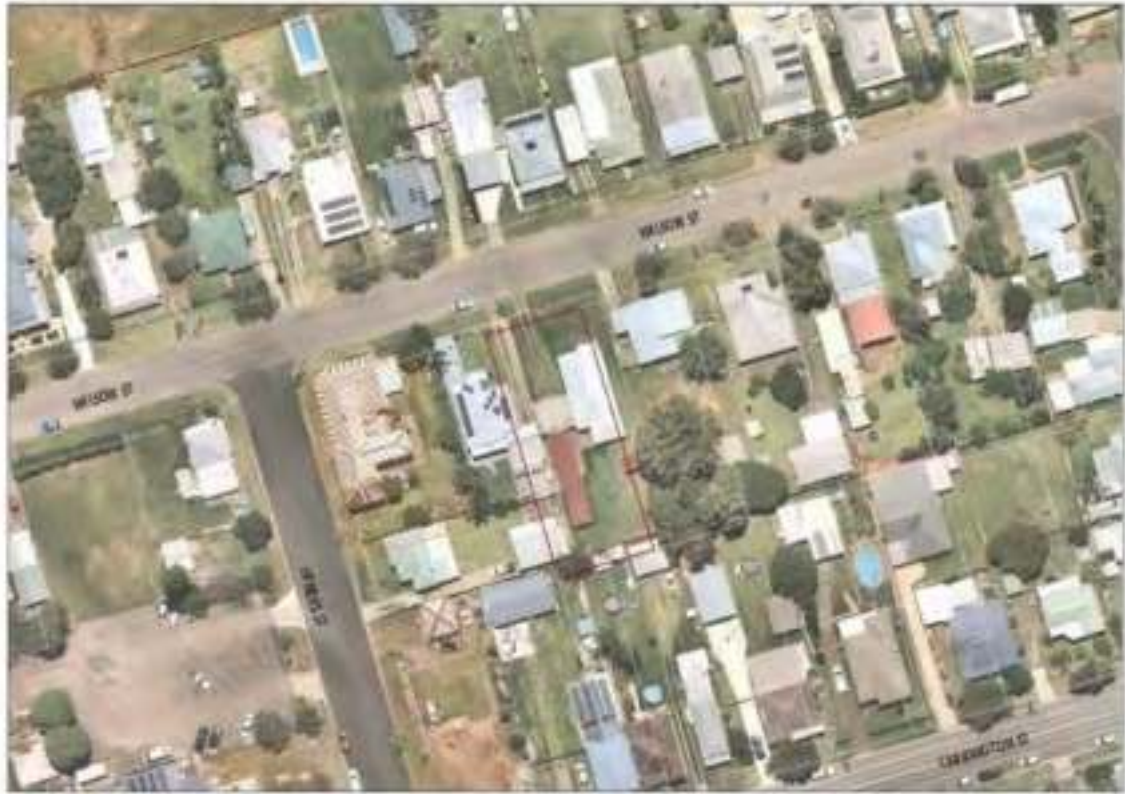
32 WILSON STREET, WEST WALLSEND 2286

Conservation Area Contribution Level	Est. Construction Date	Previous studies and/or community input
Contributory 1	1915–1930	No prior heritage investigations and no additional information required
Assessment Text		Observed Modifications
<p>Single story simplified Federation Bungalow style dwelling with double gable Colourbond roof and weatherboard cladding. The veranda roof is skillion and supported by timber posts.</p> <p>The veranda is partially enclosed by a metal balustrade.</p> <p>The gables have simple battening, decorative shingles and extended eaves. The bay window has four panes and two sash windows. A timber awning is above.</p> <p>A car port and garage are located to the west of the dwelling.</p> <p>A metal wire fence encloses the property.</p> <p>The dwelling displays architectural features of a heritage style and is representative of the local development of this period, being of historical significance for the HCA.</p>		<p>Western and eastern windows have been replaced with contemporary sliding designs.</p> <p>The metal veranda balustrade are a contemporary style, likely replacing an original timber design.</p> <p>An extension has been constructed on the back southern side of the dwelling, however this is not visible from the street and does not detract.</p>

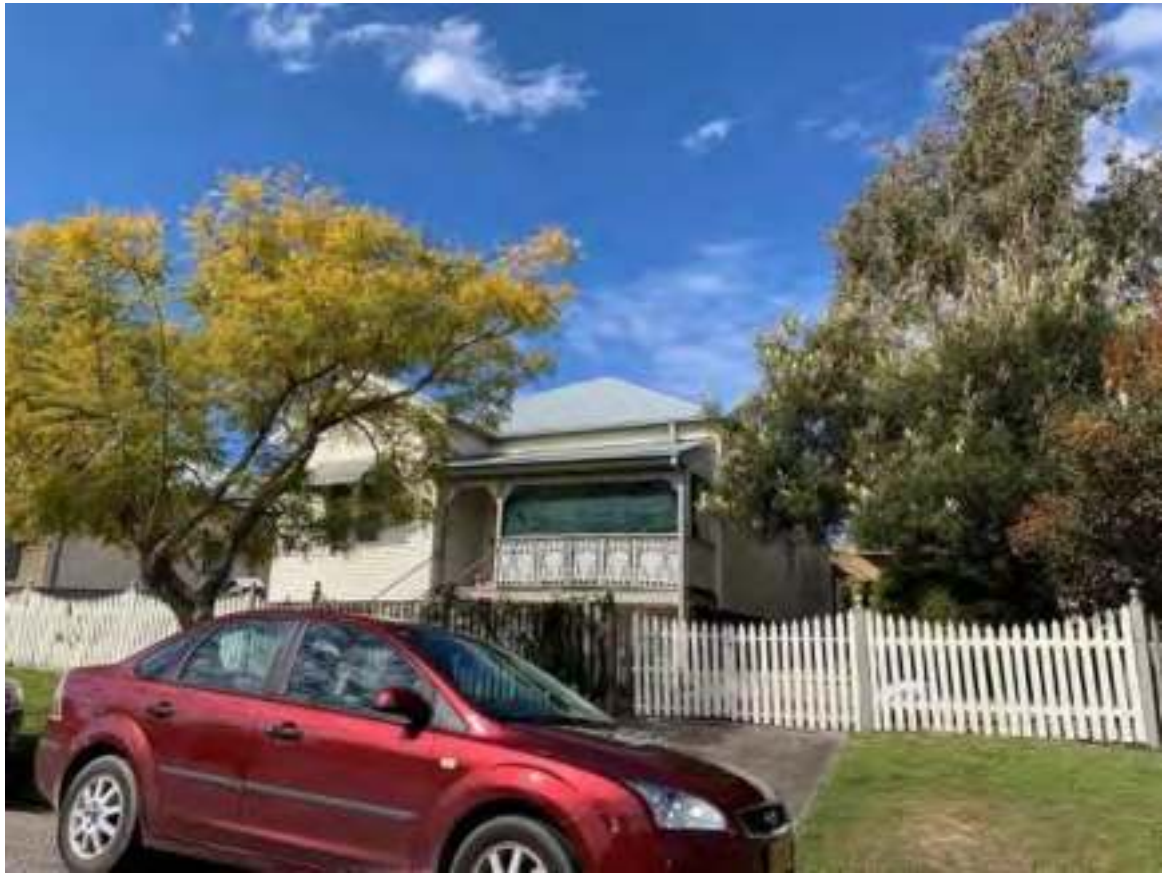
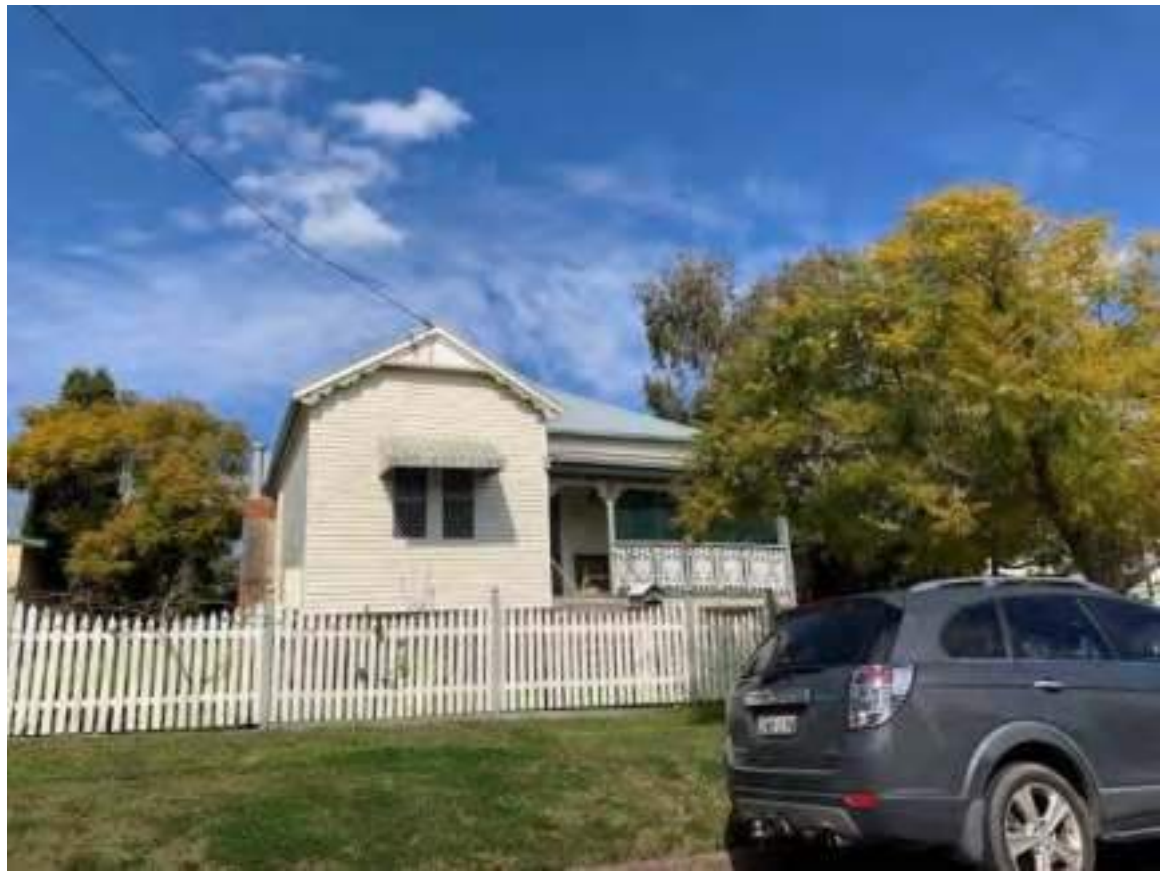
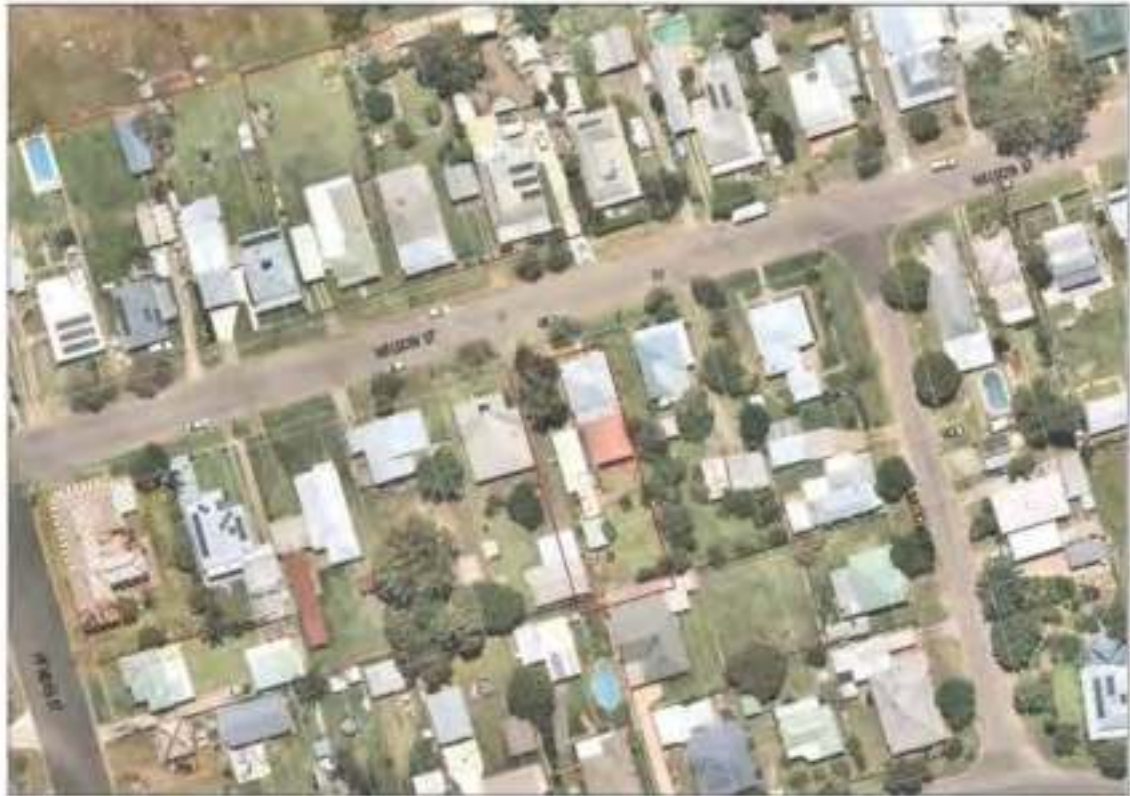
26 WILSON STREET, WEST WALLSEND 2286

Conservation Area Contribution Level	Est. Construction Date	Previous studies and/or community input
Contributory 1	1895–1915	No prior heritage investigations and no additional information required
Assessment Text		Observed Modifications
<p>Single story ‘workmen’s cottage’ style dwelling with hipped Colourbond roof with gable projection, and weatherboard cladding. The veranda roof is skillion and supported by timber posts. The veranda is framed by a cast iron lace valance.</p> <p>The veranda is partially enclosed by a metal and timber ornate balustrade and brick steps leading to the veranda landing.</p> <p>The front door is timber framed with metal security screen. Double sash windows are either side, with similar security screens.</p> <p>The gable has decoratively carved barge boards and extended eaves. The gable window has a metal hood.</p> <p>A red brickwork chimney is visible to the eastern side of the dwelling.</p> <p>A timber picket fence enclosed the property</p> <p>The dwelling displays architectural features of a heritage style and is representative of the local development of this period, being of historical significance for the HCA.</p>		<p>The security screens on the main door and façade windows are unsympathetic to the heritage style and detract from the streetscape.</p> <p>Timber boarding has been installed underneath the veranda to obscure the under house cavity. This is in a contemporary style.</p> <p>The chimney shaft has been removed.</p>

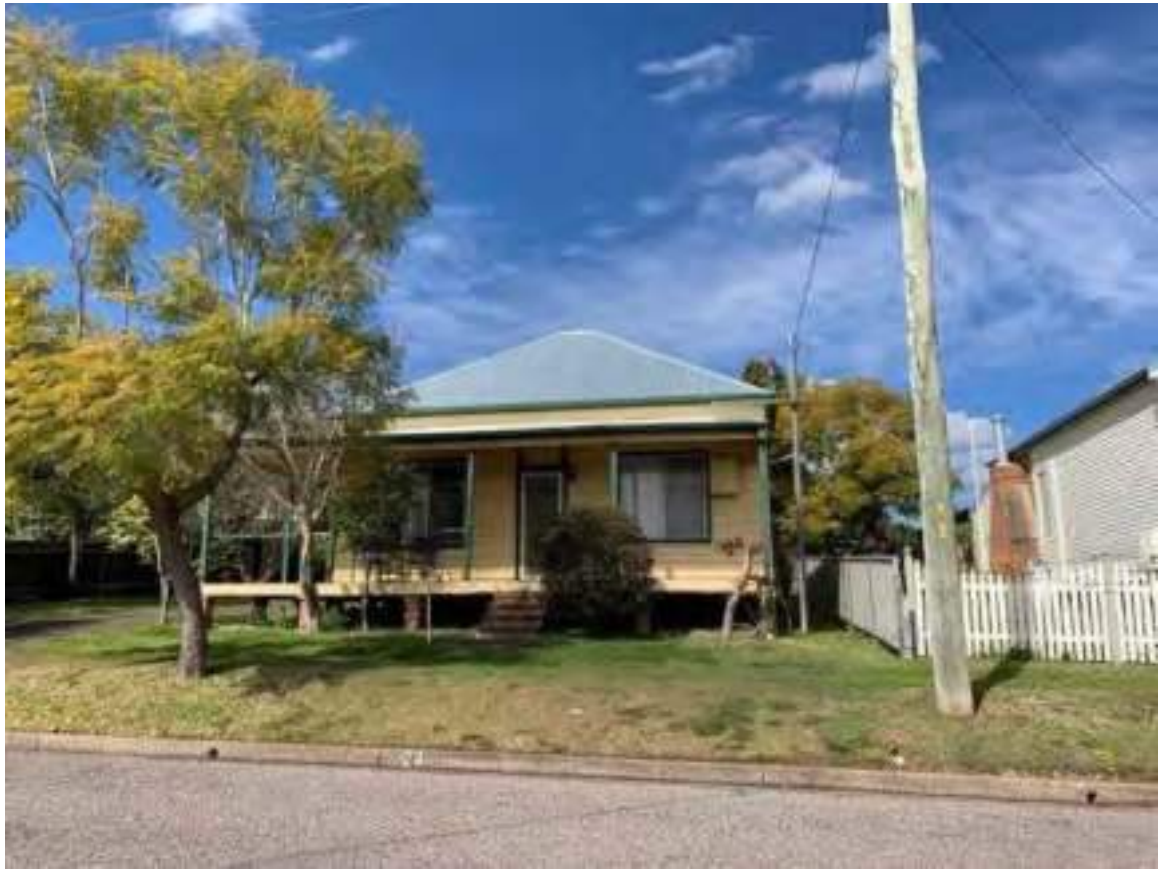
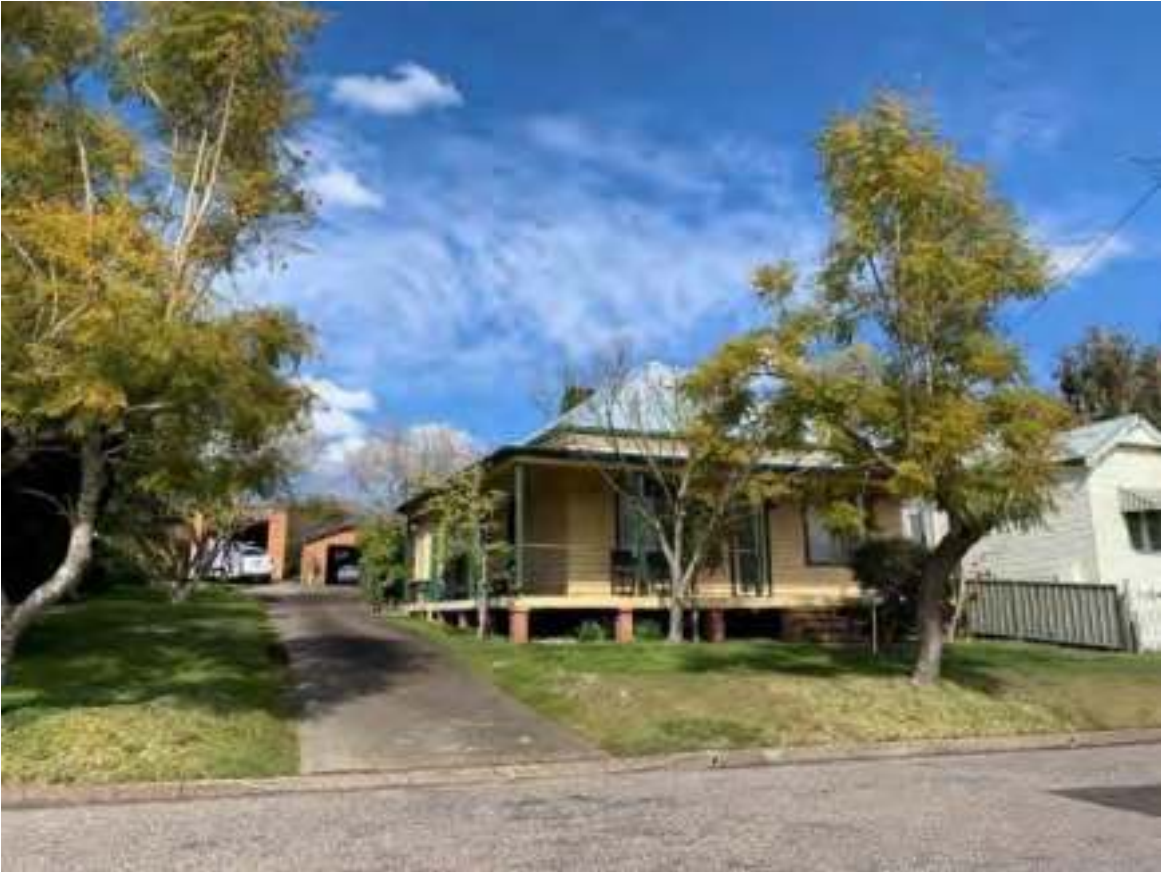
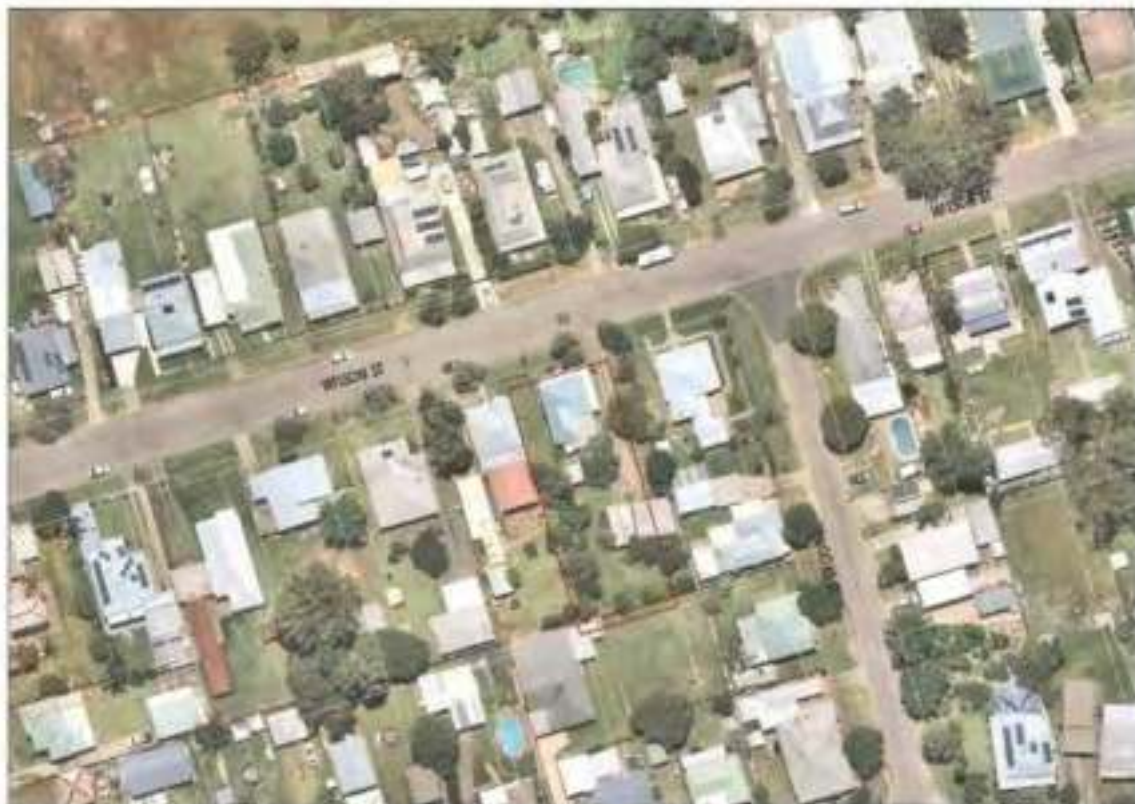
24 WILSON STREET, WEST WALLSEND 2286

Conservation Area Contribution Level	Est. Construction Date	Previous studies and/or community input
Contributory 1	1890–1915	No prior heritage investigations and no additional information required
Assessment Text		Observed Modifications
<p>Single story Vernacular ‘Mining Cottage’ style dwelling with hipped Colourbond roof and weatherboard cladding. The veranda roof is hipped and encircles the northern and eastern sides of the dwelling. the roof is supported by timber posts.</p> <p>The veranda is partially enclosed by a simple metal rail. Brick steps lead onto the landing.</p> <p>The front door is timber framed with sliding windows either side.</p> <p>The dwelling displays architectural features of a heritage style and is representative of the local development of this period, being of historical significance for the HCA.</p>		<p>The metal railing is a contemporary addition to the dwelling, likely replacing an original timber design.</p> <p>The visible windows have been replaced with contemporary sliding styles.</p> <p>An extension has been constructed in the back southern portion of the property, however this is not visible from the street and does not detract.</p>

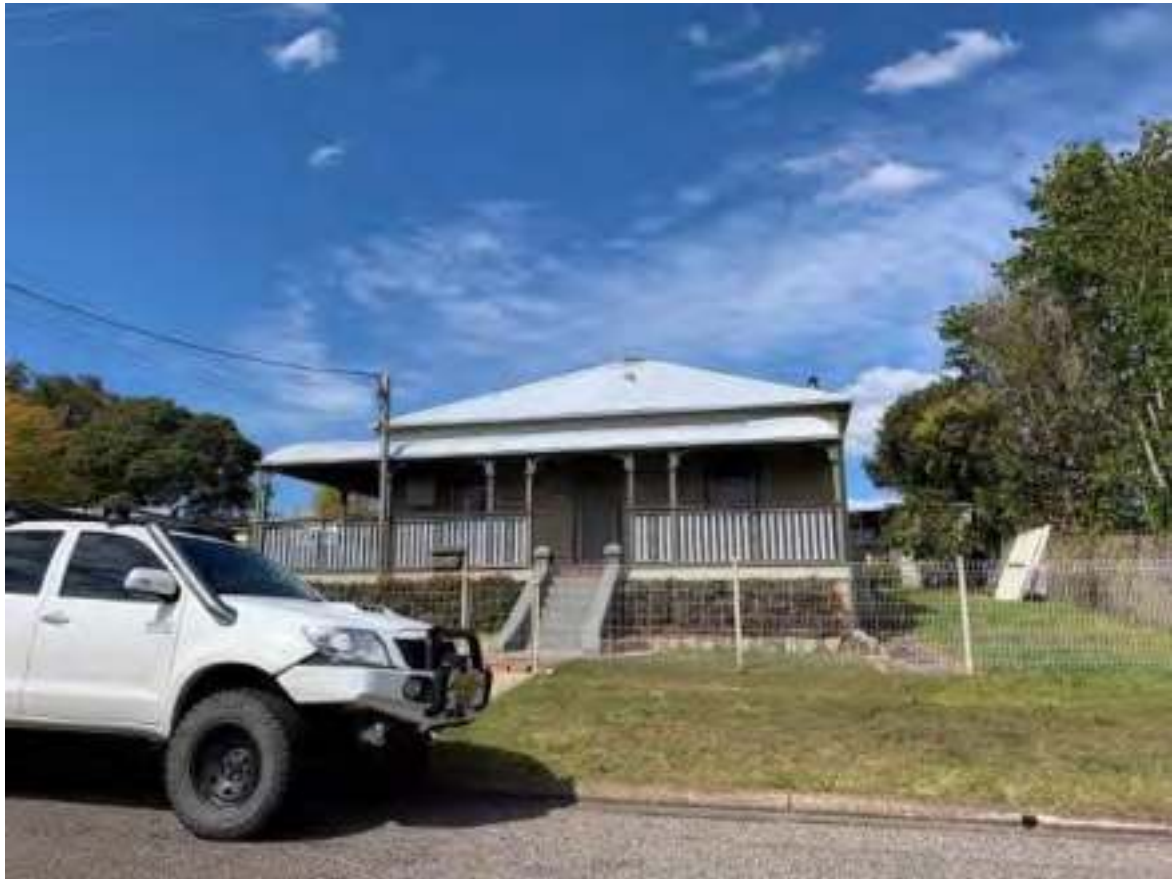
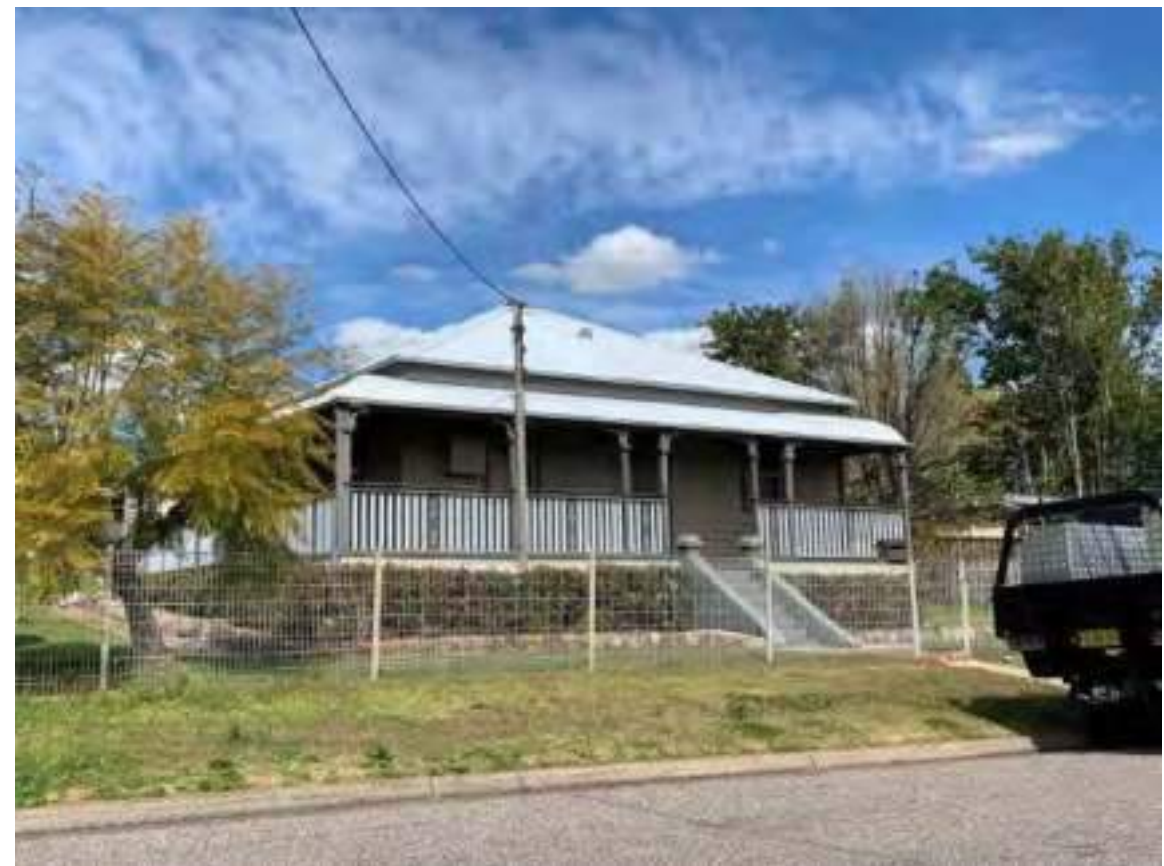
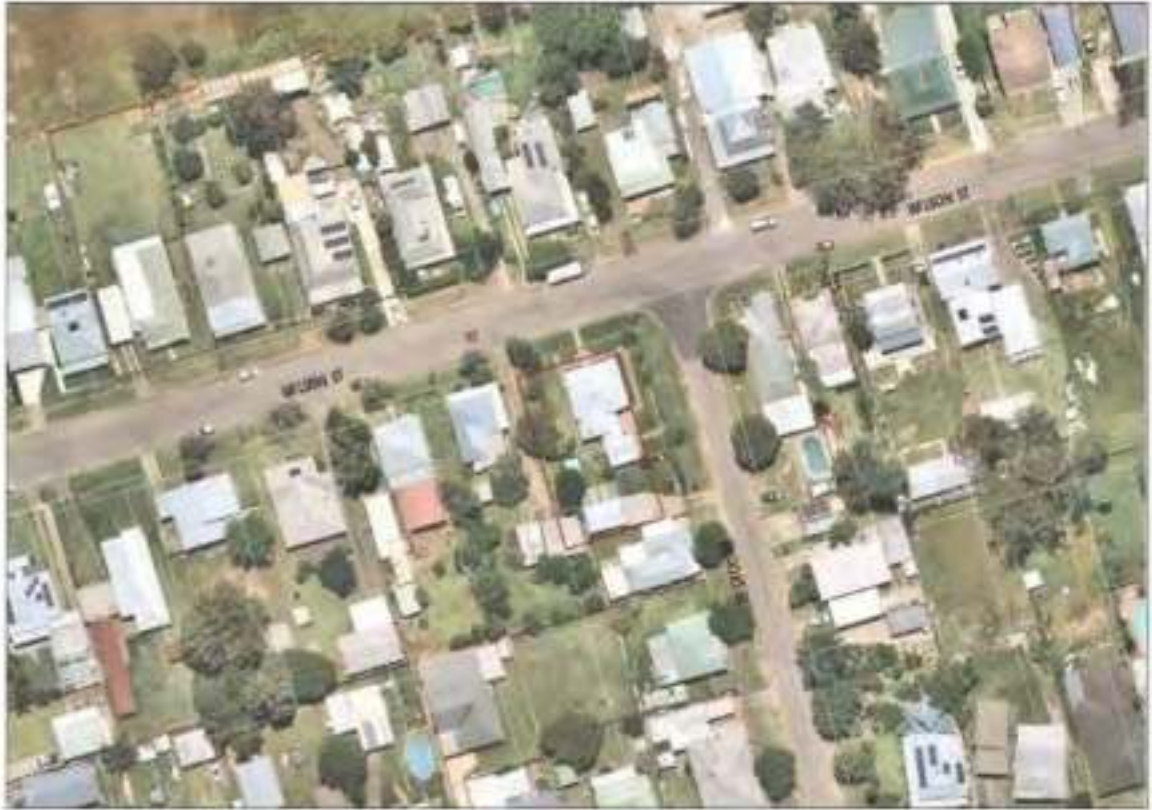
22 WILSON STREET, WEST WALLSEND 2286

Conservation Area Contribution Level	Est. Construction Date	Previous studies and/or community input
Contributory 1	1890–1915	No prior heritage investigations and no additional information required
Assessment Text		Observed Modifications
<p>Singles tory Vernacular ‘Mining Cottage’ style dwelling with Colourbond hipped roof and timber weatherboard cladding. The veranda roof is bull nosed and supported by ornately carved posts. The veranda is partially enclosed by a timber balustrade. Tiled masonry stairs lead onto the landing, with masonry rendered balustrade and piers.</p> <p>The front door is timber framed with sash windows either side. A metal wire fence encloses the property.</p> <p>A carport and garage are located to the south of the dwelling.</p> <p>The dwelling displays architectural features of a heritage style and is representative of the local development of this period, being of historical significance for the HCA.</p>		<p>The veranda wraps around the eastern side of the dwelling, likely a contemporary modification as this is not a common feature for the housing style.</p> <p>All visible windows are contemporary replications of heritage sash styles.</p> <p>The veranda balustrade is a recent addition, however, is constructed in a sympathetic manner and does not detract.</p> <p>An extension has been constructed on the southern end of the dwelling, however, is not visible from the northern street front.</p>

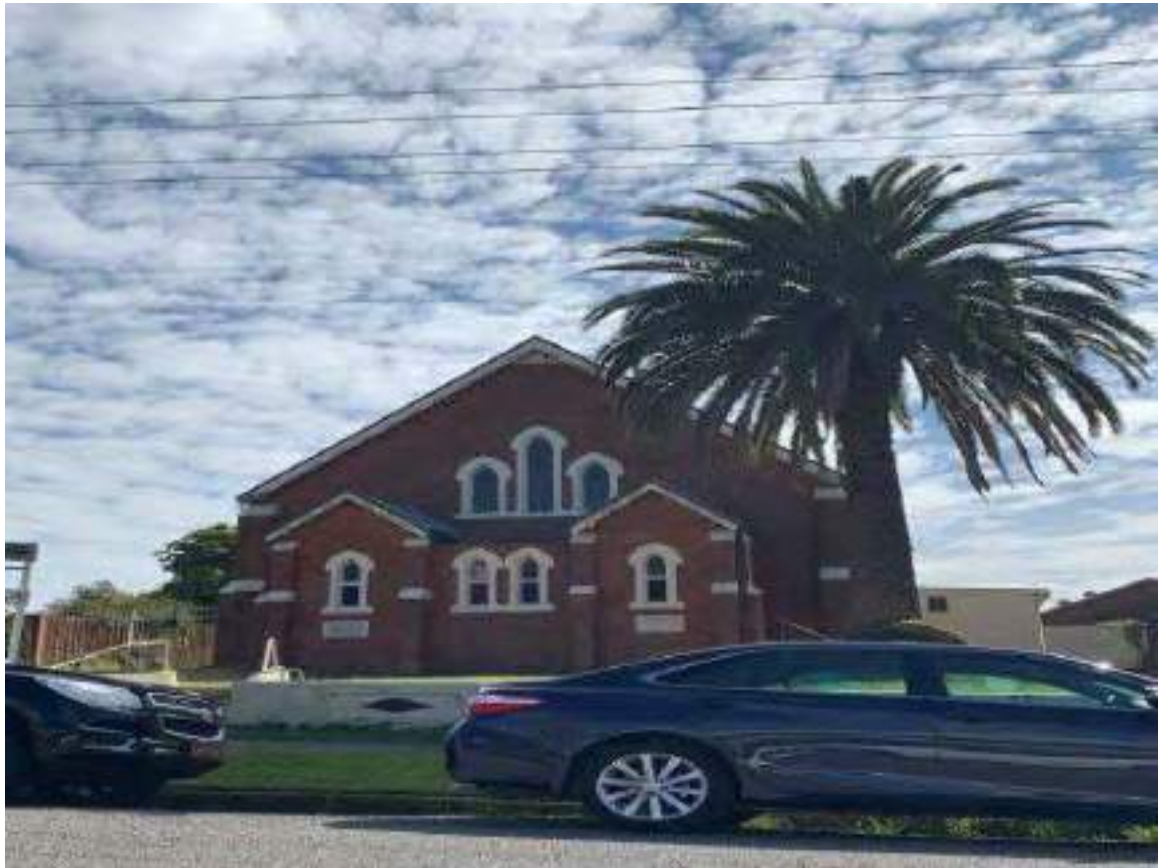
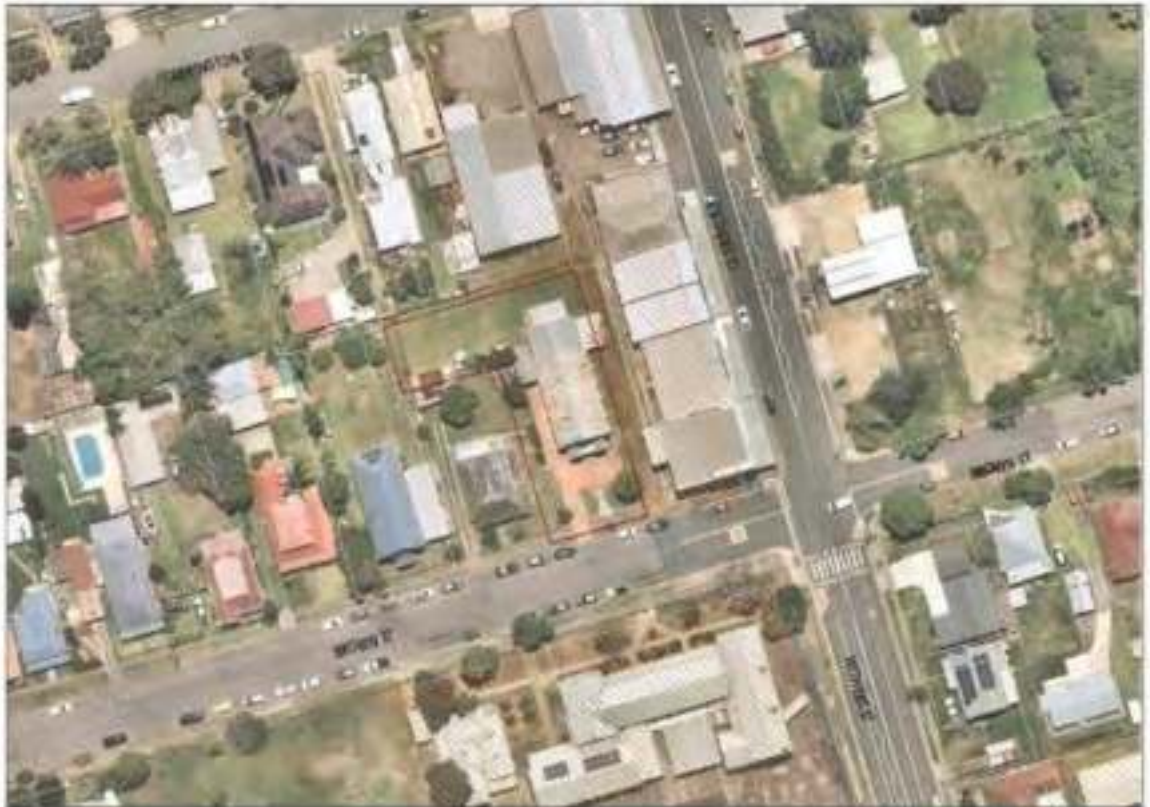
41 BROWN STREET, WEST WALLSEND 2286

Conservation Area Contribution Level	Est. Construction Date	Previous studies and/or community input
Contributory 1	1910	West Wallsend Heritage Study 1993 Moderate local significance.
Assessment Text		Observed Modifications
<p>A two-story simple Federation Gothic church building with local red brick façade with painted white rendered detailing. The windows are pointed arch frames with some visible stained glass. The consists of three high Colourbond gables, with extended and simply decorated eaves.</p> <p>A rendered masonry low lying fence lozenge pattern inlaid detailing encloses the property.</p> <p>The dwelling displays architectural features of a heritage style and is representative of the local development of this period, being of historical significance for the HCA.</p>		No prior heritage investigations and no additional information required

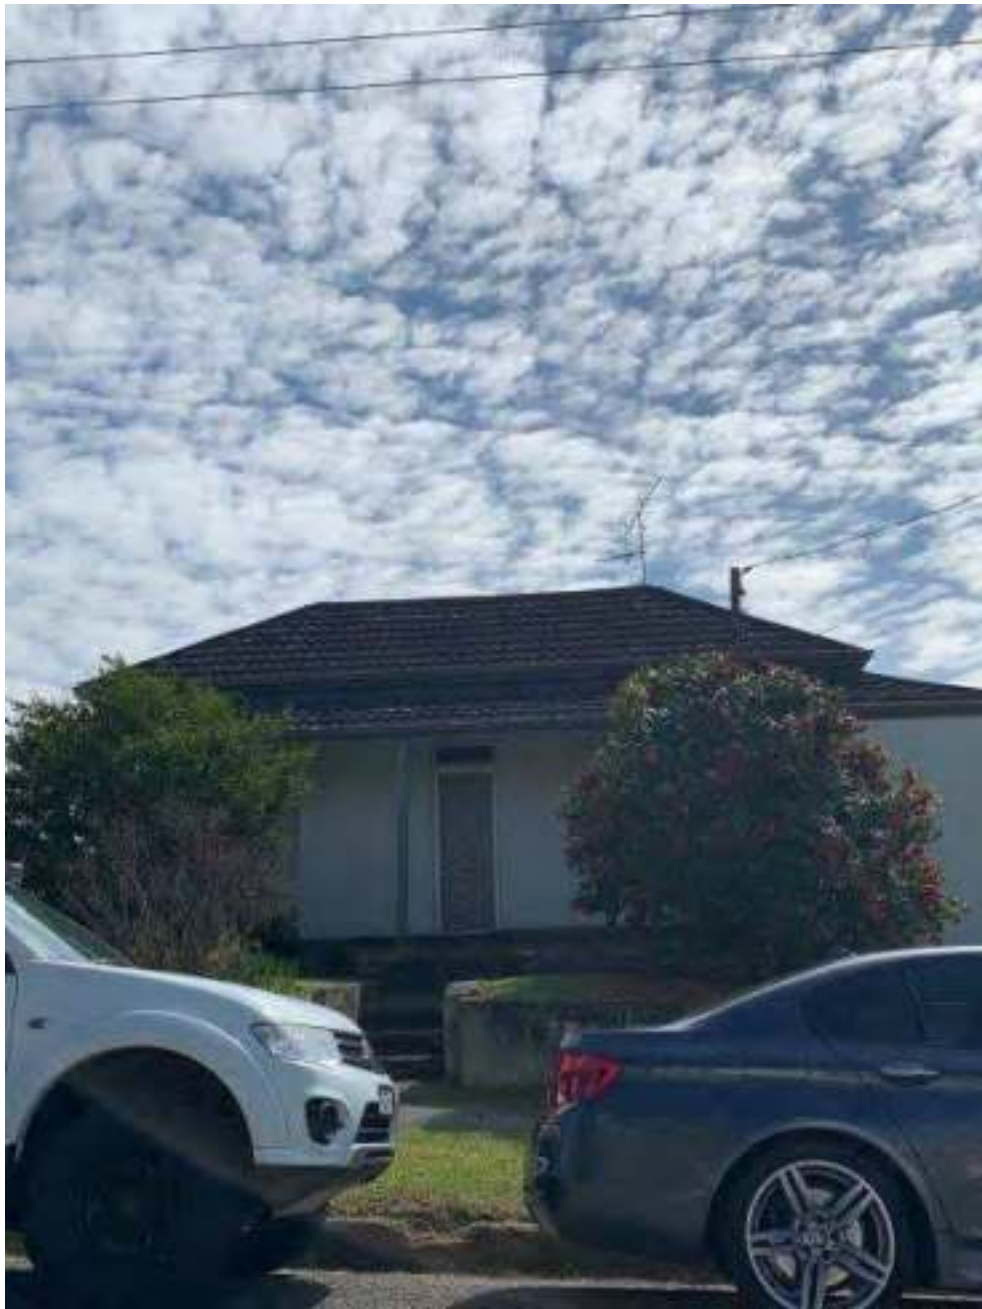
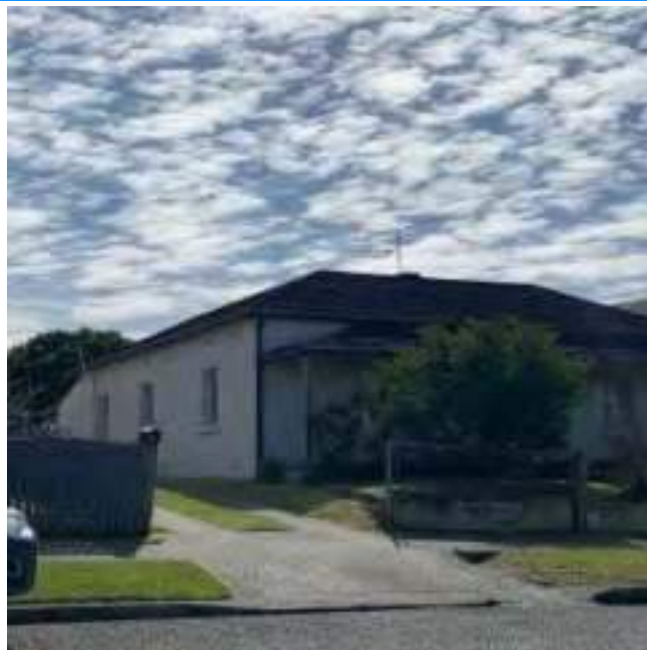
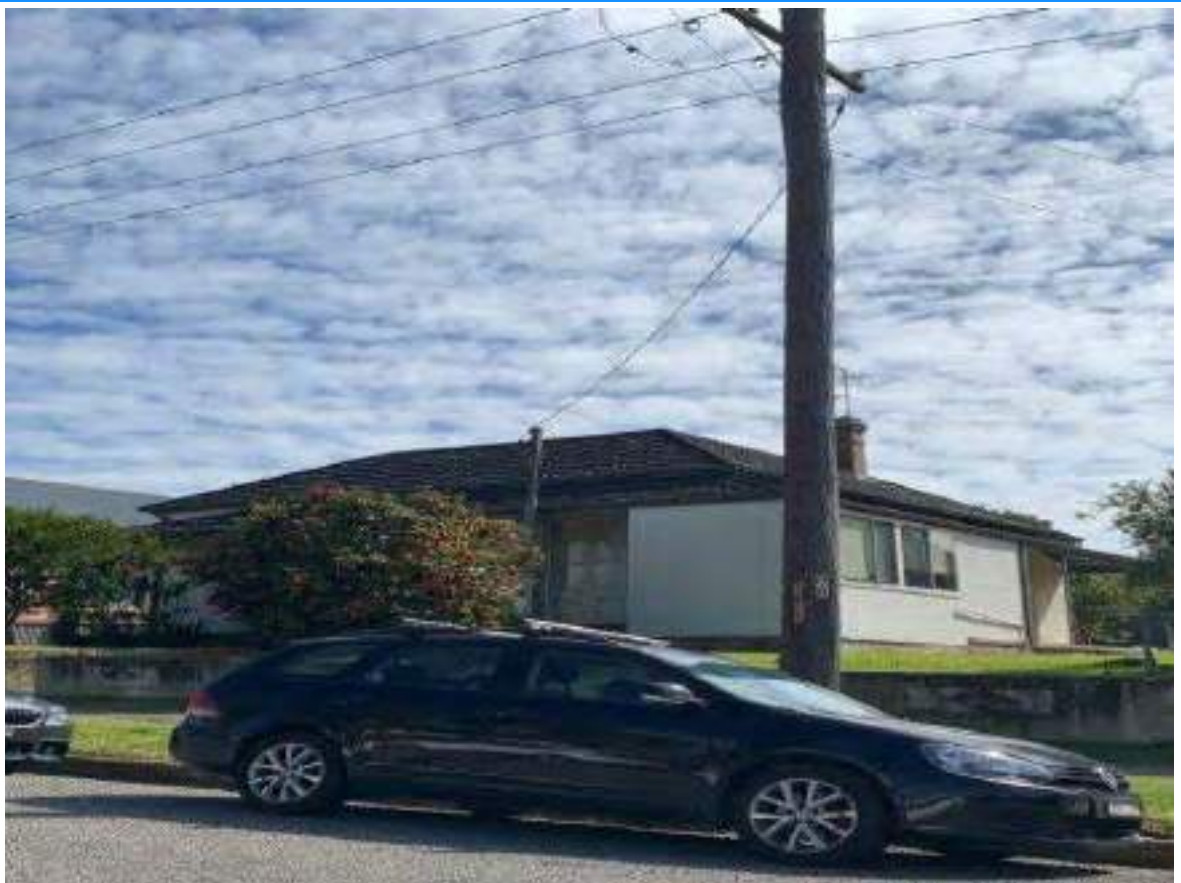
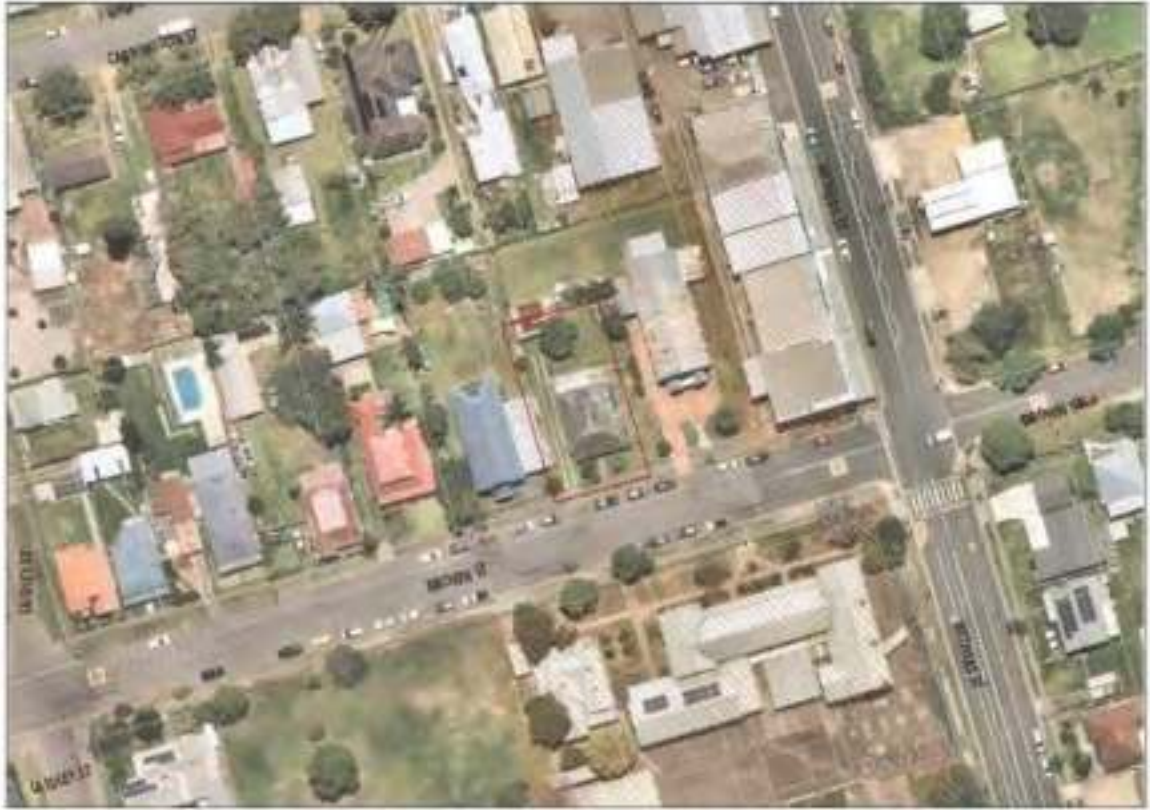
Conservation Area Contribution Level	Est. Construction Date	Previous studies and/or community input
Contributory 1	1888	West Wallsend Heritage Study 1993 Former Police Station High to moderate local significance and potential archaeological site.
Assessment Text		Observed Modifications
<p>Single story Vernacular 'Mining Cottage' style dwelling with tiled hipped roof and rendered brick facade. The veranda roof is steeply hipped.</p> <p>Two front doors are visible, both timber framed. Visible windows are original timber framed sash with projecting timber sill. French doors are original.</p> <p>The dwelling displays architectural features of a heritage style and is representative of the local development of this period, being of historical significance for the HCA.</p>		<p>In reference to the 1993 study, the original corrugated roof has been replaced with a contemporary tiled design.</p> <p>The veranda roof has been extended to the east, with a small built in room constructed on the end of the veranda.</p>

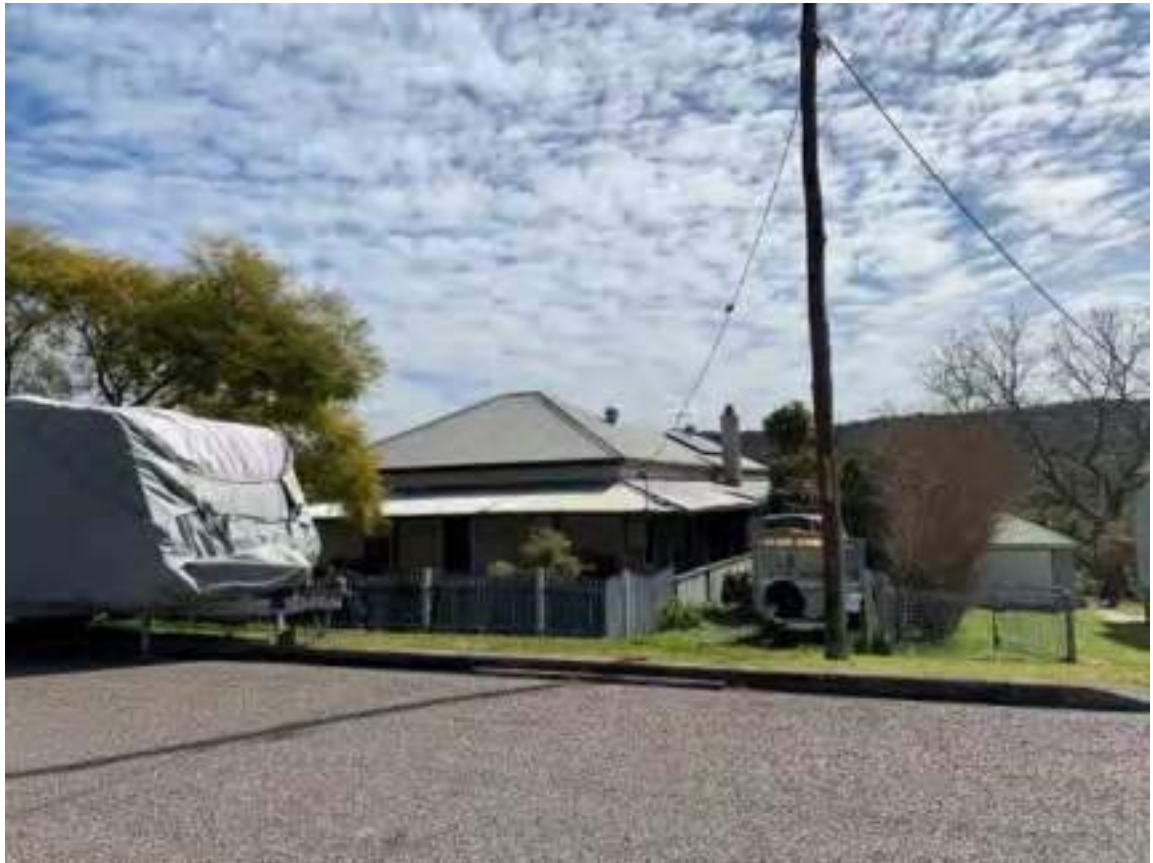
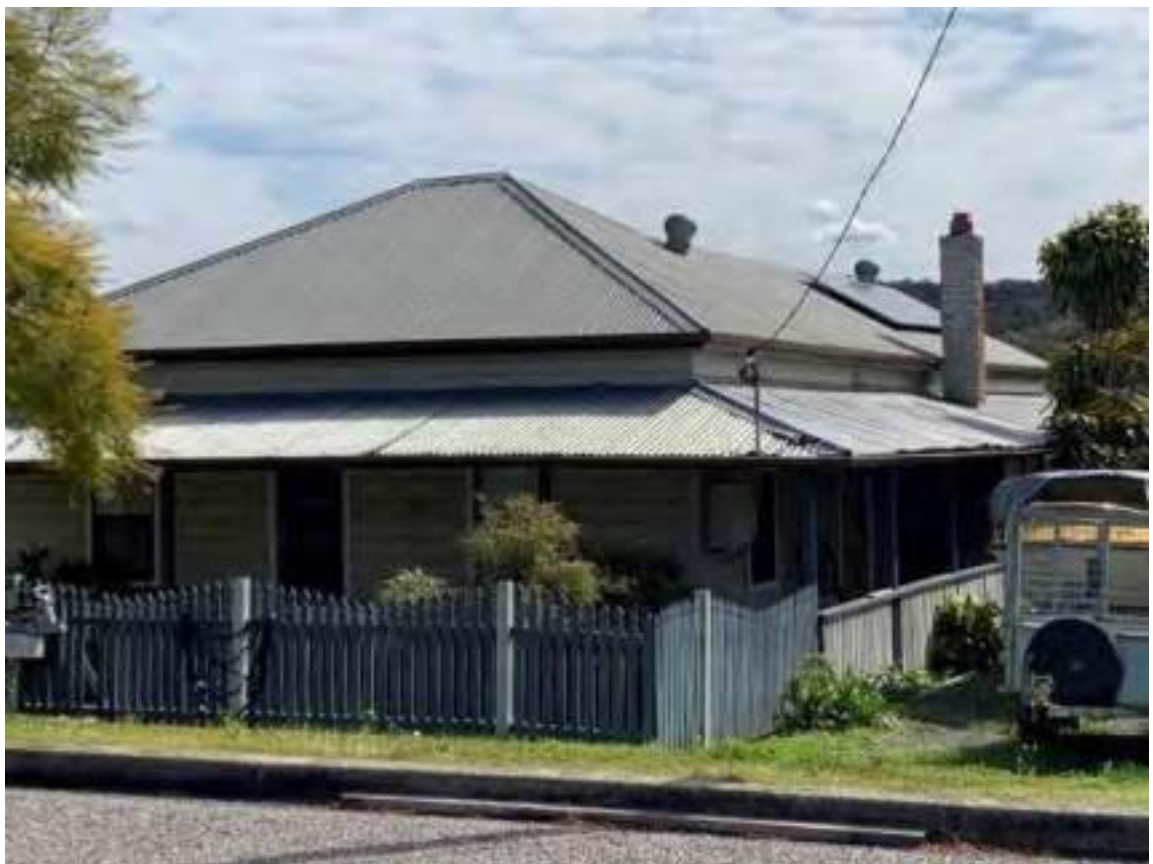
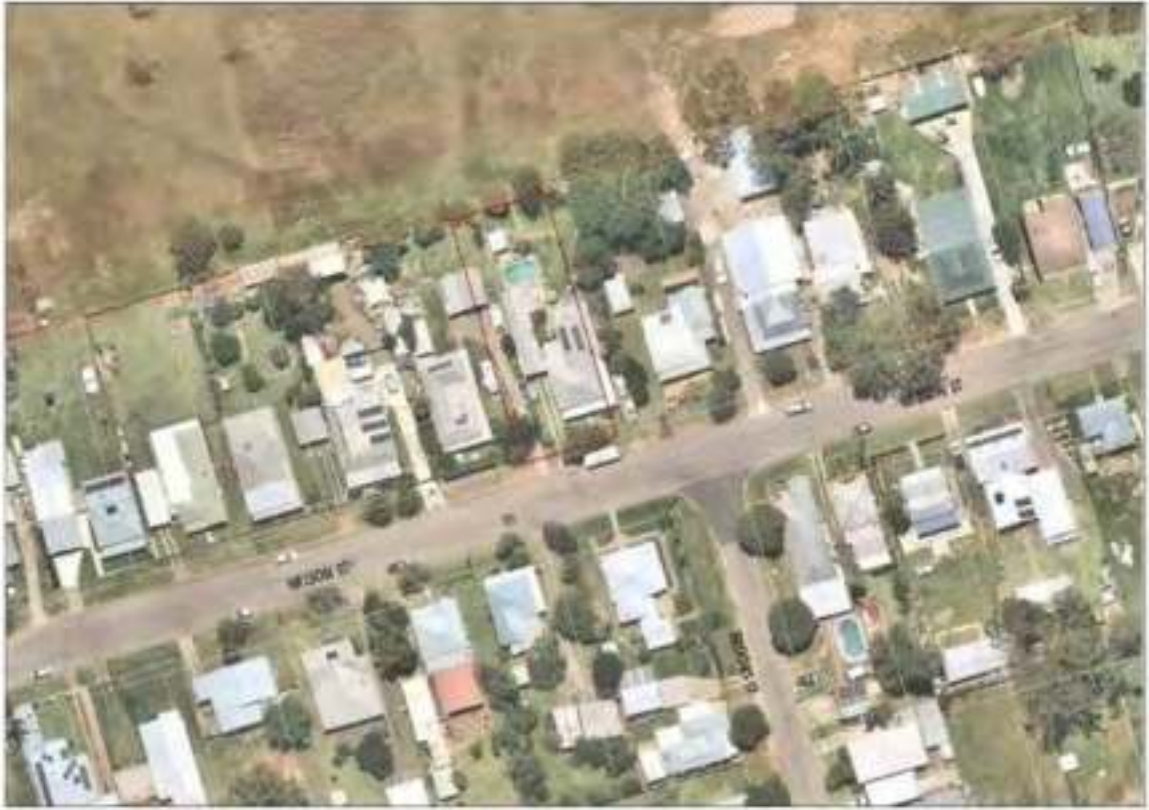
21 WILSON STREET, WEST WALLSEND 2286

Conservation Area Contribution Level	Est. Construction Date	Previous studies and/or community input
Contributory 1	1890–1915	No prior heritage investigations and no additional information required
Assessment Text		Observed Modifications
<p>Single story Vernacular ‘Mining Cottage’ style dwelling with Colourbond hipped roof and timber weatherboard cladding. The veranda roof is hipped.</p> <p>The veranda is partially enclosed by a simple timber balustrade.</p> <p>The front door is timber framed with sash windows either side.</p> <p>Car port and garage is located to the west of the dwelling in a comparative heritage style.</p> <p>A timber picket fence encloses the property.</p> <p>The dwelling displays architectural features of a heritage style and is representative of the local development of this period, being of historical significance for the HCA.</p>		<p>All visible windows are contemporary replications of the original heavy timber framed sash designs.</p> <p>An extension has been constructed on the northern back side of the dwelling, however is not visible from the street and does not detract.</p>
