APPENDIX 2

Building Assessment Sheets (Inventory Sheets)

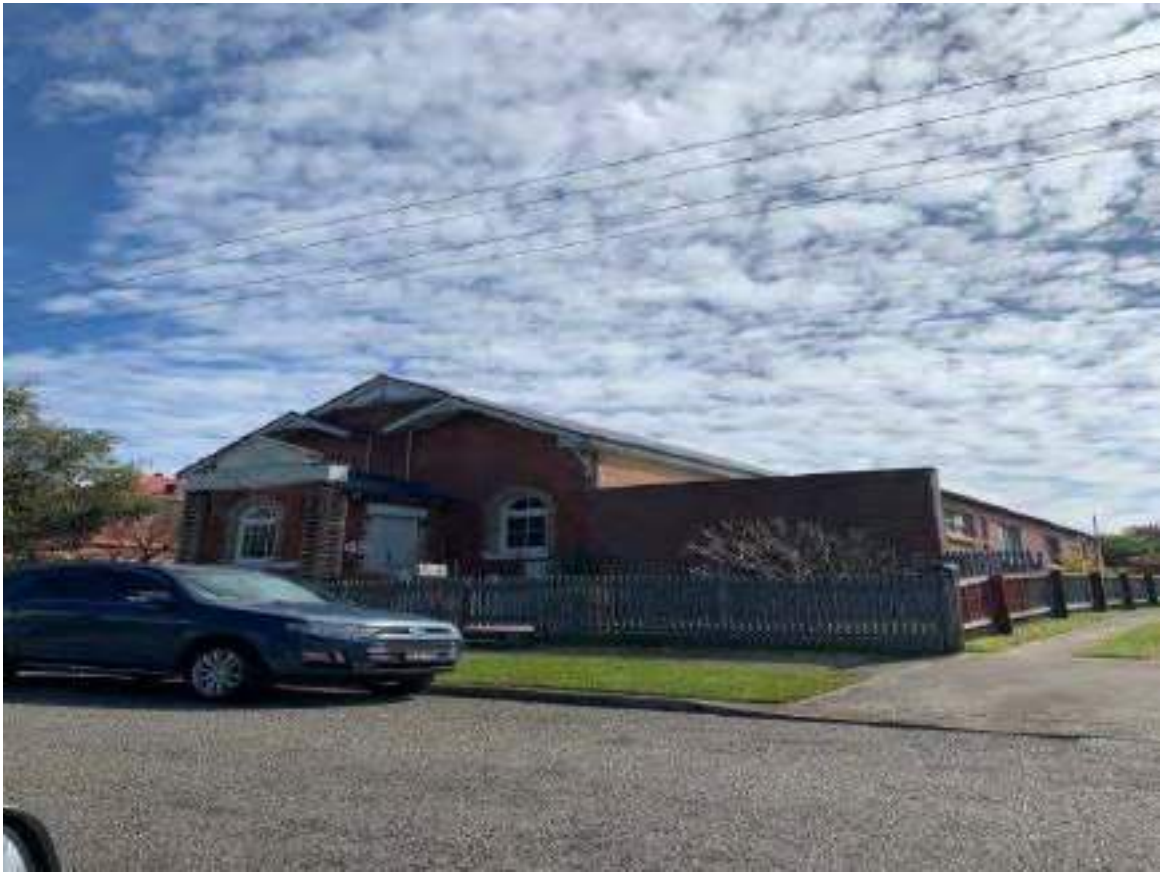
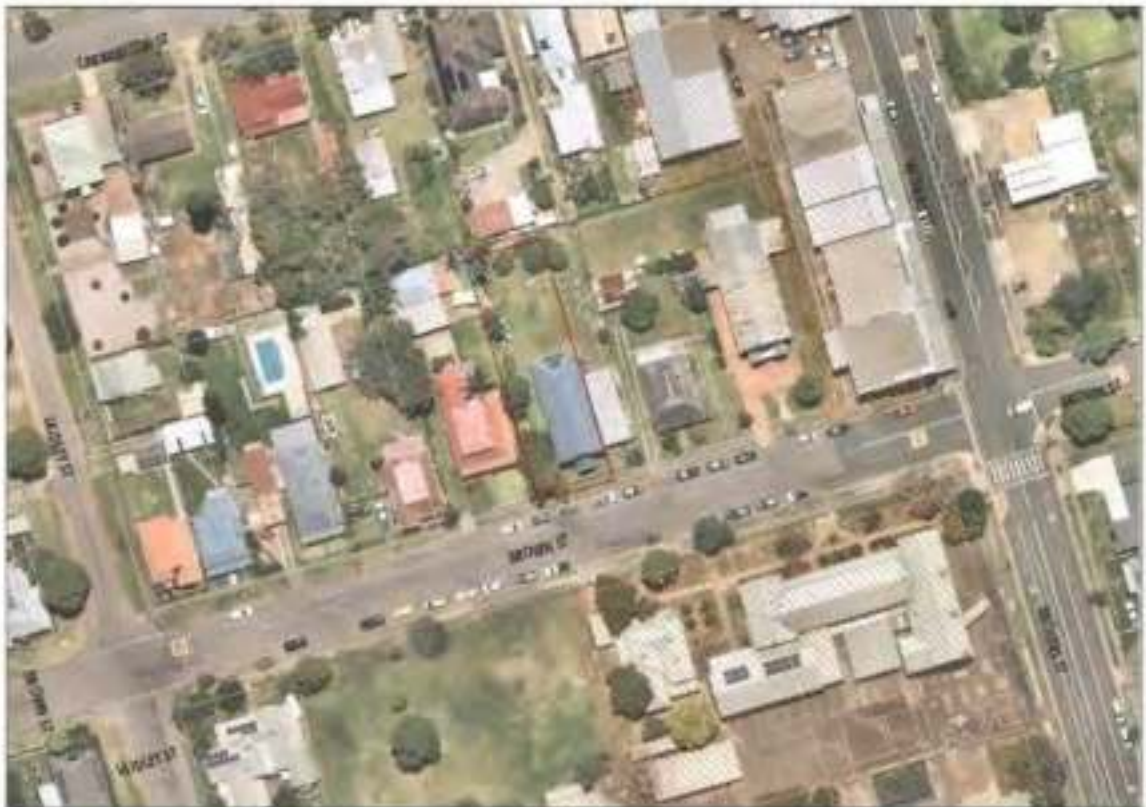
45 BROWN STREET, WEST WALLSEND 2286

Conservation Area Contribution Level	Est. Construction Date	Previous studies and/or community input
Contributory 1	1909	West Wallsend Heritage Study 1993 Moderate local significance
Assessment Text		Observed Modifications
<p>Federation Arts and Crafts building with red brick façade and triple Colourbond gable roof. The front two gables are false. The corners of the façade have decorative alternating brick colourations with a combination of red brick and white bricks.</p> <p>A rendered parapet sits atop the entrance, with 'Masonic Temple' visible.</p> <p>The windows are within arched brick alcoves, with multi-pane timber frames.</p> <p>The gables have extended eaves and minimal decorative detailing.</p> <p>The dwelling displays architectural features of a heritage style and is representative of the local development of this period, being of historical significance for the HCA.</p>		<p>An extension has been constructed on the eastern side of the building. Although similar, a differential material has visibly been used, with the style of construction also contrasting with the main building.</p>

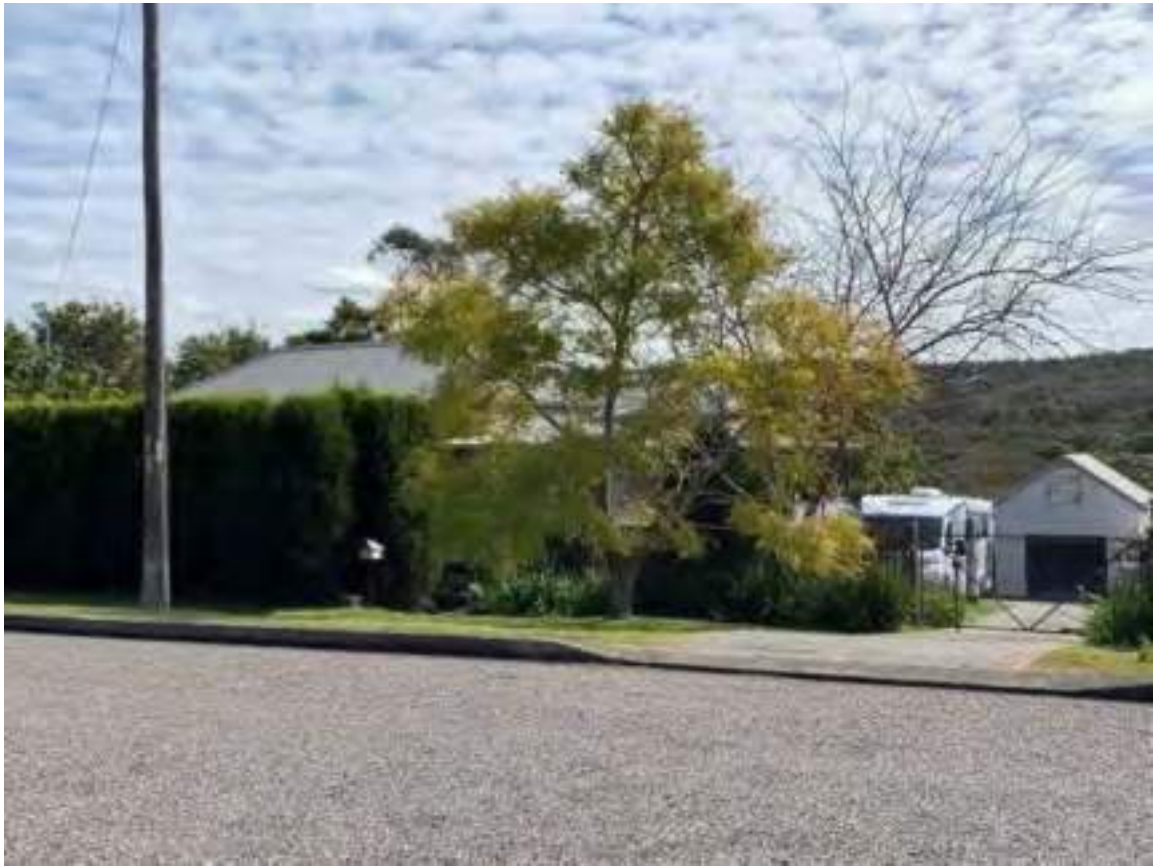
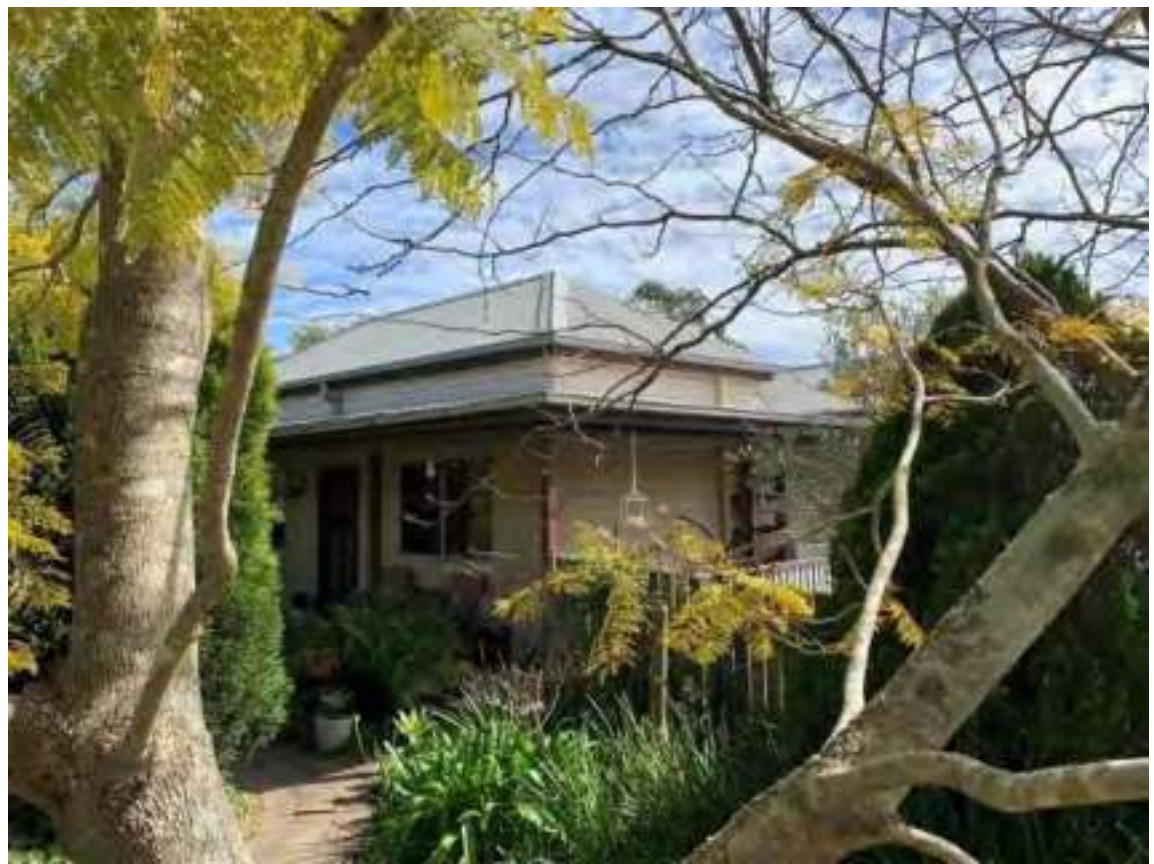
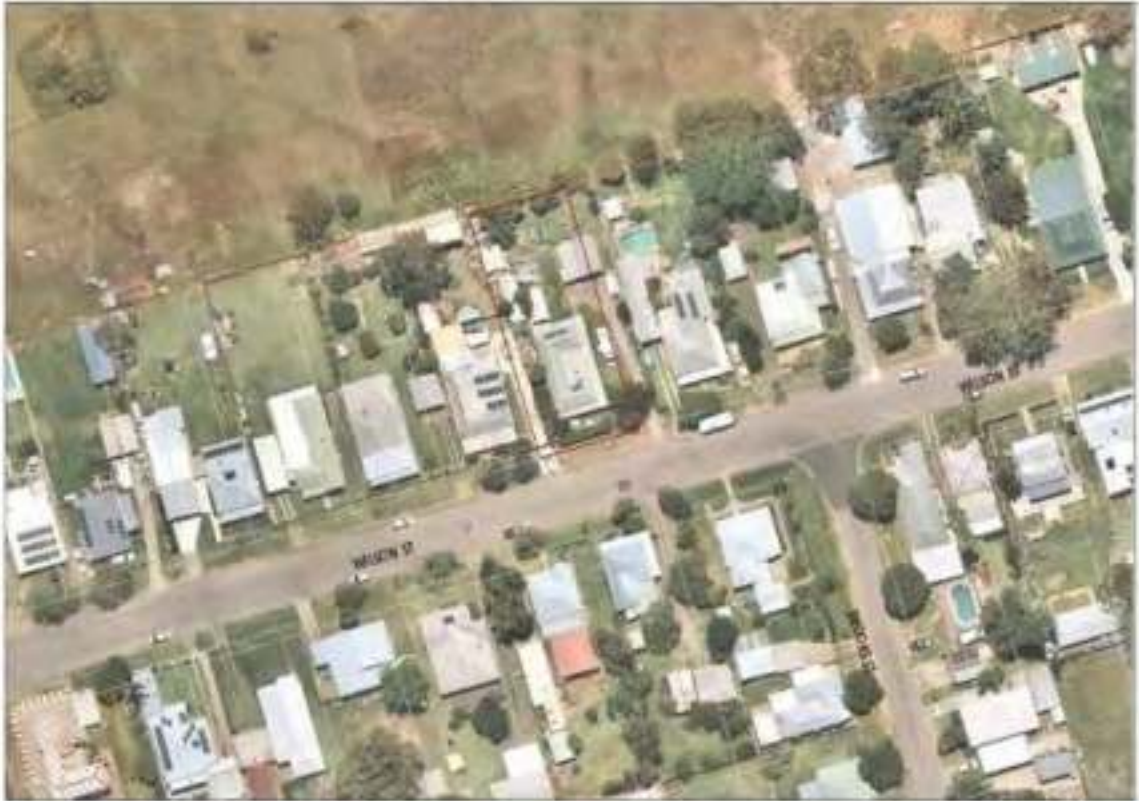
23 WILSON STREET, WEST WALLSEND 2286

Conservation Area Contribution Level	Est. Construction Date	Previous studies and/or community input
Contributory 1	1890–1915	No prior heritage investigations and no additional information required
Assessment Text		Observed Modifications
<p>Singles tory Vernacular ‘Mining Cottage’ style dwelling with Colourbond hipped roof and weatherboard cladding. The veranda roof is hipped.</p> <p>The veranda is partially enclosed by a simple timber balustrade.</p> <p>The dwelling is obscured by mature hedge growth.</p> <p>The dwelling displays architectural features of a heritage style and is representative of the local development of this period, being of historical significance for the HCA.</p>		<p>The veranda has been extended and wraps around the eastern side of the dwelling.</p> <p>A back extension has been constructed to the northern side of the dwelling. this has been undertaken in a sympathetic style and does not detract.</p> <p>All visible windows are contemporary mult pane heritage designs</p>

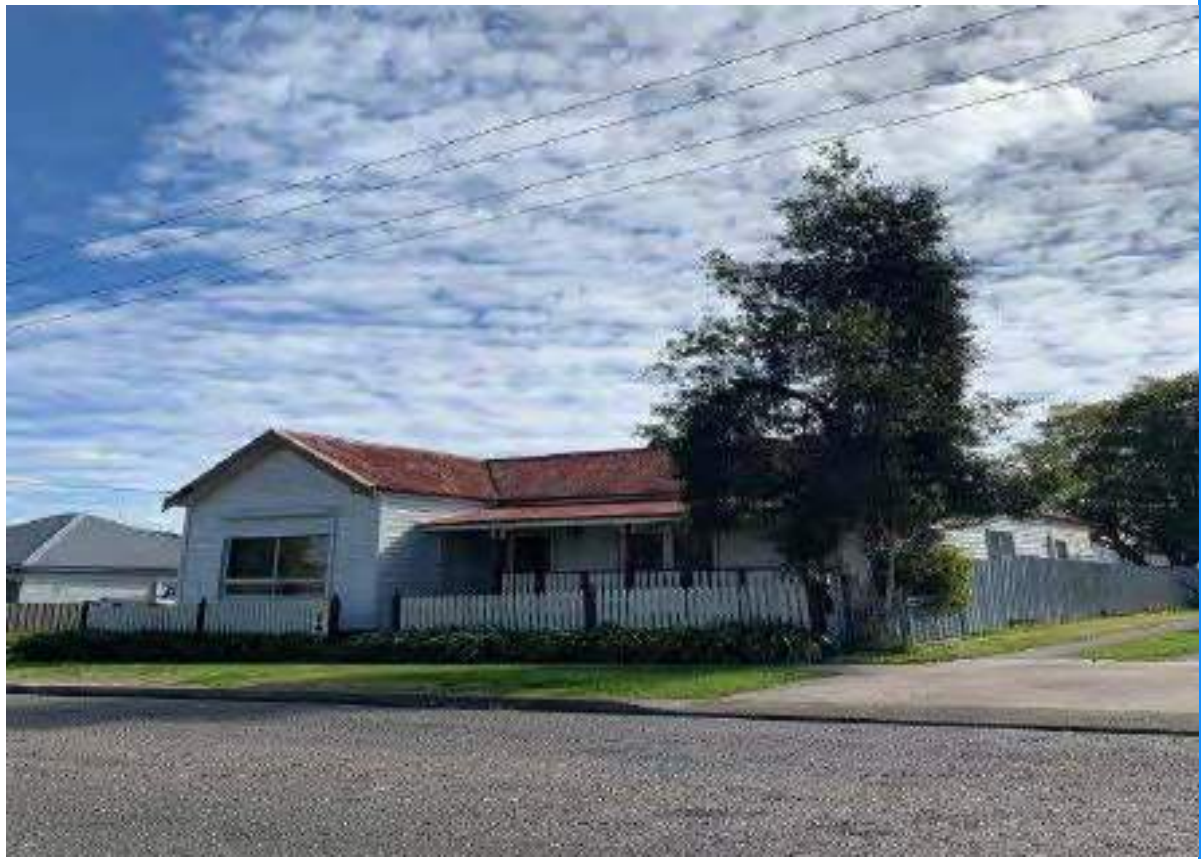
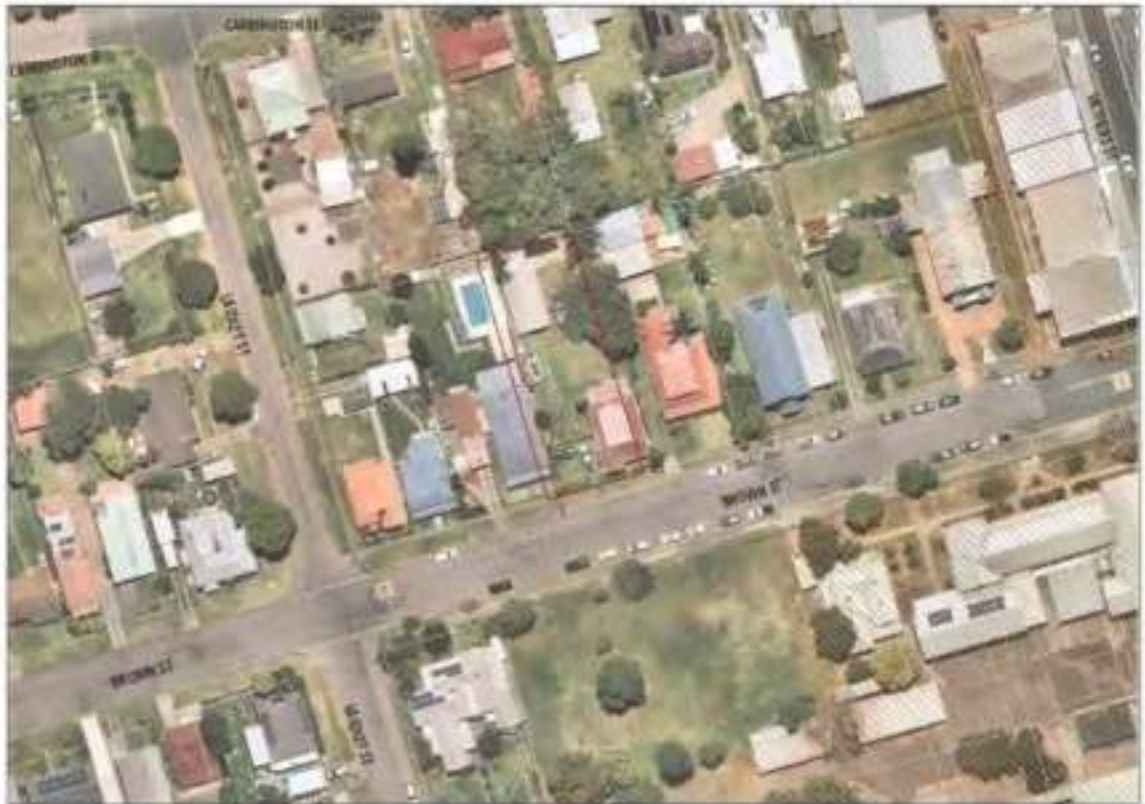
49 BROWN STREET, WEST WALLSEND 2286

Conservation Area Contribution Level	Est. Construction Date	Previous studies and/or community input
Contributory 1	1895–1915	No prior heritage investigations and no additional information required
Assessment Text		Observed Modifications
<p>Single story simple Federation ‘workmen's cottage’ style dwelling with Colourbond hipped roof with gable projection and weatherboard cladding. The veranda roof is hipped and supported by timber post with carved brackets.</p> <p>The veranda is partially enclosed by a simple timber balustrade.</p> <p>A partially rendered brickwork chimney is visible on the western side of the dwelling, with double corbel decoration.</p> <p>The gable has an extended eave.</p> <p>A timber picket fence encloses the property.</p> <p>The dwelling displays architectural features of a heritage style and is representative of the local development of this period, being of historical significance for the HCA.</p>		<p>An additional front door has been installed, being double doored and with a prominent metal security screen. The other front door similarly has security screening.</p> <p>All visible windows are contemporary sliding designs with metal shutters.</p> <p>The veranda balustrade is likely a contemporary replication of the original heritage design.</p>

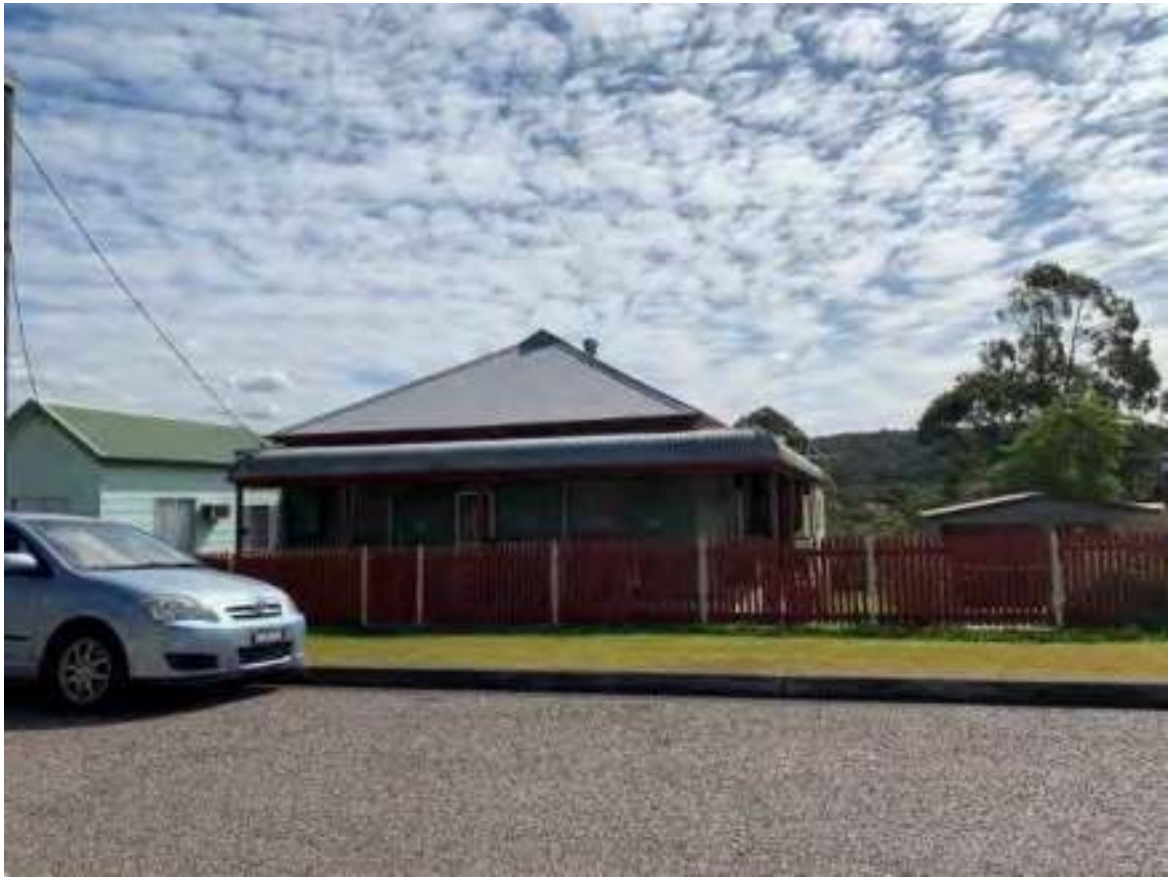
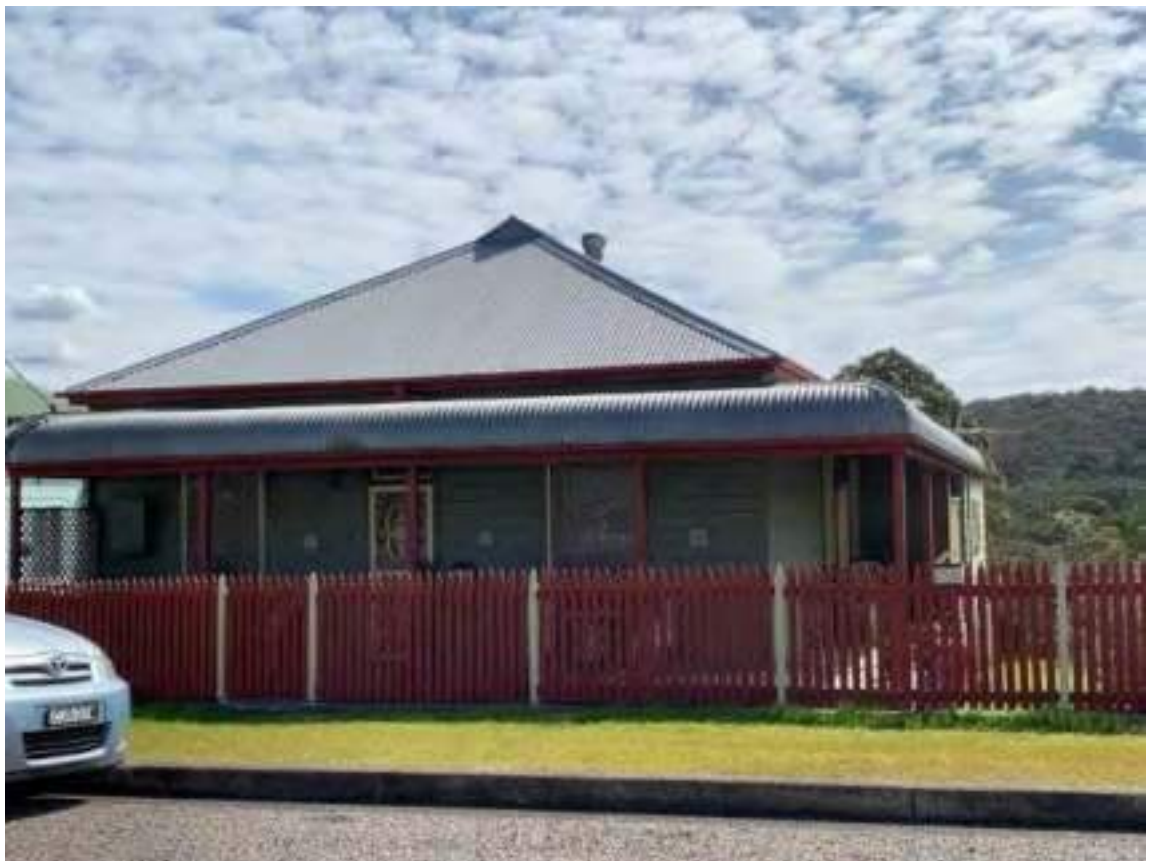
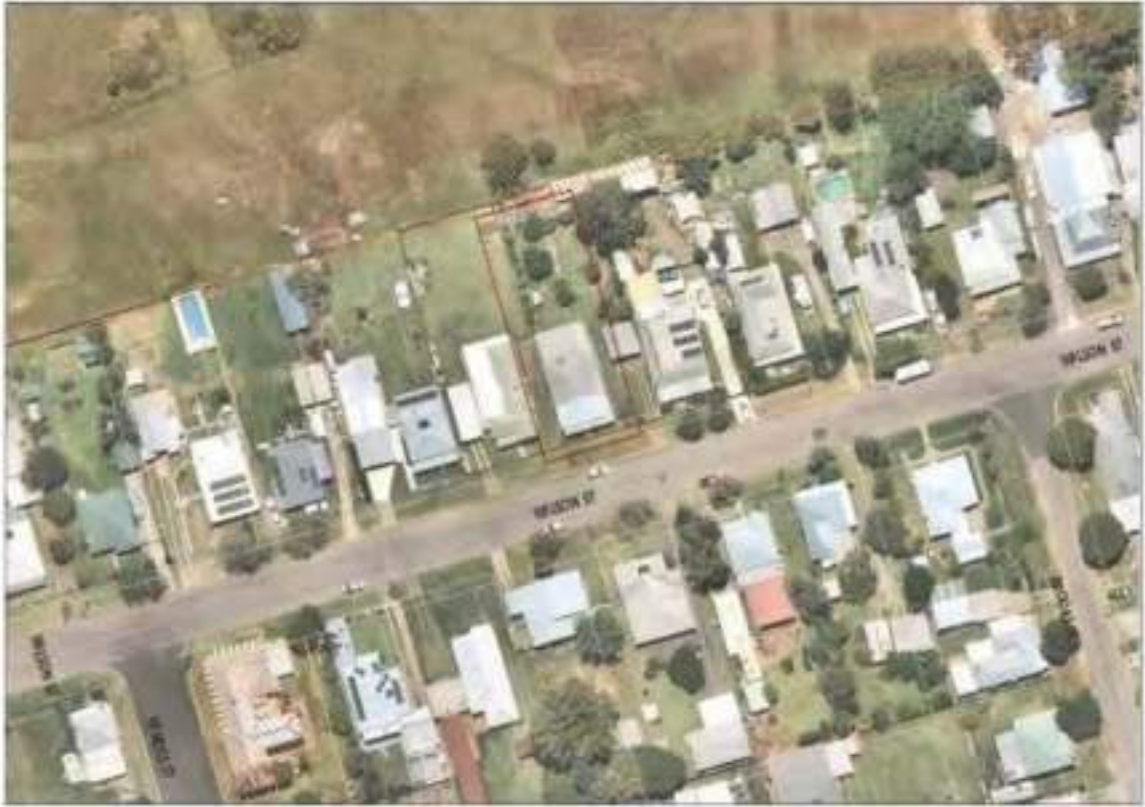
27 WILSON STREET, WEST WALLSEND 2286

Conservation Area Contribution Level	Est. Construction Date	Previous studies and/or community input
Contributory 1	1890–1915	No prior heritage investigations and no additional information required
Assessment Text		Observed Modifications
<p>Single story Vernacular ‘Mining Cottage’ style dwelling with Colourbond hipped roof and weatherboard cladding. The veranda roof is bull nosed.</p> <p>The veranda is partially enclosed by lattice boarding on the western and northern end.</p> <p>A double door garage is located to the east of the dwelling, in sympathetic colour scheme and style.</p> <p>A timber picket fence encloses the property</p> <p>The dwelling displays architectural features of a heritage style and is representative of the local development of this period, being of historical significance for the HCA.</p>		<p>The front door and adjacent windows have metal security screening, with the door being ornately designed.</p> <p>The veranda has been extended to wrap around the eastern side of the dwelling, this is likely an early modification. The northern end has been built in to form an additional living area.</p>

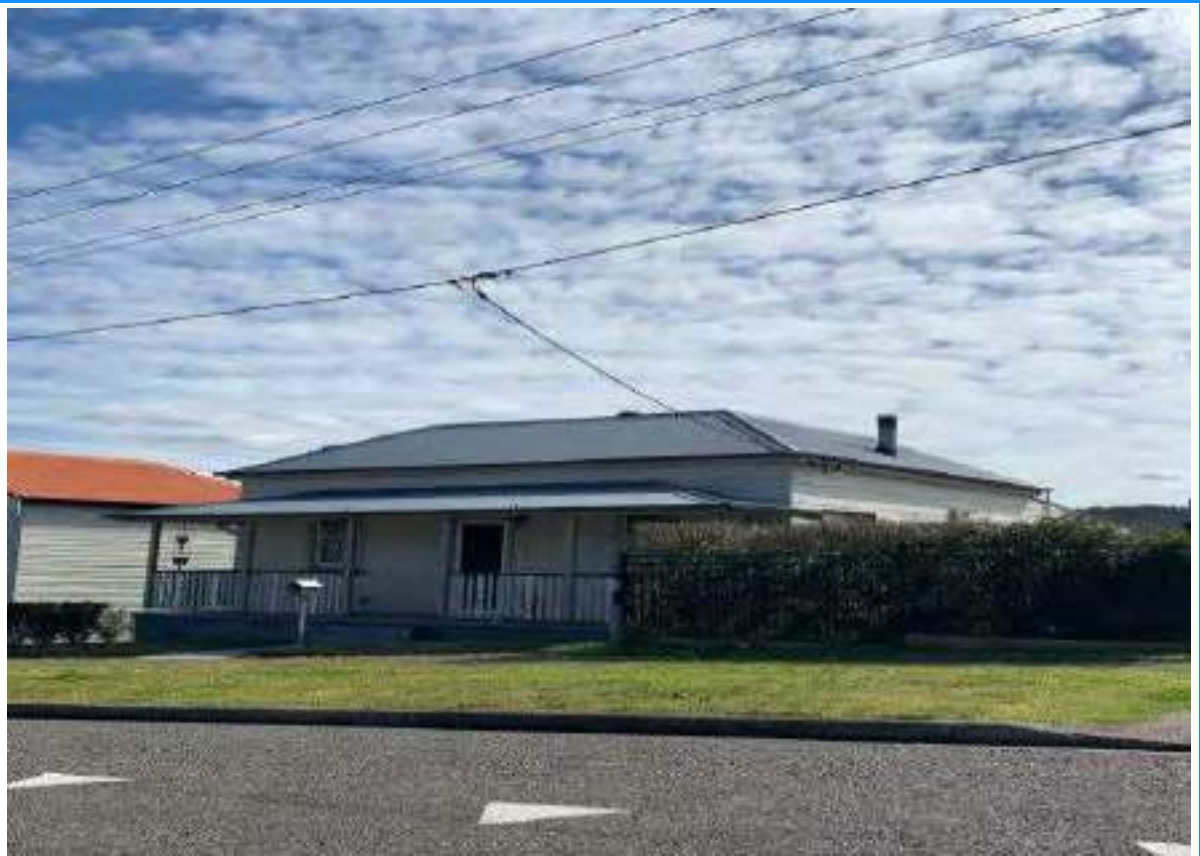
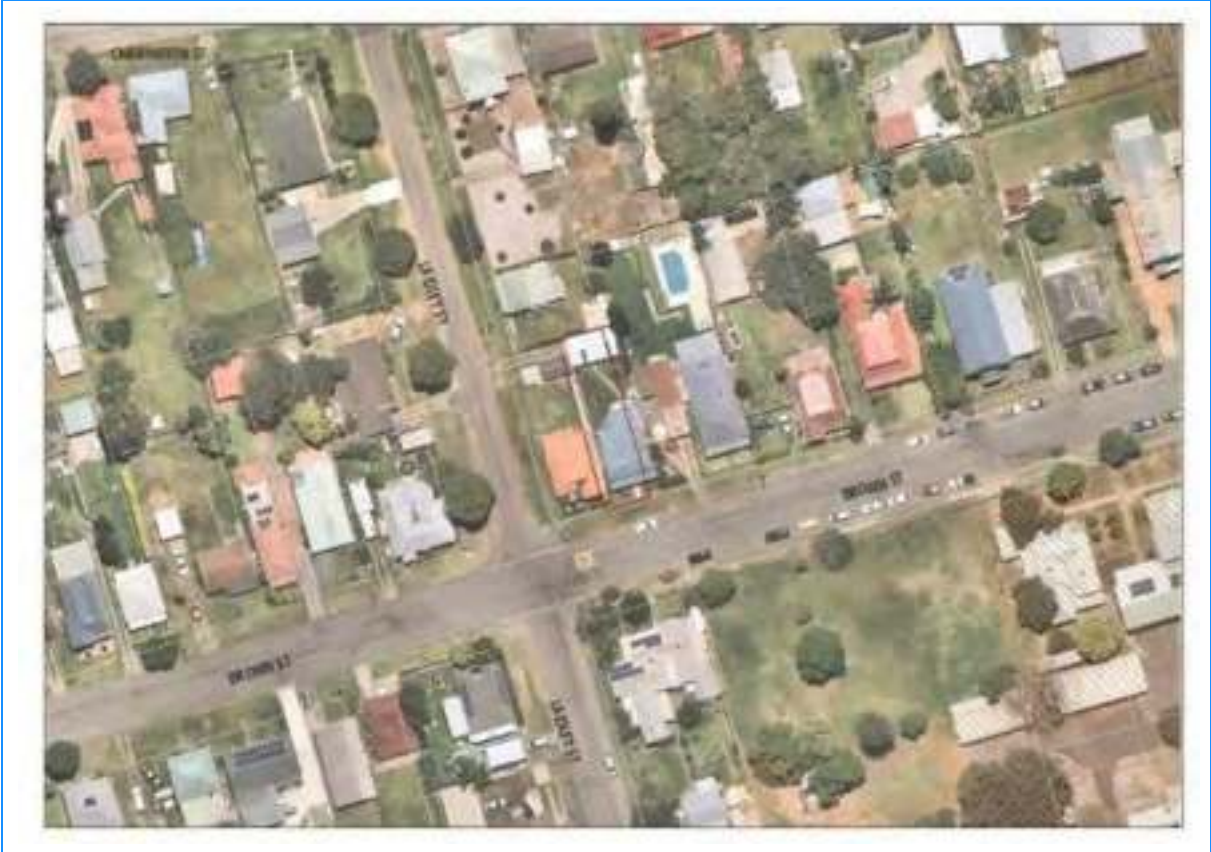
Conservation Area Contribution Level	Est. Construction Date	Previous studies and/or community input
Contributory 1	1890–1915	No prior heritage investigations and no additional information required
Assessment Text		Observed Modifications
<p>Single story Vernacular ‘Mining Cottage’ style dwelling with Colourbond hipped roof and weatherboard cladding. The veranda roof is hipped.</p> <p>The veranda is partially enclosed by a timber balustrade.</p> <p>The front door is timber framed with diamond paned leadlight sash windows with decorative sills on either side. the windows are likely original.</p> <p>The dwelling displays architectural features of a heritage style and is representative of the local development of this period, being of historical significance for the HCA.</p>		<p>The western and eastern windows are contemporary sliding designs.</p> <p>The veranda balustrade is likely a contemporary replication of the original heritage design.</p> <p>And extension has been constructed on the north eastern side of the dwelling, however is not visible from the street and does not detract.</p>

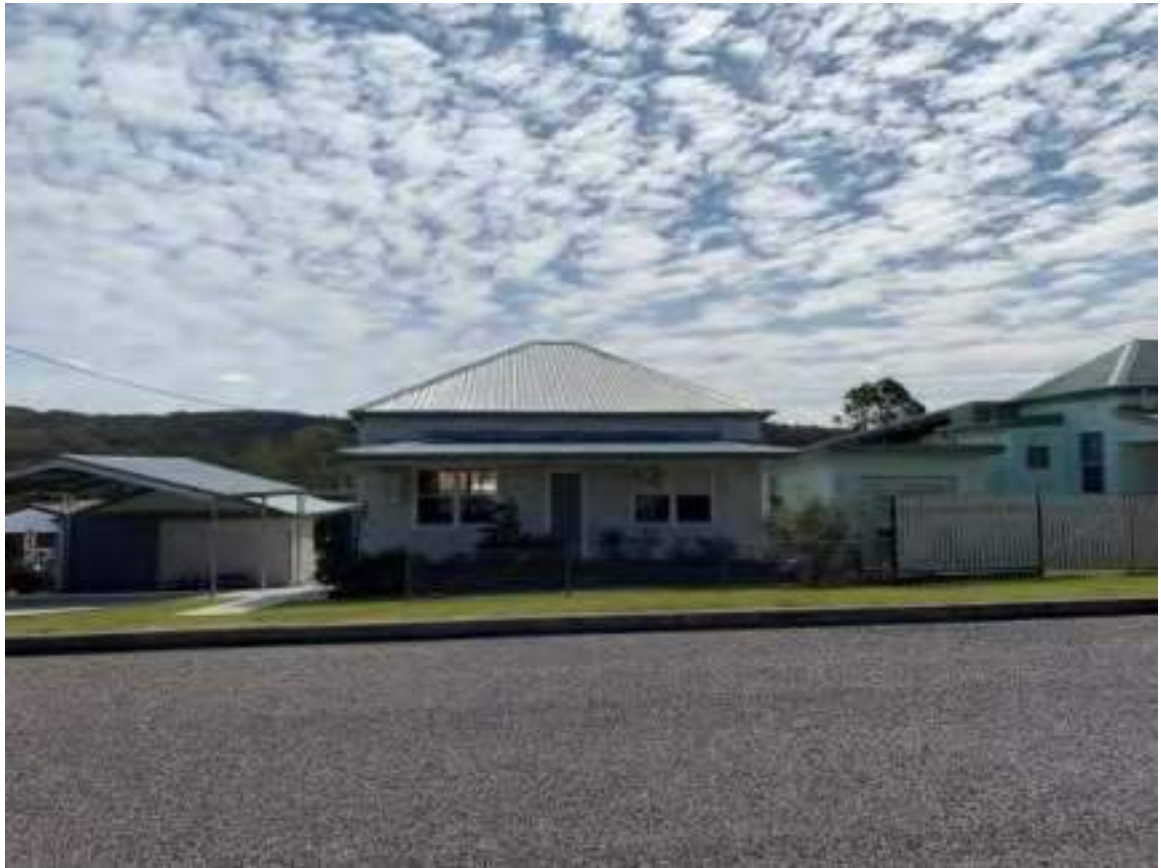
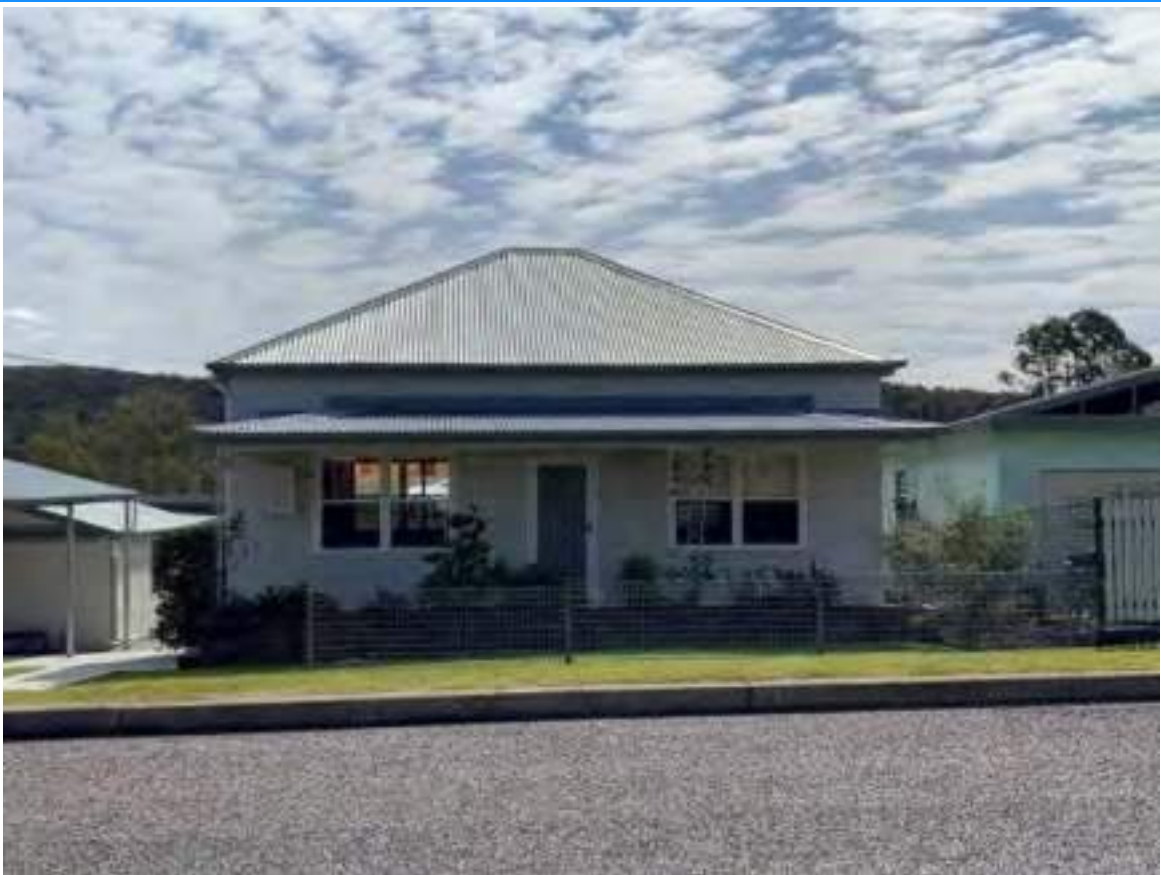
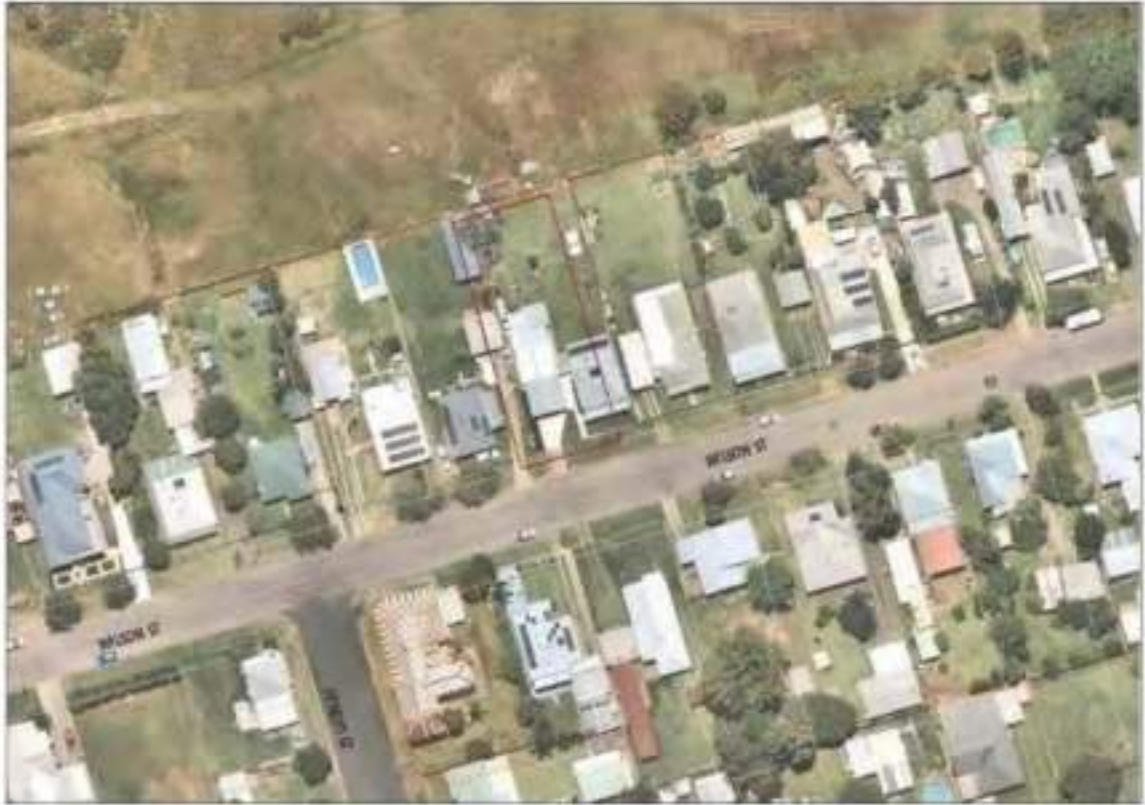
31 WILSON STREET, WEST WALLSEND 2286

Conservation Area Contribution Level	Est. Construction Date	Previous studies and/or community input
Contributory 1	1890–1915	No prior heritage investigations and no additional information required
Assessment Text		Observed Modifications
<p>Single story Vernacular ‘Mining Cottage’ style dwelling with hipped Colourbond roof and weatherboard cladding. The veranda roof is hipped and supported by metal pillars.</p> <p>All visible windows are double pane sash designs, with the western and eastern sides having timber window hoods with ornate bracketing. The windows are potentially original or early modifications.</p> <p>A carport and garage are located on the west of the dwelling.</p> <p>A metal wire fence encloses the property.</p> <p>The dwelling displays architectural features of a heritage style and is representative of the local development of this period, being of historical significance for the HCA.</p>		<p>The veranda roof was likely originally bull nosed and has been replaced with a hipped design. This is a very common modification and is found on the majority of houses in the area.</p> <p>The veranda support pillars are ornate metal designs.</p>

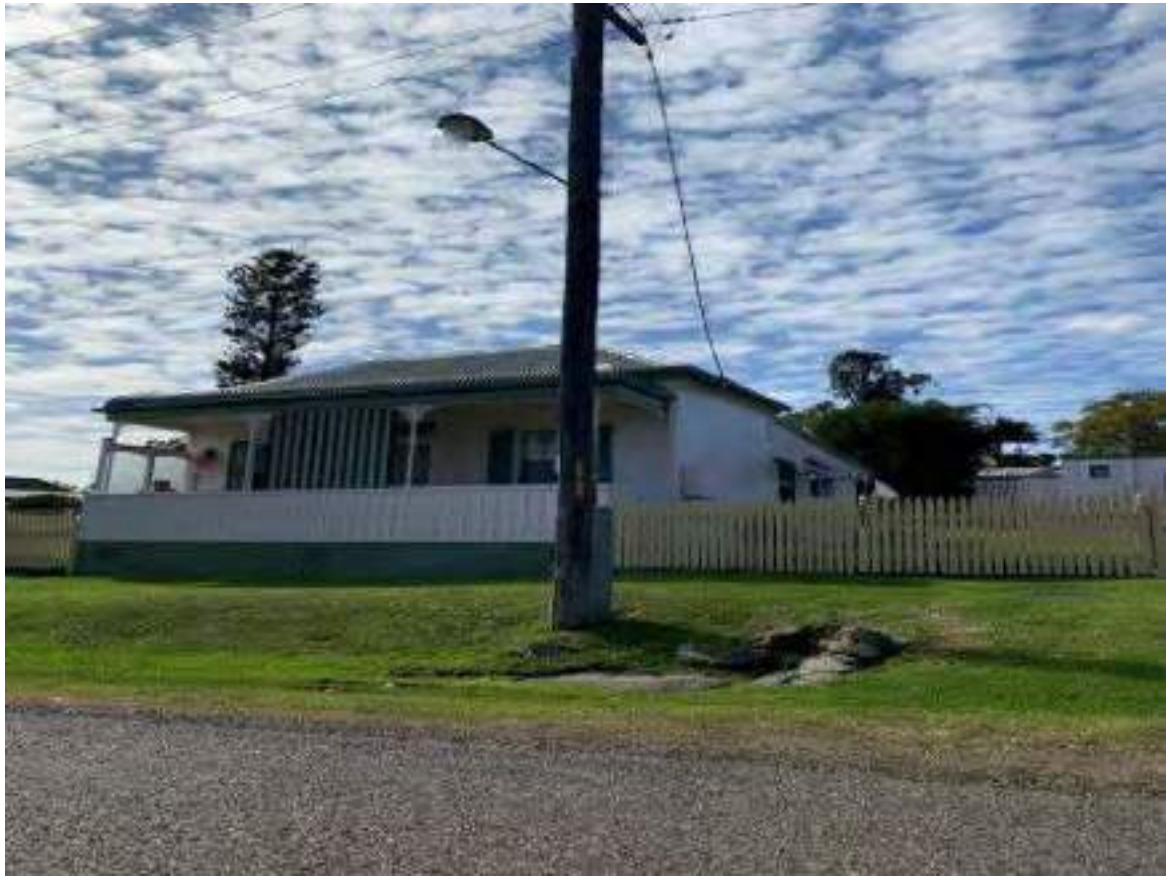
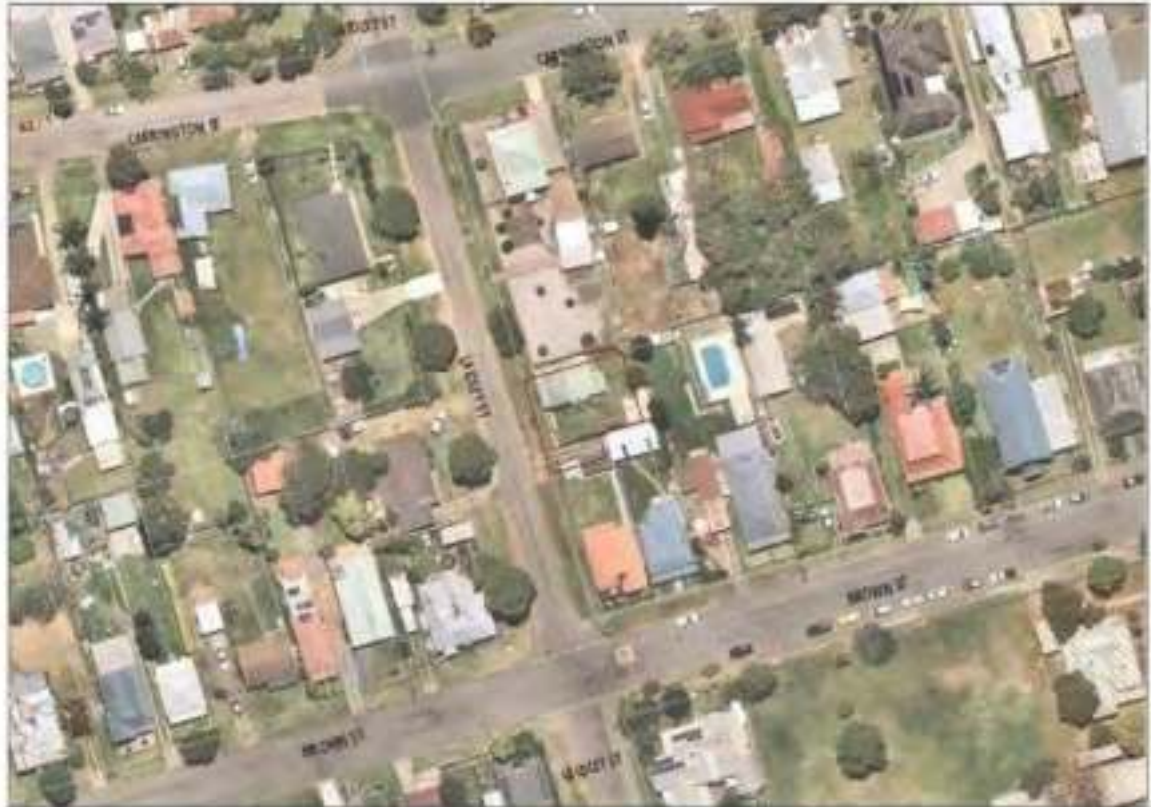
21 LAIDLEY STREET, WEST WALLSEND 2286

Conservation Area Contribution Level	Est. Construction Date	Previous studies and/or community input
Contributory 1	1890–1915	No prior heritage investigations and no additional information required
Assessment Text		Observed Modifications
<p>Single story Vernacular ‘Mining Cottage’ style dwelling with hipped Colourbond roof and weatherboard cladding. The veranda roof is bull nosed and framed by a decorative cast iron lace valance.</p> <p>The veranda has been enclosed by a fibro-clad timber framed veranda wall and frosted glass panel. A striped canvas blind is also visible.</p> <p>The western façade windows are sash with timber shutters. The northern and southern windows have metal window hoods.</p> <p>A garage is located to the east of the dwelling.</p> <p>A timber picket fence encloses the property.</p> <p>The dwelling displays architectural features of a heritage style and is representative of the local development of this period, being of historical significance for the HCA.</p>		<p>The veranda wall is a contemporary modification, as is the glass panel and canvas blind. This is sympathetic to the heritage style.</p> <p>The shutters of the façade windows are likely an addition, as this is not a common feature of this housing style.</p>

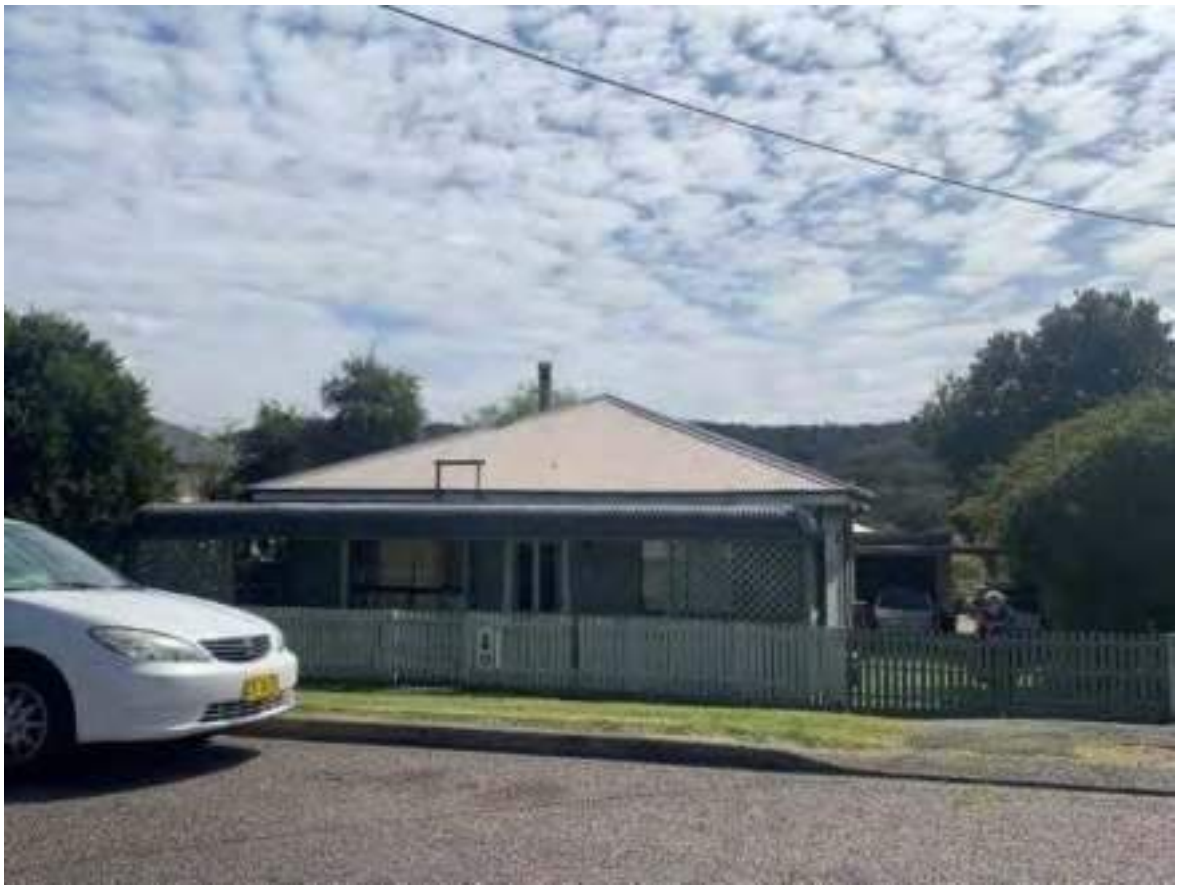
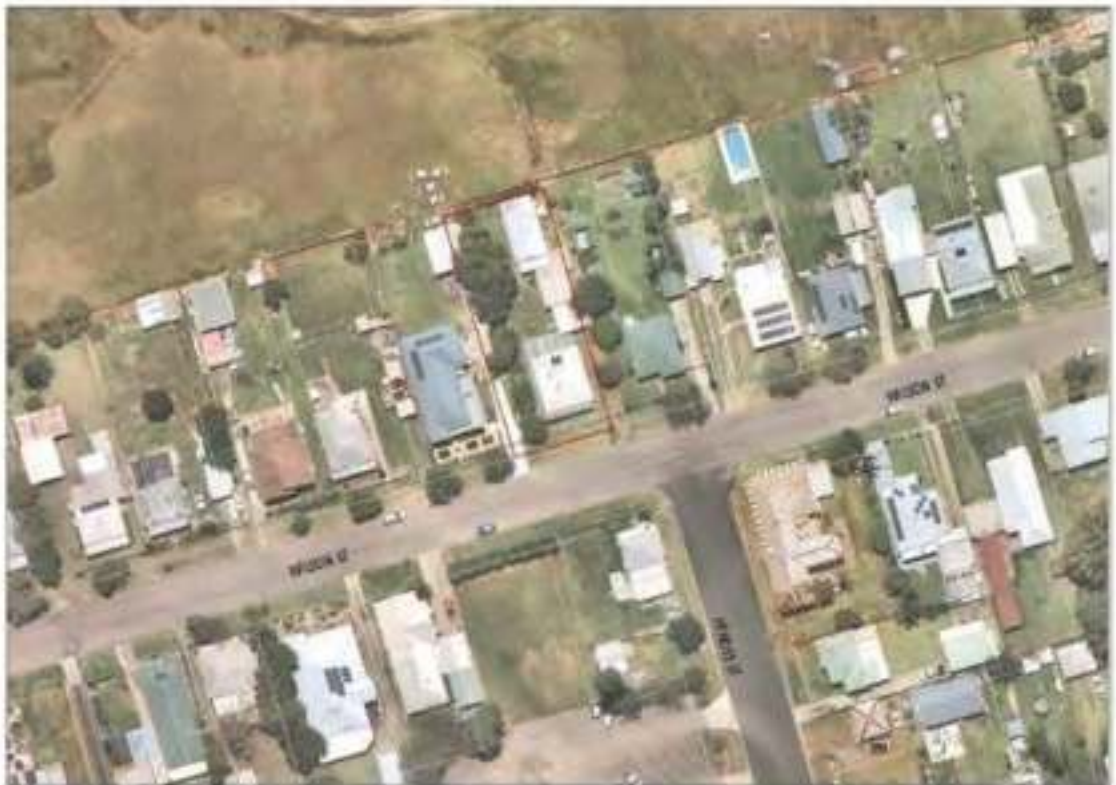
39 WILSON STREET, WEST WALLSEND 2286

Conservation Area Contribution Level	Est. Construction Date	Previous studies and/or community input
Contributory 1	1890–1915	No prior heritage investigations and no additional information required
Assessment Text		Observed Modifications
<p>Single story Vernacular ‘Mining Cottage’ style dwelling with hipped Colourbond roof and weatherboard cladding. The veranda roof is bull nosed.</p> <p>The veranda is partially enclosed by a timber balustrade and lattice panelling.</p> <p>The front door is timber framed.</p> <p>Timber balustrade connects the veranda to the front gate, providing support railing.</p> <p>Tiber picket fencing encloses the property</p> <p>A car port and garage is located to the north of the dwelling.</p> <p>The dwelling displays architectural features of a heritage style and is representative of the local development of this period, being of historical significance for the HCA.</p>		<p>The visible windows are contemporary multil panel or sliding designs.</p> <p>An additional structure is located to the north of the dwelling, however this is obscured and does not detract.</p> <p>The lattice and balustrade of the veranda are contemporary additions.</p>
