APPENDIX 2

Building Assessment Sheets (Inventory Sheets)

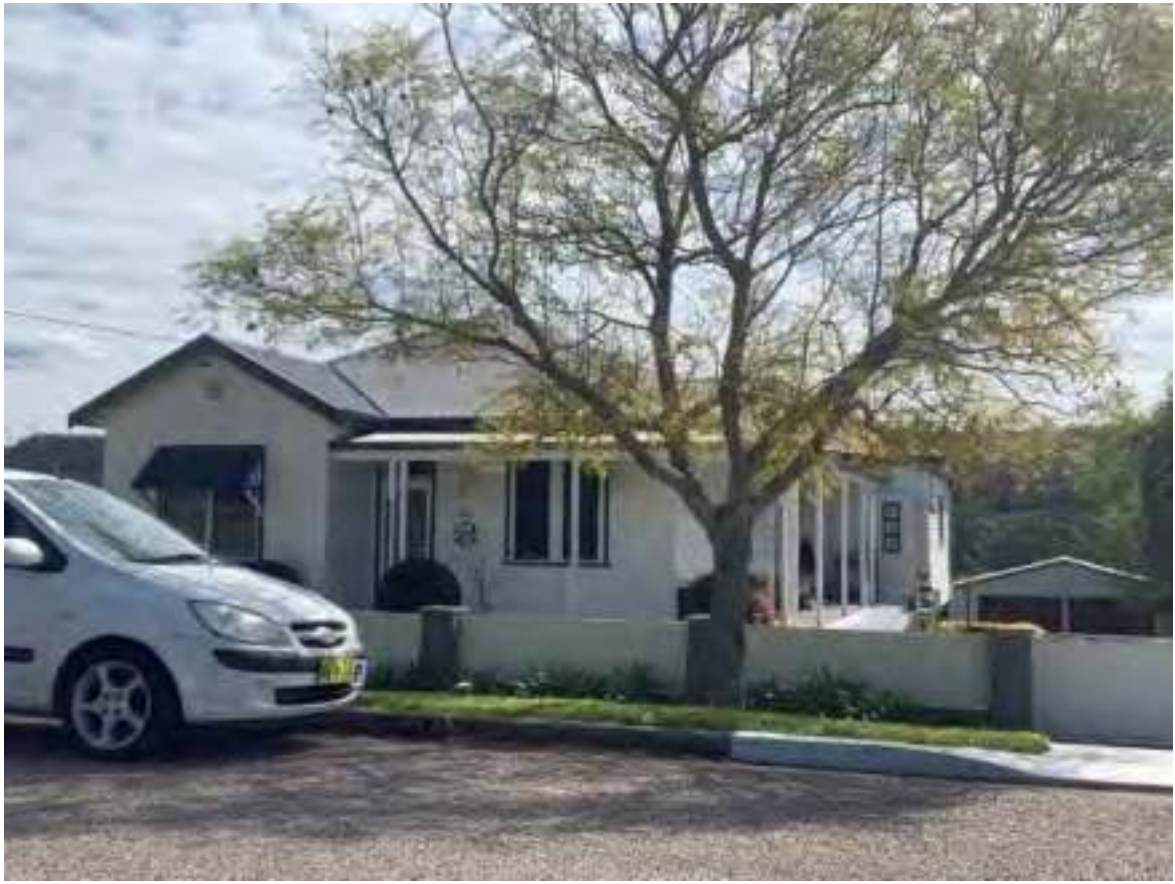
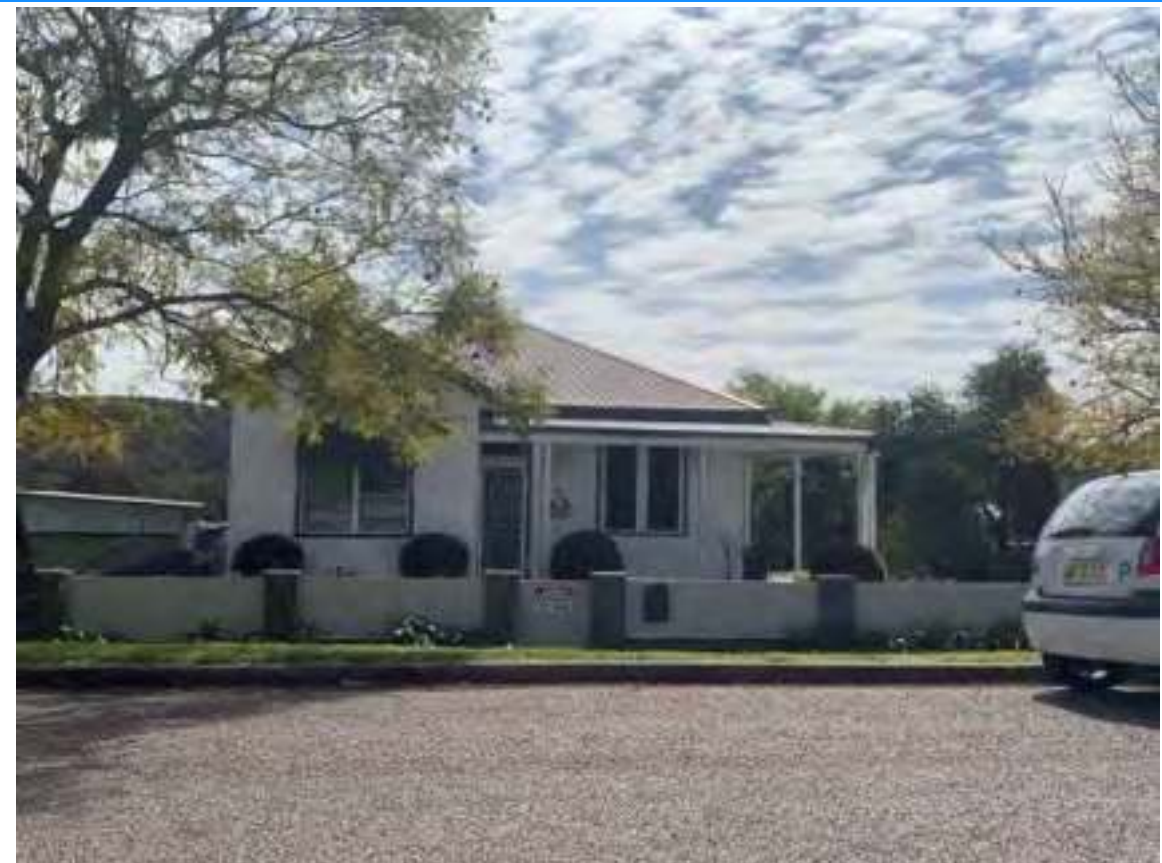
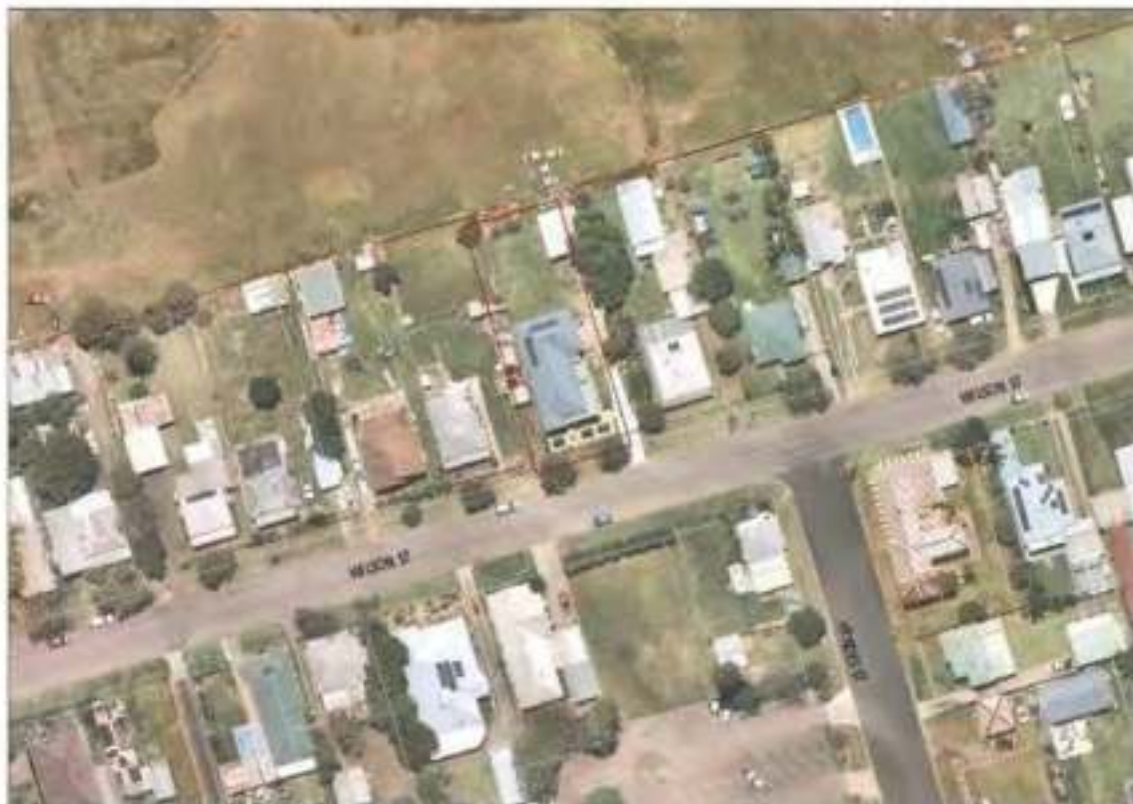
41 WILSON STREET, WEST WALLSEND 2286

Conservation Area Contribution Level	Est. Construction Date	Previous studies and/or community input
Contributory 1	1895–1915	No prior heritage investigations and no additional information required
Assessment Text		Observed Modifications
<p>Single story simple Federation ‘workmen’s cottage’ style dwelling with hipped Colourbond roof with gable projection, and weatherboard cladding. The veranda roof is hipped.</p> <p>The veranda is partially enclosed by wrought iron ornate metal balustrade. The veranda floor is timber boarding.</p> <p>The front door is timber framed with decorative metal screen and fanlight. The adjacent windows are double sash.</p> <p>The gable has extended eaves, with a shingle timber awnings and carved brackets.</p> <p>A double garage is located to the north of the dwelling.</p> <p>A brick pillar and timber board fence encloses the property.</p> <p>The dwelling displays architectural features of a heritage style and is representative of the local development of this period, being of historical significance for the HCA.</p>		<p>The veranda extends to the eastern side of the dwelling. This is a common modification noted in various other comparative houses of the area.</p> <p>The metal balustrade is a contemporary addition, however the style does not detract from the dwellings heritage design.</p> <p>An extension has been constructed at the back northern side of the dwelling. This is partially visible from the street but does not detract.</p> <p>A concrete ramp with metal and timber balustrade is visible on the eastern side of the dwelling.</p> <p>Potentially a historically based reconstruction.</p>

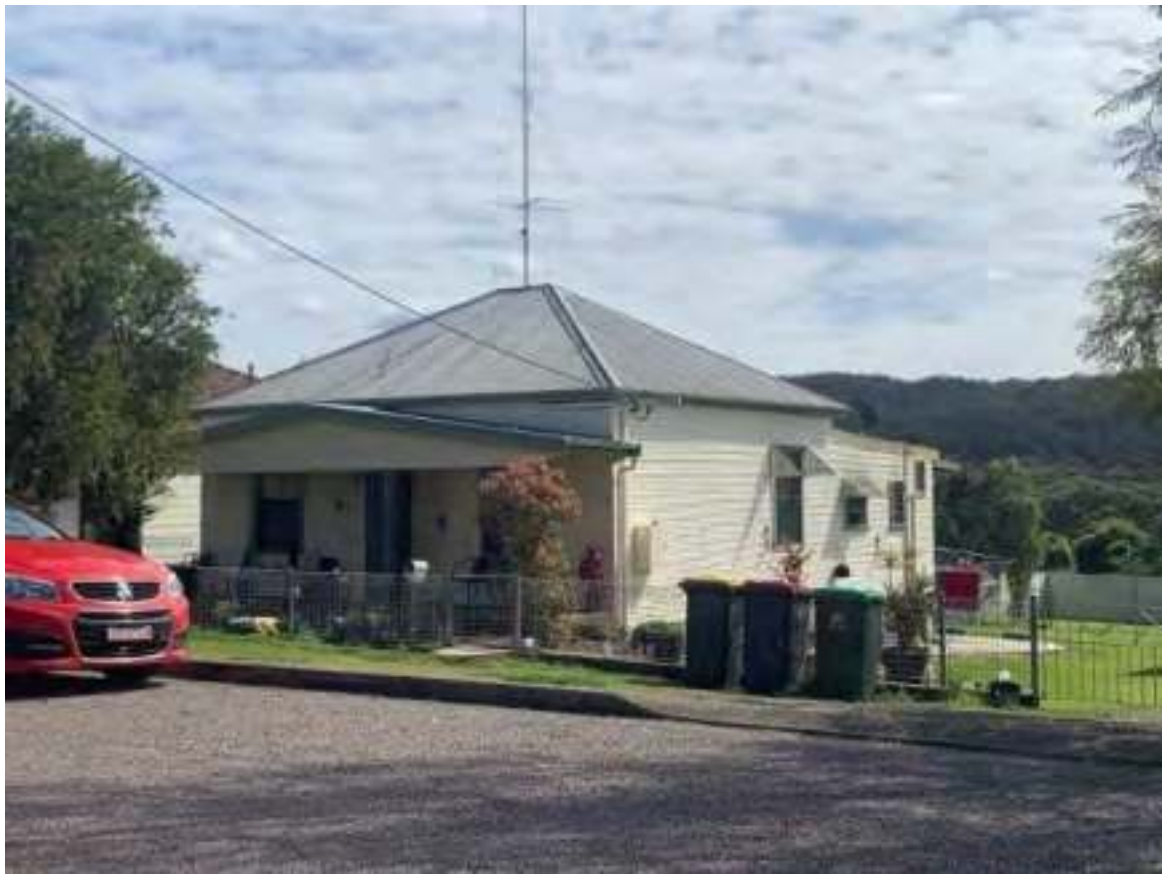
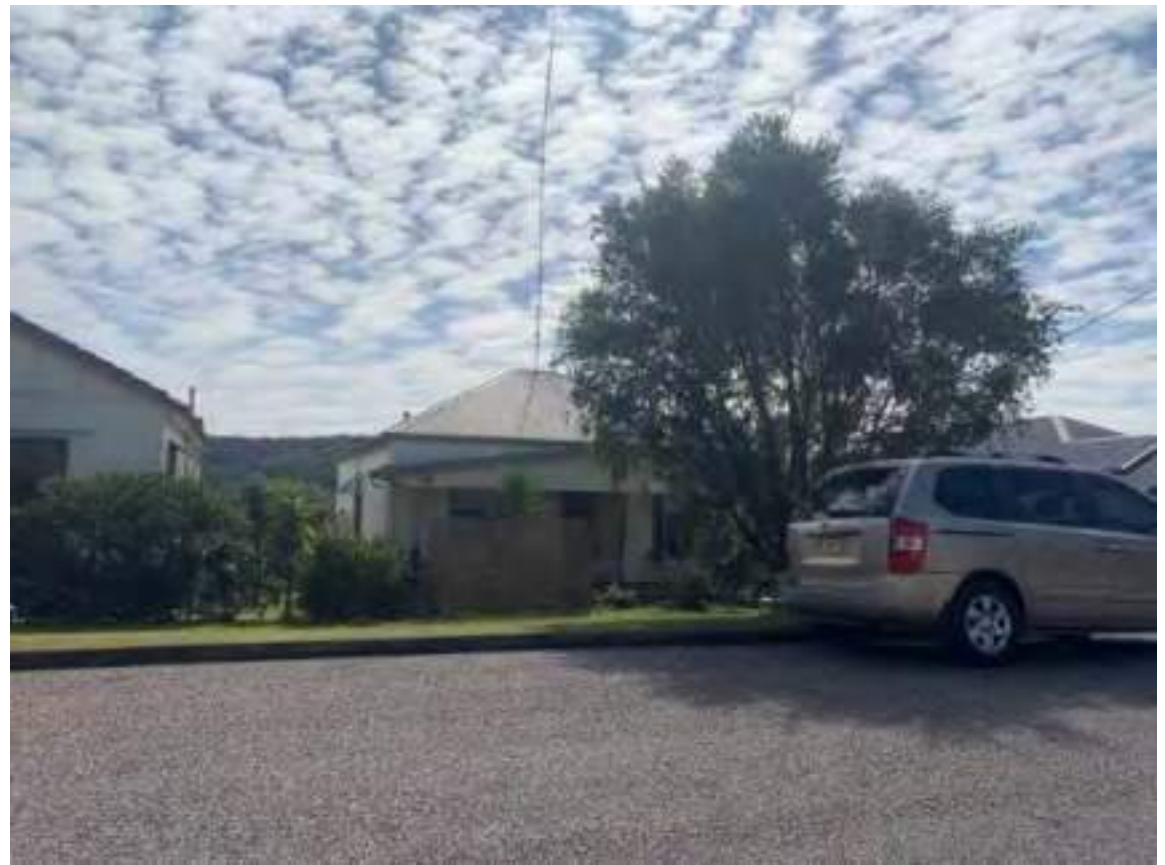
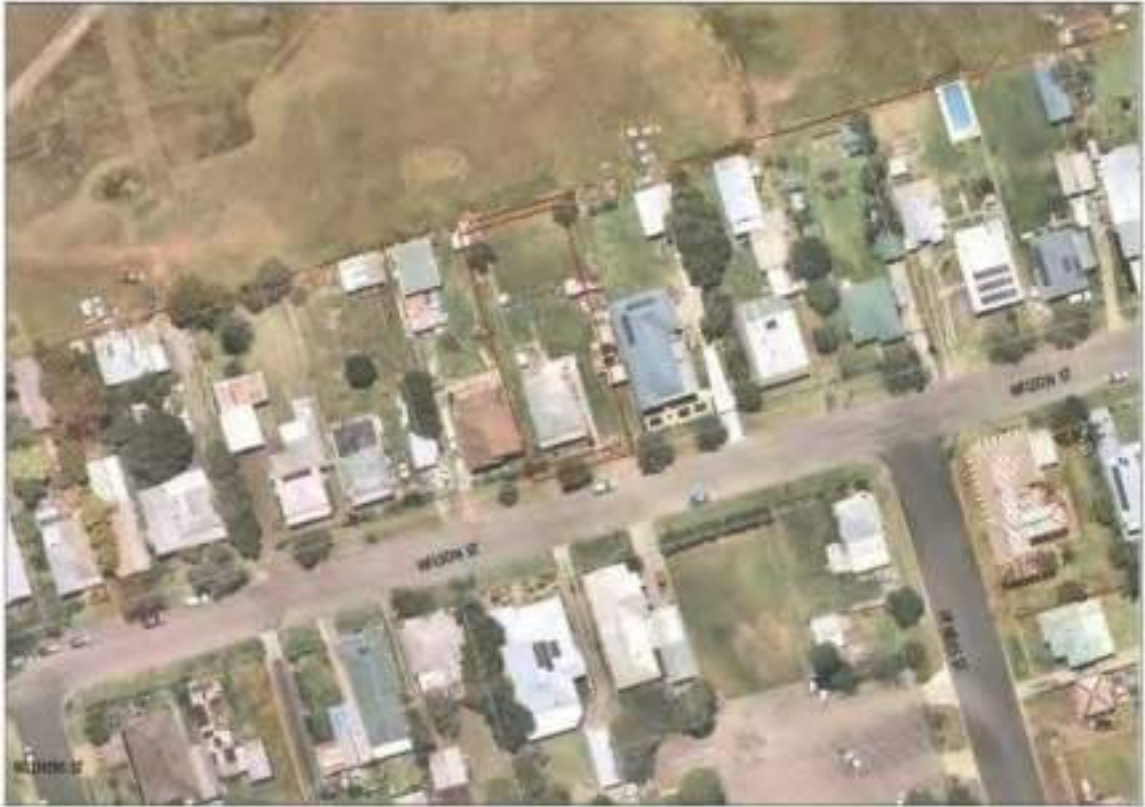
43 WILSON STREET, WEST WALLSEND 2286

Conservation Area Contribution Level	Est. Construction Date	Previous studies and/or community input
Contributory 1	1890–1915	No prior heritage investigations and no additional information required
Assessment Text		Observed Modifications
<p>Single story Vernacular ‘Mining Cottage’ style dwelling with hipped Colourbond roof and weatherboard cladding. The veranda roof is gabled.</p> <p>The visible windows are original heavy timber framed sash designs, with the easter and western windows having timber hoods.</p> <p>A metal wire fence encloses the property.</p> <p>A garage structure is located to the east of the dwelling.</p> <p>The dwelling displays architectural features of a heritage style and is representative of the local development of this period, being of historical significance for the HCA.</p>		<p>The veranda roof is gabled and a very uncommon modification for the housing style. This is unsympathetic to the heritage streetscape.</p> <p>The metal support poles are a contemporary modification, likely replacing the original timber posts.</p>

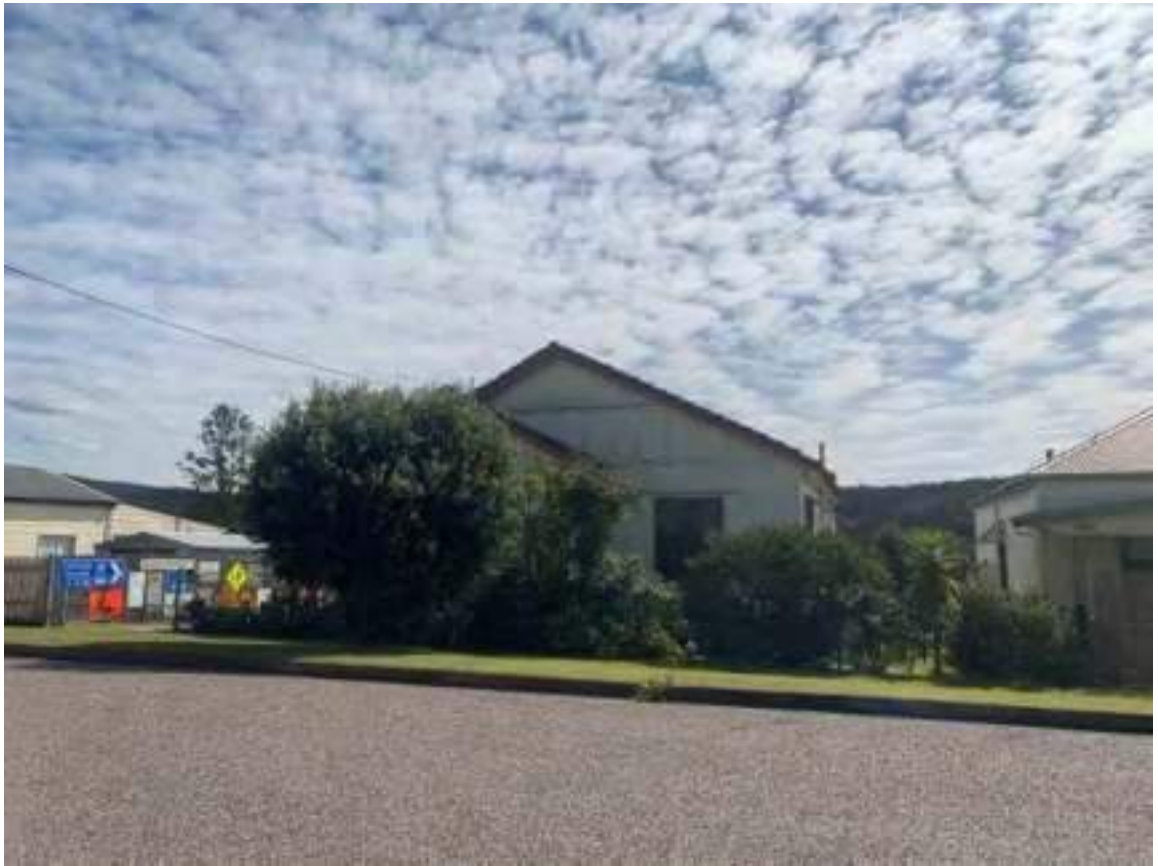
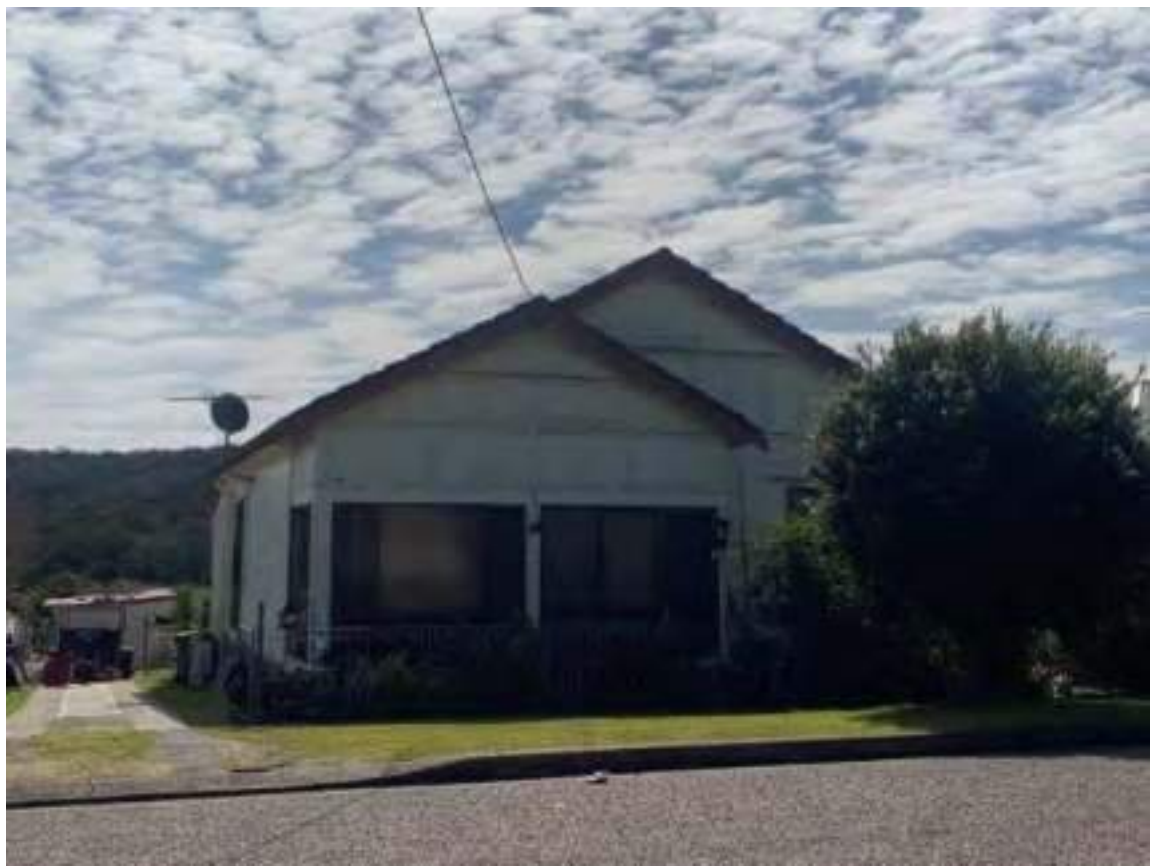
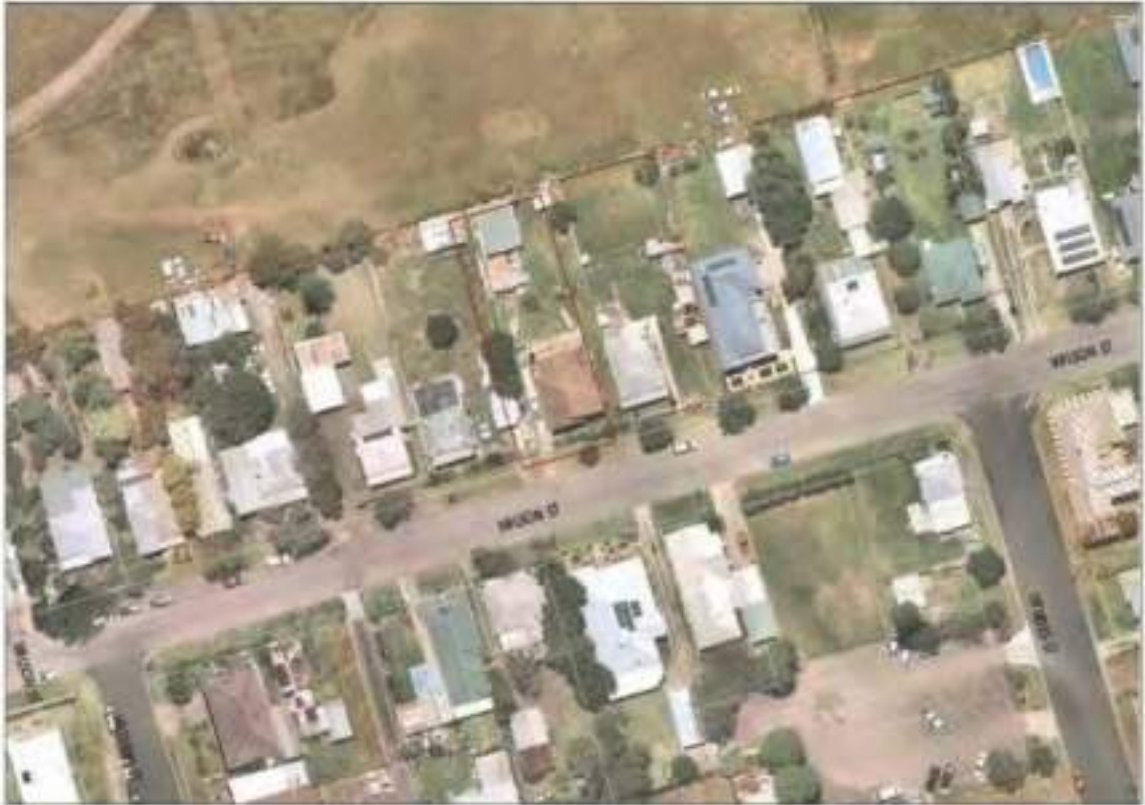
45 WILSON STREET, WEST WALLSEND 2286

Conservation Area Contribution Level	Est. Construction Date	Previous studies and/or community input
Contributory 1	1920–1930	No prior heritage investigations and no additional information required
Assessment Text		Observed Modifications
<p>Single story Federation Bungalow style dwelling with double terracotta tiled gable roof and weatherboard cladding. The gables have extended eaves and battening detailing. A metal wire fence encloses the dwelling. The dwelling displays architectural features of a heritage style and is representative of the local development of this period, being of historical significance for the HCA.</p>		<p>The veranda space has been fully enclosed, with the façade dominated by large multi pane contemporary windows with metal frames. All visible windows are of a similar style. This variation detracts from the heritage style of the dwelling.</p> <p>The front door has been relocated to the enclosed veranda and consists of a metal screen door.</p>

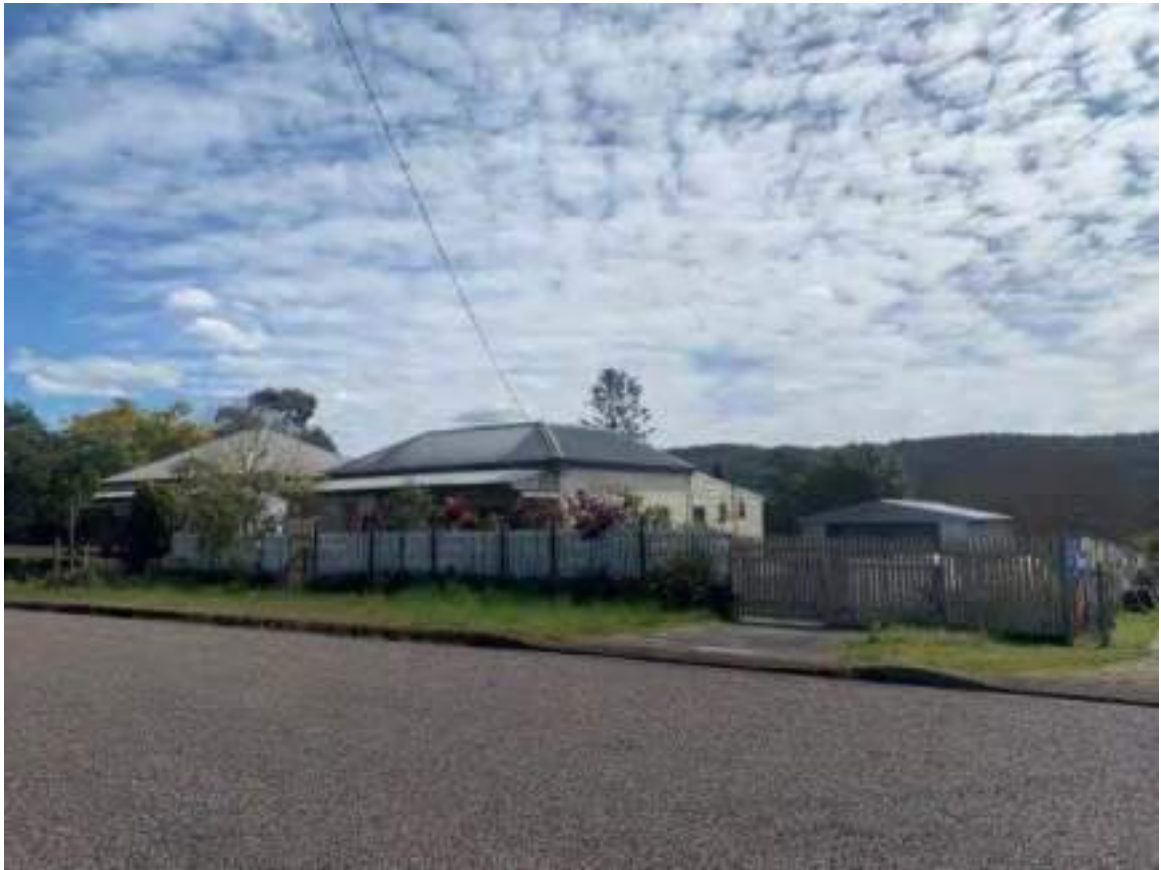
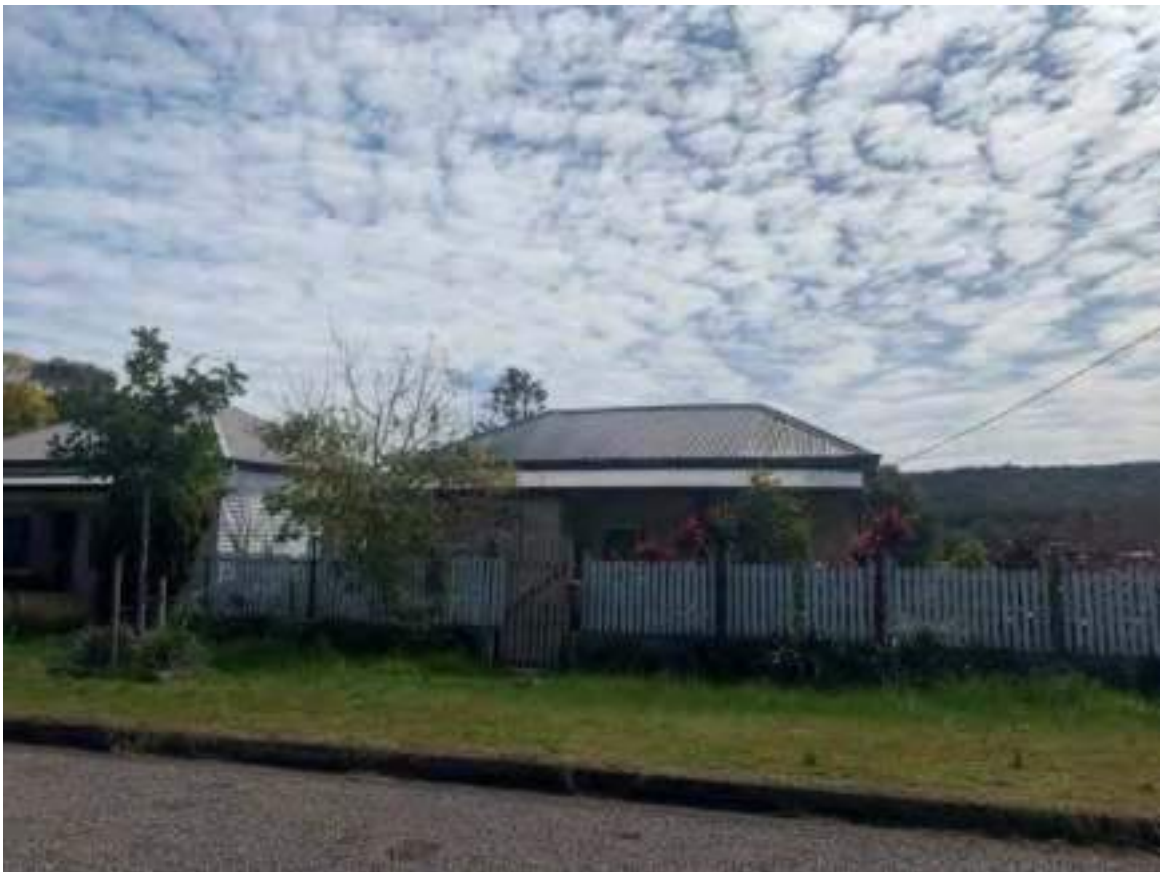
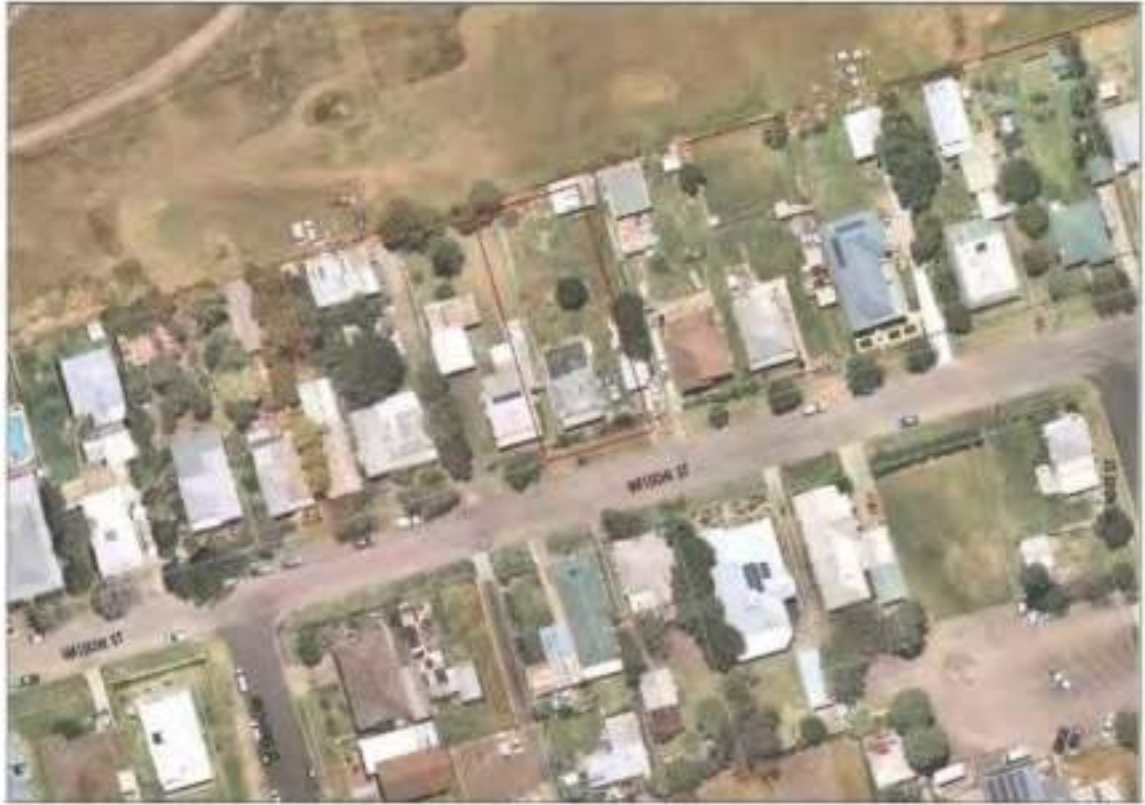
47 WILSON STREET, WEST WALLSEND 2286

Conservation Area Contribution Level	Est. Construction Date	Previous studies and/or community input
Contributory 1	1890–1915	No prior heritage investigations and no additional information required
Assessment Text		Observed Modifications
Single story Vernacular ‘Mining Cottage’ style dwelling with hipped Colourbond roof and weatherboard cladding. The veranda roof is skillion and supported by timber posts.		The dwelling was heavily obscured by vegetation growth. No modifications observed.

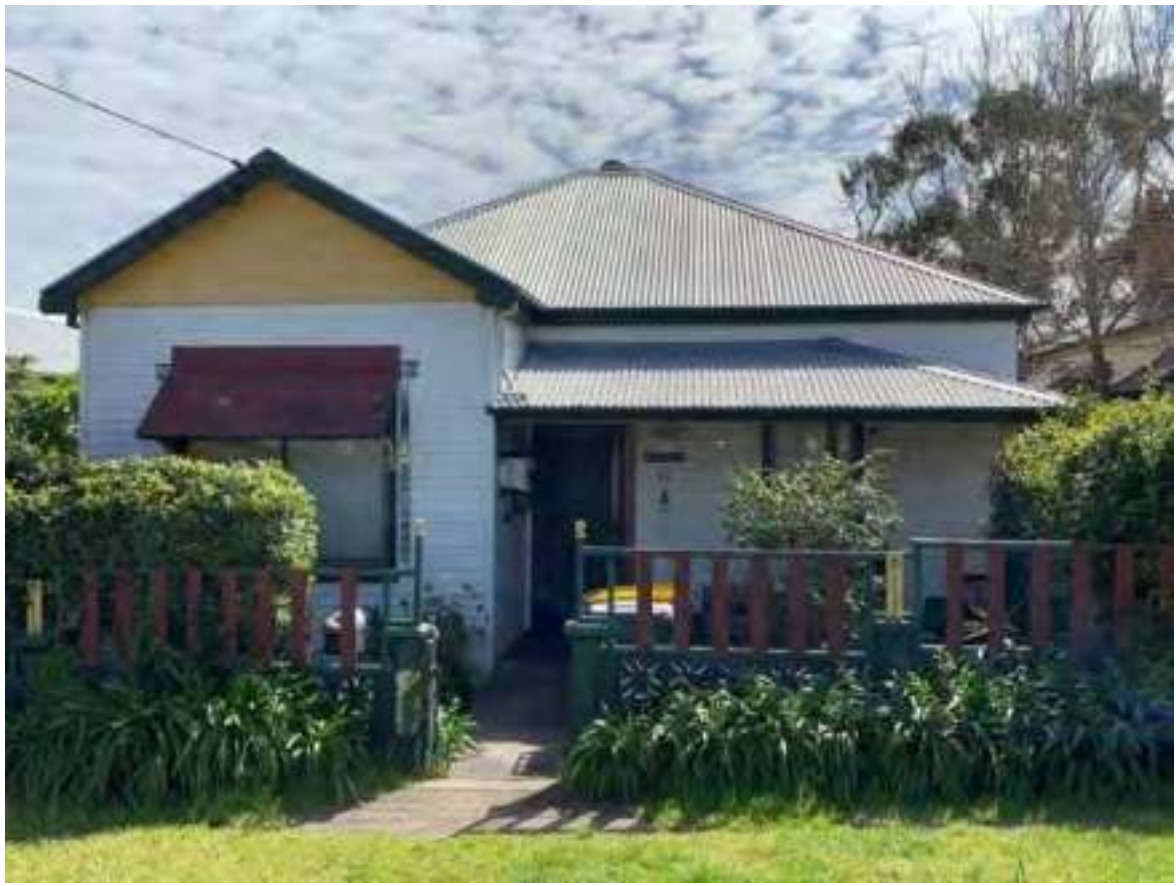
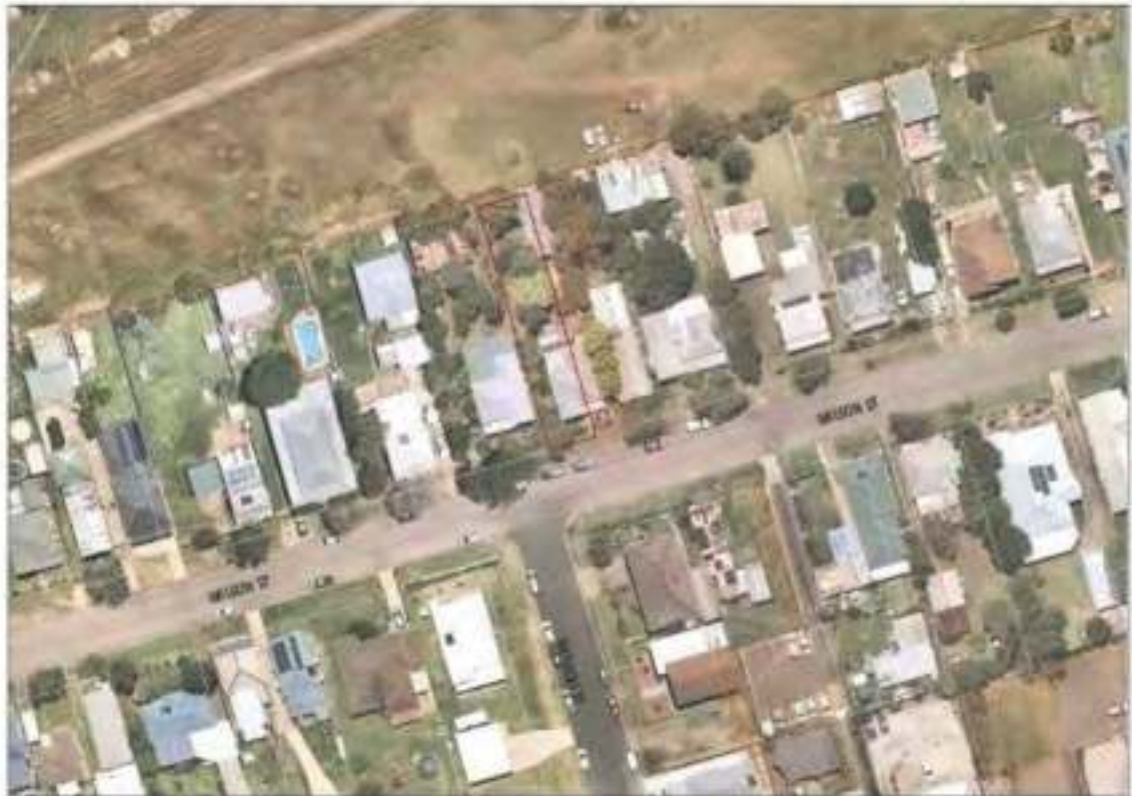
55 WILSON STREET, WEST WALLSEND 2286

Conservation Area Contribution Level	Est. Construction Date	Previous studies and/or community input
Contributory 1	1895–1915	No prior heritage investigations and no additional information required
Assessment Text		Observed Modifications
<p>Single story simple Federation ‘workmen's cottage’ style dwelling with Colourbond hipped roof and weatherboard cladding. The veranda roof is hipped.</p> <p>The veranda window appears to be the original timber framed sash style.</p> <p>The gable has timber shingle detailing and a timber shingle window awning.</p> <p>Timber balustrade fencing encloses the property.</p> <p>The dwelling displays architectural features of a heritage style and is representative of the local development of this period, being of historical significance for the HCA.</p>		<p>The gable window is a contemporary sliding design, contrasting with the heritage features of the dwelling.</p> <p>The timber shingle detailing on the gable is a likely original, but has been painted a bright yellow colour which contrast with the dwellings remaining colour scheme.</p> <p>The veranda roof was likely originally bull nosed.</p>

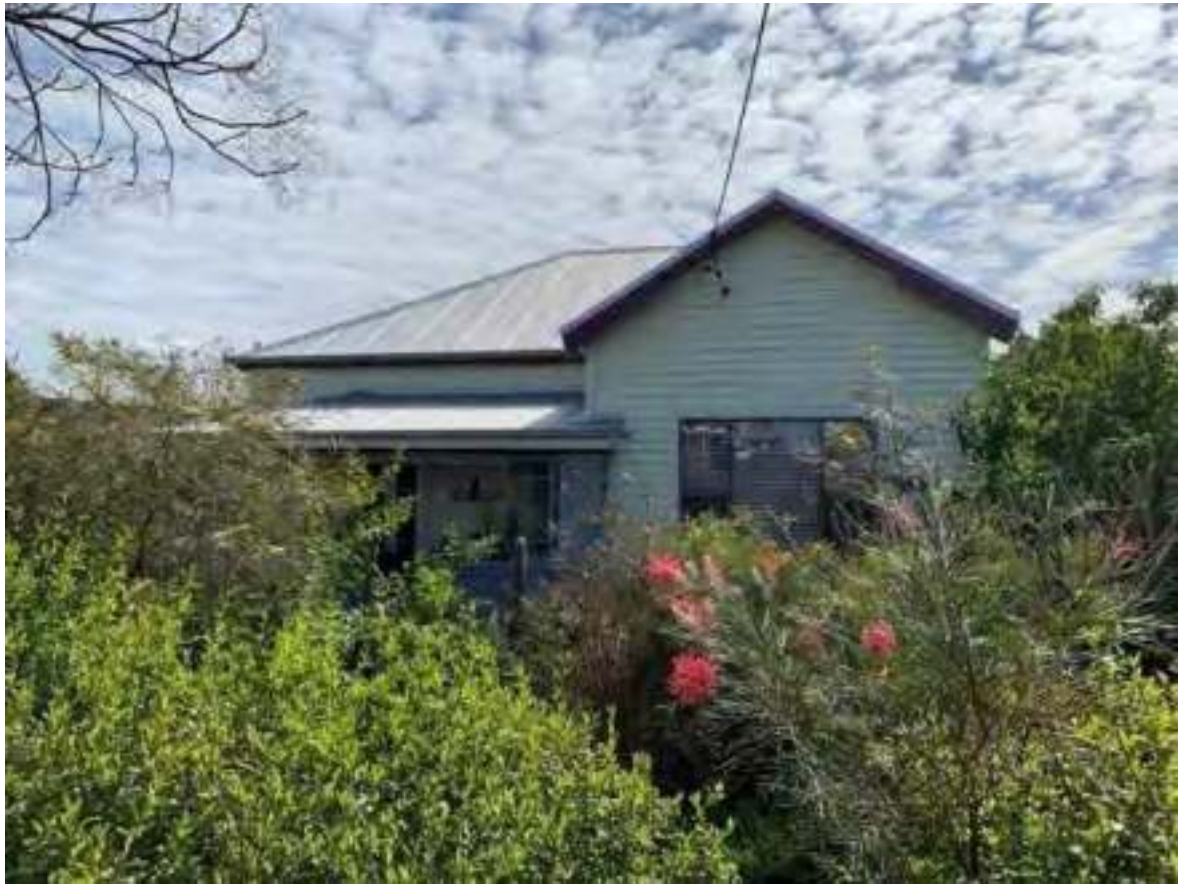
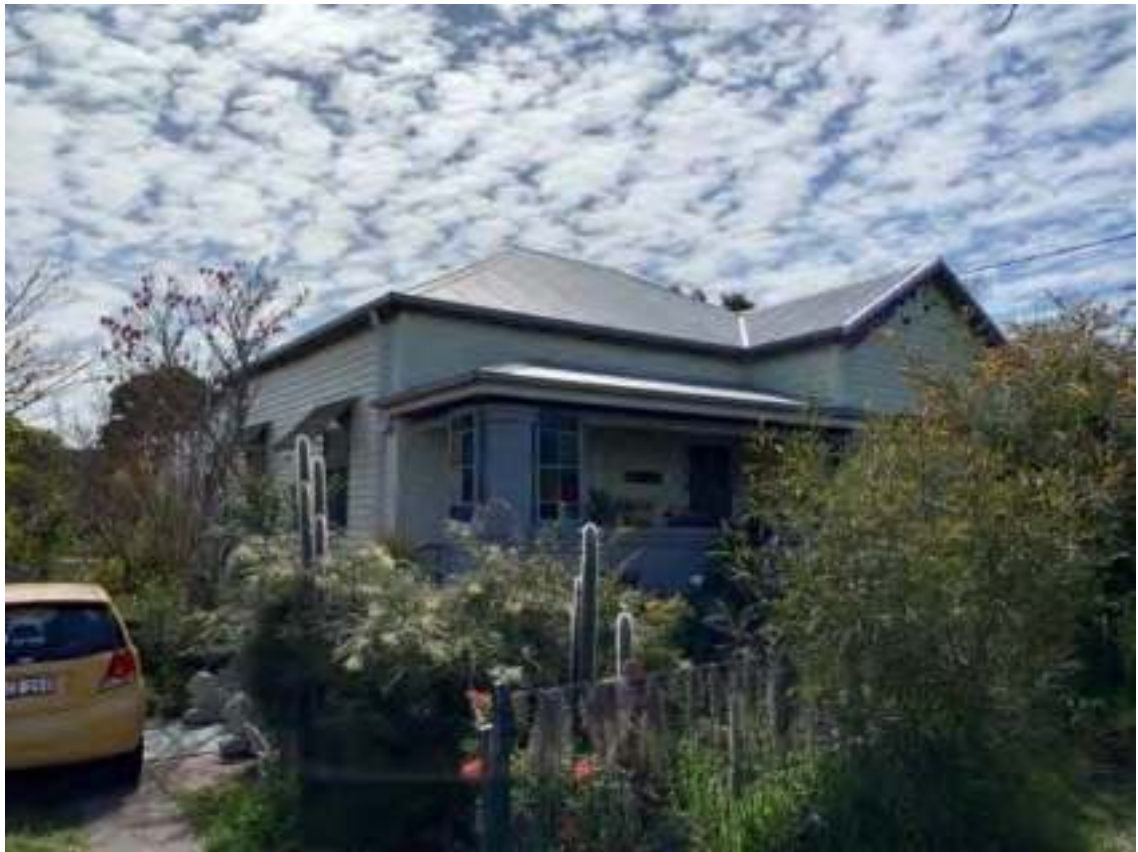
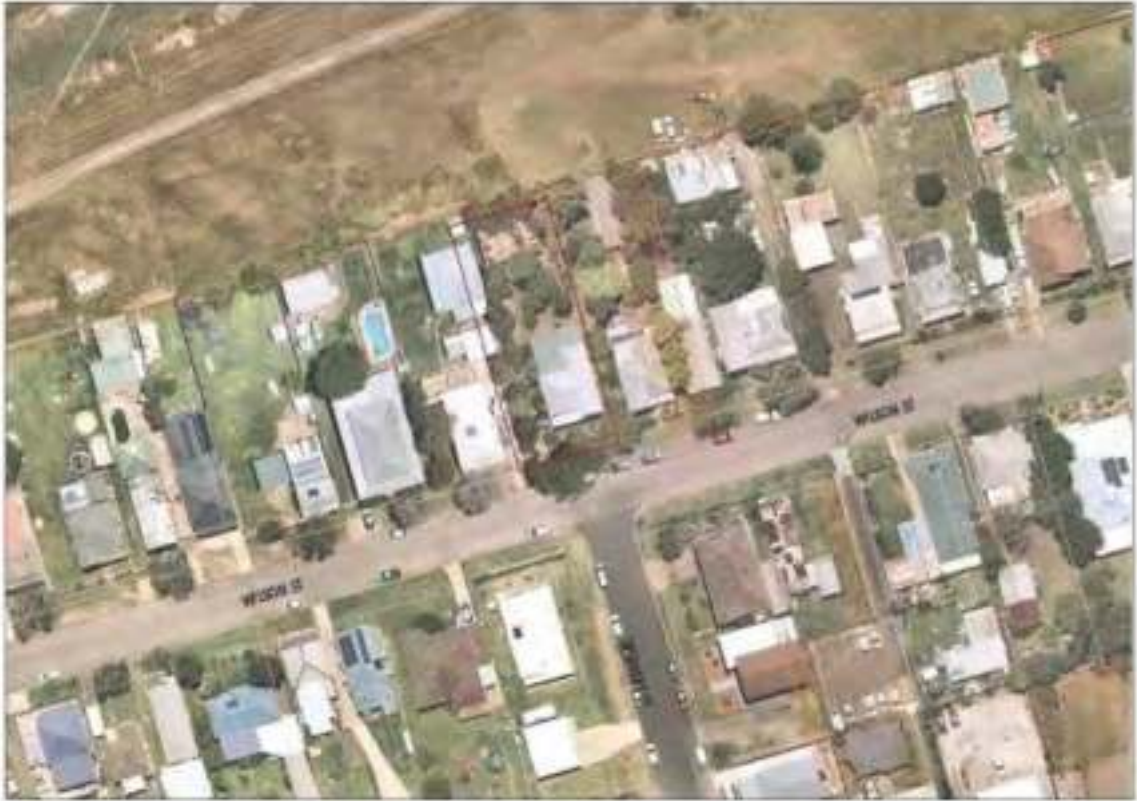
57 WILSON STREET, WEST WALLSEND 2286

Conservation Area Contribution Level	Est. Construction Date	Previous studies and/or community input
Contributory 1	1895–1915	No prior heritage investigations and no additional information required
Assessment Text		Observed Modifications
<p>Single story simple Federation ‘workmen's cottage’ style dwelling with hipped Colourbond roof and weatherboard cladding. The veranda roof is hipped.</p> <p>The veranda is partially enclosed by a brick veranda wall with supportive pillars and fragmented cast iron lace valance. Multiple panels of multi-pane stained glass is visible.</p> <p>The gable has ornately carved barge board.</p> <p>The dwelling is partially obscure by mature vegetation.</p> <p>The dwelling displays architectural features of a heritage style and is representative of the local development of this period, being of historical significance for the HCA.</p>		<p>The gable window is a contemporary picture style design, contrasting with the heritage features.</p>

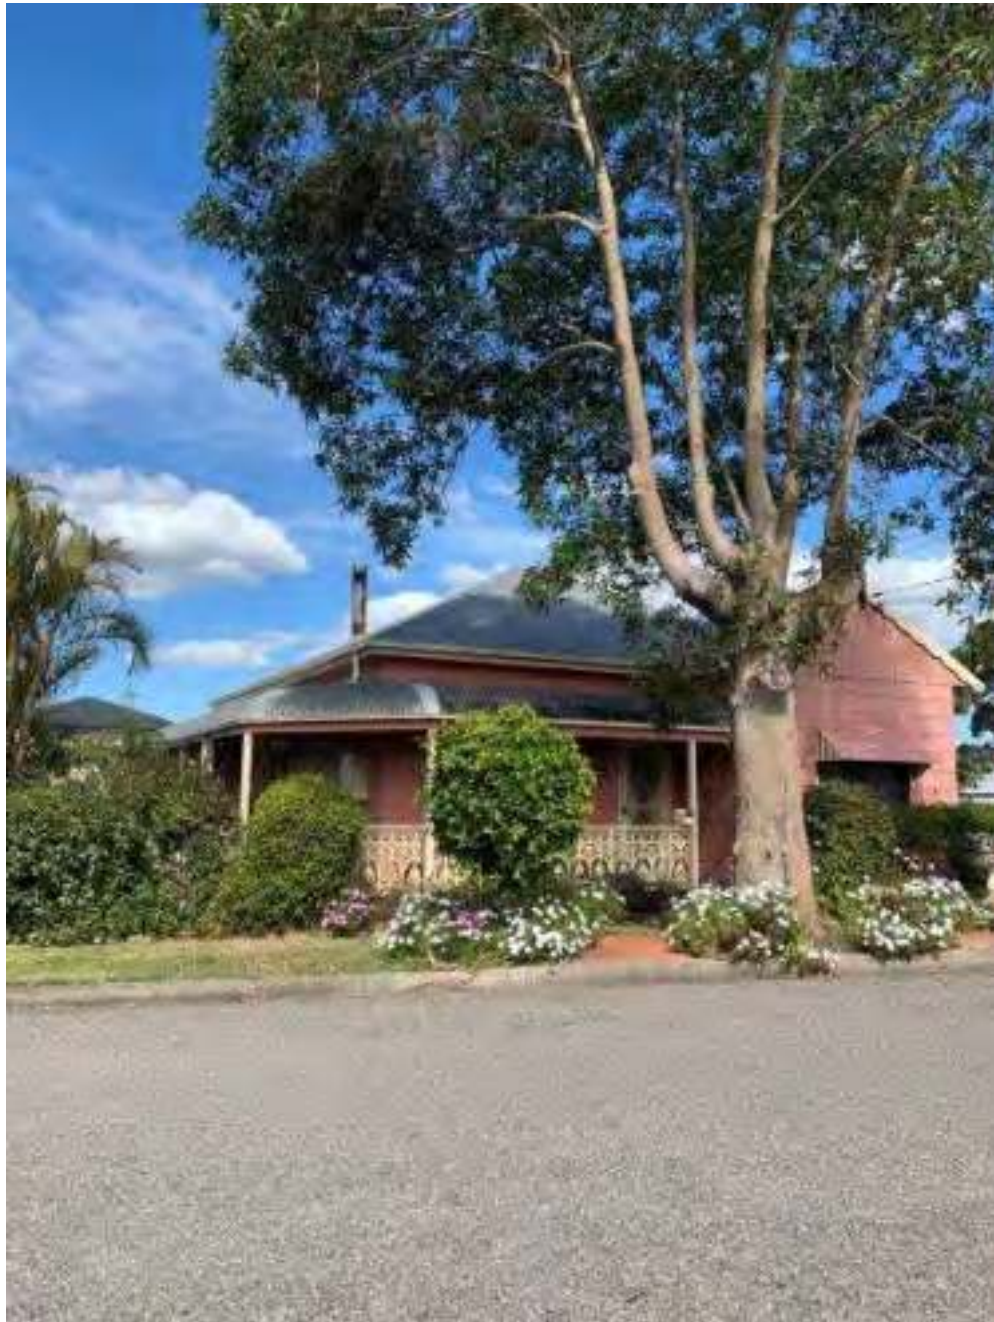
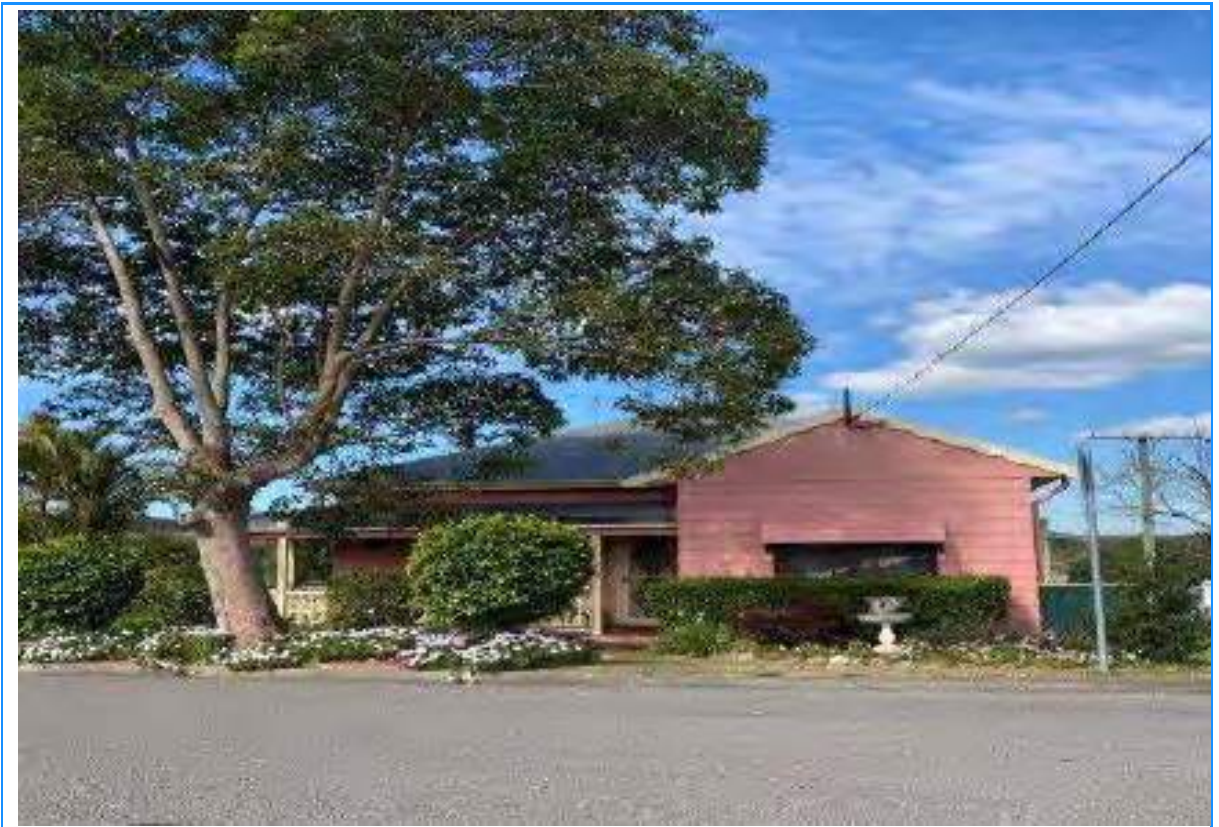
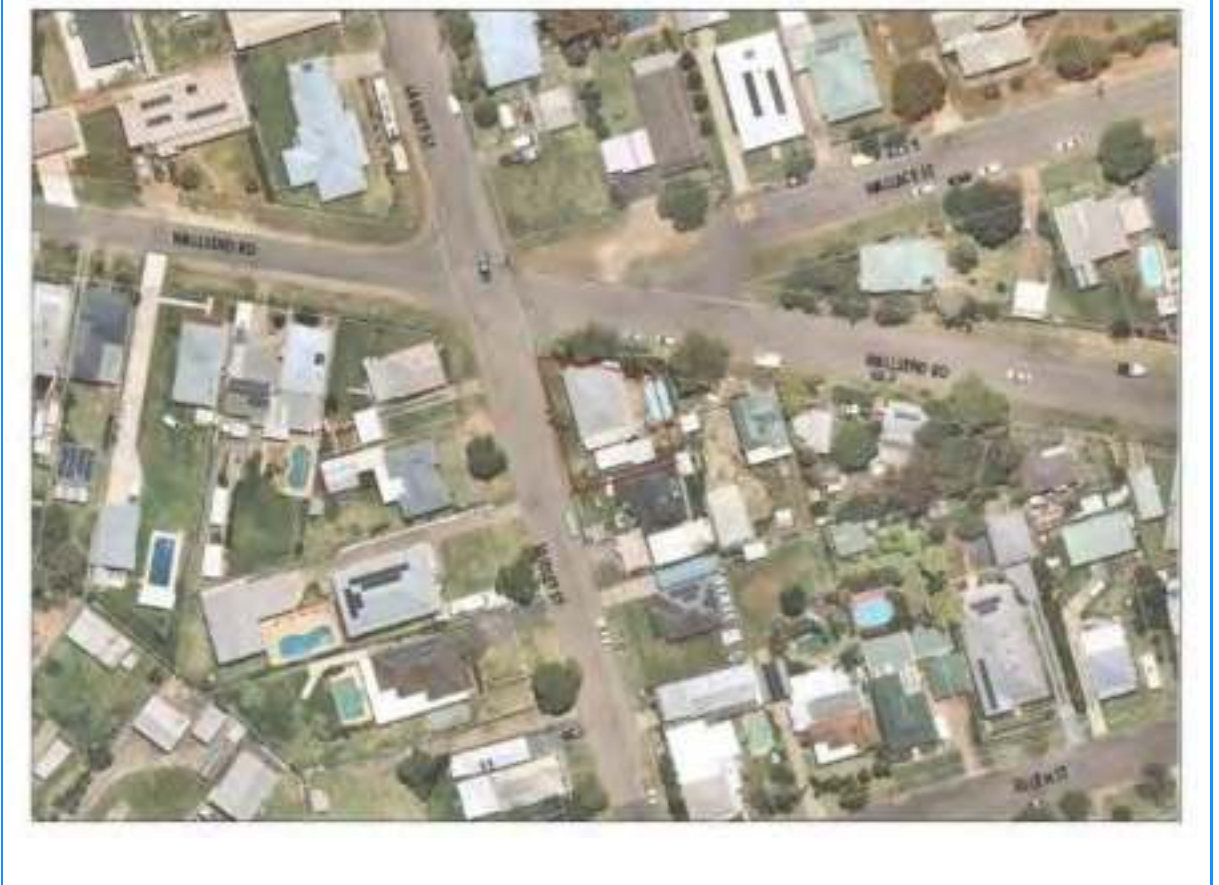
18 WALLSEND ROAD, WEST WALLSEND 2286

Conservation Area Contribution Level	Est. Construction Date	Previous studies and/or community input
Contributory 1	1895–1915	No prior heritage investigations and no additional information required
Assessment Text		Observed Modifications
<p>Single story simple Federation ‘workmen’s cottage’ style dwelling with hipped Colourbond roof and weatherboard cladding. The veranda roof is bull nosed.</p> <p>The veranda is partially enclosed by wrought iron decorative balustrade.</p> <p>The gable has a decorative barge board, timber finial and vertical timber panelling. A timber awnings sits above the gable window.</p> <p>A garage is located to the south of the dwelling.</p> <p>The dwelling displays architectural features of a heritage style and is representative of the local development of this period, being of historical significance for the HCA.</p>		<p>The dwelling is a bright pink colour, contrasting with the heritage streetscape.</p> <p>The visible windows are contemporary replications of inspired designs.</p> <p>The veranda wraps around the eastern side of the dwelling, but this appears to be an early modification common with houses of this style.</p>
