APPENDIX 2

Building Assessment Sheets (Inventory Sheets)

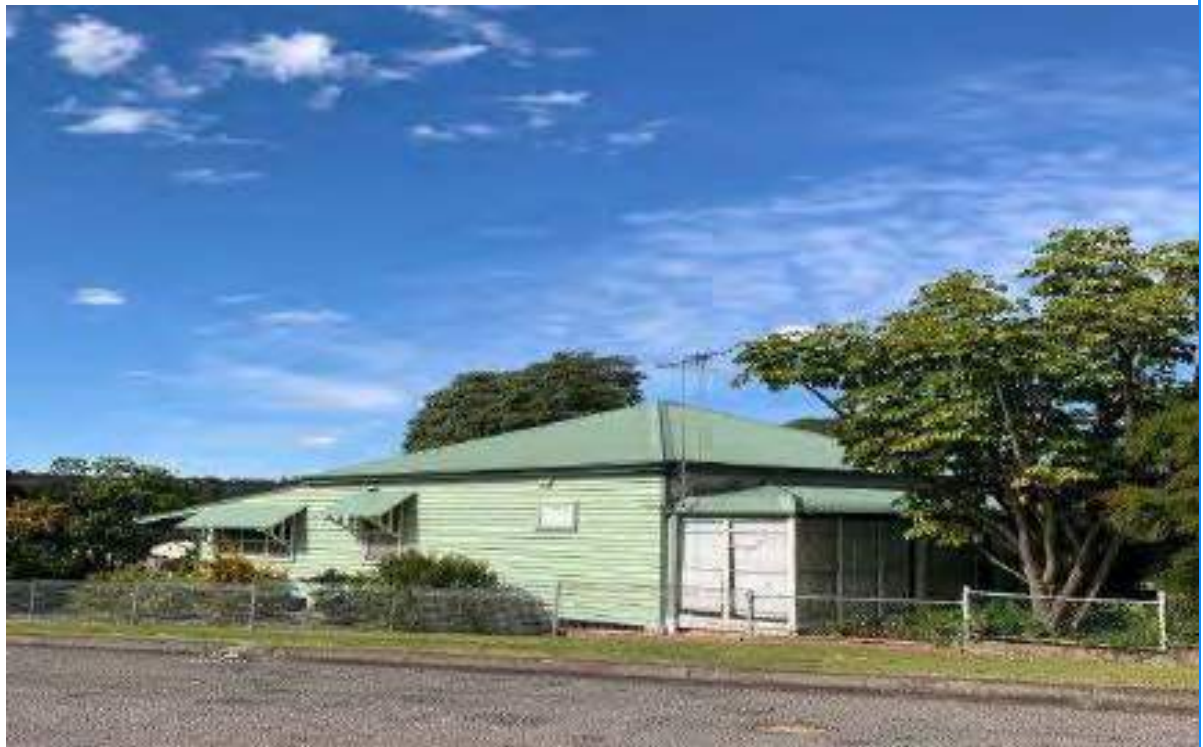
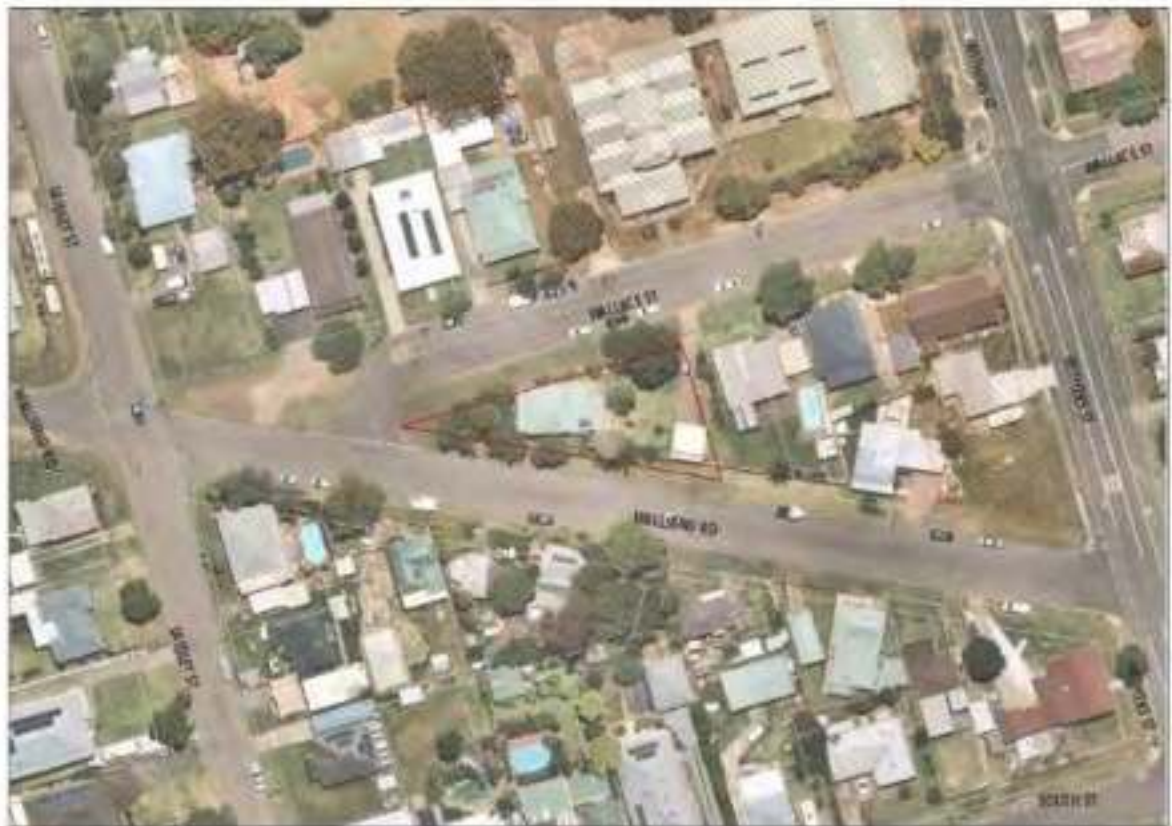
54 WALLACE STREET, WEST WALLSEND 2286

Conservation Area Contribution Level	Est. Construction Date	Previous studies and/or community input
Contributory 1	1890–1915	No prior heritage investigations and no additional information required
Assessment Text		Observed Modifications
<p>Single story Vernacular ‘Mining Cottage’ style dwelling with hipped Colourbond roof and hardy plank cladding. The veranda roof is bull nosed.</p> <p>The veranda has been enclosed by a built in addition.</p> <p>All visible windows have aluminium awnings above, and are constructed of aluminium frames.</p> <p>The dwelling displays architectural features of a heritage style and is representative of the local development of this period, being of historical significance for the HCA.</p>		<p>The veranda has been built in, with the façade being dominated by timber framed windows.</p> <p>All visible windows are contemporary replications of sash styles.</p> <p>Information provided from the current property owner states two brickwork chimneys were originally present, however removed during earlier renovation works.</p>

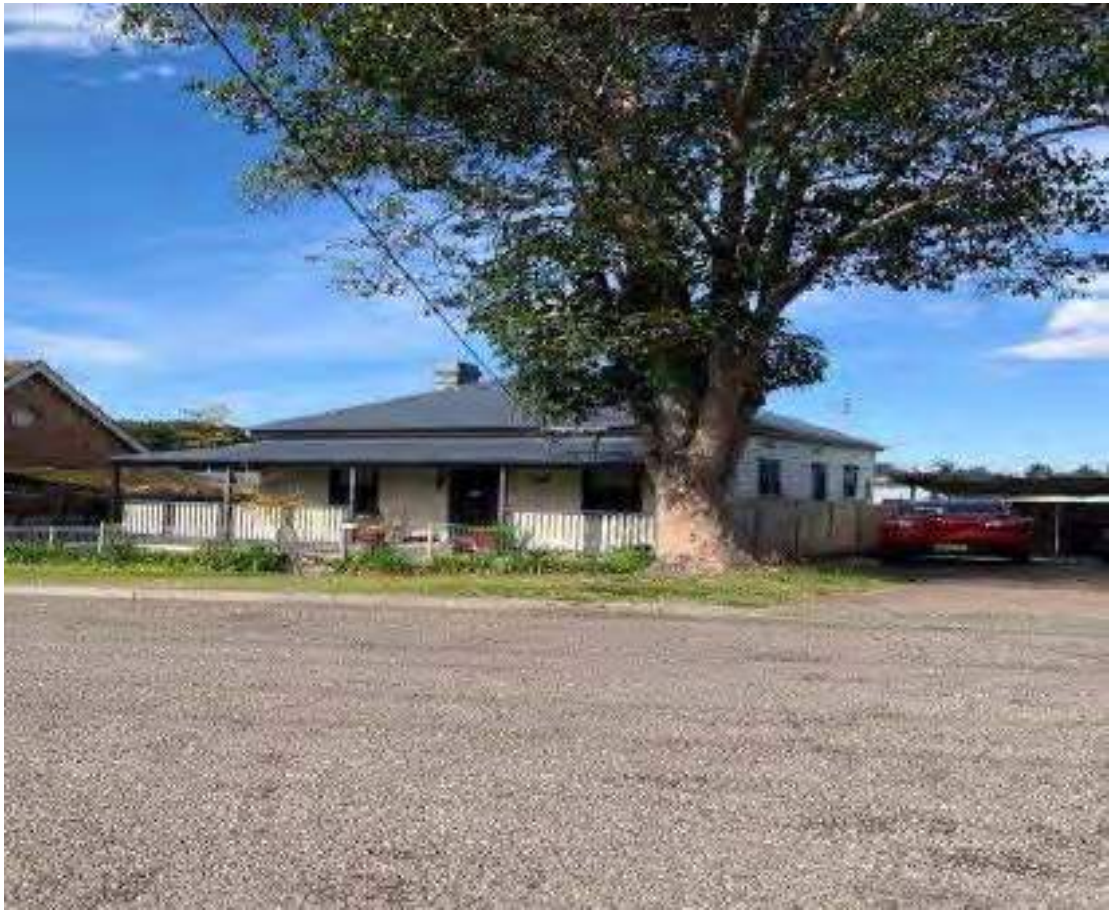
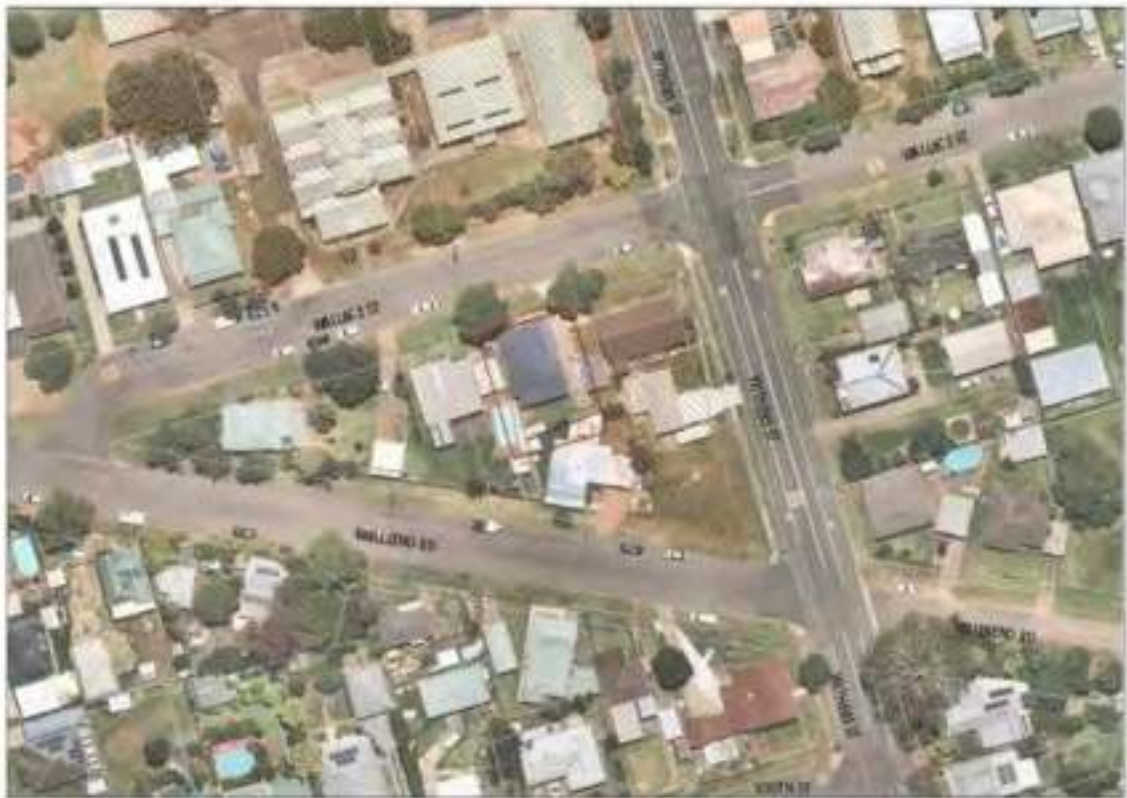
50 WALLACE STREET, WEST WALLSEND 2286

Conservation Area Contribution Level	Est. Construction Date	Previous studies and/or community input
Contributory 1	1890–1915	No prior heritage investigations and no additional information required
Assessment Text		Observed Modifications
<p>Single story Vernacular ‘Mining Cottage’ style dwelling with hipped Colourbond roof and weatherboard cladding. The veranda roof is hipped.</p> <p>The veranda is partially enclosed with a timber balustrade.</p> <p>The front door is timber framed with original heavy timber framed sash windows on either side.</p> <p>A rendered brick chimney is visible on the eastern side of the dwelling.</p> <p>A garage is located to the east of the dwelling.</p> <p>The dwelling displays architectural features of a heritage style and is representative of the local development of this period, being of historical significance for the HCA.</p>		<p>The veranda has been extended to the eastern side of the dwelling, converting the previously skillion veranda roof to a hipped roof.</p> <p>The veranda roof would have originally been bull nosed.</p> <p>An extension is partially visible at the southern back end of the dwelling.</p>

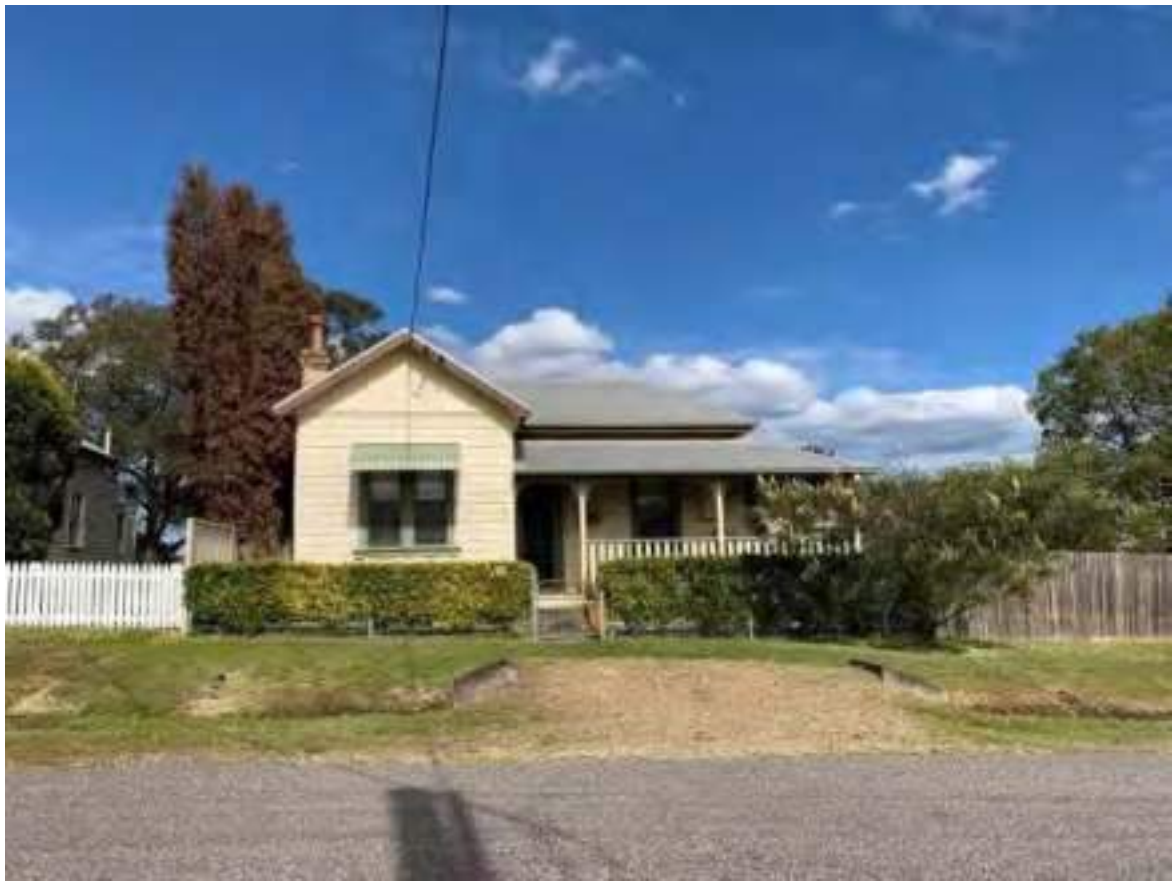
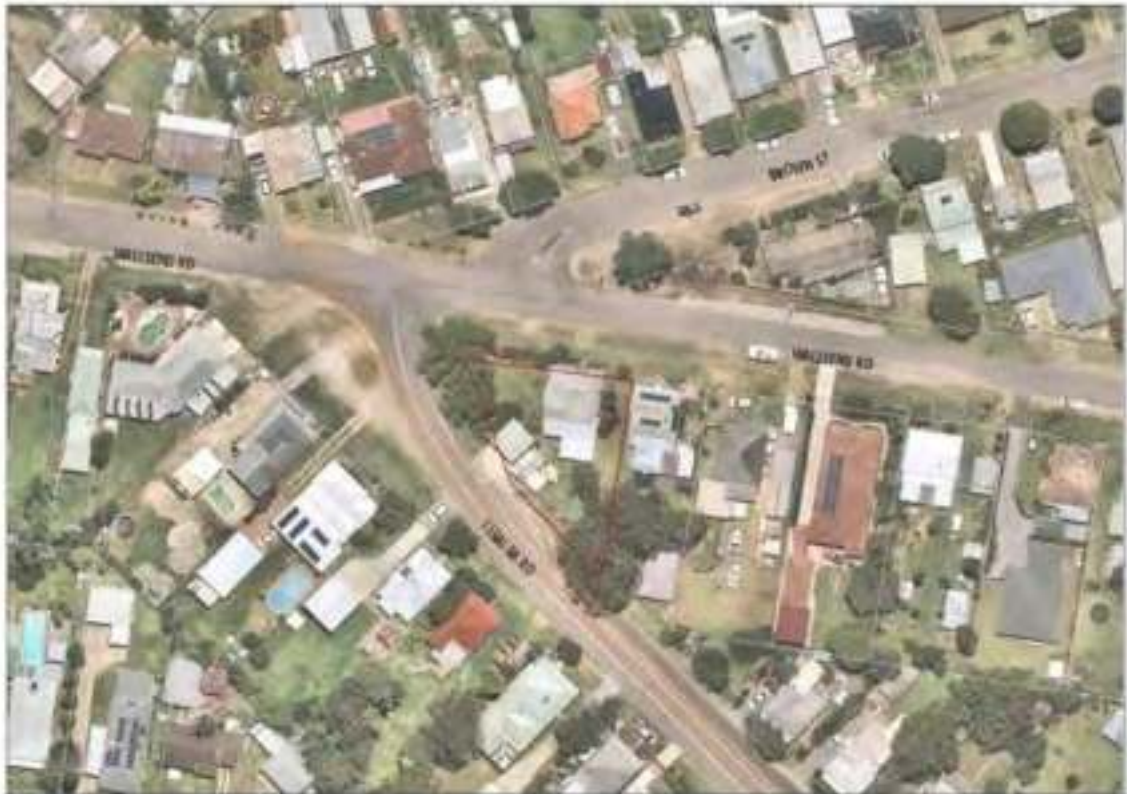
42 WALLSEND ROAD, WEST WALLSEND 2286

Conservation Area Contribution Level	Est. Construction Date	Previous studies and/or community input
Contributory 1	1919	West Wallsend Heritage Study 1993 Moderate local significance
Assessment Text		Observed Modifications
<p>Single story Vernacular version of a Federation Queen Anne dwelling with half hipped and gable Colourbond roof and timber weatherboard cladding.</p> <p>The veranda roof is hipped and framed with cast iron lace valance.</p> <p>The front door is timber framed with original heavy timber framed sash windows either side.</p> <p>The gable window has a decorative carved timber sill.</p> <p>Two brickwork chimneys are visible on the eastern side of the dwelling, with double corbel and decorative terracotta pots.</p> <p>The gable has some battening detailing.</p> <p>The dwelling displays architectural features of a heritage style and is representative of the local development of this period, being of historical significance for the HCA.</p>		<p>In reference to the 1993 study, the cast iron horses head finials on the gable ends have been removed and the timber veranda balustrade has been added as a contemporary replication of a heritage style.</p> <p>Many of the visible windows have security screening, which is unsympathetic to the heritage style of the dwelling.</p> <p>Some windows have contemporary metal awnings, juxtaposing the established timber heritage features.</p>

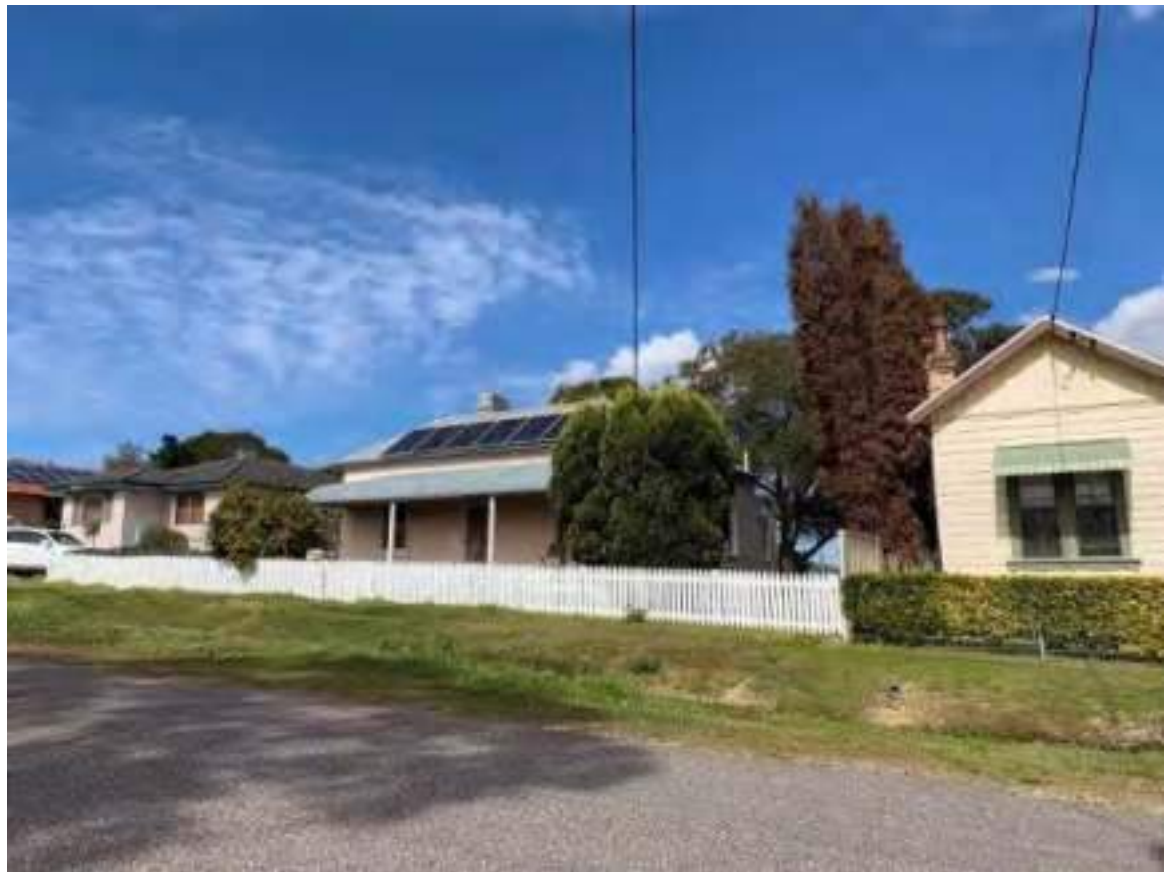
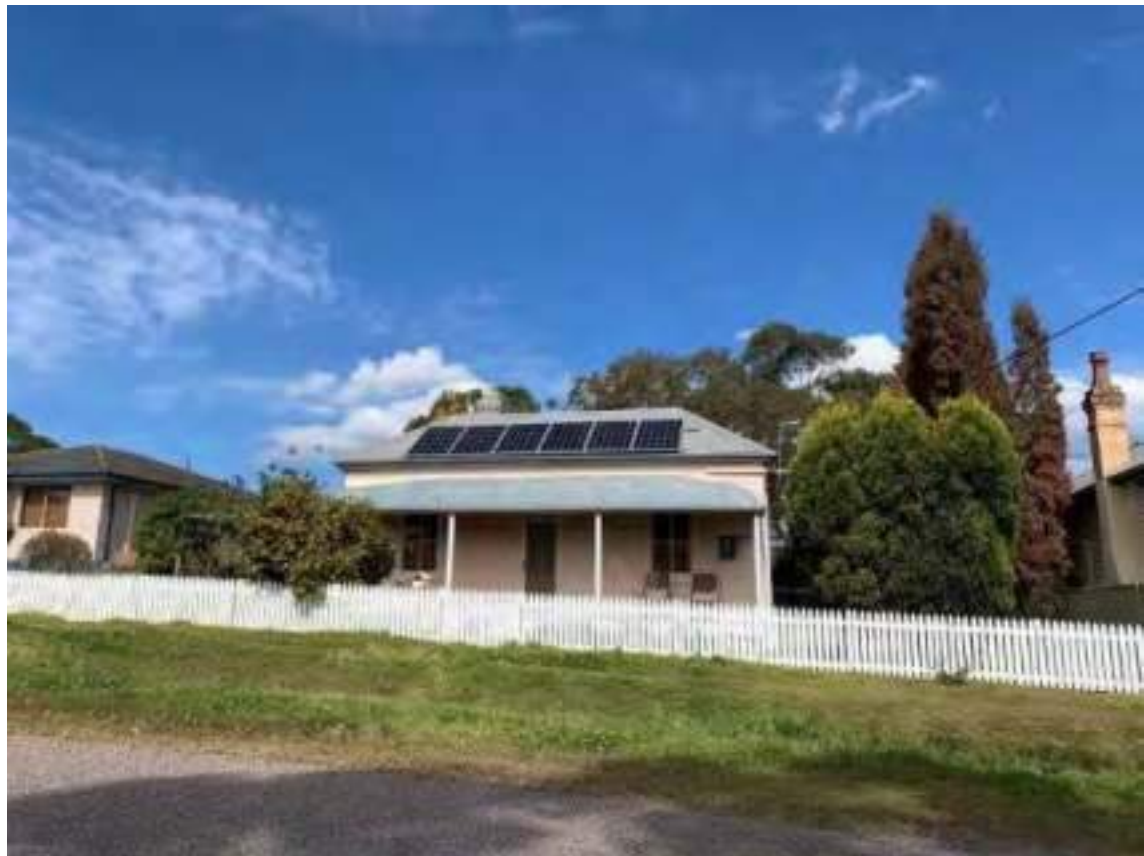
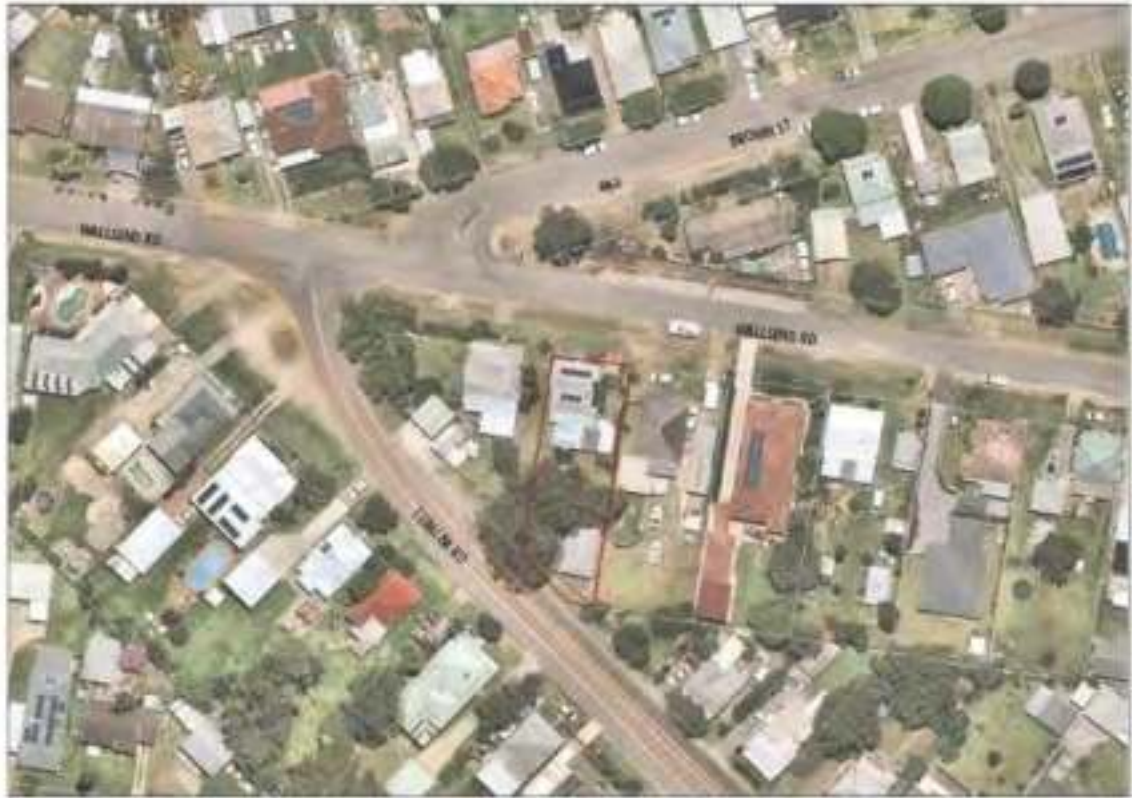
40 WALLSEND ROAD, WEST WALLSEND 2286

Conservation Area Contribution Level	Est. Construction Date	Previous studies and/or community input
Contributory 1	1890–1915	No prior heritage investigations and no additional information required
Assessment Text		Observed Modifications
<p>Single story Vernacular ‘Mining Cottage’ style dwelling with hipped Colourbond roof and weatherboard cladding. The veranda roof is the original bull nosed design.</p> <p>The visible windows are the original heavy timber framed sash styles.</p> <p>A brickwork chimney is visible on the eastern side of the dwelling, with decorative corbel details.</p> <p>A timber picket fence encloses the property.</p> <p>The dwelling displays architectural features of a heritage style and is representative of the local development of this period, being of historical significance for the HCA.</p>		<p>Solar panels are highly visible on the northern side of the dwelling.</p>

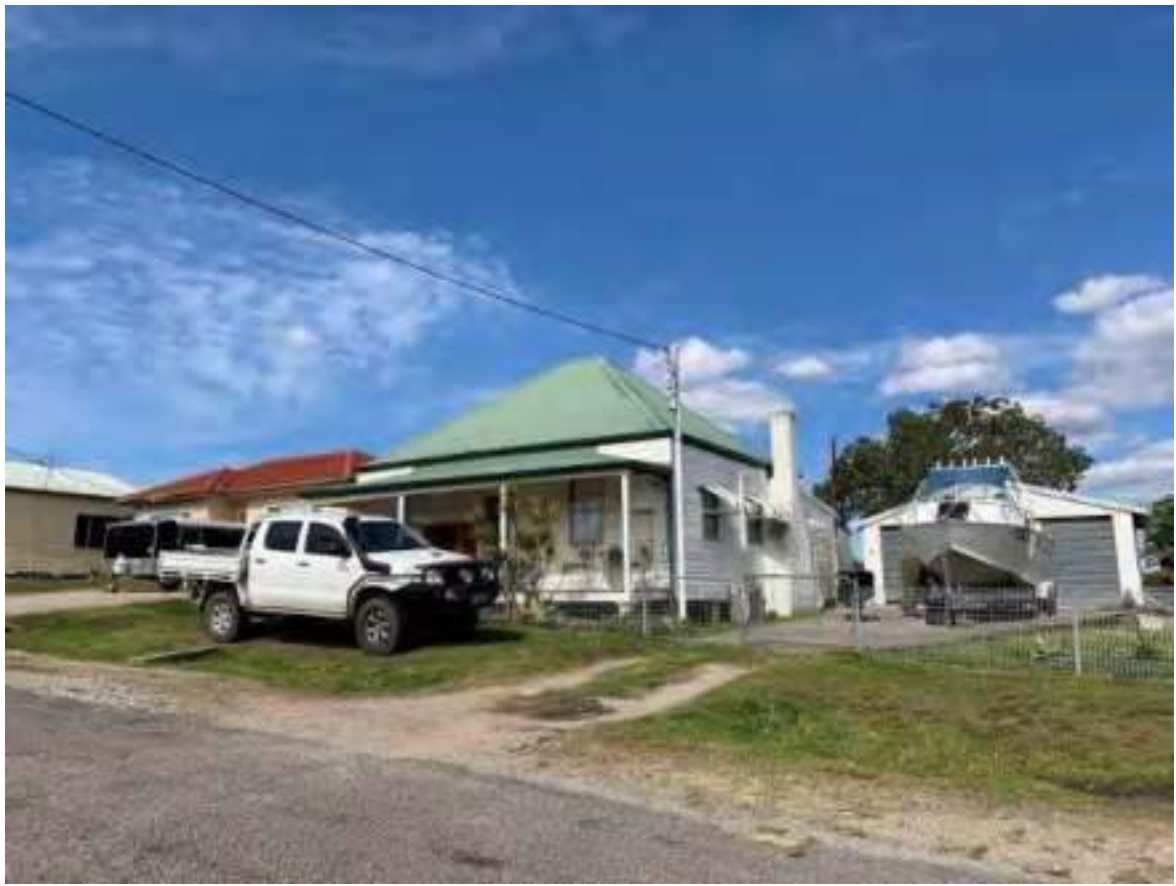
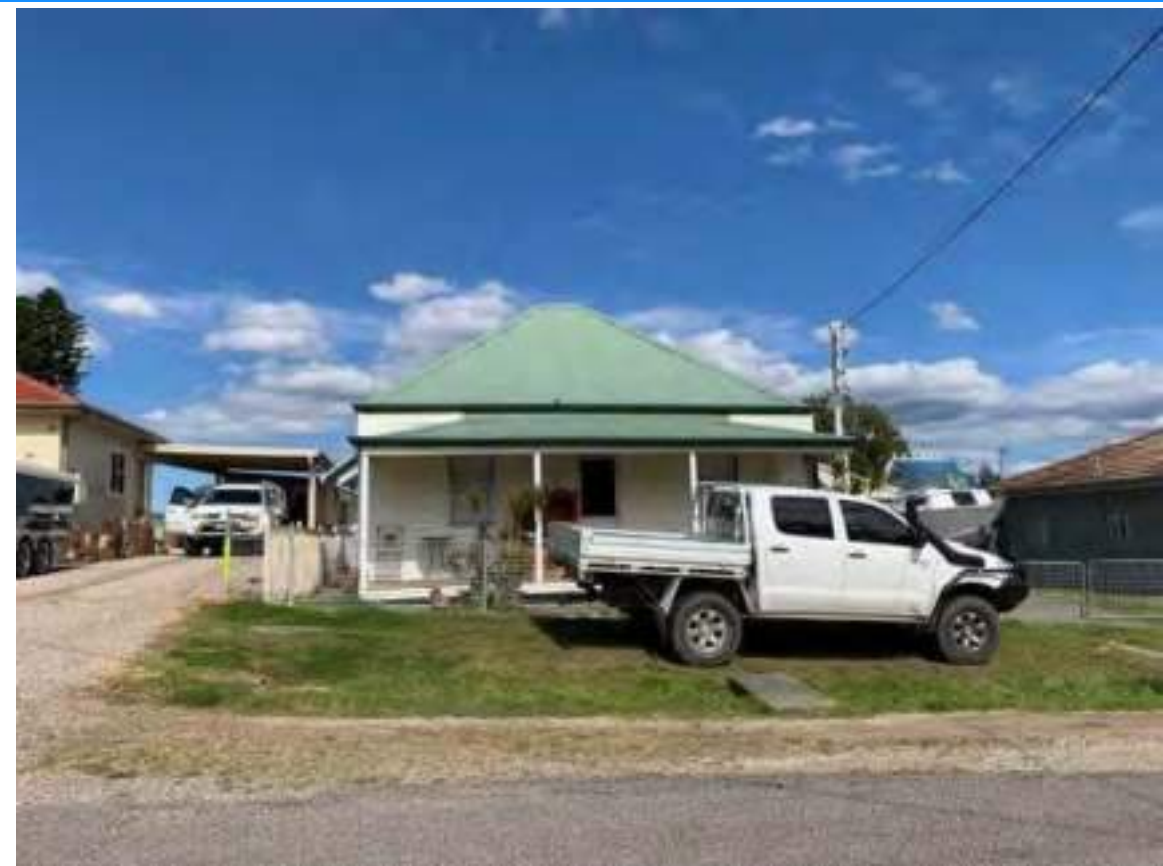
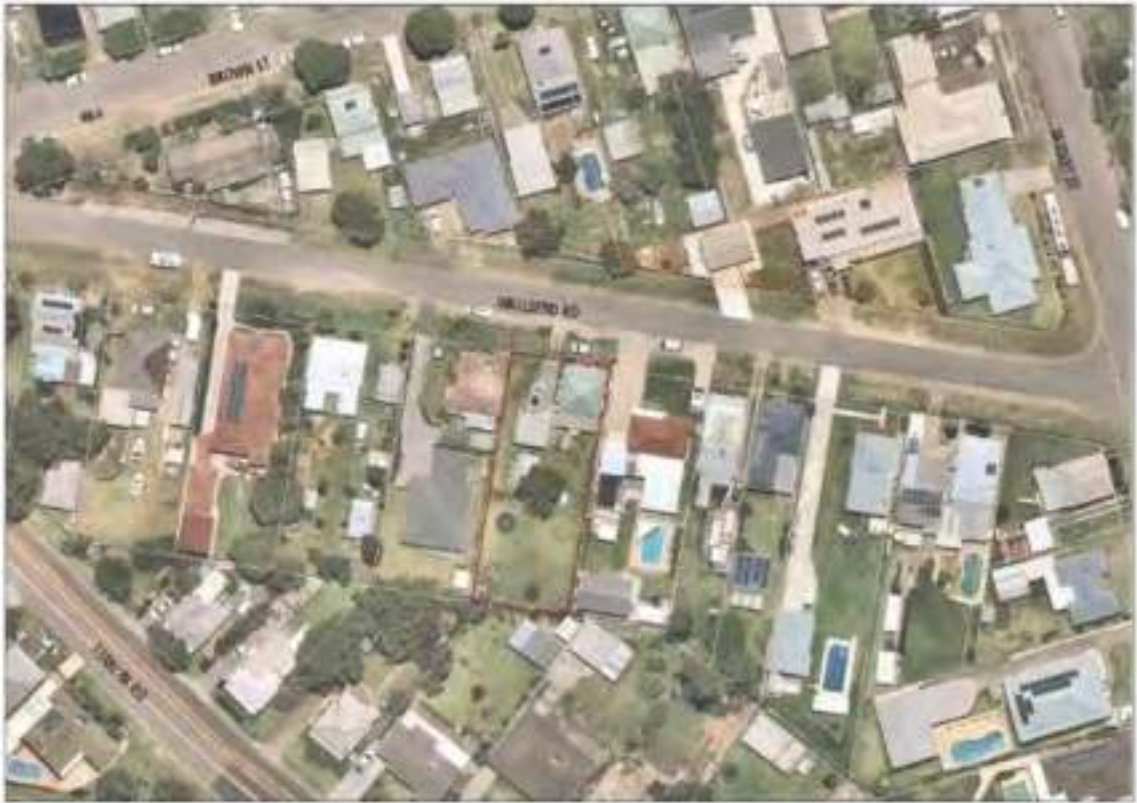
30 WALLSEND ROAD, WEST WALLSEND 2286

Conservation Area Contribution Level	Est. Construction Date	Previous studies and/or community input
Contributory 1	1890–1915	No prior heritage investigations and no additional information required
Assessment Text		Observed Modifications
<p>Single story Vernacular ‘Mining Cottage’ style dwelling with steep Colourbond hipped roof and weatherboard cladding. The veranda roof is hipped.</p> <p>A rendered brickwork chimney is visible on the western side of the dwelling.</p> <p>A gable roof double garage is located to the west of the dwelling.</p> <p>A metal fence encloses the property.</p> <p>The dwelling displays architectural features of a heritage style and is representative of the local development of this period, being of historical significance for the HCA.</p>		<p>All visible windows have been replaced with contemporary sash designs.</p> <p>The front door is a half mesh and timber design, likely replacing an original timber design.</p> <p>The veranda roof would have originally been bull nosed.</p> <p>The eastern and eastern windows have metal striped hoods, likely an aged modification.</p>

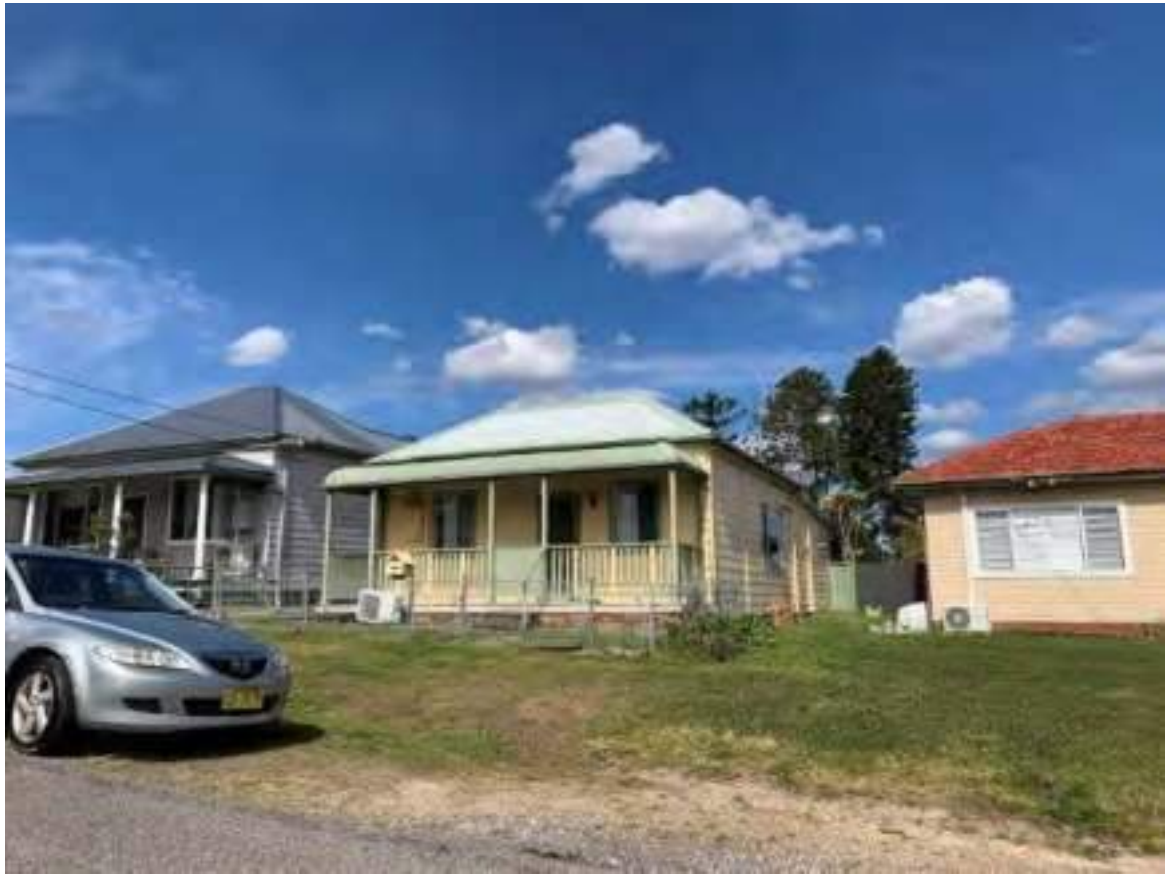
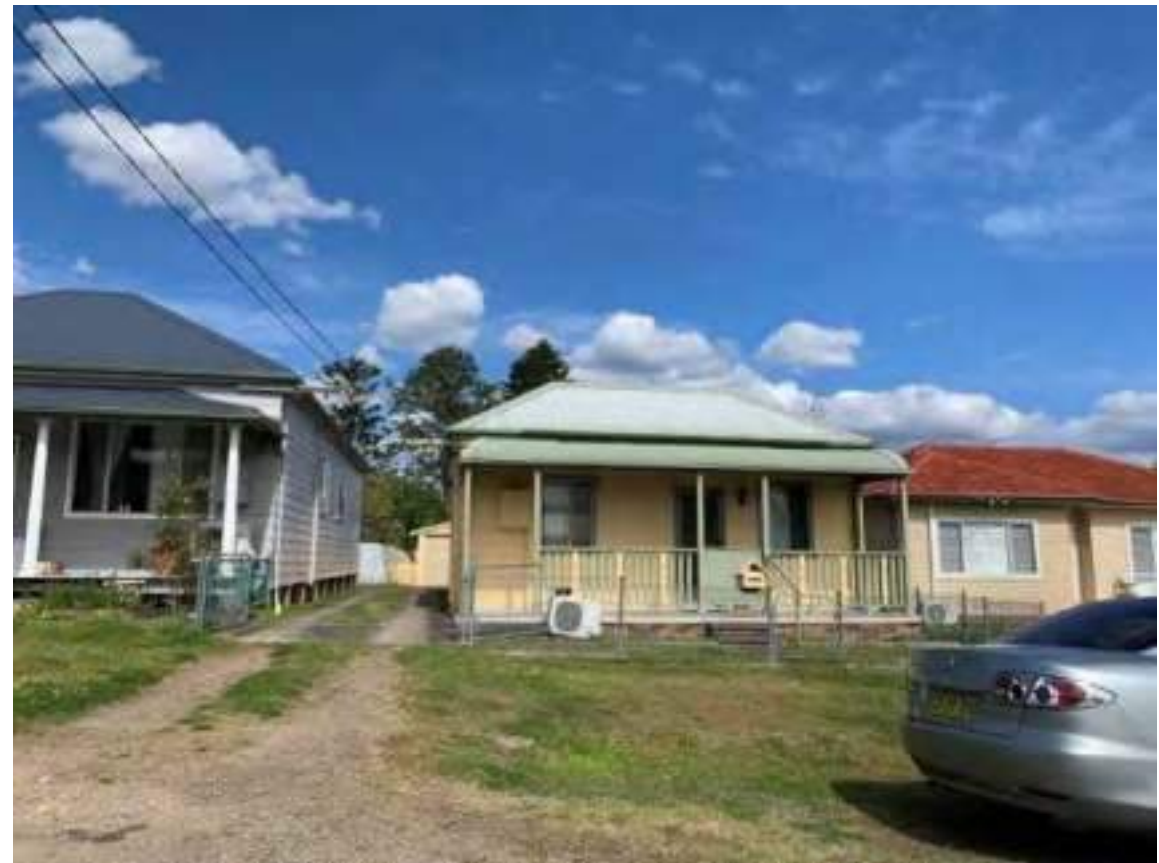
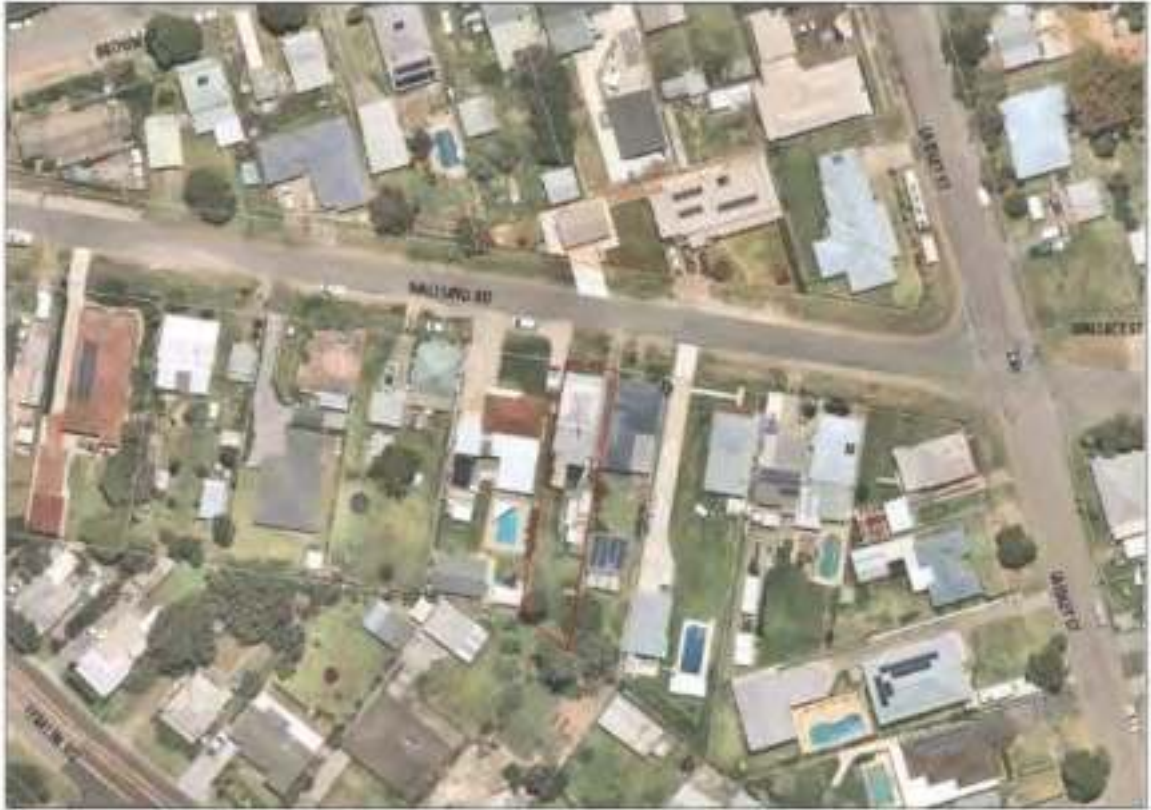
26 WALLSEND ROAD, WEST WALLSEND 2286

Conservation Area Contribution Level	Est. Construction Date	Previous studies and/or community input
Contributory 1	1890–1915	No prior heritage investigations and no additional information required
Assessment Text		Observed Modifications
<p>Single story Vernacular ‘mining Cottage’ style dwelling with hipped Colourbond roof and weatherboard cladding. The veranda roof is the original bull nosed design.</p> <p>The veranda is partially enclosed with timber balustrade and timber panels.</p> <p>The front door is timber framed with metal security screen. Windows are located on either side of the door.</p> <p>Metal fencing encloses the property</p> <p>The dwelling displays architectural features of a heritage style and is representative of the local development of this period, being of historical significance for the HCA.</p>		<p>All visible windows are contemporary sliding designs.</p> <p>The veranda balustrade and panels are a contemporary addition.</p>

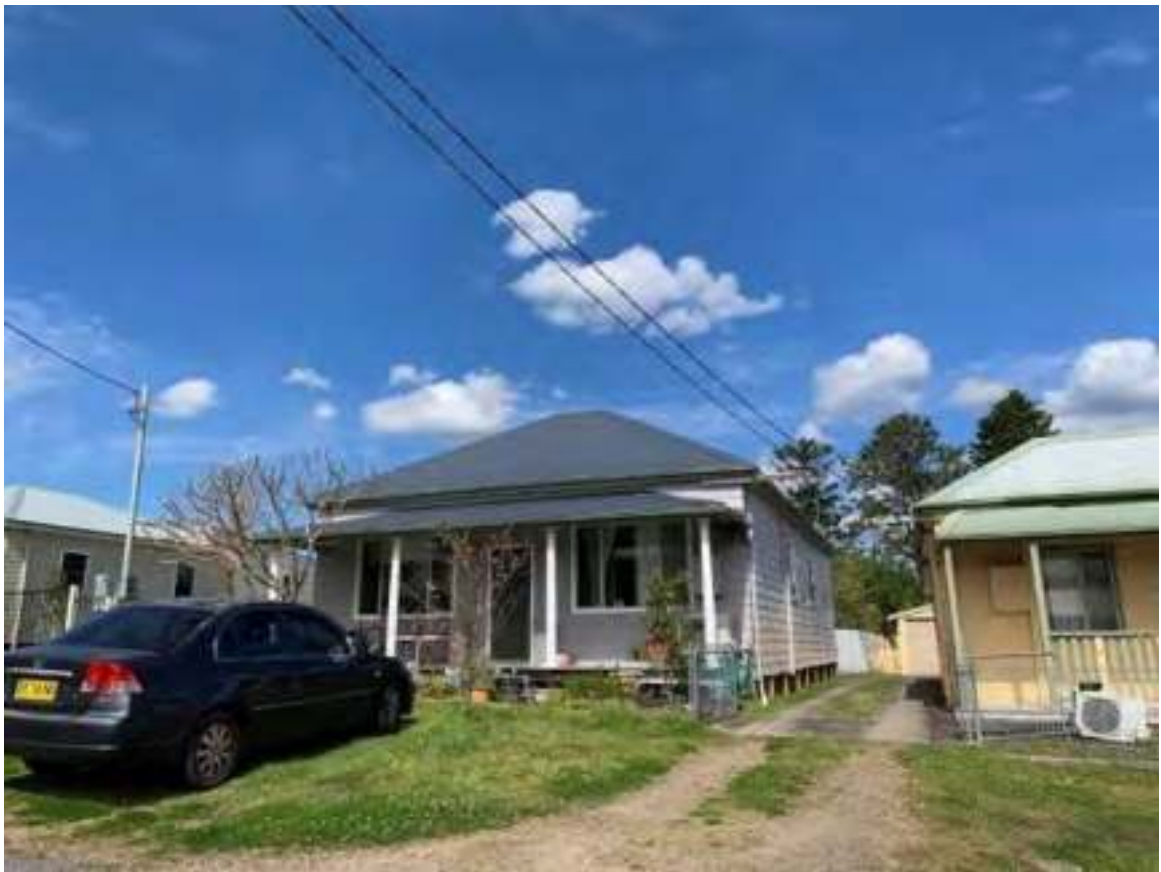
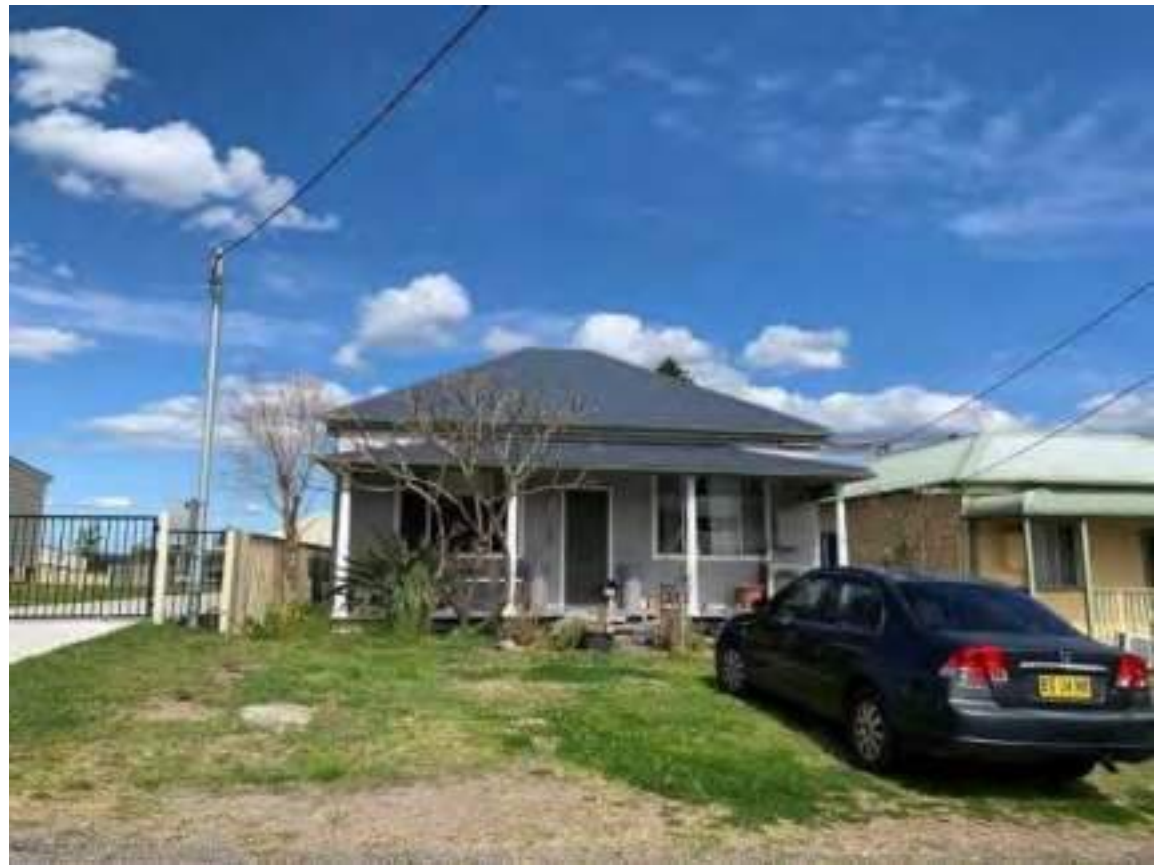
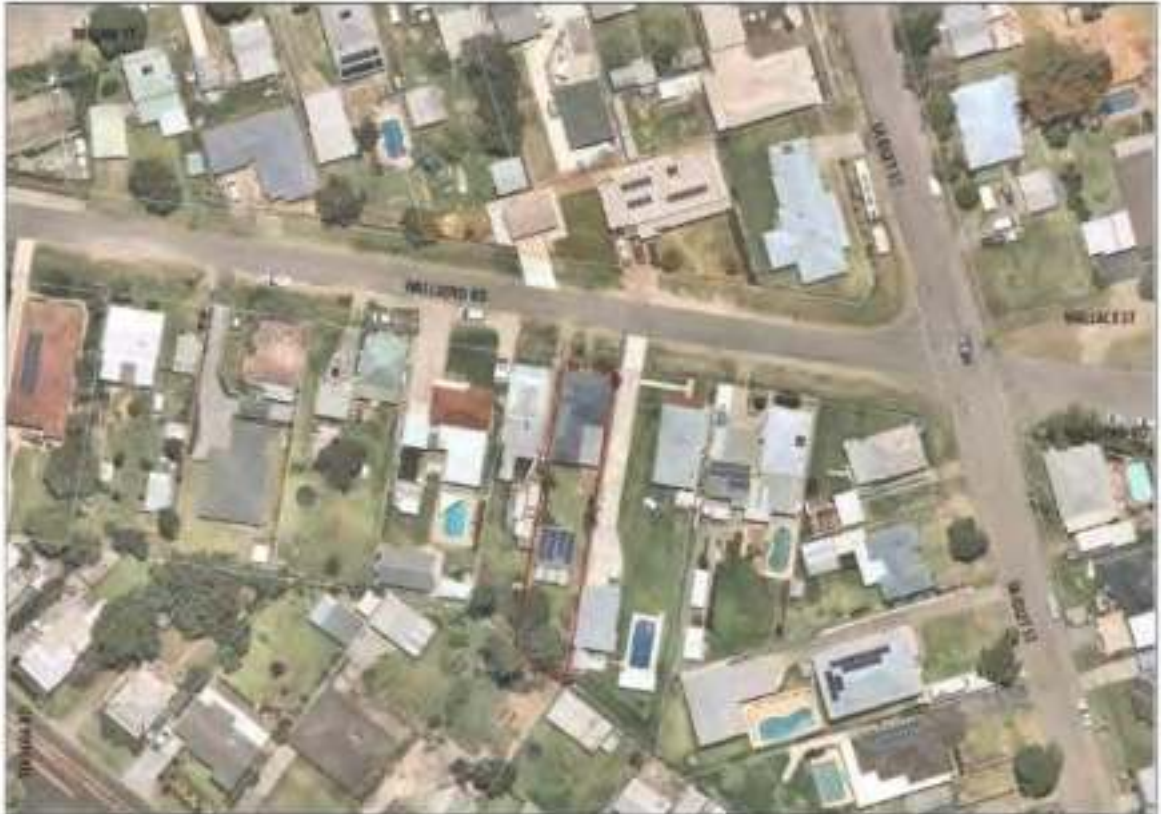
24 WALLSEND ROAD, WEST WALLSEND 2286

Conservation Area Contribution Level	Est. Construction Date	Previous studies and/or community input
Contributory 1	1890–1915	No prior heritage investigations and no additional information required
Assessment Text		Observed Modifications
<p>Single story Vernacular ‘Mining Cottage’ style dwelling with hipped Colourbond roof and weatherboard cladding. The veranda roof is hipped and supported by faux Corinthian pillars.</p> <p>The front door is timber framed with a metal security screen. Large picture windows are either side.</p> <p>The dwelling displays architectural features of a heritage style and is representative of the local development of this period, being of historical significance for the HCA.</p>		<p>The Corinthian inspired pillars are a contemporary addition and are inappropriate for the style of house.</p> <p>The visible windows are contemporary picture styles.</p> <p>The veranda roof would have originally been a bull nosed design.</p> <p>An extension has been constructed at the back southern end of the dwelling, however this is not visible from the street and does not detract.</p>

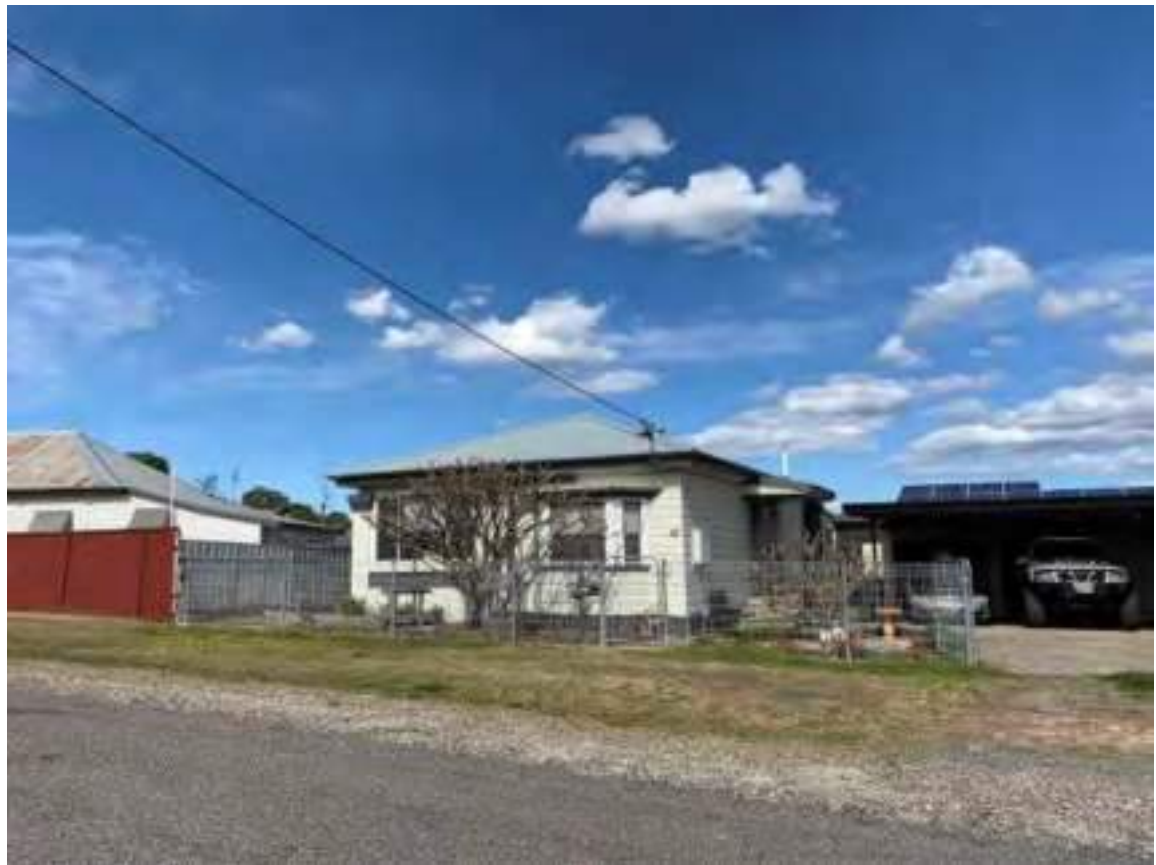
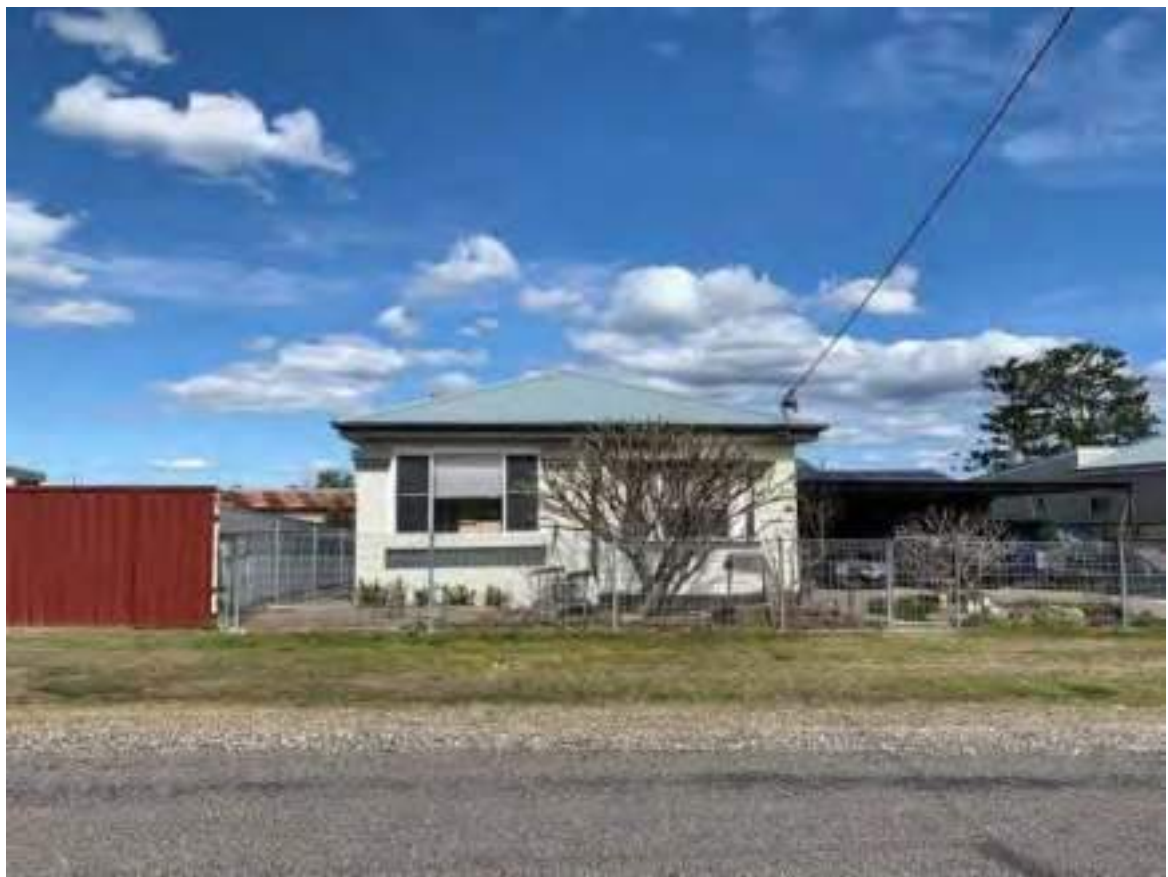
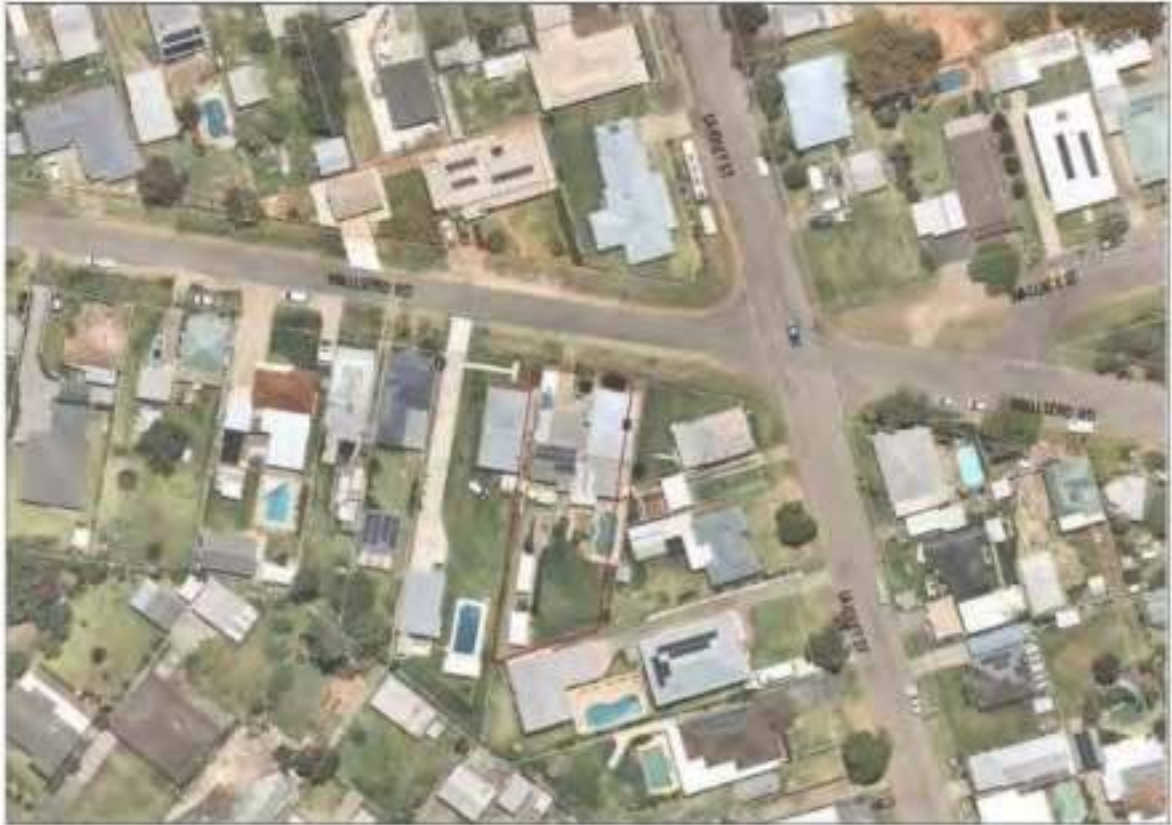
20 WALLSEND ROAD, WEST WALLSEND 2286

Conservation Area Contribution Level	Est. Construction Date	Previous studies and/or community input
Contributory 1	1915–1930	No prior heritage investigations and no additional information required
Assessment Text		Observed Modifications
<p>Single story Inter-War dwelling with Colourbond hipped roof and weatherboard cladding.</p> <p>The front façade of the dwelling has rendered masonry pillars, likely originally a part of an open veranda.</p> <p>The bay window has a triple panel sash window design and simple sill.</p> <p>A car port and garage is located to the east of the dwelling.</p> <p>The dwelling displays architectural features of a heritage style and is representative of the local development of this period, being of historical significance for the HCA.</p>		<p>The dwelling has been extensively modified, with the veranda being built in to create an additional living area, all visible windows being contemporary installations and an extension being constructed on the back southern portion of the dwelling.</p>
