APPENDIX 2

Building Assessment Sheets (Inventory Sheets)

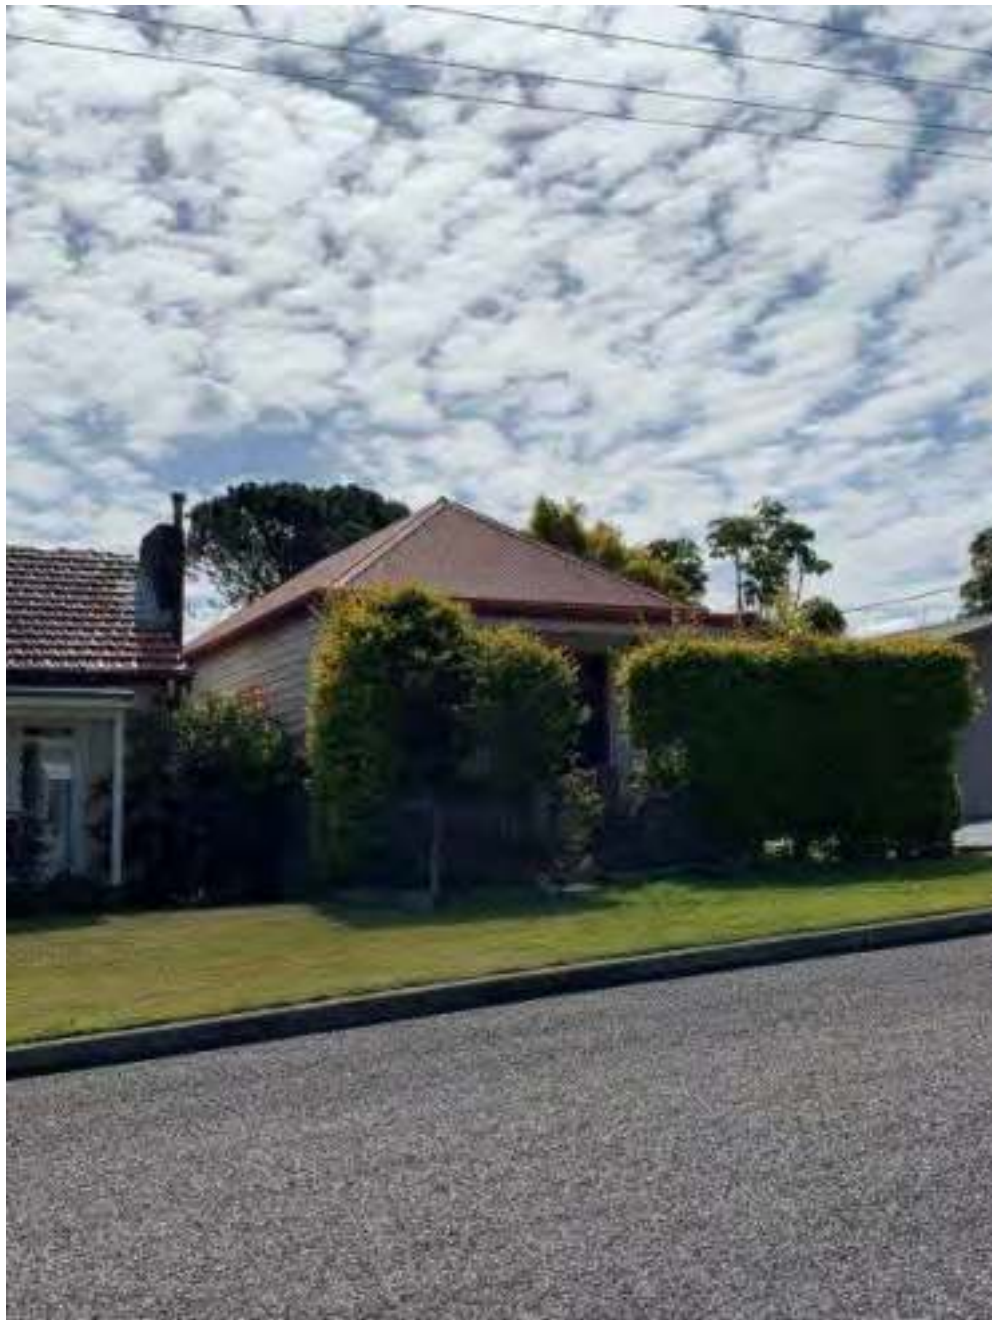
Conservation Area Contribution Level	Est. Construction Date	Previous studies and/or community input
Contributory 1	1915–1930	No prior heritage investigations and no additional information required
Assessment Text		Observed Modifications
<p>Single story Inter-War dwelling with Colourbond hipped roof and weatherboard cladding.</p> <p>The front façade of the dwelling has rendered masonry pillars, likely originally a part of an open veranda.</p> <p>The bay window has a triple panel sash window design and simple sill.</p> <p>A car port and garage is located to the east of the dwelling.</p> <p>The dwelling displays architectural features of a heritage style and is representative of the local development of this period, being of historical significance for the HCA.</p>		<p>The dwelling has been extensively modified, with the veranda being built in to create an additional living area, all visible windows being contemporary installations and an extension being constructed on the back southern portion of the dwelling.</p>

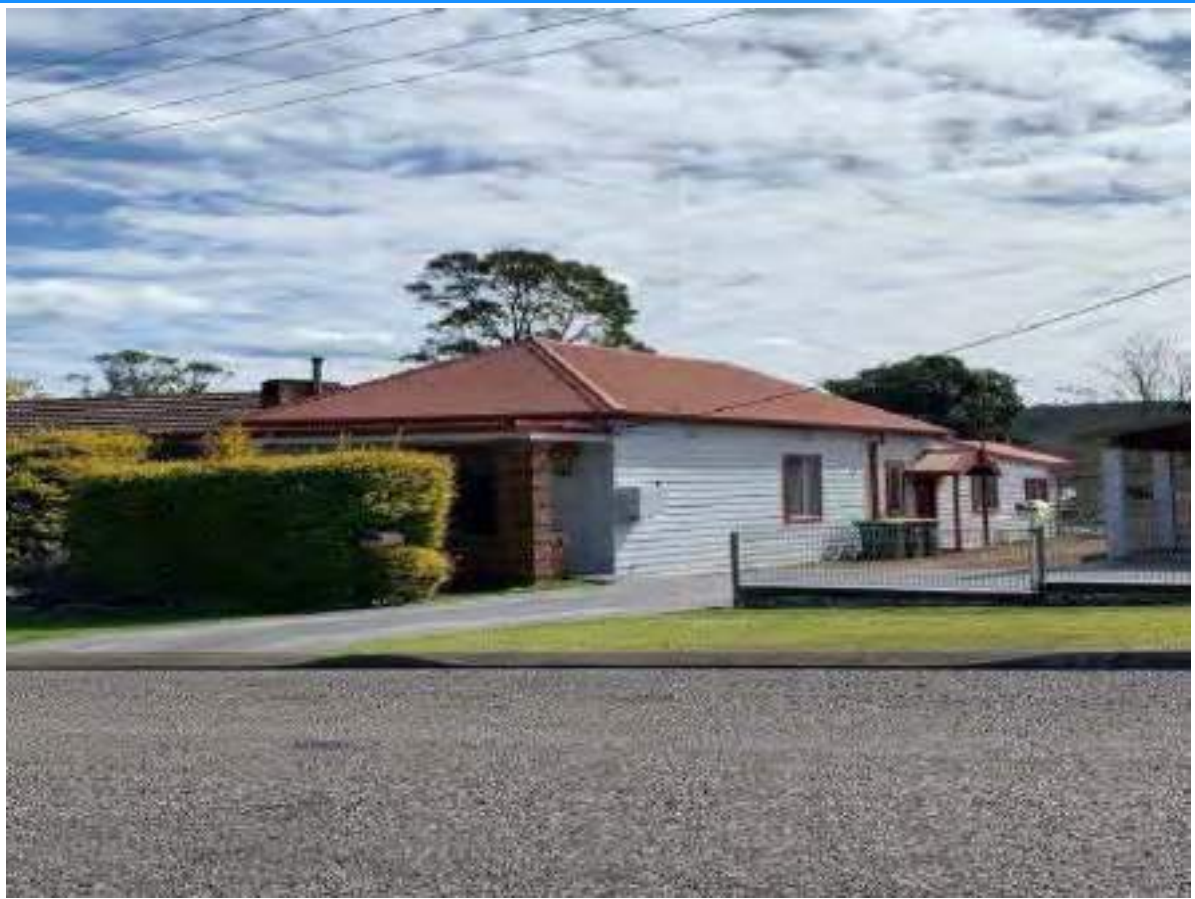
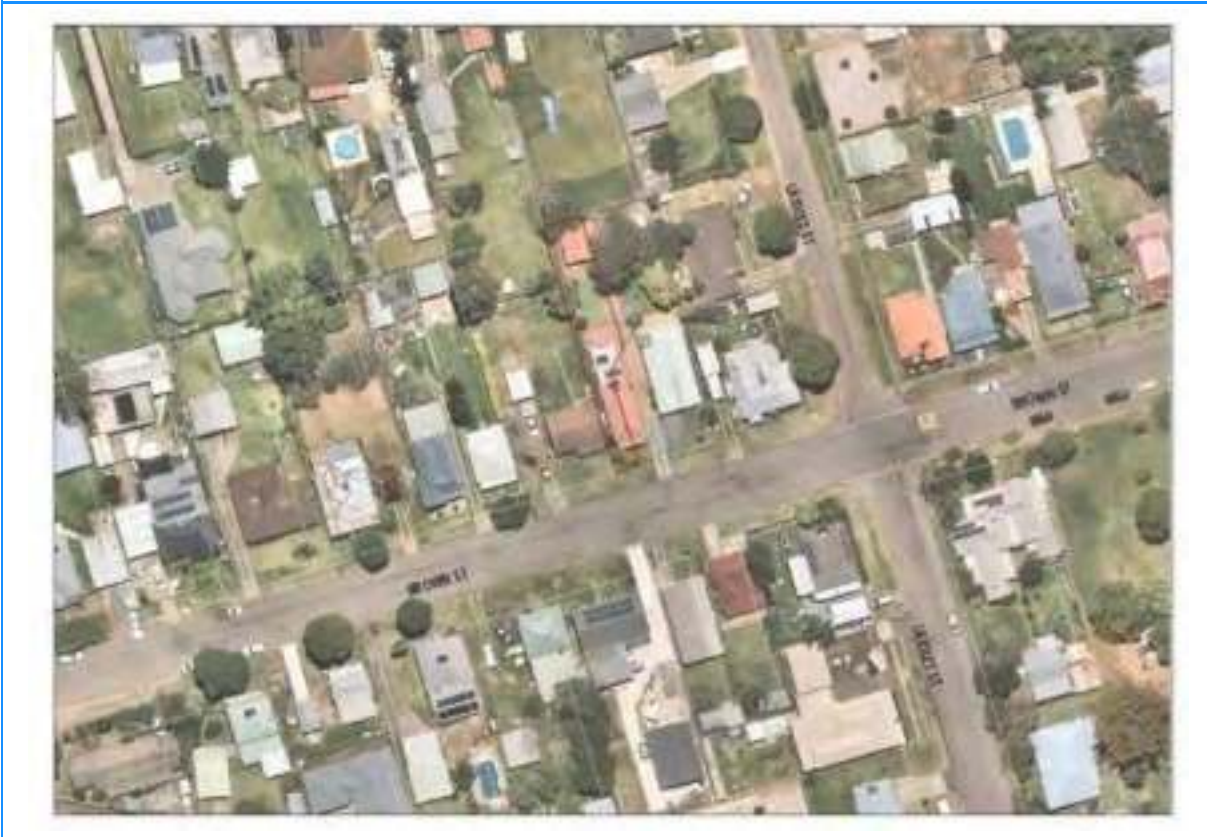
Conservation Area Contribution Level	Est. Construction Date	Previous studies and/or community input
Contributory 1	1900–1915	No prior heritage investigations and no additional information required
Assessment Text		Observed Modifications
<p>Singles tory simplified Victorian Regency style dwelling with Colourbond hipped roof and weatherboard cladding. The veranda roof is flat and supported by brick pillars.</p> <p>The veranda is partially enclosed by brickwork pillars and brick wall with dental coursework features. A section of metal balustrade is also visible.</p> <p>A gabled projection on the eastern side of the dwelling leads to the front door, a timber finial is atop.</p> <p>A skillion roof garage is located to the north of the dwelling.</p> <p>The dwelling displays architectural features of a heritage style and is representative of the local development of this period, being of historical significance for the HCA.</p>		<p>All visible windows are contemporary timber framed sliding designs.</p> <p>It is likely that the gabled projection entrance archway is a contemporary addition to the dwelling, and has been constructed in a heritage style.</p> <p>The veranda balustrade, wall and brick pillars are all additions, likely replacing timber structures.</p>

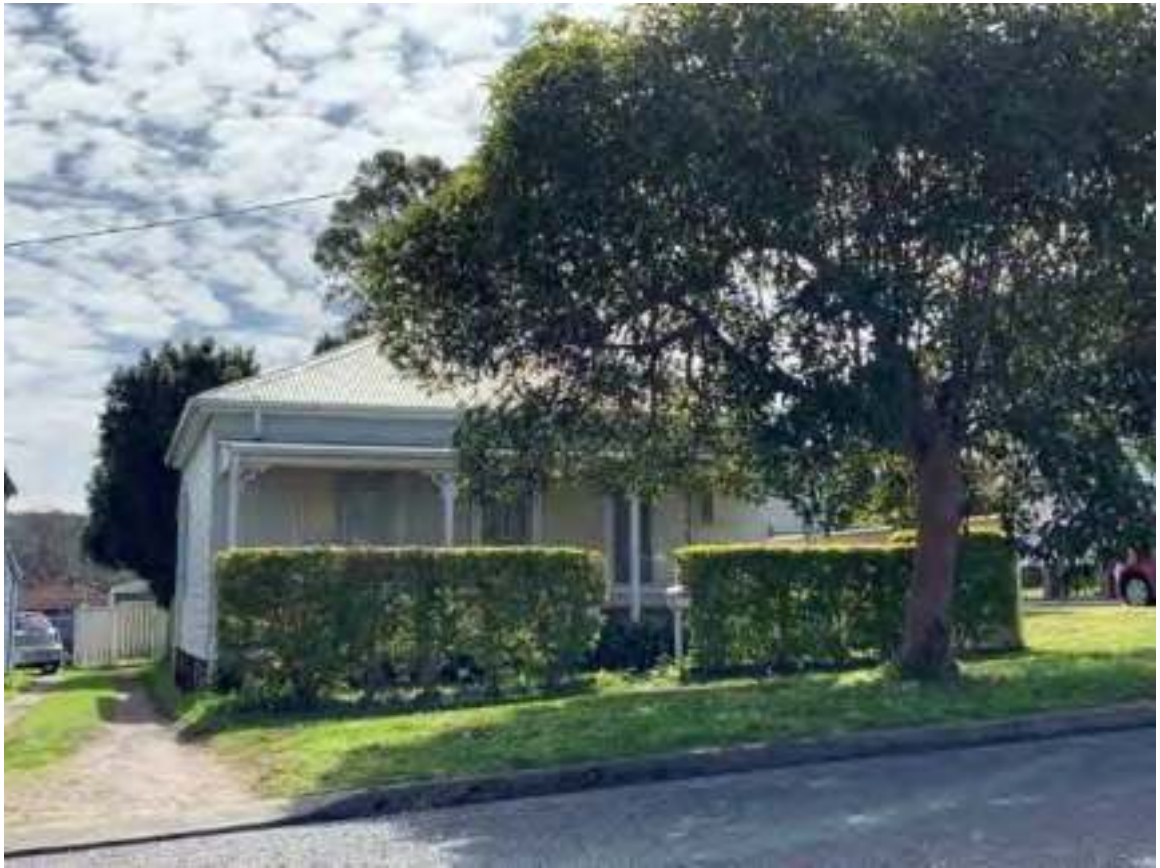
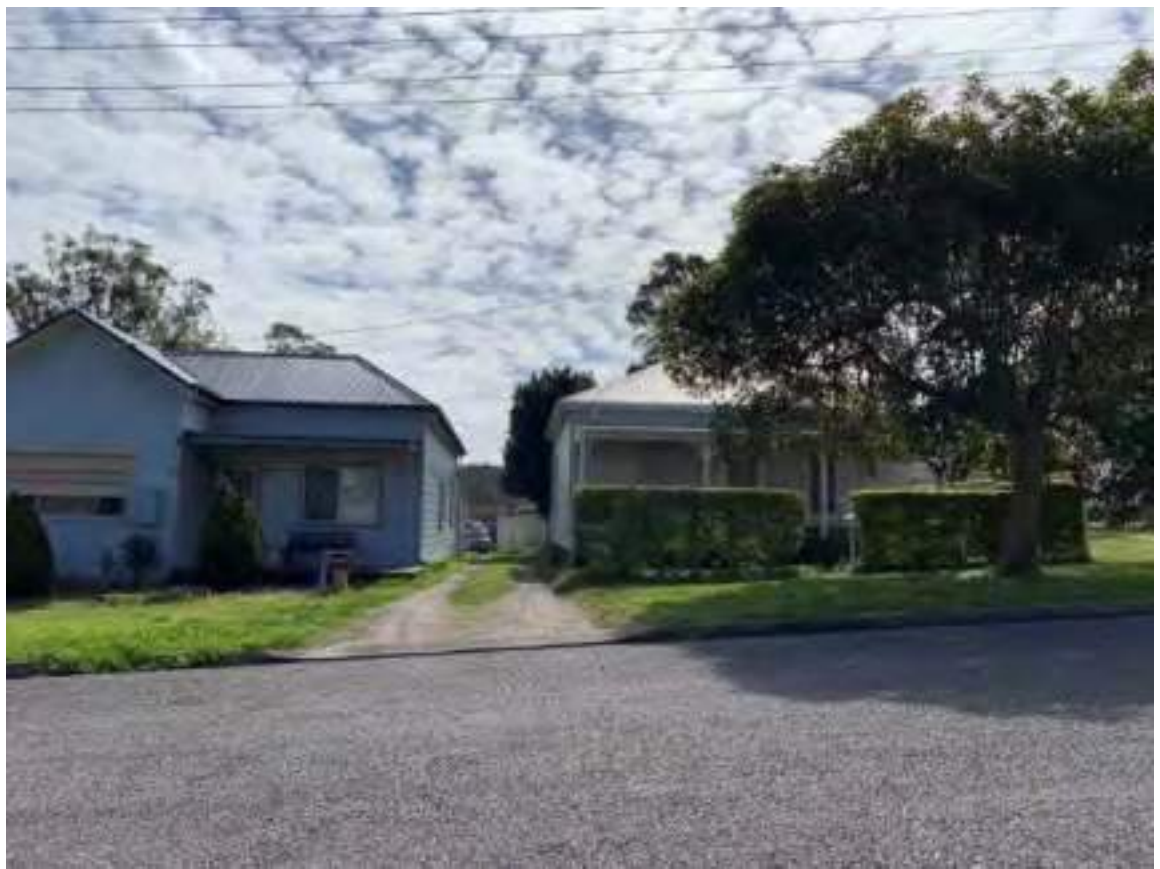
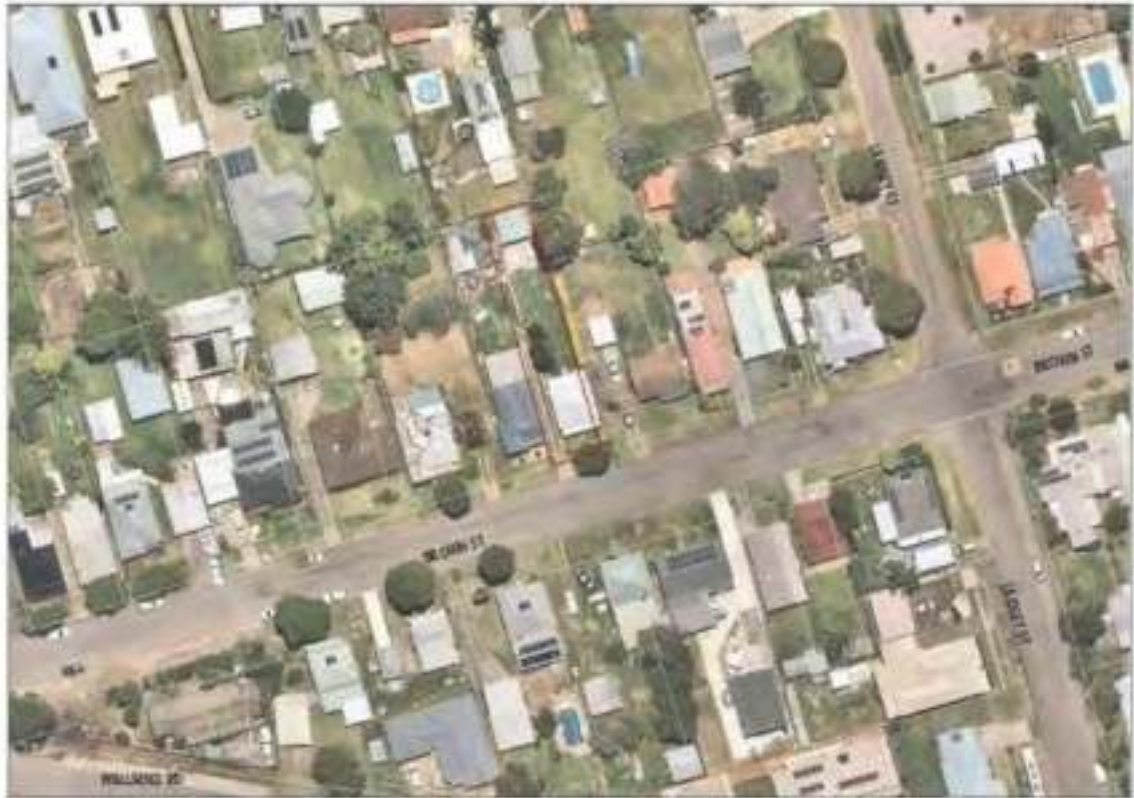
63 BROWN STREET, WEST WALLSEND 2286

Conservation Area Contribution Level	Est. Construction Date	Previous studies and/or community input
Contributory 1	1890–1915	No prior heritage investigations and no additional information required
Assessment Text		Observed Modifications
<p>Single story Vernacular ‘Mining Cottage’ style dwelling with hipped Colourbond roof and weatherboard cladding. The veranda roof is skillion and supported by ornately carved timber posts.</p> <p>The dwelling displays architectural features of a heritage style and is representative of the local development of this period, being of historical significance for the HCA.</p>		<p>All visible windows have been replaced with contemporary timber framed sliding designs.</p> <p>the front door has a prominent metal ornately designed screen door.</p> <p>The veranda roof is skillion, replacing the original bull nosed design.</p> <p>The timber carved support pillars are likely a contemporary replication of a heritage style.</p>

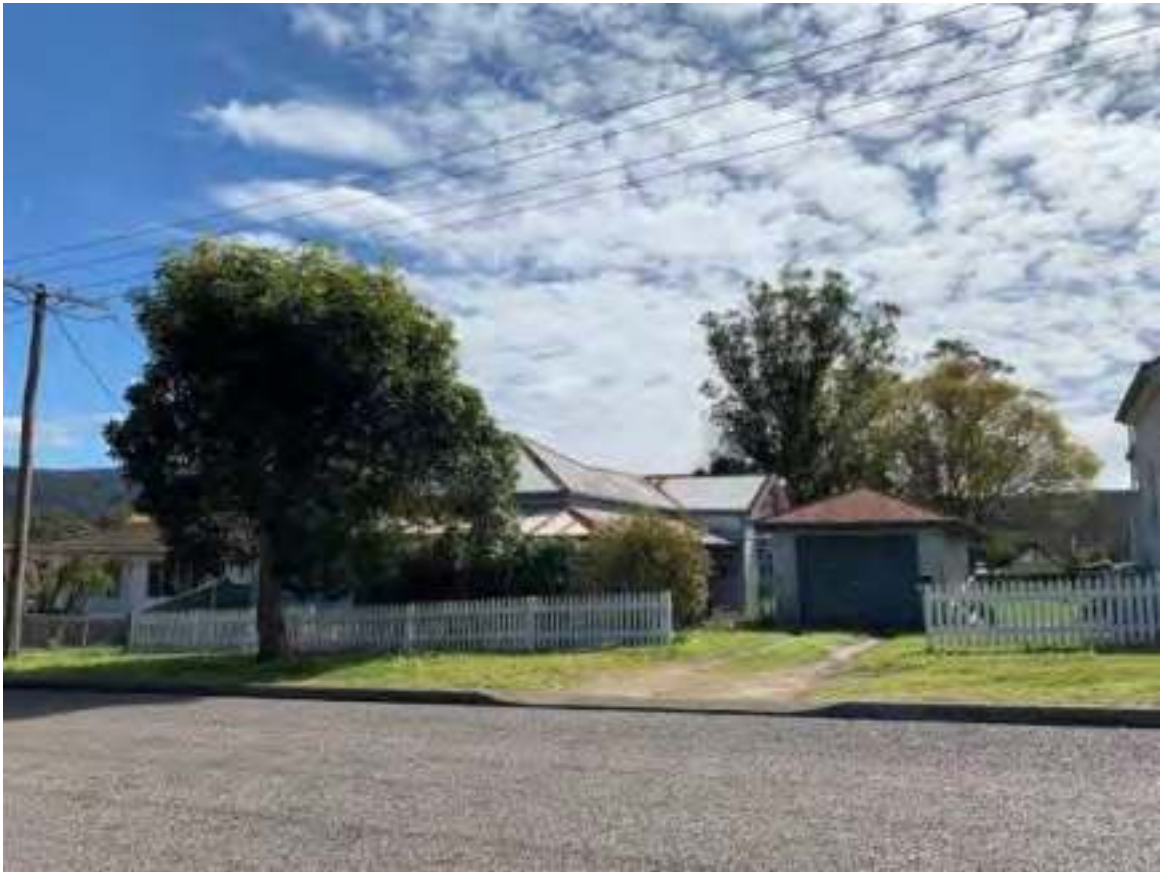
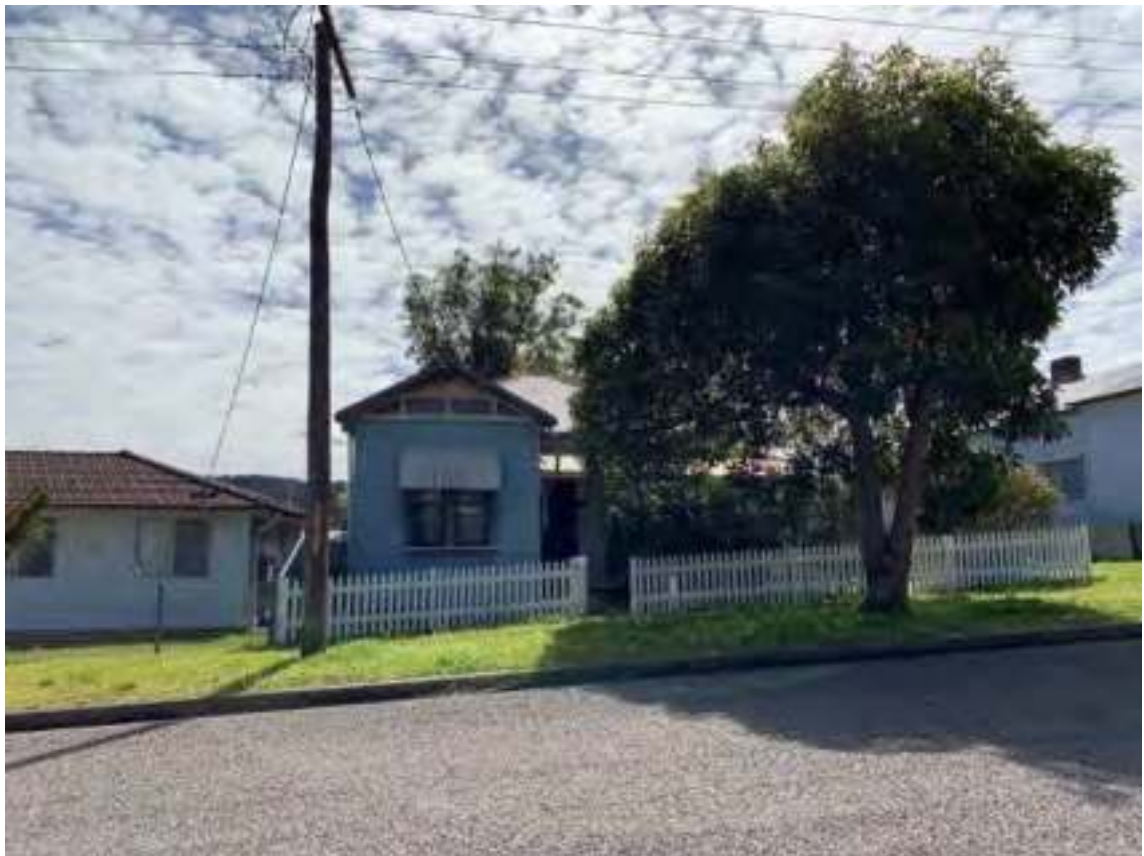
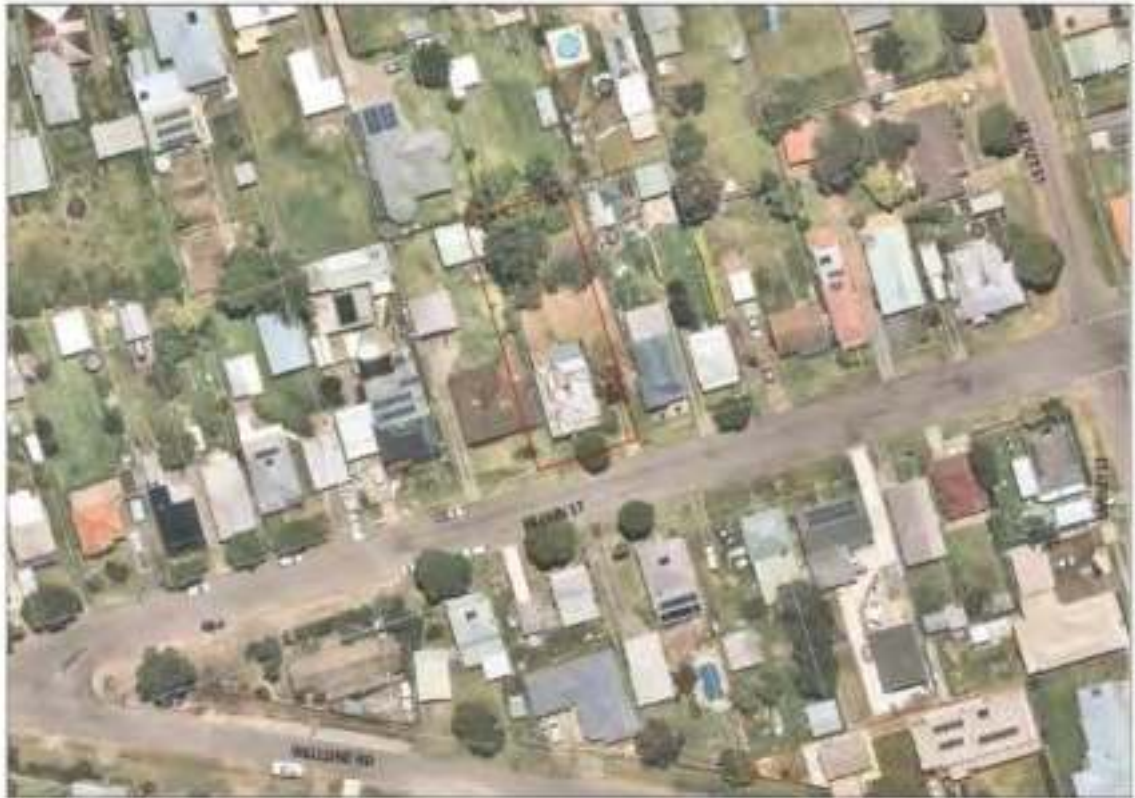
67 BROWN STREET, WEST WALLSEND 2286

Conservation Area Contribution Level	Est. Construction Date	Previous studies and/or community input
Contributory 1	1910–1930	No prior heritage investigations and no additional information required
Assessment Text		Observed Modifications
<p>Singles story Vernacular version of a Federation Queen Anne dwelling with half hipped and gable Colourbond roof and timber weatherboard cladding. The veranda roof is hipped.</p> <p>The veranda encircles the southern and eastern sides of the dwelling, with the roof supported by timber posts with ornate brackets.</p> <p>All visible windows appear to be the original heavy timber framed sash styles. The gable window has an ornately carved sill.</p> <p>The gable has a simply decorated barge board and battening detailing.</p> <p>A timber fence encloses the property.</p> <p>A garage is located to the east of the dwelling.</p> <p>The dwelling displays architectural features of a heritage style and is representative of the local development of this period, being of historical significance for the HCA.</p>		<p>The dwelling likely originally had a decorative valance framing the veranda roof.</p> <p>The gable window awning was likely originally a more ornate timber design.</p>

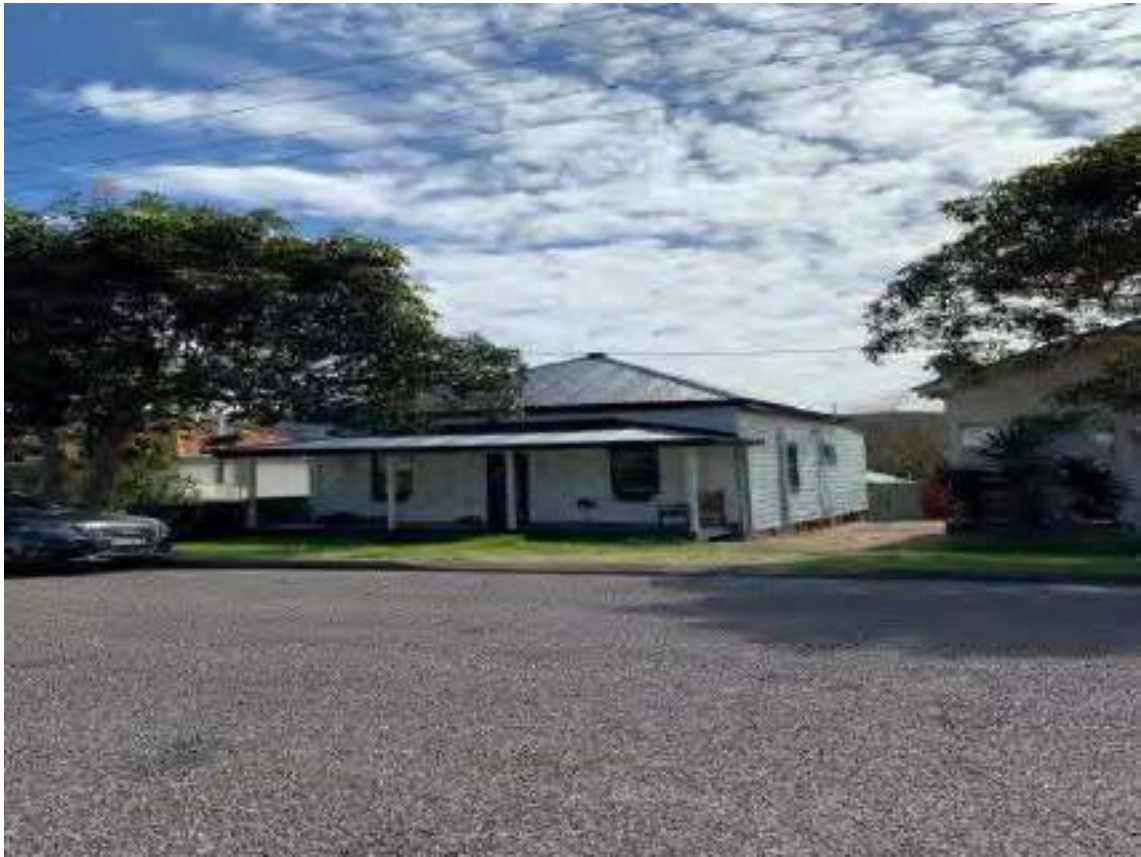
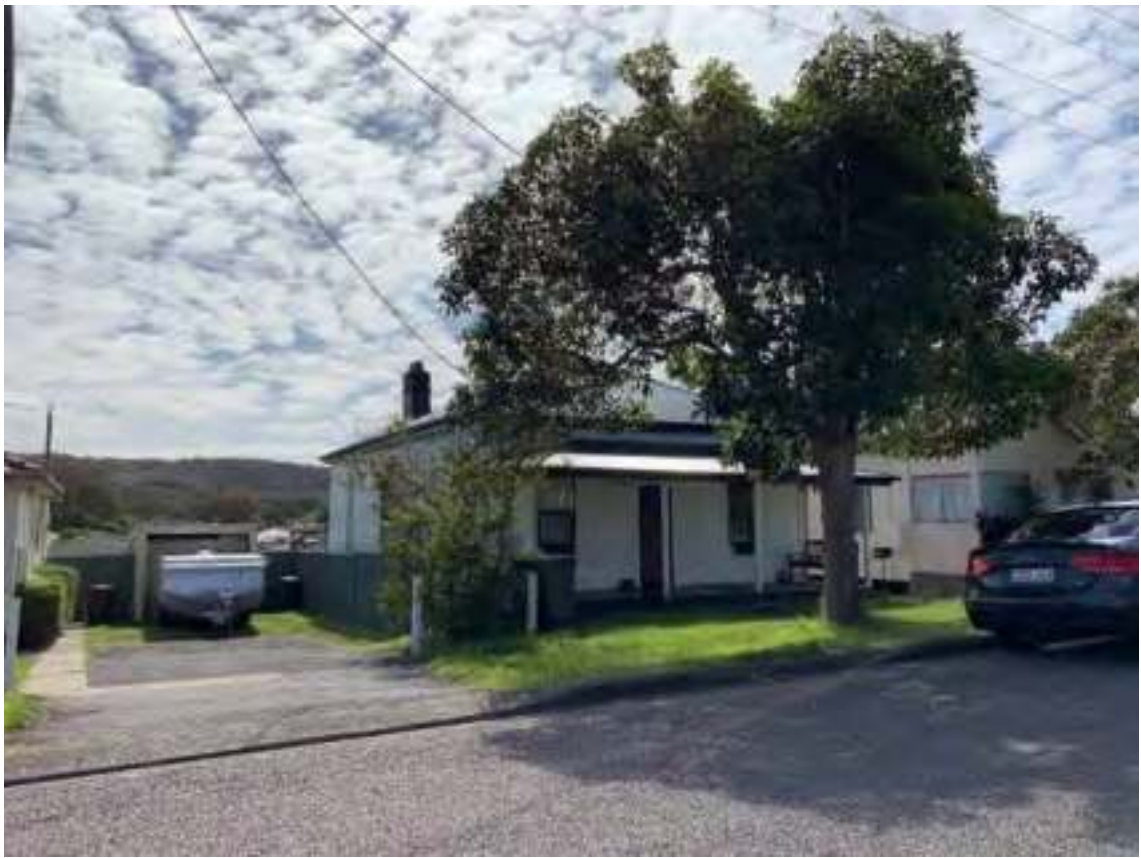
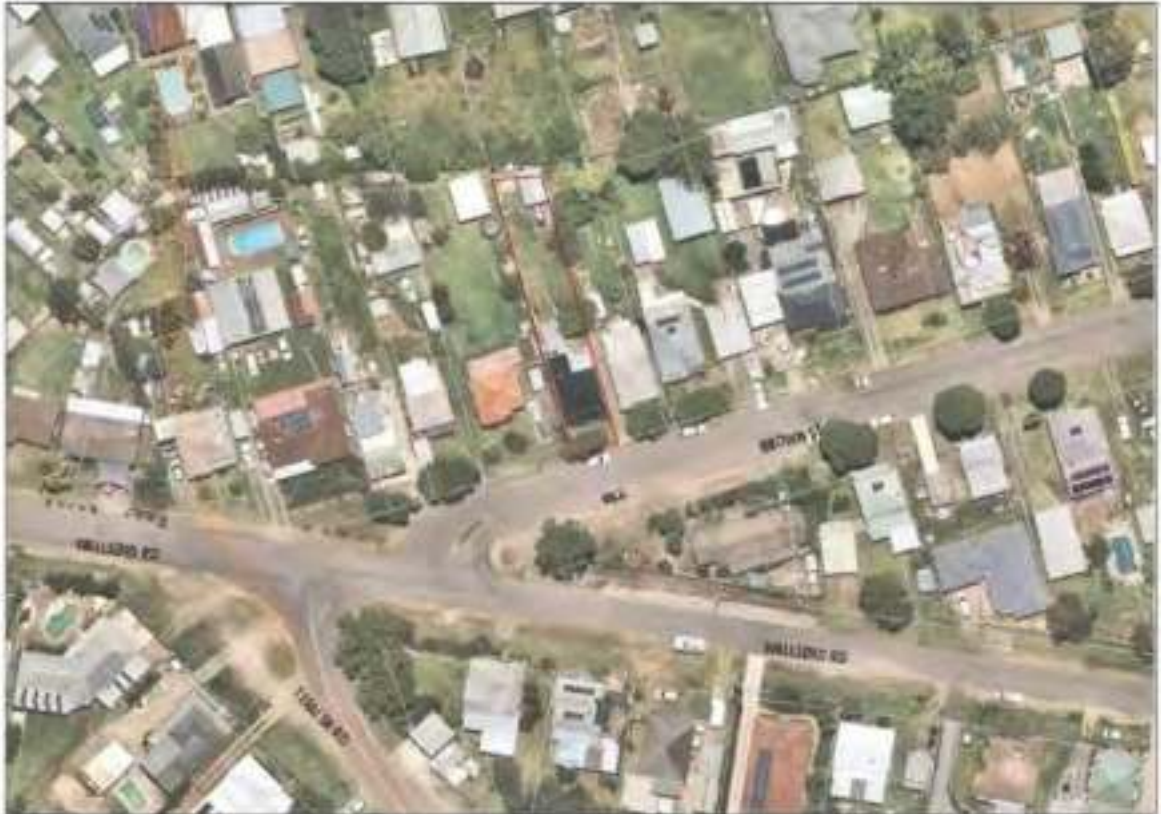
79 BROWN STREET, WEST WALLSEND 2286

Conservation Area Contribution Level	Est. Construction Date	Previous studies and/or community input
Contributory 1	1890–1915	No prior heritage investigations and no additional information required
Assessment Text		Observed Modifications
<p>Single story Vernacular ‘Mining Cottage’ style dwelling with hipped Colourbond roof and weatherboard cladding. The veranda roof is hipped.</p> <p>The front door is timber framed with a metal security screen. Sash windows are located on either side. the visible windows are potentially the original styles.</p> <p>A rendered brickwork chimney is visible on the western side of the dwelling, with two terracotta pots.</p> <p>The dwelling displays architectural features of a heritage style and is representative of the local development of this period, being of historical significance for the HCA.</p>		<p>The hipped veranda roof is a contemporary replacement of the original bull nosed design.</p> <p>The timber support posts are likely a contemporary replication of the original timber supports.</p>

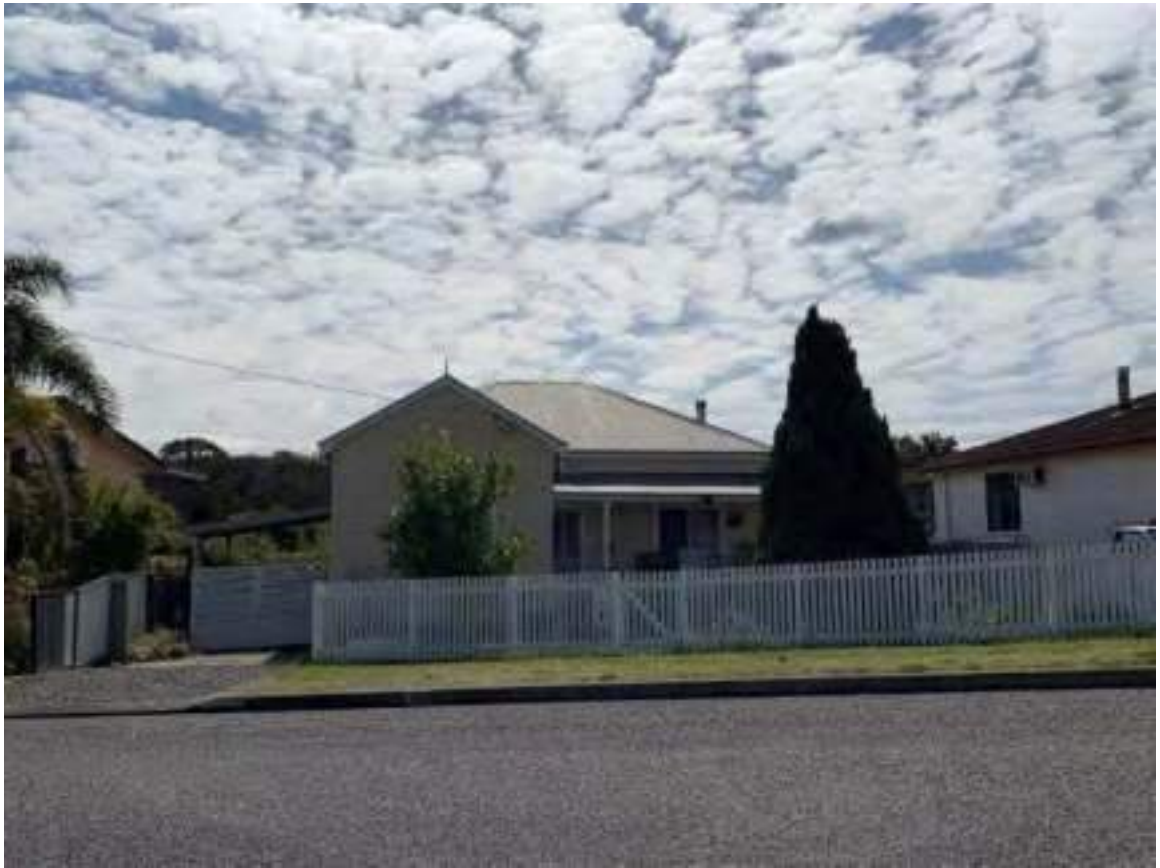
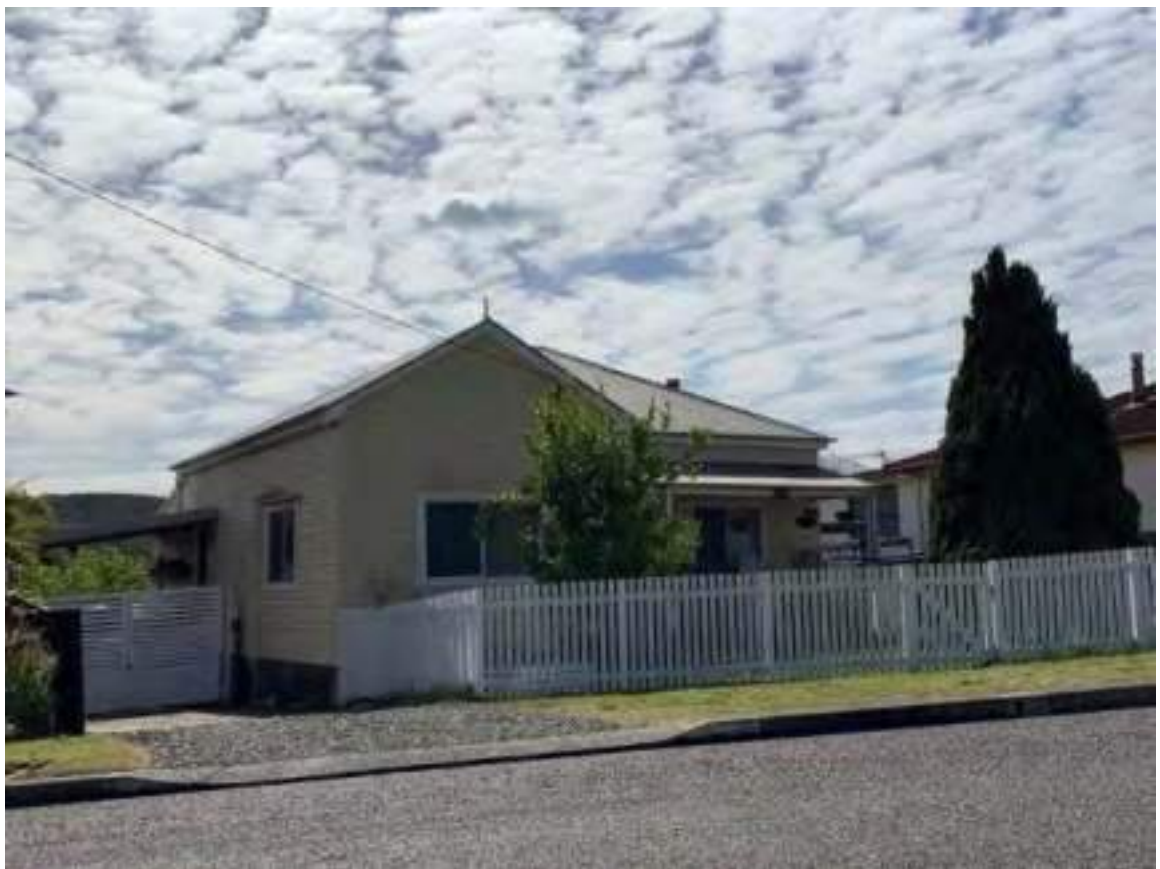
13 WALLSEND ROAD, WEST WALLSEND 2286

Conservation Area Contribution Level	Est. Construction Date	Previous studies and/or community input
Contributory 1	1895–1915	No prior heritage investigations and no additional information required
Assessment Text		Observed Modifications
<p>Single story simple Federation ‘workmen’s cottage’ style dwelling with hipped Colourbond roof with gable projection and weatherboard cladding. The veranda roof is skillion.</p> <p>The gable has simple extended eaves and a timber finial.</p> <p>A timber fence encloses the property.</p> <p>The dwelling displays architectural features of a heritage style and is representative of the local development of this period, being of historical significance for the HCA.</p>		<p>All visible windows have contemporary timber framed sliding designs installed, replacing the original sash or casement styles.</p> <p>A car port has been constructed directly attached to the western side of the dwelling.</p>

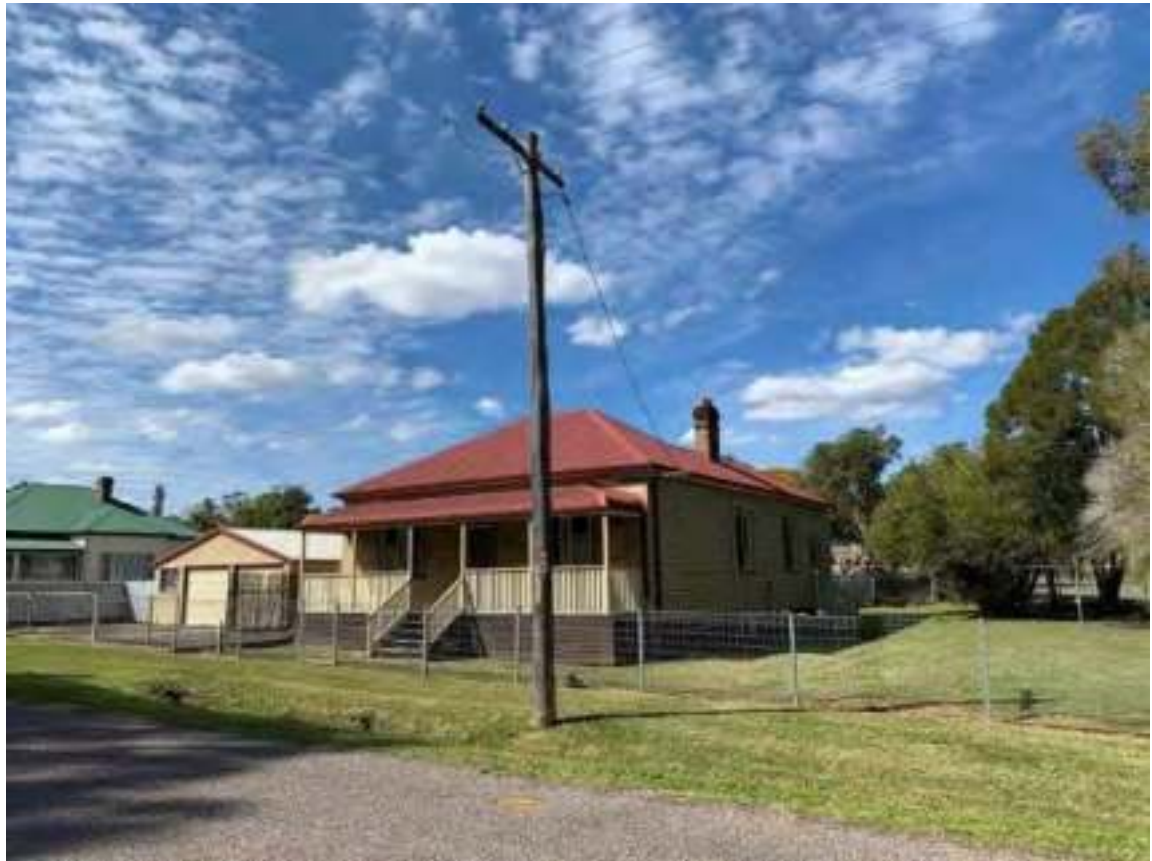
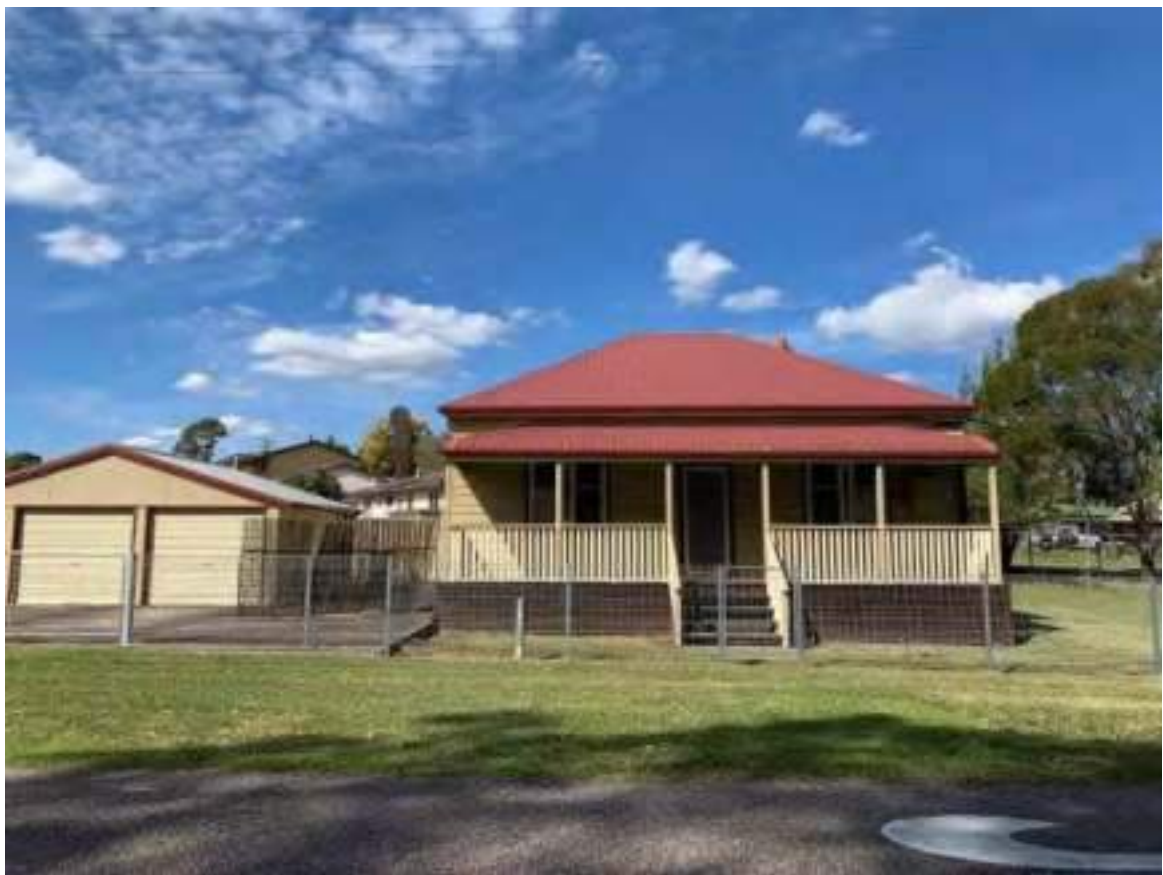
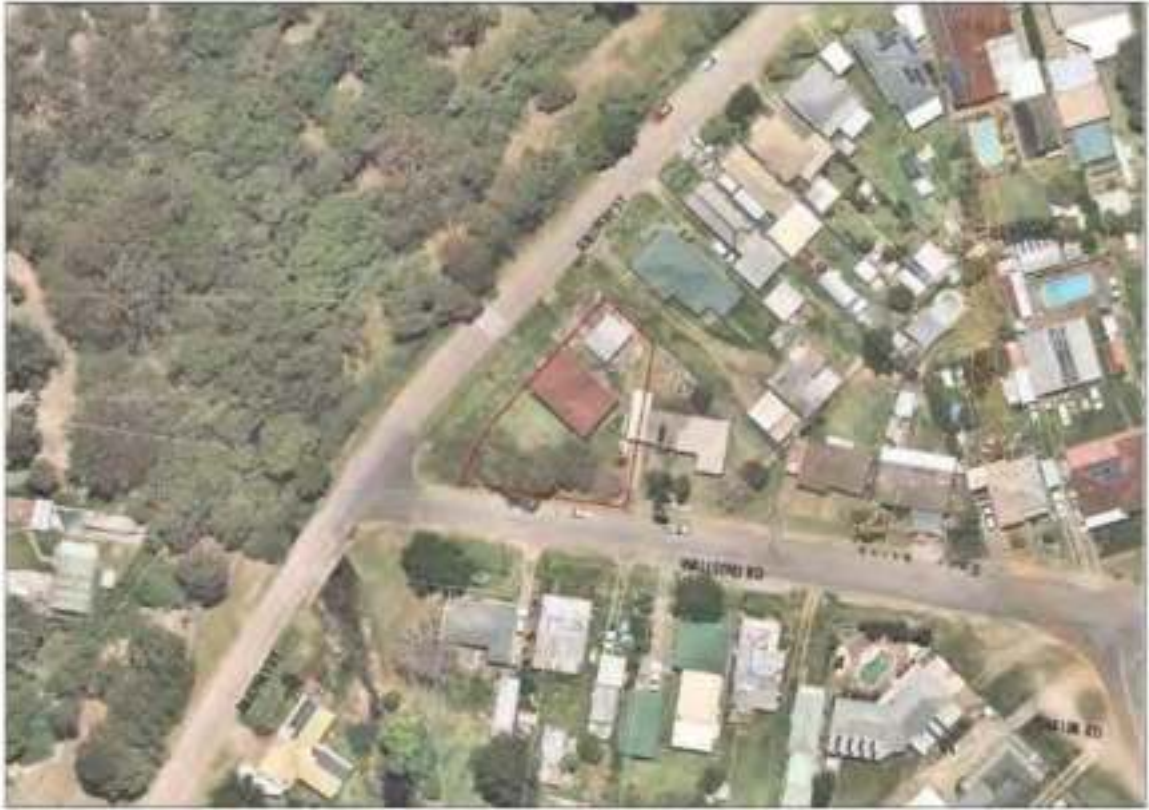
19 RAILWAY STREET, WEST WALLSEND 2286

Conservation Area Contribution Level	Est. Construction Date	Previous studies and/or community input
Contributory 1	1890–1915	No prior heritage investigations and no additional information required
Assessment Text		Observed Modifications
<p>Single story Vernacular ‘Mining Cottage’ style dwelling with Colourbond hipped roof and weatherboard cladding. The veranda has a bull nosed roof, potentially the original.</p> <p>The veranda is partially enclosed by timber balustrade, with the timber stairs leading onto the veranda landing having the same balustrade acting as support rails.</p> <p>The front door is timber framed with a metal security screen, with double panel sash windows to either side. An elaborately carved timber pilaster is situated between the two sash windows. the windows are the original heavy timber framed styles.</p> <p>A brickwork chimney is visible on the south western side of the dwelling, with two terracotta pots.</p> <p>A metal wire fence encloses the property.</p> <p>The dwelling displays architectural features of a heritage style and is representative of the local development of this period, being of historical significance for the HCA.</p>		<p>The timber balustrade of the veranda and stairs are a recent addition, however have been constructed in a sympathetic style and do not detract from the heritage streetscape.</p> <p>Timber boarding encloses the under house cavity, however this is a contemporary style and contrasts with the heritage style.</p> <p>An extension has been built onto the back south eastern side of the dwelling. this is visible however has been constructed in a sympathetic manner. A secondary entrance and timber staircase has been constructed in conjunction with the extension.</p>

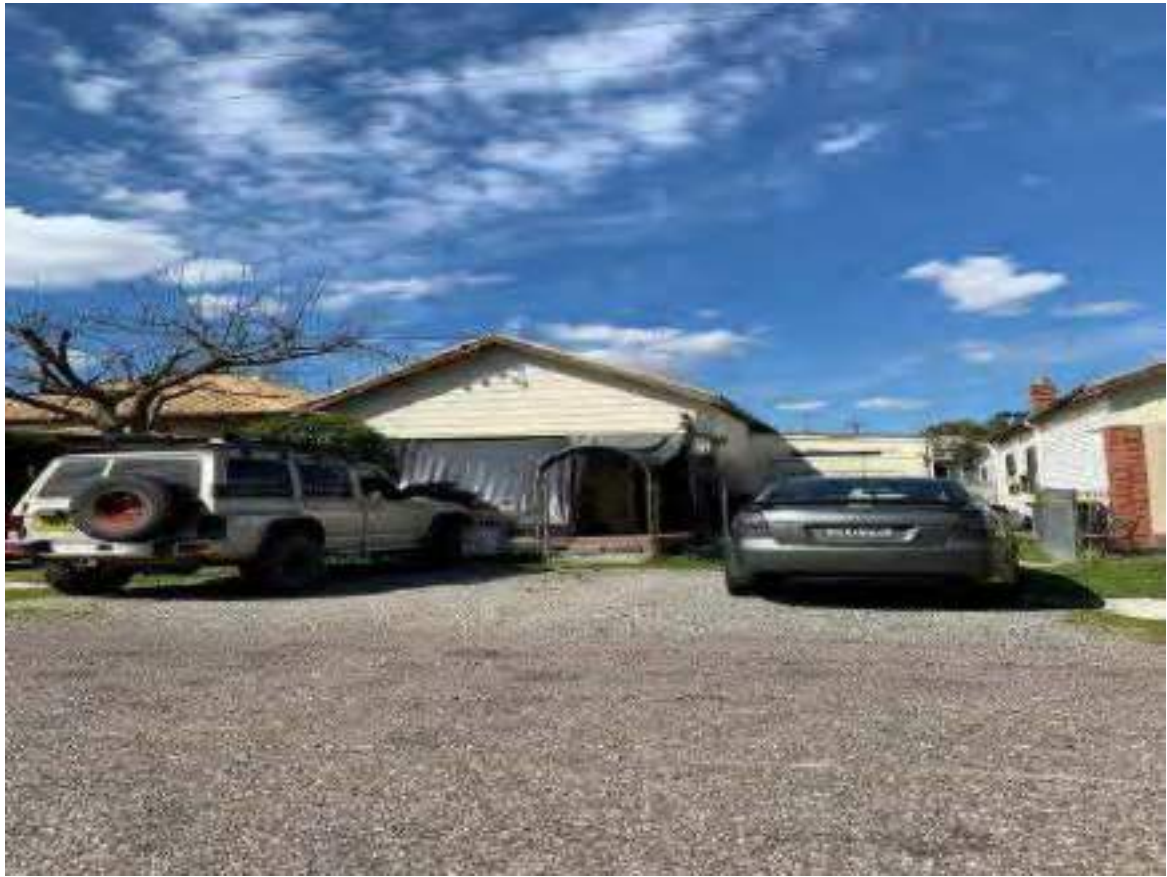
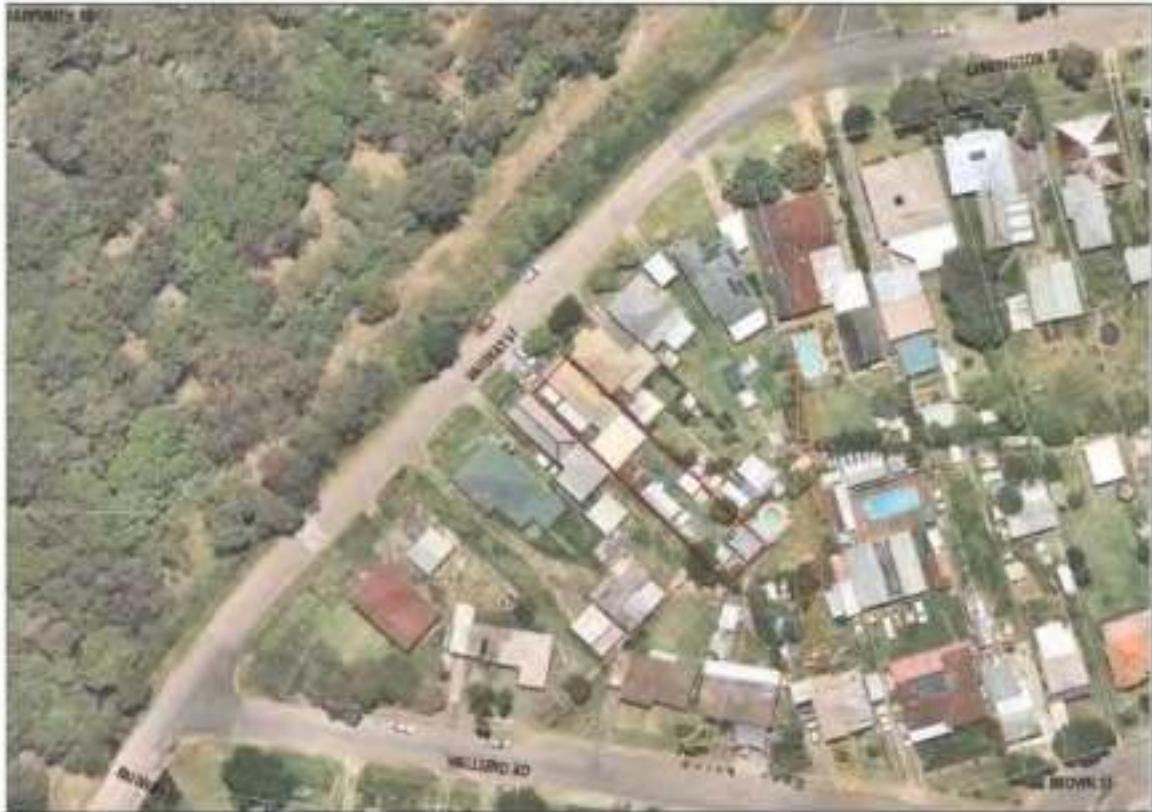
13 RAILWAY STREET, WEST WALLSEND 2286

Conservation Area Contribution Level	Est. Construction Date	Previous studies and/or community input
Contributory 1	1900–1915	No prior heritage investigations and no additional information required
Assessment Text		Observed Modifications
<p>Single story simplified Victorian Regency style dwelling with Colourbond gable roof and weatherboard cladding.</p> <p>An archway precedes the stairs leading onto the veranda landing.</p> <p>The dwelling is obscured due to the small lot size, proximity to adjacent buildings and the canvas/mesh blinds.</p> <p>The dwelling displays architectural features of a heritage style and is representative of the local development of this period, being of historical significance for the HCA.</p>		<p>An extension has been built onto the south western side of the dwelling. this is highly visible from the street and detracts.</p> <p>The veranda has been enclosed by canvas/mesh screening.</p>
