APPENDIX 2

Building Assessment Sheets (Inventory Sheets)

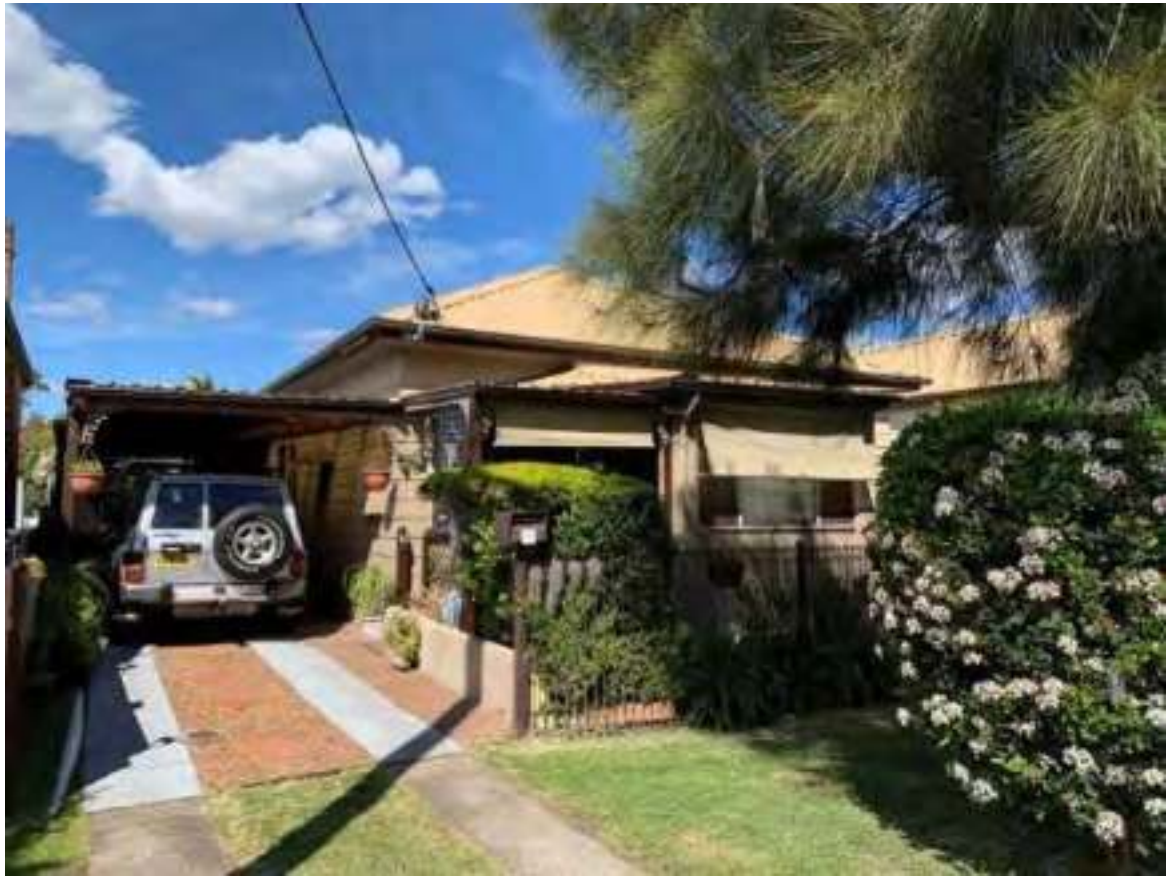
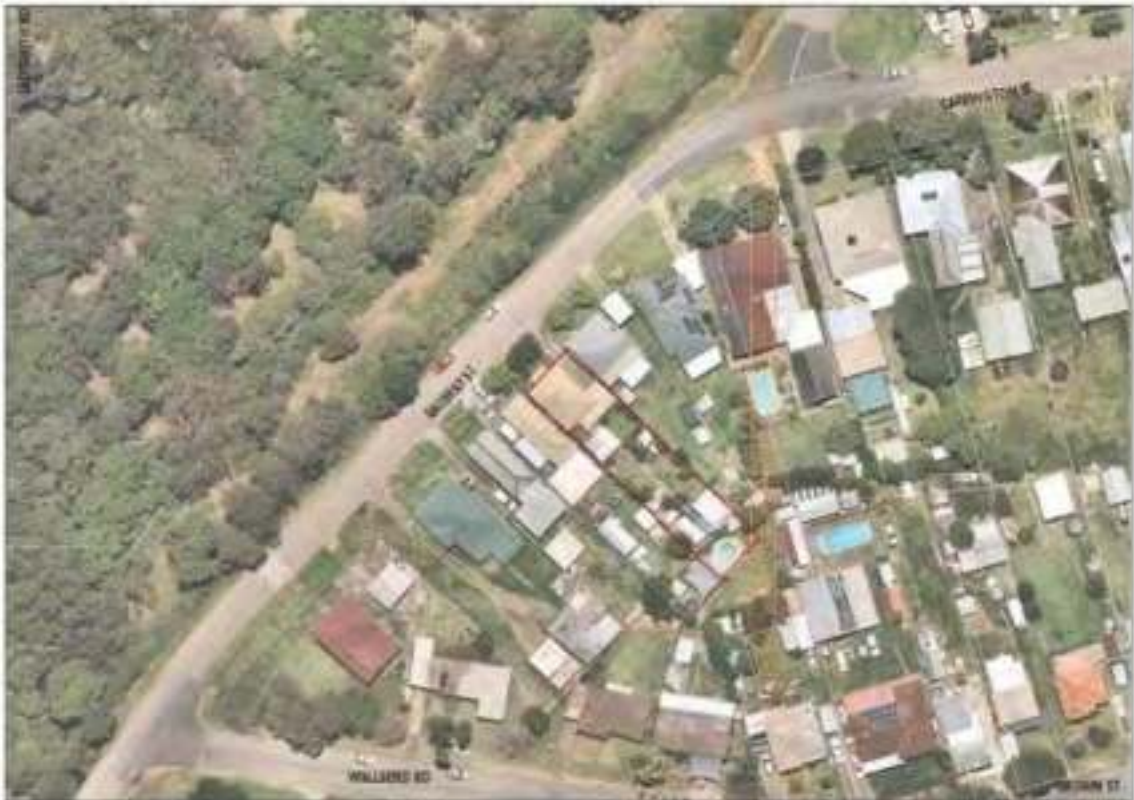
11 RAILWAY STREET, WEST WALLSEND 2286

Conservation Area Contribution Level	Est. Construction Date	Previous studies and/or community input
Contributory 1	1900–1920	No prior heritage investigations and no additional information required
Assessment Text		Observed Modifications
<p>Single story Vernacular ‘mining Cottage’ style dwelling with Colourbond hipped roof and weatherboard cladding. The veranda roof is hipped and framed by cast iron lace valance.</p> <p>The veranda is enclosed by a combination of lattice timber balustrade, canvas blinds and an in-built section.</p> <p>The front façade windows have ornate carved timber sills.</p> <p>The dwelling is partially obscured by vegetation growth.</p> <p>The dwelling displays architectural features of a heritage style and is representative of the local development of this period, being of historical significance for the HCA.</p>		<p>All visible windows are contemporary sliding styles, replacing the original timber framed sash styles.</p> <p>The veranda balustrade is a recent addition, with lattice work being common modification for the area.</p> <p>A portion of the veranda has been built in creating an additional living area.</p>

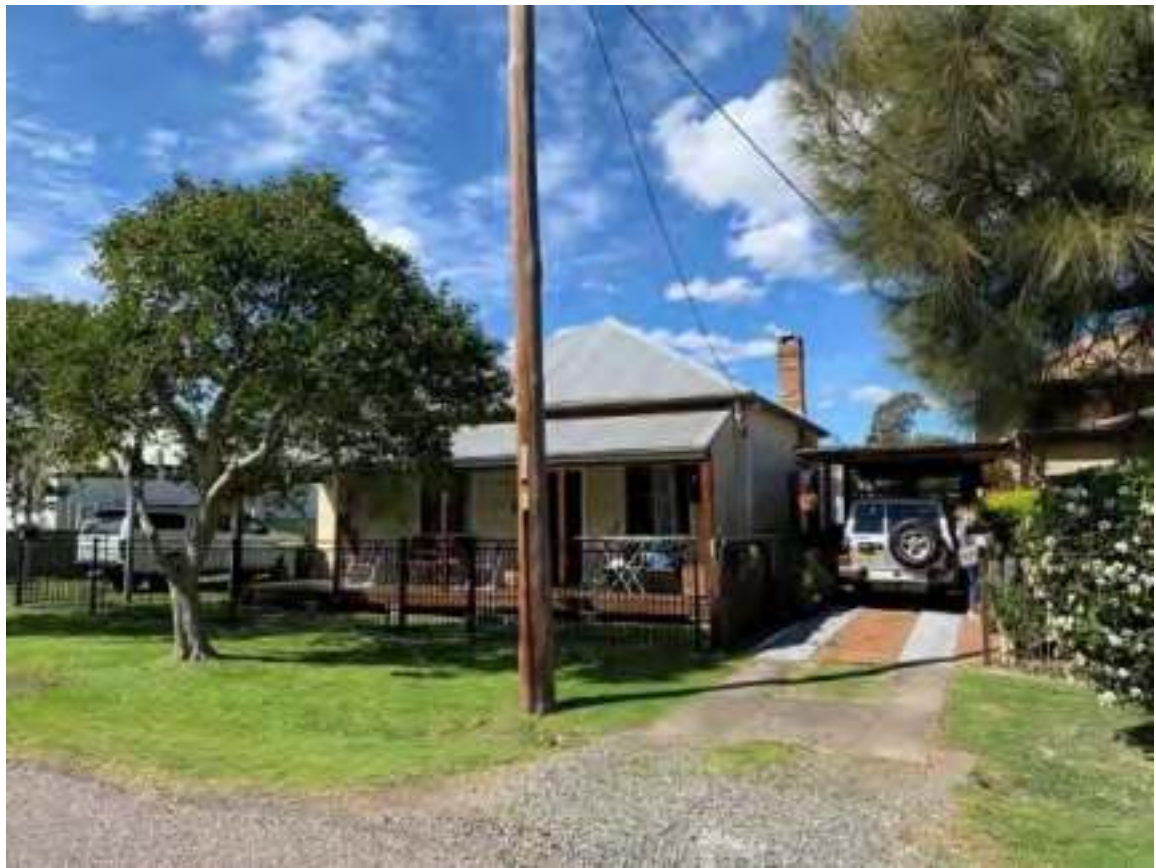
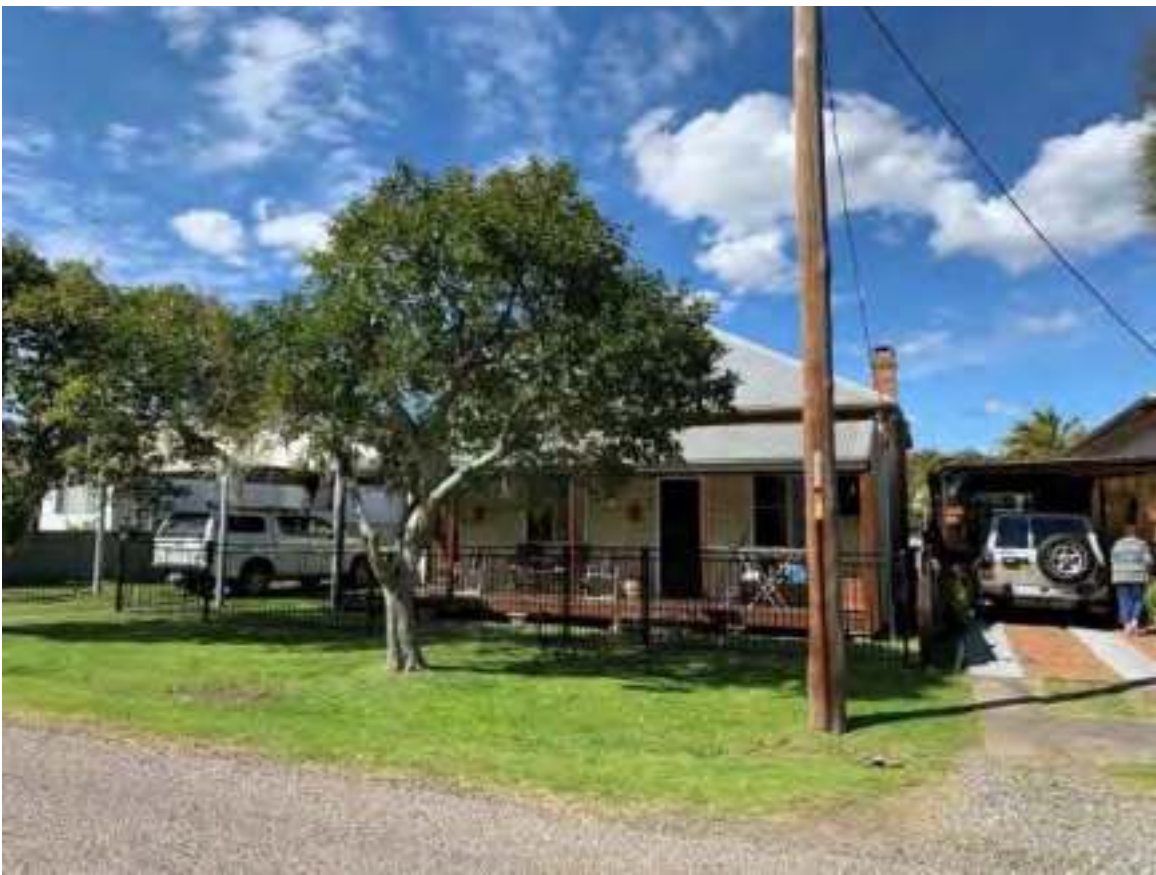
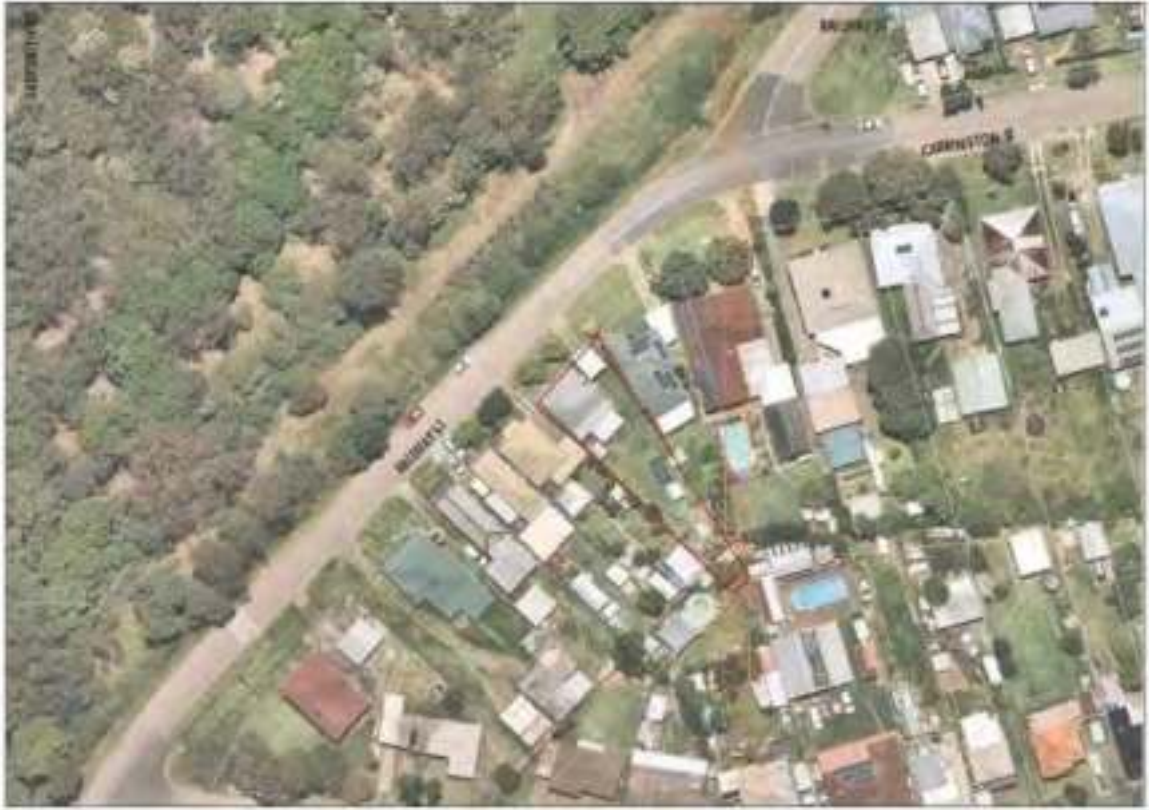
9 RAILWAY STREET, WEST WALLSEND 2286

Conservation Area Contribution Level	Est. Construction Date	Previous studies and/or community input
Contributory 1	1890–1915	No prior heritage investigations and no additional information required
Assessment Text		Observed Modifications
<p>Single story Vernacular ‘Mining Cottage’ style dwelling with hipped Colourbond roof and weatherboard cladding. The veranda roof is skillion.</p> <p>A car port is visible at the front northern side of the dwelling.</p> <p>The dwelling displays architectural features of a heritage style and is representative of the local development of this period, being of historical significance for the HCA.</p>		<p>The veranda roof would have originally been a bull nosed style.</p> <p>The visible windows are contemporary sliding styles, replacing the original sash styles.</p> <p>An extension has been constructed on the north eastern side of the veranda, creating an additional living area with secondary timber framed door.</p> <p>A gable roof extension has been constructed on the south eastern side of the dwelling. this is partially visible but has been constructed in a sympathetic manner and does not detract.</p>

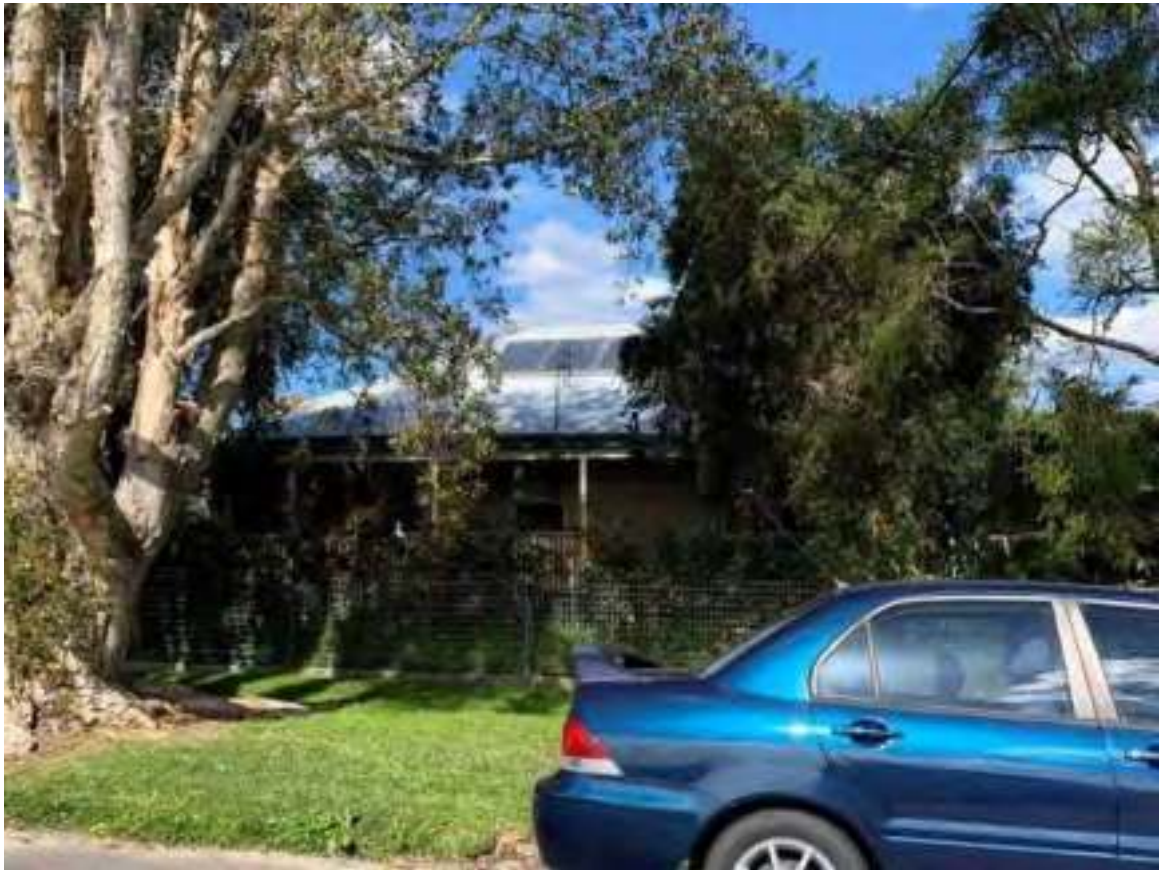
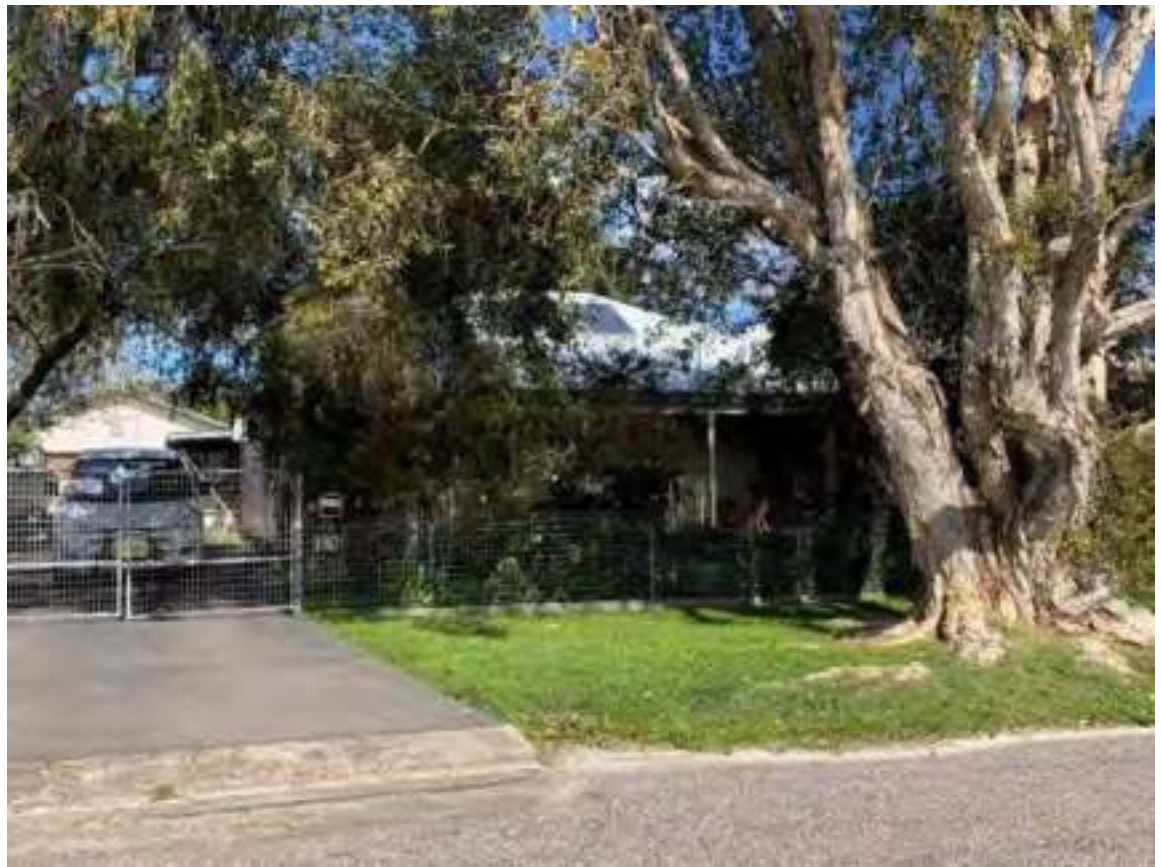
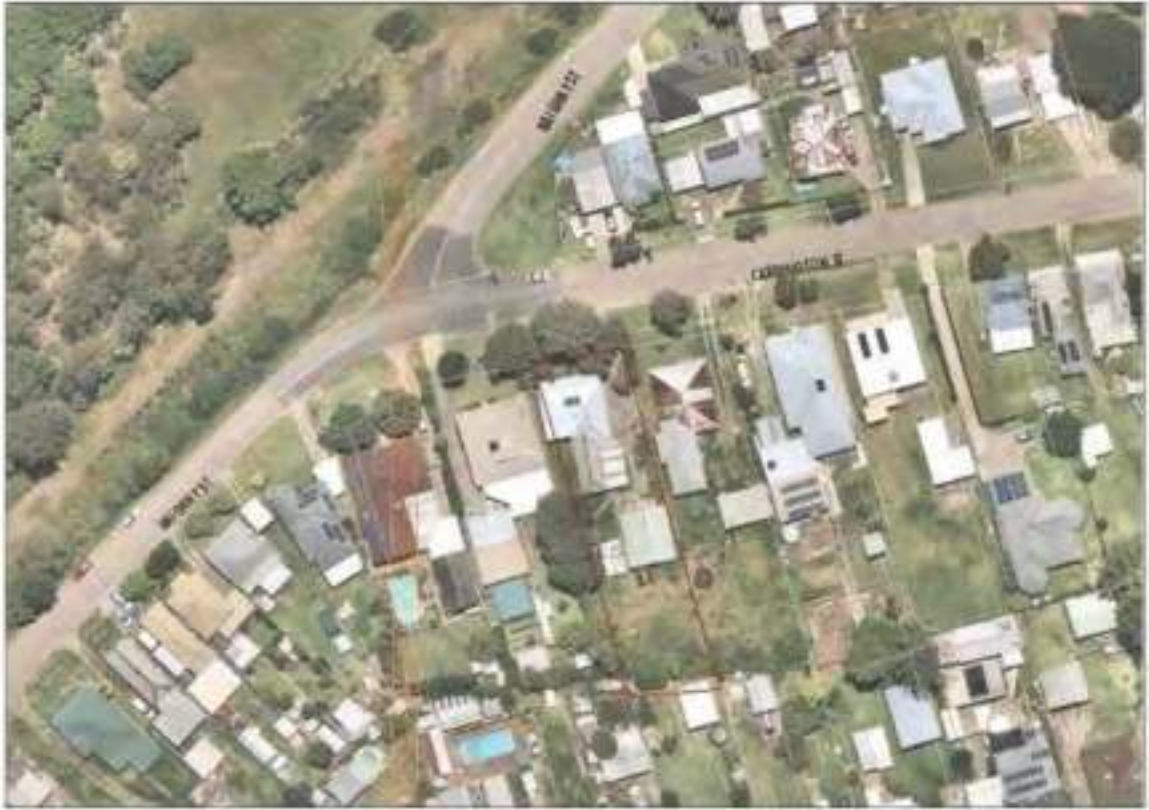
110 CARRINGTON STREET, WEST WALLSEND 2286

Conservation Area Contribution Level	Est. Construction Date	Previous studies and/or community input
Contributory 1	1890–1920	No prior heritage investigations and no additional information required
Assessment Text		Observed Modifications
<p>Single story dwelling with Colourbond hipped roof and weatherboard cladding. The veranda roof is skillion.</p> <p>The veranda is partially enclosed by timber balustrade.</p> <p>Metal wire fencing encloses the property.</p> <p>The dwelling is heavily obscured by mature vegetation and as such an accurate assessment cannot be undertaken.</p> <p>The dwelling displays architectural features of a heritage style and is representative of the local development of this period, being of historical significance for the HCA.</p>		<p>The veranda balustrade is likely a contemporary addition to the dwelling.</p>

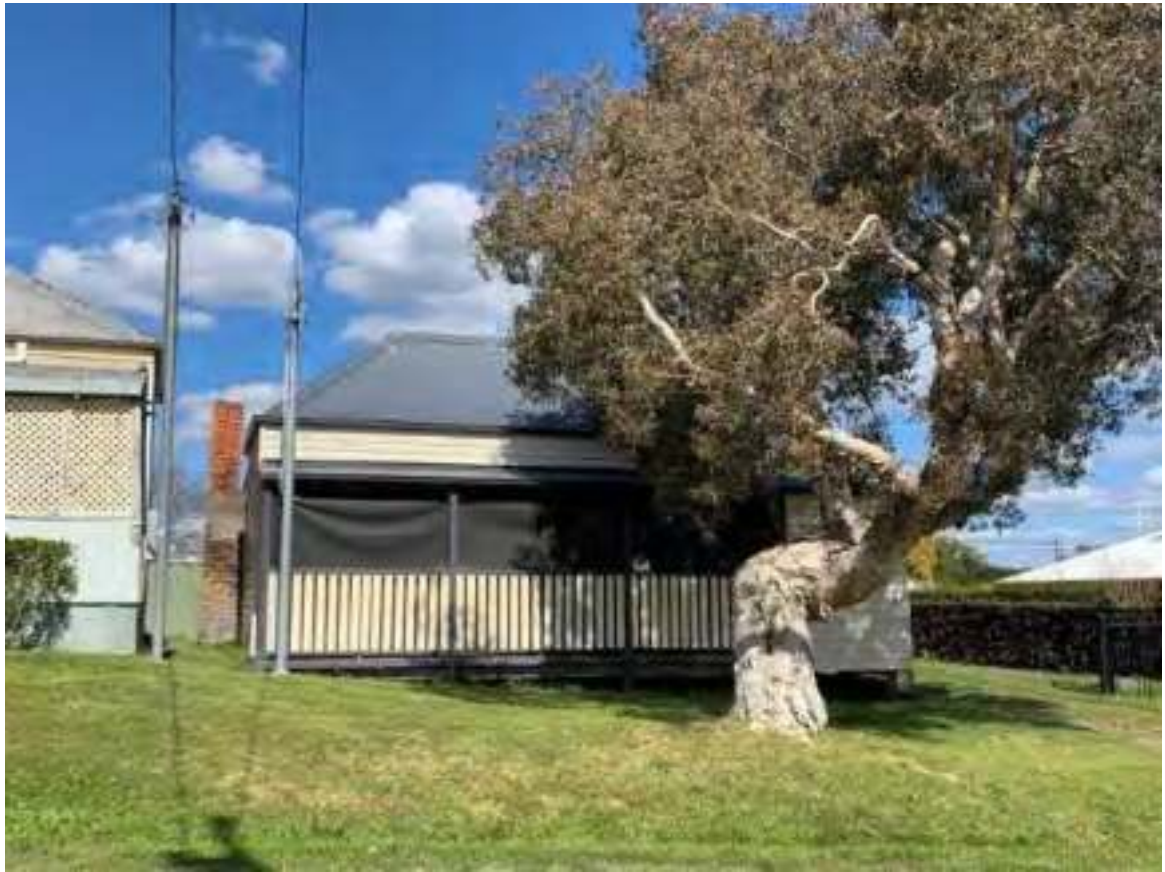
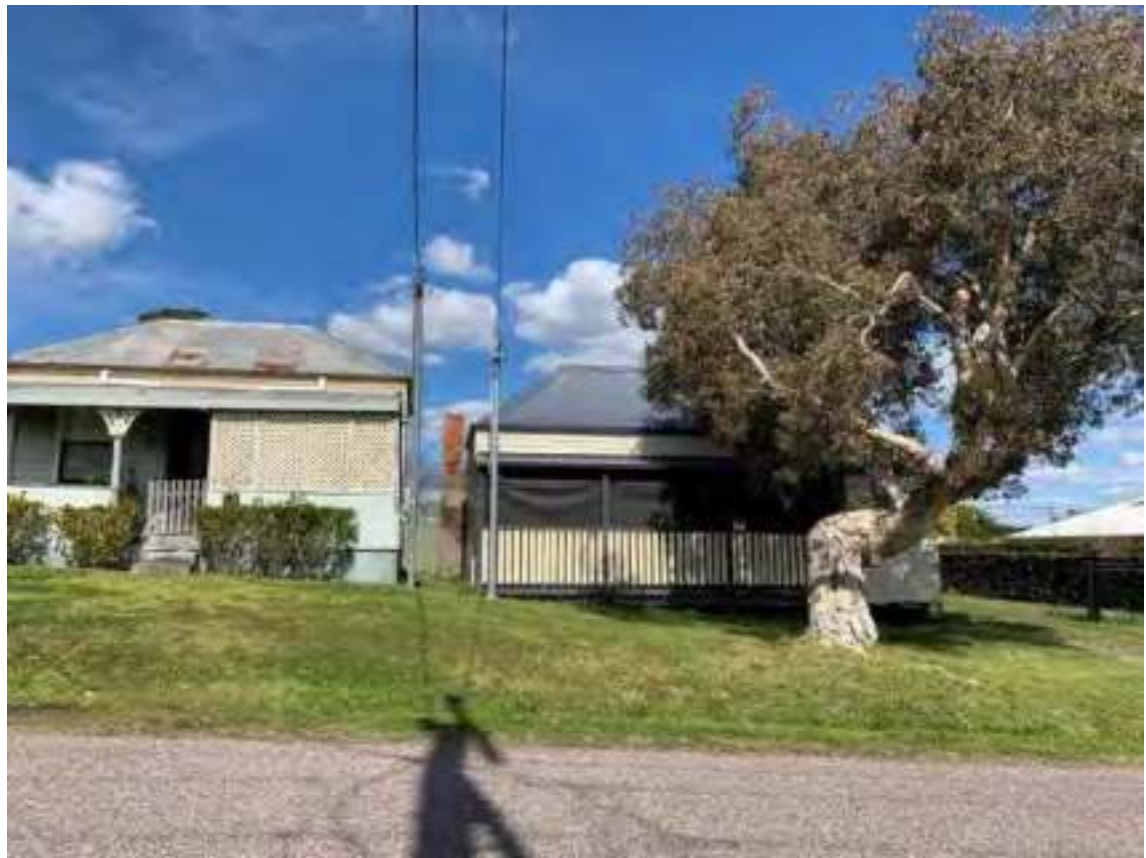
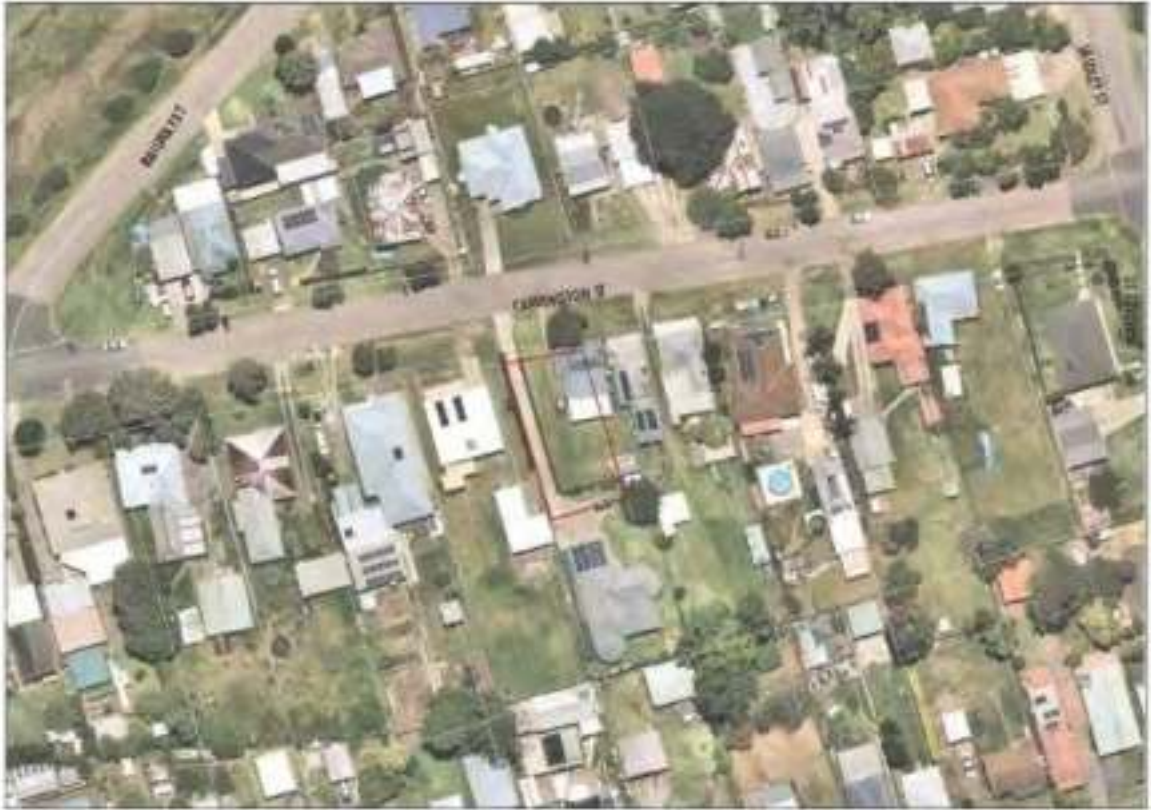
102 CARRINGTON STREET, WEST WALLSEND 2286

Conservation Area Contribution Level	Est. Construction Date	Previous studies and/or community input
Contributory 1	1890–1915	No prior heritage investigations and no additional information required
Assessment Text		Observed Modifications
<p>Single story Vernacular ‘Mining Cottage’ style dwelling with hipped Colourbond roof and weatherboard cladding. The veranda roof is skillion.</p> <p>The veranda is enclosed by both a timber balustrade and canvas blinds, the interior space is not available for evaluation.</p> <p>A brickwork chimney is visible on the eastern side of the dwelling, with no decorative features.</p> <p>The dwelling displays architectural features of a heritage style and is representative of the local development of this period, being of historical significance for the HCA.</p>		<p>The veranda roof would have been a bull nosed design originally, having been replaced by the skillion design.</p> <p>The veranda balustrade and canvas blinds are a contemporary addition.</p> <p>The western side of the veranda has been bult in, however this was undertaken in a sympathetic manner and does not detract.</p> <p>All visible windows are contemporary sliding designs.</p> <p>A back veranda extension has been constructed at the back southern side of the dwelling.</p>

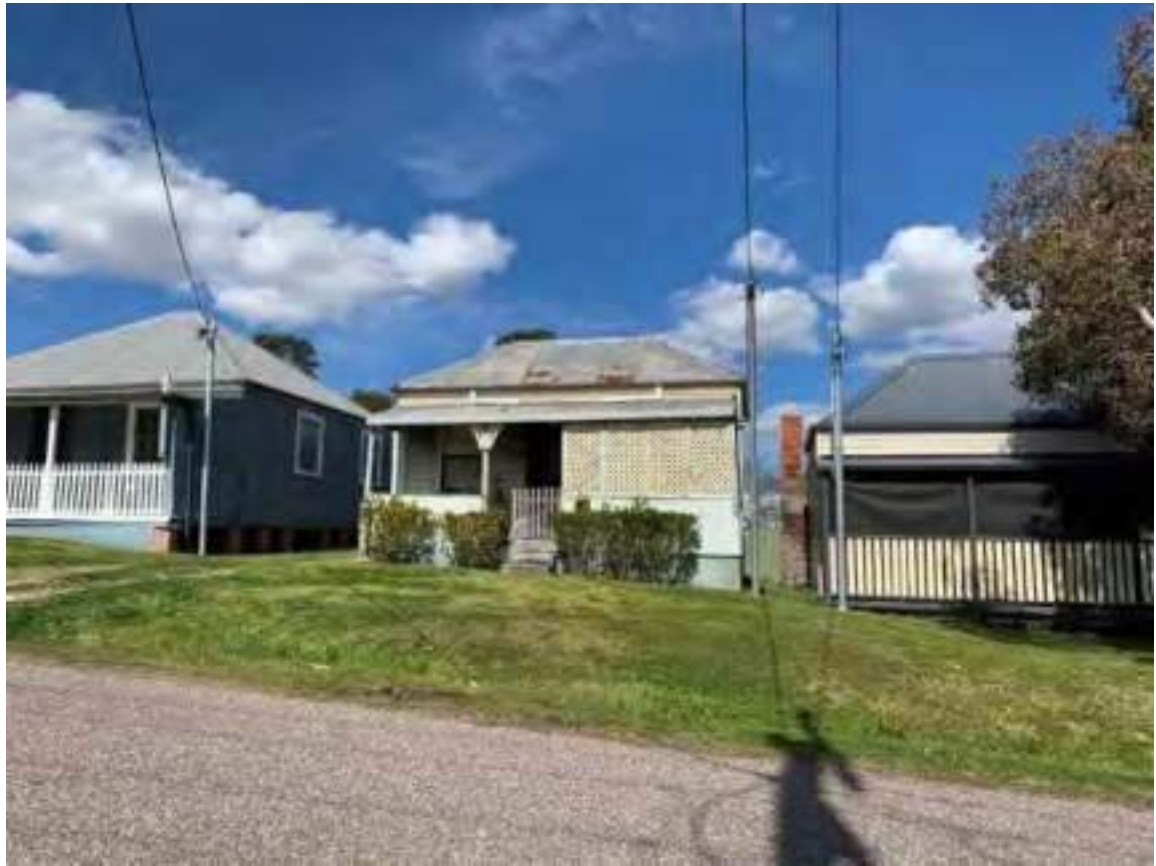
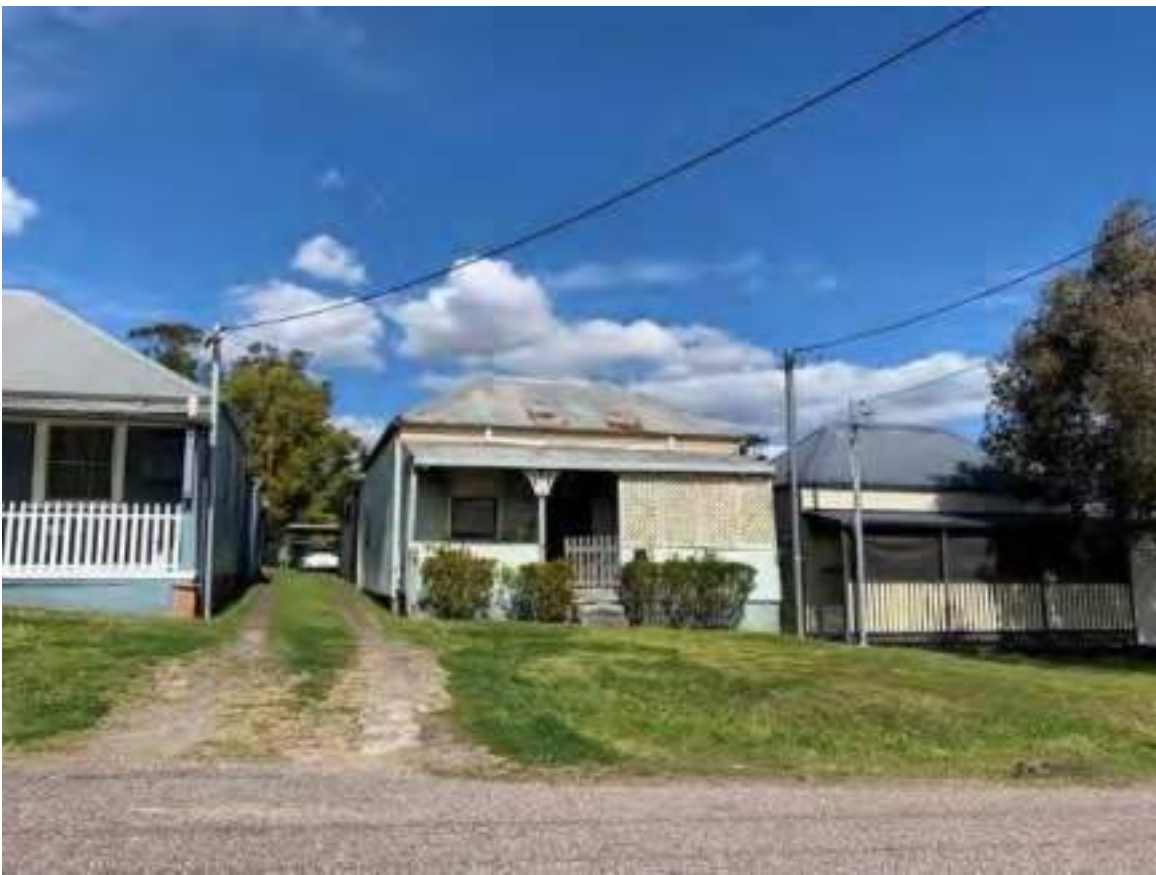
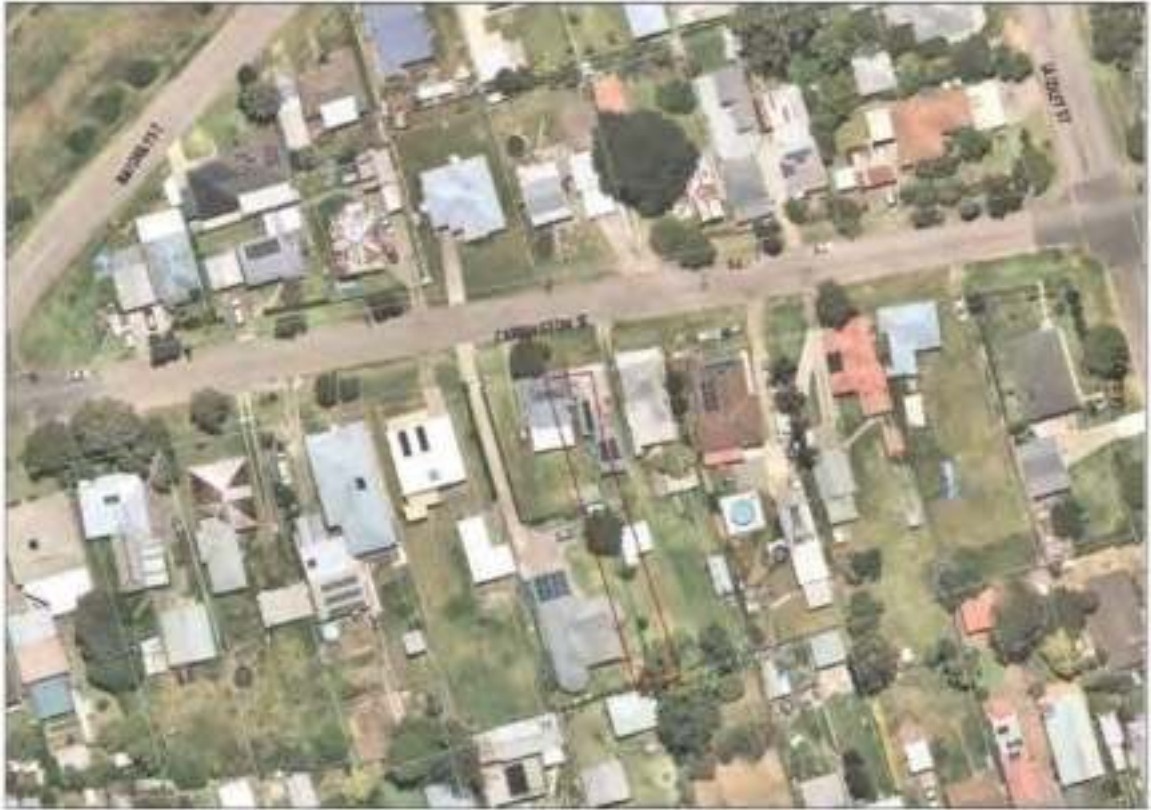
100 CARRINGTON STREET, WEST WALLSEND 2286

Conservation Area Contribution Level	Est. Construction Date	Previous studies and/or community input
Contributory 1	1890–1915	No prior heritage investigations and no additional information required
Assessment Text		Observed Modifications
<p>single story Vernacular ‘Mining Cottage’ style dwelling with hipped Colourbond roof and timber weatherboard cladding. The veranda roof is skillion and supported by timber posts with ornate bracketing.</p> <p>The veranda is partially enclosed by timber panel balustrade and lattice panels.</p> <p>The front door is timber framed with original sash windows either side. The windows have timber shutters.</p> <p>The dwelling displays architectural features of a heritage style and is representative of the local development of this period, being of historical significance for the HCA.</p>		<p>The veranda has been heavily modified, with the timber board balustrade and lattice work being a contemporary addition.</p> <p>An extension has been constructed at the back southern side of the dwelling.</p>

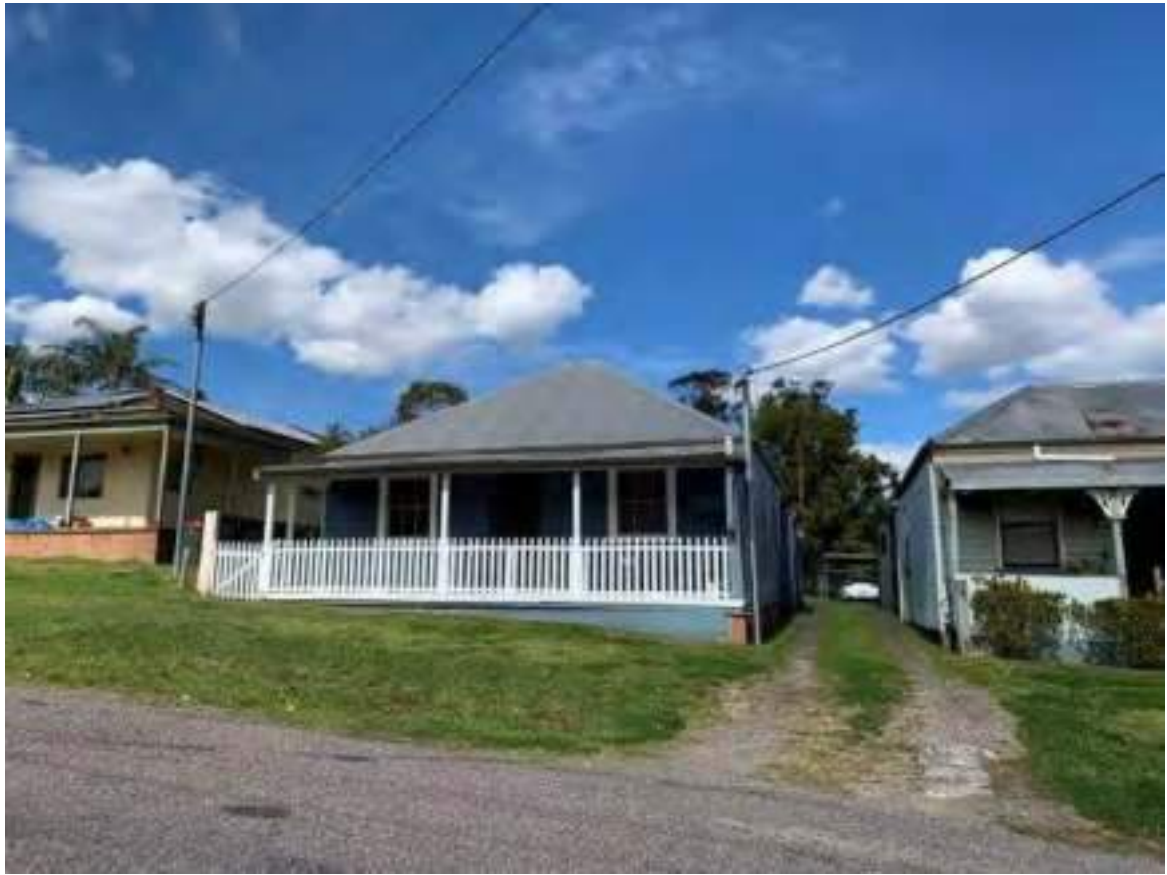
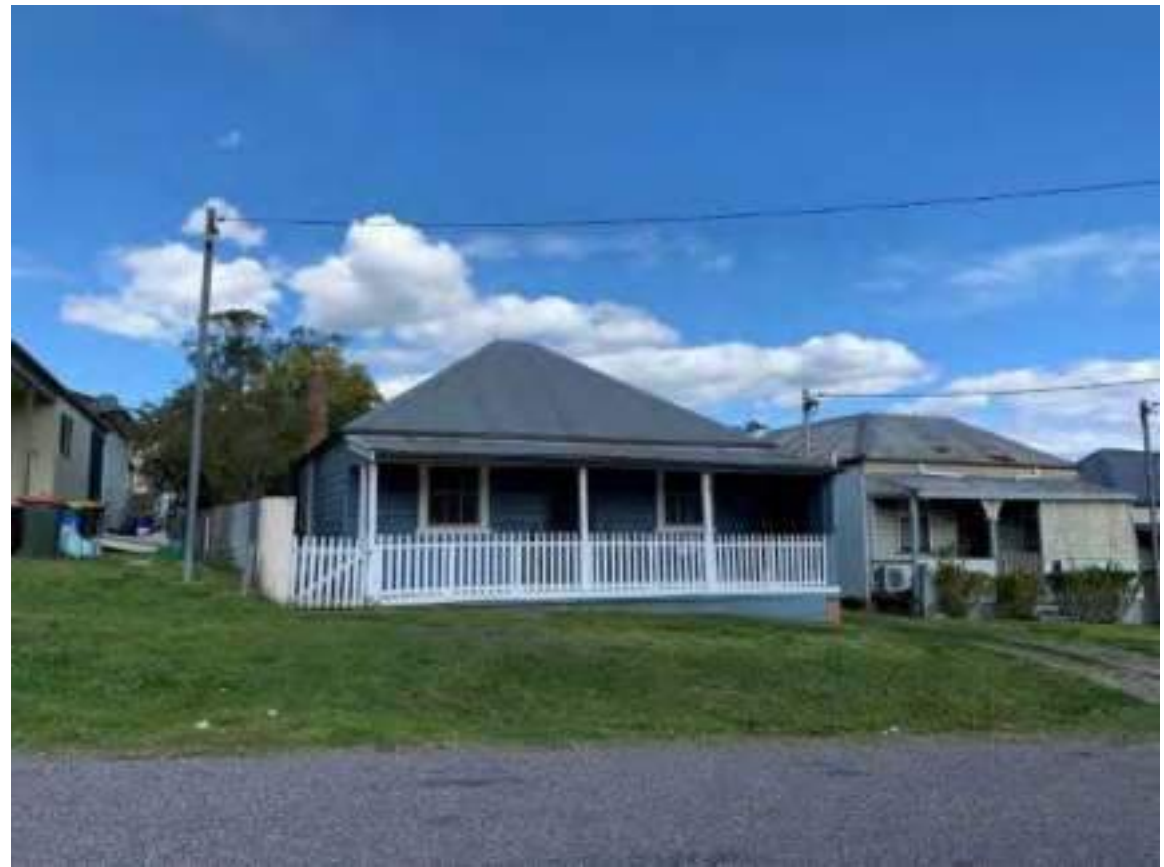
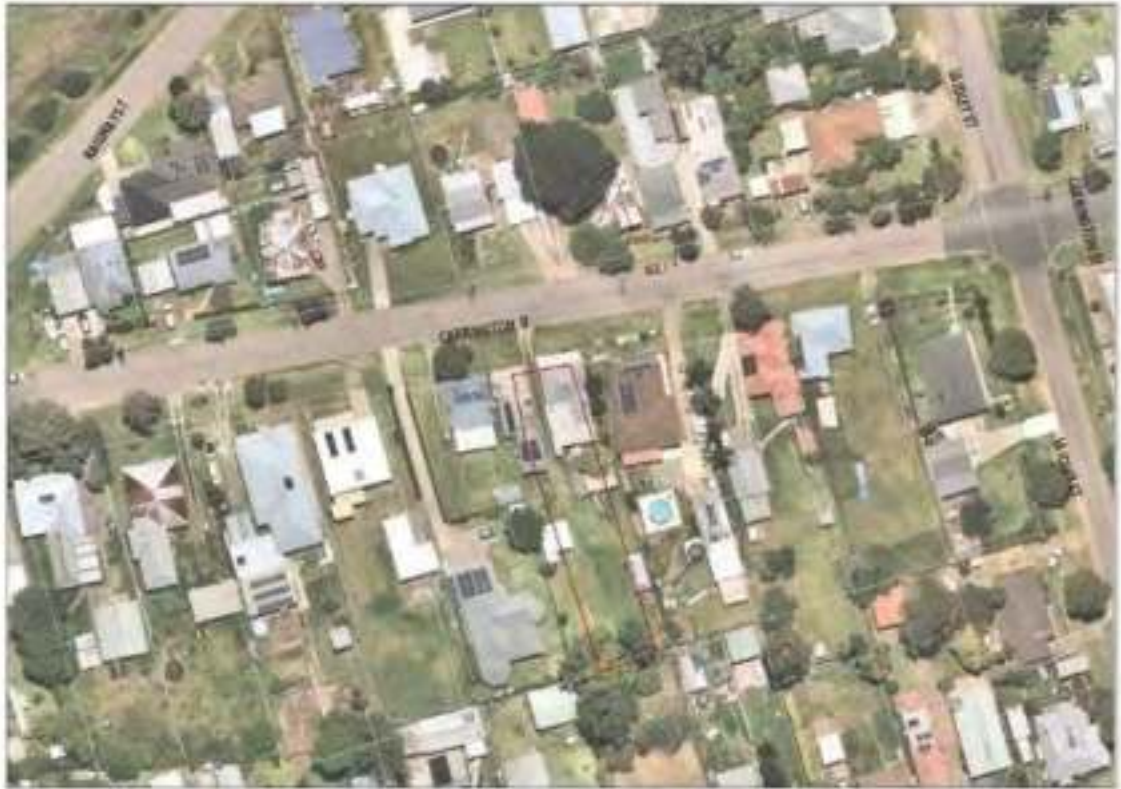
98 CARRINGTON STREET, WEST WALLSEND 2286

Conservation Area Contribution Level	Est. Construction Date	Previous studies and/or community input
Contributory 1	1890–1915	No prior heritage investigations and no additional information required
Assessment Text		Observed Modifications
<p>Single story Vernacular ‘Mining Cottage’ style dwelling with steep hipped Colourbond roof and timber weatherboard cladding. The veranda roof is skillion.</p> <p>The veranda is partially enclosed by a timber picket fence. a timber panel wall is found on the western side of the veranda.</p> <p>The front door is timber framed, with the original sash windows on either side. The windows are a heavy timber multi-pane design and are present on all sides of the dwelling.</p> <p>A brickwork chimney is visible on the eastern side of the dwelling, with corbel detailing and terracotta pot.</p> <p>The dwelling displays architectural features of a heritage style and is representative of the local development of this period, being of historical significance for the HCA.</p>		<p>The veranda roof was originally a bull nose design, having been replaced by the skillion.</p> <p>The timber picket fencing enclosing the veranda is a contemporary addition, and although a heritage style it is an inappropriate choice and not seen elsewhere in the heritage streetscape.</p>

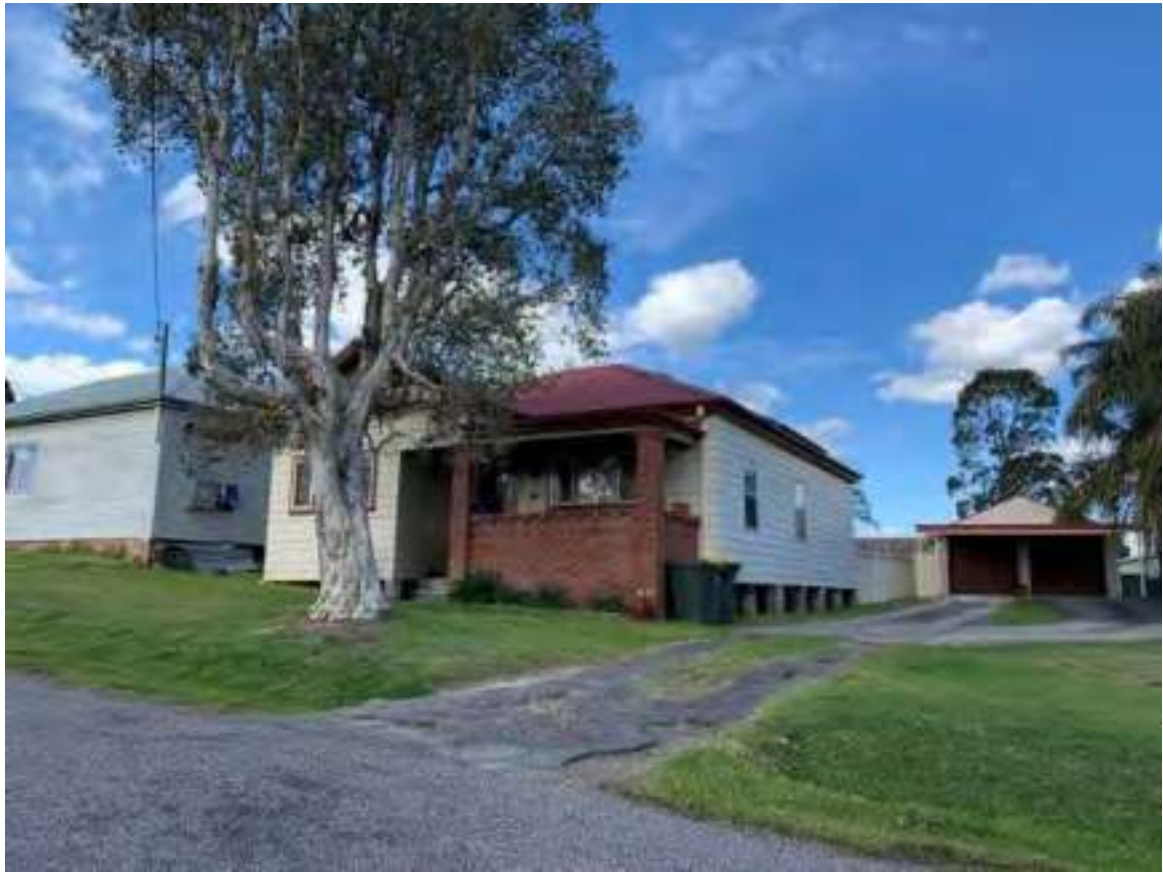
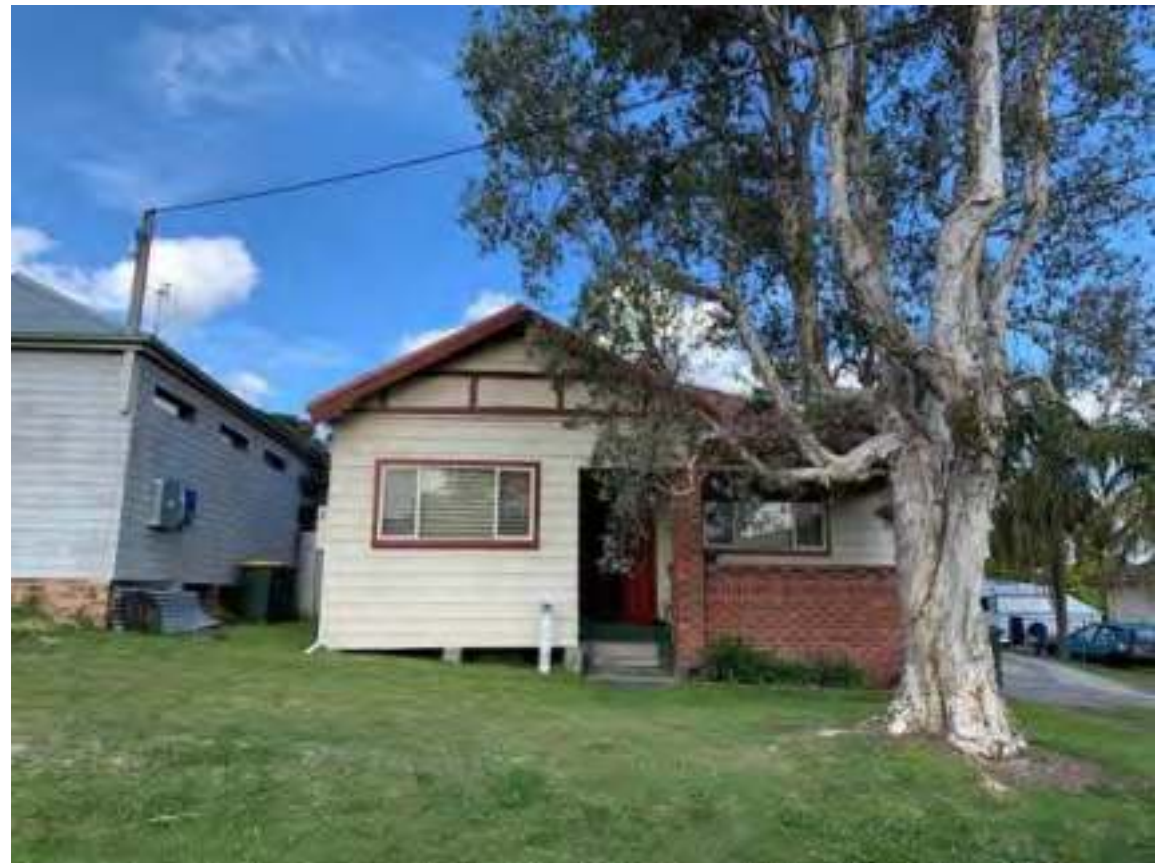
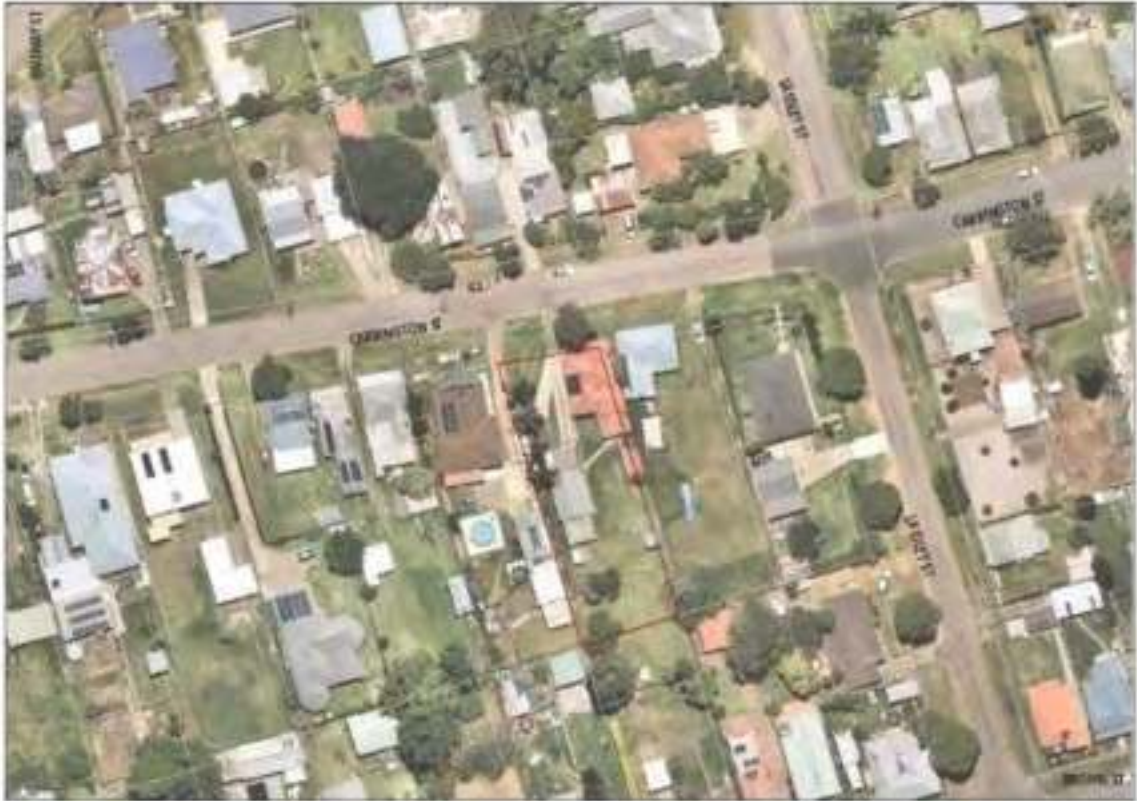
94 CARRINGTON STREET, WEST WALLSEND 2286

Conservation Area Contribution Level	Est. Construction Date	Previous studies and/or community input
Contributory 1	1895–1915	No prior heritage investigations and no additional information required
Assessment Text		Observed Modifications
<p>Single story simple Federation ‘workmen's cottage’ style dwelling with hipped Colourbond roof with gable projection and weatherboard cladding. The veranda roof is skillion and supported by brick pillars.</p> <p>The veranda is partially enclosed by a brickwork wall with dental coursework detailing.</p> <p>The front door is timber framed with a four panel design.</p> <p>The gable has extended eaves and simple battening detailing.</p> <p>A carport and garage is located to the south of the dwelling.</p> <p>The dwelling displays architectural features of a heritage style and is representative of the local development of this period, being of historical significance for the HCA.</p>		<p>The visible windows are contemporary variations of picture and sliding styles, replacing the original sash or casement designs.</p> <p>A back extension has been constructed onto the southern side of the dwelling, however this was undertaken in a sympathetic manner and does not detract.</p>
