APPENDIX 2

Building Assessment Sheets (Inventory Sheets)

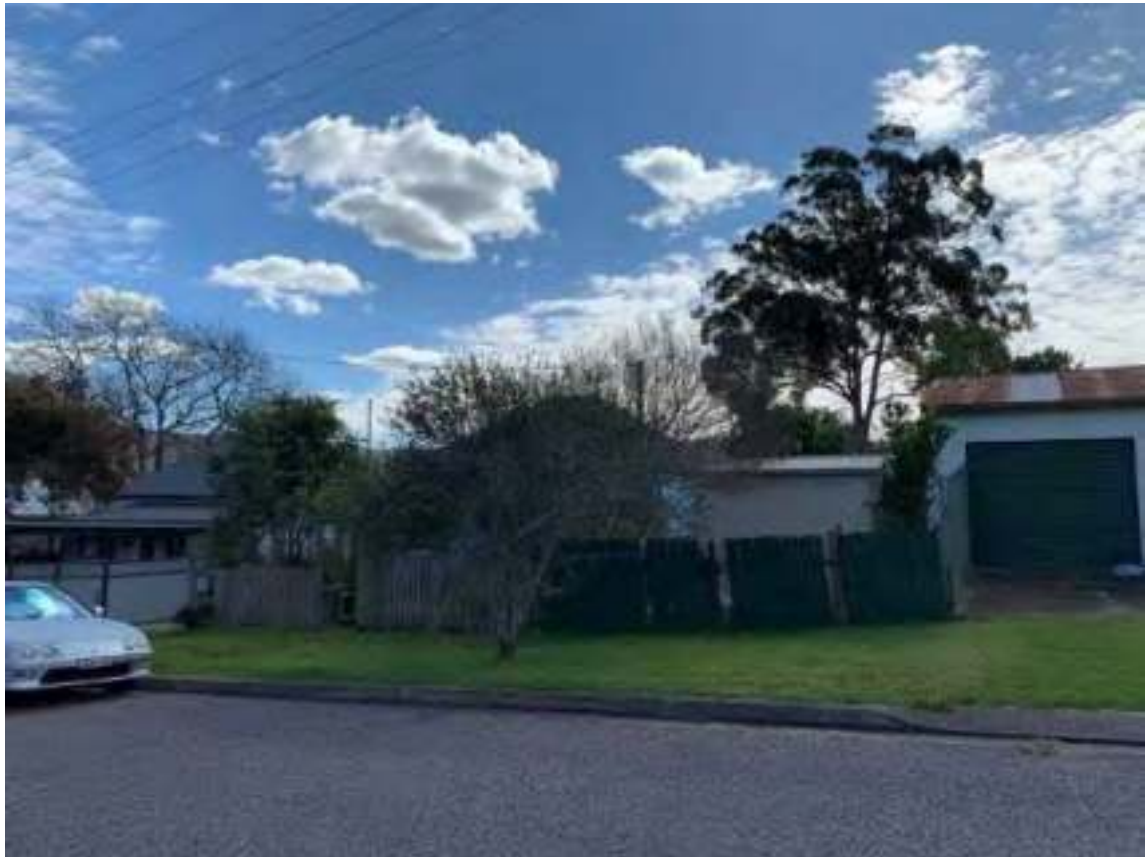
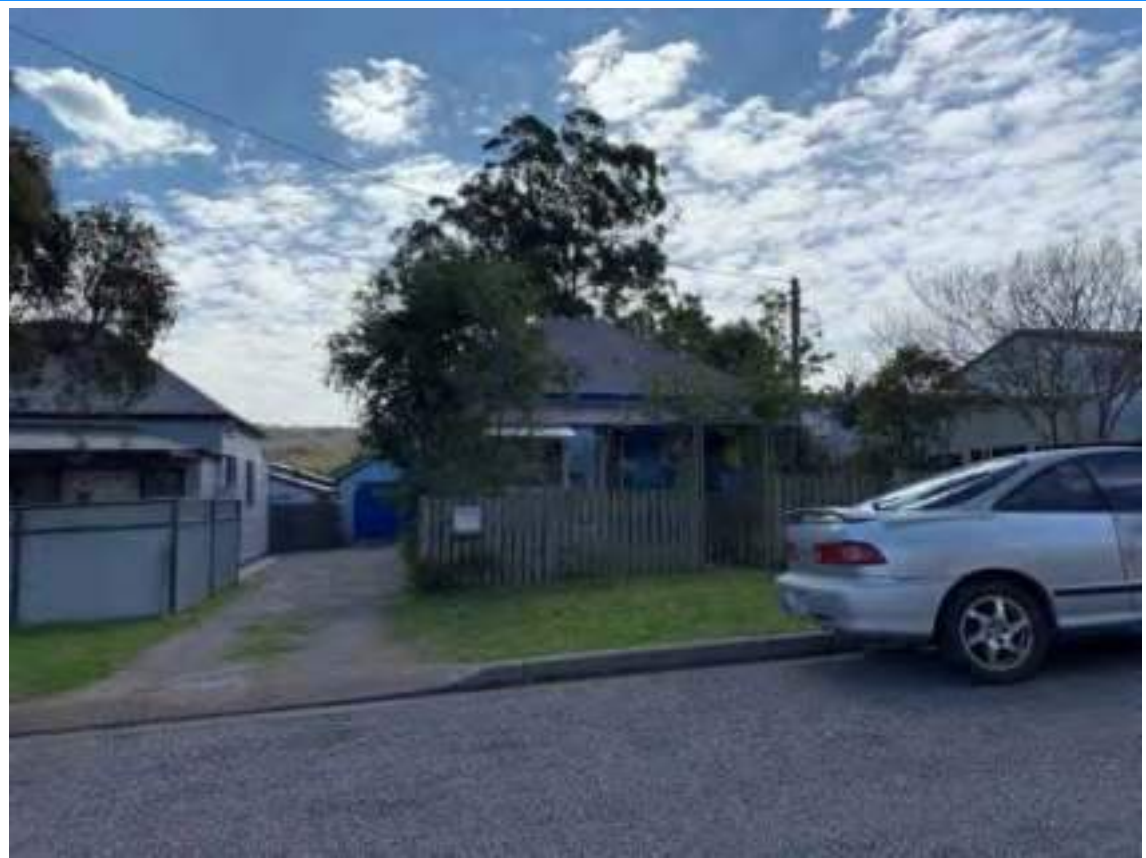
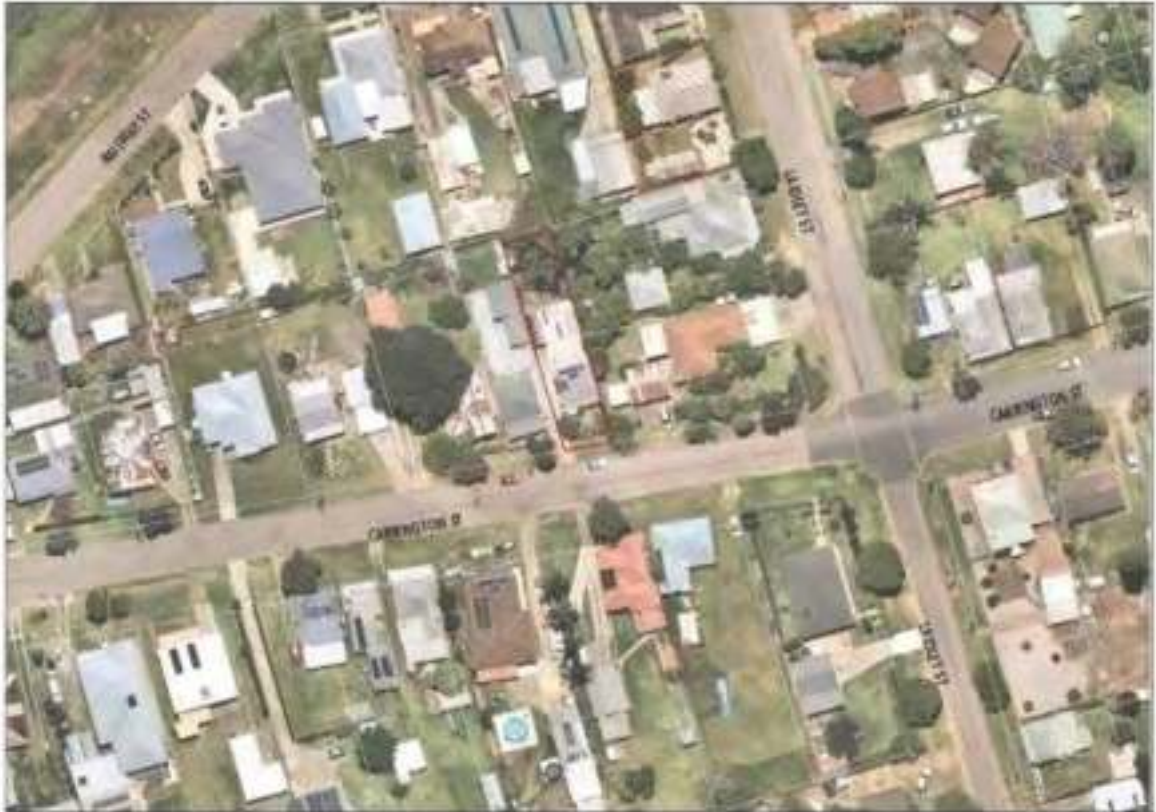
93 CARRINGTON STREET, WEST WALLSEND 2286

Conservation Area Contribution Level	Est. Construction Date	Previous studies and/or community input
Contributory 1	1890–1915	No prior heritage investigations and no additional information required
Assessment Text		Observed Modifications
<p>Single story Vernacular ‘Mining Cottage’ style dwelling with steep hipped Colourbond roof and weatherboard cladding. The veranda roof is skillion.</p> <p>A gable roof garage is located to the north of the dwelling.</p> <p>A timber fence with entrance archway encloses the property.</p> <p>The dwelling displays architectural features of a heritage style and is representative of the local development of this period, being of historical significance for the HCA.</p>		<p>The western side of the veranda has been built in to create an additional living area.</p> <p>The visible windows are contemporary timber framed multipaned sash designs, replacing the original sash styles.</p>

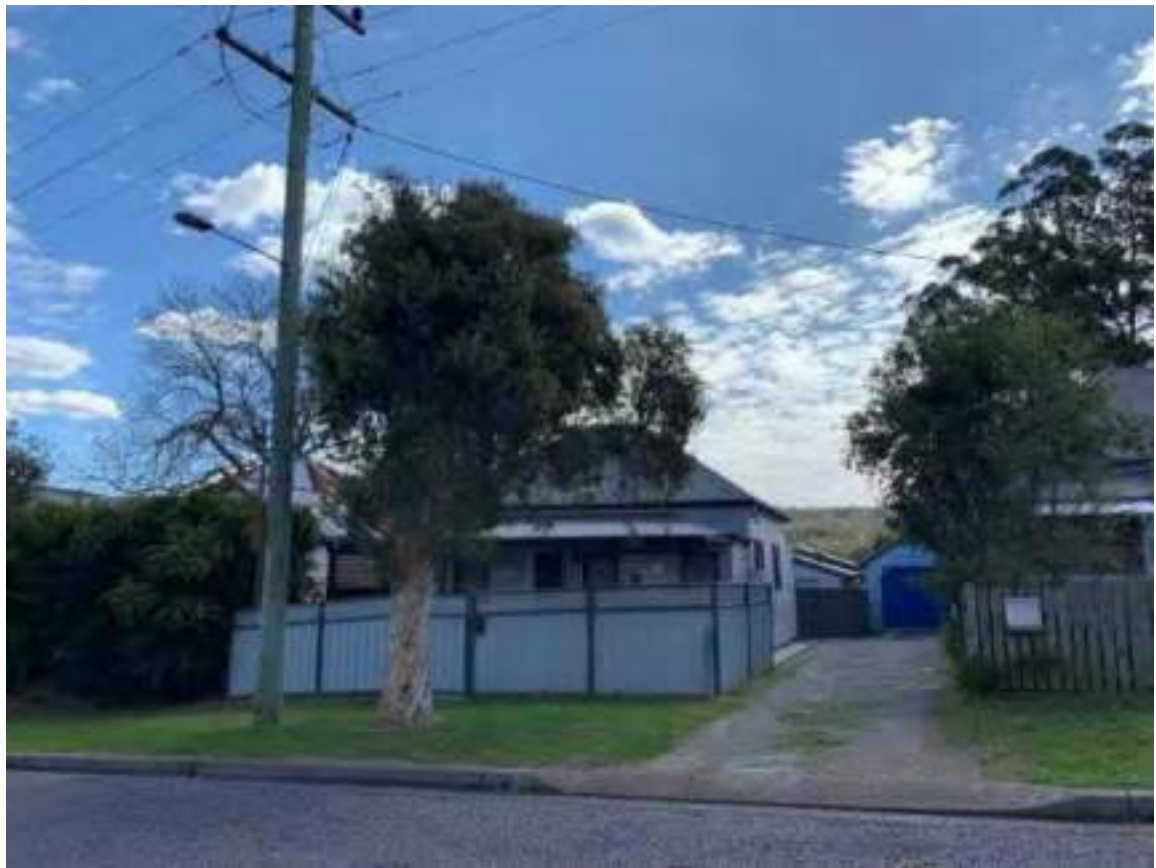
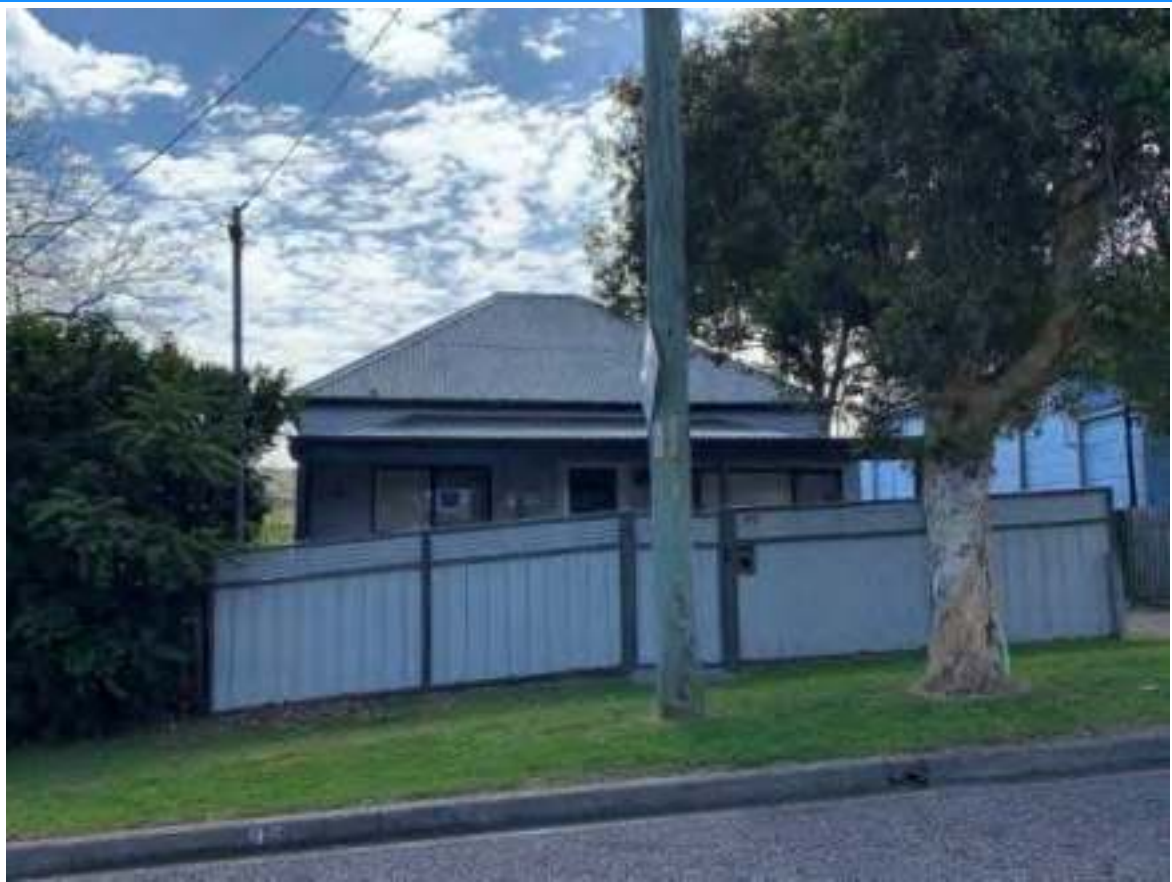
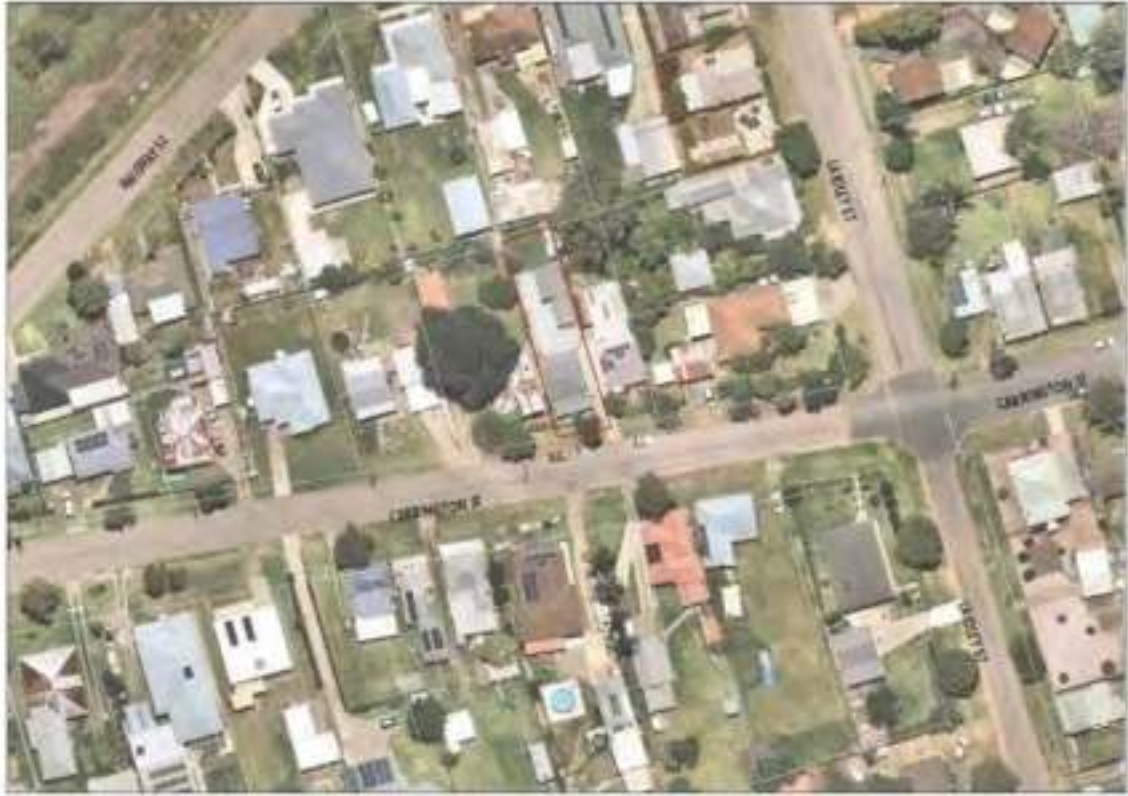
95 CARRINGTON STREET, WEST WALLSEND 2286

Conservation Area Contribution Level	Est. Construction Date	Previous studies and/or community input
Contributory 1	1890–1915	No prior heritage investigations and no additional information required
Assessment Text		Observed Modifications
<p>Single story Vernacular ‘Mining Cottage’ style dwelling with hipped Colourbond roof and weatherboard cladding. The veranda roof is hipped, with the additional secondary veranda roof being flat.</p> <p>The front door is timber framed, with picture windows either side.</p> <p>A gable roof garage is located to the north of the dwelling.</p> <p>A Colourbond fence encloses the property.</p> <p>The dwelling displays architectural features of a heritage style and is representative of the local development of this period, being of historical significance for the HCA.</p>		<p>The visible windows are contemporary variations of picture and sliding designs. This has replaced the original sash styles.</p> <p>The veranda has been built in to create additional living areas. An additional secondary veranda has been constructed.</p> <p>An additional residential structure is located to the north of the dwelling. this is not visible from the street and does not detract.</p>

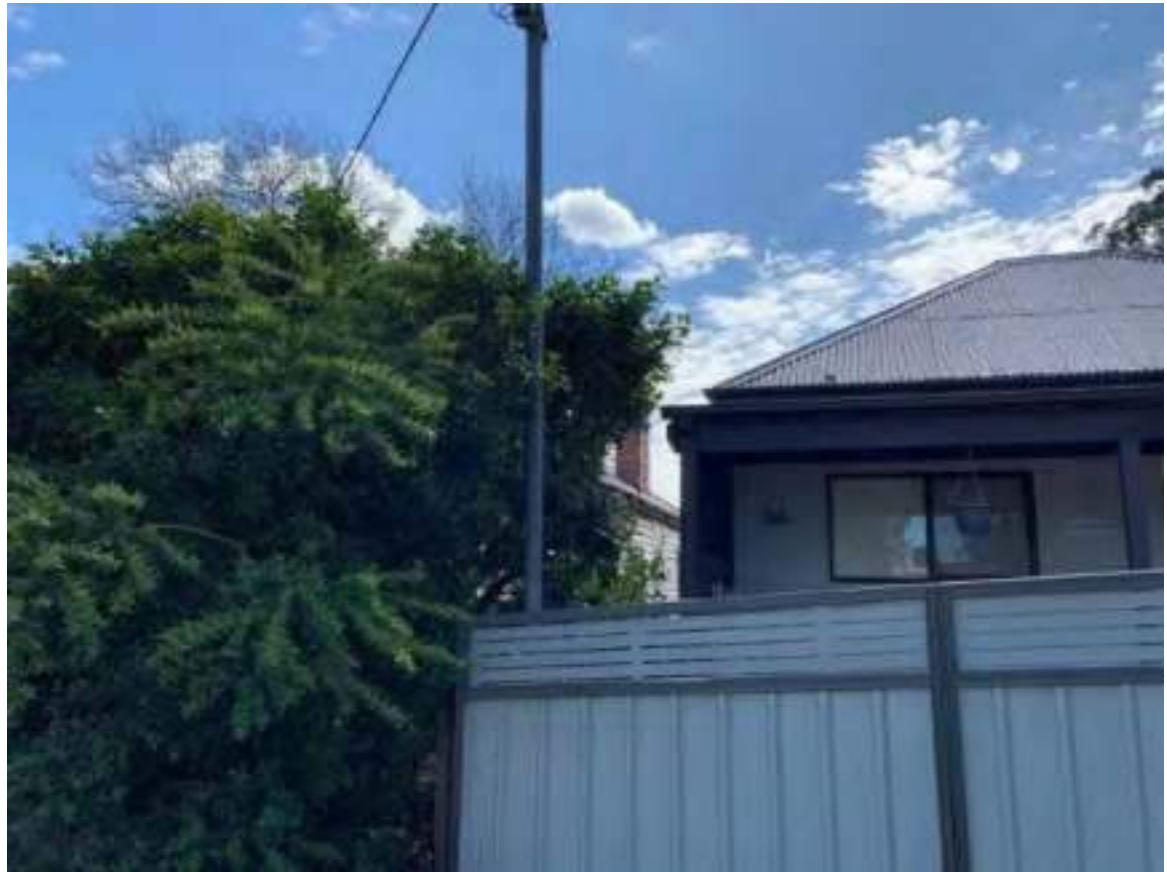
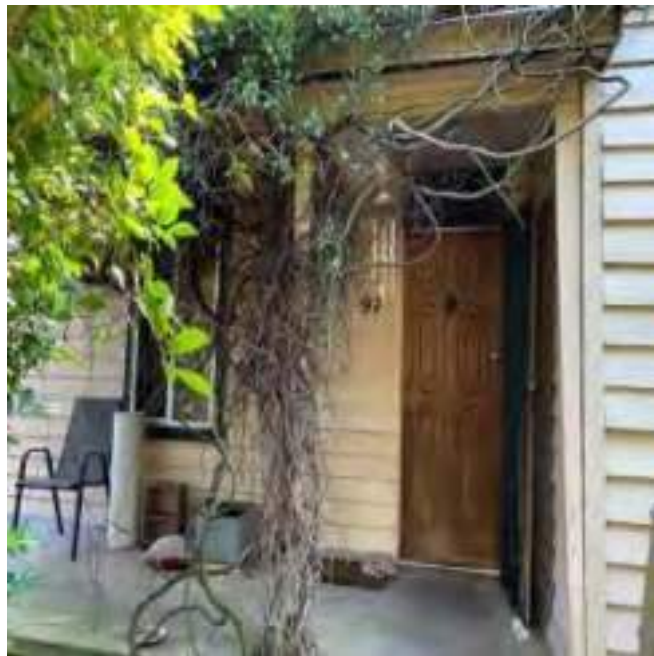
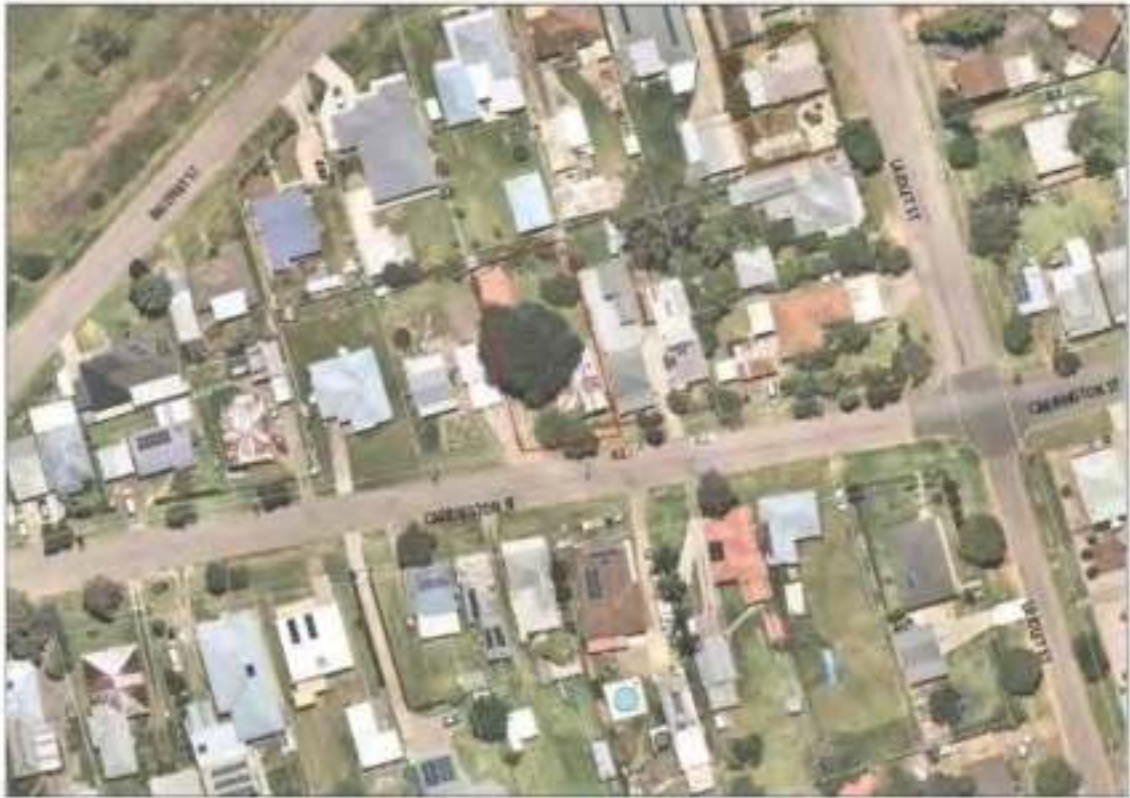
97 CARRINGTON STREET, WEST WALLSEND 2286

Conservation Area Contribution Level	Est. Construction Date	Previous studies and/or community input
Contributory 1	1900–1920	No prior heritage investigations and no additional information required
Assessment Text		Observed Modifications
Single story dwelling with weatherboard cladding and section of gable roofing.		The dwelling is heavily obscured by extensive vegetation growth. No modifications were observed.

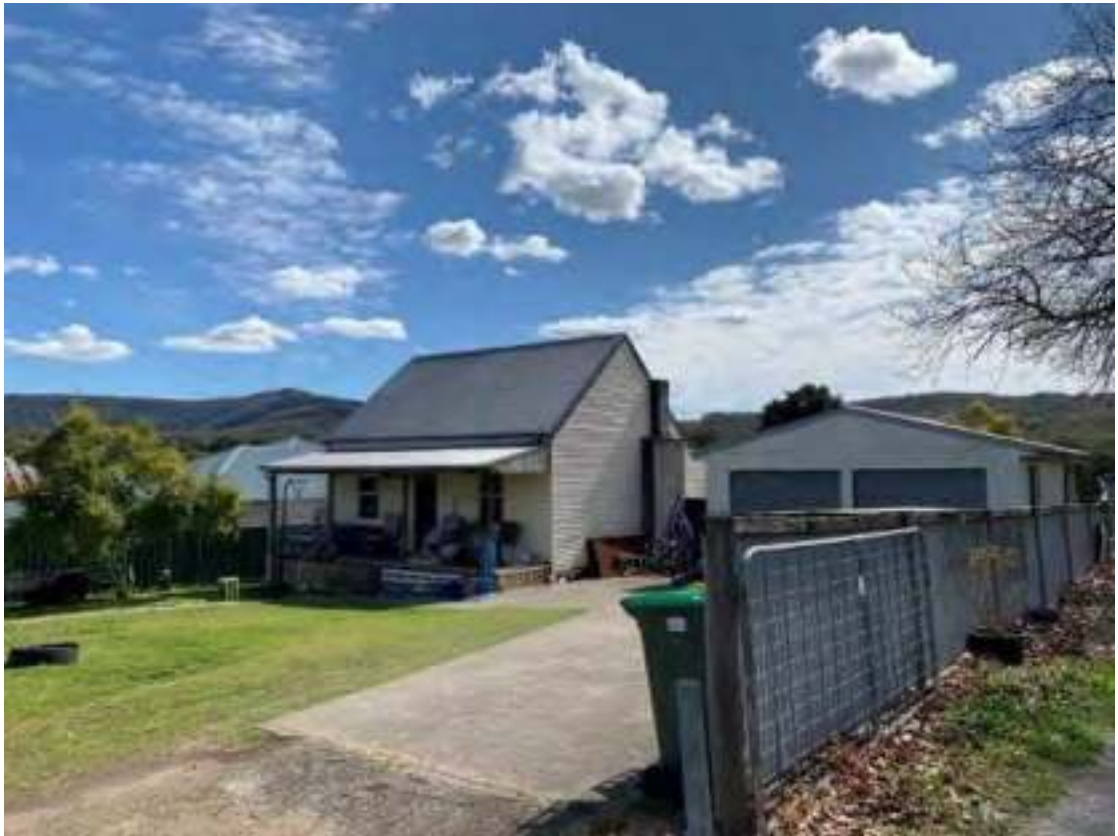
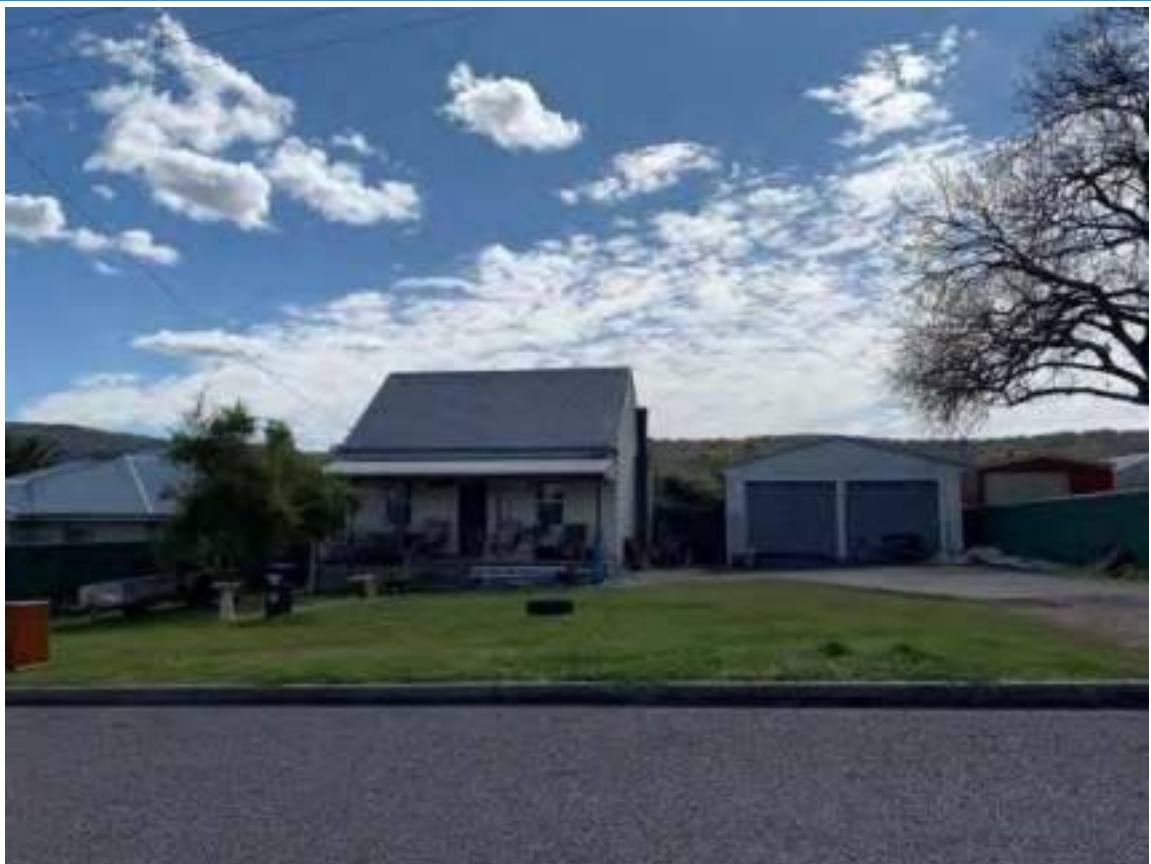
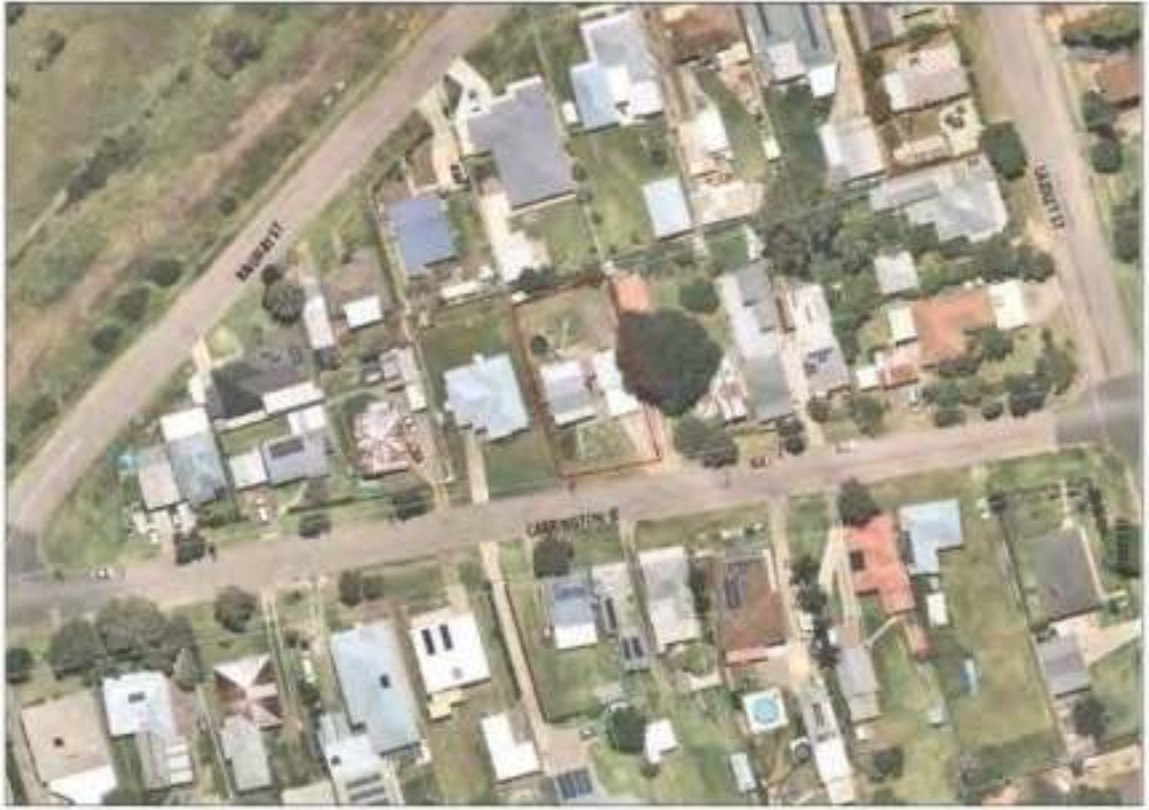
99 CARRINGTON STREET, WEST WALLSEND 2286

Conservation Area Contribution Level	Est. Construction Date	Previous studies and/or community input
Contributory 1	1880–1910	No prior heritage investigations and no additional information required
Assessment Text		Observed Modifications
<p>Single story Mid-Century Vernacular style dwelling with steep gabled Colourbond roof and timber weatherboard cladding. The veranda roof is skillion.</p> <p>The front door is timber framed and a four panel design, with sash windows either side.</p> <p>A rendered brick chimney is located on the eastern side of the dwelling, with a reduced shaft.</p> <p>A double door garage is located to the east of the dwelling.</p> <p>The dwelling displays architectural features of a heritage style and is representative of the local development of this period, being of historical significance for the HCA.</p>		<p>The façade sash windows are likely contemporary replications of the original sash designs. The remaining windows are contemporary sliding designs.</p> <p>The shaft of the chimney has been replaced with a narrow potentially metal style.</p>

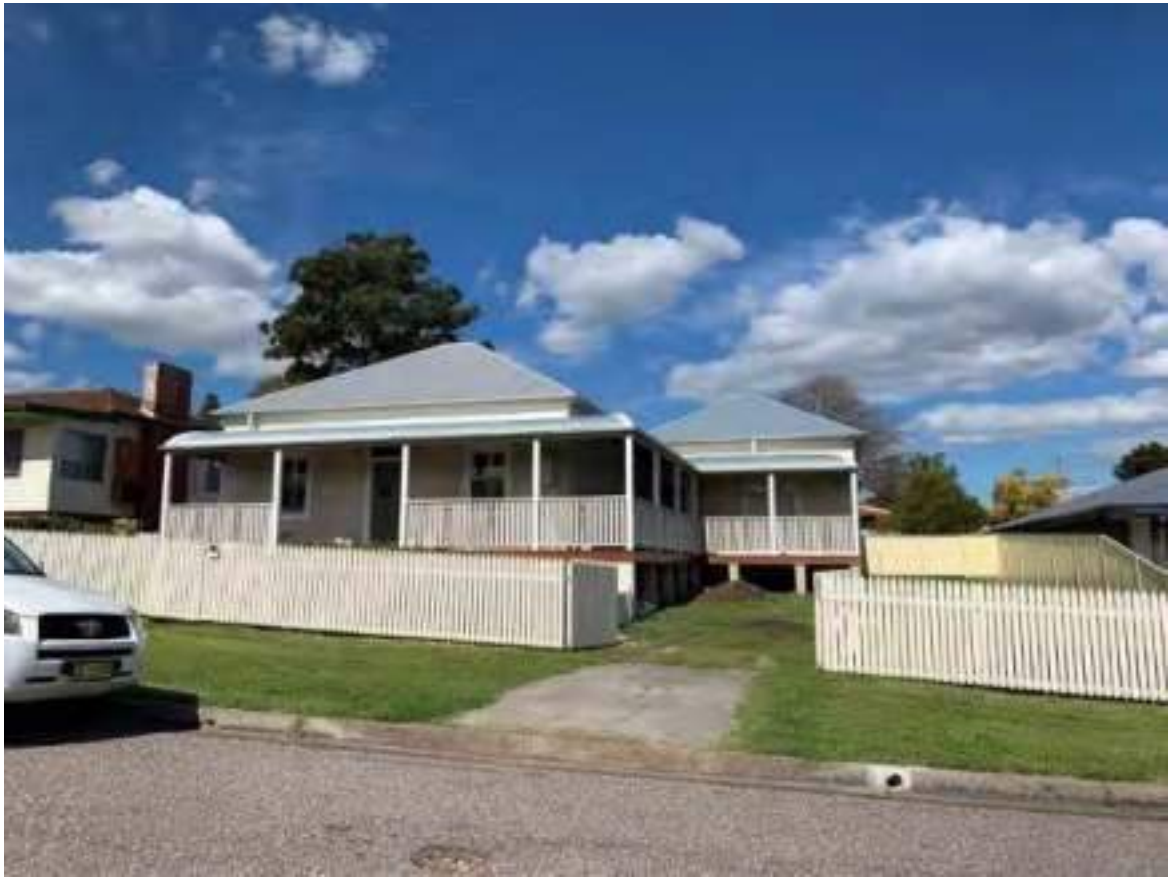
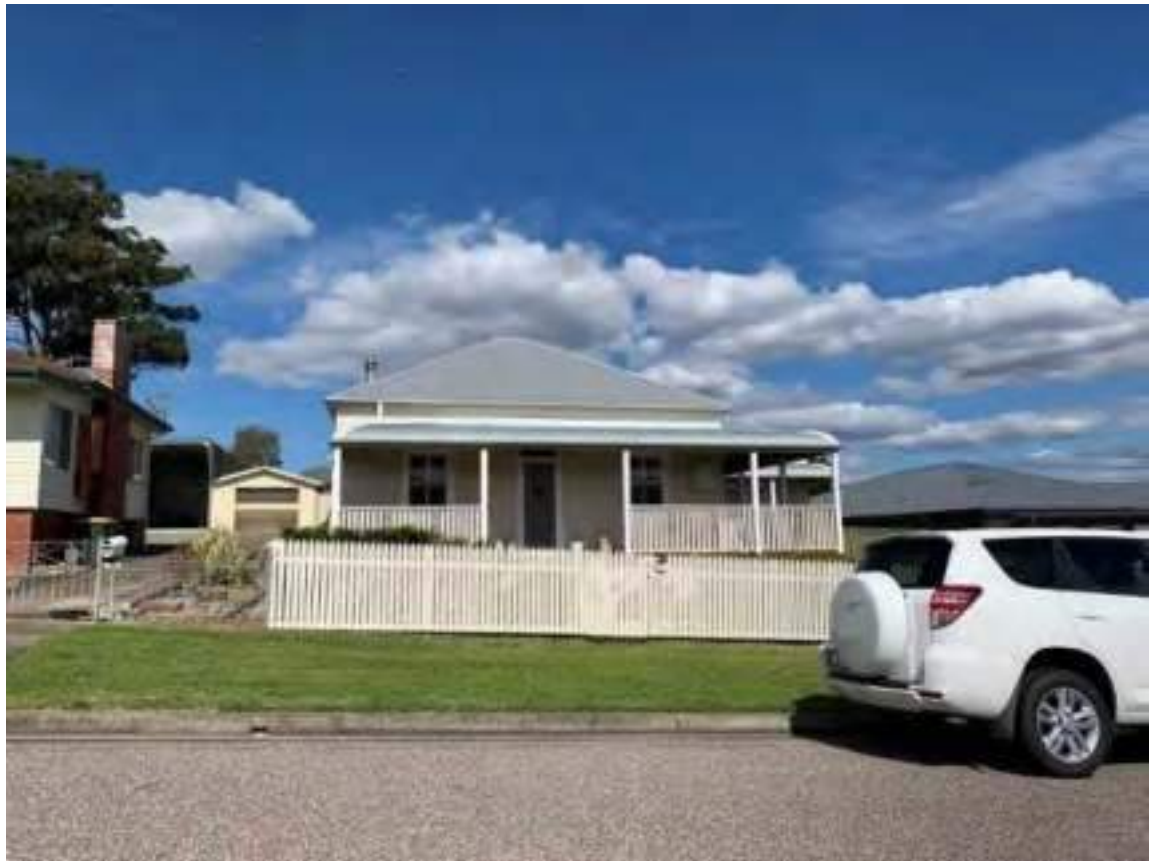
78 WILSON STREET, WEST WALLSEND 2286

Conservation Area Contribution Level	Est. Construction Date	Previous studies and/or community input
Contributory 1	1890–1915	No prior heritage investigations and no additional information required
Assessment Text		Observed Modifications
<p>Single story Vernacular ‘Mining Cottage’ style dwelling with hipped Colourbond roof and weatherboard cladding. The veranda roof is bull nosed.</p> <p>The veranda is partially enclosed by simple timber balustrade with natural motifs carved.</p> <p>The front door is timber framed with metal security screen and fanlight. Original heavy timber framed sash windows are located either side, with timber shutters.</p> <p>Timber picket fence enclosed the property.</p> <p>The dwelling displays architectural features of a heritage style and is representative of the local development of this period, being of historical significance for the HCA.</p>		<p>Although bullnosed, the veranda roof is likely a contemporary replacement for the original due to the extension along the western side of the dwelling. The veranda wraps around the western side of the dwelling and the front facing section of the back extension.</p> <p>A large extension has been constructed, however in a sympathetic style to the dwelling. this is highly visible but does not detract due to the heritage styling undertaken.</p> <p>Remaining windows are contemporary replications of sash designs. French doors have been installed along the veranda and extension.</p>

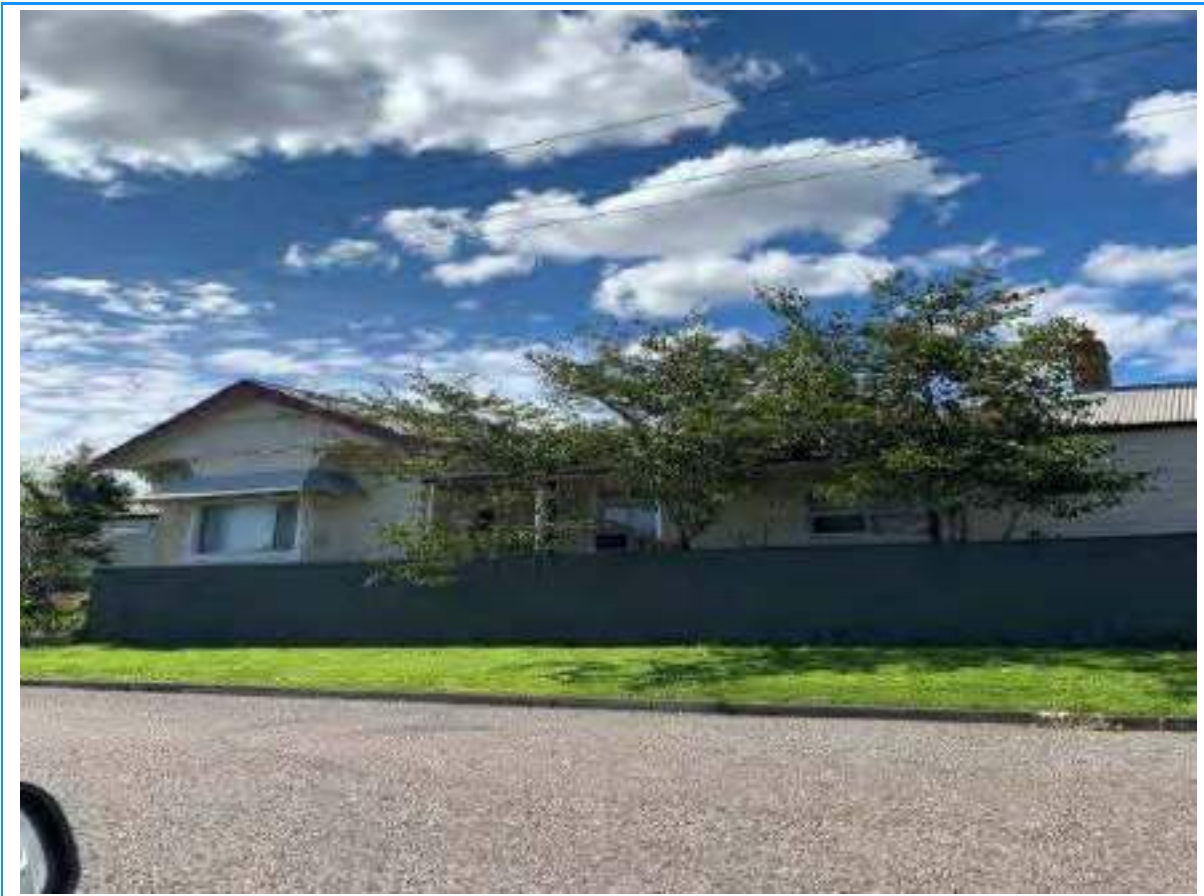
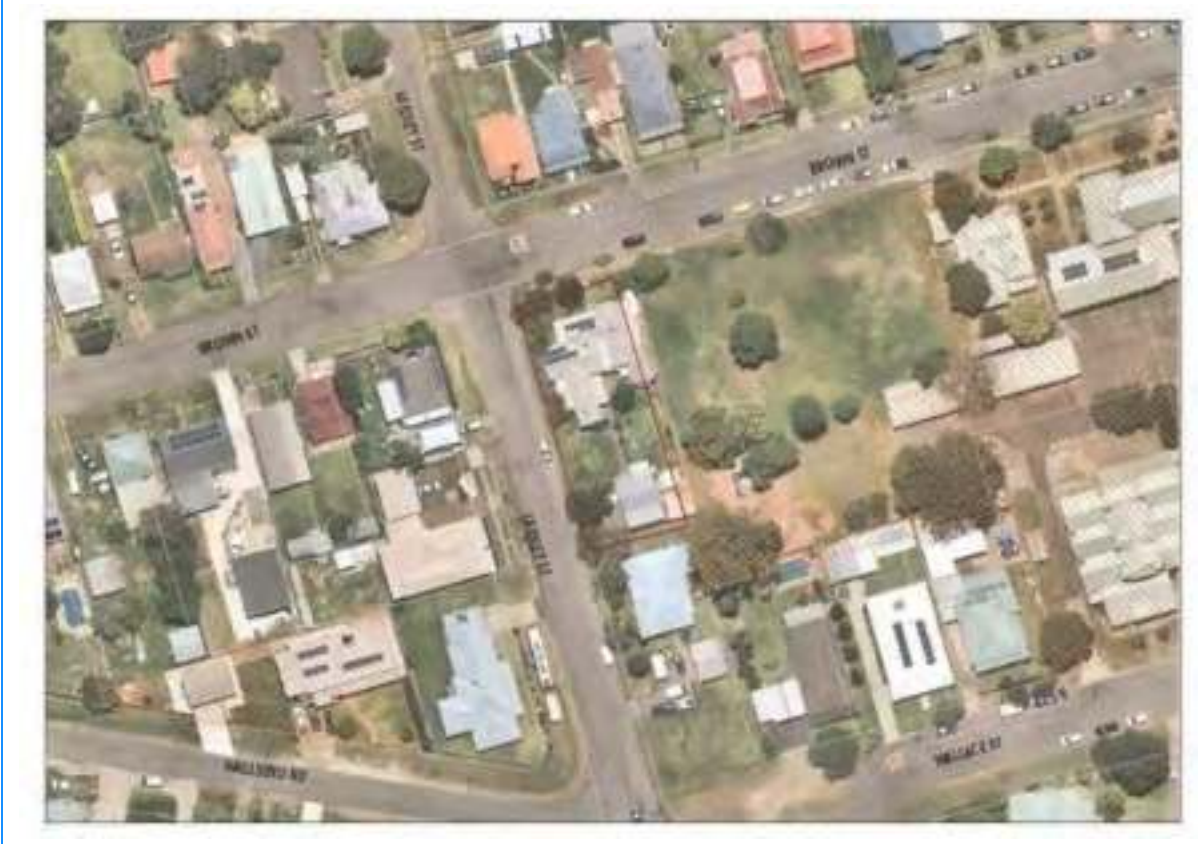
Conservation Area Contribution Level	Est. Construction Date	Previous studies and/or community input
Contributory 1	1900–1915	No prior heritage investigations and no additional information required
Assessment Text		Observed Modifications
<p>Single story Federation Queen Anne style dwelling with hipped and gable Colourbond roof with timber weatherboard cladding. The veranda roof is skillion with a timber valance.</p> <p>The gables have extended eaves, battening detailing and timber roof hoods, both flat and shingled. The gable windows have decorative sills, with the northern window being original triple sash design.</p> <p>Brickwork chimneys are visible, with corbel detailing and double terracotta pots.</p> <p>Colourbond fencing encloses the property.</p> <p>The dwelling displays architectural features of a heritage style and is representative of the local development of this period, being of historical significance for the HCA.</p>		<p>Solar panelling is highly visible along the northern roof.</p> <p>The western gable window has been replaced with a contemporary picture design.</p> <p>An extension has potentially been constructed at the southern back end of the dwelling, however due to the large layout of the dwelling and conducive building styles it is difficult to ascertain.</p>

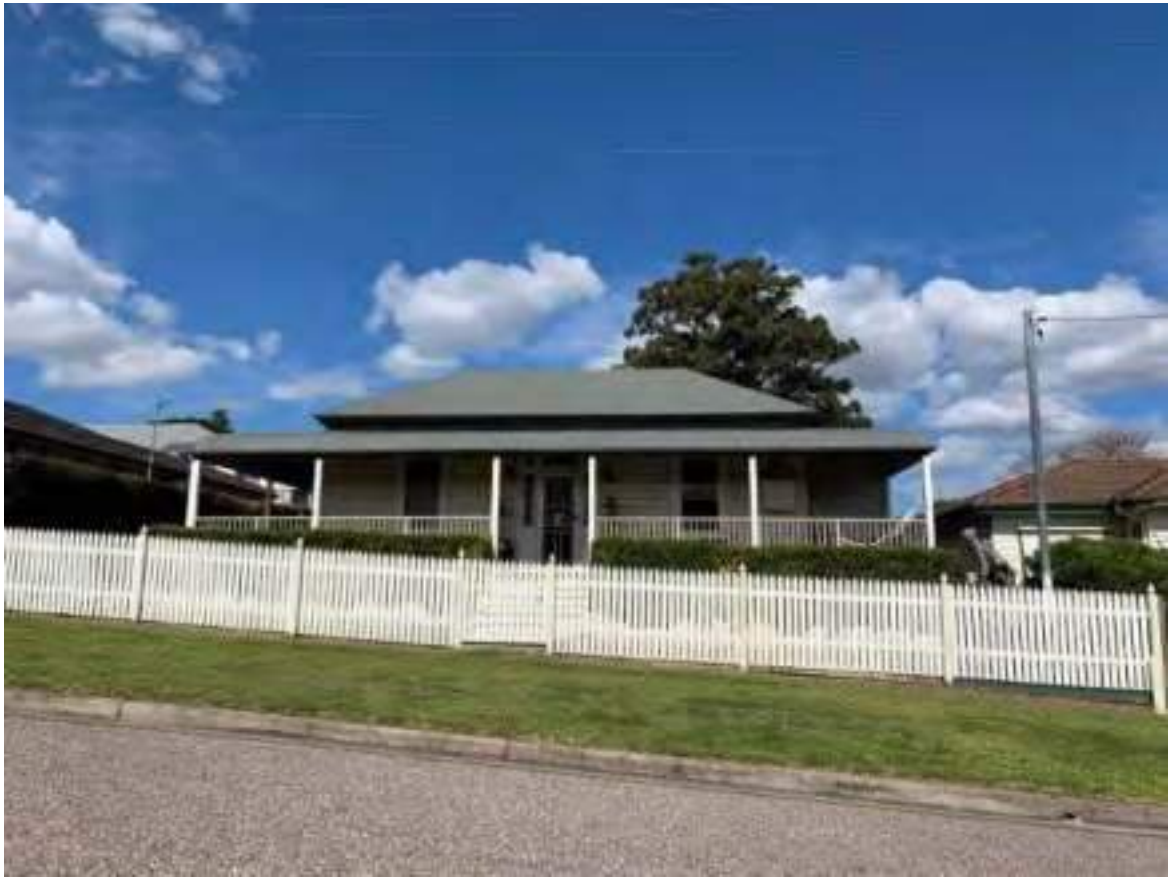
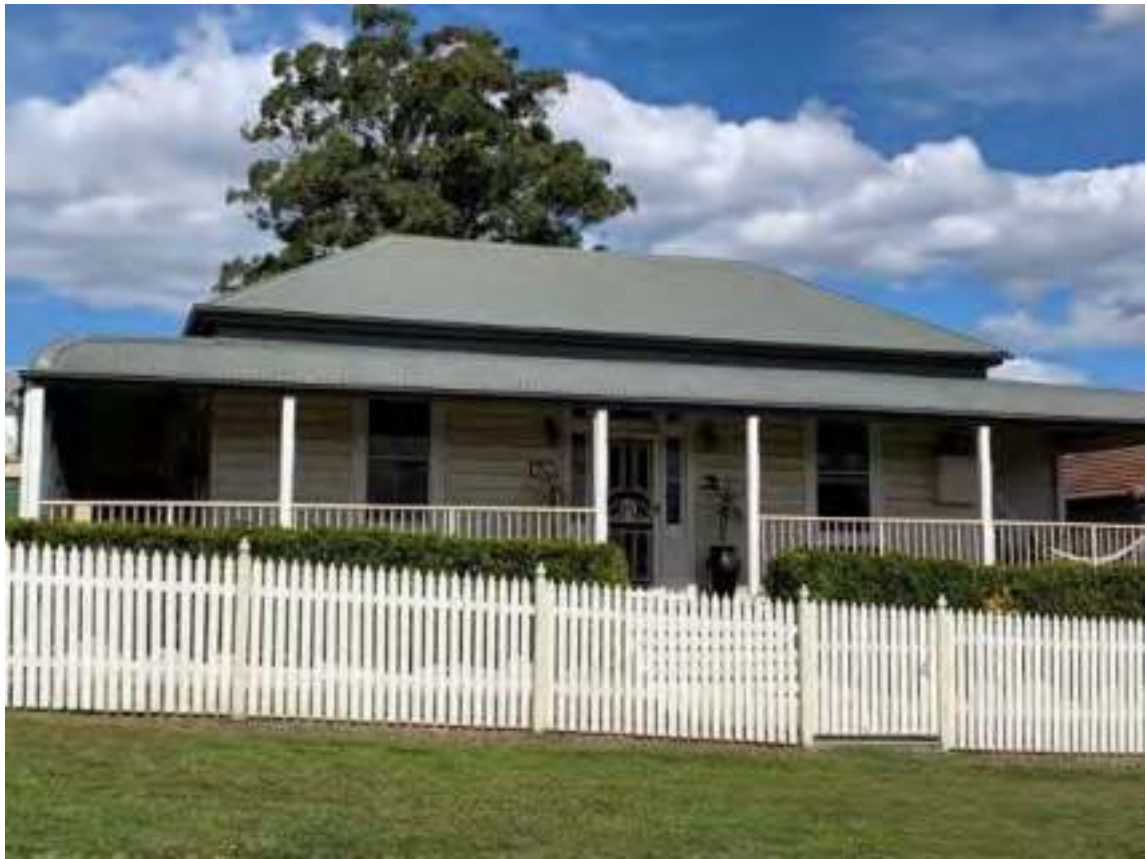
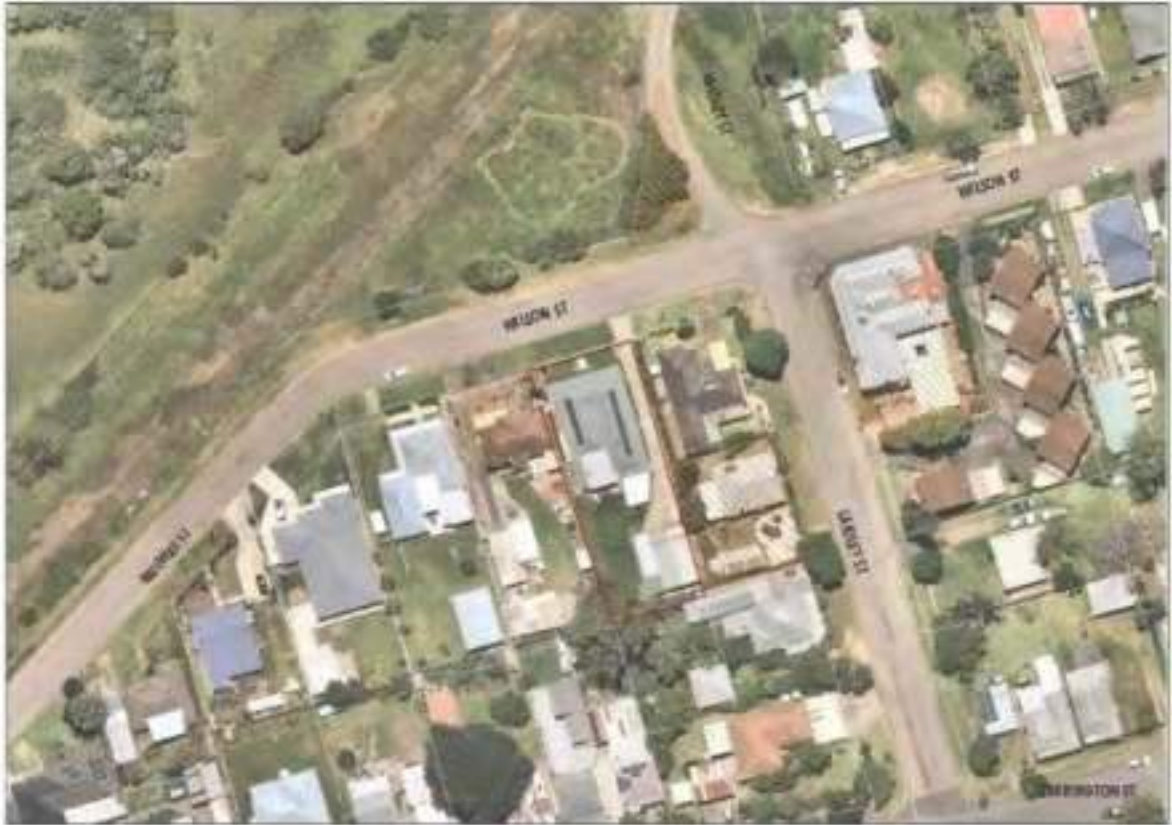
74 WILSON STREET, WEST WALLSEND 2286

Conservation Area Contribution Level	Est. Construction Date	Previous studies and/or community input
Contributory 1	1895–1900	<p>No prior heritage investigations.</p> <p>As per community input, the dwelling was constructed for William Johnson by his son, James Johnson. William Johnson had built the Museum Hotel and retired in 1898. The house was later owned by Mrs Muir, the Registrar of Births and Marriages, and served as the Registry office.</p>
Assessment Text		Observed Modifications
<p>Single story Vernacular ‘Mining Cottage’ style dwelling with Colourbond hipped roof and weatherboard cladding. The veranda roof is bull nosed.</p> <p>The veranda is partially enclosed by simple timber balustrade, and extends along the eastern and western side of the dwelling.</p> <p>The front door has panes of colour-stained glass either side, with original heavy timber framed sash windows adjacent. The original sash windows are evident along the easter side of the dwelling.</p> <p>A brickwork chimney is partially visible on the eastern side of the dwelling, however has been absorbed into the dwelling following extension works.</p> <p>A timber picket fence encloses the property.</p> <p>The dwelling displays architectural features of a heritage style and is representative of the local development of this period, being of historical significance for the HCA.</p>		<p>Solar panels are visible along the western and eastern side of the roof.</p>

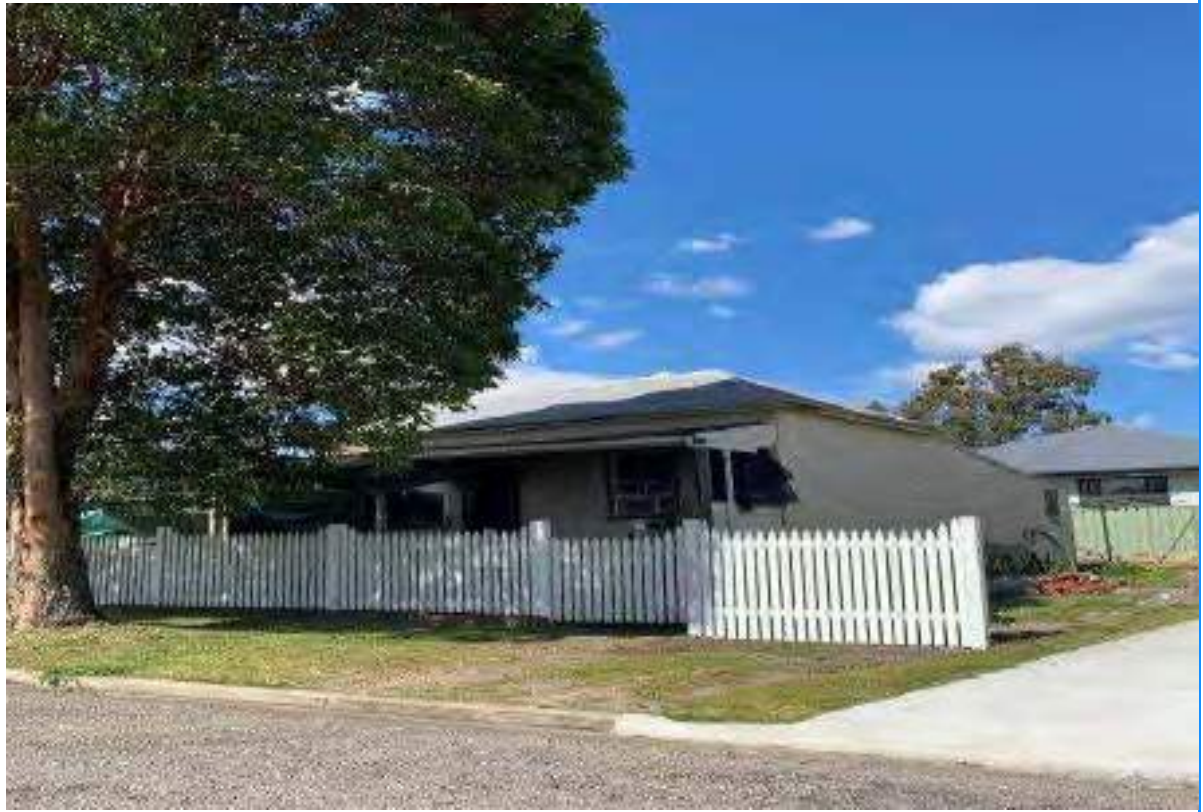
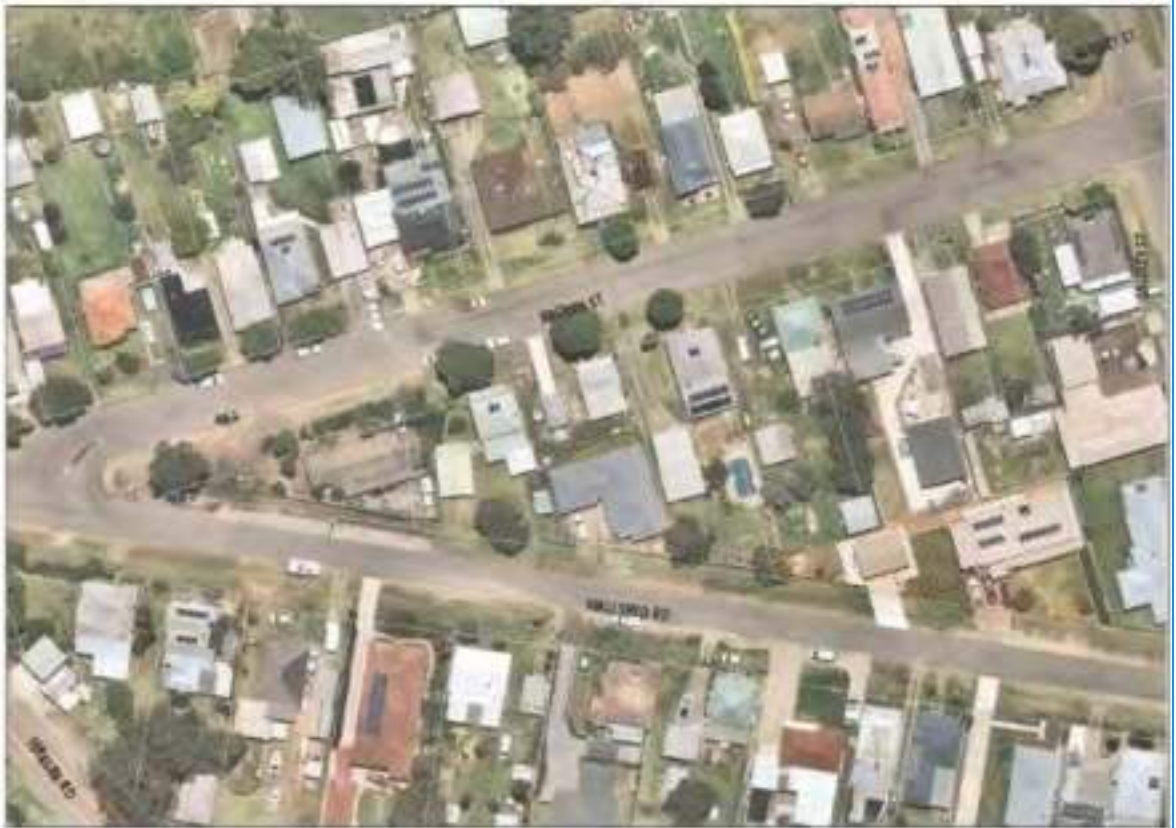
84 BROWN STREET, WEST WALLSEND 2286

Conservation Area Contribution Level	Est. Construction Date	Previous studies and/or community input
Contributory 1	1890–1915	No prior heritage investigations and no additional information required
Assessment Text		Observed Modifications
<p>Single story Vernacular ‘mining Cottage’ style dwelling with Colourbond hipped roof and weatherboard cladding. The veranda roof is skillion.</p> <p>The veranda is partially enclosed by canvas/mesh blinds and timber boarding. The western veranda window is the original heavy timber sash design.</p> <p>A brickwork chimney is visible on the eastern side, with no decorative features.</p> <p>A gable roof garage is located to the west of the dwelling</p> <p>A timber picket fence encloses the property.</p> <p>The dwelling displays architectural features of a heritage style and is representative of the local development of this period, being of historical significance for the HCA.</p>		<p>The eastern veranda window is a contemporary sliding design.</p>
