APPENDIX 2

Building Assessment Sheets (Inventory Sheets)

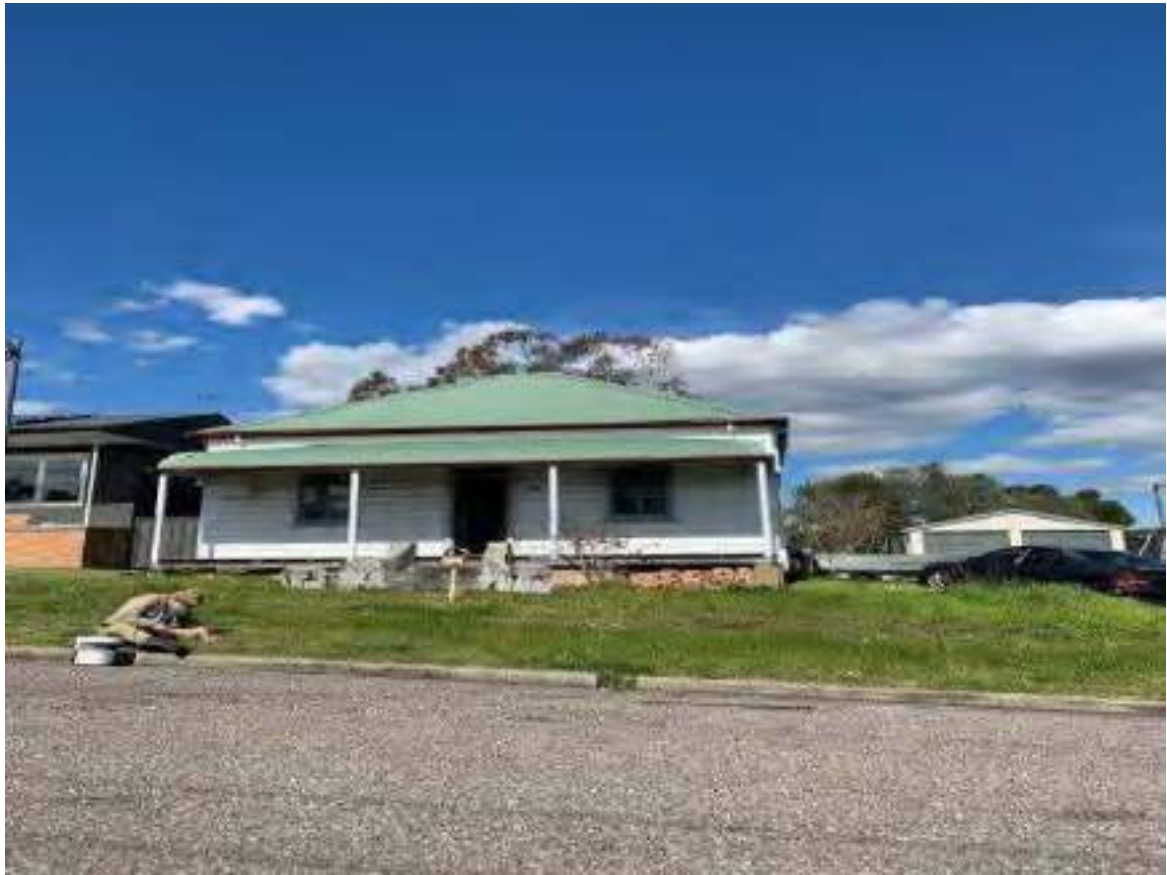
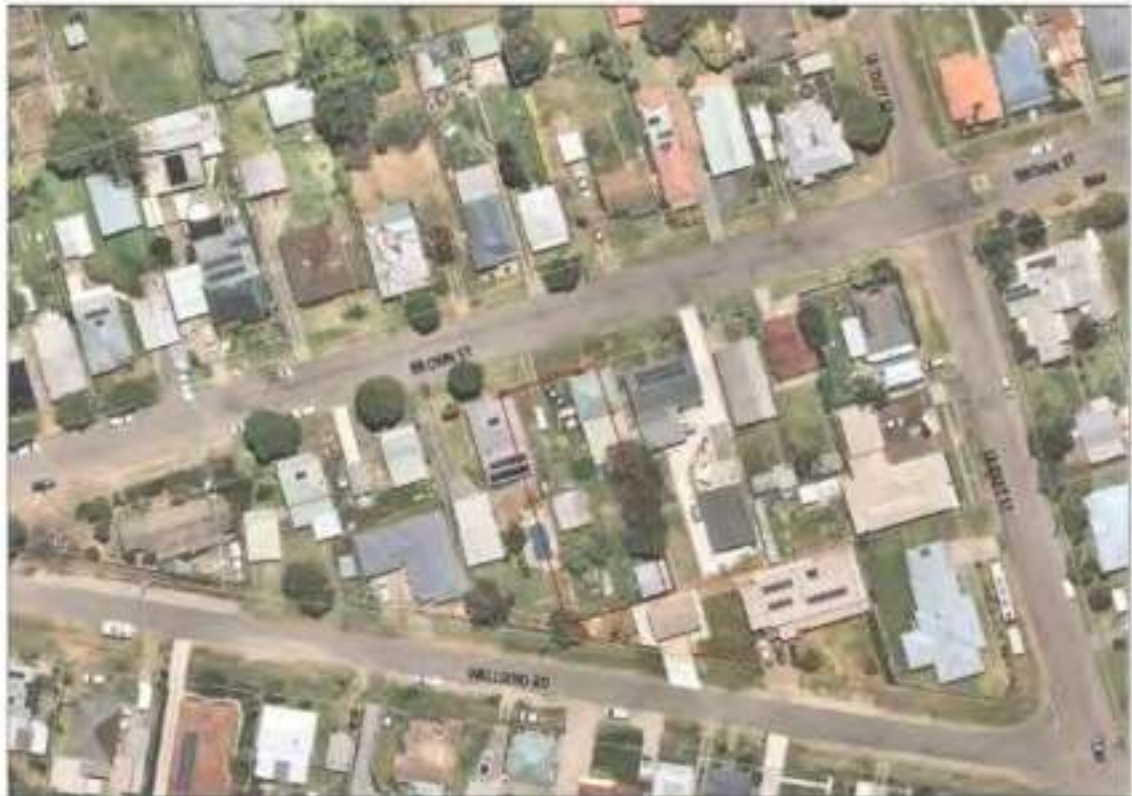
80 BROWN STREET, WEST WALLSEND 2286

Conservation Area Contribution Level	Est. Construction Date	Previous studies and/or community input
Contributory 1	1880–1915	No prior heritage investigations and no additional information required
Assessment Text		Observed Modifications
<p>Single story Vernacular ‘Mining Cottage’ style dwelling with steep hipped Colourbond roof and timber weatherboard cladding. The veranda roof is bull nosed and possibly original.</p> <p>The veranda floor is timber with exposed beams, potentially the original flooring. Concrete stairs with balustrade leads onto the landing.</p> <p>The front door is timber framed with a fanlight over head. The adjacent windows are the original timber framed sash designs. All visible windows are original.</p> <p>Brickwork chimney is visible on the eastern side.</p> <p>The dwelling displays architectural features of a heritage style and is representative of the local development of this period, being of historical significance for the HCA.</p>		<p>Dwelling shows some structural evidence for window hoods, however have since been removed.</p> <p>An extension has been built onto the back southern portion of the dwelling, however this is not visible from the street and does not detract.</p> <p>Concrete stairs are unlikely to be original, likely replacing a timber design.</p>

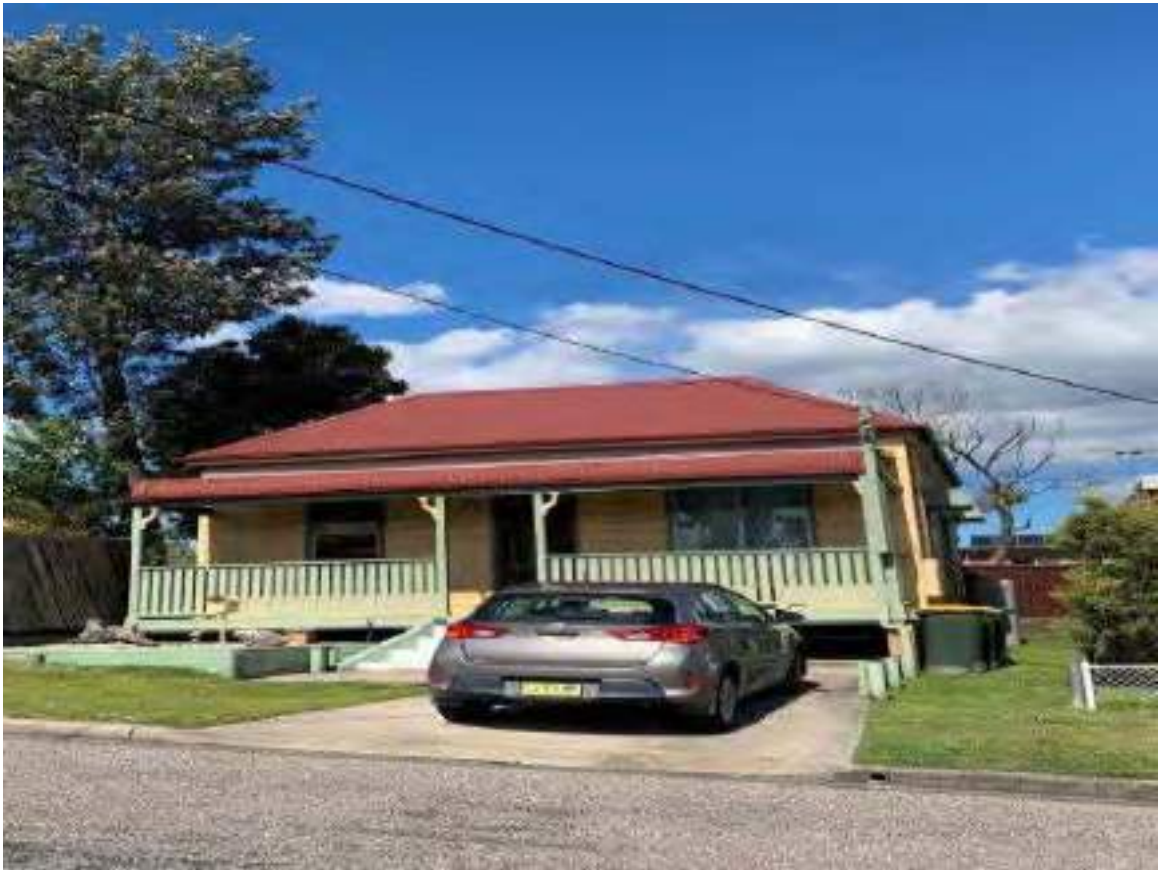
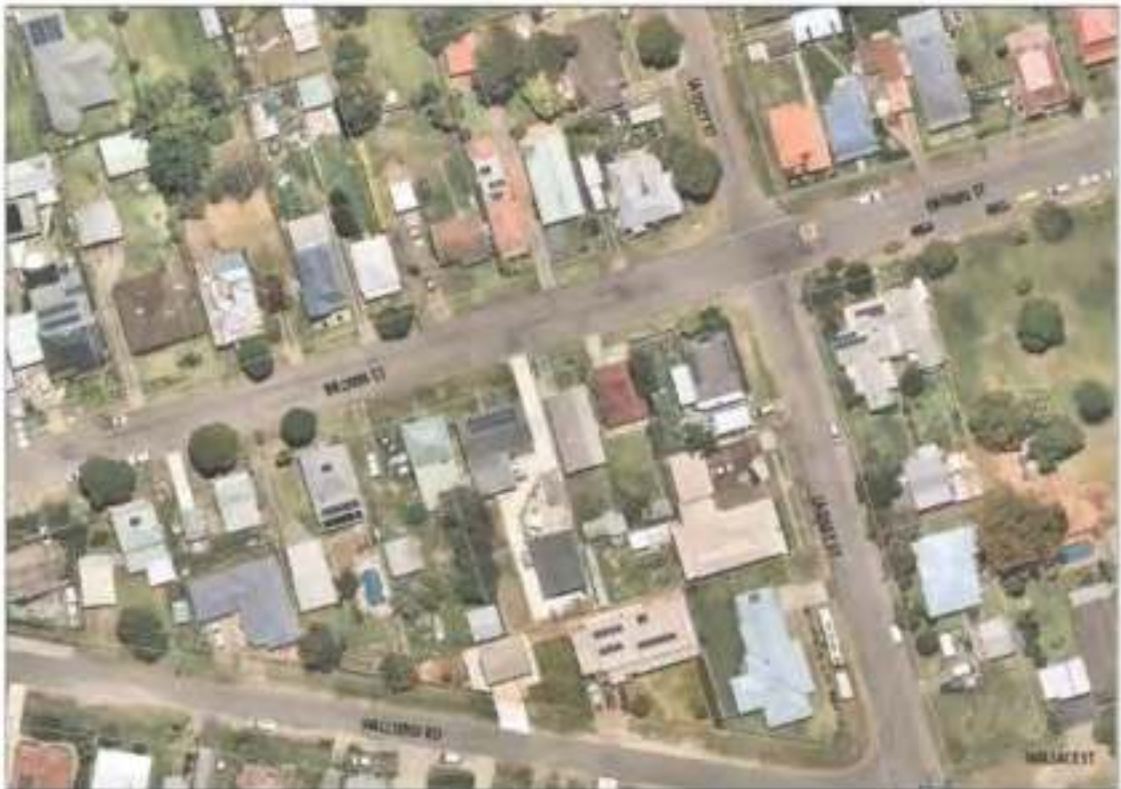
74 BROWN STREET, WEST WALLSEND 2286

Conservation Area Contribution Level	Est. Construction Date	Previous studies and/or community input
Contributory 1	1890–1915	No prior heritage investigations and no additional information required
Assessment Text		Observed Modifications
<p>Single story Vernacular ‘Mining cottage’ style dwelling with hipped Colourbond roof and timber weatherboard cladding. The veranda roof is bull nosed and potentially original.</p> <p>The veranda is partially enclosed by a simple timber balustrade and timber posts with carved brackets.</p> <p>The front door is timber framed with a four panel design, potentially original and a metal security screen. The eastern front window is an original heavy timber framed sash design, however the western is contemporary. Remaining windows appear original with metal hoods.</p> <p>The dwelling displays architectural features of a heritage style and is representative of the local development of this period, being of historical significance for the HCA.</p>		<p>The timber balustrade, posts and bracketing are a contemporary addition, likely replacing an original timber design.</p>

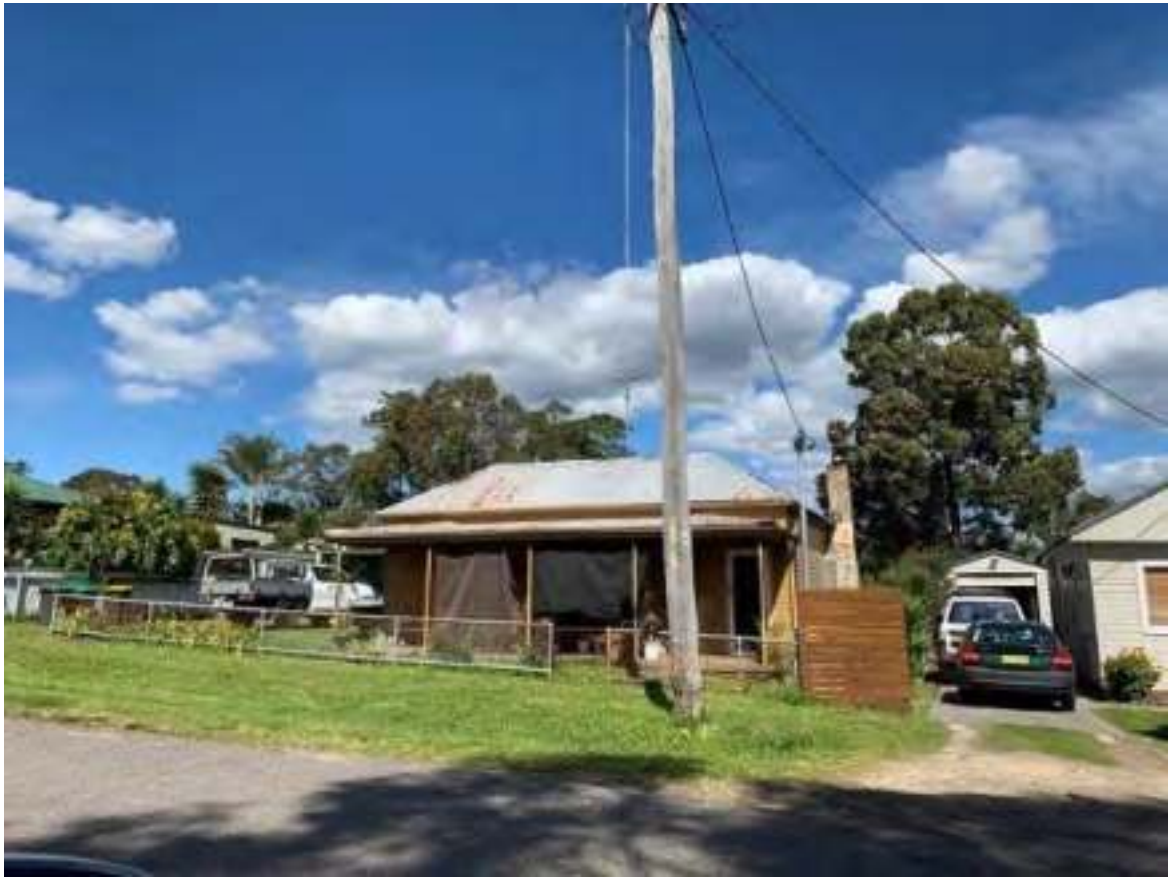
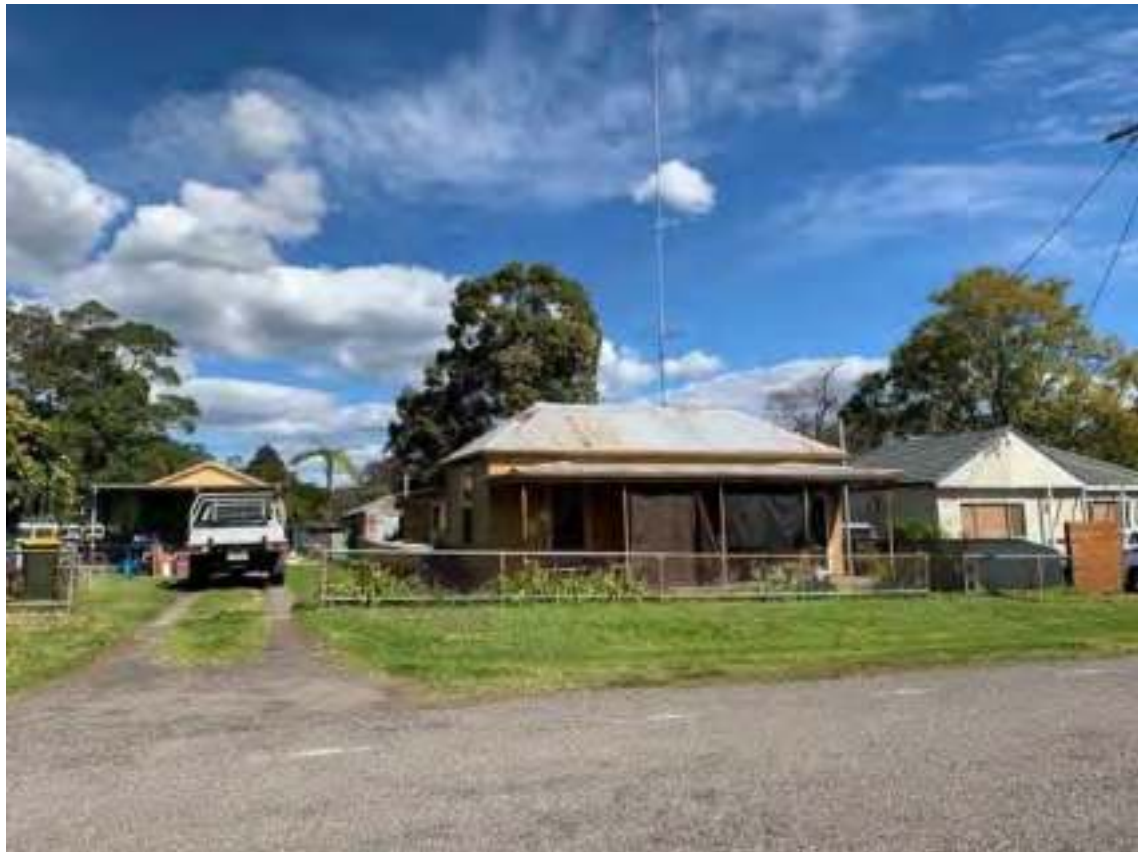
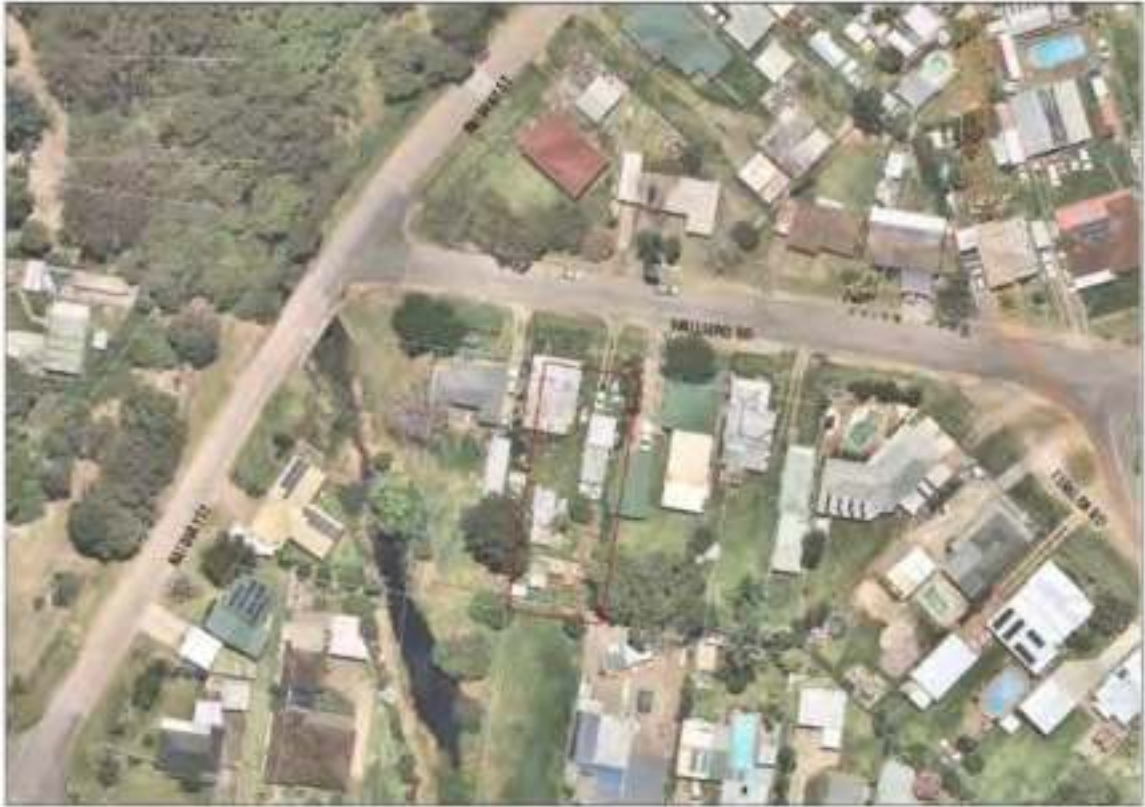
48 WALLSEND ROAD, WEST WALLSEND 2286

Conservation Area Contribution Level	Est. Construction Date	Previous studies and/or community input
Contributory 1	1890–1915	No prior heritage investigations and no additional information required
Assessment Text		Observed Modifications
<p>Single story Vernacular ‘Mining Cottage’ style dwelling with Colourbond hipped roof and weatherboard cladding. The veranda roof is hipped and supported by metal poles.</p> <p>A simple brick chimney is located on the western side of the dwelling.</p> <p>The front facing northern windows appear to be the original heavy timber framed sash designs.</p> <p>A metal wire fence encloses the property.</p> <p>Multiple shed/garage structures are located to the south-east of the dwelling.</p> <p>The dwelling displays architectural features of a heritage style and is representative of the local development of this period, being of historical significance for the HCA.</p>		<p>The front door has been relocated to the western side of the veranda and is no longer centrally positioned.</p> <p>Most windows have been replaced with contemporary sliding designs.</p> <p>An extension has been constructed at the back southern portion of the dwelling. This is not visible from the street and does not detract.</p>

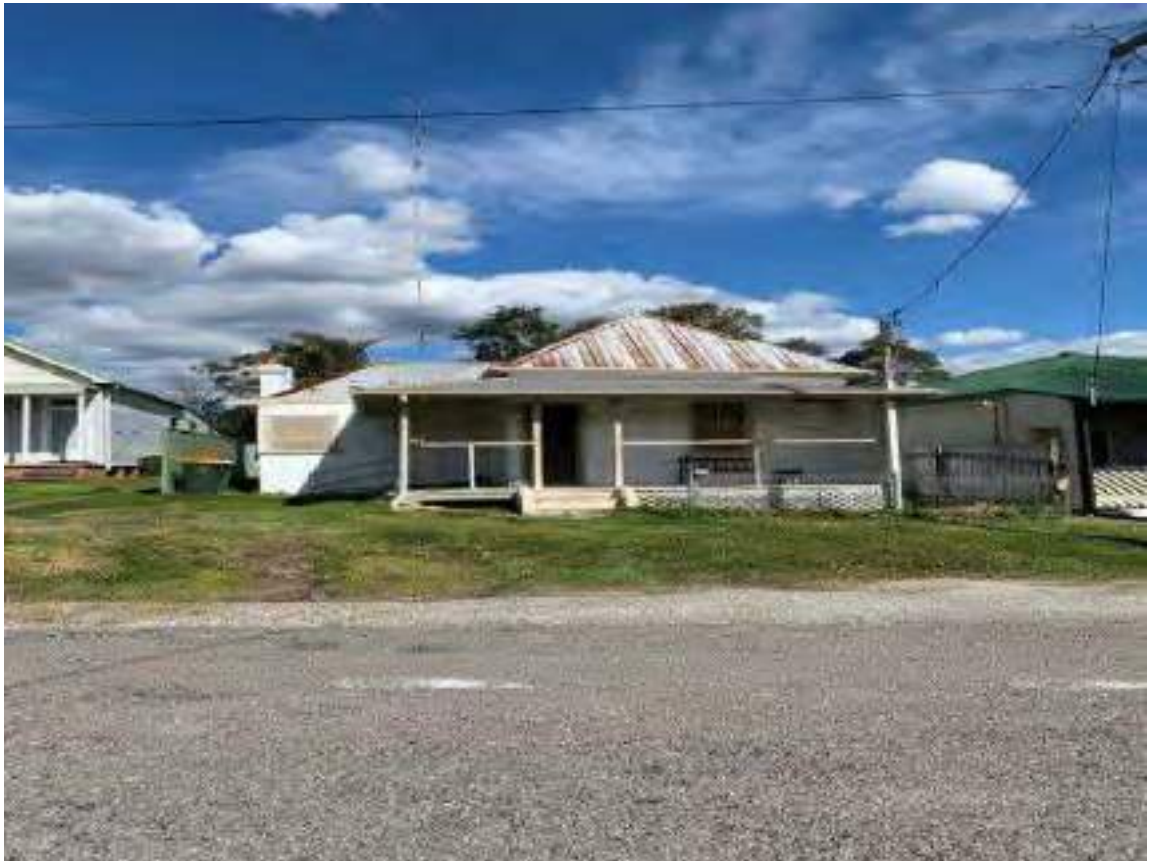
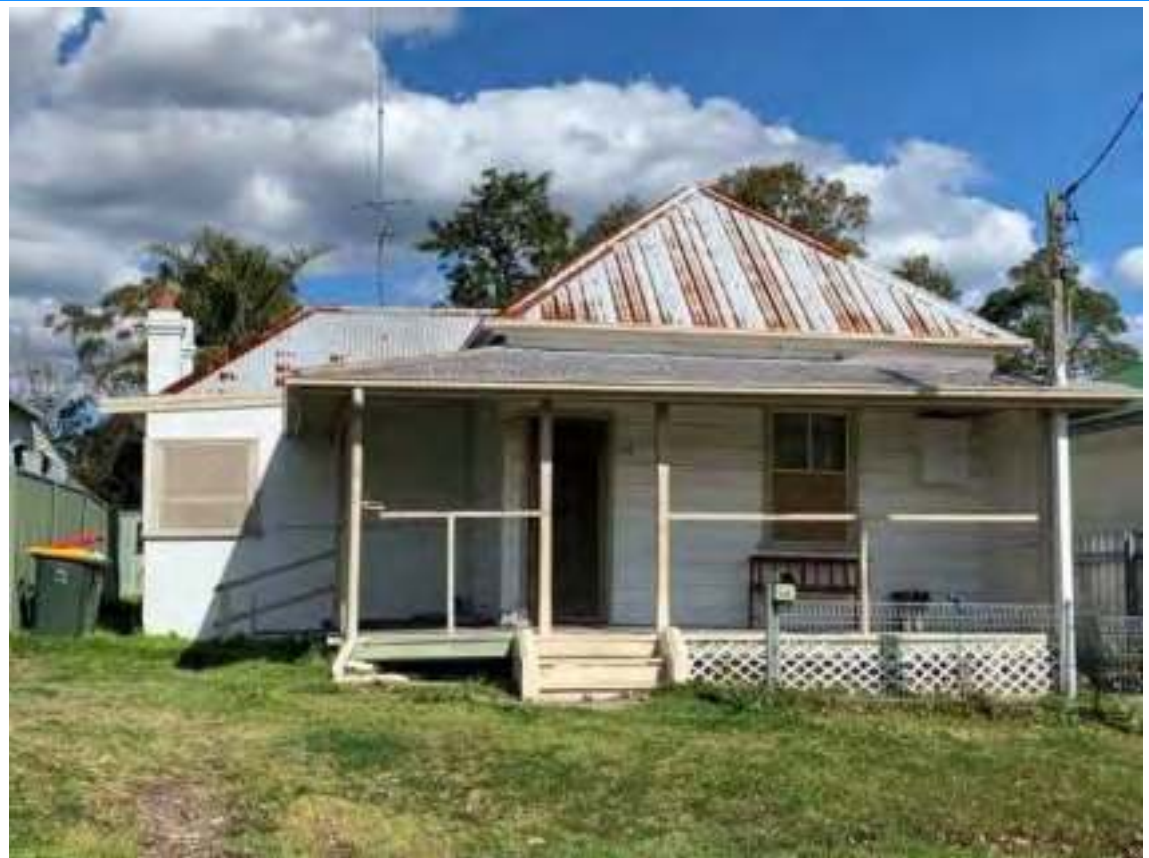
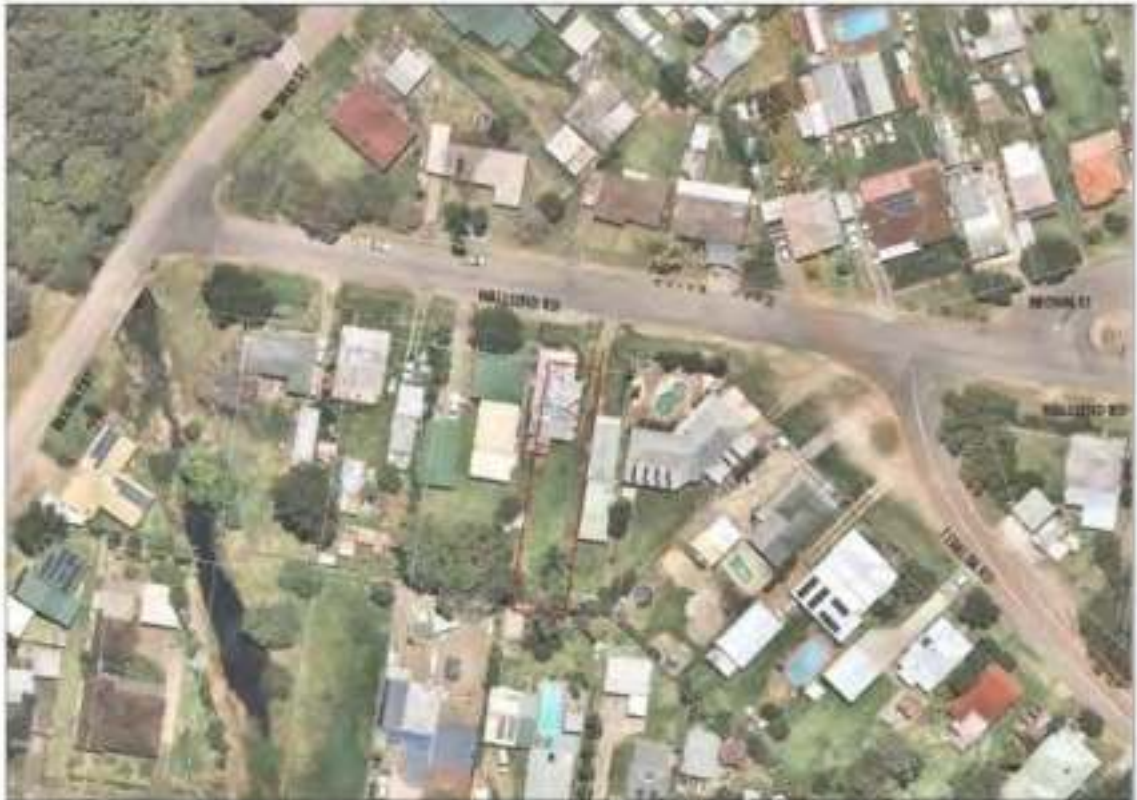
44 WALLSEND ROAD, WEST WALLSEND 2286

Conservation Area Contribution Level	Est. Construction Date	Previous studies and/or community input
Contributory 1	1900–1920	No prior heritage investigations and no additional information required
Assessment Text		Observed Modifications
<p>Single story simplified Victoriana Regency style dwelling with additional back room projection, hipped Colourbond roof and weatherboard cladding. The veranda roof is hipped.</p> <p>The veranda is partially enclosed with a simple timber balustrade and timber flooring.</p> <p>The front northern window is potentially original, with a heavy timber frame sash design.</p> <p>Two rendered brickwork chimneys are visible on the eastern side of the dwelling, with terracotta pots.</p> <p>The dwelling displays architectural features of a heritage style and is representative of the local development of this period, being of historical significance for the HCA.</p>		<p>An extension has been built onto the eastern side of the dwelling and is highly visible. This detracts from the heritage streetscape and impacts the heritage aesthetics.</p>

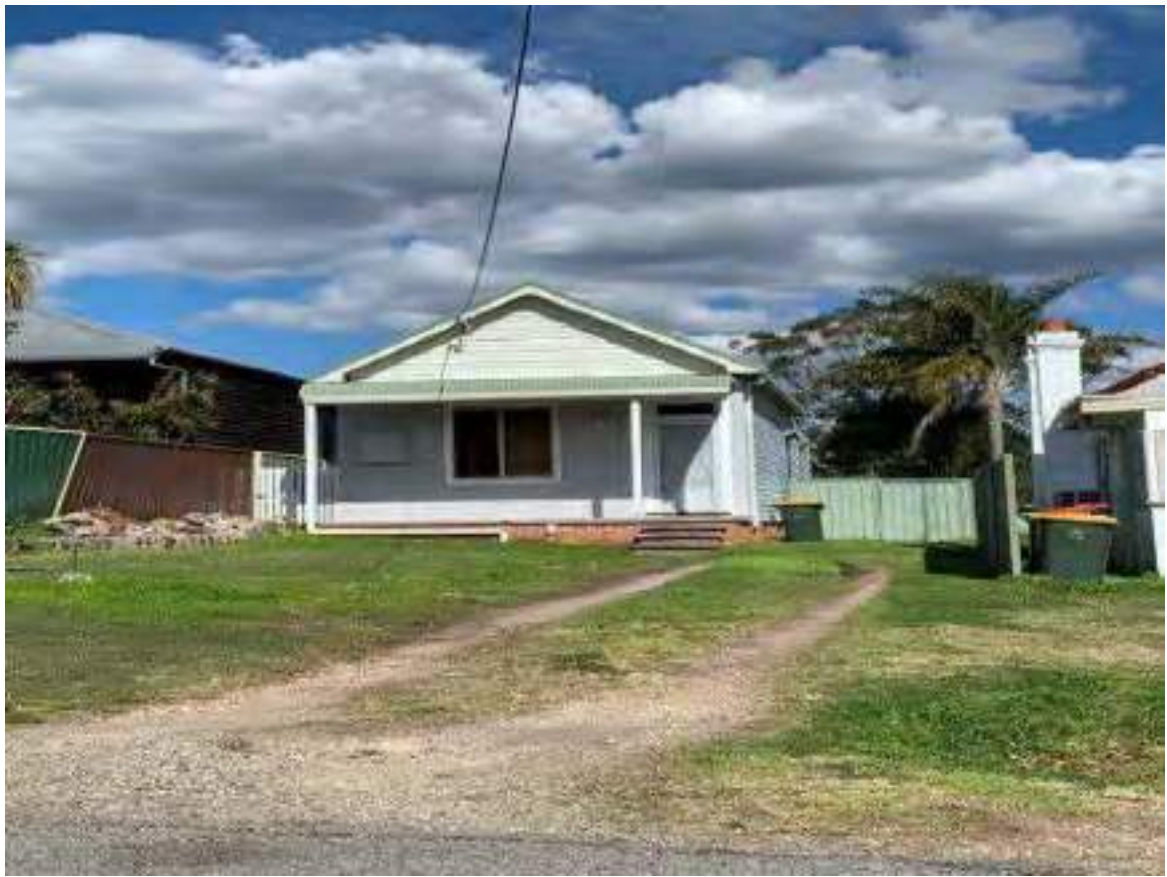
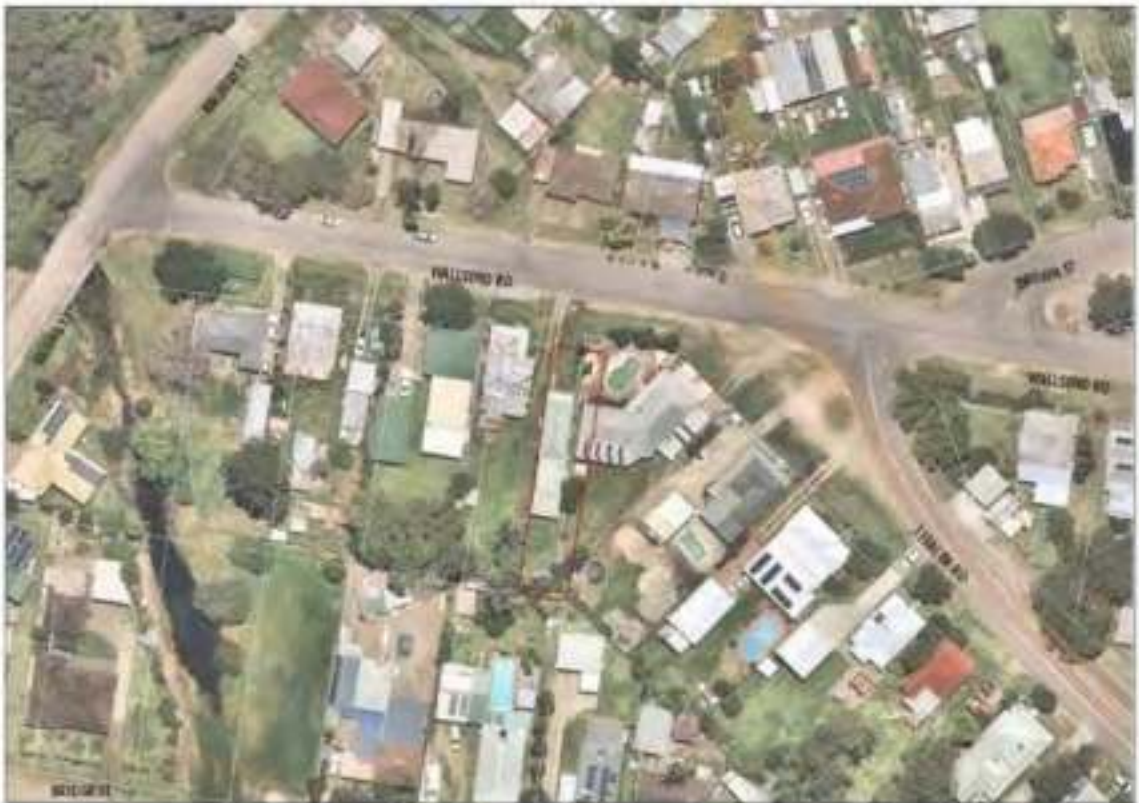
44A WALLSEND ROAD, WEST WALLSEND 2286

Conservation Area Contribution Level	Est. Construction Date	Previous studies and/or community input
Contributory 1	1900–1920	No prior heritage investigations and no additional information required
Assessment Text		Observed Modifications
<p>Singles tory simplified Victorian Regency style dwelling with gable Colourbond roof and weatherboard cladding. The veranda roof is bull nosed, potentially the original.</p> <p>The front door is timber framed with a fan light above.</p> <p>The dwelling displays architectural features of a heritage style and is representative of the local development of this period, being of historical significance for the HCA.</p>		<p>The visible windows have been replaced with contemporary sliding designs.</p> <p>An extension has been constructed to the back southern portion of the dwelling. this is not visible from the street and does not impact the heritage streetscape.</p>

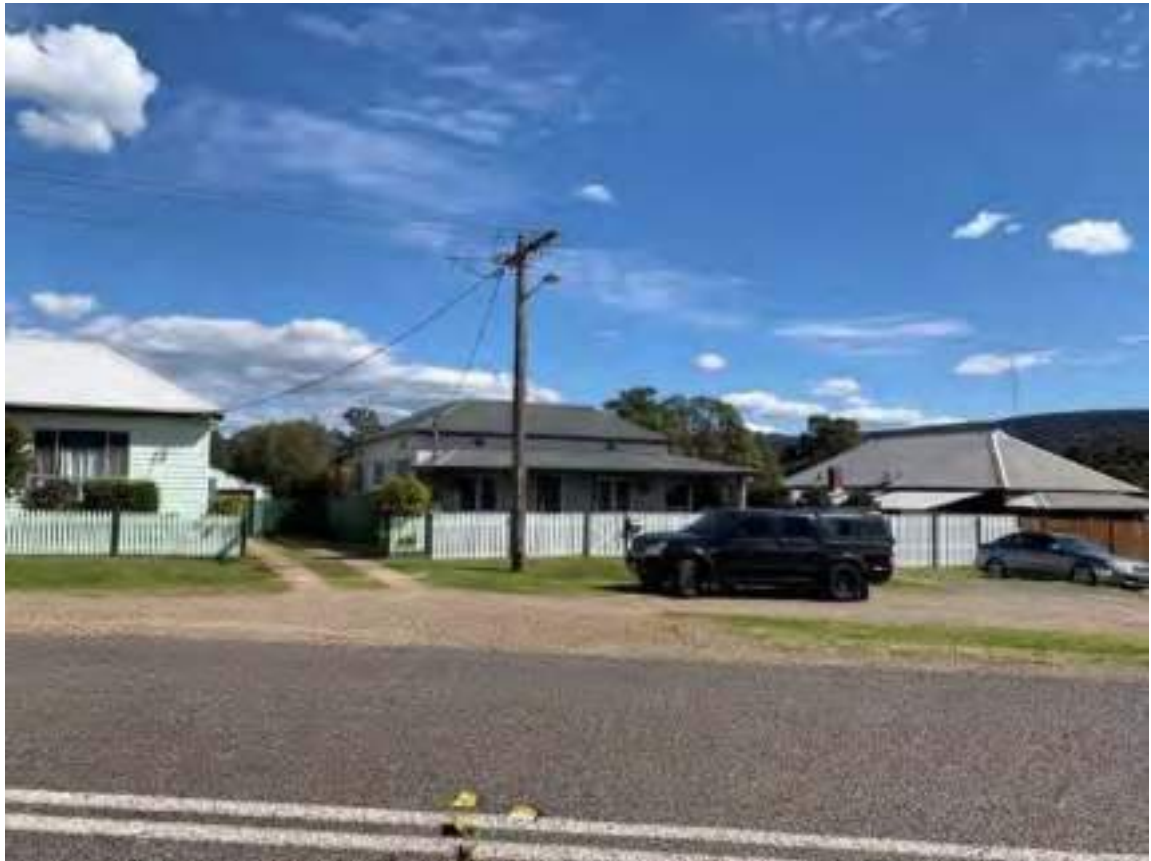
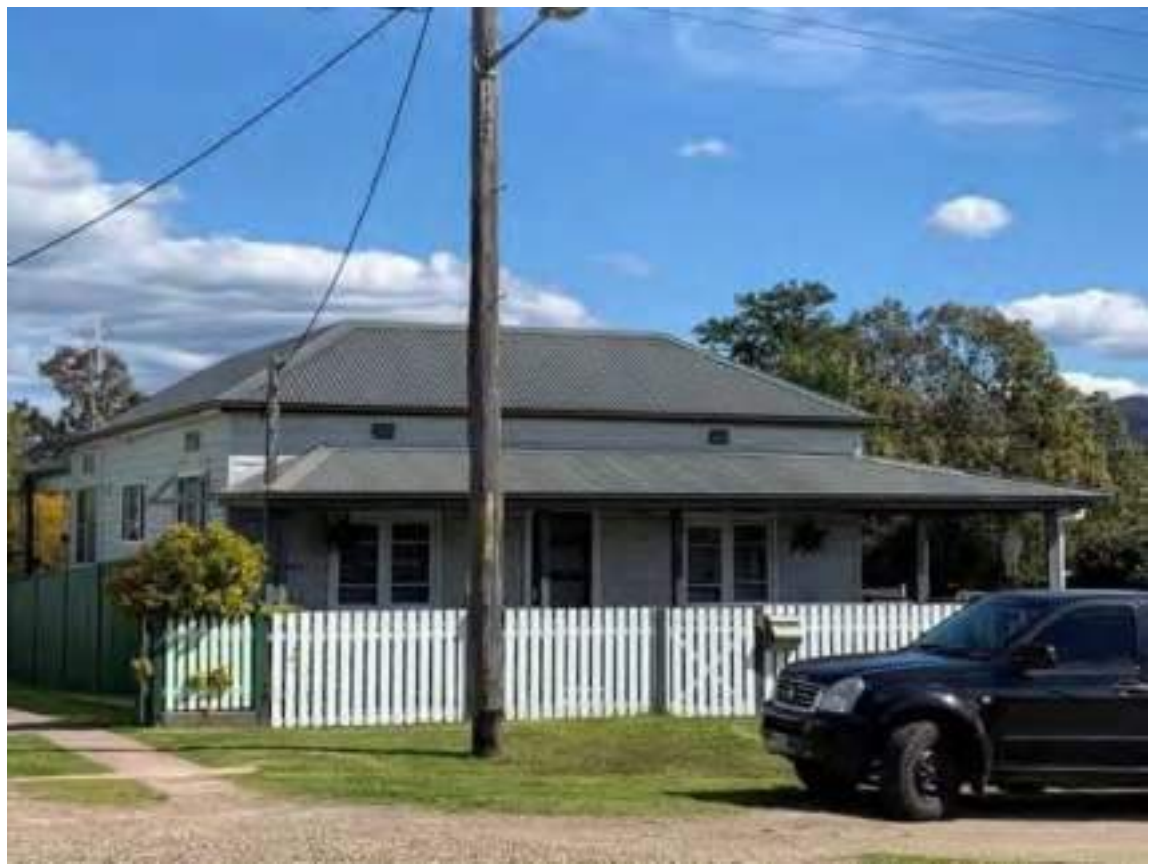
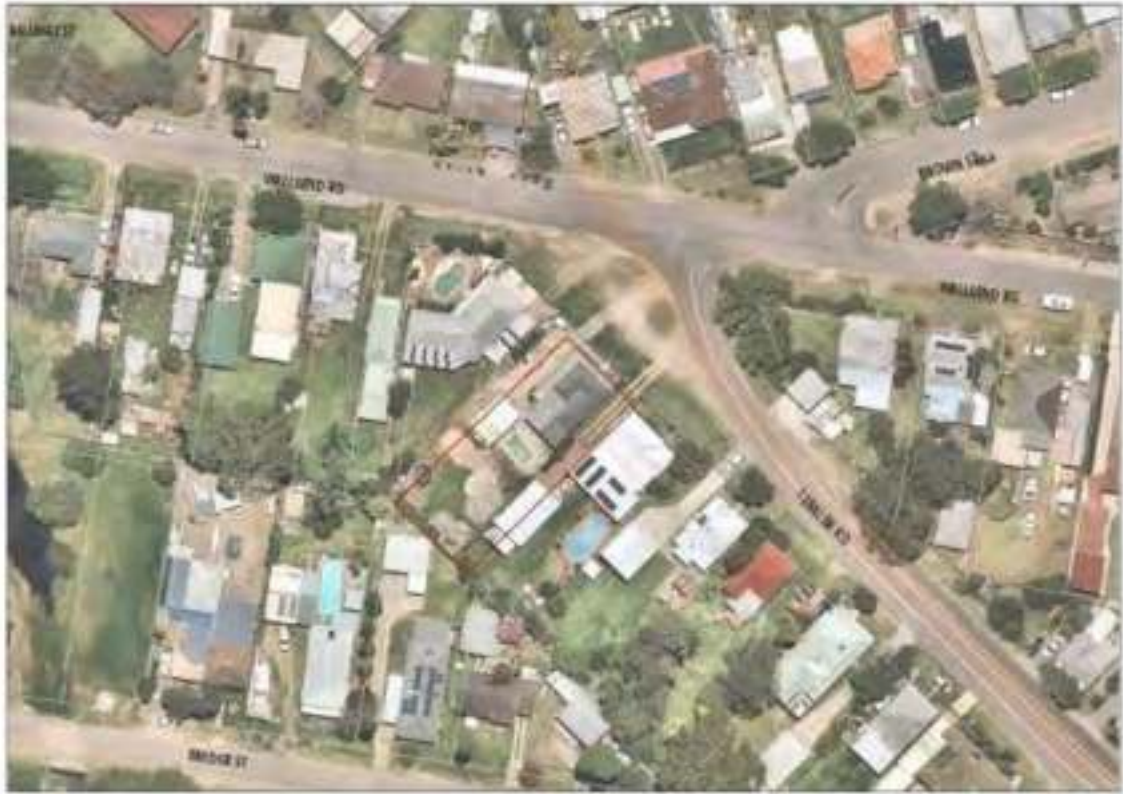
4 TERALBA ROAD, WEST WALLSEND 2286

Conservation Area Contribution Level	Est. Construction Date	Previous studies and/or community input
Contributory 1	1890–1915	No prior heritage investigations and no additional information required
Assessment Text		Observed Modifications
<p>Singles tory Vernacular ‘Mining Cottage’ style dwelling with Colourbond hipped roof and weatherboard cladding. The veranda roof is hipped.</p> <p>The veranda is partially enclosed by a simple timber balustrade. A timber fence encloses the property.</p> <p>The dwelling displays architectural features of a heritage style and is representative of the local development of this period, being of historical significance for the HCA.</p>		<p>The front door is a contemporary glass and timber design.</p> <p>The visible windows have been replaced with contemporary double sash or picture styles, however the timber frames is consistent with the heritage style of the dwelling.</p> <p>The veranda balustrade and support posts are recent additions, likely replacing a similar original design.</p> <p>The veranda roof would have been bull nosed and has been replaced with a hipped design.</p> <p>An extension has been built into the back south western portion of the dwelling.</p> <p>The veranda wraps around to the north western side of the dwelling, a contemporary modification.</p>

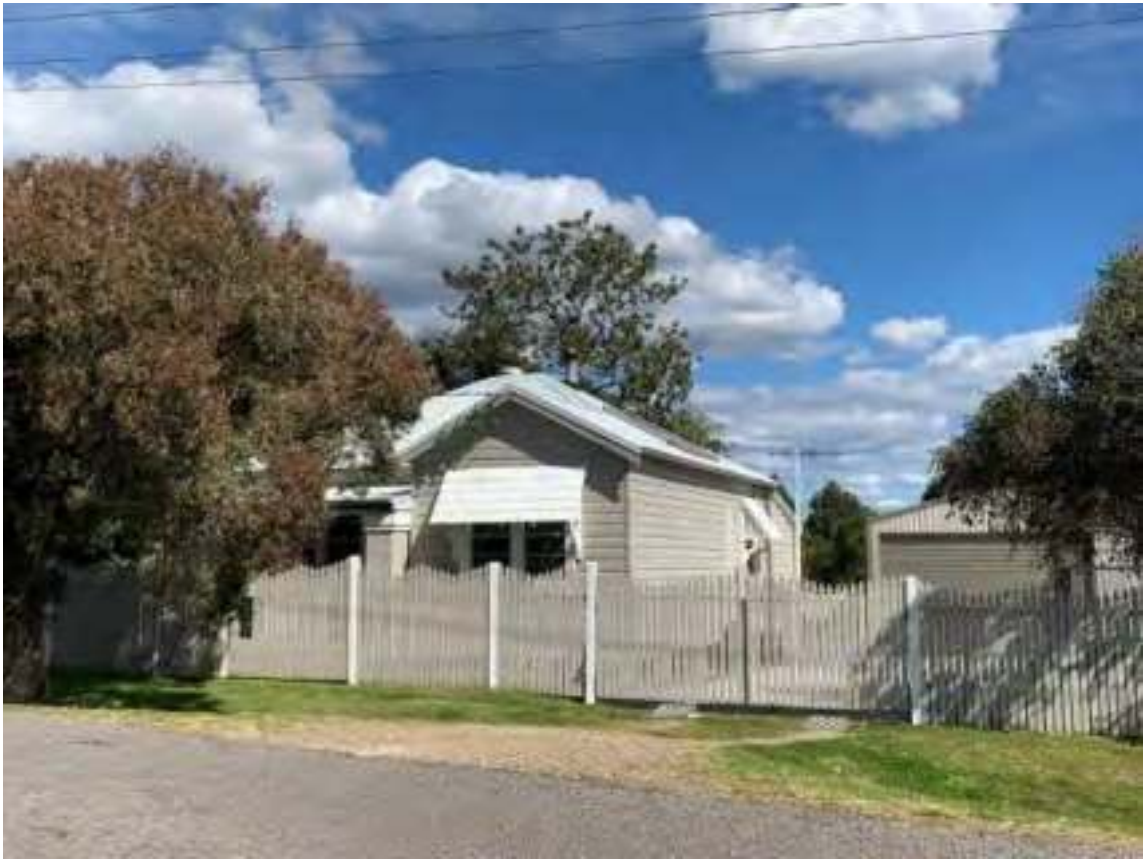
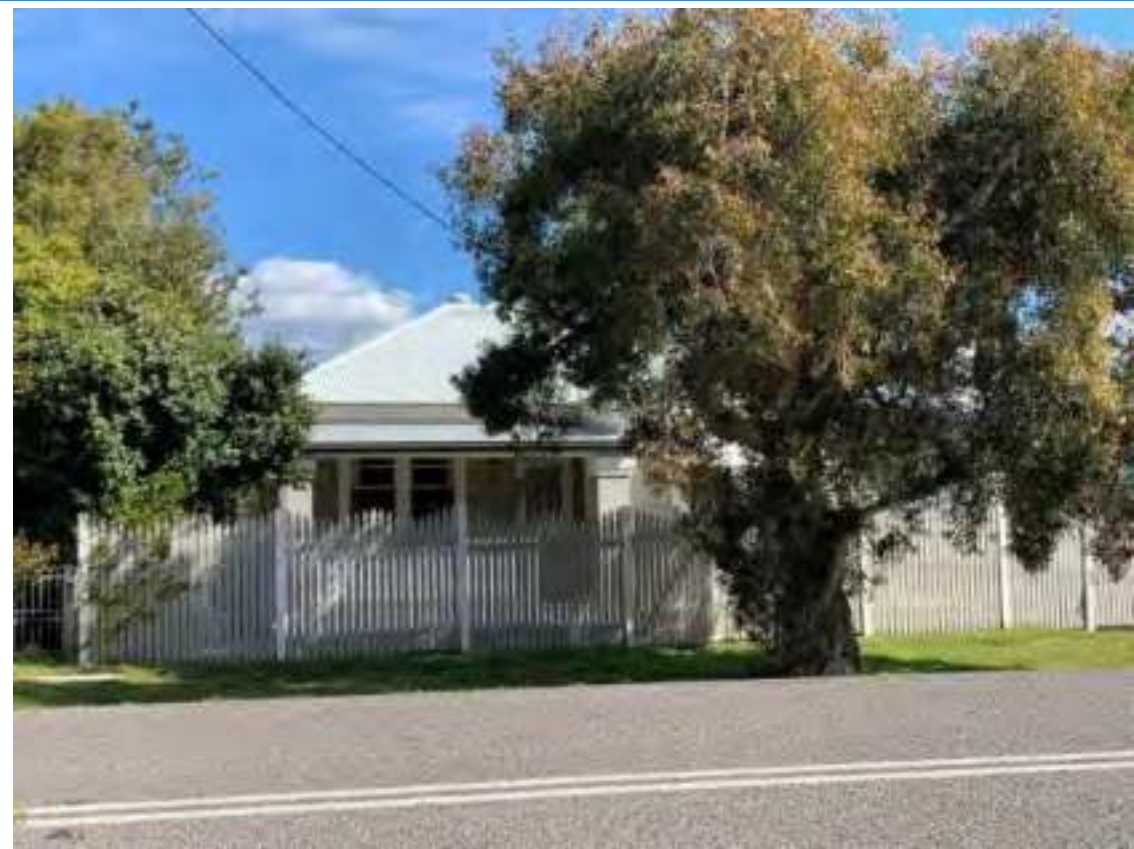
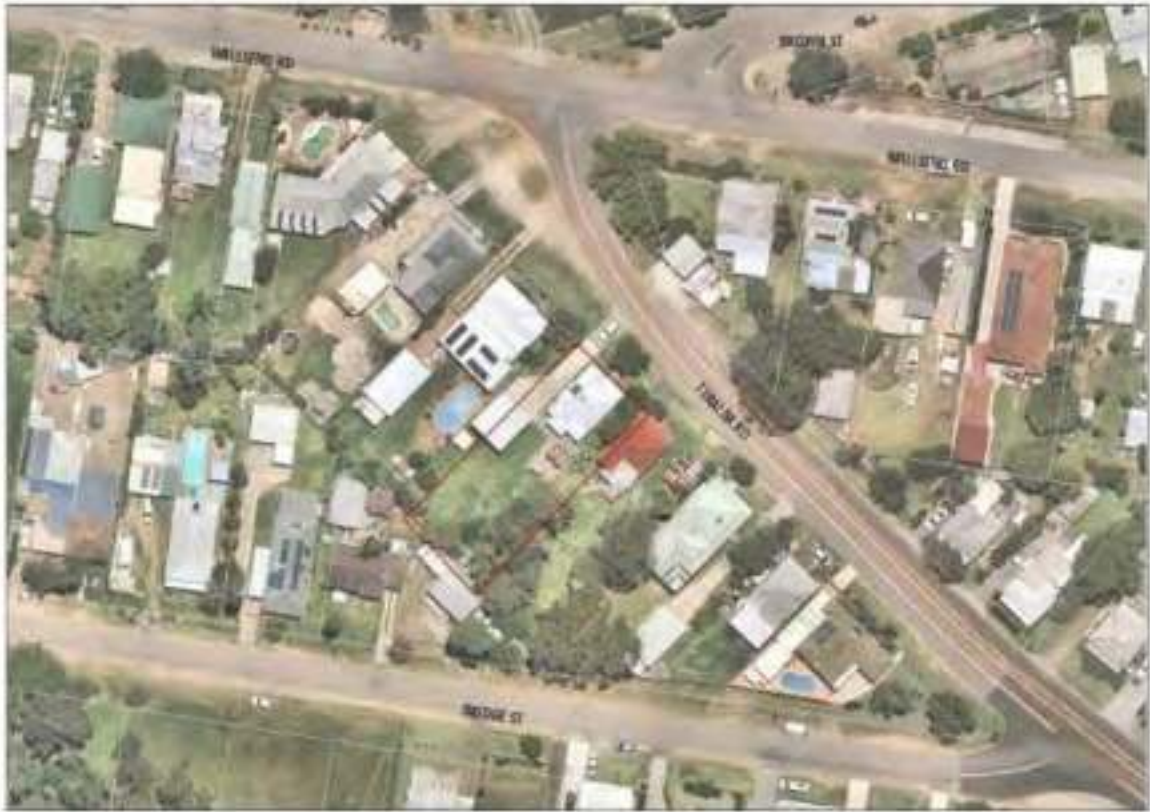
8 TERALBA ROAD, WEST WALLSEND 2286

Conservation Area Contribution Level	Est. Construction Date	Previous studies and/or community input
Contributory 1	1900–1920	No prior heritage investigations and no additional information required
Assessment Text		Observed Modifications
<p>Single story simplified Federation ‘workmen’s cottage’ style of dwelling with hipped Colourbond roof with a gable projection, and weatherboard cladding. The veranda roof is skillion and supported by brick pillars.</p> <p>The veranda is partially enclosed by a rendered brick wall with brick pillars.</p> <p>The visible windows are likely the original heavy timber frame sash designs. The gable window with a timber shingle awning with ornate carved brackets. Similar awnings are visible on the south eastern side.</p> <p>A gable roof Colourbond garage is located to the north west of the dwelling.</p> <p>A timber picket fence encloses the property.</p> <p>The dwelling displays architectural features of a heritage style and is representative of the local development of this period, being of historical significance for the HCA.</p>		<p>The brick veranda wall and pillars are likely an earlier modification to the dwelling and do not detract from the heritage quality of the dwelling.</p> <p>A metal chimney flute is visible, likely replacing an original brickwork design.</p>

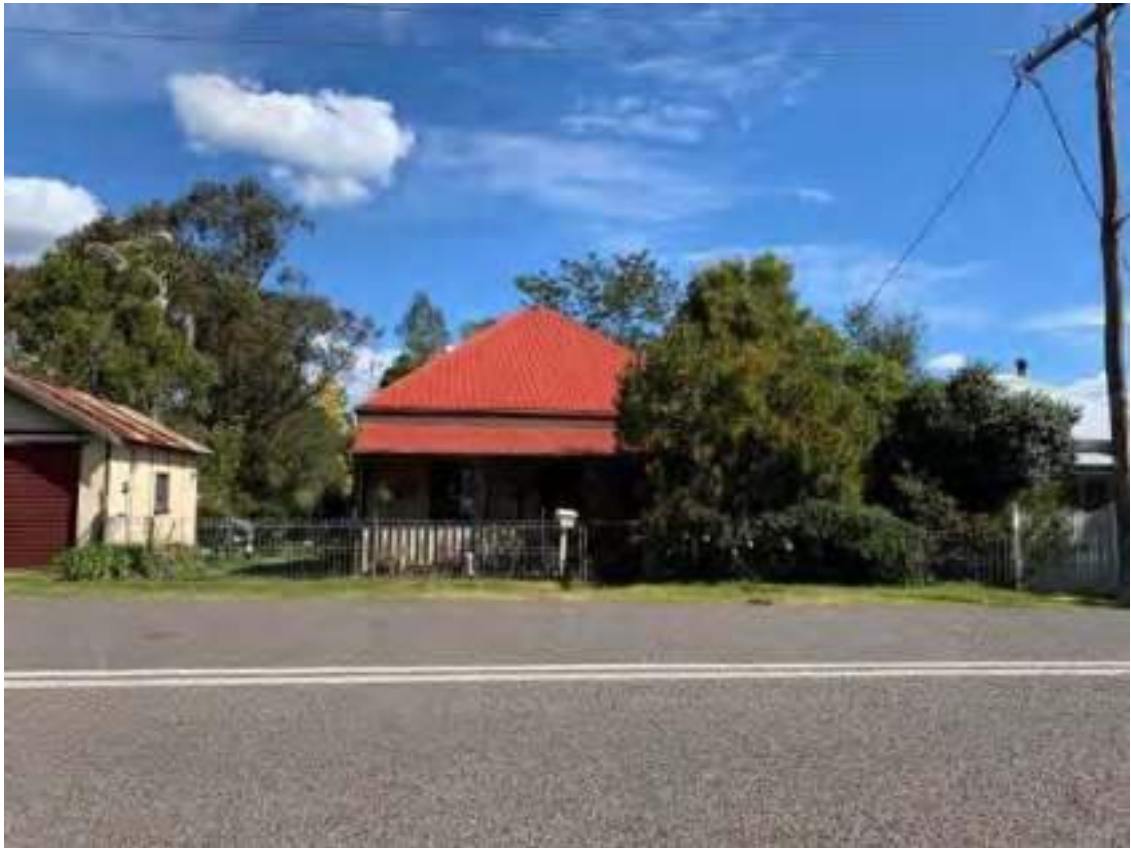
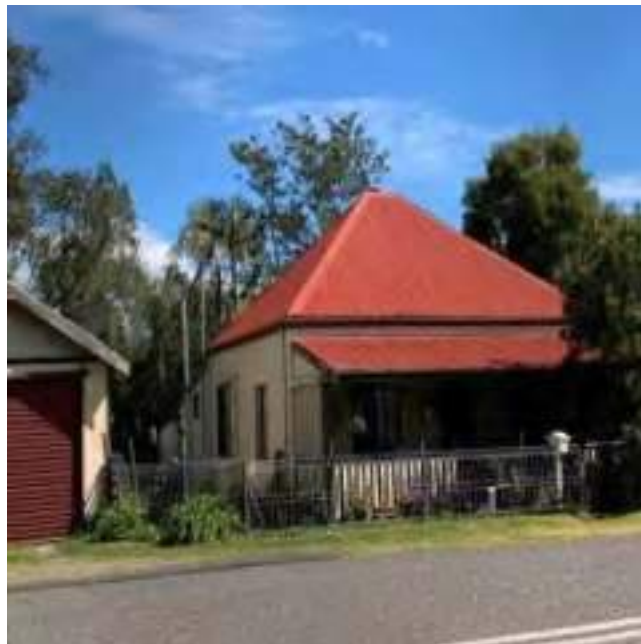
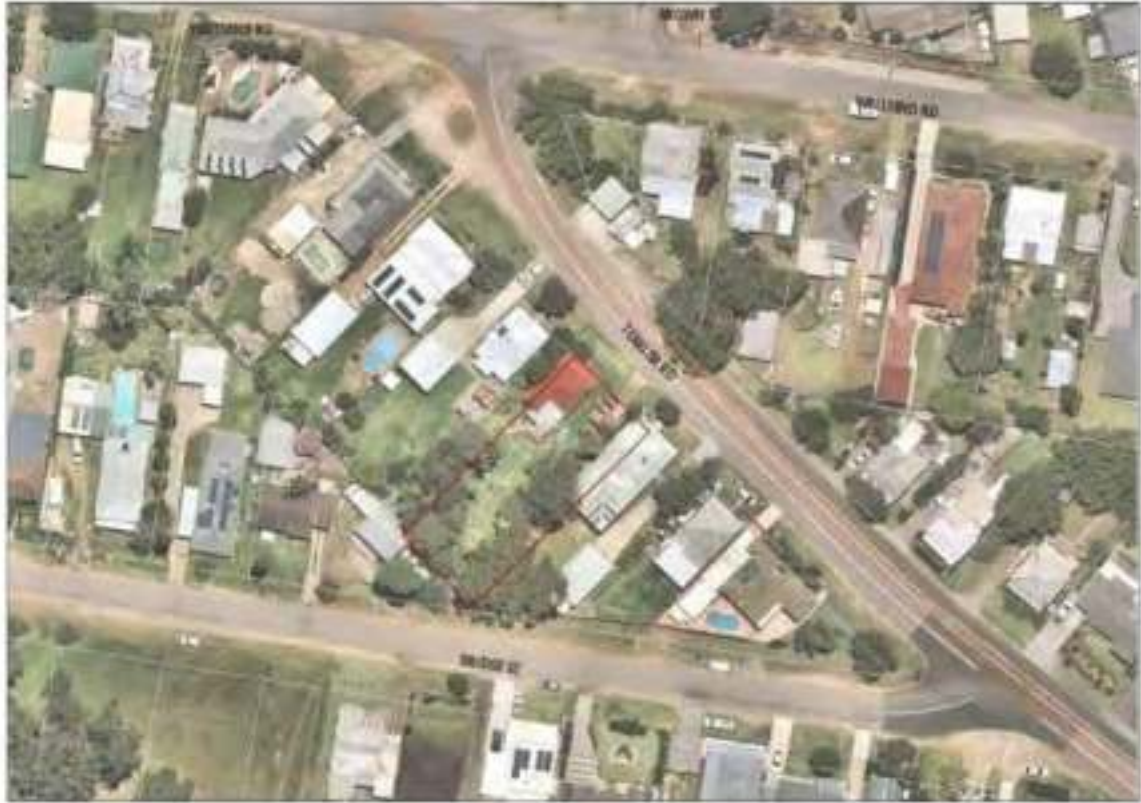
10 TERALBA ROAD, WEST WALLSEND 2286

Conservation Area Contribution Level	Est. Construction Date	Previous studies and/or community input
Contributory 1	1890–1915	No prior heritage investigations and no additional information required
Assessment Text		Observed Modifications
<p>Single story Vernacular ‘Mining Cottage’ style dwelling with a steep Colourbond hipped roof and timber weatherboard cladding. The veranda roof is skillion.</p> <p>The veranda is partially enclosed by a timber balustrade and striped canvas blinds.</p> <p>A gable roof garage is located to the south east of the dwelling.,</p> <p>A metal wire fence encloses the property.</p> <p>The dwelling displays architectural features of a heritage style and is representative of the local development of this period, being of historical significance for the HCA.</p>		<p>The veranda roof is skillion, likely replacing an original bull nosed design.</p> <p>The veranda balustrade and canvas blinds are a contemporary addition, however this does not detract from the heritage streetscape with these modifications found on comparable dwellings.</p> <p>The visible windows are contemporary metal framed designs.</p> <p>An extension has been built onto the back south western portion of the dwelling.</p>
