APPENDIX 2

Building Assessment Sheets (Inventory Sheets)

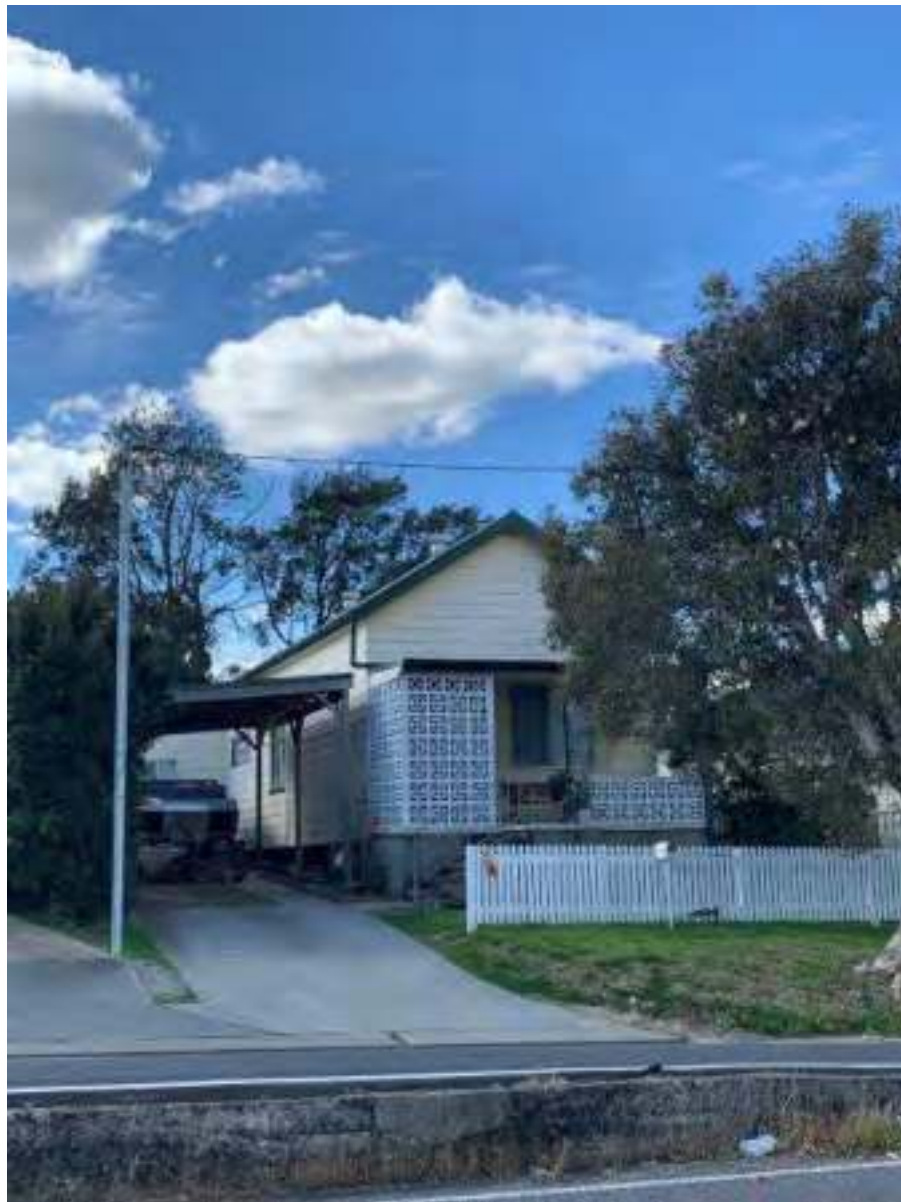
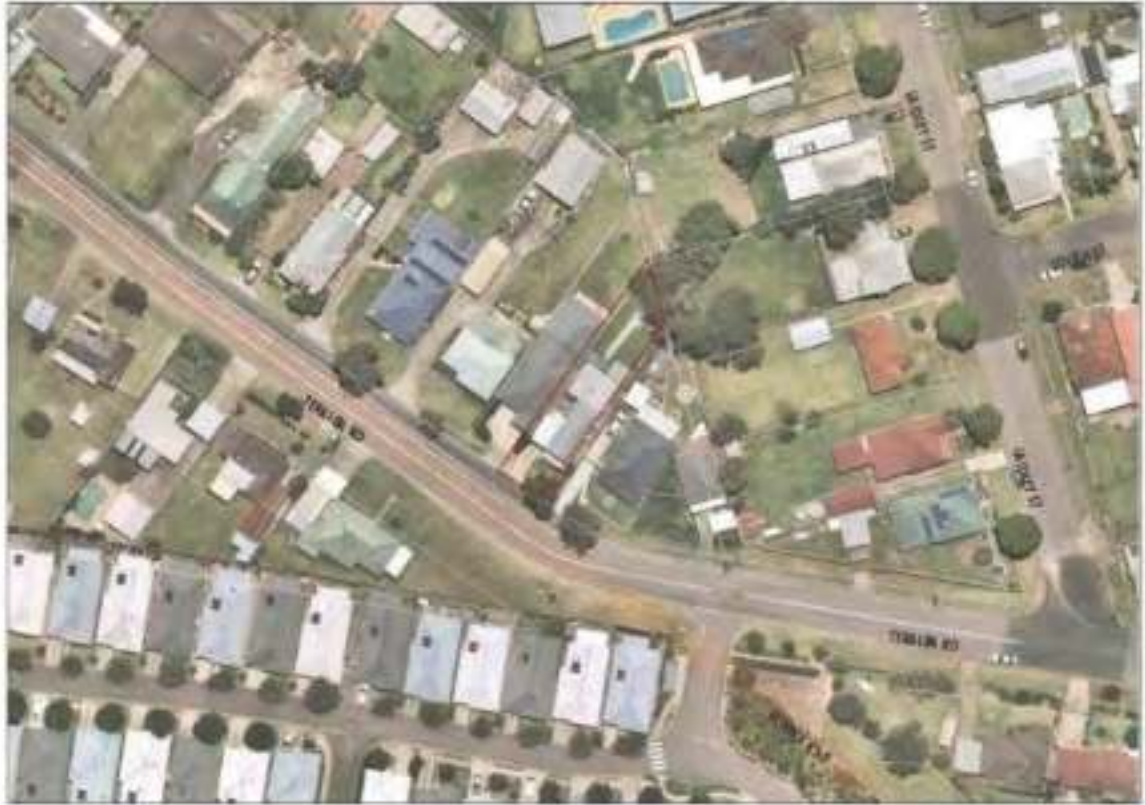
29 TERALBA ROAD, WEST WALLSEND 2286

Conservation Area Contribution Level	Est. Construction Date	Previous studies and/or community input
Contributory 1	1900–1920	No prior heritage investigations and no additional information required
Assessment Text		Observed Modifications
<p>Single story simplified Victorian Regency style dwelling with a Colourbond gable roof and weatherboard cladding. The veranda roof is flat or low skillion.</p> <p>The veranda is partially enclosed by a decorative cement block wall and veranda wall. A simple metal balustrade is found either side of cement steps leading onto the veranda landing.</p> <p>A car port is found on the western side of the dwelling.</p> <p>A timber fence encloses the property.</p> <p>The dwelling displays architectural features of a heritage style and is representative of the local development of this period, being of historical significance for the HCA.</p>		<p>The visible windows are contemporary sliding designs, replacing the original timber framed sash designs.</p> <p>The veranda cement bloc walls are contemporary modifications and contrast with the heritage style of the dwelling.</p> <p>A back extension is located on the back north eastern portion of the dwelling, however this is not visible from the street.</p>

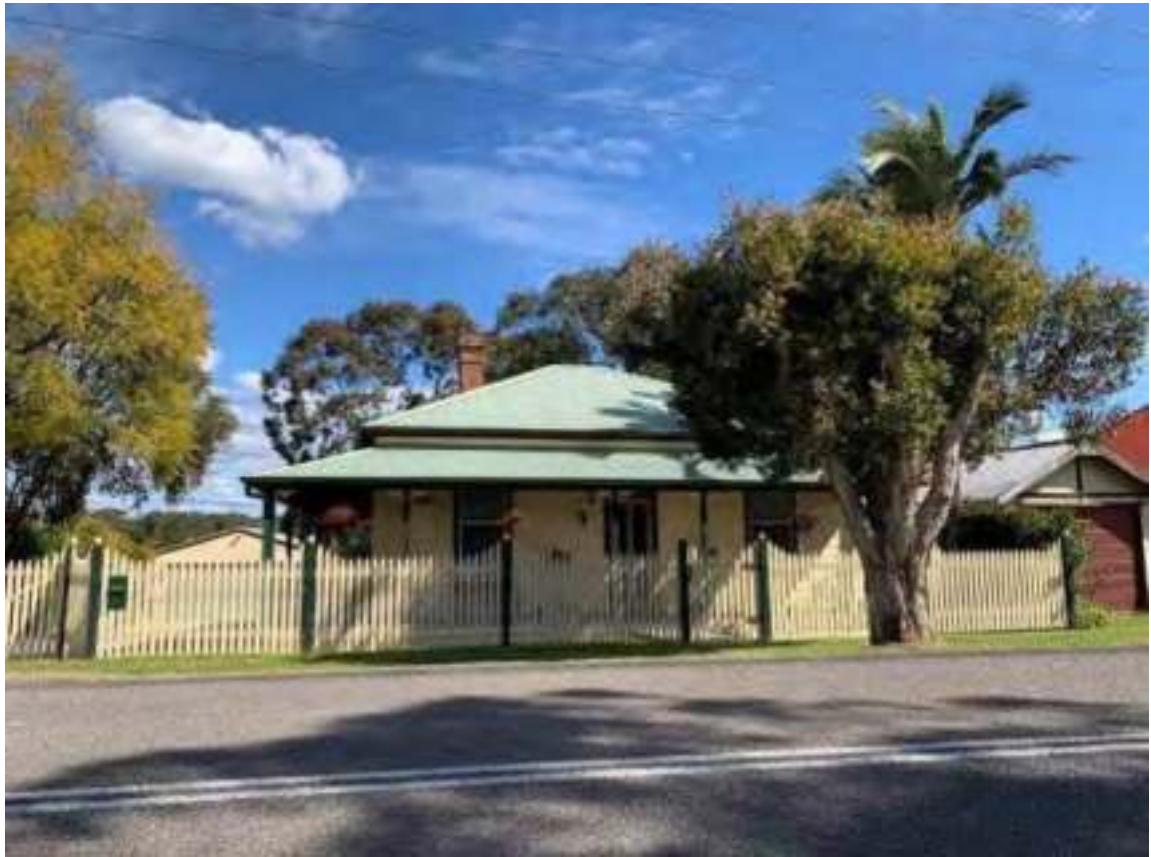
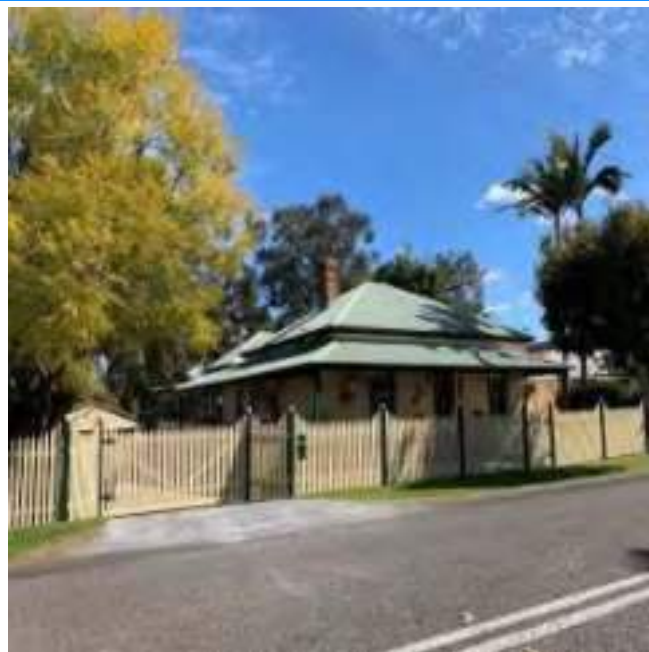
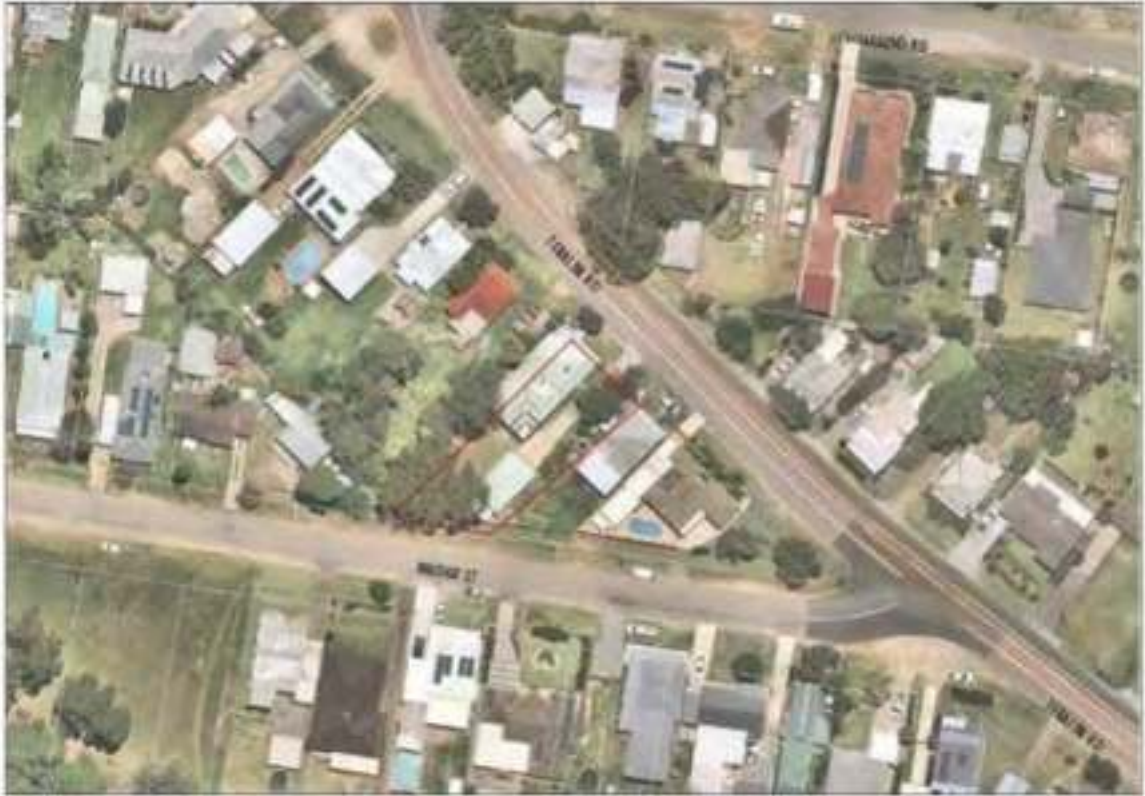
12 TERALBA ROAD, WEST WALLSEND 2286

Conservation Area Contribution Level	Est. Construction Date	Previous studies and/or community input
Contributory 1	1890–1915	No prior heritage investigations and no additional information required
Assessment Text		Observed Modifications
<p>Single story Vernacular ‘Mining Cottage’ style dwelling with hipped Colourbond roof and weatherboard cladding. The veranda roof is skillion and supported by timber posts with ornately carved brackets.</p> <p>The veranda wraps around the north eastern and south eastern sides of the dwelling. The south eastern portion is partially enclosed by a timber balustrade.</p> <p>The front door is timber framed and an original four panel design. The adjacent windows have decorative timber sills.</p> <p>A brickwork chimney is visible on the south eastern side of the dwelling, with double corbel detailing.</p> <p>A gable roof garage is located to the south of the dwelling.</p> <p>A timber picket fence encloses the property.</p> <p>The dwelling displays architectural features of a heritage style and is representative of the local development of this period, being of historical significance for the HCA.</p>		<p>The façade windows have been replaced with contemporary metal sash designs, however this does not detract.</p> <p>The south eastern extension of the veranda is a contemporary addition, however this is a common modification for the dwelling style and does not detract from the heritage streetscape.</p> <p>The veranda balustrade is a contemporary addition, likely constructed in conjunction with the veranda extension.</p> <p>A back extension is located to the south western portion of the dwelling, however this is not visible from the street and does not detract.</p>

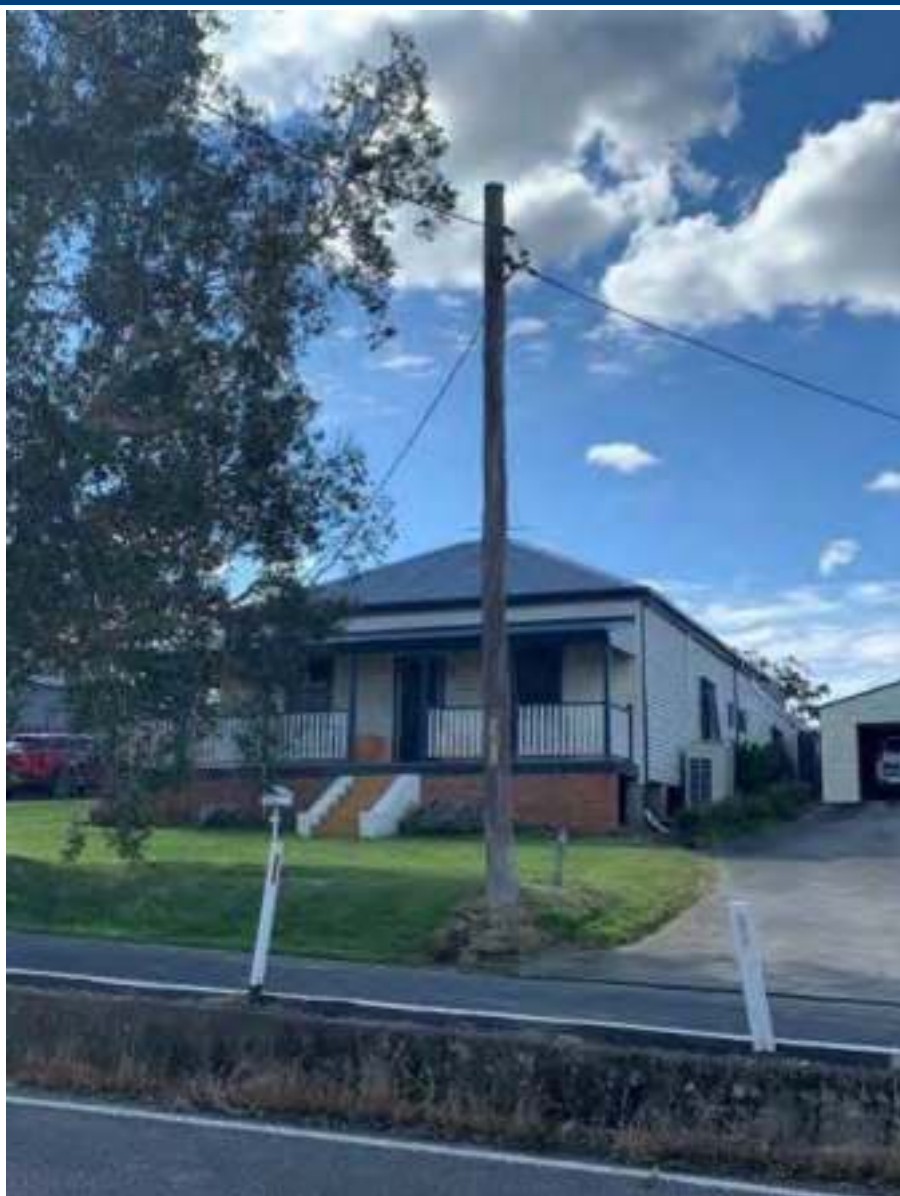
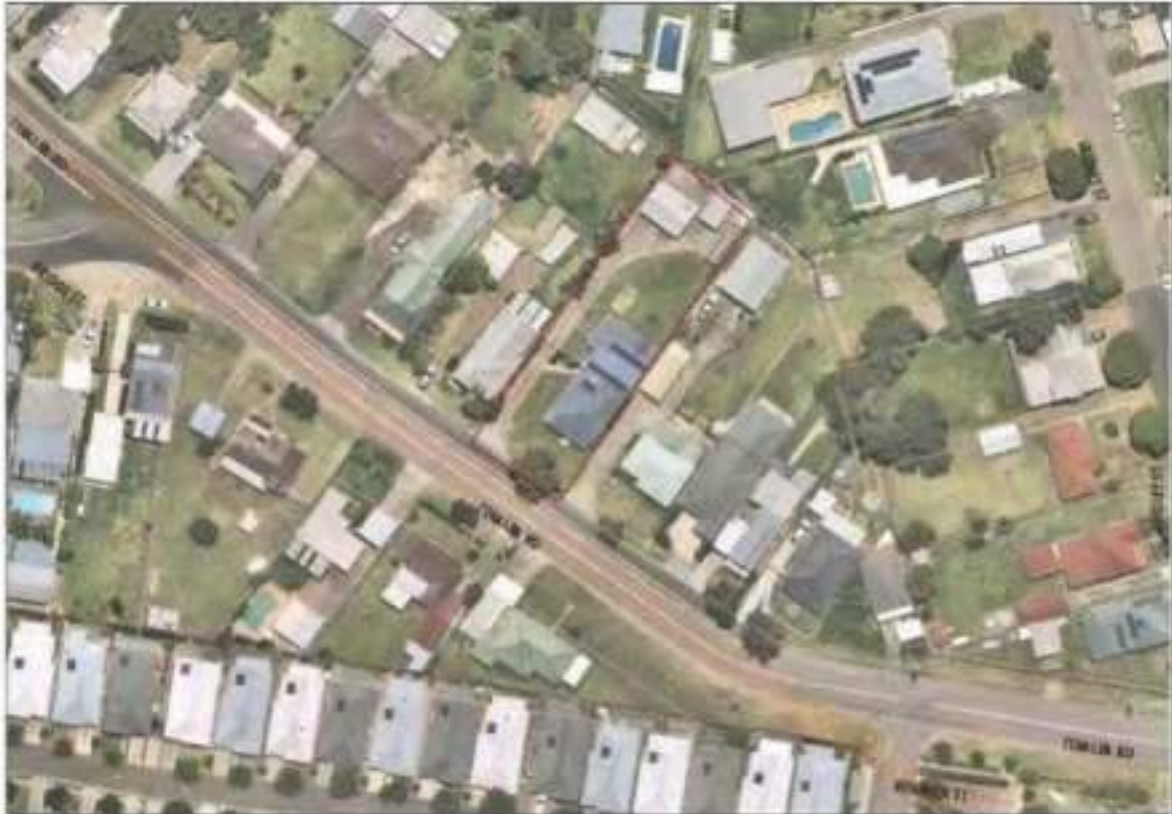
25 TERALBA ROAD, WEST WALLSEND 2286

Conservation Area Contribution Level	Est. Construction Date	Previous studies and/or community input
Contributory 1	1890–1915	No prior heritage investigations and no additional information required
Assessment Text		Observed Modifications
<p>Single story Vernacular ‘Mining Cottage’ style dwelling with hipped Colourbond roof and weatherboard cladding. The veranda roof is skillion.</p> <p>The veranda is partially enclosed by timber balustrade, wrapping around the southwestern and north western sides of the dwelling. Rendered masonry stairs lead onto the veranda landing, with masonry balustrade.</p> <p>The façade south western windows are likely the original heavy timber framed sash designs.</p> <p>The dwelling displays architectural features of a heritage style and is representative of the local development of this period, being of historical significance for the HCA.</p>		<p>The veranda roof was likely originally bull nosed, with a contemporary skillion replacement.</p> <p>The veranda balustrade is a contemporary addition, however, is constructed in a sympathetic manner.</p> <p>The masonry stairs are potentially a contemporary addition, with timber stairs being more common to the dwelling style.</p> <p>The veranda extension is a contemporary addition, however this does not detract as it is a common modification for the dwelling style.</p> <p>A back extension has been constructed at the north eastern end of the dwelling.</p> <p>Solar panels are partially visible from the western side of the dwelling.</p>

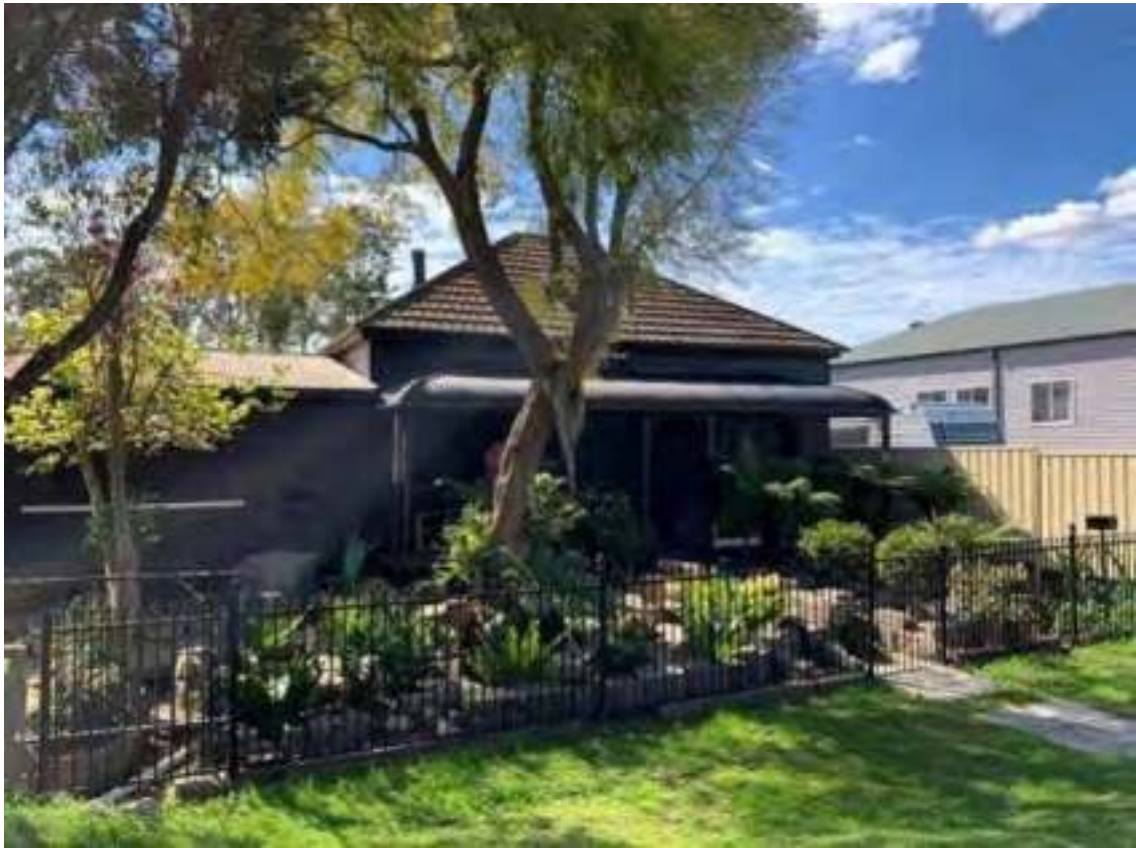
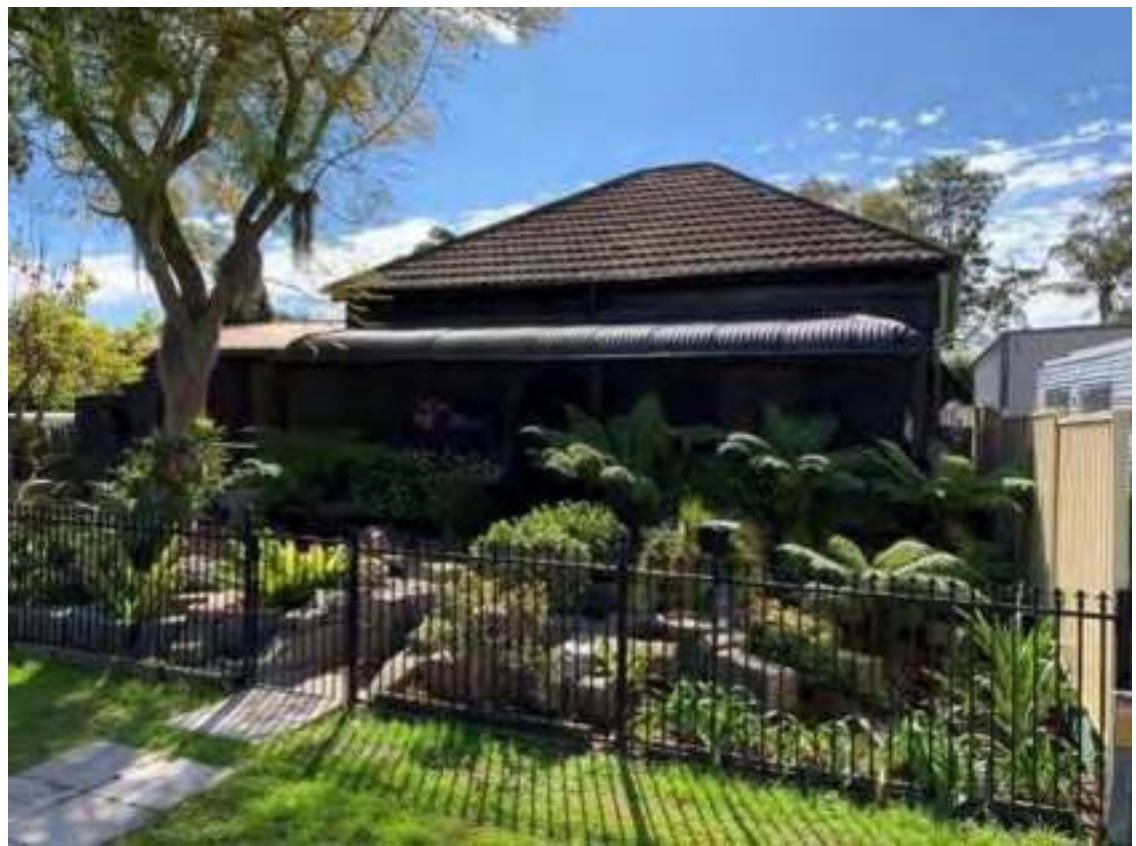
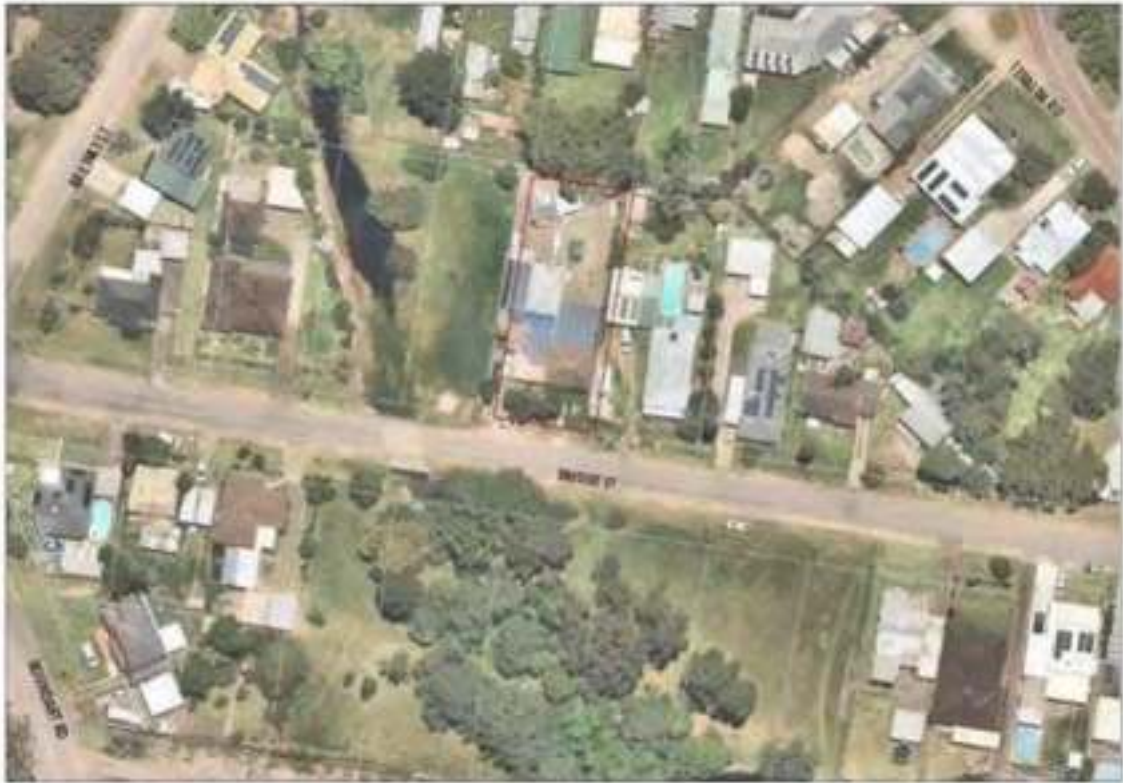
7 BRIDGE STREET, WEST WALLSEND 2286

Conservation Area Contribution Level	Est. Construction Date	Previous studies and/or community input
Contributory 1	1890–1915	No prior heritage investigations and no additional information required
Assessment Text		Observed Modifications
<p>Single story Vernacular ‘Mining Cottage’ style dwelling with tiled hipped roof and weatherboard cladding. The veranda roof is bull nosed and potentially original in design.</p> <p>The veranda is enclosed by a balustrade.</p> <p>A gothic styled metal fence encloses the property.</p> <p>The dwelling displays architectural features of a heritage style and is representative of the local development of this period, being of historical significance for the HCA.</p>		<p>The tiled roof design is a contemporary modification with the original roof being corrugated iron or Colourbond.</p> <p>An extension is visible on the western side of the dwelling. This detracts from the heritage streetscape as it alters the layout of the dwelling, contrasting with similar dwellings.</p>

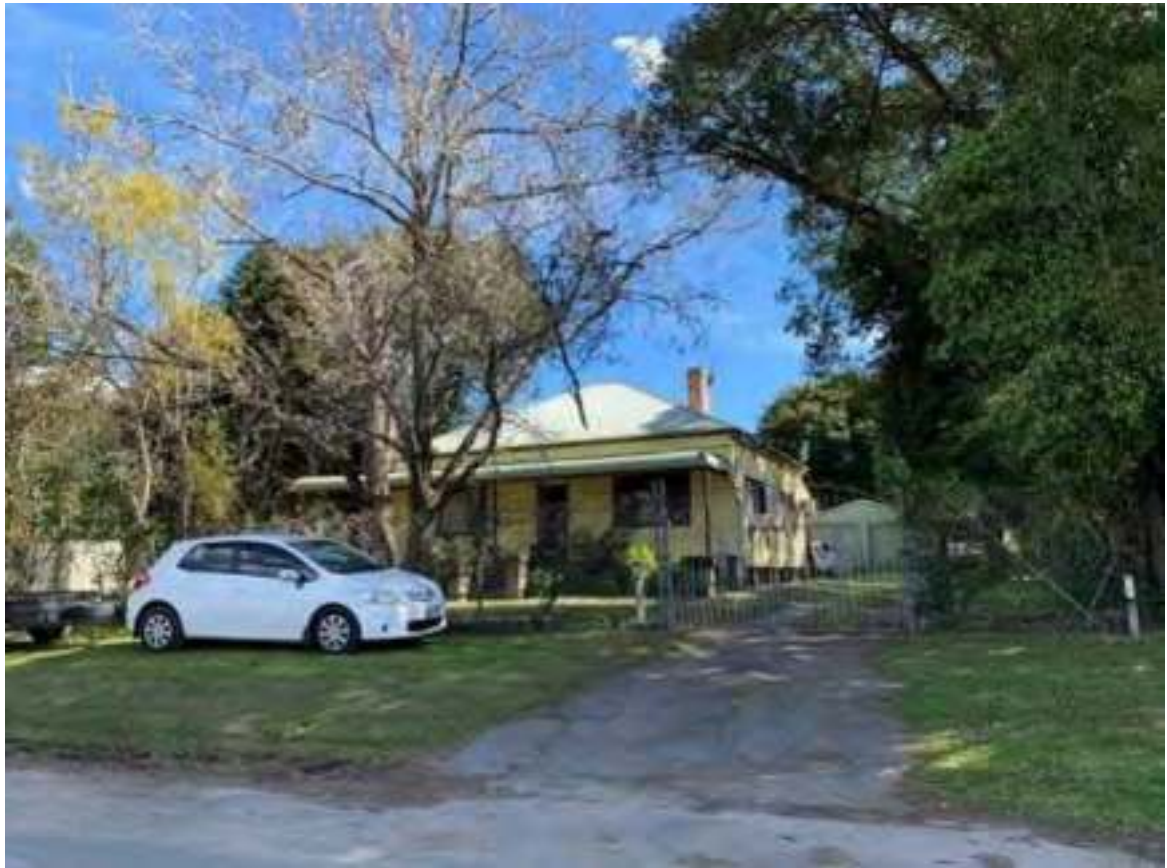
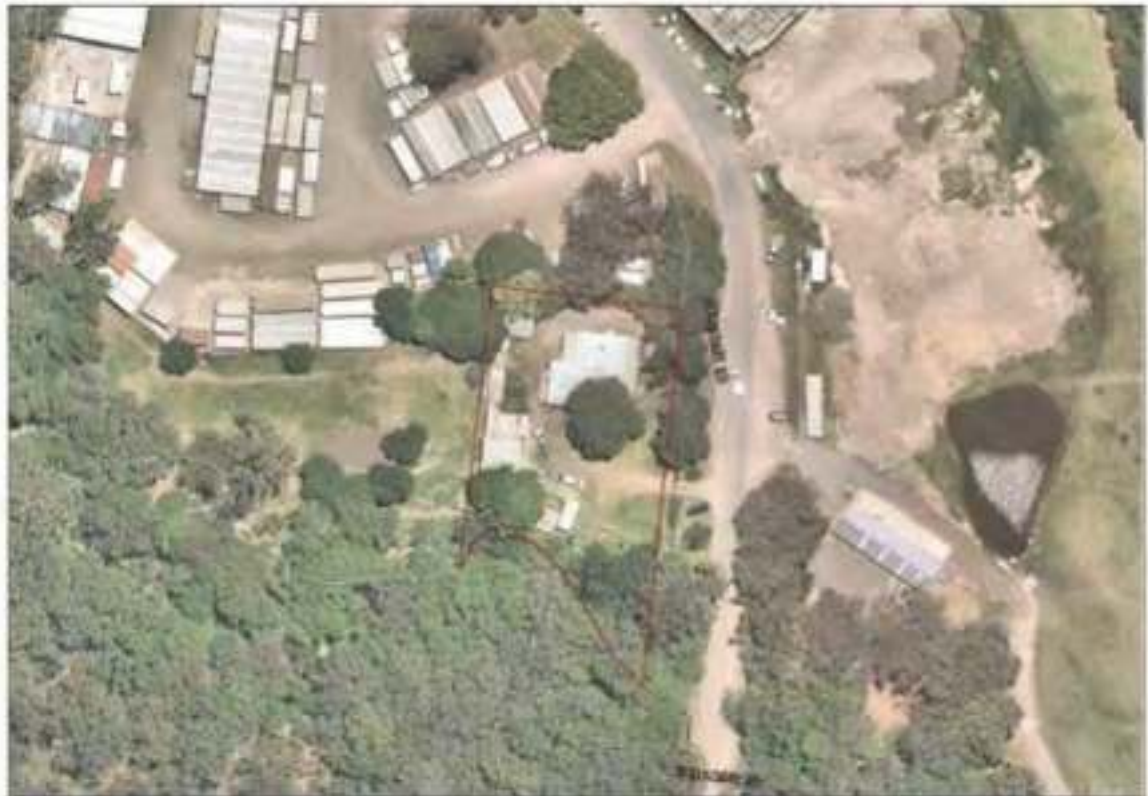
62 BOUNDARY ROAD, WEST WALLSEND 2286

Conservation Area Contribution Level	Est. Construction Date	Previous studies and/or community input
Contributory 1	1881–1890	West Wallsend Heritage Study 1993
Assessment Text		Observed Modifications
<p>Single story Vernacular ‘Mining Cottage’ style dwelling with Colourbond hipped roof and timber weatherboard cladding. The veranda roof is bulled nosed and likely original in design.</p> <p>A brickwork chimney is visible on the northern side of the dwelling.</p> <p>The veranda is open.</p> <p>A metal fence encloses the property.</p> <p>The cemetery encompasses an area of approximately 2 hectares. It occupies a mostly flat, cleared site west of West Wallsend and under the shadow of Mount Sugarloaf.</p> <p>The ground is grassy with some tree coverage. Dense vegetation growth frames the cemetery land. The perimeter has a post and wire fence.</p> <p>The dwelling displays architectural features of a heritage style and is representative of the local development of this period, being of historical significance for the HCA.</p>		<p>All visible windows are contemporary picture or sliding designs, likely replacing original sash designs.</p> <p>A 1920’s veranda enclosure modification has been removed.</p> <p>An extension has been built on to the back western side of the dwelling. This is not visible and does not detract from the heritage streetscape.</p>

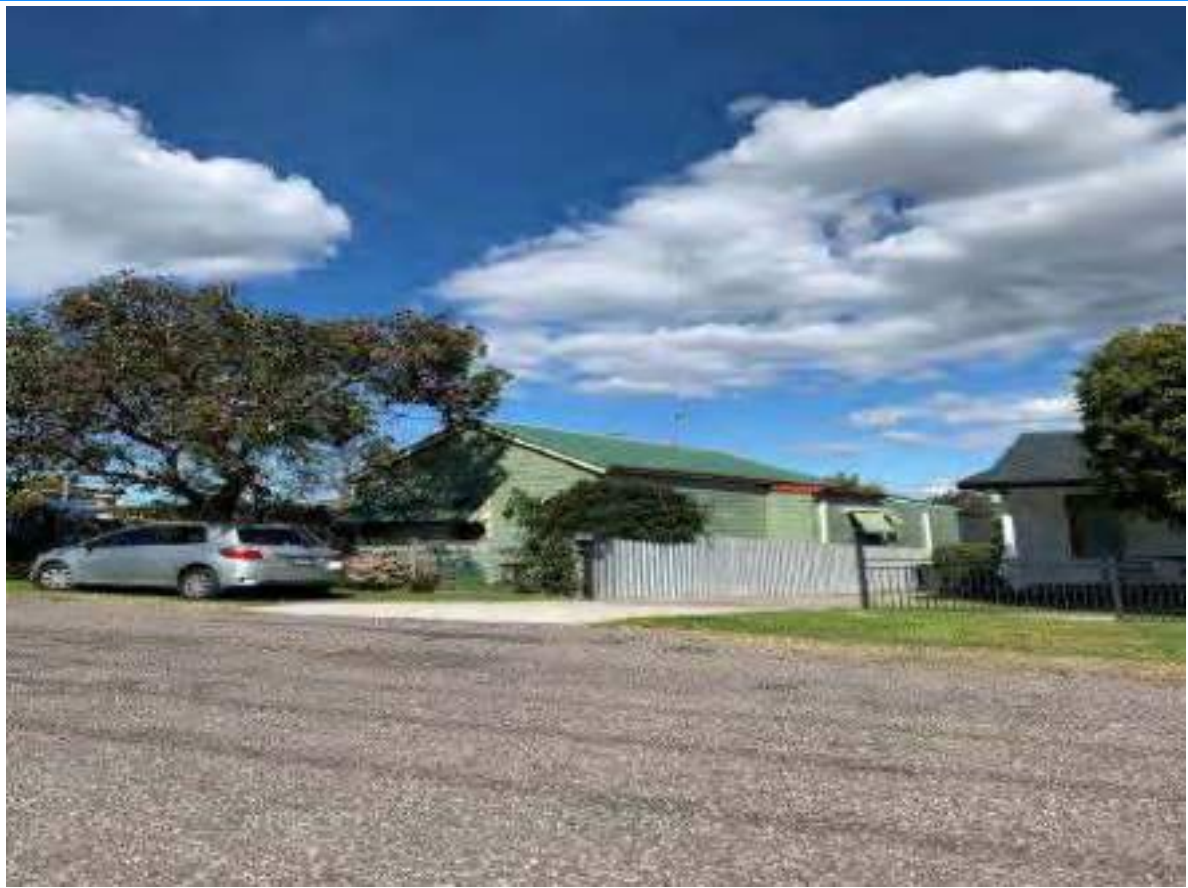
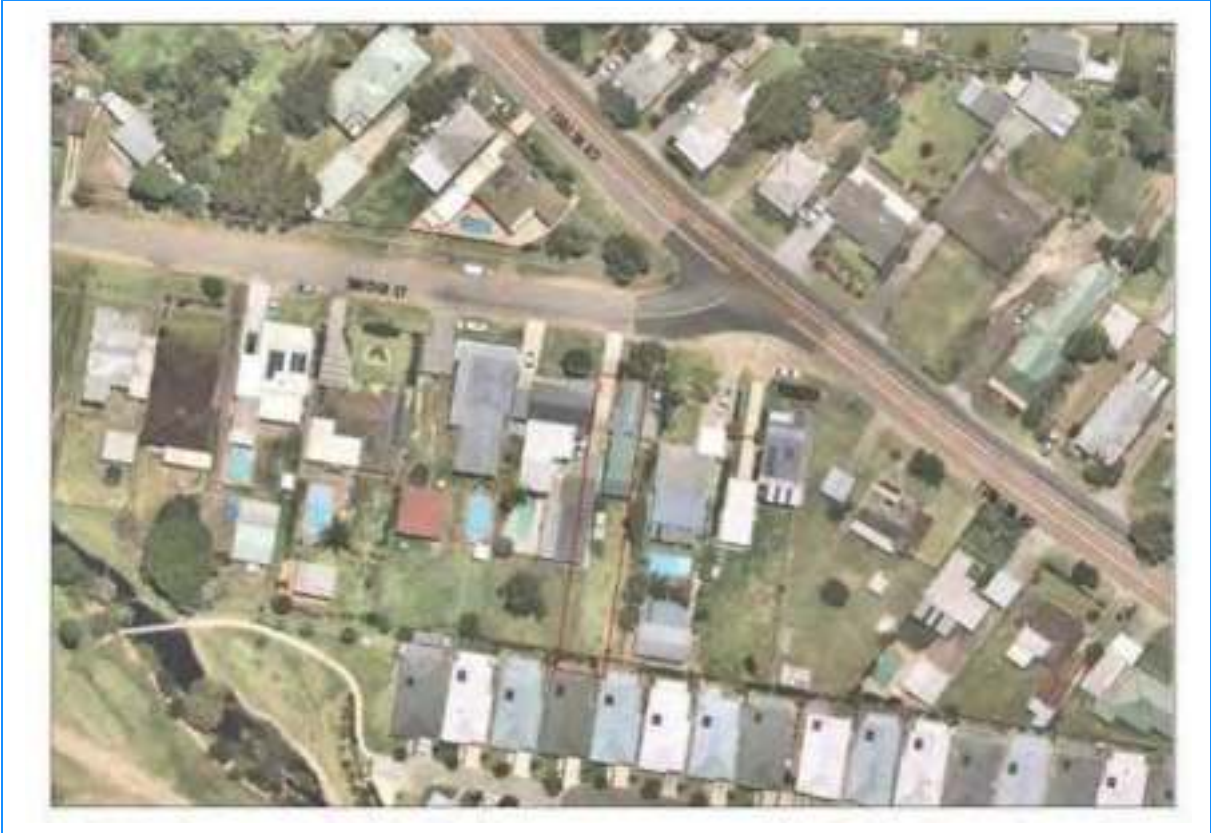
Conservation Area Contribution Level	Est. Construction Date	Previous studies and/or community input
Contributory 1	1900–1920	No prior heritage investigations and no additional information required
Assessment Text		Observed Modifications
<p>Single story Simplified Victorian Regency style dwelling with Colourbond gable roof and weatherboard cladding. The veranda consists of an alcove within the main roof structure.</p> <p>The façade gable windows has a timber shingle awning above, with simple bracketing.</p> <p>A metal wire fence encloses the property.</p> <p>The dwelling displays architectural features of a heritage style and is representative of the local development of this period, being of historical significance for the HCA.</p>		<p>Extensions have been constructed on both the western, eastern and southern sides of the dwelling.</p> <p>The northern façade windows is contemporary in design, likely replacing a timber framed sash design.</p>

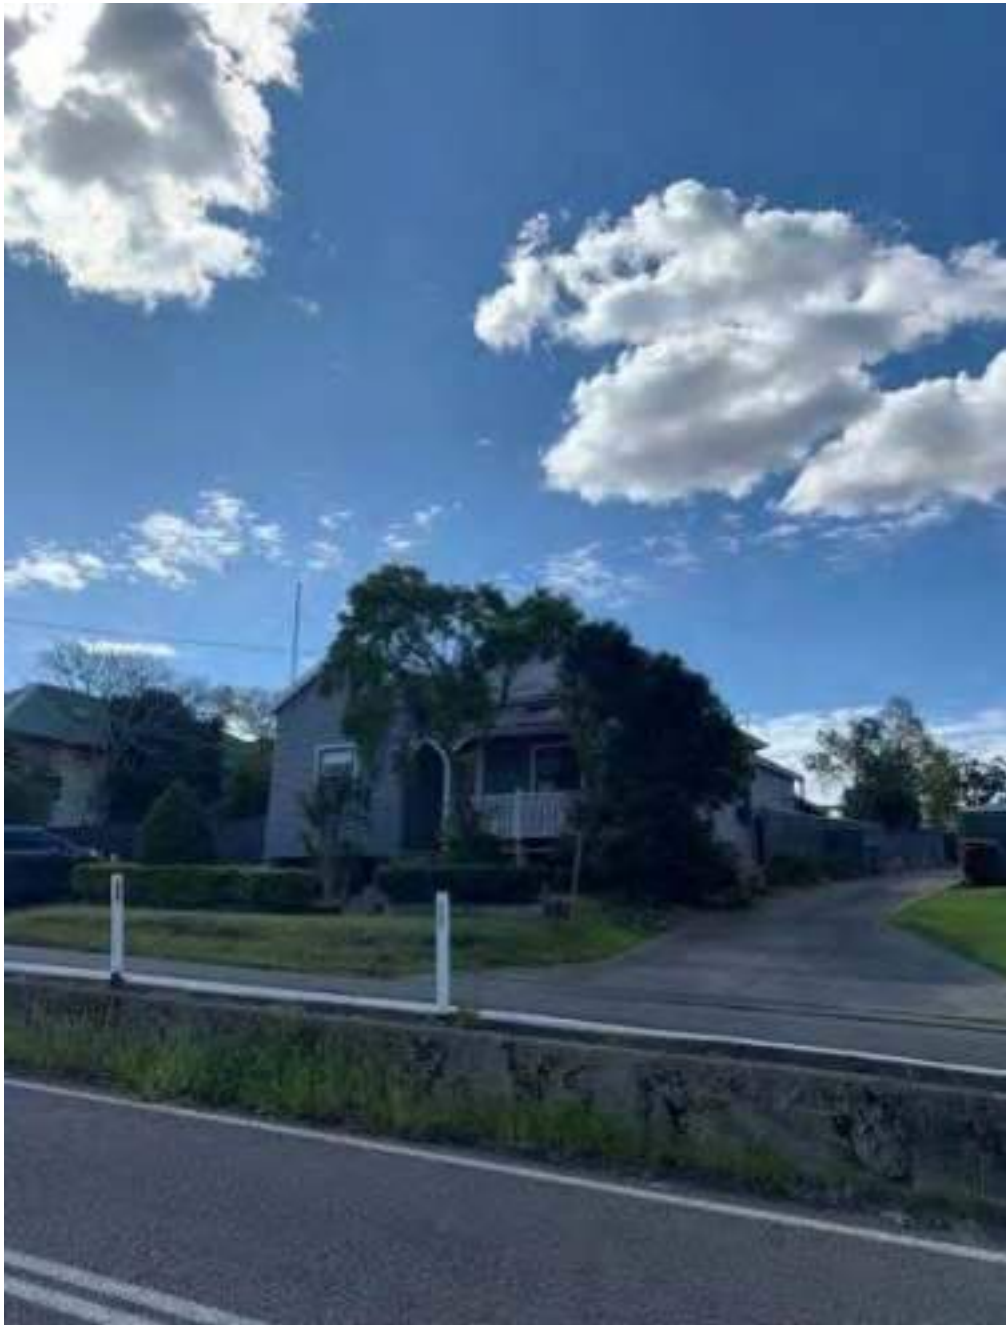
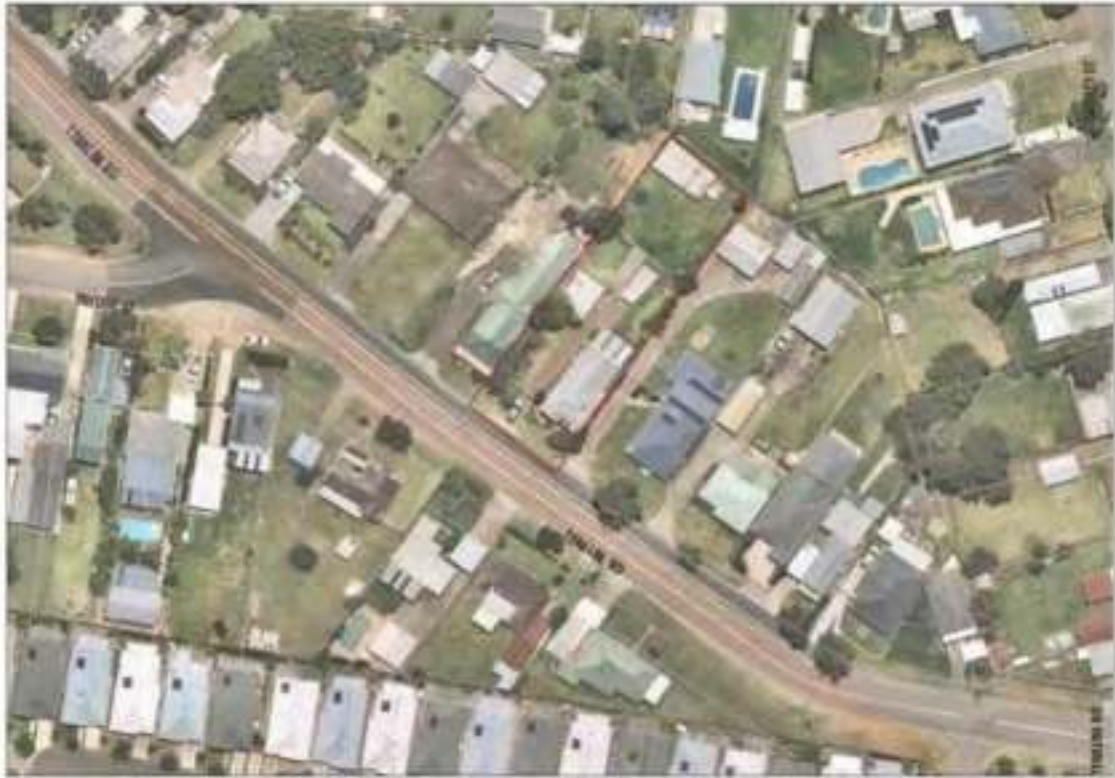
23 TERALBA ROAD, WEST WALLSEND 2286

Conservation Area Contribution Level	Est. Construction Date	Previous studies and/or community input
Contributory 1	1890–1920	No prior heritage investigations and no additional information required
Assessment Text		Observed Modifications
<p>Single story simplified Federation ‘workmen’s cottage’ style dwelling with hipped Colourbond roof with gable projection, and timber weatherboard cladding. The veranda roof is skillion and is supported by timber posts with elaborately carved bracketing. The veranda is partially enclosed by a timber balustrade and archway.</p> <p>The gable has extended eaves.</p> <p>Concrete stairs lead onto the veranda landing.</p> <p>The dwelling displays architectural features of a heritage style and is representative of the local development of this period, being of historical significance for the HCA.</p>		<p>The visible windows are contemporary sash designs.</p> <p>It is likely a timber gable window awning has been removed from the gable façade.</p> <p>The decoratively carved posts, brackets and timber balustrade are contemporary additions to the dwelling, however have been constructed in a sympathetic manner.</p> <p>An extension has been constructed at the back northern side of the dwelling, however this is not visible from the street and does not detract.</p>

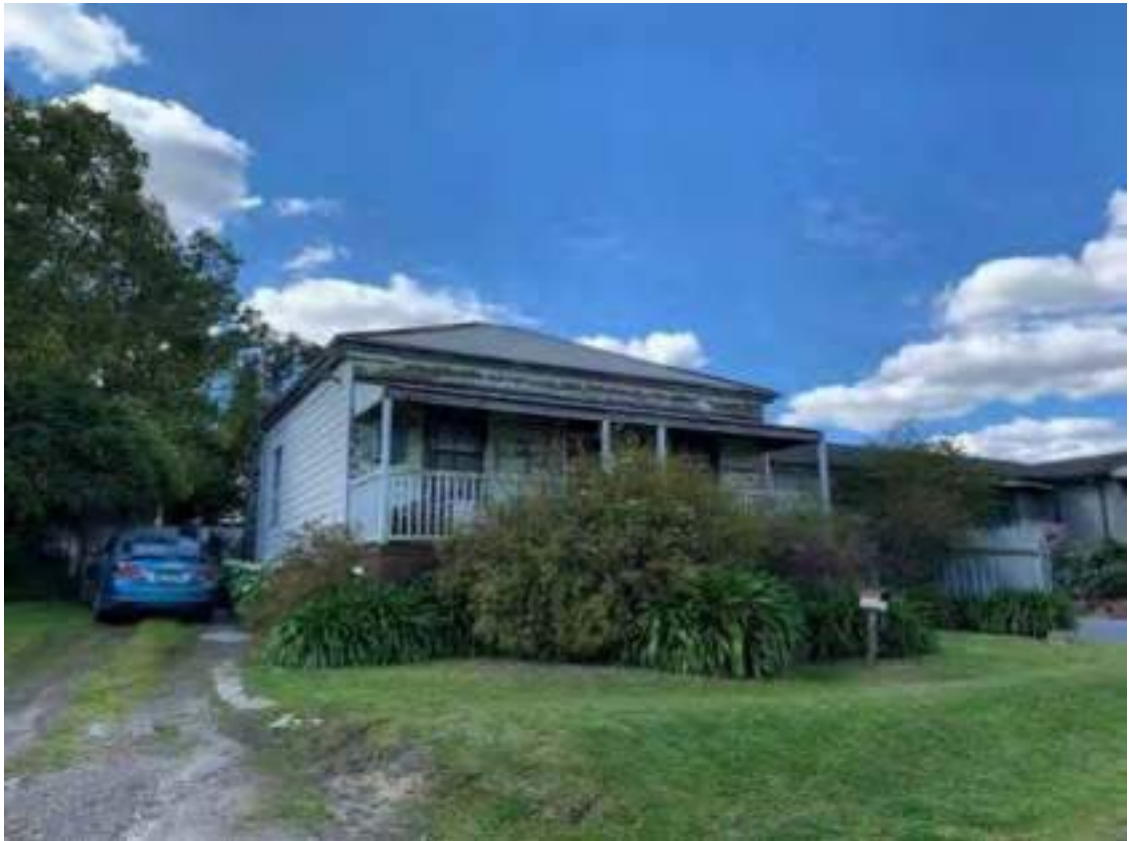
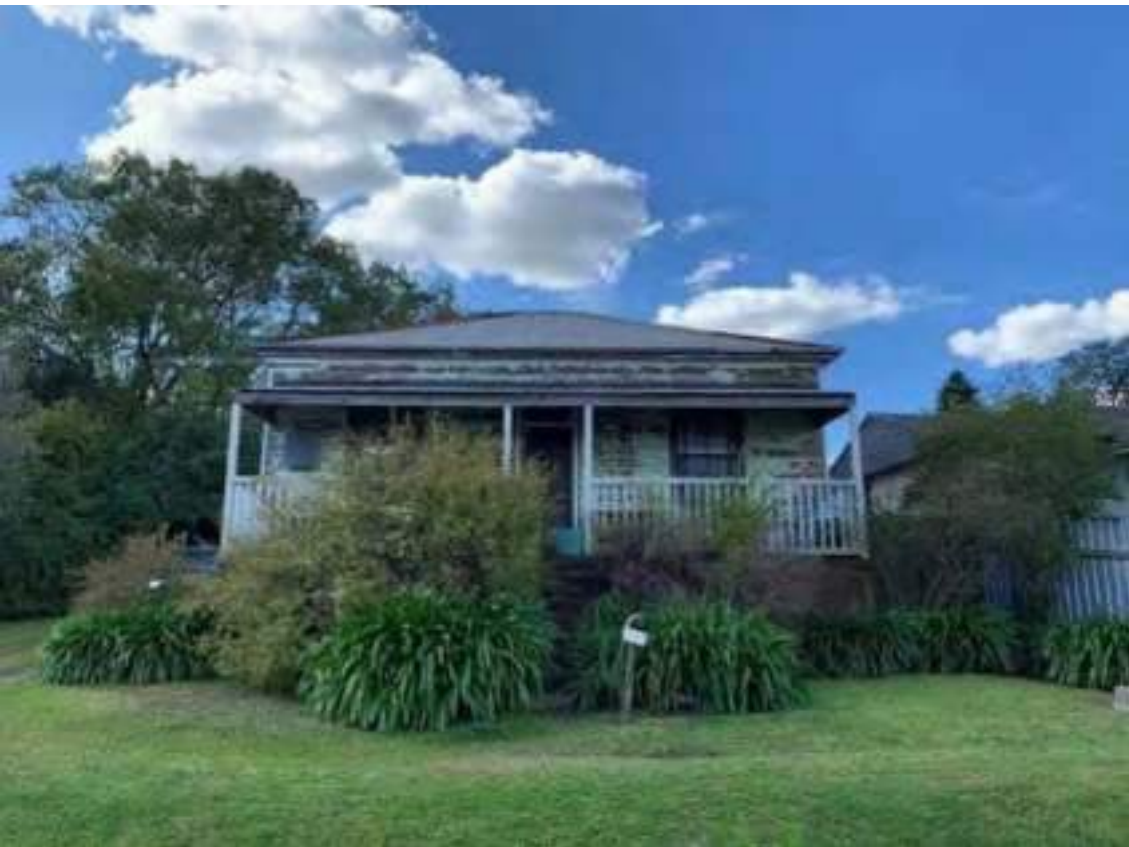
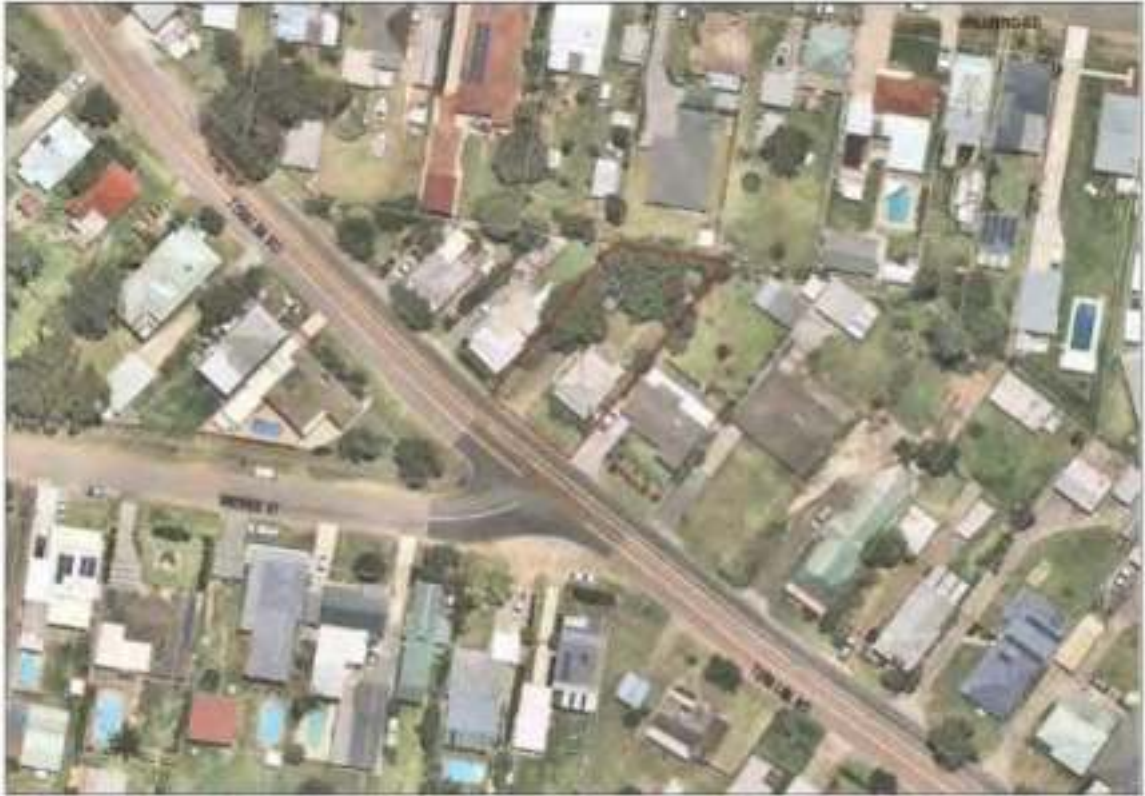
15 TERALBA ROAD, WEST WALLSEND 2286

Conservation Area Contribution Level	Est. Construction Date	Previous studies and/or community input
Contributory 1	1890–1915	No prior heritage investigations and no additional information required
Assessment Text		Observed Modifications
<p>Single story Vernacular ‘Mining Cottage’ style dwelling with hipped Colourbond roof and timber weatherboard cladding. The paint is in a state of disrepair, exposing the timber underneath. The veranda roof is skillion.</p> <p>The veranda is partially enclosed by a simple timber balustrade.</p> <p>The façade windows are timber framed leadlight sash designs. This is likely original to the dwelling. A fan light sits above the front door.</p> <p>The dwelling displays architectural features of a heritage style and is representative of the local development of this period, being of historical significance for the HCA.</p>		<p>The timber balustrade is a modification, however was likely constructed in the past.</p> <p>A small extension is located at the back north eastern side of the dwelling,</p> <p>The veranda roof would likely have been bull nosed and has been replaced by a skillion design.</p>
