APPENDIX 2

Building Assessment Sheets (Inventory Sheets)

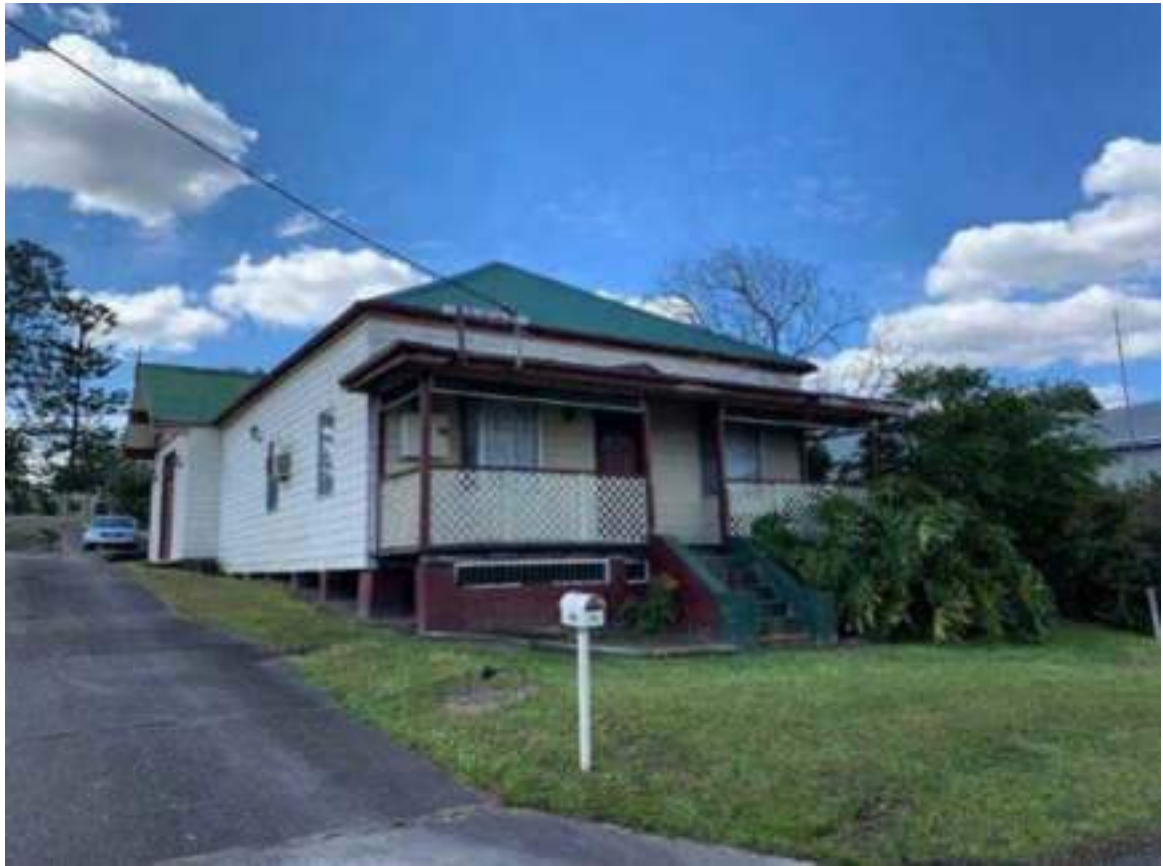
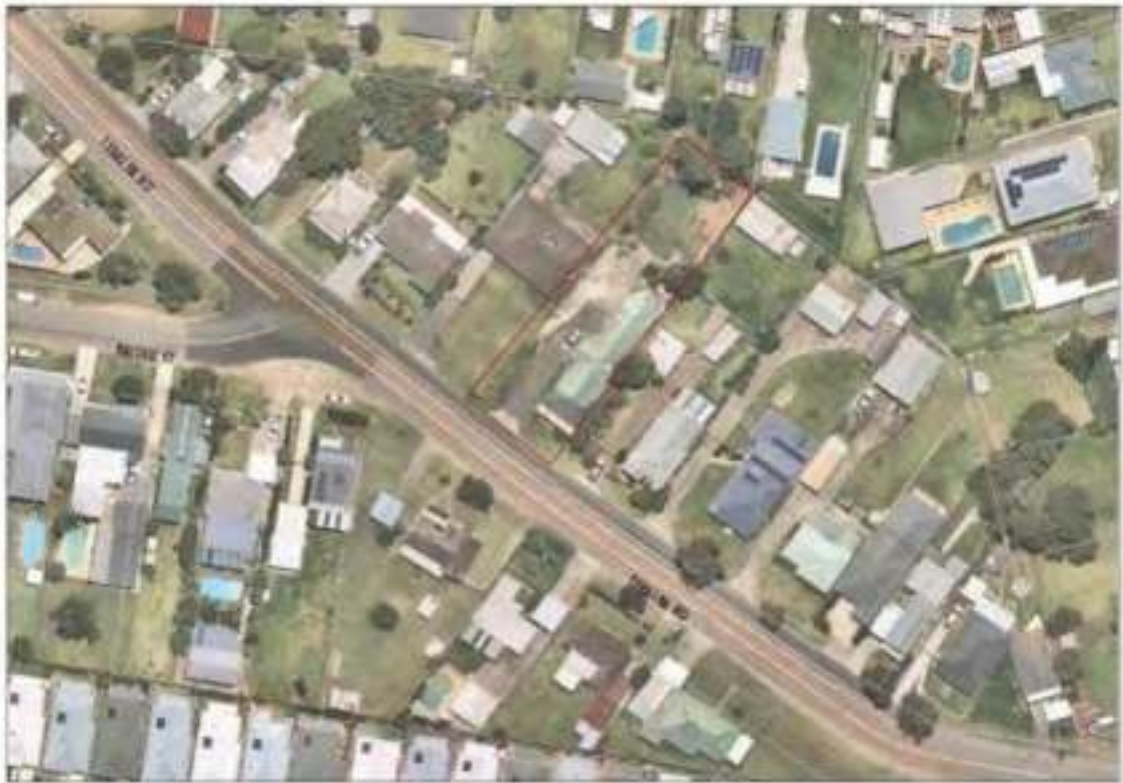
21 TERALBA ROAD, WEST WALLSEND 2286

Conservation Area Contribution Level	Est. Construction Date	Previous studies and/or community input
Contributory 1	1890–1915	No prior heritage investigations and no additional information required
Assessment Text		Observed Modifications
<p>Single story Vernacular ‘Mining Cottage’ style dwelling with hipped Colourbond roof and weatherboard cladding. The veranda roof is flat.</p> <p>The veranda is partially enclosed by lattice work timber balustrade, with a timber valance.</p> <p>A set of rendered masonry stairs lead to the veranda landing, with masonry pier.</p> <p>The front door is timber framed with a four-panel design.</p> <p>The dwelling displays architectural features of a heritage style and is representative of the local development of this period, being of historical significance for the HCA.</p>		<p>The front façade windows are contemporary designs. All visible windows have been replaced with contemporary sliding designs.</p> <p>A gable roof extension has been constructed, with battening detailing and timber finial.</p>

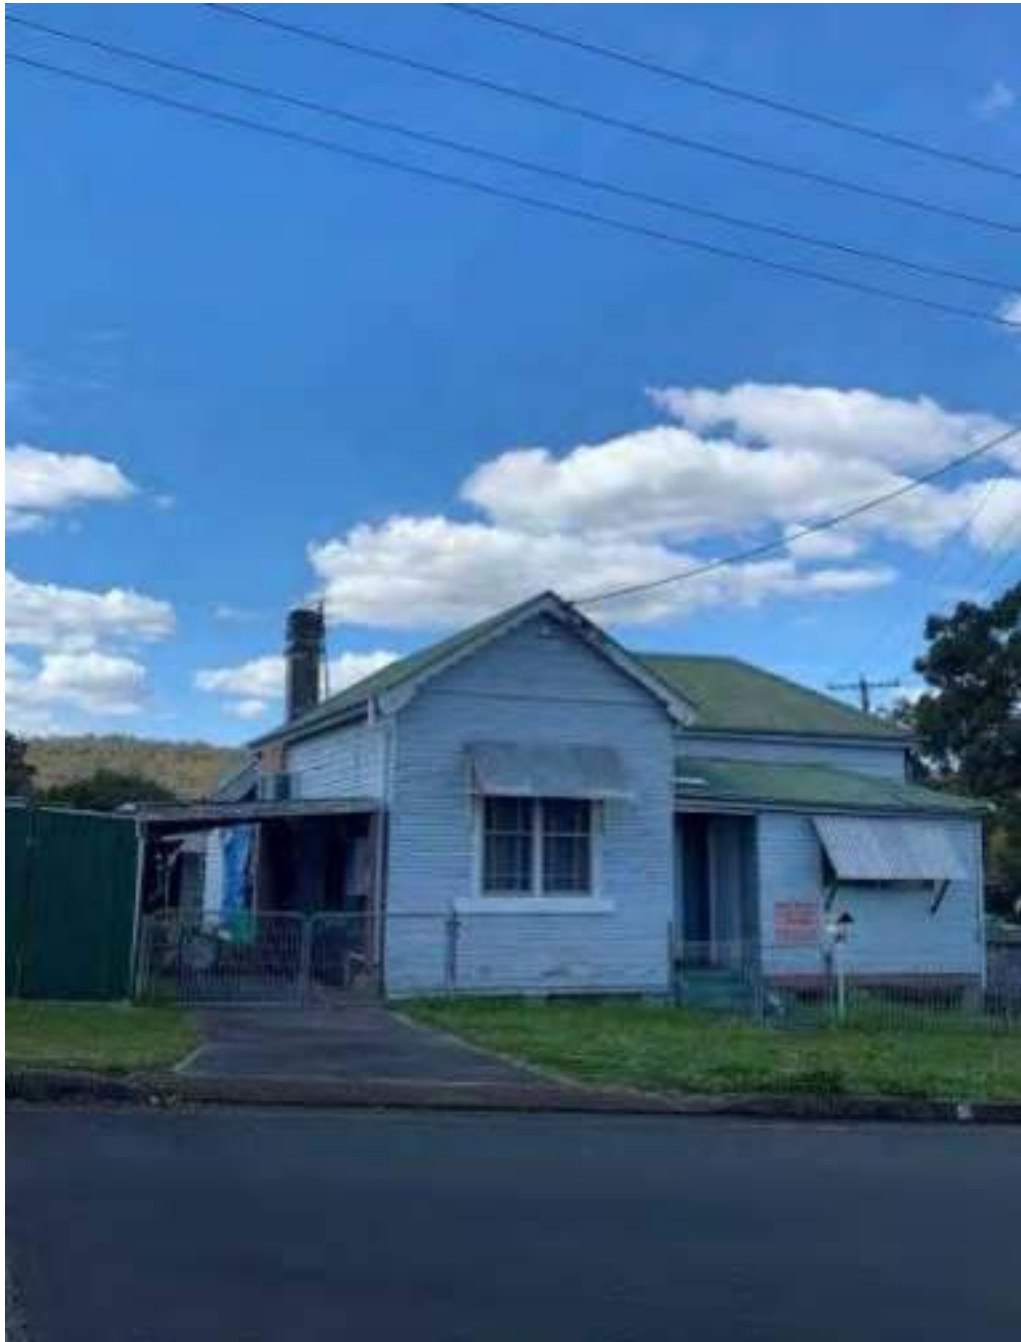
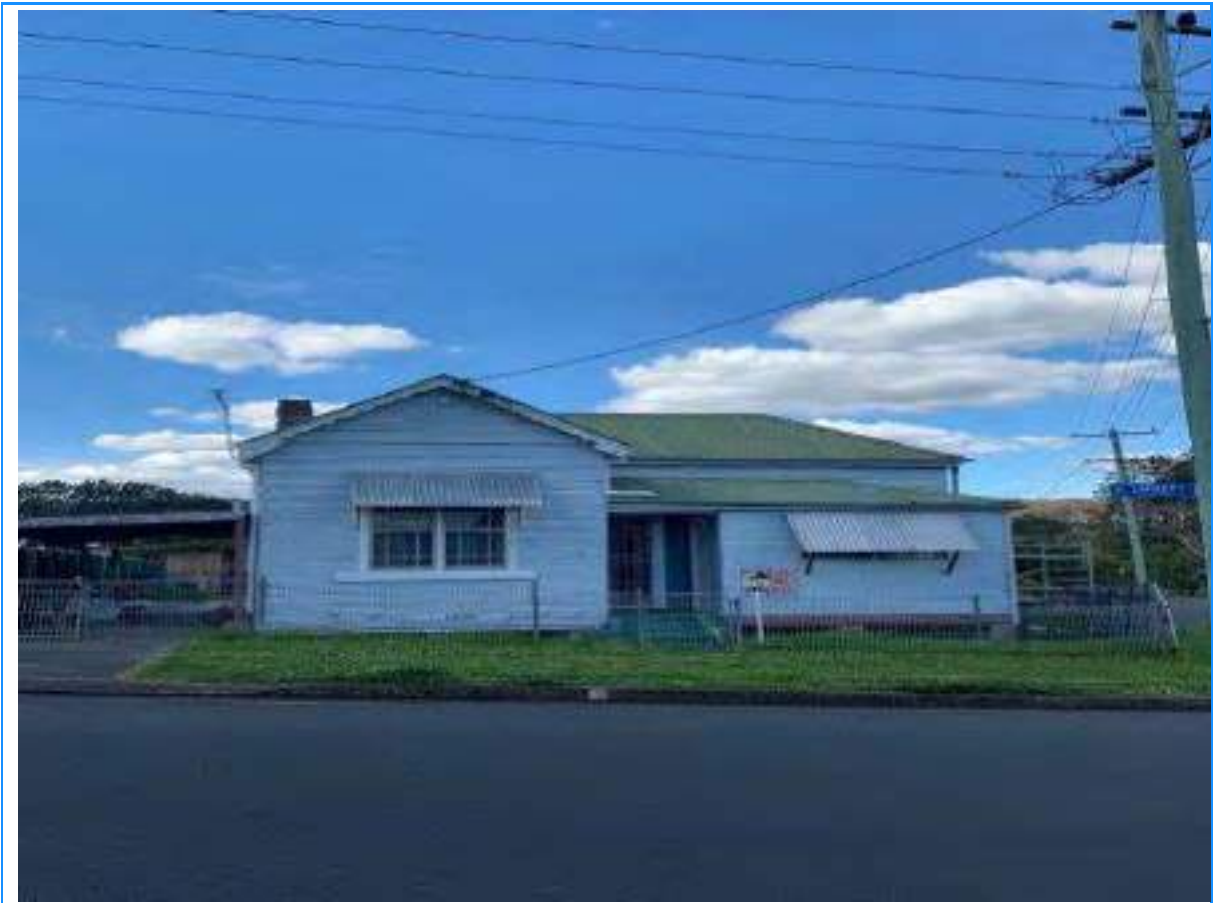
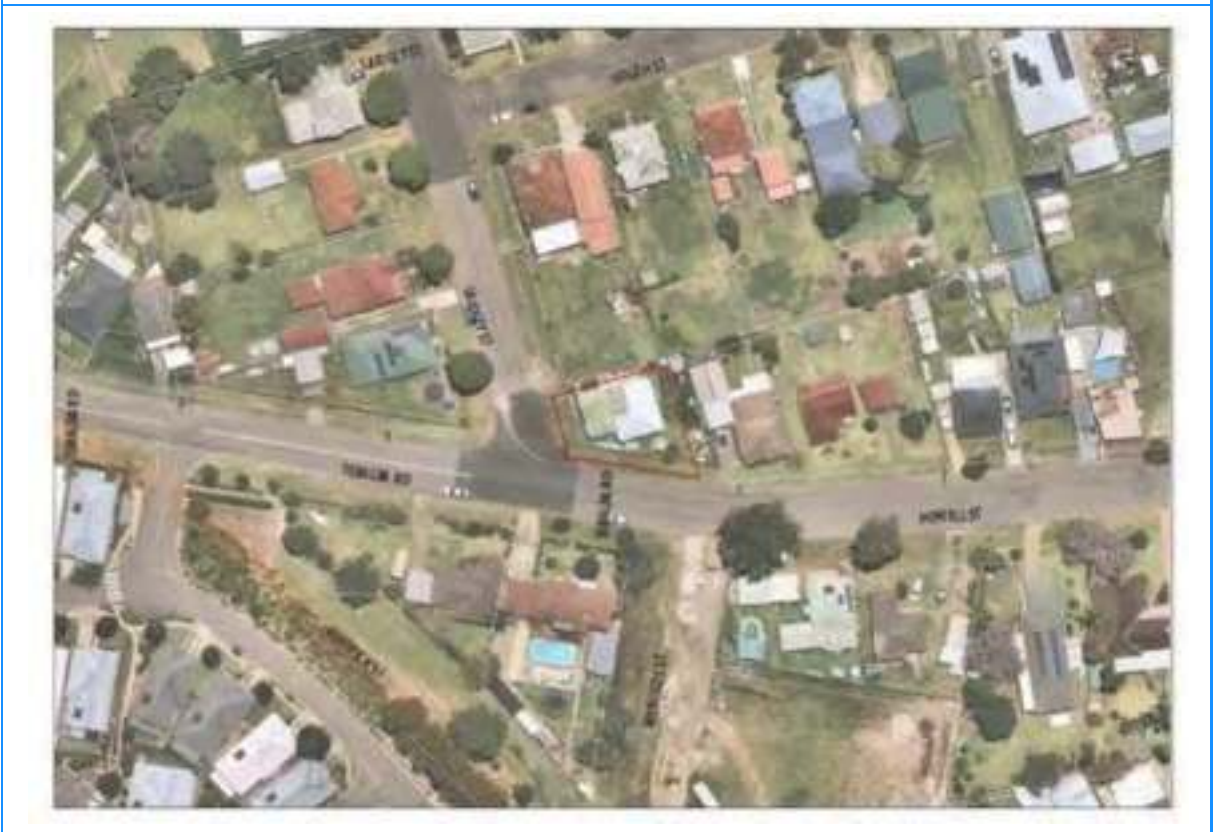
39 LAIDLEY STREET, WEST WALLSEND 2286

Conservation Area Contribution Level	Est. Construction Date	Previous studies and/or community input
Contributory 1	Circa. 1900	No prior heritage investigations and no additional information required
Assessment Text		Observed Modifications
<p>Single story simple Federation 'workmen's cottage' style dwelling with hipped Colourbond roof with gable projection, and timber weatherboard cladding. The veranda roof is hipped.</p> <p>The gable has decorative barge boards. The gable window is an aluminium framed double sash design, with a pronounced sill. An awning is located above.</p> <p>A carport is located to the north of the dwelling.</p> <p>The dwelling displays architectural features of a heritage style and is representative of the local development of this period, being of historical significance for the HCA.</p>		<p>The veranda, although previously noted as partially enclosed, has been restored to an open space. This has been undertaken in a highly sympathetic manner.</p> <p>The visible windows are a contemporary addition undertaken in a sympathetic style.</p> <p>It is understood that the brickwork chimney is not longer present, due to storm damage.</p> <p>An extension has been built onto the eastern and southern sides of the dwelling. this is visible due to the corner location, detracting from the heritage streetscape.</p>

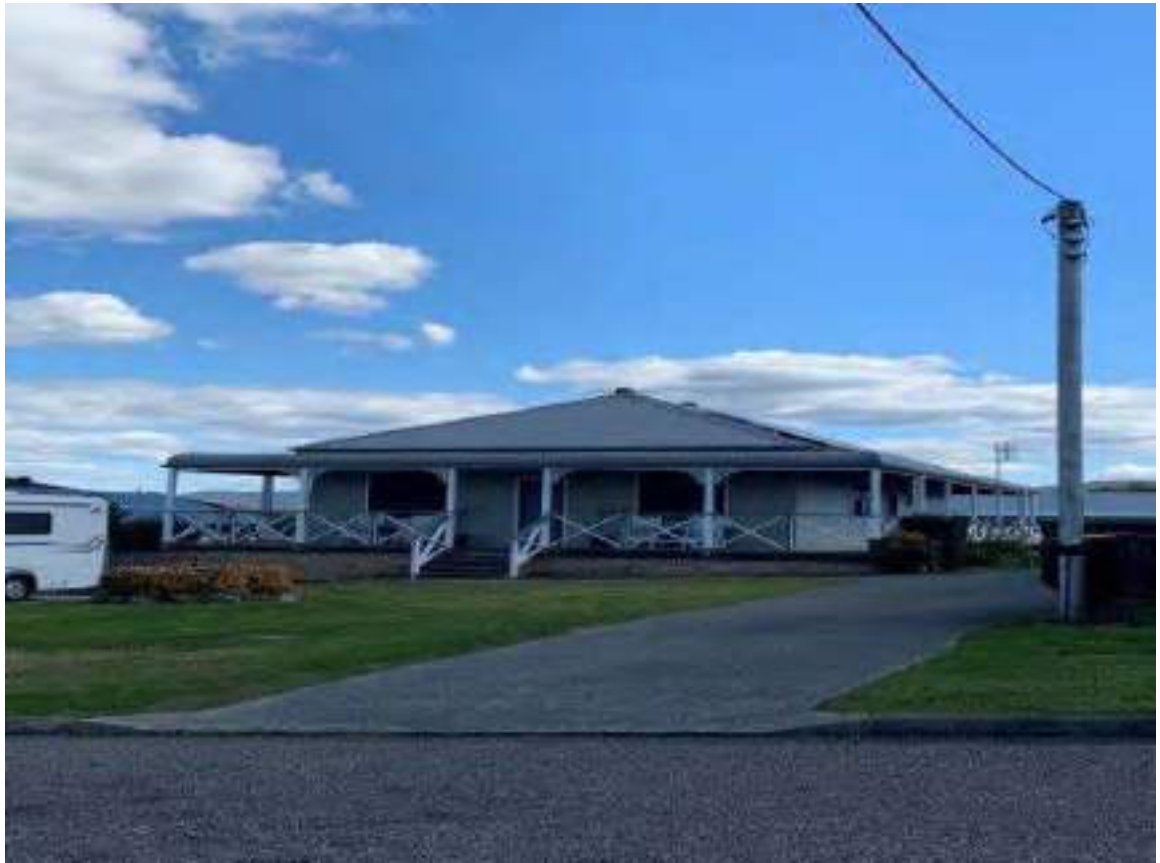
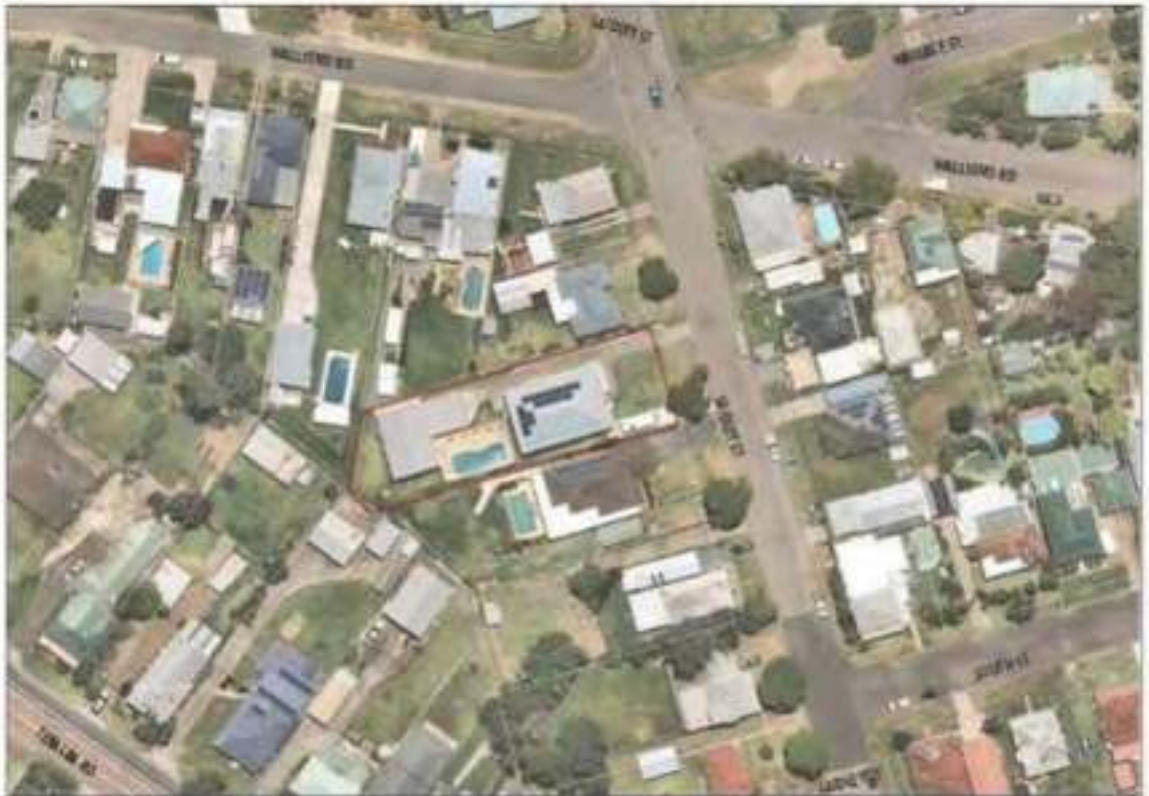
30 LAIDLEY STREET, WEST WALLSEND 2286

Conservation Area Contribution Level	Est. Construction Date	Previous studies and/or community input
Contributory 1	1890–1915	No prior heritage investigations and no additional information required
Assessment Text		Observed Modifications
<p>Single story Vernacular dwelling with Colourbond hipped roof and weatherboard cladding. The veranda roof is bull nosed, with portions potentially original.</p> <p>The veranda is partially enclosed by crossed timber balustrade, with timber posts and cast iron lace brackets. Cement and brick stairs lead to the veranda landing, with timber balustrade.</p> <p>The front door is timber framed with a four panel design. The windows have decorative timber sills.</p> <p>The dwelling displays architectural features of a heritage style and is representative of the local development of this period, being of historical significance for the HCA.</p>		<p>The veranda raps around the northern and southern sides of the dwelling, as well as the front facing eastern side. This is a common modification for the dwelling style.</p> <p>The visible windows are multi-pane sash contemporary designs.</p> <p>Solar panels are visible on the northern side of the dwelling.</p> <p>A large garage/residential structure is located to the west of the dwelling,</p>

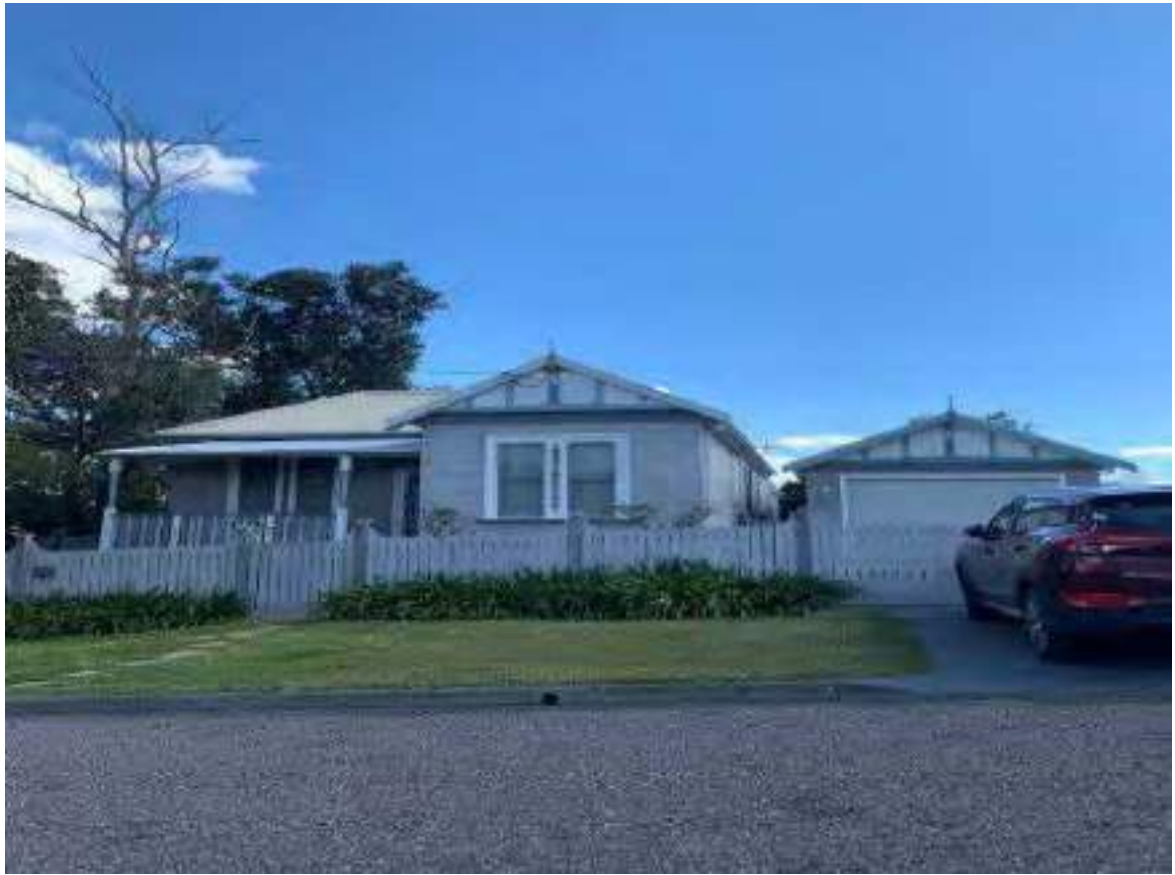
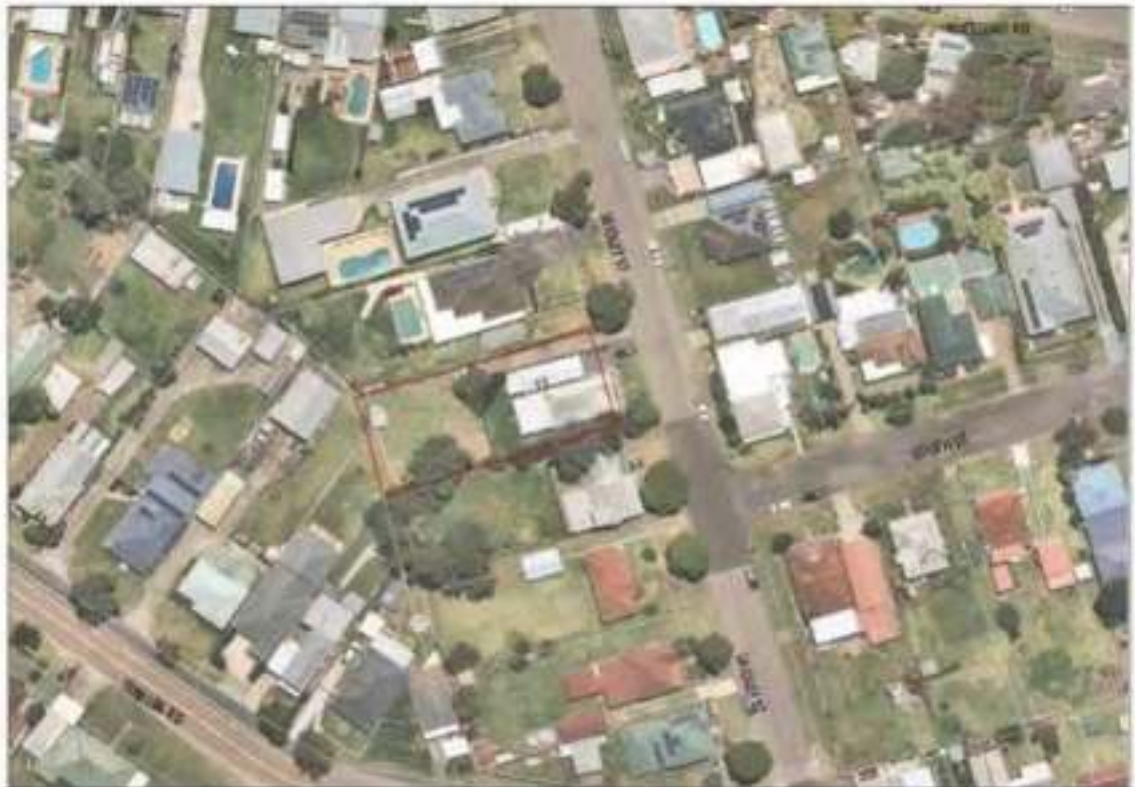
34 LAIDLEY STREET, WEST WALLSEND 2286

Conservation Area Contribution Level	Est. Construction Date	Previous studies and/or community input
Contributory 1	1900–1920	No prior heritage investigations and no additional information required
Assessment Text		Observed Modifications
<p>Single story simple Federation ‘workmen's cottage’ style dwelling with hipped Colourbond roof with a gable projection and weatherboard cladding. The veranda roof is hipped and supported with decoratively carved timber posts.</p> <p>The veranda is partially enclosed by timber balustrade.</p> <p>The visible windows are timber framed original sash designs. The gable window has an elaborately carved timber pilaster is situated between the two sash windows.</p> <p>The gable has battening detailing, extended eaves and a timber finial.</p> <p>A garage is located to the north of the dwelling, similarly with finial and battening detailing.</p> <p>Timber fencing encloses the property.</p> <p>The dwelling displays architectural features of a heritage style and is representative of the local development of this period, being of historical significance for the HCA.</p>		<p>The balustrade is likely a contemporary replication of the original timber design.</p> <p>An extension has been constructed to the back western portion of the dwelling, however is not visible from the street and does not detract from the heritage streetscape.</p>

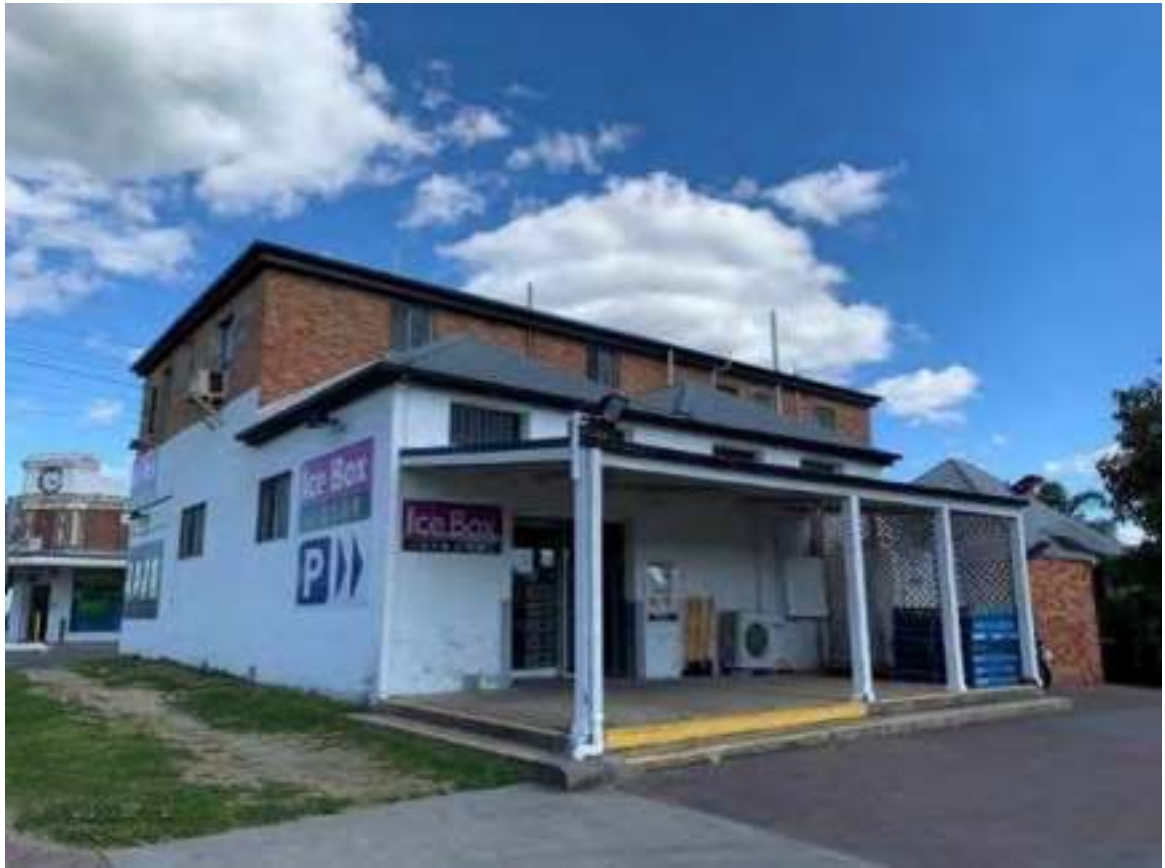
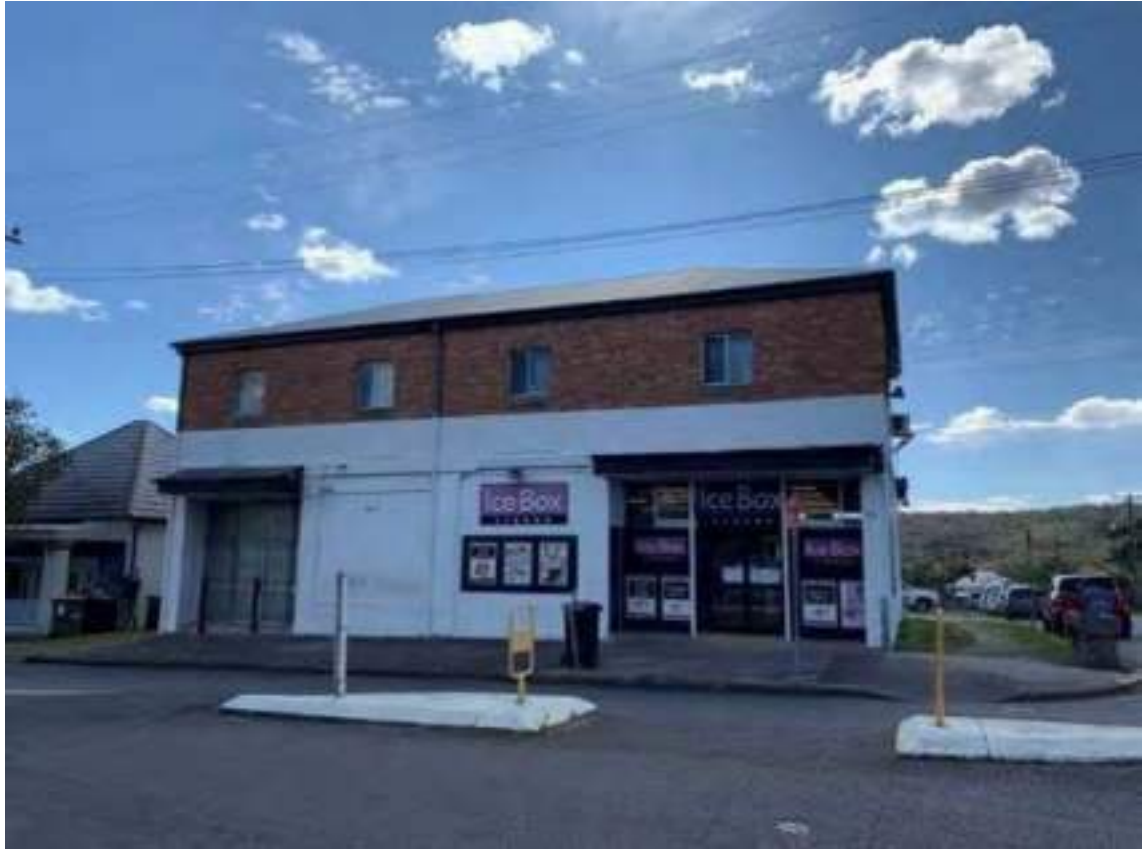
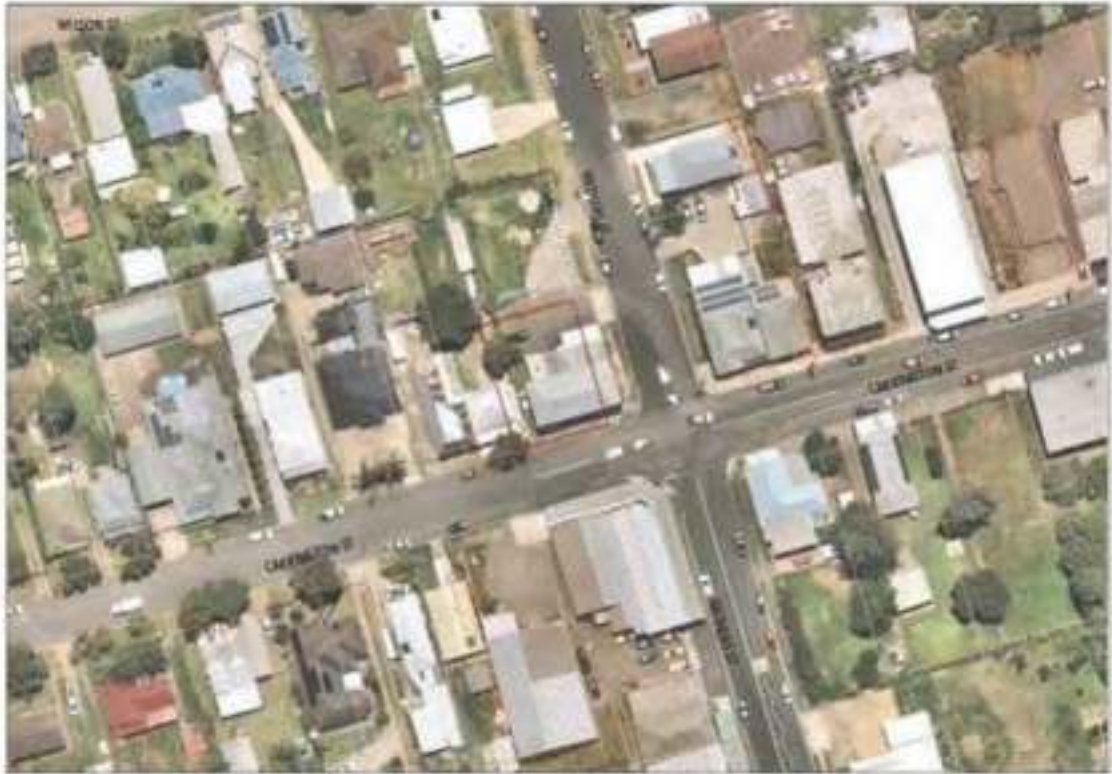
UNIT 1, 69 CARRINGTON STREET, WEST WALLSEND 2286

Conservation Area Contribution Level	Est. Construction Date	Previous studies and/or community input
Contributory 1	1897	West Wallsend Heritage Study 1993 Moderate local significance
Assessment Text		Observed Modifications
<p>Two storey commercial building with hipped Colourbond roof and brick façade. The veranda roof is skillion.</p> <p>The second storey widows have arched brickwork heads and concrete sills.</p> <p>The dwelling displays architectural features of a heritage style and is representative of the local development of this period, being of historical significance for the HCA.</p>		<p>The ground level portion of the building has been extensively modified, with the white paint work, advertisement material, windows and doors being contemporary alterations.</p> <p>The visible windows are contemporary sliding designs. Metal bars have further been installed.</p> <p>In reference to the 1993 study, the building originally contained affine two-storey veranda on the Carrington St front.</p>

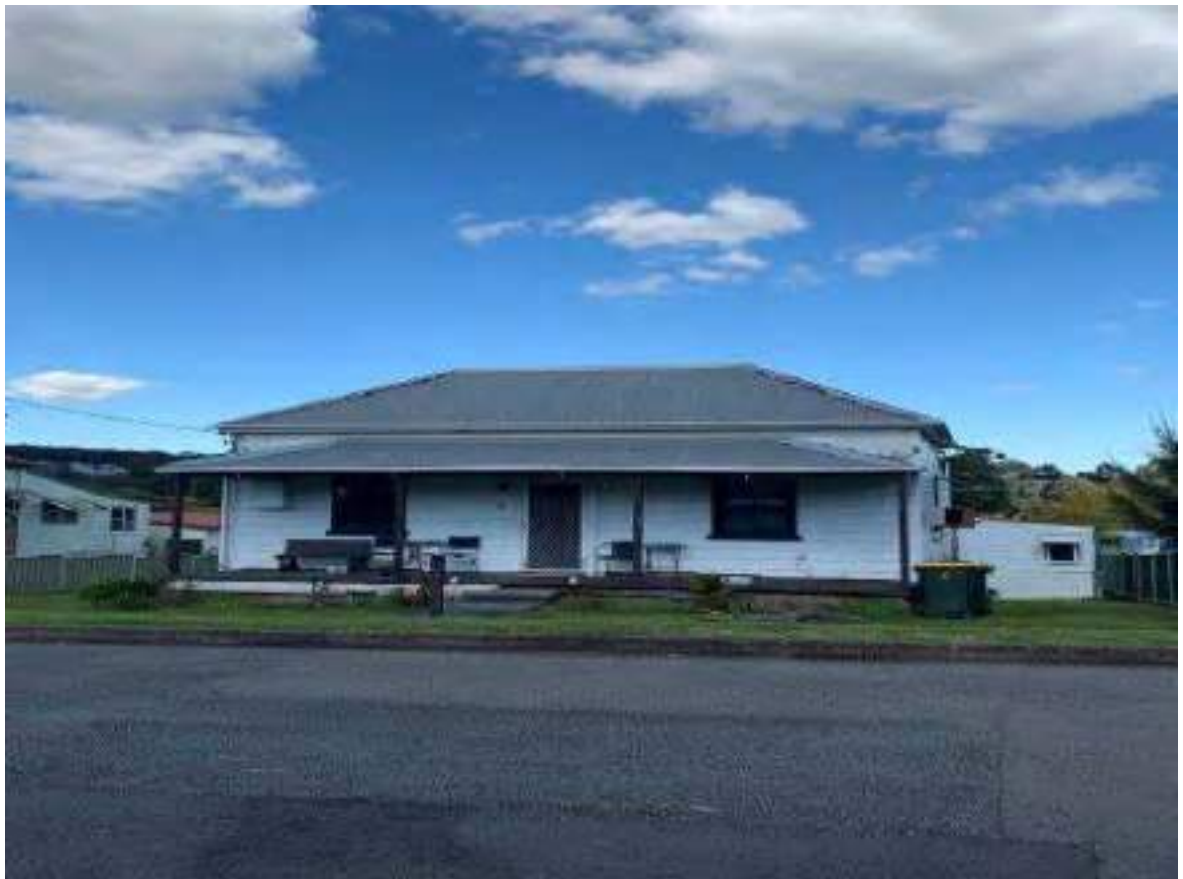
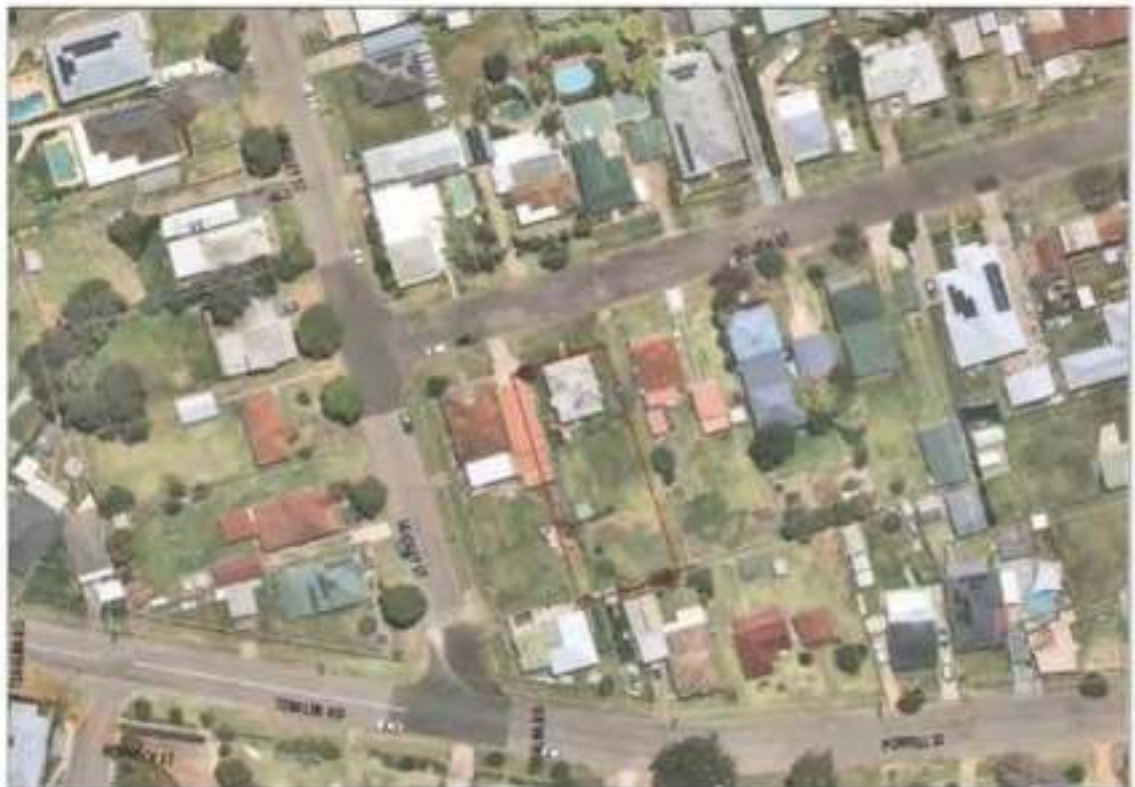
8 SOUTH STREET, WEST WALLSEND 2286

Conservation Area Contribution Level	Est. Construction Date	Previous studies and/or community input
Contributory 1	1890–1915	No prior heritage investigations and no additional information required
Assessment Text		Observed Modifications
<p>Single story Vernacular ‘Mining Cottage’ style dwelling with hipped Colourbond roof and timber weatherboard cladding. The veranda roof is hipped.</p> <p>The veranda is open with timber flooring.</p> <p>The northern front façade windows are the original heavy timber frame sash designs. The eastern and southern windows have awnings and pronounced sills.</p> <p>A rendered brickwork chimney is located on the eastern side of the dwelling.</p> <p>The dwelling displays architectural features of a heritage style and is representative of the local development of this period, being of historical significance for the HCA.</p>		<p>The front door has a prominent metal security screen door installed, detracting from the heritage streetscape.</p> <p>The veranda roof would have originally been bull nosed and has been replaced with a hipped design.</p>

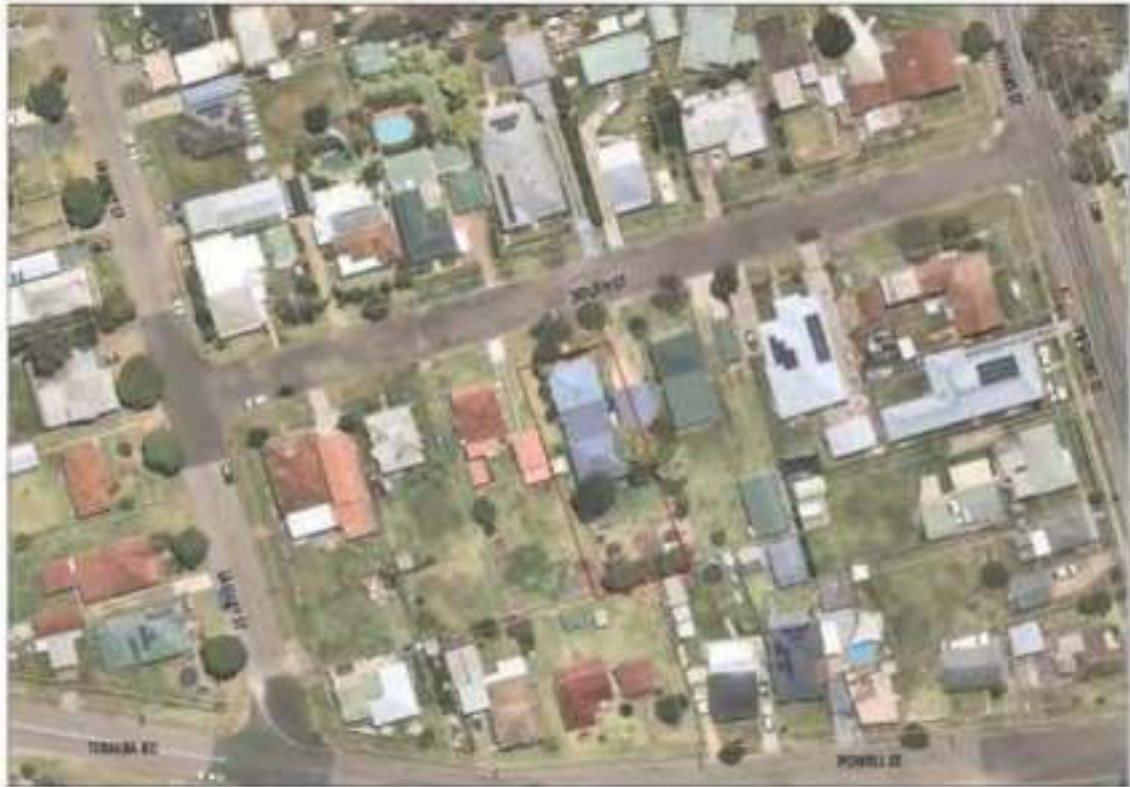
Conservation Area Contribution Level	Est. Construction Date	Previous studies and/or community input
Contributory 1	1890–1915	No prior heritage investigations and no additional information required
Assessment Text		Observed Modifications
<p>Single story Vernacular ‘Mining Cottage’ style dwelling with hipped Colourbond roof and weatherboard cladding. The veranda roof is hipped.</p> <p>The veranda is open.</p> <p>The front northern façade windows are the original heavy timber framed sash designs. The eastern and western windows are similarly original, with timber awnings with decorative brackets.</p> <p>A rendered brickwork chimney is located to the western side of the dwelling, with terracotta pot a top.</p> <p>A timber picket fence encloses the property.</p> <p>The dwelling displays architectural features of a heritage style and is representative of the local development of this period, being of historical significance for the HCA.</p>		<p>An extensive back extension has been constructed at the southern end of the dwelling. this is not visible from the street and does not detract, it has further been constructed in a sympathetic manner.</p> <p>The front door has a prominent metal screen door.</p>

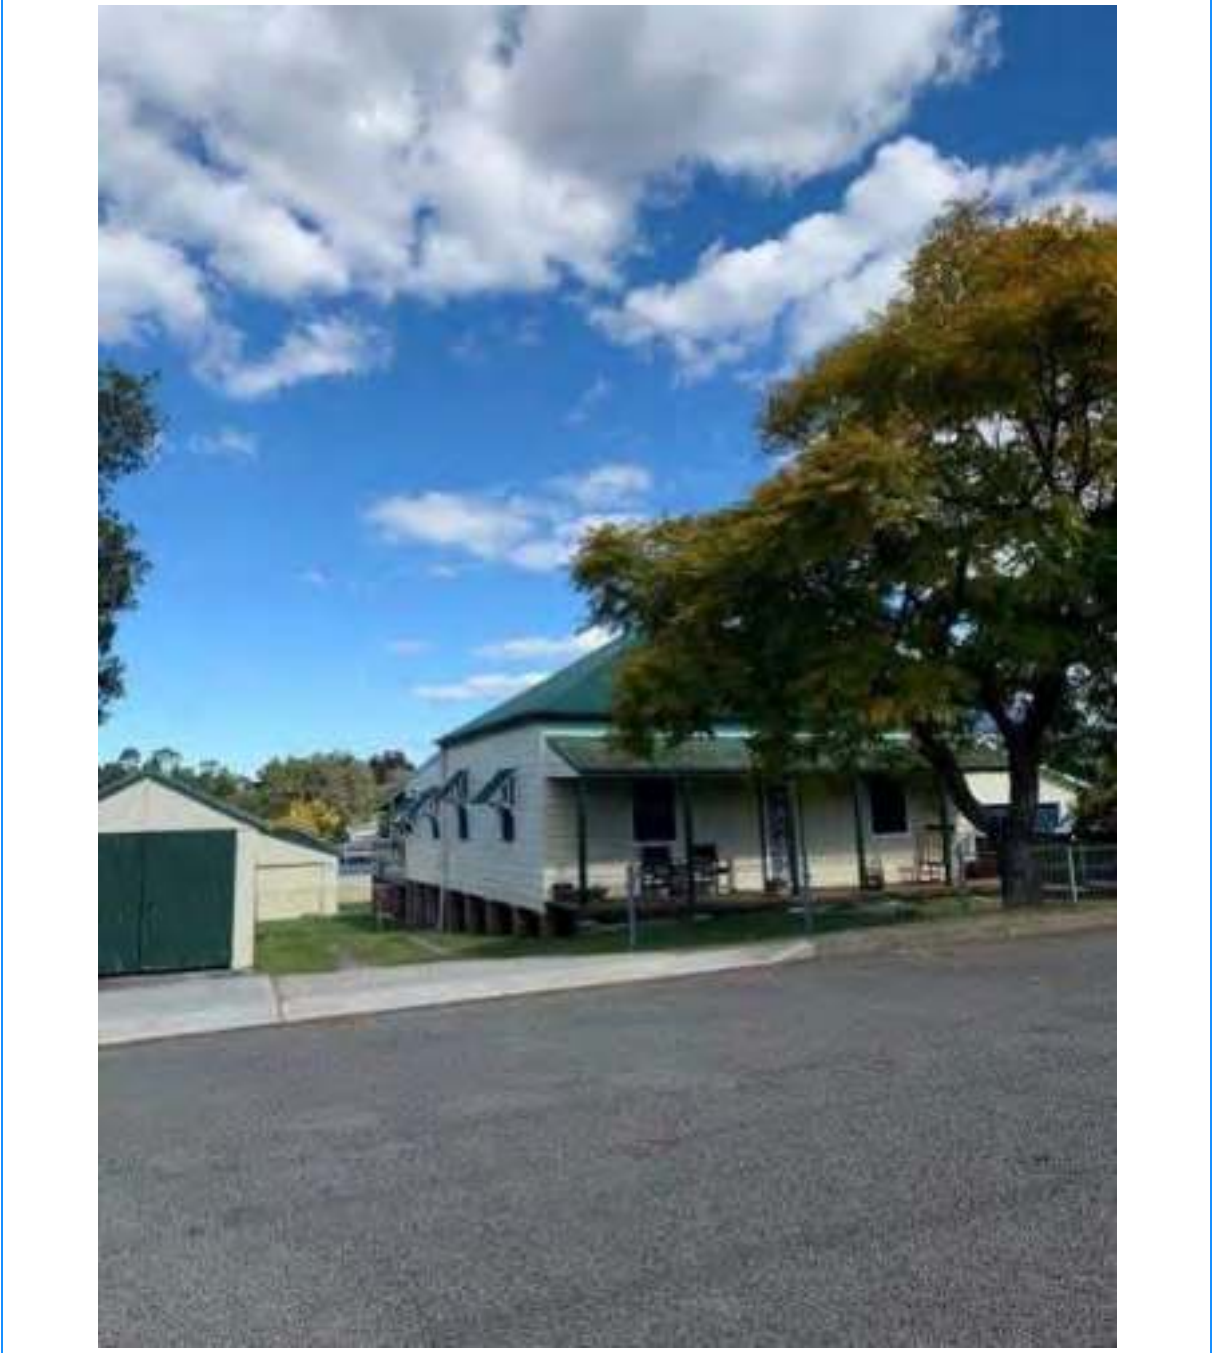
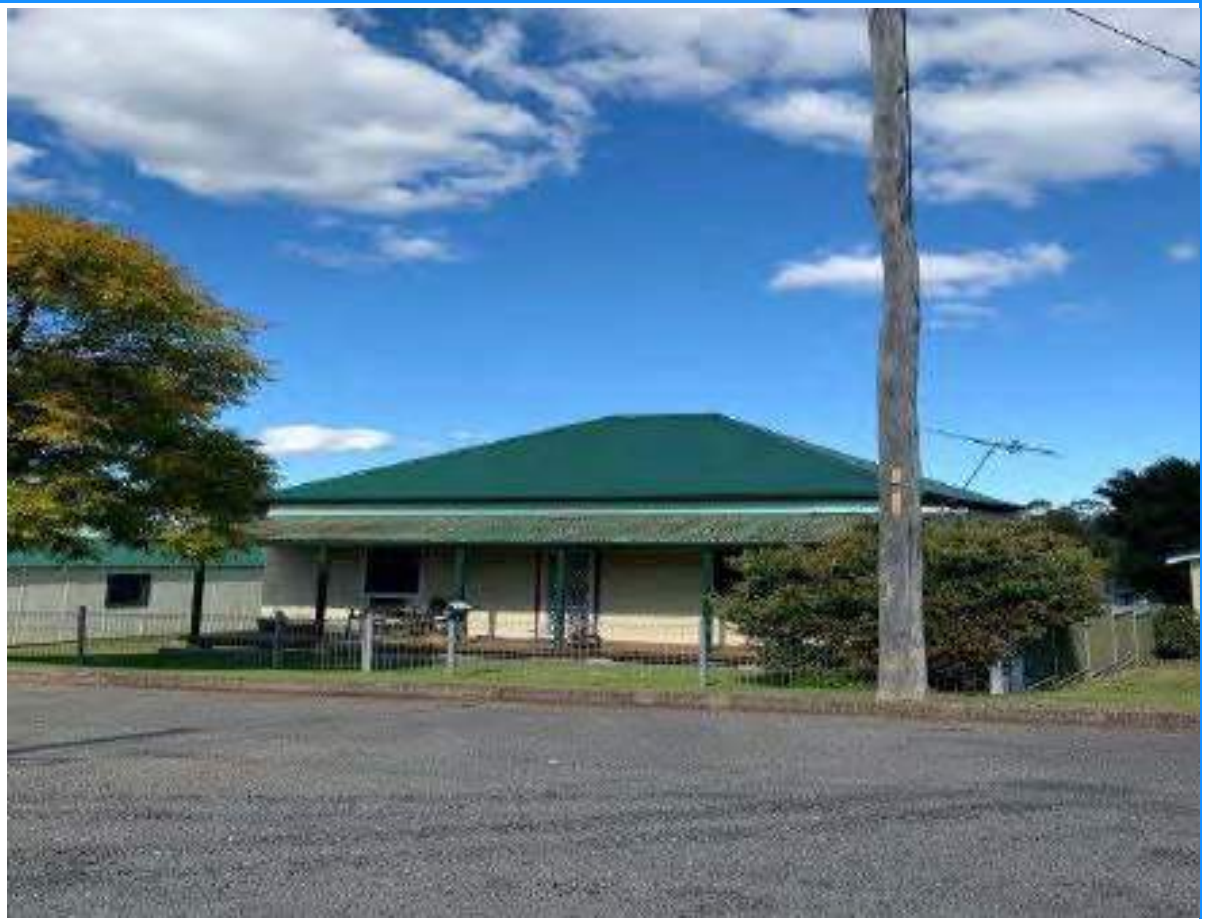
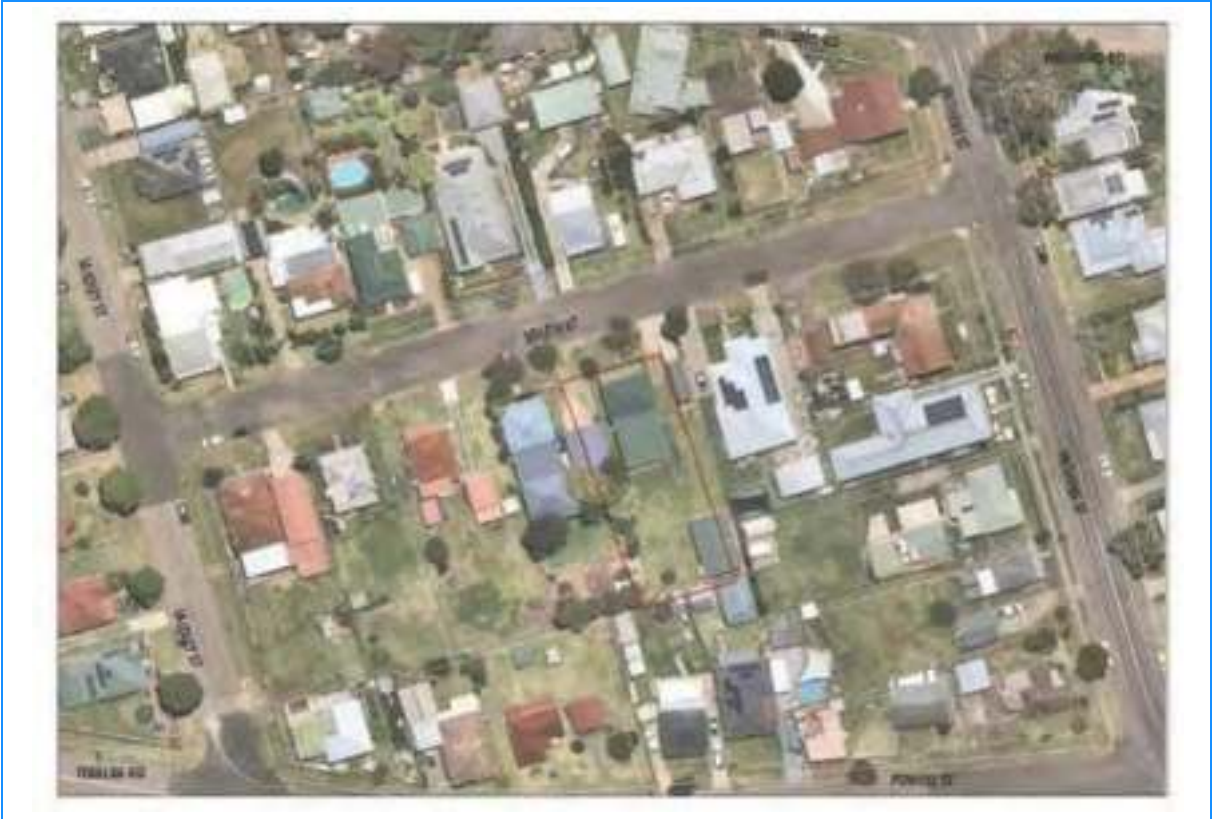
2 SOUTH STREET, WEST WALLSEND 2286

Conservation Area Contribution Level	Est. Construction Date	Previous studies and/or community input
Contributory 1	1890–1915	No prior heritage investigations and no additional information required
Assessment Text		Observed Modifications
<p>Single story Vernacular ‘Mining Cottage’ style dwelling with steep hipped Colourbond roof and weatherboard cladding. The veranda roof is skillion.</p> <p>The veranda is open.</p> <p>The easter and western windows are the original sash designs, with metal and timber awnings.</p> <p>A gable roof garage is located to the east of the dwelling.</p> <p>A metal wire fence encloses the property.</p> <p>The dwelling displays architectural features of a heritage style and is representative of the local development of this period, being of historical significance for the HCA.</p>		<p>A back veranda extension has been constructed at the southern end of the dwelling.</p> <p>The veranda roof would have likely been bull nosed and has been replaced by a skillion design.</p>
