APPENDIX 2

Building Assessment Sheets (Inventory Sheets)

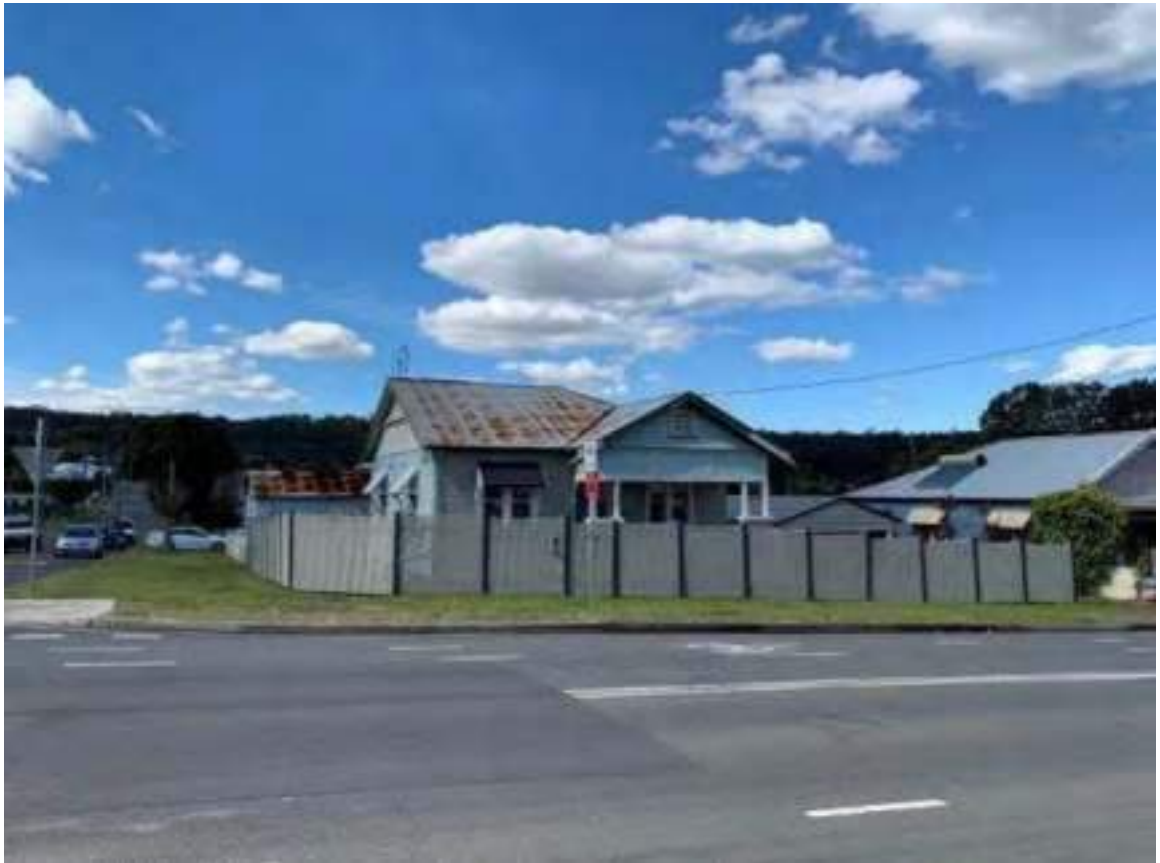
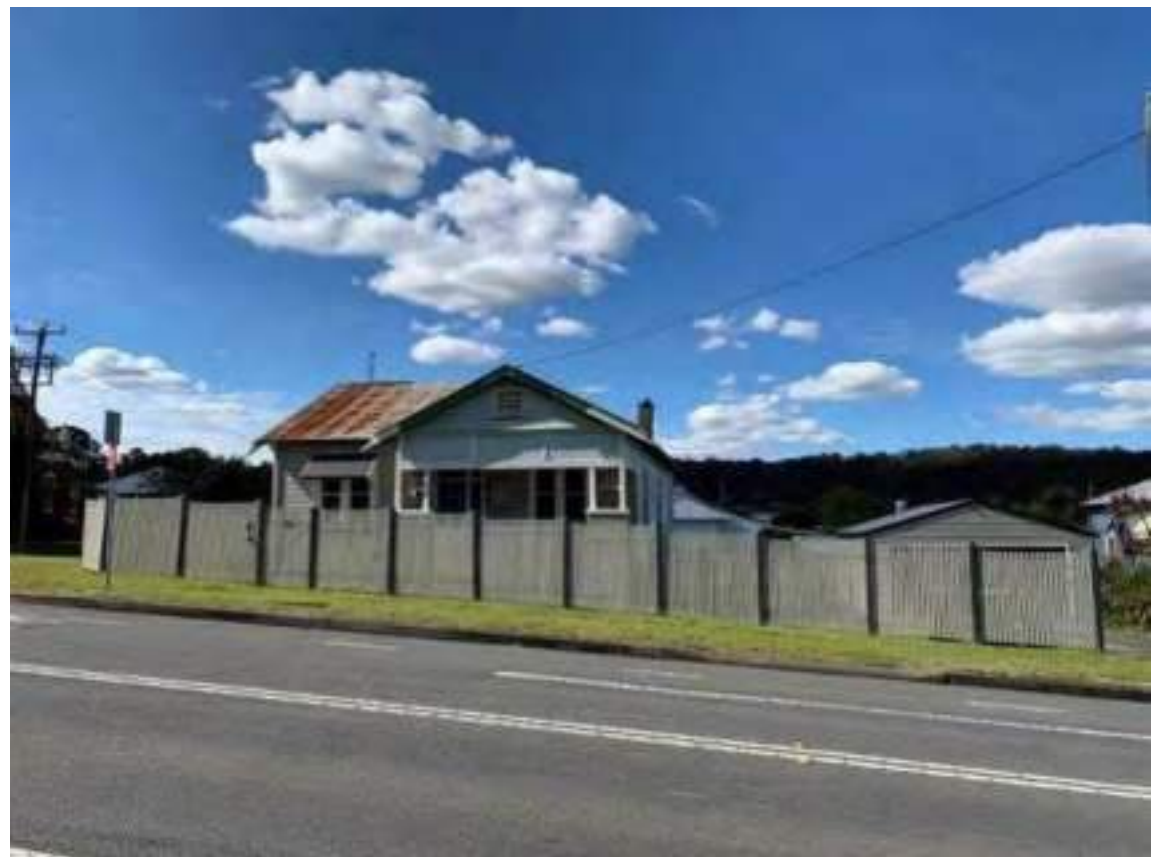
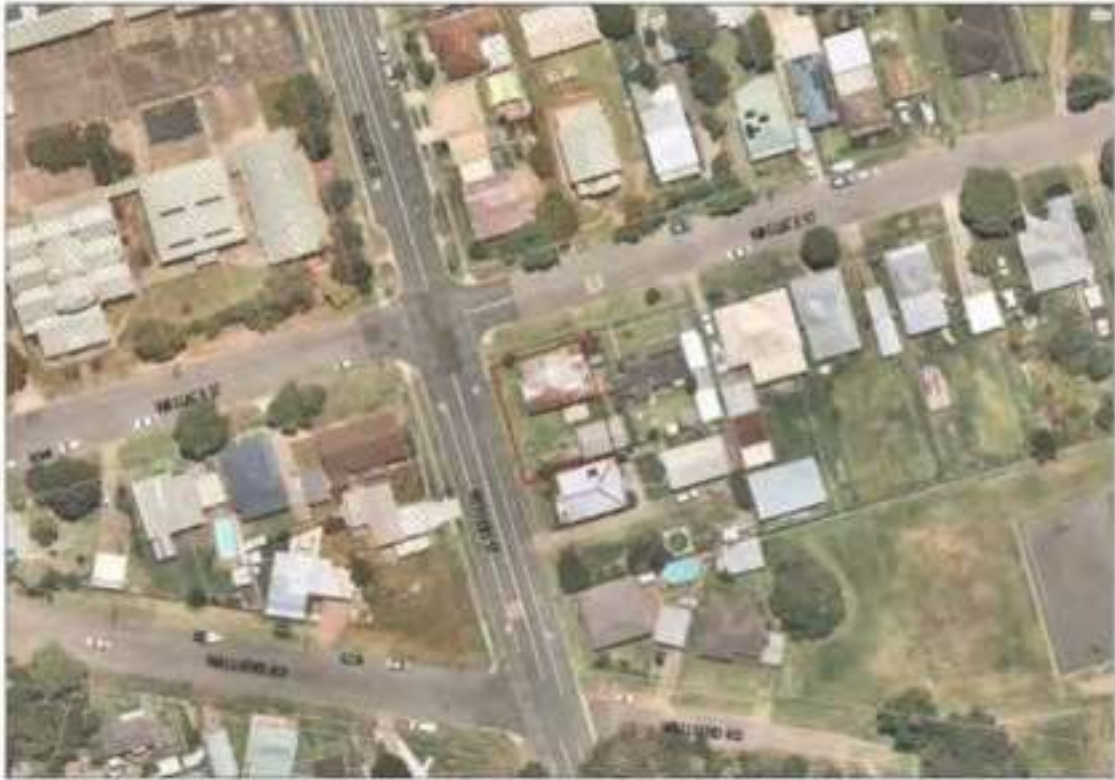
15 WITHERS STREET, WEST WALLSEND 2286

Conservation Area Contribution Level	Est. Construction Date	Previous studies and/or community input
Contributory 1	1920–1930	No prior heritage investigations and no additional information required
Assessment Text		Observed Modifications
<p>Single story Federation Bungalow style dwelling with gable Colourbond roof and weatherboard cladding.</p> <p>The veranda is partially enclosed by a rendered brick veranda wall, with brick piers and timber posts.</p> <p>The visible windows are the original timber framed double sash designs, with pronounced timber sills. Canvas awnings with timber brackets are found on the western side, with timber awnings on the northern side. The front door has a fanlight and adjacent glass panel.</p> <p>A cement rendered chimney is located on the eastern side of the dwelling.</p> <p>The gables have extended eaves and battening detailing.</p> <p>A timber picket fence encloses the property.</p> <p>The dwelling displays architectural features of a heritage style and is representative of the local development of this period, being of historical significance for the HCA.</p>		<p>A veranda extension has been constructed on the eastern side of the dwelling. this is not visible from the street and does not detract.</p> <p>The canvas awnings detail on the western façade is a contemporary addition.</p>

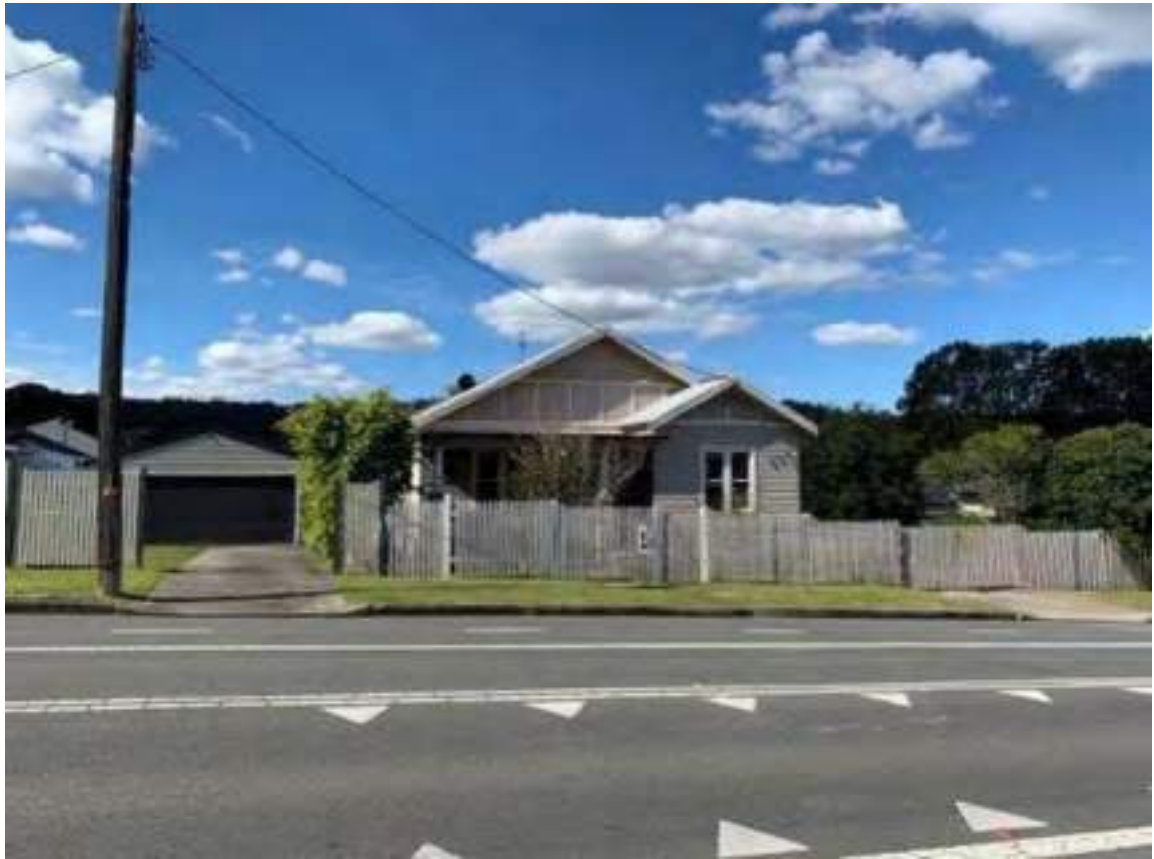
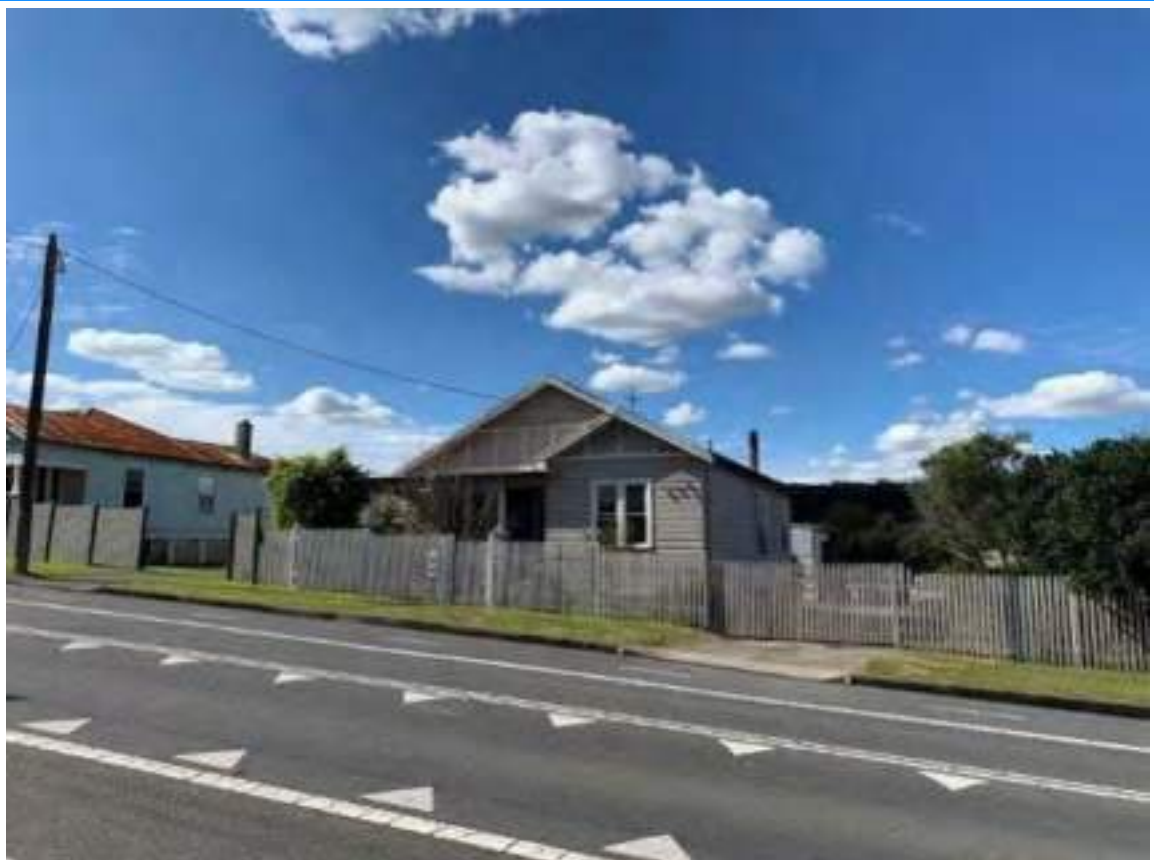
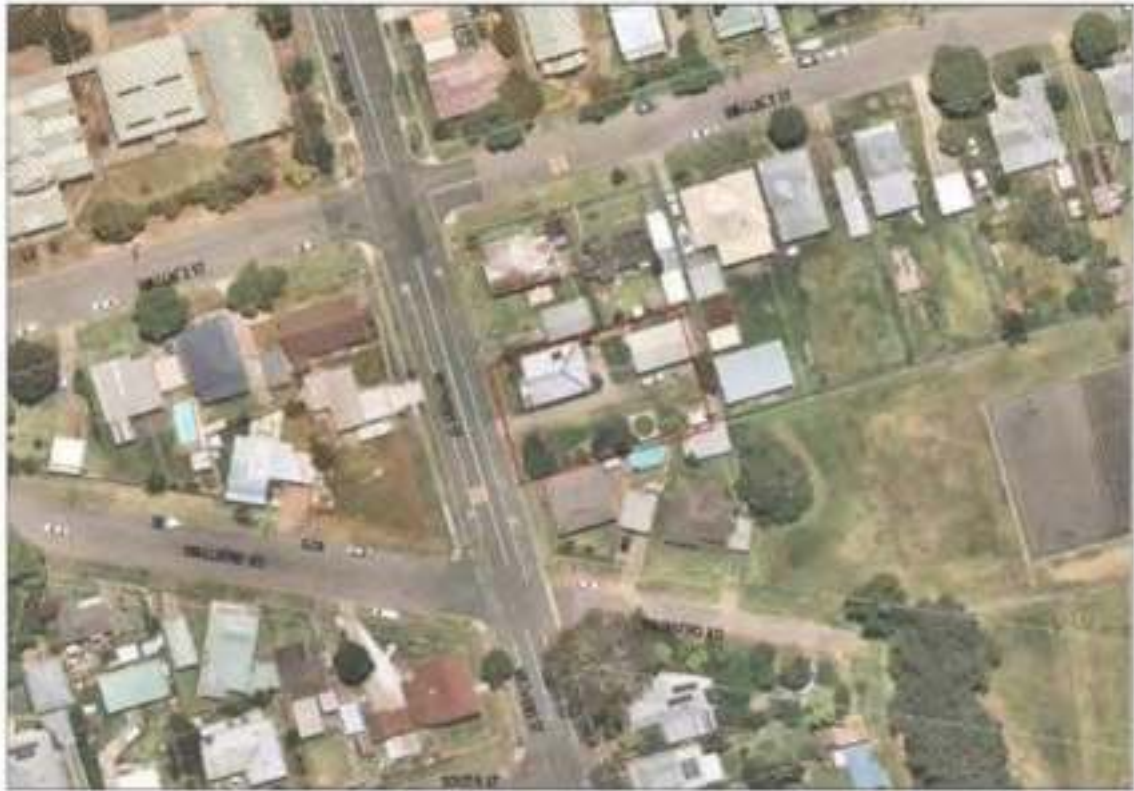
17 WITHERS STREET, WEST WALLSEND 2286

Conservation Area Contribution Level	Est. Construction Date	Previous studies and/or community input
Contributory 1	1920–1930	No prior heritage investigations and no additional information required
Assessment Text		Observed Modifications
<p>Single story Federation Bungalow style dwelling with Colourbond double gable roof and weatherboard cladding. The veranda roof is flat and supported by masonry/timber columnar pillars.</p> <p>The veranda is partially enclosed by a brick veranda wall.</p> <p>The visible windows are the original timber framed double sash design.</p> <p>The gables have extended eaves and battening details.</p> <p>A timber picket fence encloses the property.</p> <p>The dwelling displays architectural features of a heritage style and is representative of the local development of this period, being of historical significance for the HCA.</p>		No modifications observed.

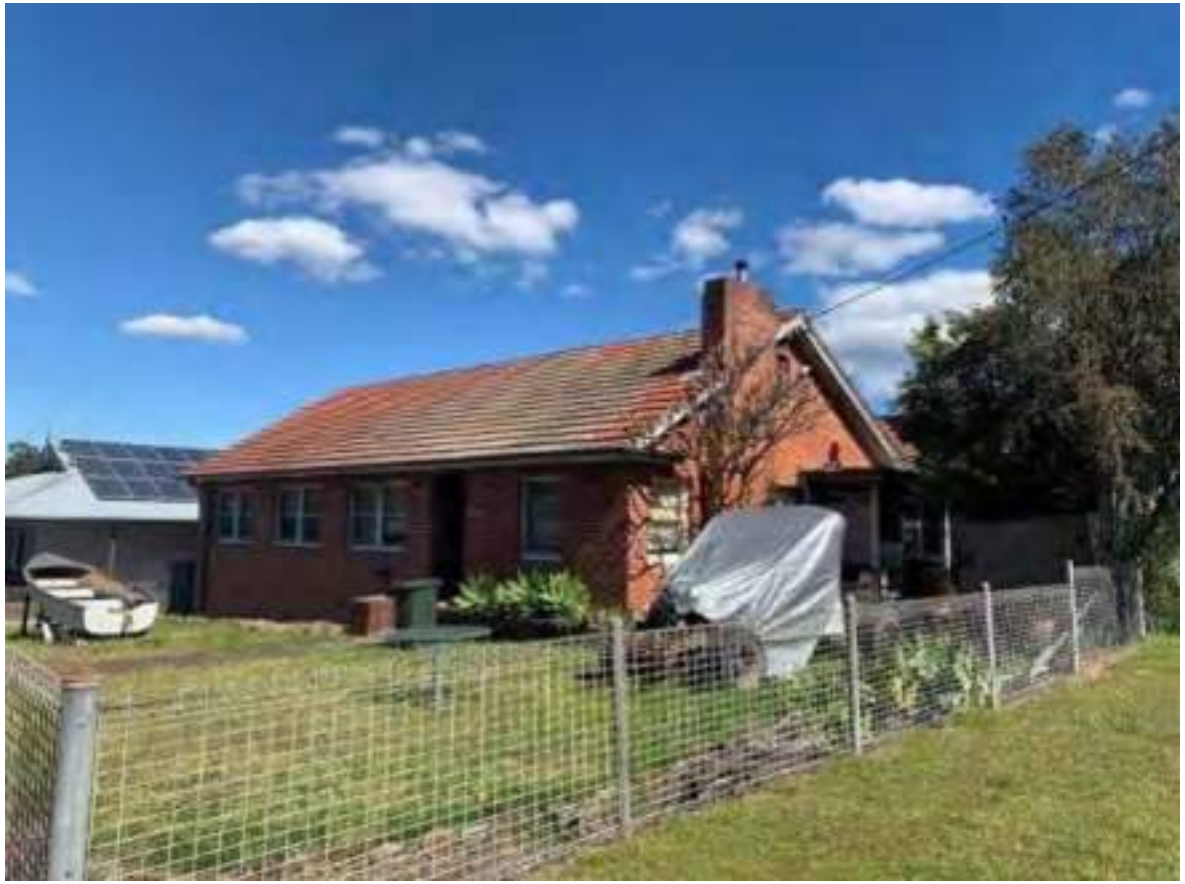
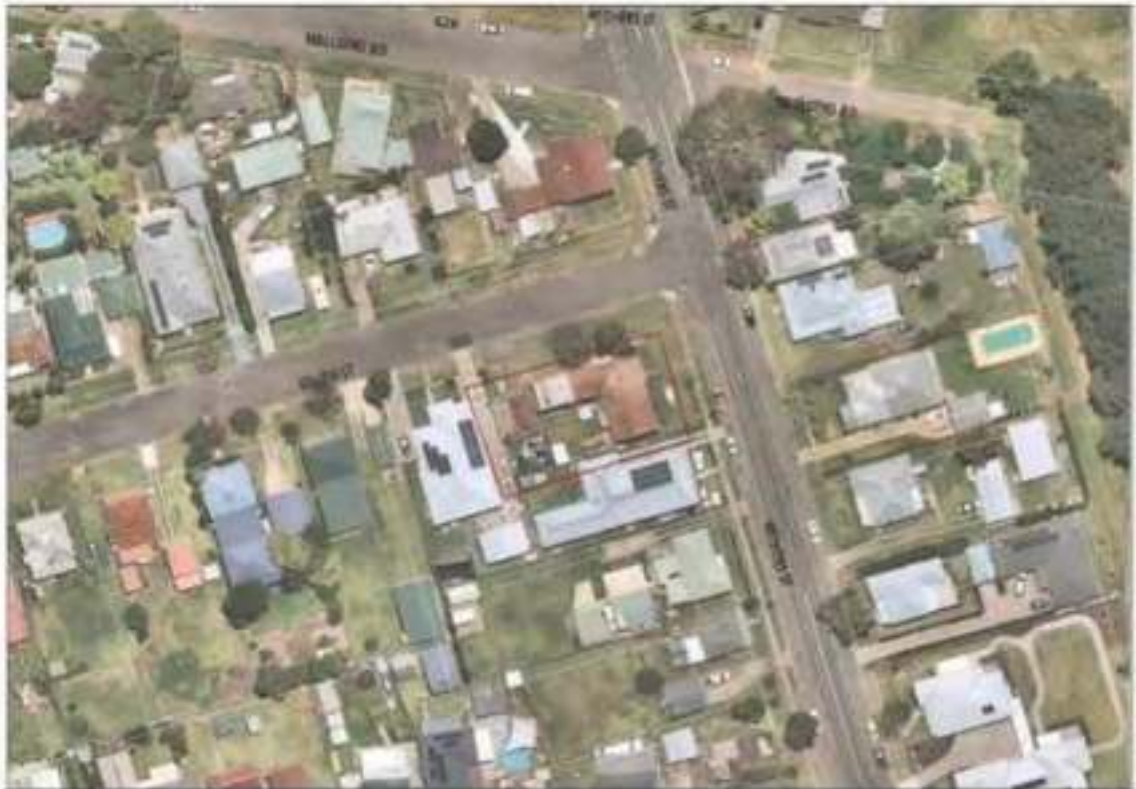
UNIT 3, 12 WITHERS STREET, WEST WALLSEND 2286

Conservation Area Contribution Level	Est. Construction Date	Previous studies and/or community input
Contributory 1	1950	The former West Wallsend Police Station.
Assessment Text		Observed Modifications
<p>Single story post-war dwelling with red brick façade and terracotta tile gable roof. The western portion is flat roofed.</p> <p>The visible windows are timber framed jealousy and sash designs, likely original.</p> <p>A brickwork chimney is visible on the northern side of the dwelling.</p> <p>A metal wire fence encloses the property.</p> <p>The dwelling displays architectural features of a heritage style and is representative of the local development of this period, being of historical significance for the HCA.</p>		No modifications observed.

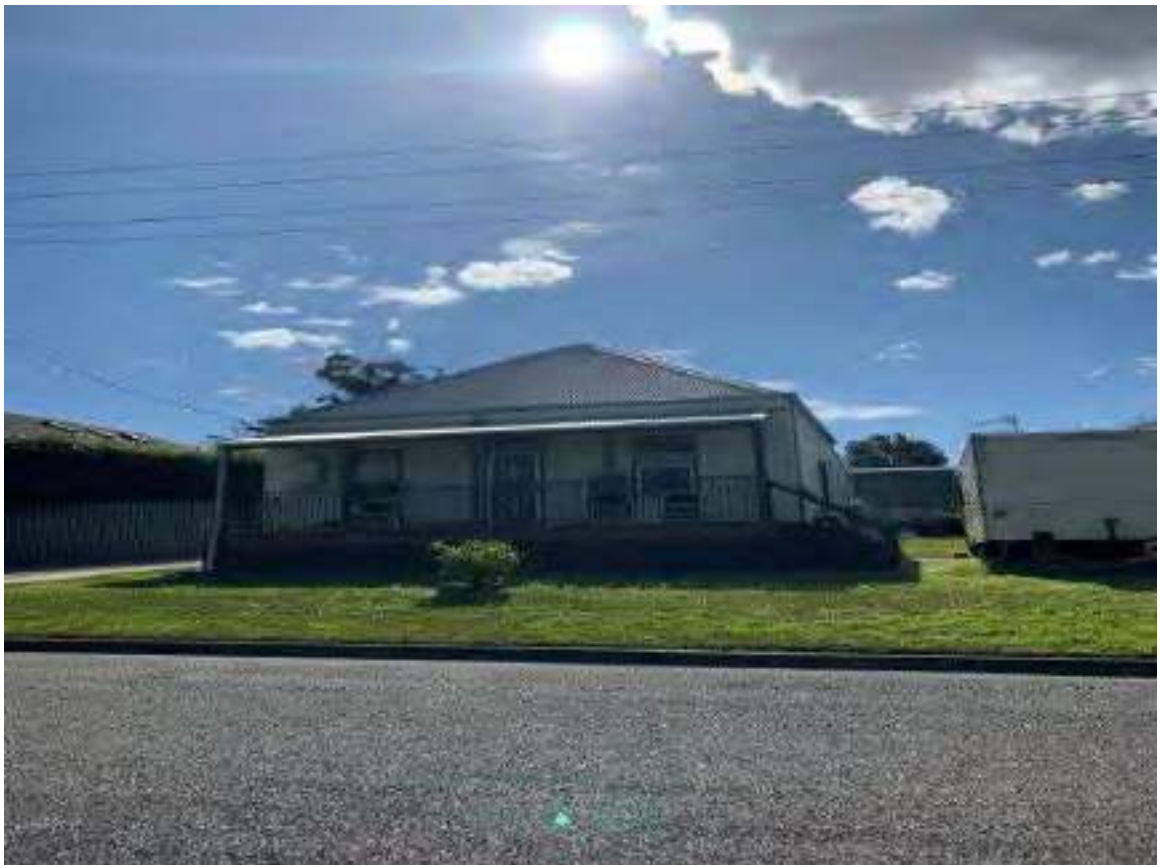
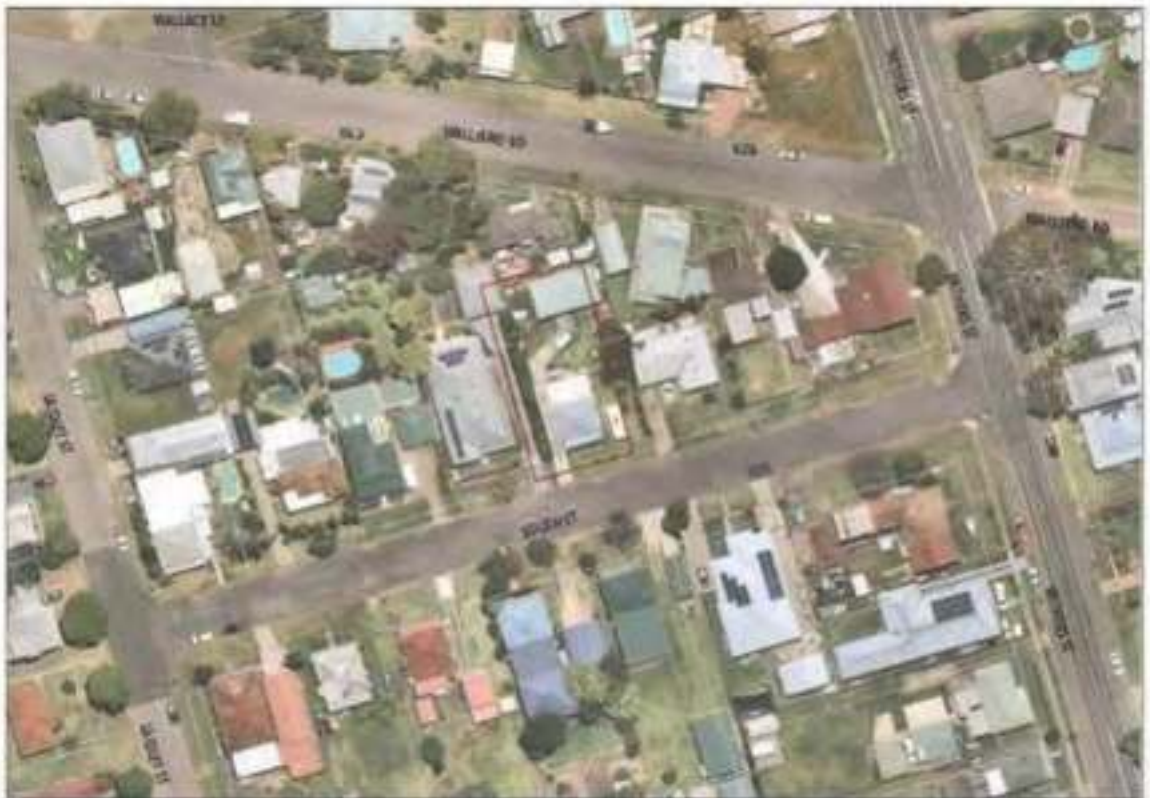
1 SOUTH STREET, WEST WALLSEND 2286

Conservation Area Contribution Level	Est. Construction Date	Previous studies and/or community input
Contributory 1	1890–1915	No prior heritage investigations and no additional information required
Assessment Text		Observed Modifications
<p>Single story Vernacular ‘Mining Cottage’ style dwelling with steep hipped Colourbond roof and weatherboard cladding. The veranda roof is skillion.</p> <p>The veranda is partially enclosed by a simple metal balustrade.</p> <p>The visible windows are the original timber framed sash designs. The front door has a fanlight at the top.</p> <p>The dwelling displays architectural features of a heritage style and is representative of the local development of this period, being of historical significance for the HCA.</p>		<p>The front door has an ornately designed metal screen door, juxtaposing with the original heritage style of the dwelling.</p> <p>The metal balustrade is a contemporary addition to the dwelling, likely replacing a timber style.</p>

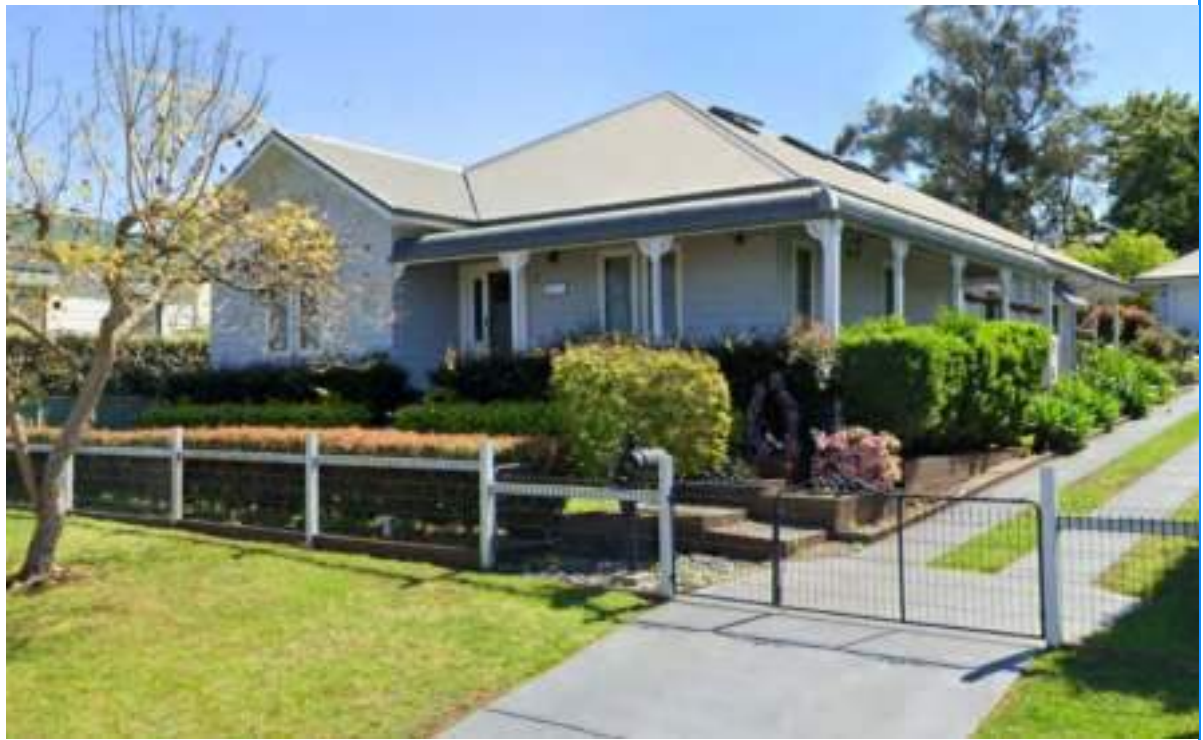
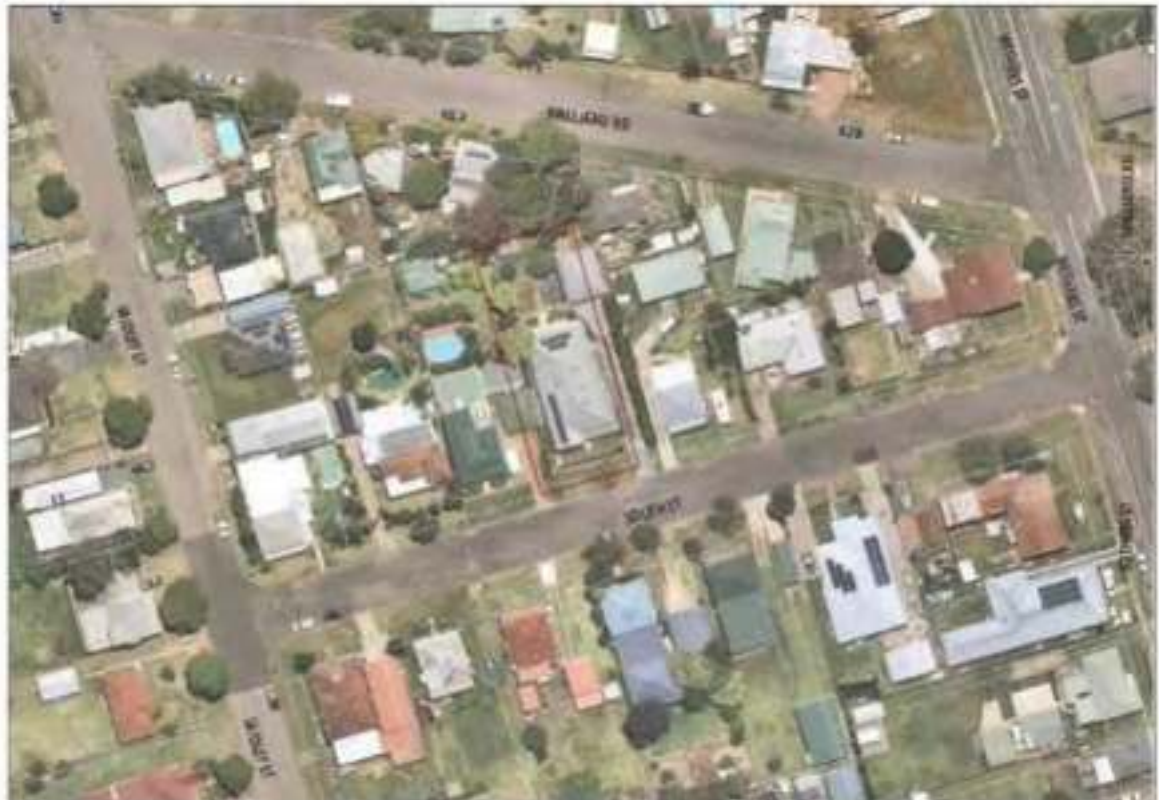
3 SOUTH STREET, WEST WALLSEND 2286

Conservation Area Contribution Level	Est. Construction Date	Previous studies and/or community input
Contributory 1	1900–1920	No prior heritage investigations and no additional information required
Assessment Text		Observed Modifications
<p>Single story simply Federation ‘workmen's cottage’ style dwelling with steep hipped Colourbond roof with gable projection, and weatherboard cladding. The veranda roof is bull nosed and supported by timber posts with ornate brackets.</p> <p>The visible windows are the original timber framed double sash design. The gable window has a Colourbond awning with timber brackets.</p> <p>A timber post and metal fence encloses the property.</p> <p>The dwelling displays architectural features of a heritage style and is representative of the local development of this period, being of historical significance for the HCA.</p>		<p>The veranda roof extends along the eastern side of the dwelling. This is a common modification for the housing style and does not detract from the heritage streetscape.</p> <p>A back extension has been built onto the northern end of the dwelling, this is not visible from the street and does not detract.</p> <p>Potentially a recent reconstruction of a heritage dwelling.</p>

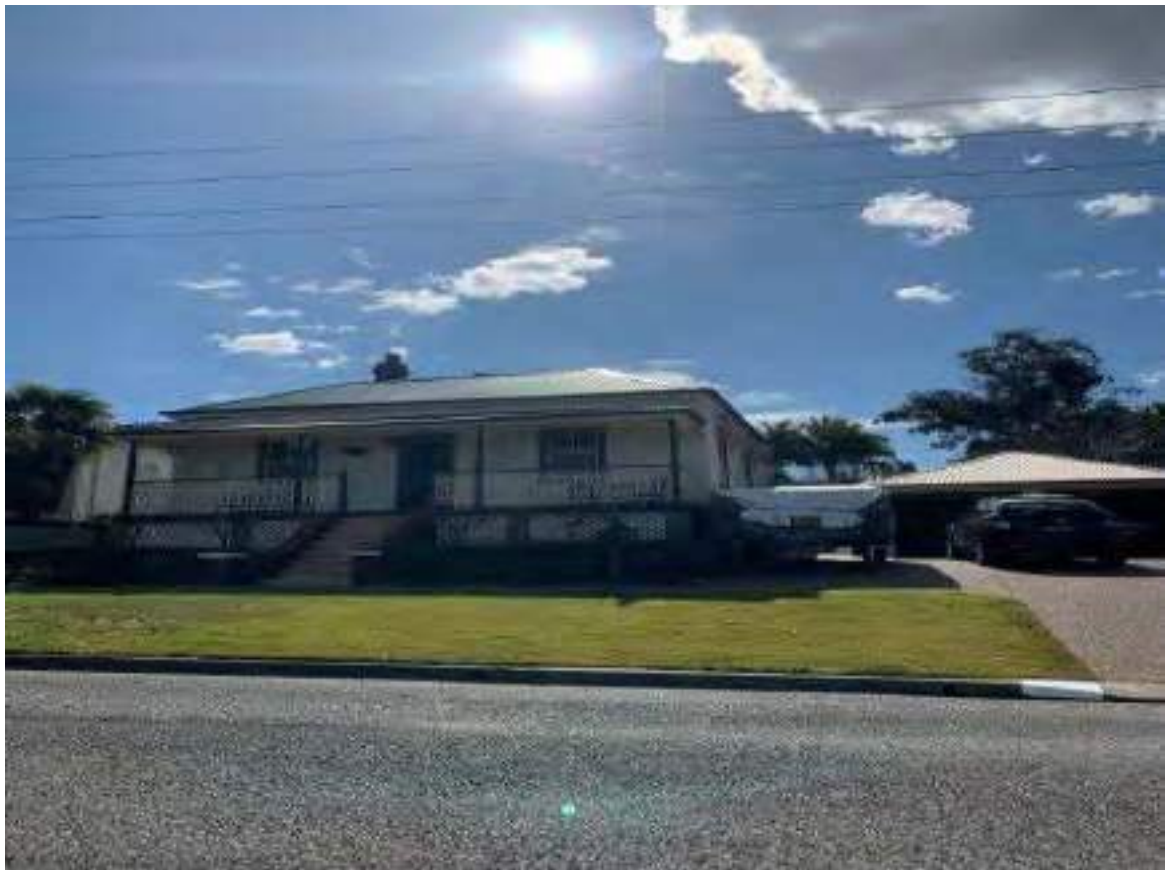
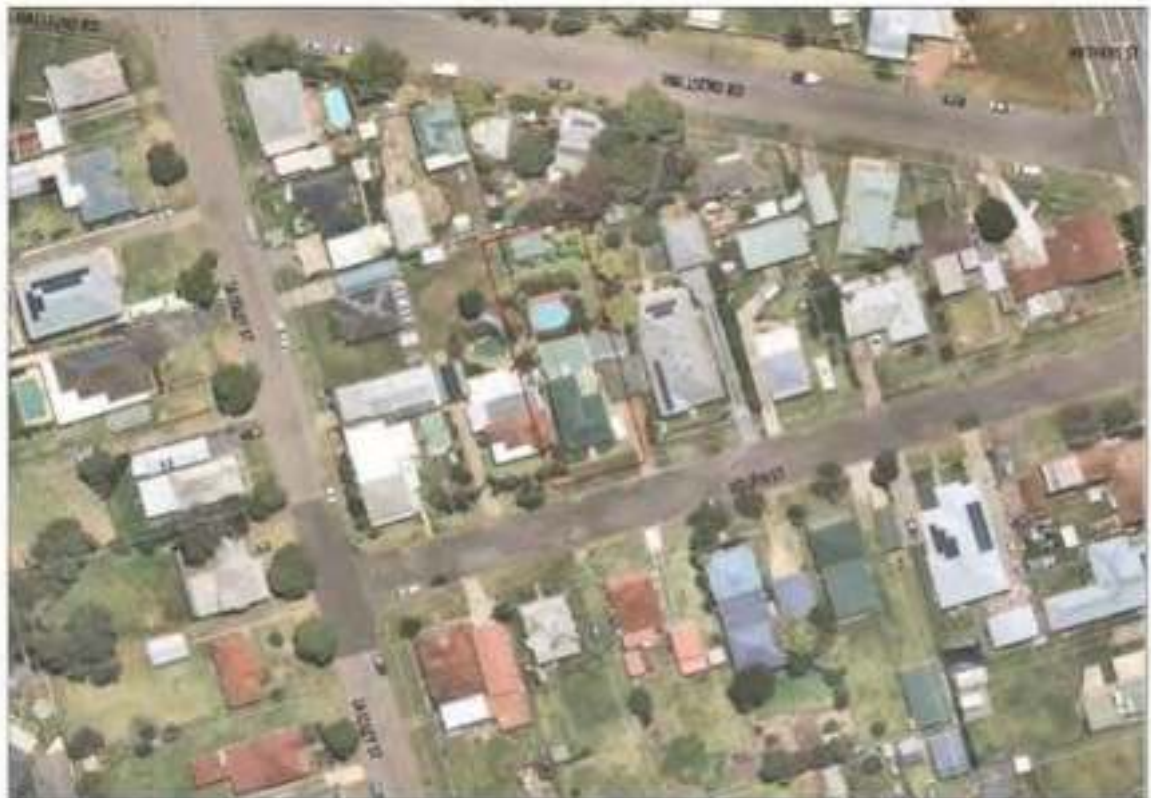
5 SOUTH STREET, WEST WALLSEND 2286

Conservation Area Contribution Level	Est. Construction Date	Previous studies and/or community input
Contributory 1	1890–1915	No prior heritage investigations and no additional information required
Assessment Text		Observed Modifications
<p>Single story Vernacular ‘Mining Cottage’ style dwelling with steep hipped Colourbond roof and weatherboard cladding. The veranda roof is skillion.</p> <p>The veranda is partially enclosed by metal balustrade.</p> <p>The front door is timber framed with a fanlight a top. The adjacent windows are potentially the original sash designs.</p> <p>The dwelling displays architectural features of a heritage style and is representative of the local development of this period, being of historical significance for the HCA.</p>		<p>The metal balustrade of the veranda, and timber balustrade of the stairs are a contemporary addition.</p> <p>The front door has a pronounced metal screen door.</p>

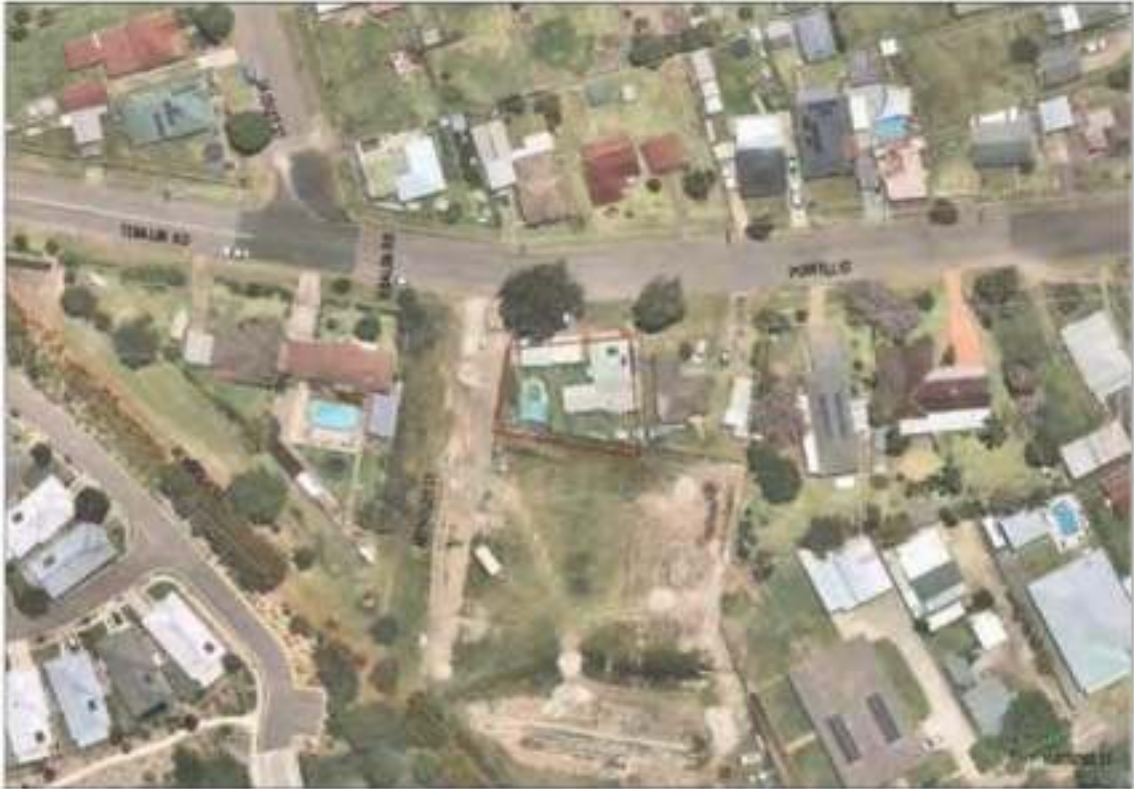
Conservation Area Contribution Level	Est. Construction Date	Previous studies and/or community input
Contributory 1	1890–1915	No prior heritage investigations and no additional information required
Assessment Text		Observed Modifications
<p>Single story Vernacular style dwelling with hipped Colourbond roof and timber weatherboard cladding. The façade maintains a natural wood design. The veranda roof is bullnose and potentially original. Metal posts with cast iron lace brackets support the veranda roof.</p> <p>The front door is an ornate timber framed design, with side glass panels.</p> <p>The visible windows are sash designs with timber shingle hoods.</p> <p>A timber fence encloses the property.</p> <p>A car port and garage are located to the west of the dwelling.</p> <p>The dwelling displays architectural features of a heritage style and is representative of the local development of this period, being of historical significance for the HCA.</p>		<p>The veranda roof has potentially been relocated to the western side of the front façade, to create an asymmetric effect.</p> <p>The hot water solar panel is prominently located at the front northern side of the dwelling.</p> <p>The front door is bright red, juxtaposing the timber detailing.</p>

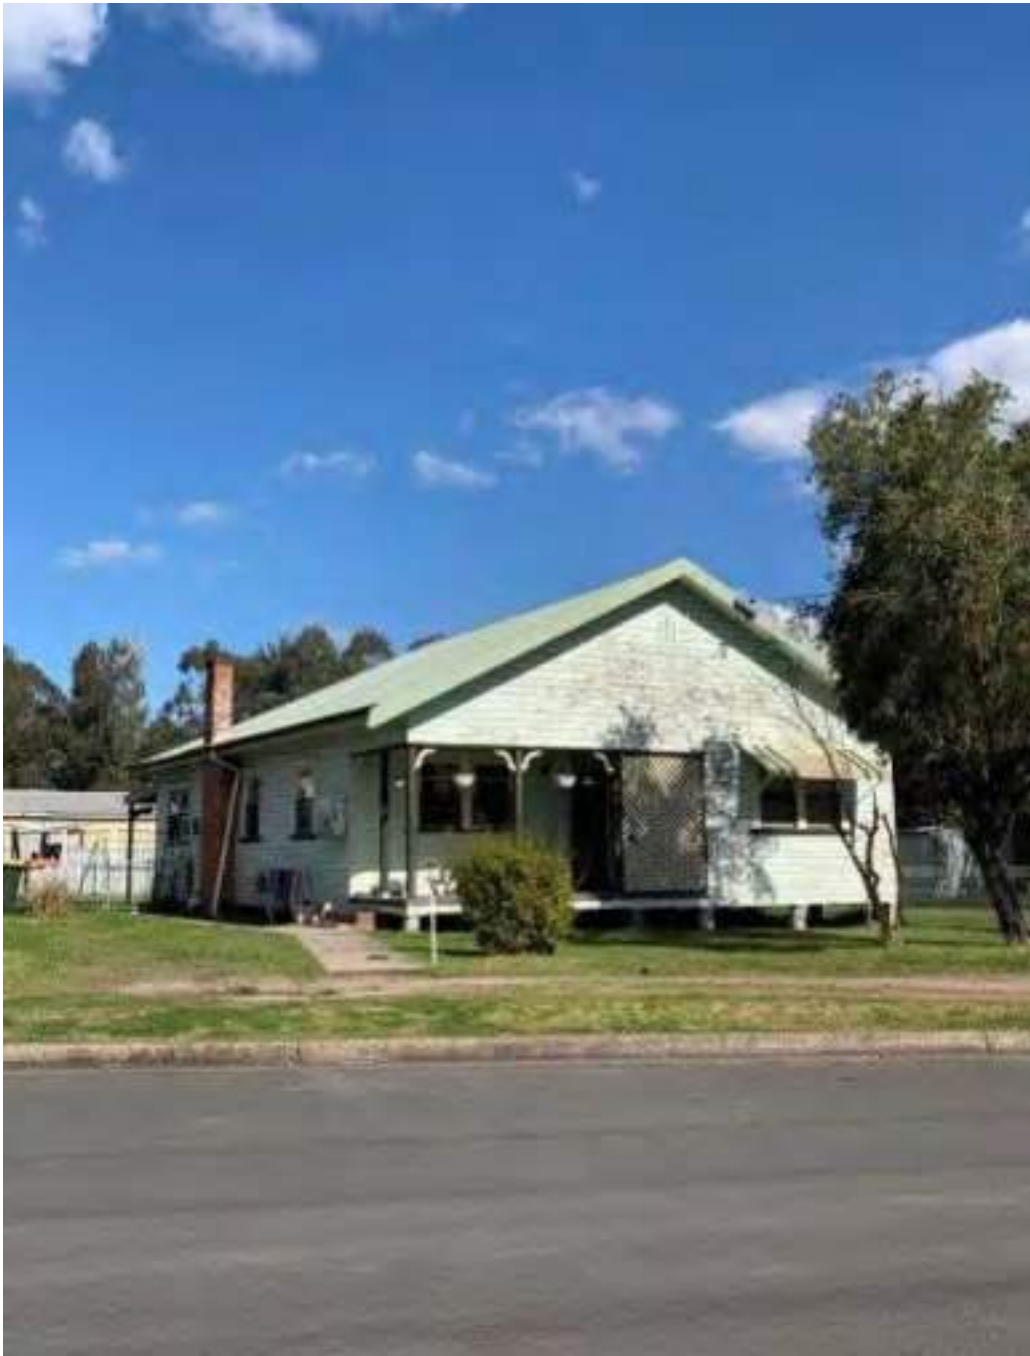
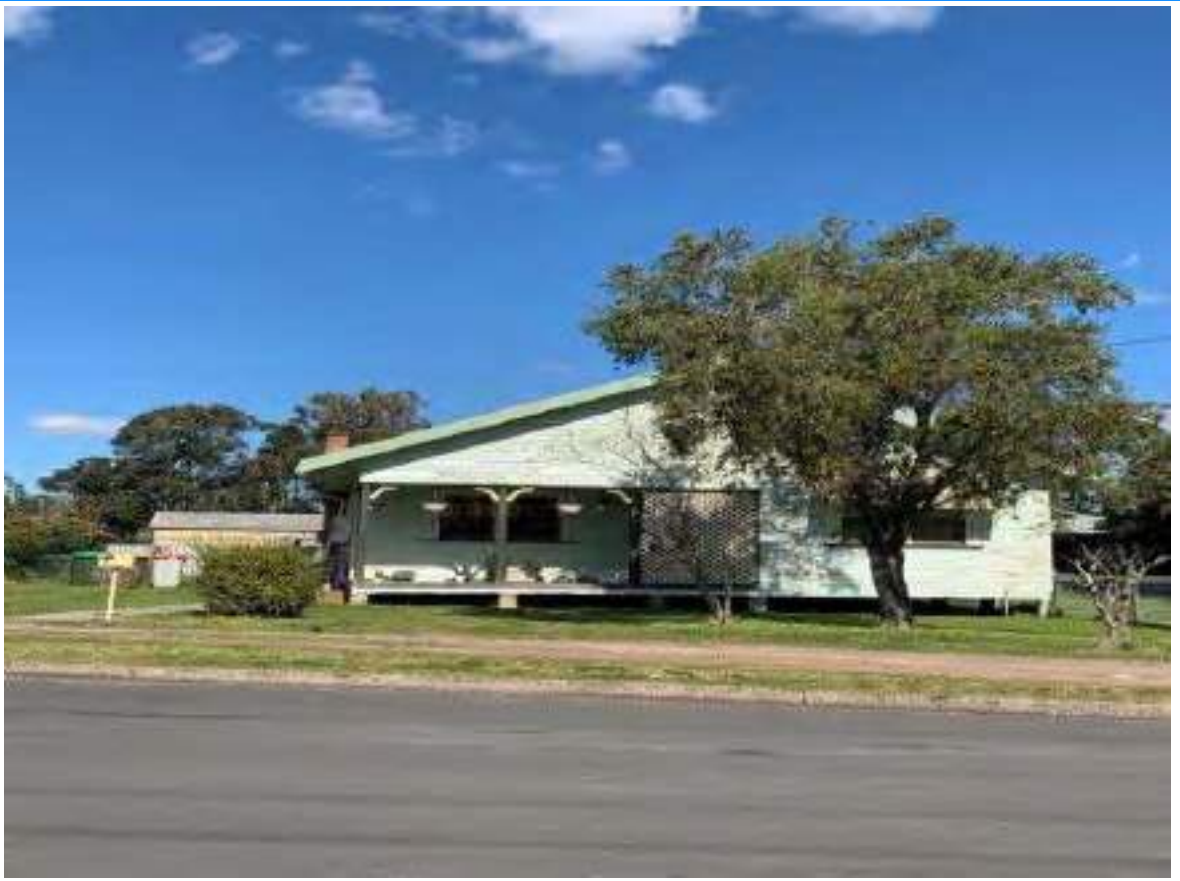
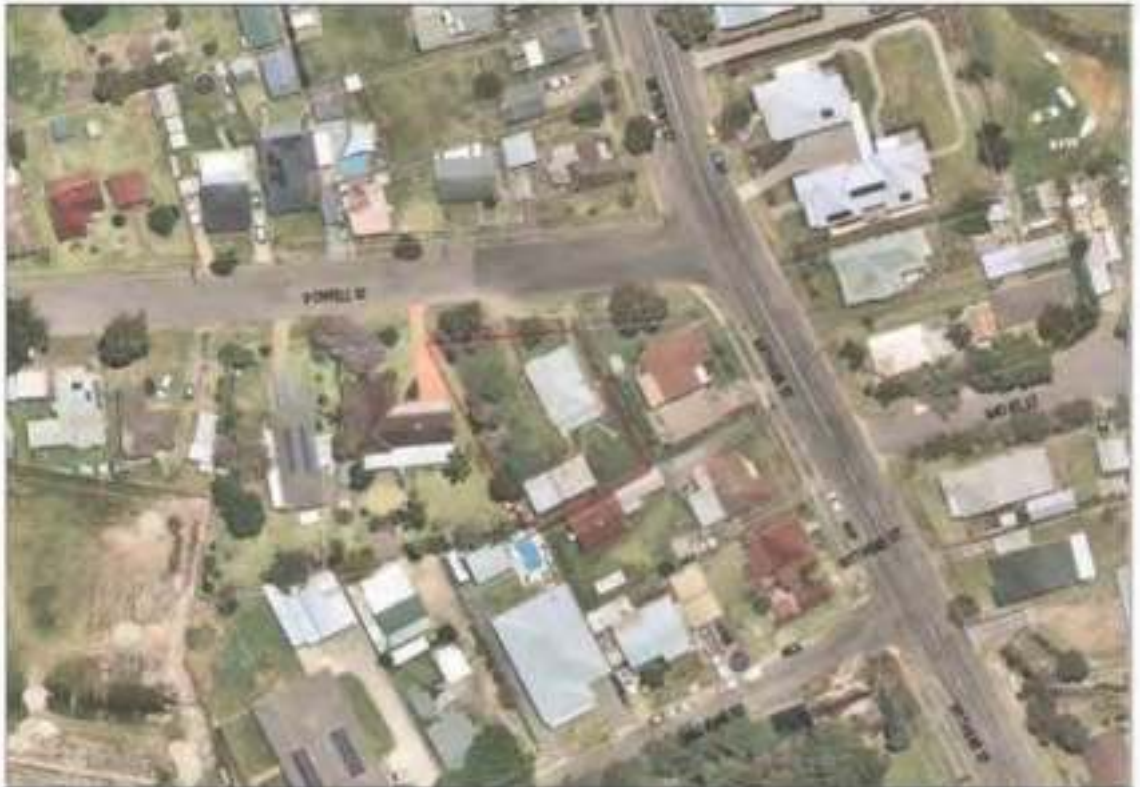
2 POWELL STREET, WEST WALLSEND 2286

Conservation Area Contribution Level	Est. Construction Date	Previous studies and/or community input
Contributory 1	1920–1930	No prior heritage investigations and no additional information required
Assessment Text		Observed Modifications
<p>Single story Bungalow style dwelling with gable Colourbond roof and timber weatherboard cladding. The cladding paint is in a state of disrepair, exposing the underlying timber.</p> <p>The veranda is partially enclosed by timber latticing, with timber posts and ornate brackets supporting the roof.</p> <p>The visible windows are the original heavy timber framed sash designs.</p> <p>A red brickwork chimney is visible on the eastern side of the dwelling.</p> <p>The dwelling displays architectural features of a heritage style and is representative of the local development of this period, being of historical significance for the HCA.</p>		<p>A canvas striped awning overlies the front northern window and is a contemporary addition.</p> <p>The lattice veranda boarding is likely a contemporary addition.</p> <p>A back veranda has been constructed at the southern side of the dwelling.</p>

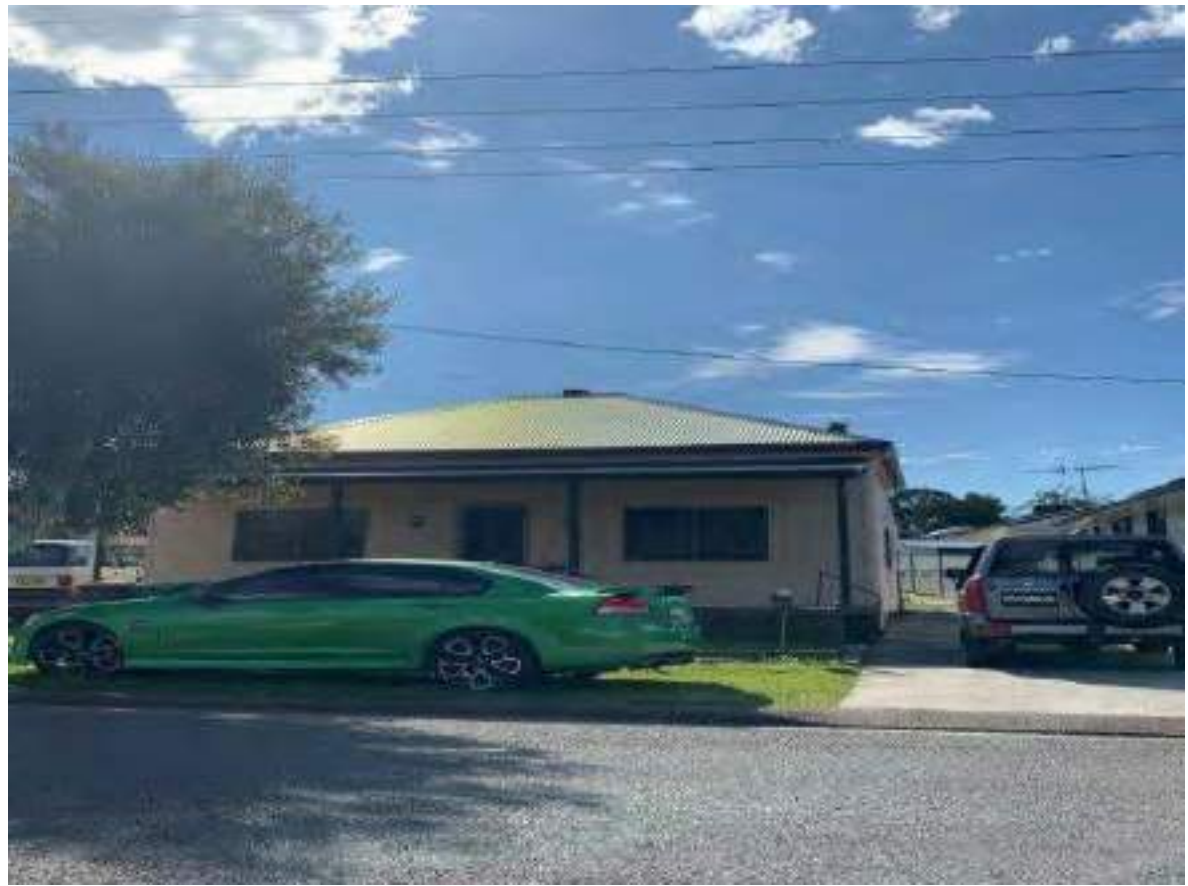
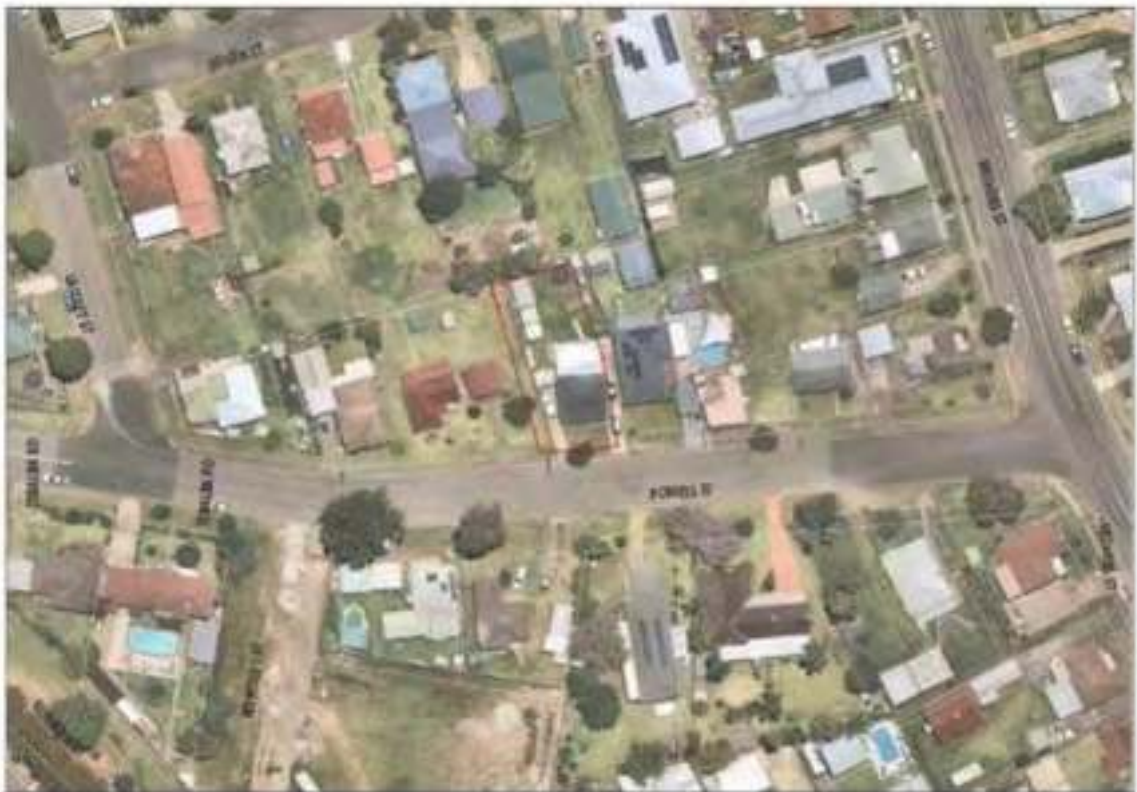
5 POWELL STREET, WEST WALLSEND 2286

Conservation Area Contribution Level	Est. Construction Date	Previous studies and/or community input
Contributory 1	1890–1915	No prior heritage investigations and no additional information required
Assessment Text		Observed Modifications
<p>Single story Vernacular 'Mining Cottage' style dwelling with hipped Colourbond roof and weatherboard cladding.</p> <p>The veranda roof is skillion.</p> <p>The veranda is open.</p> <p>A metal wire fence encloses the property.</p> <p>The dwelling displays architectural features of a heritage style and is representative of the local development of this period, being of historical significance for the HCA.</p>		<p>The front door and visible windows are contemporary designs.</p> <p>The veranda roof was likely bull nosed and replaced with the skillion design.</p>
