APPENDIX 2

Building Assessment Sheets (Inventory Sheets)

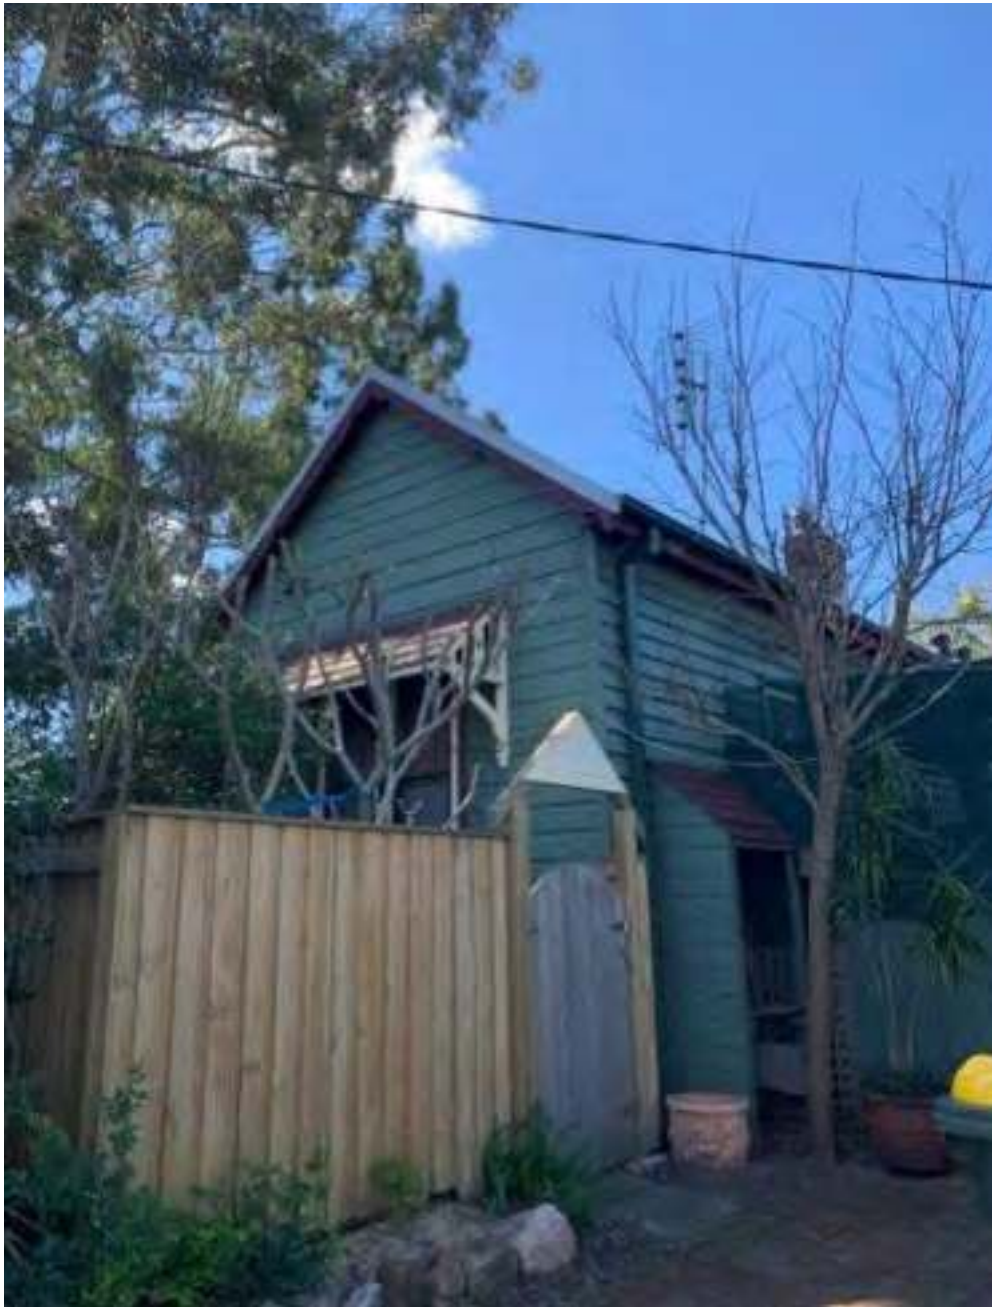
Conservation Area Contribution Level	Est. Construction Date	Previous studies and/or community input
Contributory 1	1890–1915	No prior heritage investigations and no additional information required
Assessment Text		Observed Modifications
<p>Single story Vernacular 'Mining Cottage' style dwelling with hipped Colourbond roof and weatherboard cladding.</p> <p>The veranda roof is skillion.</p> <p>The veranda is open.</p> <p>A metal wire fence encloses the property.</p> <p>The dwelling displays architectural features of a heritage style and is representative of the local development of this period, being of historical significance for the HCA.</p>		<p>The front door and visible windows are contemporary designs.</p> <p>The veranda roof was likely bull nosed and replaced with the skillion design.</p>

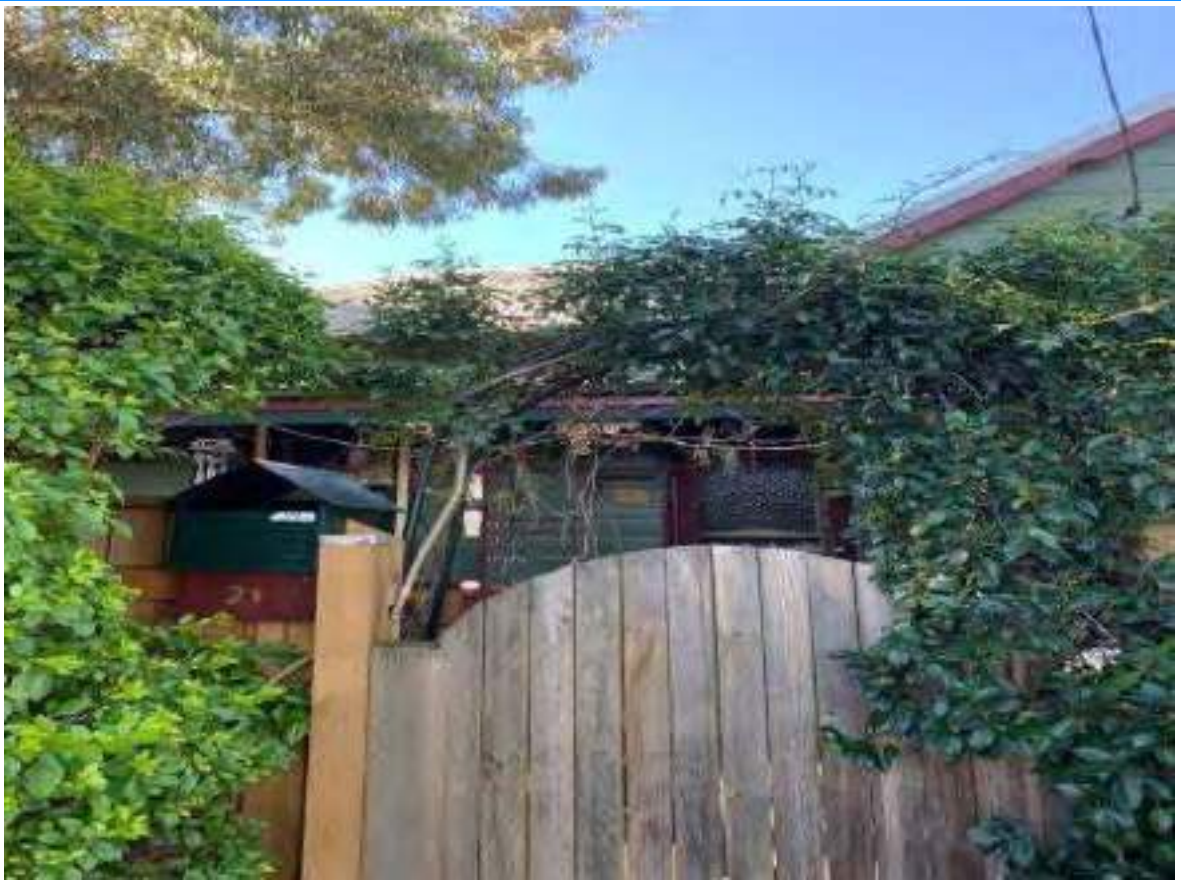
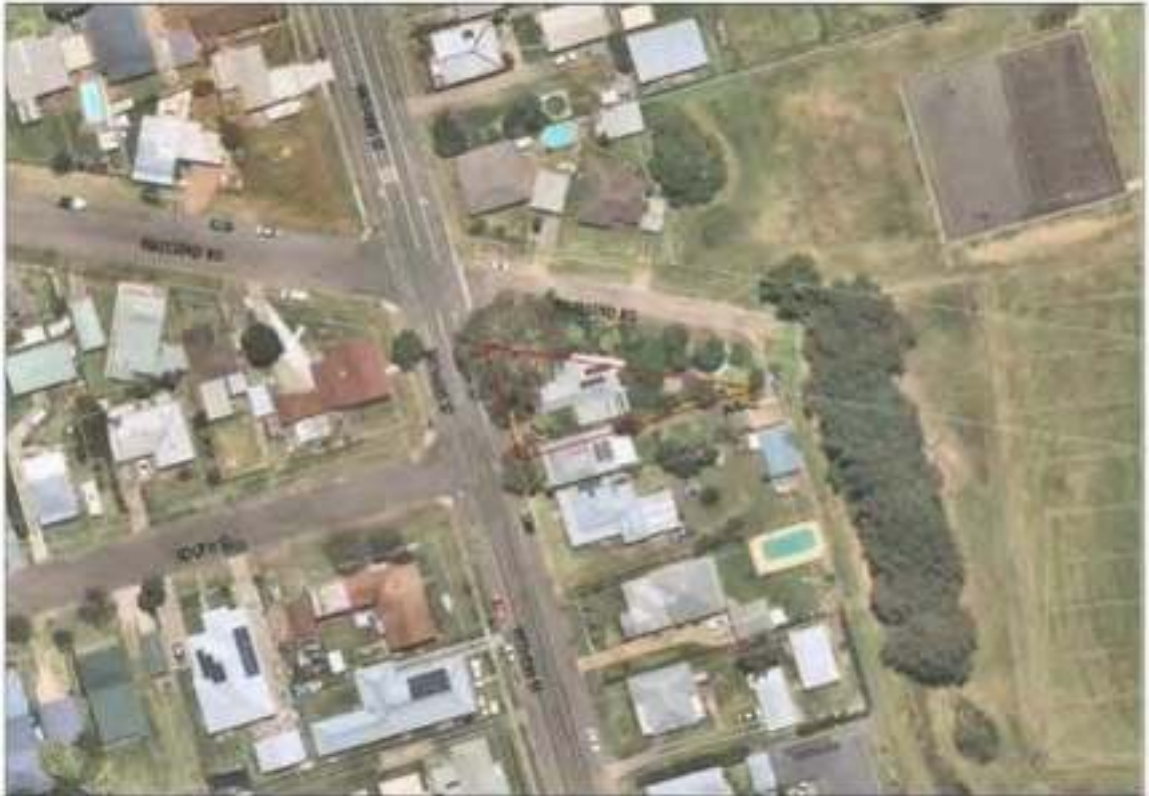
Conservation Area Contribution Level	Est. Construction Date	Previous studies and/or community input
Contributory 1	1900–1920	No prior heritage investigations and no additional information required
Assessment Text		Observed Modifications
<p>Single story Simple Federation ‘workmen's cottage’ style dwelling with Colourbond hipped roof with gable projection, and weatherboard cladding. The veranda roof is hipped.</p> <p>The gable has extended eaves and a timber shingled awning with decorative brackets.</p> <p>A high garden hedge and timber fence encloses the property, obscuring the dwelling.</p> <p>A brickwork chimney is visible on the southern side of the dwelling.</p> <p>The dwelling displays architectural features of a heritage style and is representative of the local development of this period, being of historical significance for the HCA.</p>		<p>The veranda wraps around to the northern side of the dwelling, likely an early modification and commonly seen in comparative house styles.</p> <p>Multiple extensions have been constructed on the southern, northern and eastern sides of the dwelling, however they are not visible from the street and do not detract from the heritage streetscape.</p>

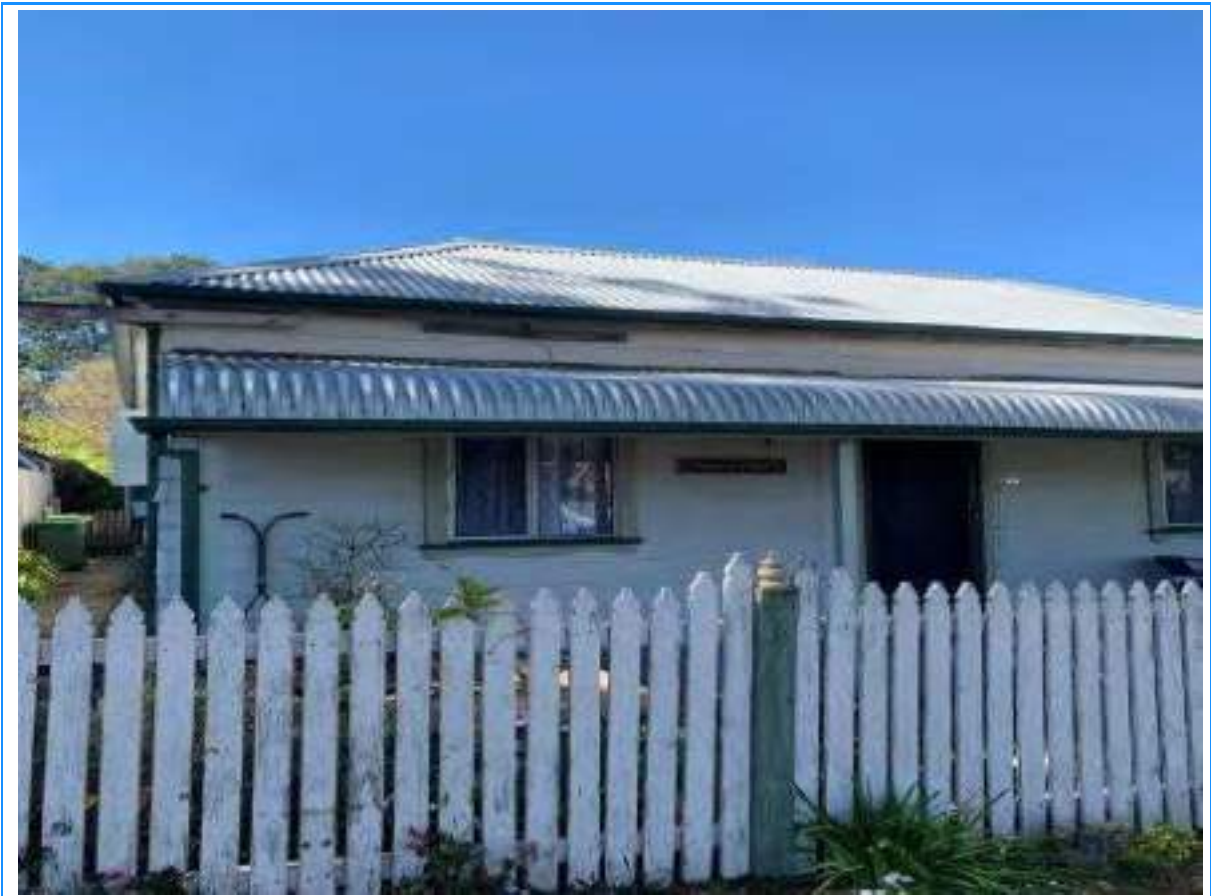
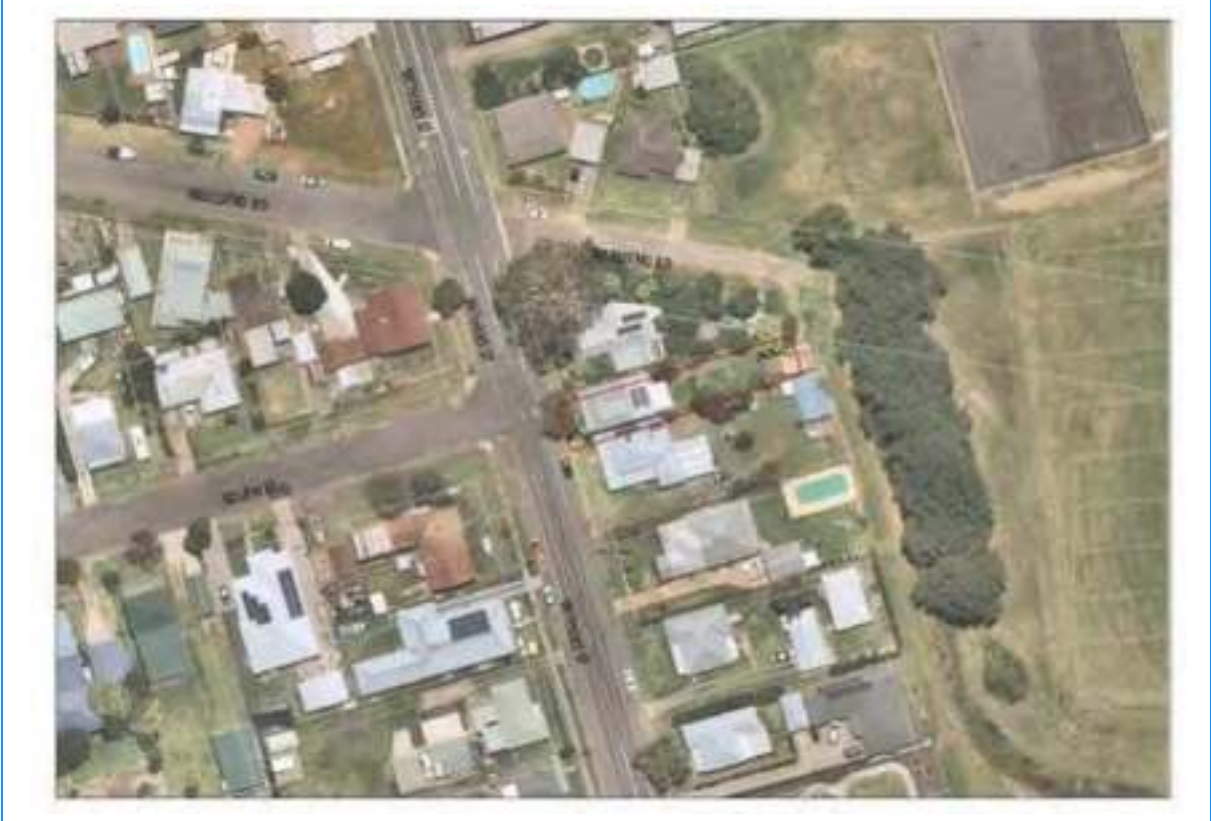
Conservation Area Contribution Level	Est. Construction Date	Previous studies and/or community input
Contributory 1	1890–1915	No prior heritage investigations and no additional information required
Assessment Text		Observed Modifications
<p>Single story Vernacular ‘Mining Cottage’ style dwelling with hipped Colourbond roof and timber weatherboard cladding. The veranda roof is bull nosed.</p> <p>The western windows retain the timber decorative sill.</p> <p>A timber picket fence encloses the property.</p> <p>The dwelling displays architectural features of a heritage style and is representative of the local development of this period, being of historical significance for the HCA.</p>		<p>The visible windows are contemporary sliding designs.</p> <p>An extension has been constructed at the back eastern side of the dwelling, however this is not visible from the street and does not detract.</p>

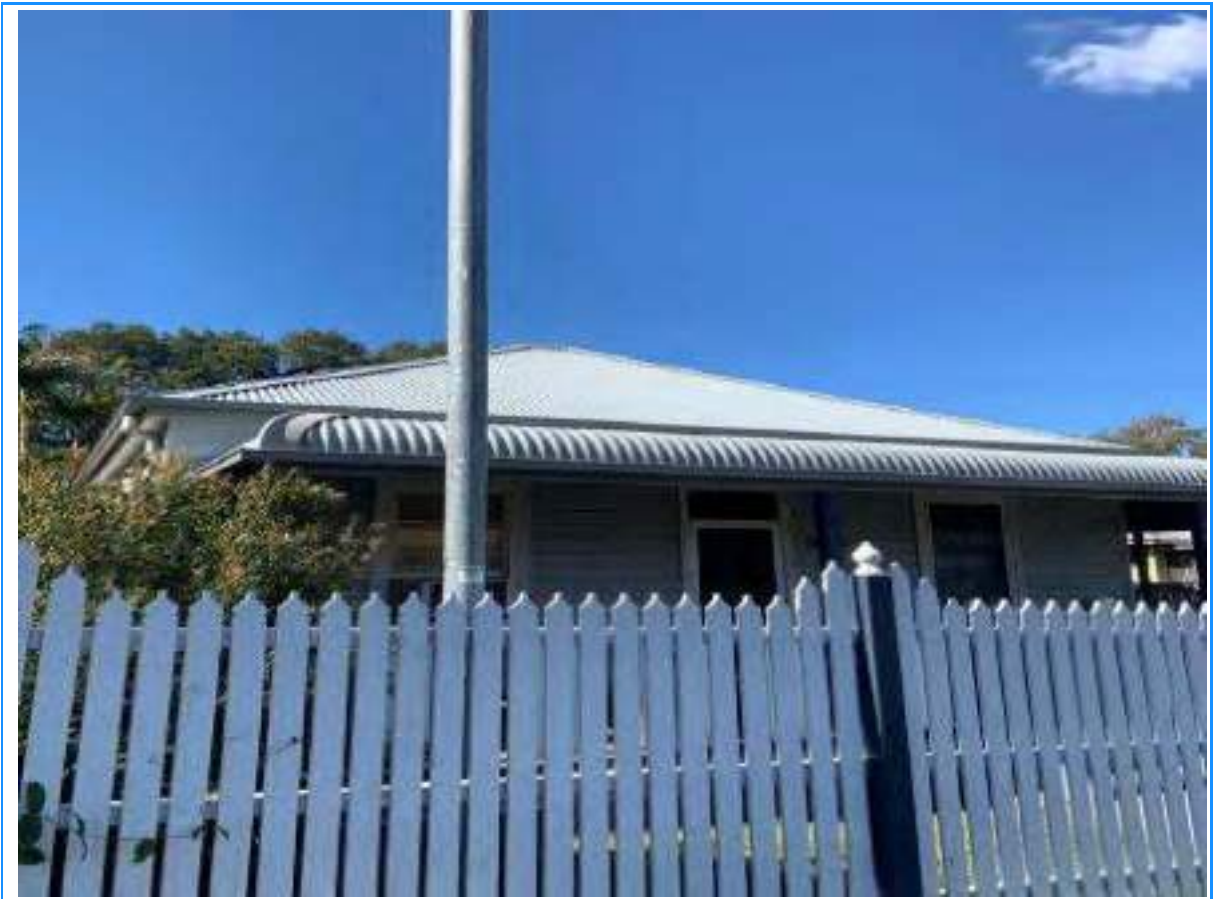
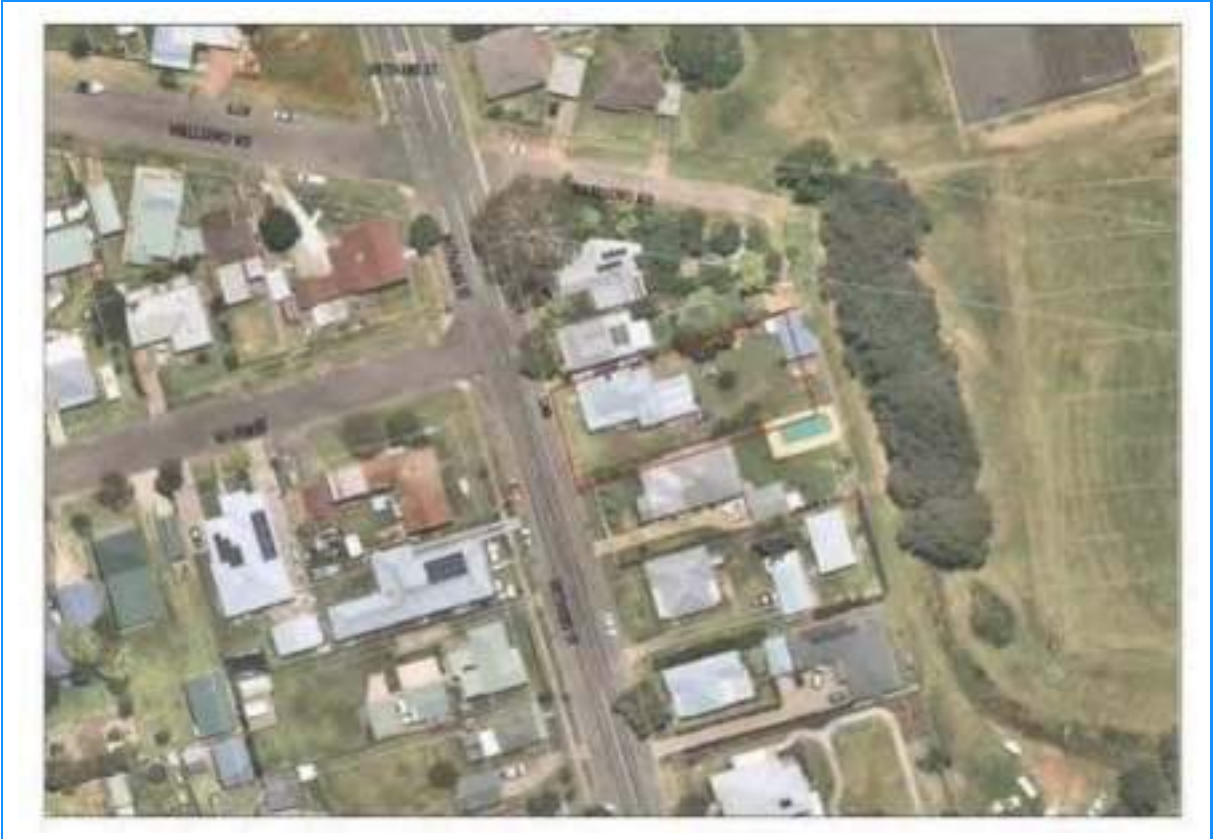
Conservation Area Contribution Level	Est. Construction Date	Previous studies and/or community input
Contributory 1	1890–1915	No prior heritage investigations and no additional information required
Assessment Text		Observed Modifications
<p>Single story Vernacular ‘Mining Cottage’ style dwelling with steep Colourbond hipped roof and weatherboard cladding. The veranda roof is bull nosed and potentially partially original.</p> <p>The veranda is partially enclosed by a timber balustrade.</p> <p>The western façade windows are the original timber framed sash designs. The front door is timber framed with four panel design.</p> <p>Timber picket fencing encloses the property.</p> <p>The dwelling displays architectural features of a heritage style and is representative of the local development of this period, being of historical significance for the HCA.</p>		<p>The veranda has been extended to wrap around the southern side of the dwelling. a set of timber stairs leads onto the new veranda landing.</p> <p>The balustrade is likely a contemporary replication of the original timber design.</p> <p>Solar panels are visible on the northern side of the roof.</p> <p>An extension has been constructed to the east of the dwelling. this is partially visible from the street, however has been constructed in a sympathetic style.</p>

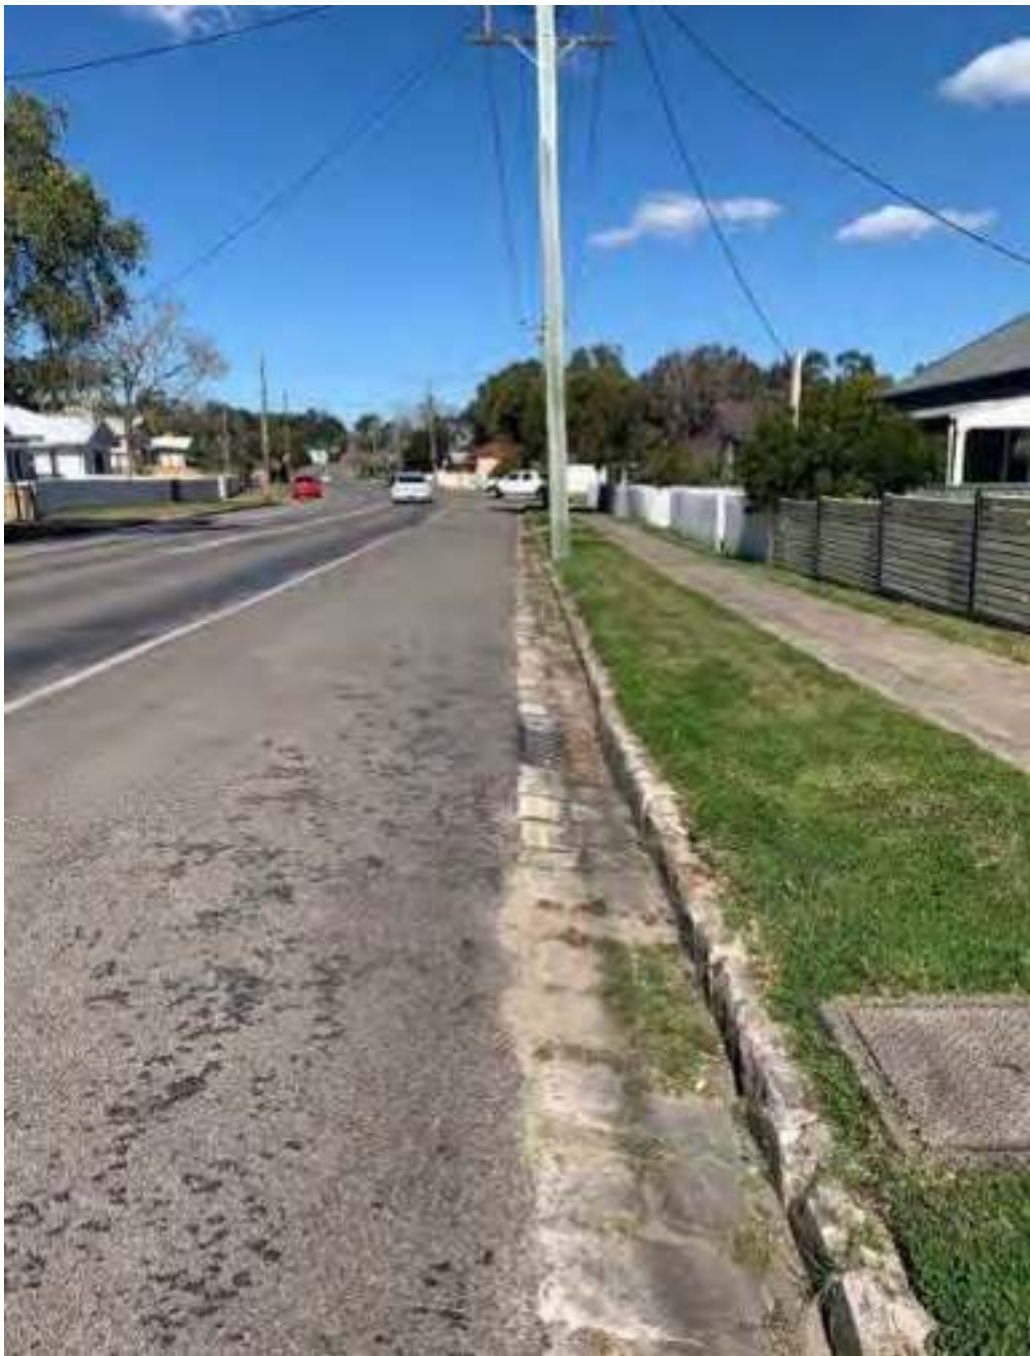
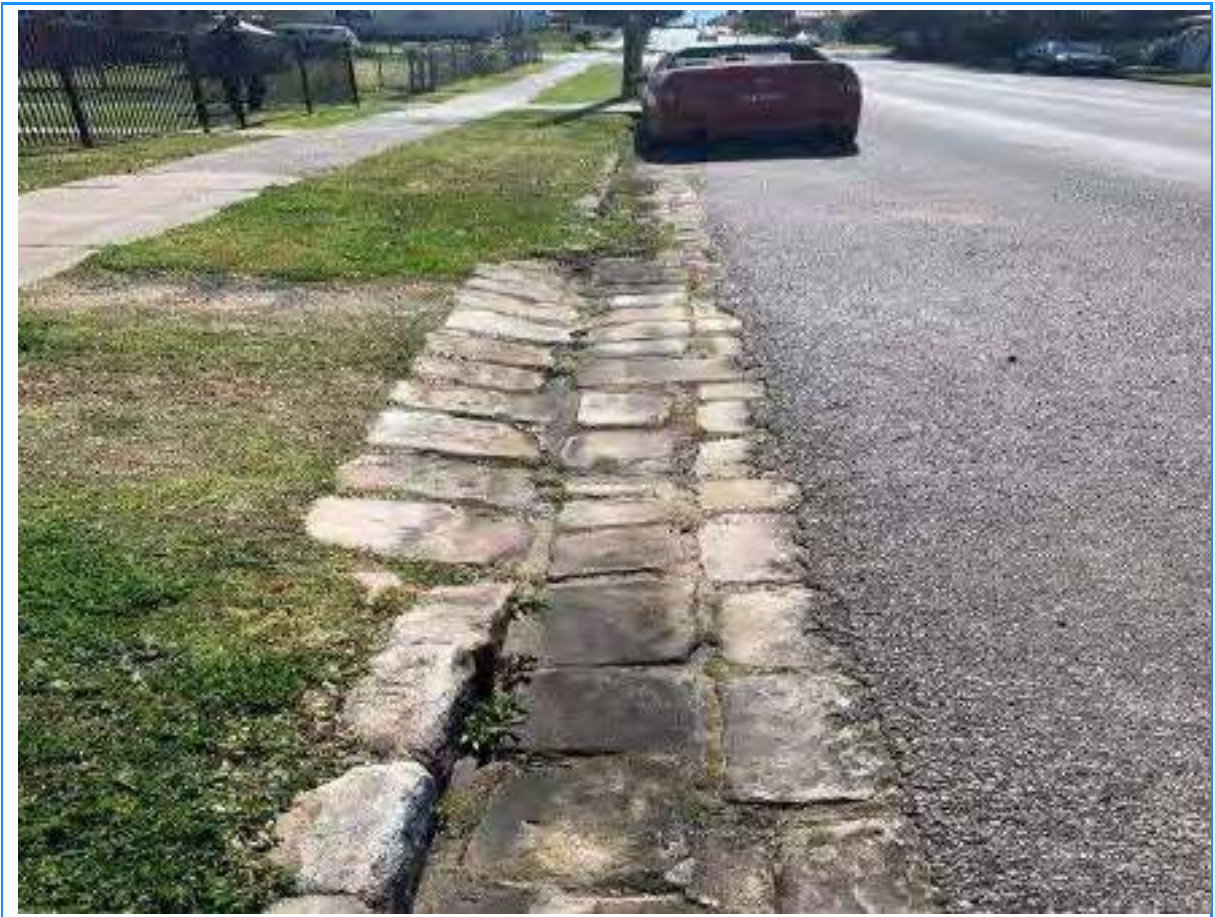
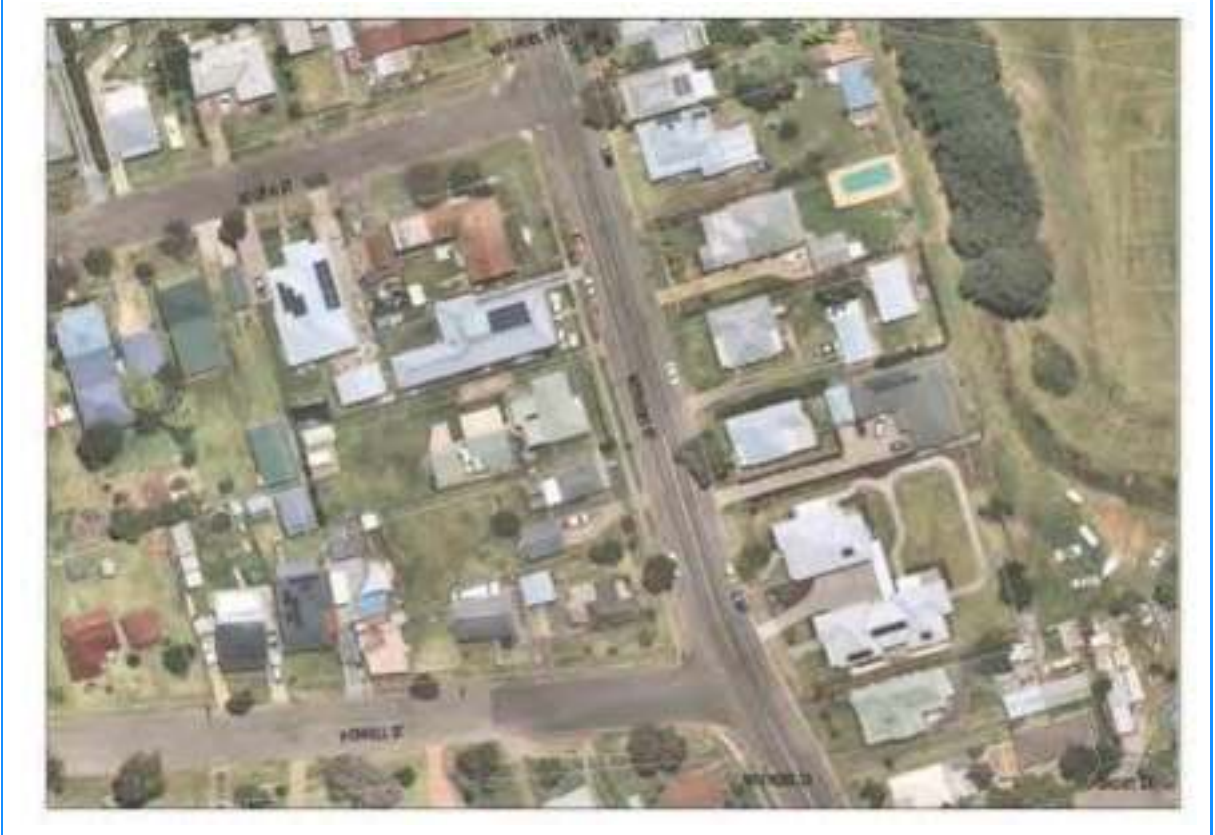
WITHERS STREET, WEST WALLSEND 2286

Conservation Area Contribution Level	Est. Construction Date	Previous studies and/or community input
Contributory 1	1930	West Wallsend Heritage Study 1993 Moderate local significance
Assessment Text		Observed Modifications
<p>A section of guttering constructed from potentially local sandstone and by local workmen. Potentially once ran from Withers Street, Wilson Street to Powell Street.</p> <p>The feature is representative of the local development of this period, being of historical significance for the HCA.</p>		<p>The majority of the curbing has been removed/destroyed during the preceding 90 years.</p>

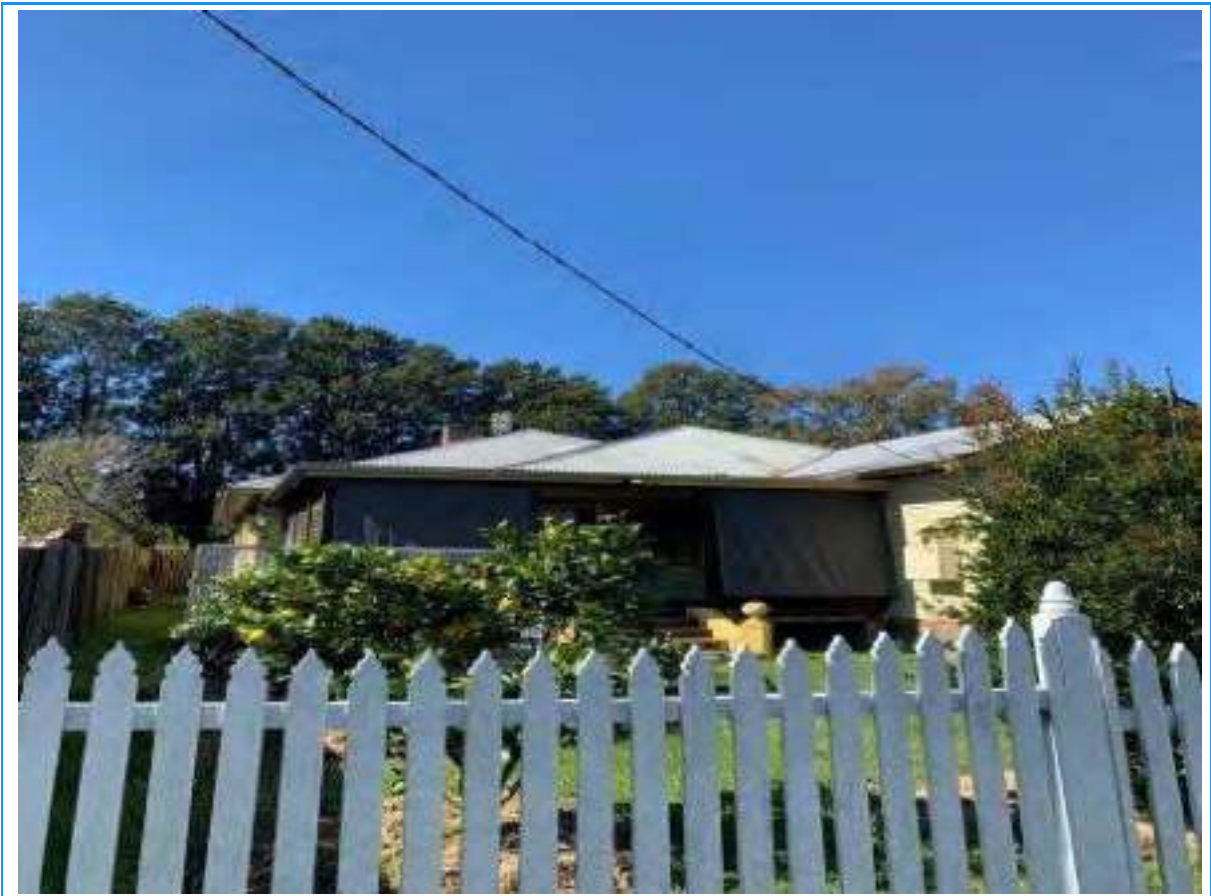
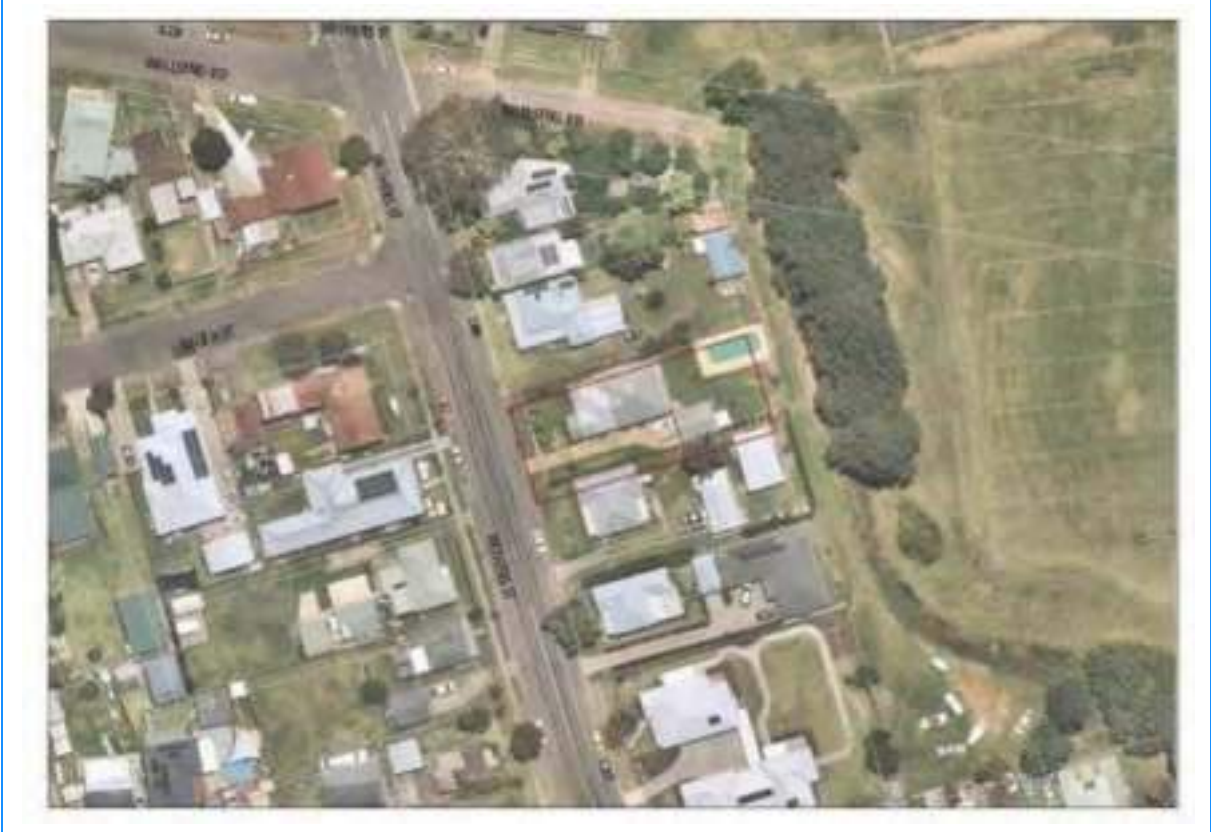
Conservation Area Contribution Level	Est. Construction Date	Previous studies and/or community input
Contributory 1	1890–1920	No prior heritage investigations and no additional information required
Assessment Text		Observed Modifications
<p>Single story Simple Federation ‘workmen's cottage’ style dwelling with hipped Colourbond roof and gable projection, and weatherboard cladding. The veranda roof is hipped.</p> <p>The western façade windows retain their original timber frame sash design.</p> <p>The gable has battening detailing, timber finial and fretwork. An elaborately carved timber pilaster is situated between the two sash windows.</p> <p>A red brick chimney is partially visible on the northern side of the dwelling.</p> <p>A timber picket fence encloses the property.</p> <p>The dwelling displays architectural features of a heritage style and is representative of the local development of this period, being of historical significance for the HCA.</p>		<p>Blue canvas blinds have been installed, obscuring the front veranda and façade of the dwelling.</p> <p>A timber gable roof archway leads into the property, with timber finial and solar panels attached. This is a contemporary addition, however is constructed in a sympathetic manner.</p> <p>A large back extension has been constructed on the back eastern portion of the dwelling, encompassing the brickwork chimney.</p>

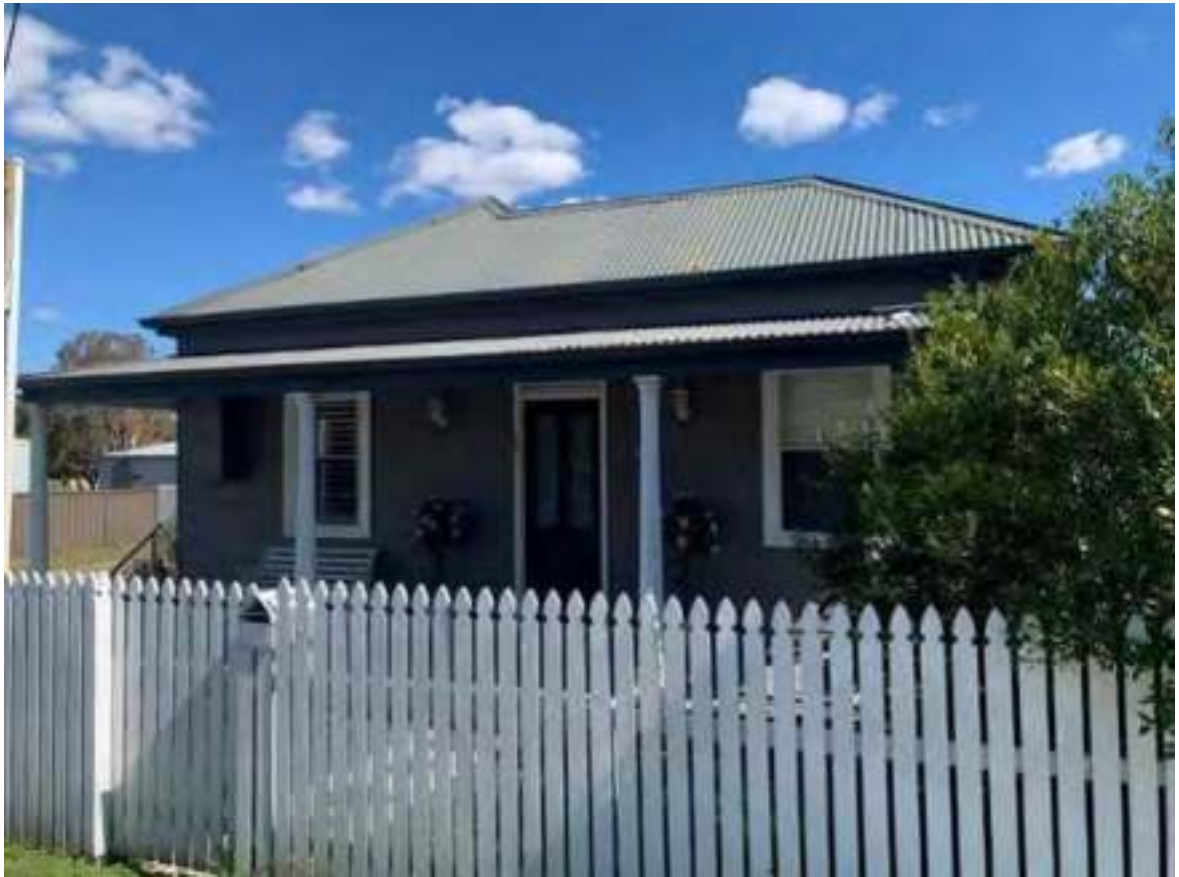
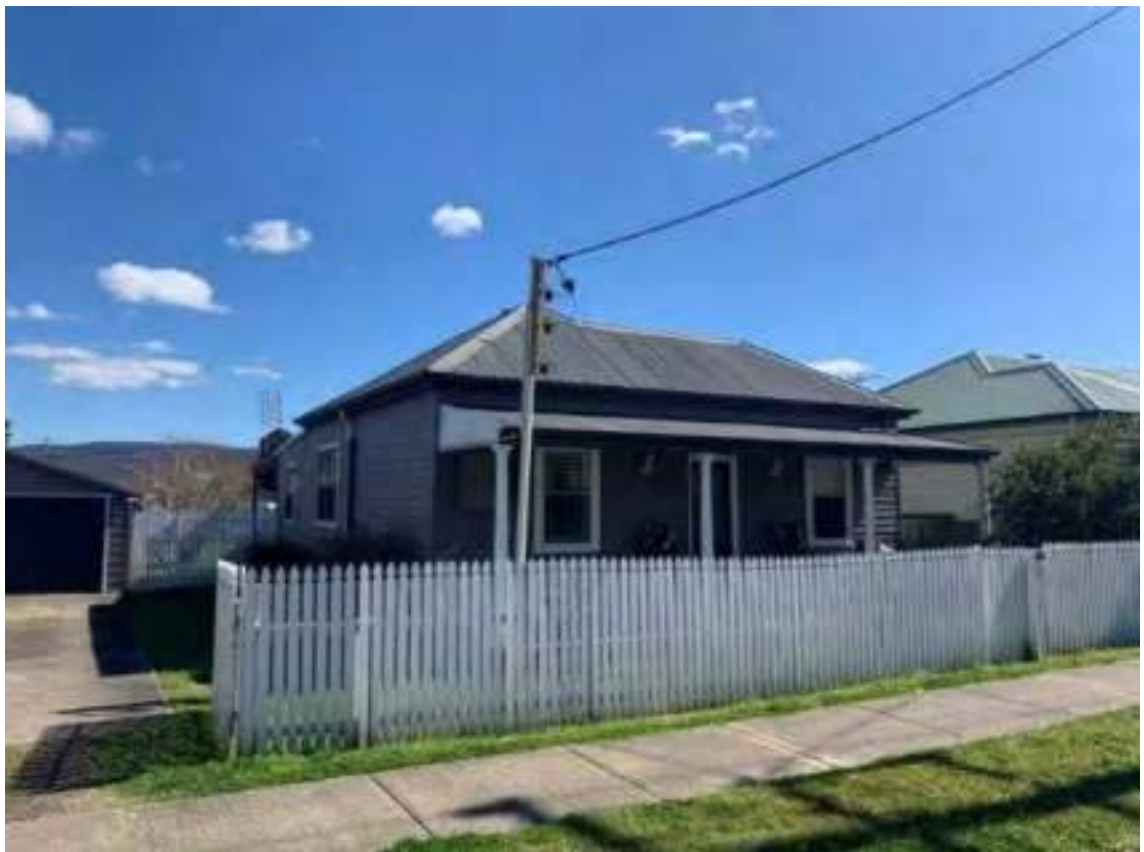
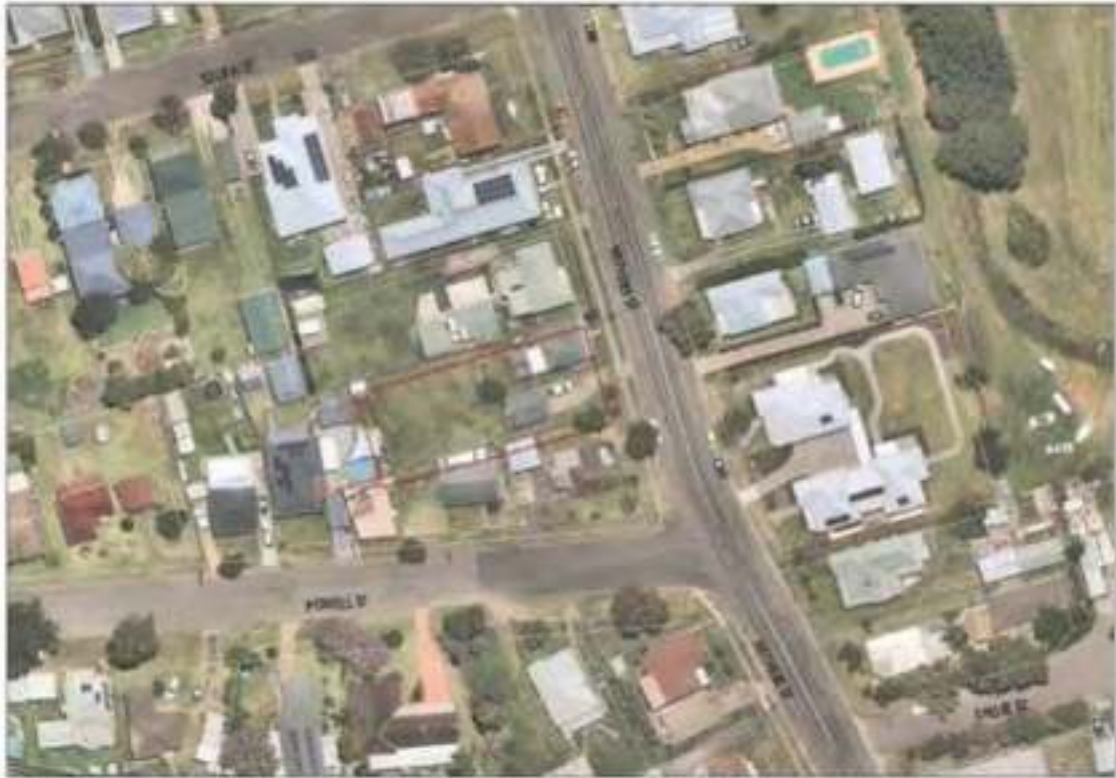
18 WITHERS STREET, WEST WALLSEND 2286

Conservation Area Contribution Level	Est. Construction Date	Previous studies and/or community input
Contributory 1	1890–1915	No prior heritage investigations and no additional information required
Assessment Text		Observed Modifications
<p>Single story Vernacular ‘Mining Cottage’ style dwelling with hipped Colourbond roof and weatherboard cladding. The veranda roof is skillion and supported by faux Corinthian style pillars.</p> <p>Aa gable roof garage is located to the south of the dwelling.</p> <p>A timber picket fence encloses the property.</p> <p>The dwelling displays architectural features of a heritage style and is representative of the local development of this period, being of historical significance for the HCA.</p>		<p>The Corinthian inspired support pillars are a contemporary addition, likely replacing simple timber posts.</p> <p>All visible windows are contemporary designs.</p> <p>An extension has been build onto the back western portion of the dwelling. this is not visible from the street and does not detract from the heritage streetscape.</p>

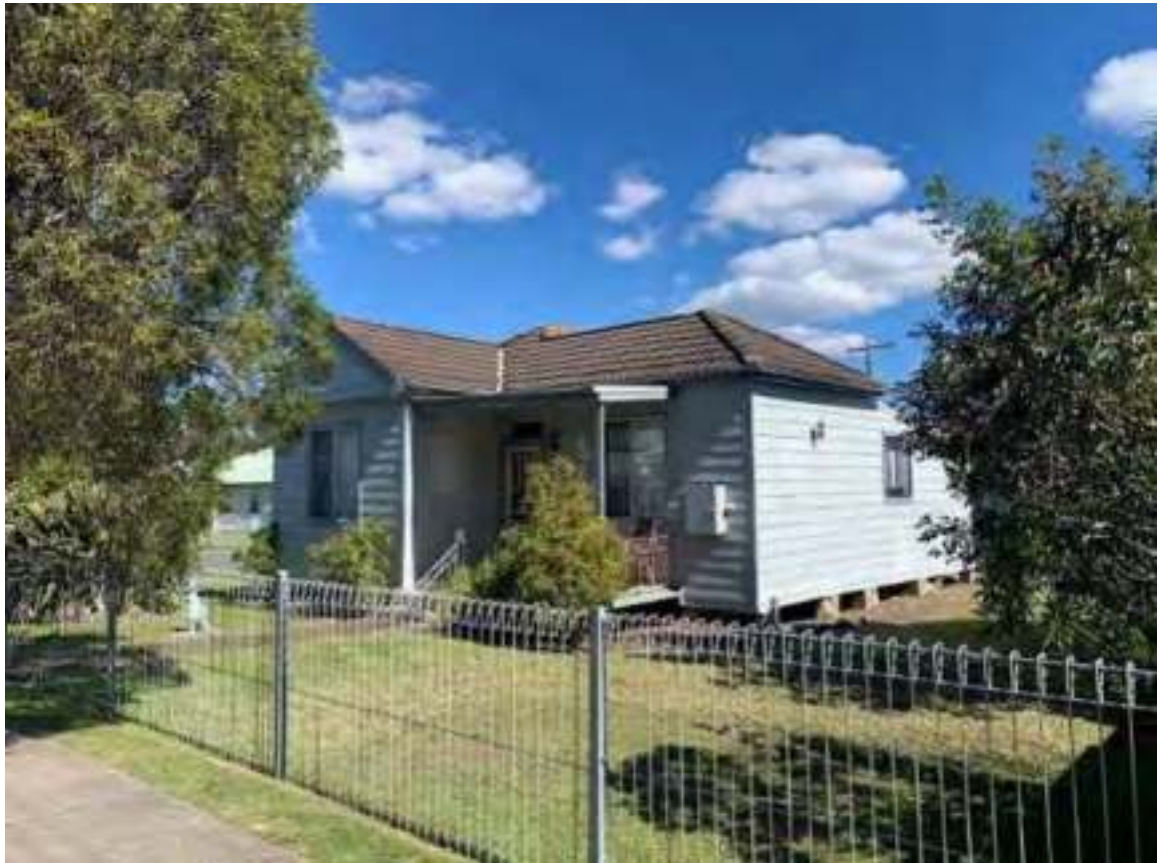
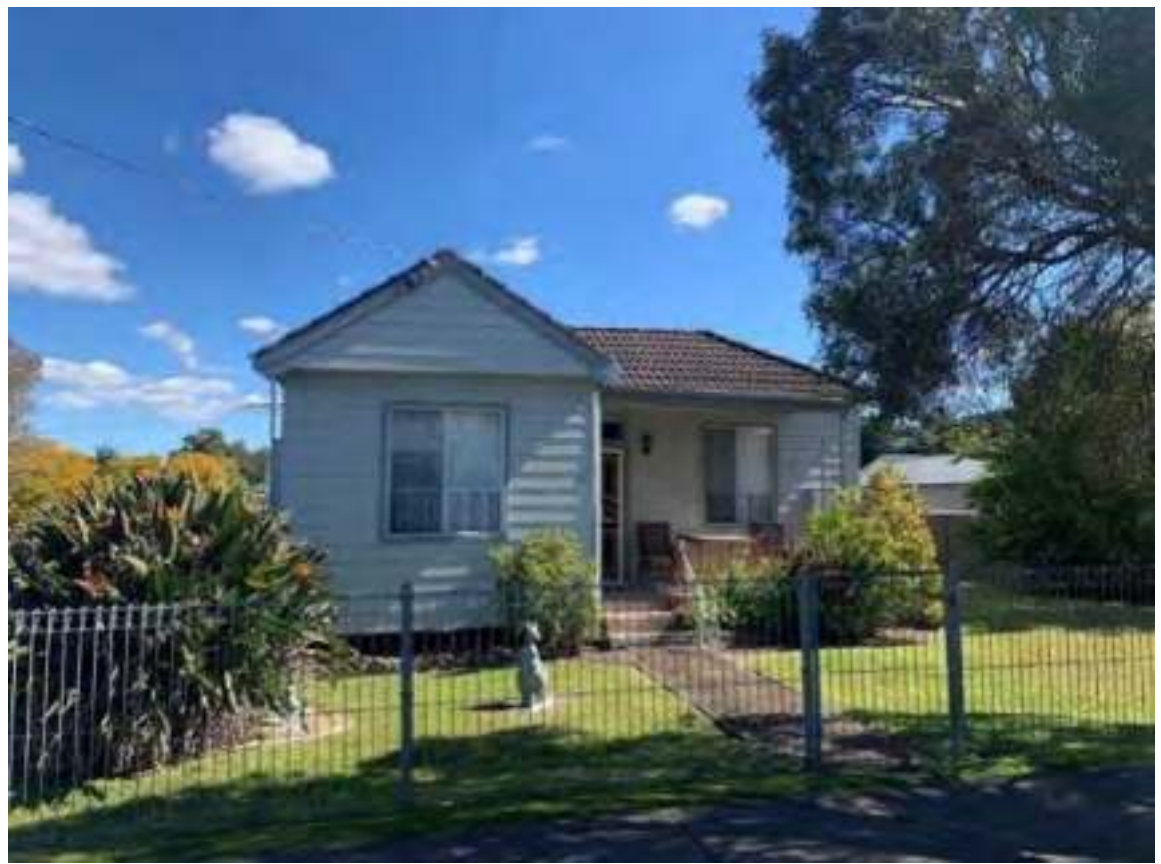
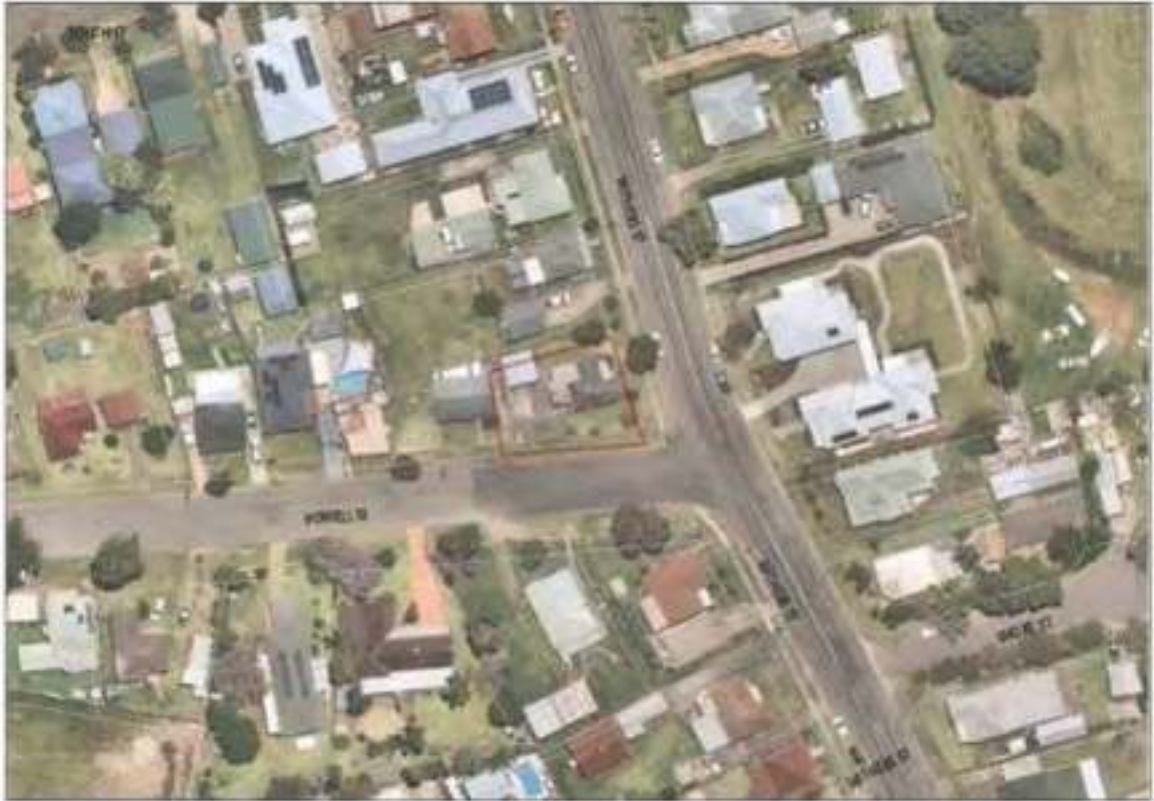
20 WITHERS STREET, WEST WALLSEND 2286

Conservation Area Contribution Level	Est. Construction Date	Previous studies and/or community input
Contributory 1	1920–1930	No prior heritage investigations and no additional information required
Assessment Text		Observed Modifications
<p>Single storey Vernacular 'Workman's Cottage' style dwelling with half hipped and gable concrete tile roof and weatherboard cladding. The veranda roof is flat and supported by timber posts. The veranda is enclosed by a metal balustrade, with some decoration.</p> <p>A metal wire fence encloses the property.</p>		<p>The visible windows are contemporary in style.</p> <p>The bottom half of a brickwork chimney is visible on the southern side of the dwelling.</p>
