APPENDIX 2

Building Assessment Sheets (Inventory Sheets)

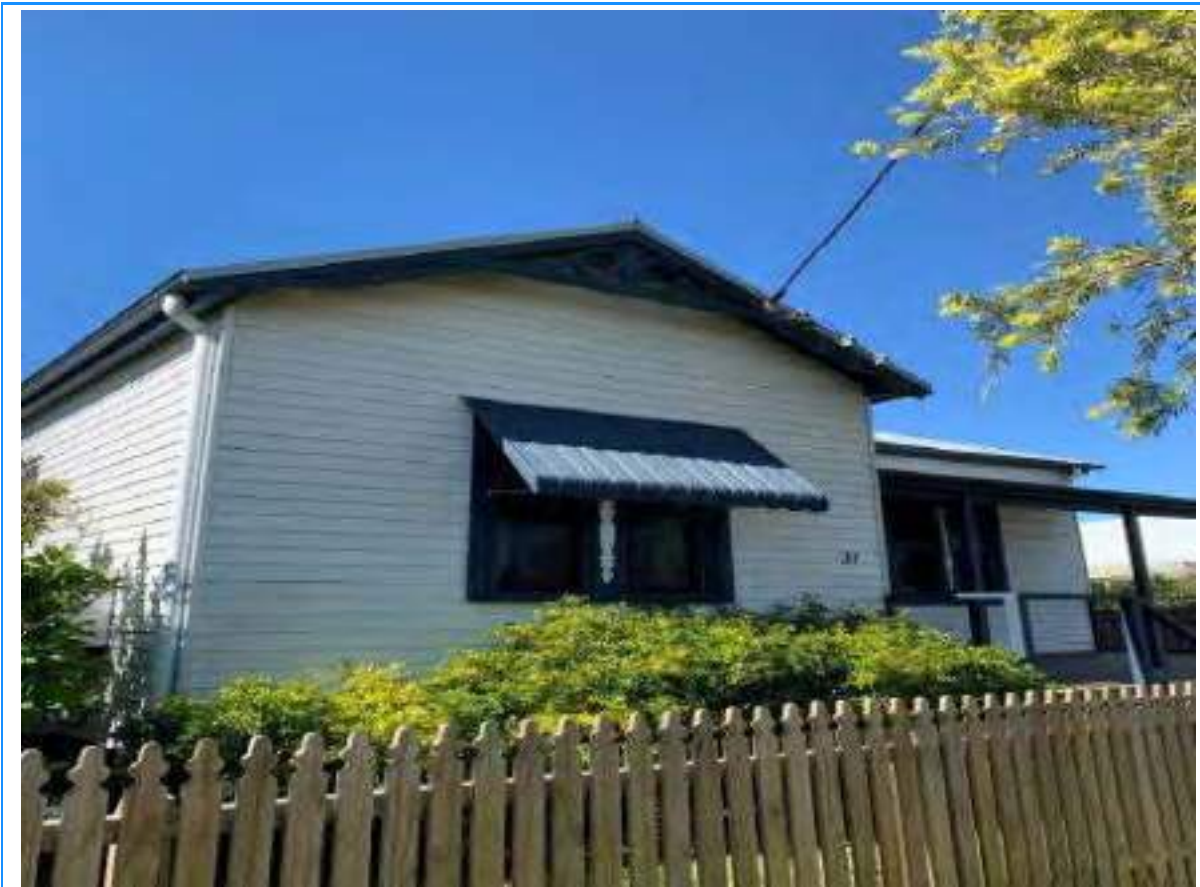
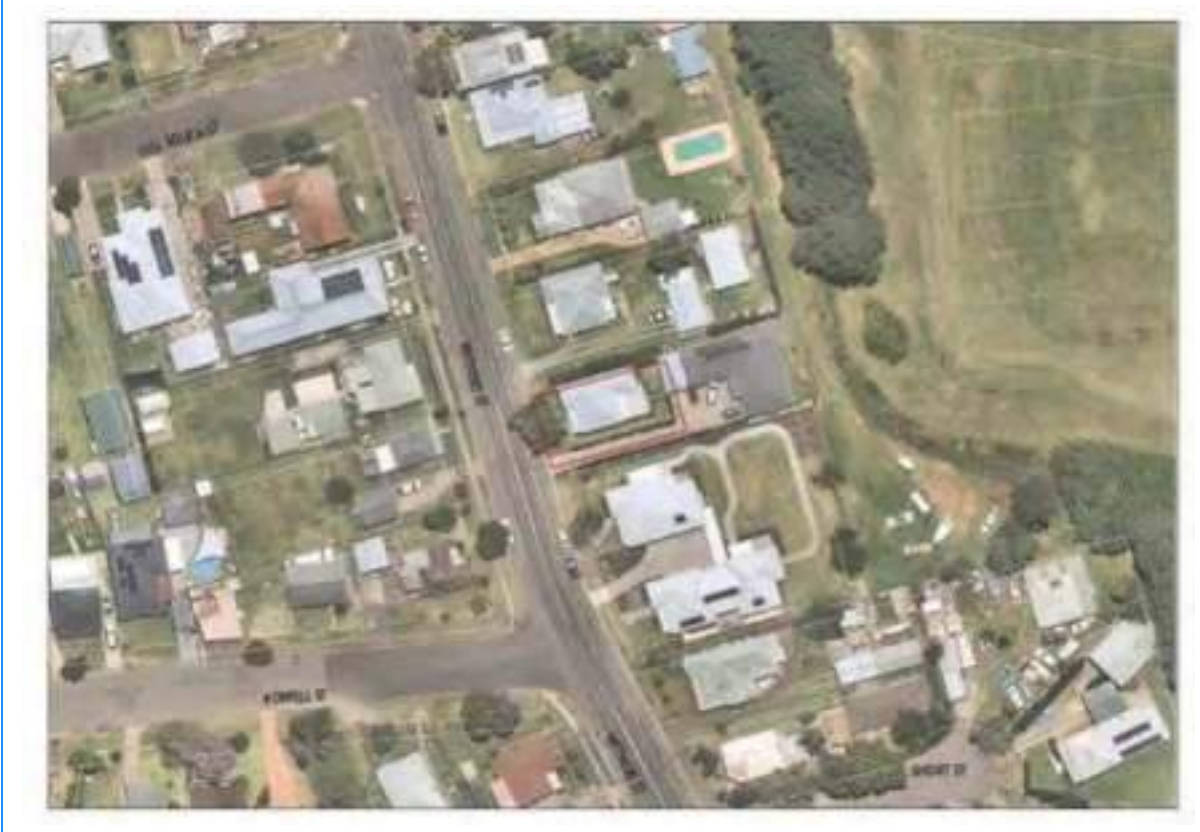
Conservation Area Contribution Level	Est. Construction Date	Previous studies and/or community input
Contributory 1	1900–1920	No prior heritage investigations and no additional information required
Assessment Text		Observed Modifications
<p>Single story Simple Federation ‘workmen's cottage’ style dwelling with hipped Colourbond roof with gable projection, and weatherboard cladding. The veranda roof is skillion.</p> <p>The veranda is partially enclosed with a timber and wire balustrade. Timber stairs with simple balustrade lead onto the veranda landing.</p> <p>The western façade windows are original heavy timber frame sash designs, with an elaborately carved timber pilaster between the two sash windows.</p> <p>The dwelling displays architectural features of a heritage style and is representative of the local development of this period, being of historical significance for the HCA.</p>		<p>The timber balustrade is a contemporary modification, likely replicating an original timber design.</p> <p>The skillion veranda roof was likely originally bull nosed.</p> <p>An extension has been constructed at the back eastern side of the dwelling. this is not visible from the street and does not detract.</p>

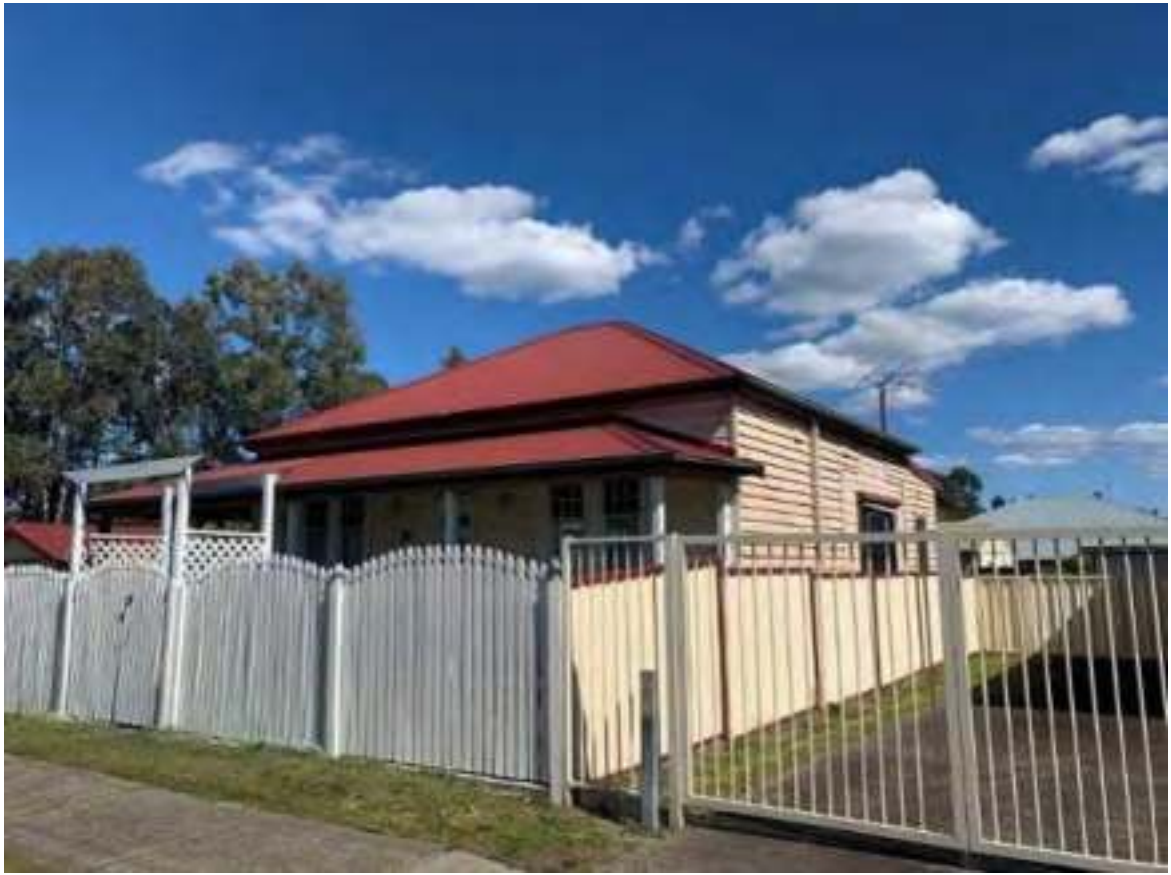
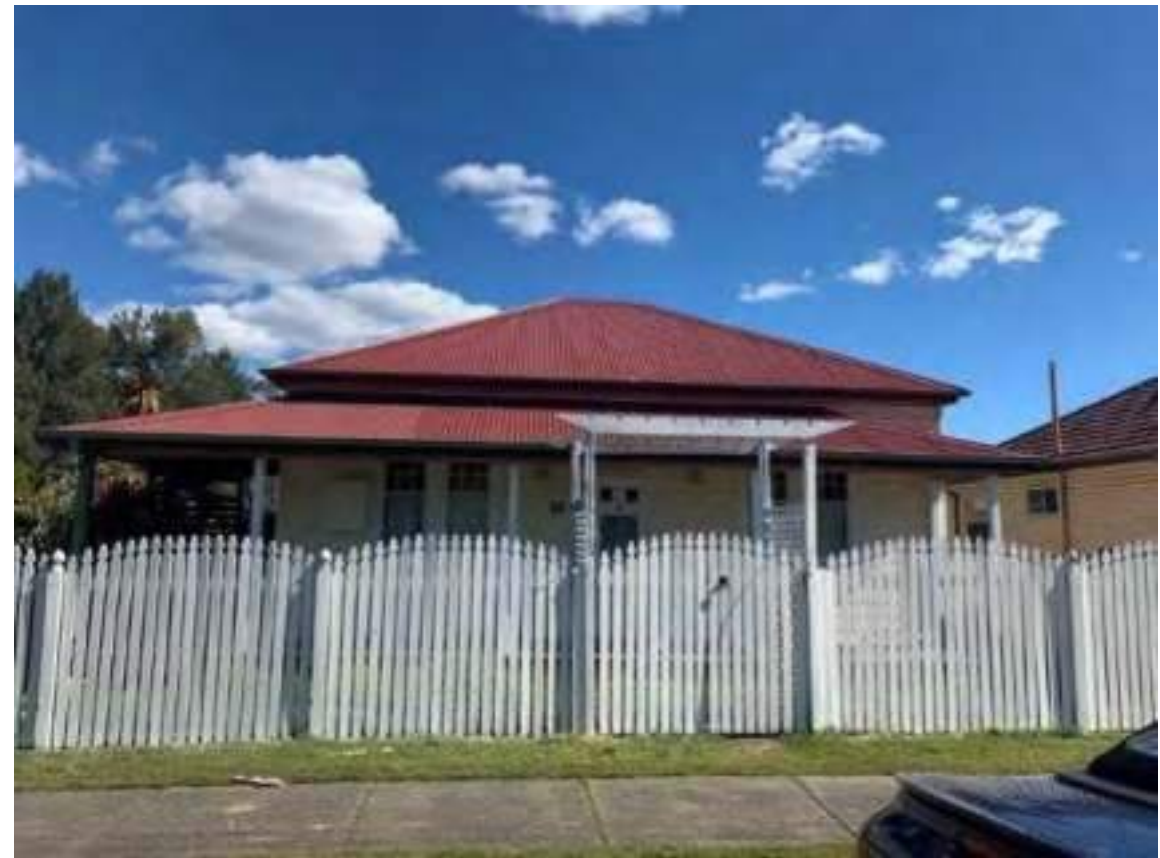
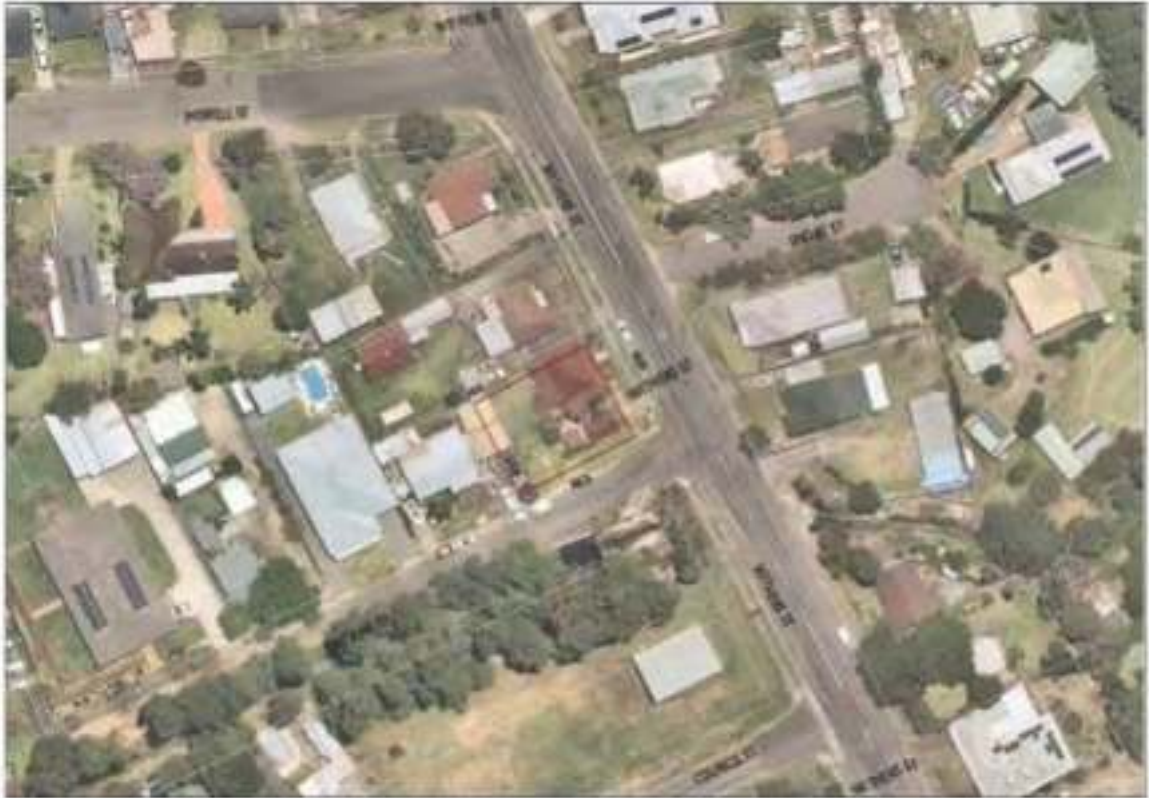
Conservation Area Contribution Level	Est. Construction Date	Previous studies and/or community input
Contributory 1	1890–1915	No prior heritage investigations and no additional information required
Assessment Text		Observed Modifications
<p>Single story Vernacular ‘Mining Cottage’ style dwelling with steep hipped Colourbond roof and weatherboard cladding. The veranda roof is hipped.</p> <p>The front door is timber framed with glass detailing, potentially original. The visible windows are the original heavy timber framed sash designs, with coloured glass panes.</p> <p>A timber picket fence encloses the property.</p> <p>A gable roof garage with timber finial is located to the south of the dwelling.</p> <p>The dwelling displays architectural features of a heritage style and is representative of the local development of this period, being of historical significance for the HCA.</p>		<p>The veranda extends around the southern side of the dwelling. this is a common modification for houses of this style.</p>

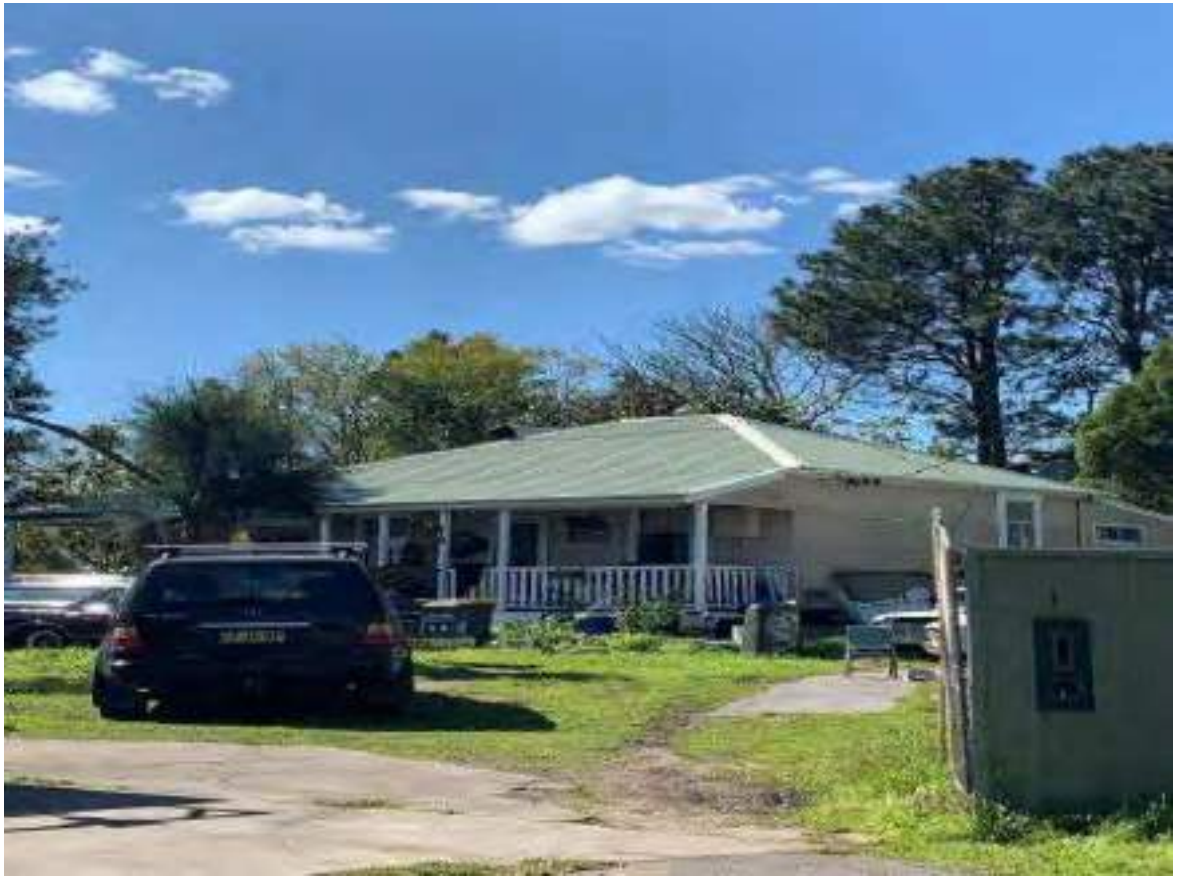
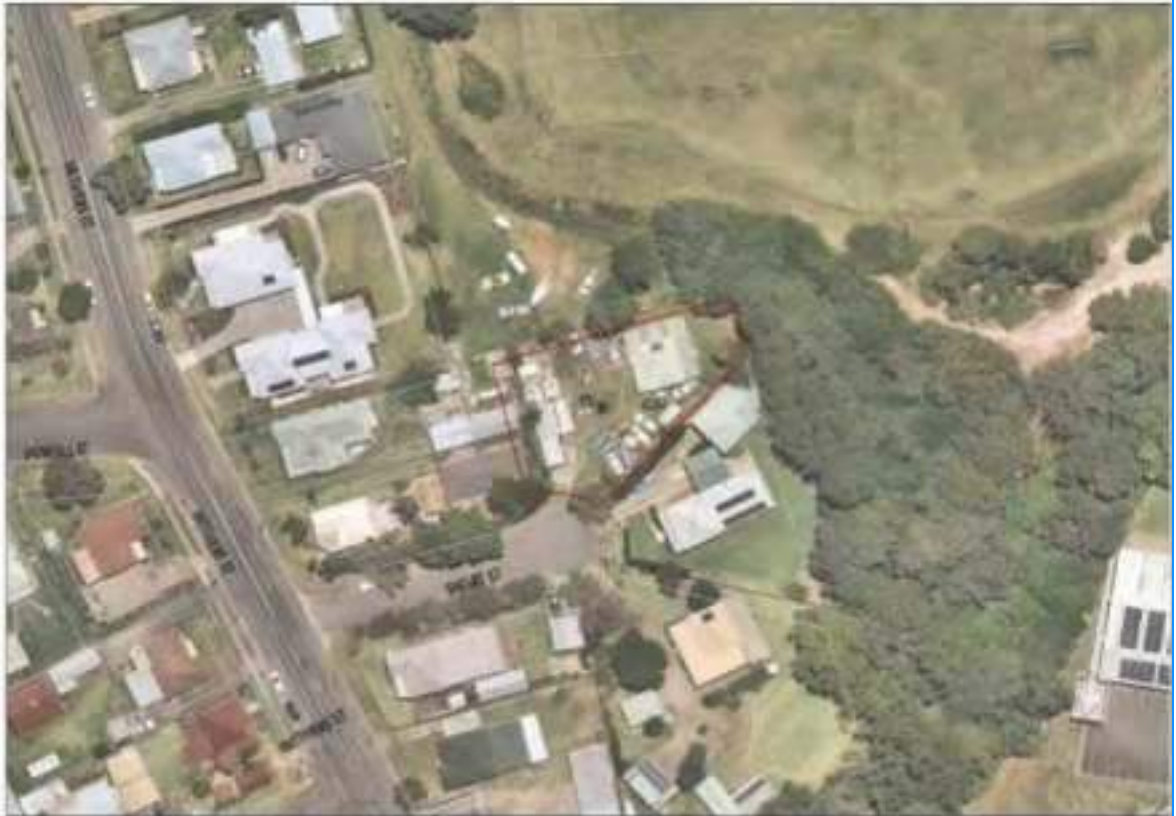
1 SHORT STREET, WEST WALLSEND 2286

Conservation Area Contribution Level	Est. Construction Date	Previous studies and/or community input
Contributory 1	1880–1915	No prior heritage investigations and no additional information required
Assessment Text		Observed Modifications
<p>Single story Vernacular dwelling with hipped Colourbond roof and timber weatherboard cladding. The veranda roof is skillion. The veranda is partially enclosed by a timber balustrade. The western front façade windows are heavy timber framed sash designs, likely original.</p> <p>The dwelling displays architectural features of a heritage style and is representative of the local development of this period, being of historical significance for the HCA.</p>		<p>The veranda roof was likely originally bull nosed and since replaced with a skillion style.</p> <p>The timber balustrade is a contemporary addition, likely replacing an original timber style.</p>

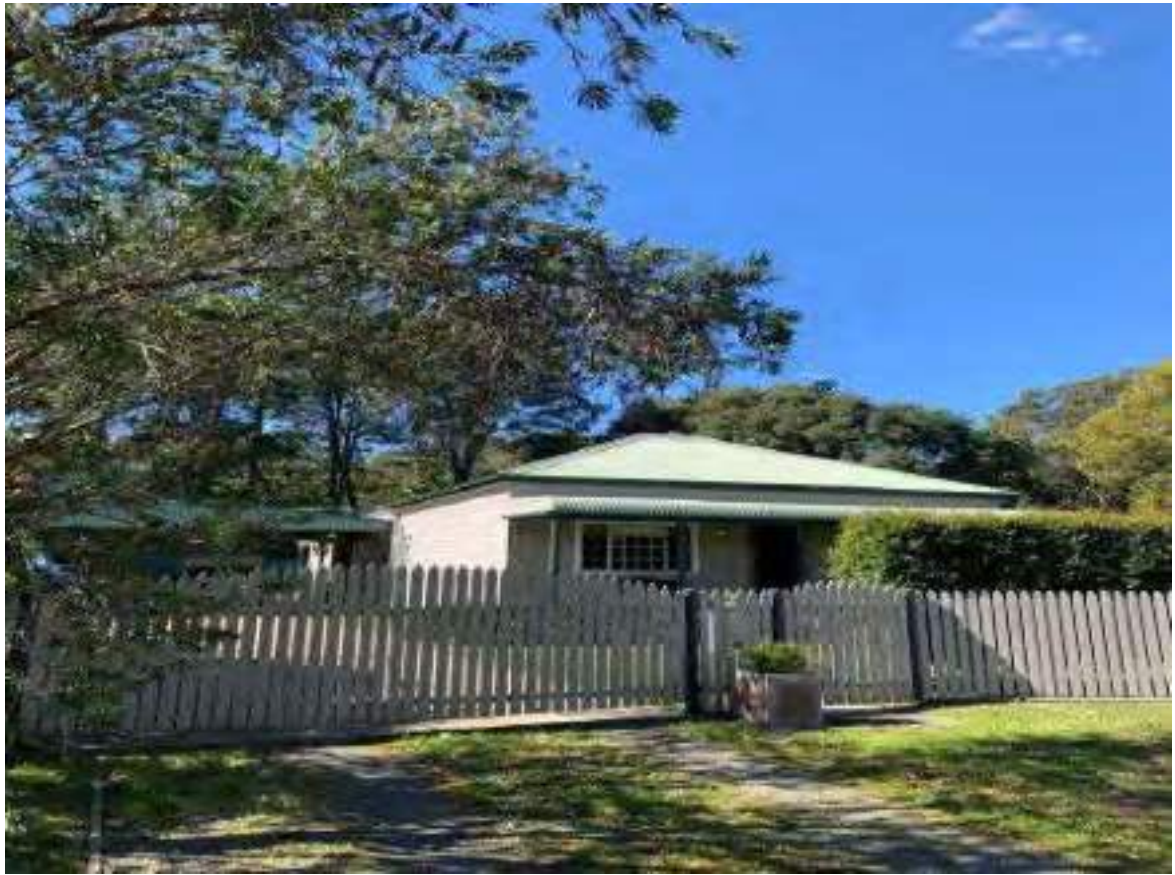
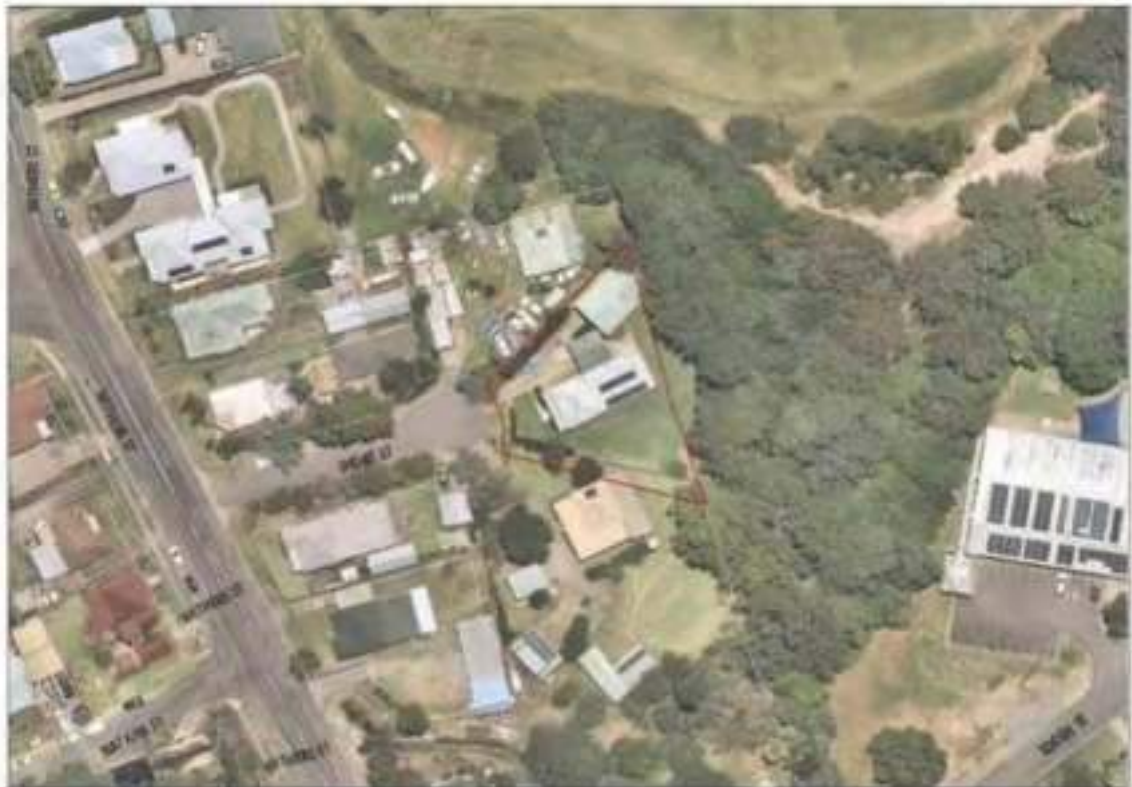
2 SHORT STREET, WEST WALLSEND 2286

Conservation Area Contribution Level	Est. Construction Date	Previous studies and/or community input
Contributory 1	1890–1915	No prior heritage investigations and no additional information required
Assessment Text		Observed Modifications
<p>Single story Vernacular style dwelling with hipped Colourbond roof and weatherboard cladding. The veranda roof is bull nosed.</p> <p>A timber picket fence encloses the property.</p> <p>a large gable roof garage is located to the north of the dwelling.</p> <p>The dwelling displays architectural features of a heritage style and is representative of the local development of this period, being of historical significance for the HCA.</p>		<p>An extension has been constructed at the back eastern side of the dwelling. this is not visible form the street and does not impact upon the heritage streetscape.</p> <p>The visible windows are contemporary multi-pane designs.</p>

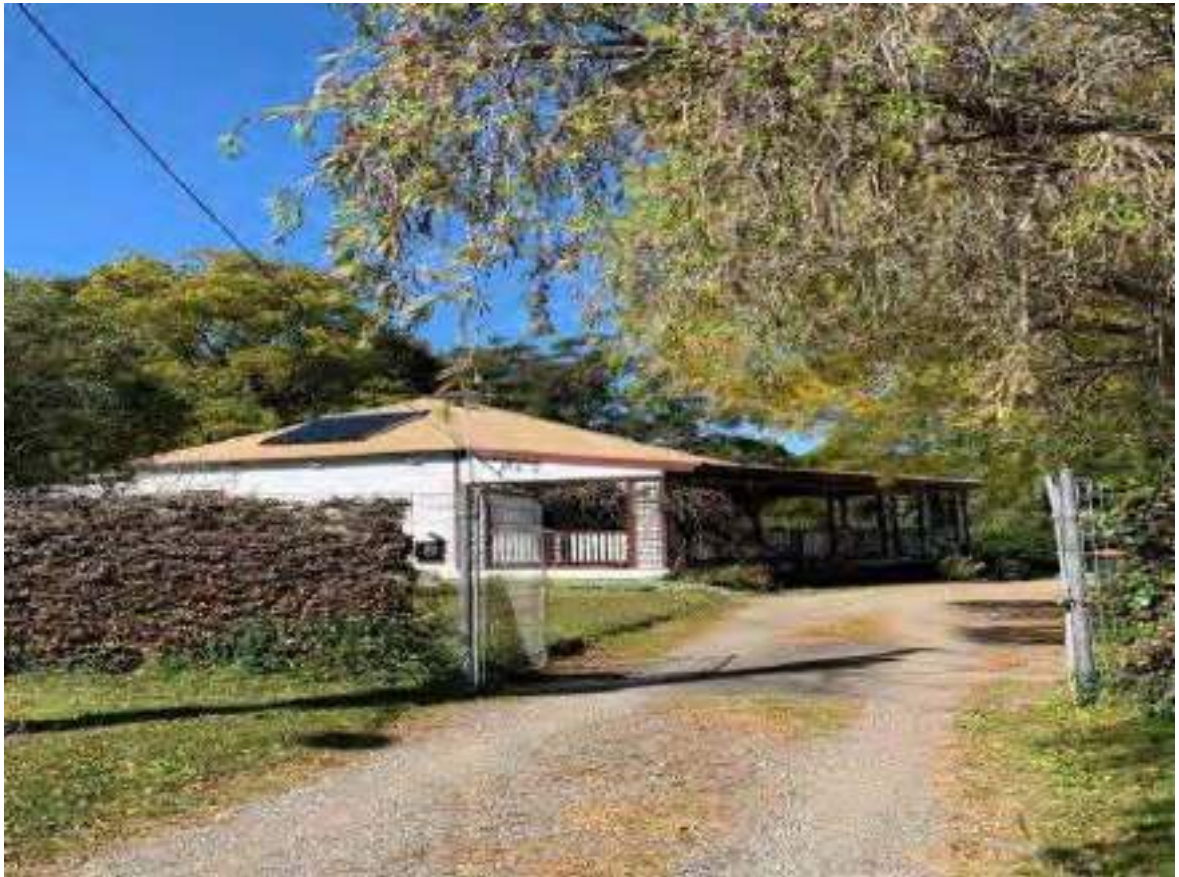
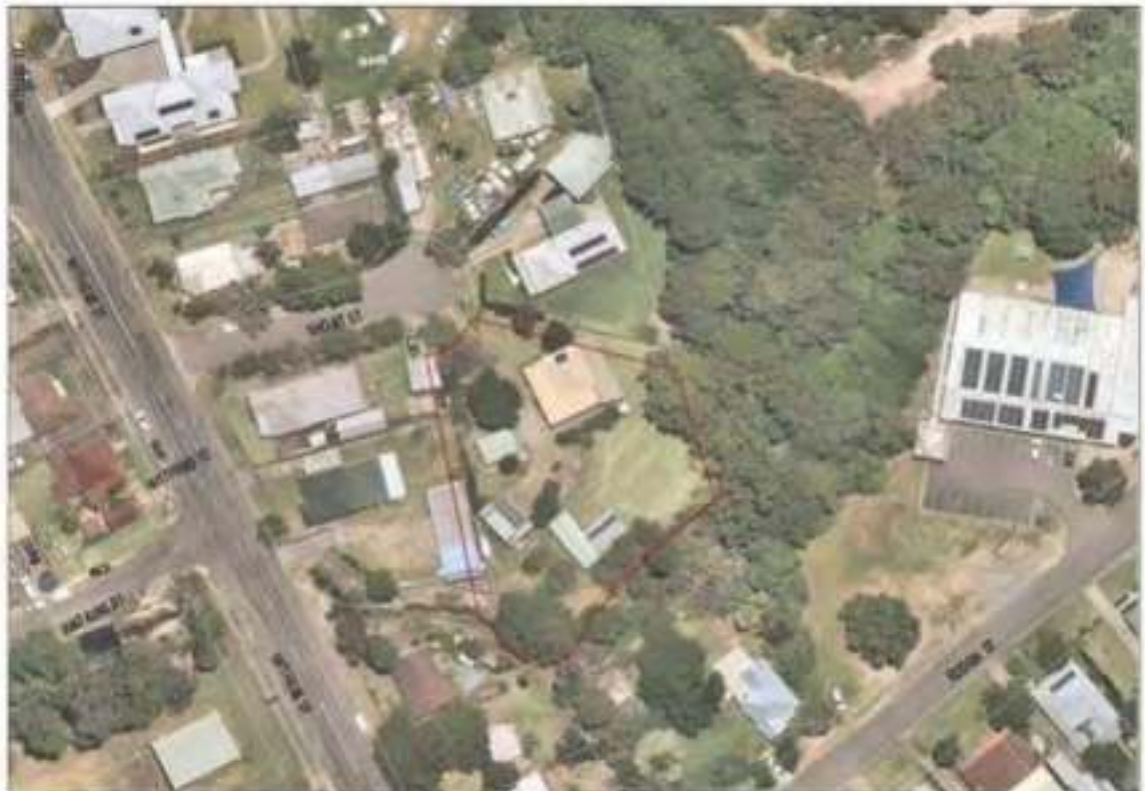
3 SHORT STREET, WEST WALLSEND 2286

Conservation Area Contribution Level	Est. Construction Date	Previous studies and/or community input
Contributory 1	1890–1915	No prior heritage investigations and no additional information required
Assessment Text		Observed Modifications
<p>Single story Vernacular style dwelling with Colourbond hipped roof and timber weatherboard cladding. The veranda roof is skillion and substantial.</p> <p>The veranda is partially enclosed by timber lattice boarding and a timber balustrade.</p> <p>A metal fence encloses the property.</p> <p>The dwelling displays architectural features of a heritage style and is representative of the local development of this period, being of historical significance for the HCA.</p>		<p>The substantial skillion veranda roof is likely a contemporary modification.</p> <p>The lattice and timber balustrade are contemporary additions to the dwelling.</p> <p>Solar/heat panels are visible on the northern side of the dwelling.</p>

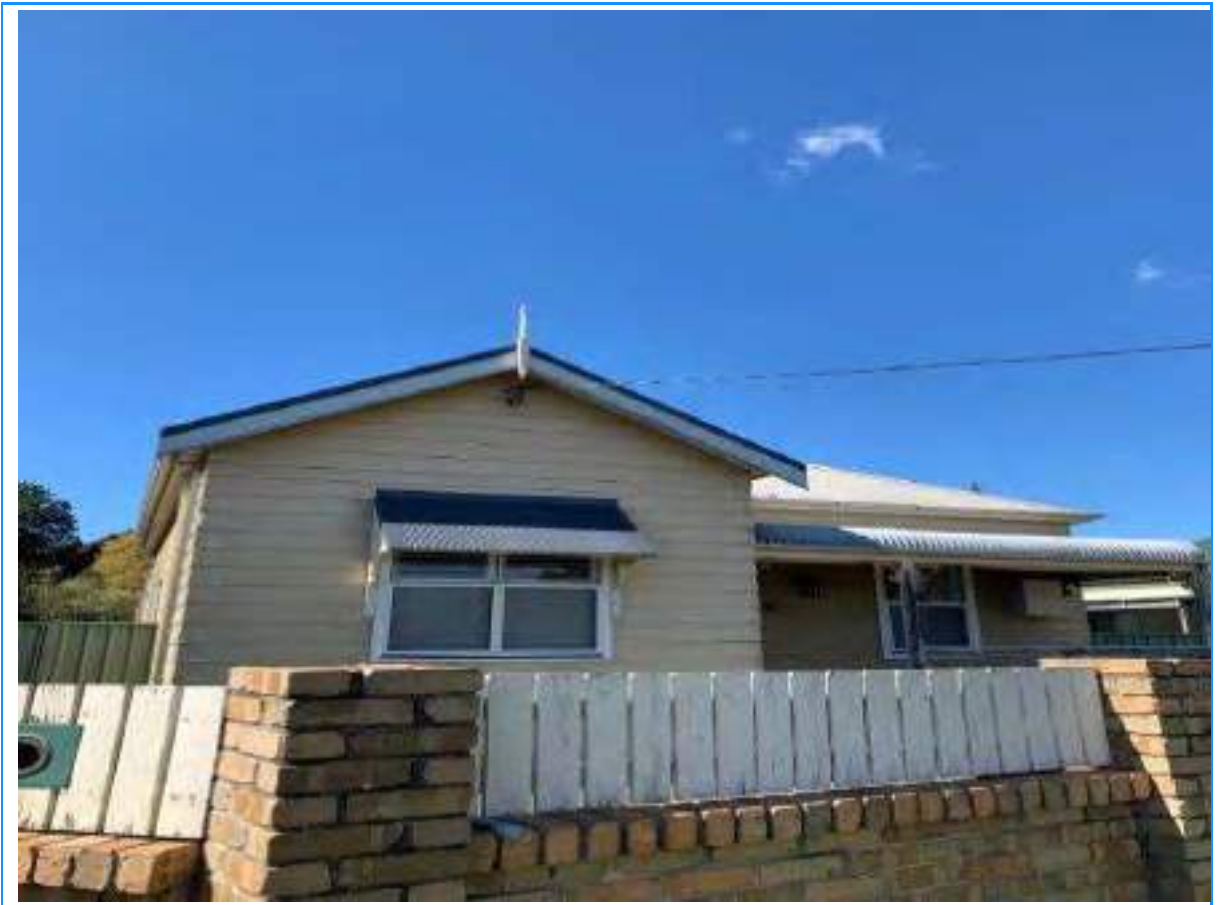
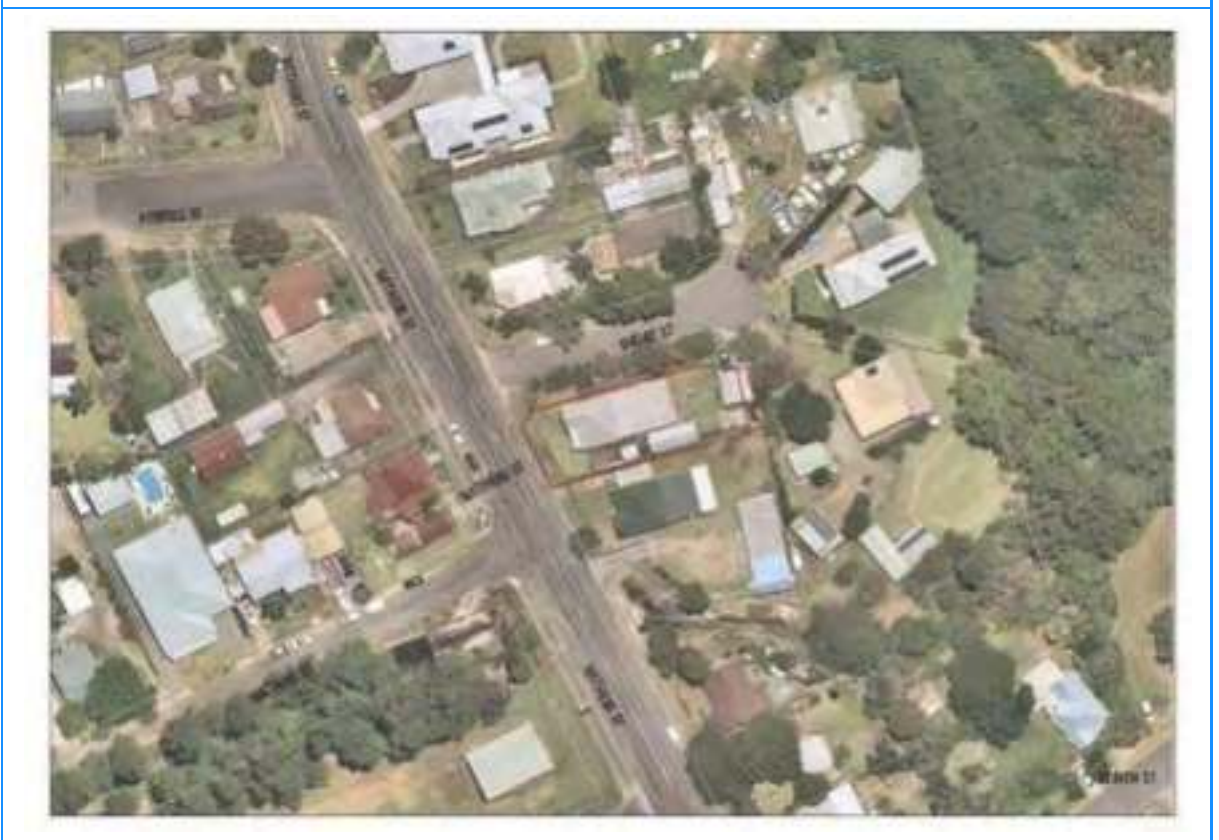
Conservation Area Contribution Level	Est. Construction Date	Previous studies and/or community input
Contributory 1	1900–1920	No prior heritage investigations and no additional information required
Assessment Text		Observed Modifications
<p>Single story Simplified Federation ‘workmen's cottage’ style dwelling with hipped Colourbond roof with gable projection and weatherboard cladding. The veranda roof is bull nosed and supported by timber posts with ornate bracketing.</p> <p>The veranda is partially enclosed with timber crossed balustrade.</p> <p>The front door is timber framed with a fanlight a top. The western façade front windows appear to be the original heavy timber framed sash designs. The windows have internal timber shutters</p> <p>The gable has extended eaves, timber finial and metal awnings.</p> <p>A brickwork chimney is visible on the southern side of the dwelling.</p> <p>Brick and timber fencing encloses the property.</p> <p>The dwelling displays architectural features of a heritage style and is representative of the local development of this period, being of historical significance for the HCA.</p>		<p>The shaft of the chimney has been removed and replaced with a slim metal design.</p> <p>The crossed balustrade is likely a contemporary addition, likely replacing an original timber design.</p>

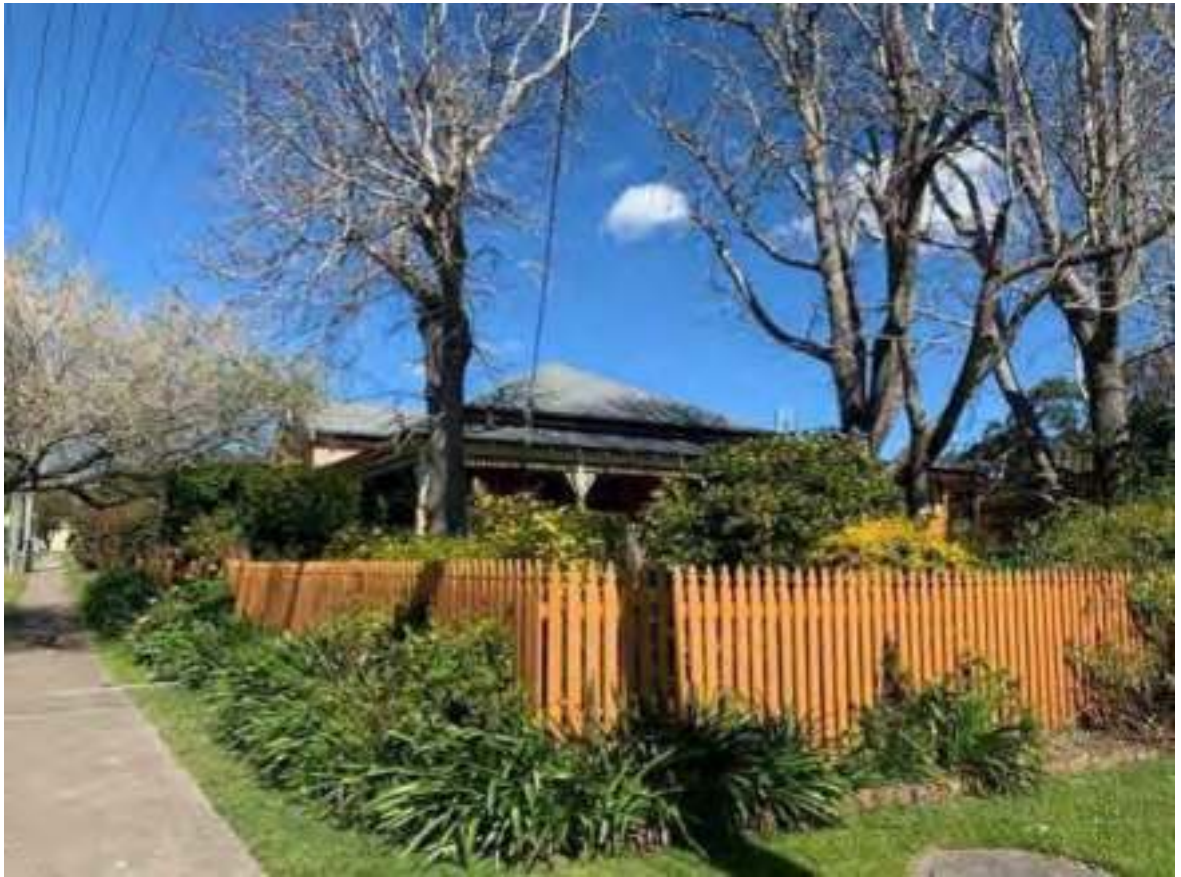
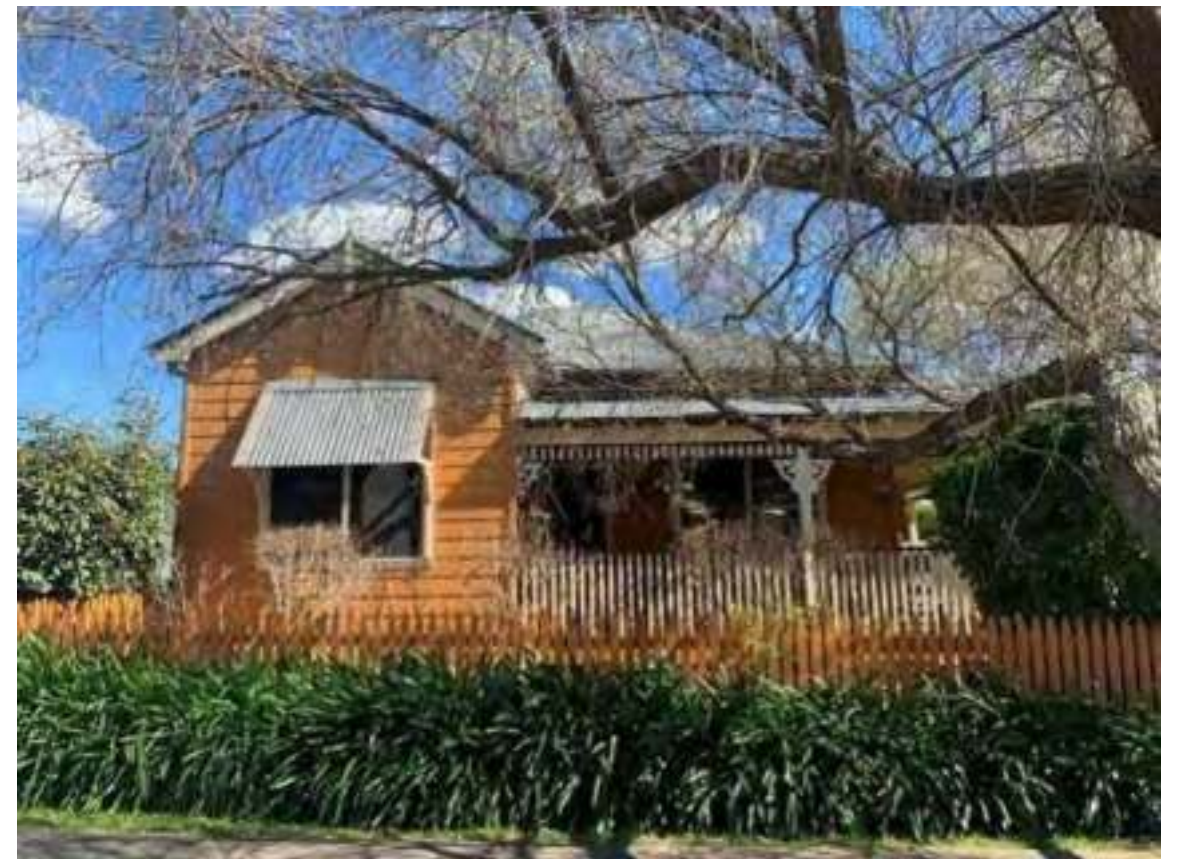
30 WITHERS STREET, WEST WALLSEND 2286

Conservation Area Contribution Level	Est. Construction Date	Previous studies and/or community input
Contributory 1	1900–1920	No prior heritage investigations and no additional information required
Assessment Text		Observed Modifications
<p>Single story Simplified Federation ‘workmen's cottage’ style dwelling with hipped Colourbond roof with gable projection and weatherboard cladding. The veranda roof is bull nosed and supported by ornately carved timber posts.</p> <p>The veranda is partially enclosed by a timber balustrade.</p> <p>The gable has decorative extended eaves and timber finial. The gable window has a metal awning.</p> <p>The dwelling is partially obscured by vegetation.</p> <p>The dwelling displays architectural features of a heritage style and is representative of the local development of this period, being of historical significance for the HCA.</p>		<p>The timber balustrade is likely a contemporary replication of an original timber design.</p> <p>The bright orange colour scheme is unsympathetic to the heritage streetscape.</p>

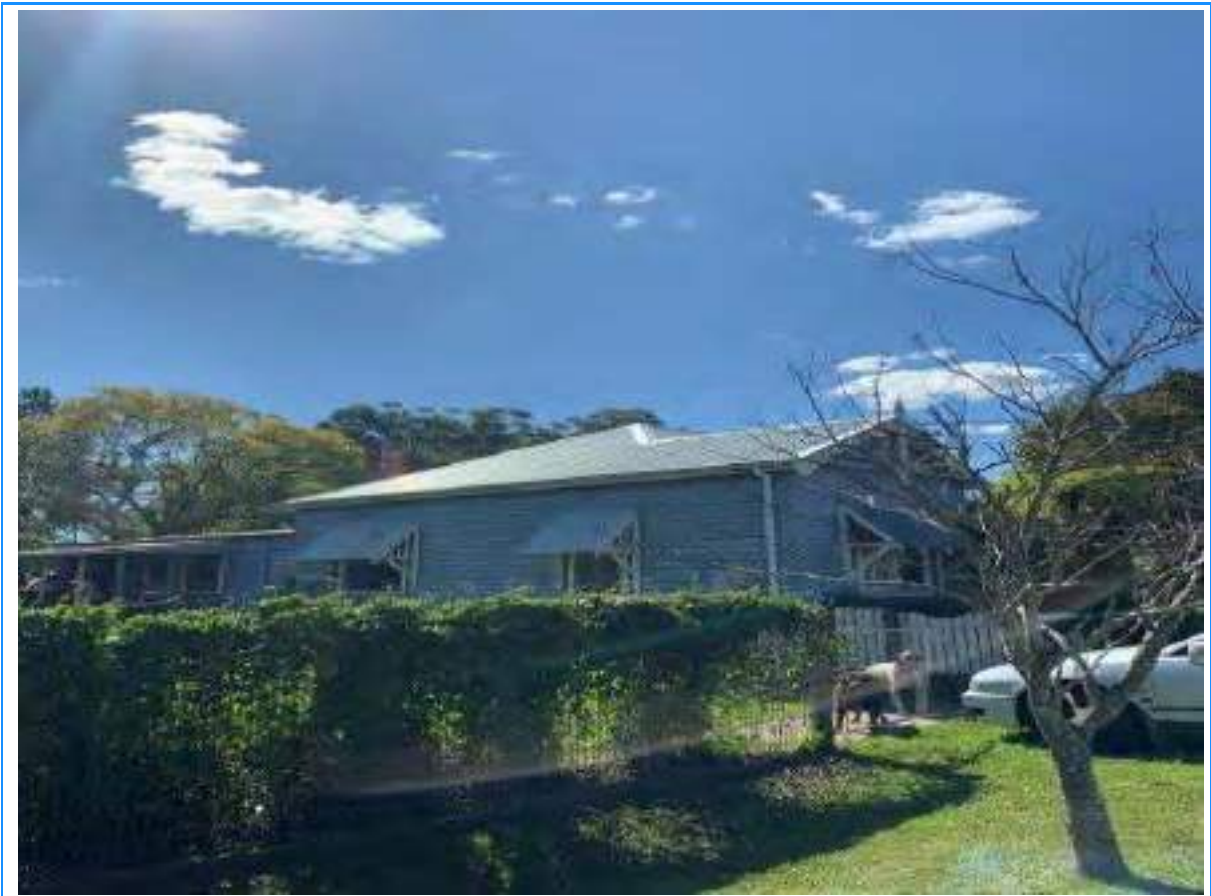
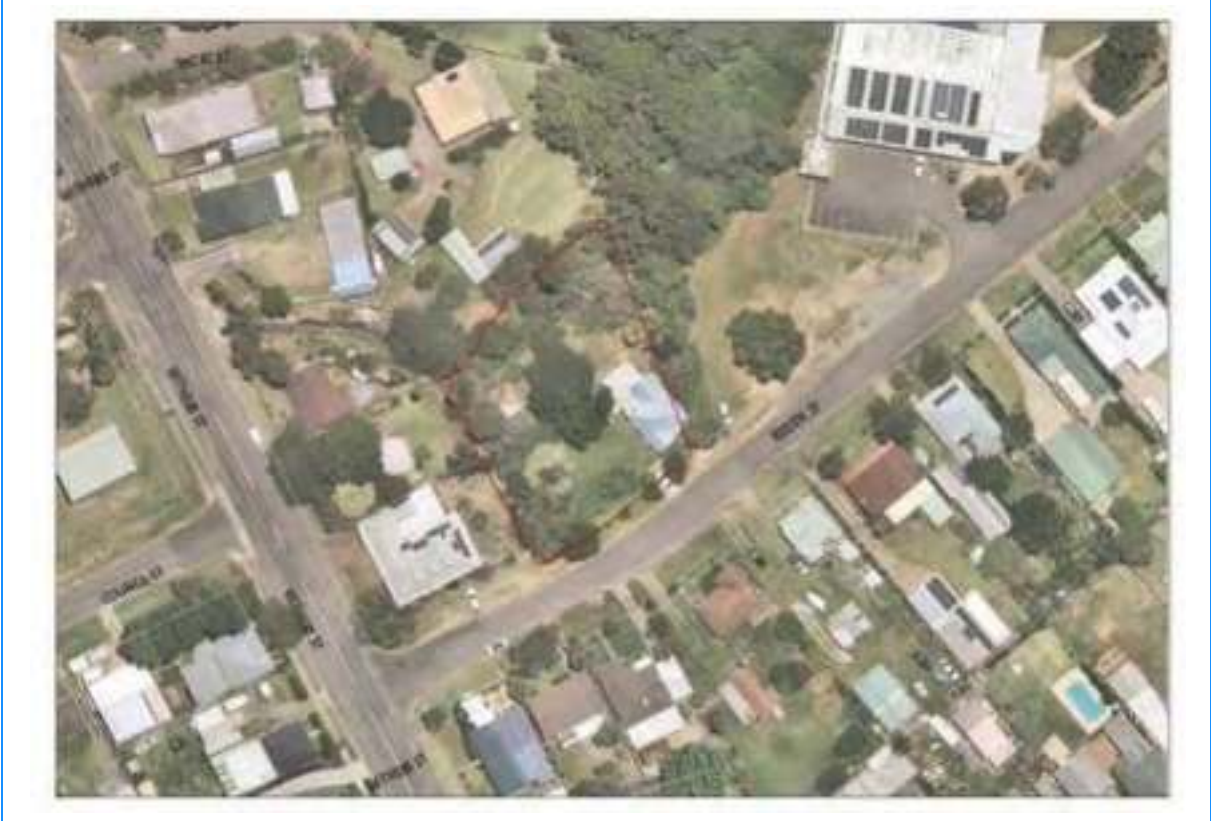
Conservation Area Contribution Level	Est. Construction Date	Previous studies and/or community input
Contributory 1	1900–1920	No prior heritage investigations and no additional information required
Assessment Text		Observed Modifications
<p>Single story Simplified Federation 'workmen's cottage with Colourbond hipped roof with gable projection and weatherboard cladding. The veranda roof is bull nosed.</p> <p>The front door is timber framed with a fan light a top. The visible south eastern façade windows appear the original heavy framed timber sash designs.</p> <p>The gable has decorative barge boards, false collar tie and timber finial. The gable window has a timber shingle awning.</p> <p>A brickwork chimney is located on the western side of the dwelling.</p> <p>The dwelling is partially obscured by vegetation.</p> <p>A timber and metal fence encloses the property.</p> <p>The dwelling displays architectural features of a heritage style and is representative of the local development of this period, being of historical significance for the HCA.</p>		<p>An extension has been constructed at the back northern back portion o the dwelling. This is not visible from the street and does not detract.</p> <p>The dwelling is currently undergoing construction on the western side of the dwelling.</p>

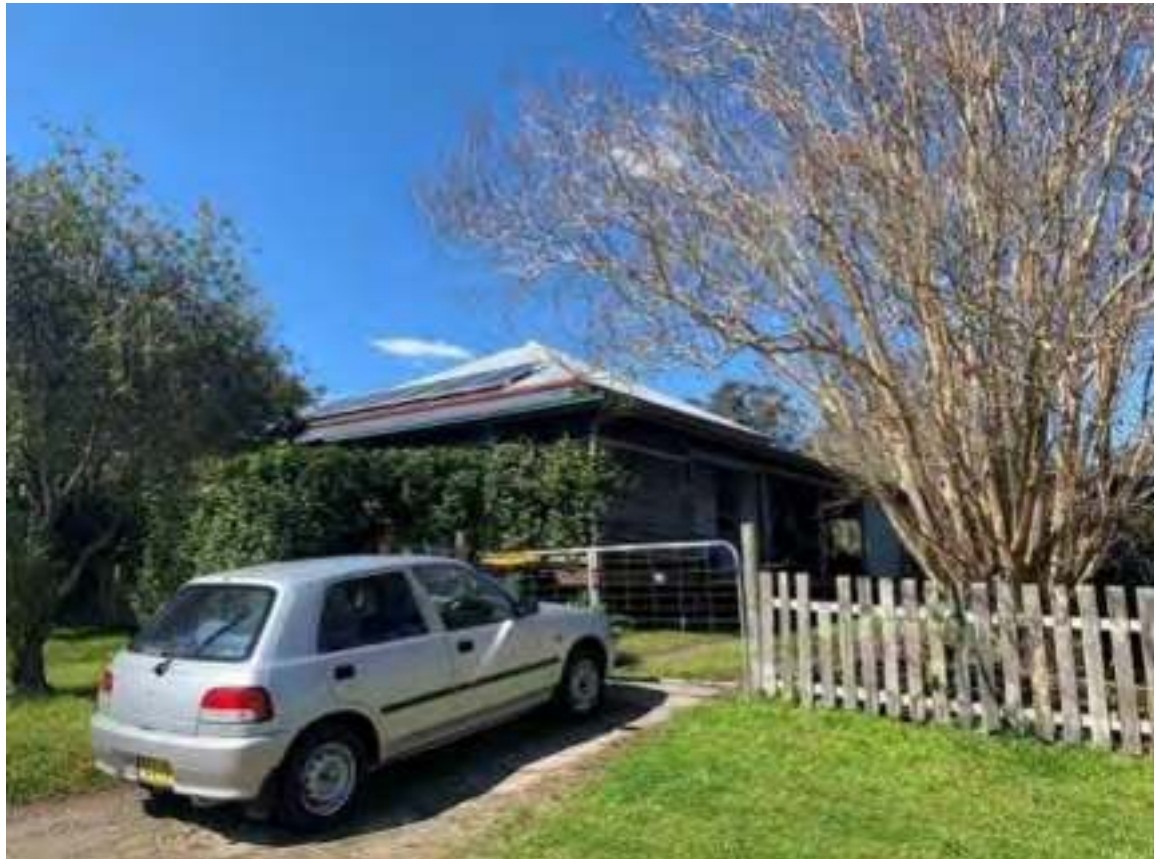
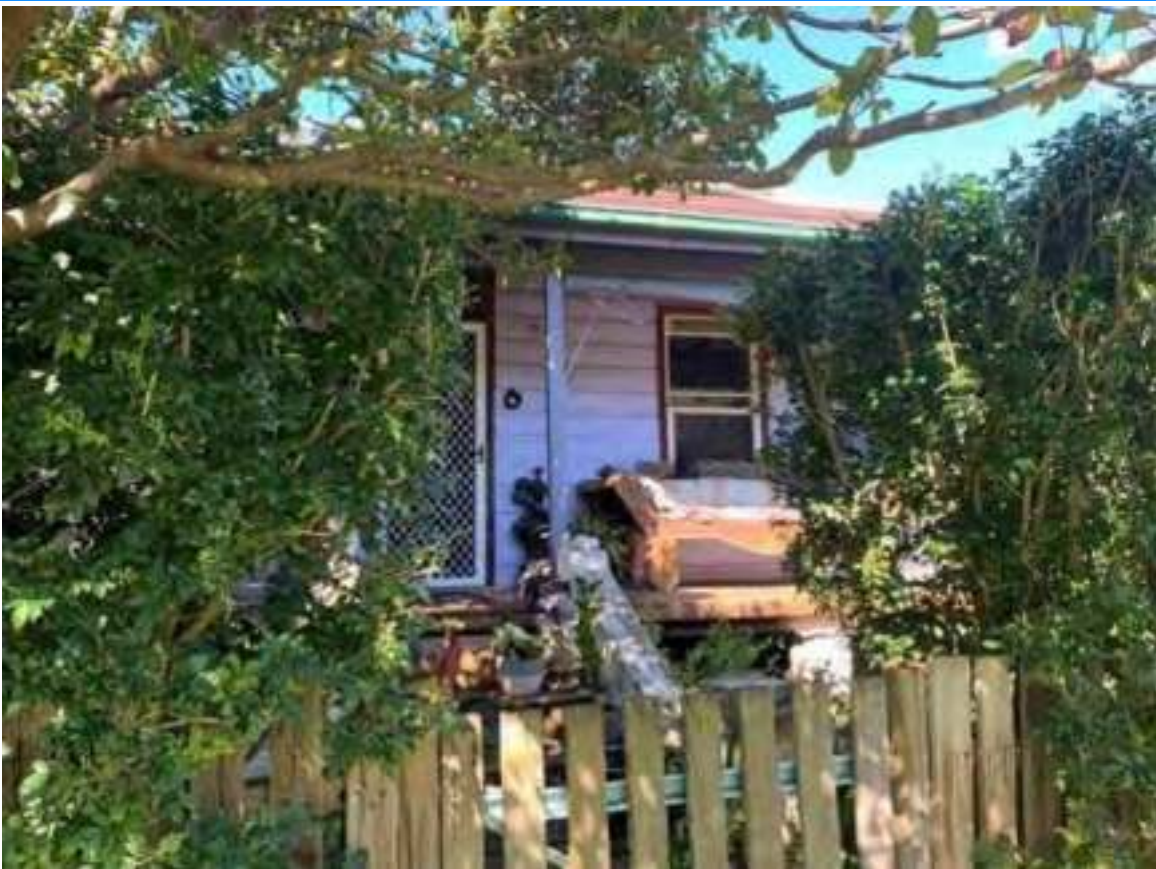
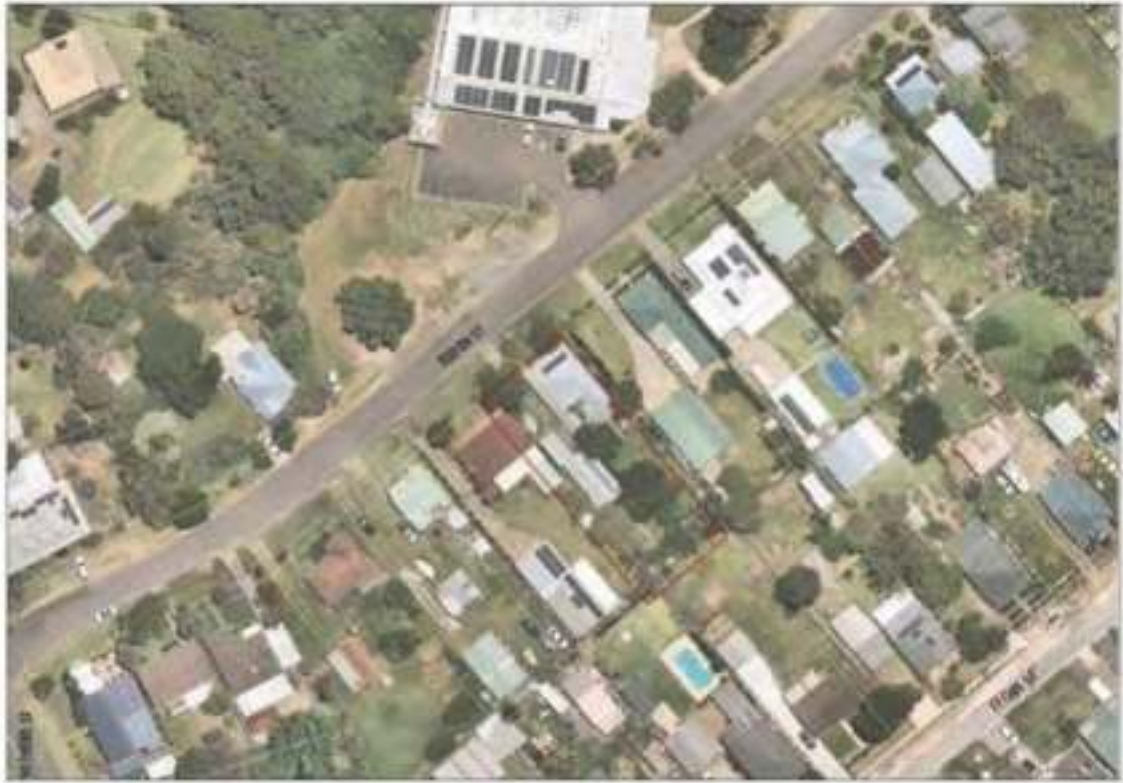
30 EDDEN STREET, WEST WALLSEND 2286

Conservation Area Contribution Level	Est. Construction Date	Previous studies and/or community input
Contributory 1	1890–1915	No prior heritage investigations and no additional information required
Assessment Text		Observed Modifications
<p>Single story Vernacular style dwelling with hipped Colourbond roof and weatherboard cladding. The veranda roof is hipped.</p> <p>The veranda is partially enclosed by timber boarding.</p> <p>The front door is timber framed with a fan light atop.</p> <p>The visible windows appear to be the original timber framed sash designs.</p> <p>A timber fence encloses the property.</p> <p>A garage is located to the south of the dwelling,</p> <p>The dwelling displays architectural features of a heritage style and is representative of the local development of this period, being of historical significance for the HCA.</p>		<p>Solar panels are visible on the front north western side of the dwelling. this juxtaposes the heritage features of the dwelling.</p> <p>The veranda extends and wraps around the south western side of the dwelling. this is a common modification and does not detract from the heritage streetscape.</p> <p>A back extension has been constructed at the south eastern side of the dwelling.</p>
