APPENDIX 2

Building Assessment Sheets (Inventory Sheets)

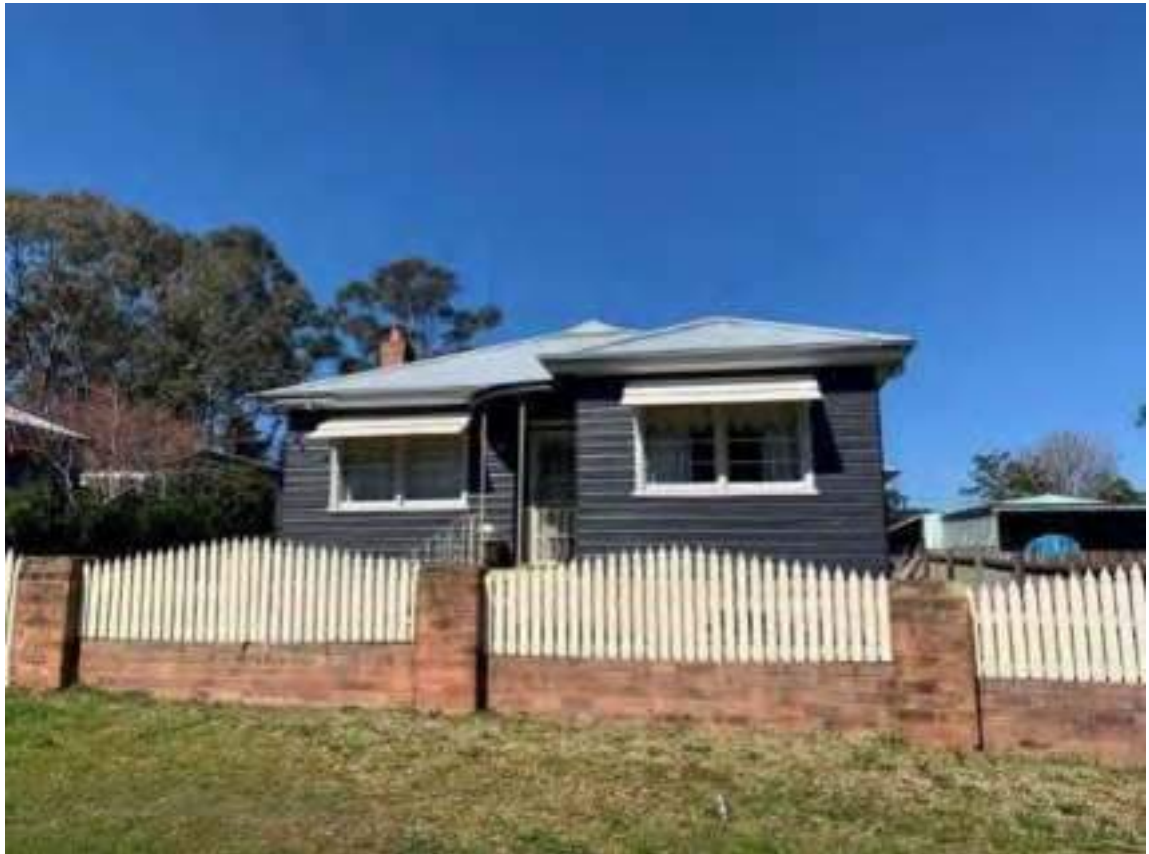
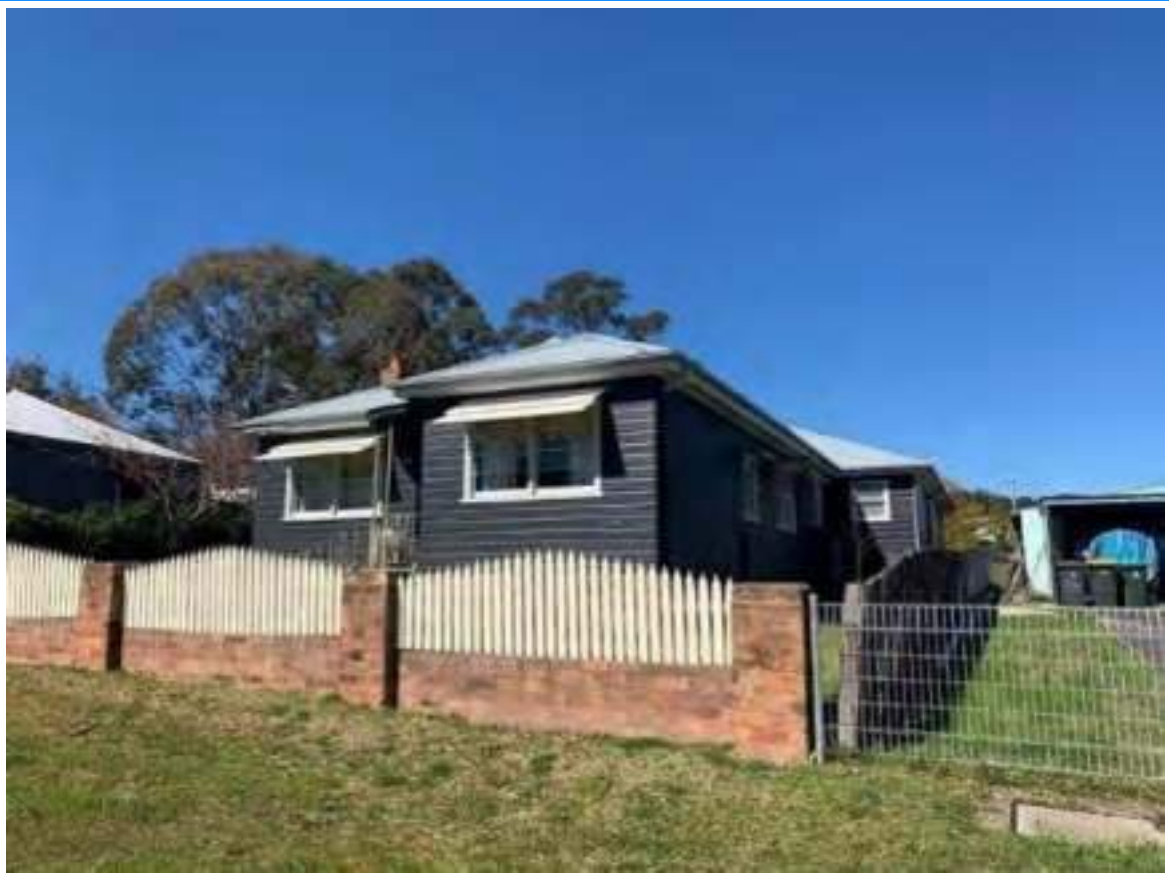
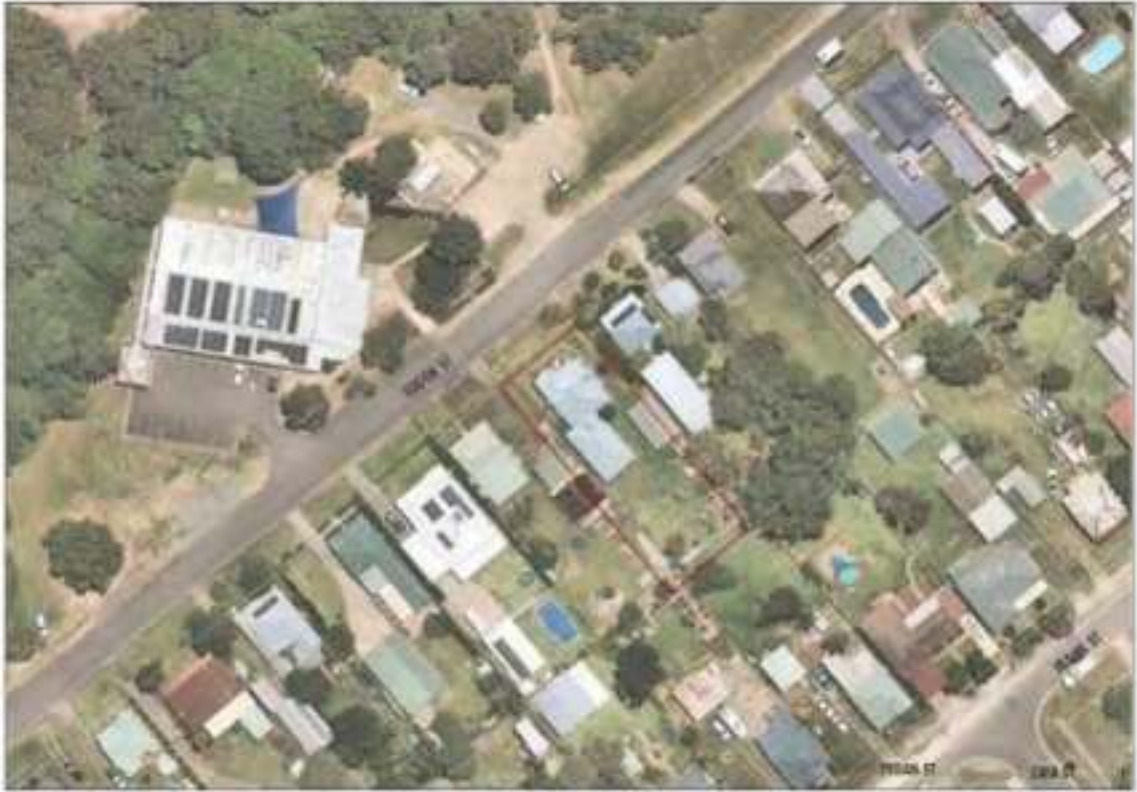
22 EDDEN STREET, WEST WALLSEND 2286

Conservation Area Contribution Level	Est. Construction Date	Previous studies and/or community input
Contributory 1	1920–1935	No prior heritage investigations and no additional information required
Assessment Text		Observed Modifications
<p>Single story Simple Inter-war dwelling with hipped Colourbond roof and weatherboard cladding. The veranda roof curved and flat. The veranda is a small, curved platform with metal balustrade and tiled flooring.</p> <p>The front door is timber framed and four panel design. The north western façade windows are timber framed with timber awnings. Windows appear to be original.</p> <p>A red brickwork chimney with terracotta pot is visible on the north eastern side of the dwelling.</p> <p>Timber and brick fence encloses the property.</p> <p>The dwelling displays architectural features of a heritage style and is representative of the local development of this period, being of historical significance for the HCA.</p>		<p>An extension has been constructed at the back south eastern side of the dwelling, this is partially visible from the street but is constructed in a sympathetic style.</p> <p>The veranda balustrade and metal front door are contemporary additions to the dwelling.</p>

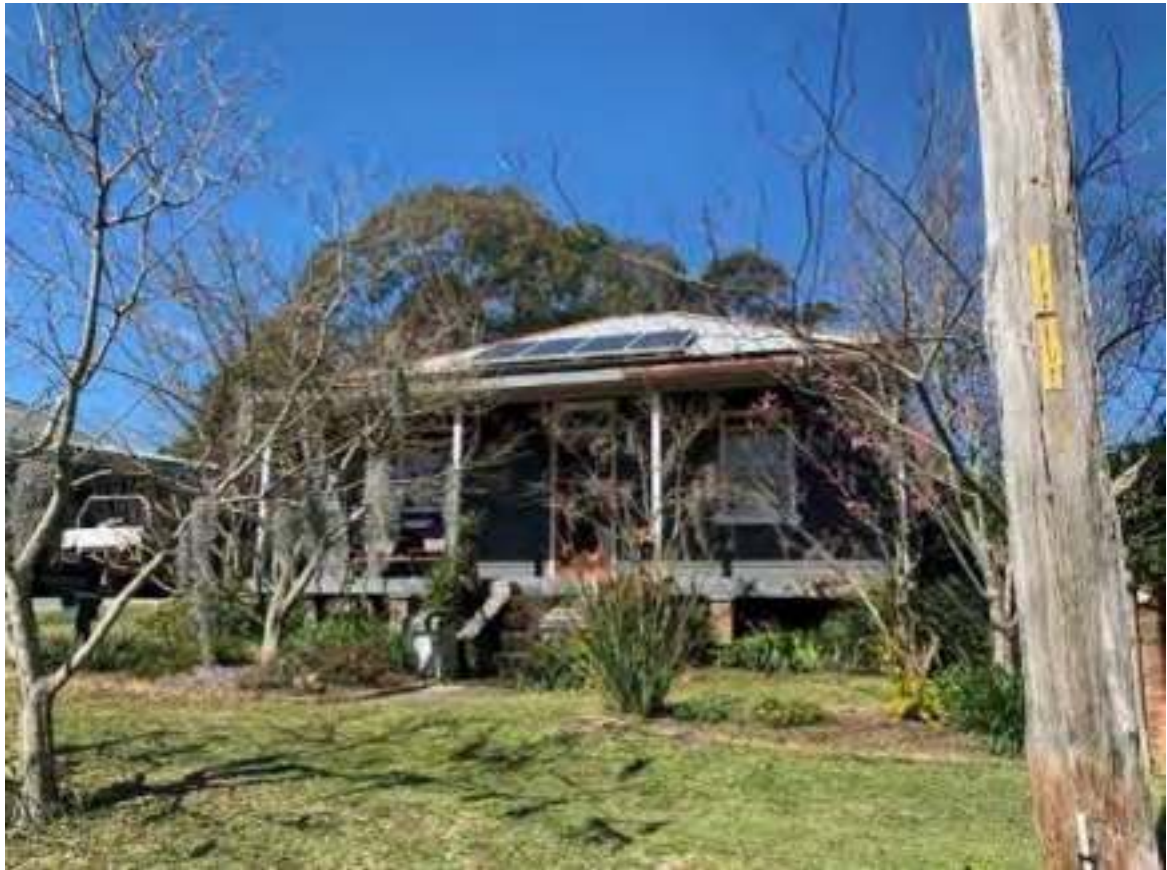
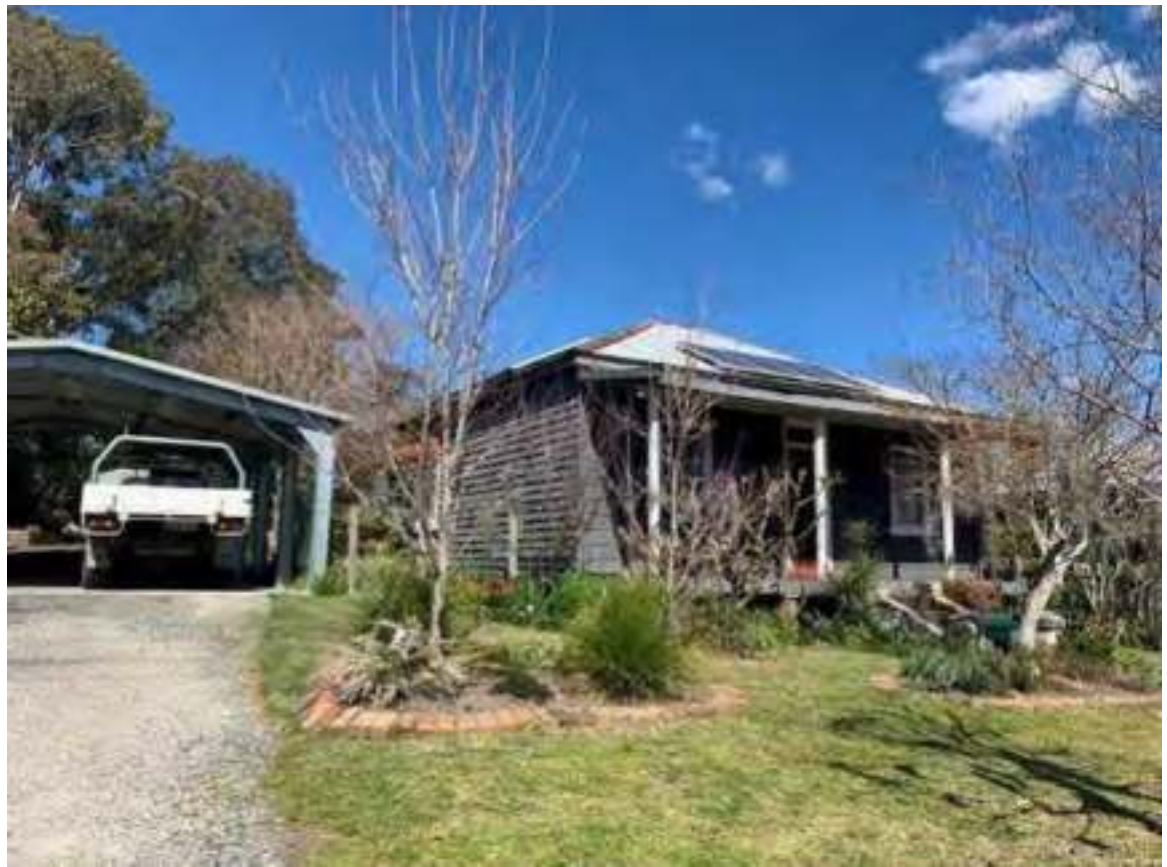
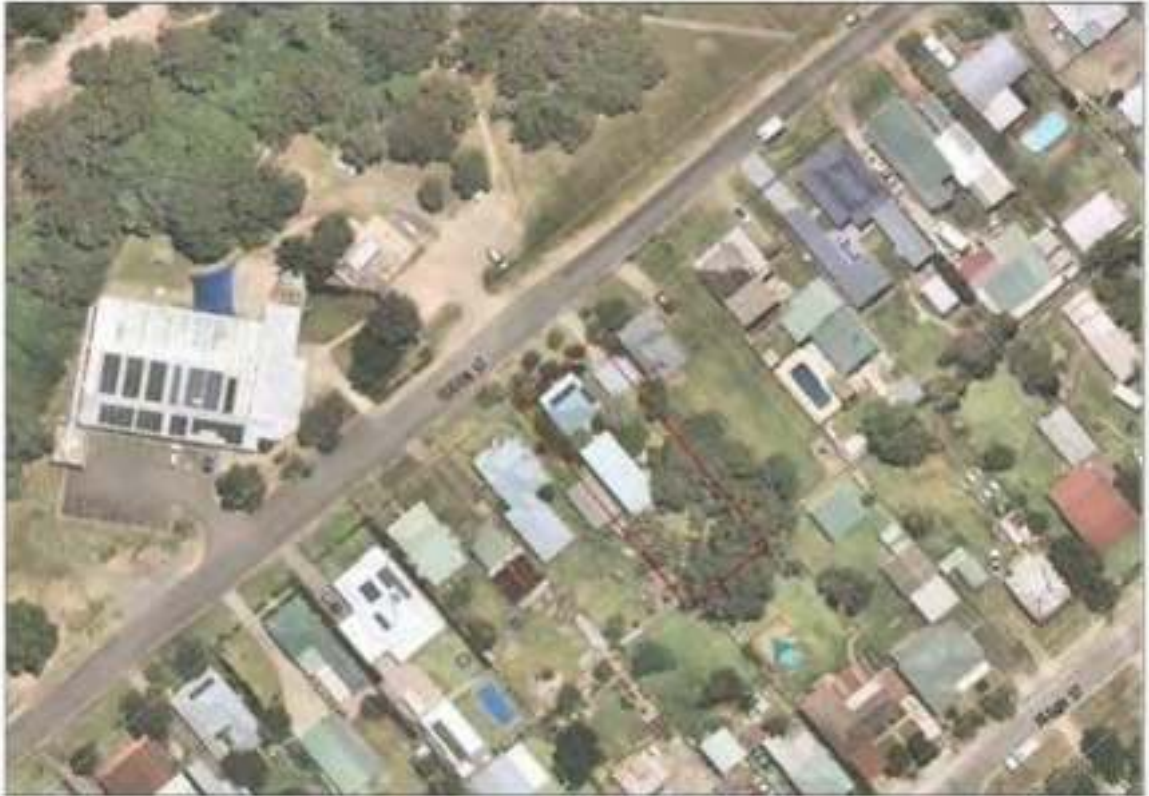
20 EDDEN STREET, WEST WALLSEND 2286

Conservation Area Contribution Level	Est. Construction Date	Previous studies and/or community input
Contributory 1	1890–1915	No prior heritage investigations and no additional information required
Assessment Text		Observed Modifications
<p>Single story Vernacular ‘Mining Cottage’ style dwelling with steep hipped Colourbond roof and weatherboard cladding. The veranda roof is skillion.</p> <p>The veranda is open, with masonry/brick stairs leading to the landing, with low balustrade.</p> <p>The front door is timber framed with a fan light atop. The windows all appear as original timber framed sash designs.</p> <p>A car port is located to the east, and garage to the south of the dwelling.</p> <p>The dwelling displays architectural features of a heritage style and is representative of the local development of this period, being of historical significance for the HCA.</p>		<p>The veranda roof was likely originally bull nosed and has been replaced with a skillion design.</p>

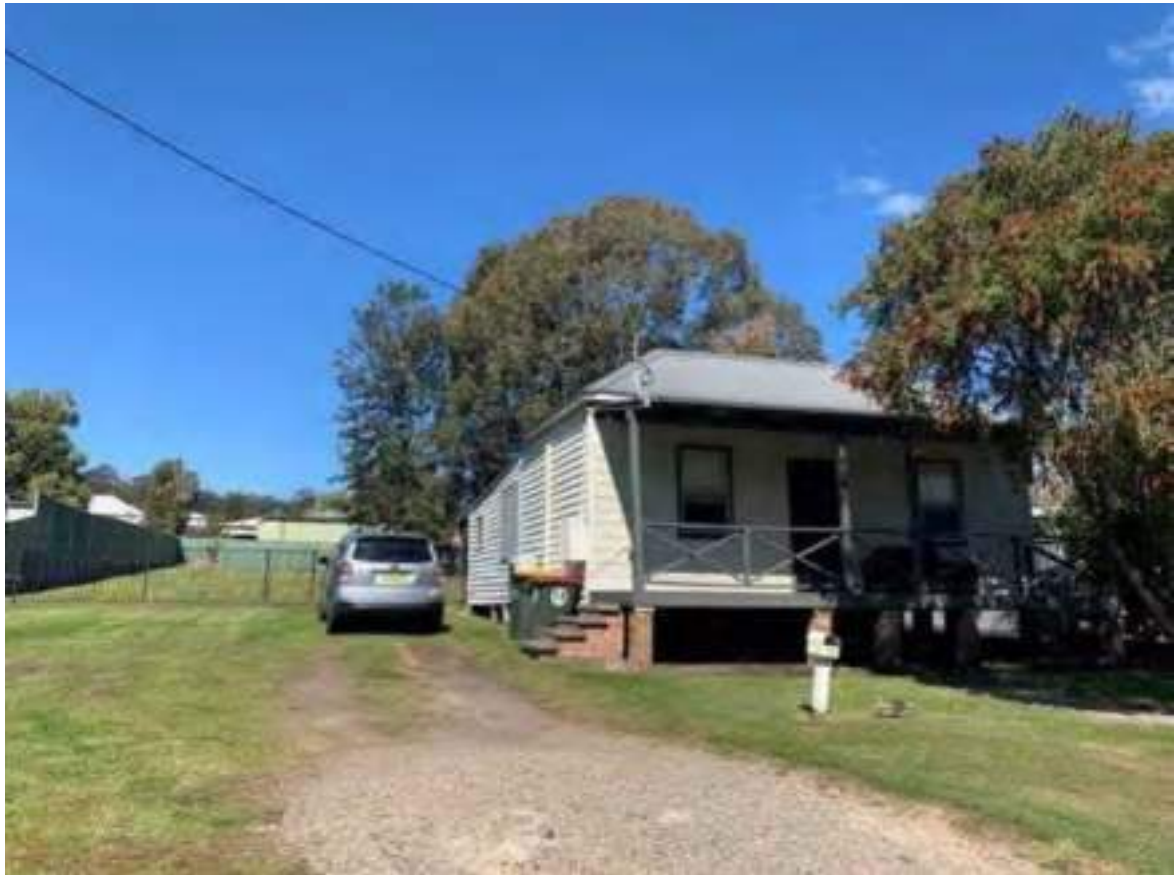
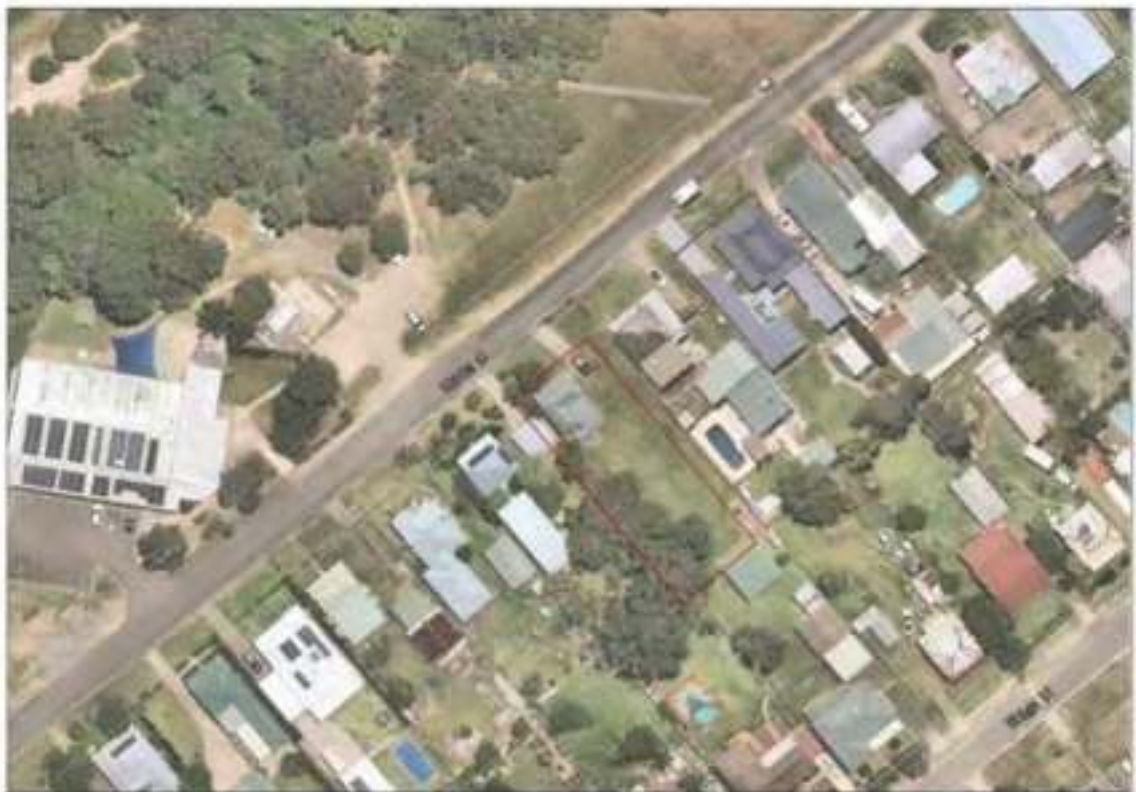
18 EDDEN STREET, WEST WALLSEND 2286

Conservation Area Contribution Level	Est. Construction Date	Previous studies and/or community input
Contributory 1	1890–1915	No prior heritage investigations and no additional information required
Assessment Text		Observed Modifications
<p>Single story Vernacular ‘Mining Cottage’ style dwelling with steep hipped Colourbond roof and timber weatherboard cladding. The veranda roof is skillion.</p> <p>The veranda is partially enclosed by a timber crossed balustrade.</p> <p>The windows are timber framed and sash design.</p> <p>The dwelling displays architectural features of a heritage style and is representative of the local development of this period, being of historical significance for the HCA.</p>		<p>An extension has been built into the back south eastern side of the dwelling. this is not visible from the street and does not detract from the heritage streetscape.</p>

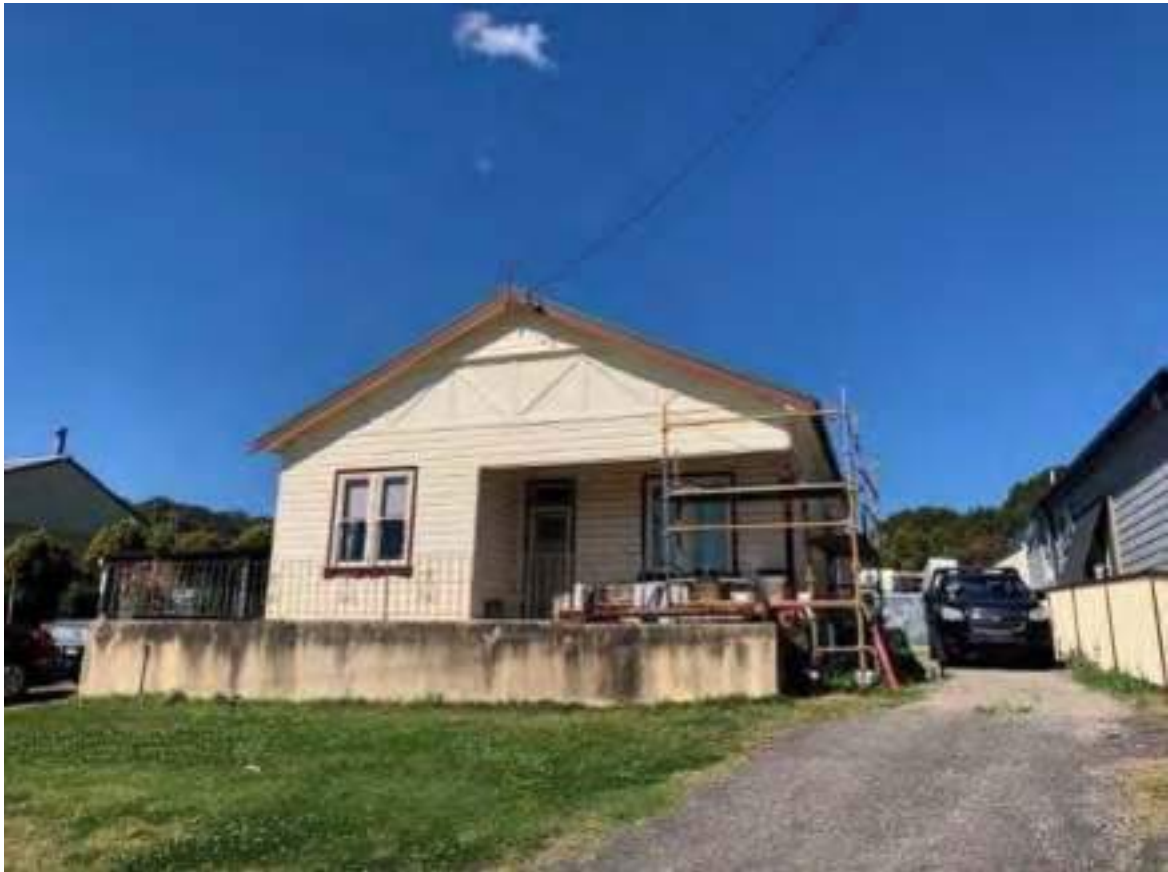
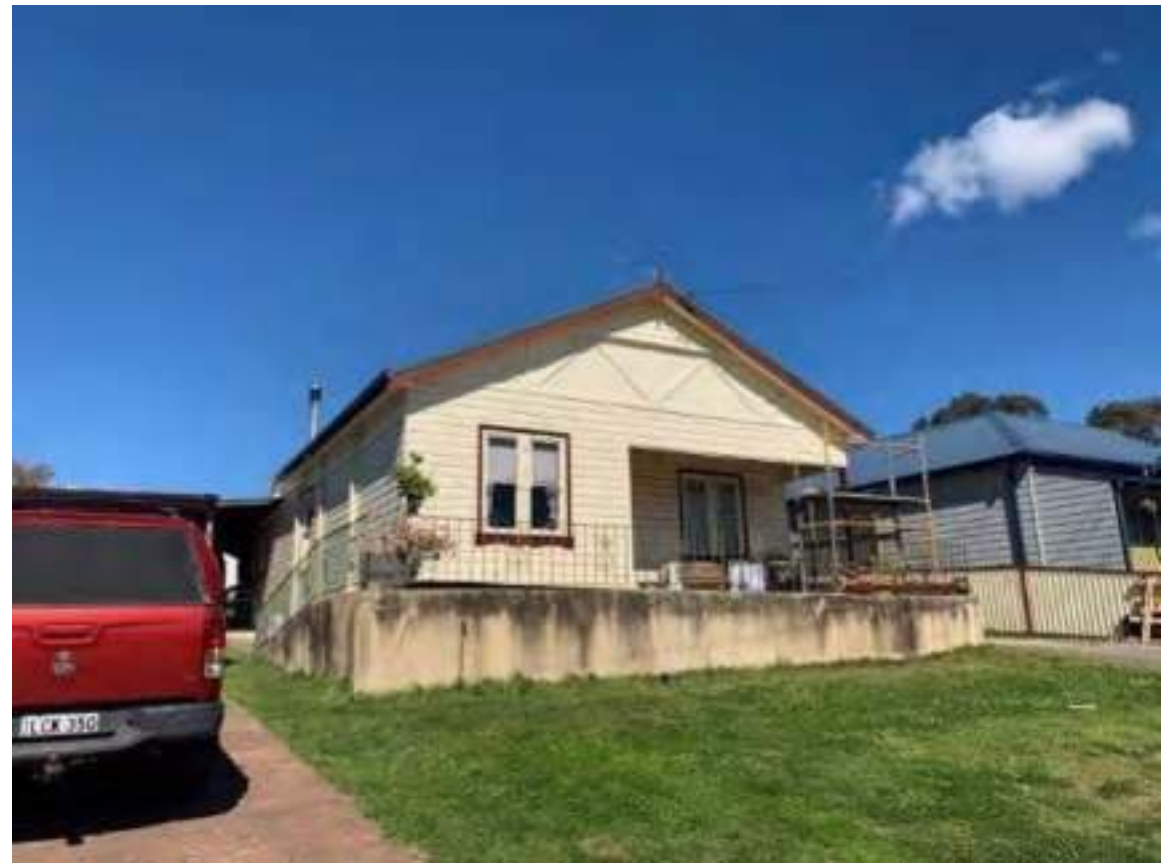
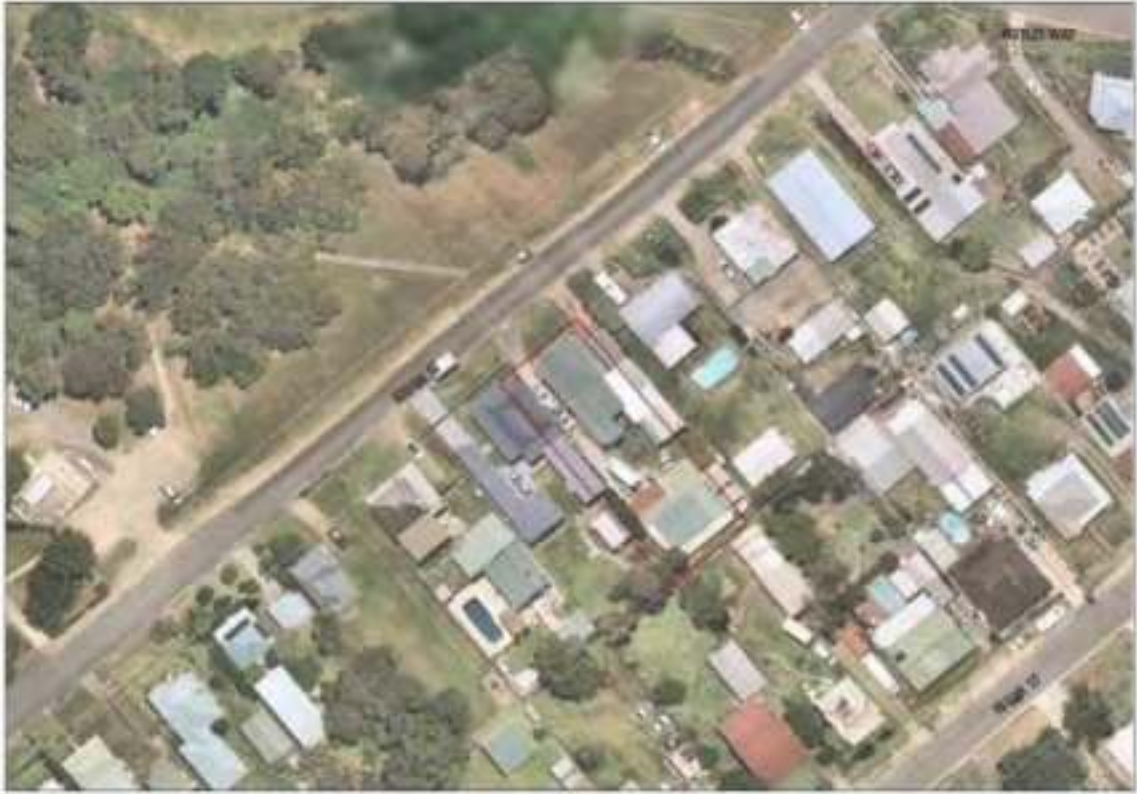
12 EDDEN STREET, WEST WALLSEND 2286

Conservation Area Contribution Level	Est. Construction Date	Previous studies and/or community input
Contributory 1	1920–1930	No prior heritage investigations and no additional information required
Assessment Text		Observed Modifications
<p>Single story Bungalow style dwelling with gable Colourbond roof and weatherboard cladding.</p> <p>The veranda is partially enclosed by a metal balustrade and ornately carved timber posts.</p> <p>The visible windows are the original heavy timber framed sash designs, an elaborately carved timber pilaster is situated between the two sash windows. the front door is timber framed with fan light a top.</p> <p>The gable has decorative battening detailing and timber finial.</p> <p>The dwelling displays architectural features of a heritage style and is representative of the local development of this period, being of historical significance for the HCA.</p>		<p>The metal balustrade is a contemporary addition to the front façade.</p> <p>An extension has been constructed at the back south eastern portion of the dwelling. This is not visible however and does not detract.</p>

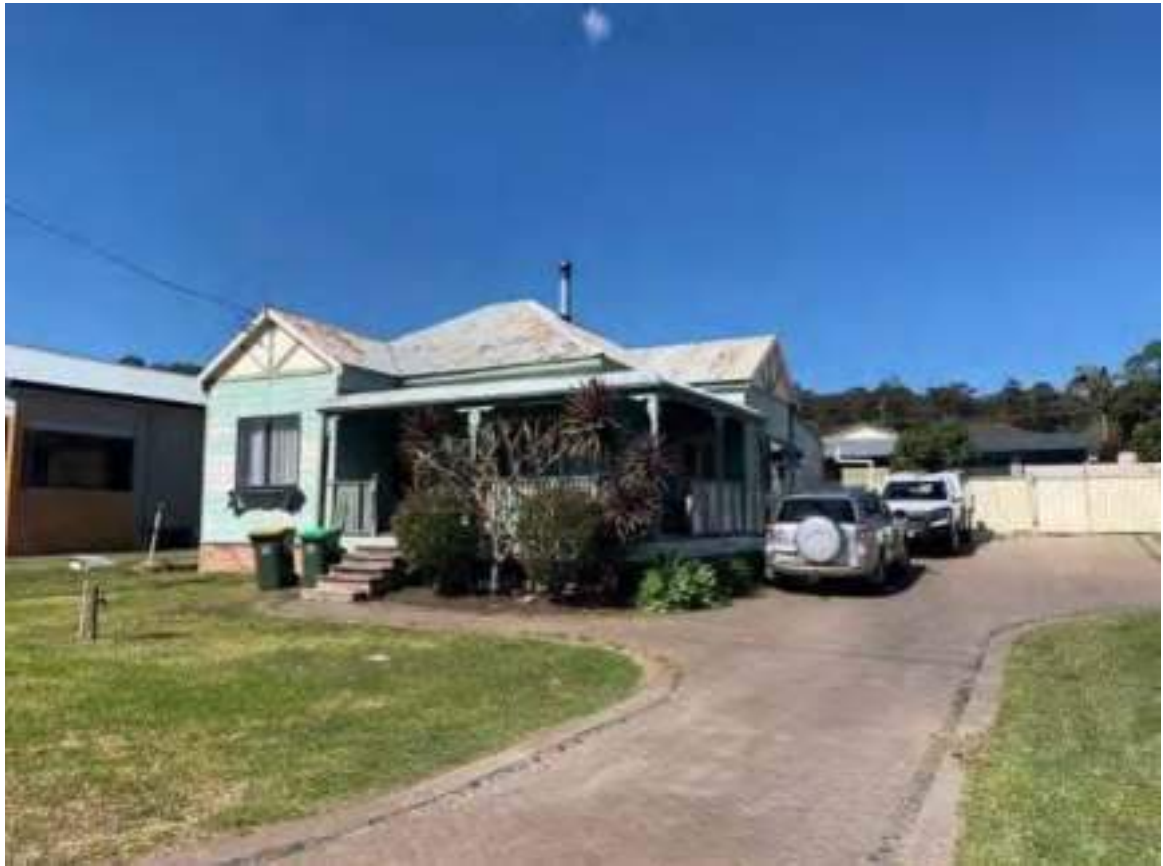
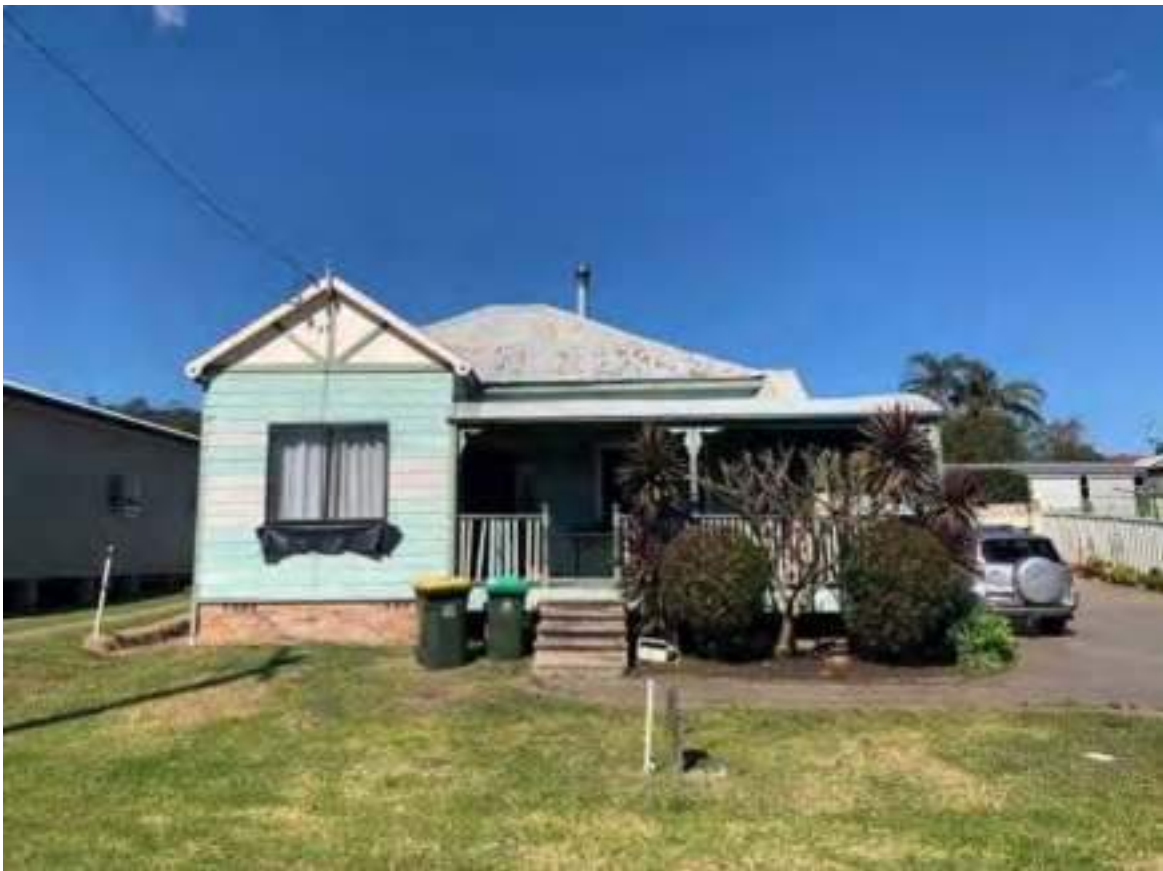
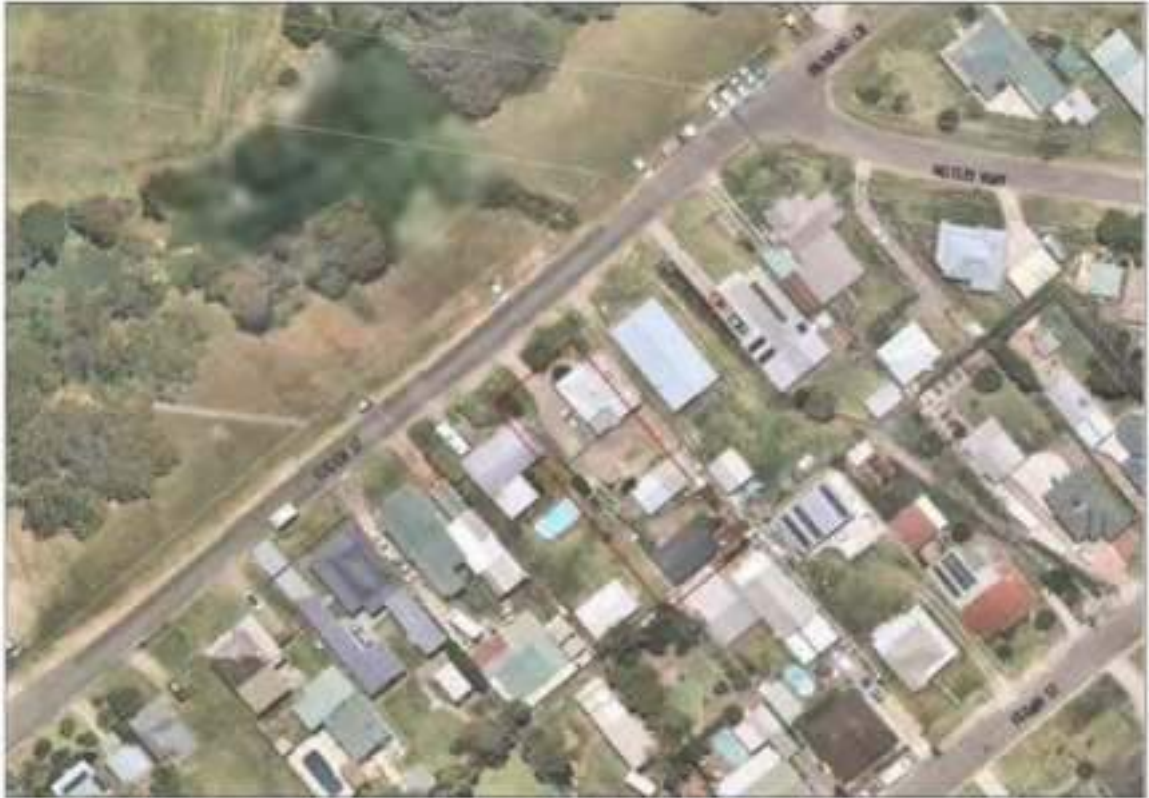
8 EDDEN STREET, WEST WALLSEND 2286

Conservation Area Contribution Level	Est. Construction Date	Previous studies and/or community input
Contributory 1	1890–1915	No prior heritage investigations and no additional information required
Assessment Text		Observed Modifications
<p>Single story simplified Federation Queen Anne style dwelling with Colourbond hipped roof with two gable projections and weatherboard cladding. The veranda roof is bull nosed and extends along the north western and southern western sides of the dwelling, the roof is supported by timber posts with ornately carved timber brackets.</p> <p>The veranda is partially enclosed by a timber balustrade. Portions are missing and need repair.</p> <p>Both gables have timber finial, decorative eaves and battening detailing. an original timber shingle awning is located at the back southern gable end.</p> <p>The dwelling displays architectural features of a heritage style and is representative of the local development of this period, being of historical significance for the HCA.</p>		<p>The north western façade front windows has been replaced with a contemporary sliding design. It is likely a timber awning was also removed. The front door has similarly been replaced with a contemporary design.</p> <p>A small extension has been constructed at the southern side of the dwelling. This is not visible from the street and does not detract.</p> <p>The aqua blood colour scheme is sympathetic, however seems aged.</p> <p>Renovation work are currently underway across the entirety of the dwelling.</p>

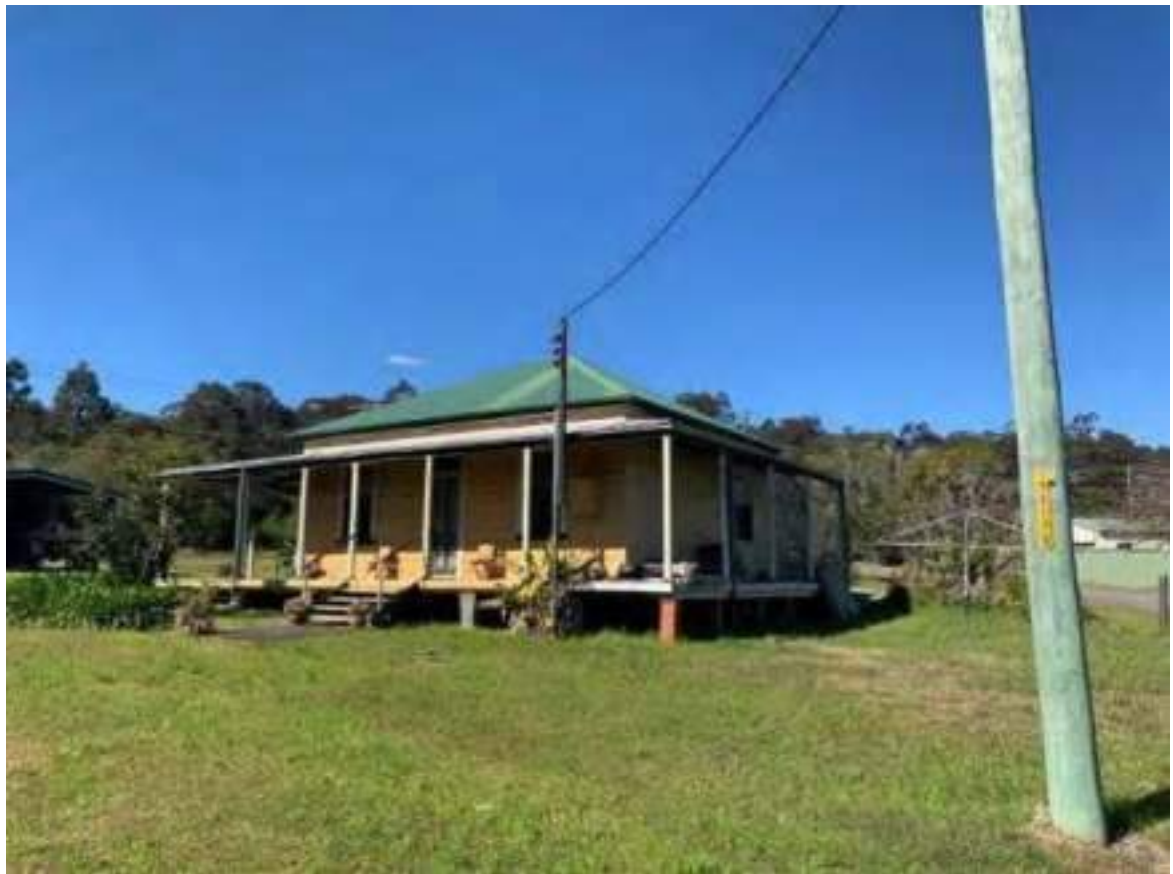
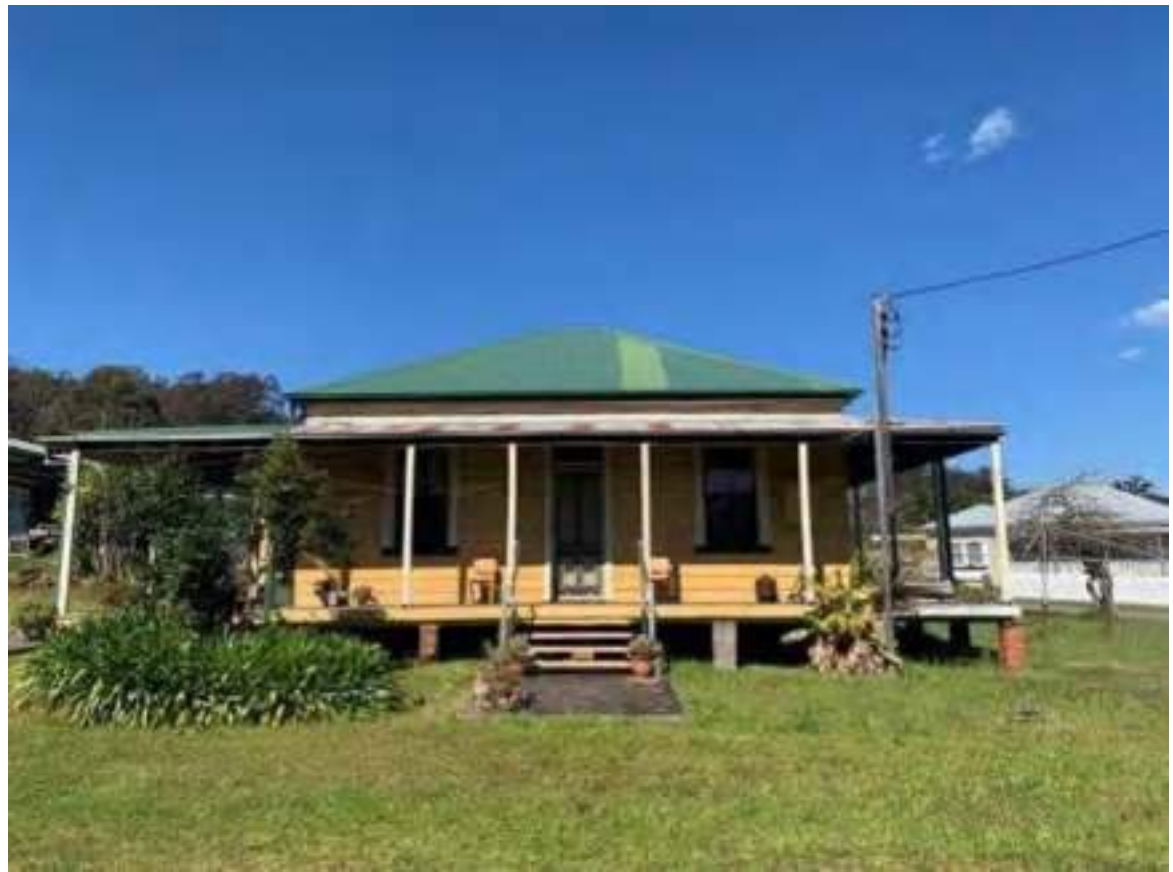
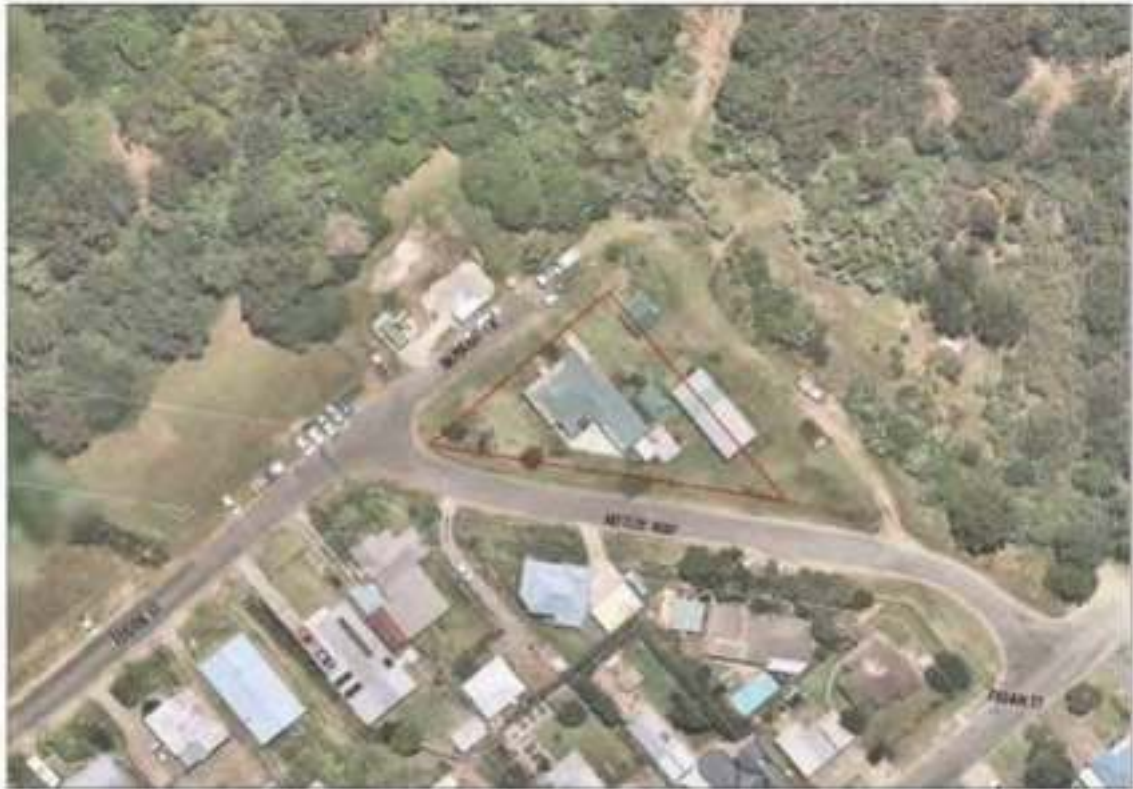
2 EDDEN STREET, WEST WALLSEND 2286

Conservation Area Contribution Level	Est. Construction Date	Previous studies and/or community input
Contributory 1	1890–1915	No prior heritage investigations and no additional information required
Assessment Text		Observed Modifications
<p>Single story Vernacular dwelling with hipped Colourbond roof and weatherboard cladding. The roof is hipped and encircles the north western, south western, and north eastern sides of the dwelling.</p> <p>The veranda is open with timber flooring.</p> <p>The visible windows are timber framed sash designs, potentially original. The front door is timber framed with a fan light above.</p> <p>The dwelling displays architectural features of a heritage style and is representative of the local development of this period, being of historical significance for the HCA.</p>		<p>The veranda has been extended to the north eastern and south western sides of the dwelling, with the original skillion red striped roof still visible.</p> <p>All doors have had ornate metal screens installed.</p> <p>An extension has been built onto the back southern eastern portion of the dwelling.</p> <p>Multiple garage structures are visible to the east of the dwelling.</p>

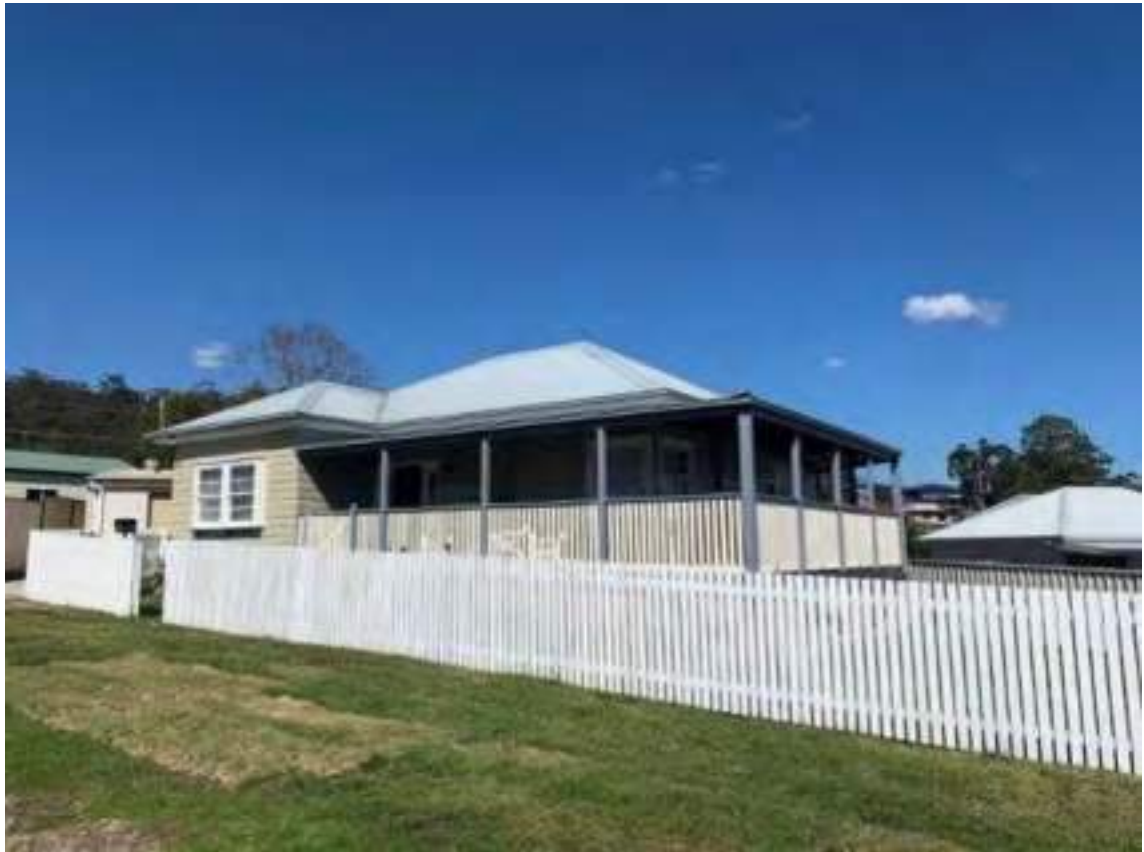
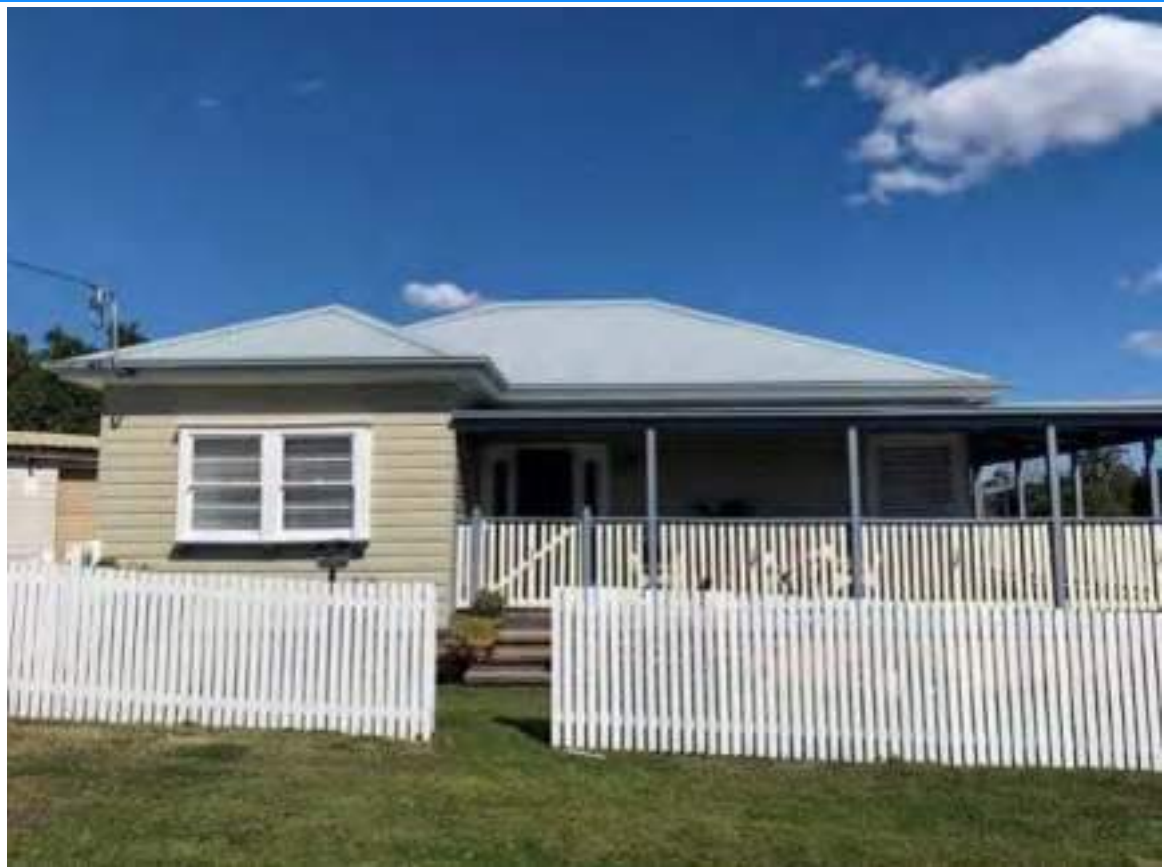
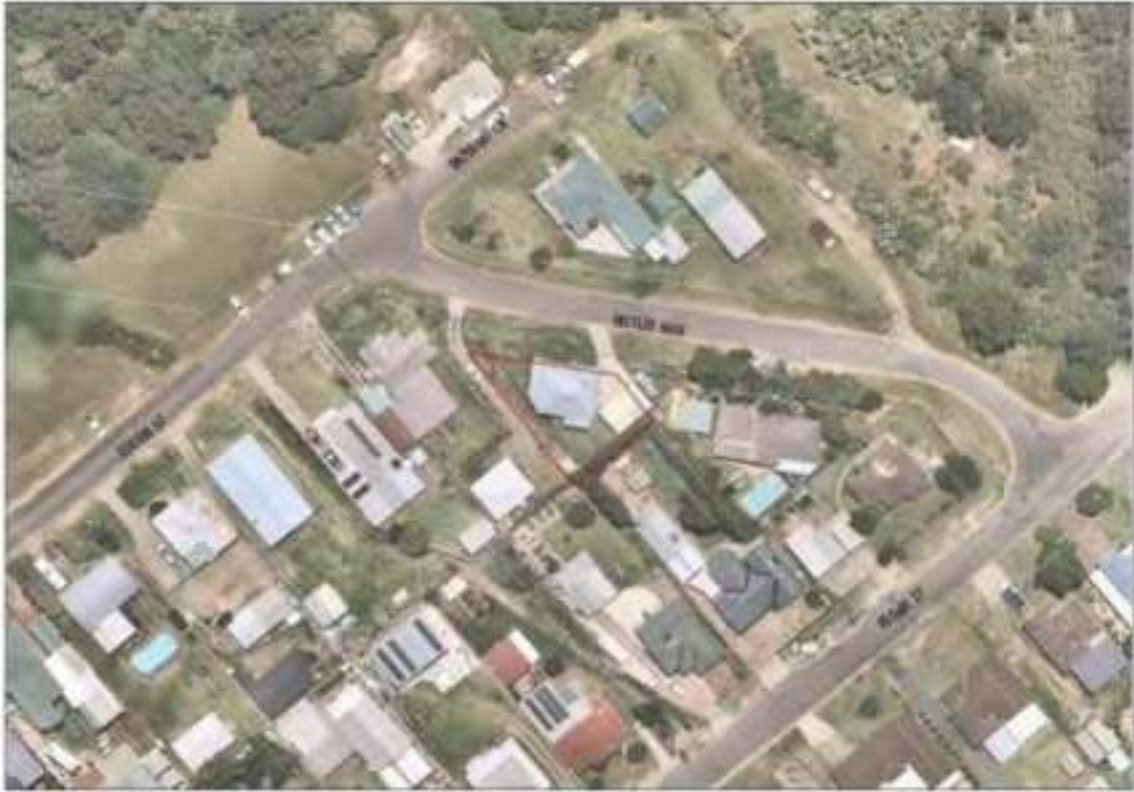
2 NOTLEY WAY, WEST WALLSEND 2286

Conservation Area Contribution Level	Est. Construction Date	Previous studies and/or community input
Contributory 1	1900–1930	No prior heritage investigations and no additional information required
Assessment Text		Observed Modifications
<p>Single story dwelling with hipped Colourbond roof and weatherboard cladding. The veranda roof is hipped.</p> <p>The veranda is partially enclosed by a timber balustrade, and entrance gate.</p> <p>The front door is timber framed with glass panels either side. the visible windows are similarly timber and awning styles, possibly original.</p> <p>A timber picket fence encloses the property.</p> <p>The dwelling displays architectural features of a heritage style and is representative of the local development of this period, being of historical significance for the HCA.</p>		<p>The veranda wraps around to the western side of the dwelling, potentially a contemporary modification. This is a common feature and does not detract from the heritage streetscape.</p>
