APPENDIX 2

Building Assessment Sheets (Inventory Sheets)

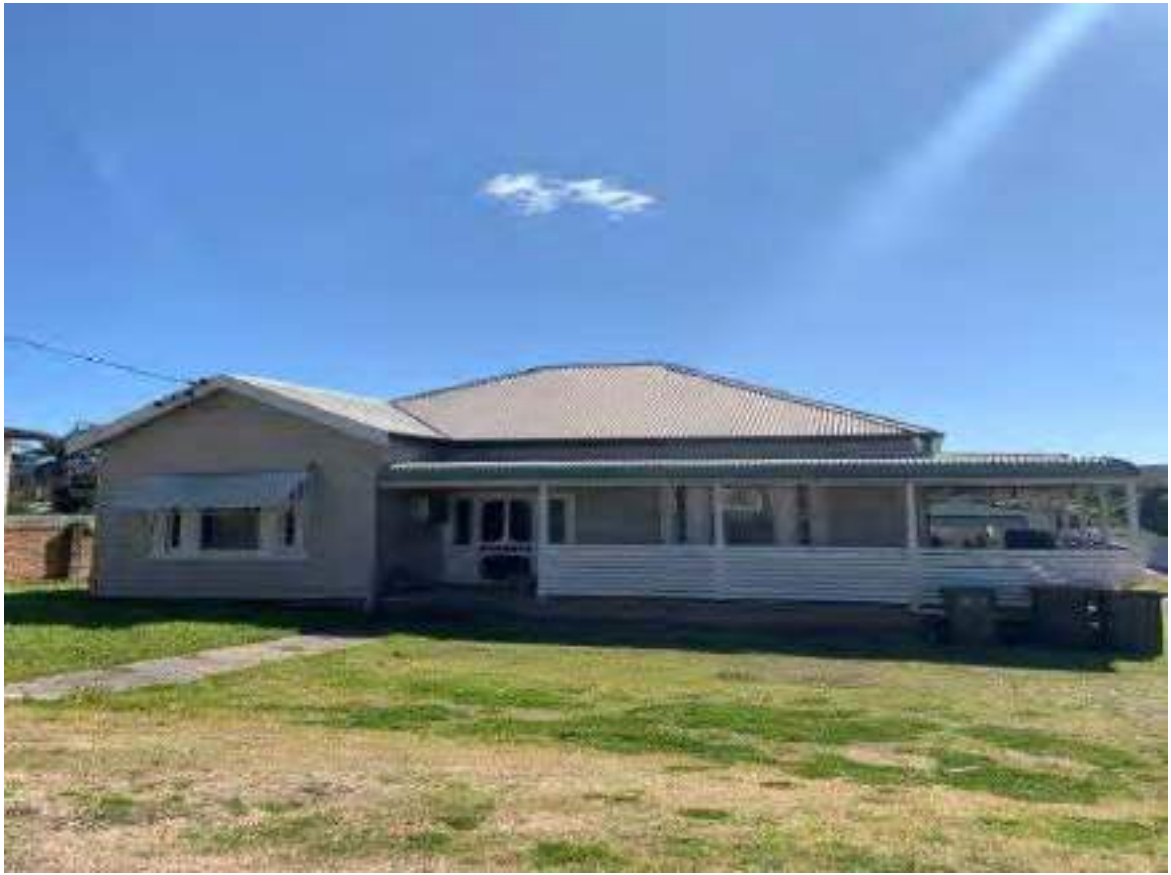
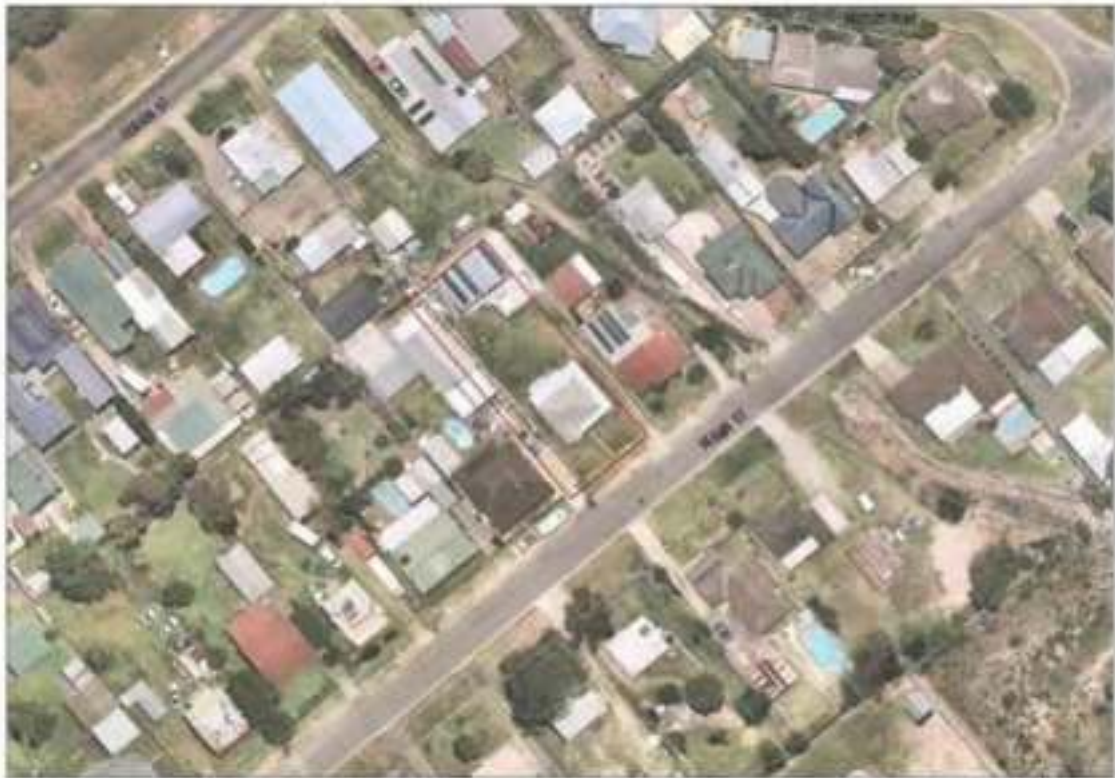
9 FEGAN STREET, WEST WALLSEND 2286

Conservation Area Contribution Level	Est. Construction Date	Previous studies and/or community input
Contributory 1	1900–1915	No prior heritage investigations and no additional information required
Assessment Text		Observed Modifications
<p>Single story simply Federation ‘workmen's cottage’ style dwelling with steep hipped Colourbond roof with gable projection and timber weatherboard cladding. The veranda is bulled nosed. The veranda is partially enclosed by timber balustrade.</p> <p>The front door is timber framed with a timber screen door and window panels either side.</p> <p>The visible windows are heavy timber framed sash designs, with leadlight detailing. Stained colour glass panels are found either side. This is likely original. A metal awning is found above the gable window.</p> <p>The dwelling displays architectural features of a heritage style and is representative of the local development of this period, being of historical significance for the HCA.</p>		<p>The timber screen door is potentially a contemporary modification, however has been constructed in a sympathetic manner and to a similar style.</p> <p>The veranda extension is potentially a modification, however is commonly seen on comparable dwellings of the area.</p> <p>The timber balustrade is contemporary in style and does not suite the style of the dwelling.</p>

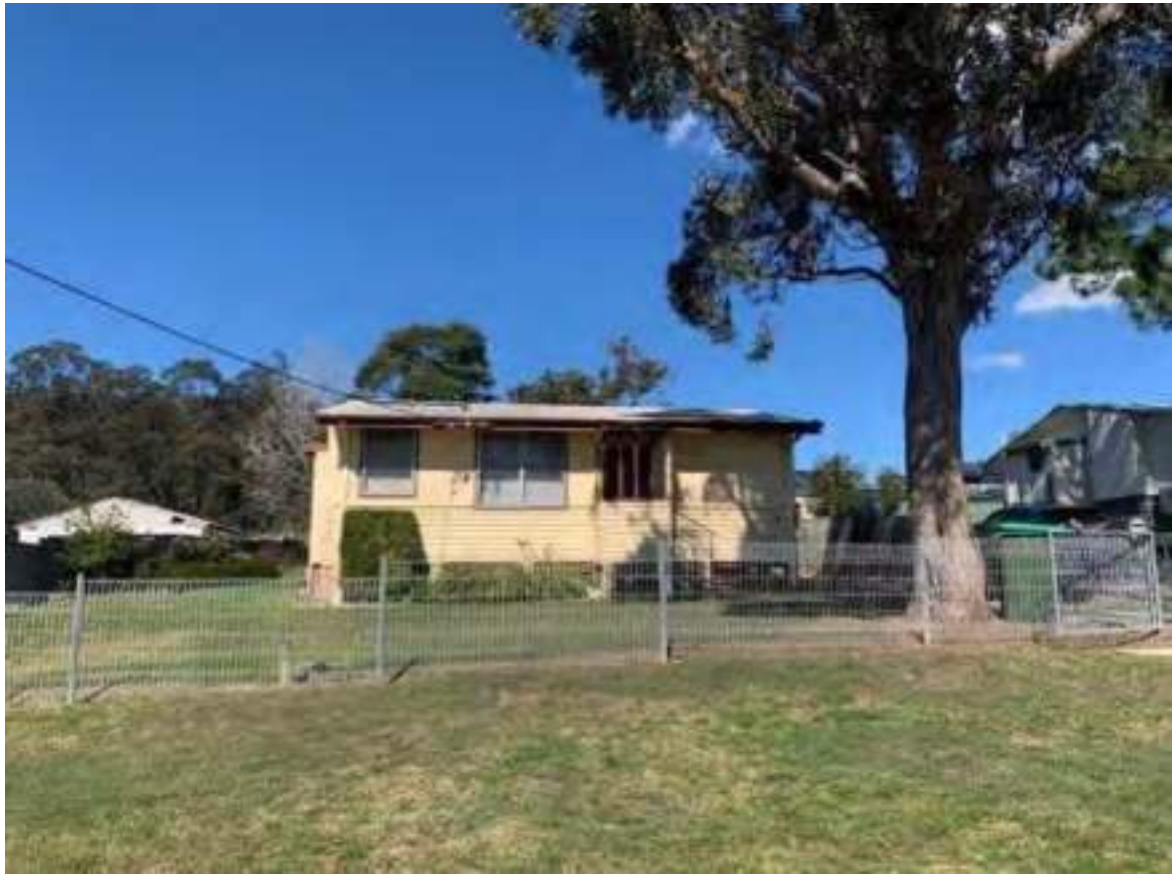
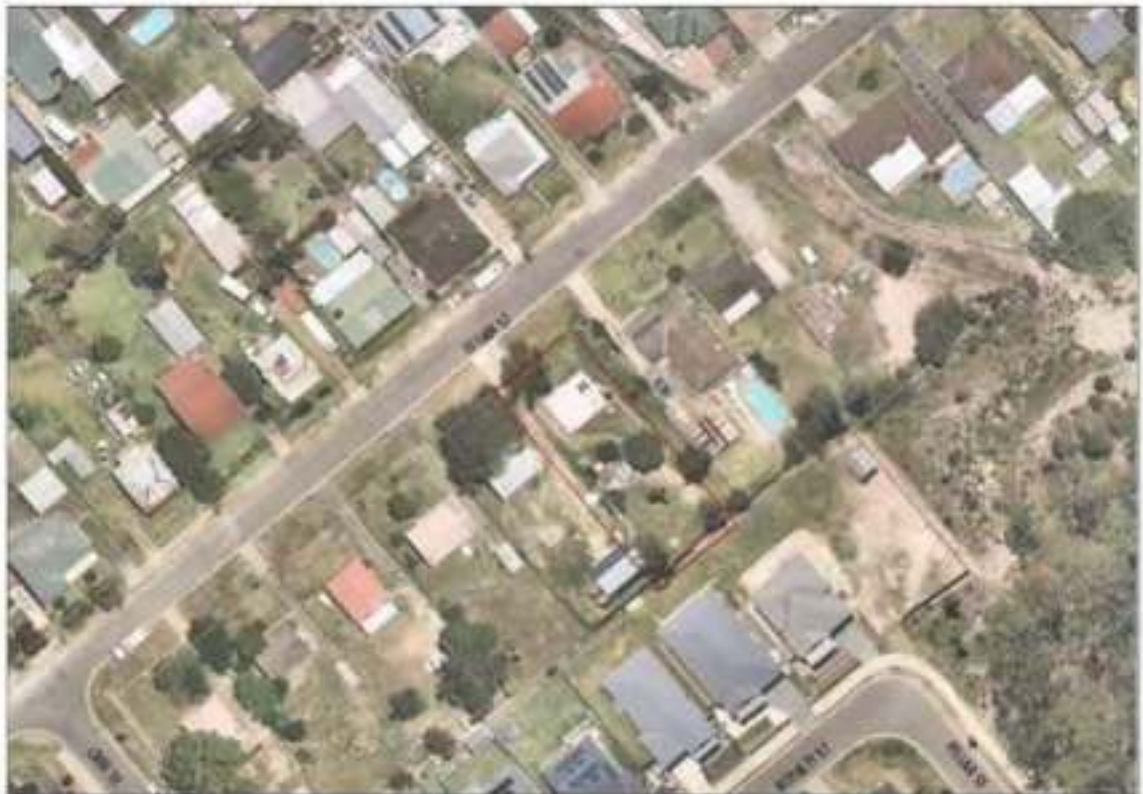
18 FEGAN STREET, WEST WALLSEND 2286

Conservation Area Contribution Level	Est. Construction Date	Previous studies and/or community input
Contributory 1	1930–1950	Potential ex-military accommodation.
Assessment Text		Observed Modifications
<p>Single story Inter-war dwelling with Colourbond gable roof and fibro-clad timber sheeting and boarding façade.</p> <p>The front door is located within a small alcove, with concrete steps and metal support rail.</p> <p>The visible windows are timber framed sash designs.</p> <p>A metal wire fence encloses the property.</p> <p>The dwelling displays architectural features of a heritage style and is representative of the local development of this period, being of historical significance for the HCA.</p>		<p>The visible windows are potential contemporary replacements of a similar design.</p>

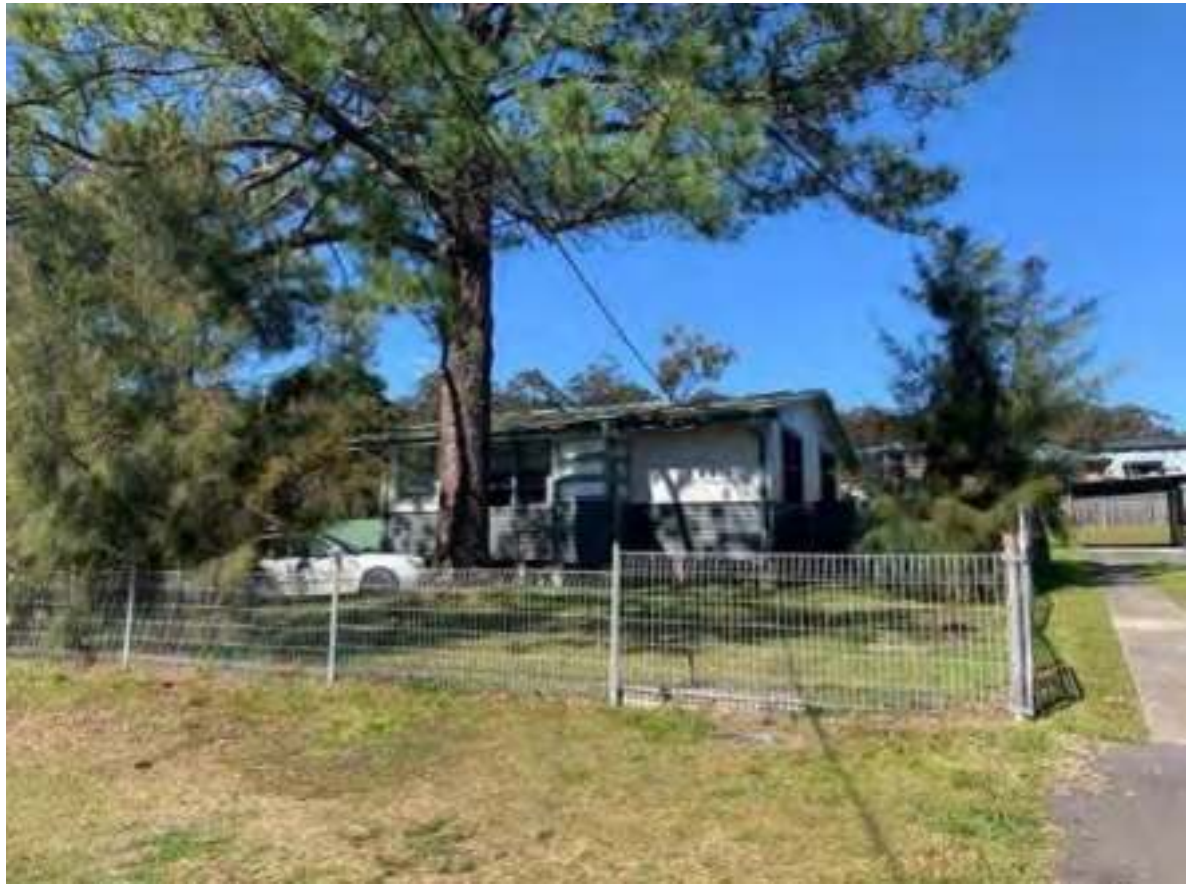
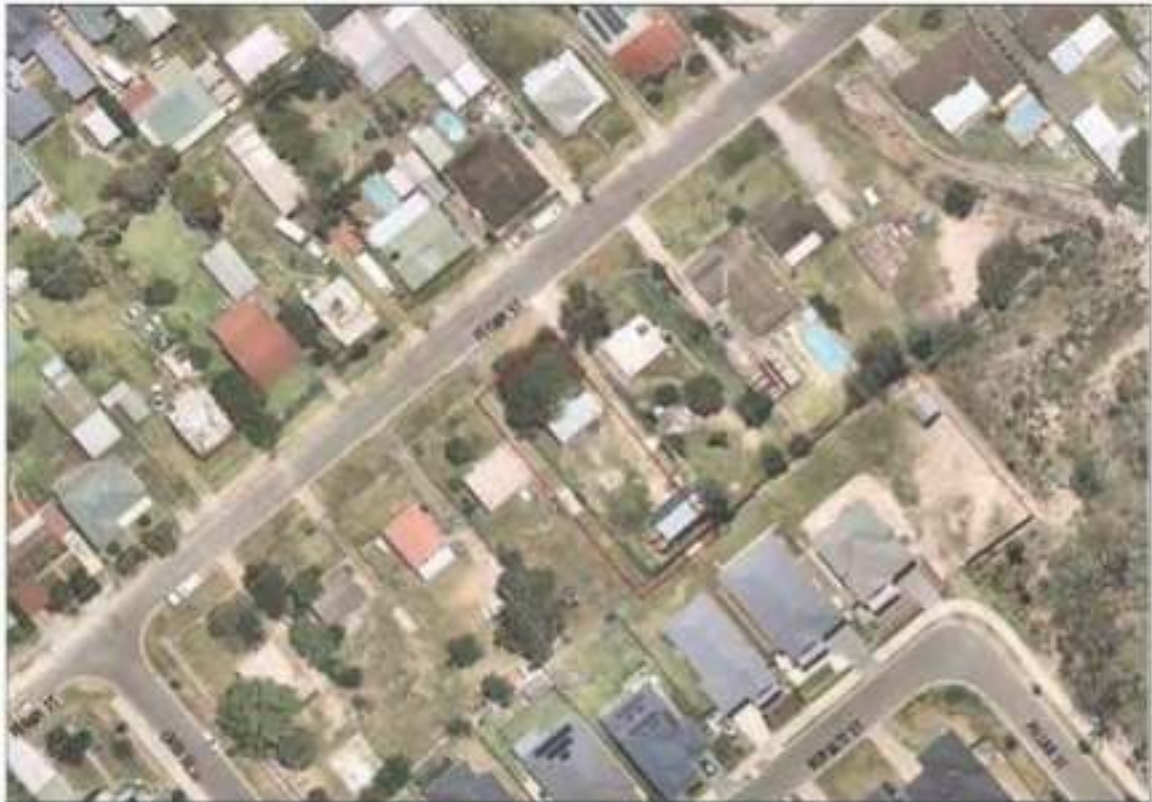
20 FEGAN STREET, WEST WALLSEND 2286

Conservation Area Contribution Level	Est. Construction Date	Previous studies and/or community input
Contributory 1	1930–1950	Potential ex-military accommodation.
Assessment Text		Observed Modifications
<p>Single story Inter-war dwelling with Colourbond gable roof and fibro-clad timber sheeting and boarding façade.</p> <p>The front door is located within a small alcove, with concrete steps and metal support rail.</p> <p>The visible windows are timber framed sash or awnings designs.</p> <p>A metal wire fence encloses the property.</p> <p>The dwelling displays architectural features of a heritage style and is representative of the local development of this period, being of historical significance for the HCA.</p>		No modifications observed.

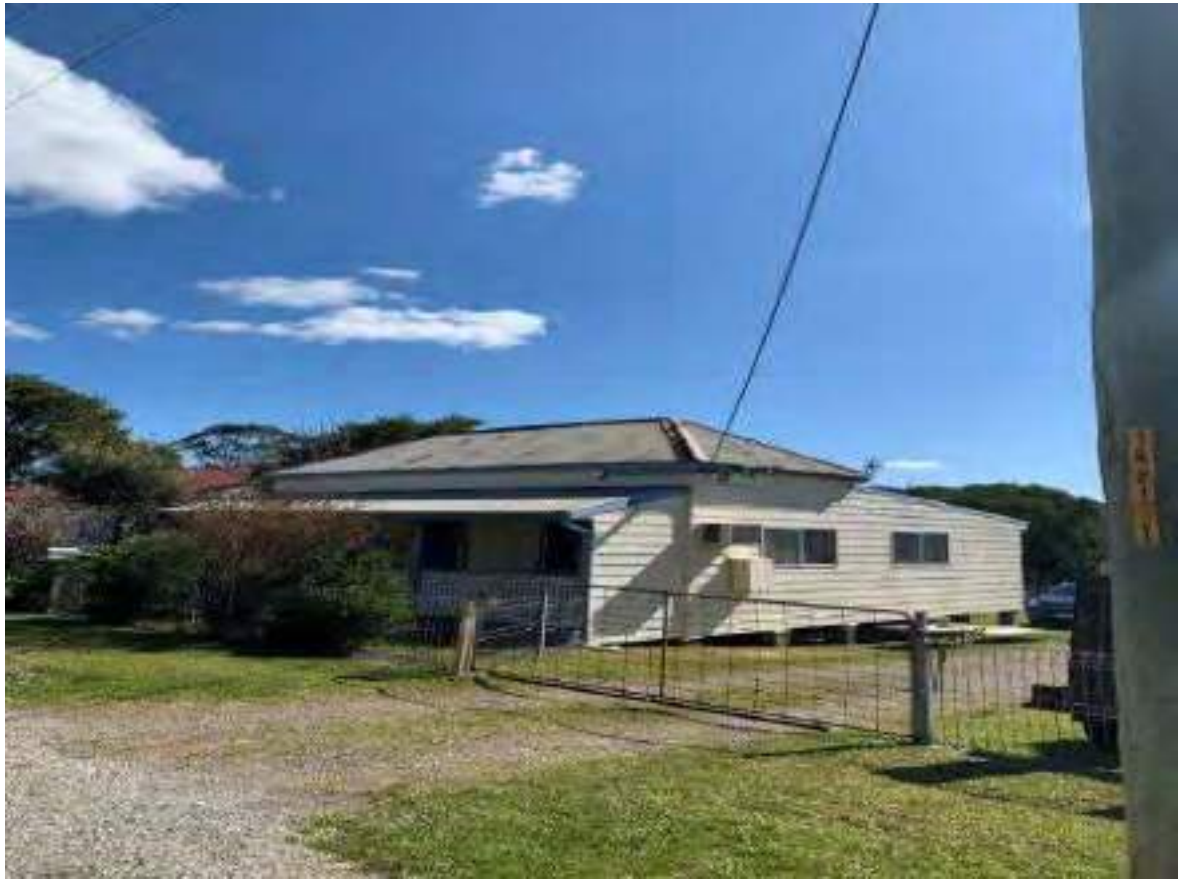
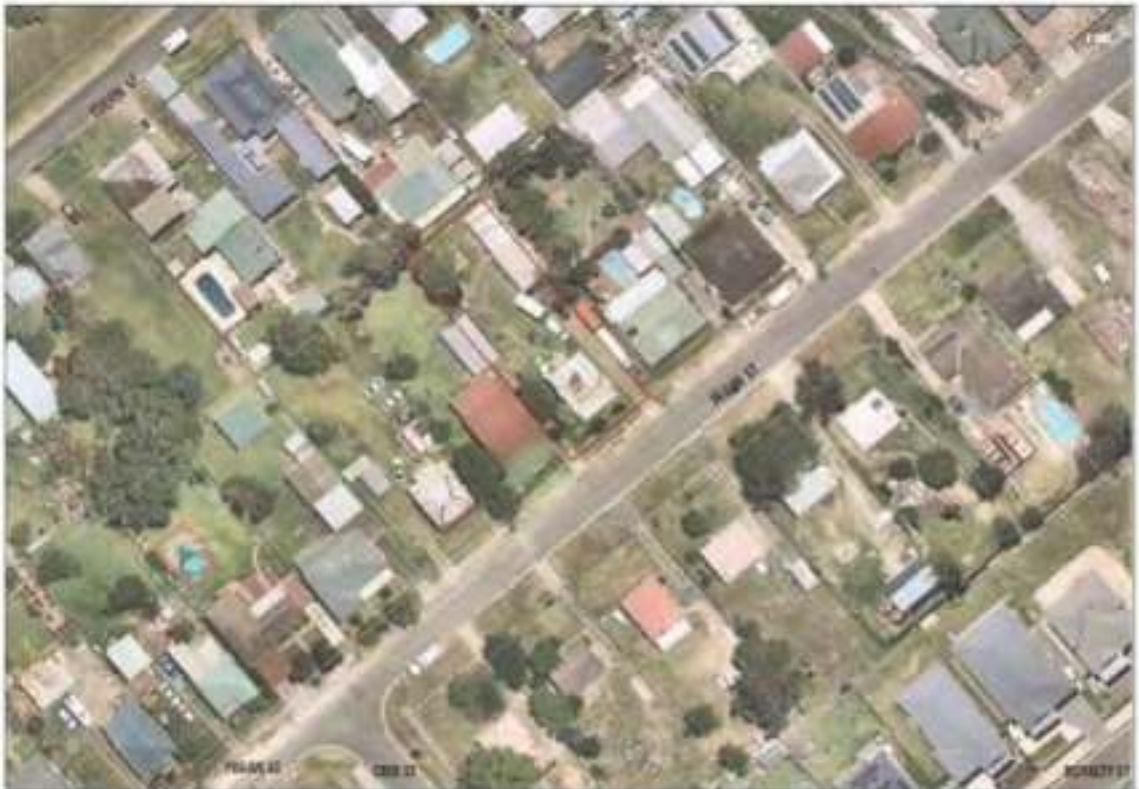
15 FEGAN STREET, WEST WALLSEND 2286

Conservation Area Contribution Level	Est. Construction Date	Previous studies and/or community input
Contributory 1	1890–1915	No prior heritage investigations and no additional information required
Assessment Text		Observed Modifications
<p>Single story Vernacular ‘Mining Cottage’ style dwelling with Colourbond hipped roof and weatherboard cladding. The veranda roof is skillion.</p> <p>The veranda is partially enclosed with timber lattice balustrade and solid wall constructions at either end.</p> <p>The front façade windows are heavy timber framed sash designs, with pronounced timber sill.</p> <p>A metal wire fence encloses the property.</p> <p>The dwelling displays architectural features of a heritage style and is representative of the local development of this period, being of historical significance for the HCA.</p>		<p>The lattice balustrade is a contemporary addition, likely replacing a timber design.</p> <p>The eastern and southern windows are contemporary sliding designs.</p>

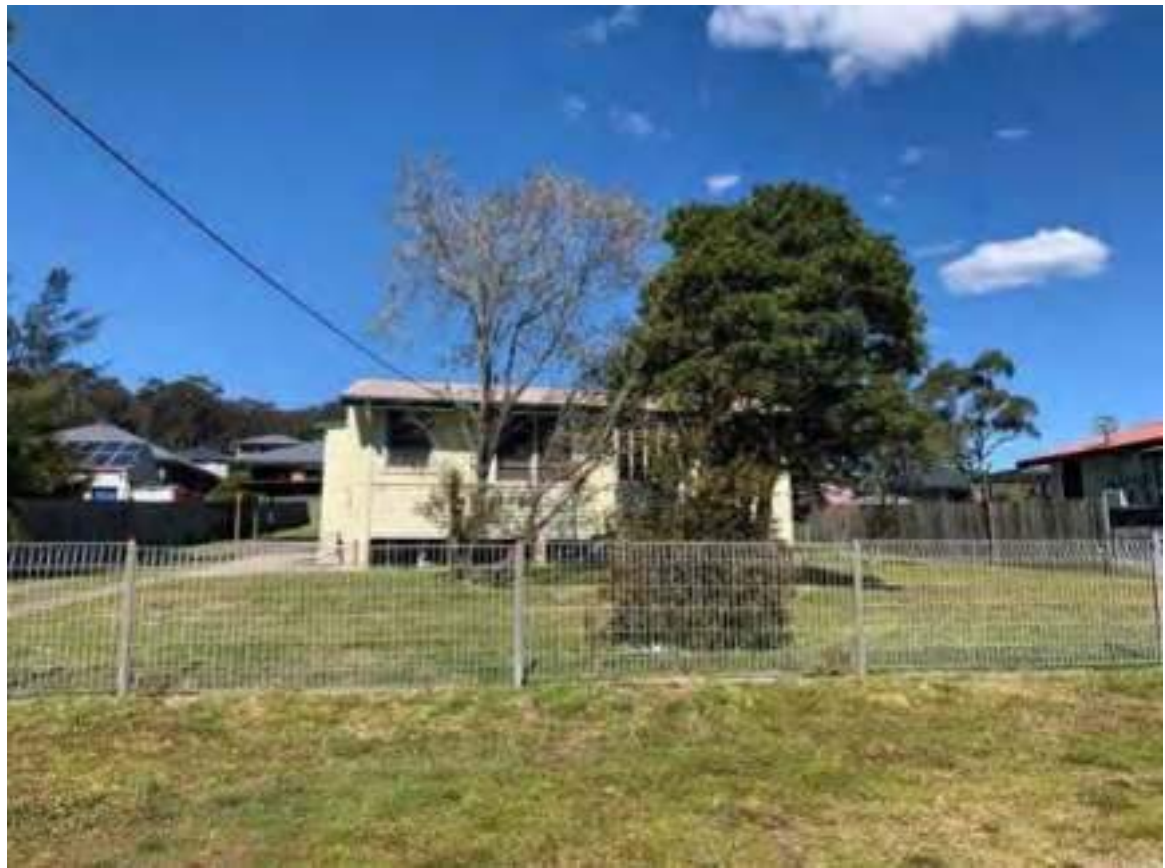
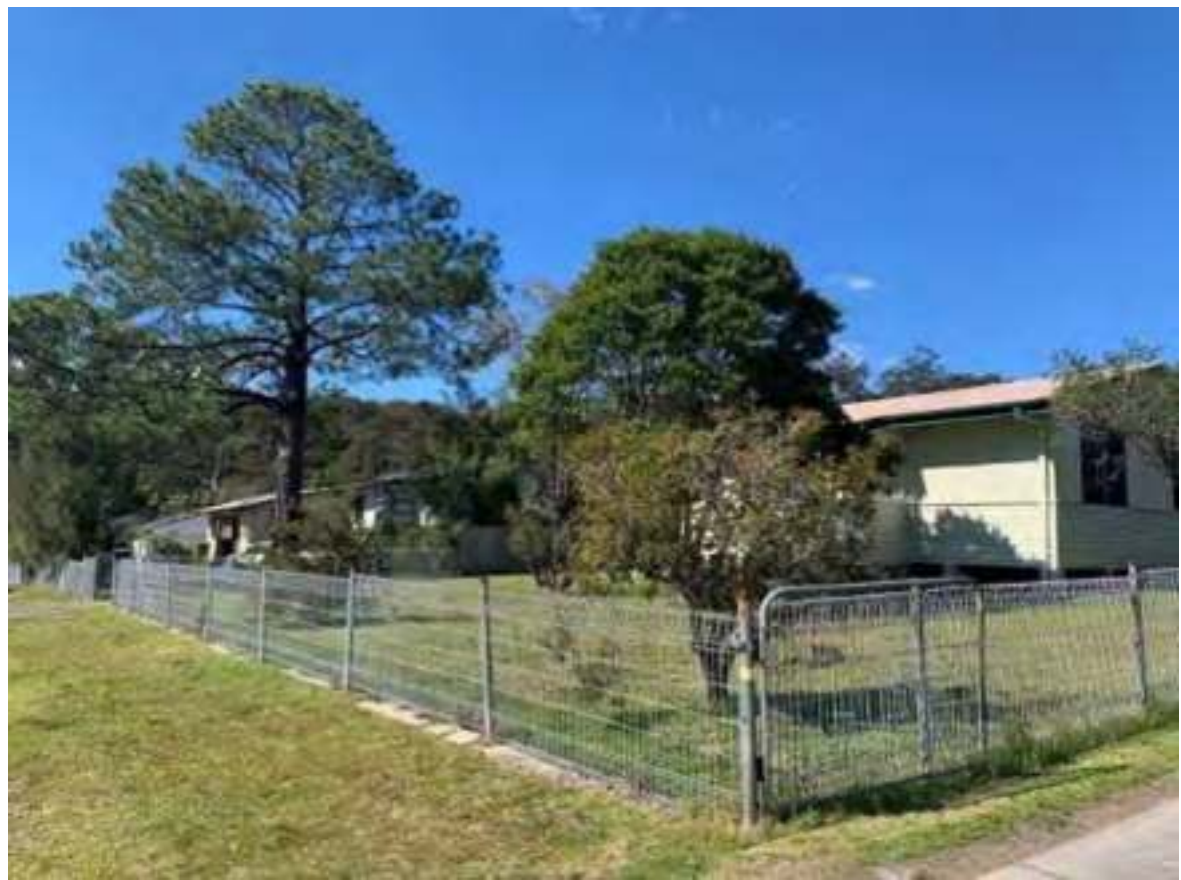
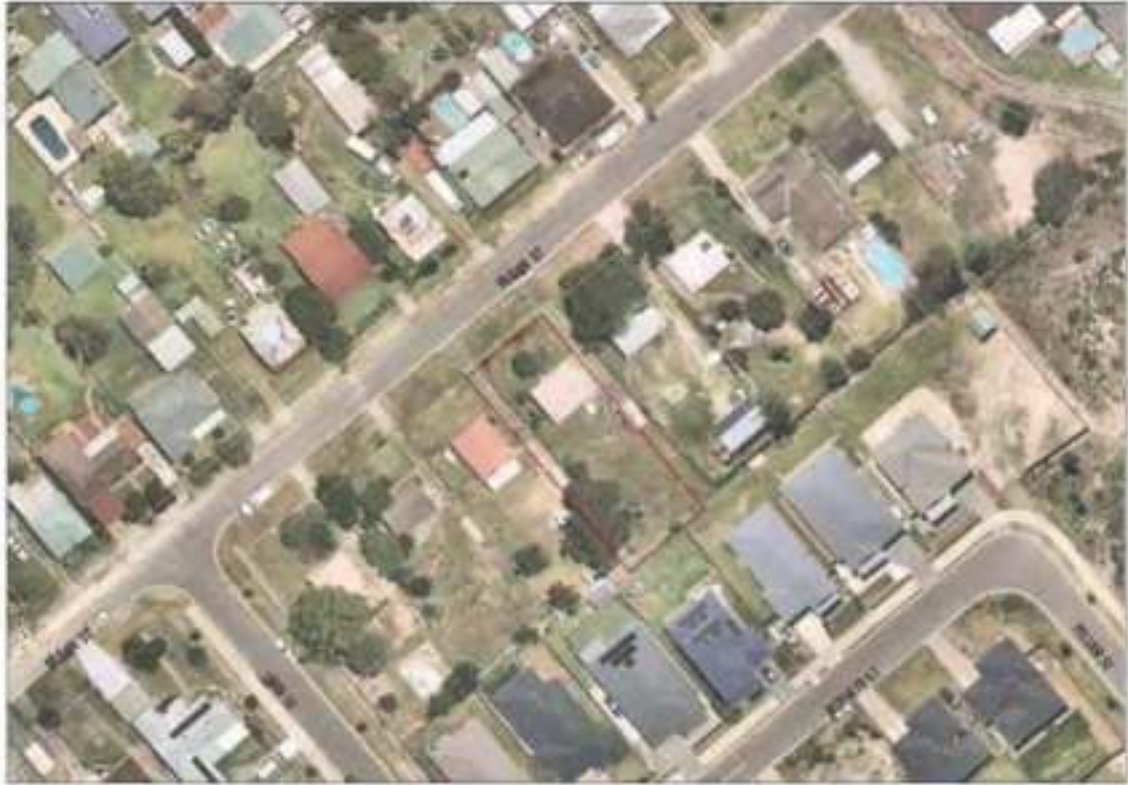
22 FEGAN STREET, WEST WALLSEND 2286

Conservation Area Contribution Level	Est. Construction Date	Previous studies and/or community input
Contributory 1	1930–1950	Potential ex-military accommodation.
Assessment Text		Observed Modifications
<p>Single story Inter-war dwelling with Colourbond gable roof and fibro-clad timber sheeting and boarding façade.</p> <p>The front door is located within a small alcove, with concrete steps and metal support rail.</p> <p>The visible windows are timber framed sash or awnings designs.</p> <p>A metal wire fence encloses the property.</p> <p>The dwelling displays architectural features of a heritage style and is representative of the local development of this period, being of historical significance for the HCA.</p>		No modifications observed.

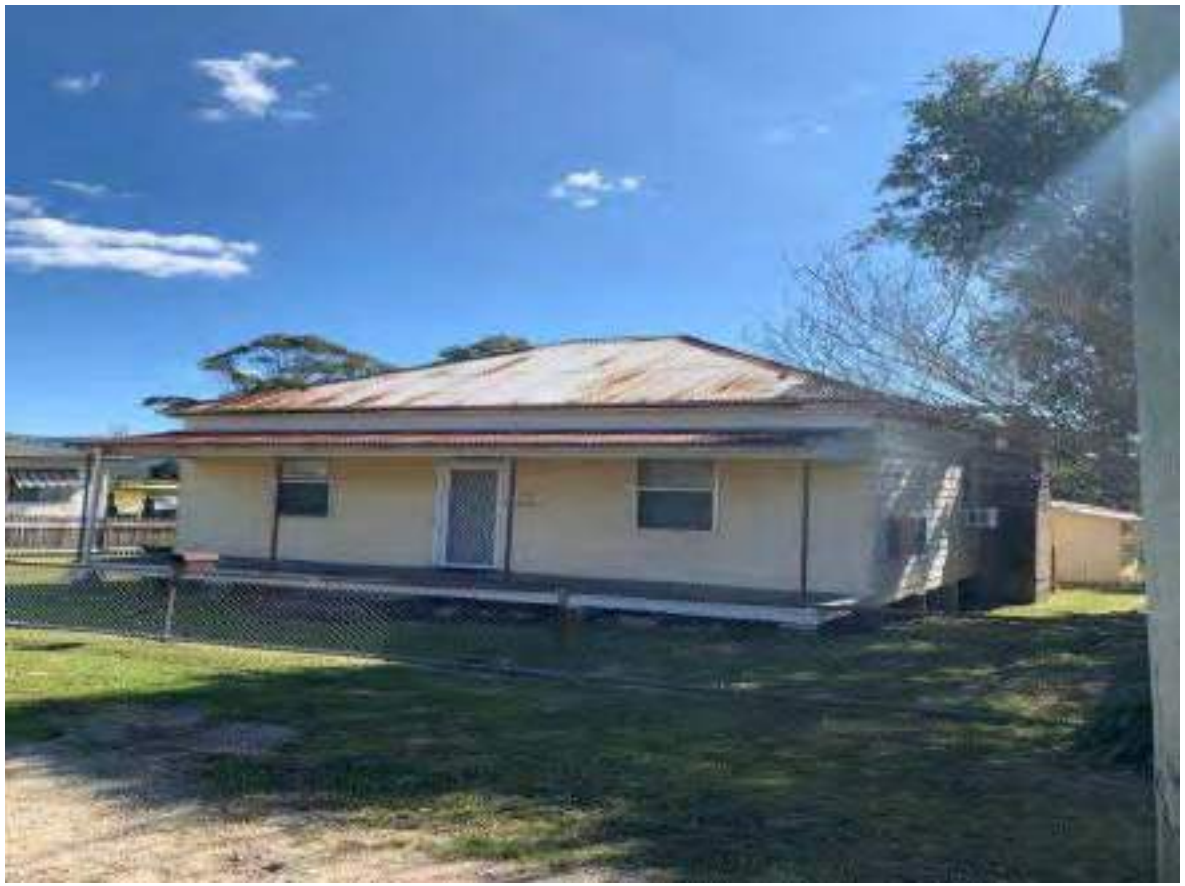
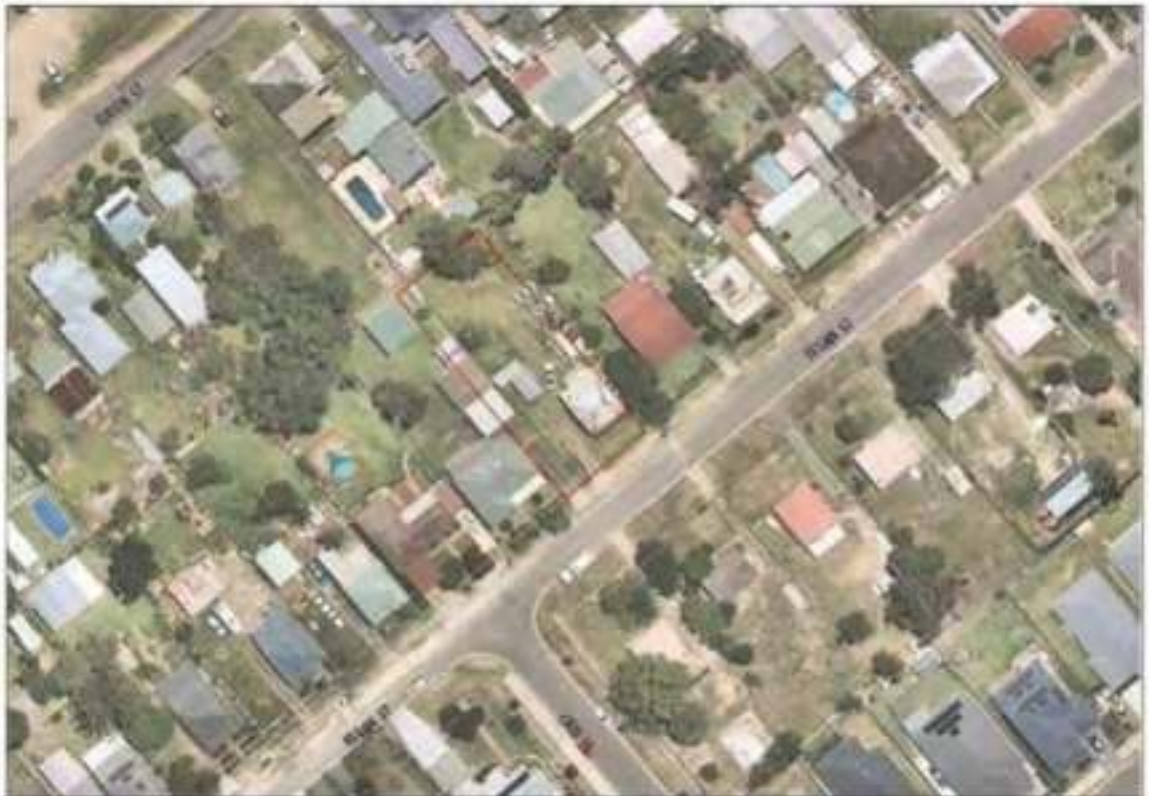
19 FEGAN STREET, WEST WALLSEND 2286

Conservation Area Contribution Level	Est. Construction Date	Previous studies and/or community input
Contributory 1	1890–1915	No prior heritage investigations and no additional information required
Assessment Text		Observed Modifications
<p>Single story Vernacular dwelling with hipped Colourbond roof and weatherboard cladding. The veranda roof is skillion.</p> <p>The veranda is open with timber flooring.</p> <p>The front door has a fan light above, timber framed.</p> <p>The dwelling displays architectural features of a heritage style and is representative of the local development of this period, being of historical significance for the HCA.</p>		<p>The visible windows are contemporary sash designs, likely replacing the original timber versions.</p> <p>The metal support poles are likely additions, replacing original timber posts.</p>

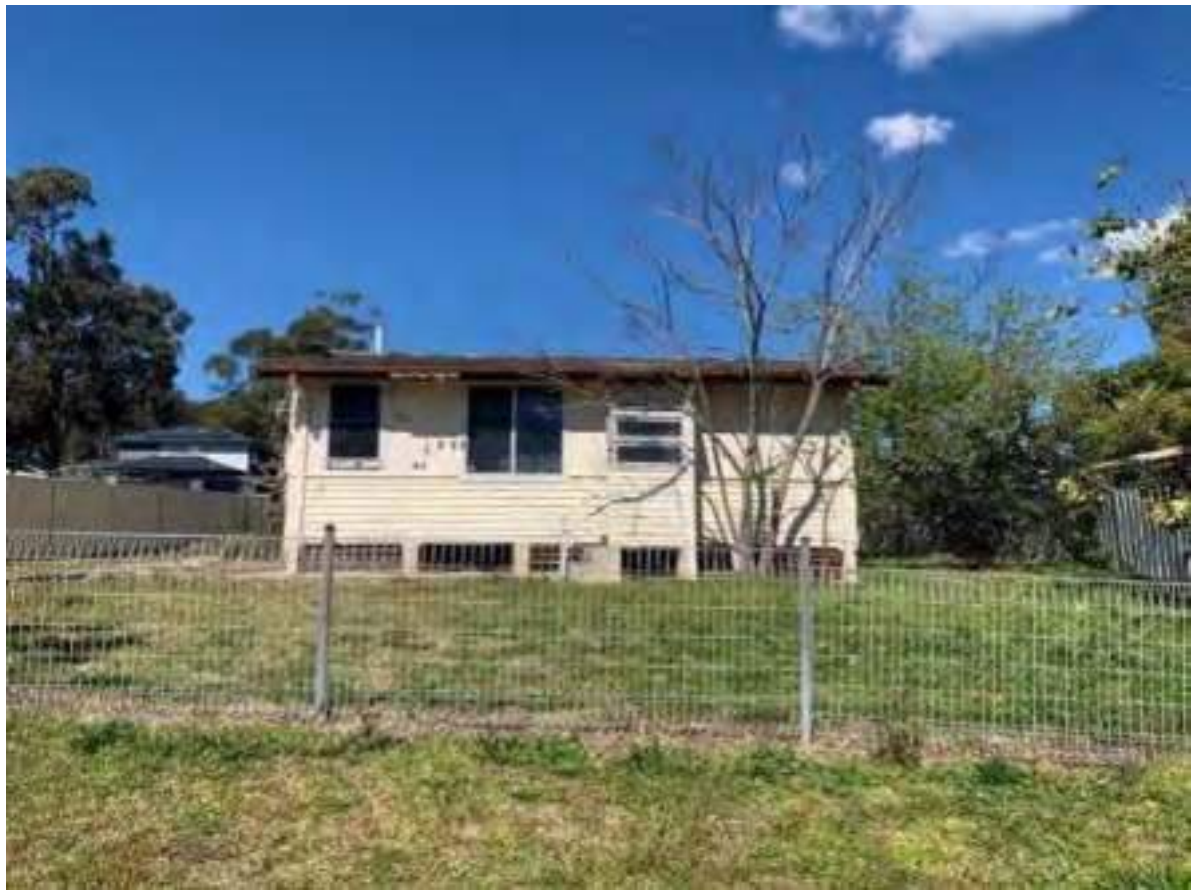
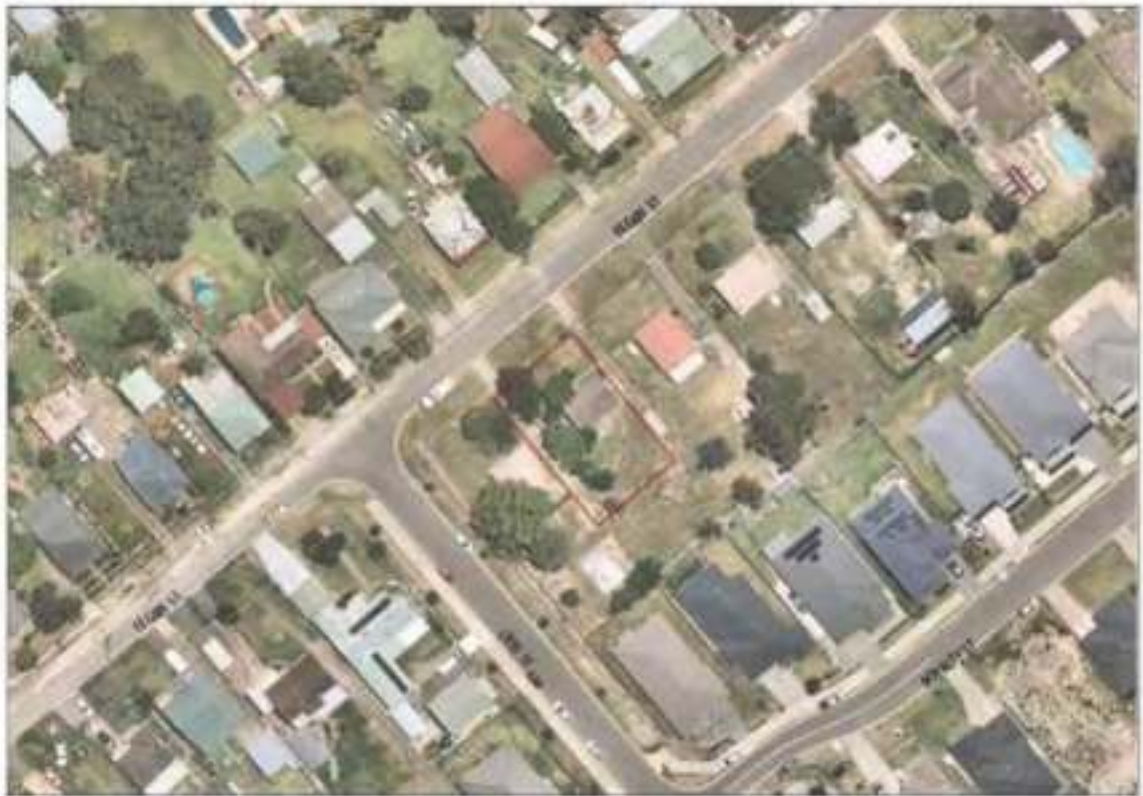
26 FEGAN STREET, WEST WALLSEND 2286

Conservation Area Contribution Level	Est. Construction Date	Previous studies and/or community input
Contributory 1	1930–1950	Potential ex-military accommodation.
Assessment Text		Observed Modifications
<p>Single story Inter-war dwelling with Colourbond gable roof and fibro-clad timber sheeting and boarding façade.</p> <p>The front door is located within a small alcove, with concrete steps and metal support rail.</p> <p>The visible windows are timber framed sash or awnings designs.</p> <p>A metal wire fence encloses the property.</p> <p>The dwelling displays architectural features of a heritage style and is representative of the local development of this period, being of historical significance for the HCA.</p>		No modifications observed.

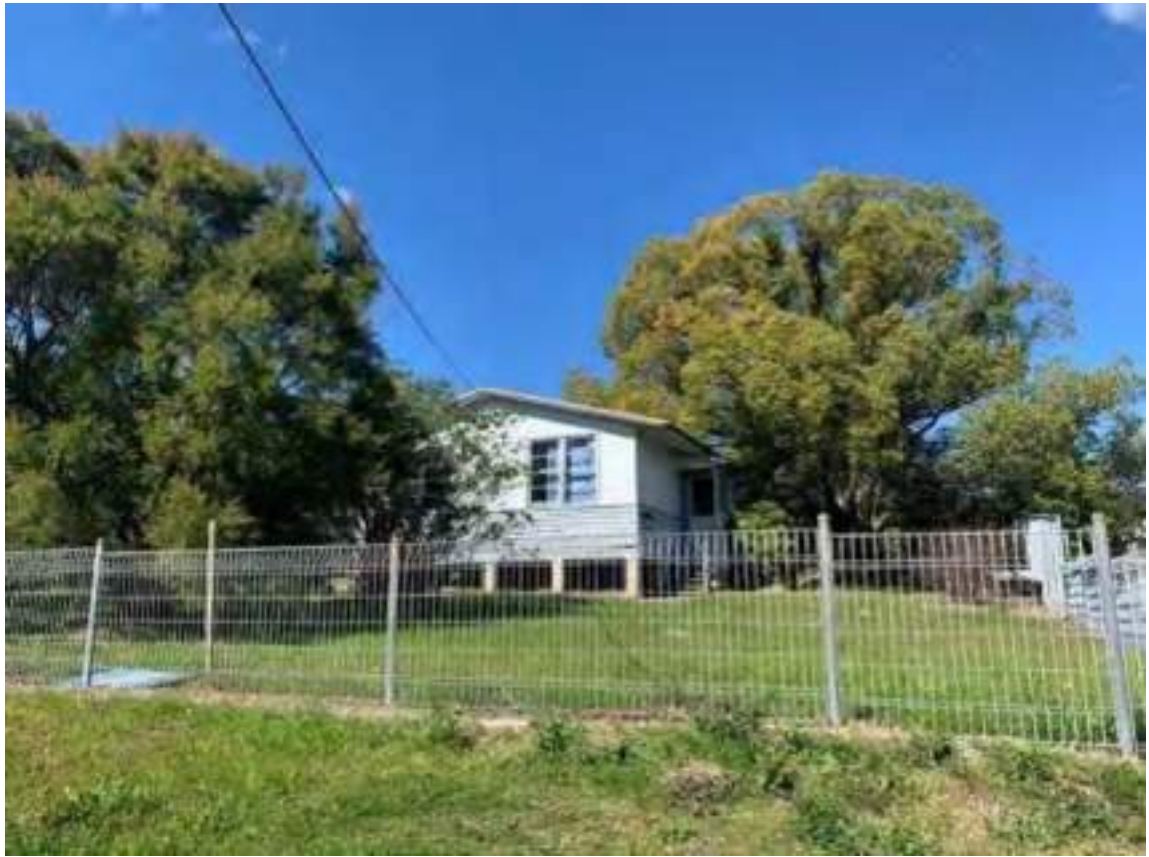
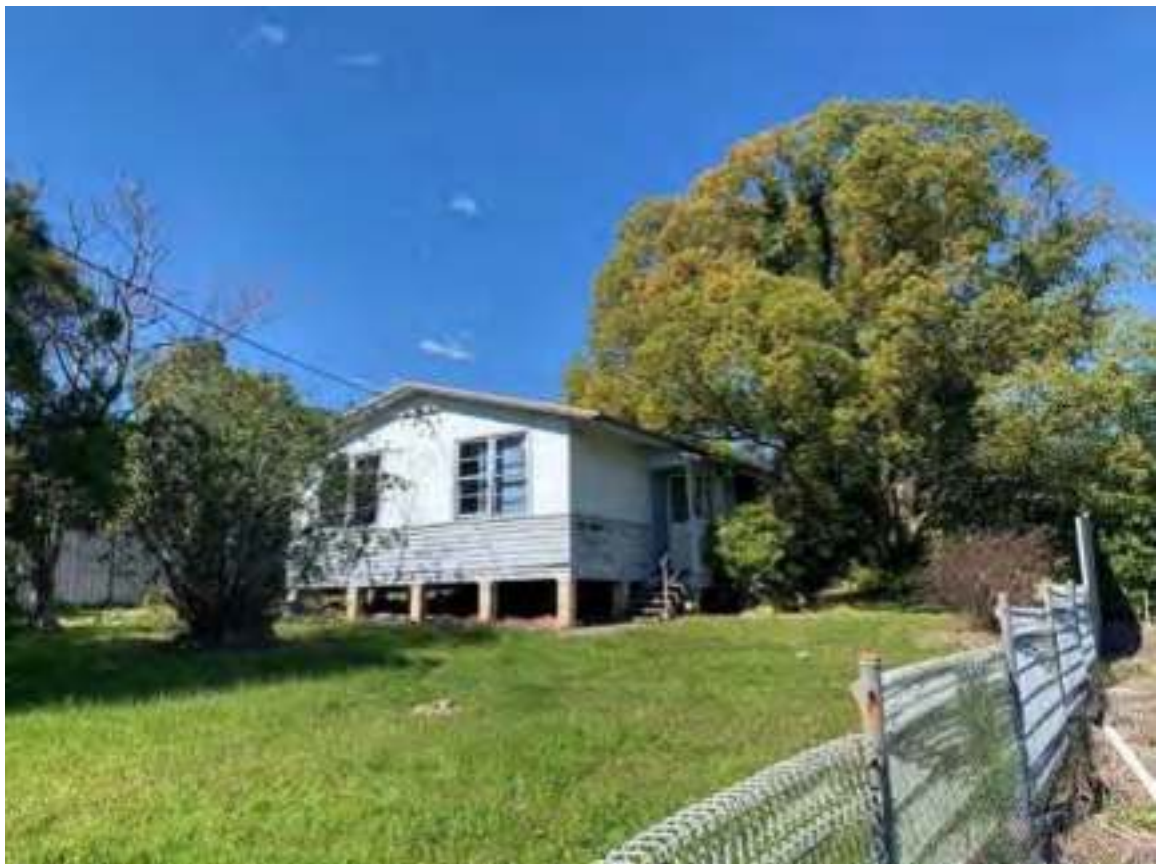
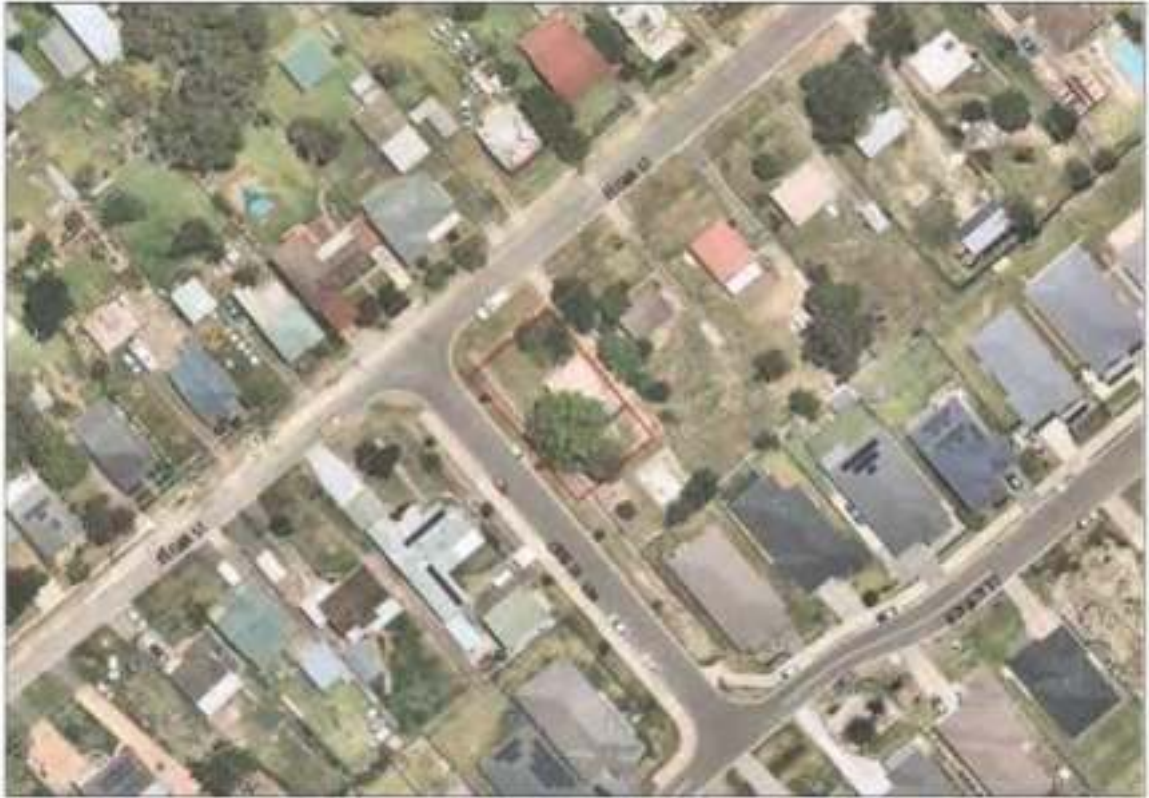
28 FEGAN STREET, WEST WALLSEND 2286

Conservation Area Contribution Level	Est. Construction Date	Previous studies and/or community input
Contributory 1	1930–1950	Potential ex-military accommodation.
Assessment Text		Observed Modifications
<p>Single story Inter-war dwelling with Colourbond gable roof and fibro-clad timber sheeting and boarding façade.</p> <p>The front door is located within a small alcove, with concrete steps and metal support rail.</p> <p>The visible windows are timber framed sash or awnings designs.</p> <p>A metal wire fence encloses the property.</p> <p>The dwelling displays architectural features of a heritage style and is representative of the local development of this period, being of historical significance for the HCA.</p>		No modifications observed.

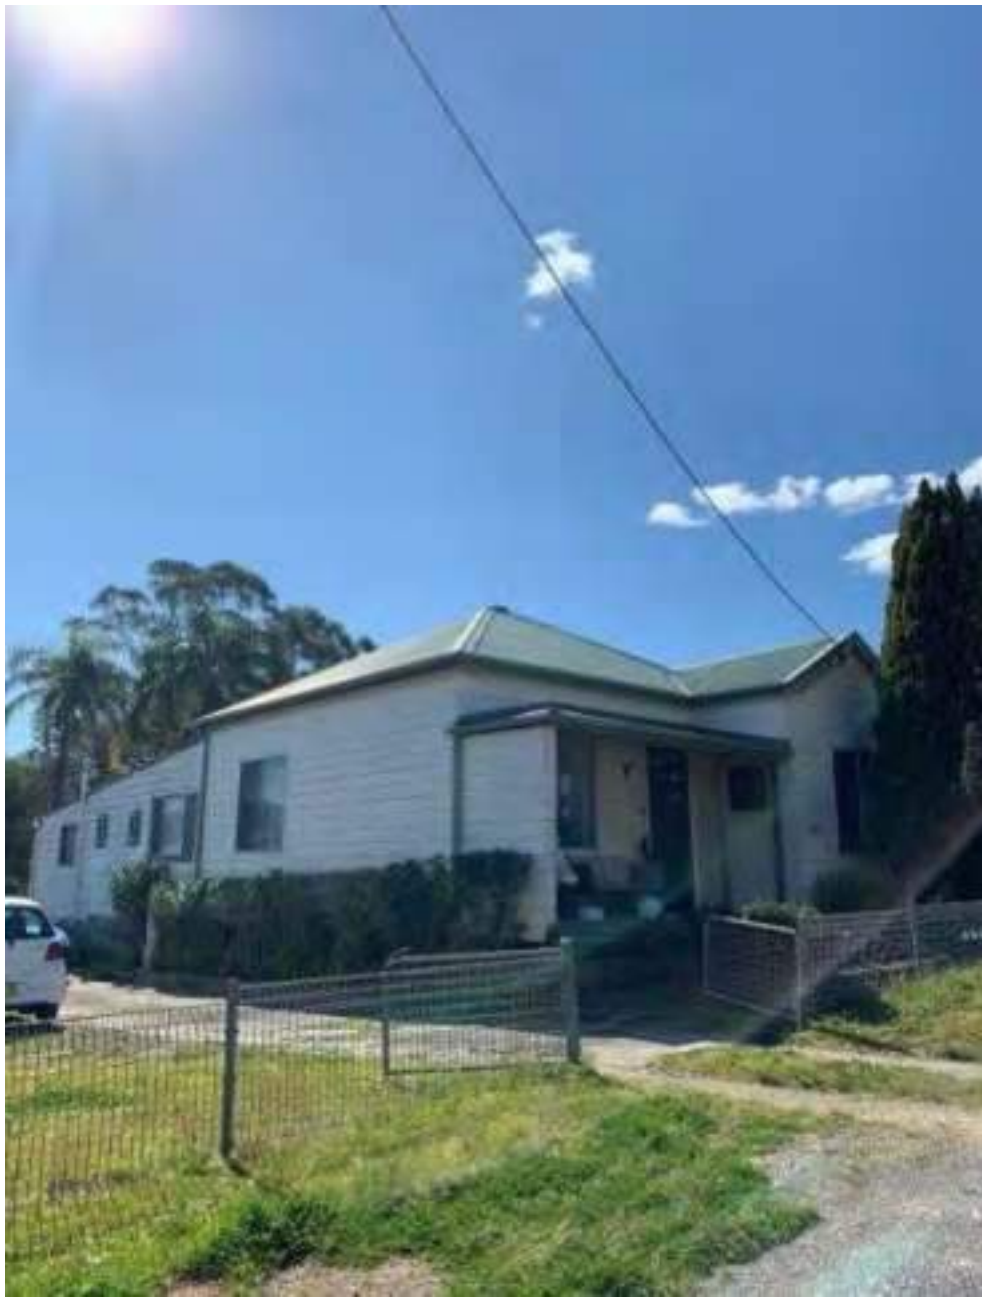
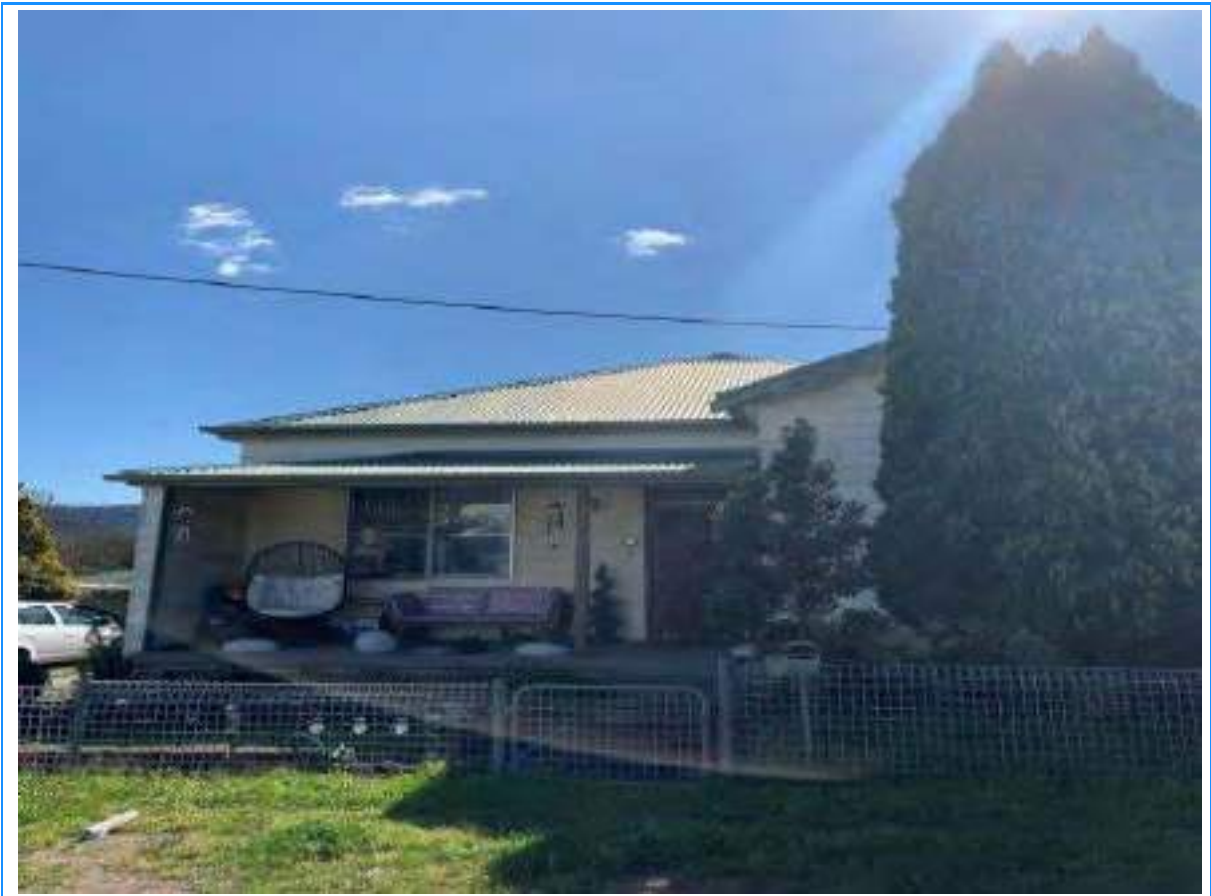
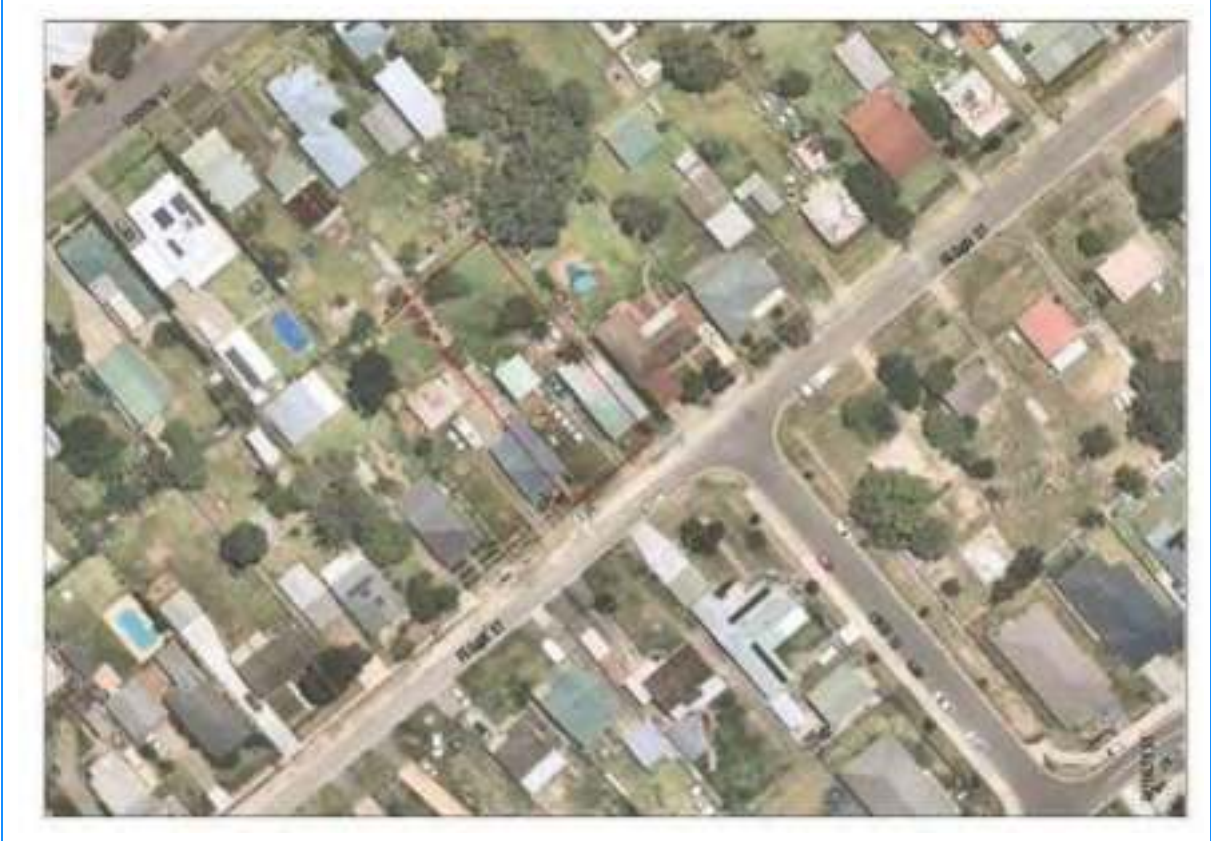
Conservation Area Contribution Level	Est. Construction Date	Previous studies and/or community input
Contributory 1	1900–1915	No prior heritage investigations and no additional information required
Assessment Text		Observed Modifications
<p>Single story simple Federation ‘workmen's cottage’ style dwelling with hipped Colourbond roof with gable projection and weatherboard cladding. The veranda roof is hipped.</p> <p>The veranda is open with timber flooring.</p> <p>The gable roof has decorative barge boards.</p> <p>A metal wire fence encloses the property.</p> <p>The dwelling displays architectural features of a heritage style and is representative of the local development of this period, being of historical significance for the HCA.</p>		<p>The visible windows are contemporary sliding designs.</p> <p>An extension has been constructed at the back northern side of the dwelling.</p>
