APPENDIX 2

Building Assessment Sheets (Inventory Sheets)

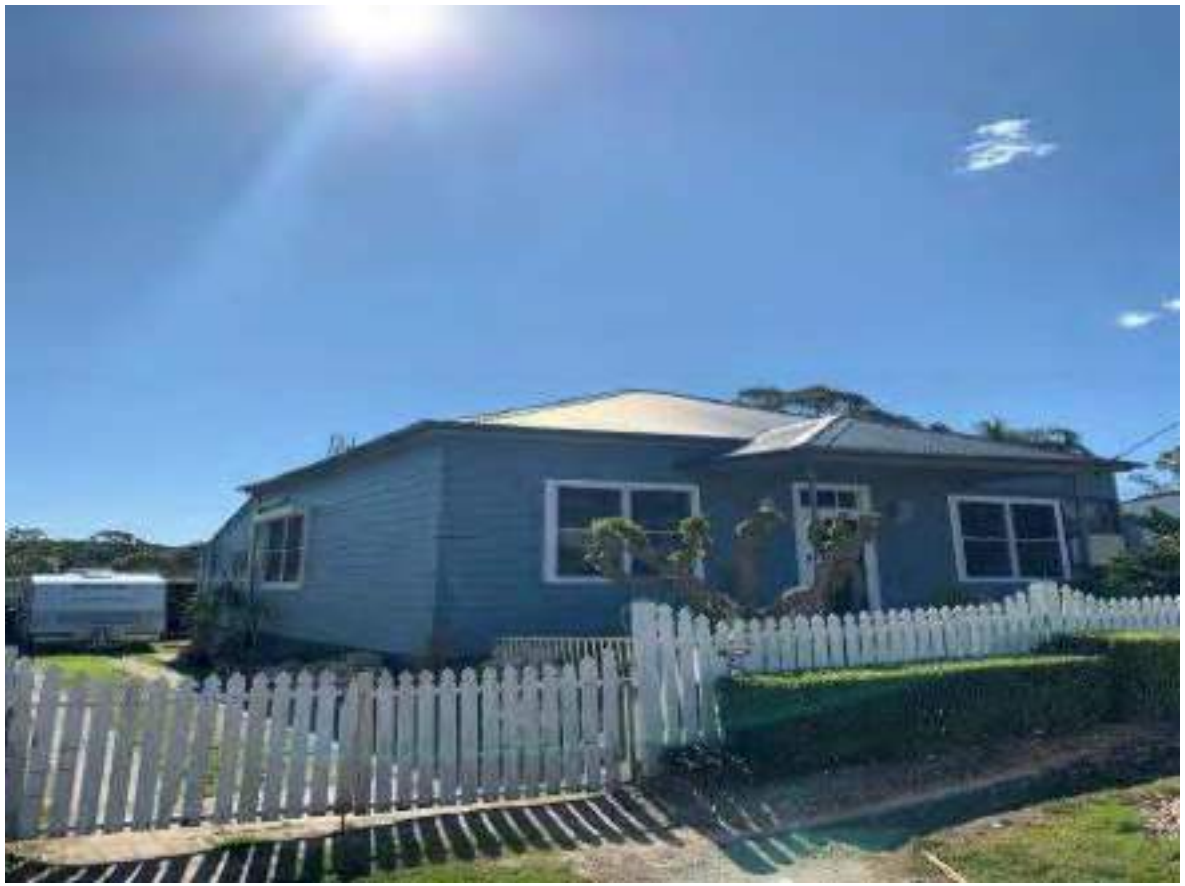
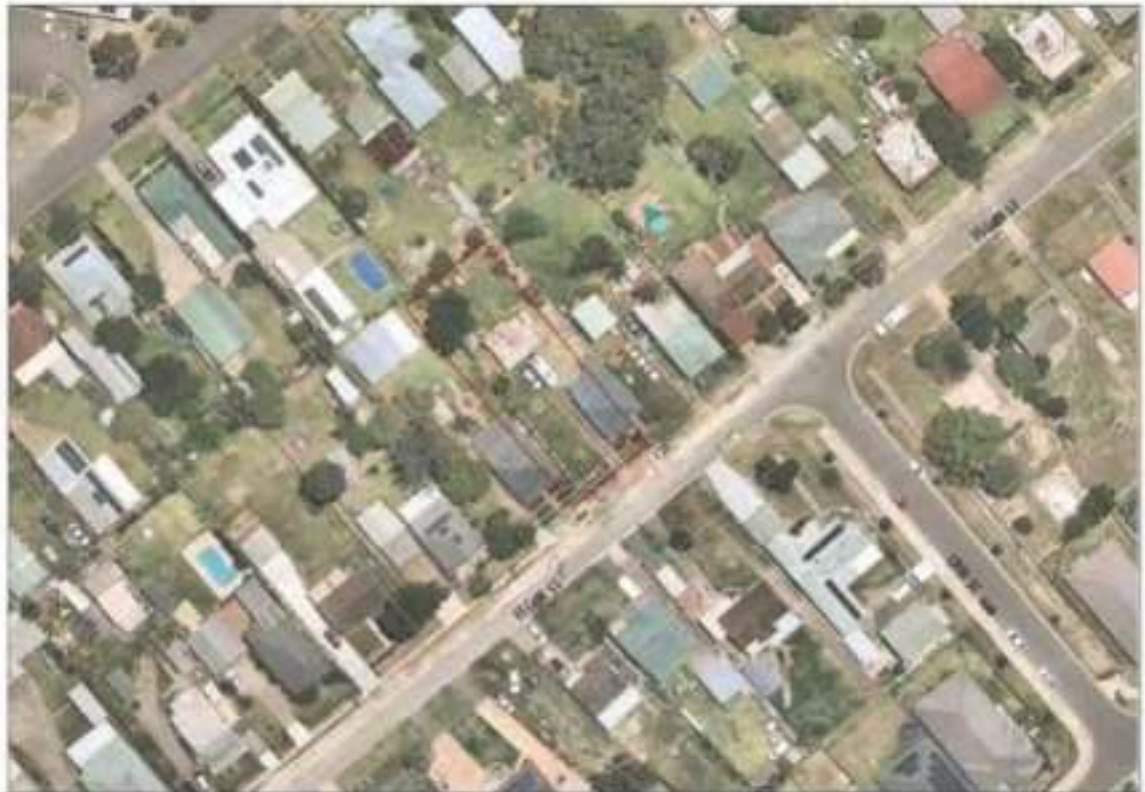
27 FEGAN STREET, WEST WALLSEND 2286

Conservation Area Contribution Level	Est. Construction Date	Previous studies and/or community input
Contributory 1	1890–1915	No prior heritage investigations and no additional information required
Assessment Text		Observed Modifications
<p>Single story Vernacular cottage style dwelling with hipped Colourbond roof and weatherboard cladding. The veranda roof is a small hipped projection.</p> <p>The front door is timber framed with a triple panel fan light above. The visible windows are similarly timber framed.</p> <p>Timber picket fence encloses the property.</p> <p>The dwelling displays architectural features of a heritage style and is representative of the local development of this period, being of historical significance for the HCA.</p>		<p>The façade windows are likely contemporary additions, however are sympathetic in style.</p>

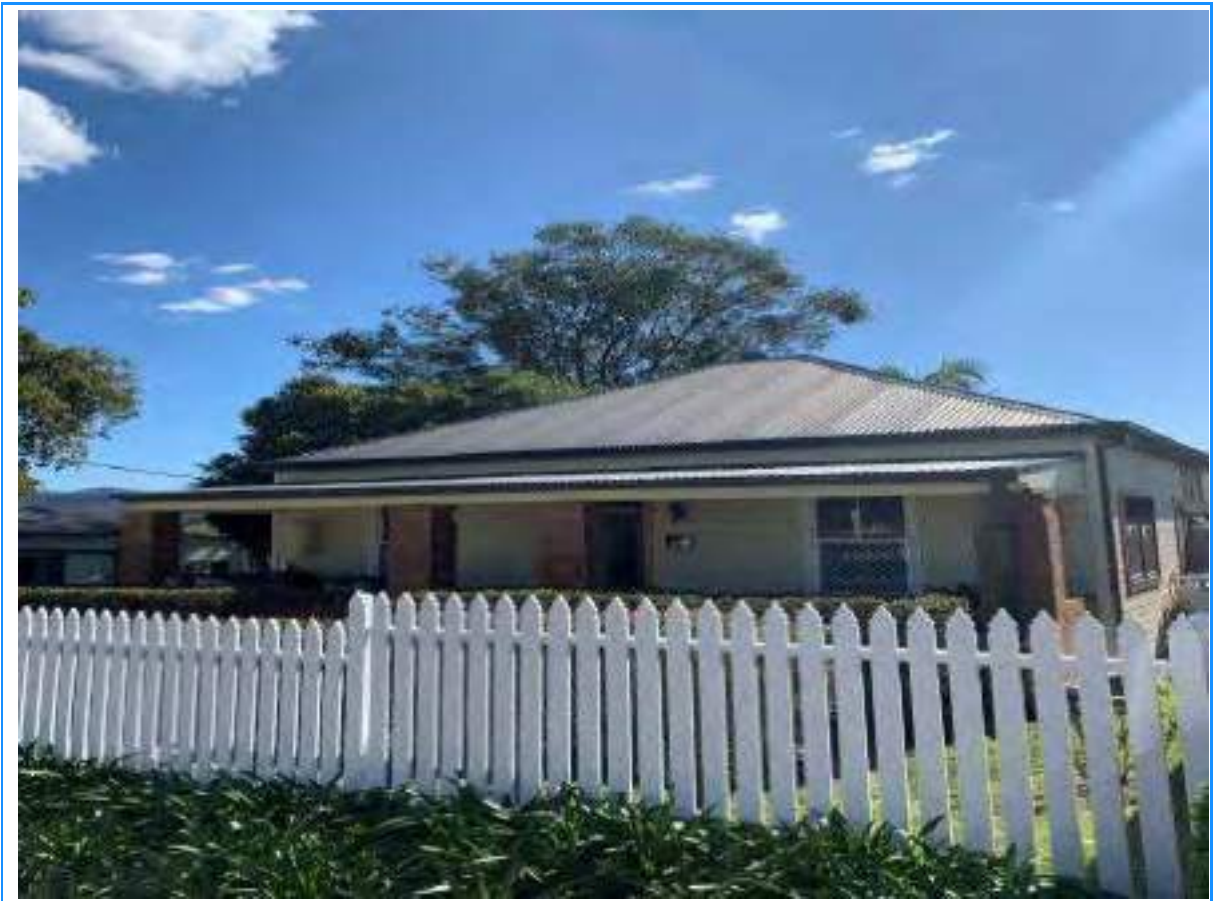
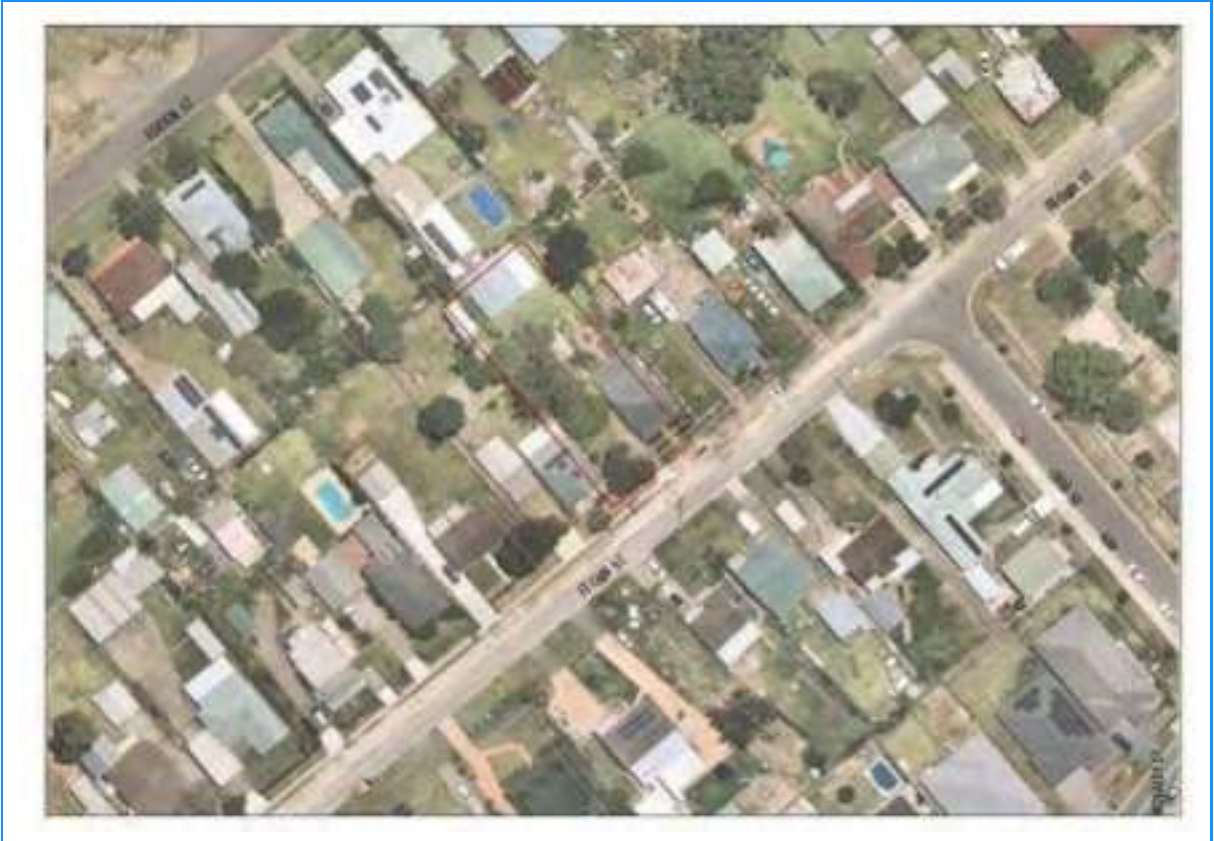
Conservation Area Contribution Level	Est. Construction Date	Previous studies and/or community input
Contributory 1	1890–1915	No prior heritage investigations and no additional information required
Assessment Text		Observed Modifications
<p>Single story Vernacular ‘Mining Cottage’ style dwelling with steep hipped Colourbond roof and timber weatherboard cladding. The veranda roof is skillion and supported by brick pillars.</p> <p>The visible windows are the original heavy timber framed sash designs. The western windows retain their timber awnings.</p> <p>Two brickwork chimneys are visible on the eastern side of the dwelling.</p> <p>A timber picket fence encloses the property.</p> <p>The dwelling displays architectural features of a heritage style and is representative of the local development of this period, being of historical significance for the HCA.</p>		<p>The brick support pillars are a contemporary modification, likely replacing original timber posts.</p> <p>The chimney shafts have been removed.</p> <p>An extension has been constructed at the back northern end of the dwelling.</p>

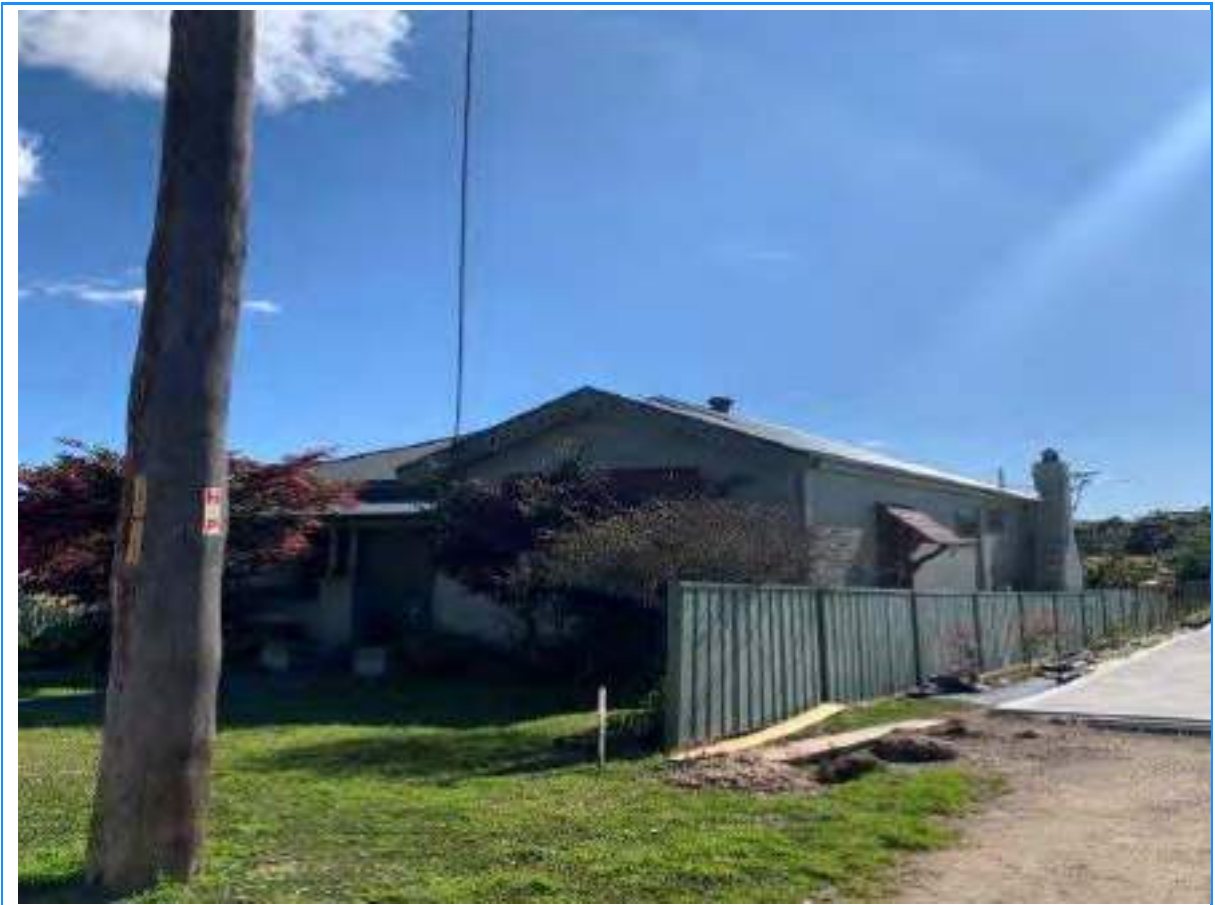
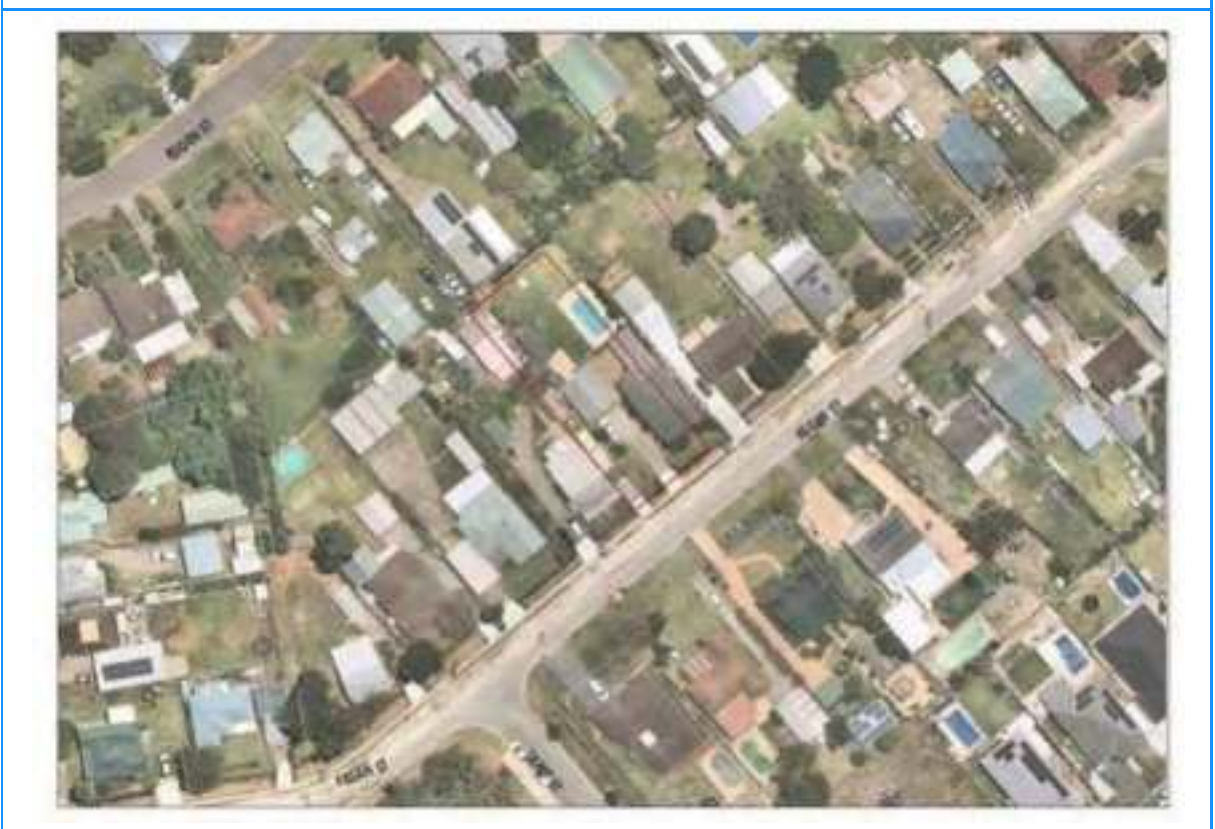
Conservation Area Contribution Level	Est. Construction Date	Previous studies and/or community input
Contributory 1	1900–1915	No prior heritage investigations and no additional information required
Assessment Text		Observed Modifications
<p>Single story simply Federation ‘workmen's cottage’ style dwelling with hipped Colourbond roof with gable projection and weatherboard cladding. The veranda roof is skillion and supported by brick piers with tapered timber posts.</p> <p>The veranda is partially enclosed with a rendered brick wall and piers.</p> <p>The front door is timber framed with a fan light above.</p> <p>The gable has decorative barge boards and a timber shingle awnings. shingled awnings are also found on the eastern and western sides of the dwelling,</p> <p>A brickwork chimney is visible on the eastern side, with a terracotta pot.</p> <p>The dwelling displays architectural features of a heritage style and is representative of the local development of this period, being of historical significance for the HCA.</p>		<p>An extension has been built onto the back north western portion of the dwelling, however this is not visible and does not detract from the heritage streetscape.</p> <p>The brick veranda wall and piers are likely dated modifications and were constructed in a sympathetic manner.</p>

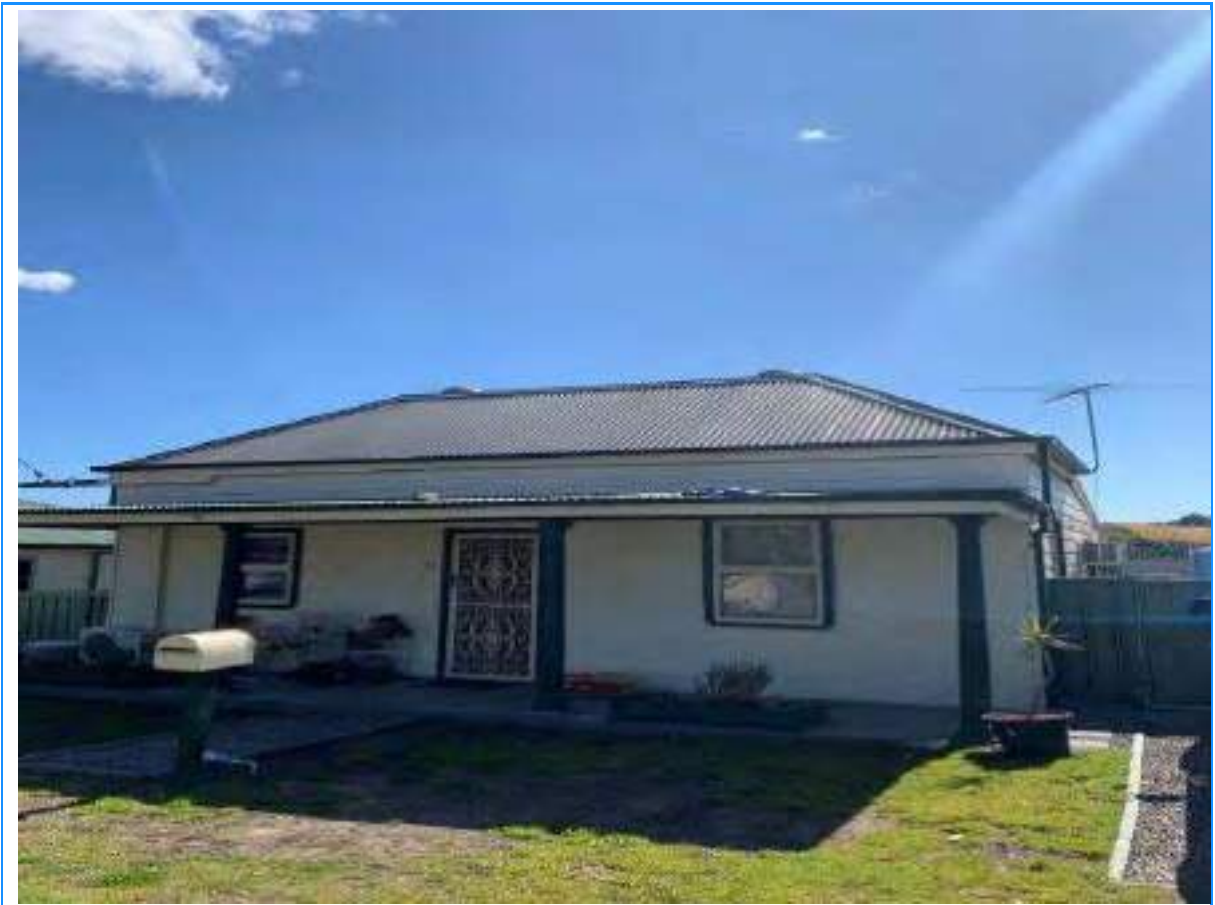
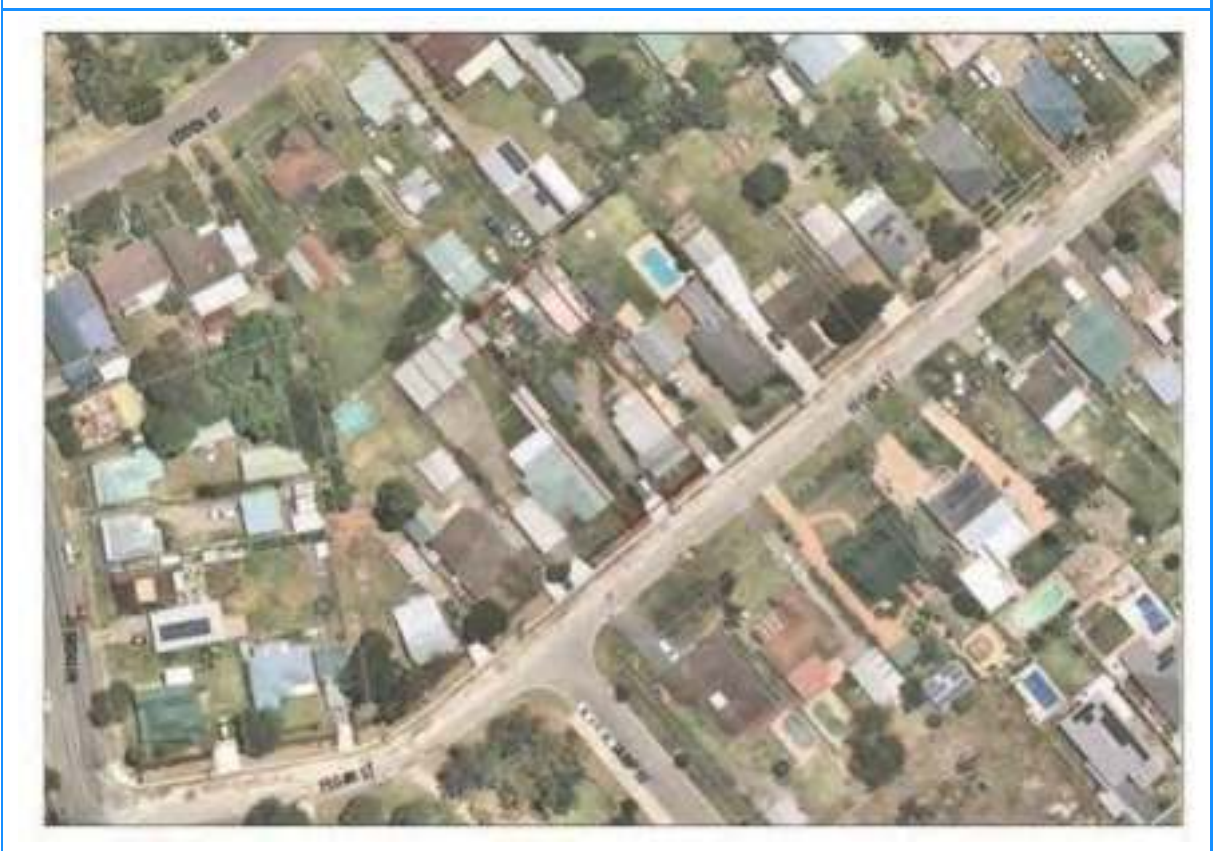
Conservation Area Contribution Level	Est. Construction Date	Previous studies and/or community input
Contributory 1	1890–1915	No prior heritage investigations and no additional information required
Assessment Text		Observed Modifications
<p>Single story Vernacular ‘Mining Cottage’ style dwelling with hipped Colourbond roof and weatherboard cladding. The veranda roof is skillion and supported by faux Corinthian style pillars.</p> <p>The front façade windows are the original timber framed sash designs.</p> <p>The dwelling displays architectural features of a heritage style and is representative of the local development of this period, being of historical significance for the HCA.</p>		<p>The front door has a prominent metal screen decorative door, which detracts from the heritage features of the dwelling.</p> <p>The Corinthian style pillars are a contemporary addition, likely replacing original timber posts.</p>

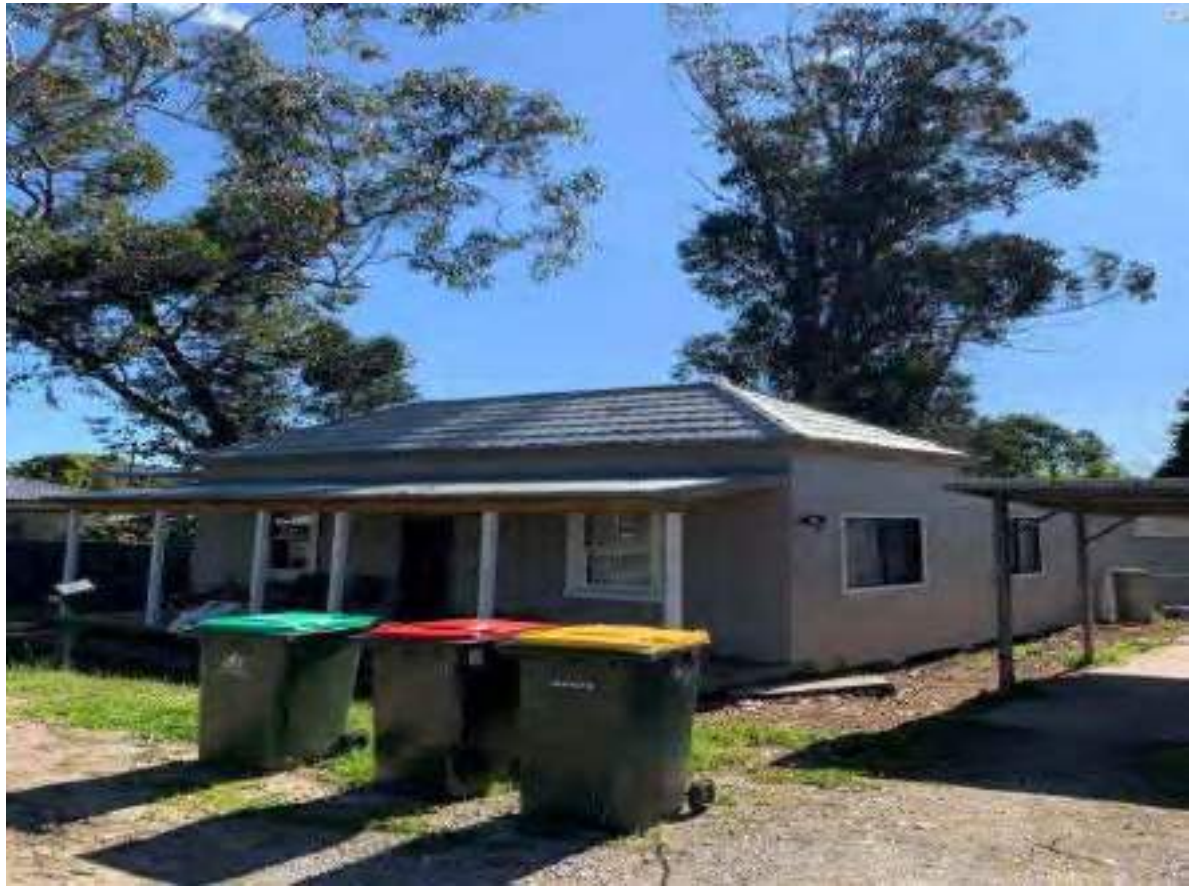
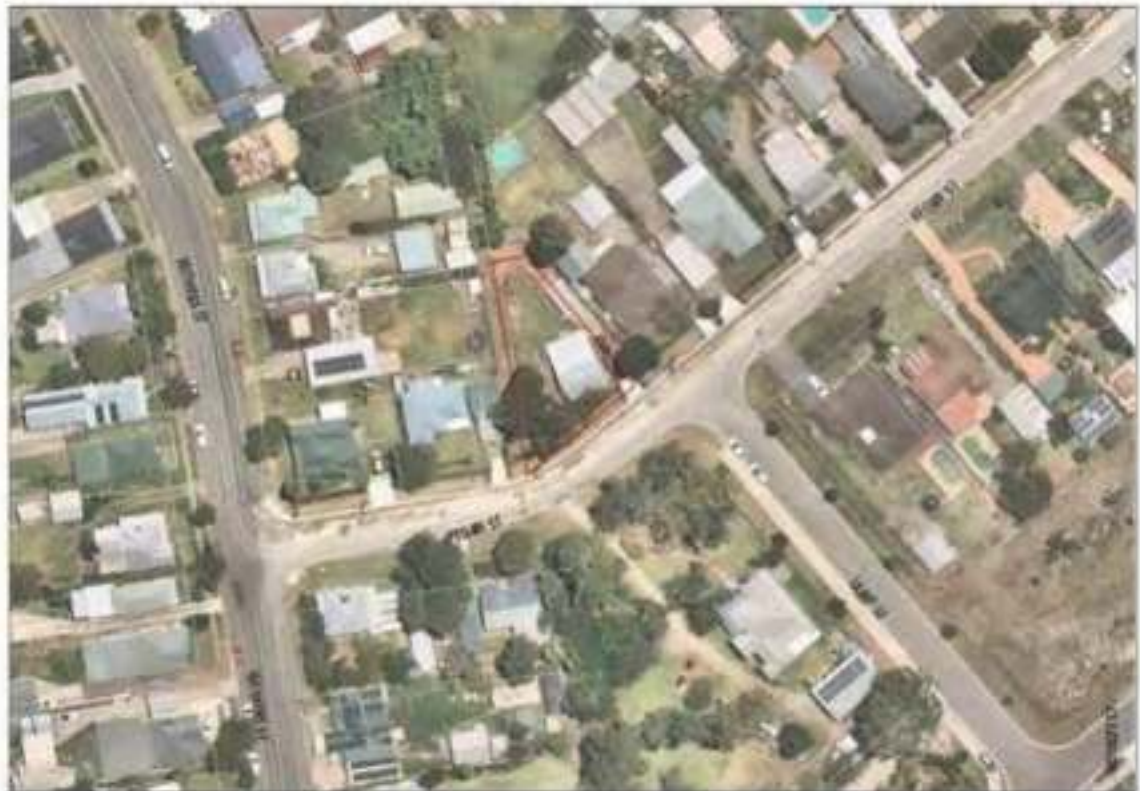
43 FEGAN STREET, WEST WALLSEND 2286

Conservation Area Contribution Level	Est. Construction Date	Previous studies and/or community input
Contributory 1	1890–1915	No prior heritage investigations and no additional information required
Assessment Text		Observed Modifications
<p>Single story Vernacular ‘Mining Cottage’ style dwelling with tiled hipped roof and weatherboard cladding. The veranda roof is skillion.</p> <p>The front façade windows are the original timber framed sash designs.</p> <p>A car port is located directly to the east of the dwelling.</p> <p>The dwelling displays architectural features of a heritage style and is representative of the local development of this period, being of historical significance for the HCA.</p>		<p>The tiled roofing is a contemporary modification, having been recently undertaken during the renovation works of the dwelling.</p> <p>The dwelling is currently undergoing renovation works, having previously fallen into a state of disrepair.</p>

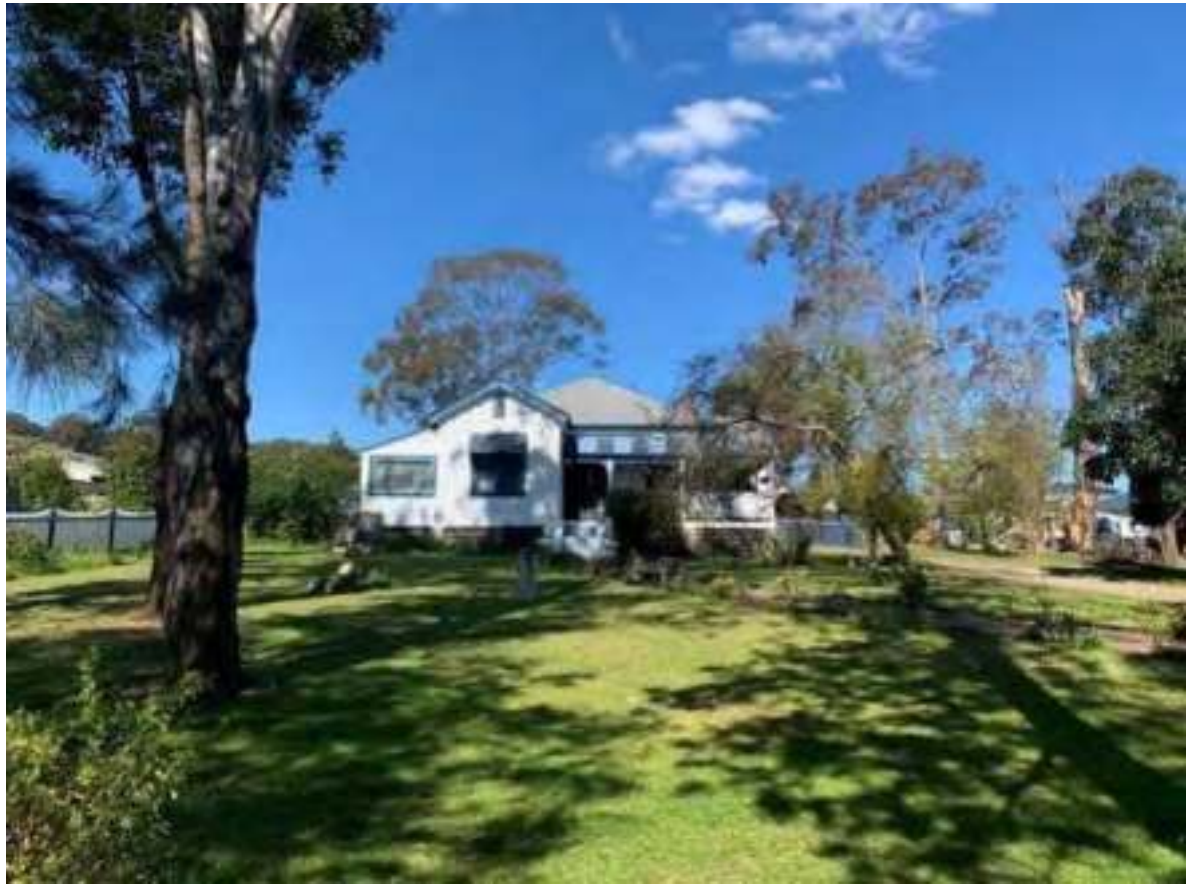
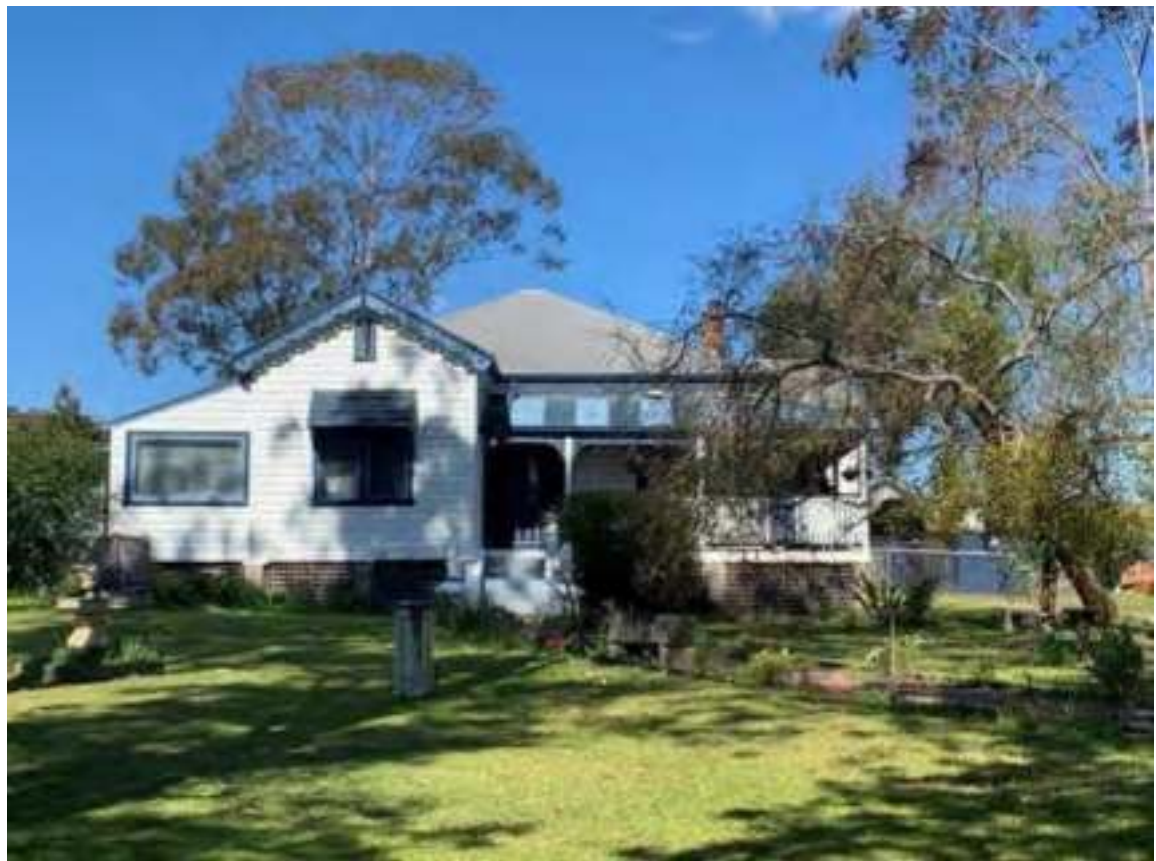
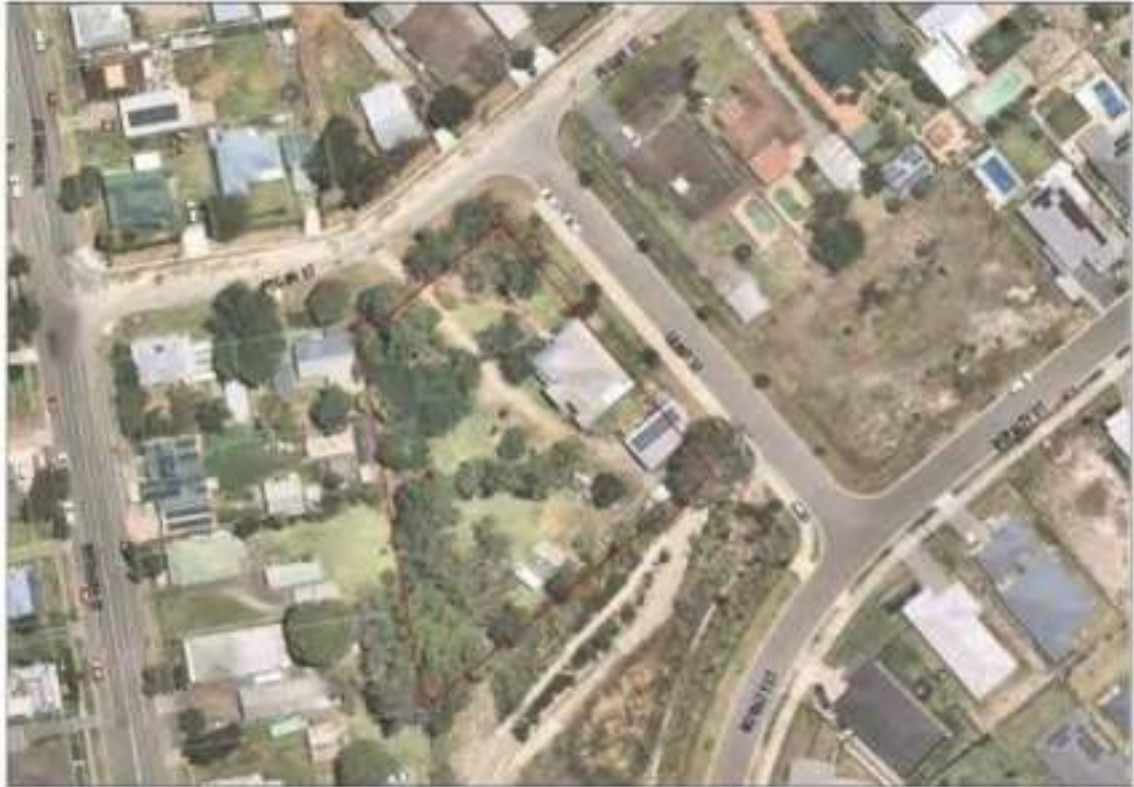
46 FEGAN STREET, WEST WALLSEND 2286

Conservation Area Contribution Level	Est. Construction Date	Previous studies and/or community input
Contributory 1	1890–1920	No prior heritage investigations and no additional information required
Assessment Text		Observed Modifications
<p>Single story simple Federation ‘workmen's cottage’ style dwelling with hipped Colourbond roof with gable projection and weatherboard cladding. The veranda roof is bull nosed, with alternating blue stripes.</p> <p>The veranda roof is supported by timber posts with ornately designed cast iron lace valance. Masonry stairs with lion topped piers lead onto the landing.</p> <p>The front door is seemingly original, with a multipaned timber design. The visible windows are the original heavy timber framed sash designs. Timber shingle awnings are above.</p> <p>A brickwork chimney is visible on the western side of the dwelling.</p> <p>The gable has decorative barge boards and timber finial.</p> <p>The dwelling displays architectural features of a heritage style and is representative of the local development of this period, being of historical significance for the HCA.</p>		<p>An extension has been constructed onto the northern portion of the dwelling. This is highly visible but has been constructed in a sympathetic manner and does not detract from the heritage streetscape.</p>

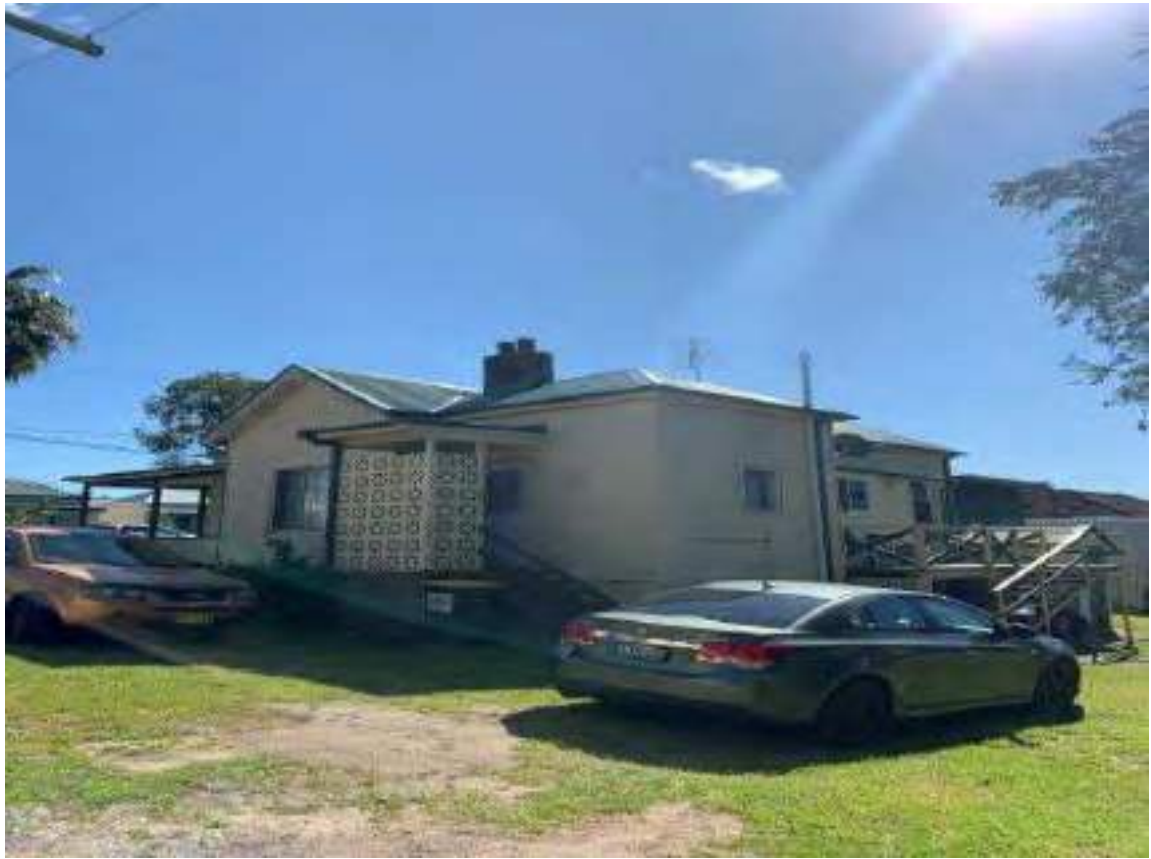
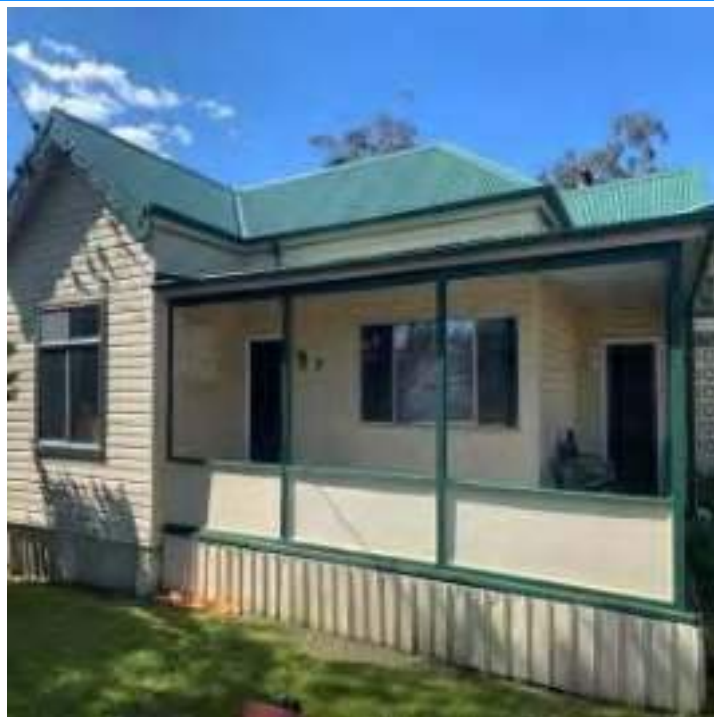
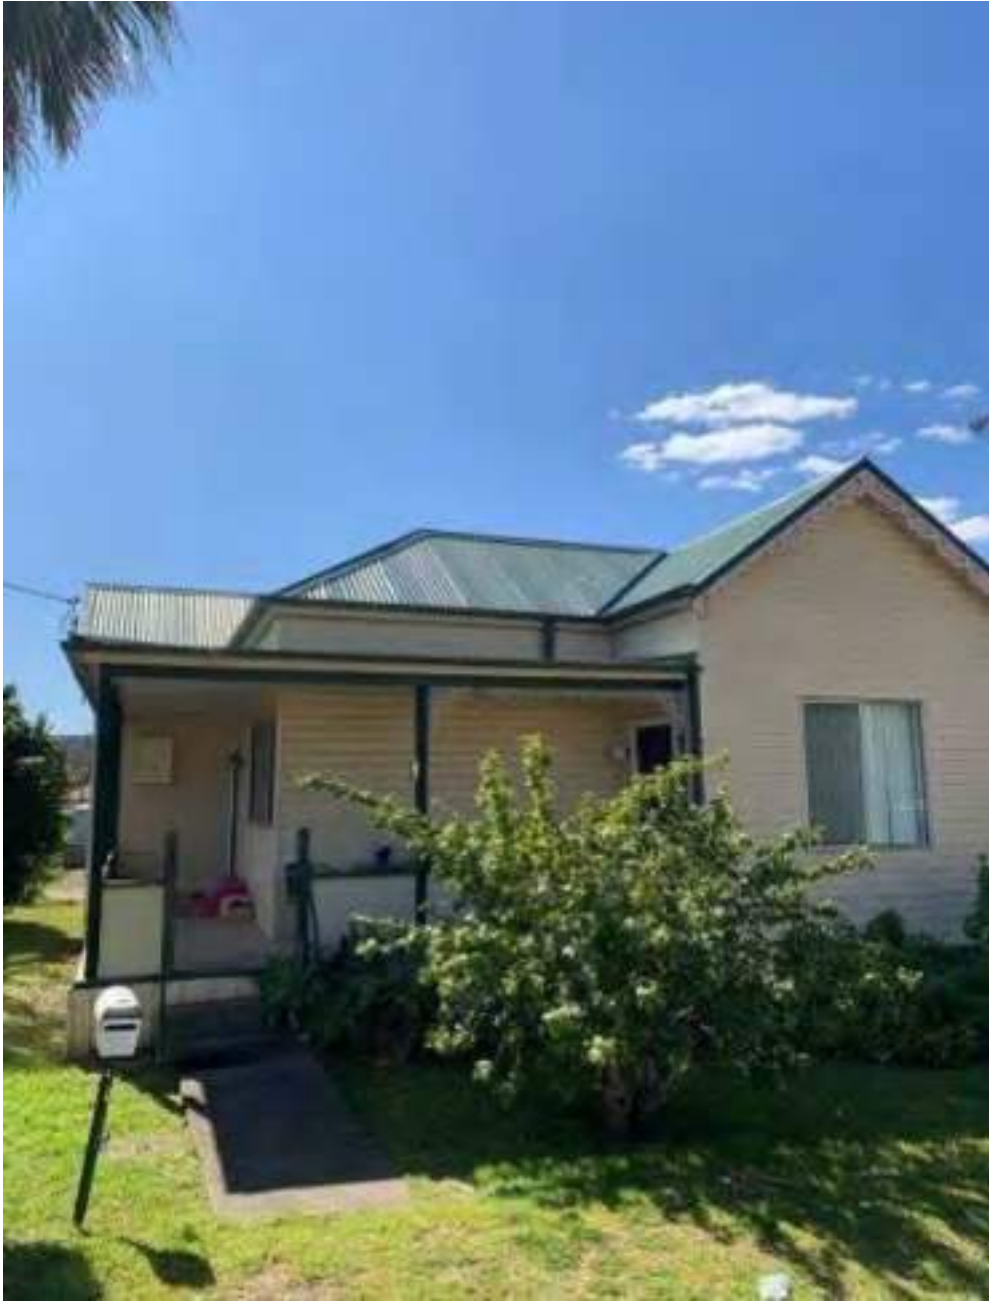
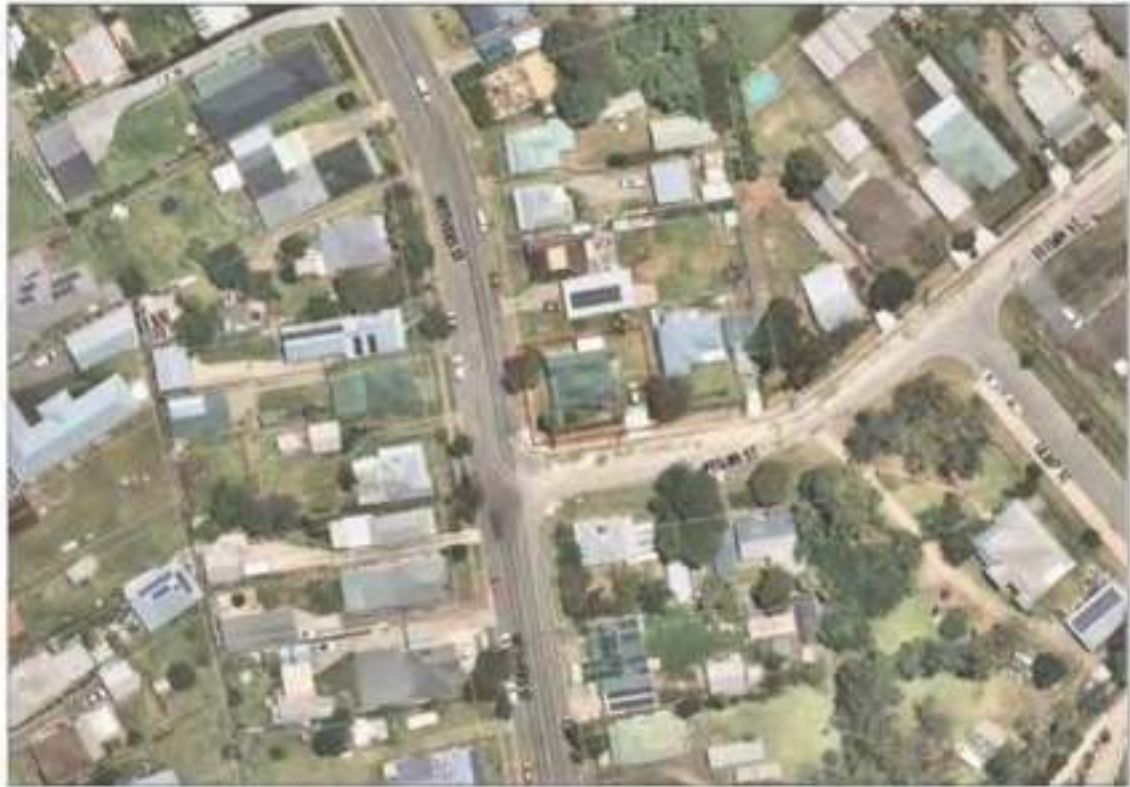
UNIT 2, 57 WITHERS STREET, WEST WALLSEND 2286

Conservation Area Contribution Level	Est. Construction Date	Previous studies and/or community input
Contributory 1	1900–1920	No prior heritage investigations and no additional information required
Assessment Text		Observed Modifications
<p>Single story simplified Federation Queen Anne style dwelling with hipped Colourbond roof with two gable projections and timber weatherboard cladding. The veranda is hipped and supported by timber posts with remnants of cast iron lace valance detailing.</p> <p>The veranda is partially enclosed with a timber board wall.</p> <p>Portion of a concrete rendered chimney with two terracotta pots is visible on the eastern side of the dwelling.</p> <p>Both gables have decorative barge boards.</p> <p>The dwelling displays architectural features of a heritage style and is representative of the local development of this period, being of historical significance for the HCA.</p>		<p>All visible windows have been replaced with contemporary designs.</p> <p>The veranda boarded wall is a contemporary addition, likely replacing an original balustrade.</p> <p>Multiple extensions have been constructed to the southern and eastern sides of the dwelling, all are highly visible due to the corner position of the dwelling.</p>

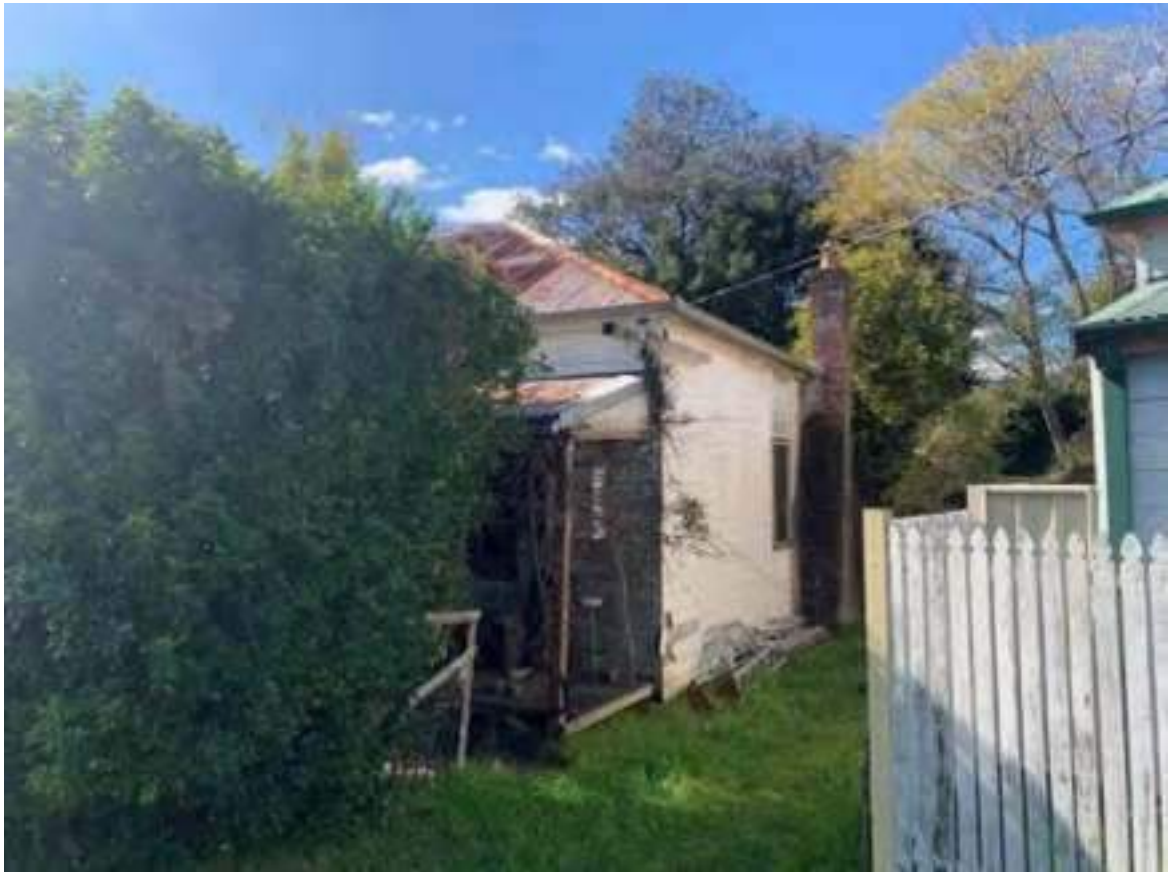
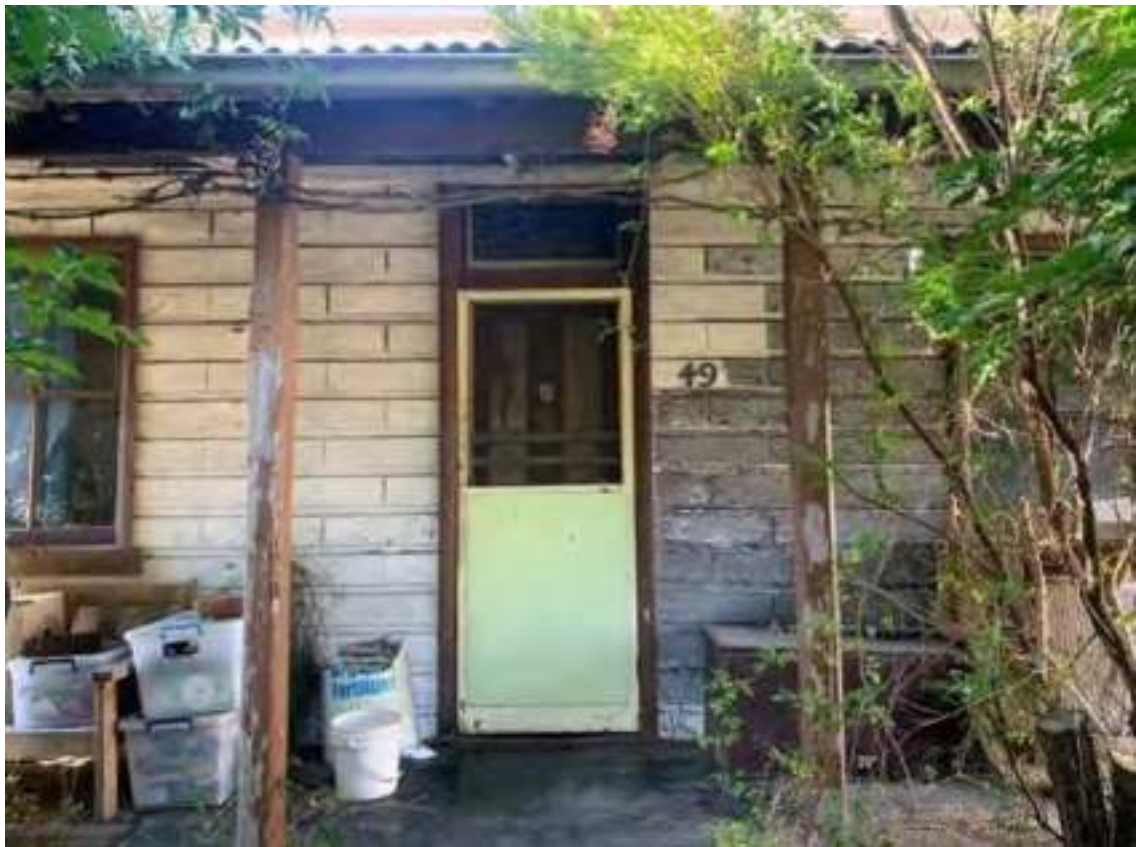
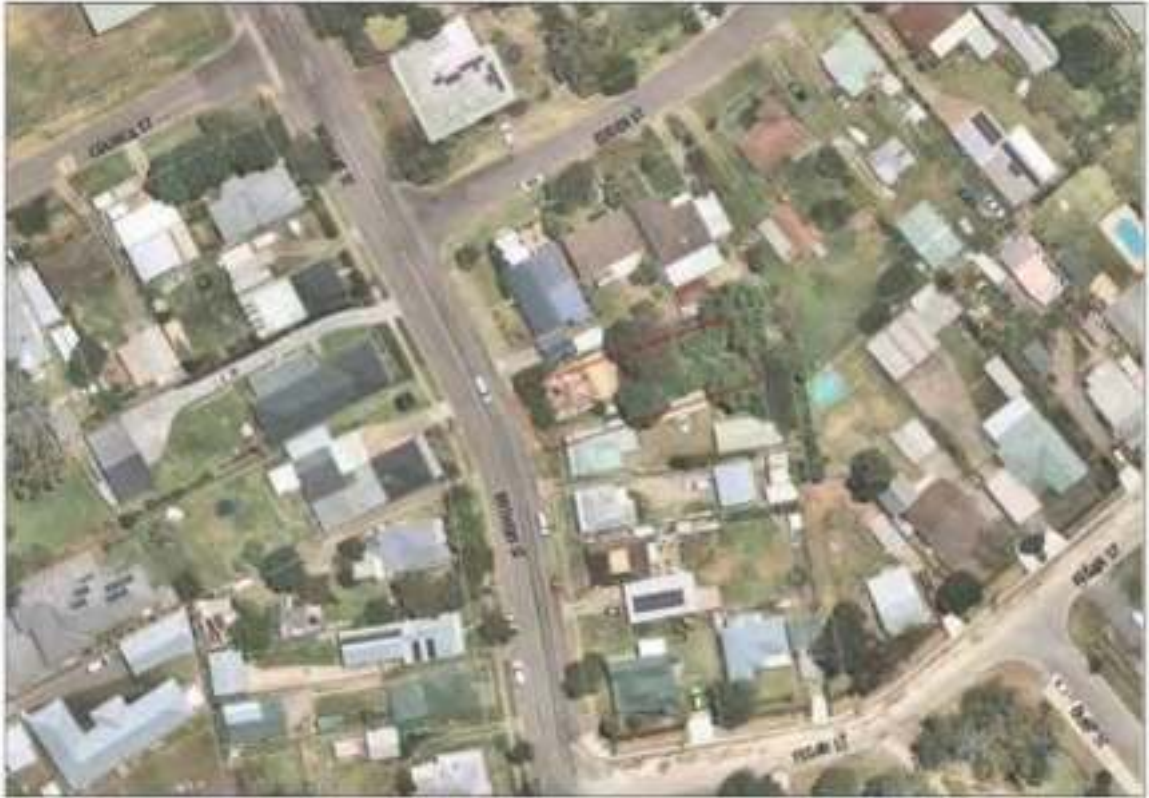
49 WITHERS STREET, WEST WALLSEND 2286

Conservation Area Contribution Level	Est. Construction Date	Previous studies and/or community input
Contributory 1	1890–1915	No prior heritage investigations and no additional information required
Assessment Text		Observed Modifications
<p>Single story Vernacular ‘Mining Cottage’ style dwelling with hipped Colourbond roof and timber weatherboard cladding. The veranda roof is skillion.</p> <p>The veranda is open, with timber flooring.</p> <p>The front door is timber framed with a fan light above. The visible windows are all the original heavy timber framed sash designs.</p> <p>A brickwork chimney is visible on the southern side of the dwelling, with terracotta pot.</p> <p>The dwelling displays architectural features of a heritage style and is representative of the local development of this period, being of historical significance for the HCA.</p>		<p>The dwelling is obscured by mature vegetation.</p> <p>No modifications observed.</p>
