APPENDIX 2

Building Assessment Sheets (Inventory Sheets)

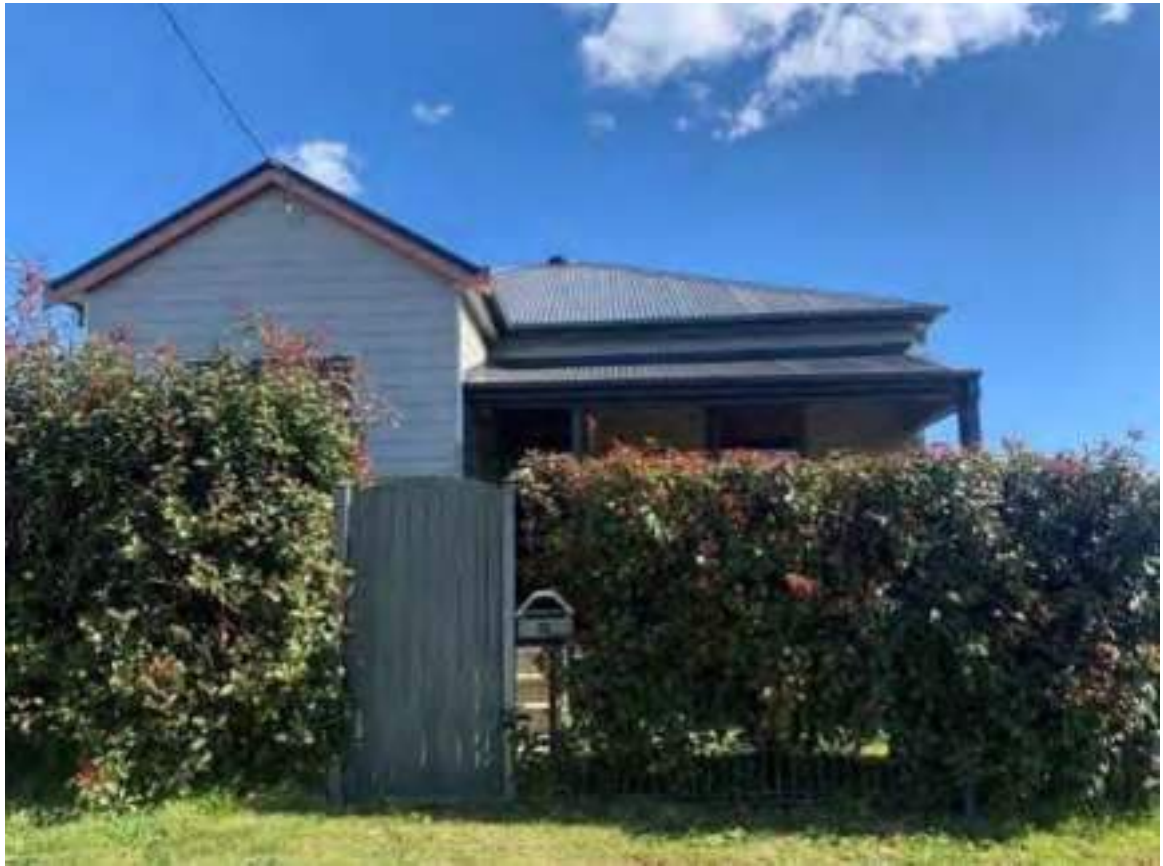
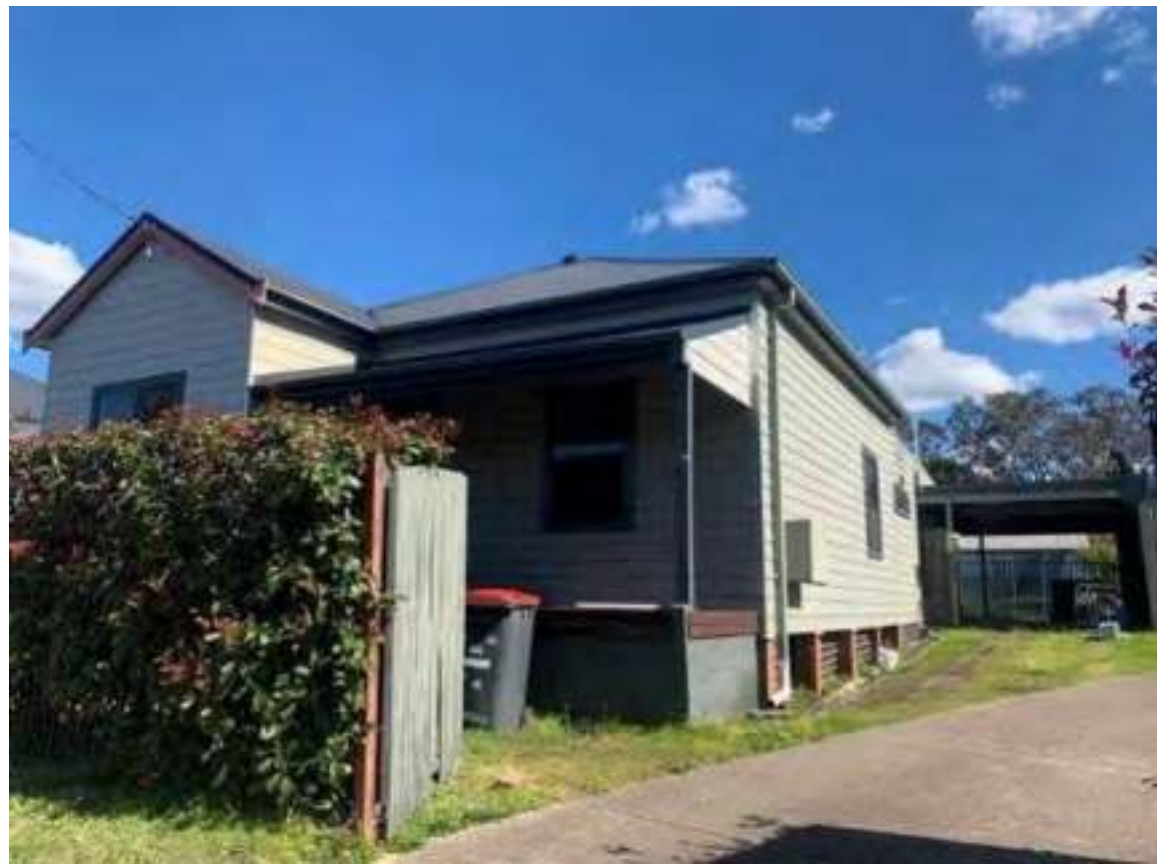
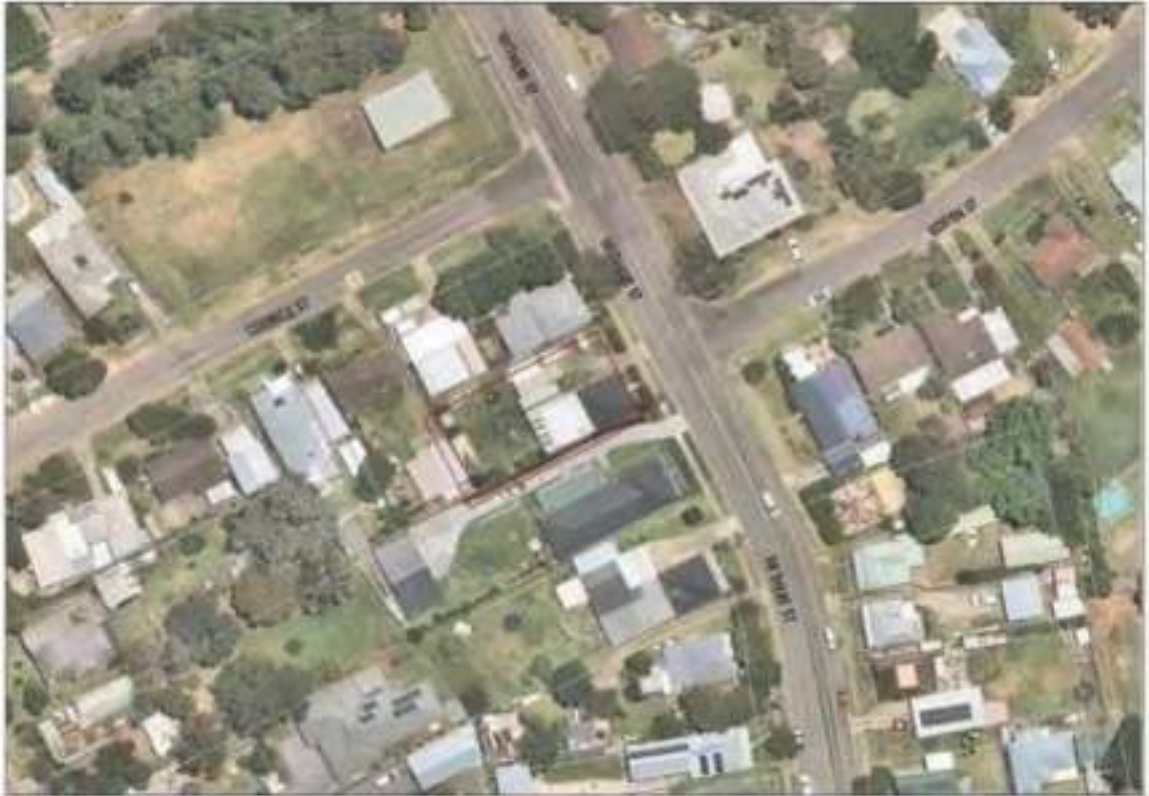
32 WITHERS STREET, WEST WALLSEND 2286

Conservation Area Contribution Level	Est. Construction Date	Previous studies and/or community input
Contributory 1	1900–1920	No prior heritage investigations and no additional information required
Assessment Text		Observed Modifications
<p>Single story simple Federation ‘workmen’s cottage’ style dwelling with hipped Colourbond roof with gable projection and weatherboard cladding. The veranda roof is skillion.</p> <p>The veranda is open.</p> <p>The gable has extended eaves, but no other decorative features.</p> <p>The dwelling displays architectural features of a heritage style and is representative of the local development of this period, being of historical significance for the HCA.</p>		<p>The visible windows are sash designs, however they are likely contemporary replications of the original style.</p> <p>An extension has been built to the western back side of the dwelling. this is not visible from the street and does not detract from the heritage streetscape.</p>

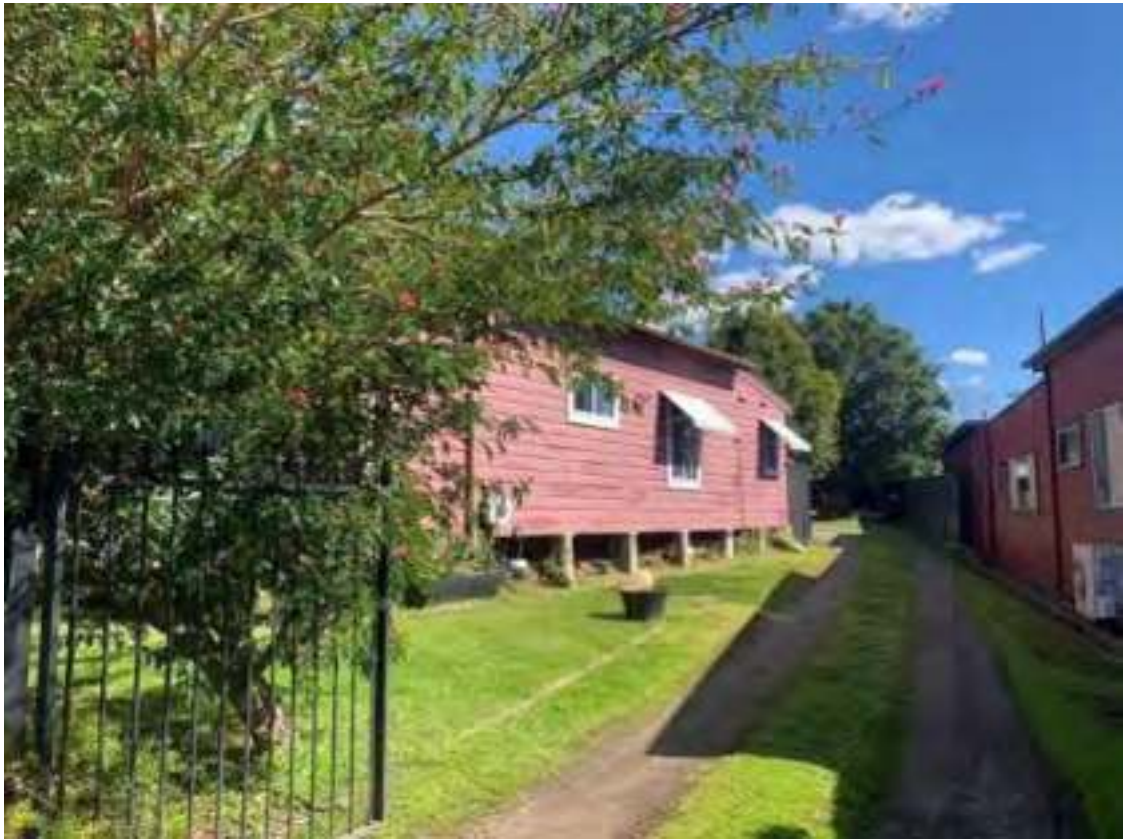
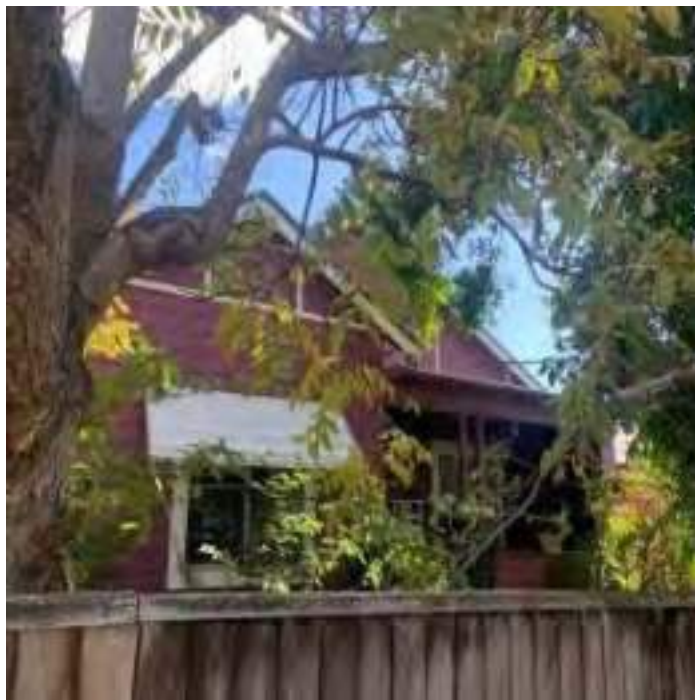
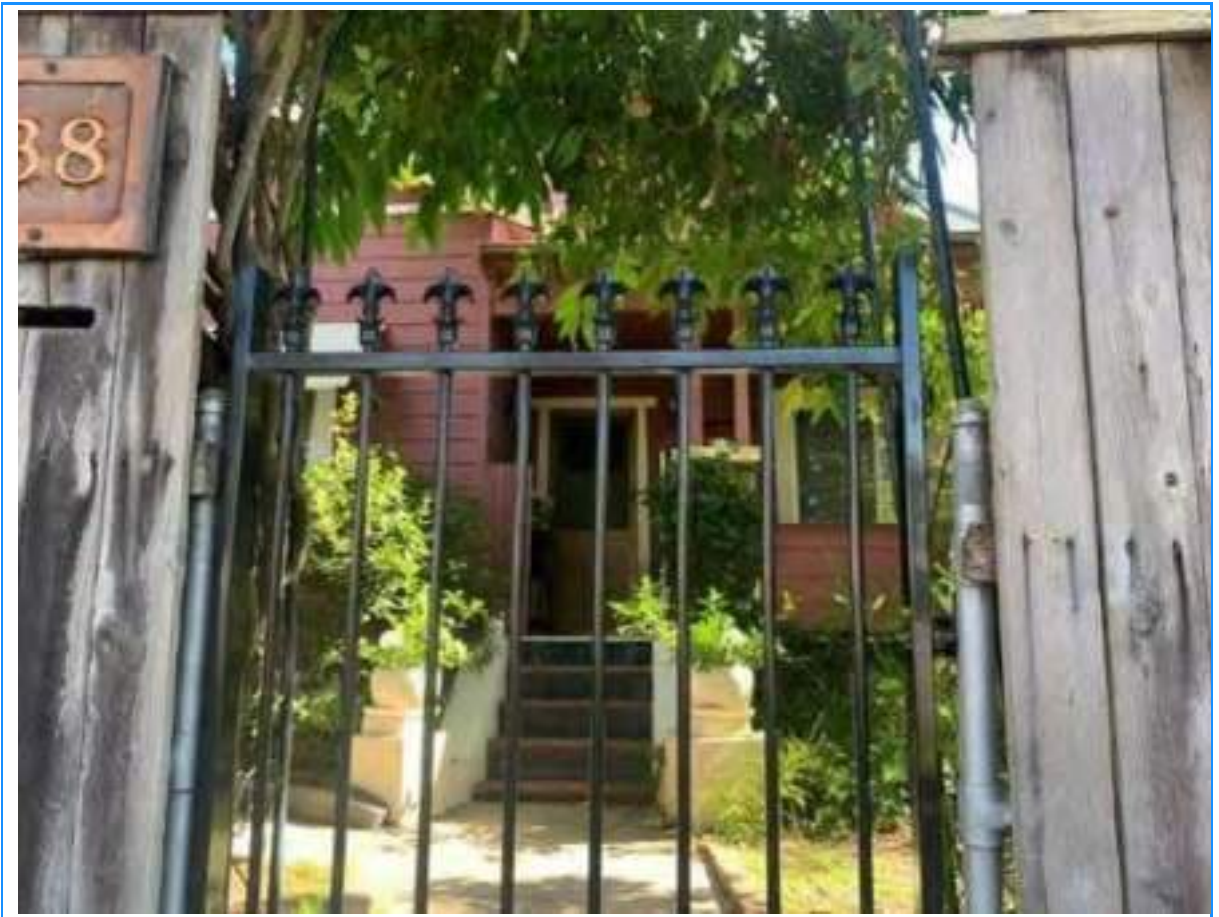
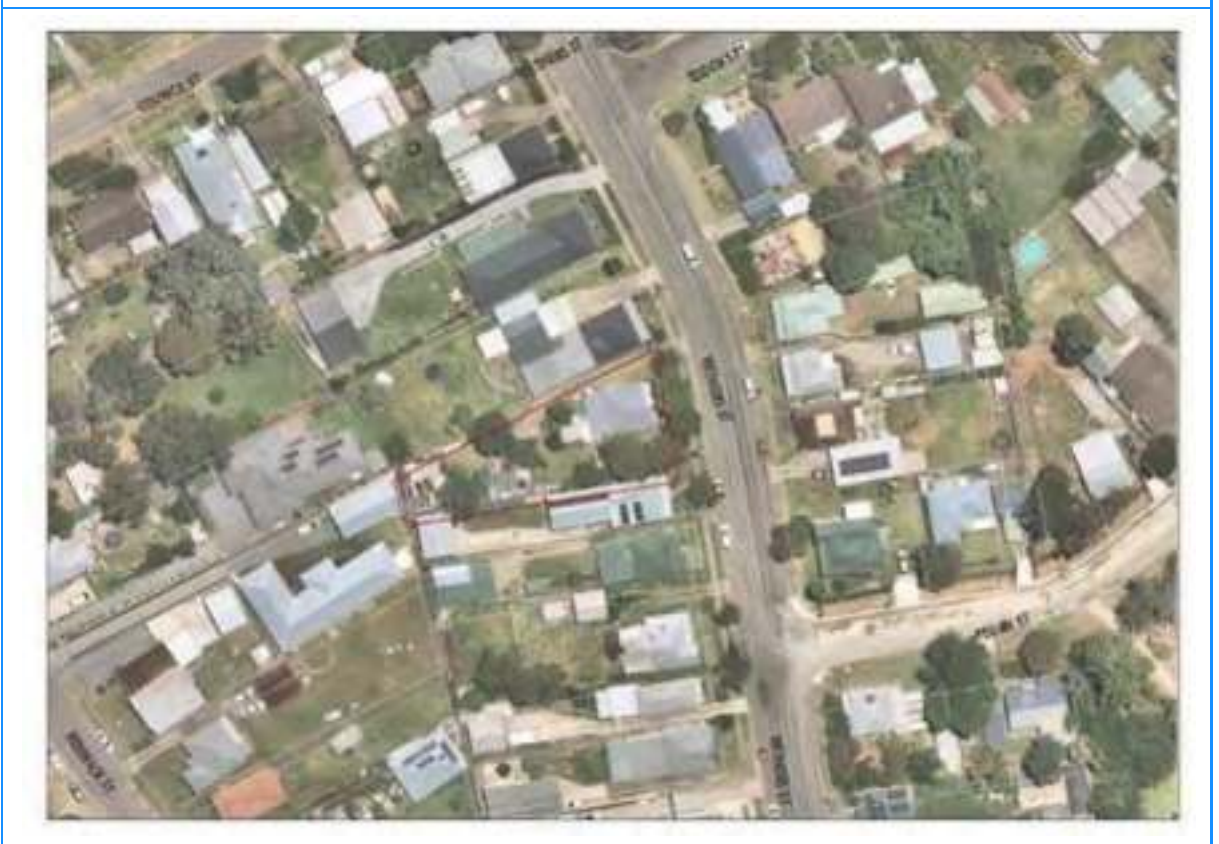
38 WITHERS STREET, WEST WALLSEND 2286

Conservation Area Contribution Level	Est. Construction Date	Previous studies and/or community input
Contributory 1	1900–1920	No prior heritage investigations and no additional information required
Assessment Text		Observed Modifications
<p>Single story simple Federation ‘workmen's cottage’ style dwelling with hipped Colourbond roof with gable projection and weatherboard cladding. The veranda roof is skillion and supported by brick piers with tapered timber posts.</p> <p>The visible windows are timber framed and potentially the original sash designs.</p> <p>A rendered masonry balustrade frames the stairs.</p> <p>The gable has battening detailing with timber shingled awnings a top the windows.</p> <p>The dwelling displays architectural features of a heritage style and is representative of the local development of this period, being of historical significance for the HCA.</p>		<p>The dwelling is obscured by vegetation growth.</p> <p>No modifications observed.</p>

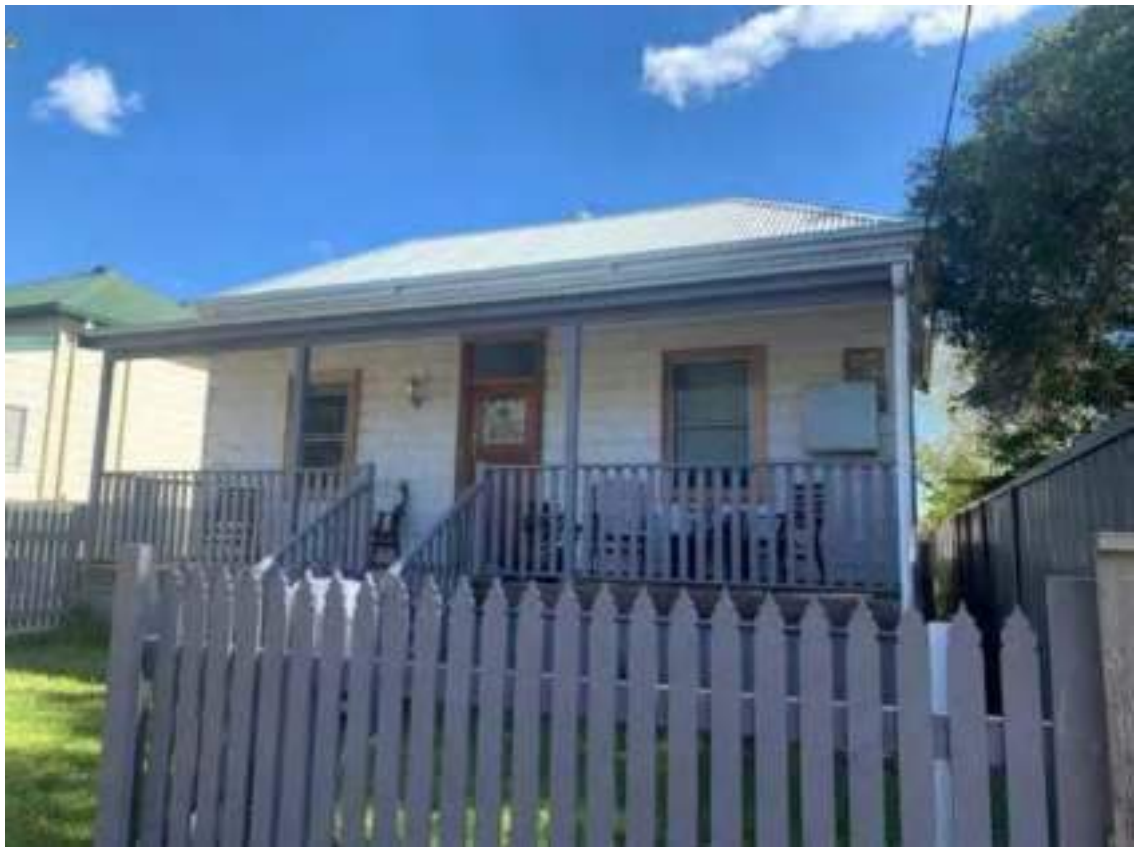
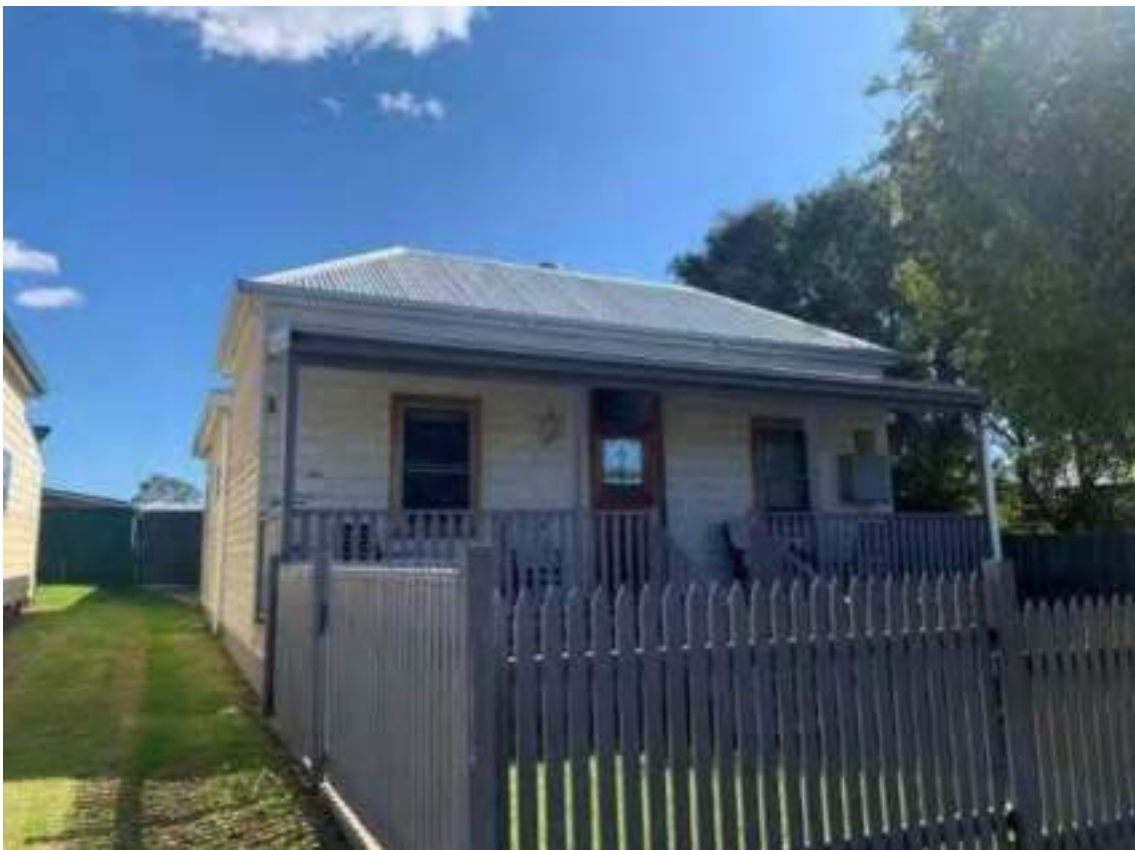
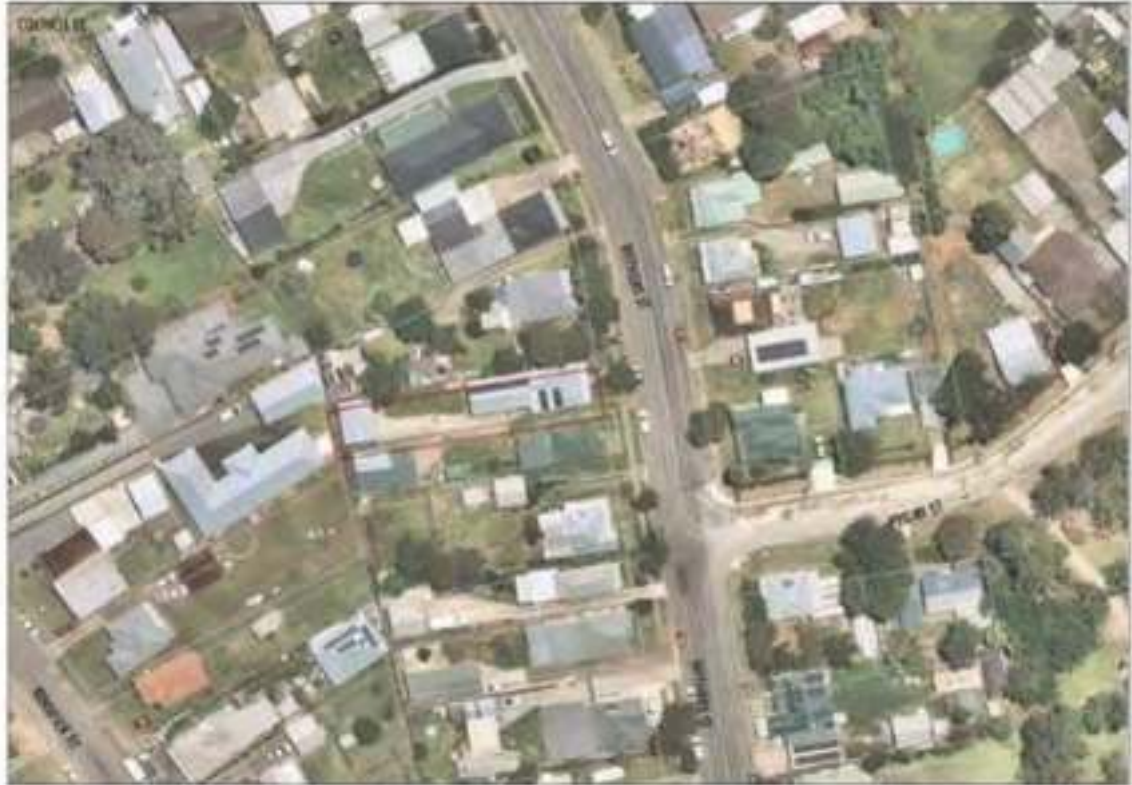
40 WITHERS STREET, WEST WALLSEND 2286

Conservation Area Contribution Level	Est. Construction Date	Previous studies and/or community input
Contributory 1	1890–1915	No prior heritage investigations and no additional information required
Assessment Text		Observed Modifications
<p>Single story Vernacular ‘Mining Cottage’ style dwelling with hipped Colourbond roof and timber weatherboard cladding. The veranda roof is skillion.</p> <p>The veranda is partially enclosed with a timber balustrade. Timber stairs with corresponding balustrade lead onto the landing.</p> <p>The eastern front façade windows are likely the original heavy timber framed sash designs. The front door is timber framed with a fan light above.</p> <p>A timber picket fence encloses the property.</p> <p>The dwelling displays architectural features of a heritage style and is representative of the local development of this period, being of historical significance for the HCA.</p>		<p>An extension has been built onto the back western portion of the dwelling. This is not visible from the street and does not detract from the heritage streetscape.</p> <p>The timber balustrade is a contemporary addition, likely replacing a similar original design.</p>

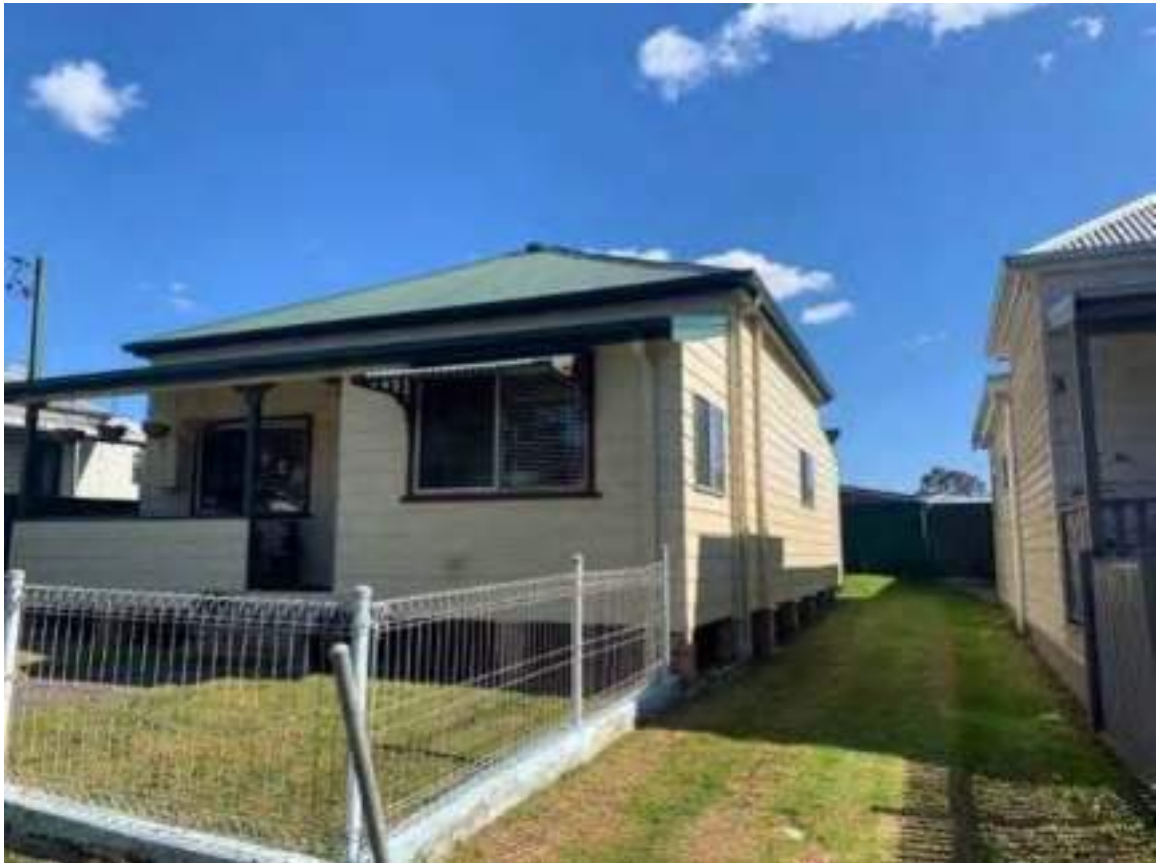
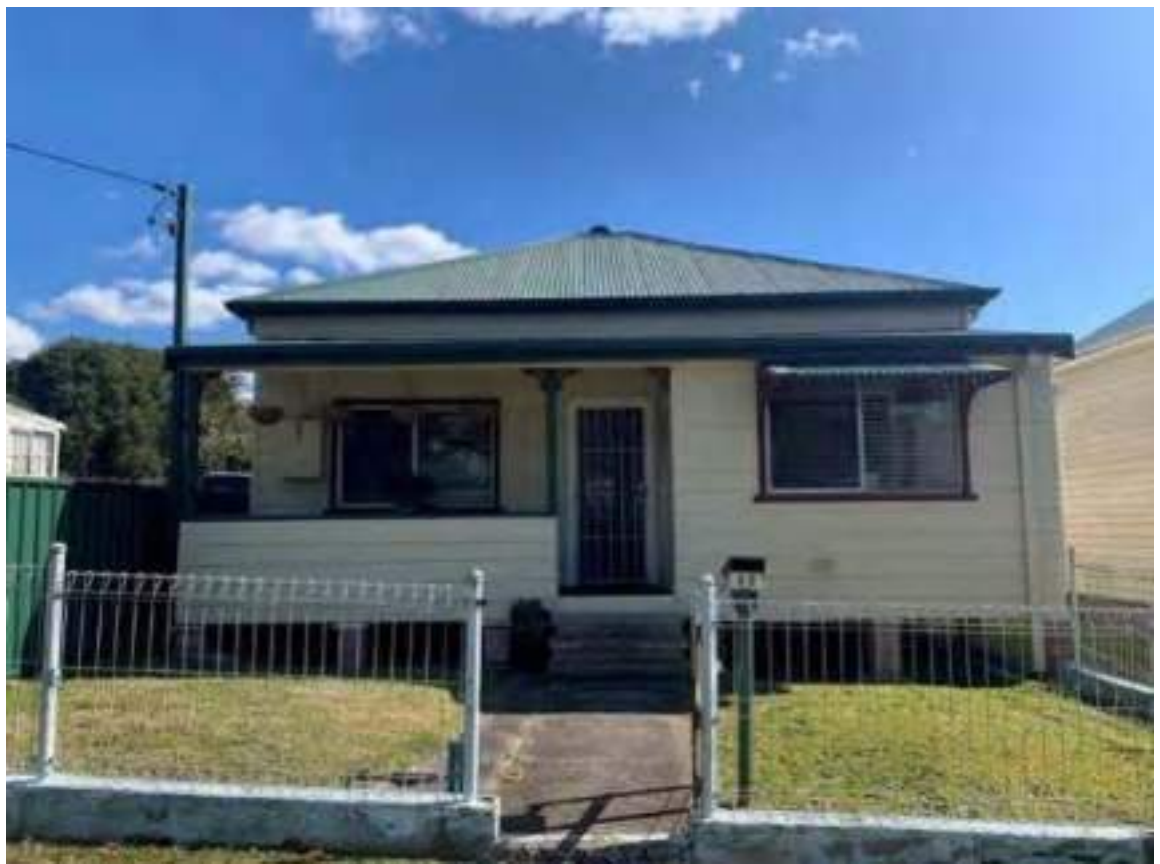
42 WITHERS STREET, WEST WALLSEND 2286

Conservation Area Contribution Level	Est. Construction Date	Previous studies and/or community input
Contributory 1	1890–1920	No prior heritage investigations and no additional information required
Assessment Text		Observed Modifications
<p>Single story Vernacular “Mining Cottage’ style dwelling with hipped Colourbond roof and weatherboard cladding. The veranda roof is skillion and supported by timber posts with ornate bracketing.</p> <p>The veranda is partially enclosed with a timber boarded veranda wall.</p> <p>The dwelling displays architectural features of a heritage style and is representative of the local development of this period, being of historical significance for the HCA.</p>		<p>The visible windows are contemporary sliding designs. The metal awning is similarly likely to be a recent addition.</p> <p>The veranda has been partially built in to create an additional living area. This is a common modification for this dwelling style.</p>

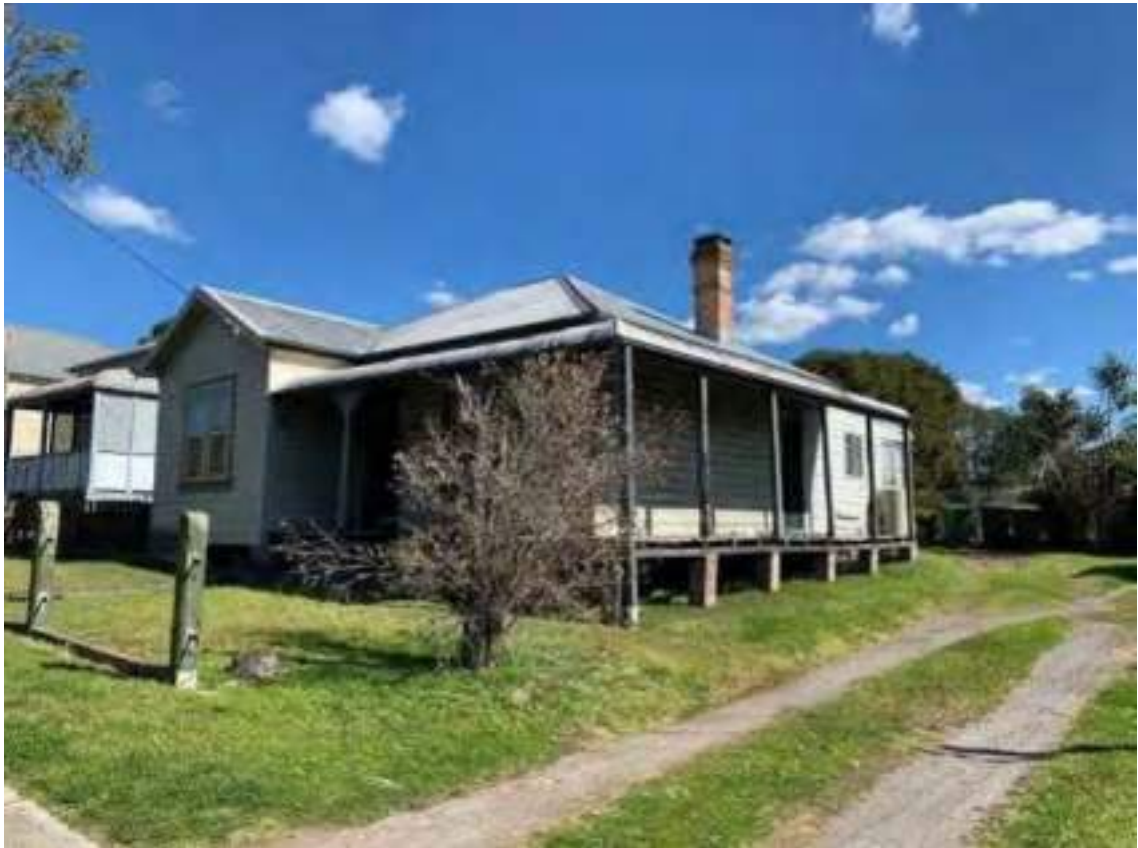
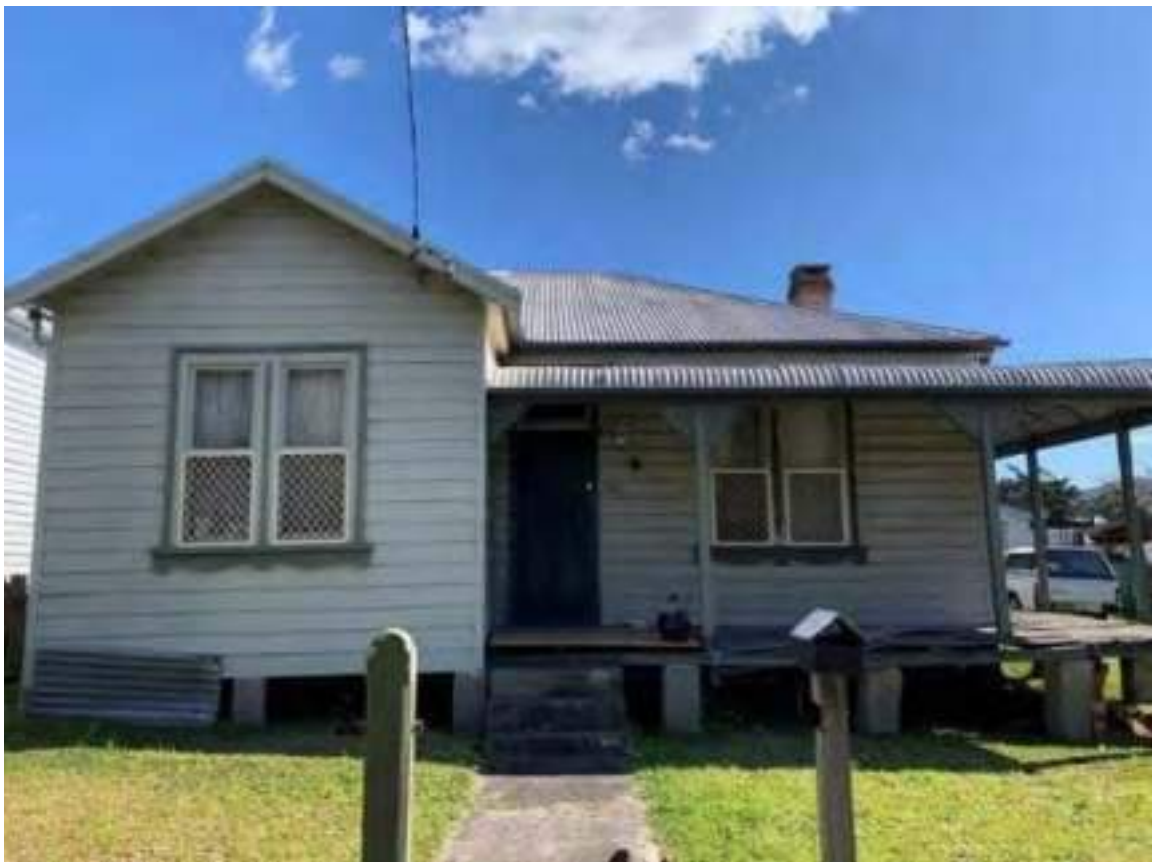
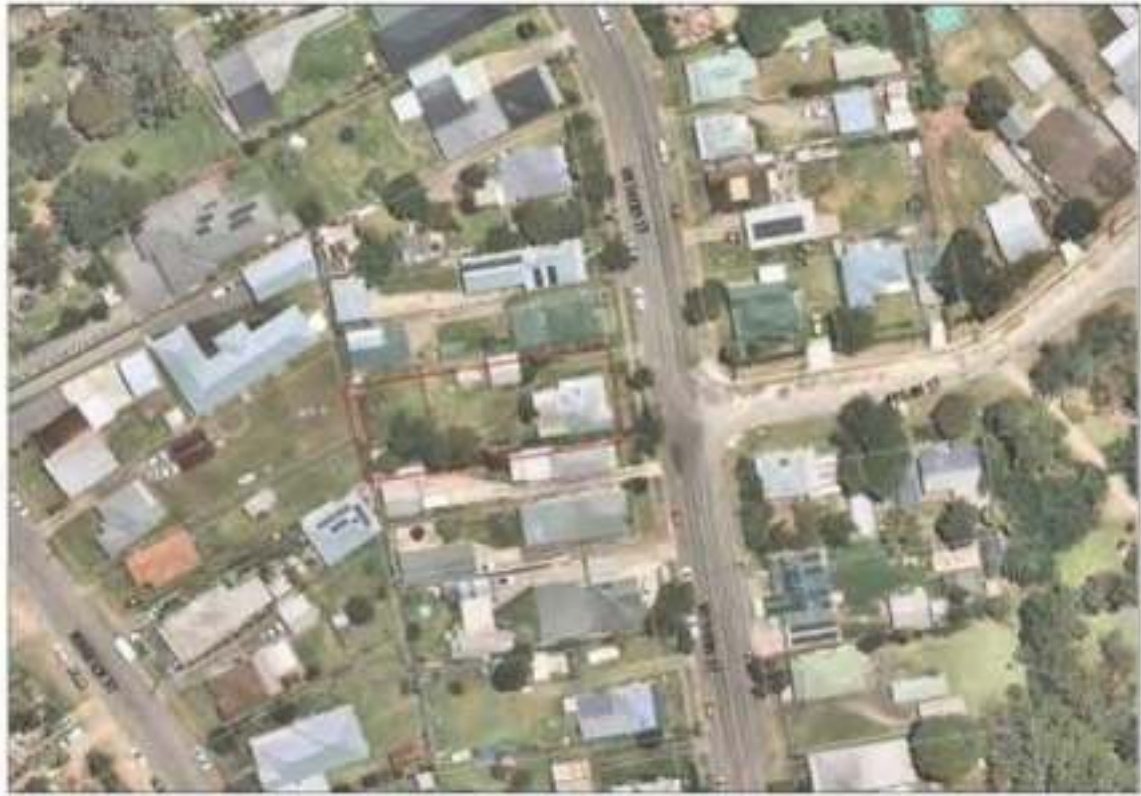
44 WITHERS STREET, WEST WALLSEND 2286

Conservation Area Contribution Level	Est. Construction Date	Previous studies and/or community input
Contributory 1	1900–1920	No prior heritage investigations and no additional information required
Assessment Text		Observed Modifications
<p>Single story simple Federation ‘workmen’s cottage’ style dwelling with hipped Colourbond roof with gable projection and timber weatherboard cladding. The veranda roof is bull nosed and extends around the eastern and northern sides of the dwelling.</p> <p>The veranda is open, with timber posts with lattice bracketing.</p> <p>The front door is timber framed with a fan light above. The visible windows are the original sash designs, with decorative timber sills.</p> <p>A brickwork chimney is visible on the northern side of the dwelling, with corbel detailing.</p> <p>The gable has extended eaves.</p> <p>The dwelling displays architectural features of a heritage style and is representative of the local development of this period, being of historical significance for the HCA.</p>		<p>The visible windows have security screening, which juxtaposes with the heritage style of the dwelling.</p> <p>An extension has been built onto the back western side of the dwelling. This is not visible from the street and does not detract from the heritage streetscape.</p>

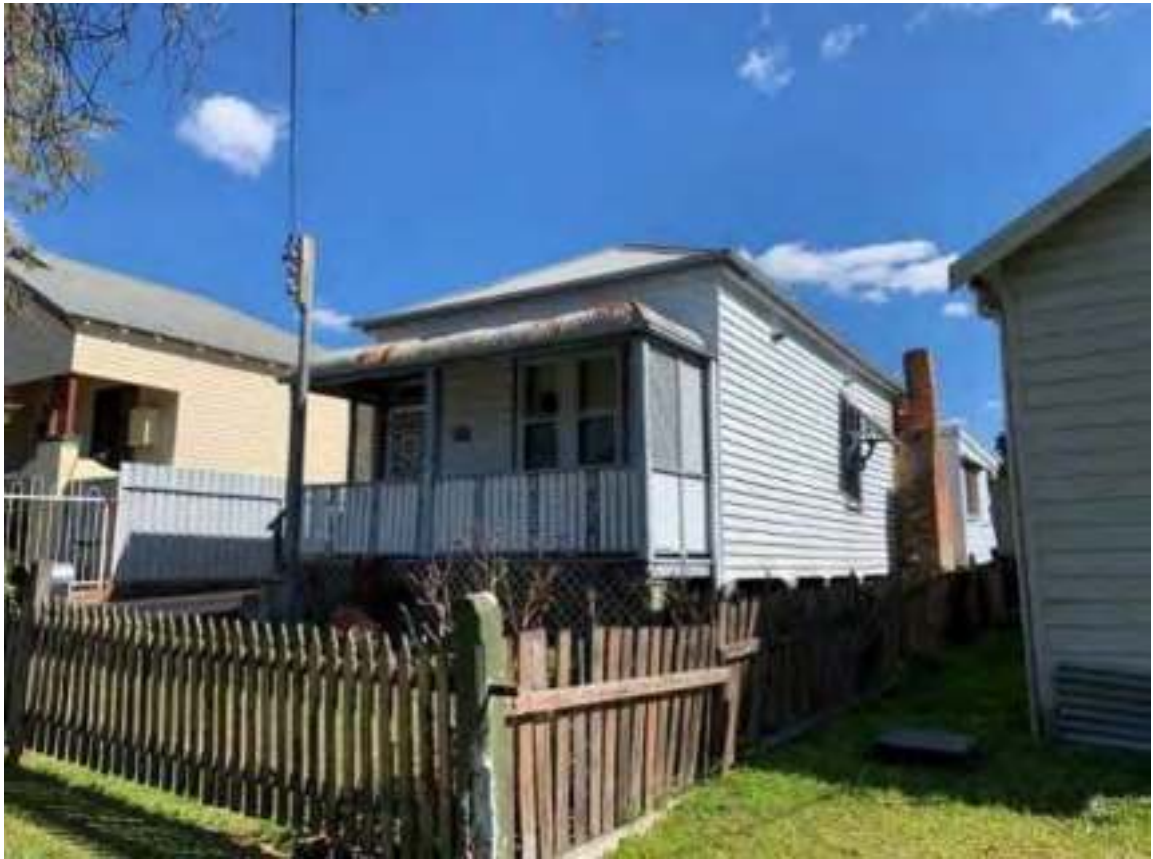
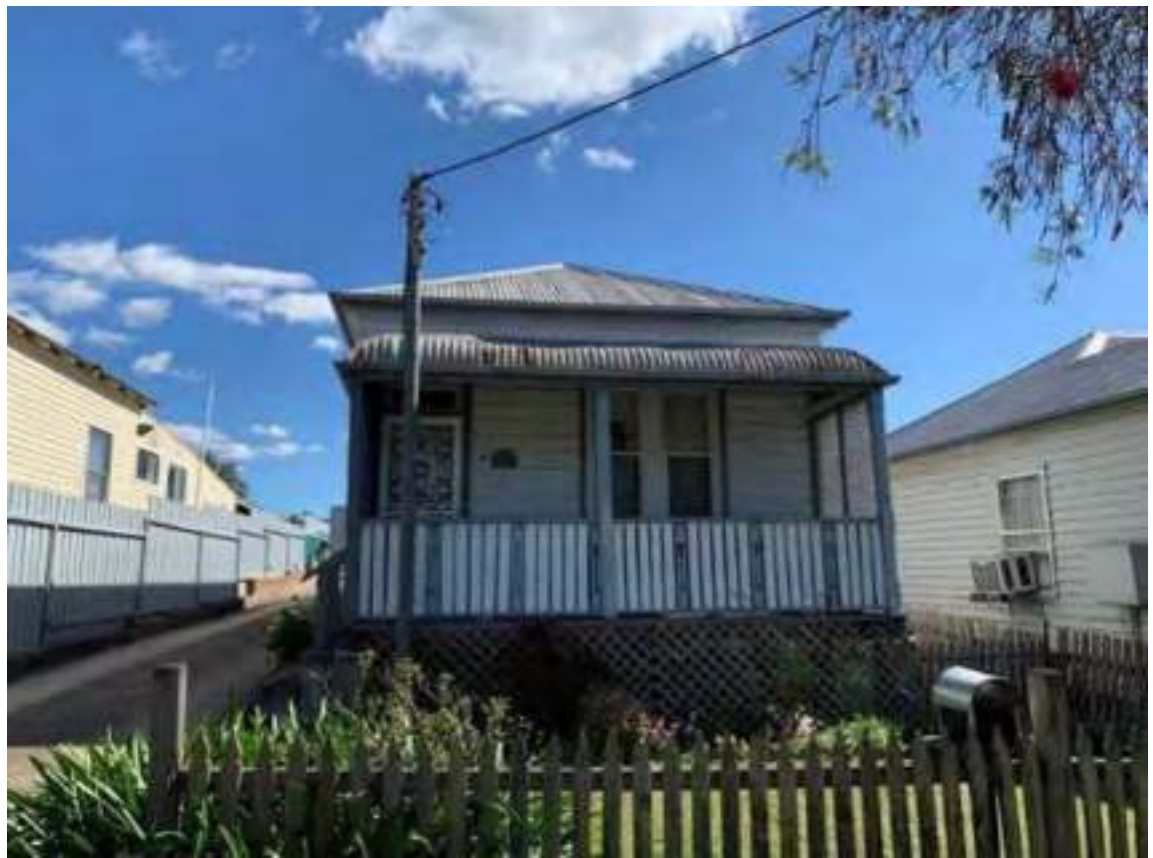
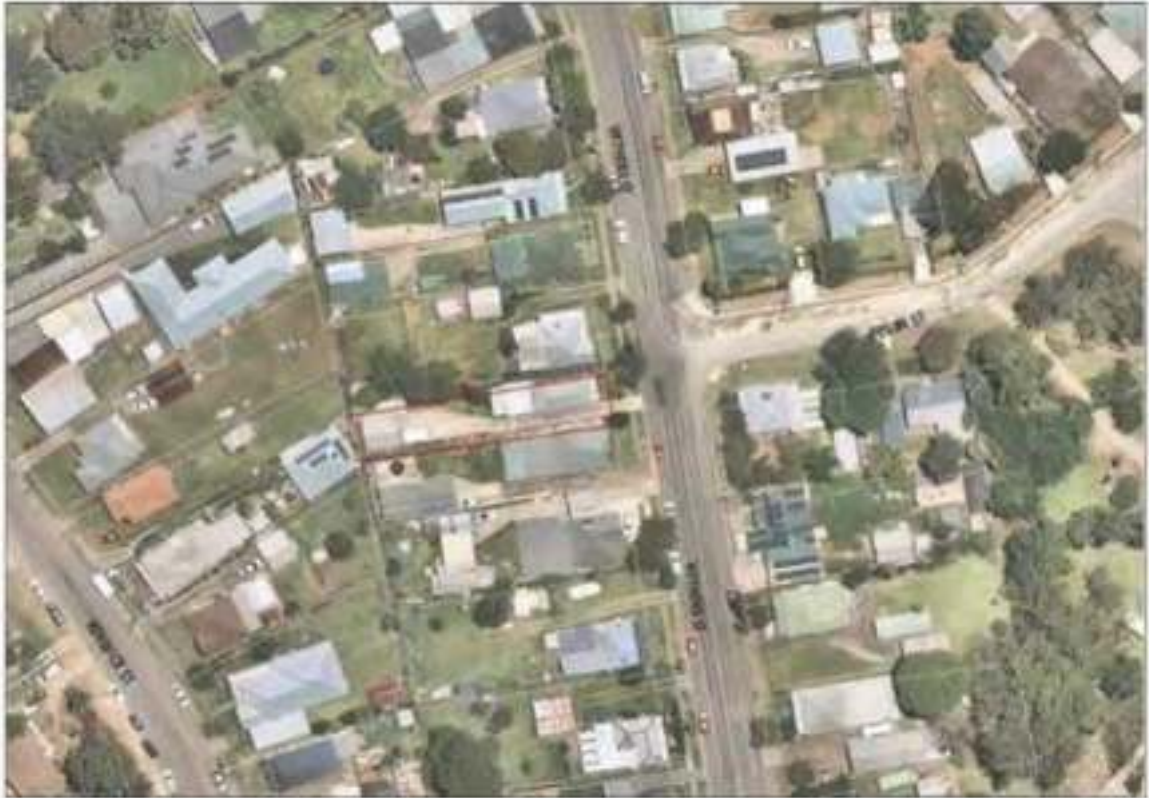
46 WITHERS STREET, WEST WALLSEND 2286

Conservation Area Contribution Level	Est. Construction Date	Previous studies and/or community input
Contributory 1	1890–1915	No prior heritage investigations and no additional information required
Assessment Text		Observed Modifications
<p>Single story simplified Victorian Regency style dwelling with hipped Colourbond roof and weatherboard cladding. The veranda roof is bull nosed, and potentially original.</p> <p>The veranda is partially enclosed by a timber balustrade.</p> <p>The visible windows are original heavy timber framed sash designs. Timber awnings are present, potentially original.</p> <p>A brickwork chimney is visible on the northern side of the dwelling.</p> <p>The dwelling displays architectural features of a heritage style and is representative of the local development of this period, being of historical significance for the HCA.</p>		<p>The front door has a prominent decorative metal screen door, which detracts from the remaining heritage features.</p> <p>The timber balustrade is a contemporary addition, likely replacing a similar original design.</p>

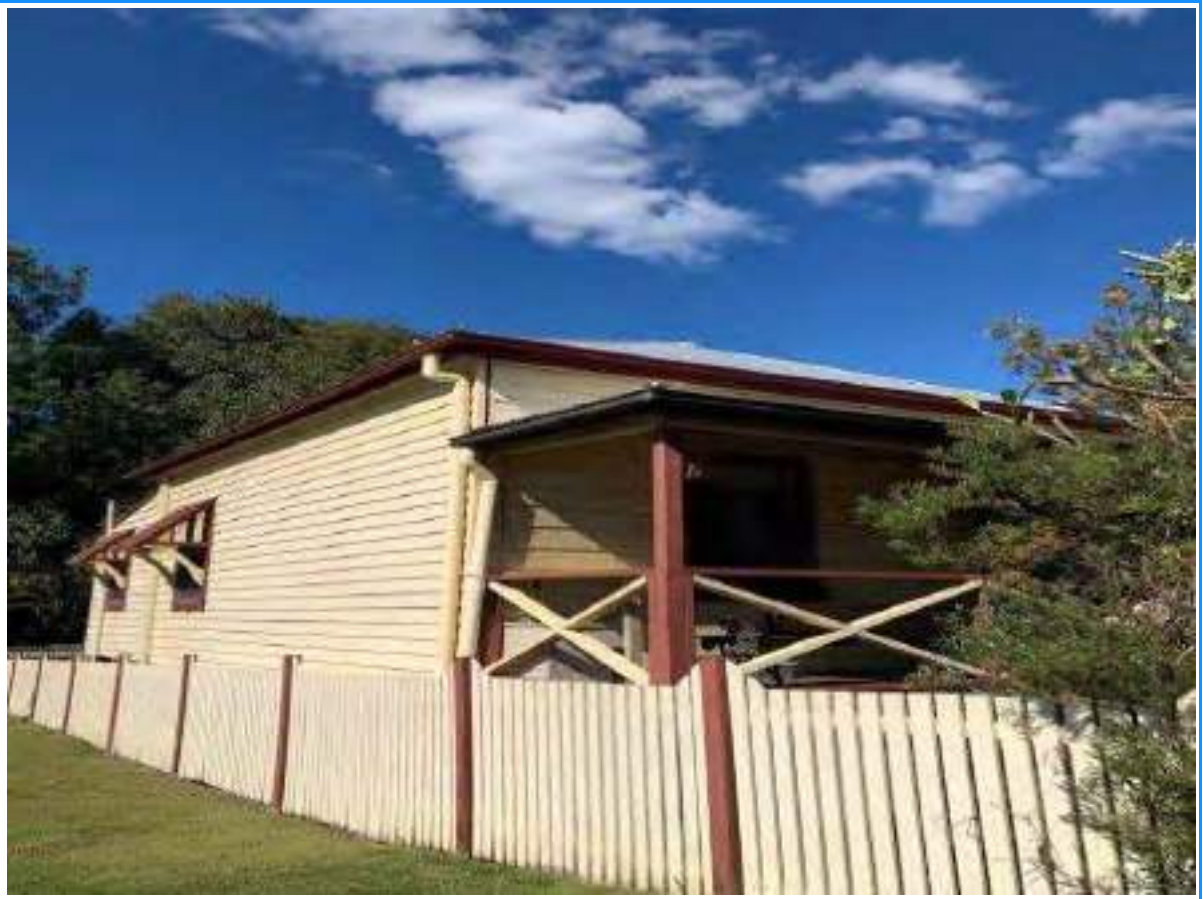
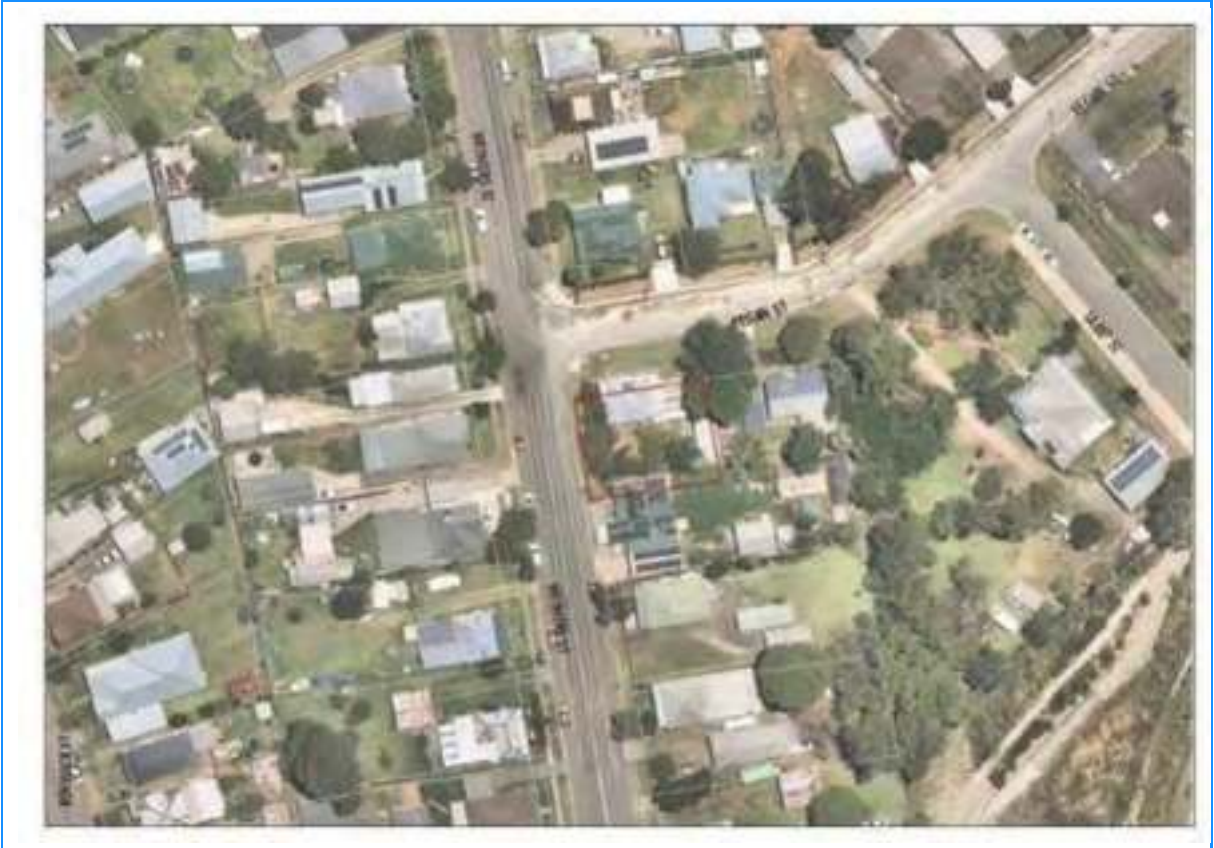
Conservation Area Contribution Level	Est. Construction Date	Previous studies and/or community input
Contributory 1	1890–1915	No prior heritage investigations and no additional information required
Assessment Text		Observed Modifications
<p>Single story Vernacular ‘Mining Cottage’ style dwelling with hipped Colourbond roof and weatherboard cladding. The veranda roof is hipped and supported by timber posts with an cast iron lace valance.</p> <p>The veranda is partially enclosed with a timber crossed balustrade.</p> <p>The visible windows are likely the original sash designs. Timber shingle awnings are visible.</p> <p>Timber picket fence encloses the property.</p> <p>The dwelling displays architectural features of a heritage style and is representative of the local development of this period, being of historical significance for the HCA.</p>		<p>The crossed timber balustrade is a contemporary addition, however is a common addition and does not detract from the heritage streetscape.</p>
