APPENDIX 2

Building Assessment Sheets (Inventory Sheets)

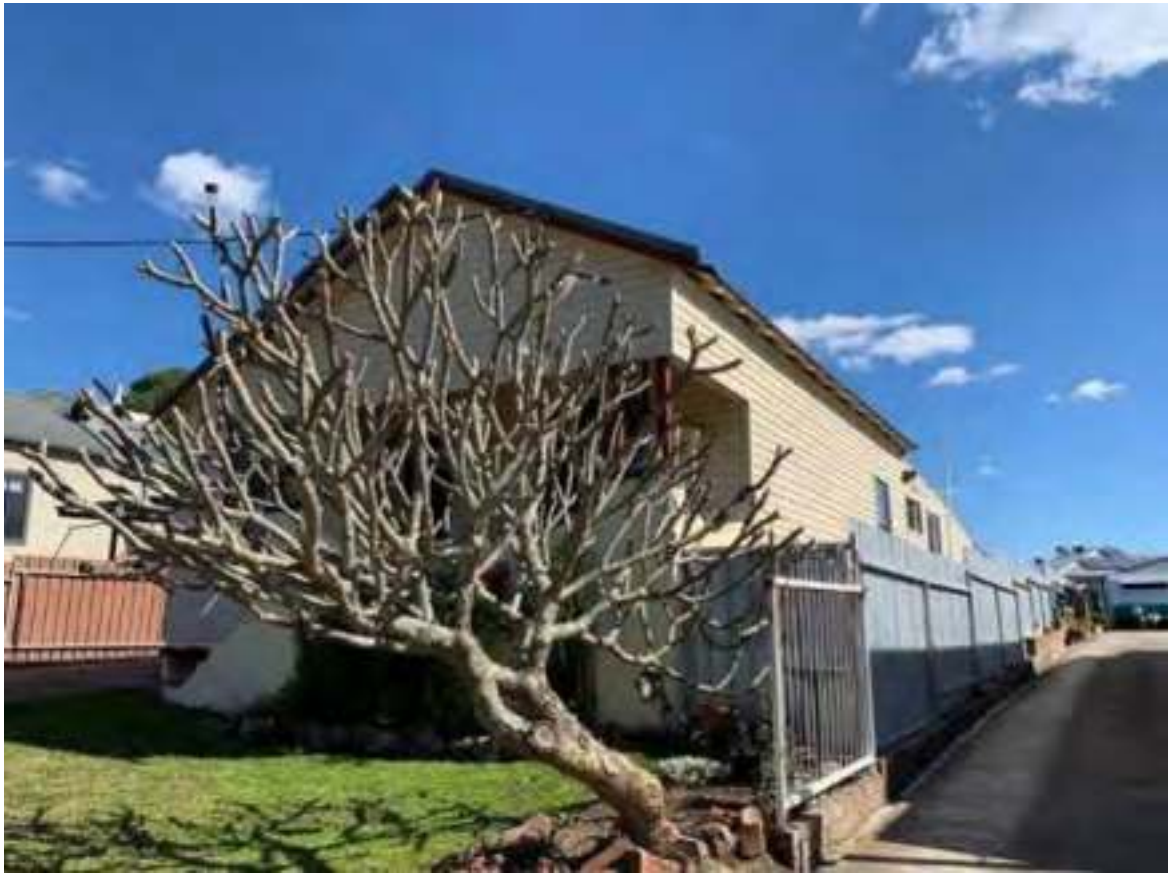
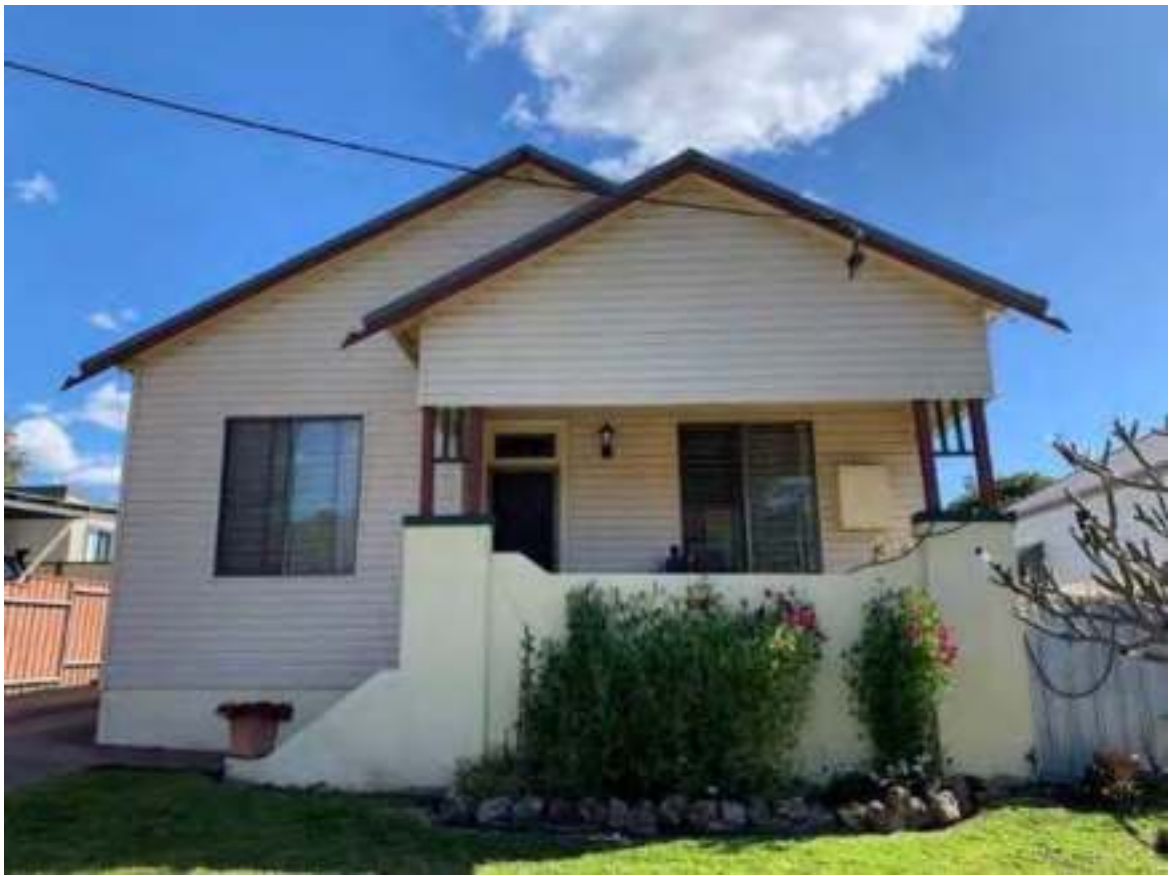
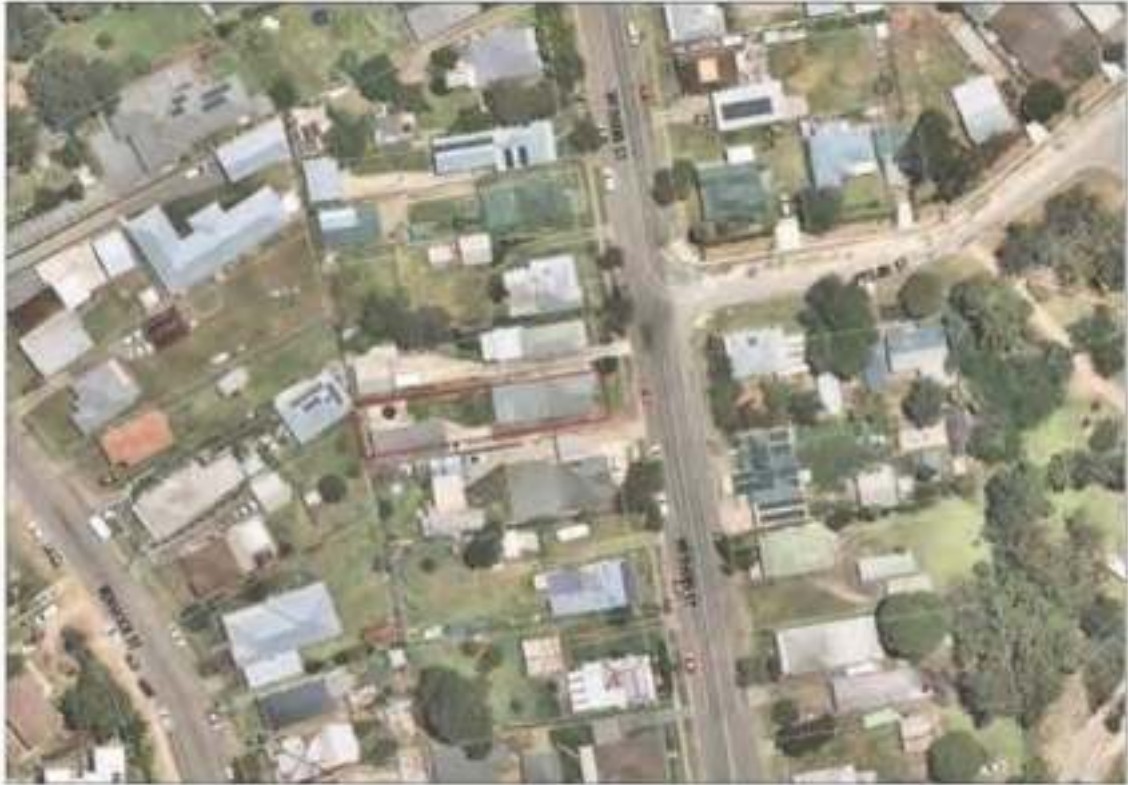
48 WITHERS STREET, WEST WALLSEND 2286

Conservation Area Contribution Level	Est. Construction Date	Previous studies and/or community input
Contributory 1	1920–1935	No prior heritage investigations and no additional information required
Assessment Text		Observed Modifications
<p>Singles tory Inter-War Bungalow style dwelling with gable Colourbond roof and weatherboard cladding. The veranda false gable is supported by a rendered brick pier with tapered timber posts.</p> <p>The veranda is partially enclosed by a rendered brick wall, with masonry stairs leading to the landing.</p> <p>The front door has a fan light above.</p> <p>The gables have extended eaves.</p> <p>The dwelling displays architectural features of a heritage style and is representative of the local development of this period, being of historical significance for the HCA.</p>		<p>All visible windows are contemporary styles, replacing the original timber sash designs.</p> <p>An extension has been built onto the back western side of the dwelling.</p>

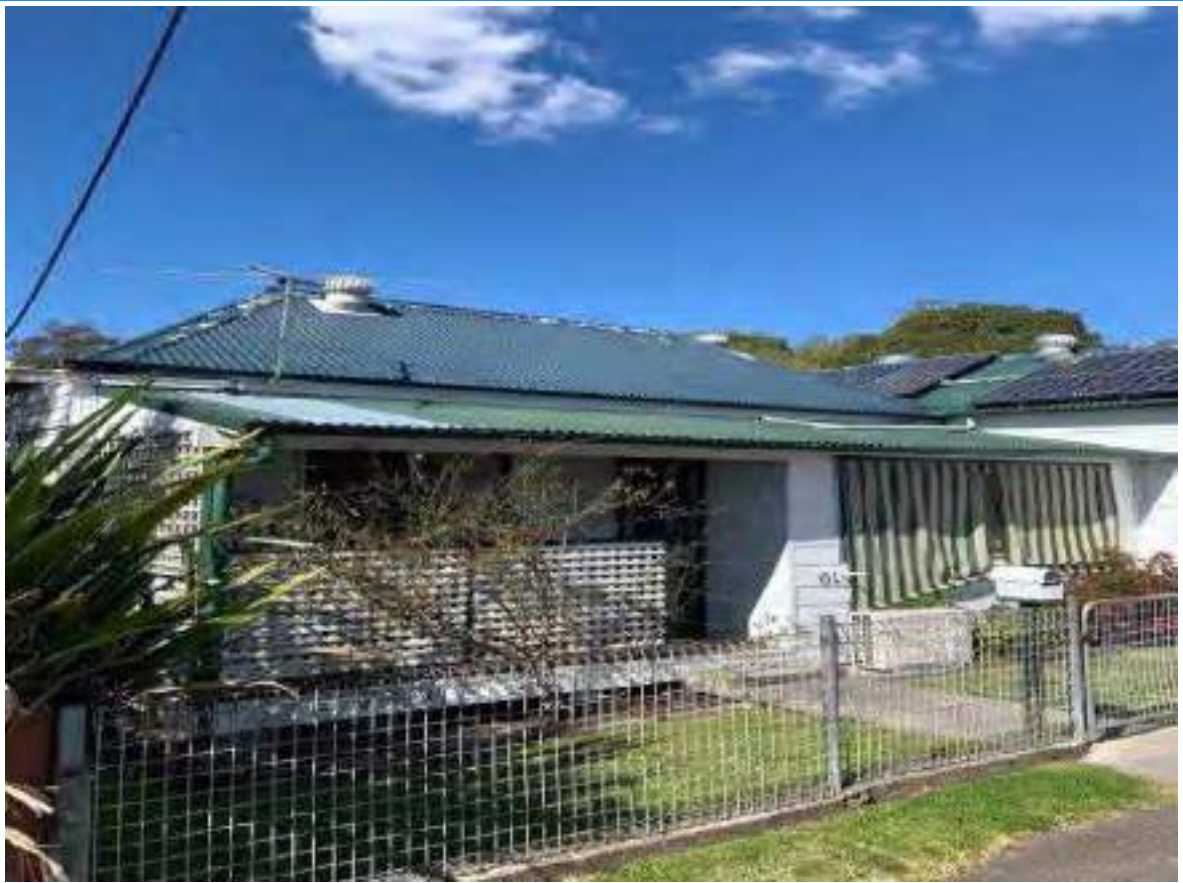
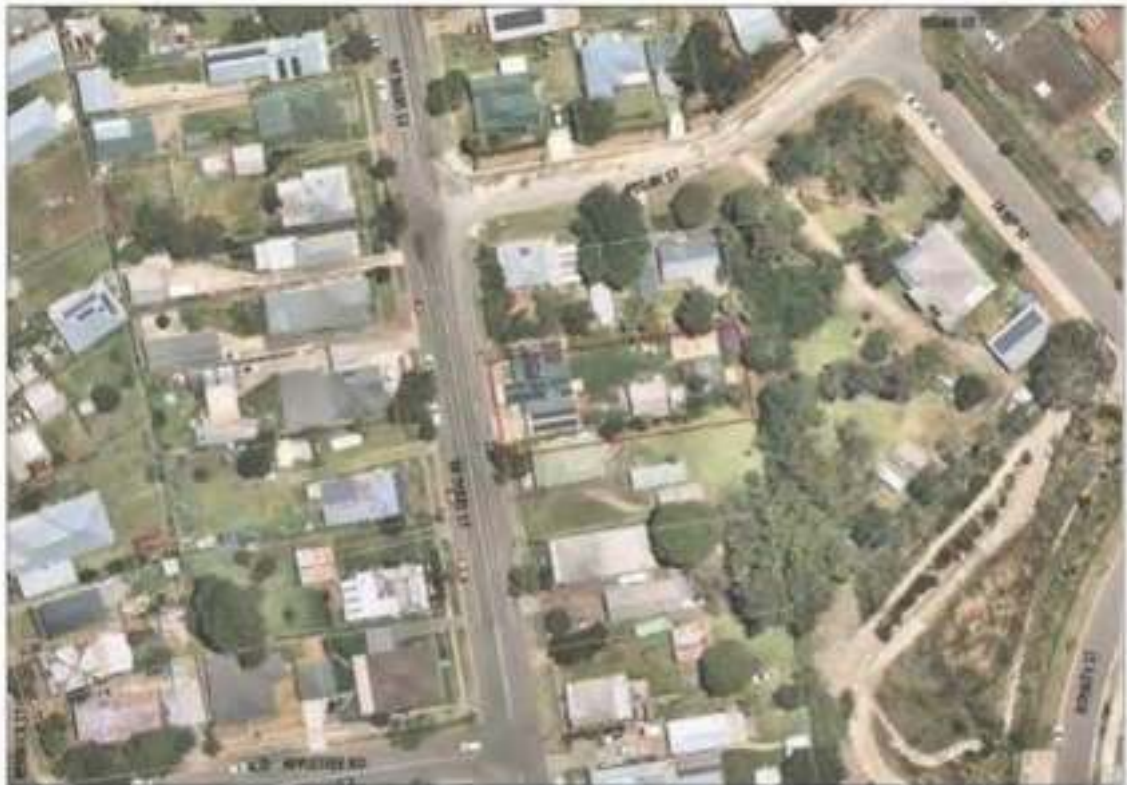
Conservation Area Contribution Level	Est. Construction Date	Previous studies and/or community input
Contributory 1	1900–1940	No prior heritage investigations and no additional information required
Assessment Text		Observed Modifications
<p>Single story dwelling with hipped Colourbond roof and weatherboard cladding. The veranda roof is skillion.</p> <p>The veranda is partially enclosed with a timber lattice balustrade and wall.</p> <p>A secondary building located immediately to the south has a gable Colourbond roof with weatherboard cladding. Currently used as a local takeaway.</p> <p>The dwelling displays architectural features of a heritage style and is representative of the local development of this period, being of historical significance for the HCA.</p>		<p>The southern side of the veranda has been built in to create an additional living area. This is a common modification in the area and reflects the family-oriented demographic.</p> <p>All visible windows are contemporary sliding designs.</p>

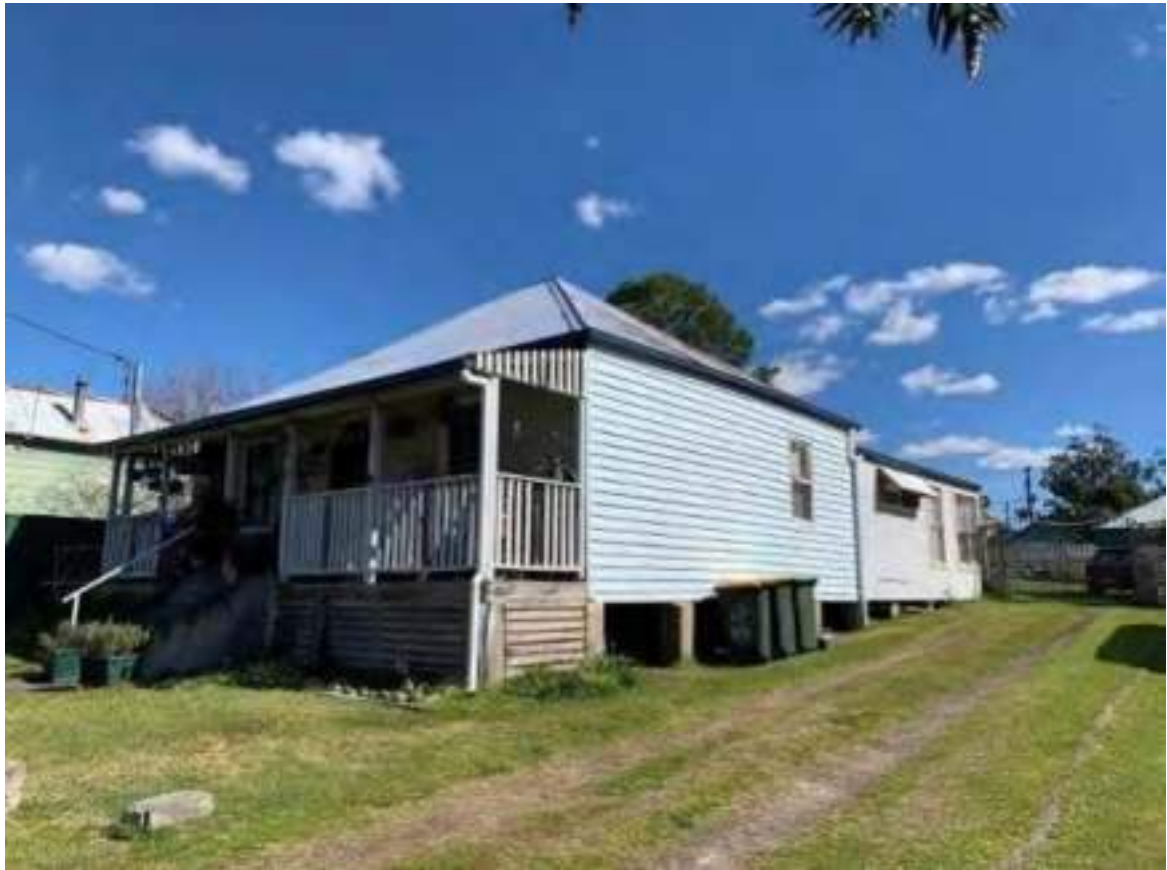
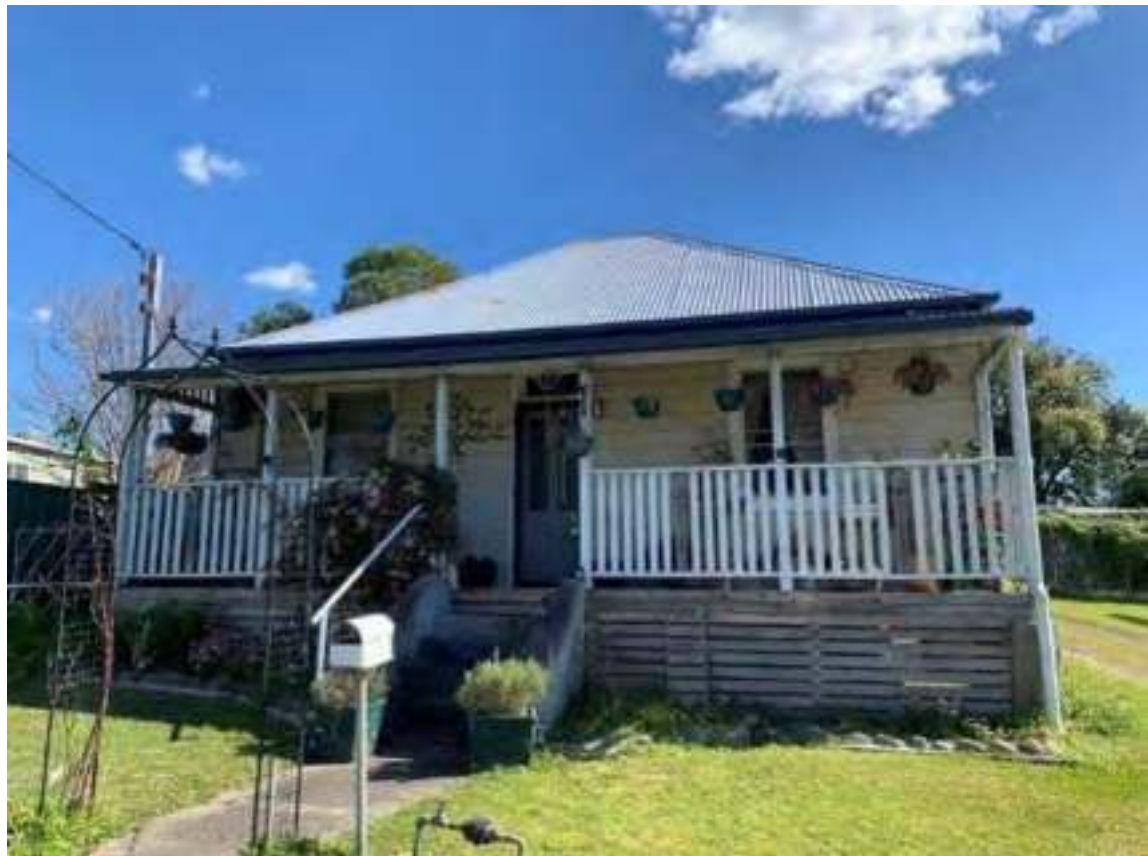
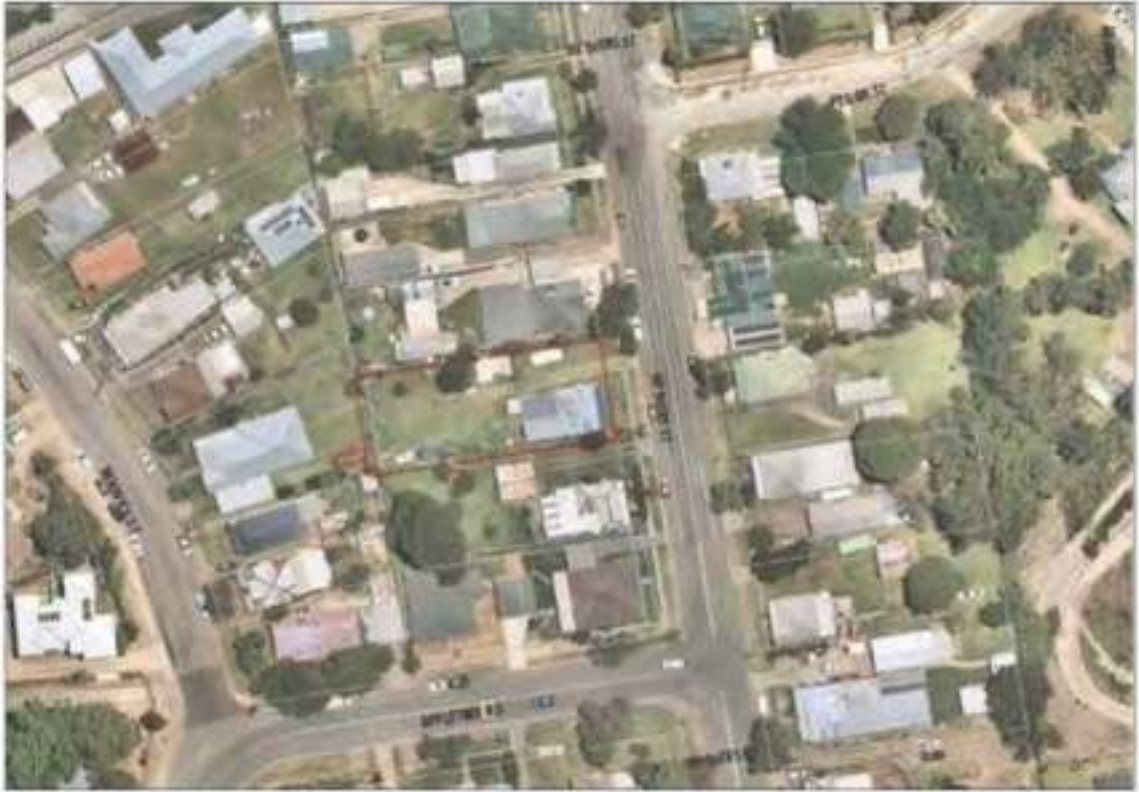
52 WITHERS STREET, WEST WALLSEND 2286

Conservation Area Contribution Level	Est. Construction Date	Previous studies and/or community input
Contributory 1	1890–1915	No prior heritage investigations and no additional information required
Assessment Text		Observed Modifications
<p>Single story Vernacular ‘Mining Cottage’ style dwelling with steep hipped Colourbond roof and weatherboard cladding. The veranda roof is skillion.</p> <p>The veranda is partially enclosed by a timber balustrade. Concrete stairs with balustrade leads onto the landing.</p> <p>The front door is timber framed with fan light above. The visible windows appear to be the original timber framed sash designs.</p> <p>The dwelling displays architectural features of a heritage style and is representative of the local development of this period, being of historical significance for the HCA.</p>		<p>An extension has been built into the back western portion of the dwelling. this is not visible from the street and does not detract from the heritage streetscape.</p> <p>The timber balustrade is a contemporary addition, likely replacing the original timber balustrade.</p>

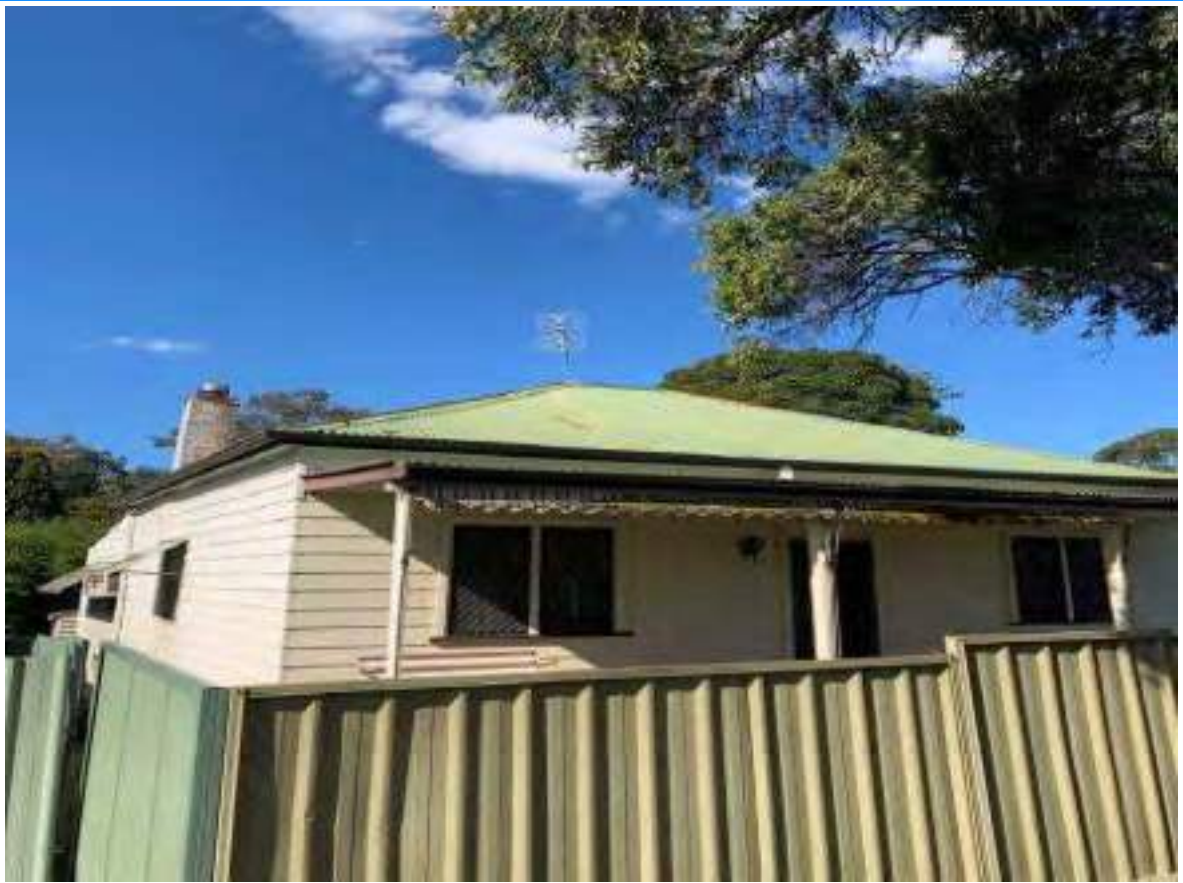
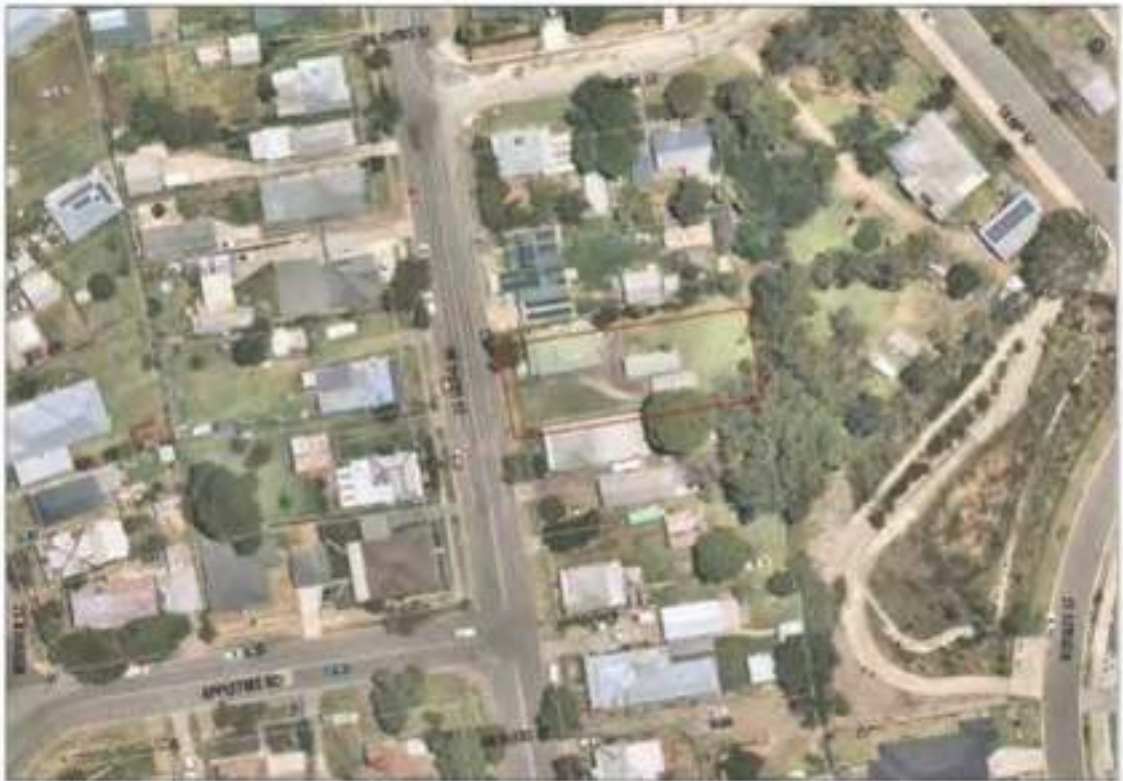
Conservation Area Contribution Level	Est. Construction Date	Previous studies and/or community input
Contributory 1	1890–1915	No prior heritage investigations and no additional information required
Assessment Text		Observed Modifications
<p>Single story Vernacular style dwelling with hipped Colourbond roof and weatherboard cladding. The veranda roof is flat. The visible windows are the original timber framed sash designs. The dwelling displays architectural features of a heritage style and is representative of the local development of this period, being of historical significance for the HCA.</p>		<p>Metal security screens have been installed on the façade windows, obscuring the sash designs.</p> <p>An extension has been built onto the back eastern side of the dwelling. this is not visible from the street and does not detract from the heritage streetscape.</p>

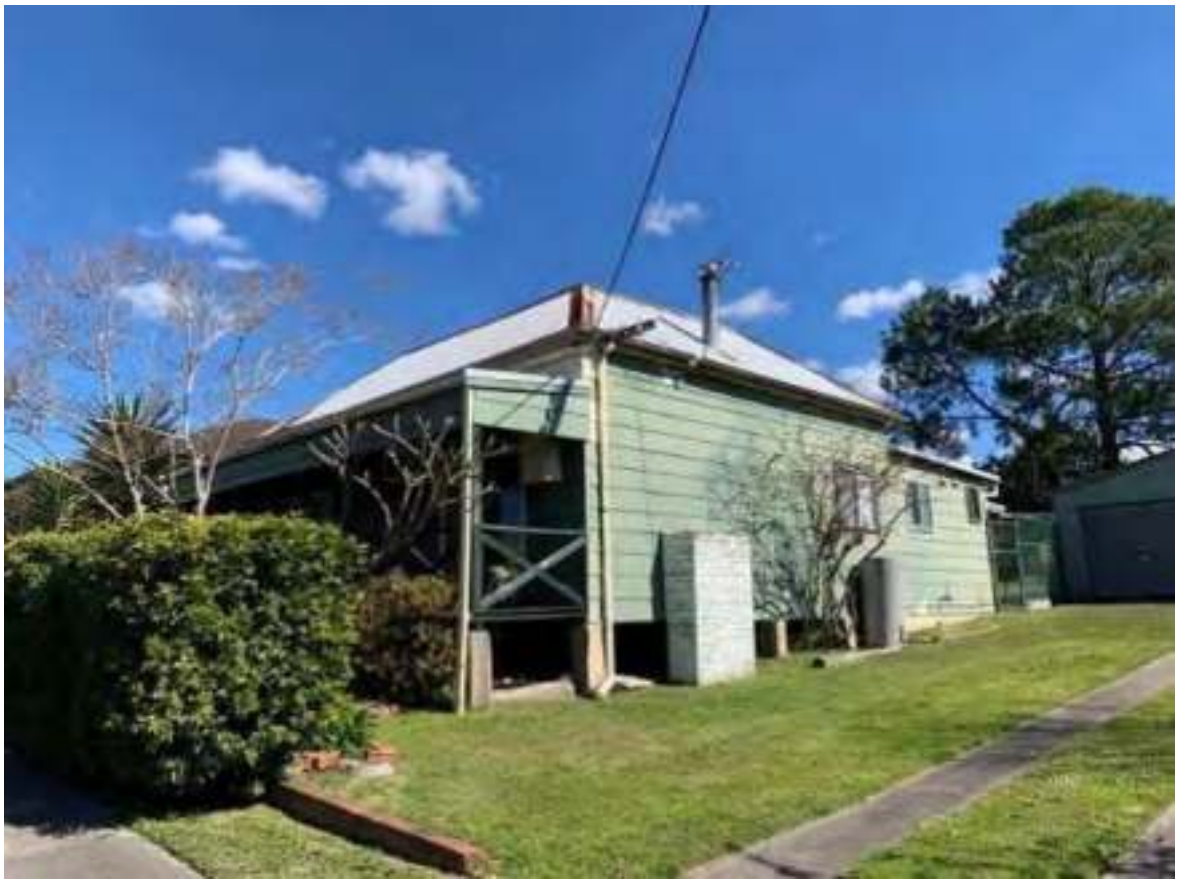
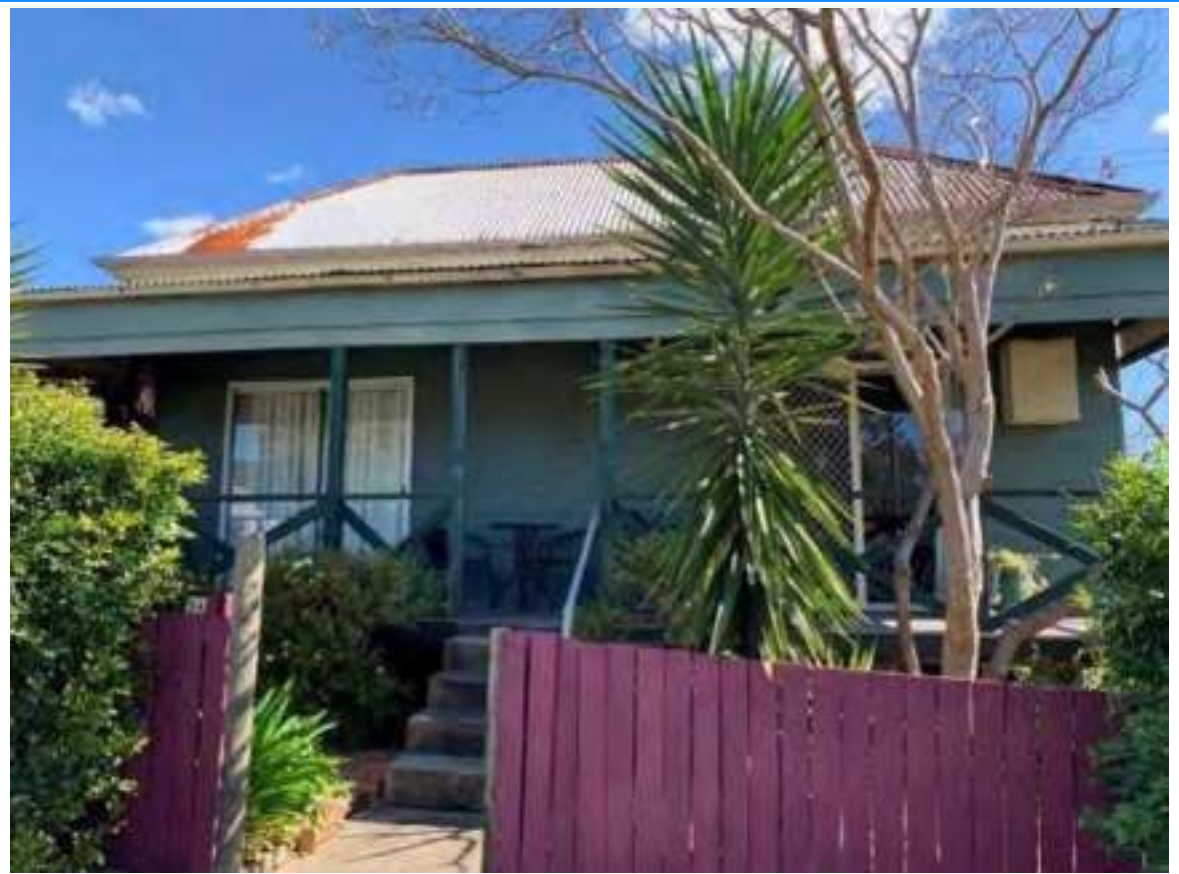
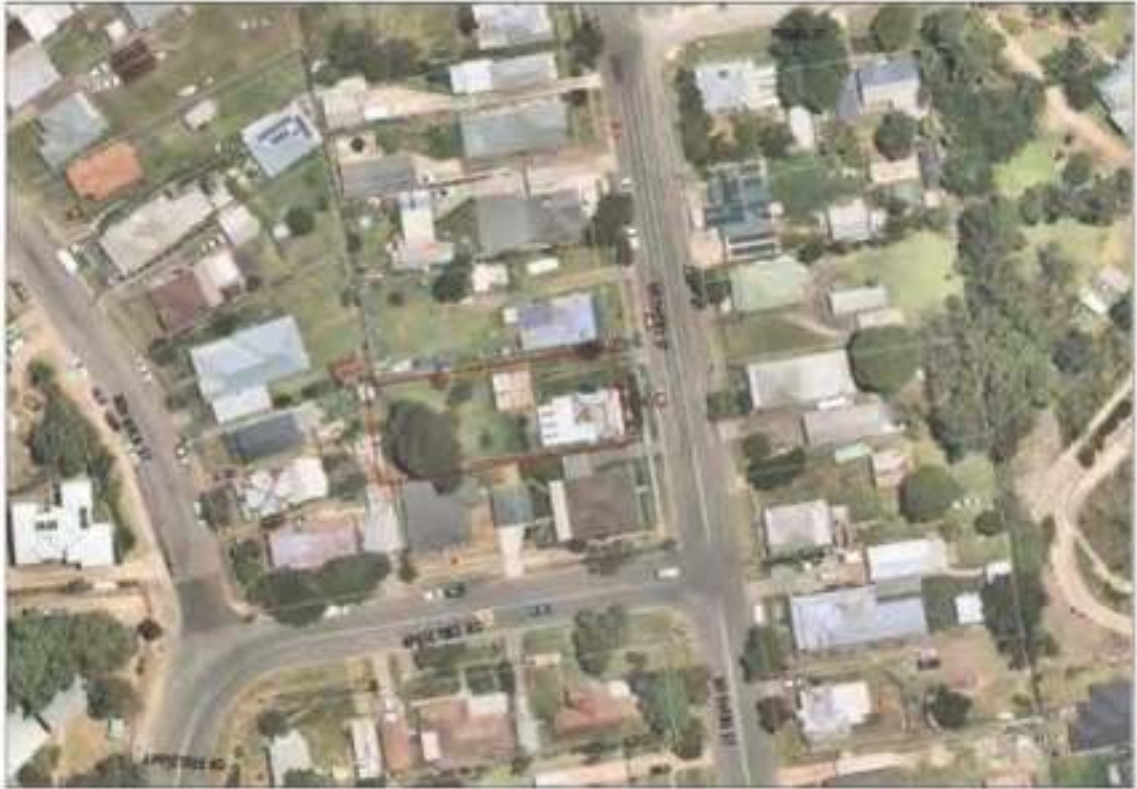
54 WITHERS STREET, WEST WALLSEND 2286

Conservation Area Contribution Level	Est. Construction Date	Previous studies and/or community input
Contributory 1	1890–1915	No prior heritage investigations and no additional information required.
Assessment Text		Observed Modifications
<p>Single story Vernacular ‘Mining Cottage’ style dwelling with hipped Colourbond roof and weatherboard cladding. The veranda roof is skillion.</p> <p>The veranda is partially enclosed with crossed timber balustrade and window installations.</p> <p>A timber fence encloses the property.</p> <p>The dwelling displays architectural features of a heritage style and is representative of the local development of this period, being of historical significance for the HCA.</p>		<p>The visible windows and doors have been replaced with contemporary designs.</p> <p>An extension has been constructed at the back western side of the dwelling. this is not visible from the street and does not detract from the heritage streetscape.</p>

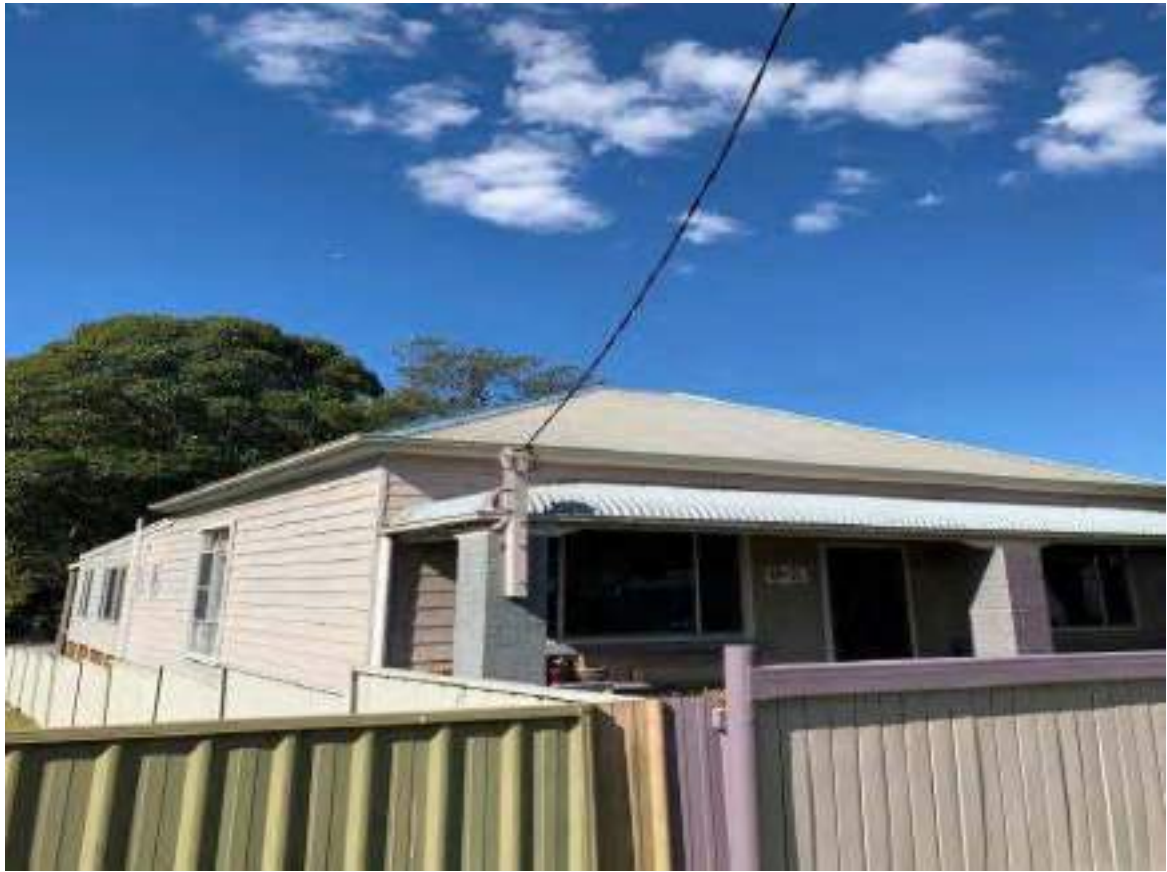
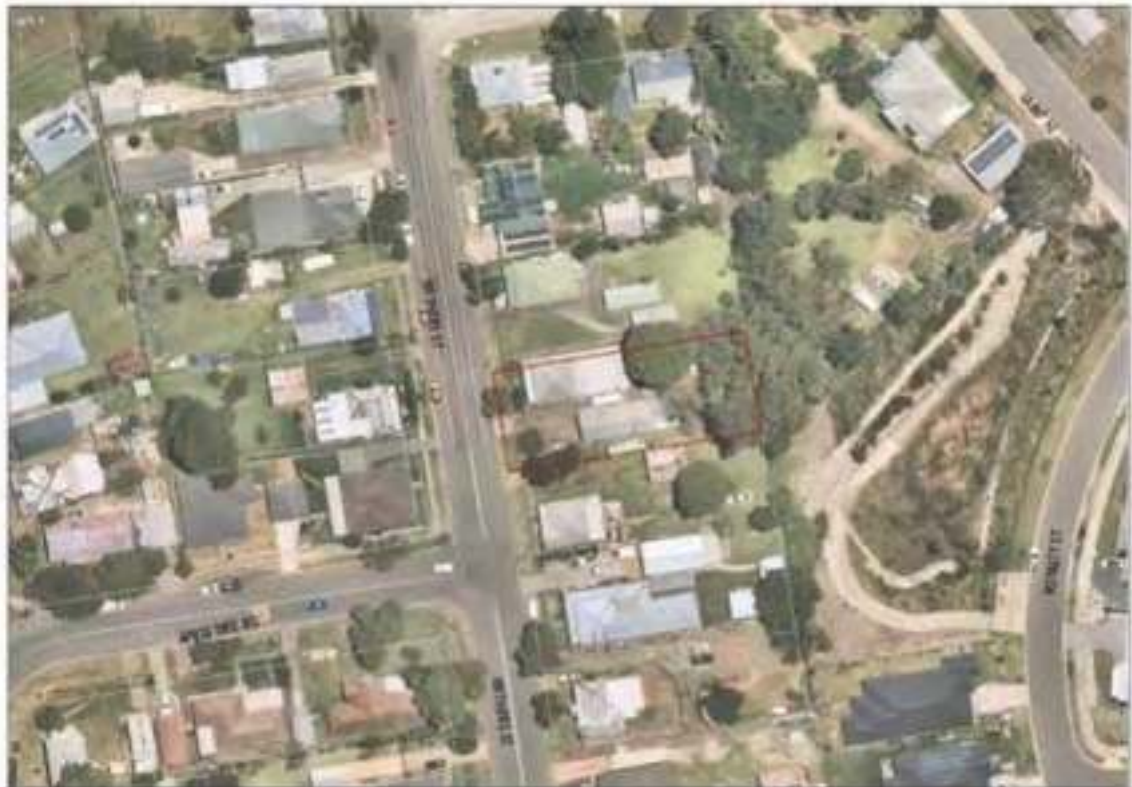
65 WITHERS STREET, WEST WALLSEND 2286

Conservation Area Contribution Level	Est. Construction Date	Previous studies and/or community input
Contributory 1	1890–1915	No prior heritage investigations and no additional information required
Assessment Text		Observed Modifications
<p>Single story Vernacular style dwelling with steep hipped Colourbond roof and weatherboard cladding. The veranda roof is bull nosed, potentially original.</p> <p>The veranda roof is supported by prominent brick pillars.</p> <p>A timber fence encloses the property.</p> <p>The dwelling displays architectural features of a heritage style and is representative of the local development of this period, being of historical significance for the HCA.</p>		<p>All visible windows have been replaced with contemporary designs, similarly the front door.</p> <p>An extension has been built onto the back eastern portion of the dwelling. this is not visible from the street and does not detract from the heritage streetscape.</p> <p>The brick pillars supporting the veranda are a recent modification, likely replacing original timber posts. This is an unsympathetic material choice and contrast with the dwellings heritage style.</p>

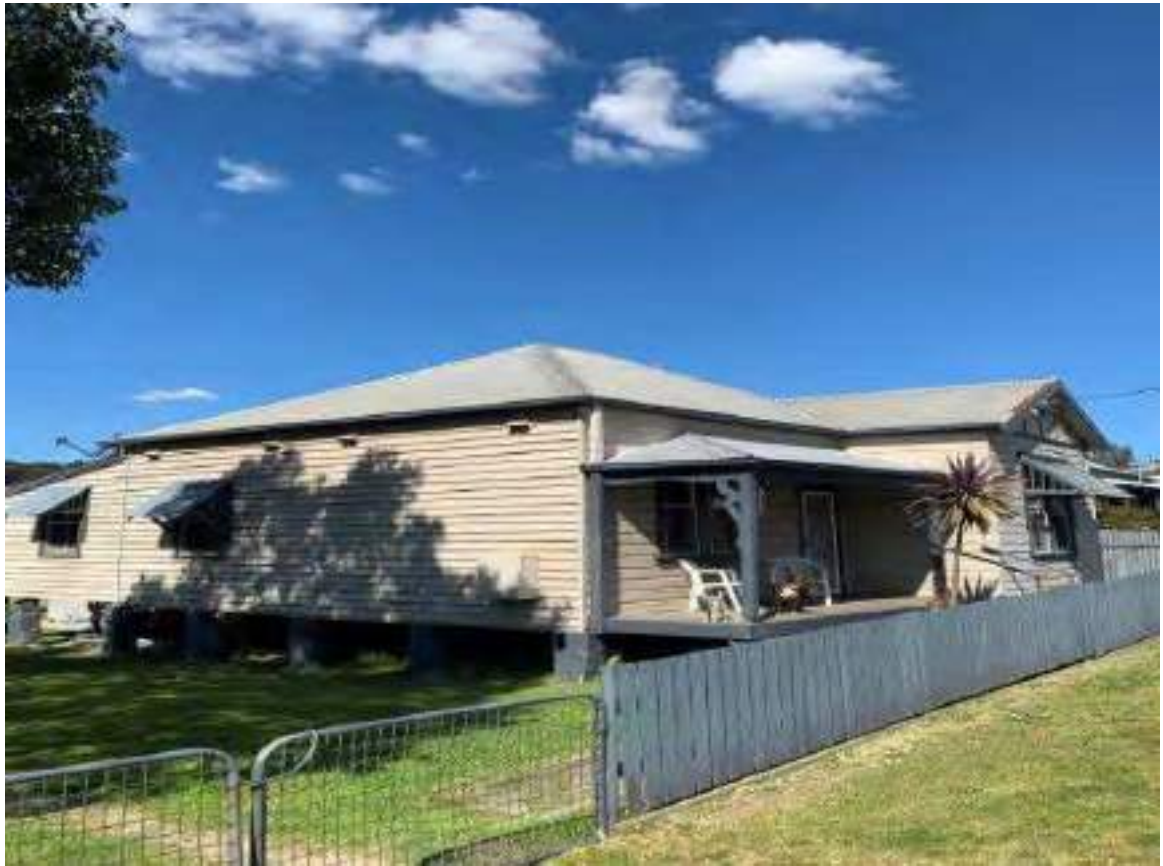
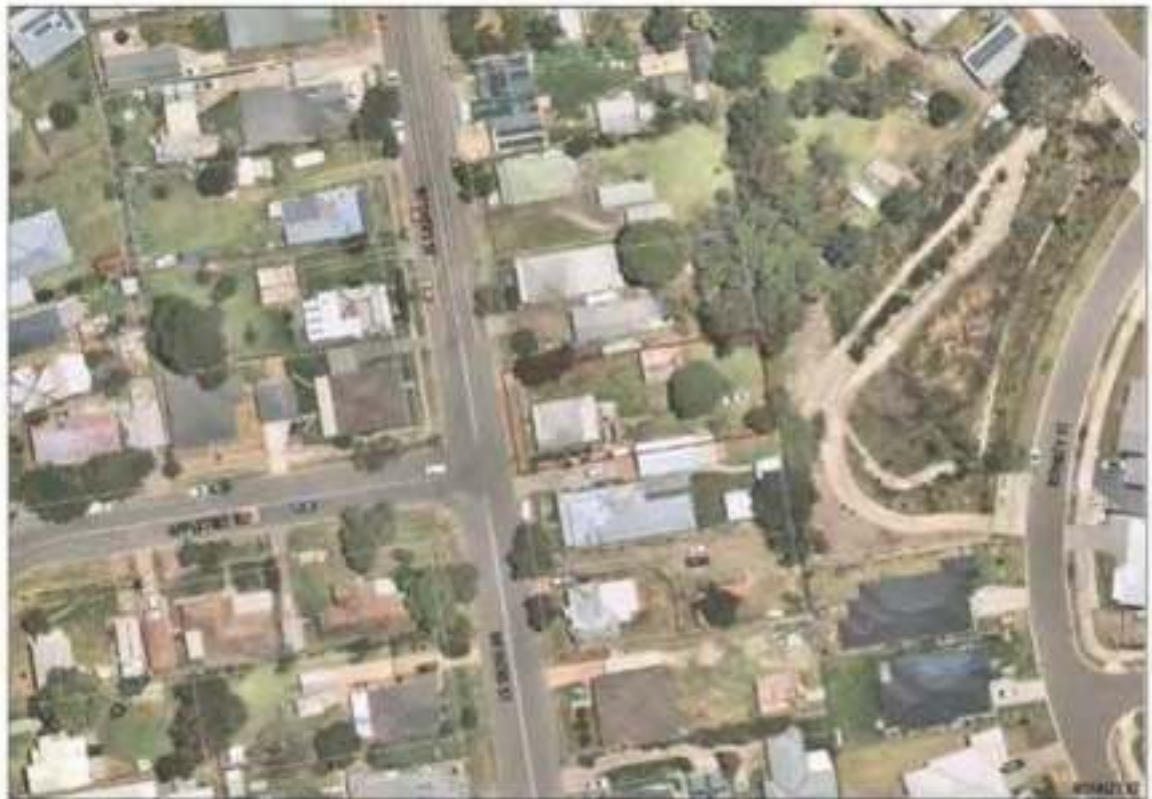
67 WITHERS STREET, WEST WALLSEND 2286

Conservation Area Contribution Level	Est. Construction Date	Previous studies and/or community input
Contributory 1	1900–1920	No prior heritage investigations and no additional information required
Assessment Text		Observed Modifications
<p>Single story Simple Federation ‘workmen's cottage’ style dwelling with hipped Colourbond roof with gable projection, and timber weatherboard cladding. The veranda is hipped with simply decorative timber valance and ornately carved support posts.</p> <p>All visible windows appear to be the original heavy timber framed sash designs, with decorative sills. The gable window and northern windows have shingle timber awnings/hoods, also potentially original.</p> <p>A brickwork chimney is visible on the southern side of the dwelling, with terracotta pot.</p> <p>The gable has simple battening detailing.</p> <p>A timber picket fence encloses the property.</p> <p>The dwelling displays architectural features of a heritage style and is representative of the local development of this period, being of historical significance for the HCA.</p>		<p>Southern side windows are contemporary in design, replacing the original designs.</p> <p>A small extension has been built onto the back eastern side of the dwelling. This is not visible from the street and does not impact the heritage streetscape.</p>

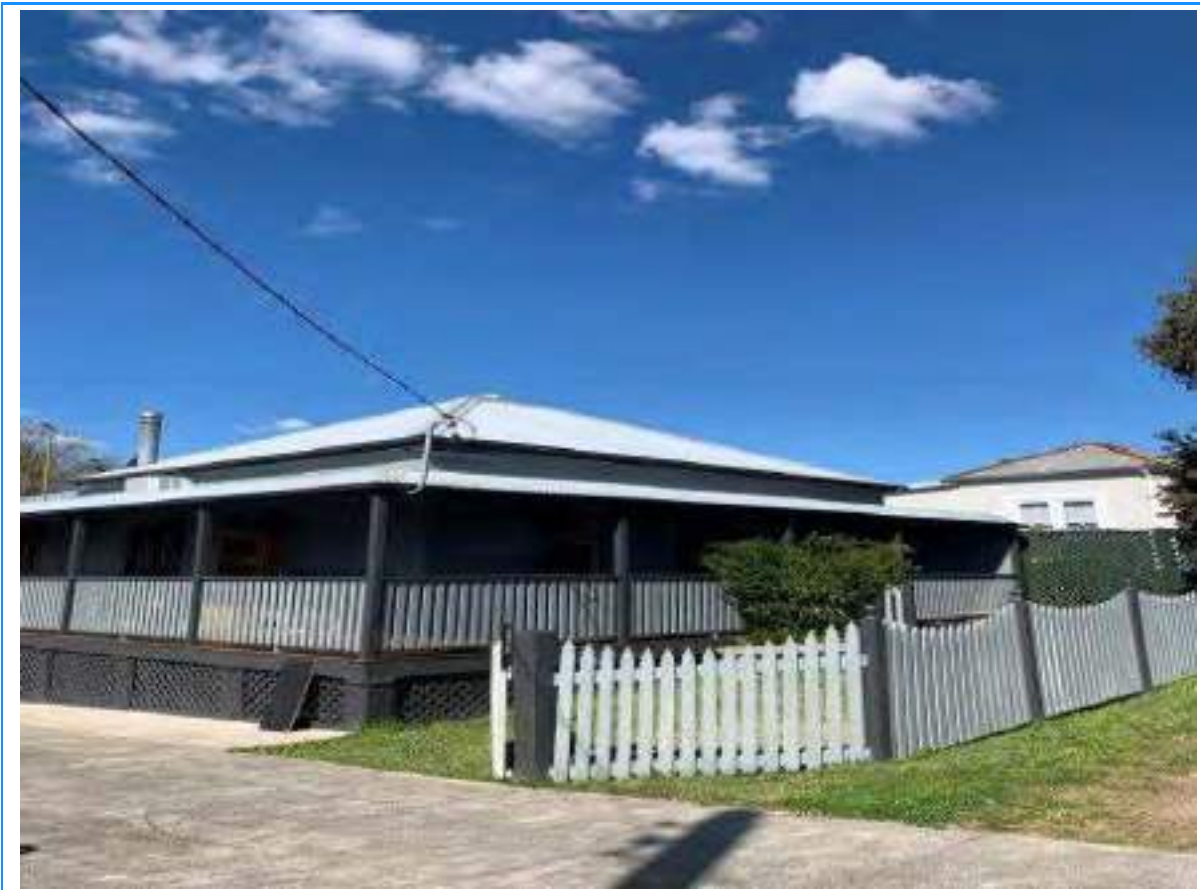
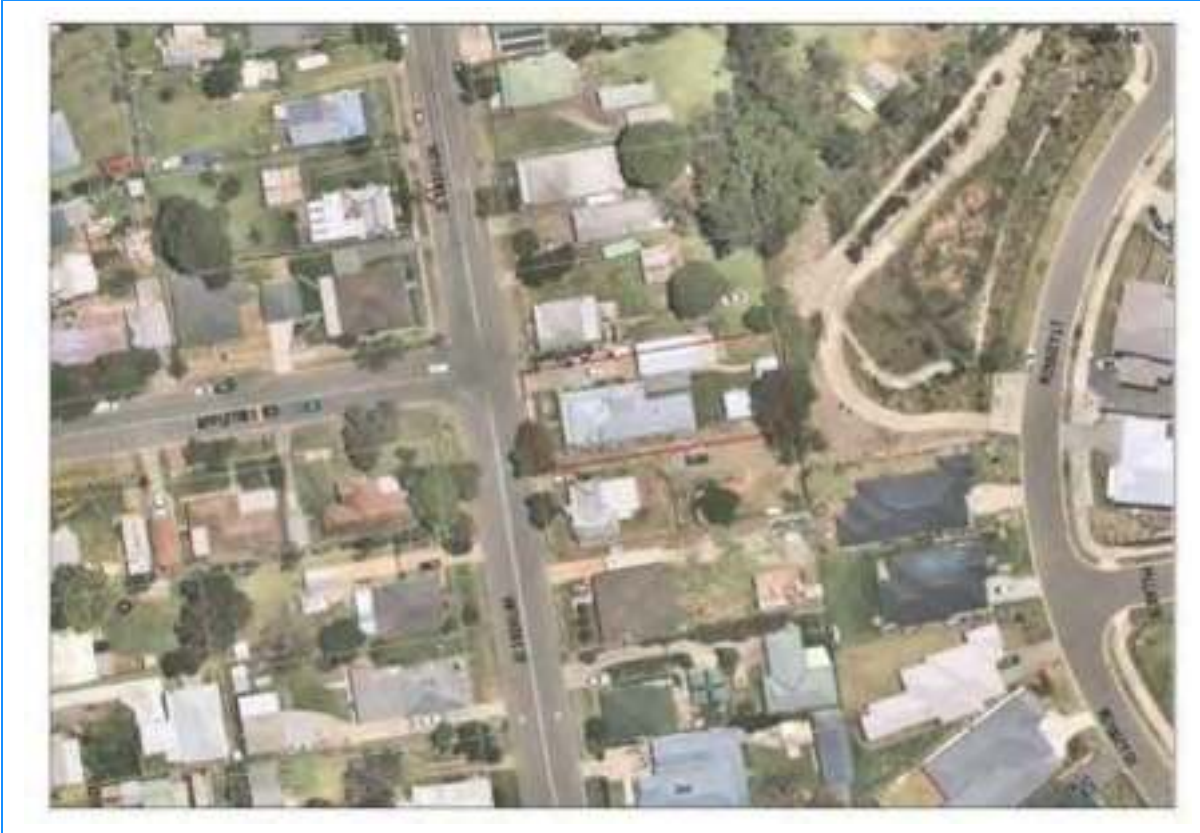
Conservation Area Contribution Level	Est. Construction Date	Previous studies and/or community input
Contributory 1	1890–1915	No prior heritage investigations and no additional information required
Assessment Text		Observed Modifications
<p>Single story Vernacular dwelling with extensive modifications. The roof is hipped Colourbond, with weatherboard cladding. The veranda roof is bull nosed, portions potentially original.</p> <p>The veranda is partially enclosed with a timber balustrade.</p> <p>A gable roof garage is constructed to the north of the dwelling.</p> <p>Timber picket fencing encloses the property.</p> <p>The dwelling displays architectural features of a heritage style and is representative of the local development of this period, being of historical significance for the HCA.</p>		<p>The visible windows are contemporary installations, however are styled in a heritage manner and do not detract.</p> <p>The veranda wraps around the northern side of the dwelling, a common modification for similar dwellings of the area. An additional double set of stairs has been constructed leading to the extended veranda.</p> <p>The timber balustrade is a contemporary addition.</p> <p>An extension has been built onto the back eastern portion of the dwelling. this is visible and detracts from the heritage streetscape.</p> <p>The southern windows have been sealed.</p>
