APPENDIX 2

Building Assessment Sheets (Inventory Sheets)

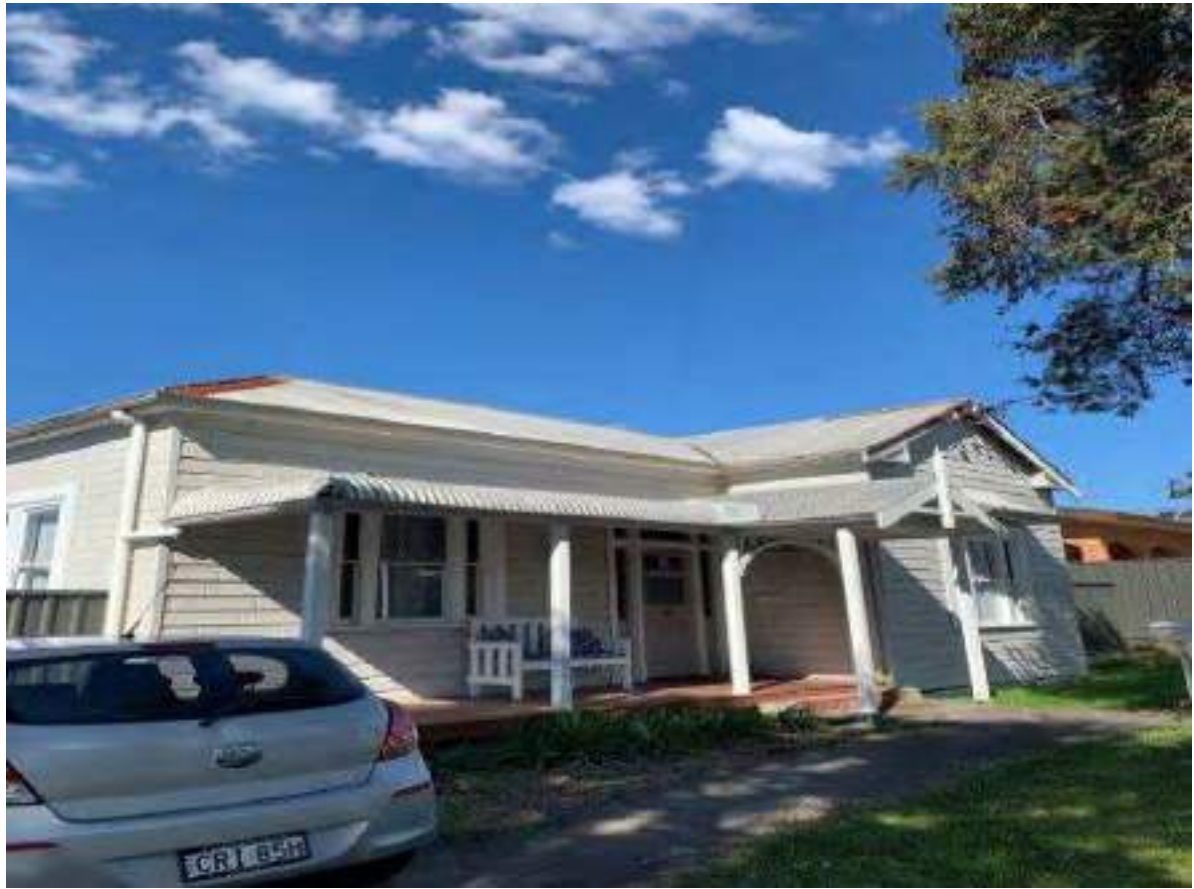
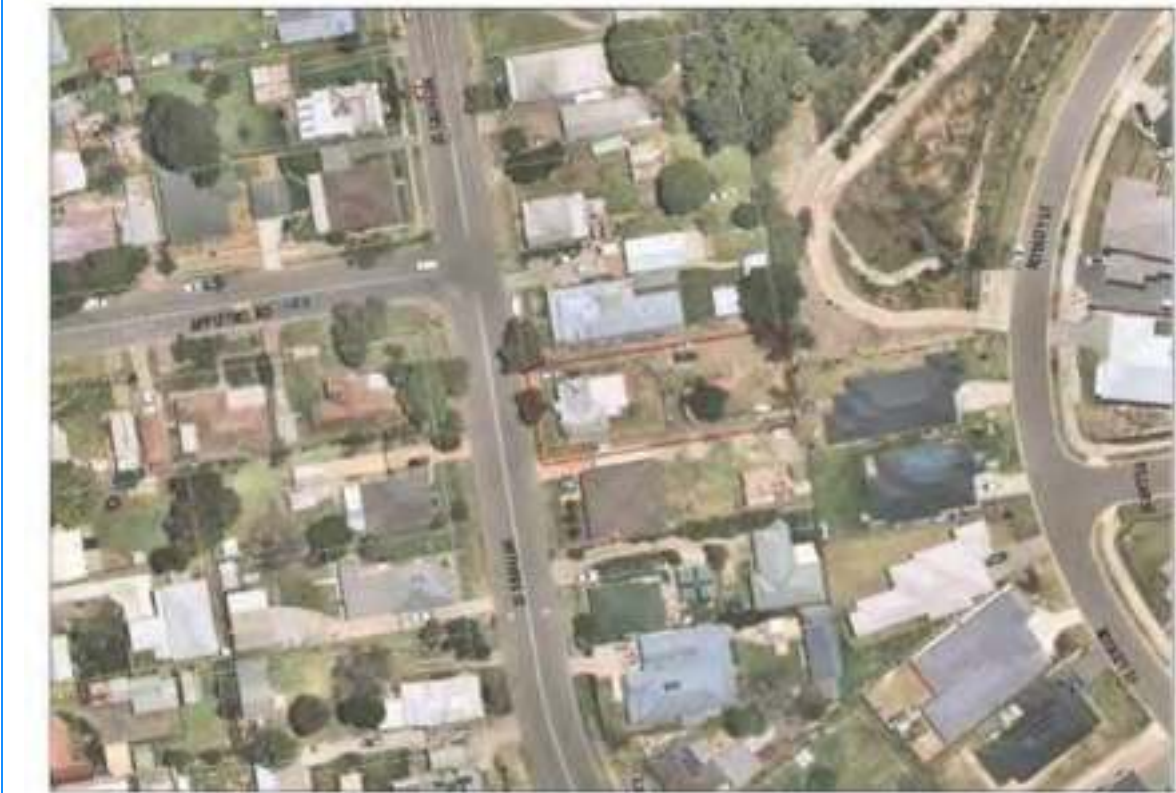
71 WITHERS STREET, WEST WALLSEND 2286

Conservation Area Contribution Level	Est. Construction Date	Previous studies and/or community input
Contributory 1	1890–1920	No prior heritage investigations and no additional information required
Assessment Text		Observed Modifications
<p>Single story Simple Federation ‘workmen's cottage’ style dwelling with Colourbond hipped roof with gable projection and timber weatherboard cladding. The veranda roof is bull nosed and potentially original.</p> <p>The veranda is open.</p> <p>The visible windows appear original, with timber framed sash design with coloured glass panels either side. the front door is timber framed with glass panels, potentially original, with similar glass panels either side.</p> <p>The gable has extended eaves and a frilled metal window hood.</p> <p>The dwelling displays architectural features of a heritage style and is representative of the local development of this period, being of historical significance for the HCA.</p>		<p>An additional gabled archway has been constructed at the entrance to the dwelling, with timber finial. Although heritage styled, this is an unsympathetic choice and is noticeably a contemporary addition.</p> <p>A small extension has been constructed at the back eastern end of the dwelling. this is not visible from the street and does not detract.</p>

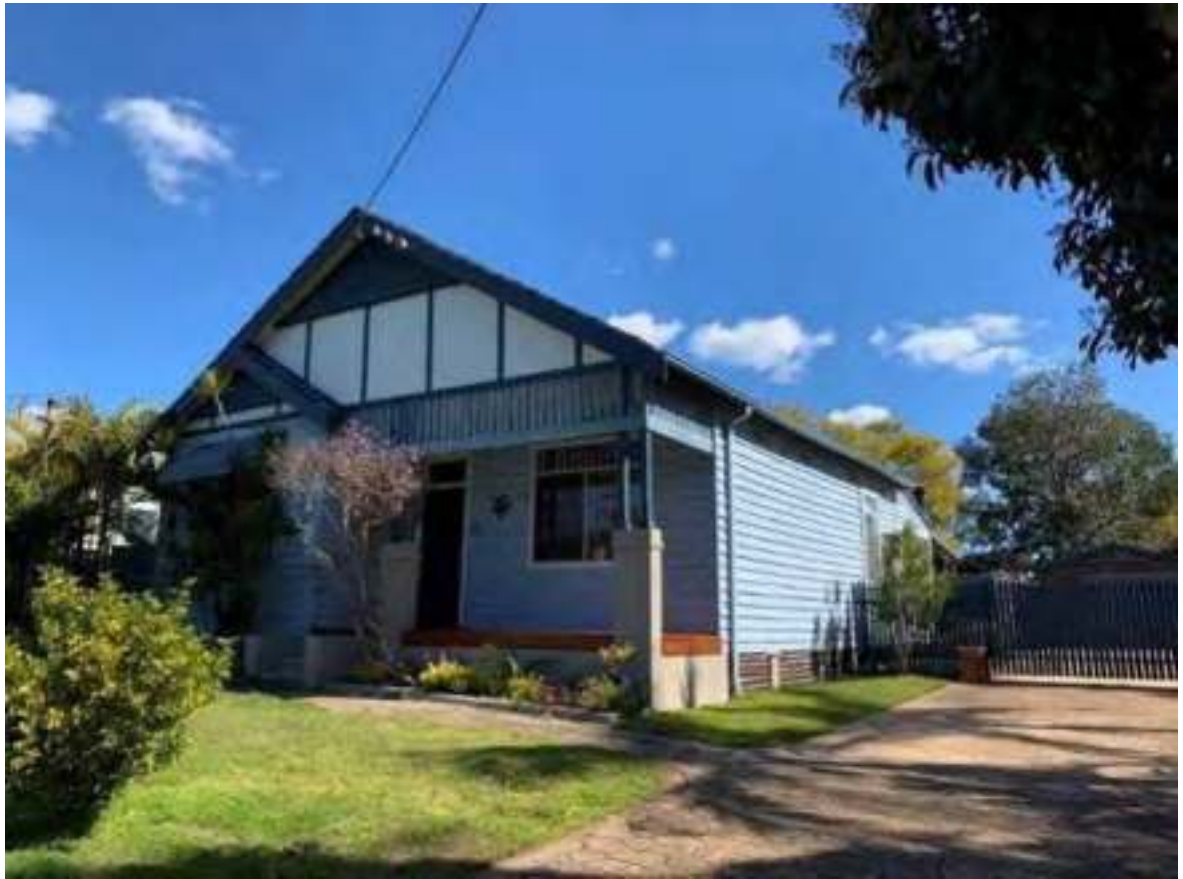
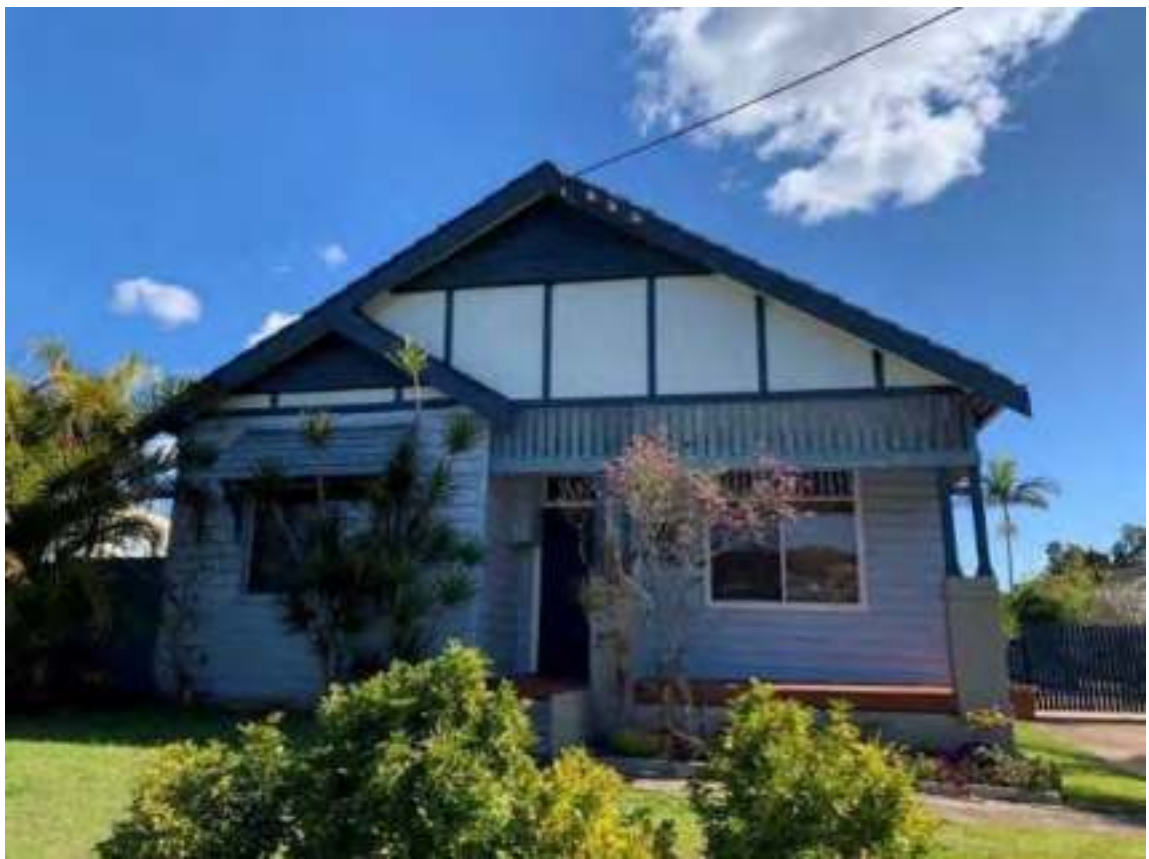
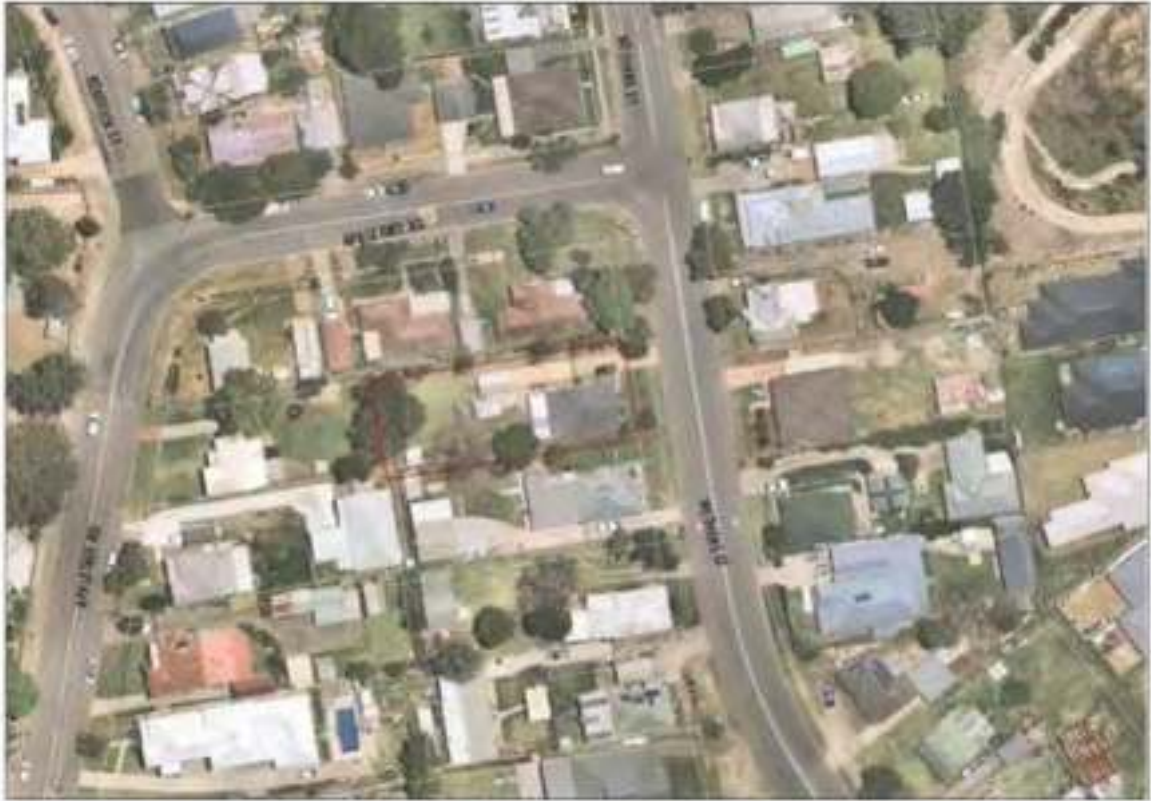
60 WITHERS STREET, WEST WALLSEND 2286

Conservation Area Contribution Level	Est. Construction Date	Previous studies and/or community input
Contributory 1	1920–1930	No prior heritage investigations and no additional information required
Assessment Text		Observed Modifications
<p>Single story Bungalow style dwelling with gabled concrete tiled roof with secondary false gable and weatherboard cladding. A prominent timber valance frames the veranda and is supported by brick piers with tapered timber posts.</p> <p>The veranda is open with masonry stairs leading onto the landing.</p> <p>The gables have extended eaves and battening detailing. The false gable has a shingled timber awnings atop the window.</p> <p>The dwelling displays architectural features of a heritage style and is representative of the local development of this period, being of historical significance for the HCA.</p>		<p>The visible windows are contemporary dan extension has been built onto the back western side of the dwelling. this is not visible from the street and does not detract.</p>

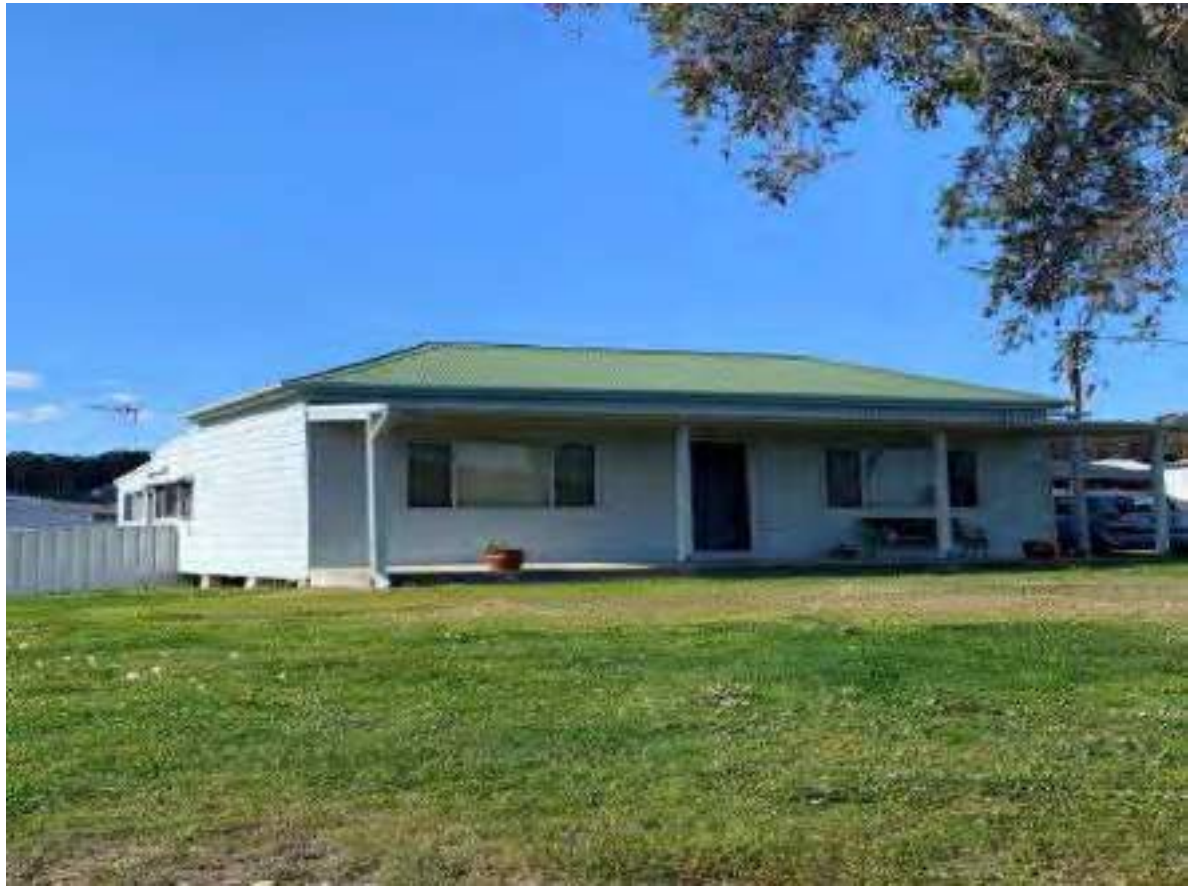
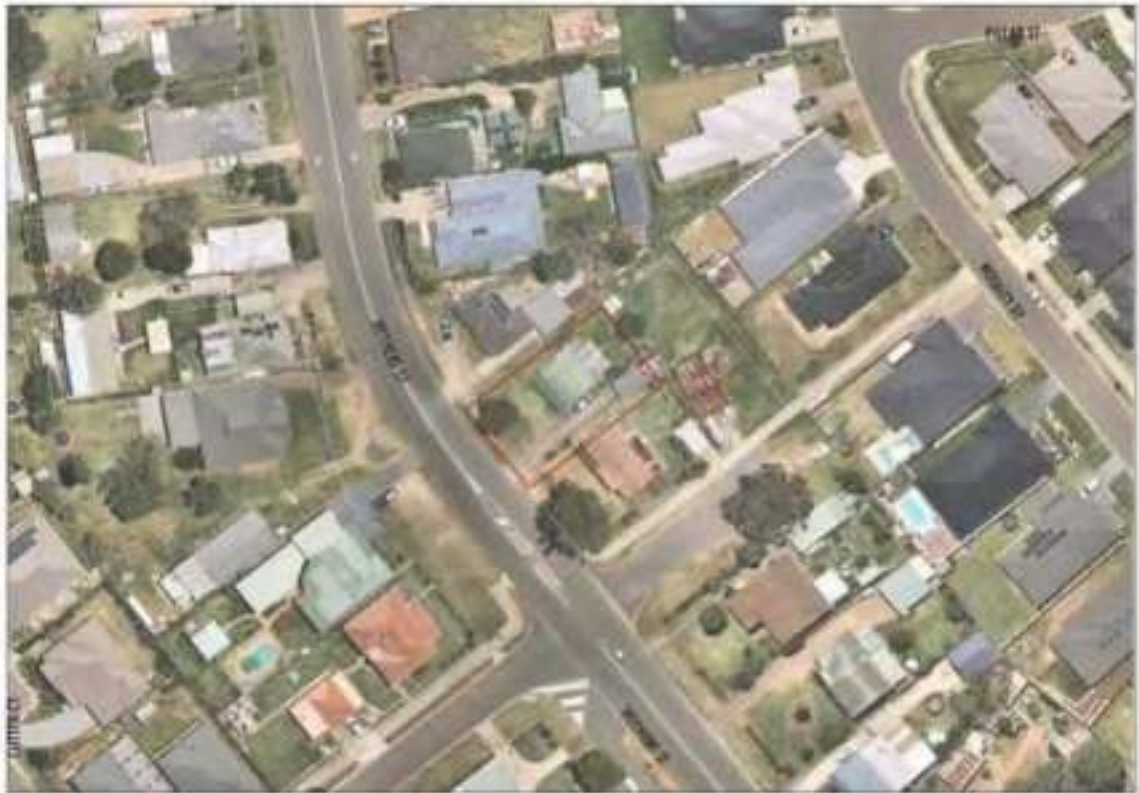
81 WITHERS STREET, WEST WALLSEND 2286

Conservation Area Contribution Level	Est. Construction Date	Previous studies and/or community input
Contributory 1	1890–1920	No prior heritage investigations and no additional information required
Assessment Text		Observed Modifications
<p>Single story Vernacular cottage style dwelling with hipped Colourbond roof and weatherboard cladding. The veranda roof is skillion.</p> <p>The veranda is open.</p>		<p>The veranda roof would have originally been hipped or bull nosed. All visible windows have been replaced with contemporary designs. The timber veranda support posts are a contemporary addition, likely replacing similar original styles.</p>

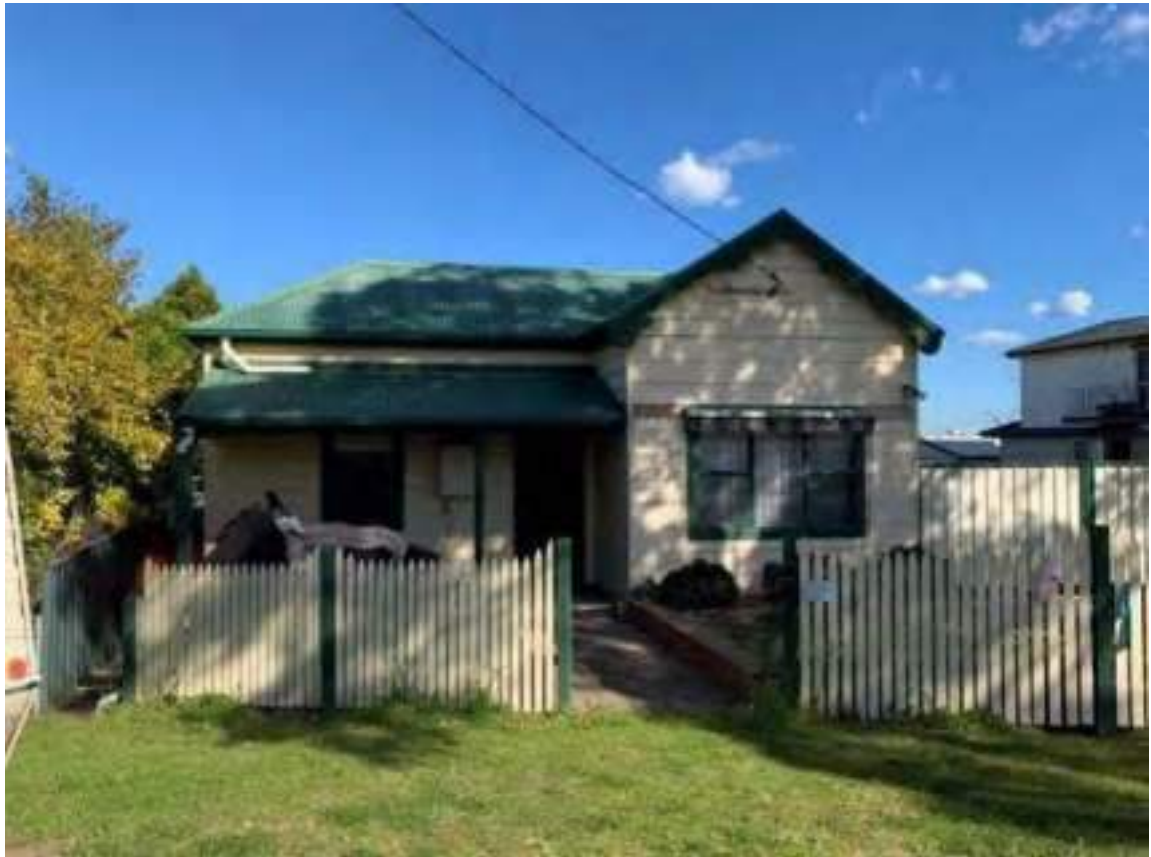
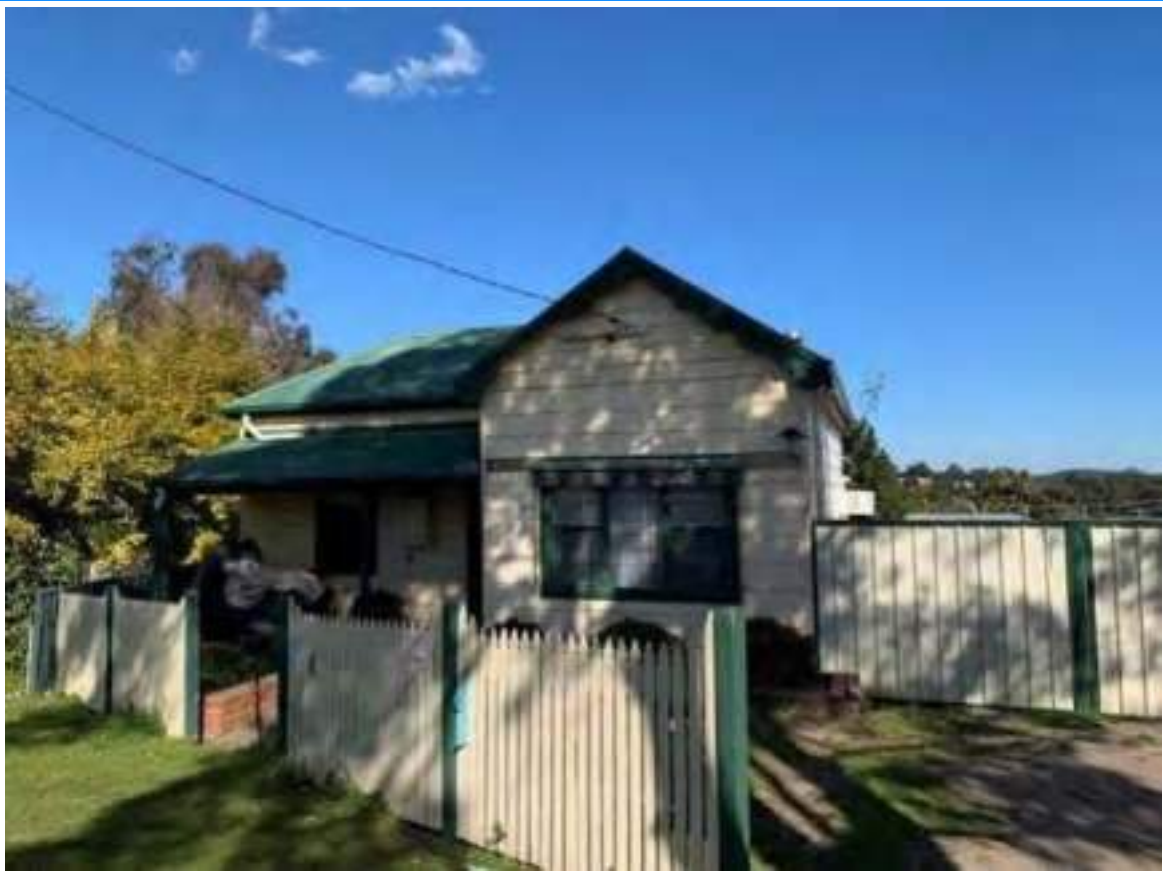
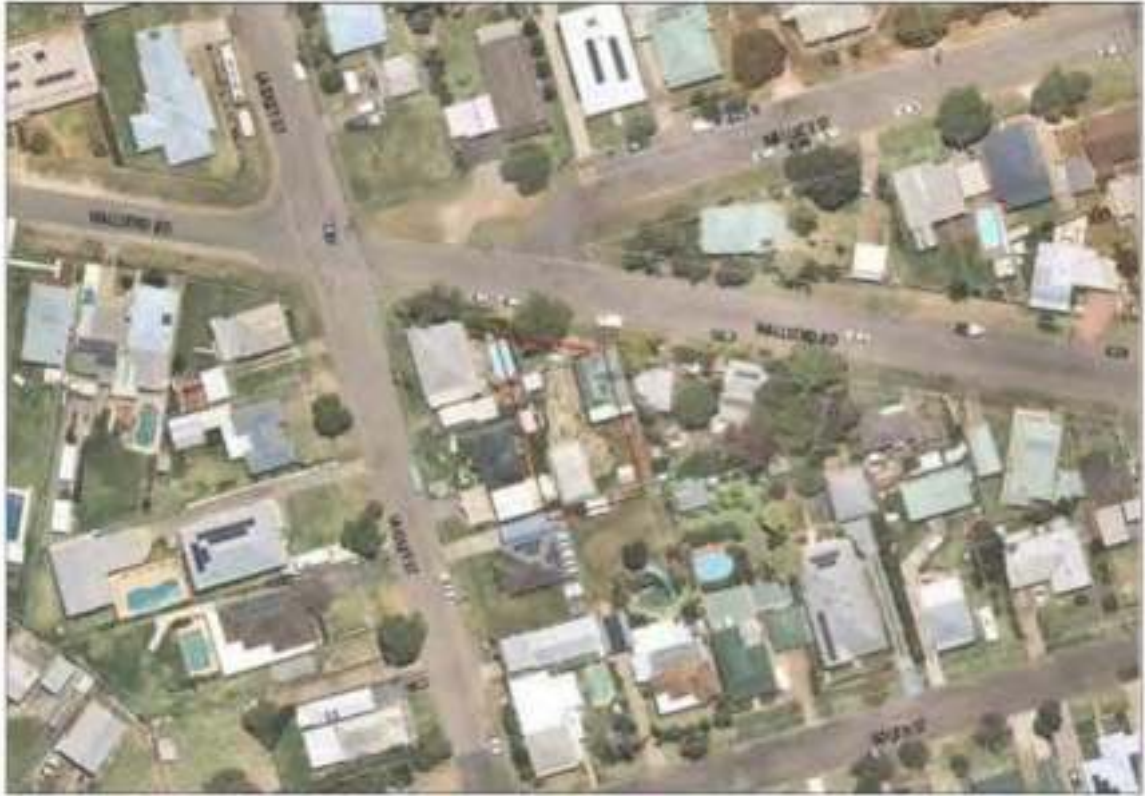
16 WALLSEND ROAD, WEST WALLSEND 2286

Conservation Area Contribution Level	Est. Construction Date	Previous studies and/or community input
Contributory 1	1900–1920	No prior heritage investigations and no additional information required
Assessment Text		Observed Modifications
<p>Single story Simple Federation ‘workmen's cottage’ style dwelling with hipped Colourbond roof and weatherboard cladding. The veranda roof is skillion.</p> <p>The gable has a decorative barge board.</p> <p>A timber picket fence encloses the property.</p> <p>The dwelling displays architectural features of a heritage style and is representative of the local development of this period, being of historical significance for the HCA.</p>		<p>A contemporary canvas striped awnings has been installed a top the gable window.</p> <p>The visible windows and front door appear to have been replaced with contemporary styles.</p> <p>The veranda roof was likely originally bull nosed and has been replaced.</p>

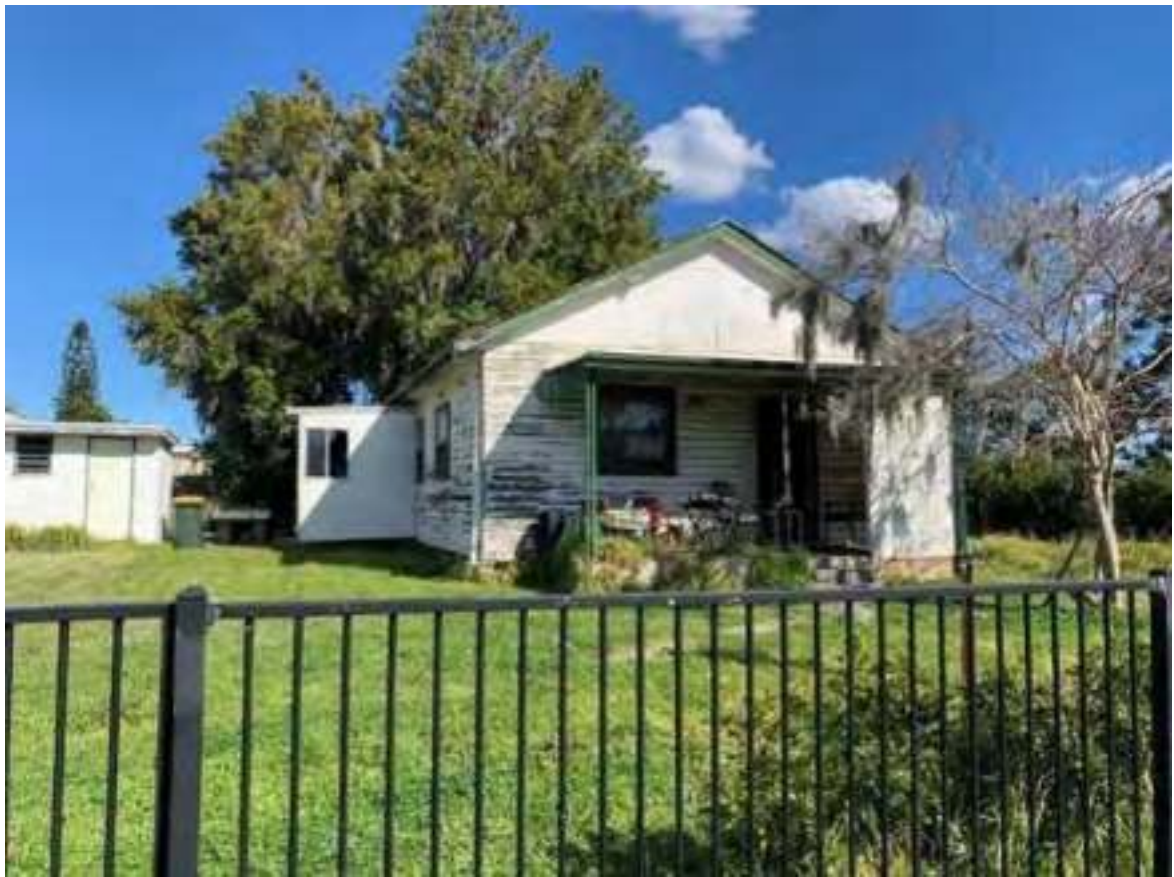
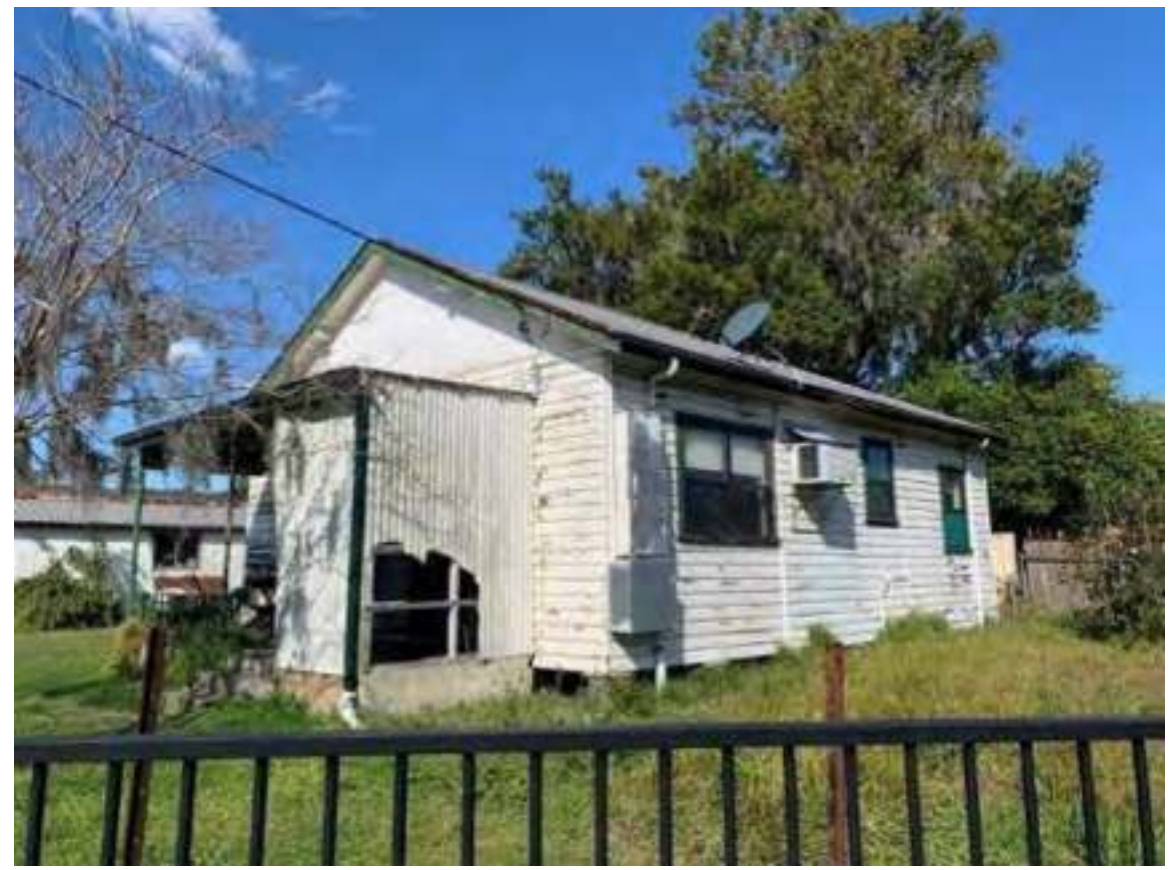
3 APPLETREE ROAD, WEST WALLSEND 2286

Conservation Area Contribution Level	Est. Construction Date	Previous studies and/or community input
Contributory 1	1900–1930	No prior heritage investigations and no additional information required.
Assessment Text		Observed Modifications
<p>Single story dwelling with gabled Colourbond roof and timber weatherboard cladding. The cladding paintwork is in poor condition. The veranda roof is flat.</p> <p>The gable has extended eaves.</p> <p>A metal fence encloses the property.</p> <p>A garage and additional structure are located to the east of the dwelling.</p> <p>The dwelling displays architectural features of a heritage style and is representative of the local development of this period, being of historical significance for the HCA.</p>		<p>The metal veranda support poles are a contemporary addition, likely replacing original timber designs.</p> <p>All visible windows are contemporary sash designs.</p> <p>A prominent extension has been built onto the eastern side of the dwelling, of fibro-clad timber sheets. This is highly visible and unsympathetic in construction.</p> <p>The veranda has been partially enclosed with a Colourbond wall.</p>

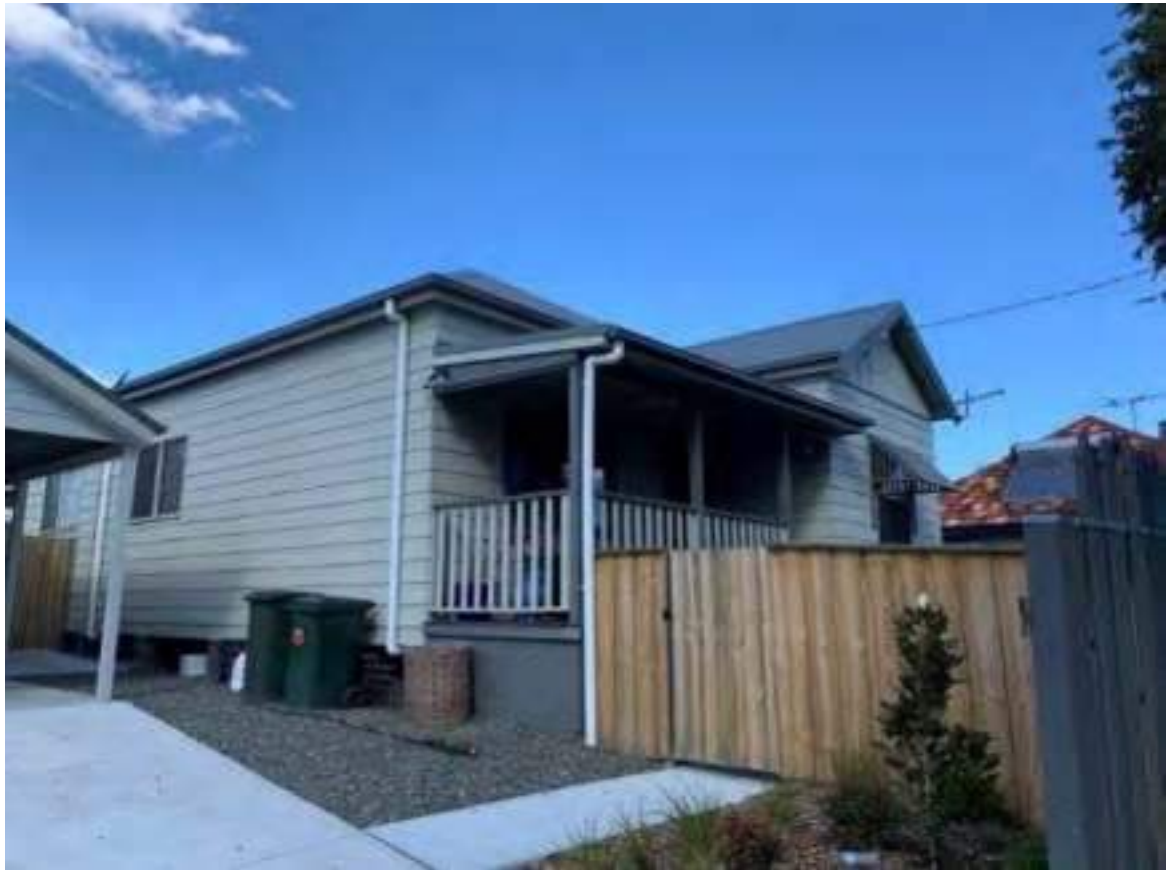
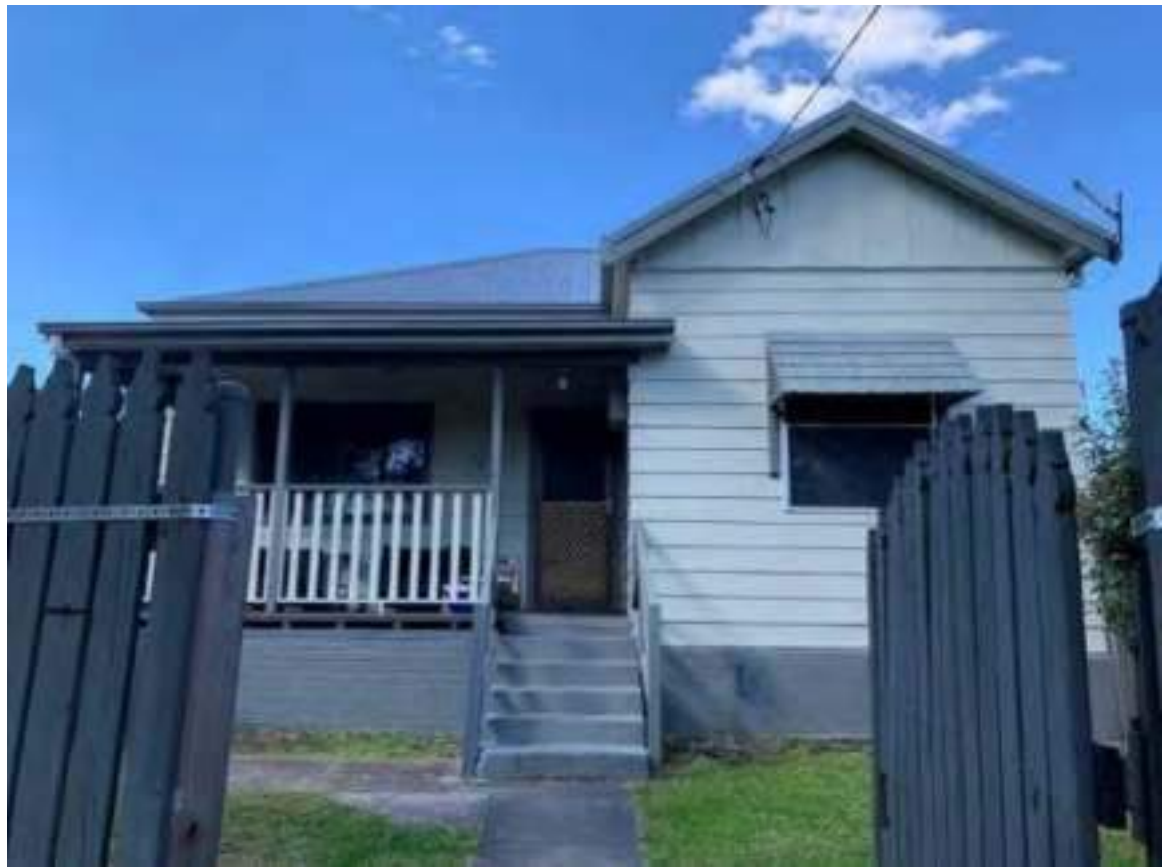
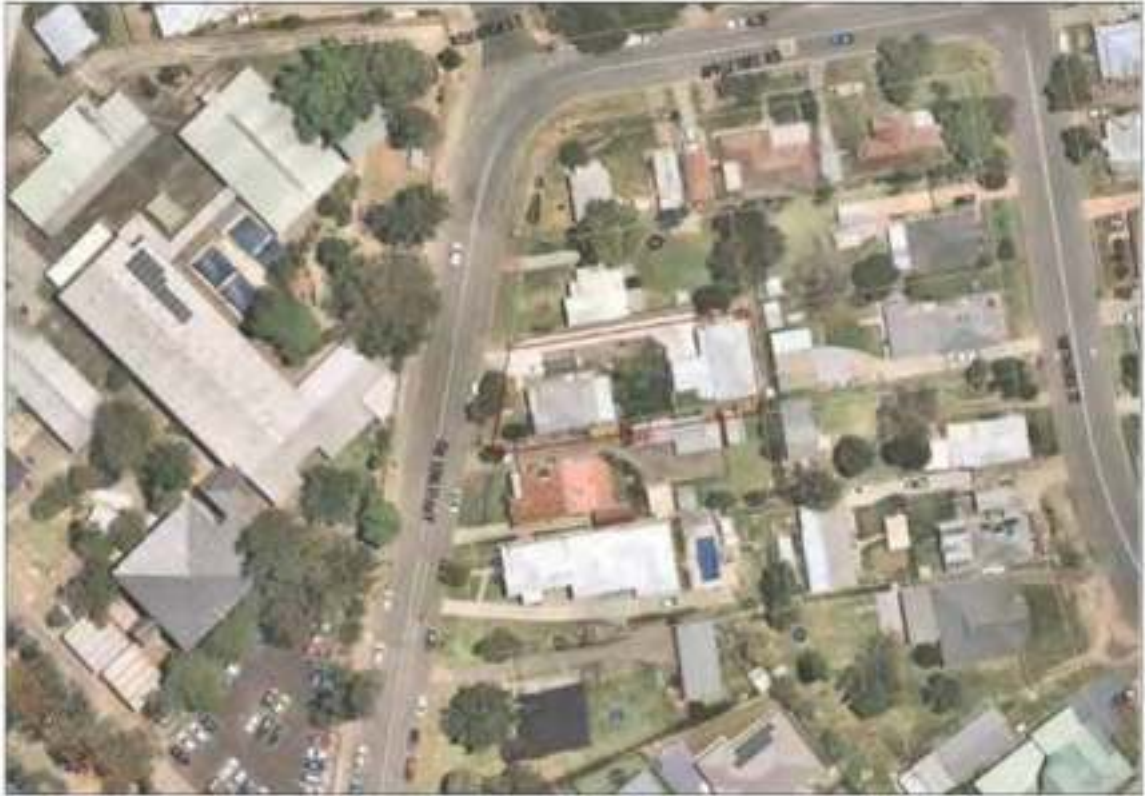
7 APPLETREE ROAD, WEST WALLSEND 2286

Conservation Area Contribution Level	Est. Construction Date	Previous studies and/or community input
Contributory 1	1900–1920	No prior heritage investigations and no additional information required
Assessment Text		Observed Modifications
<p>Single story Simple Federation ‘workmen's cottage’ style dwelling with hipped Colourbond roof with gable projection and weatherboard cladding. The veranda roof is skillion.</p> <p>The veranda is partially enclosed with a timber balustrade. Brick stairs with similar balustrade lead onto the veranda landing.</p> <p>The gable has timber boarding detailing and a timber shingled awnings above the window.</p> <p>A timber picket fence encloses the property.</p> <p>The dwelling displays architectural features of a heritage style and is representative of the local development of this period, being of historical significance for the HCA.</p>		<p>The visible windows are contemporary installations.</p> <p>The veranda roof would have originally been hipped or bull nosed and has been replaced.</p>

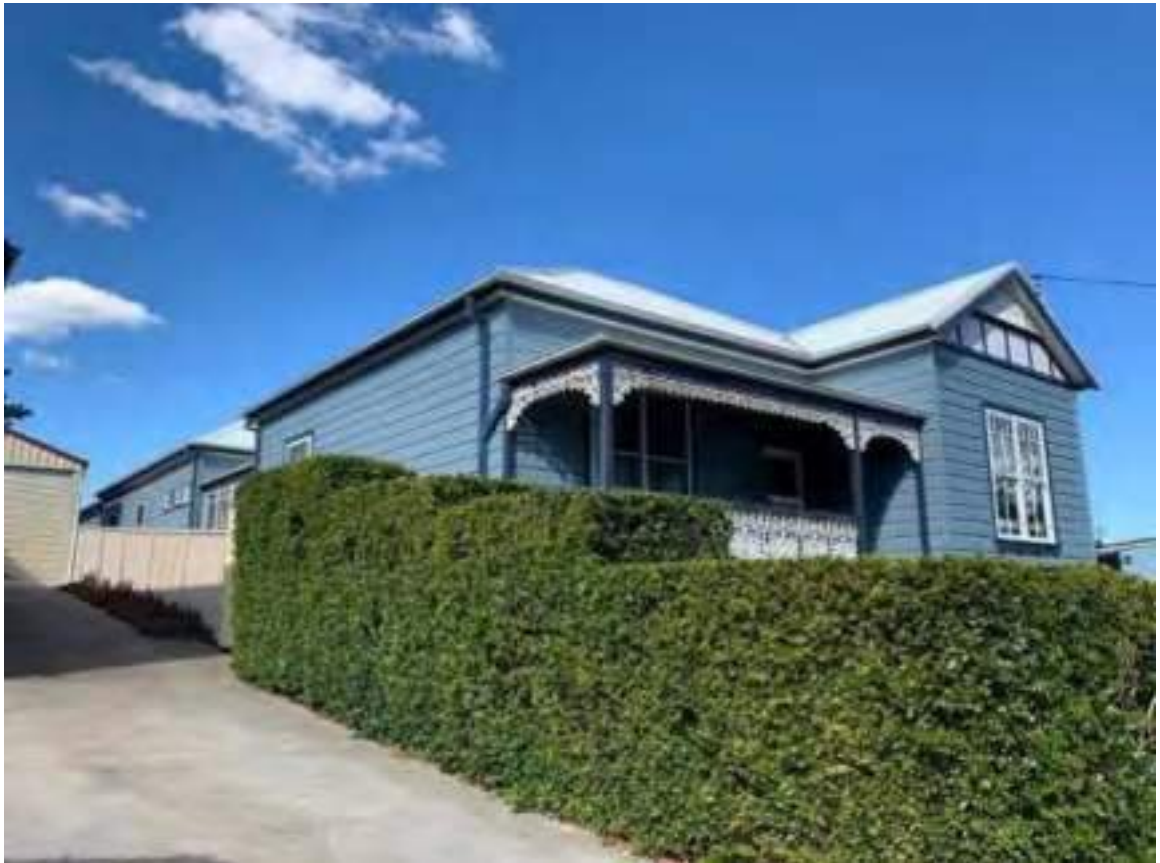
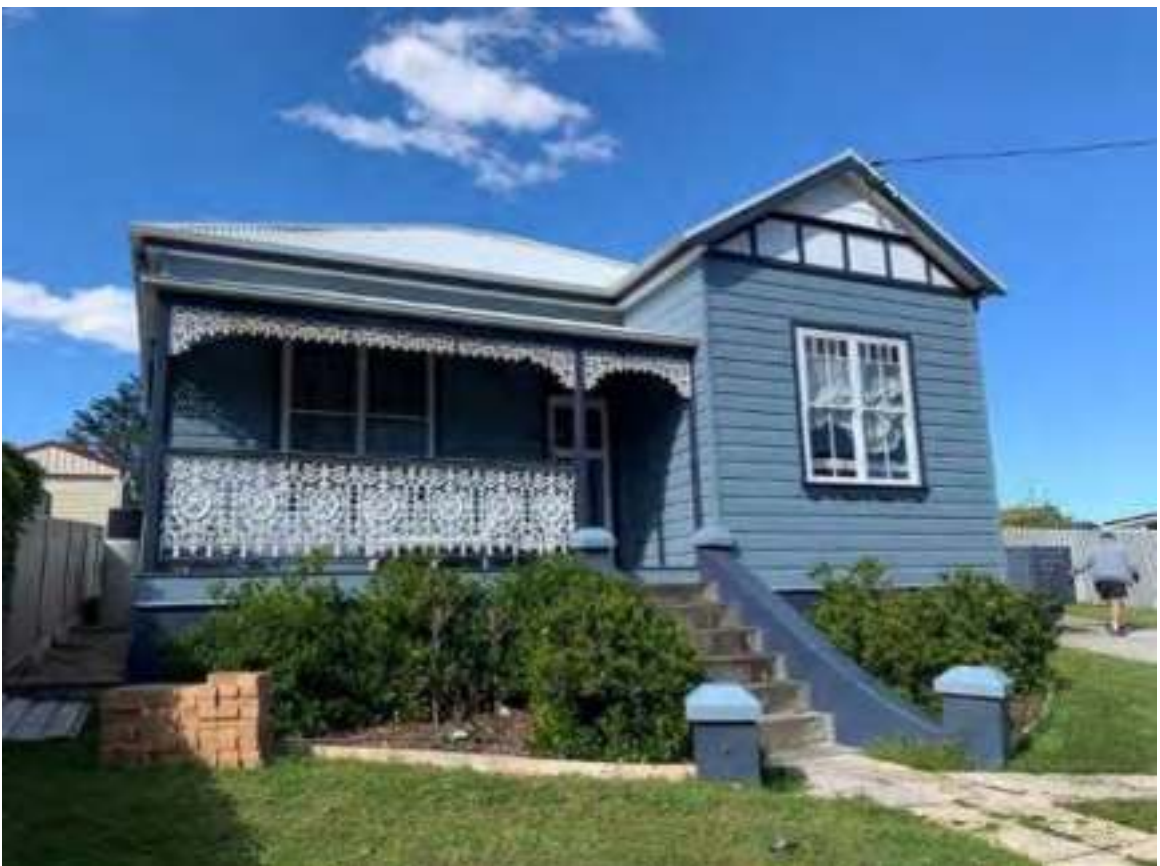
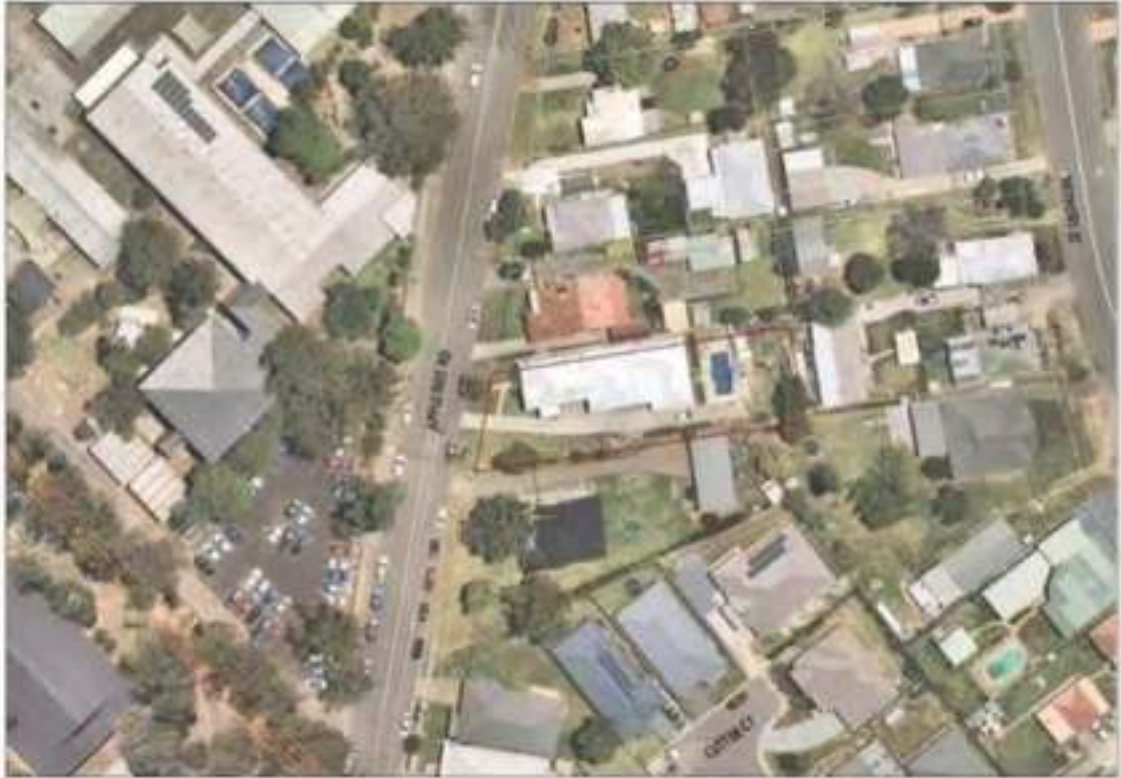
11 APPLETREE ROAD, WEST WALLSEND 2286

Conservation Area Contribution Level	Est. Construction Date	Previous studies and/or community input
Contributory 1	1900–1920	No prior heritage investigations and no additional information required
Assessment Text		Observed Modifications
<p>Single story Simple Federation ‘workmen’s cottage’ style dwelling with hipped Colourbond roof with gable projection and weatherboard cladding. The veranda roof is hipped and framed with cast iron lace valance.</p> <p>The veranda is partially enclosed by a cast iron lace balustrade, with a concrete and masonry rendered stairs with piers.</p> <p>The visible windows appear to be the original timber framed sash designs. The gable window has a decorative sill and coloured glass panels above the gable window. The front door is timber framed with decorative screen dor.</p> <p>The gable has extended eaves and battening detailing.</p> <p>The dwelling displays architectural features of a heritage style and is representative of the local development of this period, being of historical significance for the HCA.</p>		<p>An extensive back extension has been constructed at the eastern side of the dwelling. this is visible on the southern side of the dwelling and detracts from the heritage streetscape and contrast with the dwellings heritage style.</p>

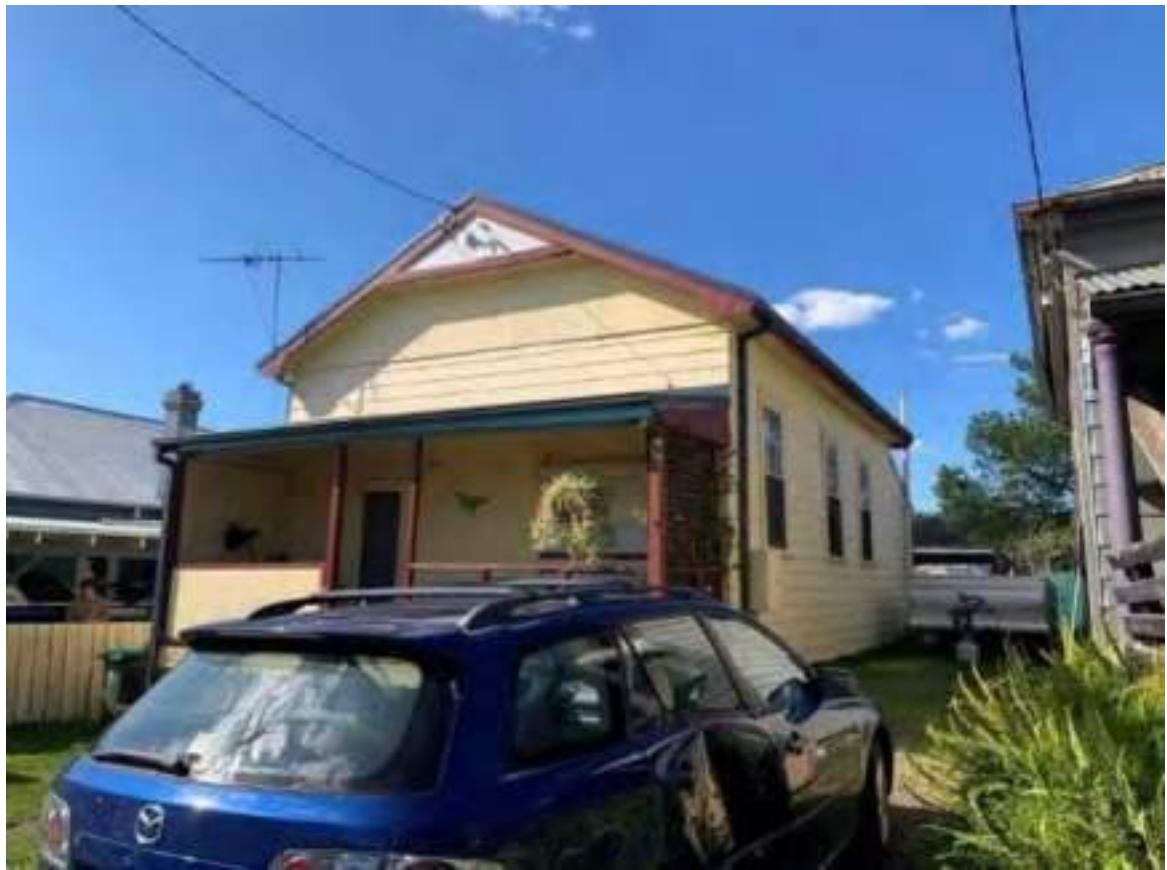
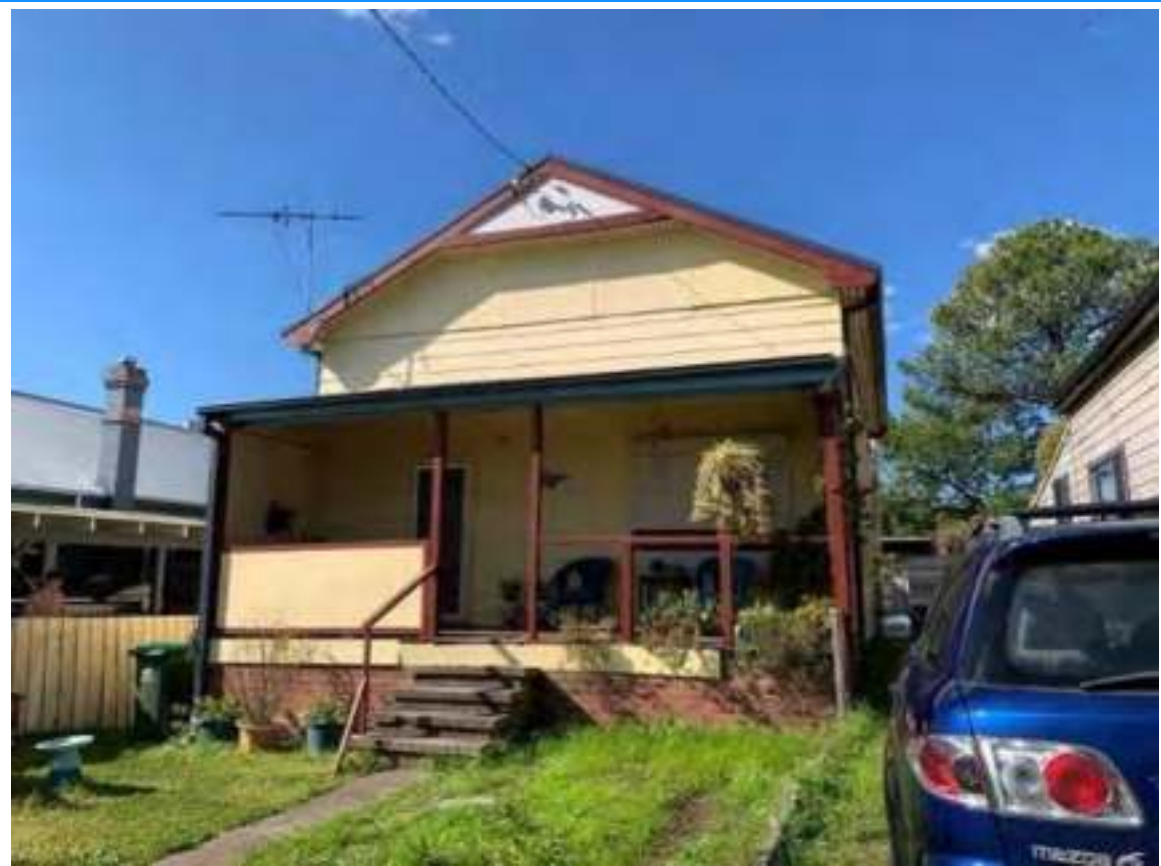
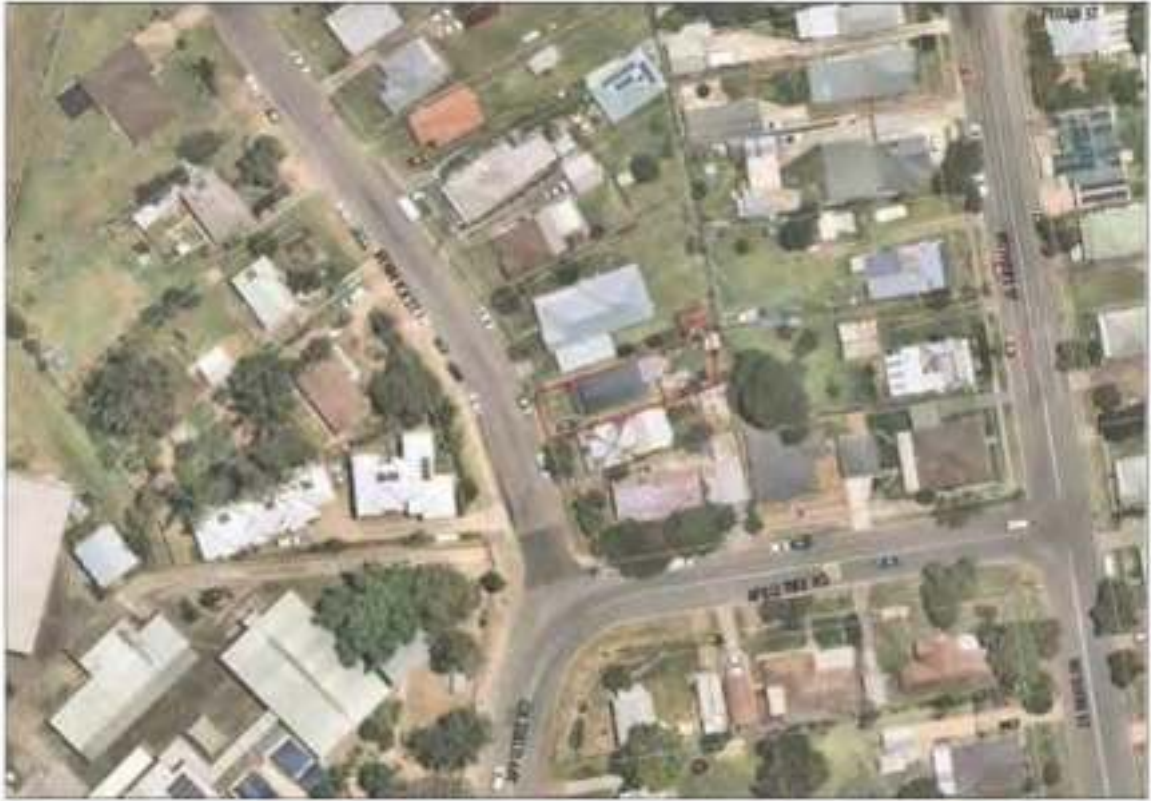
17 RENWICK STREET, WEST WALLSEND 2286

Conservation Area Contribution Level	Est. Construction Date	Previous studies and/or community input
Contributory 1	1900–1920	No prior heritage investigations and no additional information required
Assessment Text		Observed Modifications
<p>Single story Simplified Victorian Regency style dwelling with gabled Colourbond roof and weatherboard cladding. The veranda roof is skillion.</p> <p>The veranda is partially enclosed with a simple timber balustrade.</p> <p>The northern and southern windows appear to be the original timber framed sash designs.</p> <p>The gable has extended eaves and minimal battening detailing.</p> <p>The dwelling displays architectural features of a heritage style and is representative of the local development of this period, being of historical significance for the HCA.</p>		<p>Metal shutter awnings have been installed on all visible windows, contrasting with the heritage style of the dwelling,</p>
