APPENDIX 2

Building Assessment Sheets (Inventory Sheets)

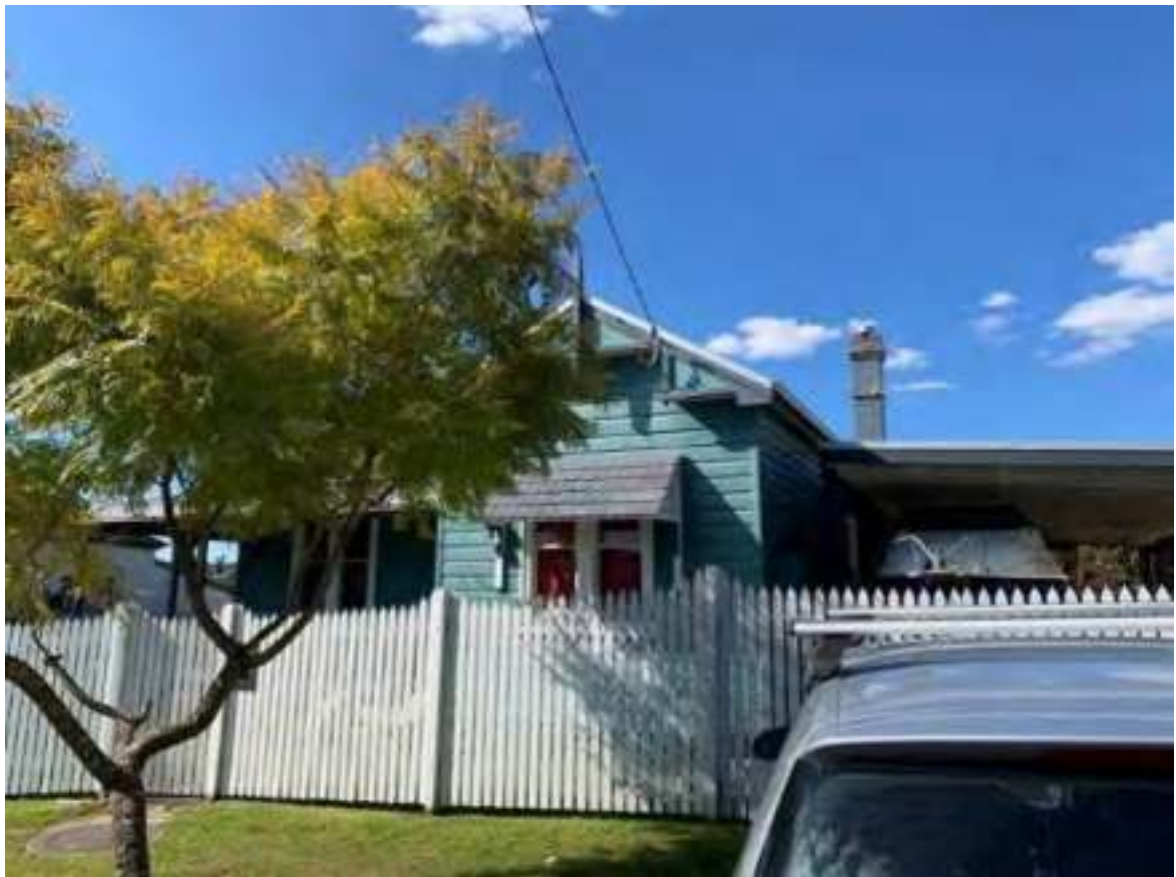
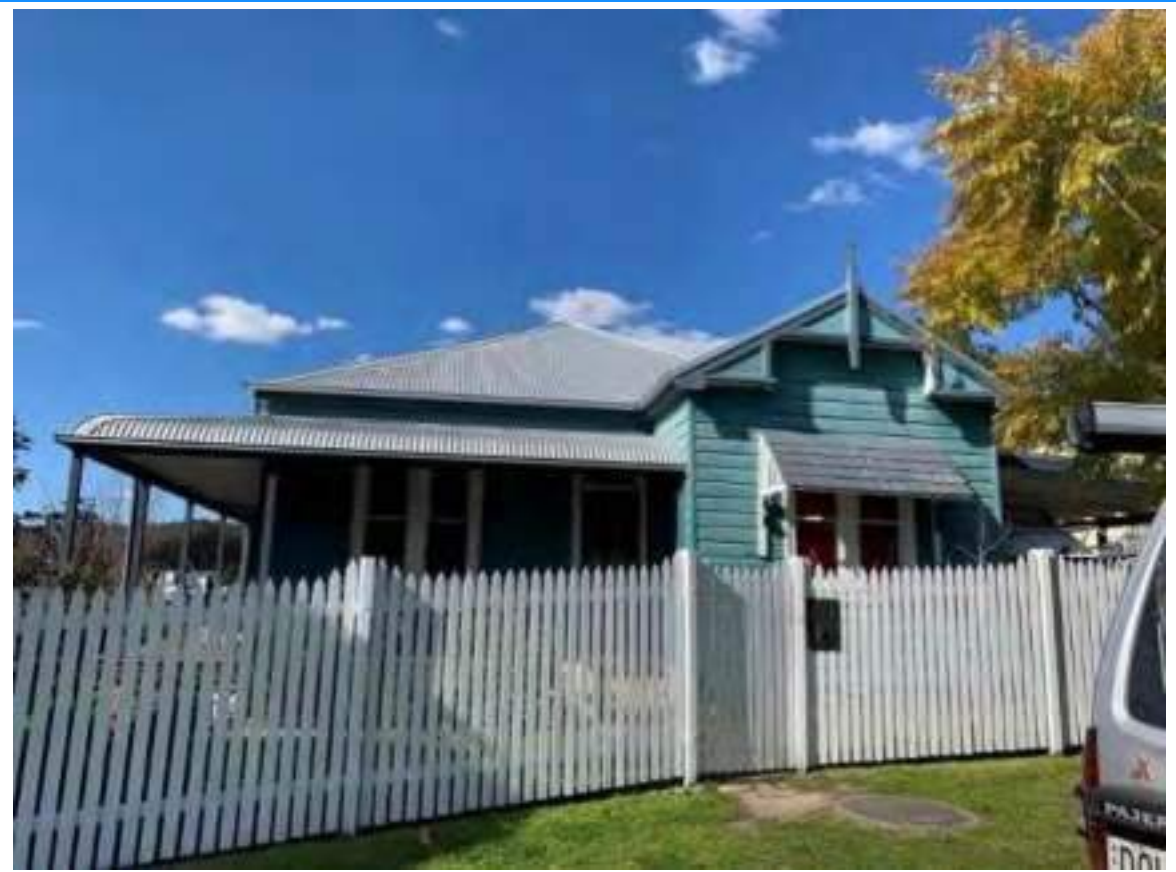
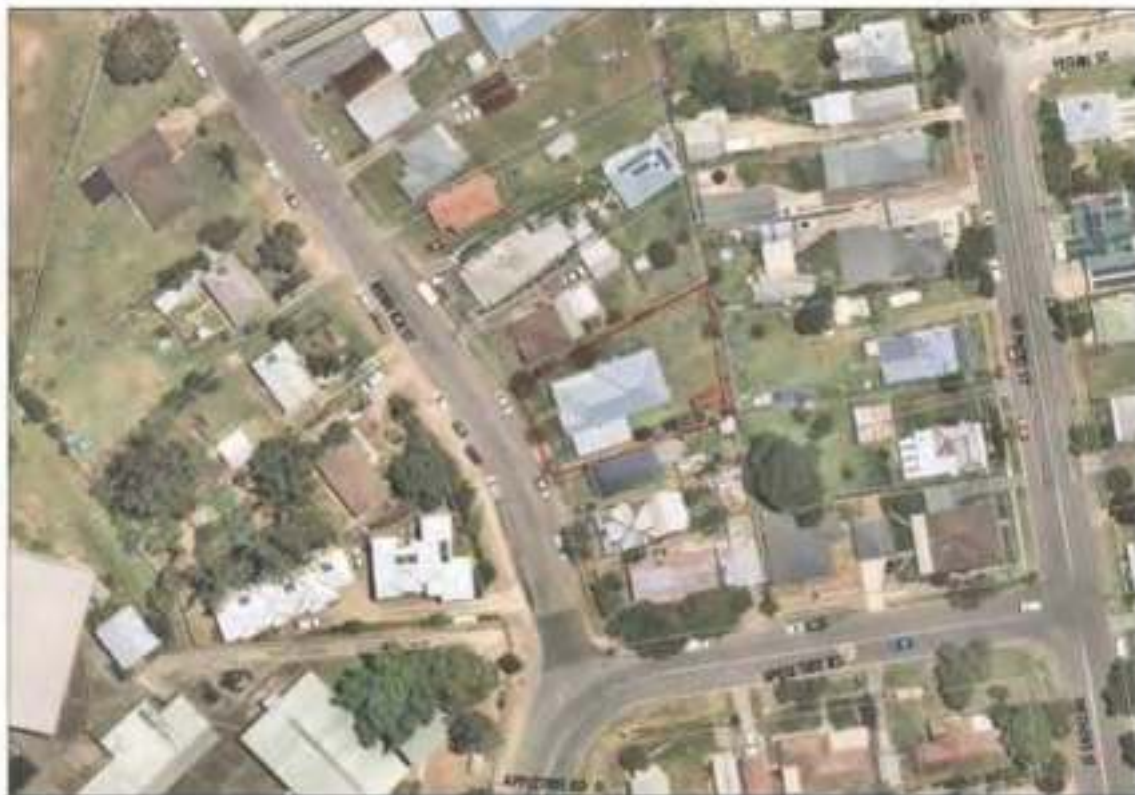
15 RENWICK STREET, WEST WALLSEND 2286

Conservation Area Contribution Level	Est. Construction Date	Previous studies and/or community input
Contributory 1	1900–1920	No prior heritage investigations and no additional information required
Assessment Text		Observed Modifications
<p>Single story Simplified Federation ‘workmen’s cottage’ style dwelling with hipped Colourbond roof with gabled projection and timber weatherboard cladding. The veranda roof is bull nosed.</p> <p>The visible windows appear to be the original heavy timber framed sash designs with prominent sills.</p> <p>The gable has a false collar tie, timber finial and shingled timber awning above the window.</p> <p>A brickwork chimney is visible on the southern side of the dwelling</p> <p>A car port is attached to the southern side of the dwelling.</p> <p>The dwelling displays architectural features of a heritage style and is representative of the local development of this period, being of historical significance for the HCA.</p>		<p>The veranda extends around the northern side of the dwelling. This is a common modification for similar dwellings of the area.</p> <p>An extension has been constructed at the back eastern side of the dwelling. This is not visible from the street and does not detract.</p>

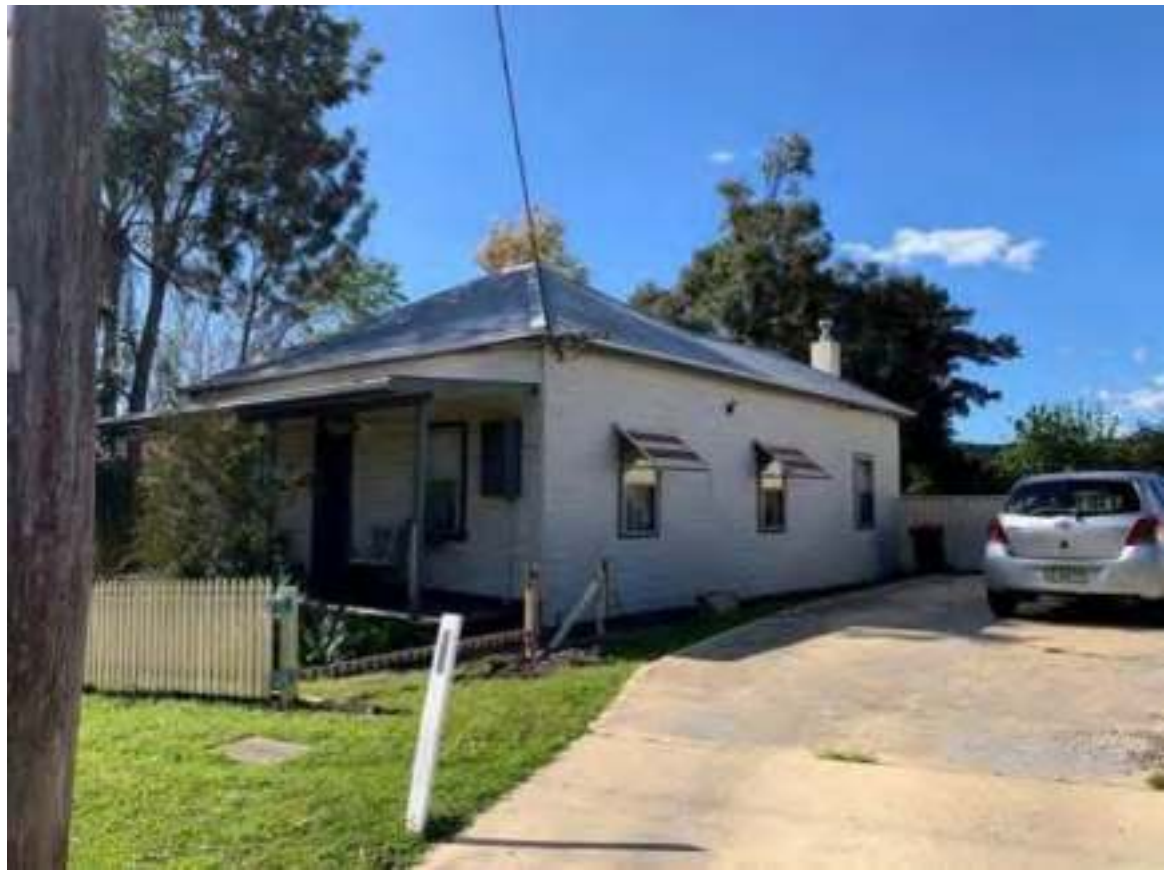
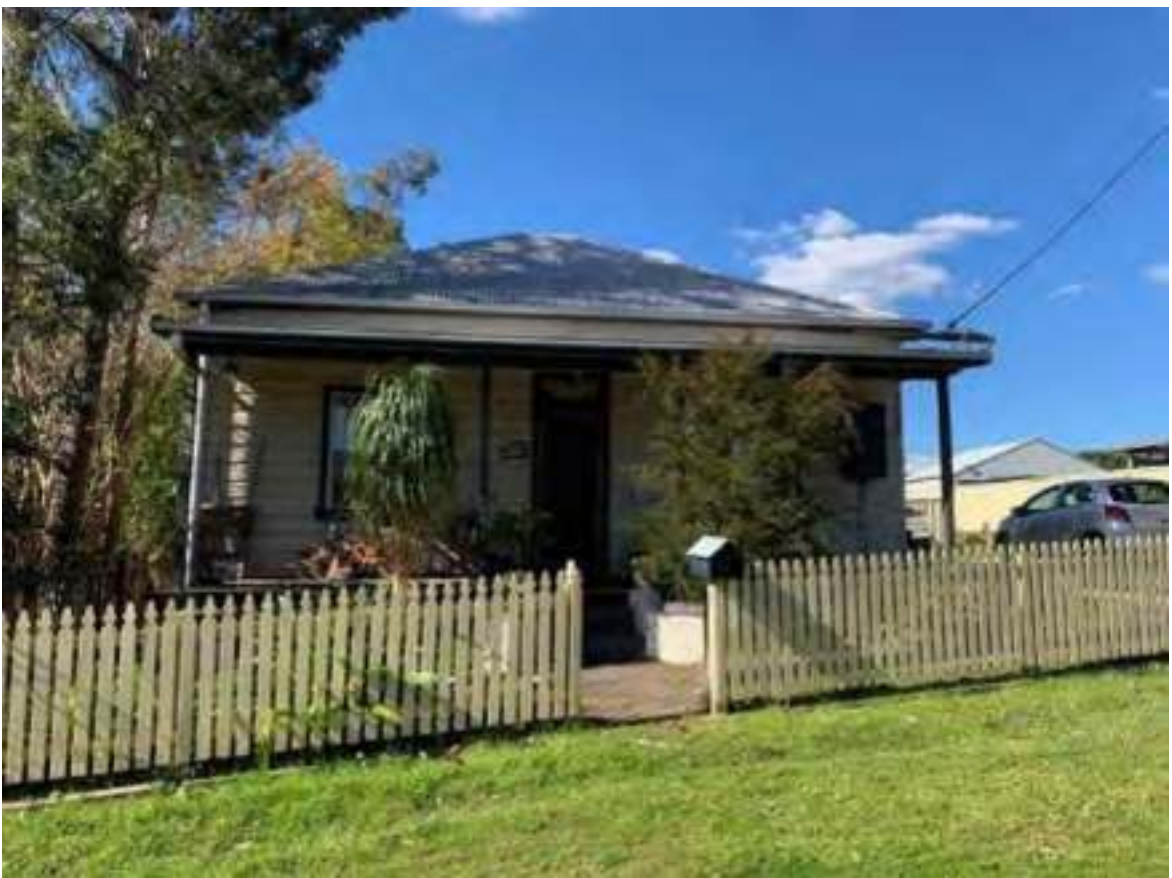
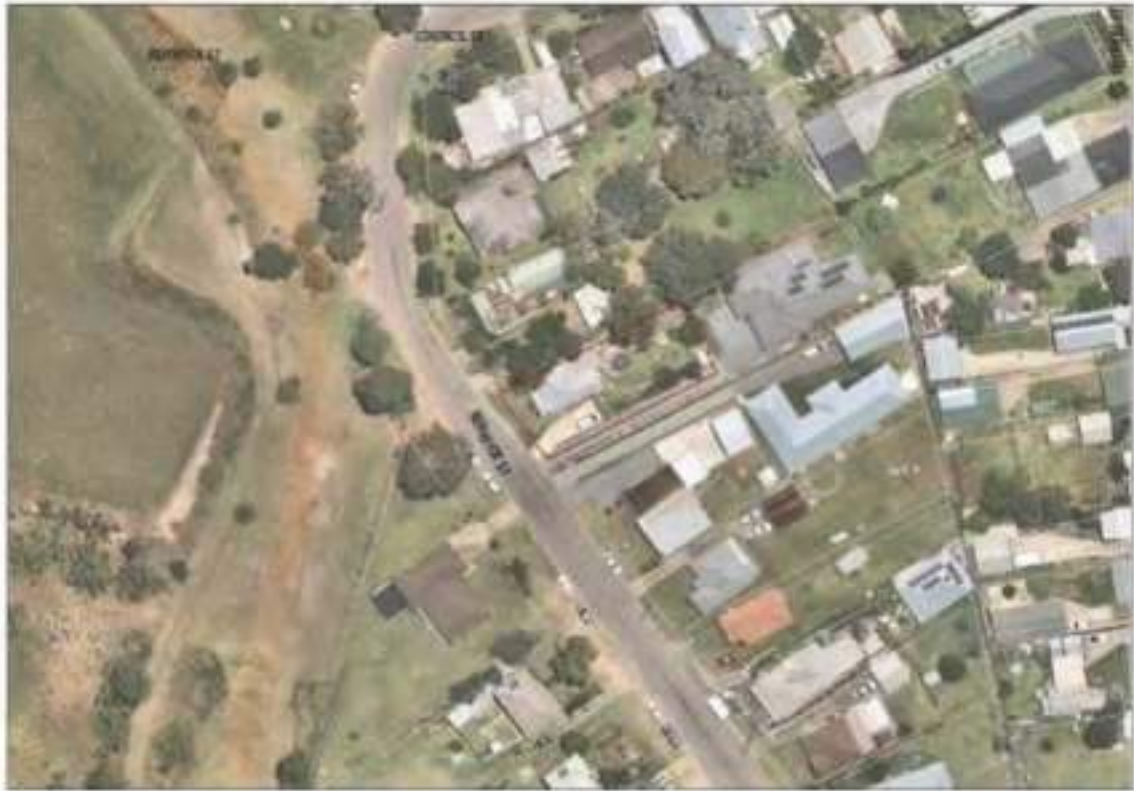
5 RENWICK STREET, WEST WALLSEND 2286

Conservation Area Contribution Level	Est. Construction Date	Previous studies and/or community input
Contributory 1	1890–1915	No prior heritage investigations and no additional information required
Assessment Text		Observed Modifications
<p>Single story Vernacular cottage style dwelling with steep hipped Colourbond roof and weatherboard cladding. The veranda roof is skillion with painted striped decoration.</p> <p>The front western windows have decorative timber sills, potentially original. The front door is timber framed with a fan light above.</p> <p>A timber picket fence encloses the property.</p> <p>The dwelling displays architectural features of a heritage style and is representative of the local development of this period, being of historical significance for the HCA.</p>		<p>The visible windows are contemporary variations of the original sash designs.</p> <p>The veranda roof would have originally been bull nosed.</p> <p>The metal striped awnings are a contemporary addition.</p> <p>An extension has been built into the back eastern portion of the dwelling. this is not visible from the street and does not detract.</p>

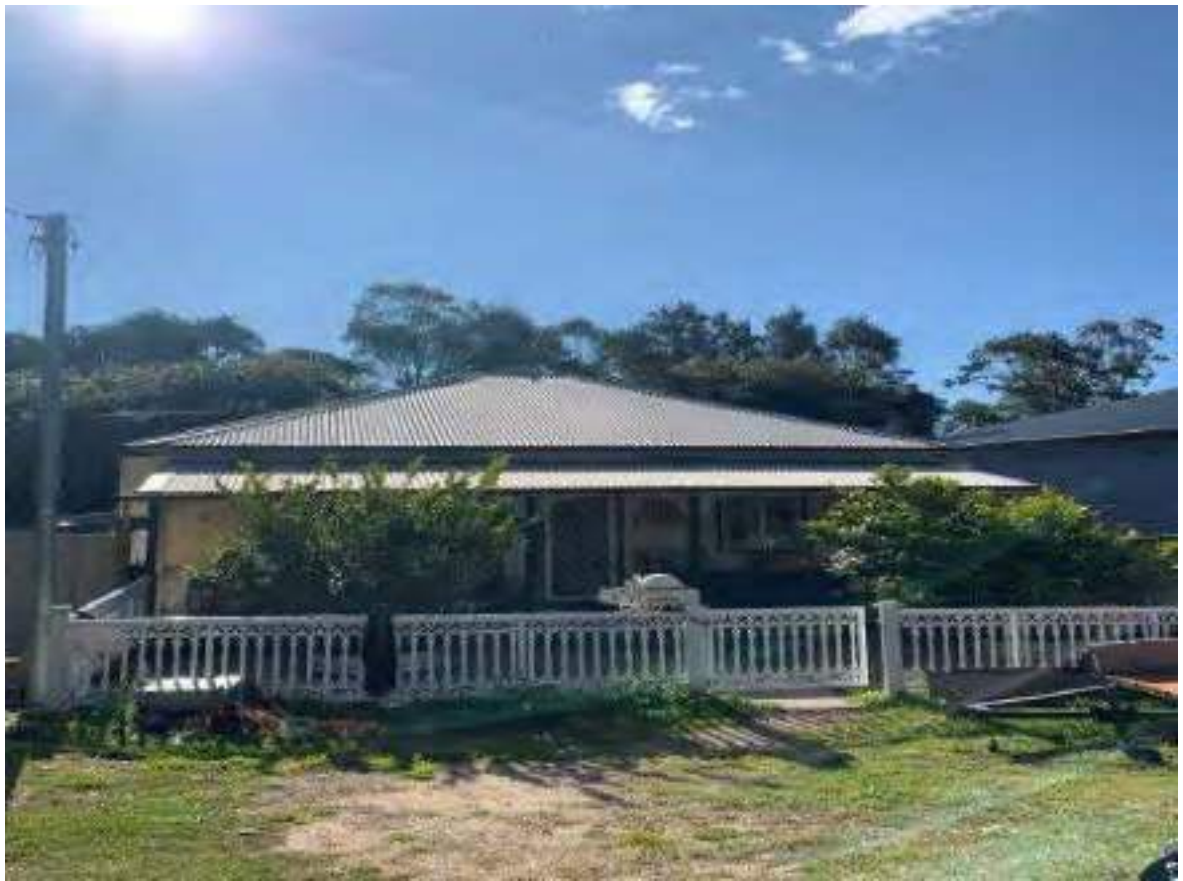
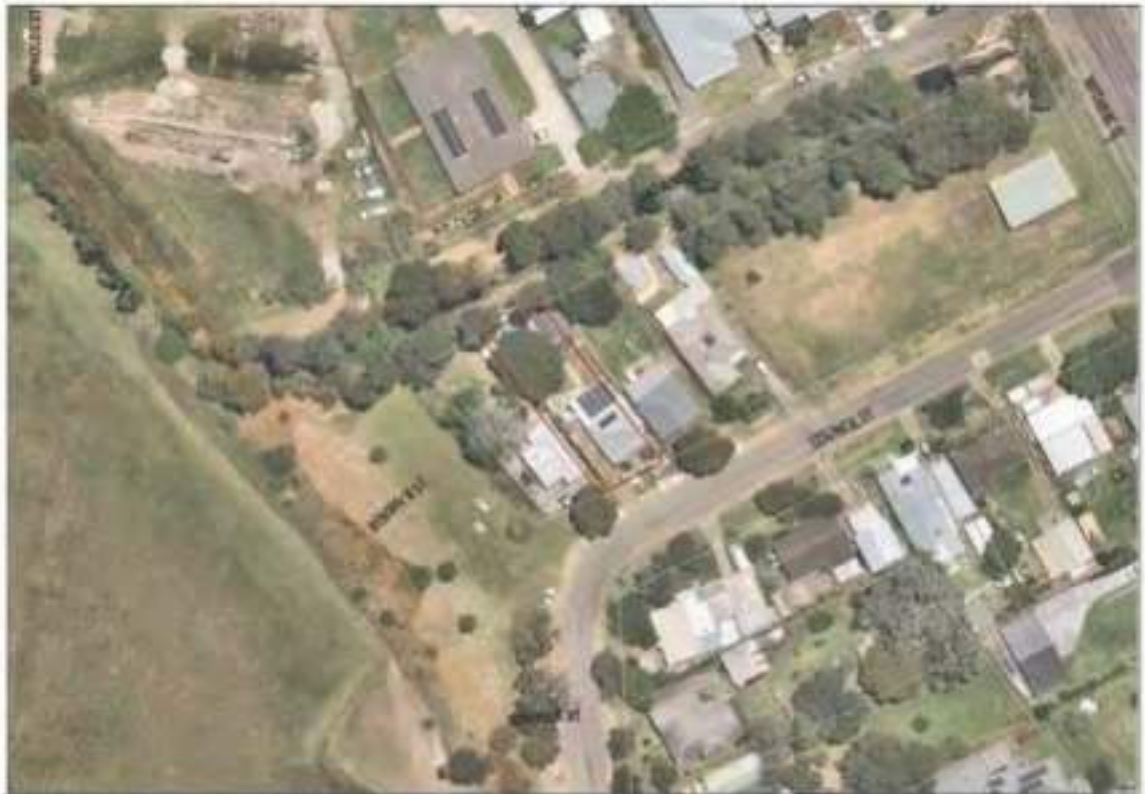
5 COUNCIL STREET, WEST WALLSEND 2286

Conservation Area Contribution Level	Est. Construction Date	Previous studies and/or community input
Contributory 1	1890–1915	No prior heritage investigations and no additional information required
Assessment Text		Observed Modifications
<p>Single story Vernacular ‘Mining Cottage’ style dwelling with steep hipped Colourbond roof and weatherboard cladding. The veranda roof is skillion, supported by timber posts with cast iron lace brackets.</p> <p>A metal decorative fence encloses the property.</p> <p>The dwelling displays architectural features of a heritage style and is representative of the local development of this period, being of historical significance for the HCA.</p>		<p>The visible windows are contemporary styles.</p> <p>A prominent metal security screen door obscures the front door.</p> <p>The veranda roof would have originally been bull nosed.</p>

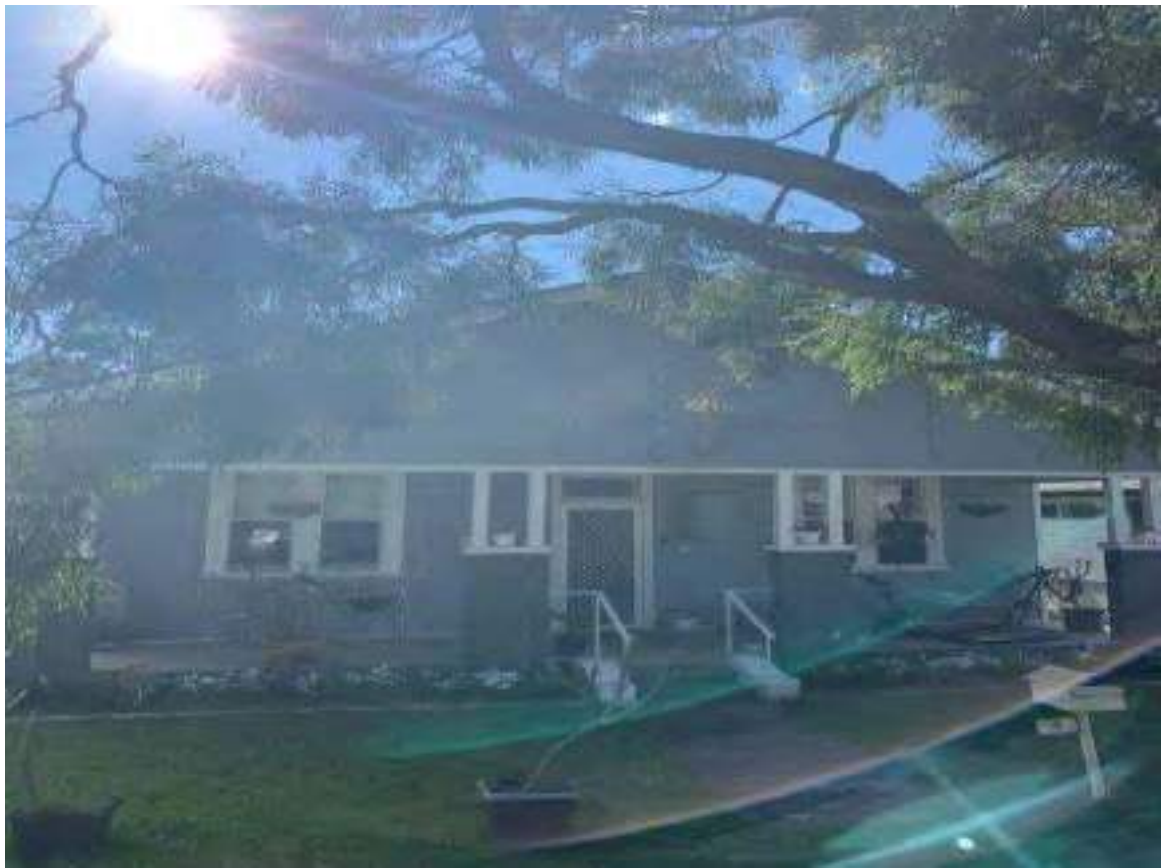
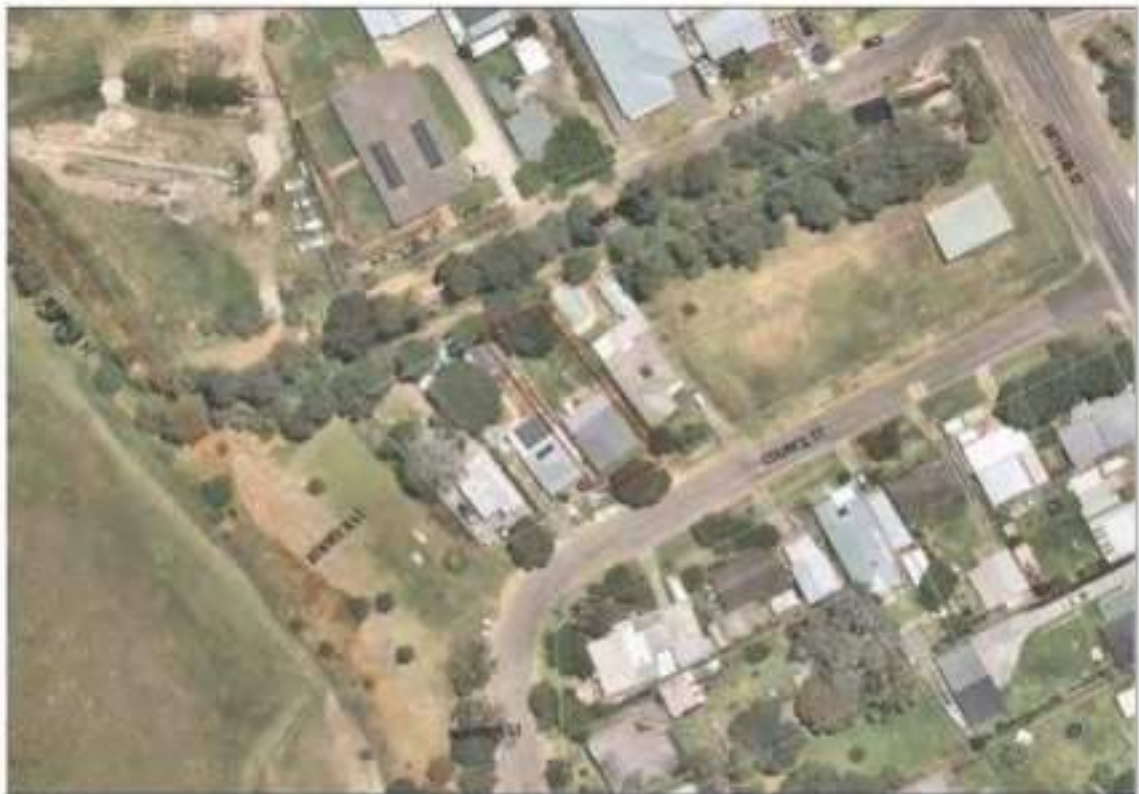
3 COUNCIL STREET, WEST WALLSEND 2286

Conservation Area Contribution Level	Est. Construction Date	Previous studies and/or community input
Contributory 1	1920–1930	No prior heritage investigations and no additional information required
Assessment Text		Observed Modifications
<p>Single story Bungalow style dwelling with gabled Colourbond roof and weatherboard cladding. The veranda roof is supported by brick piers with tapered timber posts.</p> <p>The visible windows appear to be the original timber framed sash designs. The front door is timber framed with a fan light above.</p> <p>A brickwork chimney is visible on the western side of the dwelling.</p> <p>The gable has extended eaves and battening detailing.</p> <p>The dwelling displays architectural features of a heritage style and is representative of the local development of this period, being of historical significance for the HCA.</p>		<p>A prominent metal security screen obscures the front door.</p> <p>An extension has been built onto the back northern portion of the dwelling. this is not visible from the street and does not detract.</p>

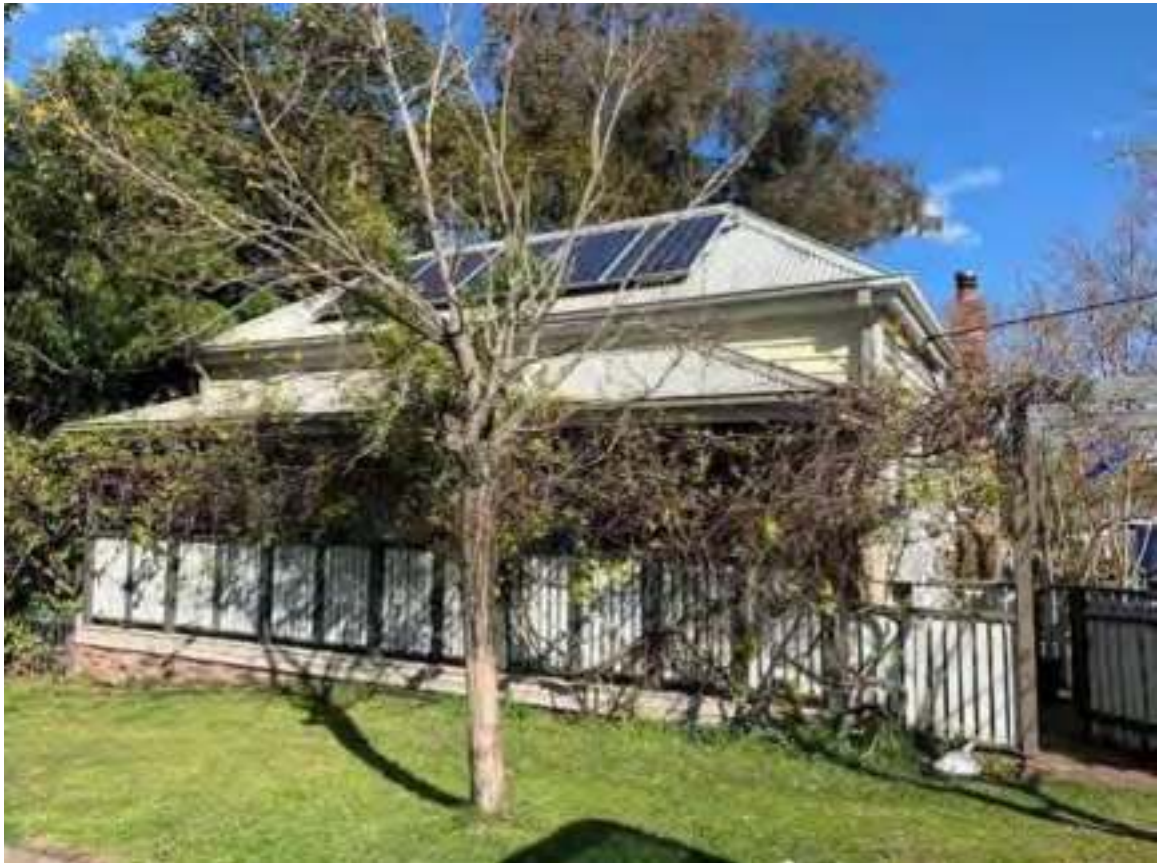
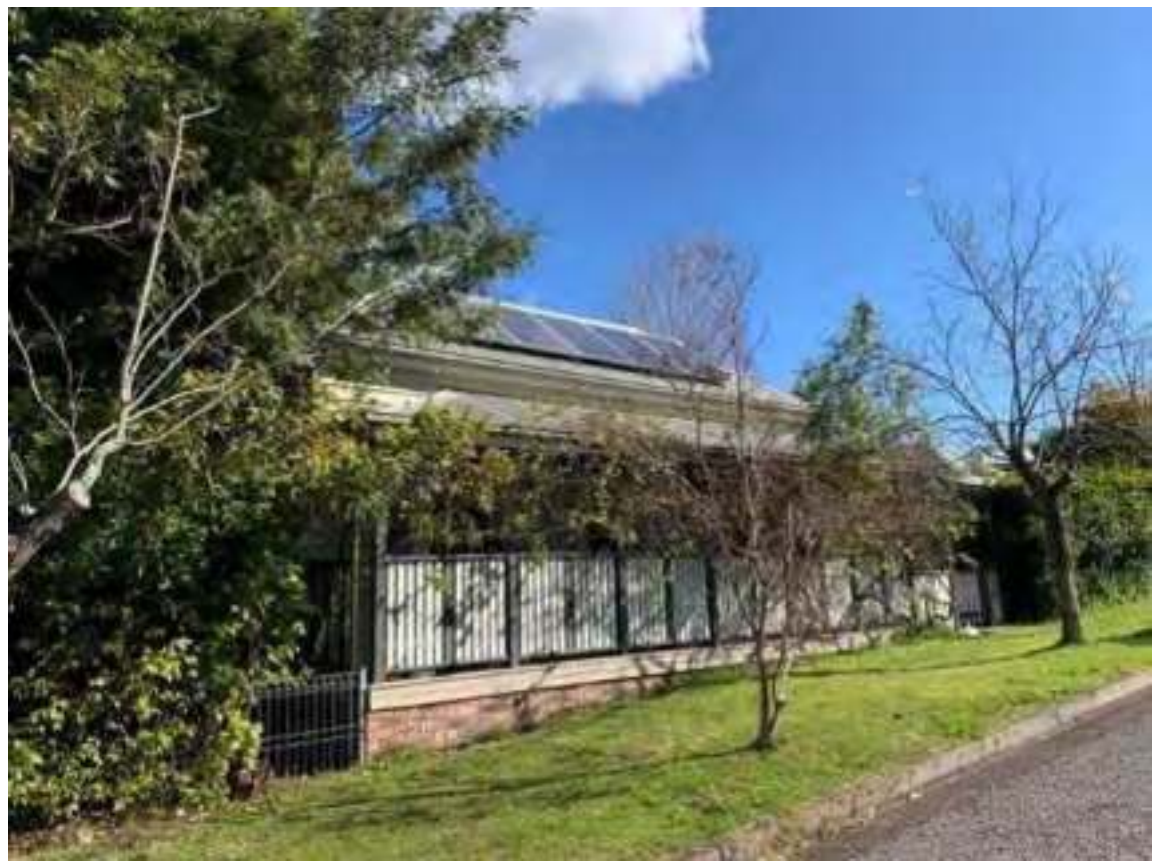
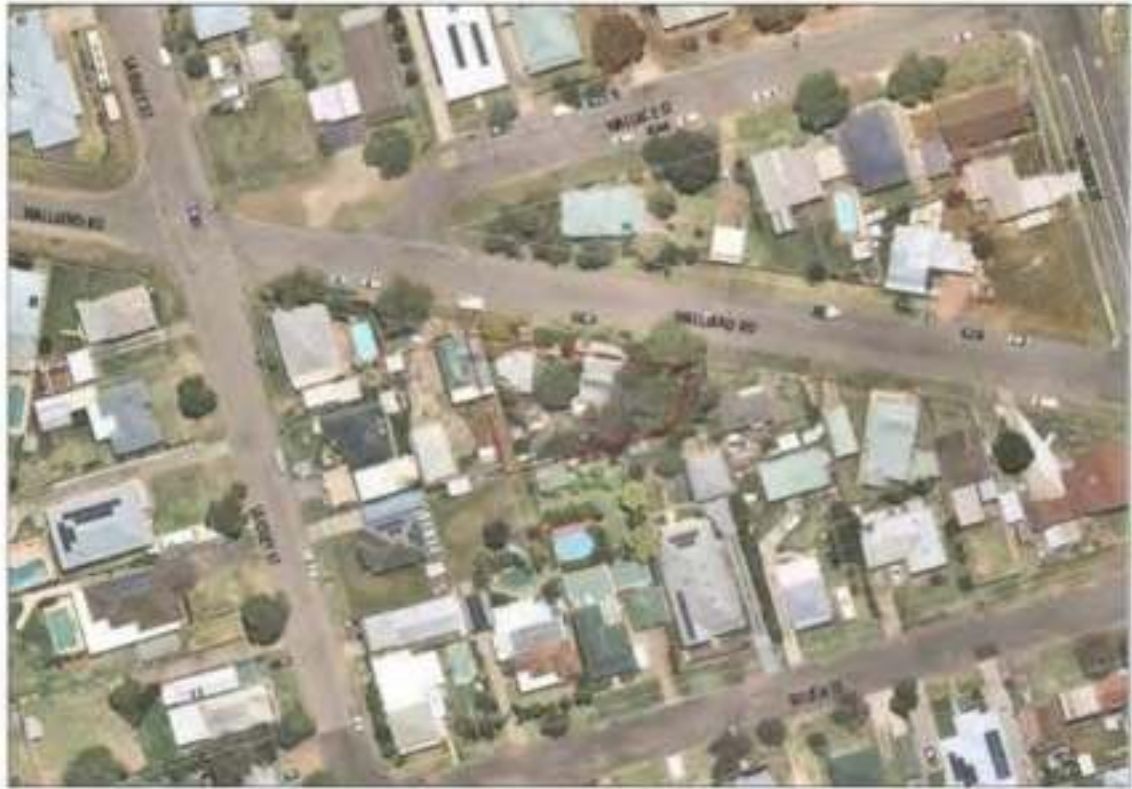
14 WALLSEND ROAD, WEST WALLSEND 2286

Conservation Area Contribution Level	Est. Construction Date	Previous studies and/or community input
Contributory 1	1890–1915	No prior heritage investigations and no additional information required
Assessment Text		Observed Modifications
<p>Single story Vernacular style dwelling with hipped Colourbond roof and weatherboard cladding. The veranda roof is hipped. The veranda is partially enclosed with timber balustrade. The dwelling is obscured by vegetation growth.</p> <p>The dwelling displays architectural features of a heritage style and is representative of the local development of this period, being of historical significance for the HCA.</p>		<p>Solar panels are highly visible along the front northern façade.</p>

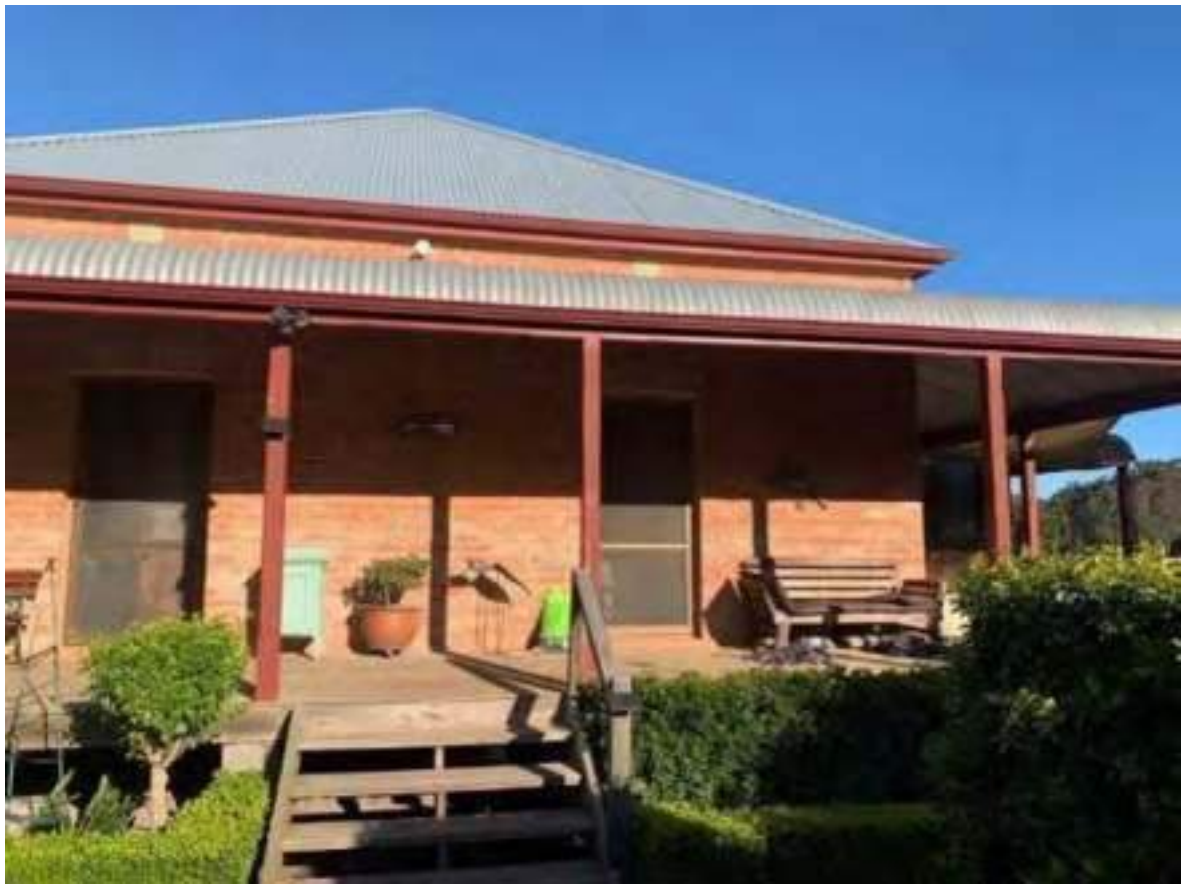
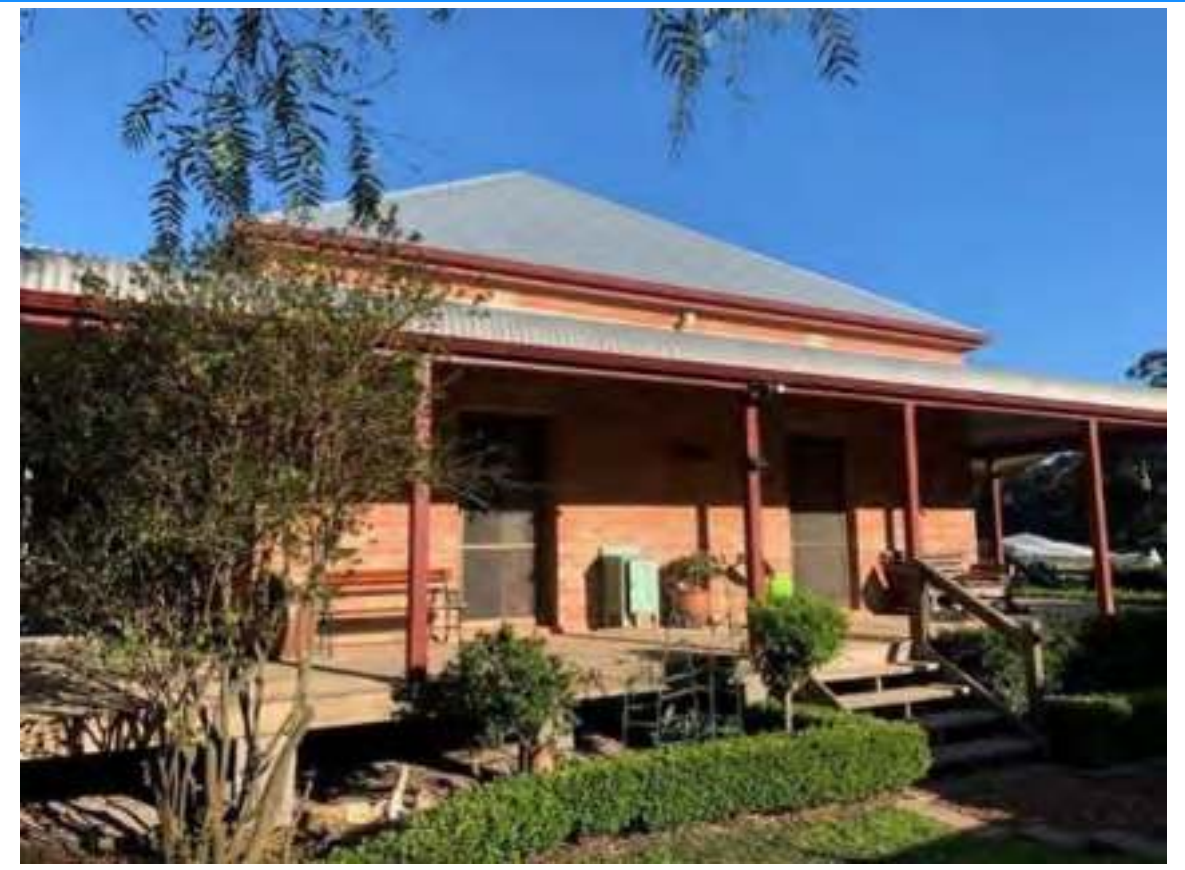
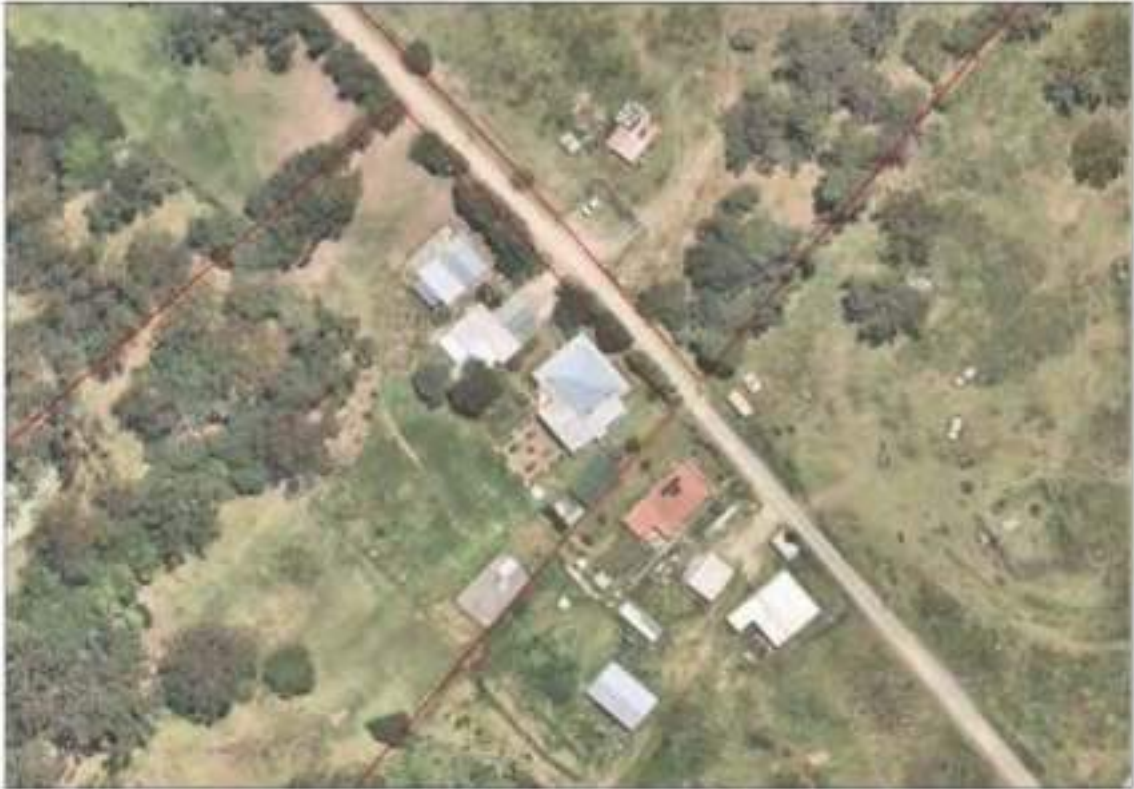
6 PRIVATE LANE, HOLMESVILLE 2286

Conservation Area Contribution Level	Est. Construction Date	Previous studies and/or community input
Contributory 1	1880–1900	Early homestead associated with the Holmes family.
Assessment Text		Observed Modifications
<p>Single story Vernacular homestead with hipped Colourbond roof and brick façade, likely locally constructed brick. The veranda roof is bull nosed and encircles the dwelling. this is potentially the original bull nosed roofing.</p> <p>Portions of the dwelling were not accessible.</p> <p>The dwelling displays architectural features of a heritage style and is representative of the local development of this period, being of historical significance for the HCA.</p>		<p>Additional doors have been installed around the veranda, likely an earlier modification.</p>

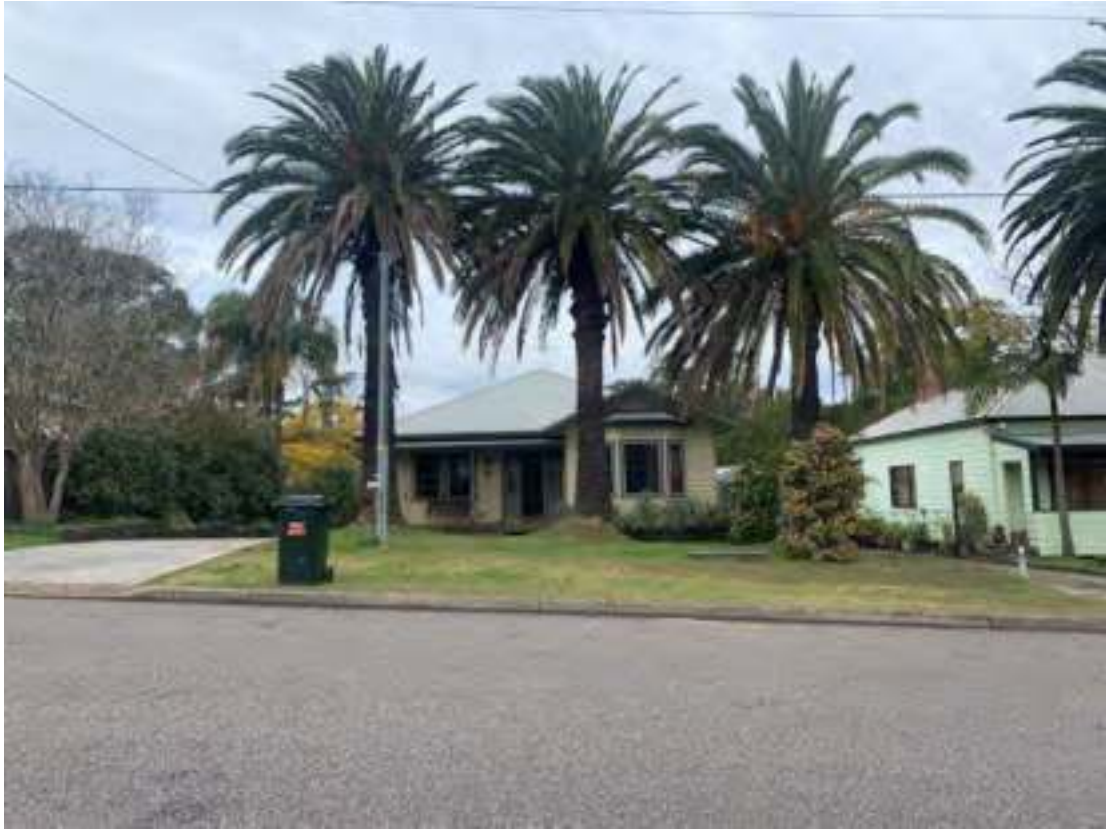
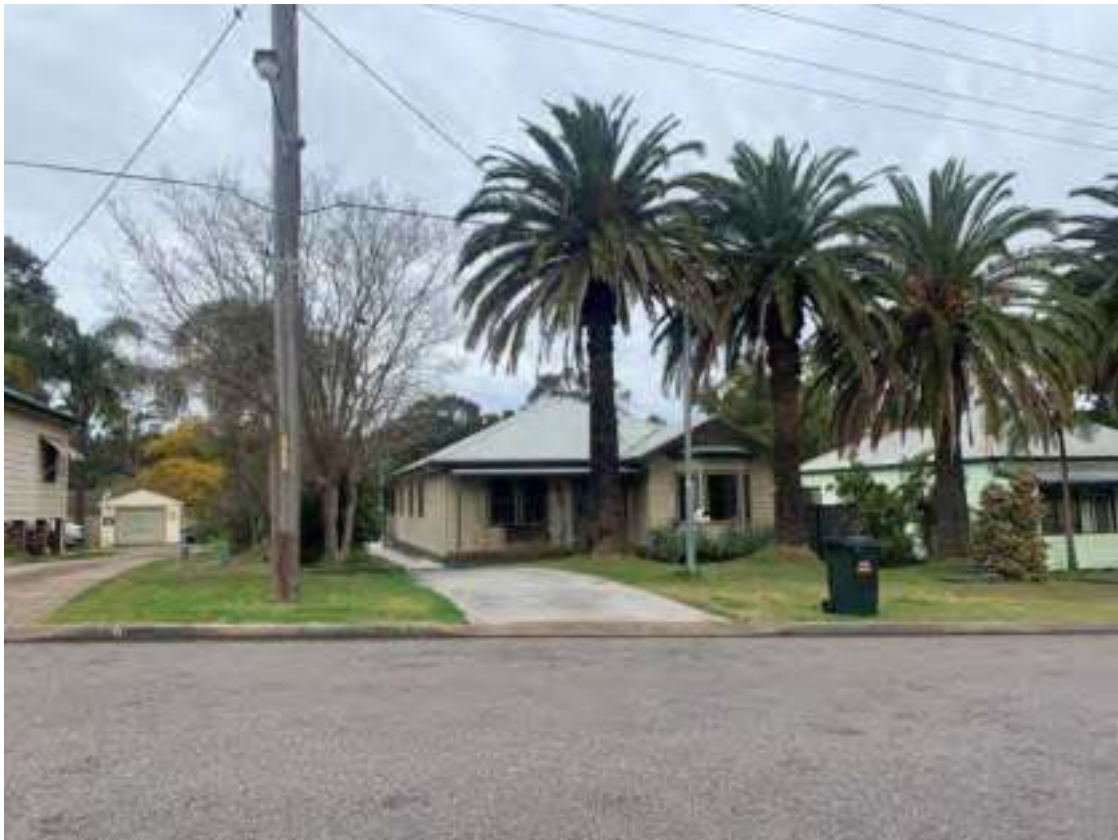
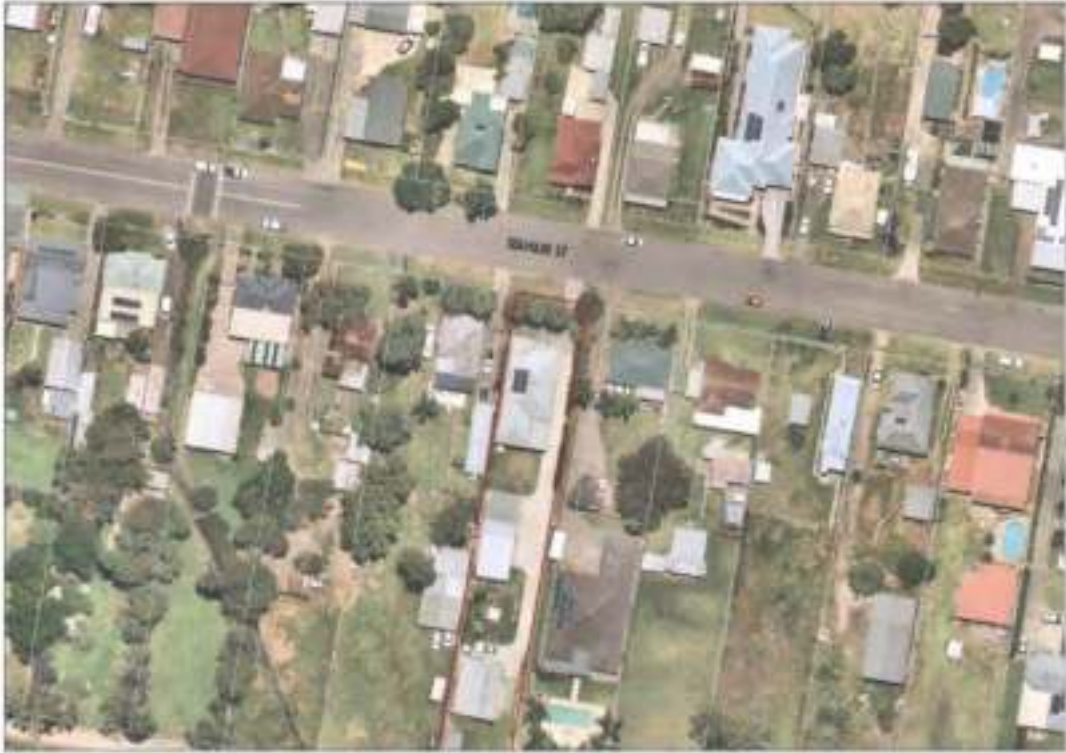
Conservation Area Contribution Level	Est. Construction Date	Previous studies and/or community input
Contributory 2	Early to late 20 th century (broad range)	Holmesville Heritage Study 1993 The large Canary trees outside the dwelling as considered of moderate local significance.
Assessment Text		Observed Modifications
<p>The scale (single-storey) and general style of the dwelling is consistent with that of the streetscape and wider HCA. Dwelling contributes positively to the streetscape and wider HCA, particularly in comparison to Non-Contributory buildings.</p> <p>The dwelling features appropriately proportioned and positioned fenestrations, an appropriate roof form (gabled or hipped) and other features consistent with the architectural character of the area (e.g. front verandah with timber or brick posts, timber detailing, corrugated metal roofing, etc). The contributory value of the dwelling is limited however by either:</p> <ul style="list-style-type: none"> • External modifications that have in some way obscured the style, scale or design intent of the building and have resulted in less physical integrity than Contributory 1 buildings. • Being a later dwelling constructed in an appropriate referential style, but comprising little to no fabric of intrinsic heritage significance. 		<p>The metal fence mentioned in the 1993 heritage study has been removed, improving the streetscape.</p>

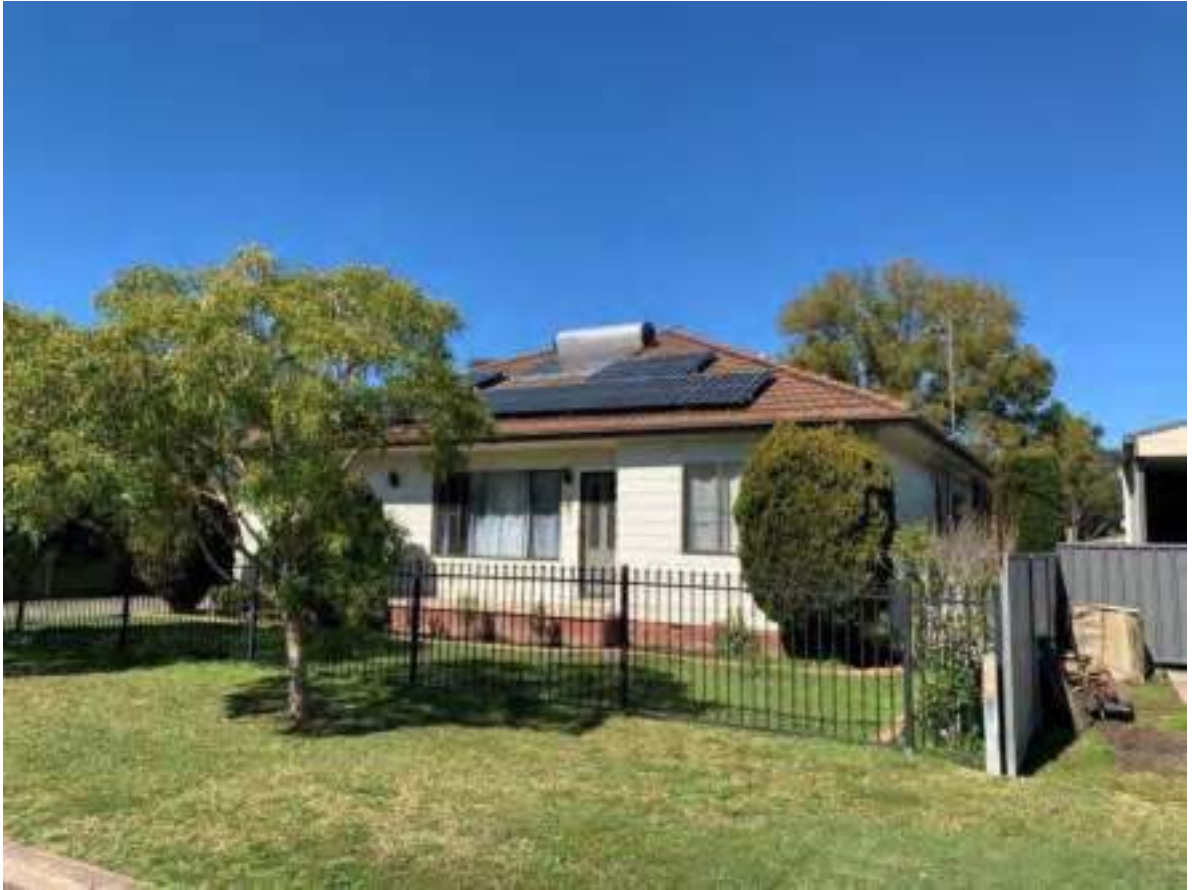
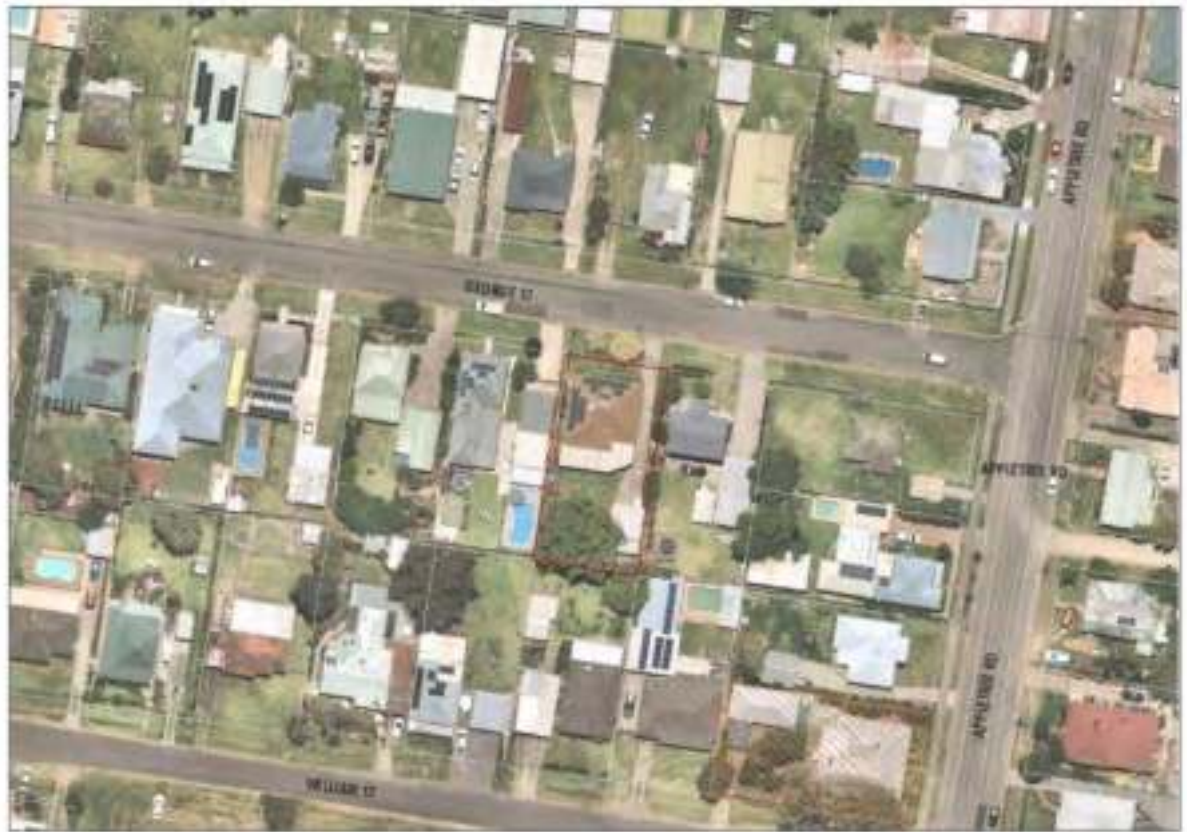
4 GEORGE STREET, HOLMESVILLE 2286		
Conservation Area Contribution Level	Est. Construction Date	Previous studies and/or community input
Contributory 2	Early to late 20 th century (broad range)	No prior heritage investigations and no additional information required.
Assessment Text		Observed Modifications
<p>The scale (single-storey) and general style of the dwelling is consistent with that of the streetscape and wider HCA. Dwelling contributes positively to the streetscape and wider HCA, particularly in comparison to Non-Contributory buildings.</p> <p>The dwelling features appropriately proportioned and positioned fenestrations, an appropriate roof form (gabled or hipped) and other features consistent with the architectural character of the area (e.g. front verandah with timber or brick posts, timber detailing, corrugated metal roofing, etc). The contributory value of the dwelling is limited however by either:</p> <ul style="list-style-type: none"> • External modifications that have in some way obscured the style, scale or design intent of the building and have resulted in less physical integrity than Contributory 1 buildings. • Being a later dwelling constructed in an appropriate referential style, but comprising little to no fabric of intrinsic heritage significance. 		<p>Solar panels are evident on the northern and western sides of the dwelling roof, being highly visible from the street and impacting upon the heritage streetscape. All visible windows are contemporary in design.</p>
