APPENDIX 2

Building Assessment Sheets (Inventory Sheets)

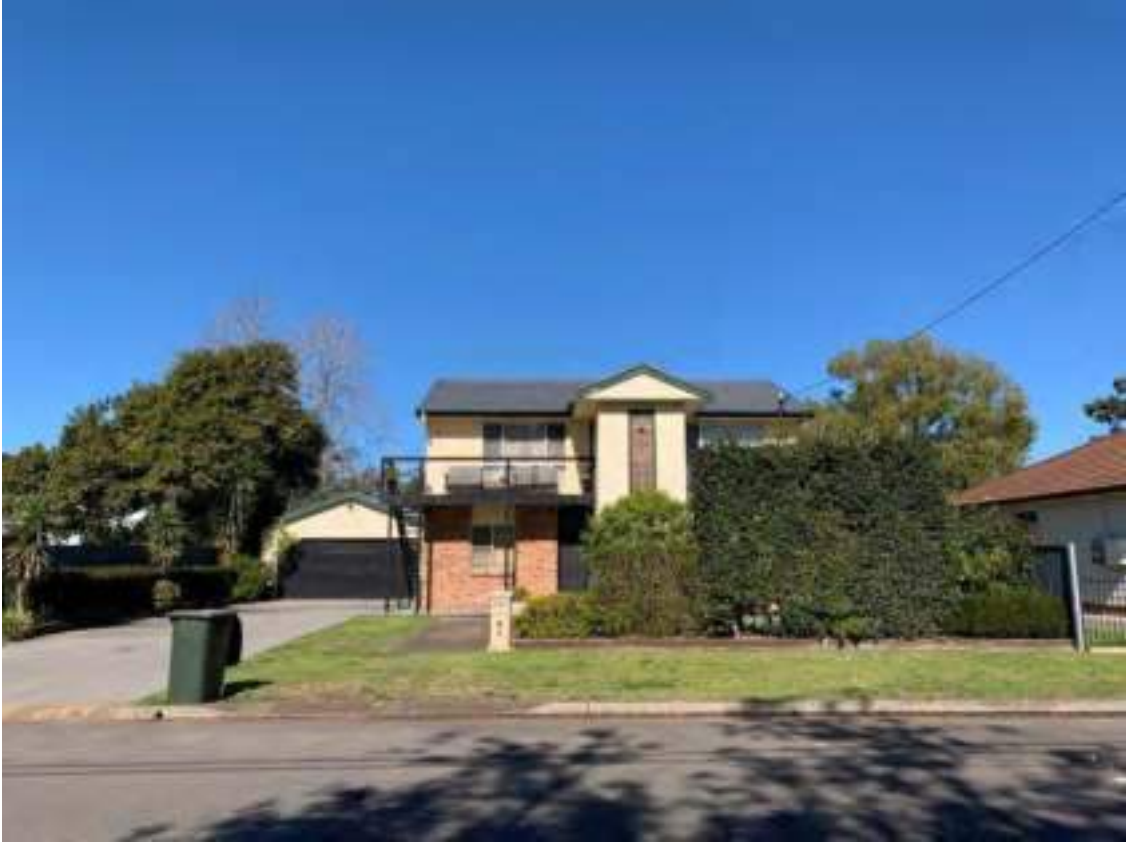
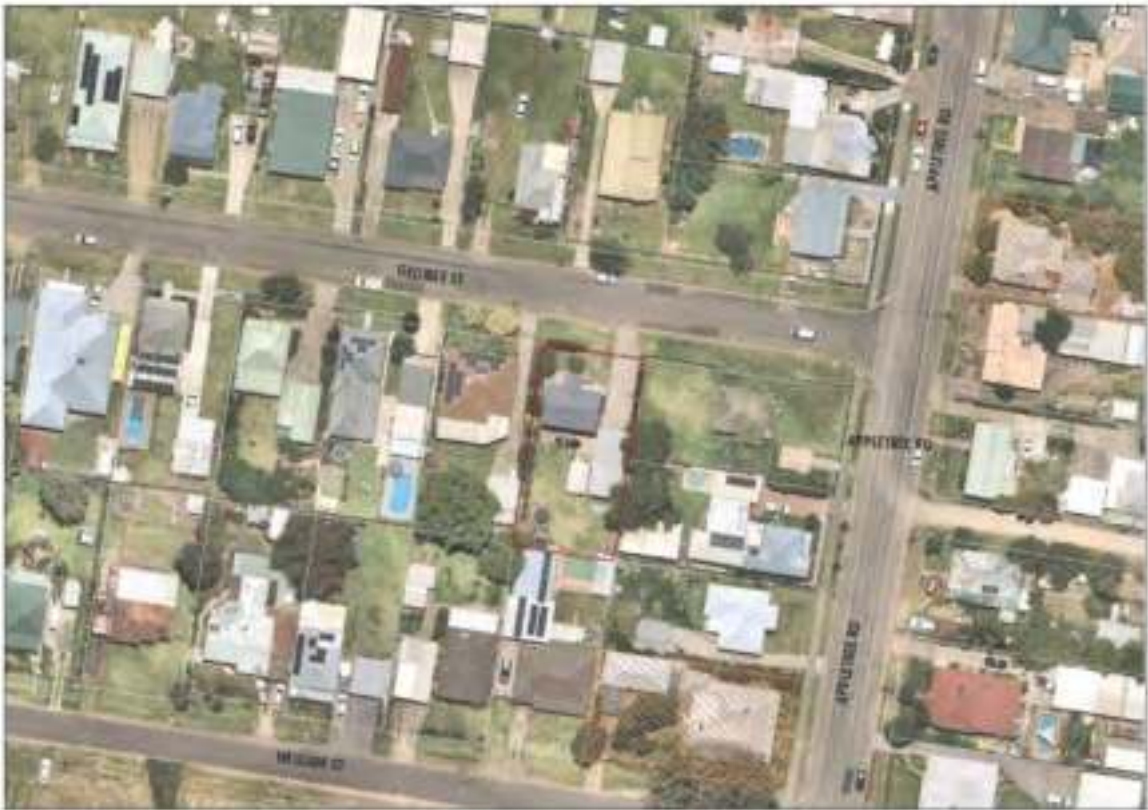
2 GEORGE STREET, HOLMESVILLE 2286		
Conservation Area Contribution Level	Est. Construction Date	Previous studies and/or community input
Non-Contributory	Mid to late 20 th century onwards	No prior heritage assessments or research undertaken.
Assessment Text		Observed Modifications
<p>The scale (e.g. double-storey or greater) and general style of the dwelling is inconsistent with that of the streetscape and wider HCA.</p> <p>The dwelling does not contribute positively to the streetscape and wider HCA, particularly in comparison to Contributory 1 and 2 buildings. The presence of the building has an adverse impact on the streetscape and/or wider HCA.</p> <p>The dwelling features inappropriately proportioned and positioned fenestrations, an inappropriate roof form (gabled or hipped) and/or other features that are inconsistent with the architectural character of the area (e.g. unsympathetic additions, inconsistent [contemporary] building materials, etc).</p>		No modifications observed due to the contemporary construction.

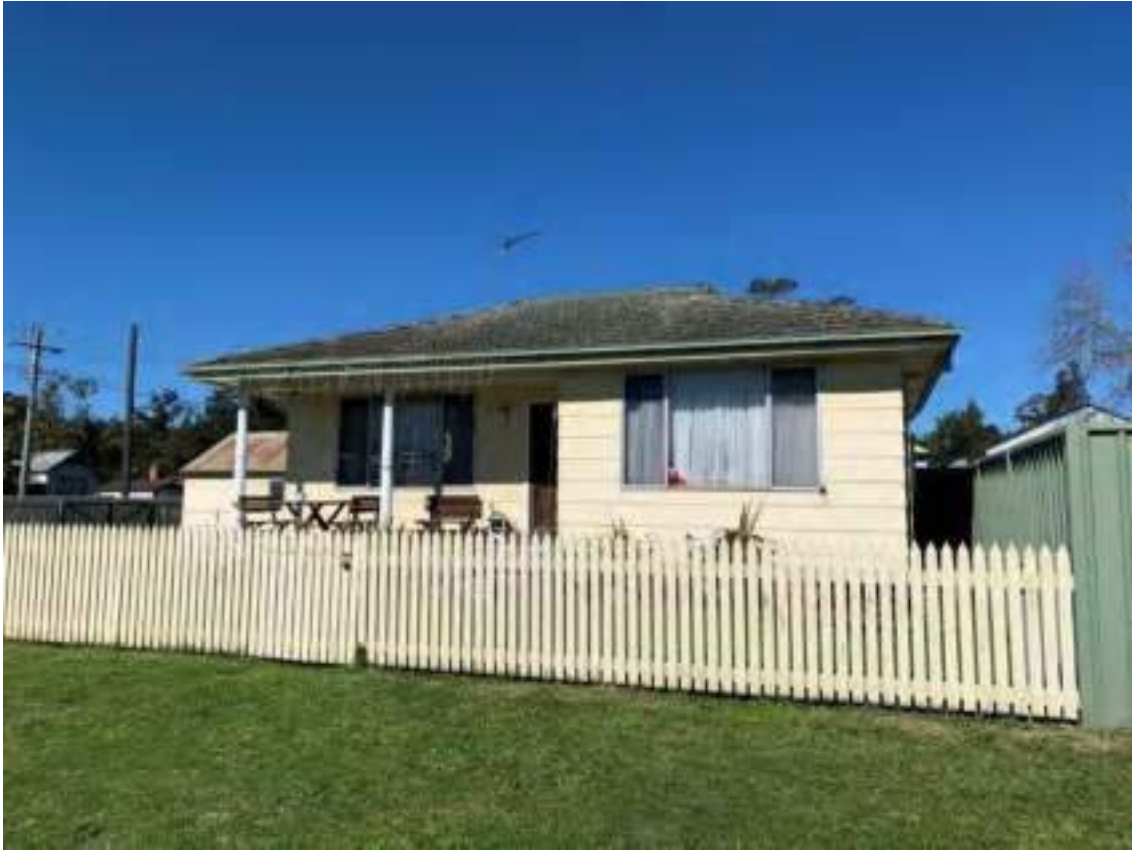
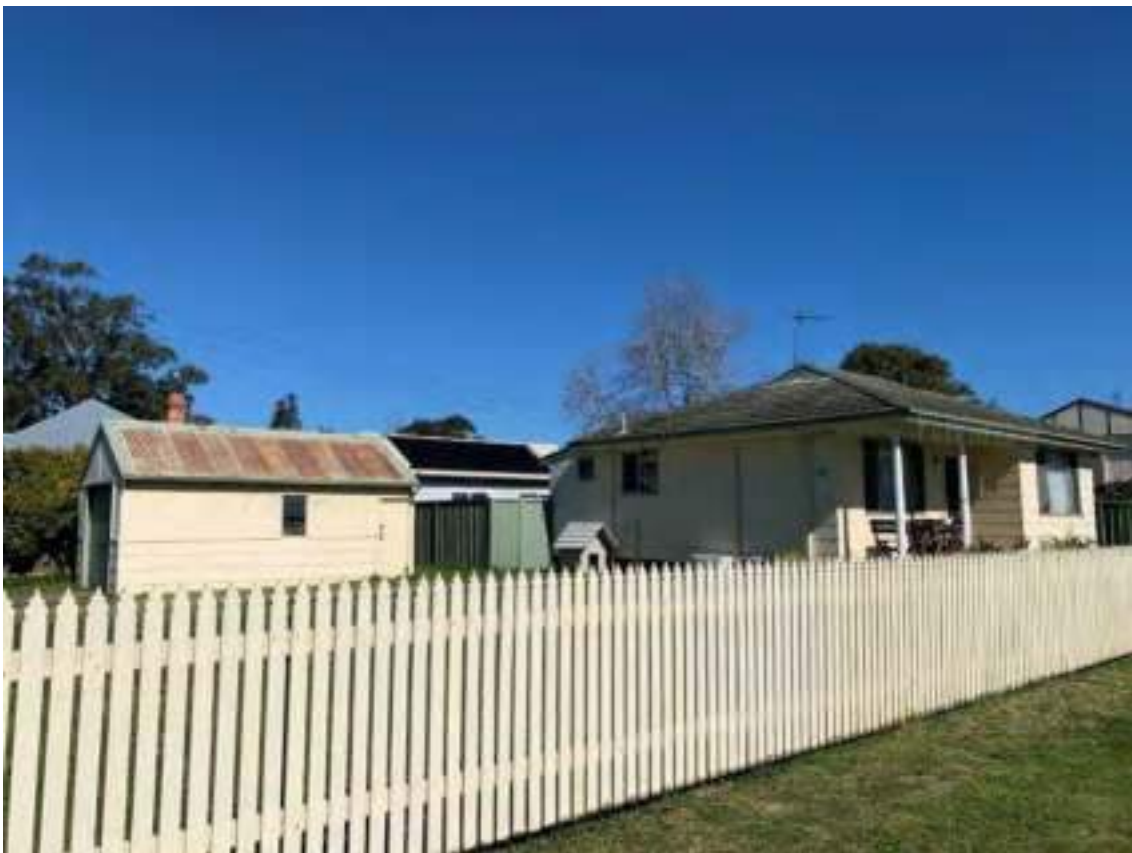
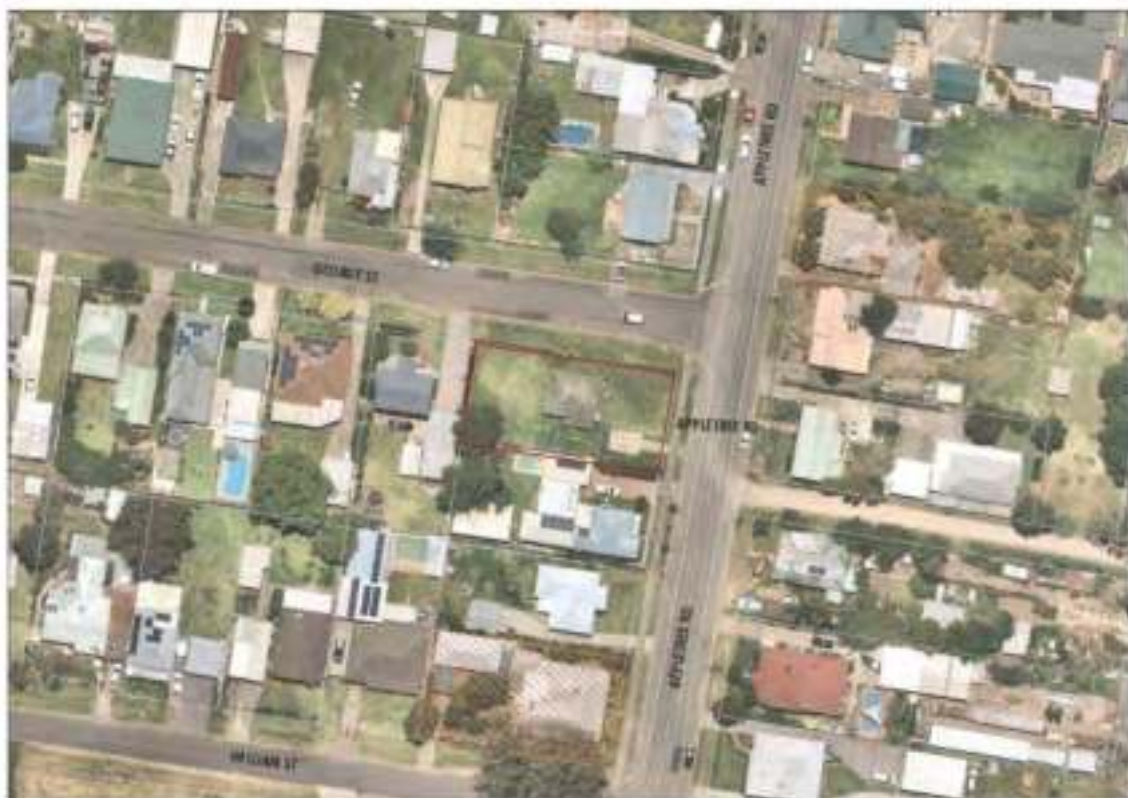
48 APPLETREE ROAD, HOLMESVILLE 2286

Conservation Area Contribution Level	Est. Construction Date	Previous studies and/or community input
Contributory 2	Early to late 20 th century (broad range)	No prior heritage assessments or research undertaken.
Assessment Text		Observed Modifications
<p>The scale (single-storey) and general style of the dwelling is consistent with that of the streetscape and wider HCA. Dwelling contributes positively to the streetscape and wider HCA, particularly in comparison to Non-Contributory buildings.</p> <p>The dwelling features appropriately proportioned and positioned fenestrations, an appropriate roof form (gabled or hipped) and other features consistent with the architectural character of the area (e.g. front verandah with timber or brick posts, timber detailing, corrugated metal roofing, etc). The contributory value of the dwelling is limited however by either:</p> <ul style="list-style-type: none"> • External modifications that have in some way obscured the style, scale or design intent of the building and have resulted in less physical integrity than Contributory 1 buildings. • Being a later dwelling constructed in an appropriate referential style, but comprising little to no fabric of intrinsic heritage significance. 		<p>All visible windows are contemporary sliding designs.</p> <p>The faux European style plaster posts are a contemporary addition, likely replacing an original timber design.</p>

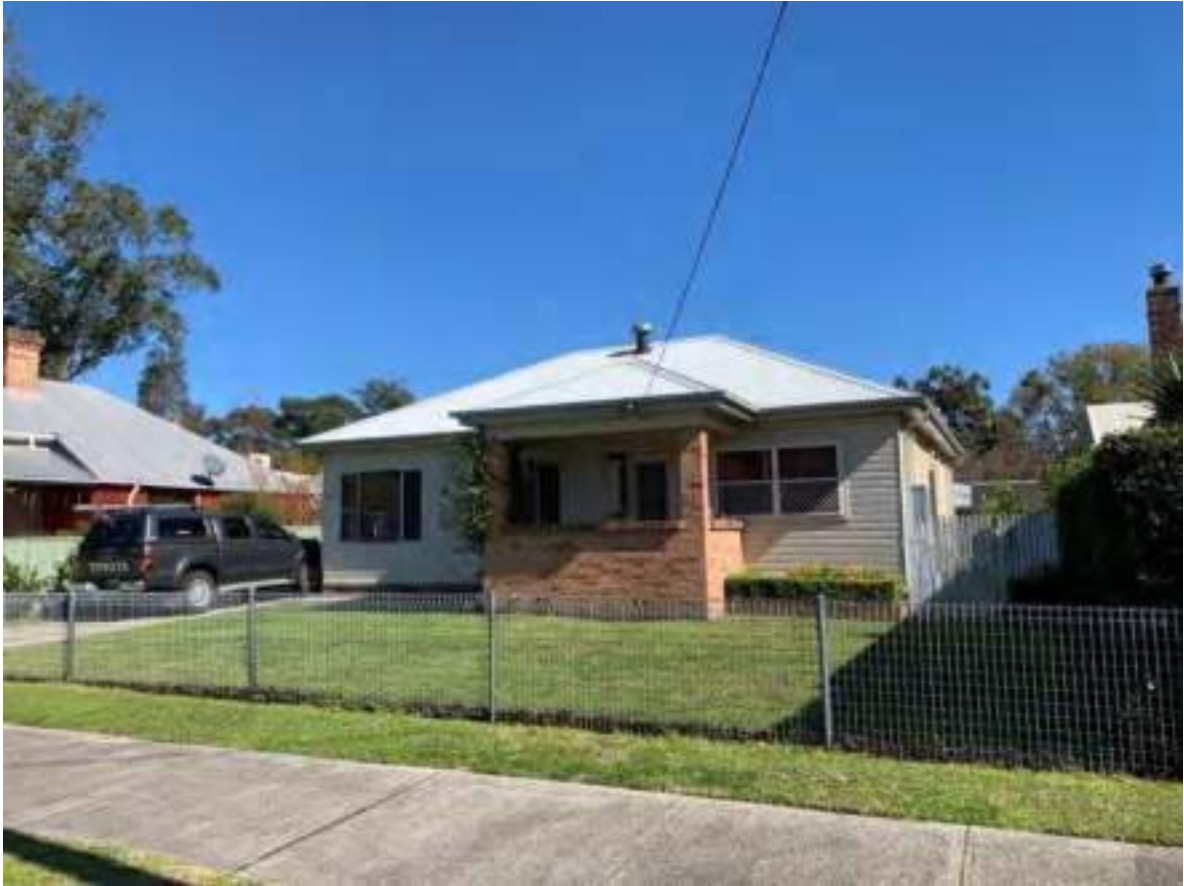
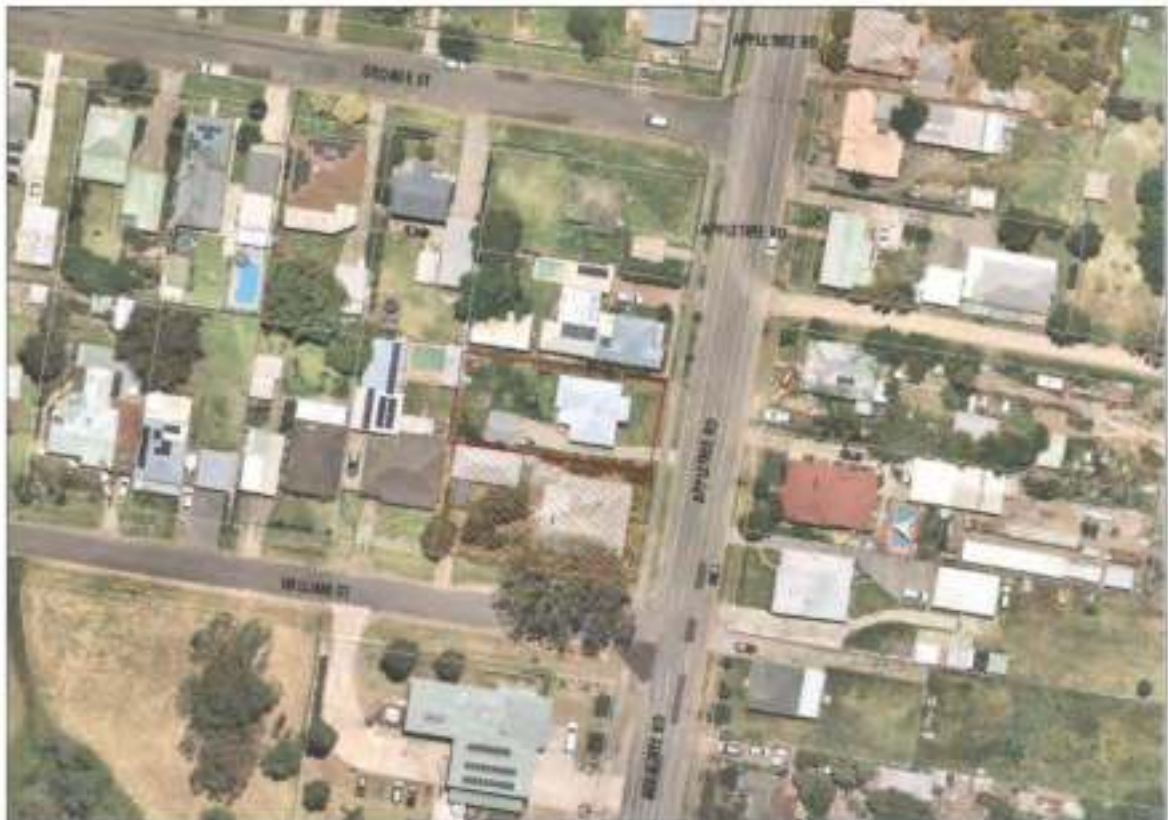
52 APPLETREE ROAD, HOLMESVILLE 2286

Conservation Area Contribution Level	Est. Construction Date	Previous studies and/or community input
Contributory 2	Early to late 20 th century (broad range)	No prior heritage assessments or research undertaken.
Assessment Text		Observed Modifications
<p>The scale (single-storey) and general style of the dwelling is consistent with that of the streetscape and wider HCA. Dwelling contributes positively to the streetscape and wider HCA, particularly in comparison to Non-Contributory buildings.</p> <p>The dwelling features appropriately proportioned and positioned fenestrations, an appropriate roof form (gabled or hipped) and other features consistent with the architectural character of the area (e.g. front verandah with timber or brick posts, timber detailing, corrugated metal roofing, etc). The contributory value of the dwelling is limited however by either:</p> <ul style="list-style-type: none"> • External modifications that have in some way obscured the style, scale or design intent of the building and have resulted in less physical integrity than Contributory 1 buildings. • Being a later dwelling constructed in an appropriate referential style, but comprising little to no fabric of intrinsic heritage significance. 		All visible windows are contemporary in design.

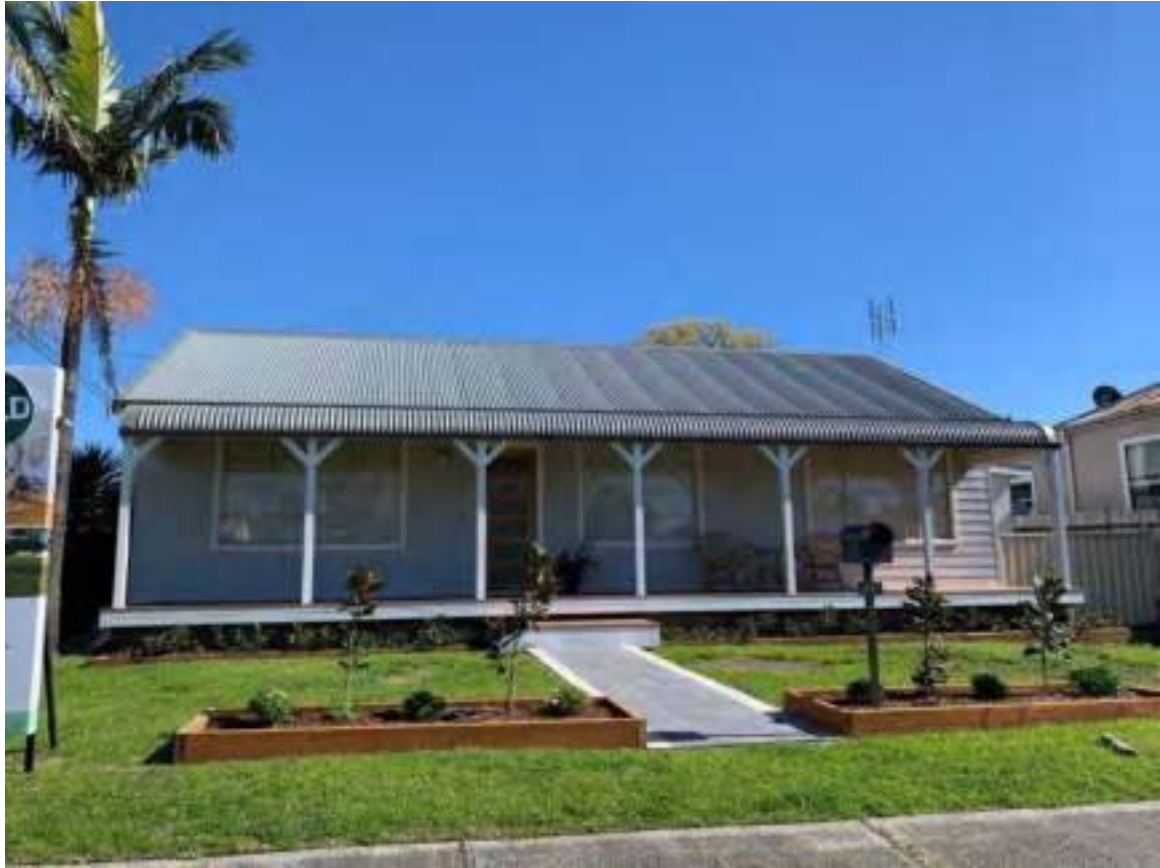
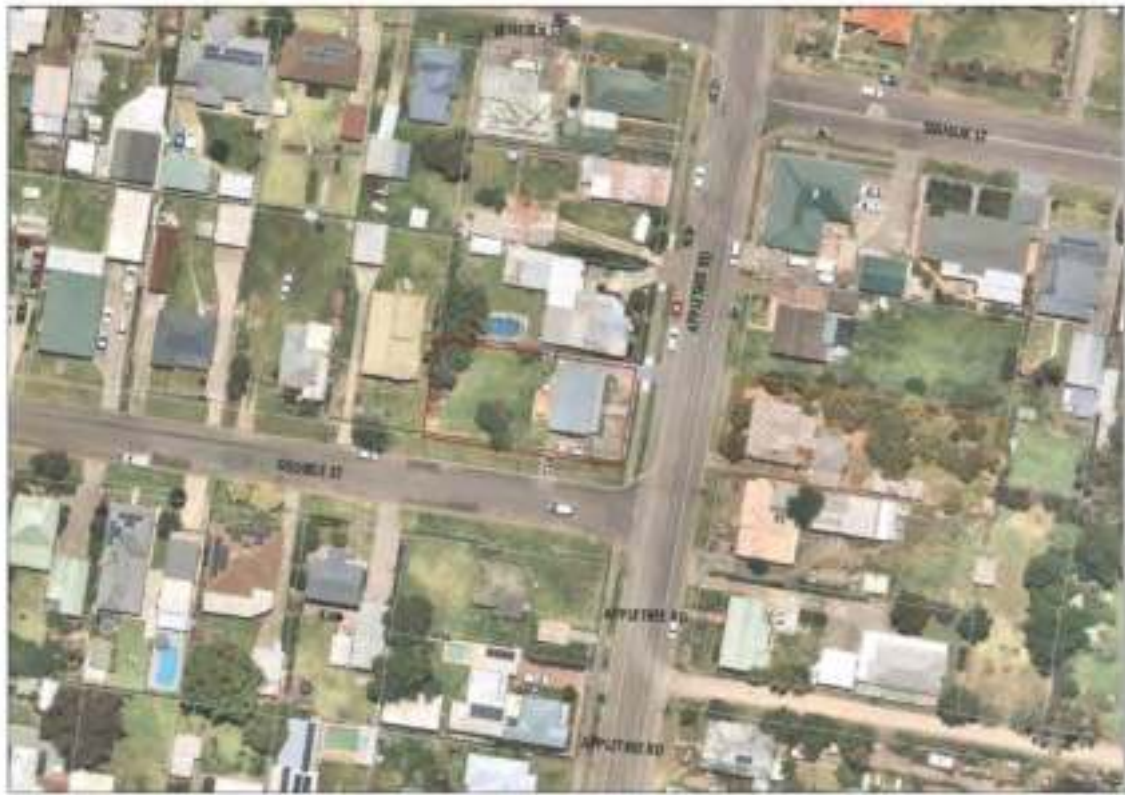
46 APPLETREE ROAD, HOLMESVILLE 2286

Conservation Area Contribution Level	Est. Construction Date	Previous studies and/or community input
Contributory 2	Early to late 20 th century (broad range)	No prior heritage assessments or research undertaken.
Assessment Text		Observed Modifications
<p>The scale (single-storey) and general style of the dwelling is consistent with that of the streetscape and wider HCA. Dwelling contributes positively to the streetscape and wider HCA, particularly in comparison to Non-Contributory buildings.</p> <p>The dwelling features appropriately proportioned and positioned fenestrations, an appropriate roof form (gabled or hipped) and other features consistent with the architectural character of the area (e.g. front verandah with timber or brick posts, timber detailing, corrugated metal roofing, etc). The contributory value of the dwelling is limited however by either:</p> <ul style="list-style-type: none"> • External modifications that have in some way obscured the style, scale or design intent of the building and have resulted in less physical integrity than Contributory 1 buildings. • Being a later dwelling constructed in an appropriate referential style, but comprising little to no fabric of intrinsic heritage significance. 		<p>The timber veranda posts are a contemporary addition, however are not unsympathetic to the heritage streetscape.</p> <p>The visible windows are of a contemporary design.</p> <p>The concrete/stone walkway leading to the dwelling and adjacent garden beds are a recent addition.</p>

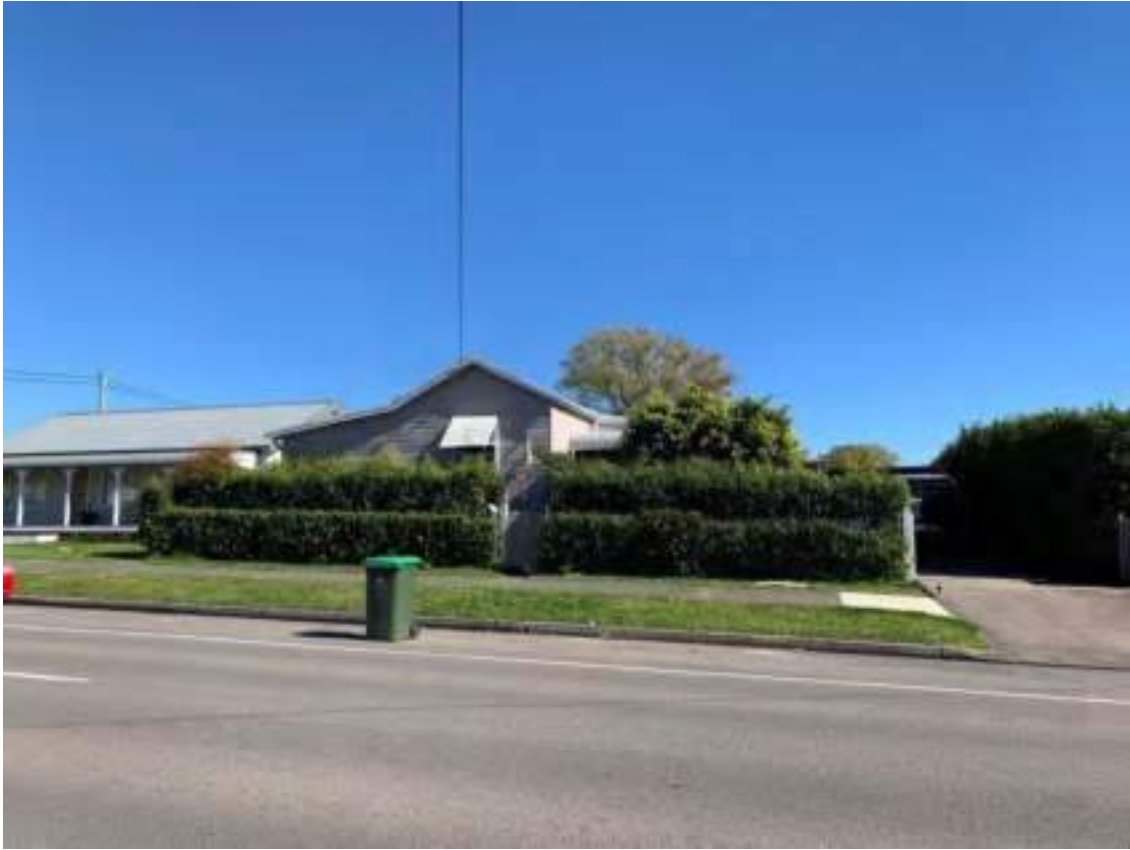
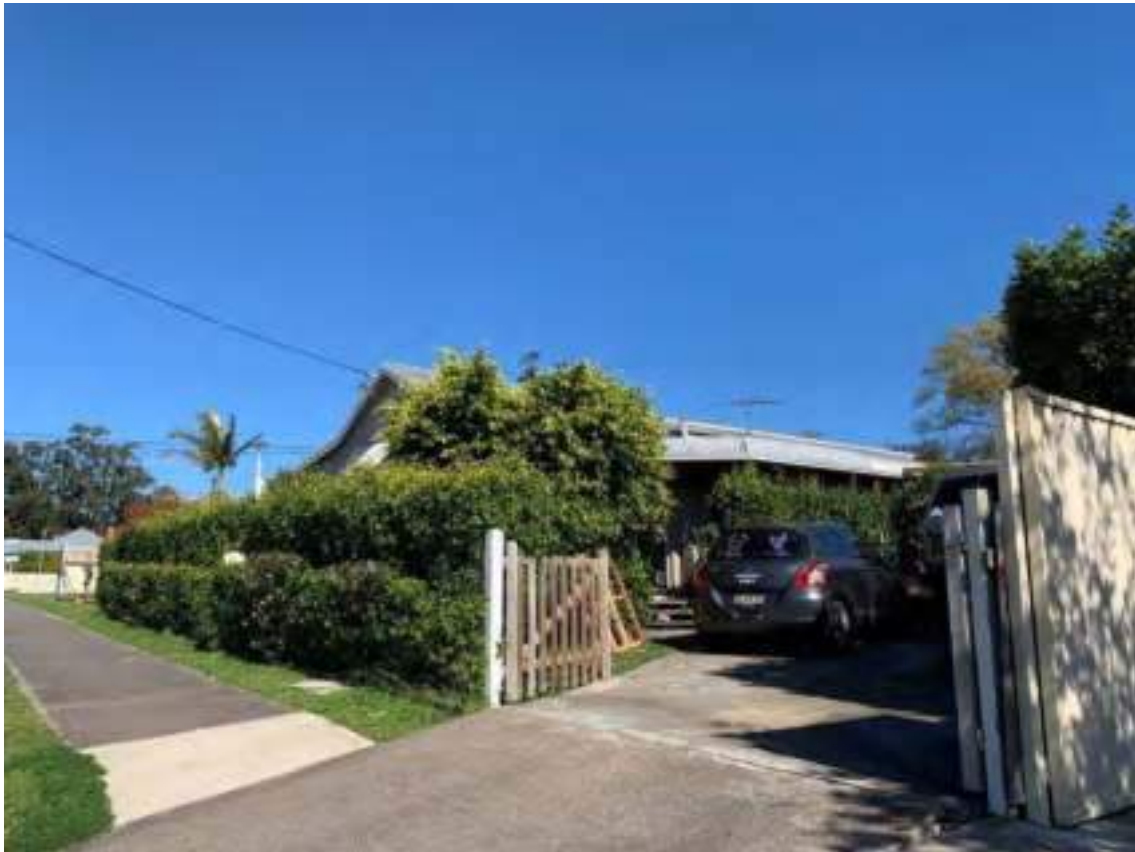
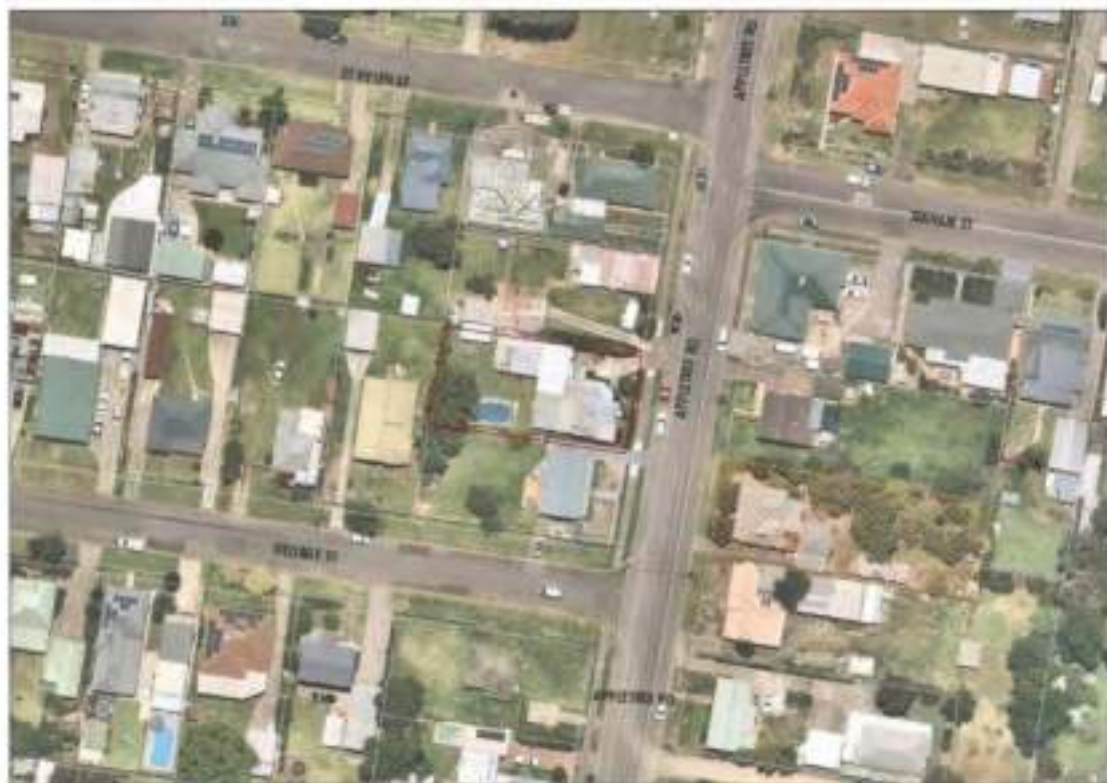
44 APPLETREE ROAD, HOLMESVILLE 2286

Conservation Area Contribution Level	Est. Construction Date	Previous studies and/or community input
Contributory 2	1910–1930	No prior heritage assessments or research undertaken.
Assessment Text		Observed Modifications
<p>The scale (single-storey) and general style of the dwelling is consistent with that of the streetscape and wider HCA. Dwelling contributes positively to the streetscape and wider HCA, particularly in comparison to Non-Contributory buildings.</p> <p>The dwelling features appropriately proportioned and positioned fenestrations, an appropriate roof form (gabled or hipped) and other features consistent with the architectural character of the area (e.g. front verandah with timber or brick posts, timber detailing, corrugated metal roofing, etc). The contributory value of the dwelling is limited however by either:</p> <ul style="list-style-type: none"> • External modifications that have in some way obscured the style, scale or design intent of the building and have resulted in less physical integrity than Contributory 1 buildings. • Being a later dwelling constructed in an appropriate referential style, but comprising little to no fabric of intrinsic heritage significance. 		<p>A northern veranda extension has been constructed, however this is obscured by vegetation and does not detract from the heritage streetscape.</p>

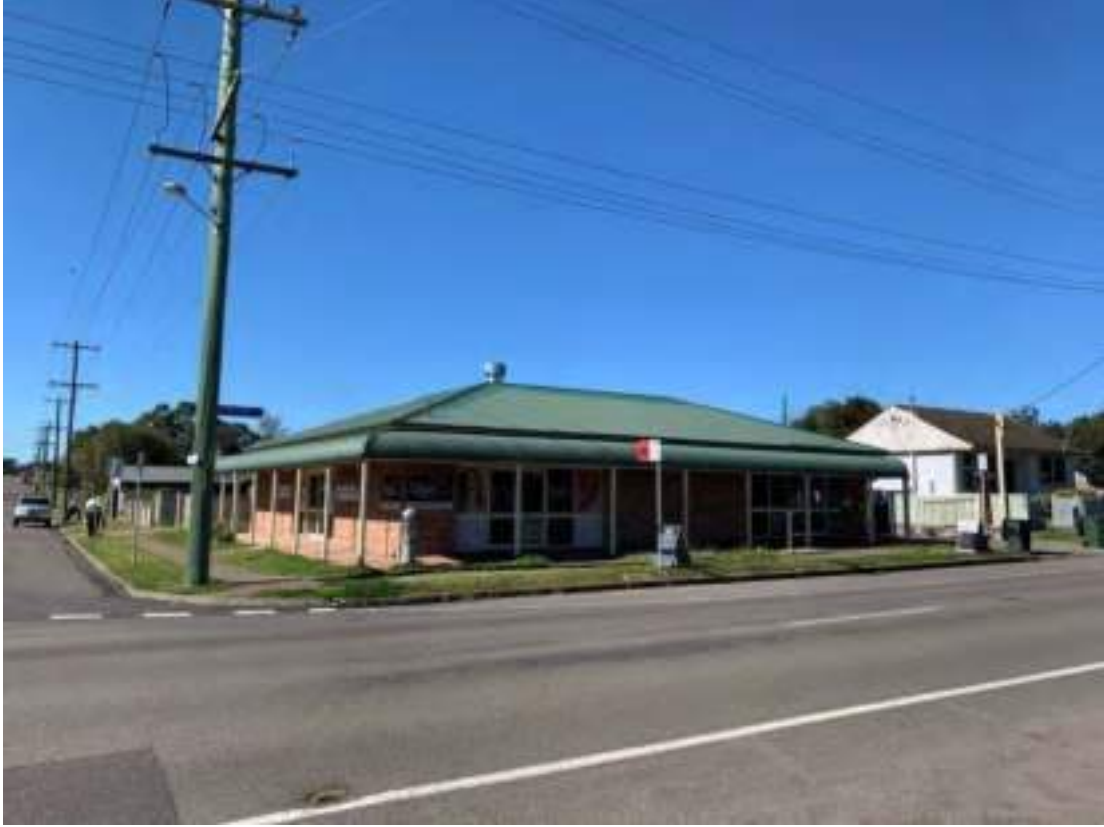
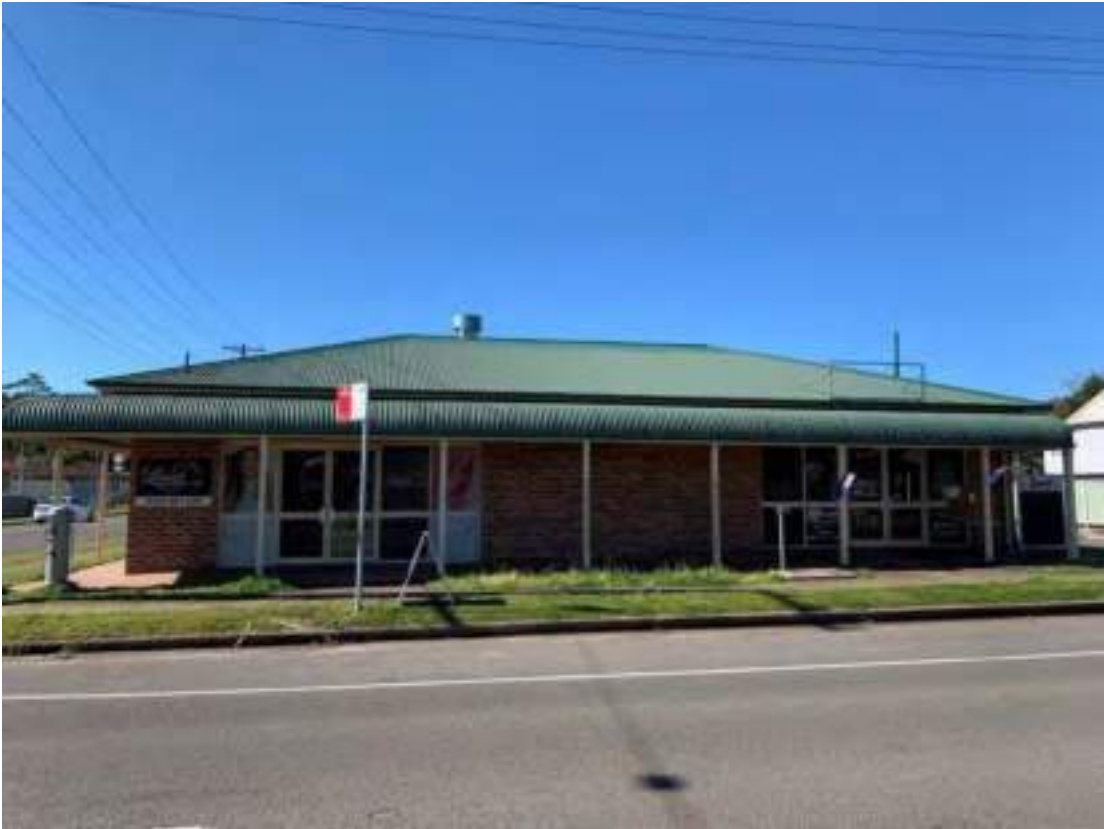
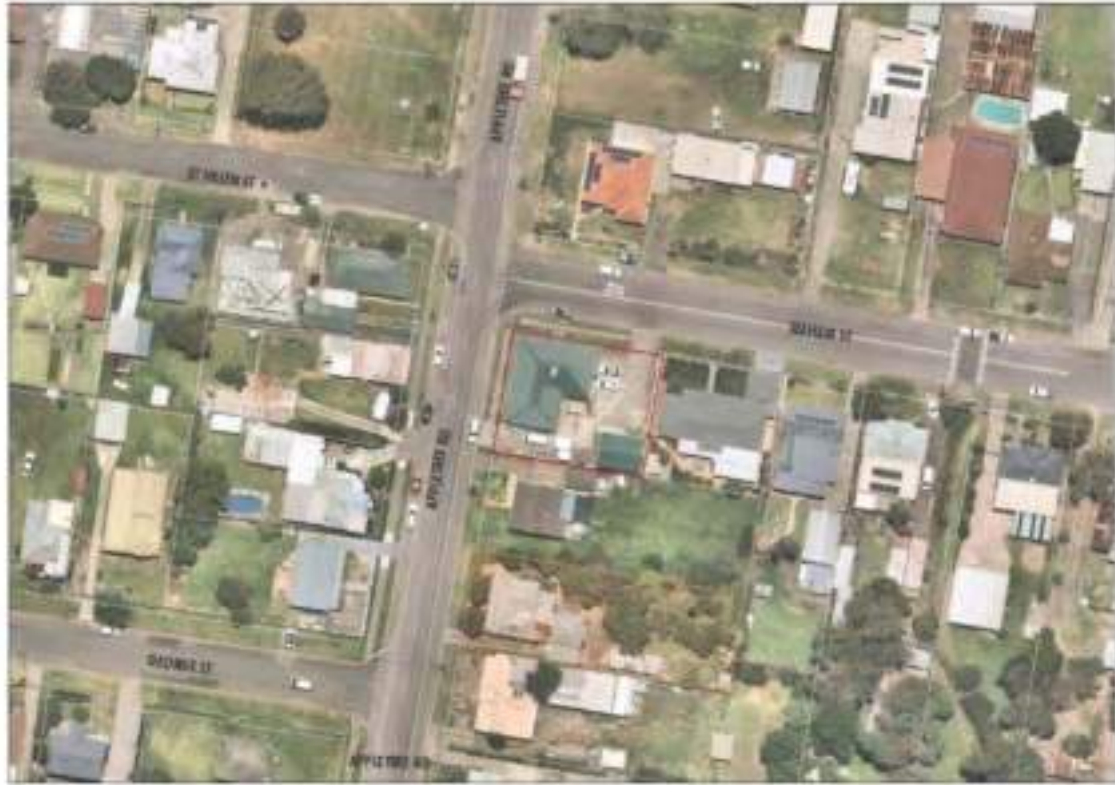
SHOP 2, 43 APPLETREE ROAD, HOLMESVILLE 2286

Conservation Area Contribution Level	Est. Construction Date	Previous studies and/or community input
Contributory 2	Early to late 20th century (broad range)	No prior heritage assessments or research undertaken.
Assessment Text		Observed Modifications
<p>The scale (single-storey) and general style of the dwelling is consistent with that of the streetscape and wider HCA. Dwelling contributes positively to the streetscape and wider HCA, particularly in comparison to Non-Contributory buildings.</p> <p>The dwelling features appropriately proportioned and positioned fenestrations, an appropriate roof form (gabled or hipped) and other features consistent with the architectural character of the area (e.g. front verandah with timber or brick posts, timber detailing, corrugated metal roofing, etc). The contributory value of the dwelling is limited however by either:</p> <ul style="list-style-type: none"> • External modifications that have in some way obscured the style, scale or design intent of the building and have resulted in less physical integrity than Contributory 1 buildings. • Being a later dwelling constructed in an appropriate referential style, but comprising little to no fabric of intrinsic heritage significance. 		No modifications observed.

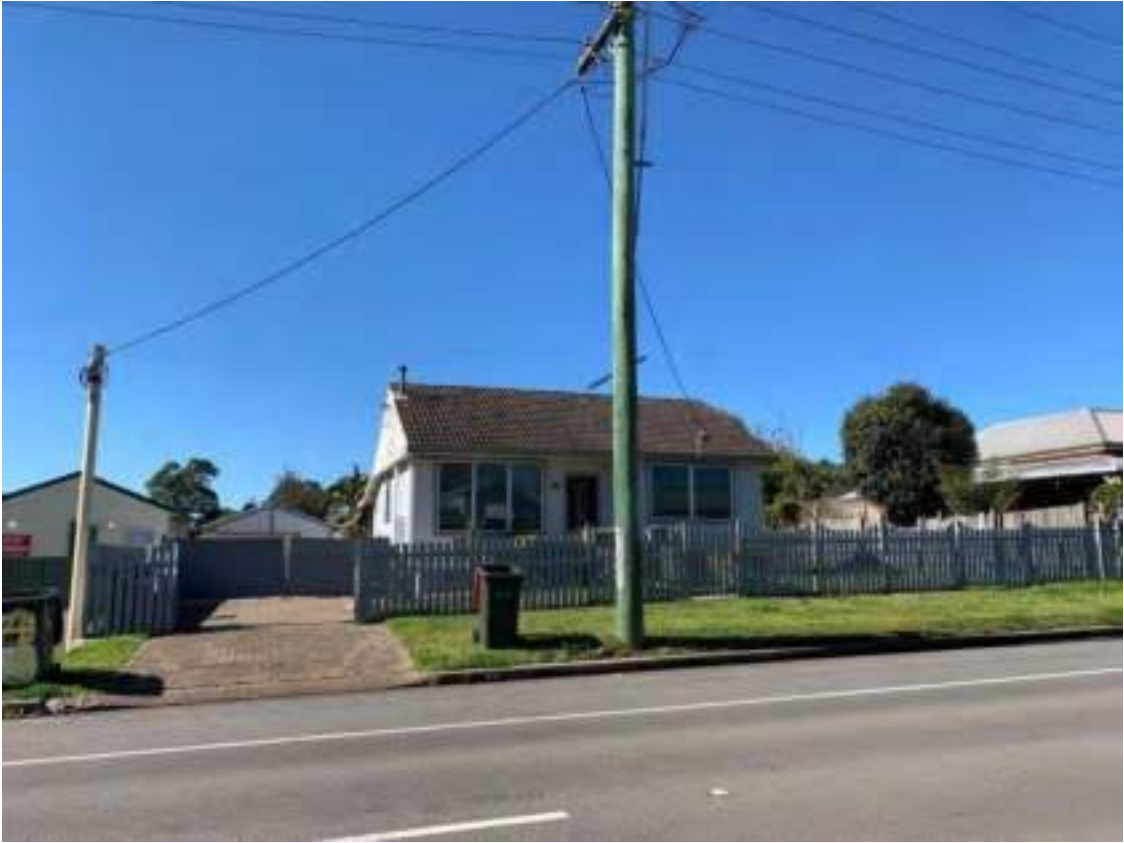
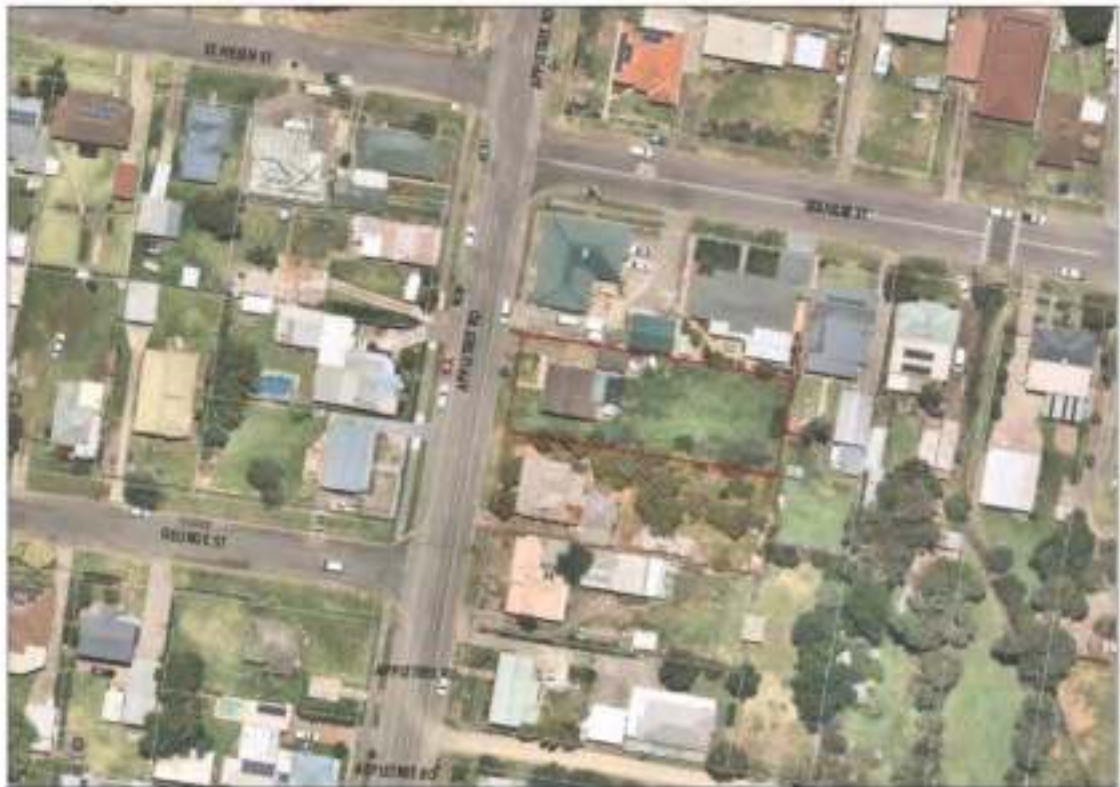
45 APPLETREE ROAD, HOLMESVILLE 2286

Conservation Area Contribution Level	Est. Construction Date	Previous studies and/or community input
Contributory 2	Early to late 20th century (broad range)	No prior heritage assessments or research undertaken.
Assessment Text		Observed Modifications
<p>The scale (single-storey) and general style of the dwelling is consistent with that of the streetscape and wider HCA. Dwelling contributes positively to the streetscape and wider HCA, particularly in comparison to Non-Contributory buildings.</p> <p>The dwelling features appropriately proportioned and positioned fenestrations, an appropriate roof form (gabled or hipped) and other features consistent with the architectural character of the area (e.g. front verandah with timber or brick posts, timber detailing, corrugated metal roofing, etc). The contributory value of the dwelling is limited however by either:</p> <ul style="list-style-type: none"> • External modifications that have in some way obscured the style, scale or design intent of the building and have resulted in less physical integrity than Contributory 1 buildings. • Being a later dwelling constructed in an appropriate referential style, but comprising little to no fabric of intrinsic heritage significance. 		<p>All visible windows are contemporary designs.</p> <p>The front door is a contemporary style, juxtaposing the heritage streetscape.</p>

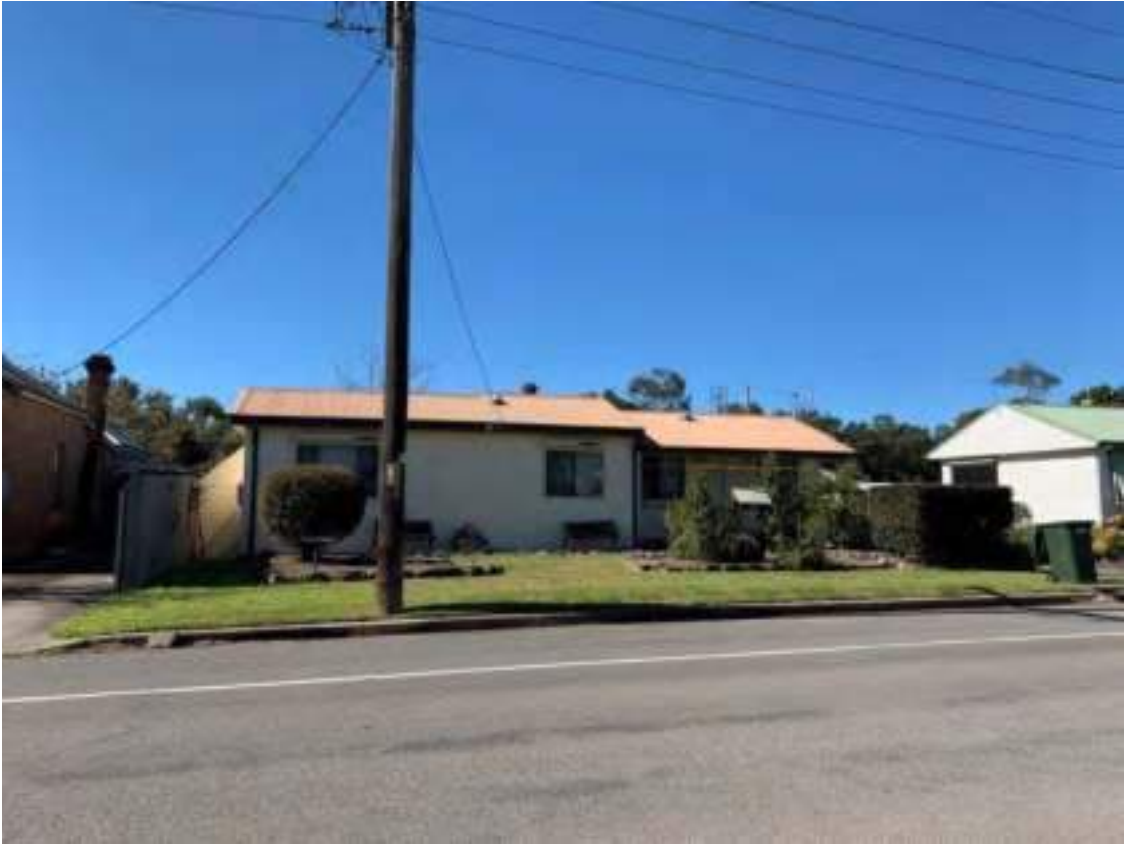
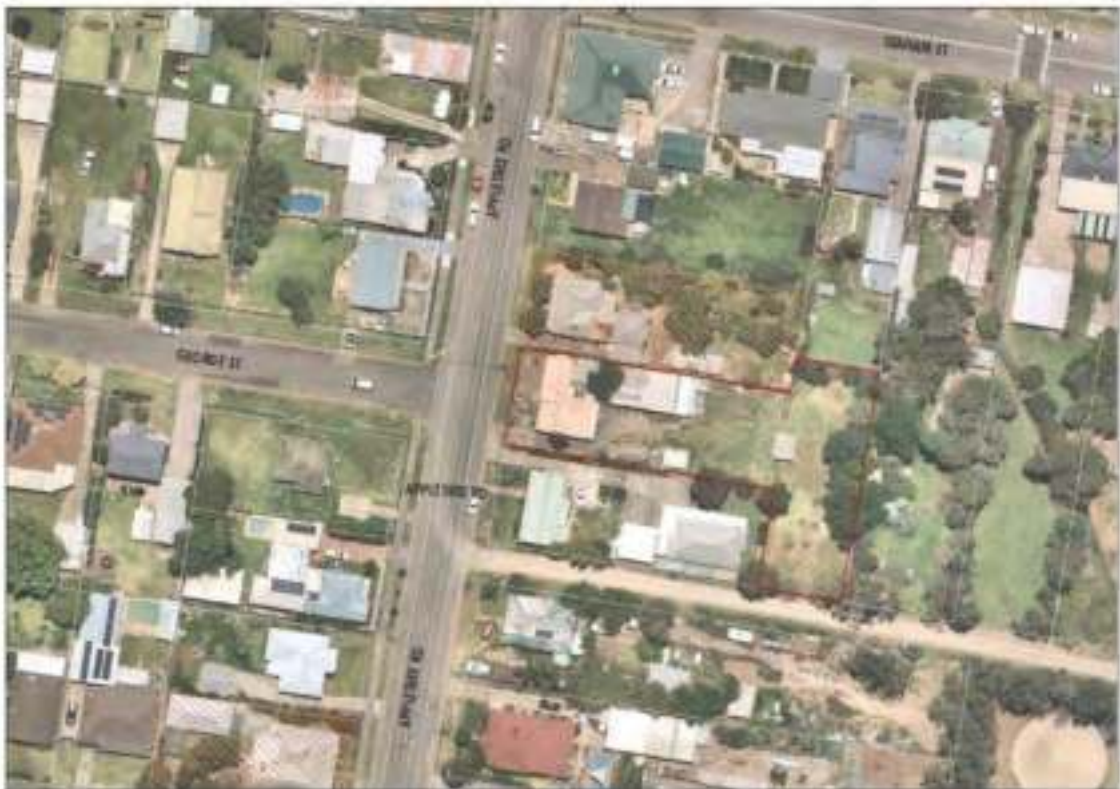
49 APPLETREE ROAD, HOLMESVILLE 2286

Conservation Area Contribution Level	Est. Construction Date	Previous studies and/or community input
Contributory 2	Early to late 20th century (broad range)	No prior heritage assessments or research undertaken.
Assessment Text		Observed Modifications
<p>The scale (single-storey) and general style of the dwelling is consistent with that of the streetscape and wider HCA. Dwelling contributes positively to the streetscape and wider HCA, particularly in comparison to Non-Contributory buildings.</p> <p>The dwelling features appropriately proportioned and positioned fenestrations, an appropriate roof form (gabled or hipped) and other features consistent with the architectural character of the area (e.g. front verandah with timber or brick posts, timber detailing, corrugated metal roofing, etc).</p> <p>The contributory value of the dwelling is limited however by either:</p> <ul style="list-style-type: none"> • External modifications that have in some way obscured the style, scale or design intent of the building and have resulted in less physical integrity than Contributory 1 buildings. • Being a later dwelling constructed in an appropriate referential style, but comprising little to no fabric of intrinsic heritage significance. 		<p>The timber lattice balustrade enclosing the veranda is a dated modification, being a common design for the area.</p> <p>All visible windows are contemporary designs, with metal roller shutters.</p>
