APPENDIX 2

Building Assessment Sheets (Inventory Sheets)

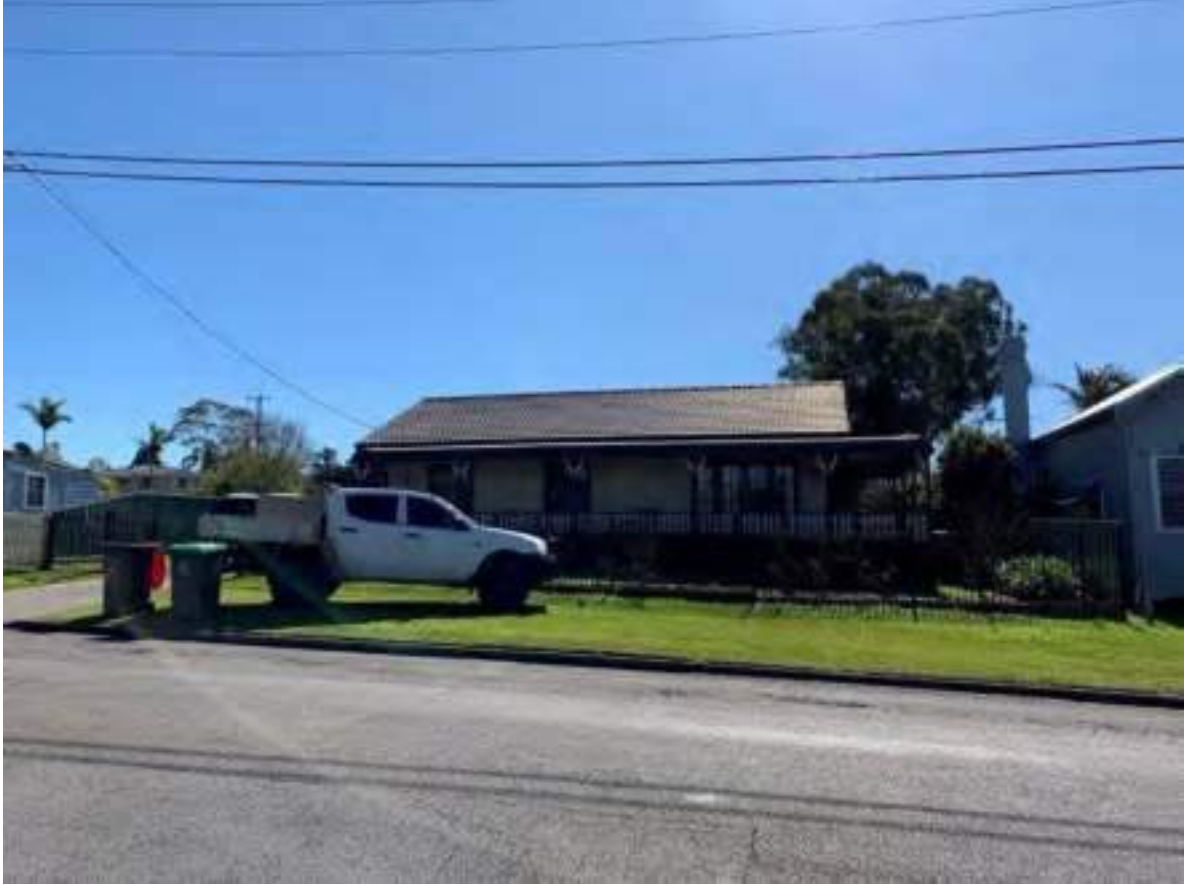
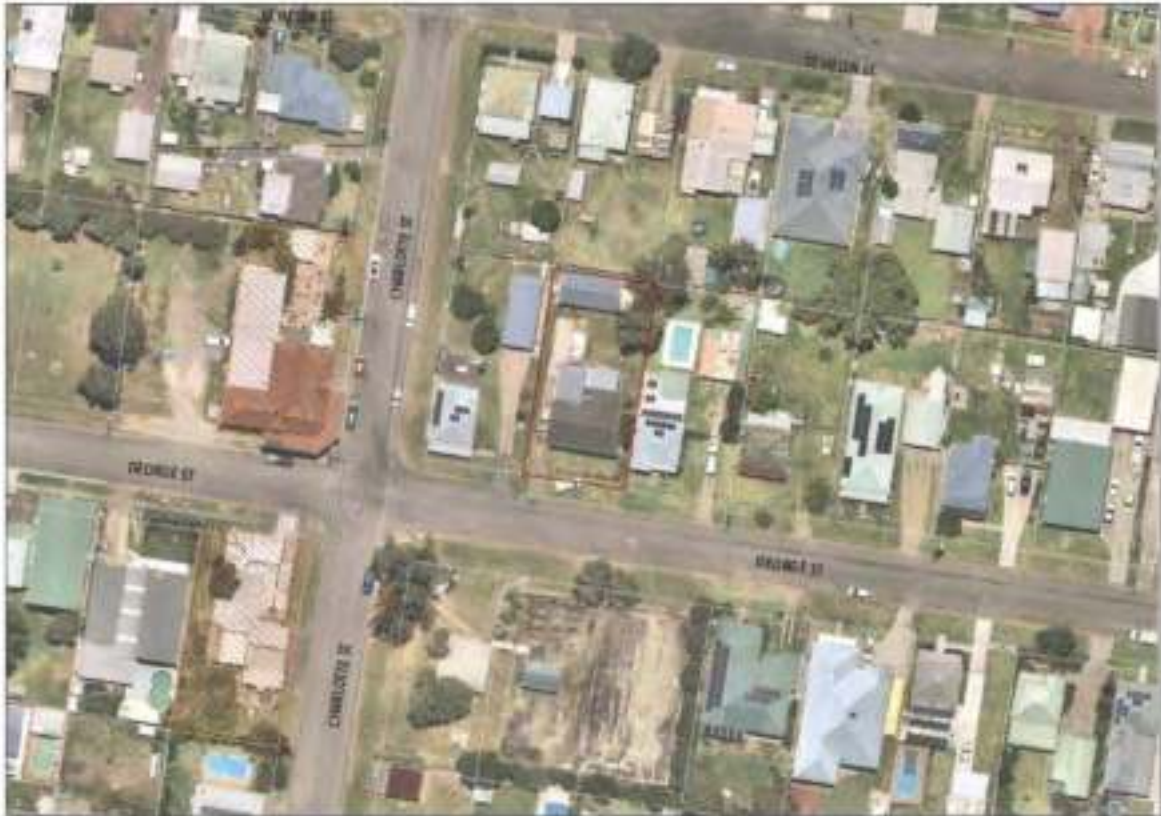
17 GEORGE STREET, HOLMESVILLE 2286

Conservation Area Contribution Level	Est. Construction Date	Previous studies and/or community input
Contributory 2	Early to late 20th century (broad range)	No prior heritage assessments or research undertaken.
Assessment Text		Observed Modifications
<p>The scale (single-storey) and general style of the dwelling is consistent with that of the streetscape and wider HCA. Dwelling contributes positively to the streetscape and wider HCA, particularly in comparison to Non-Contributory buildings.</p> <p>The dwelling features appropriately proportioned and positioned fenestrations, an appropriate roof form (gabled or hipped) and other features consistent with the architectural character of the area (e.g. front verandah with timber or brick posts, timber detailing, corrugated metal roofing, etc).</p> <p>The contributory value of the dwelling is limited however by either:</p> <ul style="list-style-type: none"> • External modifications that have in some way obscured the style, scale or design intent of the building and have resulted in less physical integrity than Contributory 1 buildings. • Being a later dwelling constructed in an appropriate referential style, but comprising little to no fabric of intrinsic heritage significance. 		<p>The veranda has undergone multiple modifications, including the timber balustrade and ornate bracketing.</p> <p>All visible windows and doors have been replaced with contemporary designs.</p>

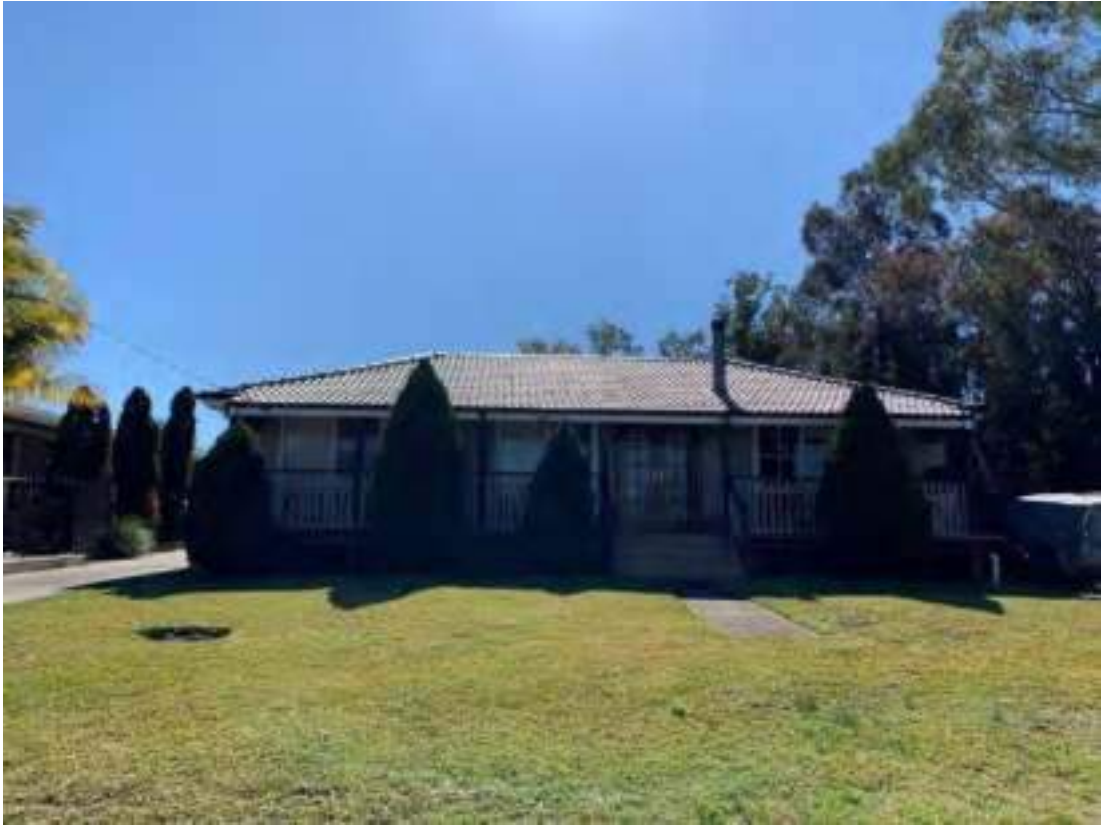
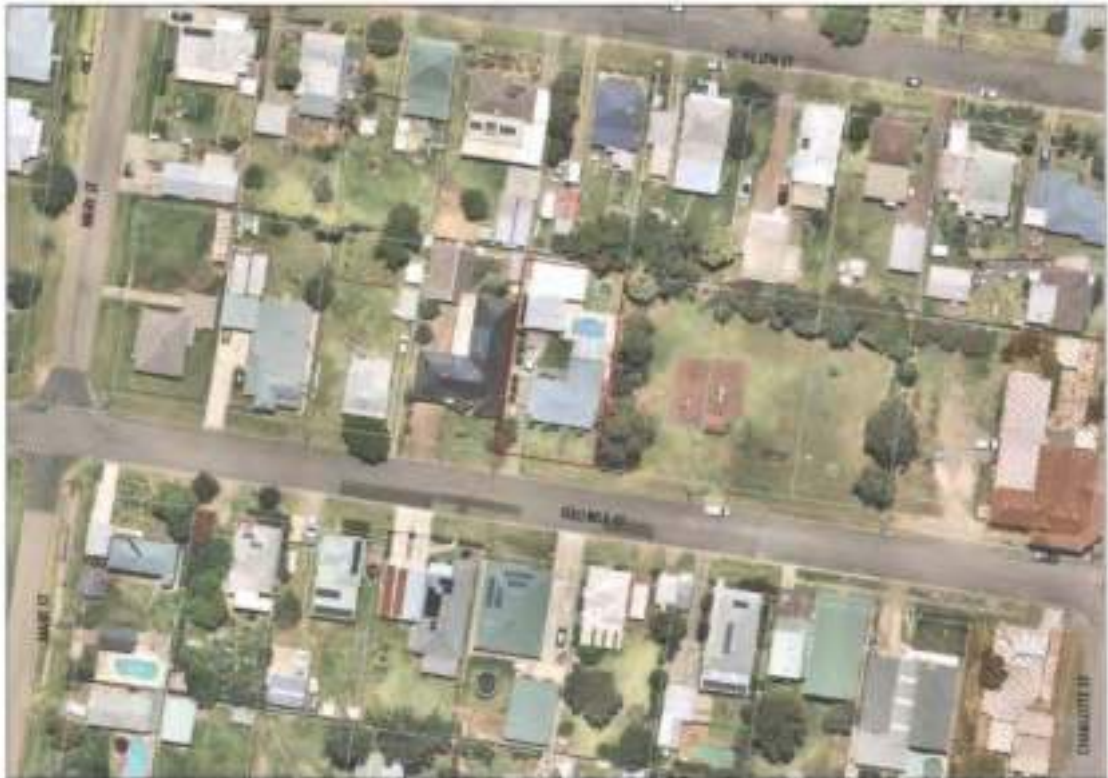
25 GEORGE STREET, HOLMESVILLE 2286

Conservation Area Contribution Level	Est. Construction Date	Previous studies and/or community input
Contributory 2	Early to late 20th century (broad range)	No prior heritage assessments or research undertaken.
Assessment Text		Observed Modifications
<p>The scale (single-storey) and general style of the dwelling is consistent with that of the streetscape and wider HCA. Dwelling contributes positively to the streetscape and wider HCA, particularly in comparison to Non-Contributory buildings.</p> <p>The dwelling features appropriately proportioned and positioned fenestrations, an appropriate roof form (gabled or hipped) and other features consistent with the architectural character of the area (e.g. front verandah with timber or brick posts, timber detailing, corrugated metal roofing, etc). The contributory value of the dwelling is limited however by either:</p> <ul style="list-style-type: none"> • External modifications that have in some way obscured the style, scale or design intent of the building and have resulted in less physical integrity than Contributory 1 buildings. • Being a later dwelling constructed in an appropriate referential style, but comprising little to no fabric of intrinsic heritage significance. 		<p>The double front door is a contemporary addition to the dwelling, in a style common to the area. All visible windows are similarly contemporary.</p> <p>The timber balustrade is a recent modification.</p>

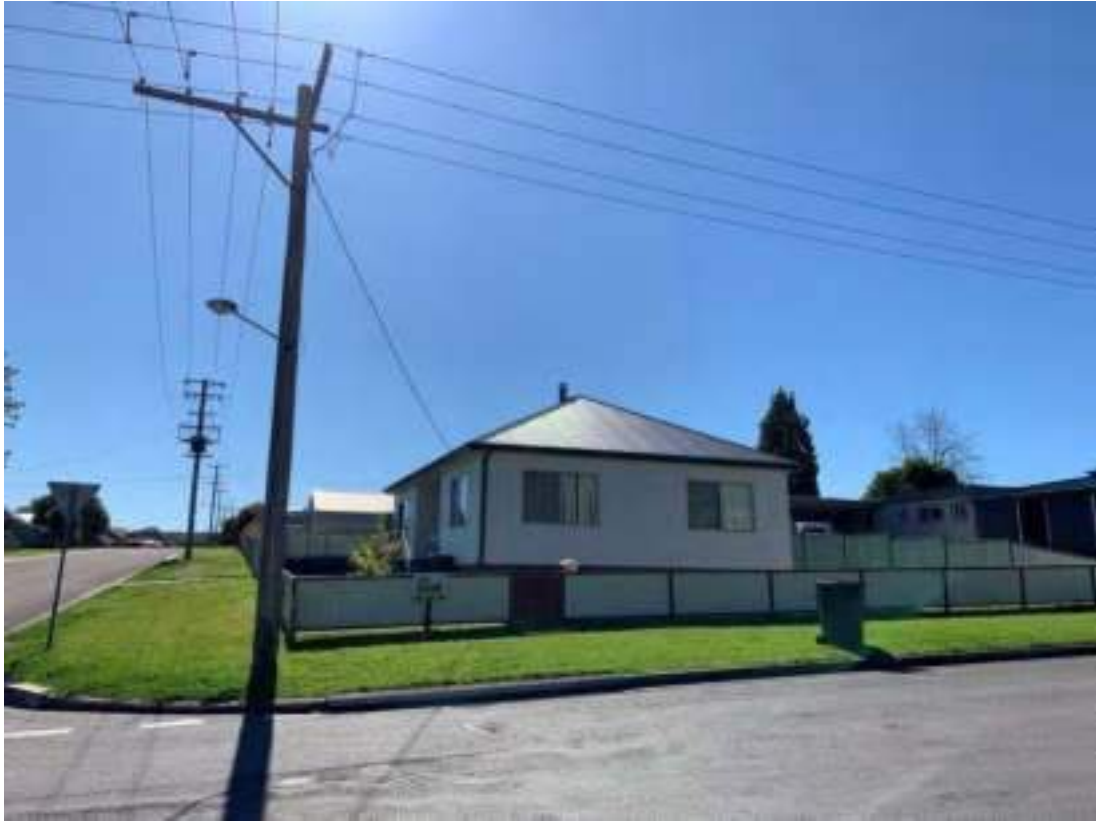
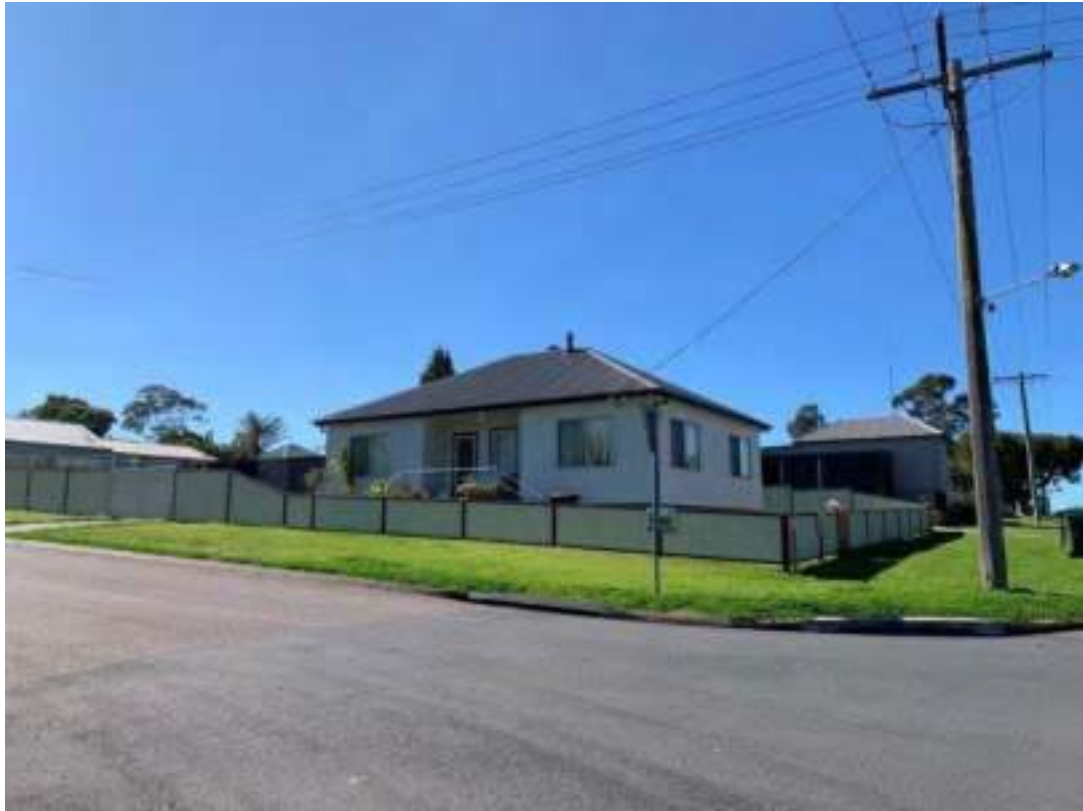
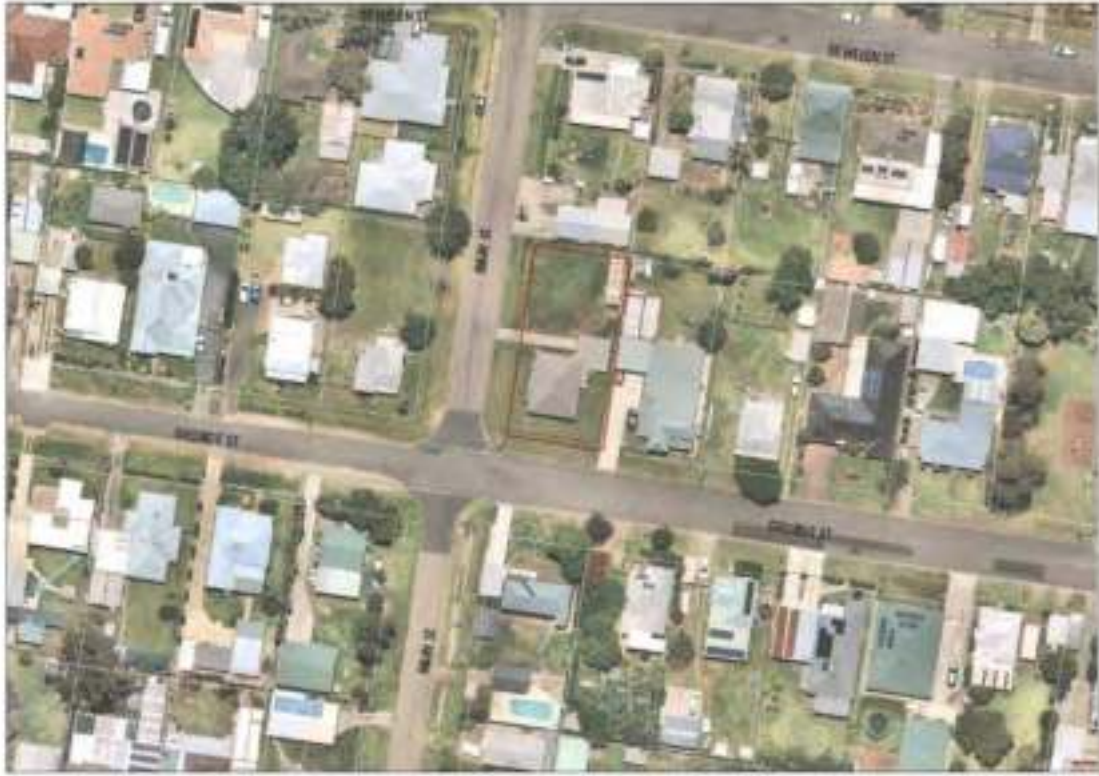
Conservation Area Contribution Level	Est. Construction Date	Previous studies and/or community input
Contributory 2	Early to late 20th century (broad range)	No prior heritage assessments or research undertaken.
Assessment Text		Observed Modifications
<p>The scale (single-storey) and general style of the dwelling is consistent with that of the streetscape and wider HCA. Dwelling contributes positively to the streetscape and wider HCA, particularly in comparison to Non-Contributory buildings.</p> <p>The dwelling features appropriately proportioned and positioned fenestrations, an appropriate roof form (gabled or hipped) and other features consistent with the architectural character of the area (e.g. front verandah with timber or brick posts, timber detailing, corrugated metal roofing, etc). The contributory value of the dwelling is limited however by either:</p> <ul style="list-style-type: none"> • External modifications that have in some way obscured the style, scale or design intent of the building and have resulted in less physical integrity than Contributory 1 buildings. • Being a later dwelling constructed in an appropriate referential style, but comprising little to no fabric of intrinsic heritage significance. 		<p>All visible windows are contemporary in design.</p> <p>The veranda space has likely undergone modification, including balustrade replacement, post removal or expansion.</p>

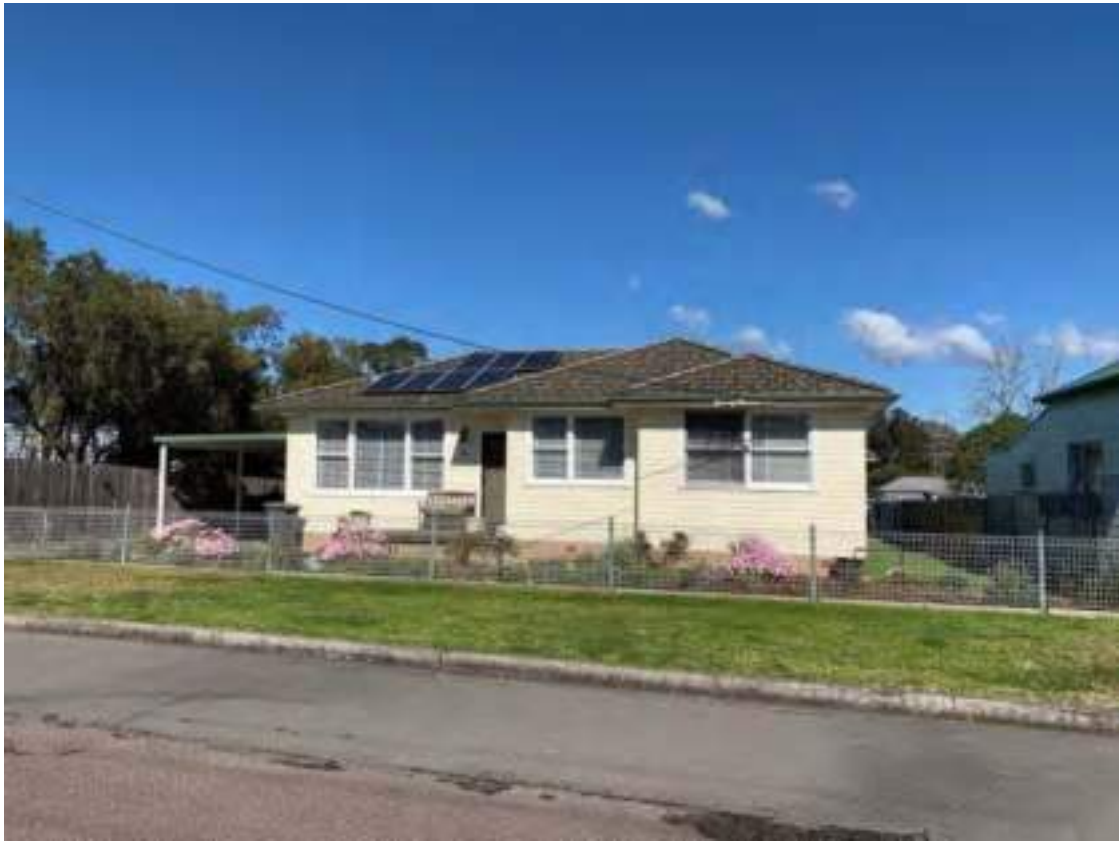
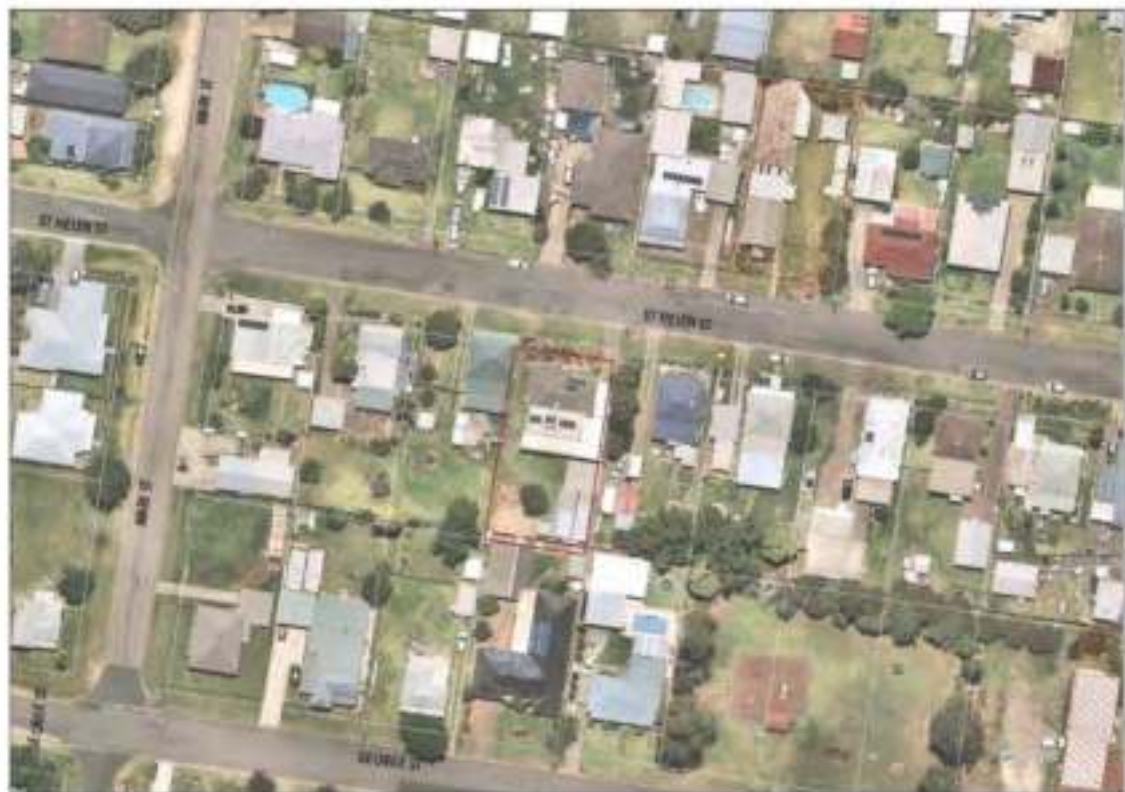
34 ST HELENS STREET, HOLMESVILLE 2286		
Conservation Area Contribution Level	Est. Construction Date	Previous studies and/or community input
Contributory 2	Early to late 20th century (broad range)	No prior heritage assessments or research undertaken.
Assessment Text		Observed Modifications
<p>The scale (single-storey) and general style of the dwelling is consistent with that of the streetscape and wider HCA. Dwelling contributes positively to the streetscape and wider HCA, particularly in comparison to Non-Contributory buildings.</p> <p>The dwelling features appropriately proportioned and positioned fenestrations, an appropriate roof form (gabled or hipped) and other features consistent with the architectural character of the area (e.g. front verandah with timber or brick posts, timber detailing, corrugated metal roofing, etc). The contributory value of the dwelling is limited however by either:</p> <ul style="list-style-type: none"> • External modifications that have in some way obscured the style, scale or design intent of the building and have resulted in less physical integrity than Contributory 1 buildings. • Being a later dwelling constructed in an appropriate referential style, but comprising little to no fabric of intrinsic heritage significance. 		<p>Solar panels are highly visible on the northern side of the roof.</p>

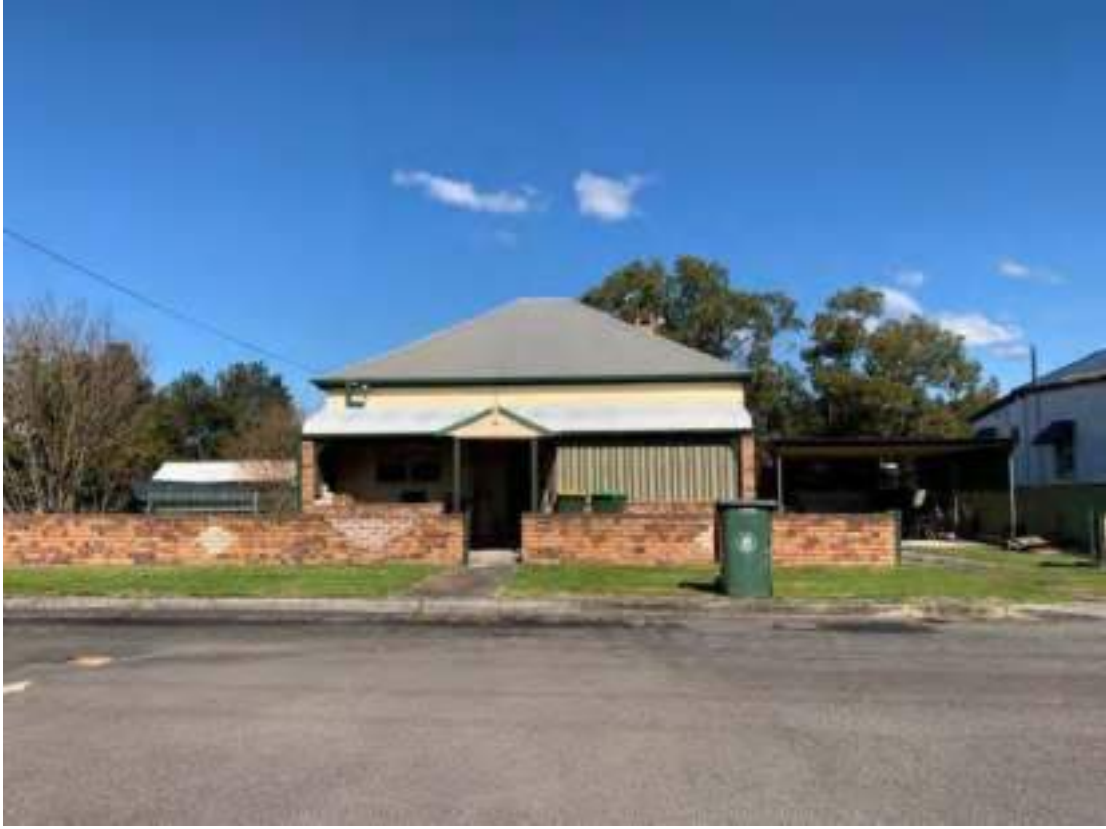
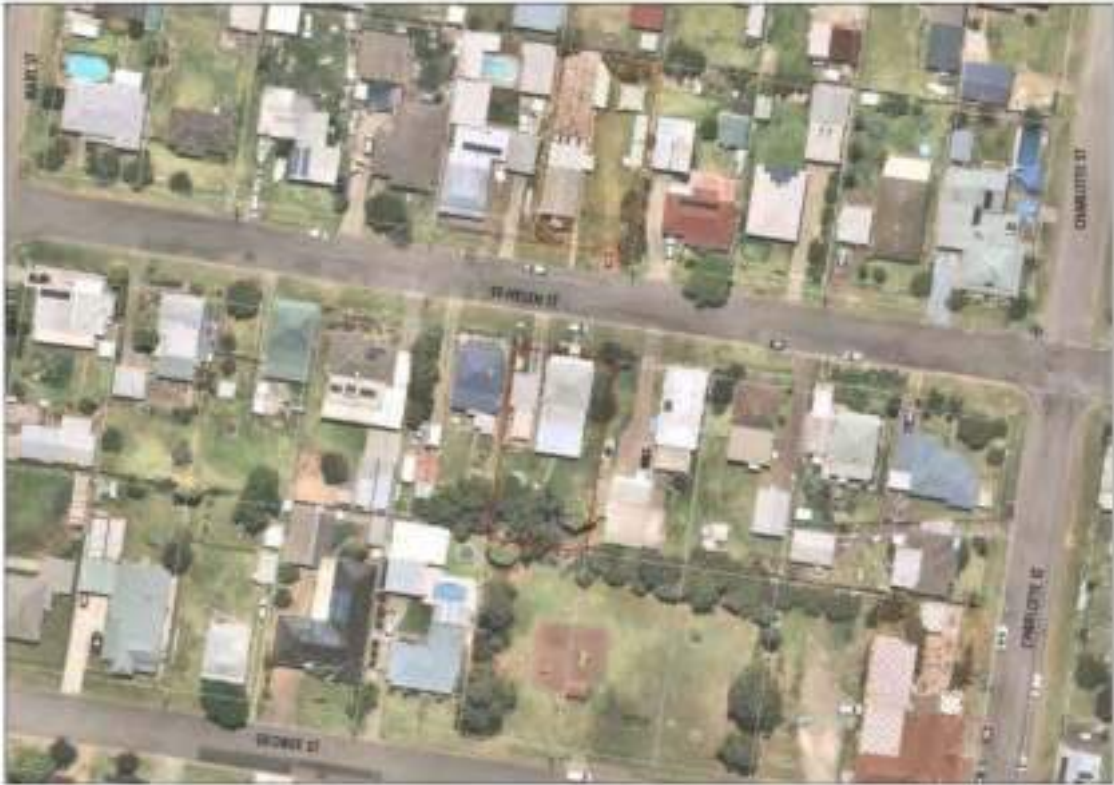
30 ST HELENS STREET, HOLMESVILLE 2286

Conservation Area Contribution Level	Est. Construction Date	Previous studies and/or community input
Contributory 2	Early to late 20th century (broad range)	No prior heritage assessments or research undertaken.
Assessment Text		Observed Modifications
<p>The scale (single-storey) and general style of the dwelling is consistent with that of the streetscape and wider HCA. Dwelling contributes positively to the streetscape and wider HCA, particularly in comparison to Non-Contributory buildings.</p> <p>The dwelling features appropriately proportioned and positioned fenestrations, an appropriate roof form (gabled or hipped) and other features consistent with the architectural character of the area (e.g. front verandah with timber or brick posts, timber detailing, corrugated metal roofing, etc). The contributory value of the dwelling is limited however by either:</p> <ul style="list-style-type: none"> • External modifications that have in some way obscured the style, scale or design intent of the building and have resulted in less physical integrity than Contributory 1 buildings. • Being a later dwelling constructed in an appropriate referential style, but comprising little to no fabric of intrinsic heritage significance. 		<p>The veranda has been partially enclosed through the addition of the timber gable roof archway, brickwork walls, timber lattice and canvas blinds. The roof has further been replaced, likely replacing an original bull nosed design.</p>

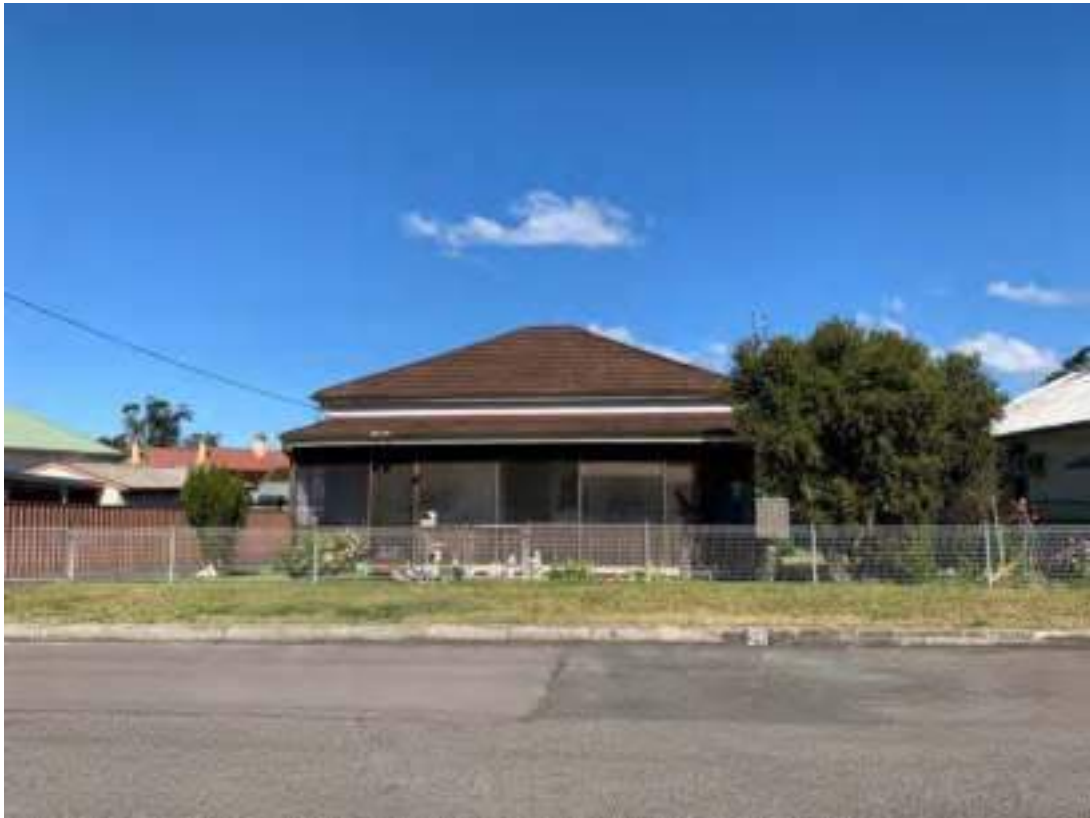
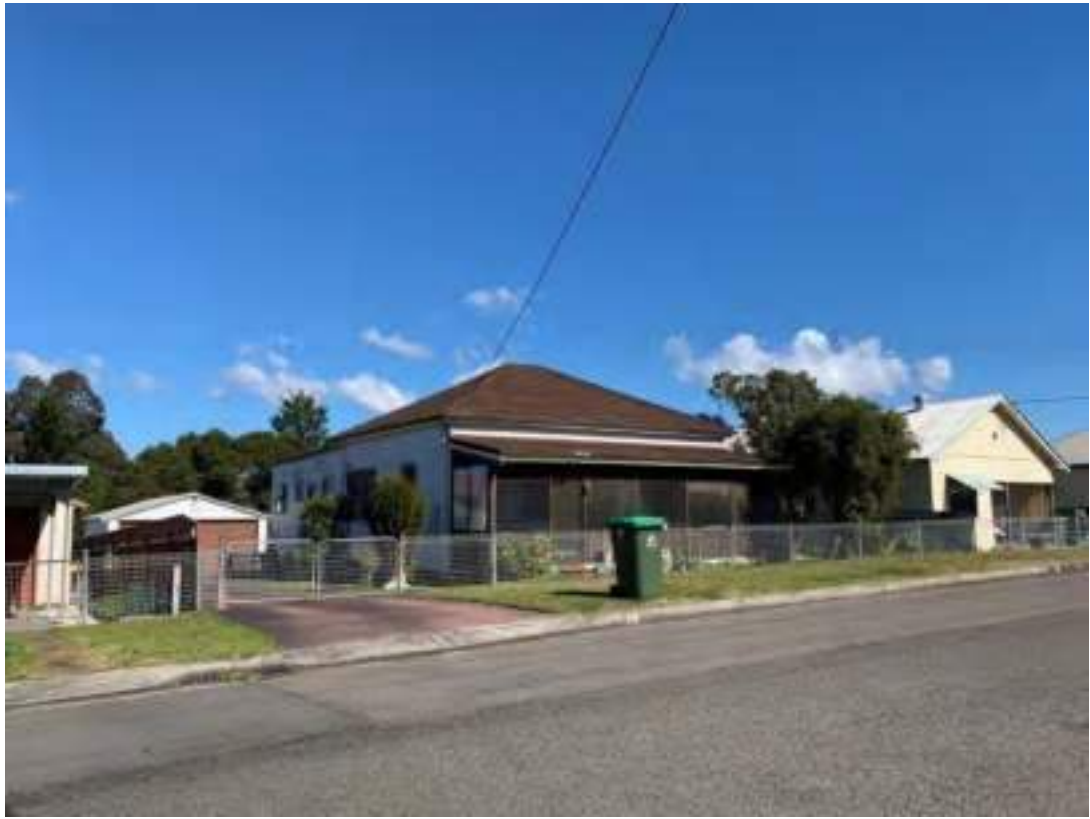
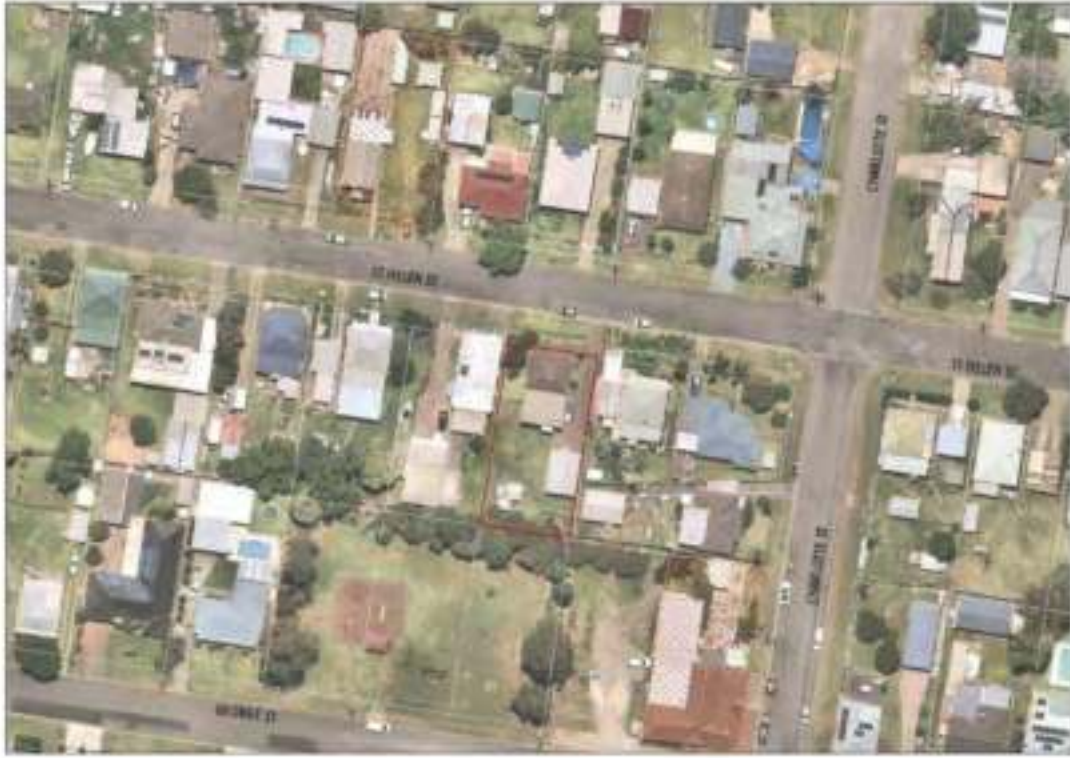
26 ST HELEN STREET, HOLMESVILLE 2286

Conservation Area Contribution Level	Est. Construction Date	Previous studies and/or community input
Contributory 2	1910-1930	No prior heritage assessments or research undertaken.
Assessment Text		Observed Modifications
<p>The scale (single-storey) and general style of the dwelling is consistent with that of the streetscape and wider HCA. Dwelling contributes positively to the streetscape and wider HCA, particularly in comparison to Non-Contributory buildings.</p> <p>The dwelling features appropriately proportioned and positioned fenestrations, an appropriate roof form (gabled or hipped) and other features consistent with the architectural character of the area (e.g. front verandah with timber or brick posts, timber detailing, corrugated metal roofing, etc). The contributory value of the dwelling is limited however by either:</p> <ul style="list-style-type: none"> • External modifications that have in some way obscured the style, scale or design intent of the building and have resulted in less physical integrity than Contributory 1 buildings. • Being a later dwelling constructed in an appropriate referential style, but comprising little to no fabric of intrinsic heritage significance. 		<p>The roof tiles are a contemporary modification, likely replacing an original iron design.</p> <p>The veranda has been enclosed by a Colourbond frame with mesh screening. This is unsympathetic to the heritage streetscape.</p>

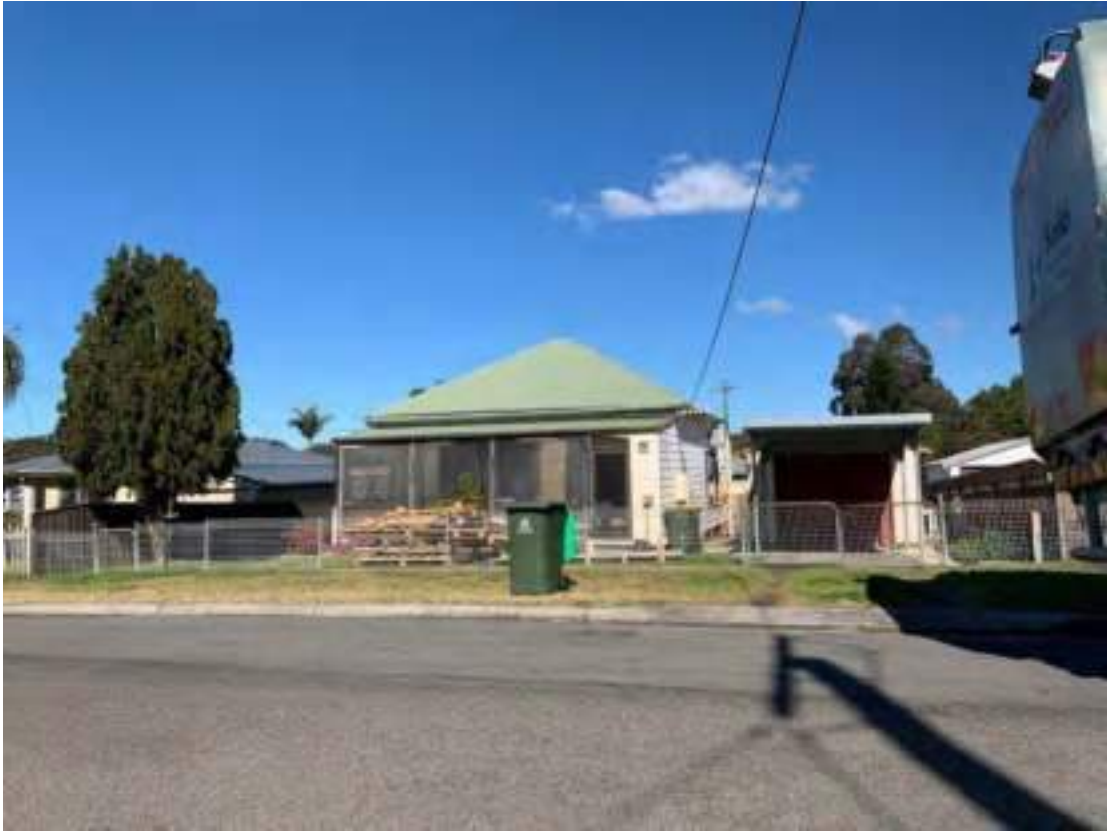
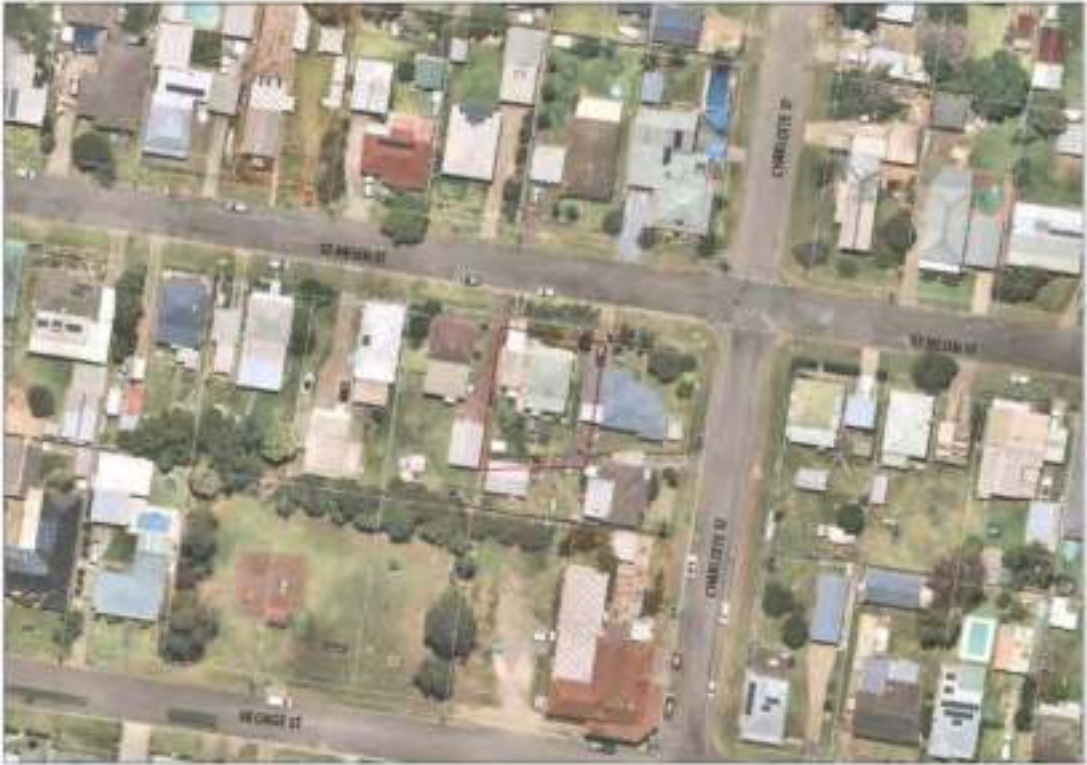
24 ST HELEN STREET, HOLMESVILLE 2286

Conservation Area Contribution Level	Est. Construction Date	Previous studies and/or community input
Contributory 2	Early to late 20th century (broad range)	No prior heritage assessments or research undertaken.
Assessment Text		Observed Modifications
<p>The scale (single-storey) and general style of the dwelling is consistent with that of the streetscape and wider HCA. Dwelling contributes positively to the streetscape and wider HCA, particularly in comparison to Non-Contributory buildings.</p> <p>The dwelling features appropriately proportioned and positioned fenestrations, an appropriate roof form (gabled or hipped) and other features consistent with the architectural character of the area (e.g. front verandah with timber or brick posts, timber detailing, corrugated metal roofing, etc). The contributory value of the dwelling is limited however by either:</p> <ul style="list-style-type: none"> • External modifications that have in some way obscured the style, scale or design intent of the building and have resulted in less physical integrity than Contributory 1 buildings. • Being a later dwelling constructed in an appropriate referential style, but comprising little to no fabric of intrinsic heritage significance. 		<p>The veranda has been enclosed by a Colourbond frame and mesh screen, with an additional metal framed screen door. This is highly visible and detracts from the heritage streetscape.</p>

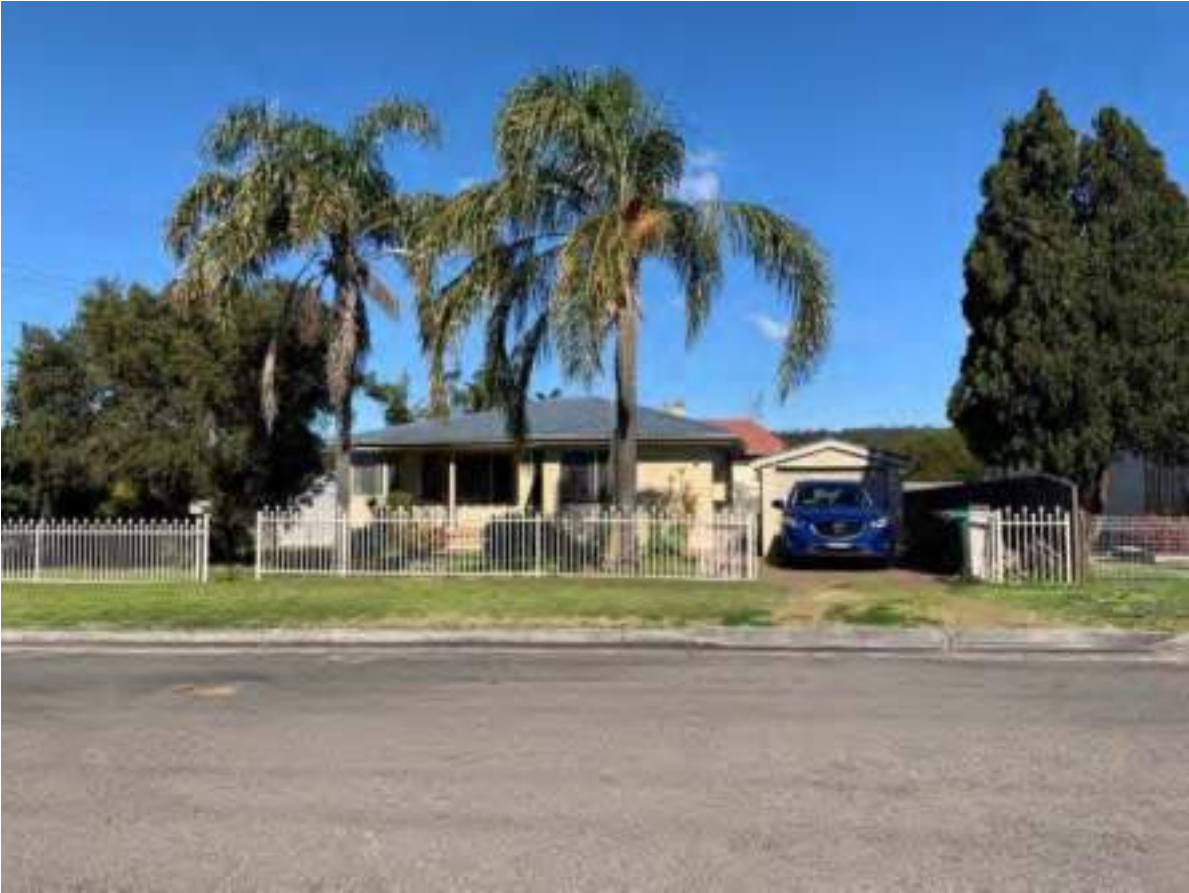
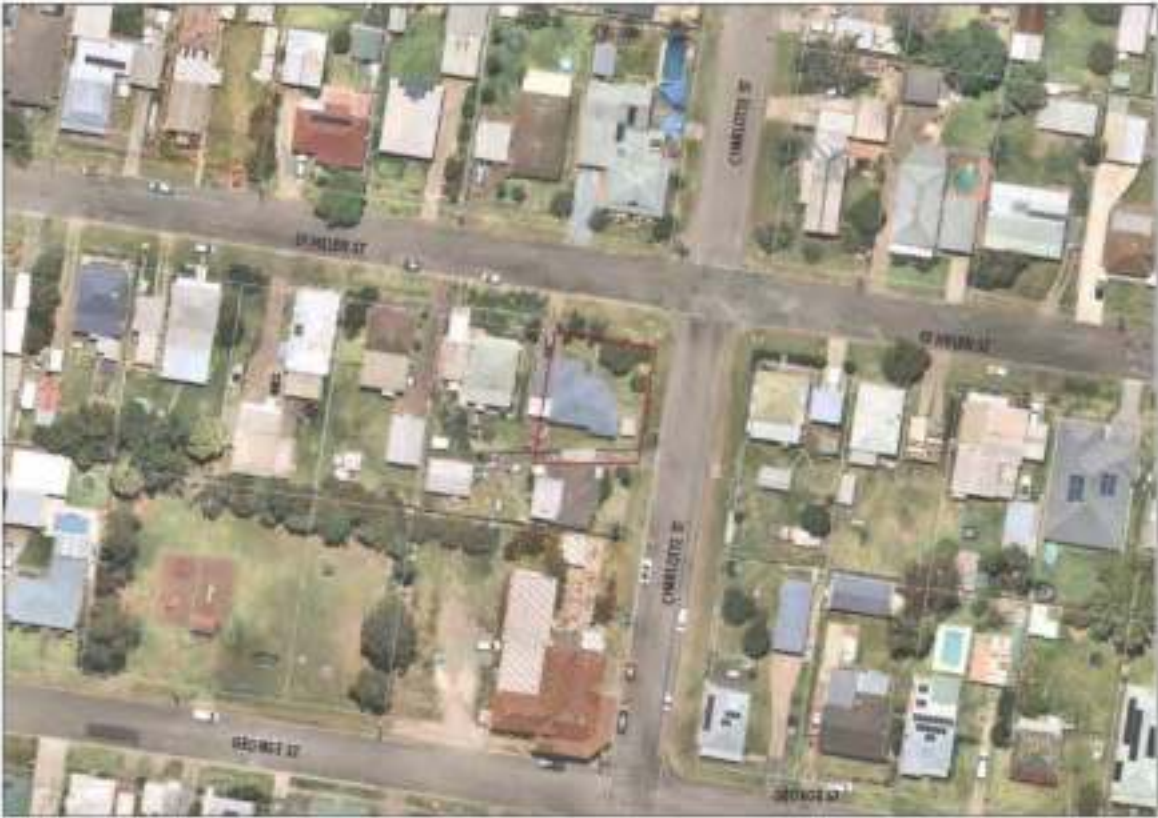
22 ST HELEN STREET, HOLMESVILLE 2286

Conservation Area Contribution Level	Est. Construction Date	Previous studies and/or community input
Contributory 2	Early to late 20th century (broad range)	No prior heritage assessments or research undertaken.
Assessment Text		Observed Modifications
<p>The scale (single-storey) and general style of the dwelling is consistent with that of the streetscape and wider HCA. Dwelling contributes positively to the streetscape and wider HCA, particularly in comparison to Non-Contributory buildings.</p> <p>The dwelling features appropriately proportioned and positioned fenestrations, an appropriate roof form (gabled or hipped) and other features consistent with the architectural character of the area (e.g. front verandah with timber or brick posts, timber detailing, corrugated metal roofing, etc). The contributory value of the dwelling is limited however by either:</p> <ul style="list-style-type: none"> • External modifications that have in some way obscured the style, scale or design intent of the building and have resulted in less physical integrity than Contributory 1 buildings. • Being a later dwelling constructed in an appropriate referential style, but comprising little to no fabric of intrinsic heritage significance. 		No modifications observed.

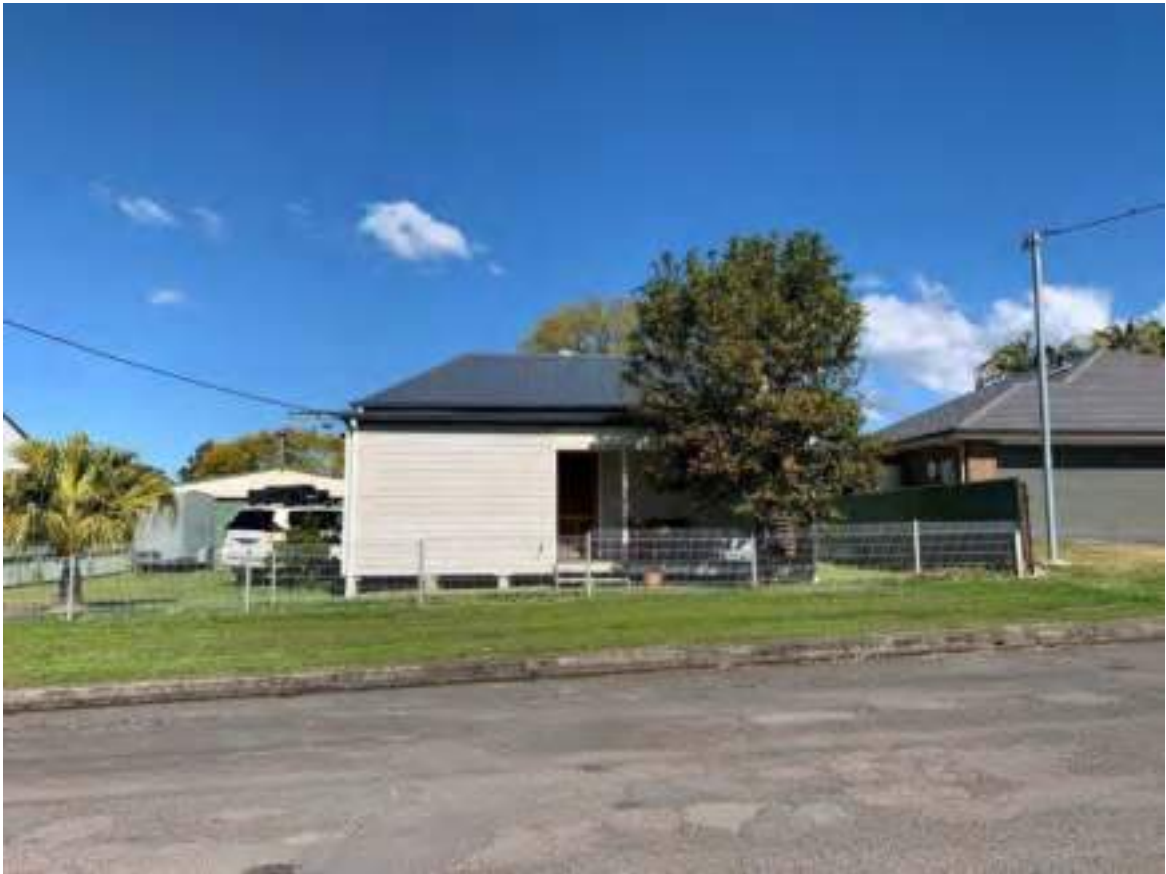
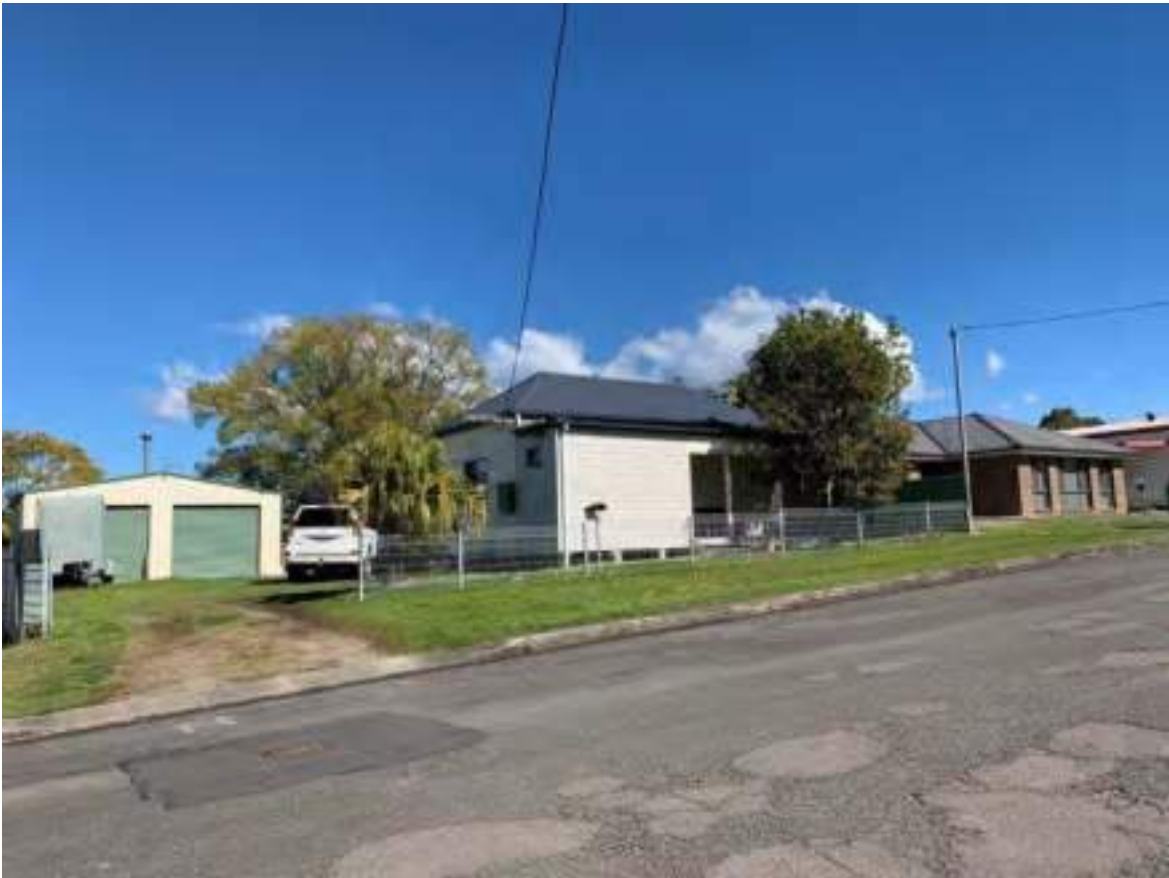
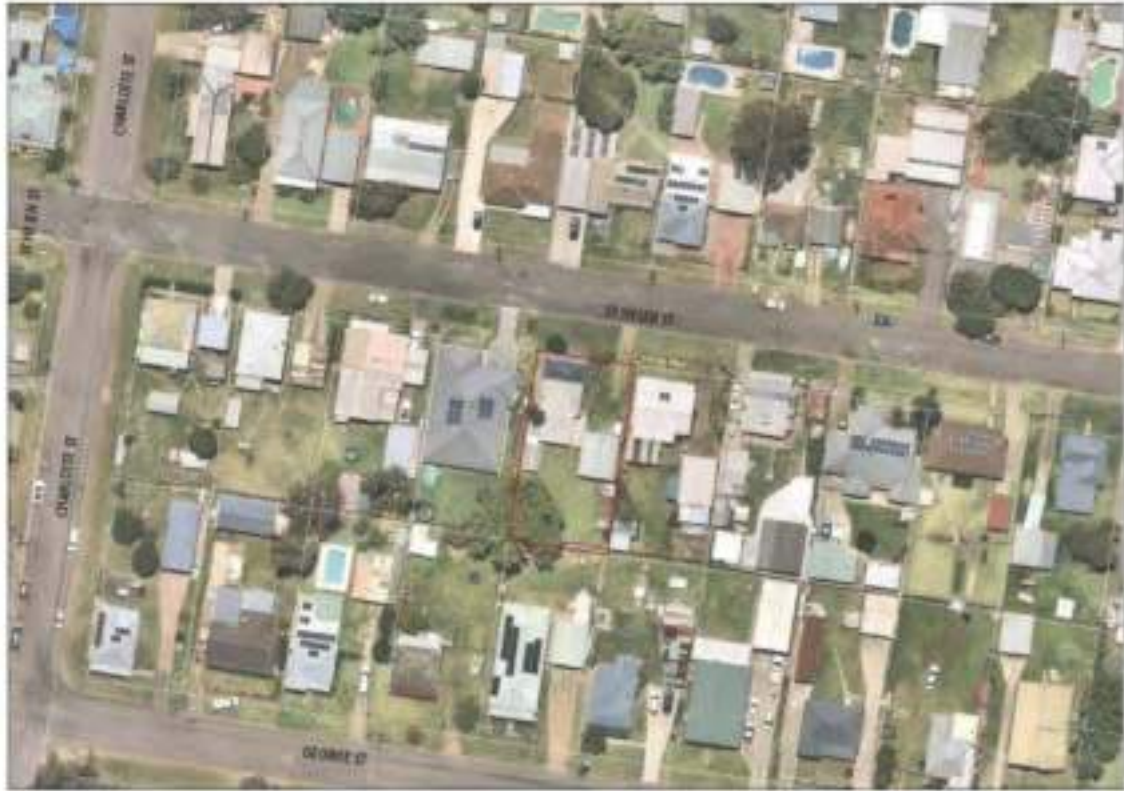
12 ST HELEN STREET, HOLMESVILLE 2286

Conservation Area Contribution Level	Est. Construction Date	Previous studies and/or community input
Contributory 2	1900–1930	No prior heritage assessments or research undertaken.
Assessment Text	Observed Modifications	
<p>The scale (single-storey) and general style of the dwelling is consistent with that of the streetscape and wider HCA. Dwelling contributes positively to the streetscape and wider HCA, particularly in comparison to Non-Contributory buildings.</p> <p>The dwelling features appropriately proportioned and positioned fenestrations, an appropriate roof form (gabled or hipped) and other features consistent with the architectural character of the area (e.g. front verandah with timber or brick posts, timber detailing, corrugated metal roofing, etc). The contributory value of the dwelling is limited however by either:</p> <ul style="list-style-type: none"> External modifications that have in some way obscured the style, scale or design intent of the building and have resulted in less physical integrity than Contributory 1 buildings. Being a later dwelling constructed in an appropriate referential style, but comprising little to no fabric of intrinsic heritage significance. 	<p>The veranda has been partially enclosed through the construction of an additional north eastern room.</p>
