APPENDIX 2

Building Assessment Sheets (Inventory Sheets)

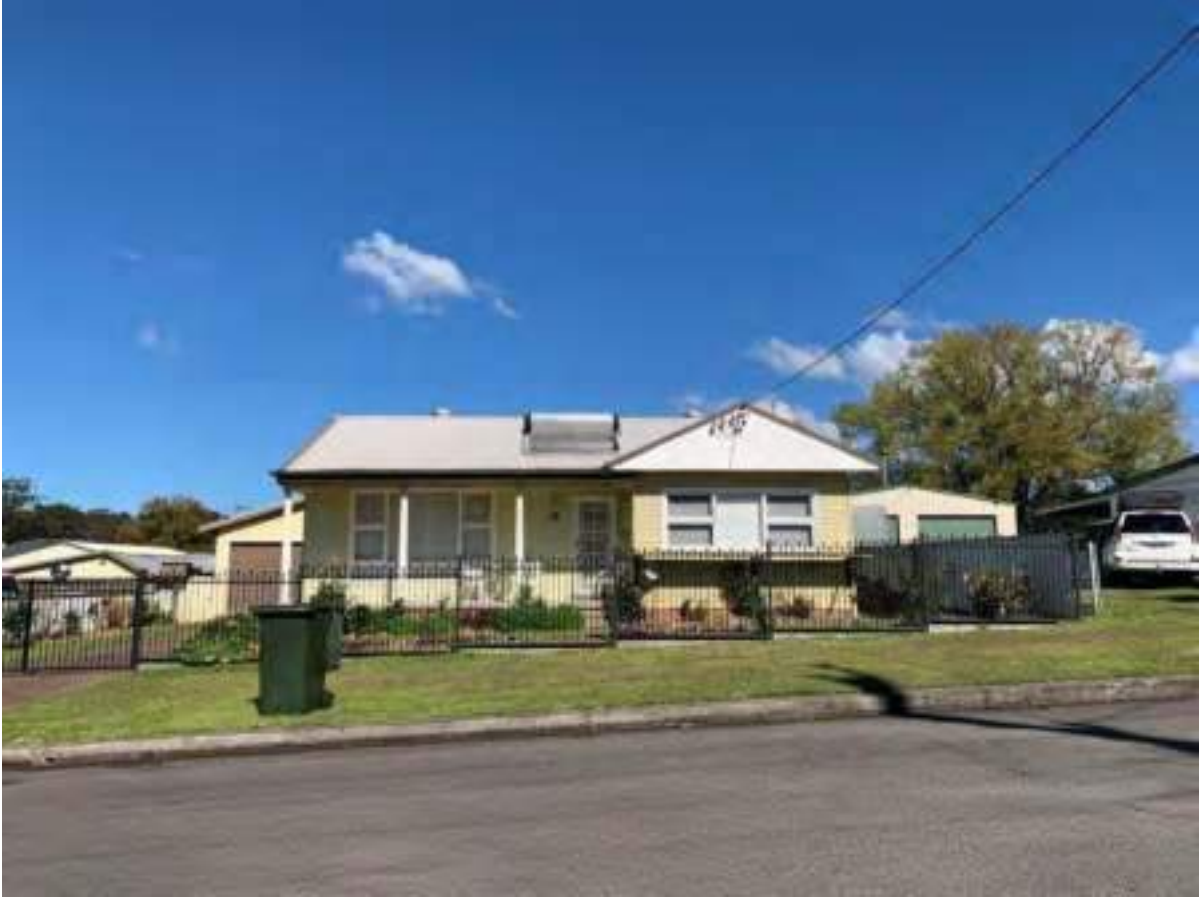
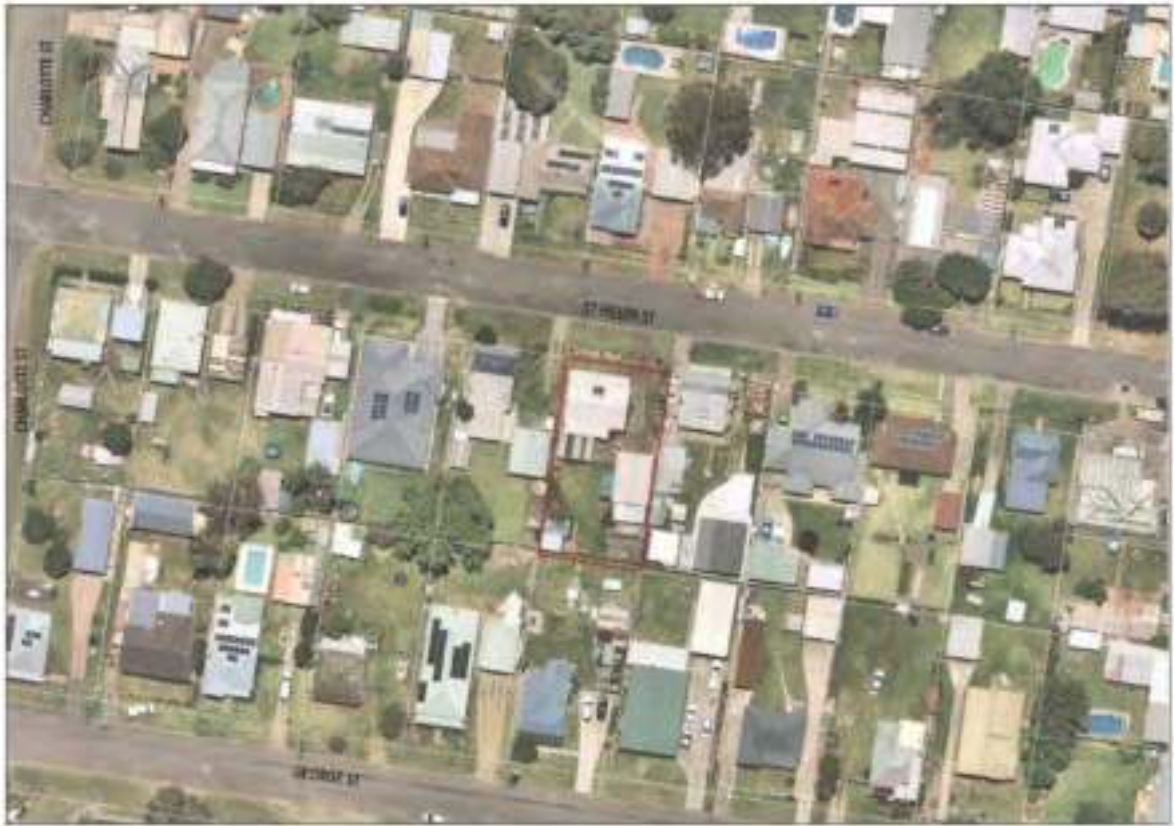
0 ST HELEN STREET, HOLMESVILLE 2286

Conservation Area Contribution Level	Est. Construction Date	Previous studies and/or community input
Contributory 2	Early to late 20th century (broad range)	No prior heritage assessments or research undertaken.
Assessment Text		Observed Modifications
<p>The scale (single-storey) and general style of the dwelling is consistent with that of the streetscape and wider HCA. Dwelling contributes positively to the streetscape and wider HCA, particularly in comparison to Non-Contributory buildings.</p> <p>The dwelling features appropriately proportioned and positioned fenestrations, an appropriate roof form (gabled or hipped) and other features consistent with the architectural character of the area (e.g. front verandah with timber or brick posts, timber detailing, corrugated metal roofing, etc).</p> <p>The contributory value of the dwelling is limited however by either:</p> <ul style="list-style-type: none"> • External modifications that have in some way obscured the style, scale or design intent of the building and have resulted in less physical integrity than Contributory 1 buildings. • Being a later dwelling constructed in an appropriate referential style, but comprising little to no fabric of intrinsic heritage significance. 		<p>A solar heating system has been installed and is highly visible on the northern portion of the roof.</p> <p>The faux European plaster pillars are a contemporary addition.</p>

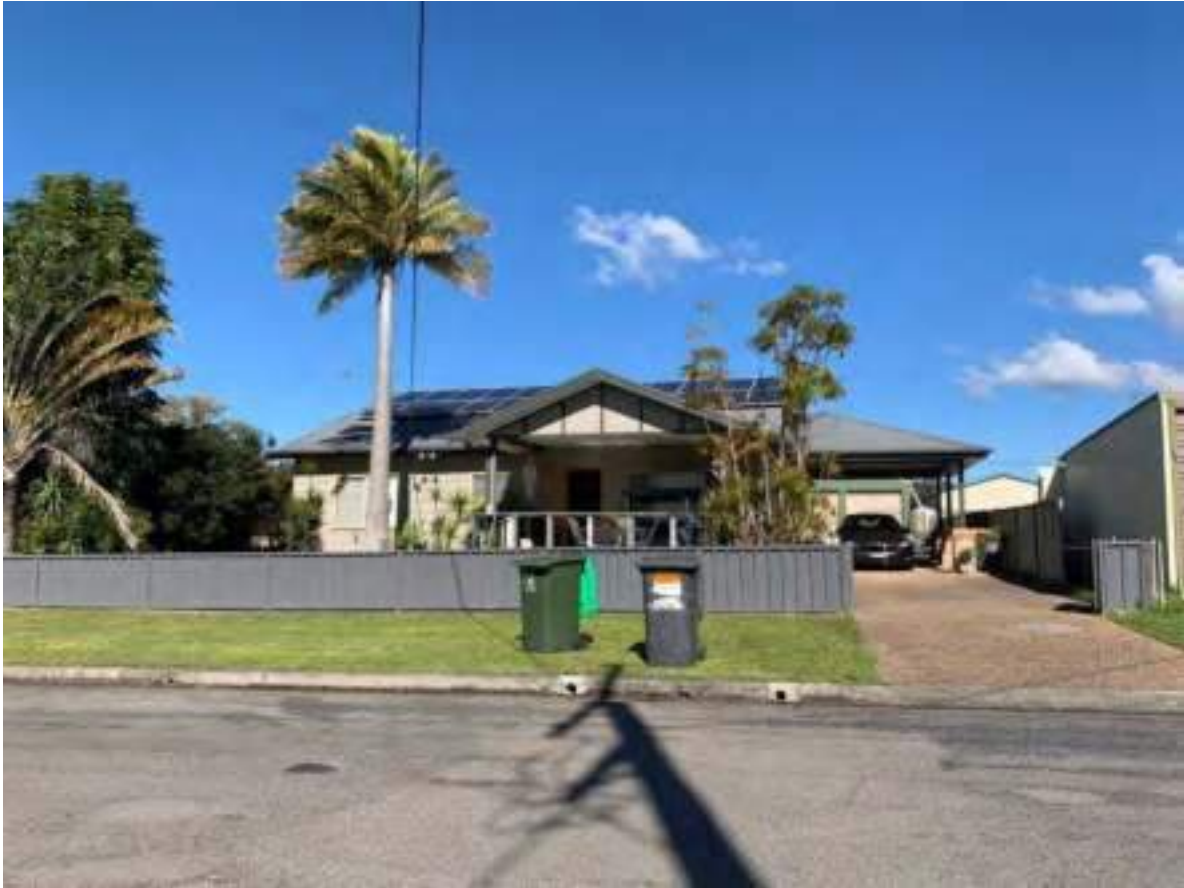
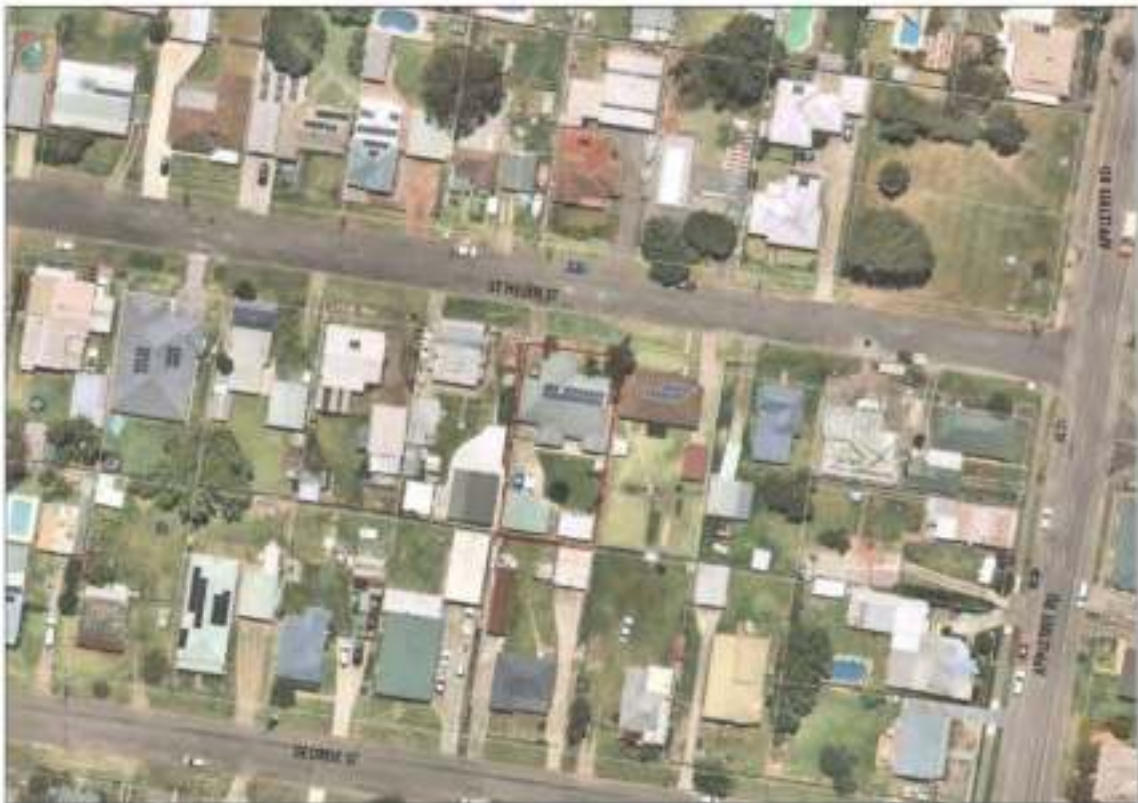
6 ST HELEN STREET, HOLMESVILLE 2286

Conservation Area Contribution Level	Est. Construction Date	Previous studies and/or community input
Contributory 2	Early to late 20 th century (broad range)	No prior heritage assessments or research undertaken.
Assessment Text		Observed Modifications
<p>The scale (single-storey) and general style of the dwelling is consistent with that of the streetscape and wider HCA. Dwelling contributes positively to the streetscape and wider HCA, particularly in comparison to Non-Contributory buildings.</p> <p>The dwelling features appropriately proportioned and positioned fenestrations, an appropriate roof form (gabled or hipped) and other features consistent with the architectural character of the area (e.g. front verandah with timber or brick posts, timber detailing, corrugated metal roofing, etc).</p> <p>The contributory value of the dwelling is limited however by either:</p> <ul style="list-style-type: none"> • External modifications that have in some way obscured the style, scale or design intent of the building and have resulted in less physical integrity than Contributory 1 buildings. • Being a later dwelling constructed in an appropriate referential style, but comprising little to no fabric of intrinsic heritage significance. 		<p>The front veranda has been extended with an additional gable roof attachment, timber balustrade and posts.</p> <p>Solar panels are highly visible along the northern portion of the roof.</p>

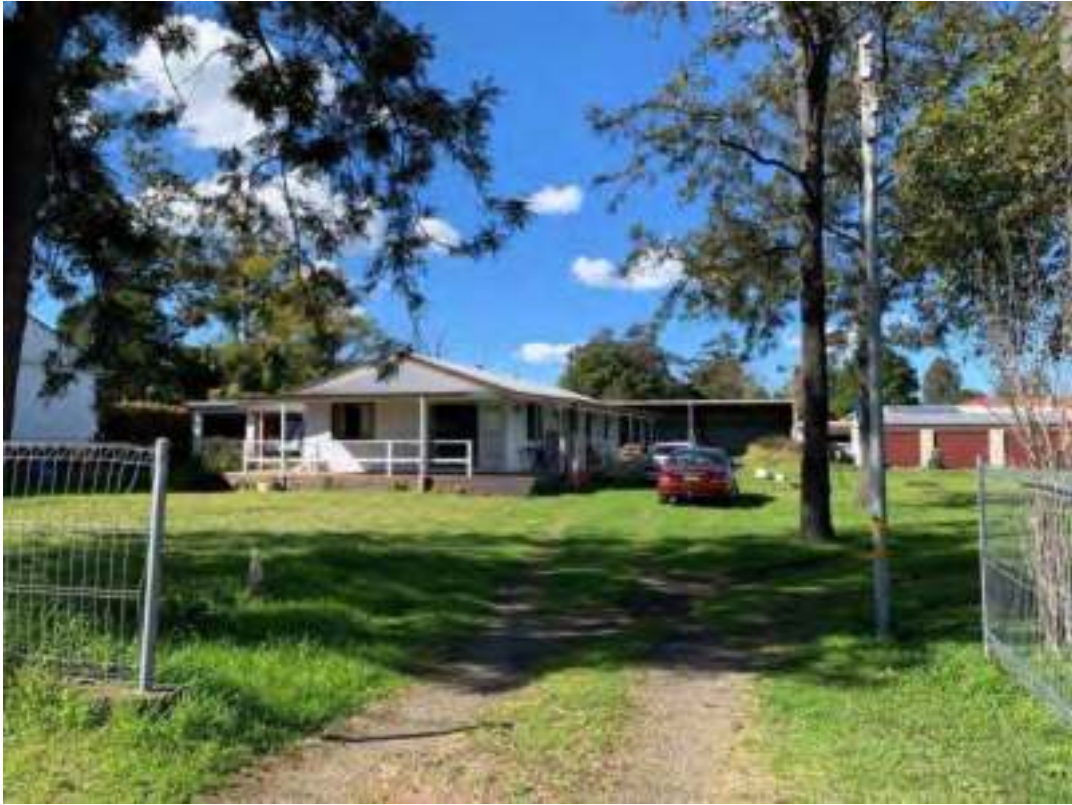
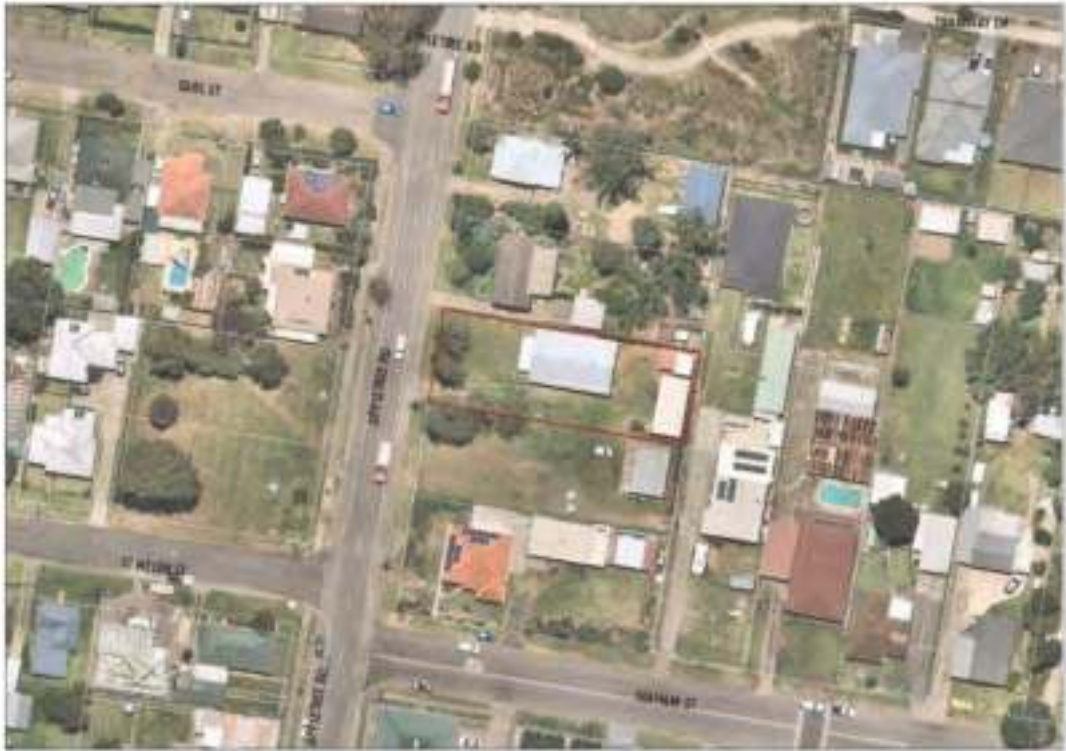
37 APPLETREE ROAD, HOLMESVILLE 2286

Conservation Area Contribution Level	Est. Construction Date	Previous studies and/or community input
Contributory 2	Early to late 20 th century (broad range)	No prior heritage assessments or research undertaken.
Assessment Text		Observed Modifications
<p>The scale (single-storey) and general style of the dwelling is consistent with that of the streetscape and wider HCA. Dwelling contributes positively to the streetscape and wider HCA, particularly in comparison to Non-Contributory buildings.</p> <p>The dwelling features appropriately proportioned and positioned fenestrations, an appropriate roof form (gabled or hipped) and other features consistent with the architectural character of the area (e.g. front verandah with timber or brick posts, timber detailing, corrugated metal roofing, etc).</p> <p>The contributory value of the dwelling is limited however by either:</p> <ul style="list-style-type: none"> • External modifications that have in some way obscured the style, scale or design intent of the building and have resulted in less physical integrity than Contributory 1 buildings. • Being a later dwelling constructed in an appropriate referential style, but comprising little to no fabric of intrinsic heritage significance. 		No modifications observed.

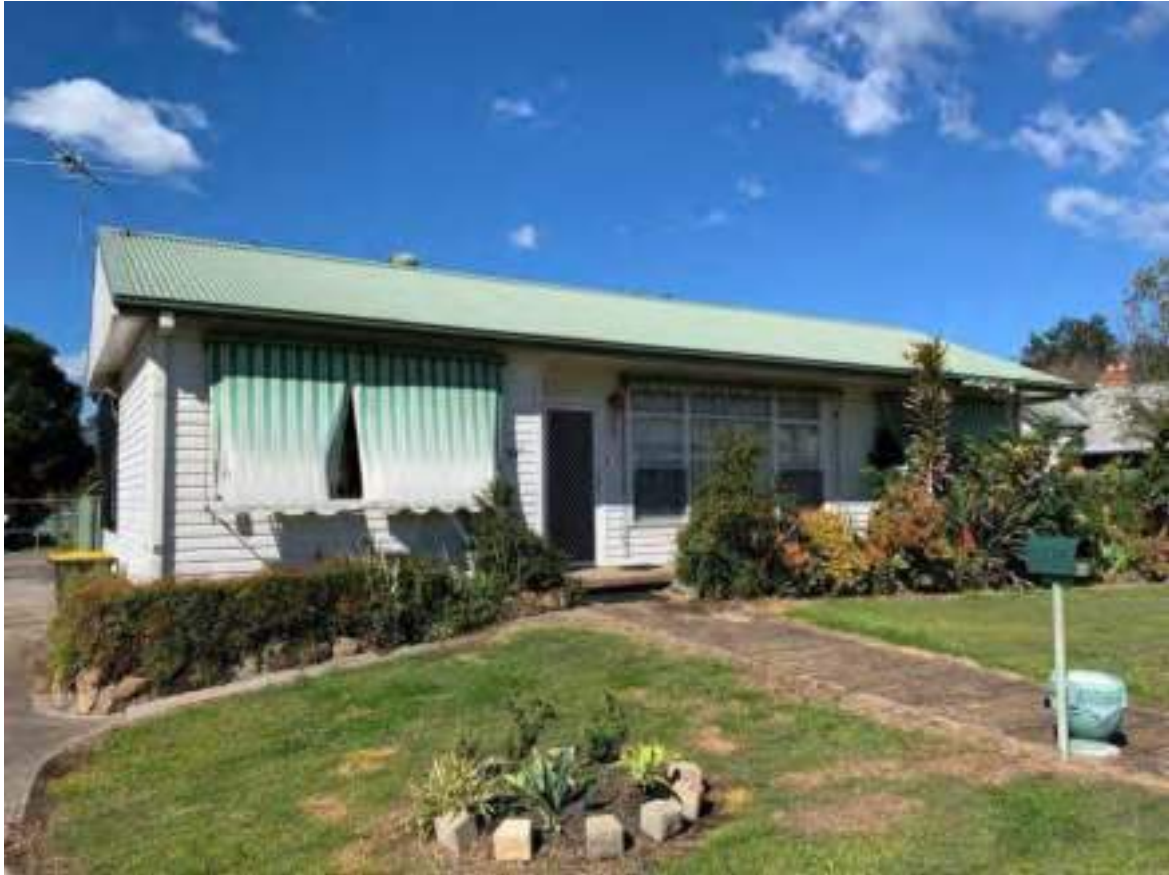
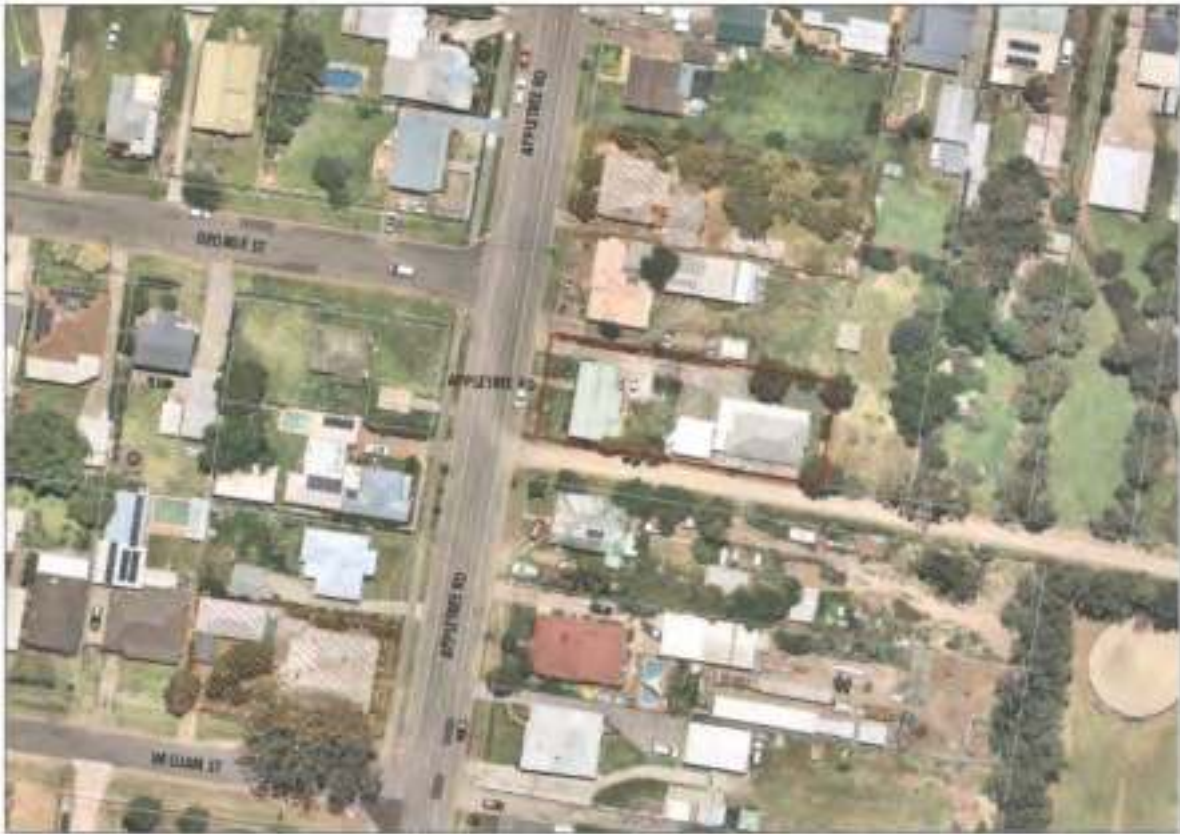
51 APPLETREE ROAD, HOLMESVILLE 2286

Conservation Area Contribution Level	Est. Construction Date	Previous studies and/or community input
Contributory 2	Early to late 20 th century (broad range)	No prior heritage assessments or research undertaken.
Assessment Text		Observed Modifications
<p>The scale (single-storey) and general style of the dwelling is consistent with that of the streetscape and wider HCA. Dwelling contributes positively to the streetscape and wider HCA, particularly in comparison to Non-Contributory buildings.</p> <p>The dwelling features appropriately proportioned and positioned fenestrations, an appropriate roof form (gabled or hipped) and other features consistent with the architectural character of the area (e.g. front verandah with timber or brick posts, timber detailing, corrugated metal roofing, etc). The contributory value of the dwelling is limited however by either:</p> <ul style="list-style-type: none"> • External modifications that have in some way obscured the style, scale or design intent of the building and have resulted in less physical integrity than Contributory 1 buildings. • Being a later dwelling constructed in an appropriate referential style, but comprising little to no fabric of intrinsic heritage significance. 		No modifications observed.

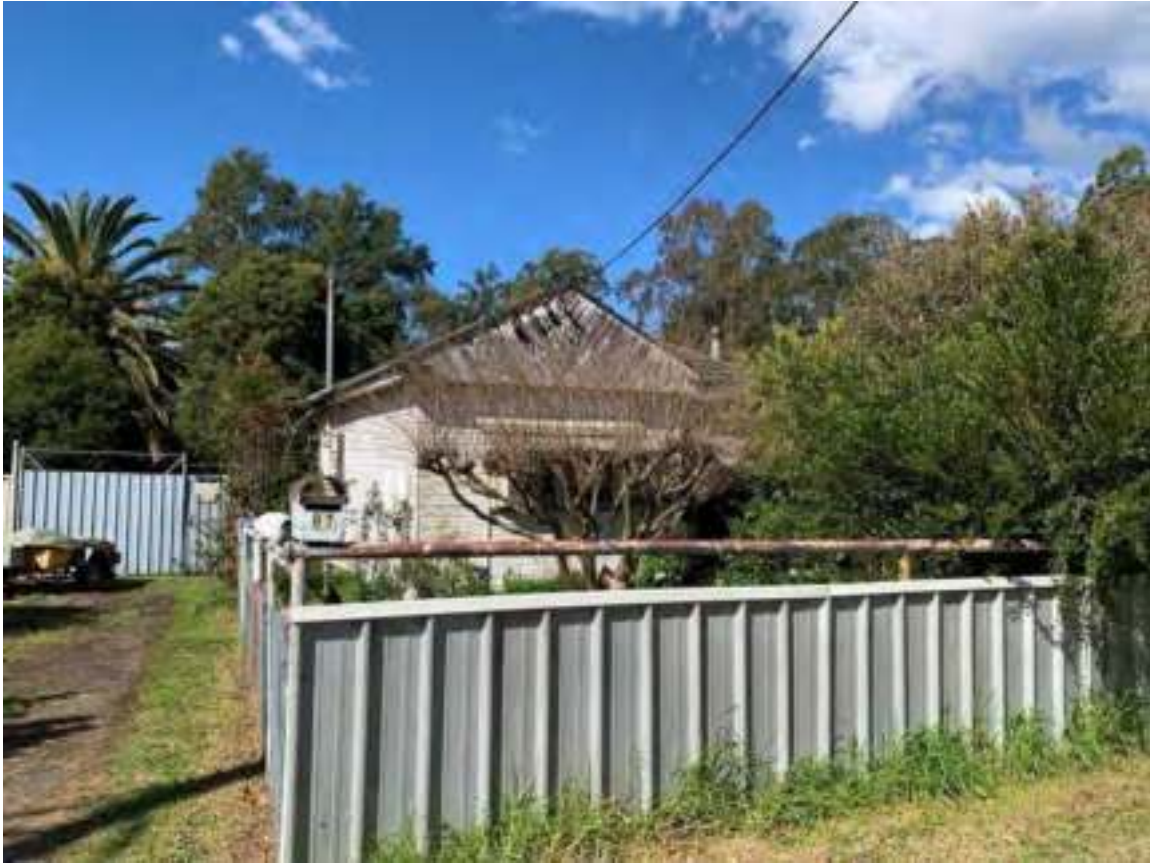
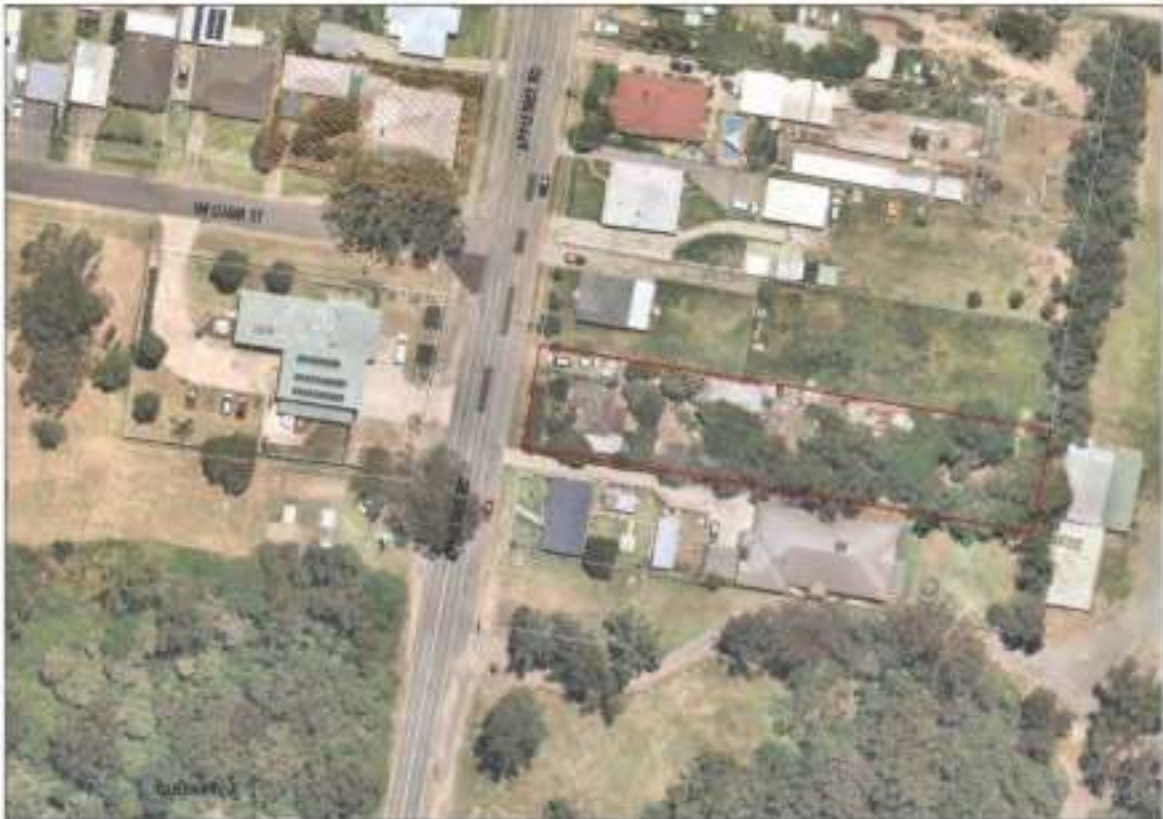
61 APPLETREE ROAD, HOLMESVILLE 2286

Conservation Area Contribution Level	Est. Construction Date	Previous studies and/or community input
Contributory 2	Early to late 20 th century (broad range)	No prior heritage assessments or research undertaken.
Assessment Text		Observed Modifications
<p>The scale (single-storey) and general style of the dwelling is consistent with that of the streetscape and wider HCA. Dwelling contributes positively to the streetscape and wider HCA, particularly in comparison to Non-Contributory buildings.</p> <p>The dwelling features appropriately proportioned and positioned fenestrations, an appropriate roof form (gabled or hipped) and other features consistent with the architectural character of the area (e.g. front verandah with timber or brick posts, timber detailing, corrugated metal roofing, etc). The contributory value of the dwelling is limited however by either:</p> <ul style="list-style-type: none"> • External modifications that have in some way obscured the style, scale or design intent of the building and have resulted in less physical integrity than Contributory 1 buildings. • Being a later dwelling constructed in an appropriate referential style, but comprising little to no fabric of intrinsic heritage significance. 		<p>No modifications observed, property is partially obscured by vegetation growth.</p>

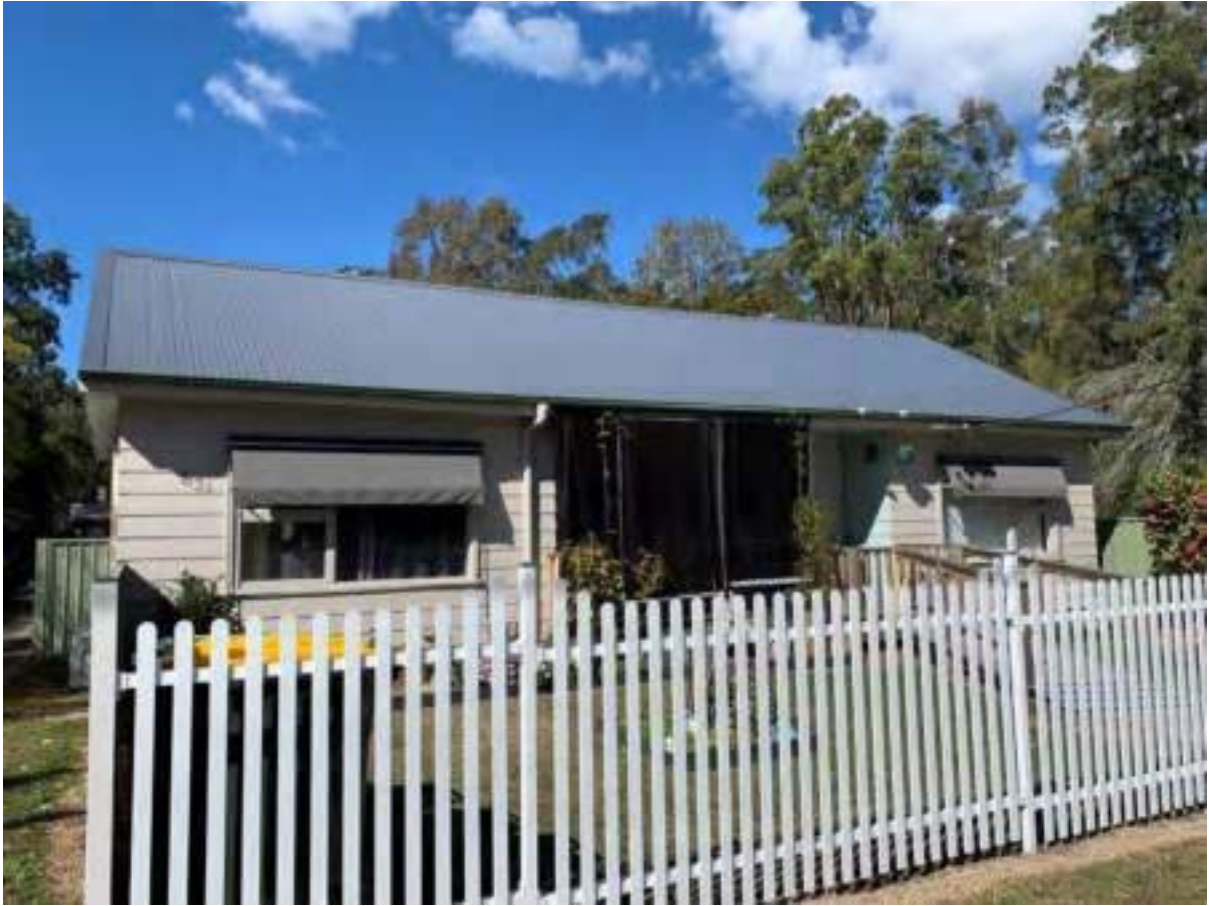
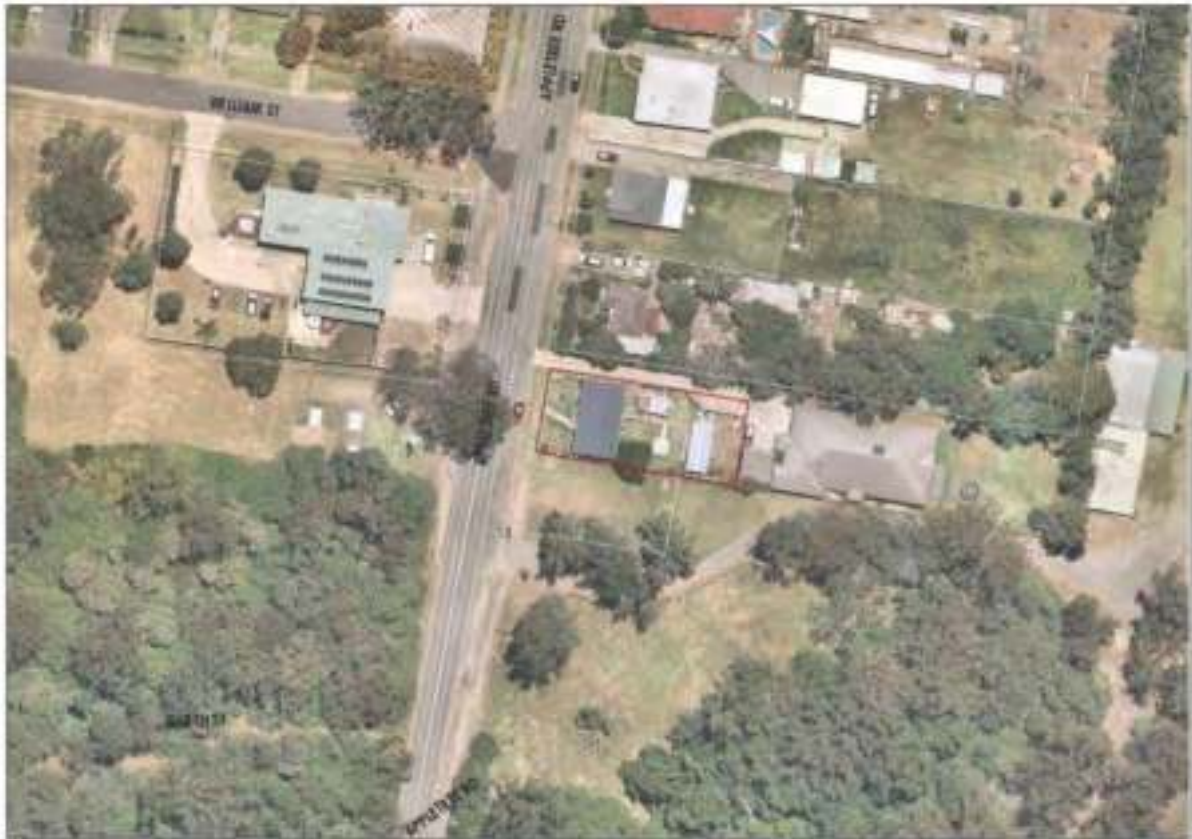
63A APPLETREE ROAD, HOLMESVILLE 2286

Conservation Area Contribution Level	Est. Construction Date	Previous studies and/or community input
Contributory 2	Early to late 20 th century (broad range)	No prior heritage assessments or research undertaken.
Assessment Text		Observed Modifications
<p>The scale (single-storey) and general style of the dwelling is consistent with that of the streetscape and wider HCA. Dwelling contributes positively to the streetscape and wider HCA, particularly in comparison to Non-Contributory buildings.</p> <p>The dwelling features appropriately proportioned and positioned fenestrations, an appropriate roof form (gabled or hipped) and other features consistent with the architectural character of the area (e.g. front verandah with timber or brick posts, timber detailing, corrugated metal roofing, etc). The contributory value of the dwelling is limited however by either:</p> <ul style="list-style-type: none"> • External modifications that have in some way obscured the style, scale or design intent of the building and have resulted in less physical integrity than Contributory 1 buildings. • Being a later dwelling constructed in an appropriate referential style, but comprising little to no fabric of intrinsic heritage significance. 		<p>A timber ramp with balustrade has been constructed at the western front of the dwelling, providing additional access. This has been constructed in a sympathetic style.</p>

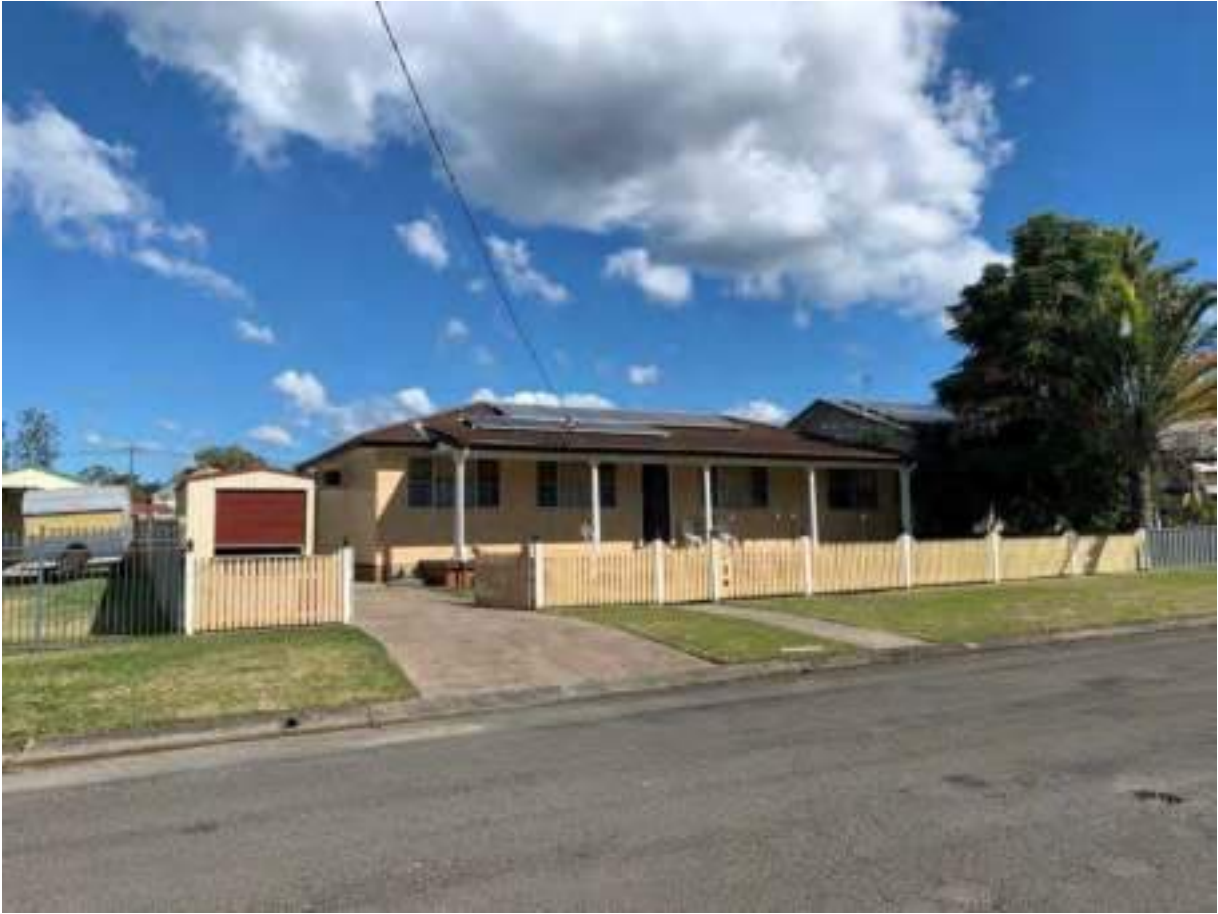
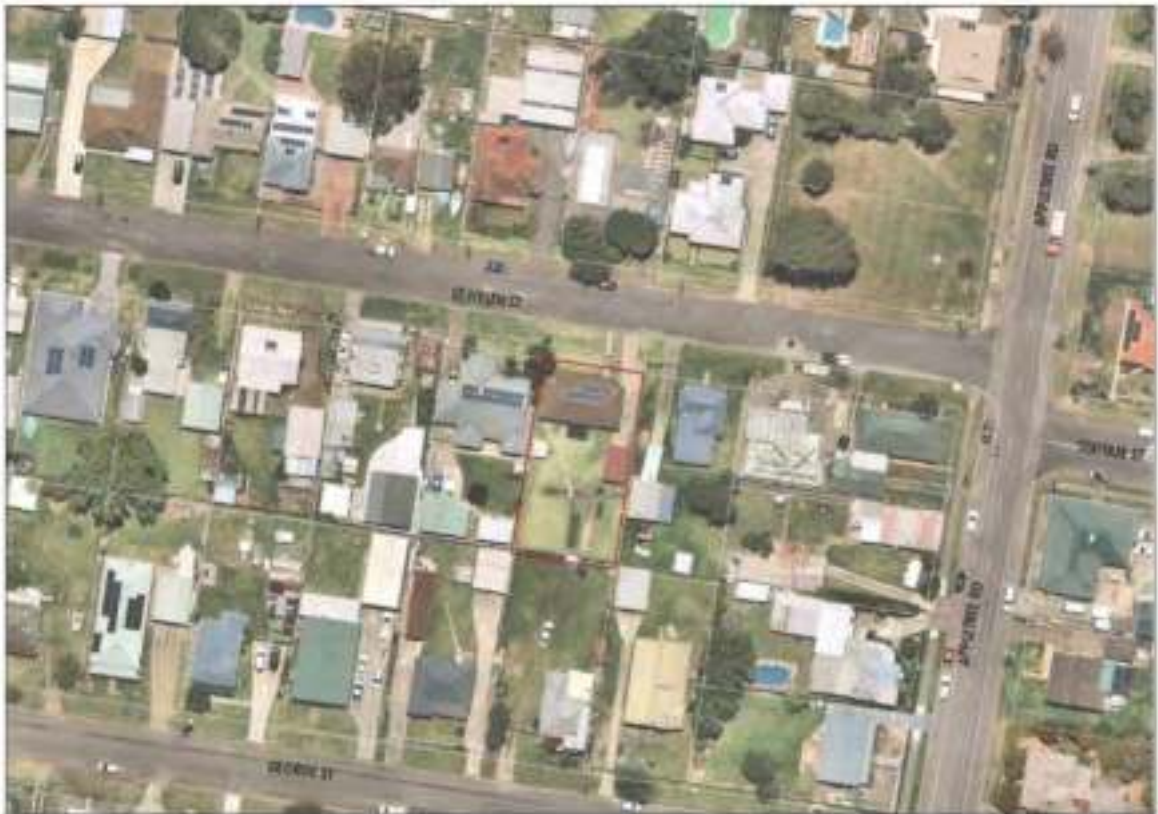
4 ST HELEN STREET, HOLMESVILLE 2286

Conservation Area Contribution Level	Est. Construction Date	Previous studies and/or community input
Contributory 2	Early to late 20 th century (broad range)	No prior heritage assessments or research undertaken.
Assessment Text		Observed Modifications
<p>The scale (single-storey) and general style of the dwelling is consistent with that of the streetscape and wider HCA. Dwelling contributes positively to the streetscape and wider HCA, particularly in comparison to Non-Contributory buildings.</p> <p>The dwelling features appropriately proportioned and positioned fenestrations, an appropriate roof form (gabled or hipped) and other features consistent with the architectural character of the area (e.g. front verandah with timber or brick posts, timber detailing, corrugated metal roofing, etc). The contributory value of the dwelling is limited however by either:</p> <ul style="list-style-type: none"> • External modifications that have in some way obscured the style, scale or design intent of the building and have resulted in less physical integrity than Contributory 1 buildings. • Being a later dwelling constructed in an appropriate referential style, but comprising little to no fabric of intrinsic heritage significance. 		Solar panels are visible on the northern side of the roof.

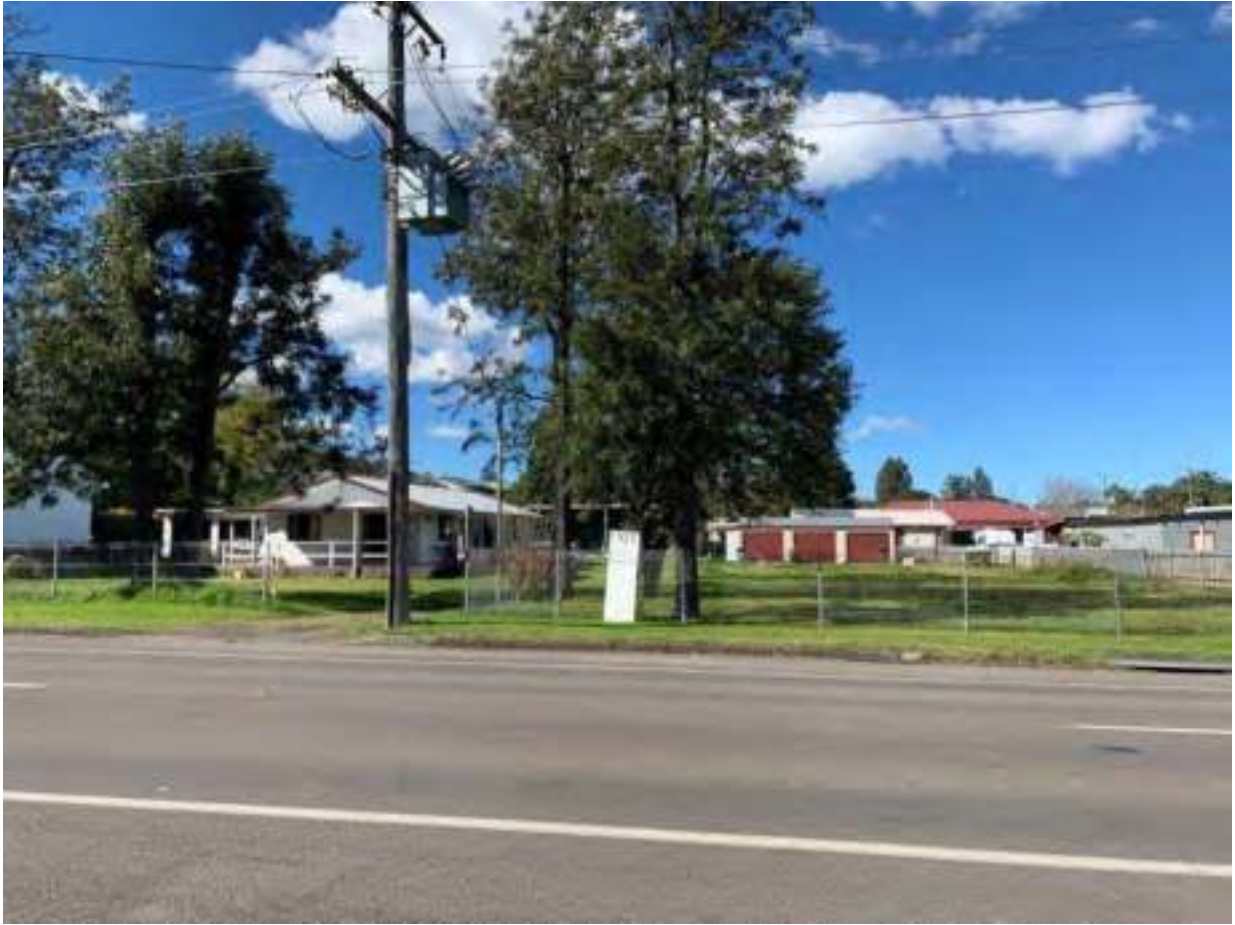
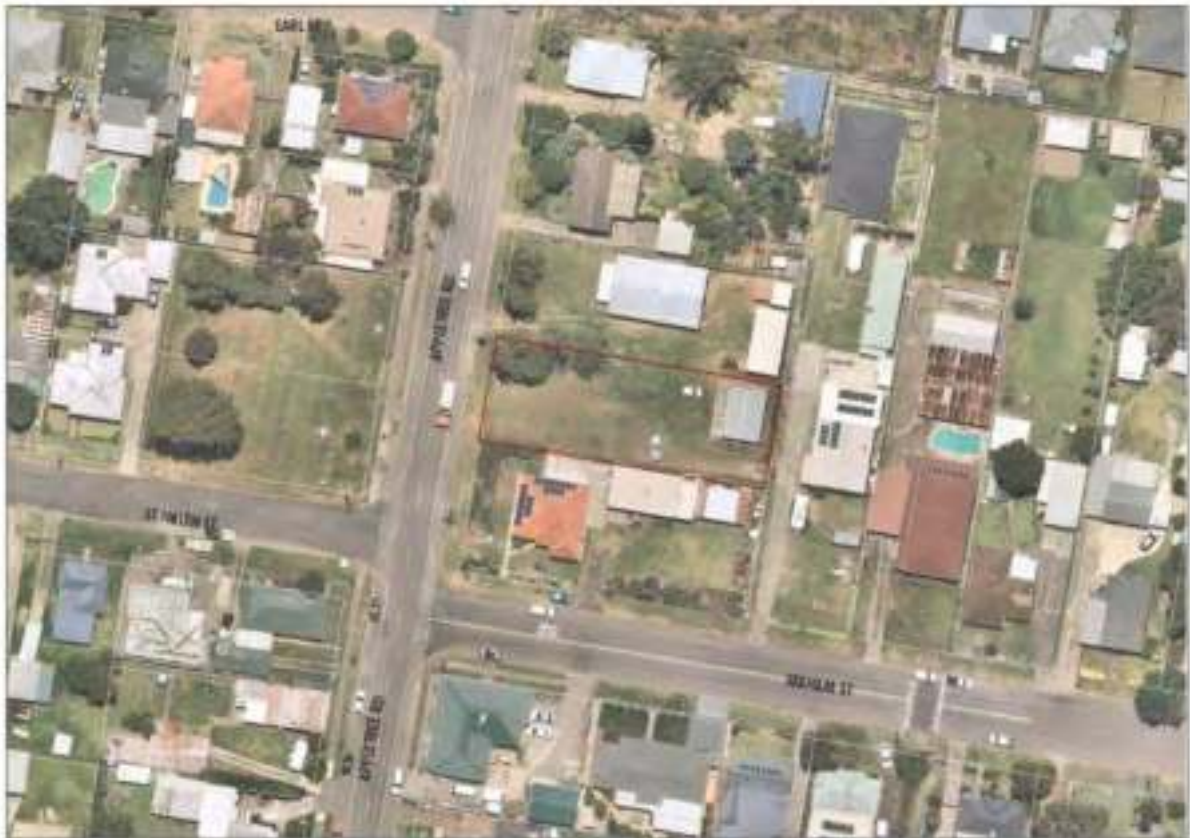
39 APPLETREE ROAD, HOLMESVILLE 2286

Conservation Area Contribution Level	Est. Construction Date	Previous studies and/or community input
Contributory 2	Early to late 20 th century (broad range)	No prior heritage assessments or research undertaken.
Assessment Text		Observed Modifications
<p>The scale (single-storey) and general style of the dwelling is consistent with that of the streetscape and wider HCA. Dwelling contributes positively to the streetscape and wider HCA, particularly in comparison to Non-Contributory buildings.</p> <p>The dwelling features appropriately proportioned and positioned fenestrations, an appropriate roof form (gabled or hipped) and other features consistent with the architectural character of the area (e.g. front verandah with timber or brick posts, timber detailing, corrugated metal roofing, etc). The contributory value of the dwelling is limited however by either:</p> <ul style="list-style-type: none"> • External modifications that have in some way obscured the style, scale or design intent of the building and have resulted in less physical integrity than Contributory 1 buildings. • Being a later dwelling constructed in an appropriate referential style, but comprising little to no fabric of intrinsic heritage significance. 		Associated with 37 Appletree Road, no modifications observed.

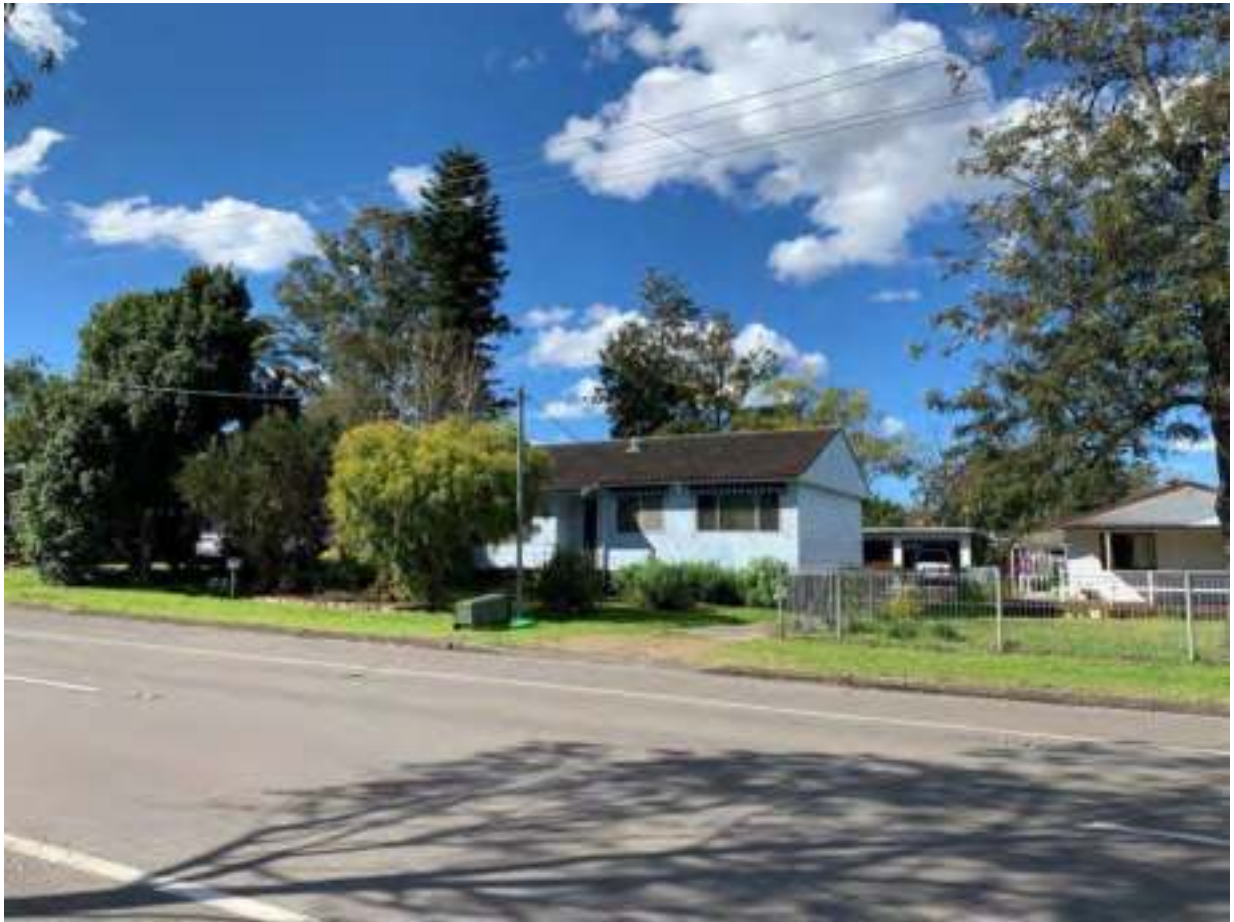
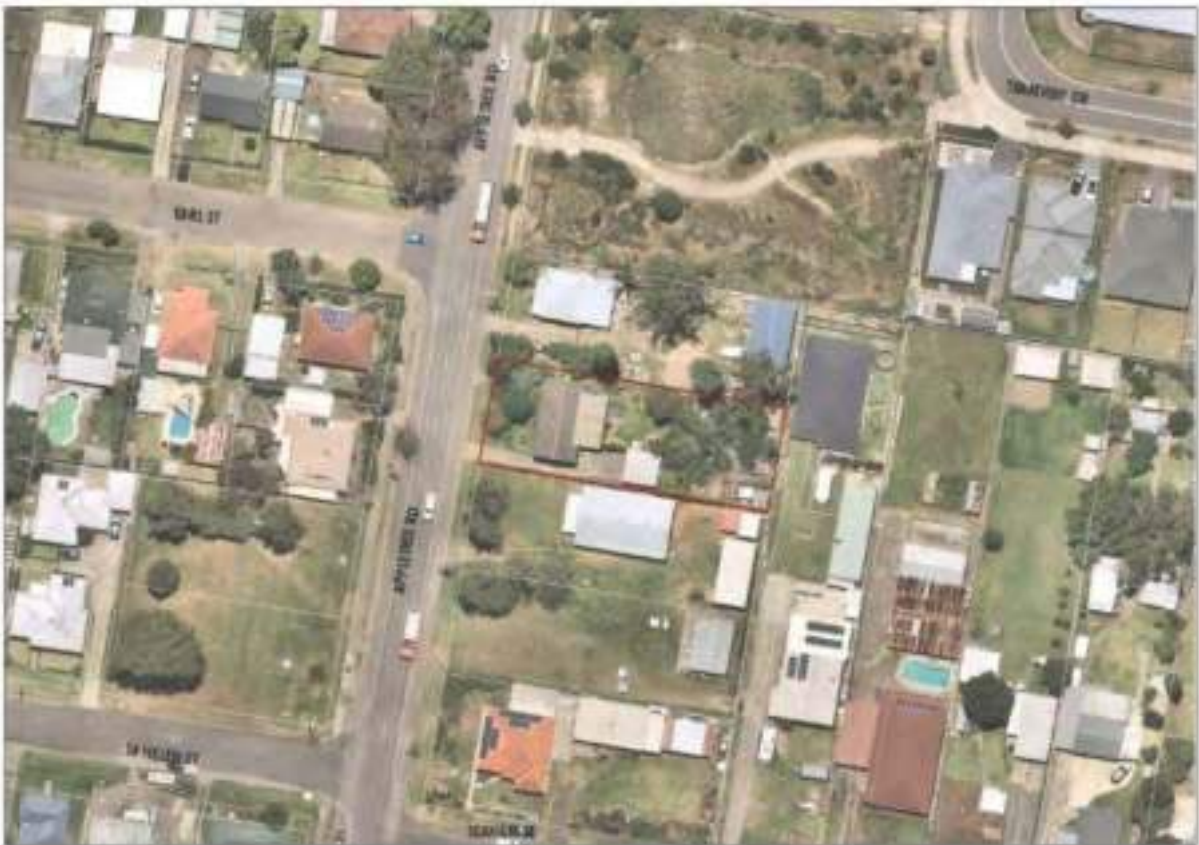
35 APPLETREE ROAD, HOLMESVILLE 2286

Conservation Area Contribution Level	Est. Construction Date	Previous studies and/or community input
Contributory 2	Early to late 20 th century (broad range)	No prior heritage assessments or research undertaken.
Assessment Text		Observed Modifications
<p>The scale (single-storey) and general style of the dwelling is consistent with that of the streetscape and wider HCA. Dwelling contributes positively to the streetscape and wider HCA, particularly in comparison to Non-Contributory buildings.</p> <p>The dwelling features appropriately proportioned and positioned fenestrations, an appropriate roof form (gabled or hipped) and other features consistent with the architectural character of the area (e.g. front verandah with timber or brick posts, timber detailing, corrugated metal roofing, etc).</p> <p>The contributory value of the dwelling is limited however by either:</p> <ul style="list-style-type: none"> • External modifications that have in some way obscured the style, scale or design intent of the building and have resulted in less physical integrity than Contributory 1 buildings. • Being a later dwelling constructed in an appropriate referential style, but comprising little to no fabric of intrinsic heritage significance. 		No modifications observed.
