APPENDIX 2

Building Assessment Sheets (Inventory Sheets)

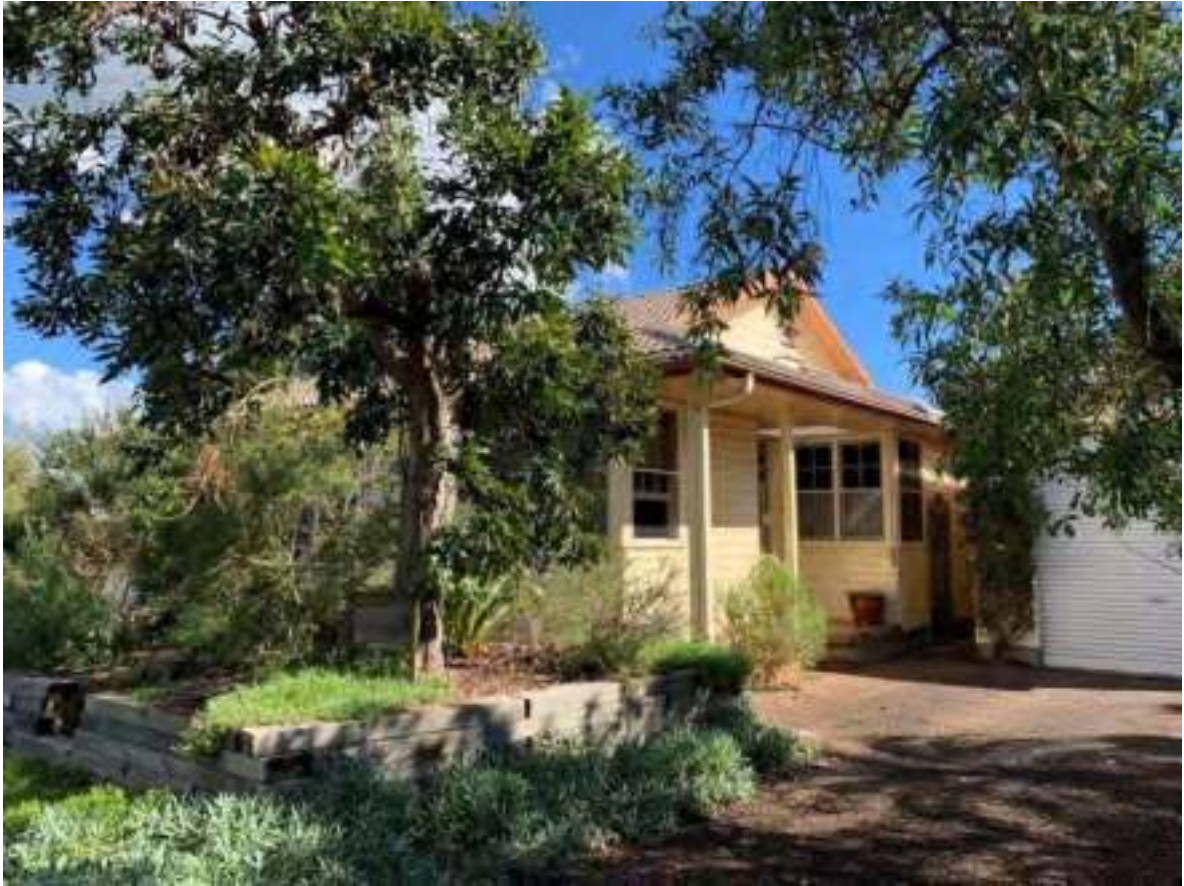
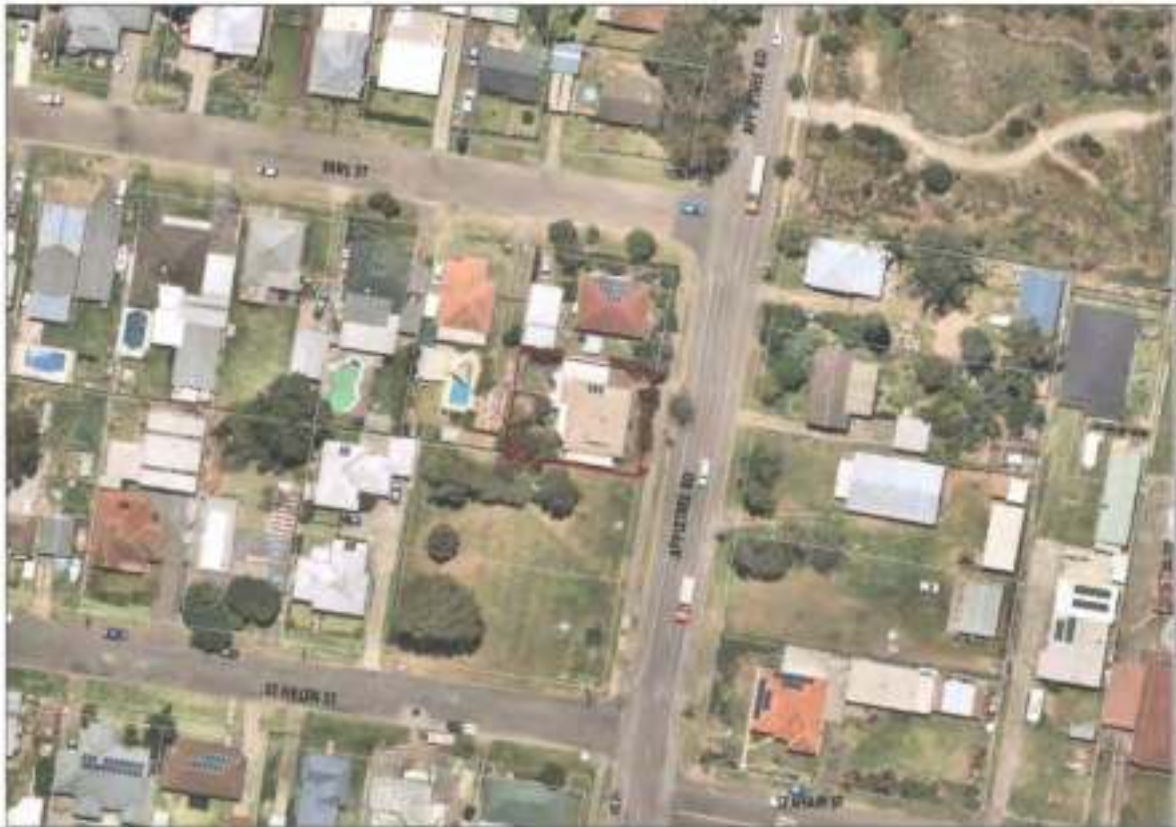
34 APPLETREE ROAD, HOLMESVILLE 2286

Conservation Area Contribution Level	Est. Construction Date	Previous studies and/or community input
Contributory 2	Early to late 20 th century (broad range)	No prior heritage assessments or research undertaken.
Assessment Text		Observed Modifications
<p>The scale (single-storey) and general style of the dwelling is consistent with that of the streetscape and wider HCA. Dwelling contributes positively to the streetscape and wider HCA, particularly in comparison to Non-Contributory buildings.</p> <p>The dwelling features appropriately proportioned and positioned fenestrations, an appropriate roof form (gabled or hipped) and other features consistent with the architectural character of the area (e.g. front verandah with timber or brick posts, timber detailing, corrugated metal roofing, etc).</p> <p>The contributory value of the dwelling is limited however by either:</p> <ul style="list-style-type: none"> • External modifications that have in some way obscured the style, scale or design intent of the building and have resulted in less physical integrity than Contributory 1 buildings. • Being a later dwelling constructed in an appropriate referential style, but comprising little to no fabric of intrinsic heritage significance. 		No modifications observed.

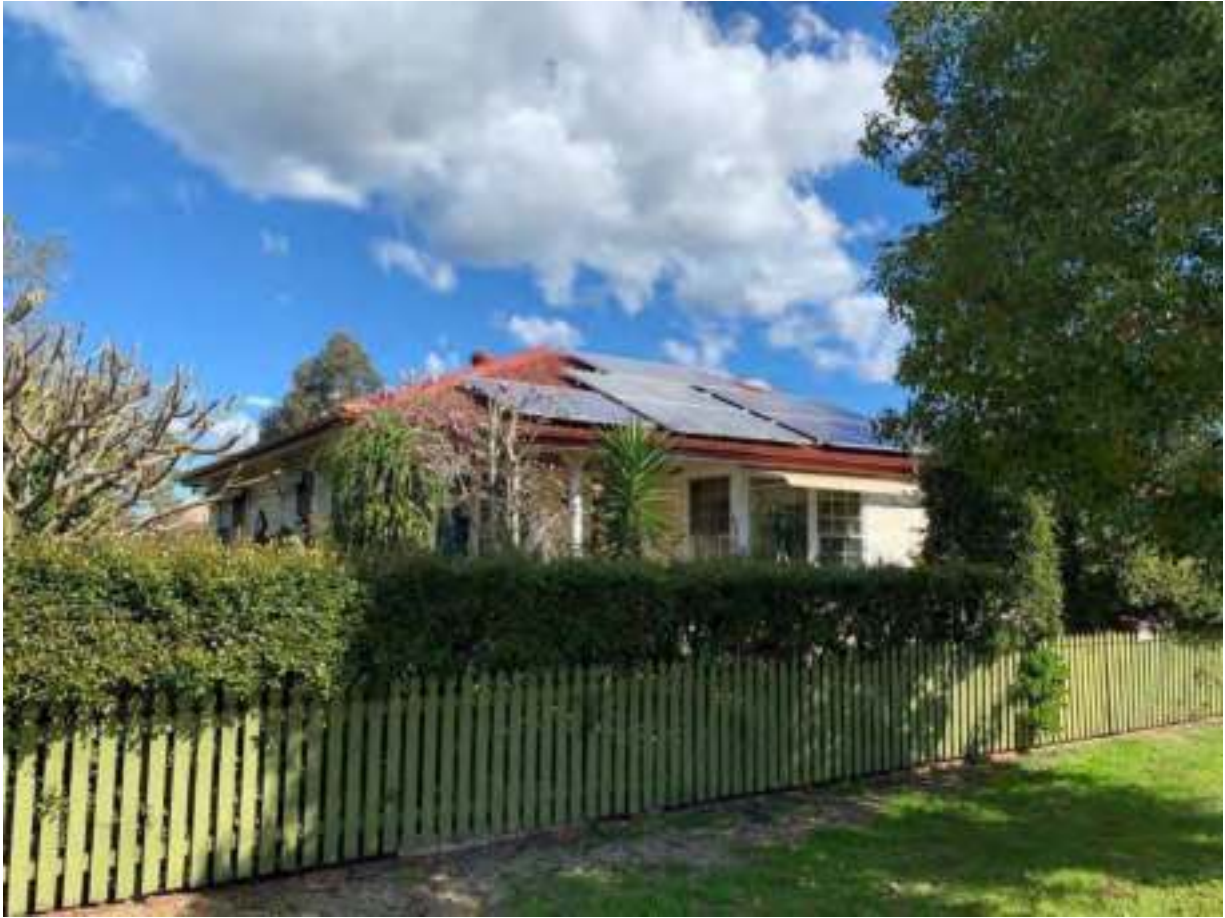
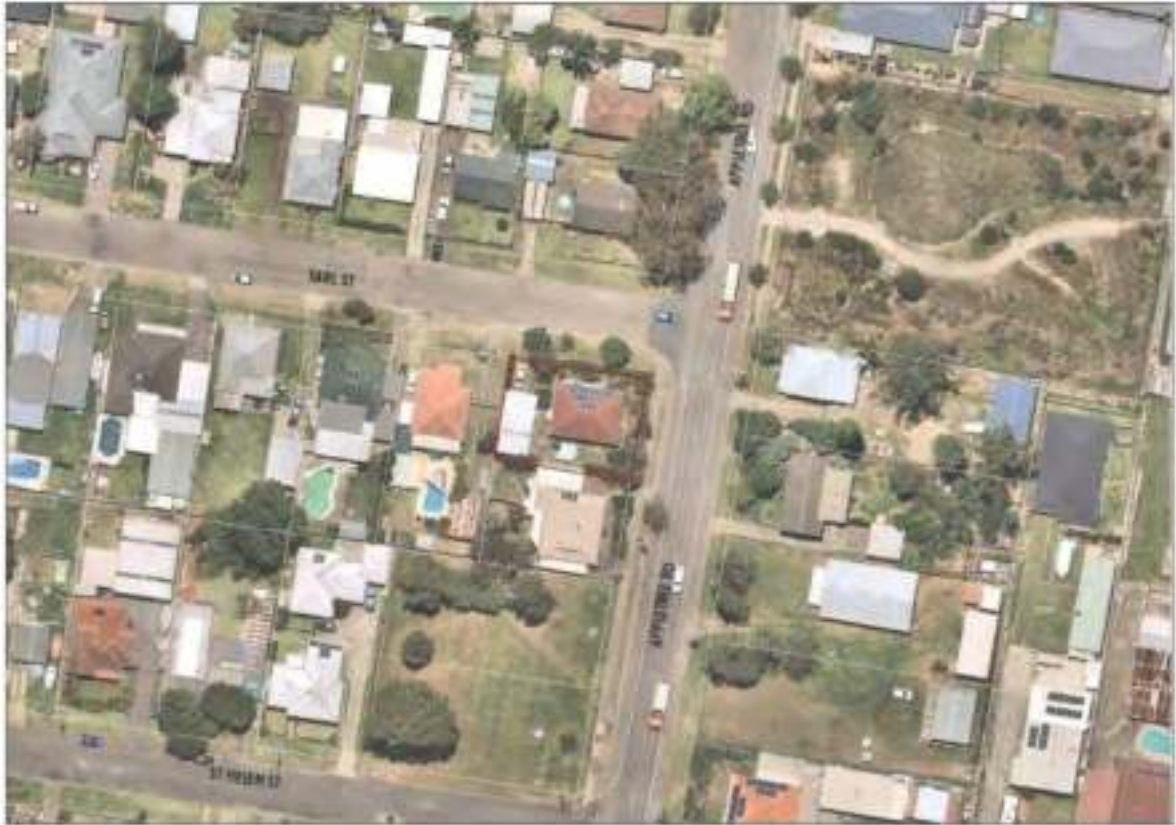
32 APPLETREE ROAD, HOLMESVILLE 2286

Conservation Area Contribution Level	Est. Construction Date	Previous studies and/or community input
Contributory 2	Early to late 20 th century (broad range)	No prior heritage assessments or research undertaken.
Assessment Text		Observed Modifications
<p>The scale (single-storey) and general style of the dwelling is consistent with that of the streetscape and wider HCA. Dwelling contributes positively to the streetscape and wider HCA, particularly in comparison to Non-Contributory buildings.</p> <p>The dwelling features appropriately proportioned and positioned fenestrations, an appropriate roof form (gabled or hipped) and other features consistent with the architectural character of the area (e.g. front verandah with timber or brick posts, timber detailing, corrugated metal roofing, etc). The contributory value of the dwelling is limited however by either:</p> <ul style="list-style-type: none"> • External modifications that have in some way obscured the style, scale or design intent of the building and have resulted in less physical integrity than Contributory 1 buildings. • Being a later dwelling constructed in an appropriate referential style, but comprising little to no fabric of intrinsic heritage significance. 		Solar panels are highly visible along the northern side of the roof.

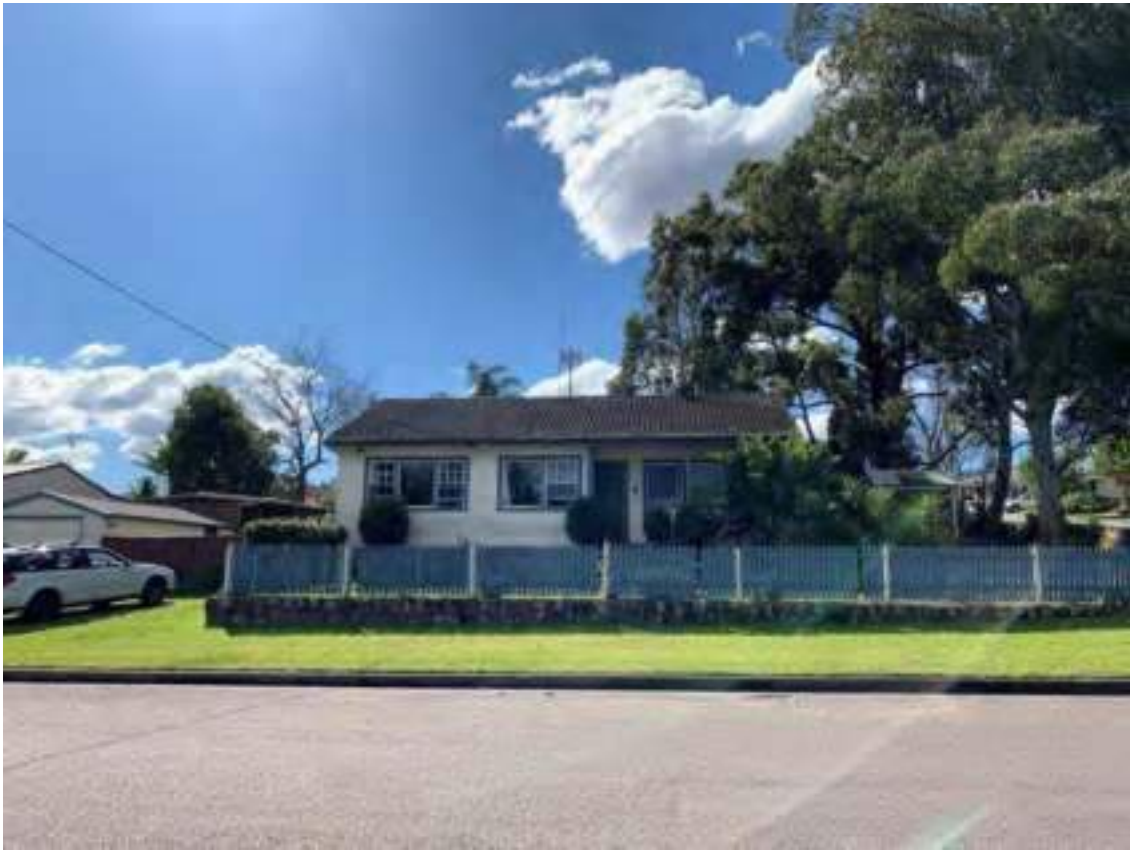
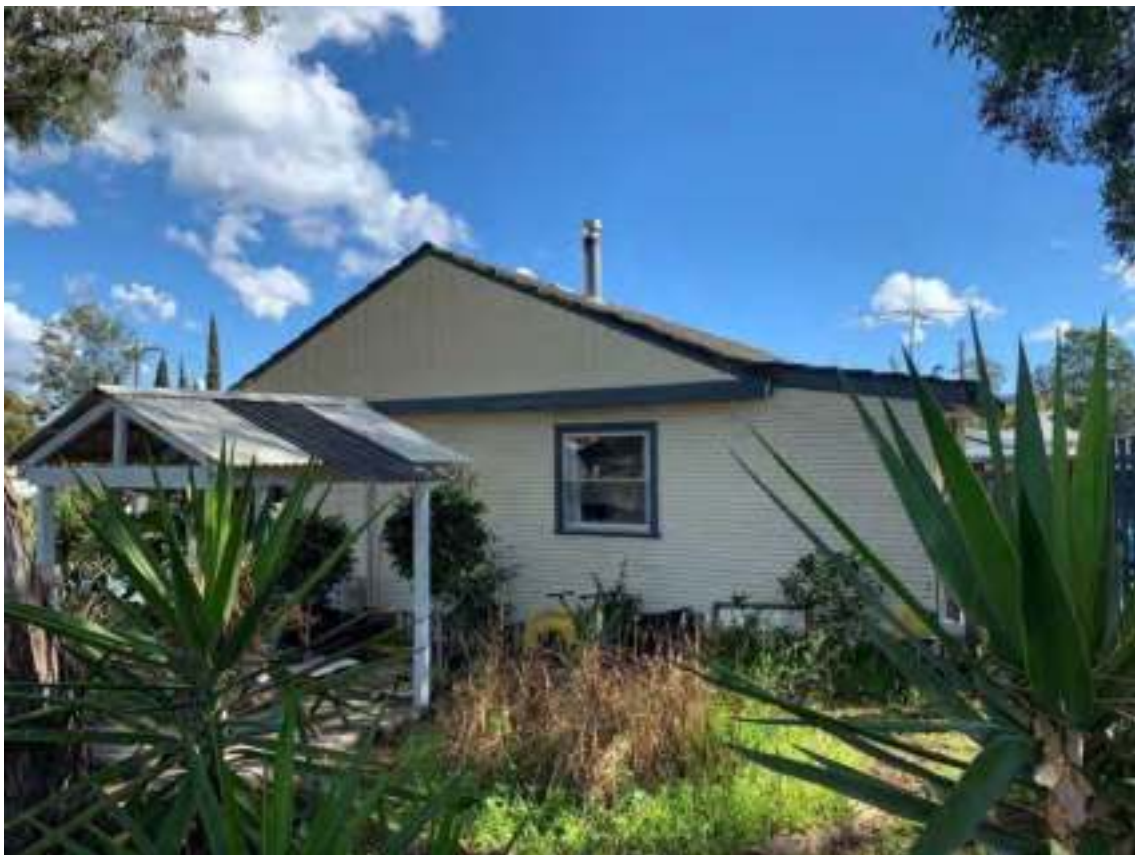
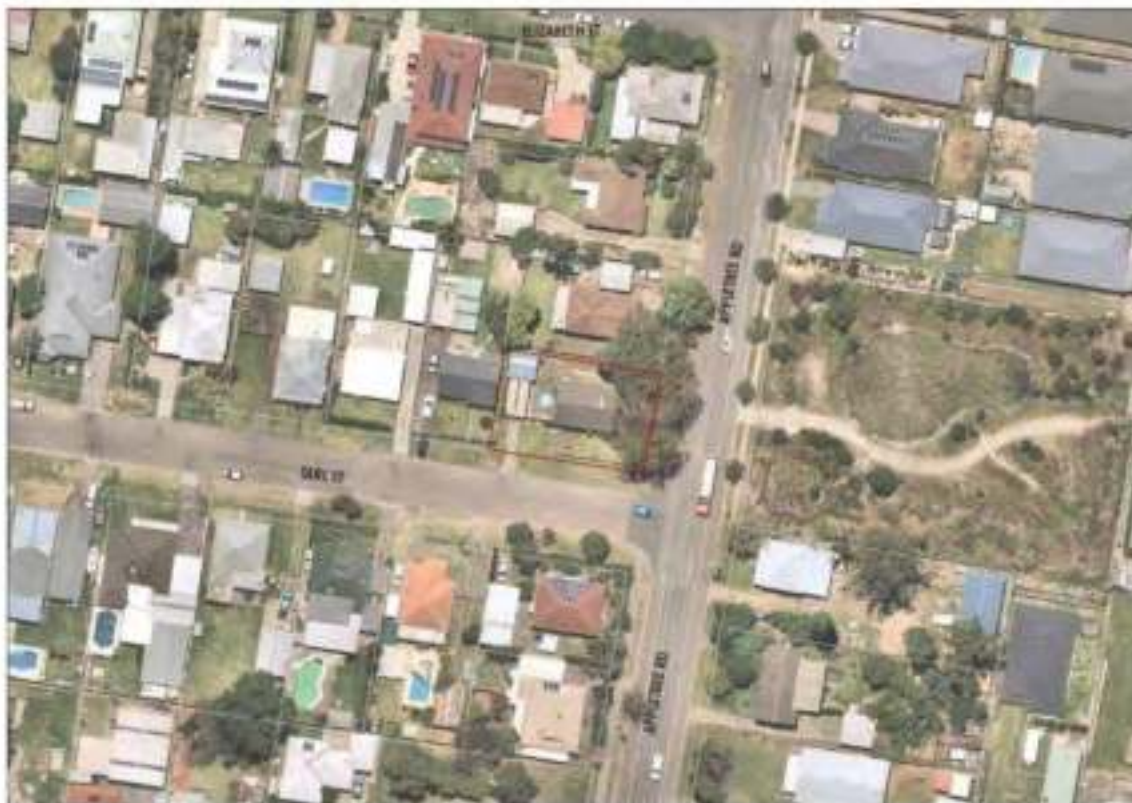
1A EARL STREET, HOLMESVILLE 2286

Conservation Area Contribution Level	Est. Construction Date	Previous studies and/or community input
Contributory 2	Early to late 20 th century (broad range)	No prior heritage assessments or research undertaken.
Assessment Text		Observed Modifications
<p>The scale (single-storey) and general style of the dwelling is consistent with that of the streetscape and wider HCA. Dwelling contributes positively to the streetscape and wider HCA, particularly in comparison to Non-Contributory buildings.</p> <p>The dwelling features appropriately proportioned and positioned fenestrations, an appropriate roof form (gabled or hipped) and other features consistent with the architectural character of the area (e.g. front verandah with timber or brick posts, timber detailing, corrugated metal roofing, etc).</p> <p>The contributory value of the dwelling is limited however by either:</p> <ul style="list-style-type: none"> External modifications that have in some way obscured the style, scale or design intent of the building and have resulted in less physical integrity than Contributory 1 buildings. Being a later dwelling constructed in an appropriate referential style, but comprising little to no fabric of intrinsic heritage significance. 		<p>The timber balustrade is likely a contemporary addition, however has been constructed in a sympathetic style and does not detract from the heritage streetscape.</p>

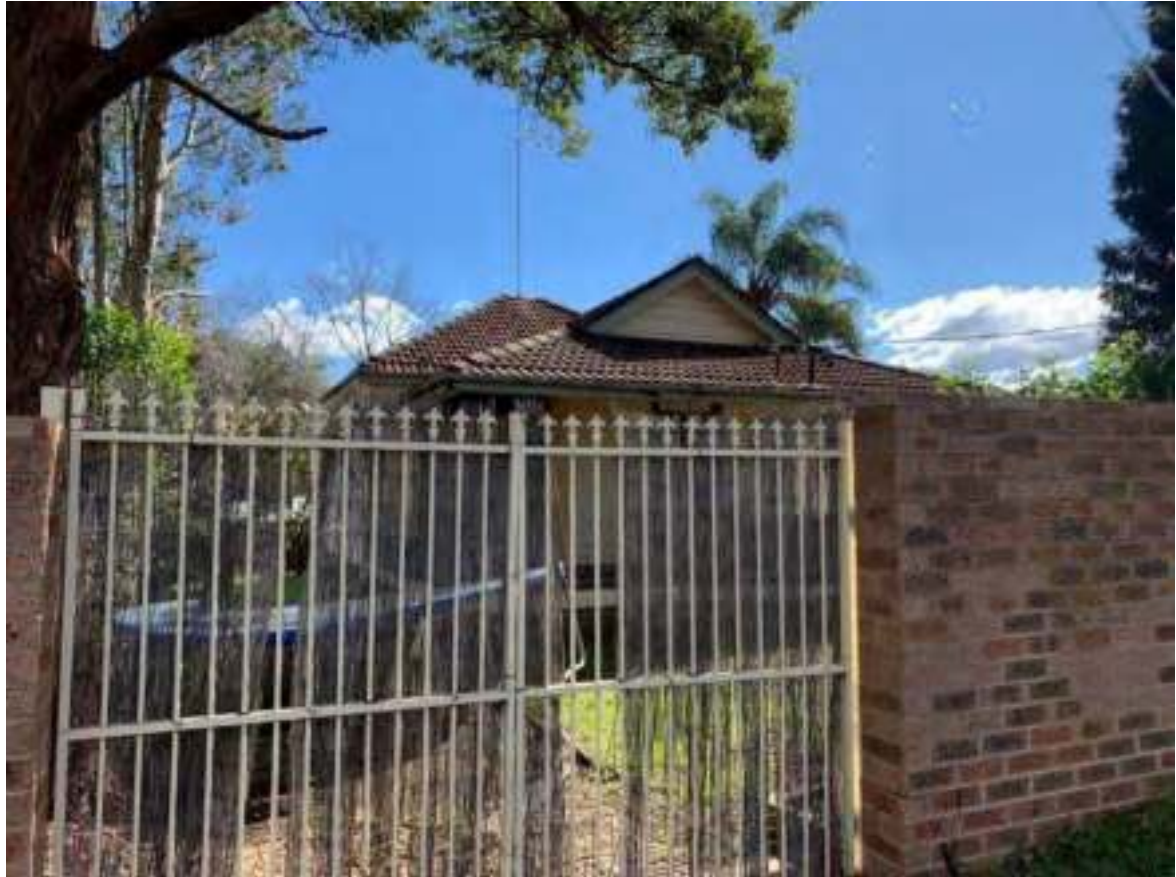
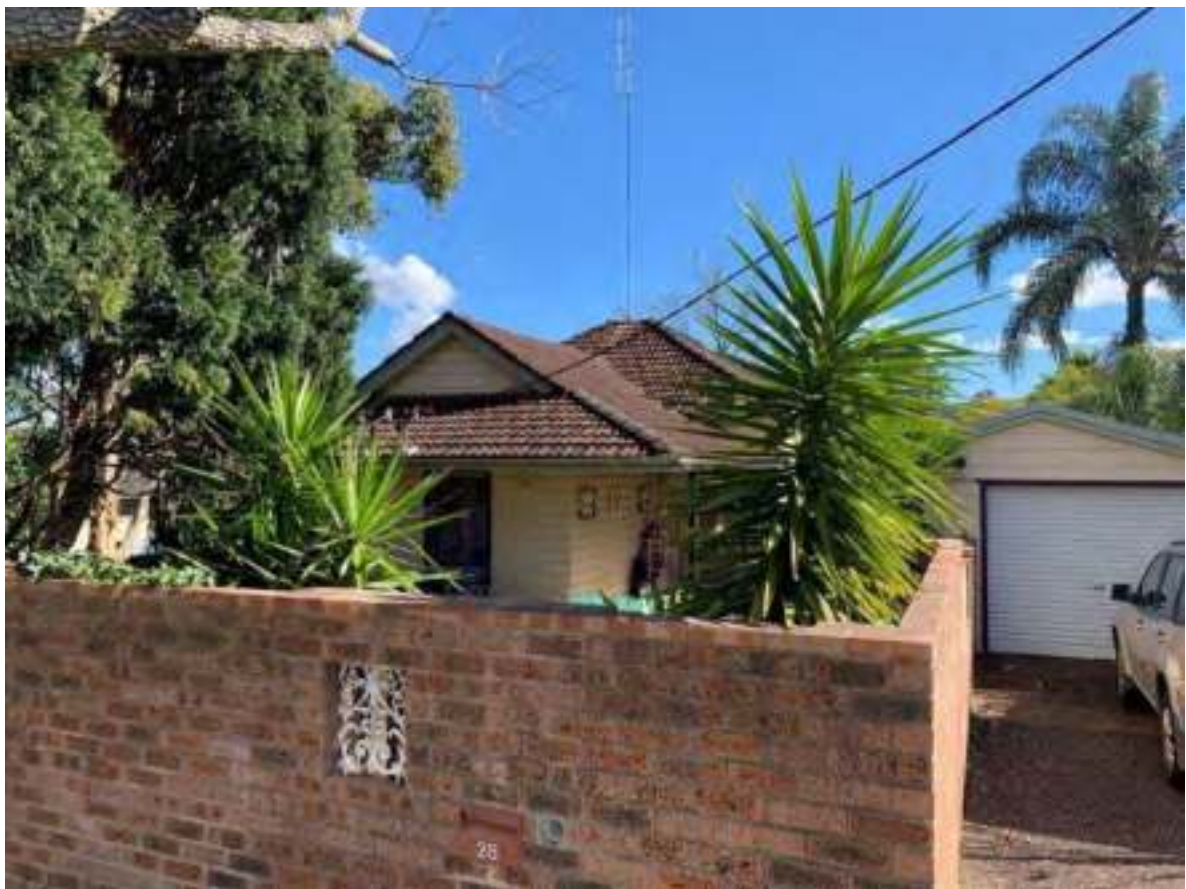
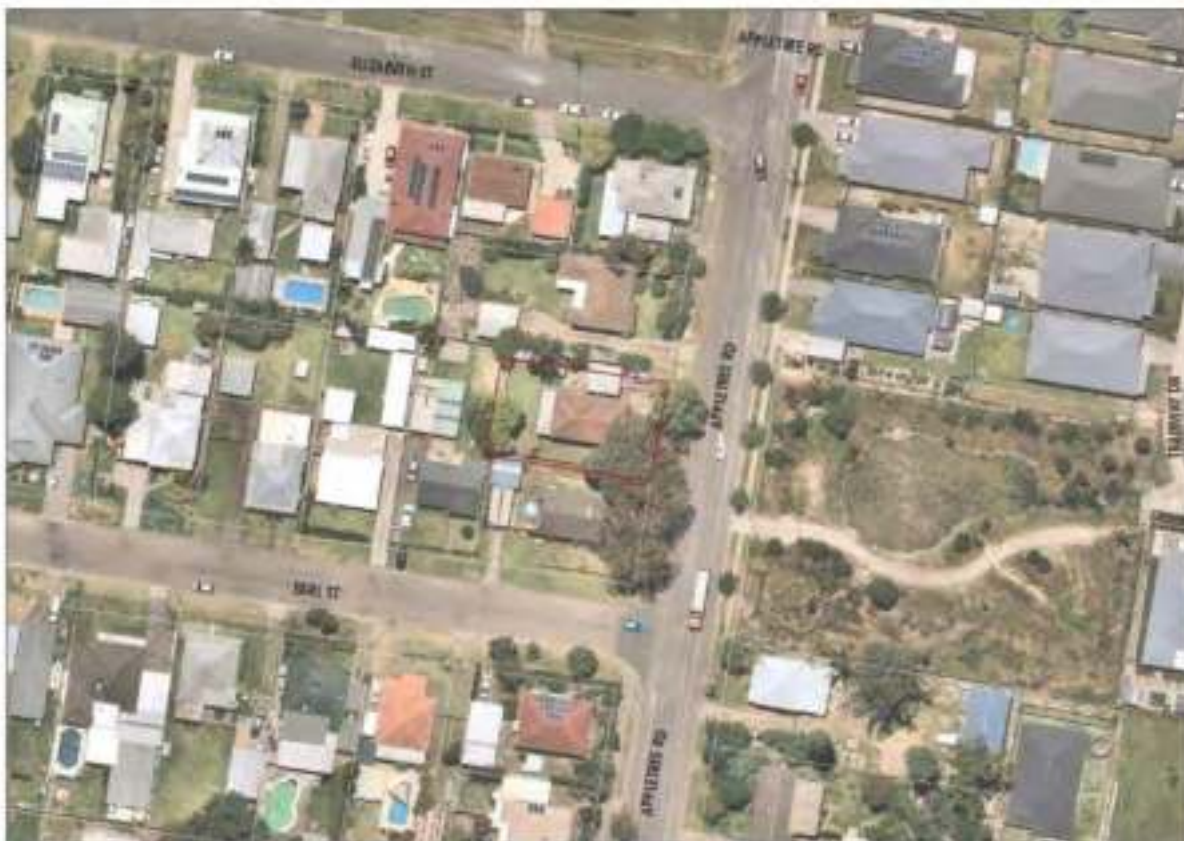
28 APPLETREE ROAD, HOLMESVILLE 2286

Conservation Area Contribution Level	Est. Construction Date	Previous studies and/or community input
Contributory 2	Early to late 20 th century (broad range)	No prior heritage assessments or research undertaken.
Assessment Text		Observed Modifications
<p>The scale (single-storey) and general style of the dwelling is consistent with that of the streetscape and wider HCA. Dwelling contributes positively to the streetscape and wider HCA, particularly in comparison to Non-Contributory buildings.</p> <p>The dwelling features appropriately proportioned and positioned fenestrations, an appropriate roof form (gabled or hipped) and other features consistent with the architectural character of the area (e.g. front verandah with timber or brick posts, timber detailing, corrugated metal roofing, etc).</p> <p>The contributory value of the dwelling is limited however by either:</p> <ul style="list-style-type: none"> • External modifications that have in some way obscured the style, scale or design intent of the building and have resulted in less physical integrity than Contributory 1 buildings. • Being a later dwelling constructed in an appropriate referential style, but comprising little to no fabric of intrinsic heritage significance. 		No modifications observed.

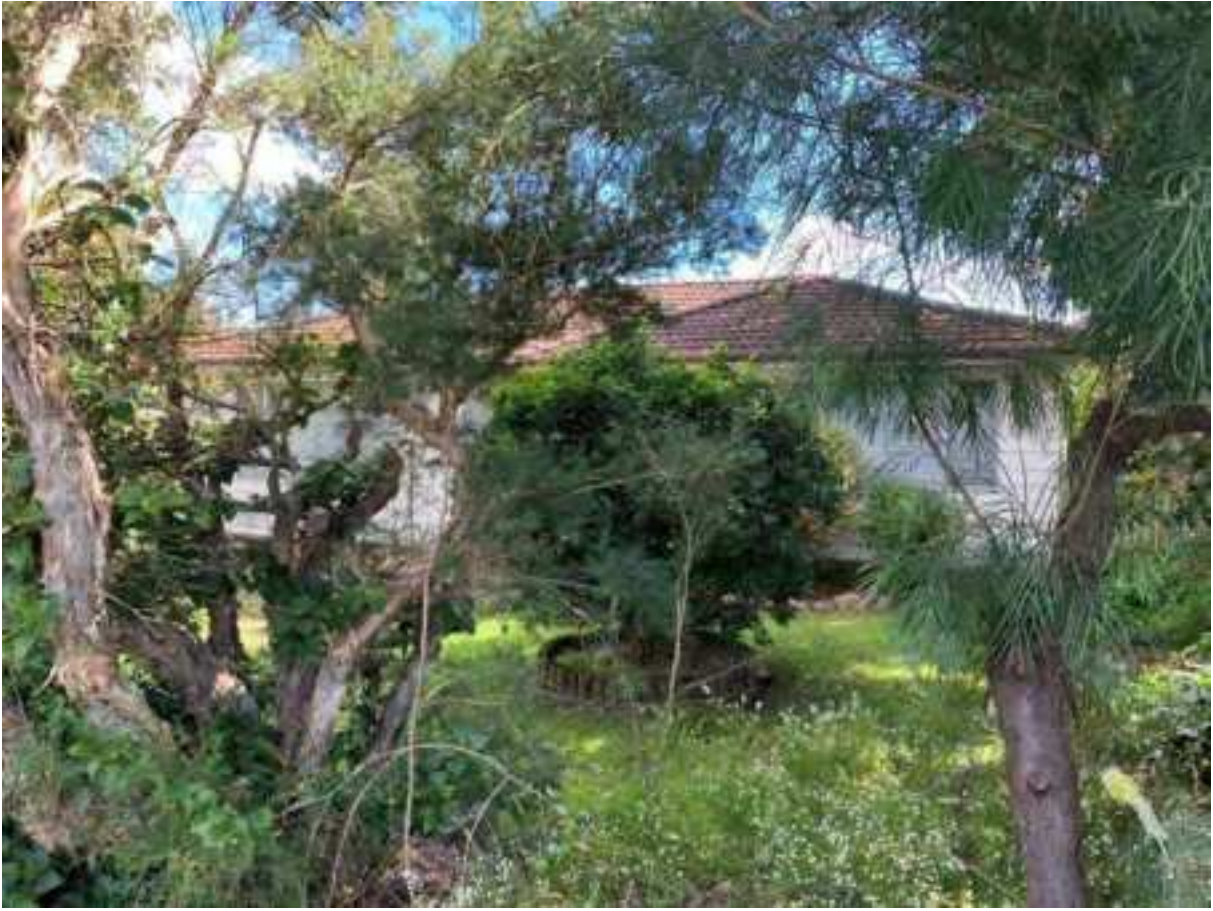
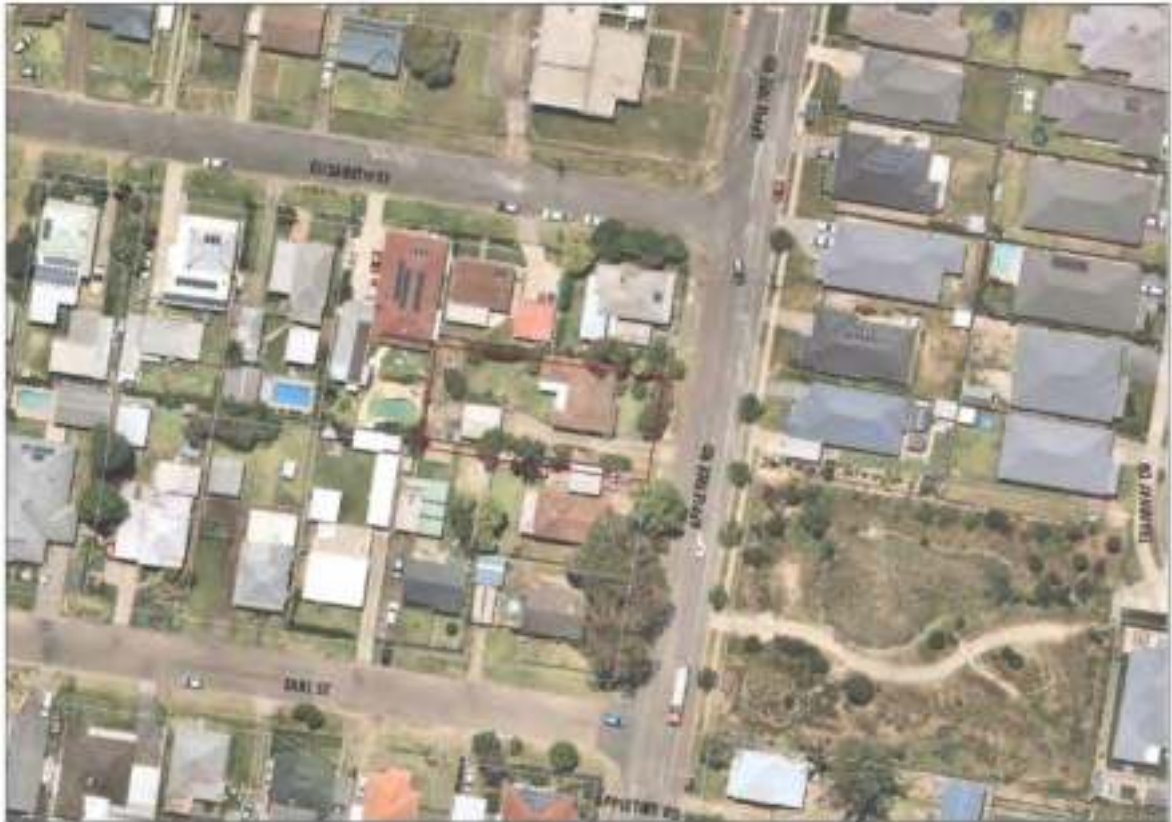
26 APPLETREE ROAD, HOLMESVILLE 2286

Conservation Area Contribution Level	Est. Construction Date	Previous studies and/or community input
Contributory 2	Early to late 20 th century (broad range)	No prior heritage assessments or research undertaken.
Assessment Text		Observed Modifications
<p>The scale (single-storey) and general style of the dwelling is consistent with that of the streetscape and wider HCA. Dwelling contributes positively to the streetscape and wider HCA, particularly in comparison to Non-Contributory buildings.</p> <p>The dwelling features appropriately proportioned and positioned fenestrations, an appropriate roof form (gabled or hipped) and other features consistent with the architectural character of the area (e.g. front verandah with timber or brick posts, timber detailing, corrugated metal roofing, etc).</p> <p>The contributory value of the dwelling is limited however by either:</p> <ul style="list-style-type: none"> • External modifications that have in some way obscured the style, scale or design intent of the building and have resulted in less physical integrity than Contributory 1 buildings. • Being a later dwelling constructed in an appropriate referential style, but comprising little to no fabric of intrinsic heritage significance. 		No modifications observed.

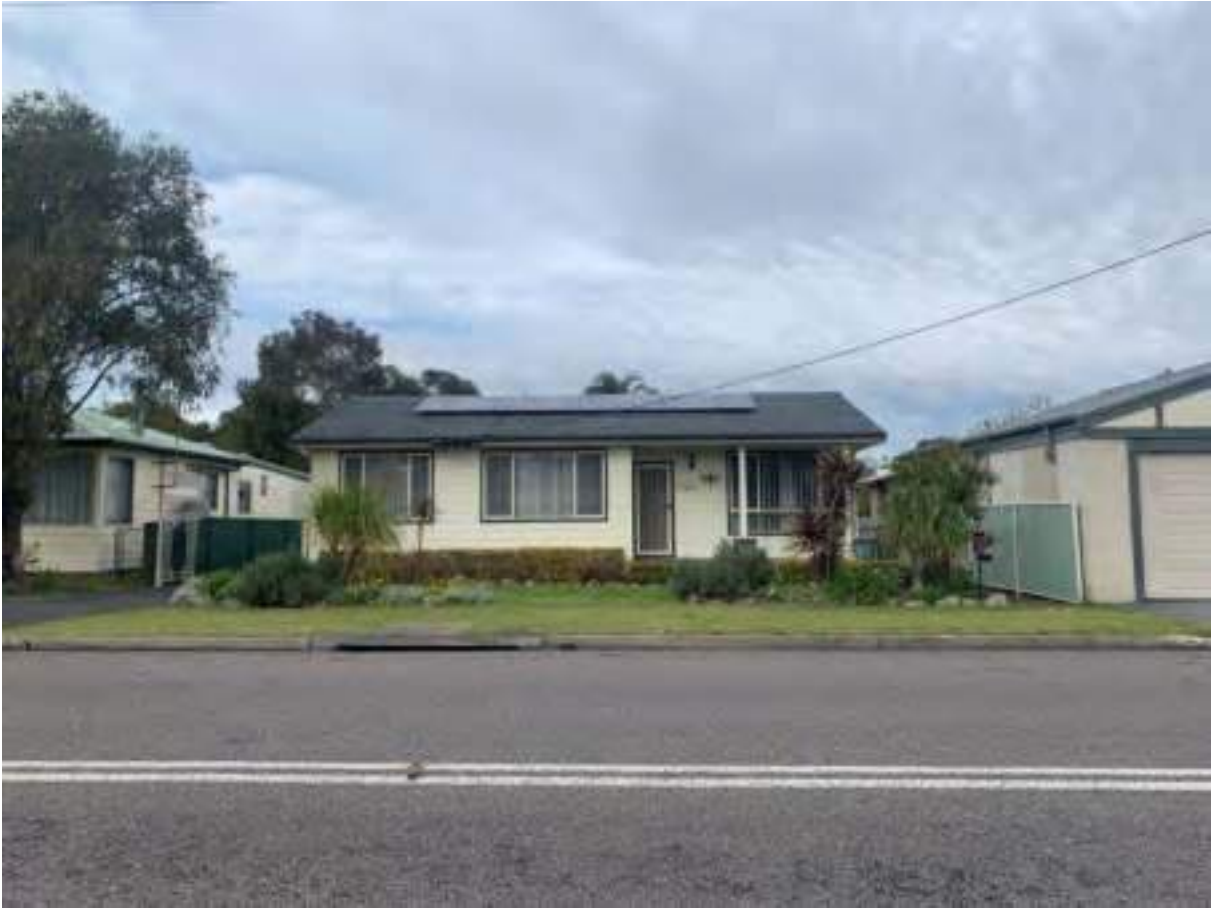
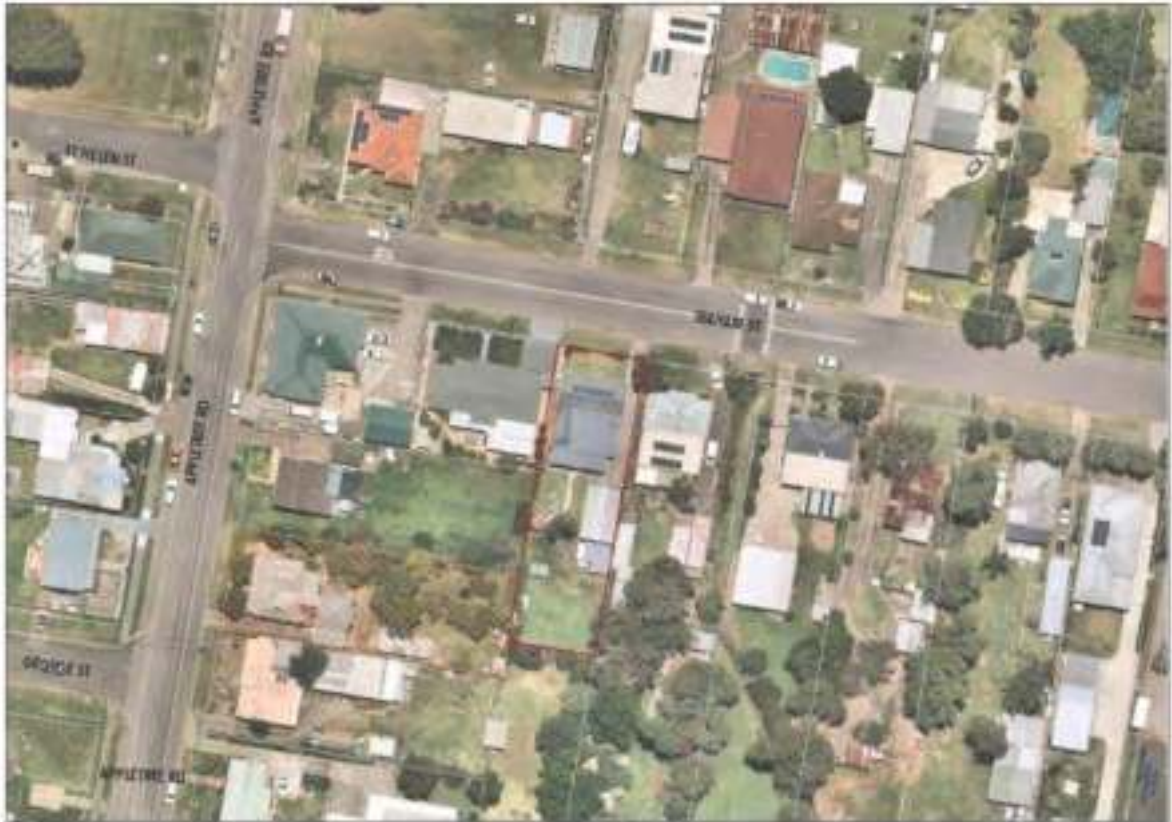
104 SEAHAM STREET, HOLMESVILLE 2286

Conservation Area Contribution Level	Est. Construction Date	Previous studies and/or community input
Contributory 2	Early to late 20 th century (broad range)	No prior heritage assessments or research undertaken.
Assessment Text		Observed Modifications
<p>The scale (single-storey) and general style of the dwelling is consistent with that of the streetscape and wider HCA. Dwelling contributes positively to the streetscape and wider HCA, particularly in comparison to Non-Contributory buildings.</p> <p>The dwelling features appropriately proportioned and positioned fenestrations, an appropriate roof form (gabled or hipped) and other features consistent with the architectural character of the area (e.g. front verandah with timber or brick posts, timber detailing, corrugated metal roofing, etc). The contributory value of the dwelling is limited however by either:</p> <ul style="list-style-type: none"> • External modifications that have in some way obscured the style, scale or design intent of the building and have resulted in less physical integrity than Contributory 1 buildings. • Being a later dwelling constructed in an appropriate referential style, but comprising little to no fabric of intrinsic heritage significance. 		<p>Solar panels are highly visible along the northern portion of the roof.</p>

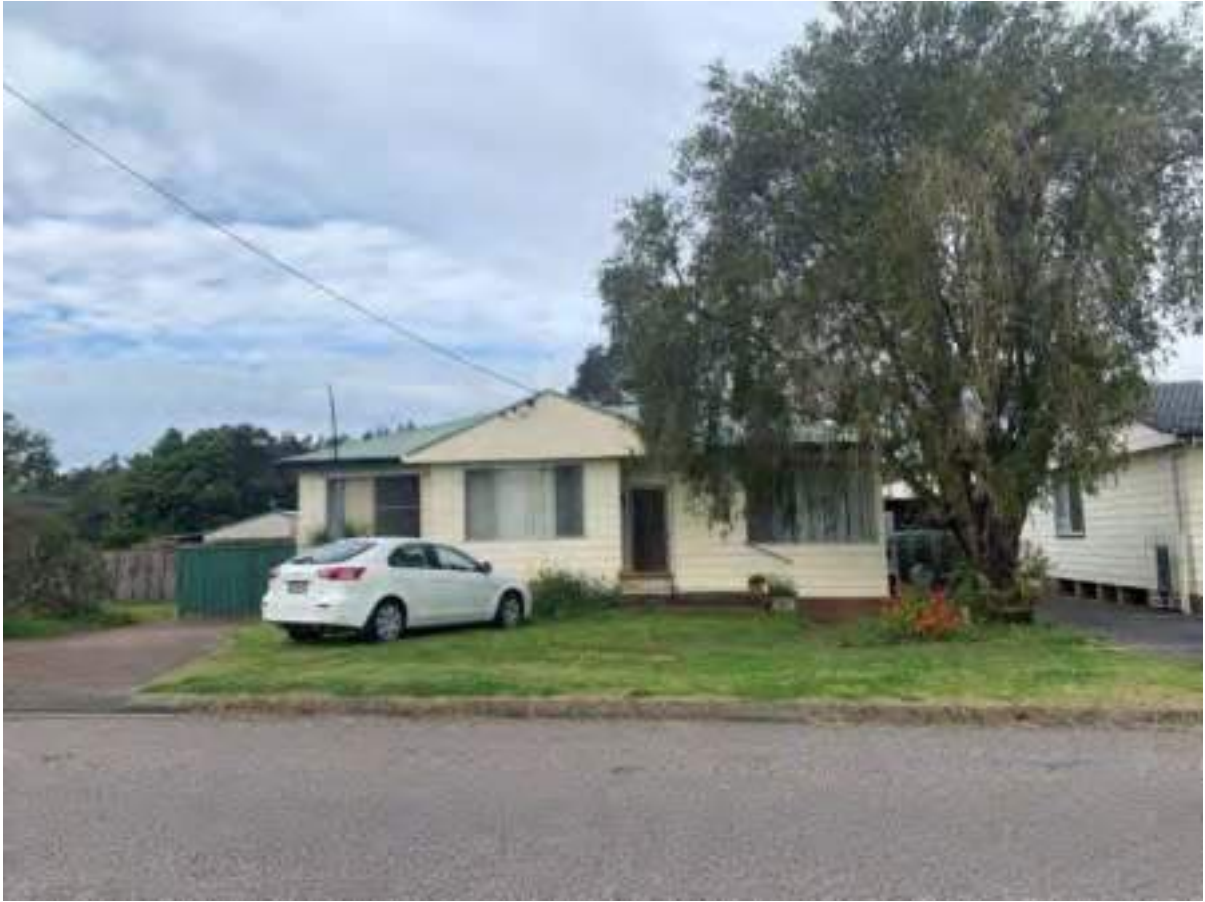
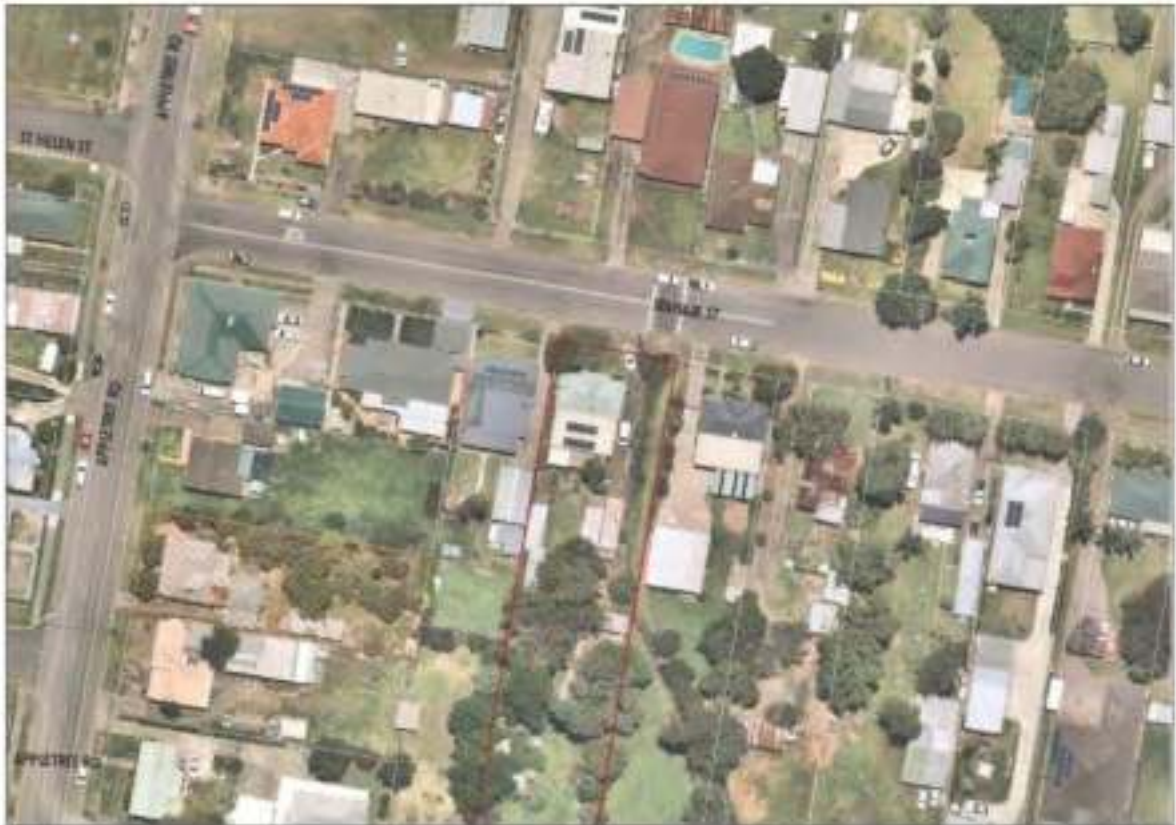
102 SEAHAM STREET, HOLMESVILLE 2286

Conservation Area Contribution Level	Est. Construction Date	Previous studies and/or community input
Contributory 2	Early to late 20 th century (broad range)	No prior heritage assessments or research undertaken.
Assessment Text		Observed Modifications
<p>The scale (single-storey) and general style of the dwelling is consistent with that of the streetscape and wider HCA. Dwelling contributes positively to the streetscape and wider HCA, particularly in comparison to Non-Contributory buildings.</p> <p>The dwelling features appropriately proportioned and positioned fenestrations, an appropriate roof form (gabled or hipped) and other features consistent with the architectural character of the area (e.g. front verandah with timber or brick posts, timber detailing, corrugated metal roofing, etc). The contributory value of the dwelling is limited however by either:</p> <ul style="list-style-type: none"> • External modifications that have in some way obscured the style, scale or design intent of the building and have resulted in less physical integrity than Contributory 1 buildings. • Being a later dwelling constructed in an appropriate referential style, but comprising little to no fabric of intrinsic heritage significance. 		No modifications observed.

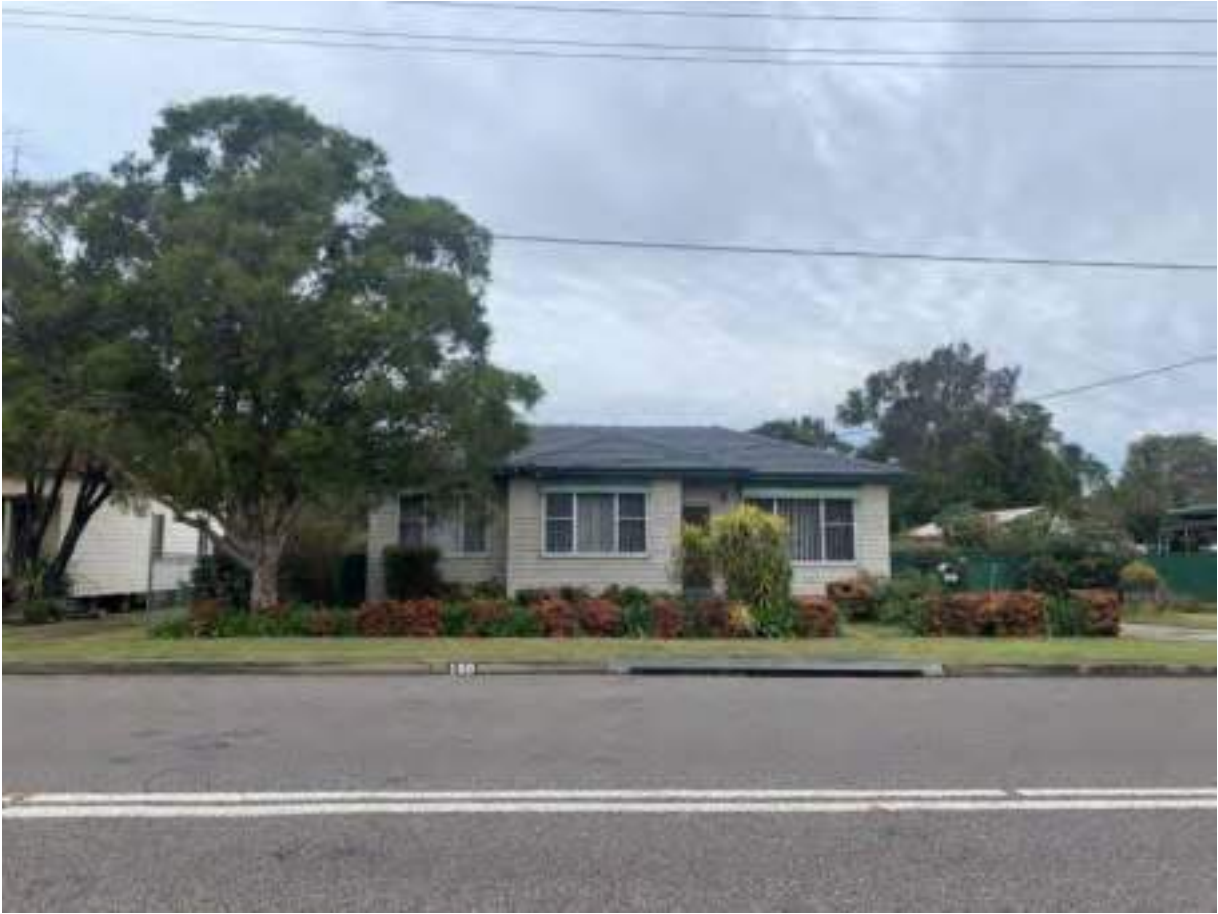
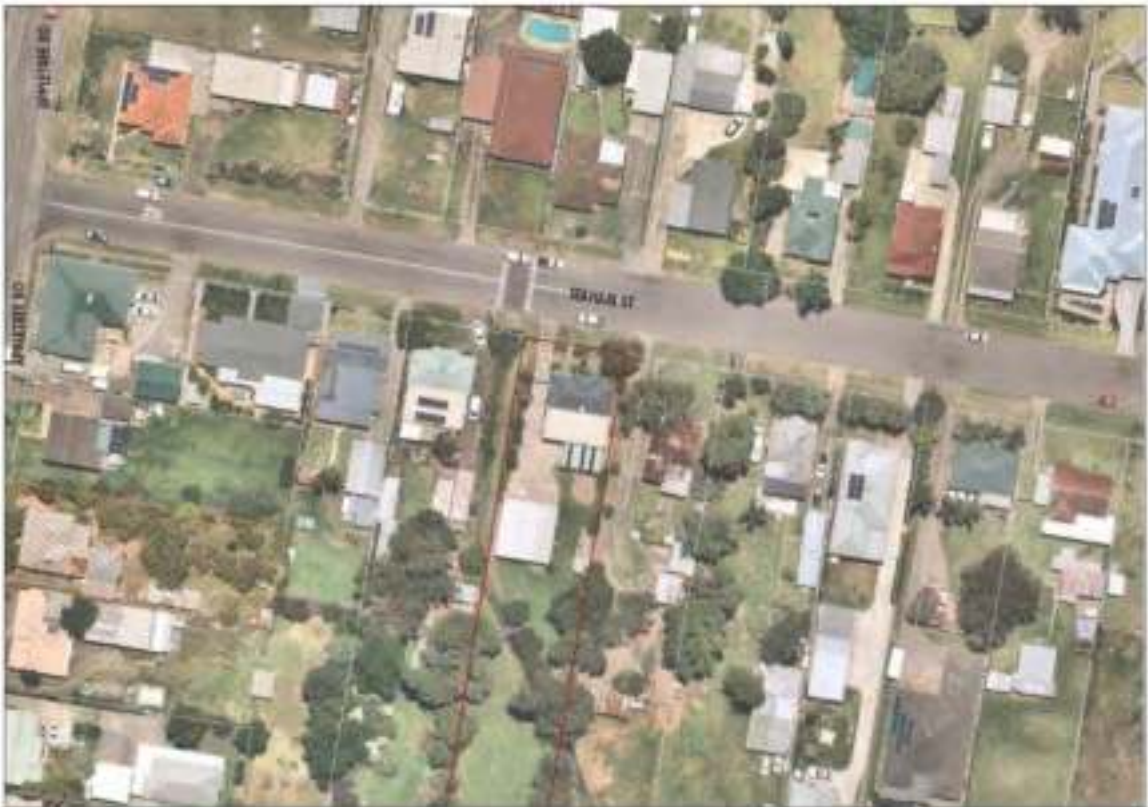
100 SEAHAM STREET, HOLMESVILLE 2286

Conservation Area Contribution Level	Est. Construction Date	Previous studies and/or community input
Contributory 2	Early to late 20 th century (broad range)	No prior heritage assessments or research undertaken.
Assessment Text		Observed Modifications
<p>The scale (single-storey) and general style of the dwelling is consistent with that of the streetscape and wider HCA. Dwelling contributes positively to the streetscape and wider HCA, particularly in comparison to Non-Contributory buildings.</p> <p>The dwelling features appropriately proportioned and positioned fenestrations, an appropriate roof form (gabled or hipped) and other features consistent with the architectural character of the area (e.g. front verandah with timber or brick posts, timber detailing, corrugated metal roofing, etc). The contributory value of the dwelling is limited however by either:</p> <ul style="list-style-type: none"> • External modifications that have in some way obscured the style, scale or design intent of the building and have resulted in less physical integrity than Contributory 1 buildings. • Being a later dwelling constructed in an appropriate referential style, but comprising little to no fabric of intrinsic heritage significance. 		No modifications observed.
