APPENDIX 2

Building Assessment Sheets (Inventory Sheets)

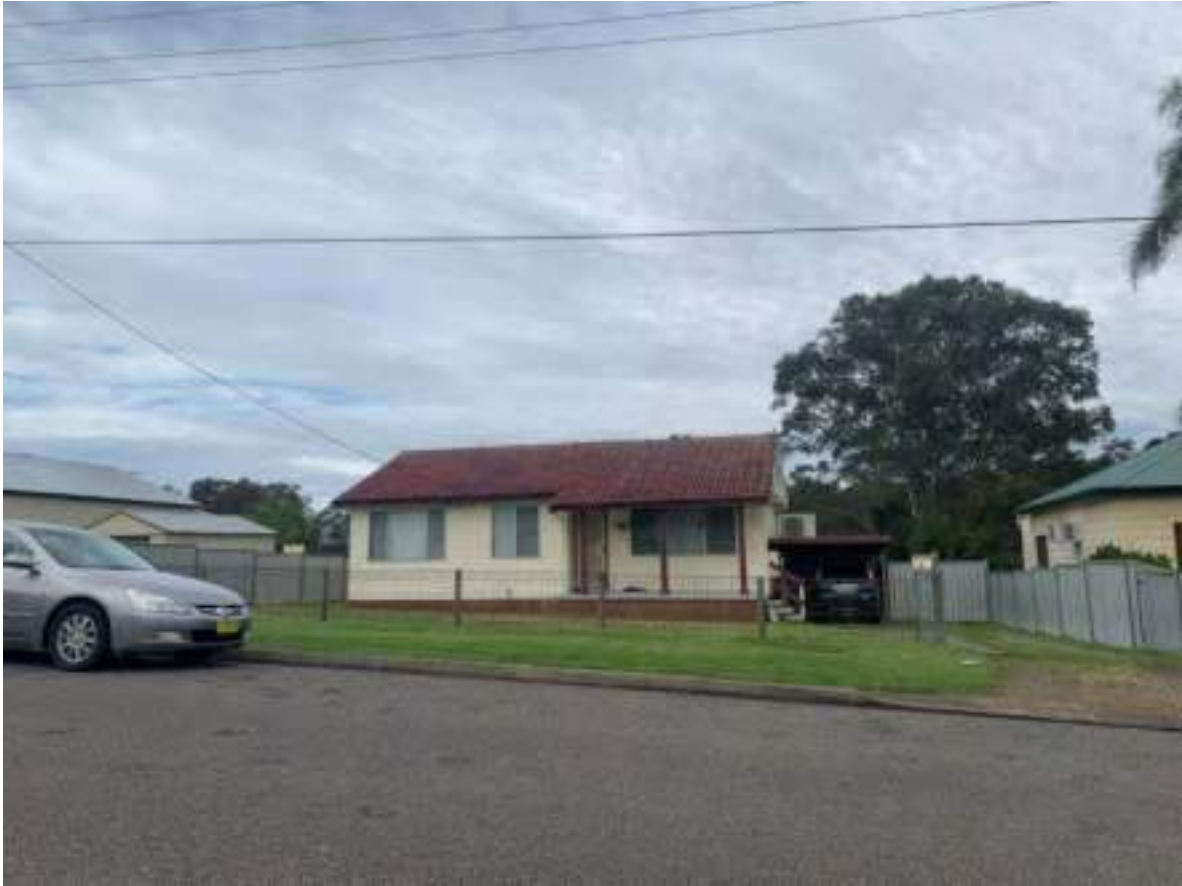
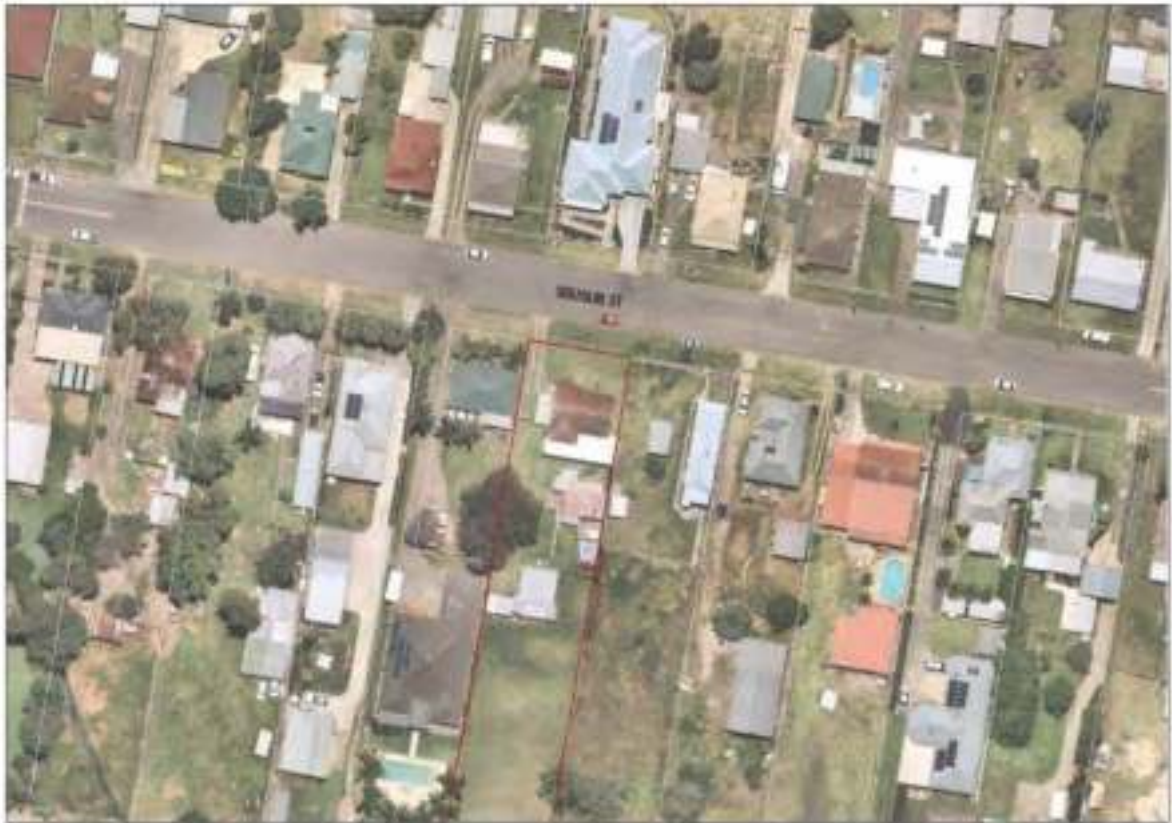
90 SEAHAM STREET, HOLMESVILLE 2286

Conservation Area Contribution Level	Est. Construction Date	Previous studies and/or community input
Contributory 2	Early to late 20 th century (broad range)	No prior heritage assessments or research undertaken.
Assessment Text		Observed Modifications
<p>The scale (single-storey) and general style of the dwelling is consistent with that of the streetscape and wider HCA. Dwelling contributes positively to the streetscape and wider HCA, particularly in comparison to Non-Contributory buildings.</p> <p>The dwelling features appropriately proportioned and positioned fenestrations, an appropriate roof form (gabled or hipped) and other features consistent with the architectural character of the area (e.g. front verandah with timber or brick posts, timber detailing, corrugated metal roofing, etc). The contributory value of the dwelling is limited however by either:</p> <ul style="list-style-type: none"> • External modifications that have in some way obscured the style, scale or design intent of the building and have resulted in less physical integrity than Contributory 1 buildings. • Being a later dwelling constructed in an appropriate referential style, but comprising little to no fabric of intrinsic heritage significance. 		No modifications observed.

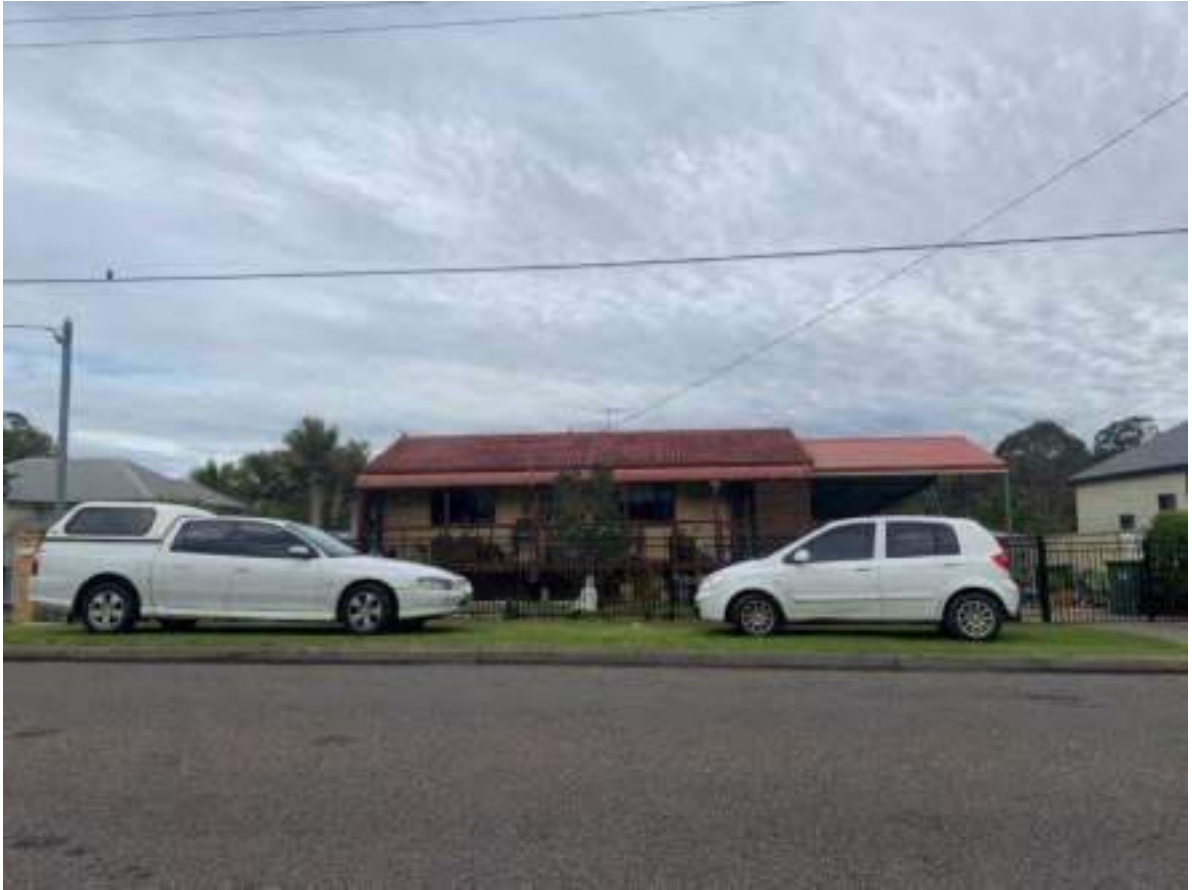
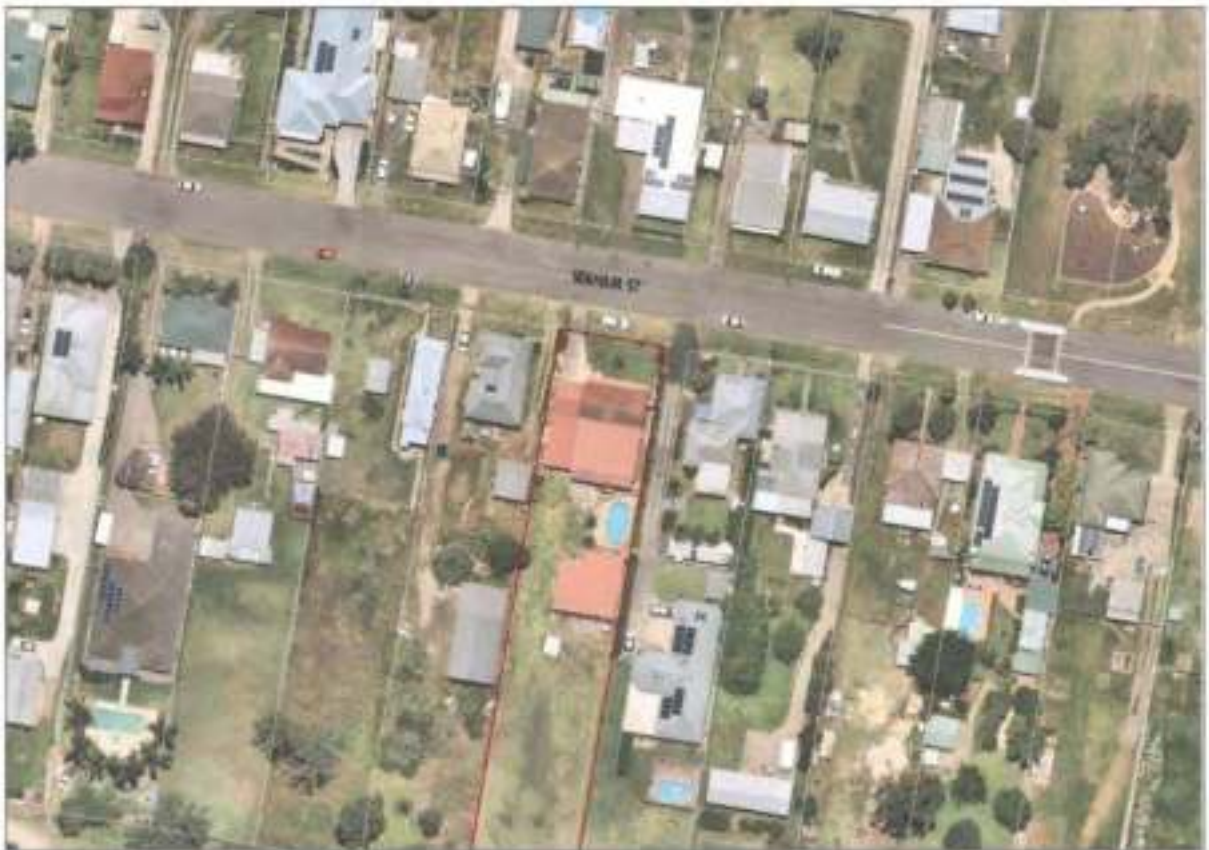
84 SEAHAM STREET, HOLMESVILLE 2286

Conservation Area Contribution Level	Est. Construction Date	Previous studies and/or community input
Contributory 2	Early to late 20 th century (broad range)	No prior heritage assessments or research undertaken.
Assessment Text		Observed Modifications
<p>The scale (single-storey) and general style of the dwelling is consistent with that of the streetscape and wider HCA. Dwelling contributes positively to the streetscape and wider HCA, particularly in comparison to Non-Contributory buildings.</p> <p>The dwelling features appropriately proportioned and positioned fenestrations, an appropriate roof form (gabled or hipped) and other features consistent with the architectural character of the area (e.g. front verandah with timber or brick posts, timber detailing, corrugated metal roofing, etc). The contributory value of the dwelling is limited however by either:</p> <ul style="list-style-type: none"> • External modifications that have in some way obscured the style, scale or design intent of the building and have resulted in less physical integrity than Contributory 1 buildings. • Being a later dwelling constructed in an appropriate referential style, but comprising little to no fabric of intrinsic heritage significance. 		<p>An extensive carport has been constructed to the western side of the dwelling. this is highly visible and is unsympathetic to the heritage streetscape of the neighbouring properties.</p> <p>A veranda extension has been constructed, potentially replacing a previous original design. It is raised with a timber and metal wire balustrade and bull nosed roof. The Colourbond roof juxtaposes the terracotta tiles used on the remaining roof. The natural timber panels enclosing this veranda space contrast the remaining dwelling features. This has been constructed in an unsympathetic manner and detracts from the heritage streetscape.</p>

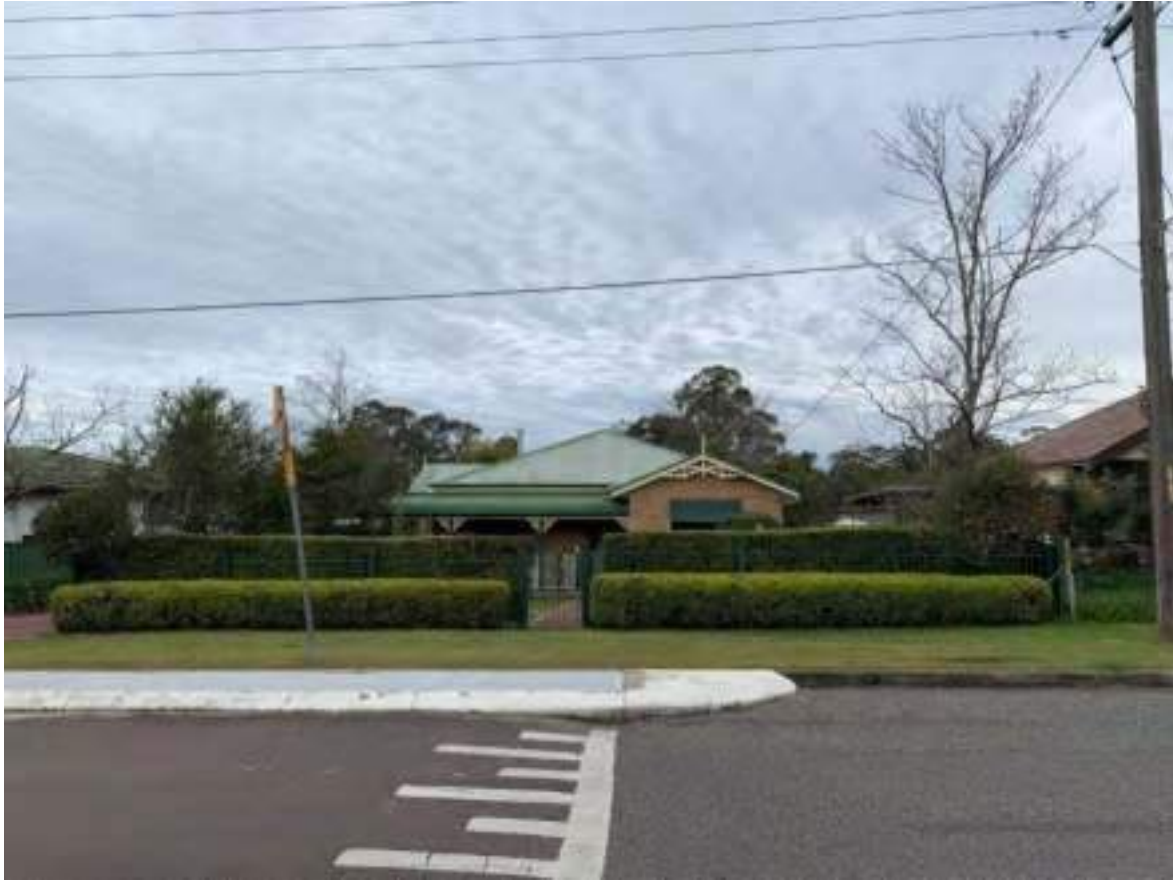
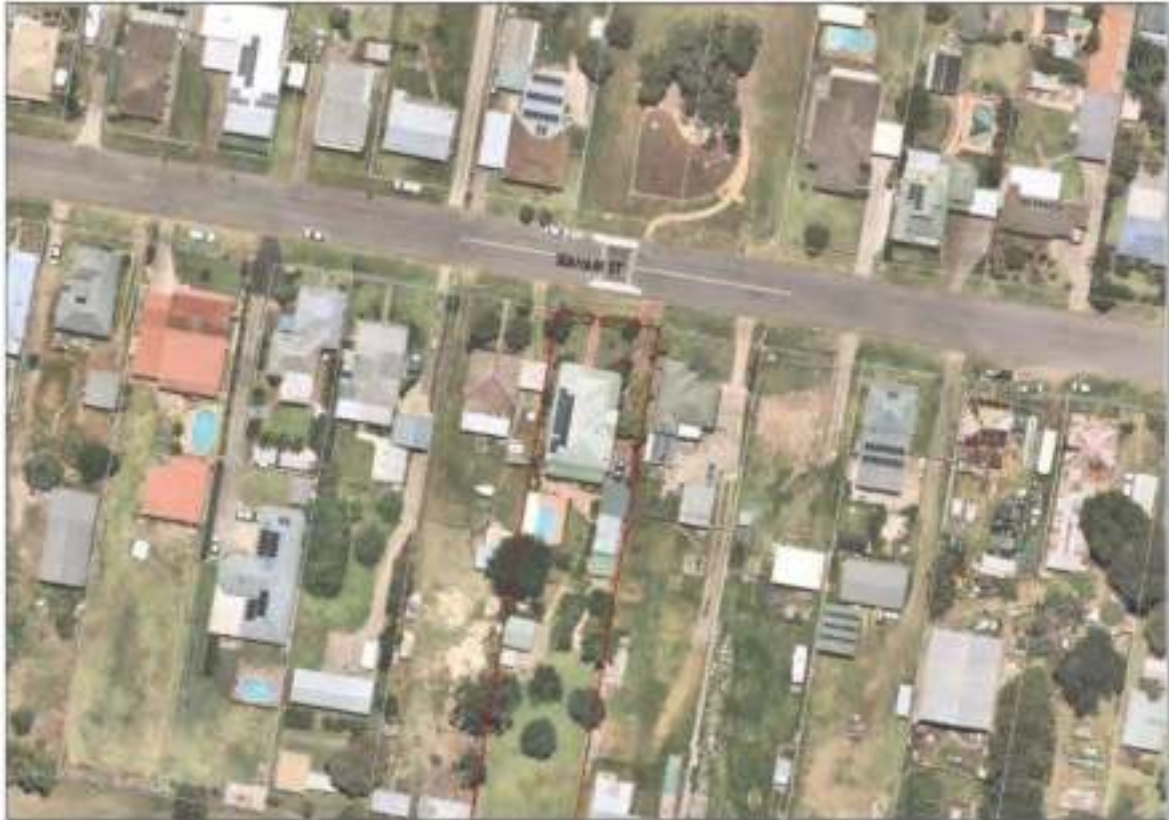
76 SEAHAM STREET, HOLMESVILLE 2286

Conservation Area Contribution Level	Est. Construction Date	Previous studies and/or community input
Contributory 2	1985-2000	No prior heritage assessments or research undertaken.
Assessment Text		Observed Modifications
<p>The scale (single-storey) and general style of the dwelling is consistent with that of the streetscape and wider HCA. Dwelling contributes positively to the streetscape and wider HCA, particularly in comparison to Non-Contributory buildings.</p> <p>The dwelling features appropriately proportioned and positioned fenestrations, an appropriate roof form (gabled or hipped) and other features consistent with the architectural character of the area (e.g. front verandah with timber or brick posts, timber detailing, corrugated metal roofing, etc). The contributory value of the dwelling is limited however by either:</p> <ul style="list-style-type: none"> • External modifications that have in some way obscured the style, scale or design intent of the building and have resulted in less physical integrity than Contributory 1 buildings. • Being a later dwelling constructed in an appropriate referential style, but comprising little to no fabric of intrinsic heritage significance. 		No modifications observed.

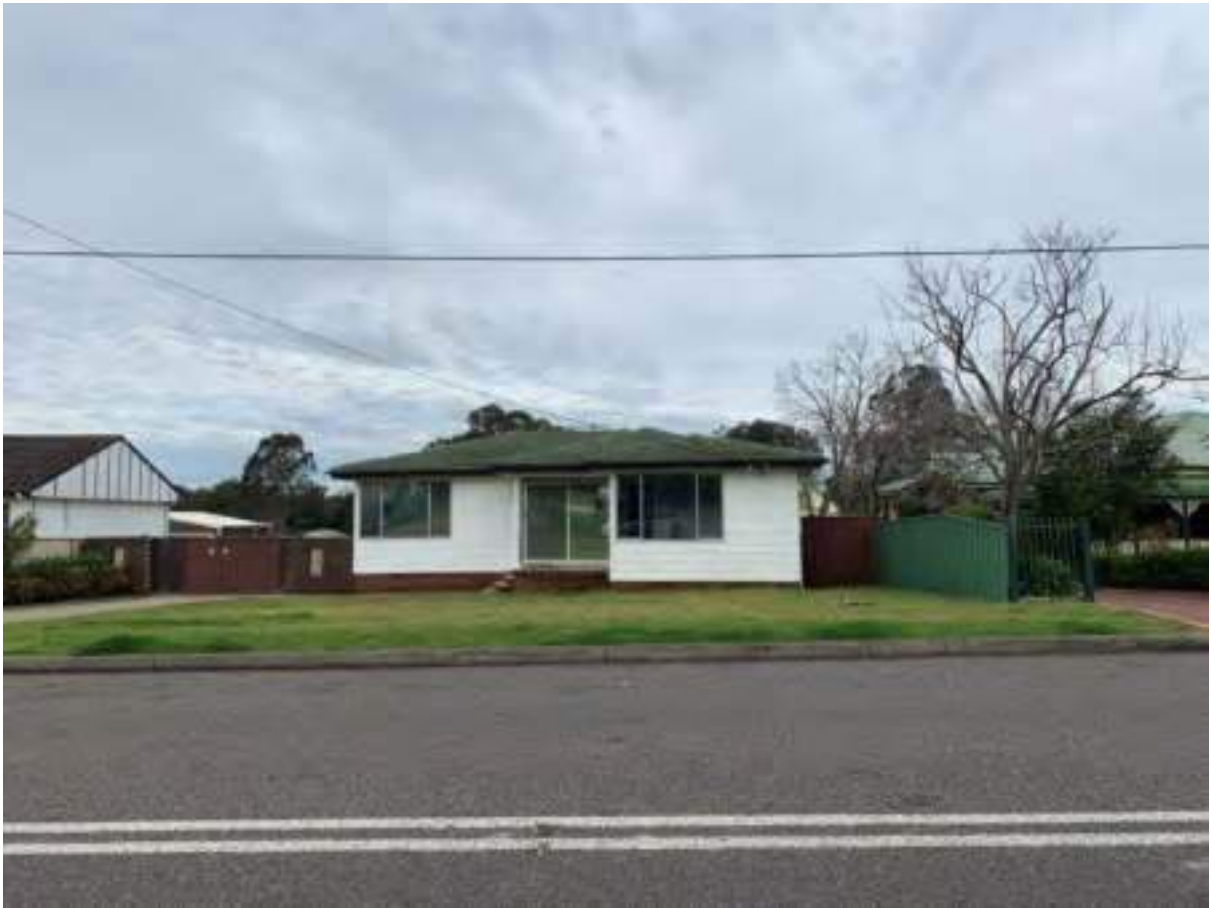
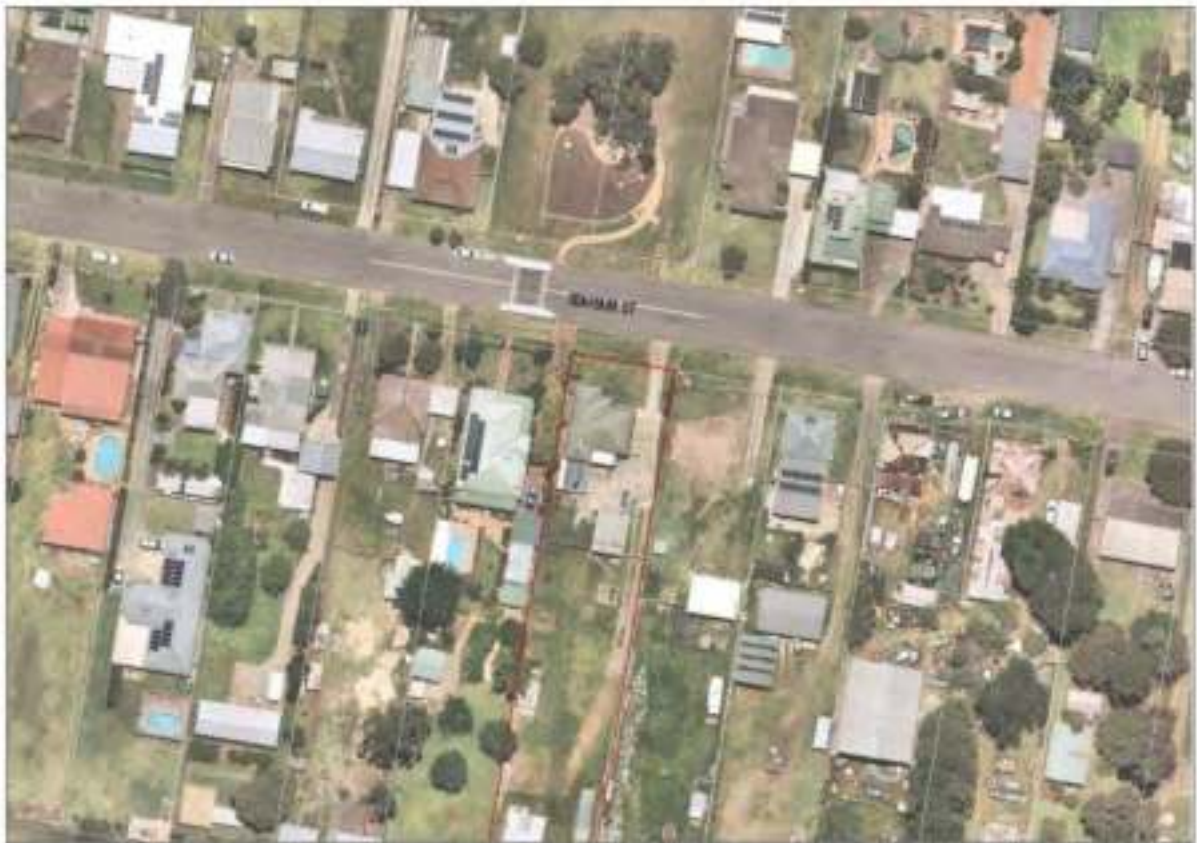
74 SEAHAM STREET, HOLMESVILLE 2286

Conservation Area Contribution Level	Est. Construction Date	Previous studies and/or community input
Contributory 2	Early to late 20 th century (broad range)	No prior heritage assessments or research undertaken.
Assessment Text		Observed Modifications
<p>The scale (single-storey) and general style of the dwelling is consistent with that of the streetscape and wider HCA. Dwelling contributes positively to the streetscape and wider HCA, particularly in comparison to Non-Contributory buildings.</p> <p>The dwelling features appropriately proportioned and positioned fenestrations, an appropriate roof form (gabled or hipped) and other features consistent with the architectural character of the area (e.g. front verandah with timber or brick posts, timber detailing, corrugated metal roofing, etc). The contributory value of the dwelling is limited however by either:</p> <ul style="list-style-type: none"> • External modifications that have in some way obscured the style, scale or design intent of the building and have resulted in less physical integrity than Contributory 1 buildings. • Being a later dwelling constructed in an appropriate referential style, but comprising little to no fabric of intrinsic heritage significance. 		<p>The double pane glass sliding door dominating the façade is a contemporary addition to the dwelling.</p>

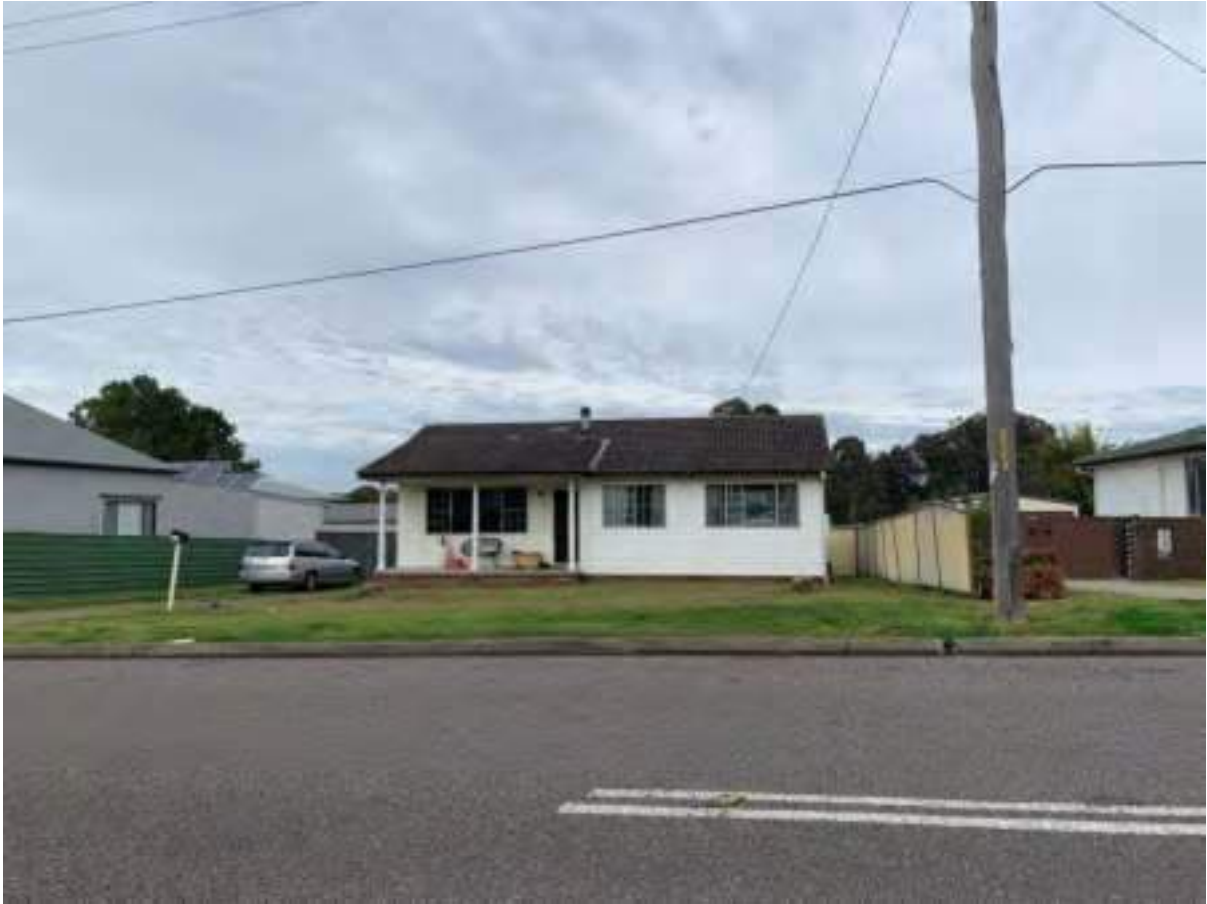
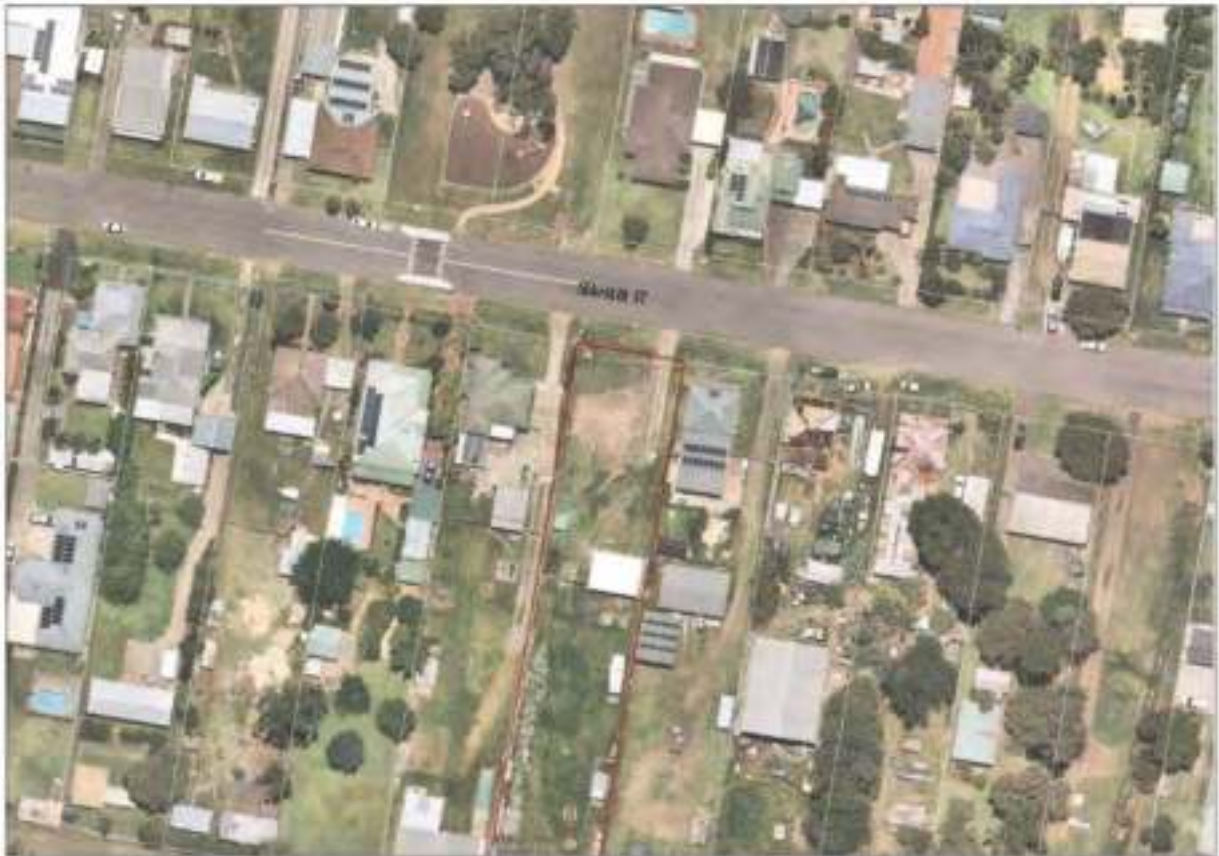
72 SEAHAM STREET, HOLMESVILLE 2286

Conservation Area Contribution Level	Est. Construction Date	Previous studies and/or community input
Contributory 2	Early to late 20 th century (broad range)	No prior heritage assessments or research undertaken.
Assessment Text		Observed Modifications
<p>The scale (single-storey) and general style of the dwelling is consistent with that of the streetscape and wider HCA. Dwelling contributes positively to the streetscape and wider HCA, particularly in comparison to Non-Contributory buildings.</p> <p>The dwelling features appropriately proportioned and positioned fenestrations, an appropriate roof form (gabled or hipped) and other features consistent with the architectural character of the area (e.g. front verandah with timber or brick posts, timber detailing, corrugated metal roofing, etc). The contributory value of the dwelling is limited however by either:</p> <ul style="list-style-type: none"> • External modifications that have in some way obscured the style, scale or design intent of the building and have resulted in less physical integrity than Contributory 1 buildings. • Being a later dwelling constructed in an appropriate referential style, but comprising little to no fabric of intrinsic heritage significance. 		<p>The faux European pillars are likely a contemporary modification.</p>

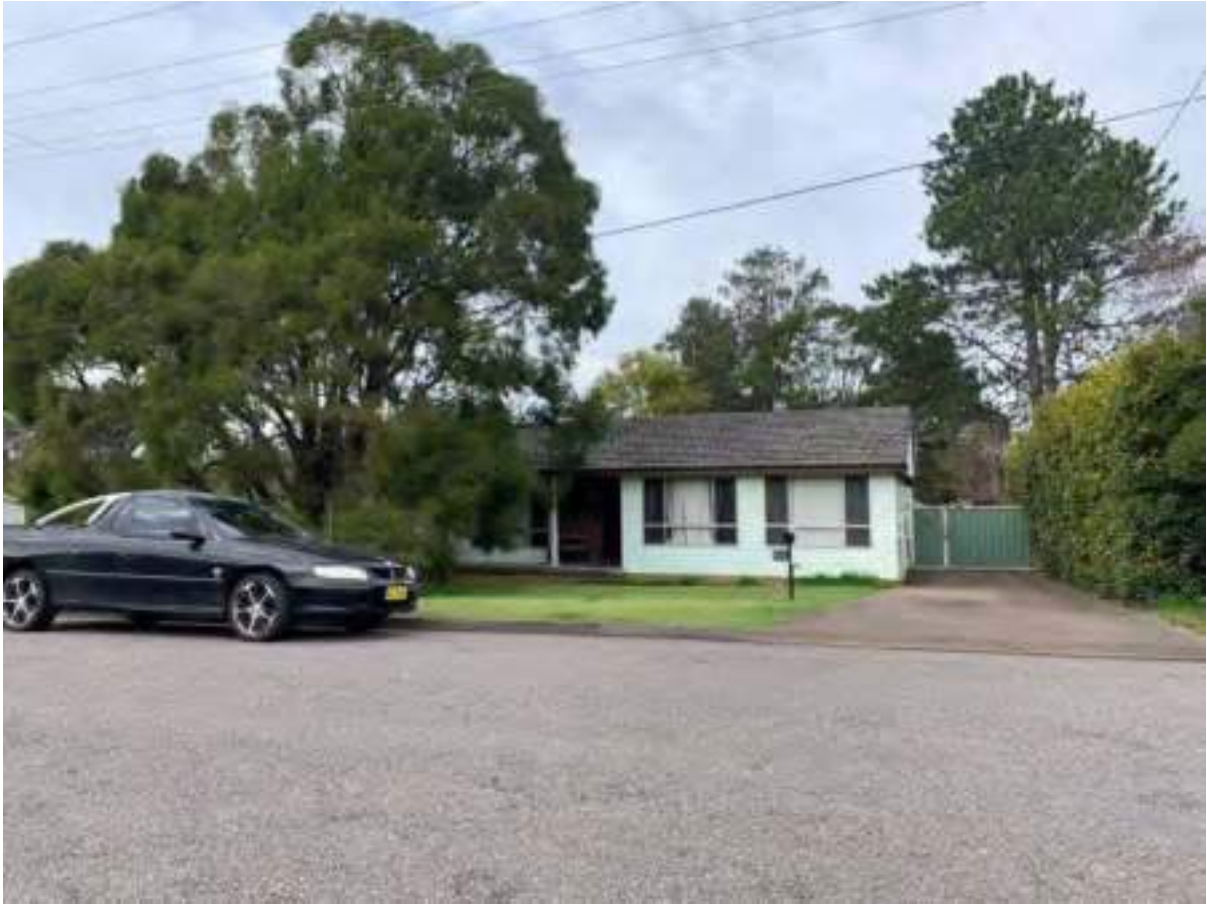
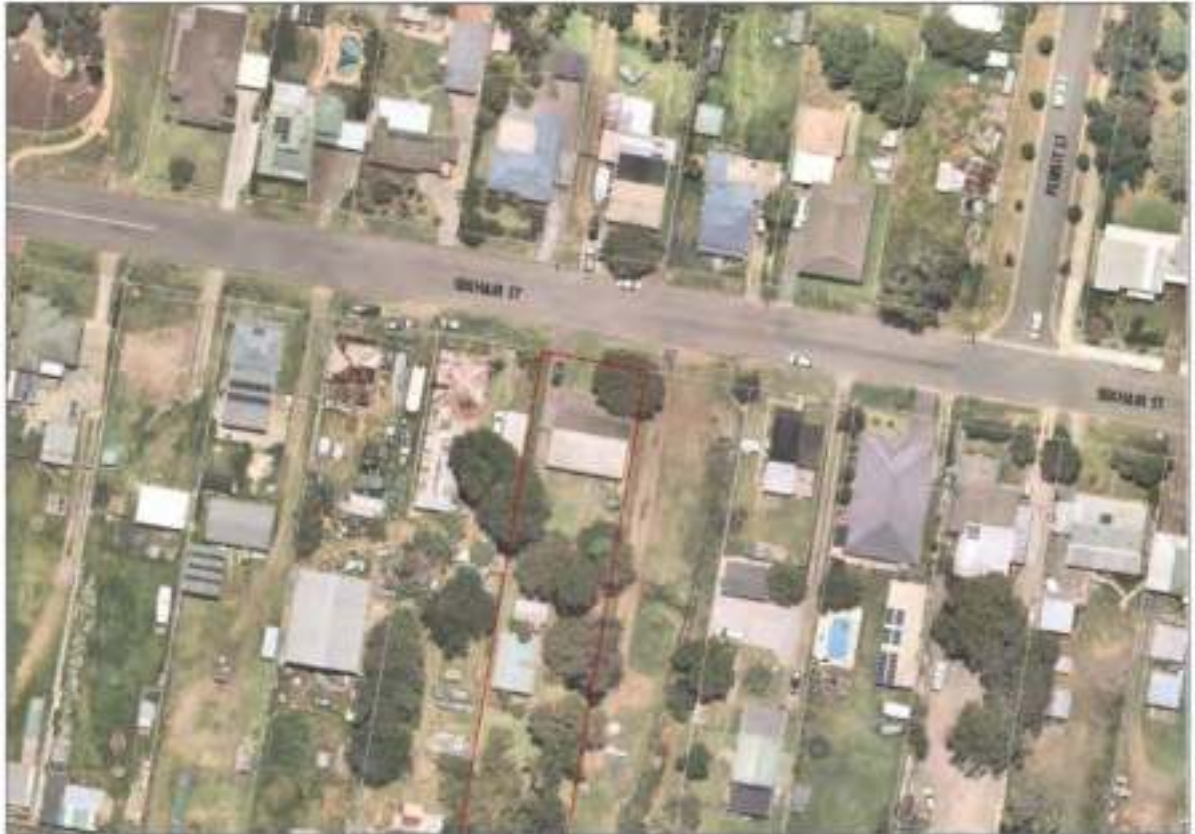
64 SEAHAM STREET, HOLMESVILLE 2286

Conservation Area Contribution Level	Est. Construction Date	Previous studies and/or community input
Contributory 2	Early to late 20 th century (broad range)	No prior heritage assessments or research undertaken.
Assessment Text		Observed Modifications
<p>The scale (single-storey) and general style of the dwelling is consistent with that of the streetscape and wider HCA. Dwelling contributes positively to the streetscape and wider HCA, particularly in comparison to Non-Contributory buildings.</p> <p>The dwelling features appropriately proportioned and positioned fenestrations, an appropriate roof form (gabled or hipped) and other features consistent with the architectural character of the area (e.g. front verandah with timber or brick posts, timber detailing, corrugated metal roofing, etc). The contributory value of the dwelling is limited however by either:</p> <ul style="list-style-type: none"> • External modifications that have in some way obscured the style, scale or design intent of the building and have resulted in less physical integrity than Contributory 1 buildings. • Being a later dwelling constructed in an appropriate referential style, but comprising little to no fabric of intrinsic heritage significance. 		<p>The faux European pillars are likely a contemporary modification.</p>

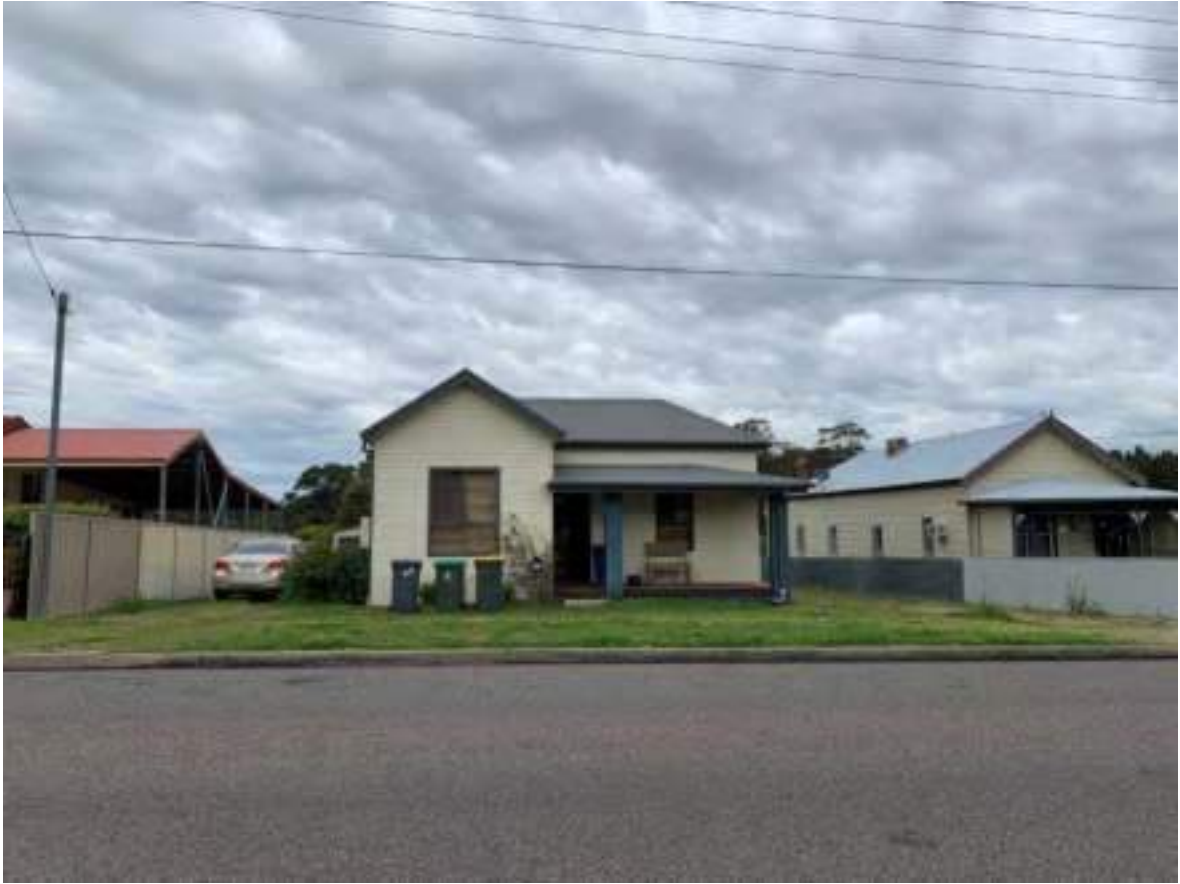
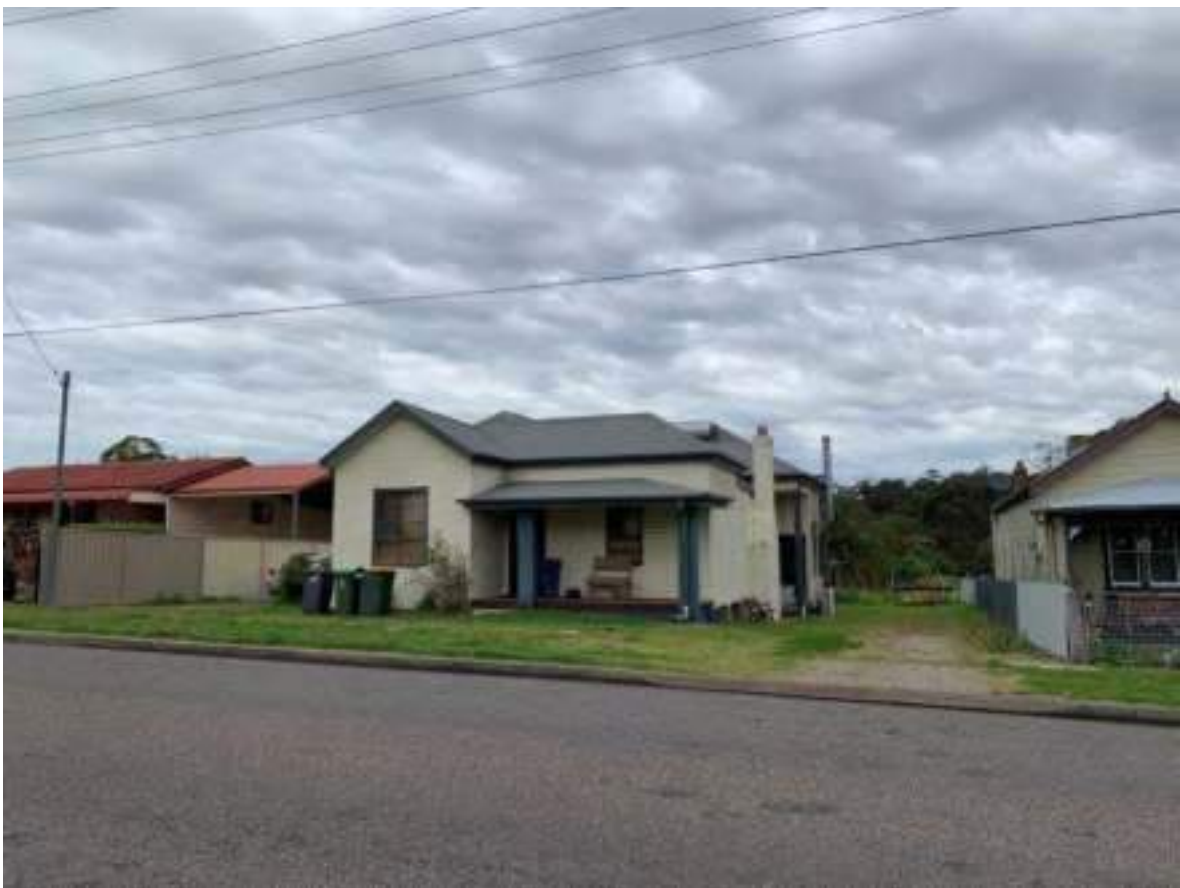
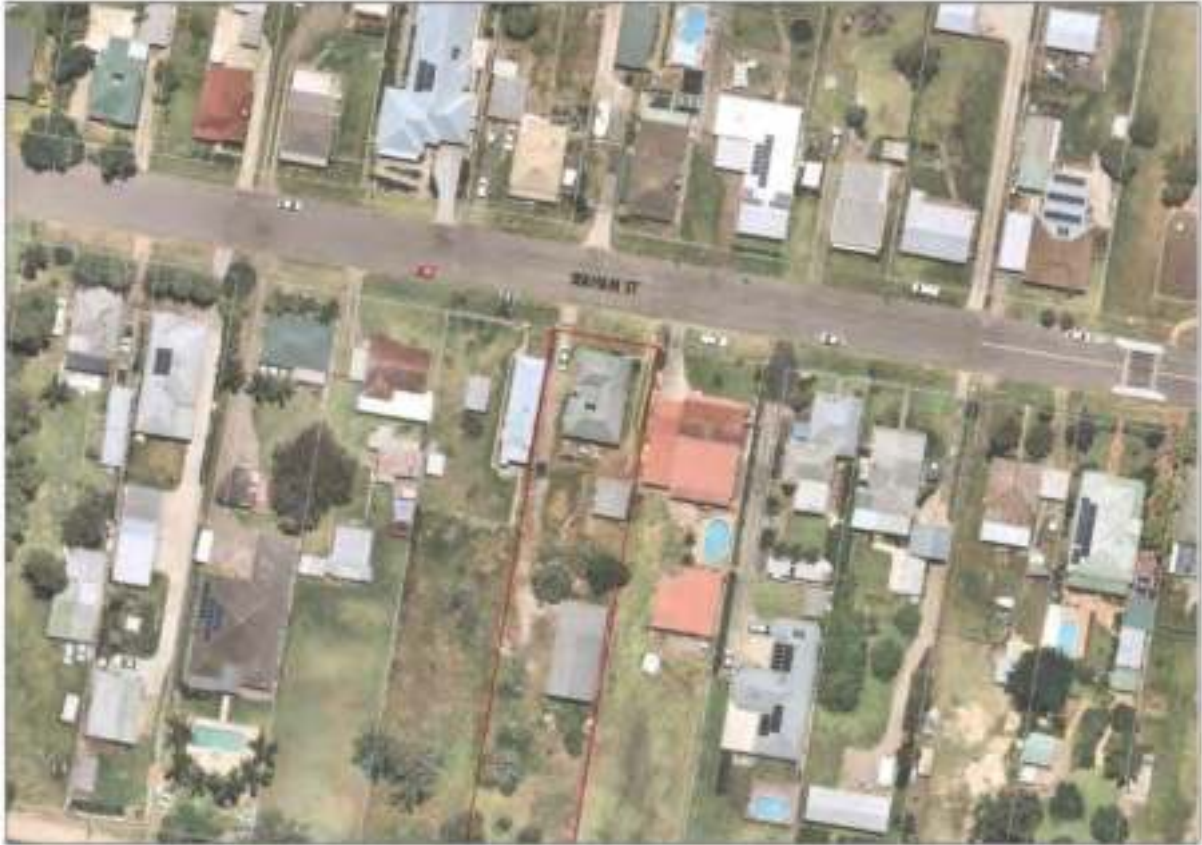
Conservation Area Contribution Level	Est. Construction Date	Previous studies and/or community input
Contributory 2	1910-1930	No prior heritage assessments or research undertaken.
Assessment Text		Observed Modifications
<p>The scale (single-storey) and general style of the dwelling is consistent with that of the streetscape and wider HCA. Dwelling contributes positively to the streetscape and wider HCA, particularly in comparison to Non-Contributory buildings. The dwelling features appropriately proportioned and positioned fenestrations, an appropriate roof form (gabled or hipped) and other features consistent with the architectural character of the area (e.g. front verandah with timber or brick posts, timber detailing, corrugated metal roofing, etc). The contributory value of the dwelling is limited however by either:</p> <ul style="list-style-type: none"> • External modifications that have in some way obscured the style, scale or design intent of the building and have resulted in less physical integrity than Contributory 1 buildings. • Being a later dwelling constructed in an appropriate referential style, but comprising little to no fabric of intrinsic heritage significance. 		<p>Decorative features such as barge boards, eaves, timber finial and the original timber veranda posts have been removed and replaced with contemporary designs.</p> <p>The visible windows retain their timber framed but are a contemporary design.</p> <p>The pillars supporting the veranda roof are rendered brick/concrete are contemporary, juxtaposing the heritage streetscape of the surrounding properties.</p> <p>An extension has been constructed at the southern end of the dwelling. this is only partially visible and does not impact the heritage streetscape.</p>

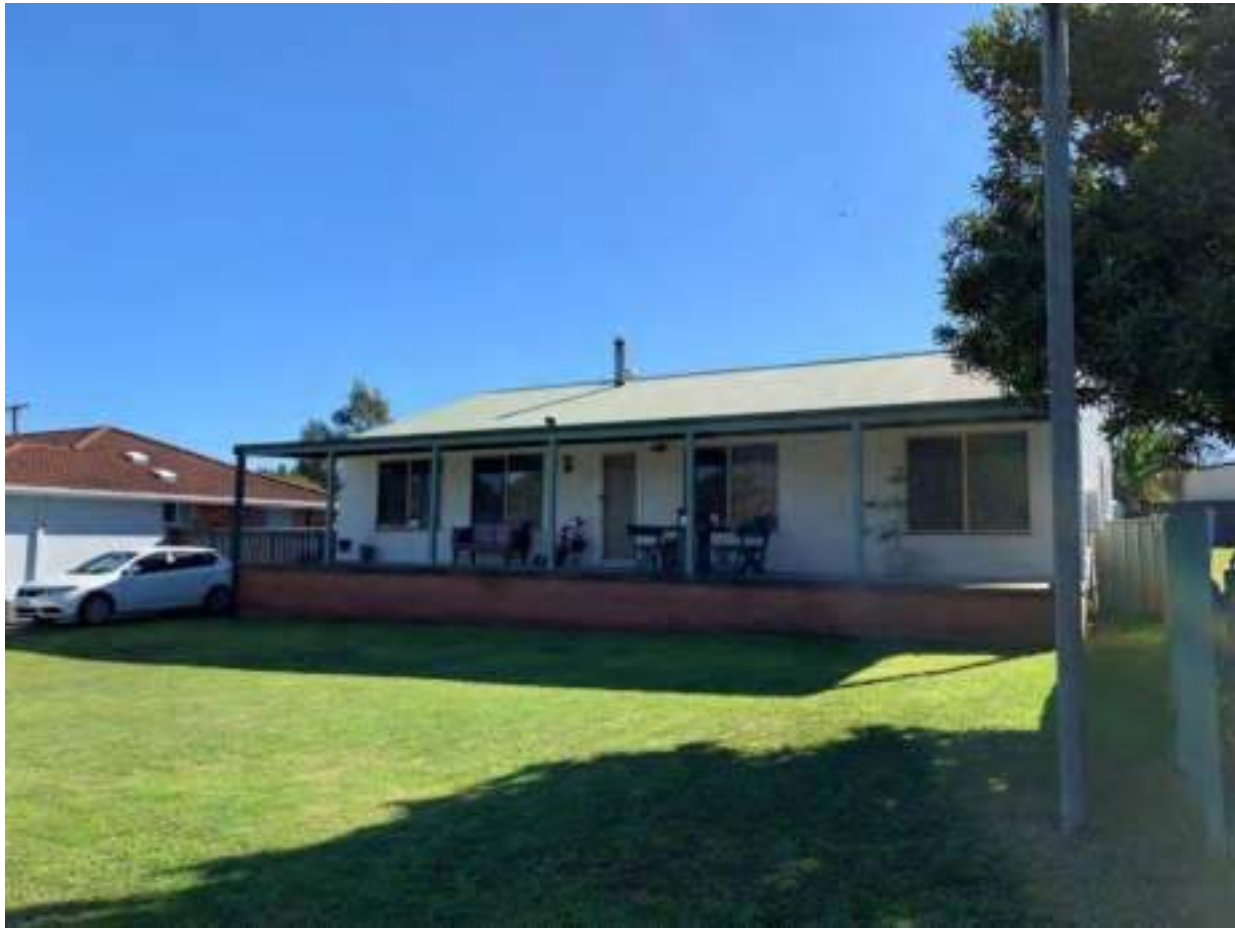
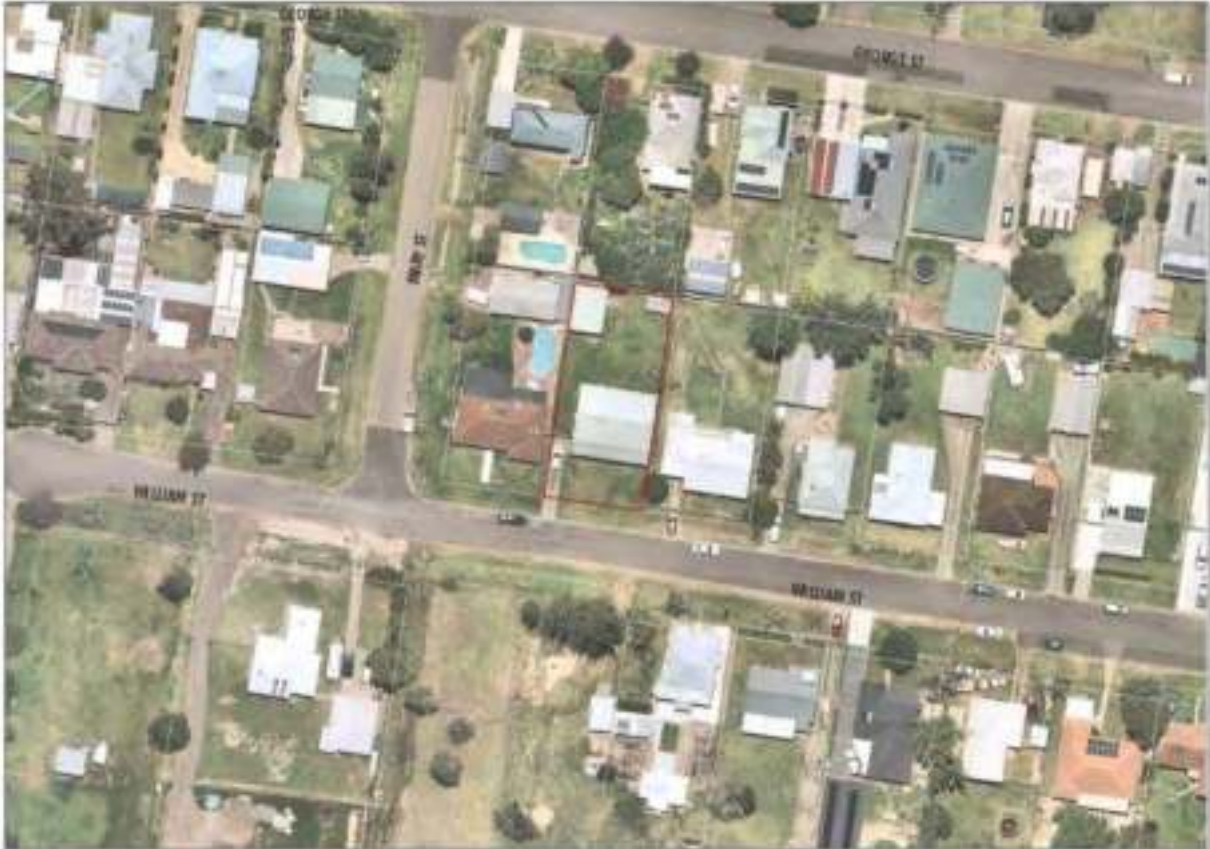
37 WILLIAM STREET, HOLMESVILLE 2286

Conservation Area Contribution Level	Est. Construction Date	Previous studies and/or community input
Contributory 2	Early to late 20 th century (broad range)	No prior heritage assessments or research undertaken.
Assessment Text		Observed Modifications
<p>The scale (single-storey) and general style of the dwelling is consistent with that of the streetscape and wider HCA. Dwelling contributes positively to the streetscape and wider HCA, particularly in comparison to Non-Contributory buildings.</p> <p>The dwelling features appropriately proportioned and positioned fenestrations, an appropriate roof form (gabled or hipped) and other features consistent with the architectural character of the area (e.g. front verandah with timber or brick posts, timber detailing, corrugated metal roofing, etc). The contributory value of the dwelling is limited however by either:</p> <ul style="list-style-type: none"> • External modifications that have in some way obscured the style, scale or design intent of the building and have resulted in less physical integrity than Contributory 1 buildings. • Being a later dwelling constructed in an appropriate referential style, but comprising little to no fabric of intrinsic heritage significance. 		<p>The visible windows are a contemporary design.</p> <p>Likely a timber balustrade has been removed, creating an open veranda space.</p>
