APPENDIX 2

Building Assessment Sheets (Inventory Sheets)

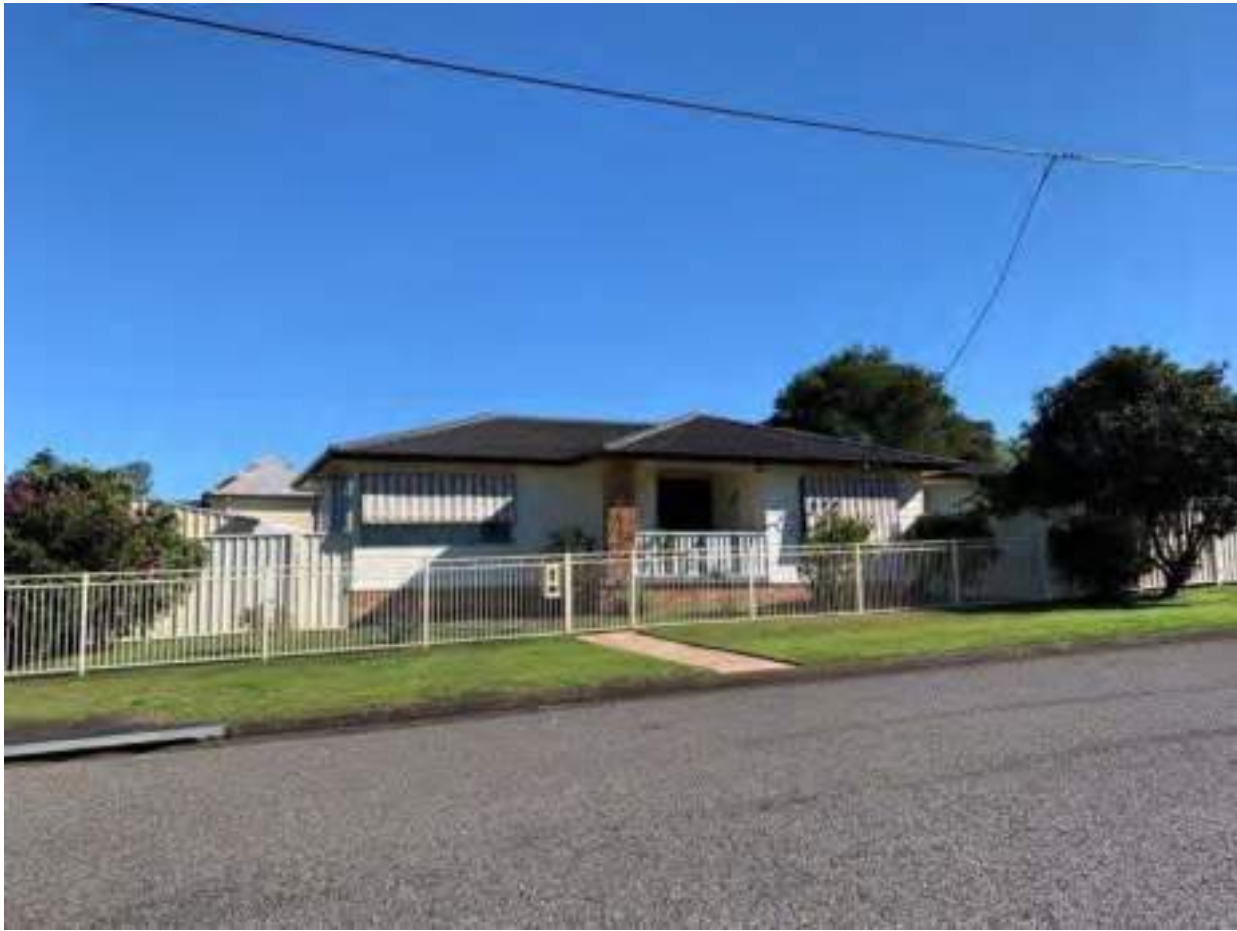
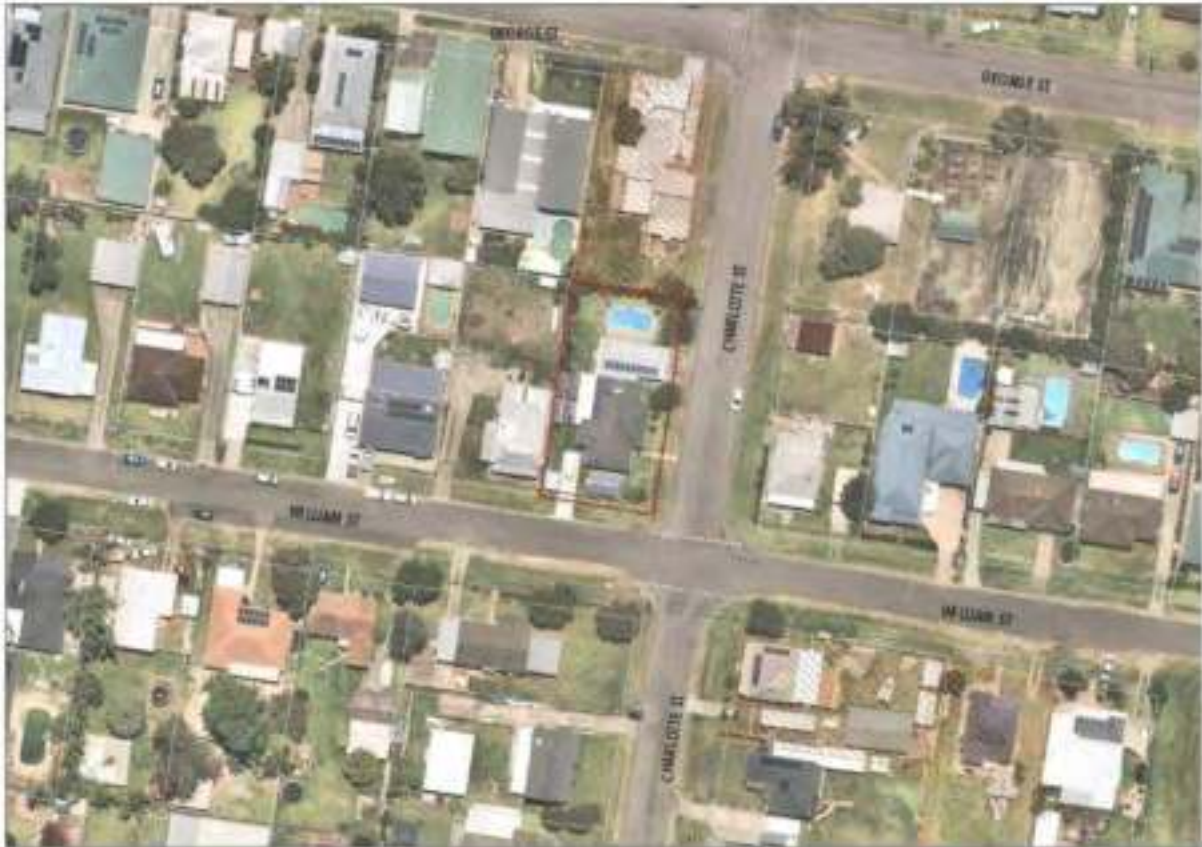
21 WILLIAM STREET, HOLMESVILLE 2286

Conservation Area Contribution Level	Est. Construction Date	Previous studies and/or community input
Contributory 2	Early to late 20 th century (broad range)	No prior heritage assessments or research undertaken.
Assessment Text		Observed Modifications
<p>The scale (single-storey) and general style of the dwelling is consistent with that of the streetscape and wider HCA. Dwelling contributes positively to the streetscape and wider HCA, particularly in comparison to Non-Contributory buildings.</p> <p>The dwelling features appropriately proportioned and positioned fenestrations, an appropriate roof form (gabled or hipped) and other features consistent with the architectural character of the area (e.g. front verandah with timber or brick posts, timber detailing, corrugated metal roofing, etc). The contributory value of the dwelling is limited however by either:</p> <ul style="list-style-type: none"> • External modifications that have in some way obscured the style, scale or design intent of the building and have resulted in less physical integrity than Contributory 1 buildings. • Being a later dwelling constructed in an appropriate referential style, but comprising little to no fabric of intrinsic heritage significance. 		No modifications observed.

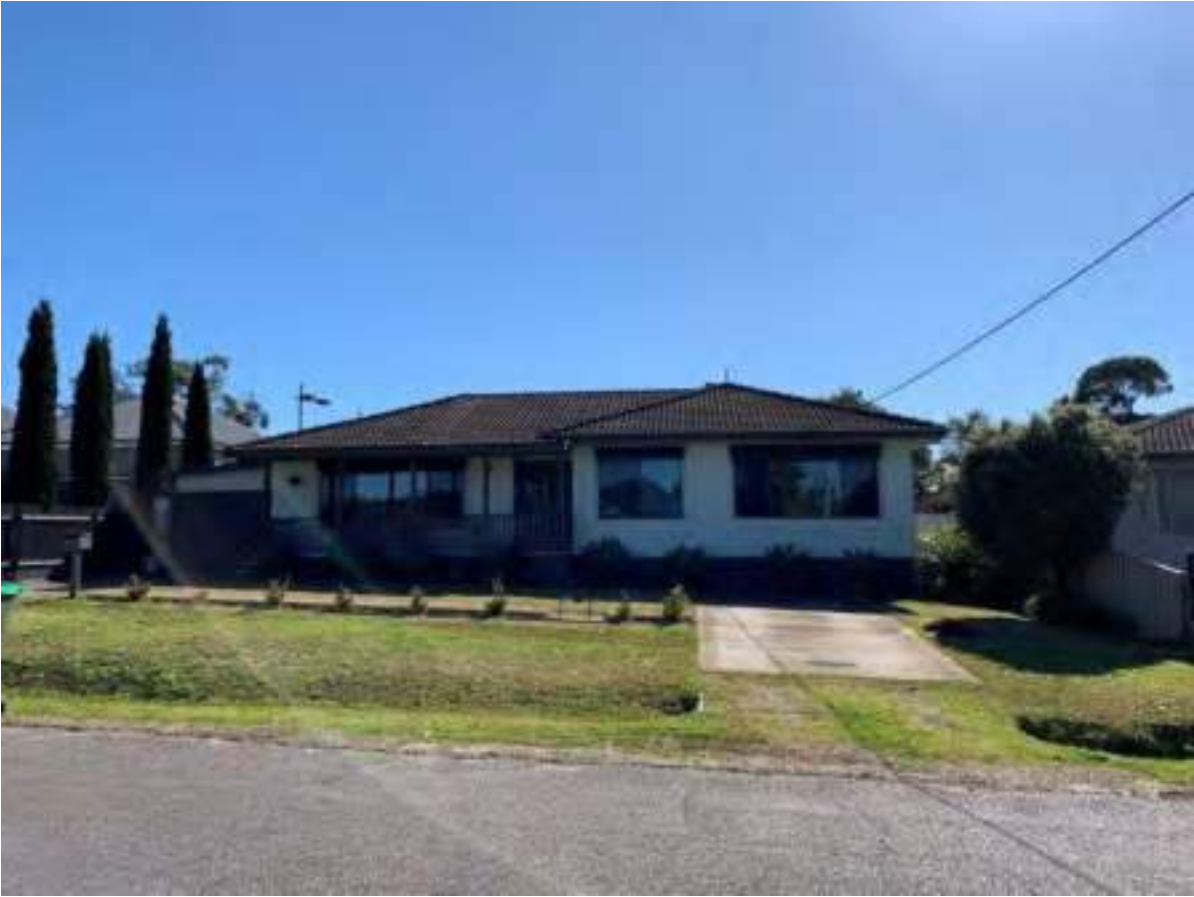
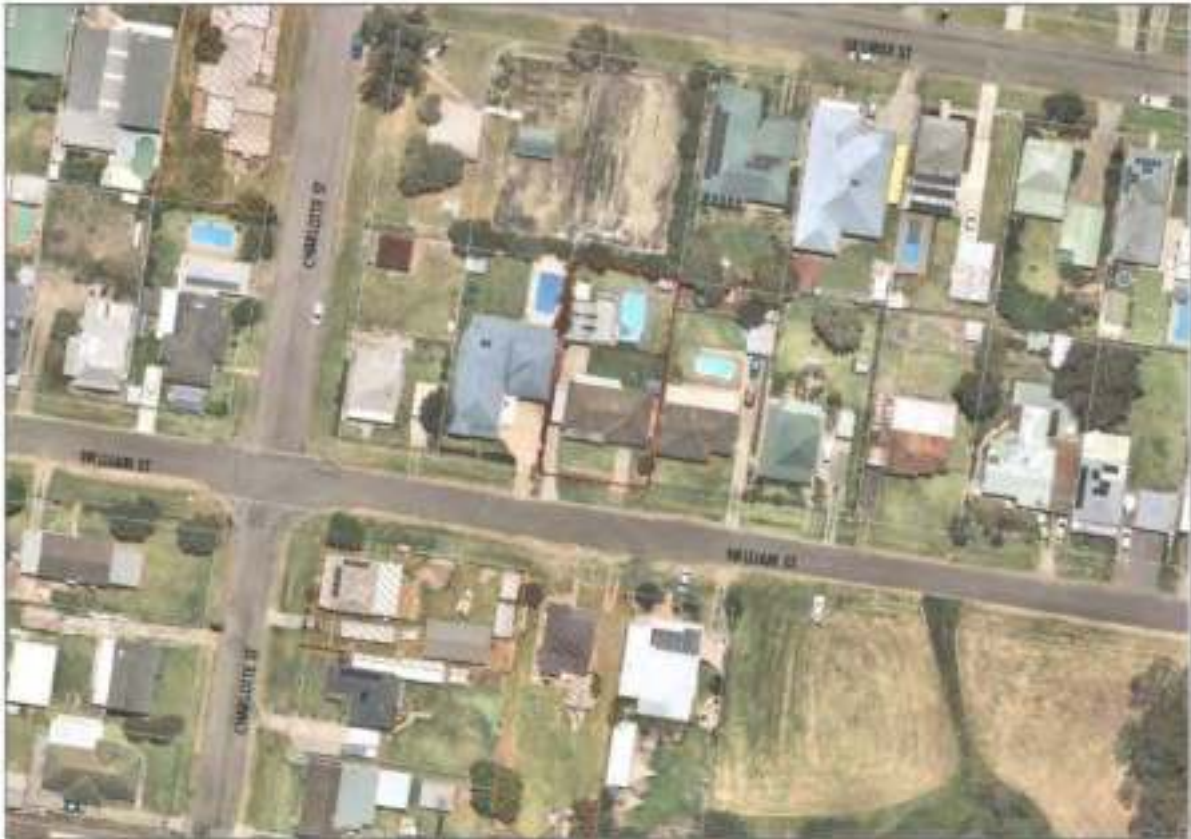
15 WILLIAM STREET, HOLMESVILLE 2286

Conservation Area Contribution Level	Est. Construction Date	Previous studies and/or community input
Contributory 2	Early to late 20 th century (broad range)	No prior heritage assessments or research undertaken.
Assessment Text		Observed Modifications
<p>The scale (single-storey) and general style of the dwelling is consistent with that of the streetscape and wider HCA. Dwelling contributes positively to the streetscape and wider HCA, particularly in comparison to Non-Contributory buildings.</p> <p>The dwelling features appropriately proportioned and positioned fenestrations, an appropriate roof form (gabled or hipped) and other features consistent with the architectural character of the area (e.g. front verandah with timber or brick posts, timber detailing, corrugated metal roofing, etc). The contributory value of the dwelling is limited however by either:</p> <ul style="list-style-type: none"> • External modifications that have in some way obscured the style, scale or design intent of the building and have resulted in less physical integrity than Contributory 1 buildings. • Being a later dwelling constructed in an appropriate referential style, but comprising little to no fabric of intrinsic heritage significance. 		<p>The timber balustrade enclosing the veranda is a contemporary addition to the dwelling. this has been constructed in a sympathetic manner and does not detract from the heritage streetscape.</p>

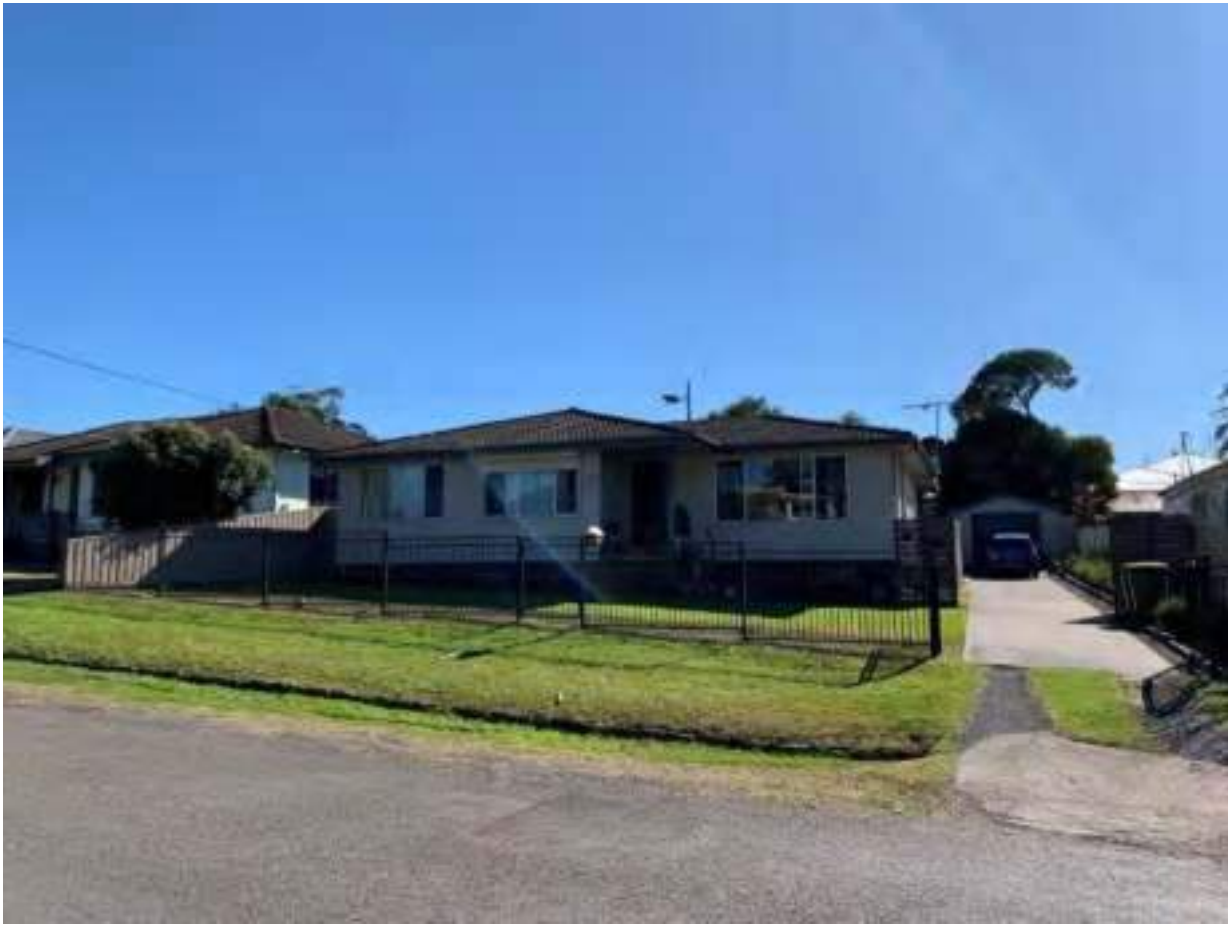
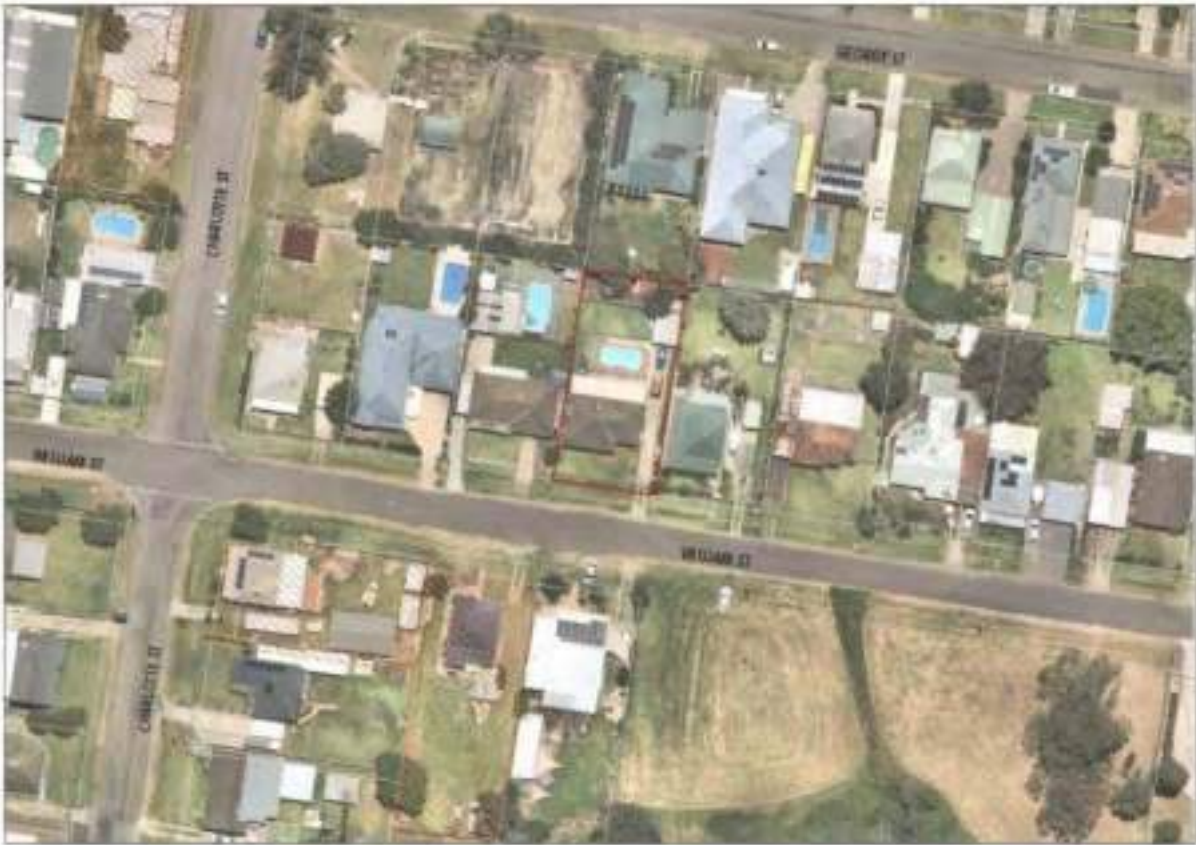
13 WILLIAM STREET, HOLMESVILLE 2286

Conservation Area Contribution Level	Est. Construction Date	Previous studies and/or community input
Contributory 2	Early to late 20 th century (broad range)	No prior heritage assessments or research undertaken.
Assessment Text		Observed Modifications
<p>The scale (single-storey) and general style of the dwelling is consistent with that of the streetscape and wider HCA. Dwelling contributes positively to the streetscape and wider HCA, particularly in comparison to Non-Contributory buildings.</p> <p>The dwelling features appropriately proportioned and positioned fenestrations, an appropriate roof form (gabled or hipped) and other features consistent with the architectural character of the area (e.g. front verandah with timber or brick posts, timber detailing, corrugated metal roofing, etc). The contributory value of the dwelling is limited however by either:</p> <ul style="list-style-type: none"> • External modifications that have in some way obscured the style, scale or design intent of the building and have resulted in less physical integrity than Contributory 1 buildings. • Being a later dwelling constructed in an appropriate referential style, but comprising little to no fabric of intrinsic heritage significance. 		<p>Roller metal shutters have been installed a top some of the southern windows.</p>

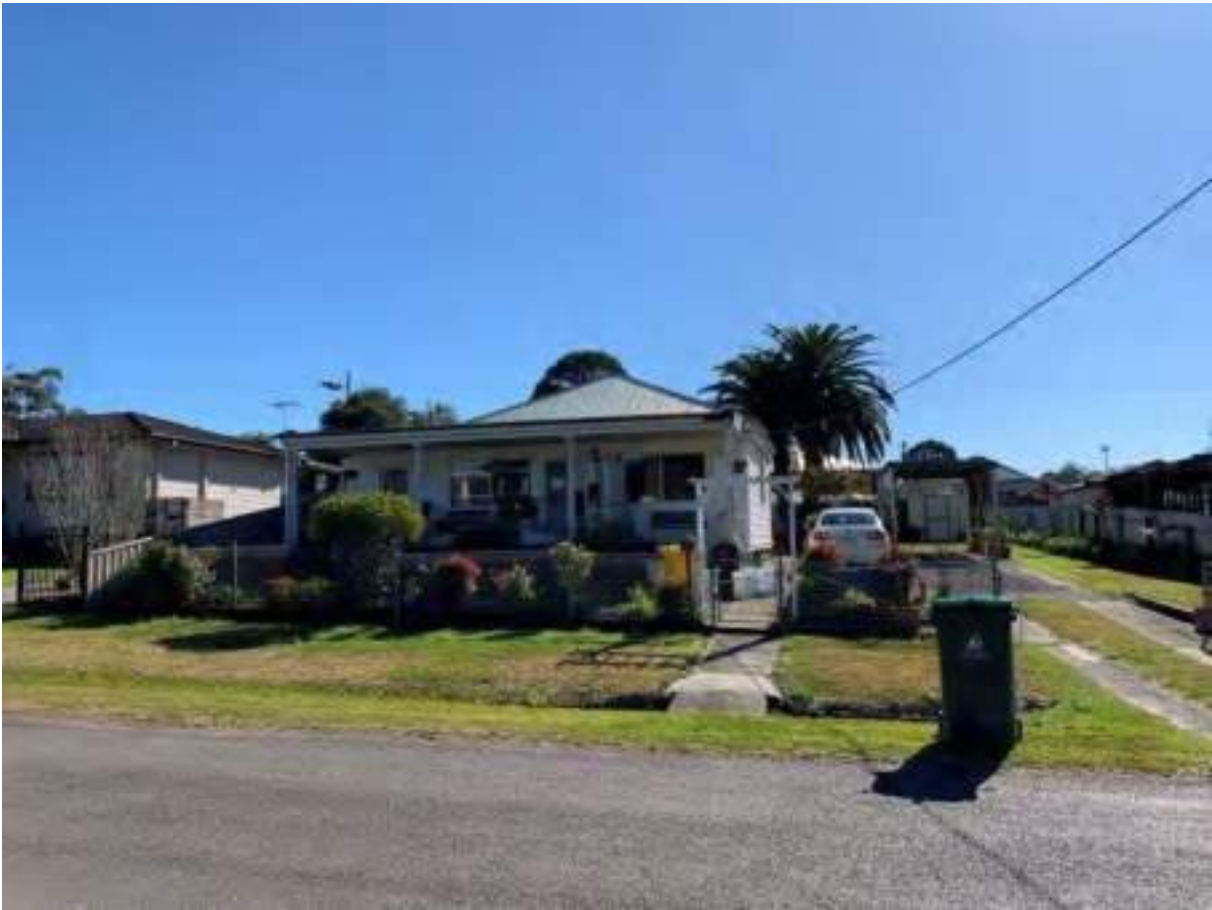
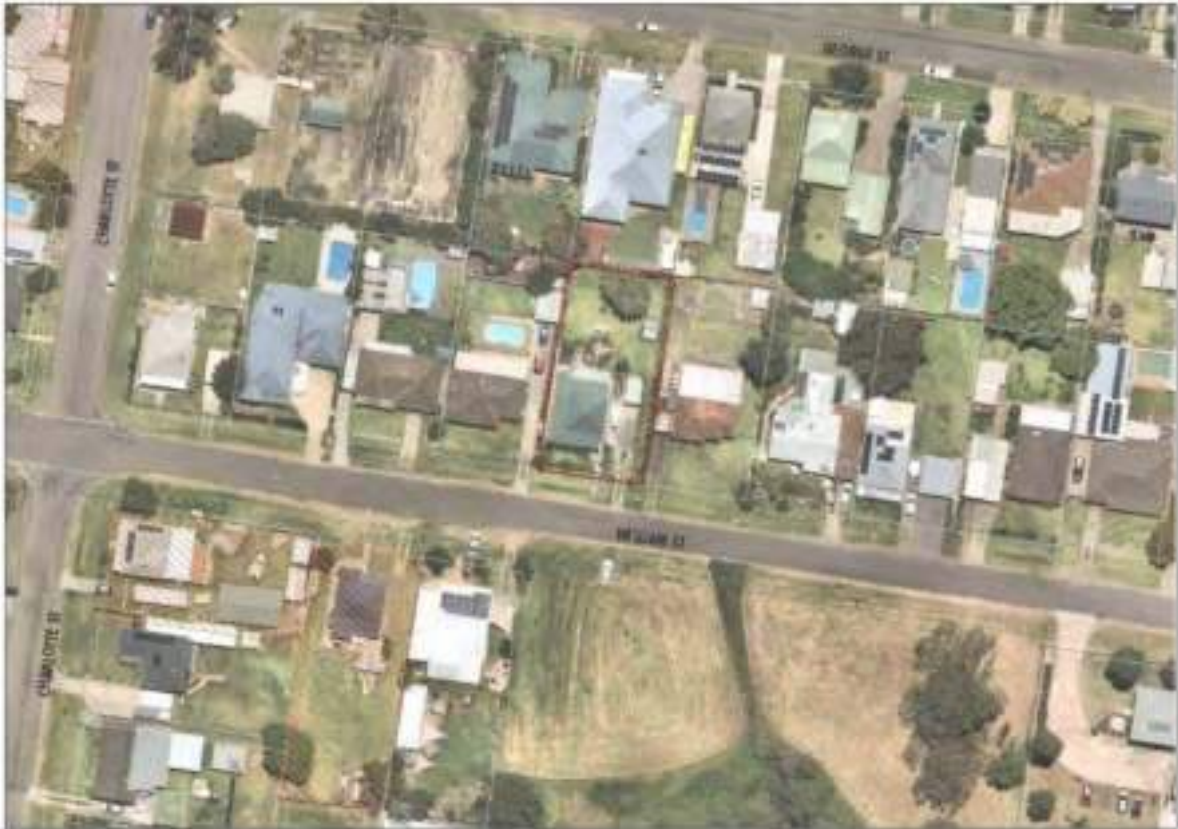
11 WILLIAM STREET, HOLMESVILLE 2286

Conservation Area Contribution Level	Est. Construction Date	Previous studies and/or community input
Contributory 2	Early to late 20 th century (broad range)	No prior heritage assessments or research undertaken.
Assessment Text		Observed Modifications
<p>The scale (single-storey) and general style of the dwelling is consistent with that of the streetscape and wider HCA. Dwelling contributes positively to the streetscape and wider HCA, particularly in comparison to Non-Contributory buildings.</p> <p>The dwelling features appropriately proportioned and positioned fenestrations, an appropriate roof form (gabled or hipped) and other features consistent with the architectural character of the area (e.g. front verandah with timber or brick posts, timber detailing, corrugated metal roofing, etc). The contributory value of the dwelling is limited however by either:</p> <ul style="list-style-type: none"> • External modifications that have in some way obscured the style, scale or design intent of the building and have resulted in less physical integrity than Contributory 1 buildings. • Being a later dwelling constructed in an appropriate referential style, but comprising little to no fabric of intrinsic heritage significance. 		<p>An extension has been constructed to the west and southern sides of the dwelling, creating an additional living room and extending the veranda space.</p> <p>The faux European pillars are likely a contemporary addition.</p> <p>All visible windows are a contemporary sliding design.</p>

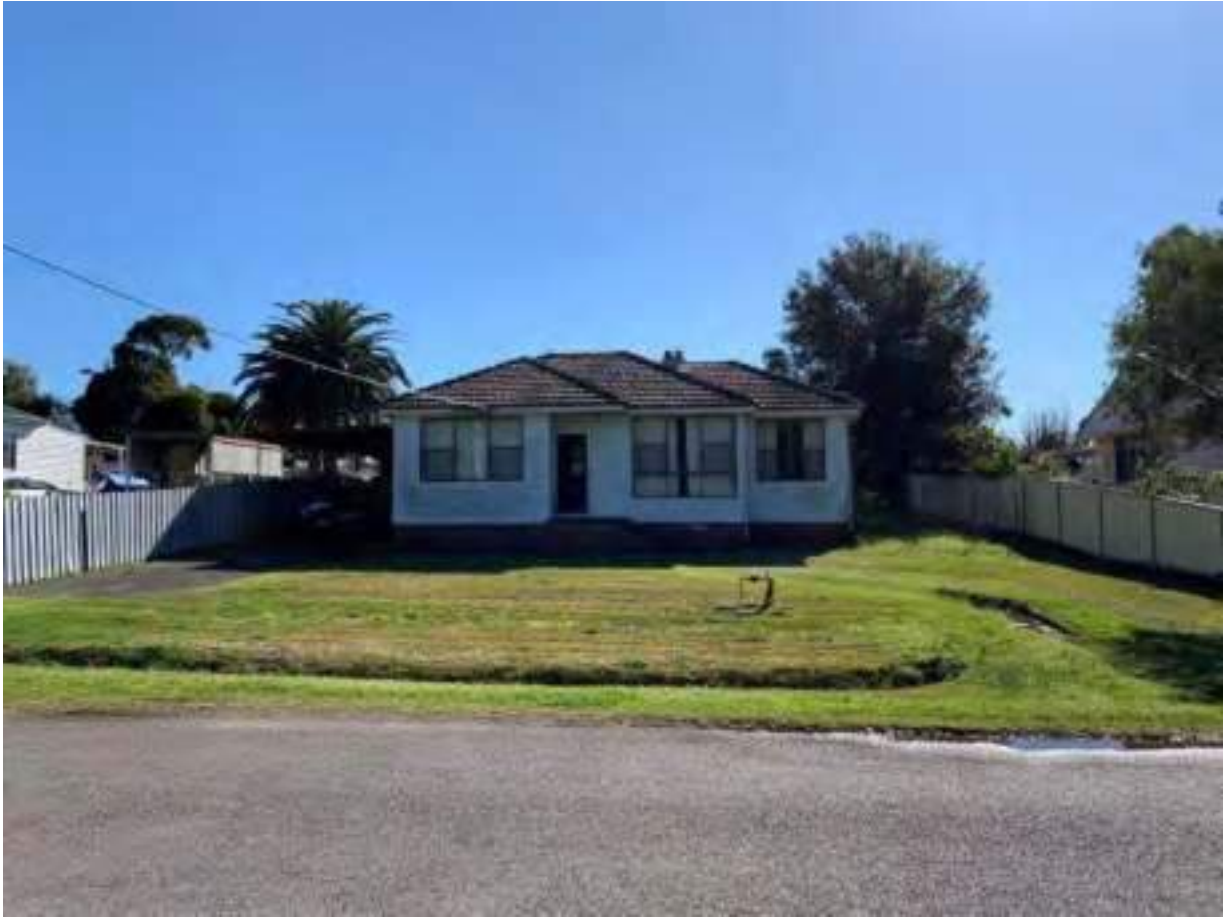
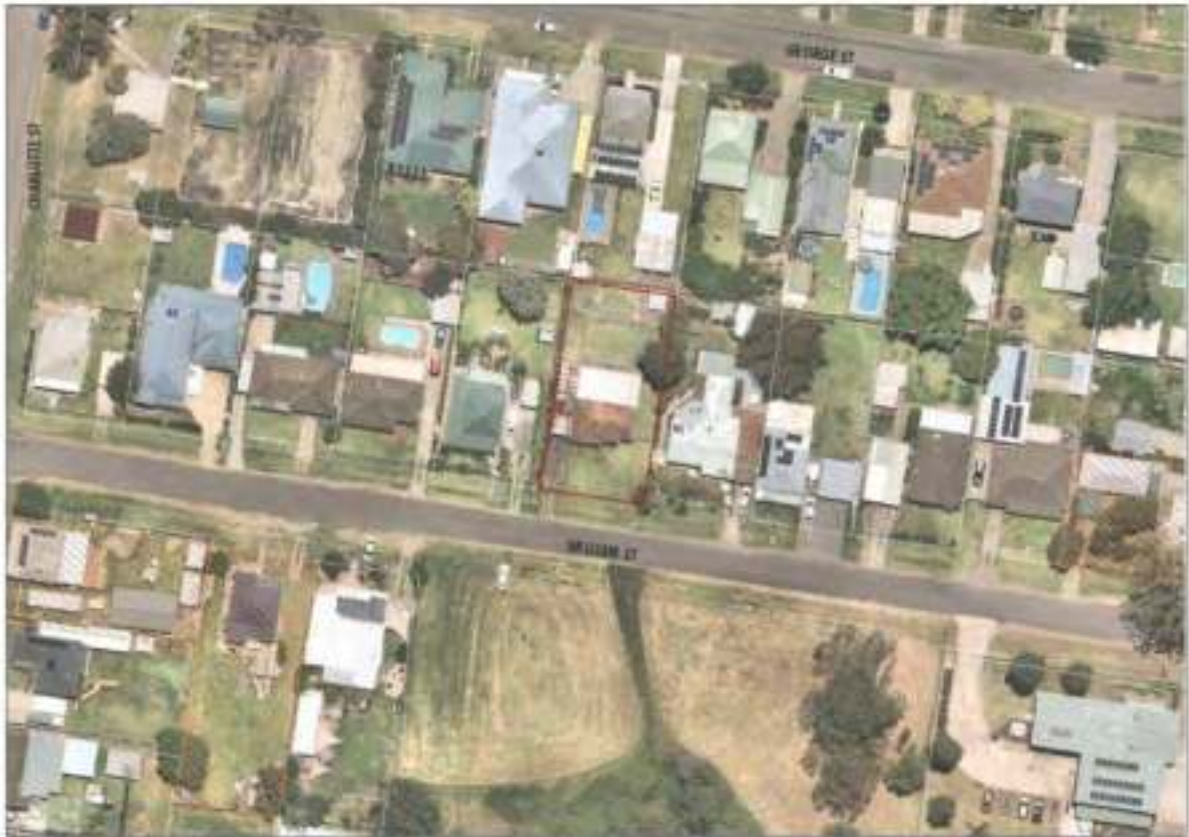
9 WILLIAM STREET, HOLMESVILLE 2286

Conservation Area Contribution Level	Est. Construction Date	Previous studies and/or community input
Contributory 2	Early to late 20 th century (broad range)	No prior heritage assessments or research undertaken.
Assessment Text		Observed Modifications
<p>The scale (single-storey) and general style of the dwelling is consistent with that of the streetscape and wider HCA. Dwelling contributes positively to the streetscape and wider HCA, particularly in comparison to Non-Contributory buildings.</p> <p>The dwelling features appropriately proportioned and positioned fenestrations, an appropriate roof form (gabled or hipped) and other features consistent with the architectural character of the area (e.g. front verandah with timber or brick posts, timber detailing, corrugated metal roofing, etc). The contributory value of the dwelling is limited however by either:</p> <ul style="list-style-type: none"> • External modifications that have in some way obscured the style, scale or design intent of the building and have resulted in less physical integrity than Contributory 1 buildings. • Being a later dwelling constructed in an appropriate referential style, but comprising little to no fabric of intrinsic heritage significance. 		No modifications observed.

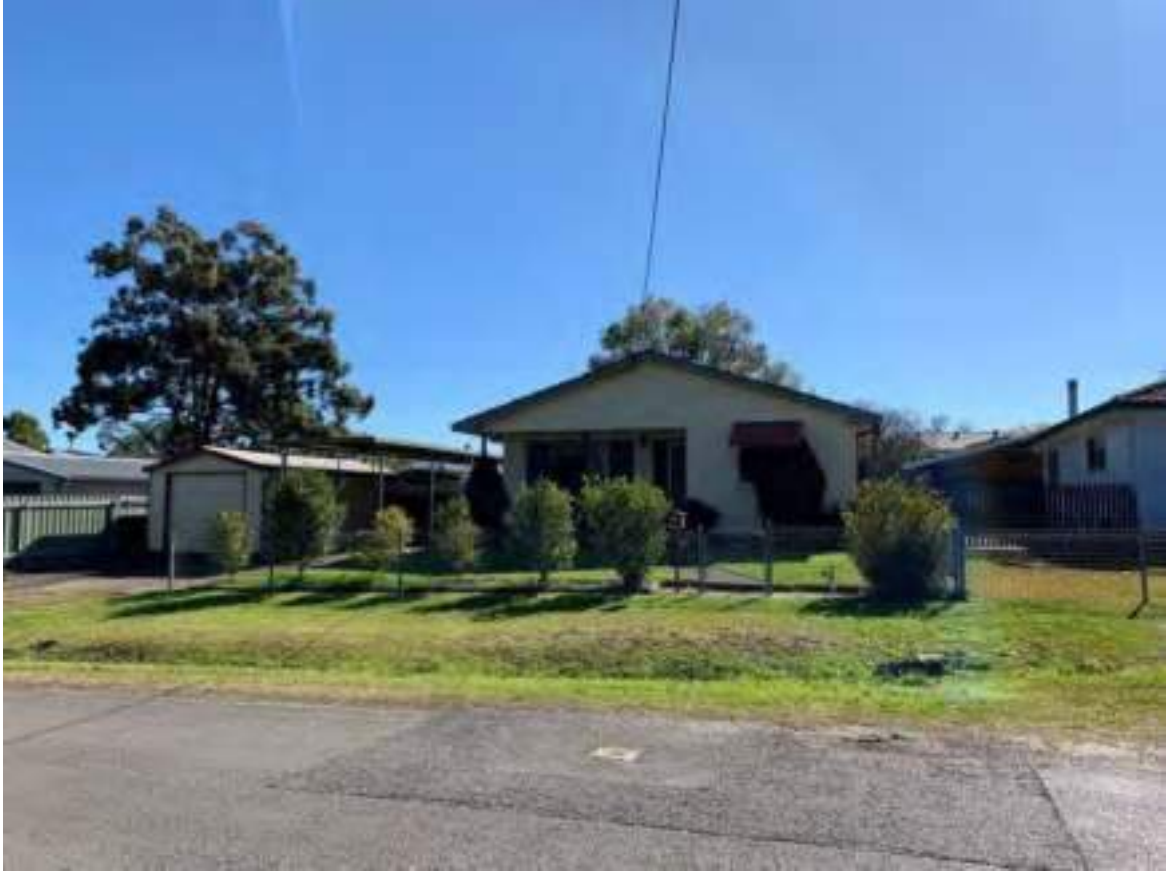
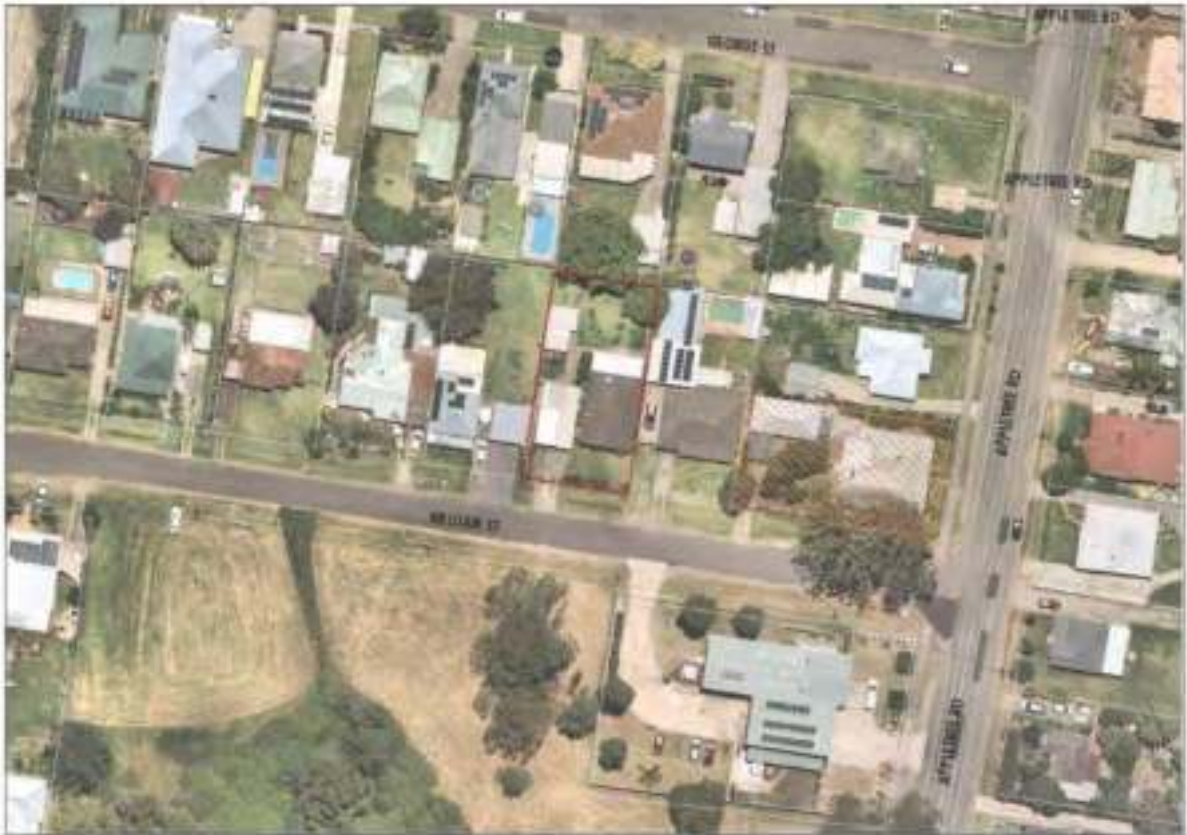
3 WILLIAM STREET, HOLMESVILLE 2286

Conservation Area Contribution Level	Est. Construction Date	Previous studies and/or community input
Contributory 2	Early to late 20 th century (broad range)	No prior heritage assessments or research undertaken.
Assessment Text		Observed Modifications
<p>The scale (single-storey) and general style of the dwelling is consistent with that of the streetscape and wider HCA. Dwelling contributes positively to the streetscape and wider HCA, particularly in comparison to Non-Contributory buildings.</p> <p>The dwelling features appropriately proportioned and positioned fenestrations, an appropriate roof form (gabled or hipped) and other features consistent with the architectural character of the area (e.g. front verandah with timber or brick posts, timber detailing, corrugated metal roofing, etc). The contributory value of the dwelling is limited however by either:</p> <ul style="list-style-type: none"> • External modifications that have in some way obscured the style, scale or design intent of the building and have resulted in less physical integrity than Contributory 1 buildings. • Being a later dwelling constructed in an appropriate referential style, but comprising little to no fabric of intrinsic heritage significance. 		<p>A car port has been constructed to the western side of the dwelling.</p>

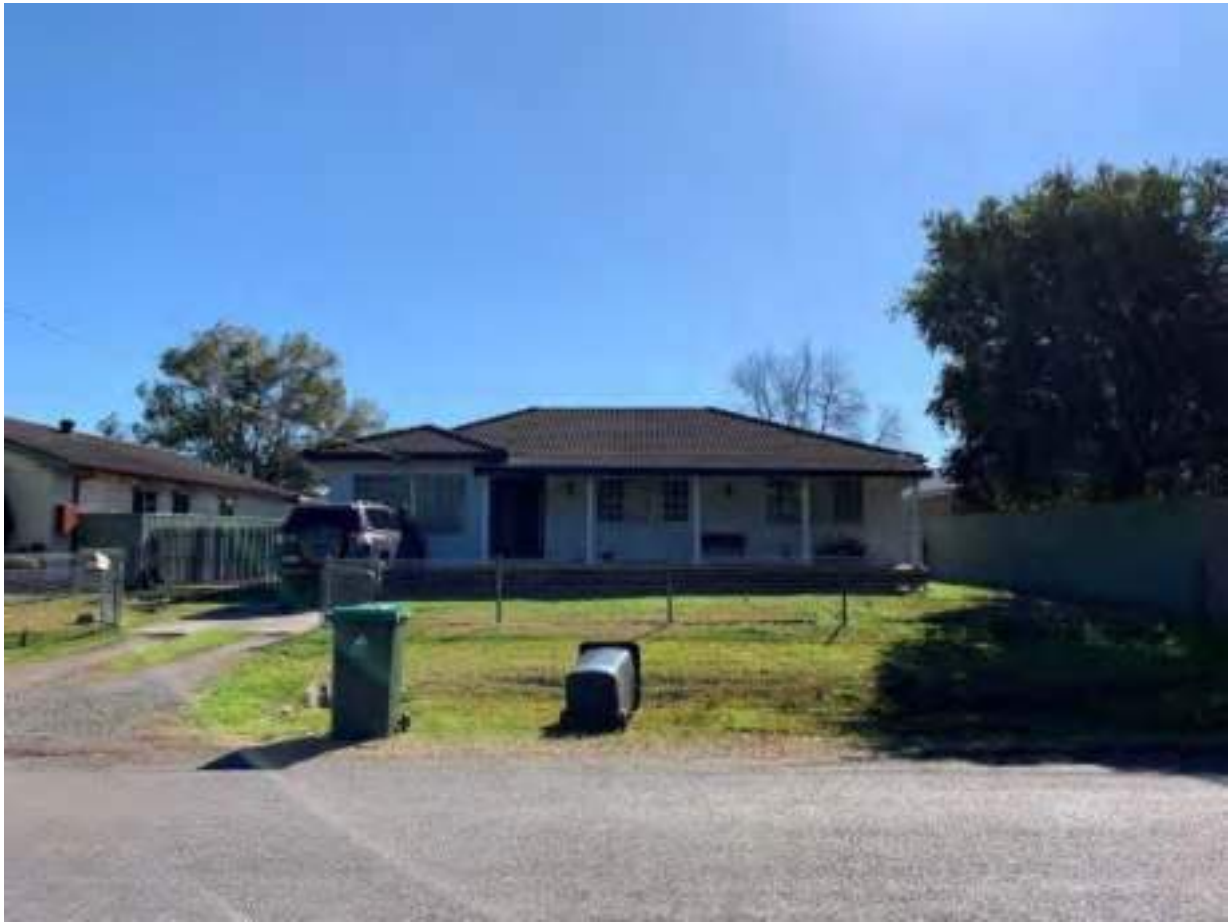
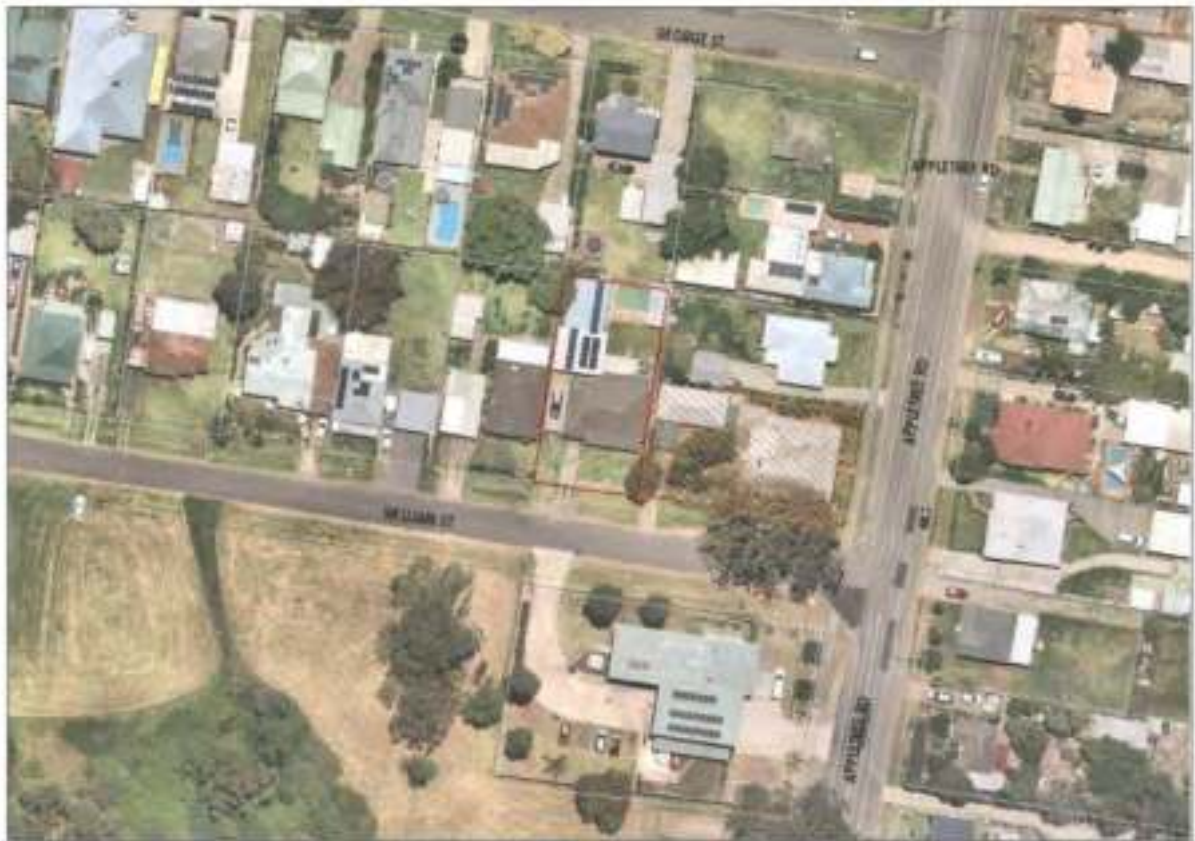
1 WILLIAM STREET, HOLMESVILLE 2286

Conservation Area Contribution Level	Est. Construction Date	Previous studies and/or community input
Contributory 2	Early to late 20 th century (broad range)	No prior heritage assessments or research undertaken.
Assessment Text		Observed Modifications
<p>The scale (single-storey) and general style of the dwelling is consistent with that of the streetscape and wider HCA. Dwelling contributes positively to the streetscape and wider HCA, particularly in comparison to Non-Contributory buildings.</p> <p>The dwelling features appropriately proportioned and positioned fenestrations, an appropriate roof form (gabled or hipped) and other features consistent with the architectural character of the area (e.g. front verandah with timber or brick posts, timber detailing, corrugated metal roofing, etc). The contributory value of the dwelling is limited however by either:</p> <ul style="list-style-type: none"> • External modifications that have in some way obscured the style, scale or design intent of the building and have resulted in less physical integrity than Contributory 1 buildings. • Being a later dwelling constructed in an appropriate referential style, but comprising little to no fabric of intrinsic heritage significance. 		<p>The faux European pillars are likely a contemporary addition. This is a common modification for the area.</p>

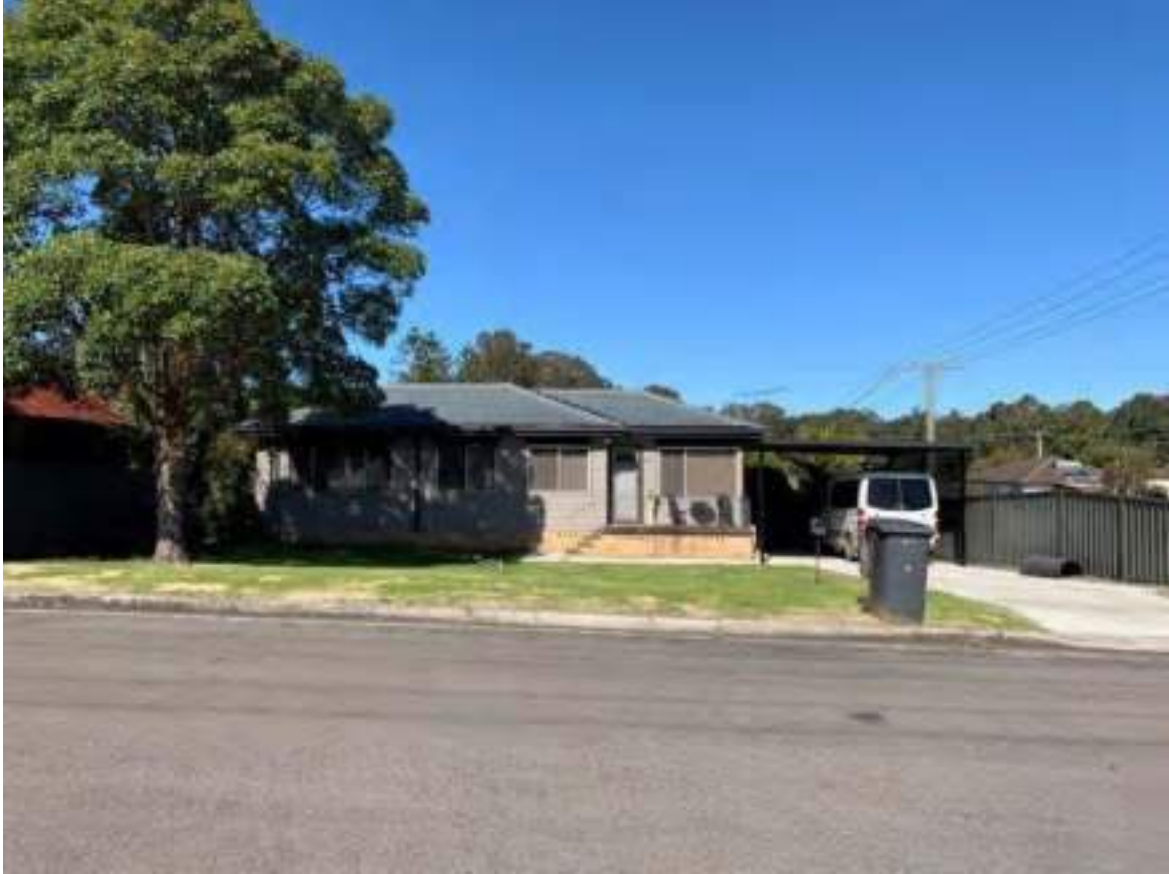
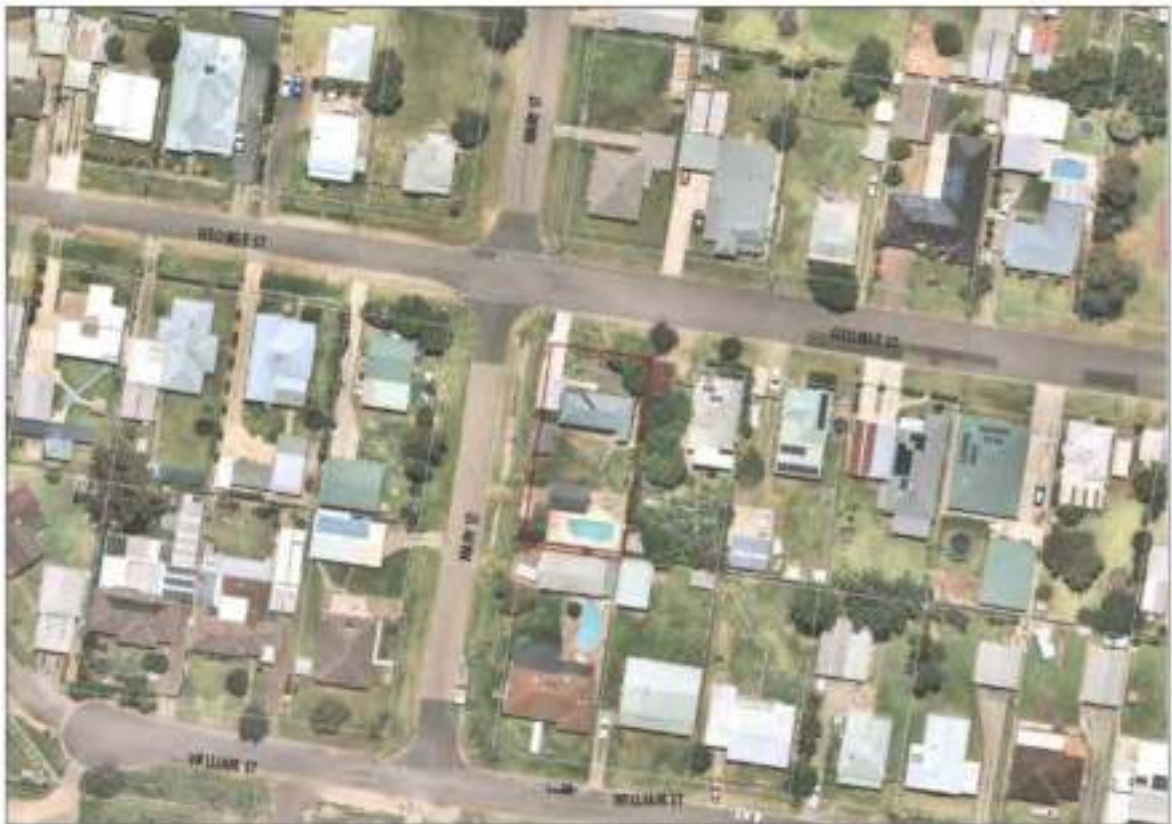
36 GEORGE STREET, HOLMESVILLE 2286

Conservation Area Contribution Level	Est. Construction Date	Previous studies and/or community input
Contributory 2	Early to late 20 th century (broad range)	No prior heritage assessments or research undertaken.
Assessment Text		Observed Modifications
<p>The scale (single-storey) and general style of the dwelling is consistent with that of the streetscape and wider HCA. Dwelling contributes positively to the streetscape and wider HCA, particularly in comparison to Non-Contributory buildings.</p> <p>The dwelling features appropriately proportioned and positioned fenestrations, an appropriate roof form (gabled or hipped) and other features consistent with the architectural character of the area (e.g. front verandah with timber or brick posts, timber detailing, corrugated metal roofing, etc). The contributory value of the dwelling is limited however by either:</p> <ul style="list-style-type: none"> • External modifications that have in some way obscured the style, scale or design intent of the building and have resulted in less physical integrity than Contributory 1 buildings. • Being a later dwelling constructed in an appropriate referential style, but comprising little to no fabric of intrinsic heritage significance. 		<p>A car port has been built onto the western side of the dwelling.</p>

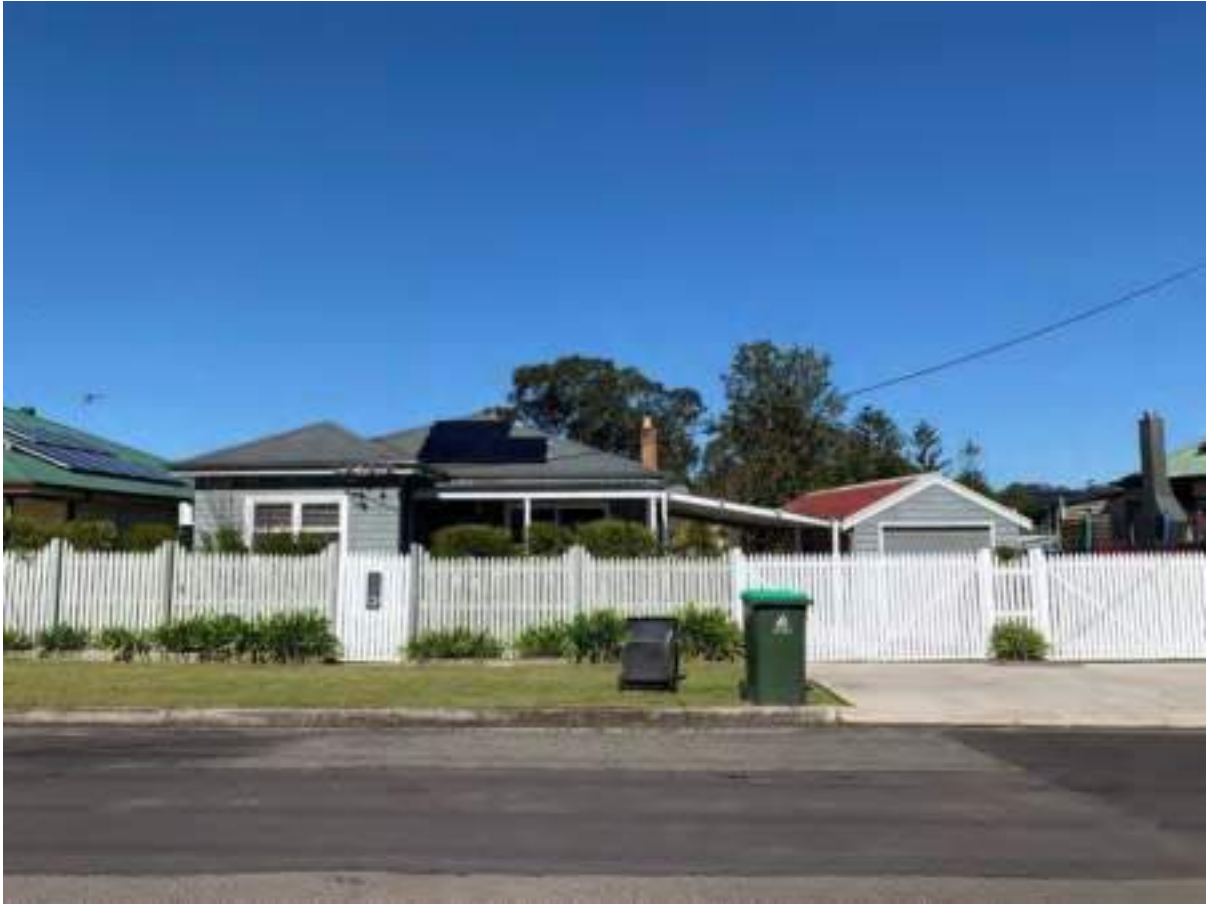
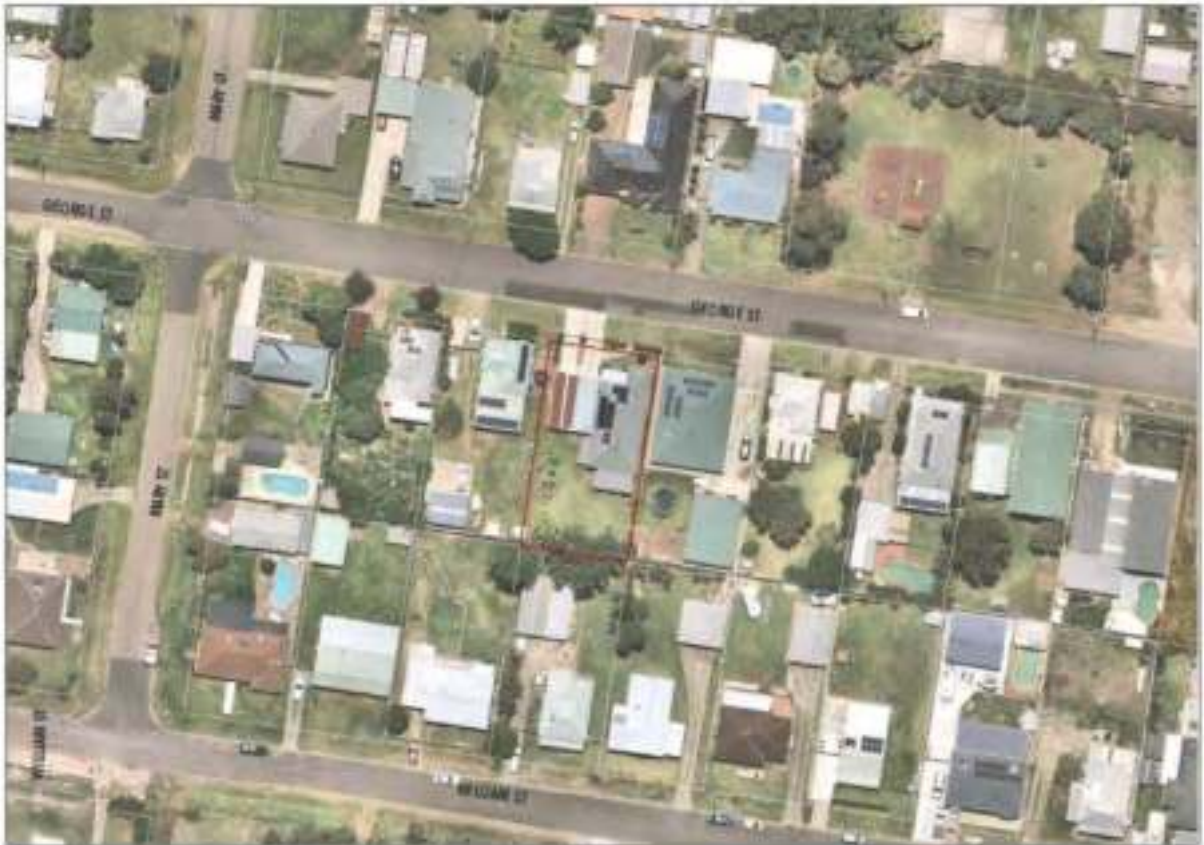
30 GEORGE STREET, HOLMESVILLE 2286

Conservation Area Contribution Level	Est. Construction Date	Previous studies and/or community input
Contributory 2	Early to late 20 th century (broad range)	No prior heritage assessments or research undertaken.
Assessment Text		Observed Modifications
<p>The scale (single-storey) and general style of the dwelling is consistent with that of the streetscape and wider HCA. Dwelling contributes positively to the streetscape and wider HCA, particularly in comparison to Non-Contributory buildings.</p> <p>The dwelling features appropriately proportioned and positioned fenestrations, an appropriate roof form (gabled or hipped) and other features consistent with the architectural character of the area (e.g. front verandah with timber or brick posts, timber detailing, corrugated metal roofing, etc). The contributory value of the dwelling is limited however by either:</p> <ul style="list-style-type: none"> • External modifications that have in some way obscured the style, scale or design intent of the building and have resulted in less physical integrity than Contributory 1 buildings. • Being a later dwelling constructed in an appropriate referential style, but comprising little to no fabric of intrinsic heritage significance. 		<p>Solar panels are highly visible along the north and western side of the roof.</p> <p>A carport has been constructed on the western side of the dwelling.</p> <p>The veranda is a contemporary addition, possibly replacing an original design. The skillion roof, posts and timber balustrade are all recent additions.</p>
