APPENDIX 2

Building Assessment Sheets (Inventory Sheets)

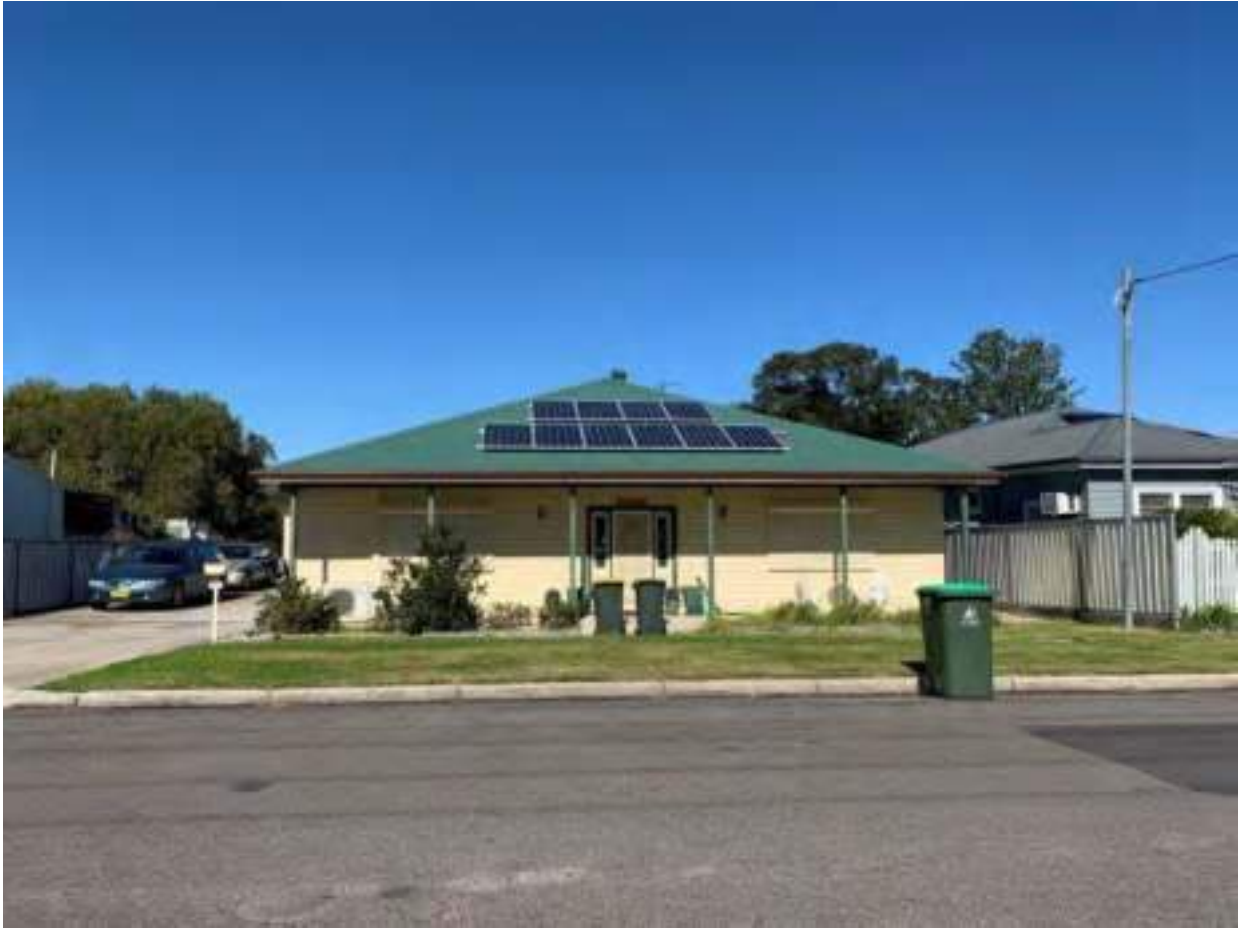
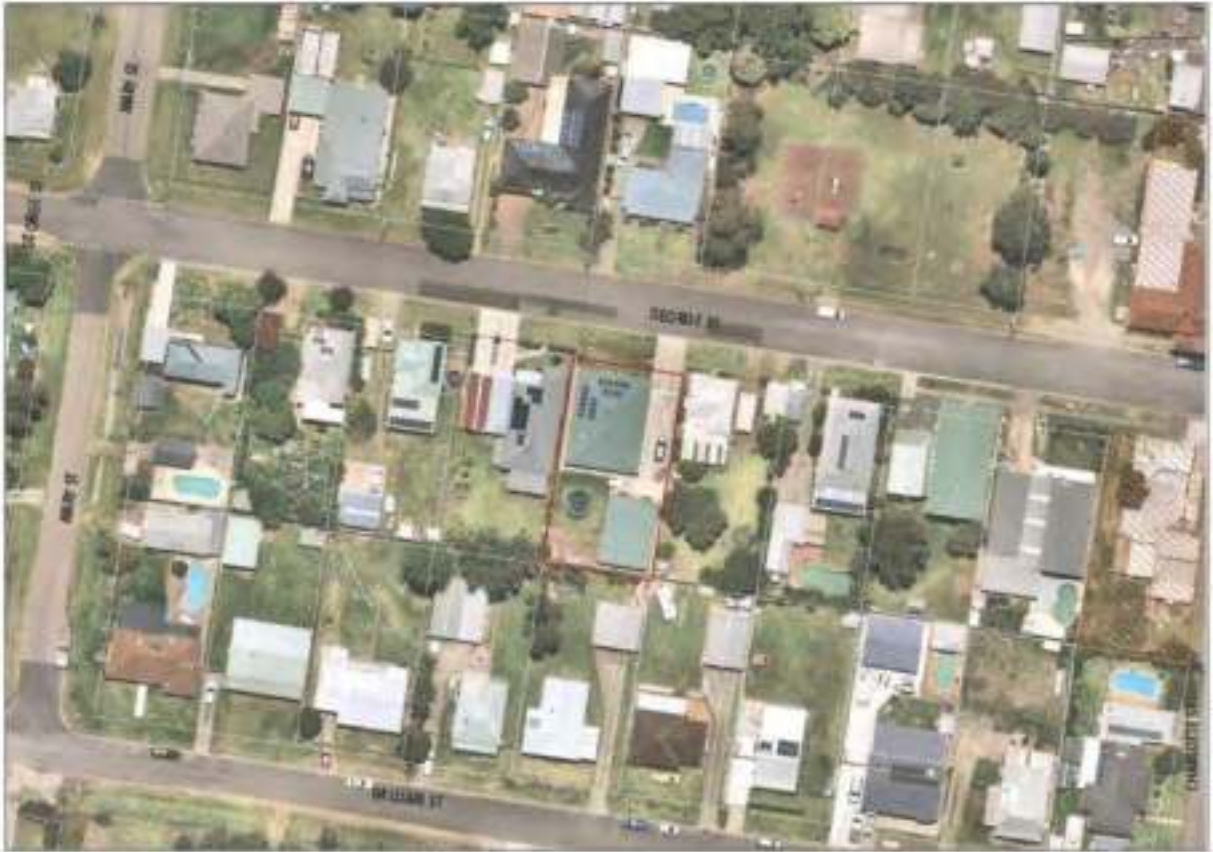
28 GEORGE STREET, HOLMESVILLE 2286

Conservation Area Contribution Level	Est. Construction Date	Previous studies and/or community input
Contributory 2	Early to late 20 th century (broad range)	No prior heritage assessments or research undertaken.
Assessment Text		Observed Modifications
<p>The scale (single-storey) and general style of the dwelling is consistent with that of the streetscape and wider HCA. Dwelling contributes positively to the streetscape and wider HCA, particularly in comparison to Non-Contributory buildings.</p> <p>The dwelling features appropriately proportioned and positioned fenestrations, an appropriate roof form (gabled or hipped) and other features consistent with the architectural character of the area (e.g. front verandah with timber or brick posts, timber detailing, corrugated metal roofing, etc). The contributory value of the dwelling is limited however by either:</p> <ul style="list-style-type: none"> • External modifications that have in some way obscured the style, scale or design intent of the building and have resulted in less physical integrity than Contributory 1 buildings. • Being a later dwelling constructed in an appropriate referential style, but comprising little to no fabric of intrinsic heritage significance. 		<p>Solar panels are highly visible along the north and western portion of the roof.</p> <p>Metal roller shutters have been installed a top the visible windows.</p>

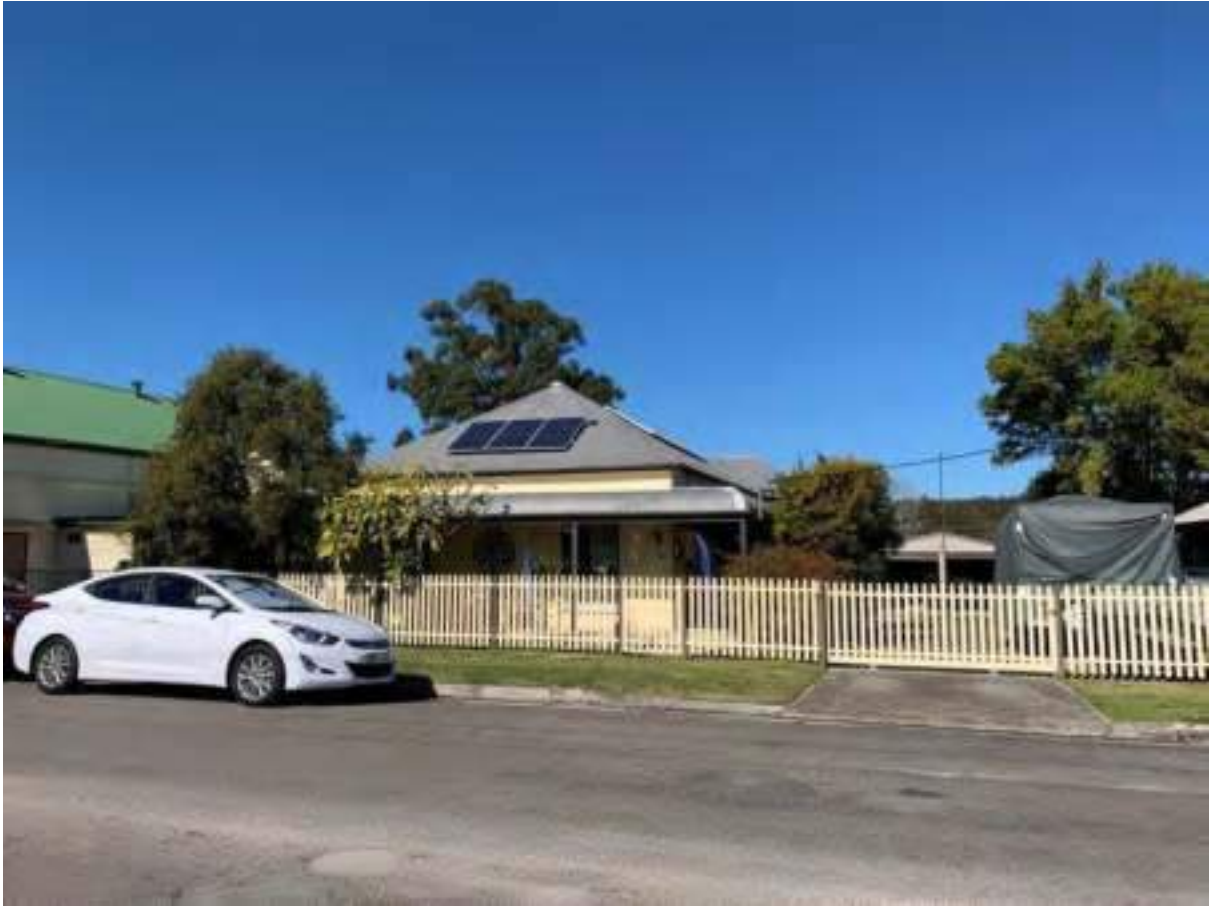
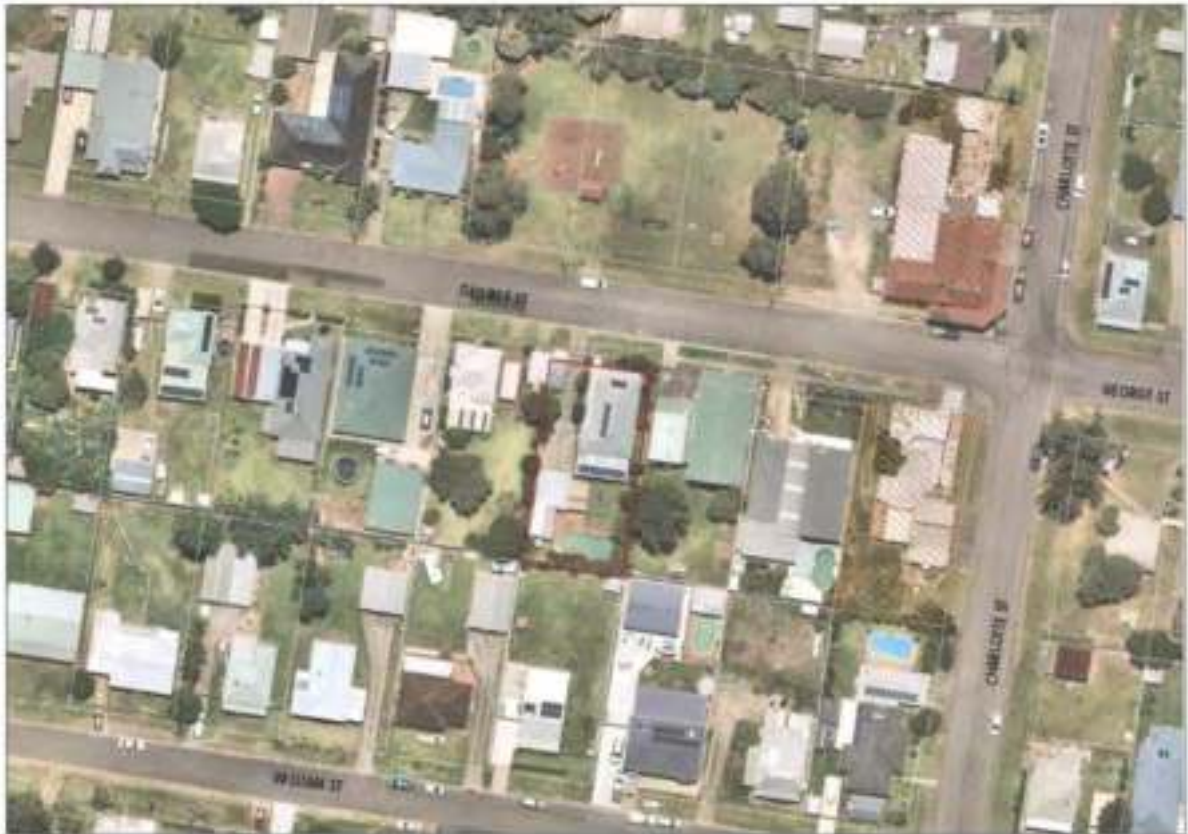
24 GEORGE STREET, HOLMESVILLE 2286

Conservation Area Contribution Level	Est. Construction Date	Previous studies and/or community input
Contributory 2	Early to late 20 th century (broad range)	No prior heritage assessments or research undertaken.
Assessment Text		Observed Modifications
<p>The scale (single-storey) and general style of the dwelling is consistent with that of the streetscape and wider HCA. Dwelling contributes positively to the streetscape and wider HCA, particularly in comparison to Non-Contributory buildings.</p> <p>The dwelling features appropriately proportioned and positioned fenestrations, an appropriate roof form (gabled or hipped) and other features consistent with the architectural character of the area (e.g. front verandah with timber or brick posts, timber detailing, corrugated metal roofing, etc). The contributory value of the dwelling is limited however by either:</p> <ul style="list-style-type: none"> • External modifications that have in some way obscured the style, scale or design intent of the building and have resulted in less physical integrity than Contributory 1 buildings. • Being a later dwelling constructed in an appropriate referential style, but comprising little to no fabric of intrinsic heritage significance. 		<p>Solar panels are highly visible on the northern portion of the roof.</p> <p>The visible windows are contemporary in design, however the dwelling is likely a contemporary replication of a heritage style and as such they may be the original.</p>

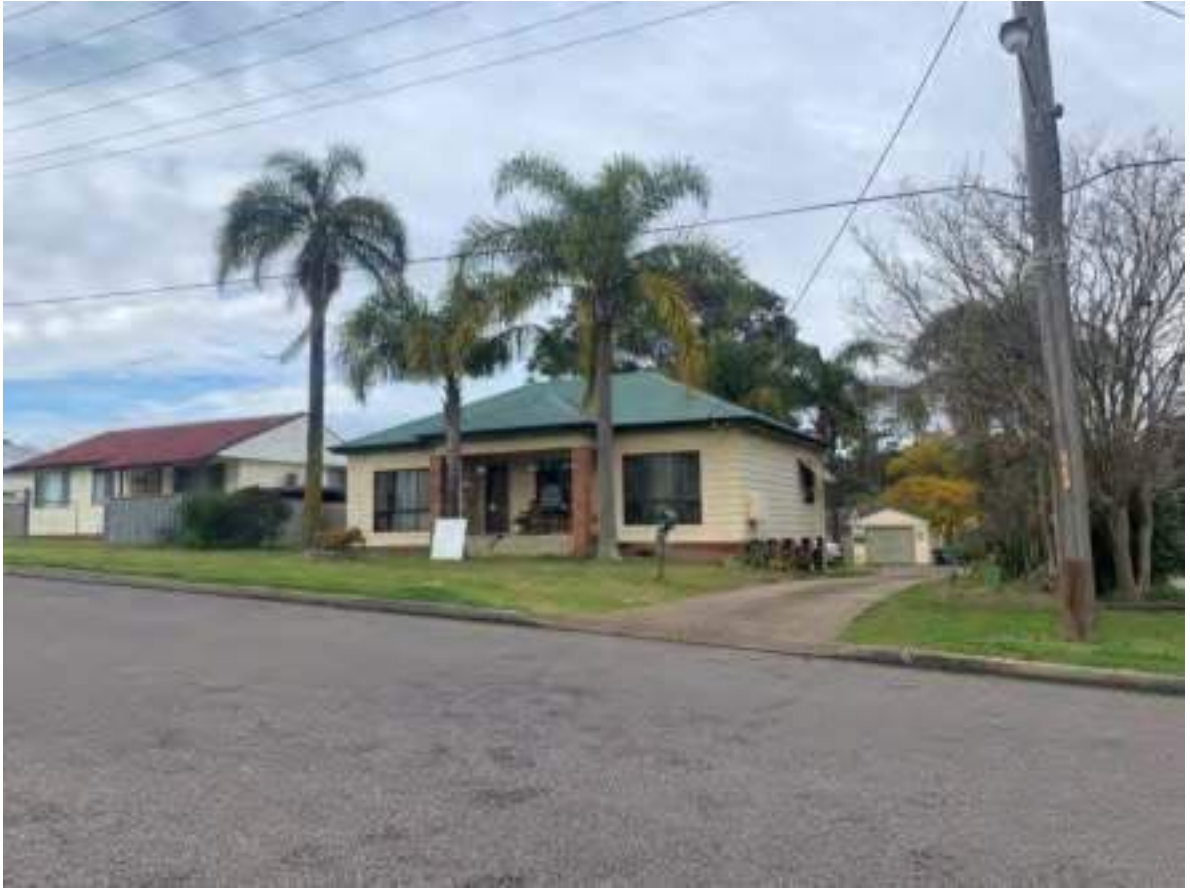
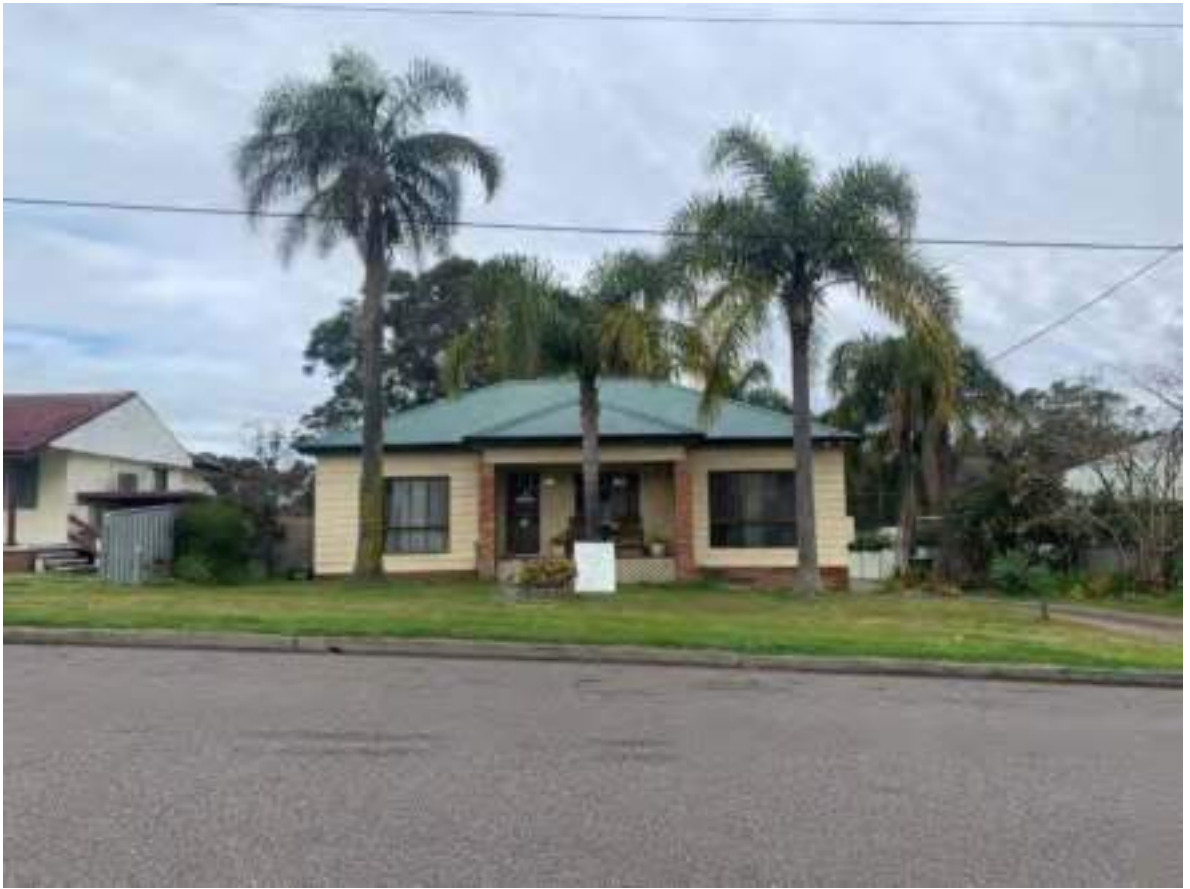
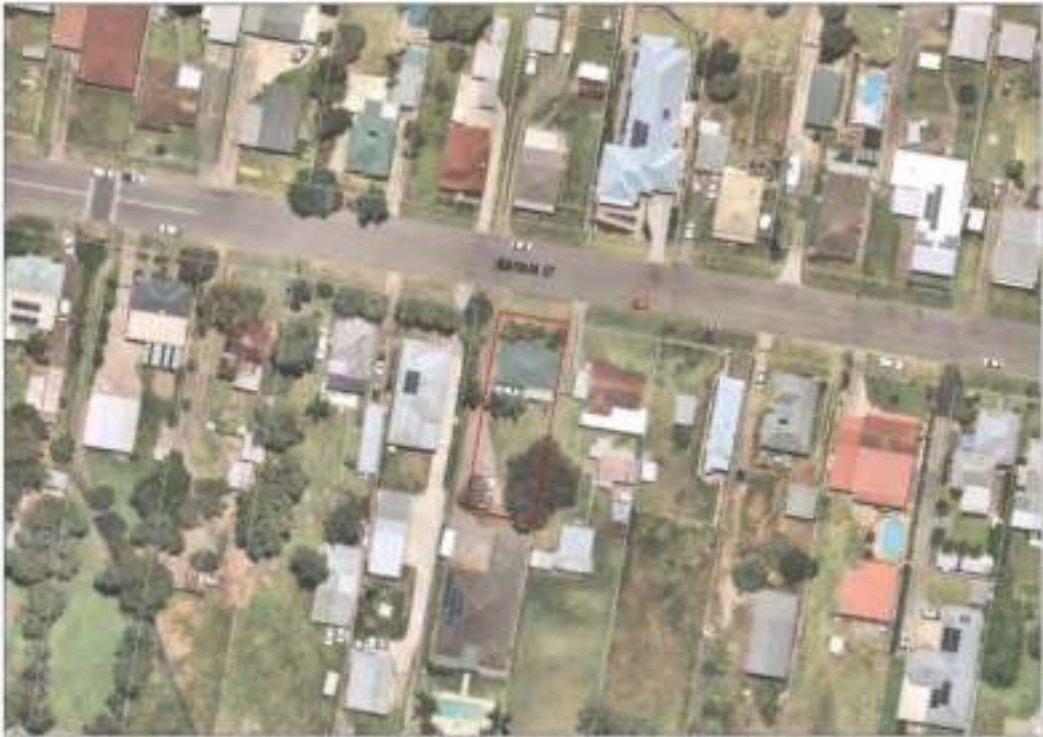
Conservation Area Contribution Level	Est. Construction Date	Previous studies and/or community input
Contributory 2	Early to late 20 th century (broad range)	No prior heritage assessments or research undertaken.
Assessment Text		Observed Modifications
<p>The scale (single-storey) and general style of the dwelling is consistent with that of the streetscape and wider HCA. Dwelling contributes positively to the streetscape and wider HCA, particularly in comparison to Non-Contributory buildings.</p> <p>The dwelling features appropriately proportioned and positioned fenestrations, an appropriate roof form (gabled or hipped) and other features consistent with the architectural character of the area (e.g. front verandah with timber or brick posts, timber detailing, corrugated metal roofing, etc). The contributory value of the dwelling is limited however by either:</p> <ul style="list-style-type: none"> External modifications that have in some way obscured the style, scale or design intent of the building and have resulted in less physical integrity than Contributory 1 buildings. Being a later dwelling constructed in an appropriate referential style, but comprising little to no fabric of intrinsic heritage significance. 		<p>All visible windows are contemporary metal designs.</p> <p>Timber latticework has been added to the front façade, under the verandah space.</p>

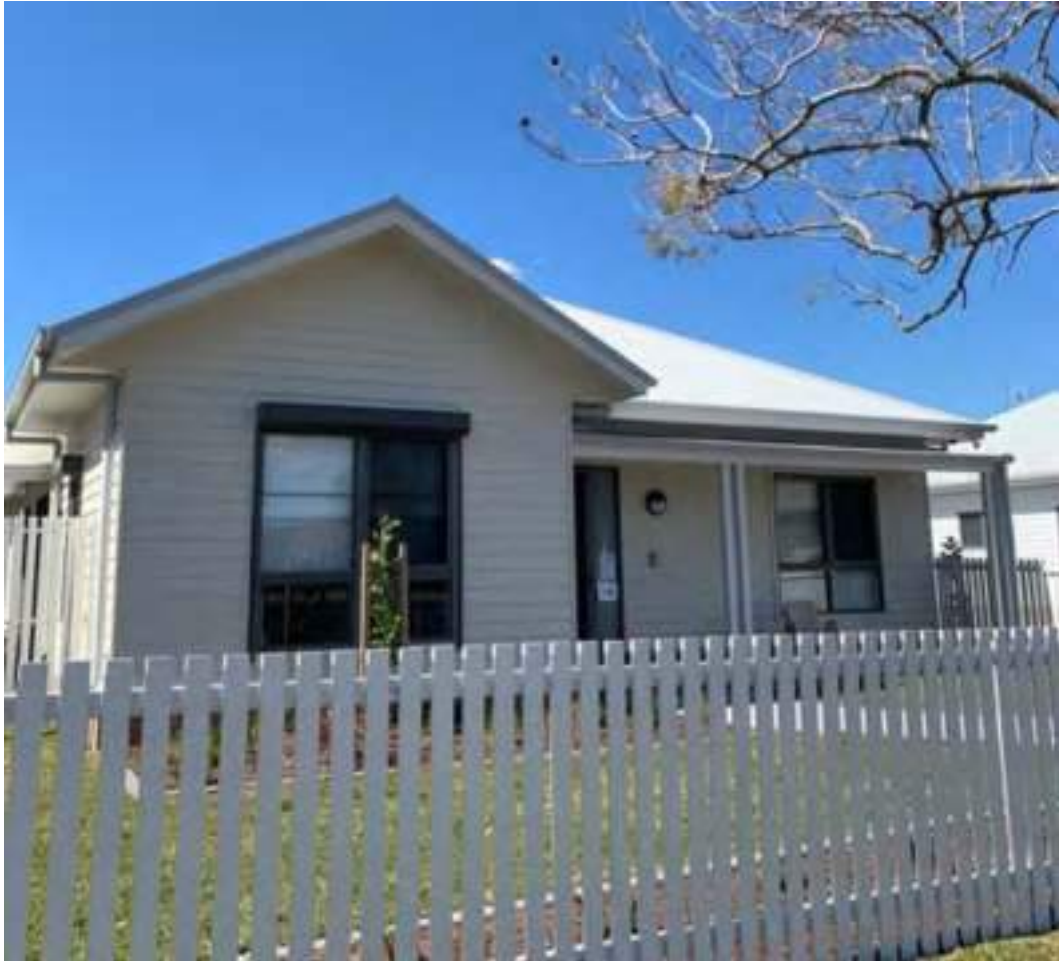
Conservation Area Contribution Level	Est. Construction Date	Previous studies and/or community input
Contributory 2	2015–2020	No prior heritage assessments or research undertaken.
Assessment Text		Observed Modifications
<p>The scale (single-storey) and general style of the dwelling is consistent with that of the streetscape and wider HCA. Dwelling contributes positively to the streetscape and wider HCA, particularly in comparison to Non-Contributory buildings.</p> <p>The dwelling features appropriately proportioned and positioned fenestrations, an appropriate roof form (gabled or hipped) and other features consistent with the architectural character of the area (e.g. front verandah with timber or brick posts, timber detailing, corrugated metal roofing, etc). The contributory value of the dwelling is limited however by either:</p> <ul style="list-style-type: none"> • External modifications that have in some way obscured the style, scale or design intent of the building and have resulted in less physical integrity than Contributory 1 buildings. • Being a later dwelling constructed in an appropriate referential style, but comprising little to no fabric of intrinsic heritage significance. 		No modifications observed.

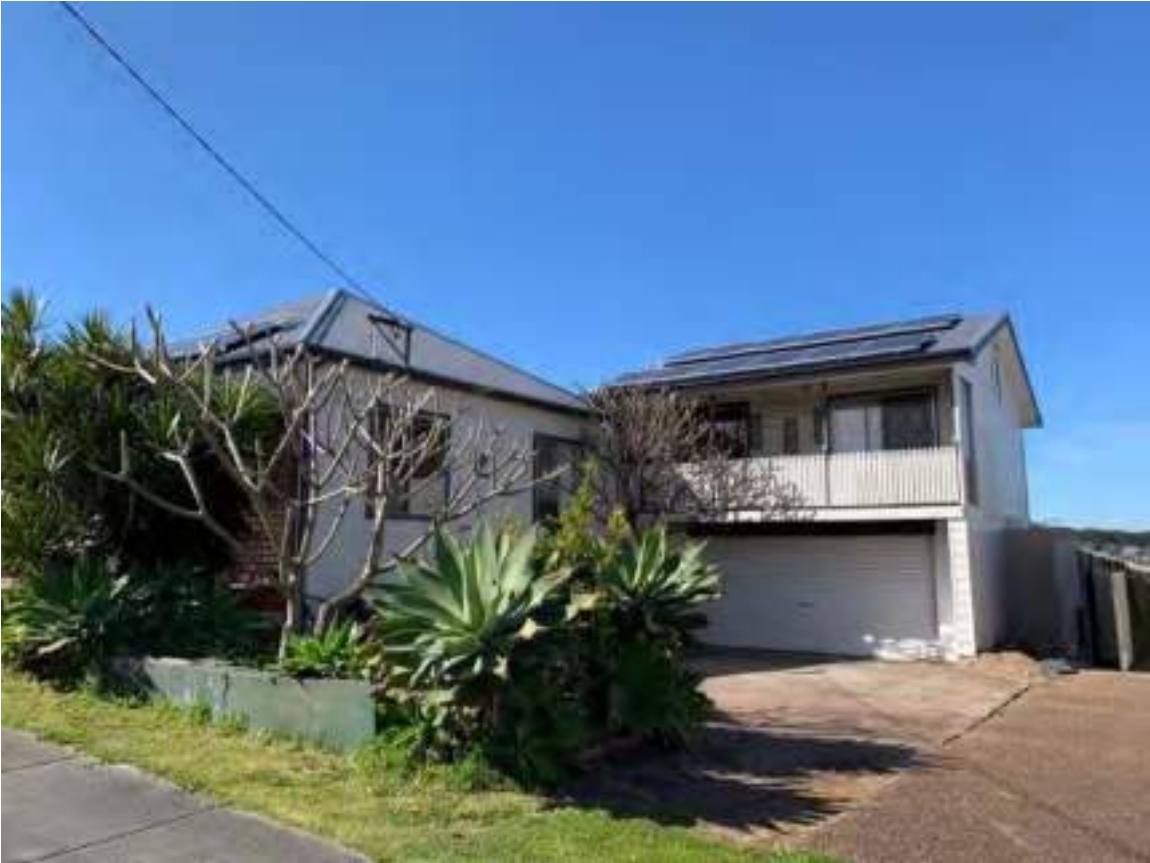
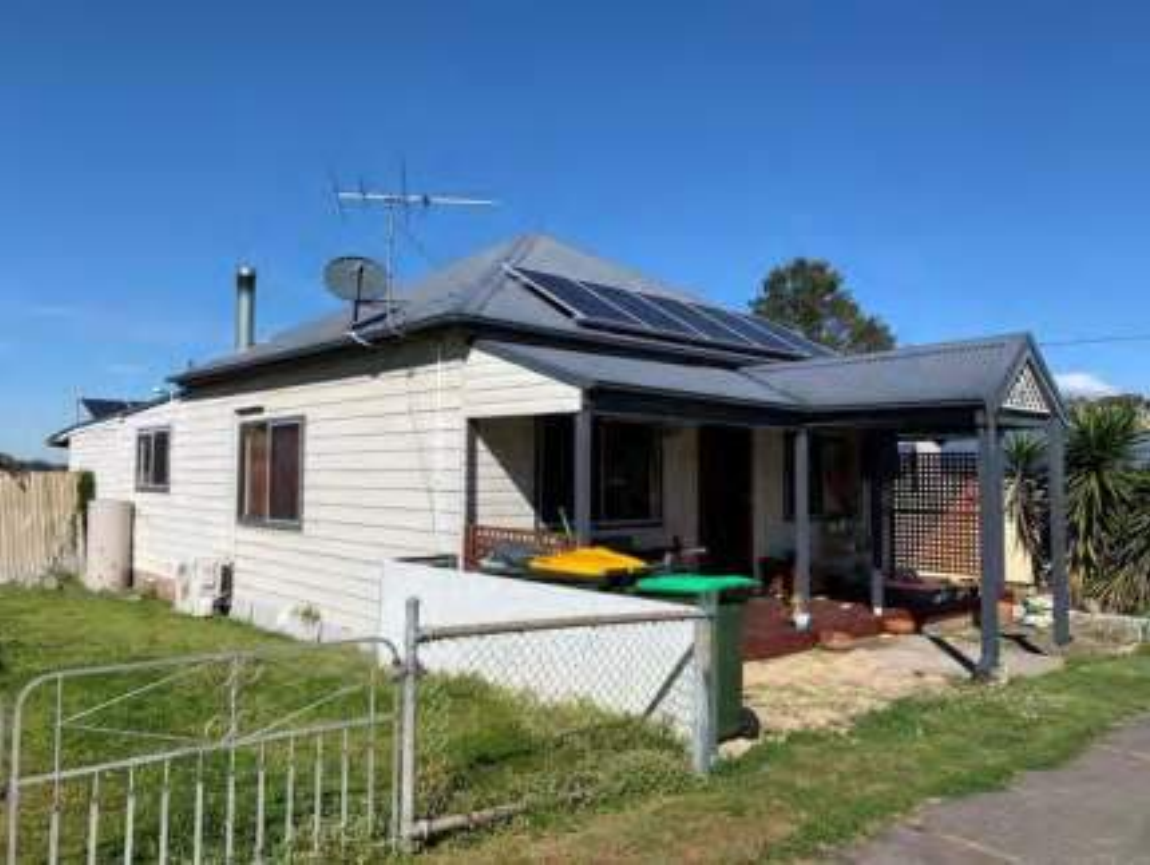
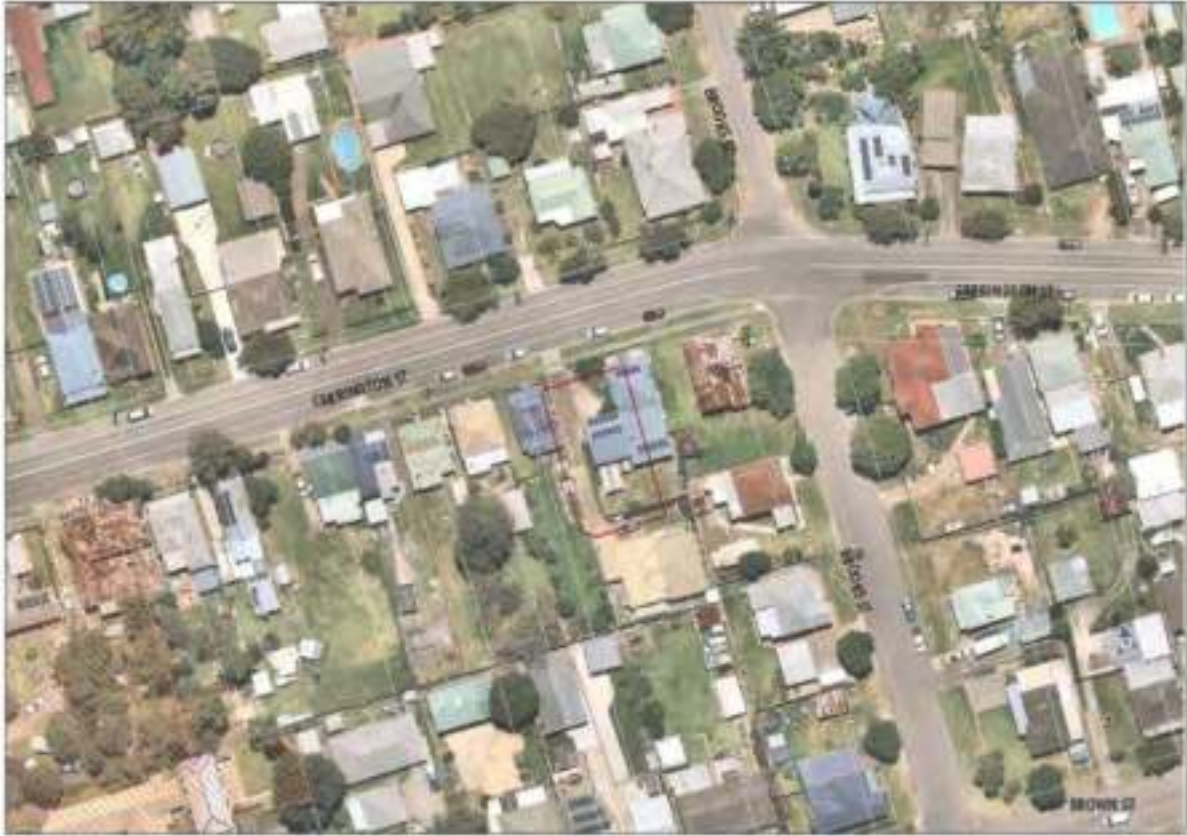
Conservation Area Contribution Level	Est. Construction Date	Previous studies and/or community input
Contributory 2	Early to late 20 th century (broad range)	No prior heritage assessments or research undertaken.
Assessment Text		Observed Modifications
<p>The scale (single-storey) and general style of the dwelling is consistent with that of the streetscape and wider HCA. Dwelling contributes positively to the streetscape and wider HCA, particularly in comparison to Non-Contributory buildings.</p> <p>The dwelling features appropriately proportioned and positioned fenestrations, an appropriate roof form (gabled or hipped) and other features consistent with the architectural character of the area (e.g. front verandah with timber or brick posts, timber detailing, corrugated metal roofing, etc). The contributory value of the dwelling is limited however by either:</p> <ul style="list-style-type: none"> • External modifications that have in some way obscured the style, scale or design intent of the building and have resulted in less physical integrity than Contributory 1 buildings. • Being a later dwelling constructed in an appropriate referential style, but comprising little to no fabric of intrinsic heritage significance. 		<p>A large two storey extension has been built at the back of the dwelling, with a double car garage located on the bottom level.</p> <p>Solar panels are highly visible on the roof of both the main dwelling and the extension.</p> <p>The dwelling has been widely renovated, with minimal original features remaining.</p>

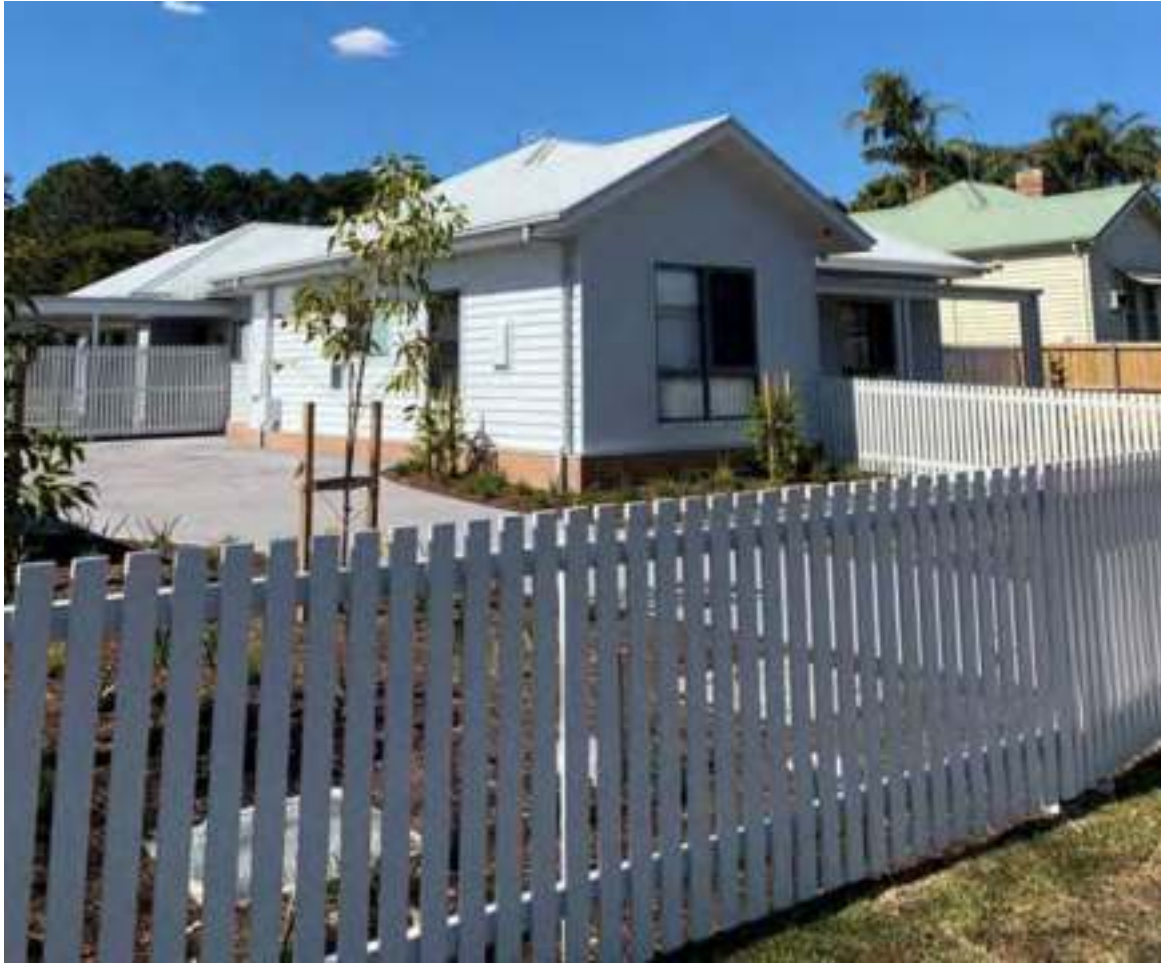
Conservation Area Contribution Level	Est. Construction Date	Previous studies and/or community input
Contributory 2	Early to late 20 th century (broad range)	No prior heritage assessments or research undertaken.
Assessment Text		Observed Modifications
<p>The scale (single-storey) and general style of the dwelling is consistent with that of the streetscape and wider HCA. Dwelling contributes positively to the streetscape and wider HCA, particularly in comparison to Non-Contributory buildings.</p> <p>The dwelling features appropriately proportioned and positioned fenestrations, an appropriate roof form (gabled or hipped) and other features consistent with the architectural character of the area (e.g. front verandah with timber or brick posts, timber detailing, corrugated metal roofing, etc). The contributory value of the dwelling is limited however by either:</p> <ul style="list-style-type: none"> • External modifications that have in some way obscured the style, scale or design intent of the building and have resulted in less physical integrity than Contributory 1 buildings. • Being a later dwelling constructed in an appropriate referential style, but comprising little to no fabric of intrinsic heritage significance. 		No modifications observed.

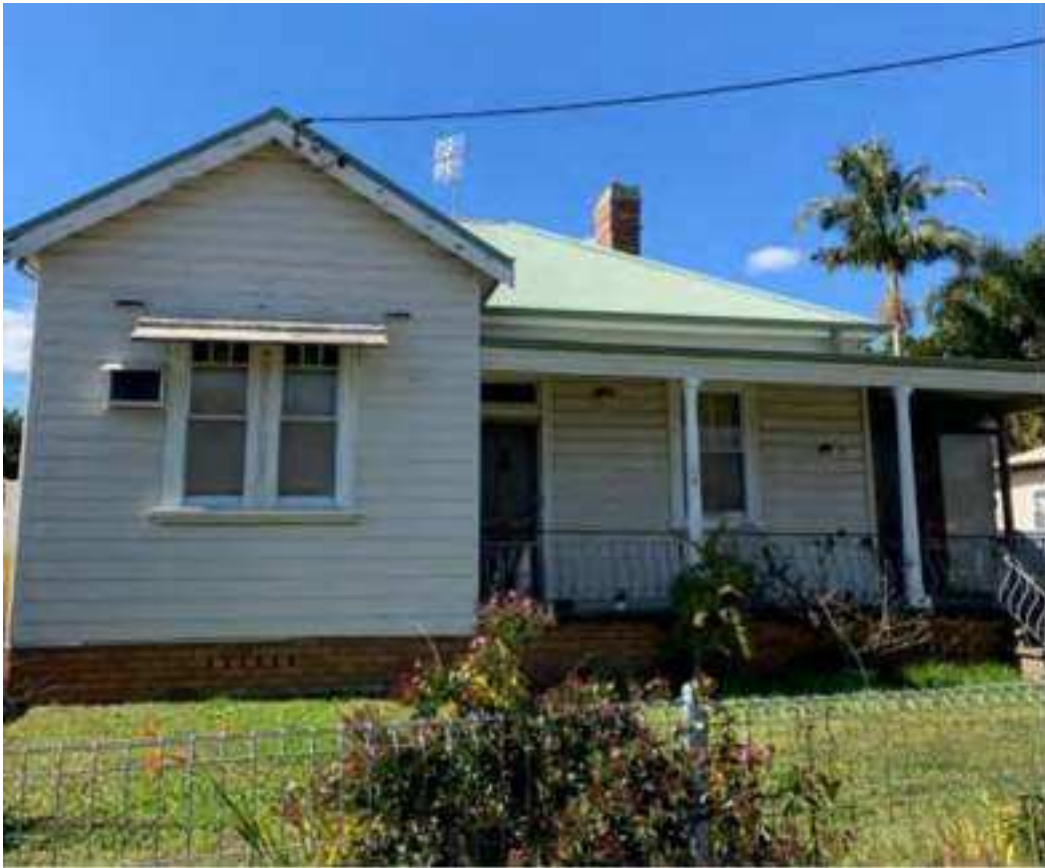
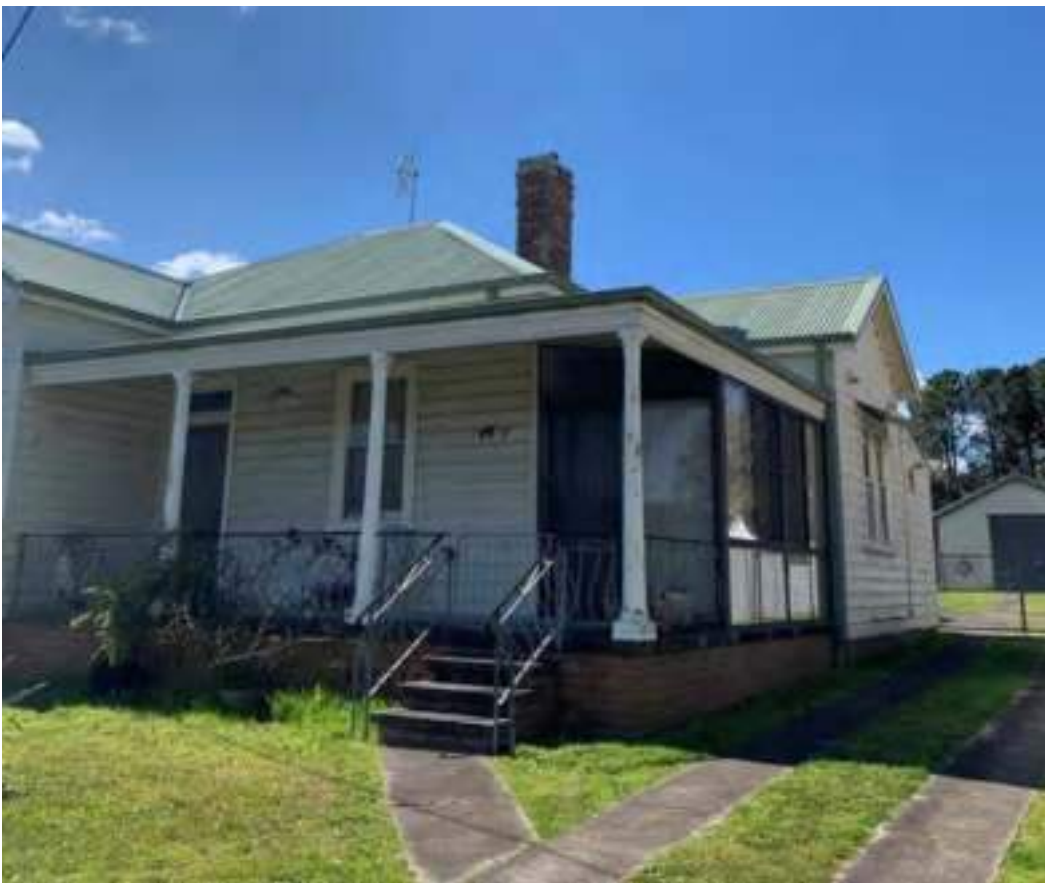
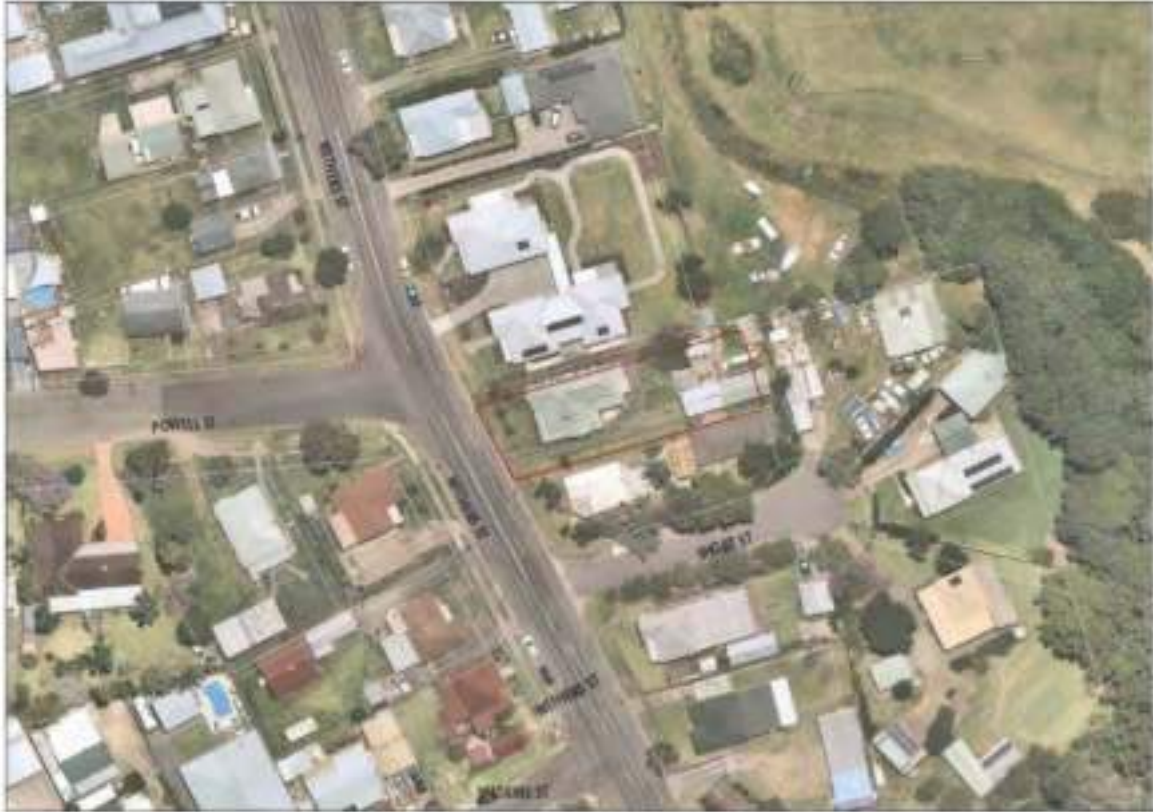
37 WITHERS STREET, WEST WALLSEND 2286

Conservation Area Contribution Level	Est. Construction Date	Previous studies and/or community input
Contributory 2	Early to late 20 th century (broad range)	No prior heritage assessments or research undertaken.
Assessment Text		Observed Modifications
<p>The scale (single-storey) and general style of the dwelling is consistent with that of the streetscape and wider HCA. Dwelling contributes positively to the streetscape and wider HCA, particularly in comparison to Non-Contributory buildings.</p> <p>The dwelling features appropriately proportioned and positioned fenestrations, an appropriate roof form (gabled or hipped) and other features consistent with the architectural character of the area (e.g. front verandah with timber or brick posts, timber detailing, corrugated metal roofing, etc). The contributory value of the dwelling is limited however by either:</p> <ul style="list-style-type: none"> • External modifications that have in some way obscured the style, scale or design intent of the building and have resulted in less physical integrity than Contributory 1 buildings. • Being a later dwelling constructed in an appropriate referential style, but comprising little to no fabric of intrinsic heritage significance. 		<p>The verandah pillars are a contemporary modification, likely replacing original timber designs. Similarly, the verandah railing is a contemporary addition.</p> <p>A small enclosed extension has been constructed on the southern side of the verandah.</p>

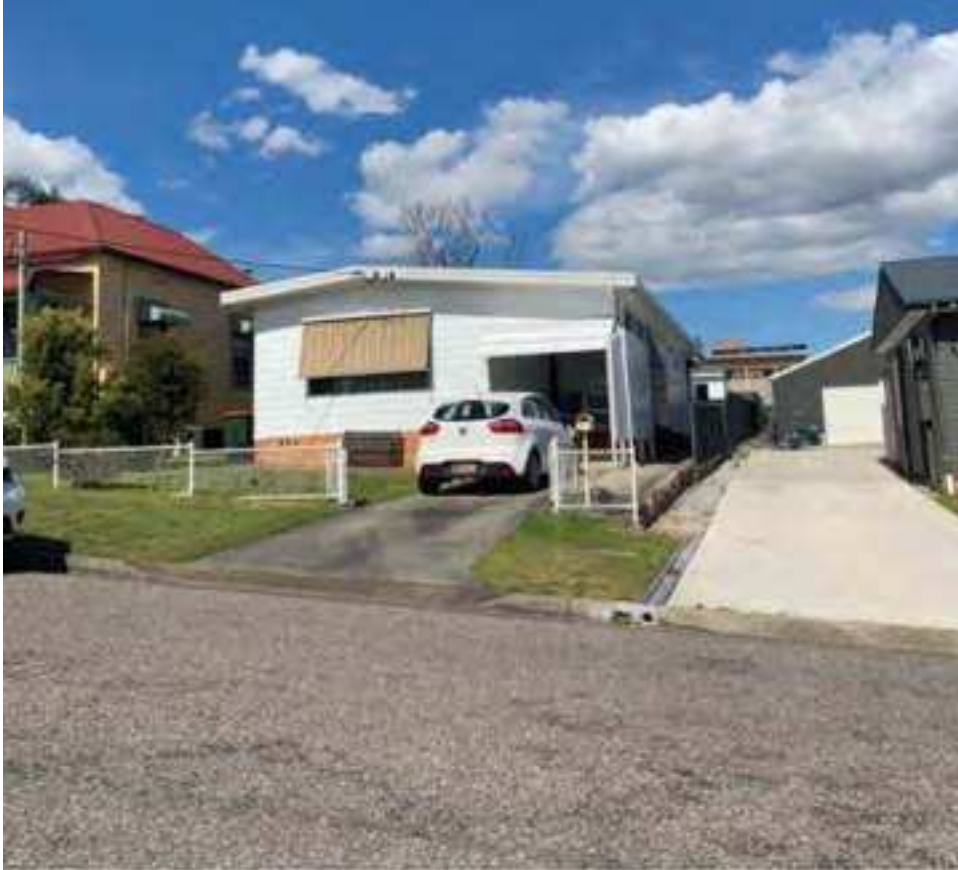
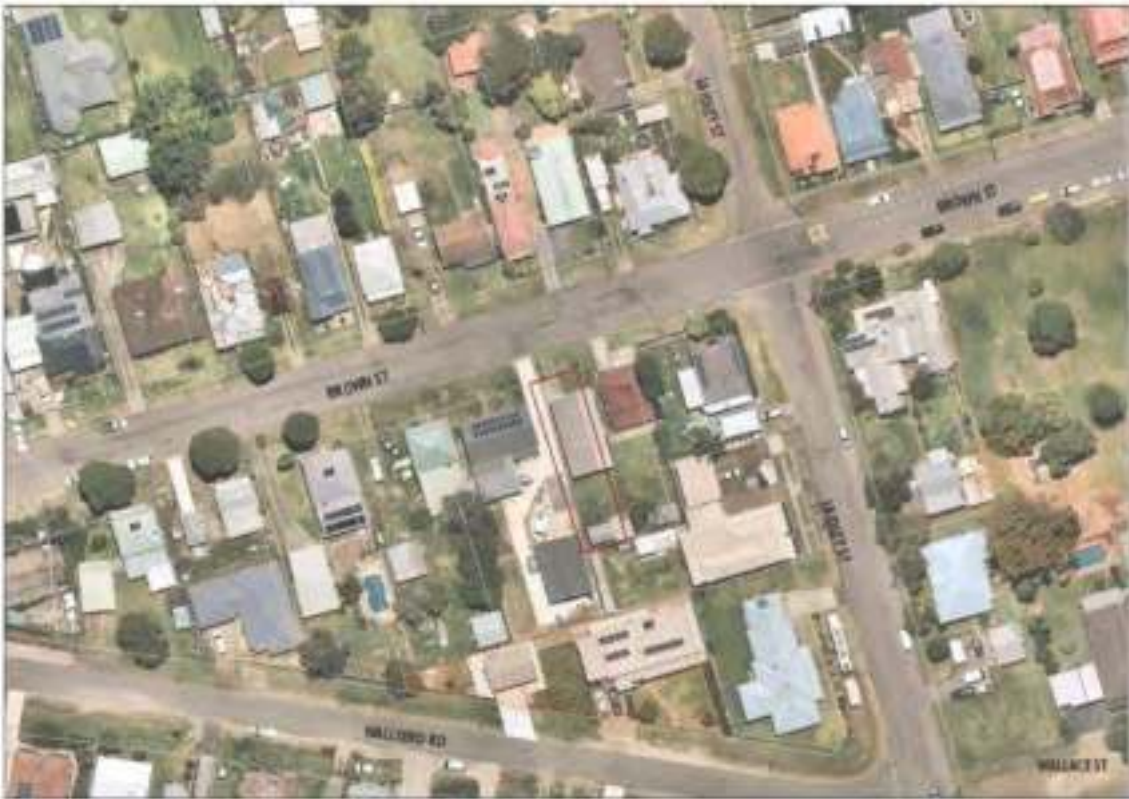
76 BROWN STREET, WEST WALLSEND 2286

Conservation Area Contribution Level	Est. Construction Date	Previous studies and/or community input
Contributory 2	Early to late 20 th century (broad range)	No prior heritage assessments or research undertaken.
Assessment Text		Observed Modifications
<p>The scale (single-storey) and general style of the dwelling is consistent with that of the streetscape and wider HCA. Dwelling contributes positively to the streetscape and wider HCA, particularly in comparison to Non-Contributory buildings.</p> <p>The dwelling features appropriately proportioned and positioned fenestrations, an appropriate roof form (gabled or hipped) and other features consistent with the architectural character of the area (e.g. front verandah with timber or brick posts, timber detailing, corrugated metal roofing, etc). The contributory value of the dwelling is limited however by either:</p> <ul style="list-style-type: none"> • External modifications that have in some way obscured the style, scale or design intent of the building and have resulted in less physical integrity than Contributory 1 buildings. • Being a later dwelling constructed in an appropriate referential style, but comprising little to no fabric of intrinsic heritage significance. 		<p>Corrugated iron sheets have been installed to enclose a carport on the western side of the dwelling.</p>

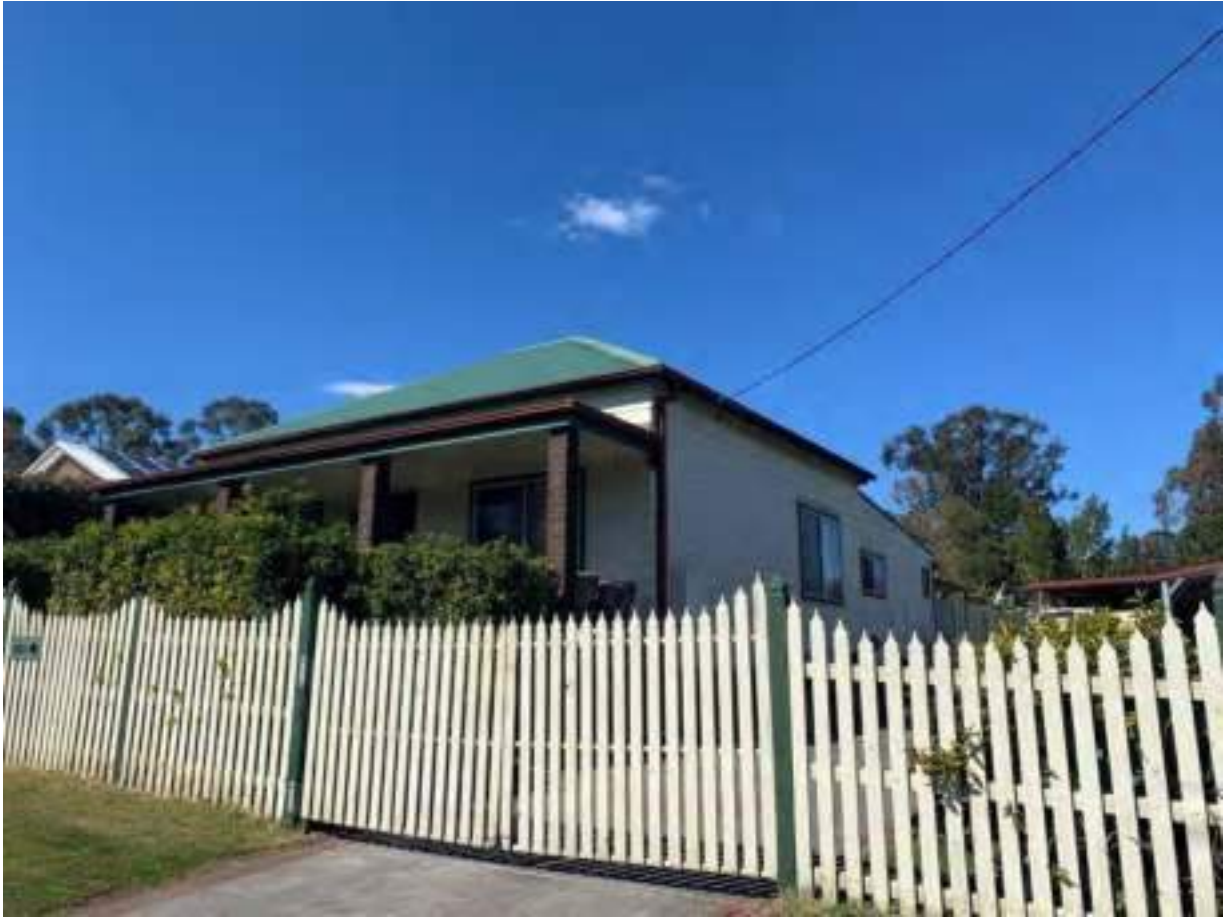
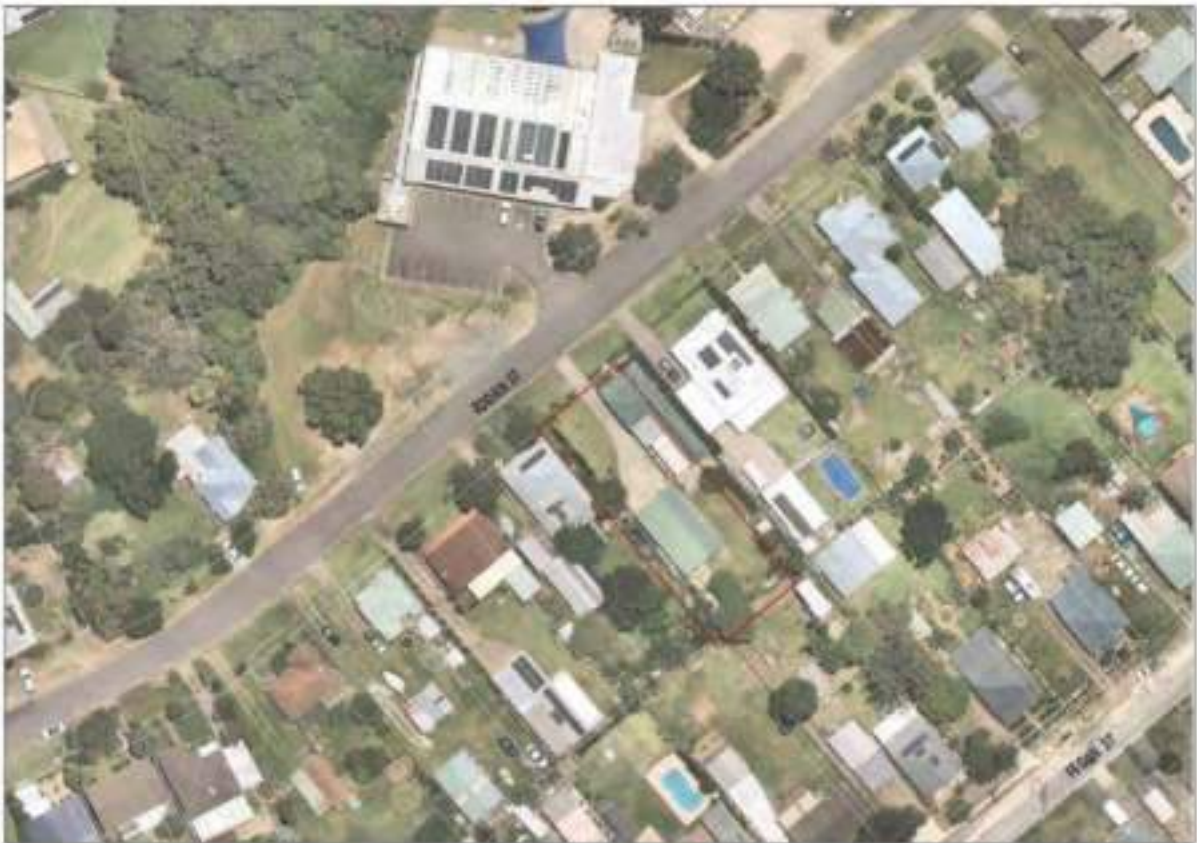
28 EDDEN STREET, WEST WALLSEND 2286

Conservation Area Contribution Level	Est. Construction Date	Previous studies and/or community input
Contributory 2	Early to late 20 th century (broad range)	No prior heritage assessments or research undertaken.
Assessment Text		Observed Modifications
<p>The scale (single-storey) and general style of the dwelling is consistent with that of the streetscape and wider HCA. Dwelling contributes positively to the streetscape and wider HCA, particularly in comparison to Non-Contributory buildings.</p> <p>The dwelling features appropriately proportioned and positioned fenestrations, an appropriate roof form (gabled or hipped) and other features consistent with the architectural character of the area (e.g. front verandah with timber or brick posts, timber detailing, corrugated metal roofing, etc). The contributory value of the dwelling is limited however by either:</p> <ul style="list-style-type: none"> • External modifications that have in some way obscured the style, scale or design intent of the building and have resulted in less physical integrity than Contributory 1 buildings. • Being a later dwelling constructed in an appropriate referential style, but comprising little to no fabric of intrinsic heritage significance. 		<p>All visible windows are a contemporary sliding design.</p> <p>The veranda support pillars are a contemporary addition, likely replacing timber posts.</p>
