APPENDIX 2

Building Assessment Sheets (Inventory Sheets)

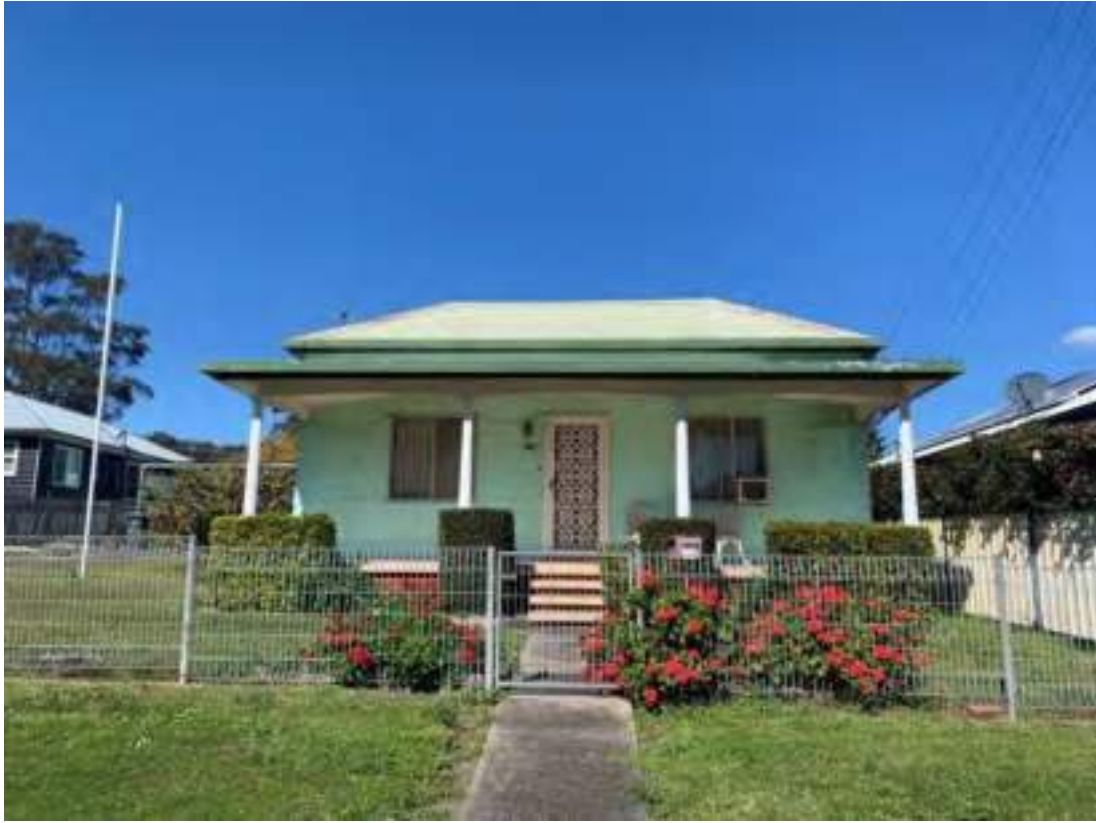
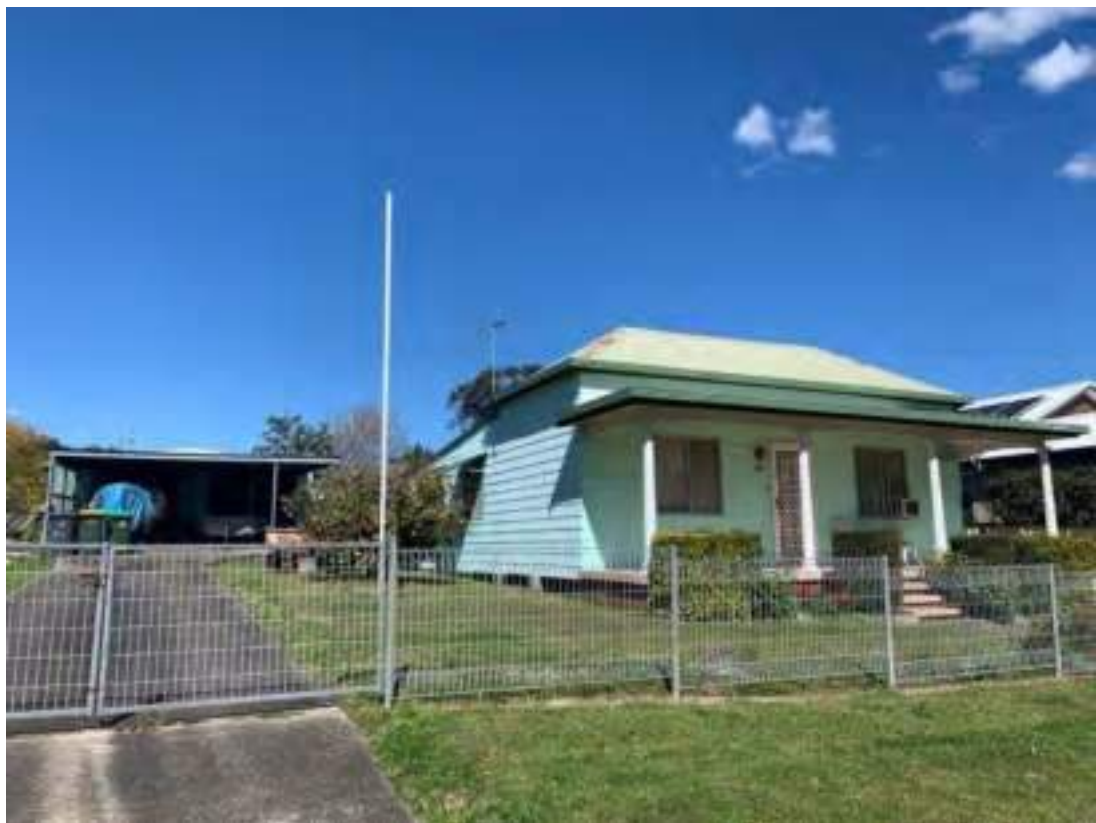
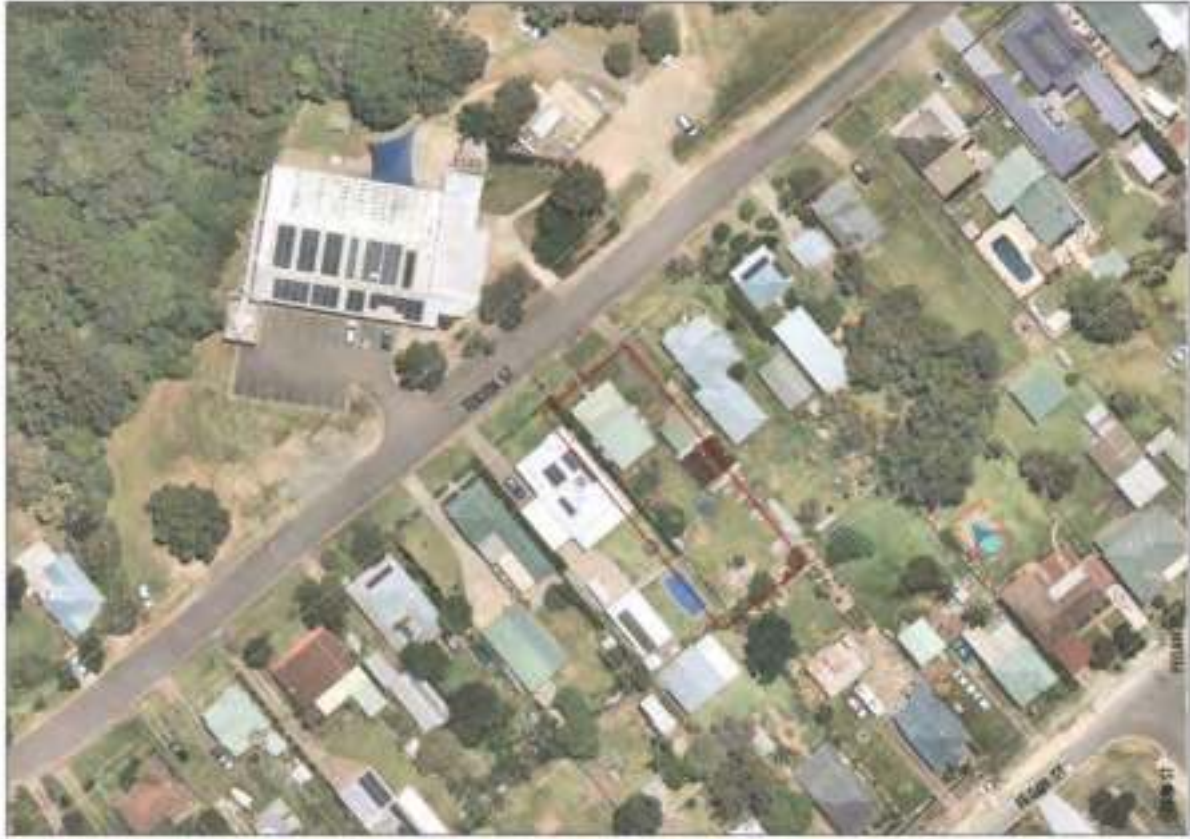
Conservation Area Contribution Level	Est. Construction Date	Previous studies and/or community input
Contributory 2	Early to late 20 th century (broad range)	No prior heritage assessments or research undertaken.
Assessment Text		Observed Modifications
<p>The scale (single-storey) and general style of the dwelling is consistent with that of the streetscape and wider HCA. Dwelling contributes positively to the streetscape and wider HCA, particularly in comparison to Non-Contributory buildings.</p> <p>The dwelling features appropriately proportioned and positioned fenestrations, an appropriate roof form (gabled or hipped) and other features consistent with the architectural character of the area (e.g. front verandah with timber or brick posts, timber detailing, corrugated metal roofing, etc). The contributory value of the dwelling is limited however by either:</p> <ul style="list-style-type: none"> • External modifications that have in some way obscured the style, scale or design intent of the building and have resulted in less physical integrity than Contributory 1 buildings. • Being a later dwelling constructed in an appropriate referential style, but comprising little to no fabric of intrinsic heritage significance. 		<p>The visible windows are contemporary sliding designs.</p> <p>The faux European pillars are a contemporary addition, likely replacing original timber posts.</p> <p>The dwelling is painted a bright aqua or turquoise colour, contrasting with the surrounding properties. This colour choice is not consistent with the heritage streetscape.</p>

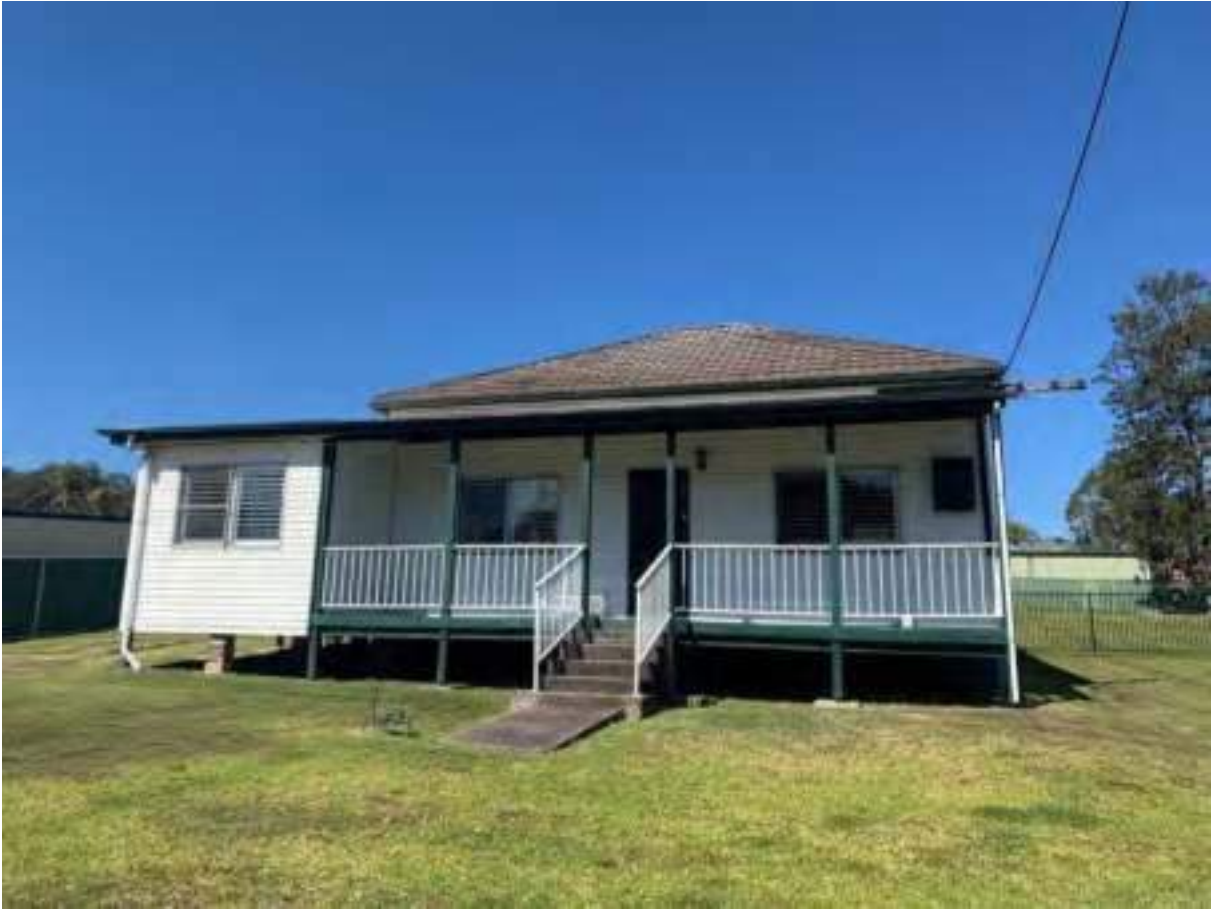
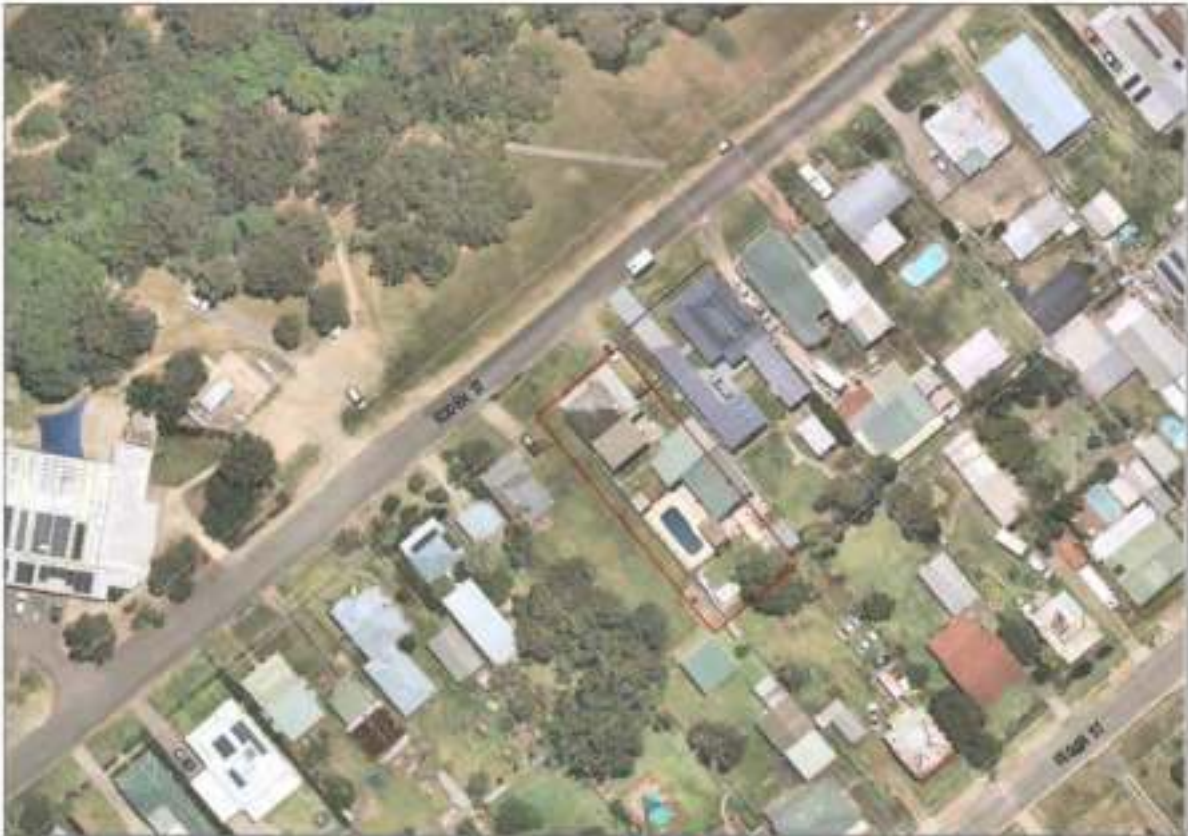
16 EDDEN STREET, WEST WALLSEND 2286

Conservation Area Contribution Level	Est. Construction Date	Previous studies and/or community input
Contributory 2	Early to late 20 th century (broad range)	No prior heritage assessments or research undertaken.
Assessment Text		Observed Modifications
<p>The scale (single-storey) and general style of the dwelling is consistent with that of the streetscape and wider HCA. Dwelling contributes positively to the streetscape and wider HCA, particularly in comparison to Non-Contributory buildings.</p> <p>The dwelling features appropriately proportioned and positioned fenestrations, an appropriate roof form (gabled or hipped) and other features consistent with the architectural character of the area (e.g. front verandah with timber or brick posts, timber detailing, corrugated metal roofing, etc). The contributory value of the dwelling is limited however by either:</p> <ul style="list-style-type: none"> • External modifications that have in some way obscured the style, scale or design intent of the building and have resulted in less physical integrity than Contributory 1 buildings. • Being a later dwelling constructed in an appropriate referential style, but comprising little to no fabric of intrinsic heritage significance. 		<p>An extension has been constructed to the north eastern side of the dwelling. This is highly visible and detracts from the heritage streetscape.</p> <p>The veranda timber balustrade, posts, stairs and support railing are all contemporary additions.</p> <p>The visible windows are contemporary designs.</p>

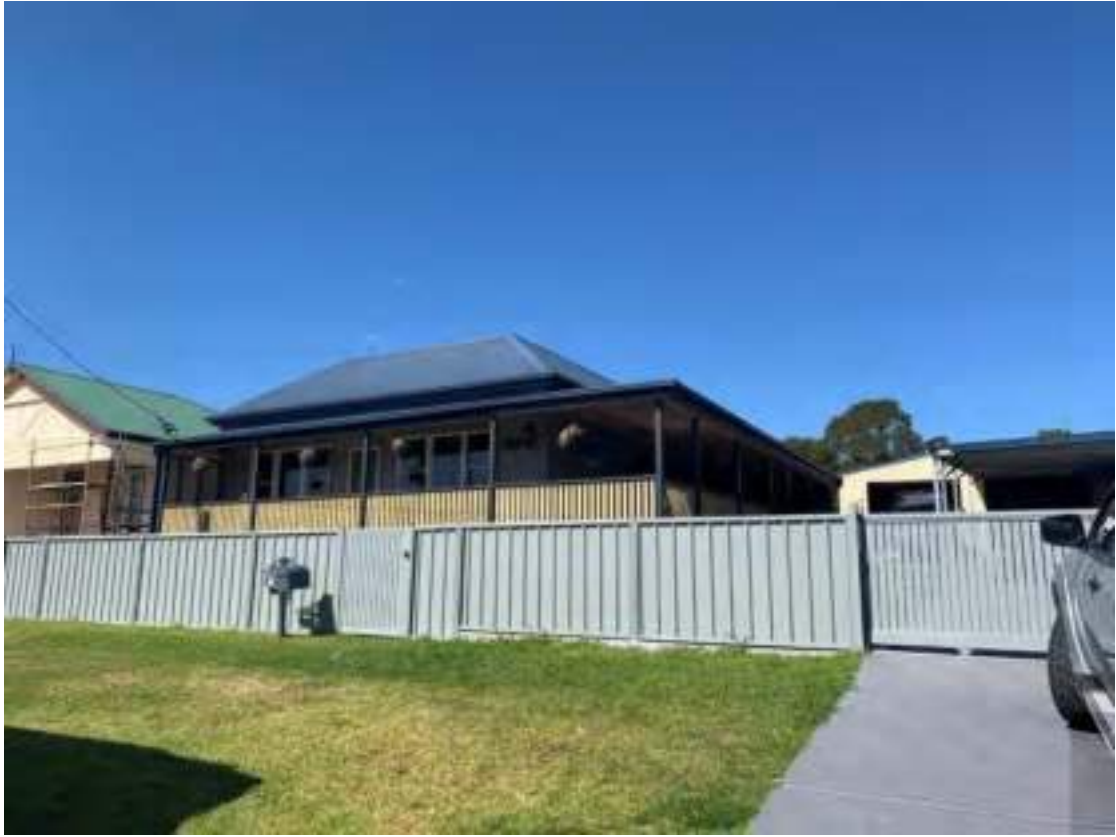
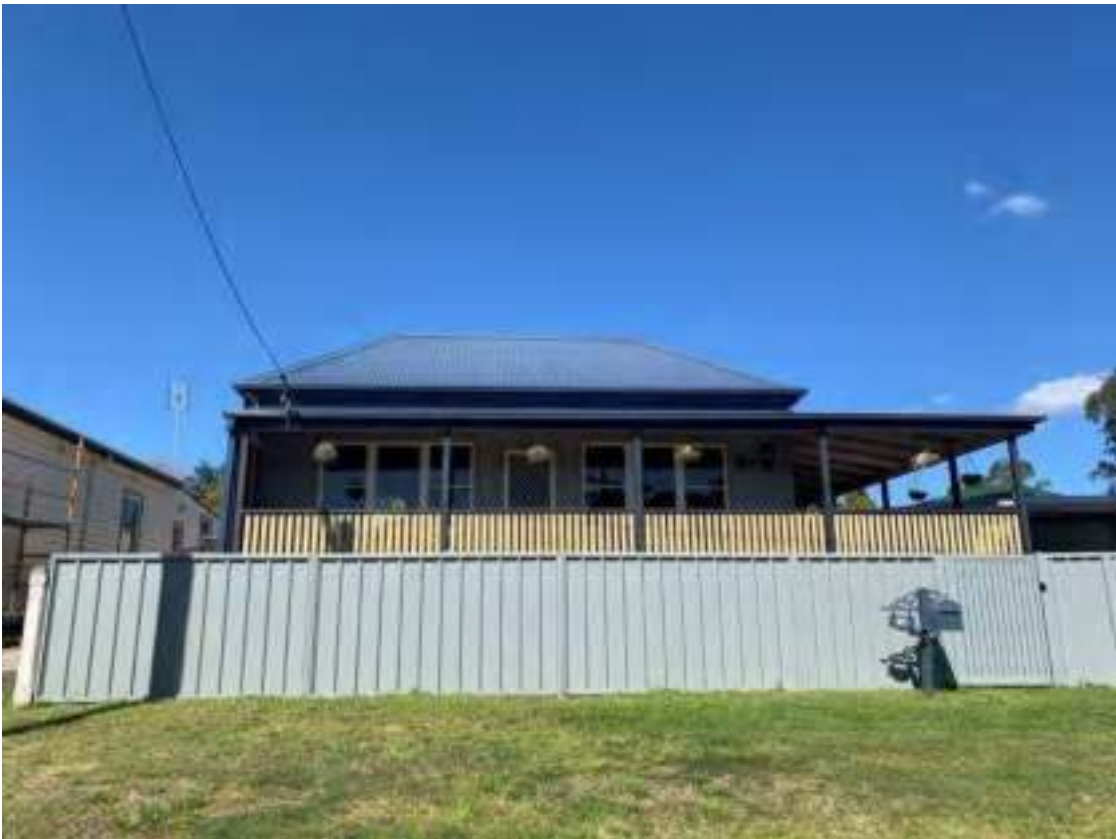
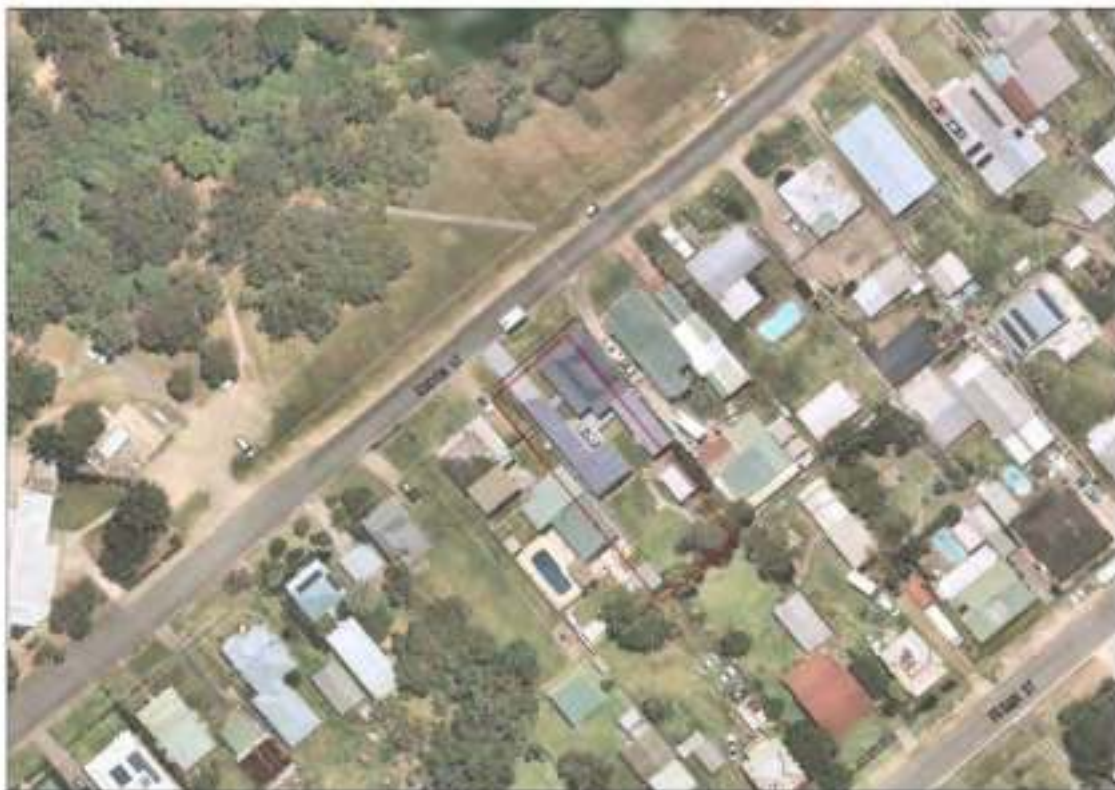
Conservation Area Contribution Level	Est. Construction Date	Previous studies and/or community input
Contributory 2	Early to late 20 th century (broad range)	No prior heritage assessments or research undertaken.
Assessment Text		Observed Modifications
<p>The scale (single-storey) and general style of the dwelling is consistent with that of the streetscape and wider HCA. Dwelling contributes positively to the streetscape and wider HCA, particularly in comparison to Non-Contributory buildings.</p> <p>The dwelling features appropriately proportioned and positioned fenestrations, an appropriate roof form (gabled or hipped) and other features consistent with the architectural character of the area (e.g. front verandah with timber or brick posts, timber detailing, corrugated metal roofing, etc). The contributory value of the dwelling is limited however by either:</p> <ul style="list-style-type: none"> • External modifications that have in some way obscured the style, scale or design intent of the building and have resulted in less physical integrity than Contributory 1 buildings. • Being a later dwelling constructed in an appropriate referential style, but comprising little to no fabric of intrinsic heritage significance. 		<p>All visible windows are contemporary designs.</p> <p>The veranda has been extended to wrap around the northern and western sides of the dwelling. The timber balustrade and support posts are similarly a recent addition. This is a common modification for Vernacular houses.</p> <p>A large carport has been constructed to the south west of the dwelling. this is contemporary in style and detracts from the heritage streetscape.</p>

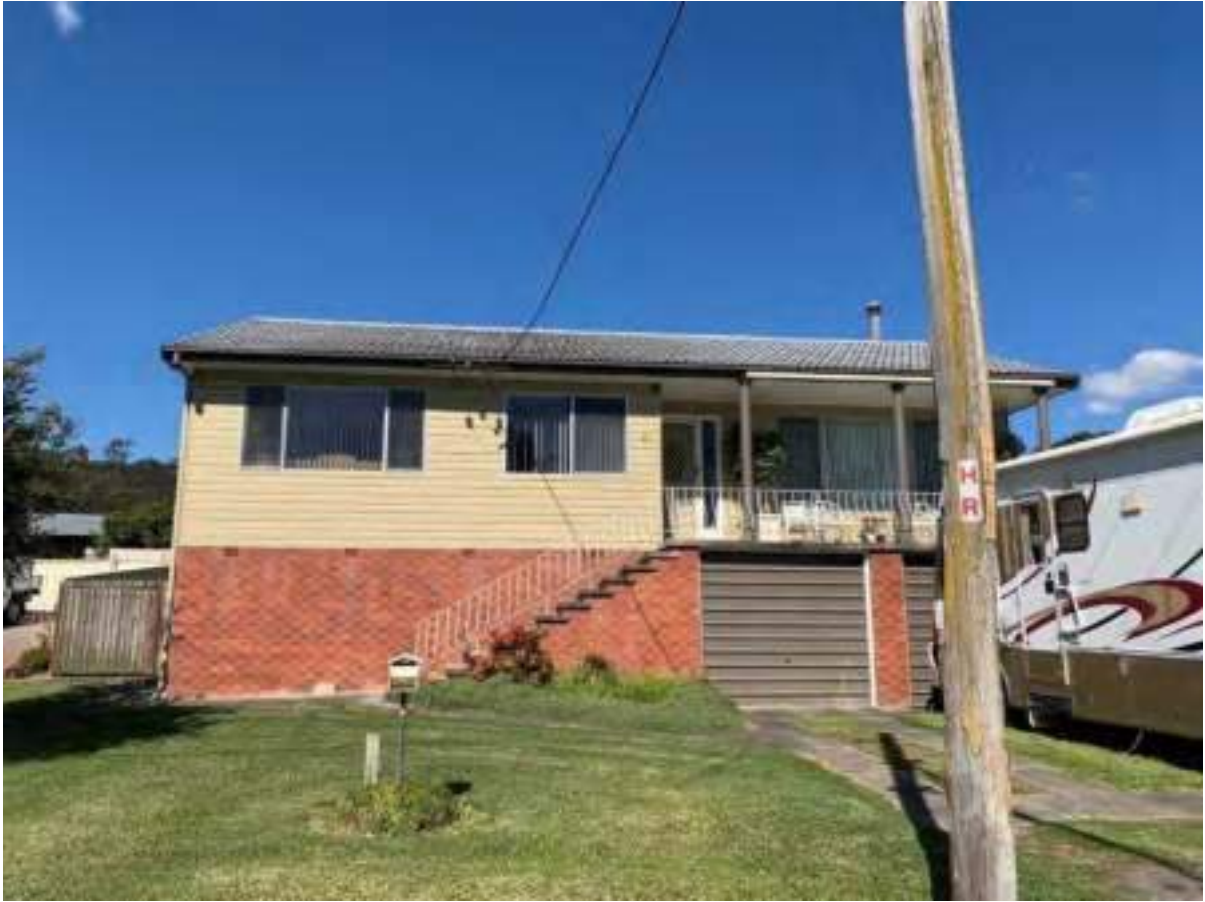
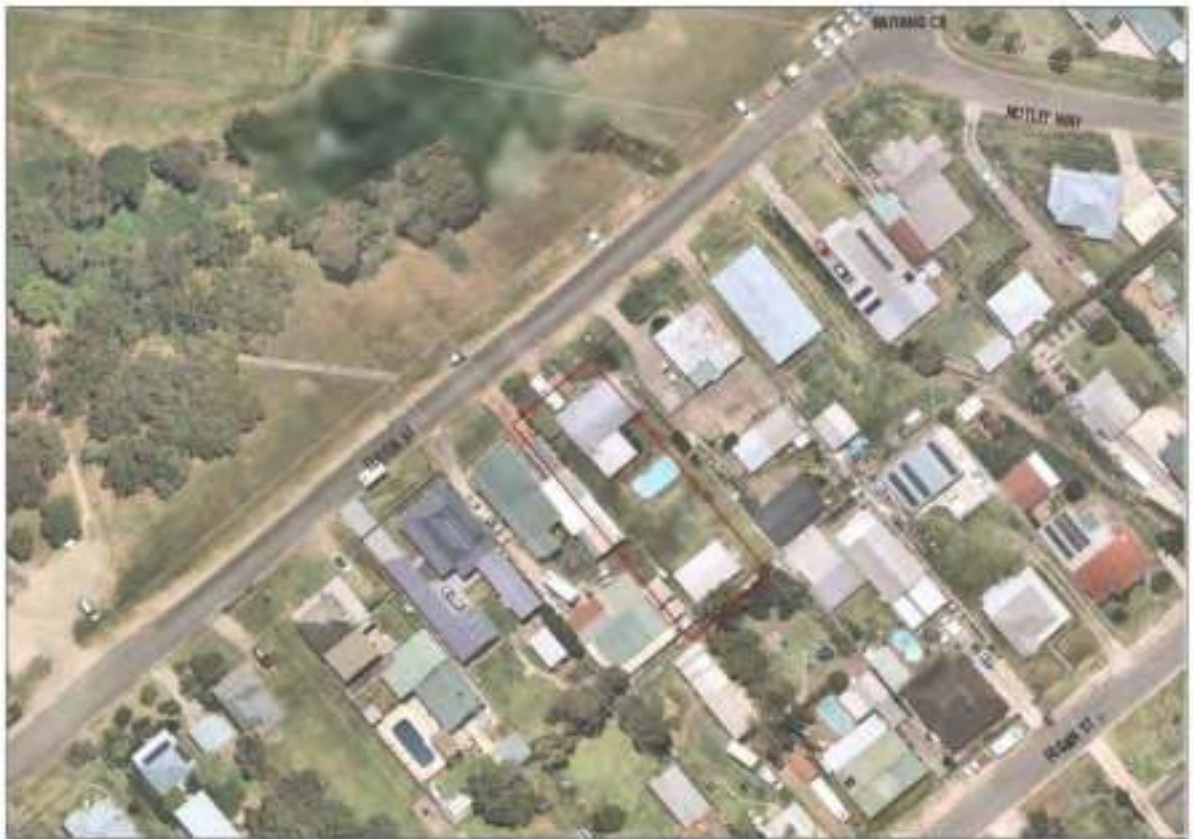
10 EDDEN STREET, WEST WALLSEND 2286

Conservation Area Contribution Level	Est. Construction Date	Previous studies and/or community input
Contributory 2	Early to late 20 th century (broad range)	No prior heritage assessments or research undertaken.
Assessment Text		Observed Modifications
<p>The scale (single-storey) and general style of the dwelling is consistent with that of the streetscape and wider HCA. Dwelling contributes positively to the streetscape and wider HCA, particularly in comparison to Non-Contributory buildings.</p> <p>The dwelling features appropriately proportioned and positioned fenestrations, an appropriate roof form (gabled or hipped) and other features consistent with the architectural character of the area (e.g. front verandah with timber or brick posts, timber detailing, corrugated metal roofing, etc). The contributory value of the dwelling is limited however by either:</p> <ul style="list-style-type: none"> • External modifications that have in some way obscured the style, scale or design intent of the building and have resulted in less physical integrity than Contributory 1 buildings. • Being a later dwelling constructed in an appropriate referential style, but comprising little to no fabric of intrinsic heritage significance. 		<p>The faux European style pillars are likely a contemporary addition.</p>

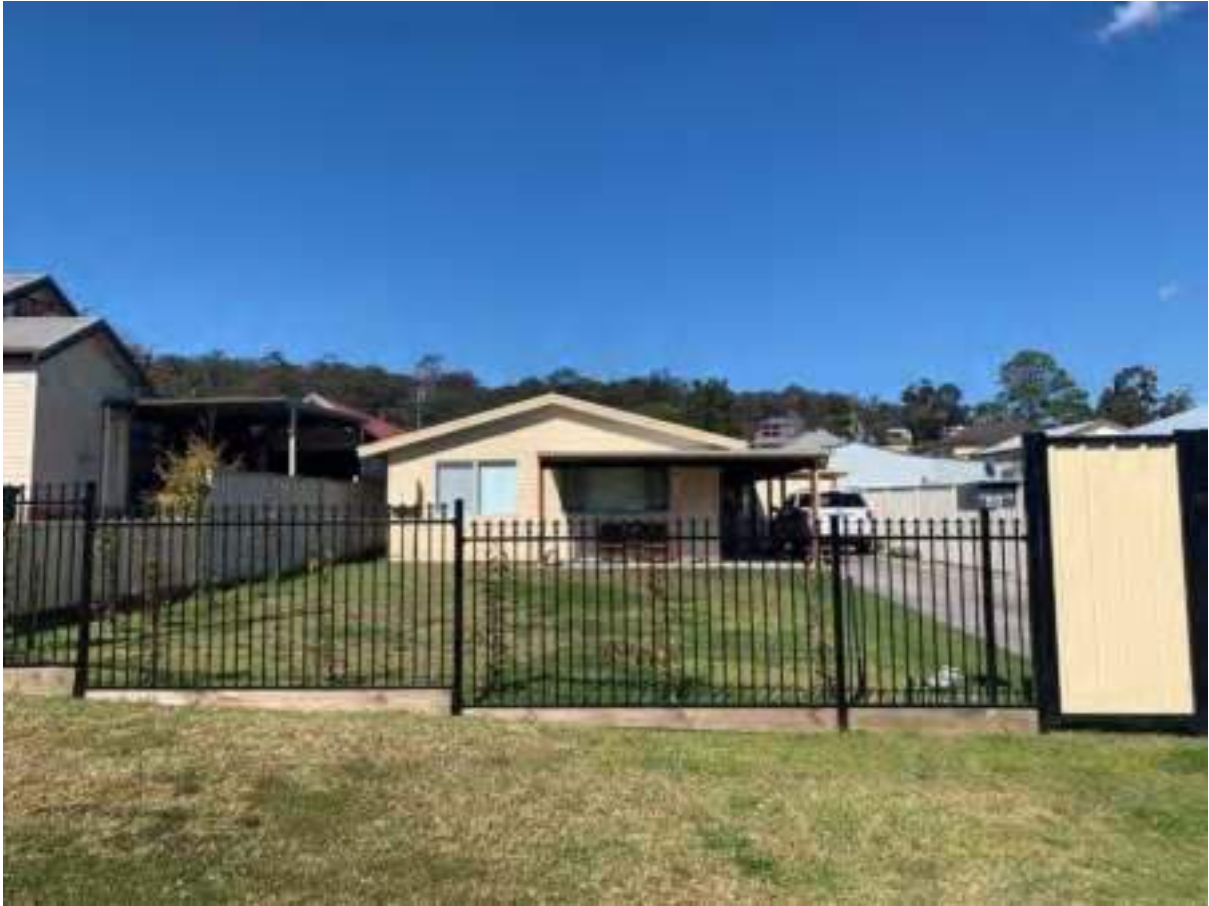
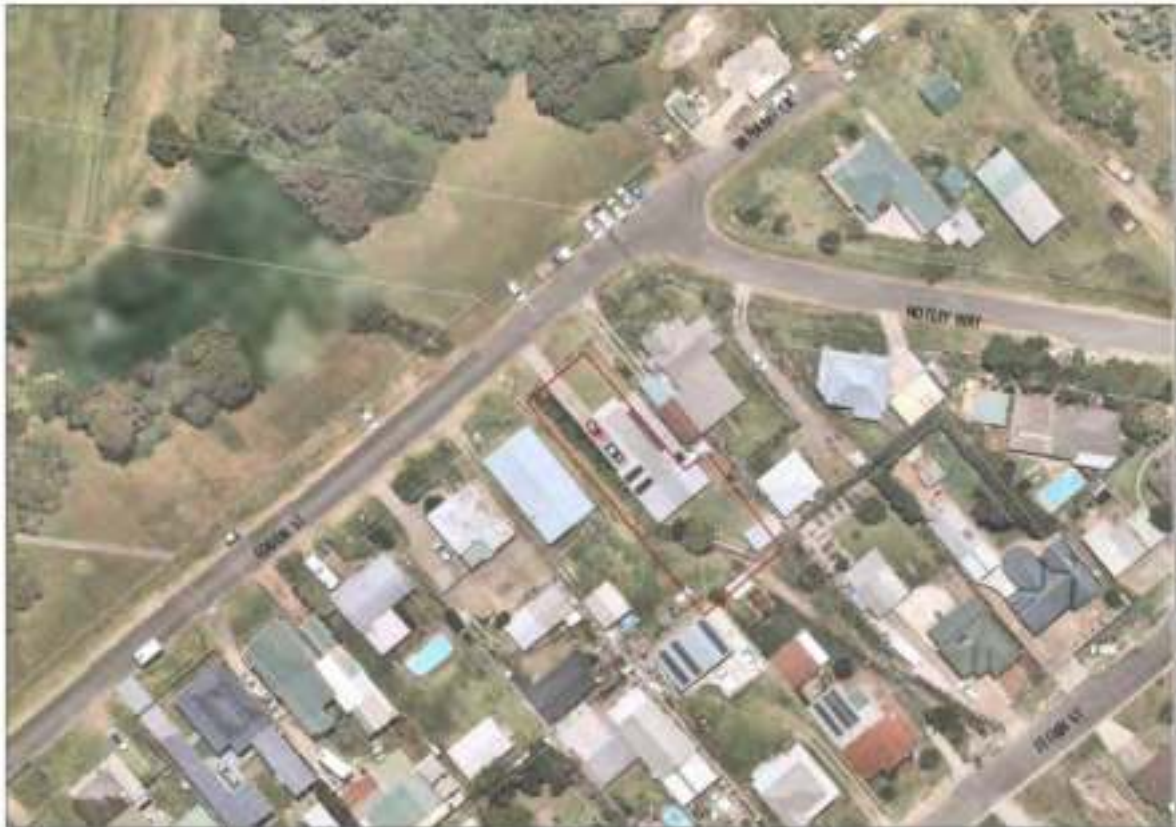
4A EDDEN STREET, WEST WALLSEND 2286

Conservation Area Contribution Level	Est. Construction Date	Previous studies and/or community input
Contributory 2	Early to late 20 th century (broad range)	No prior heritage assessments or research undertaken.
Assessment Text		Observed Modifications
<p>The scale (single-storey) and general style of the dwelling is consistent with that of the streetscape and wider HCA. Dwelling contributes positively to the streetscape and wider HCA, particularly in comparison to Non-Contributory buildings.</p> <p>The dwelling features appropriately proportioned and positioned fenestrations, an appropriate roof form (gabled or hipped) and other features consistent with the architectural character of the area (e.g. front verandah with timber or brick posts, timber detailing, corrugated metal roofing, etc). The contributory value of the dwelling is limited however by either:</p> <ul style="list-style-type: none"> • External modifications that have in some way obscured the style, scale or design intent of the building and have resulted in less physical integrity than Contributory 1 buildings. • Being a later dwelling constructed in an appropriate referential style, but comprising little to no fabric of intrinsic heritage significance. 		<p>The veranda roof has been extended to create a larger covered space to the north western side of the dwelling.</p>

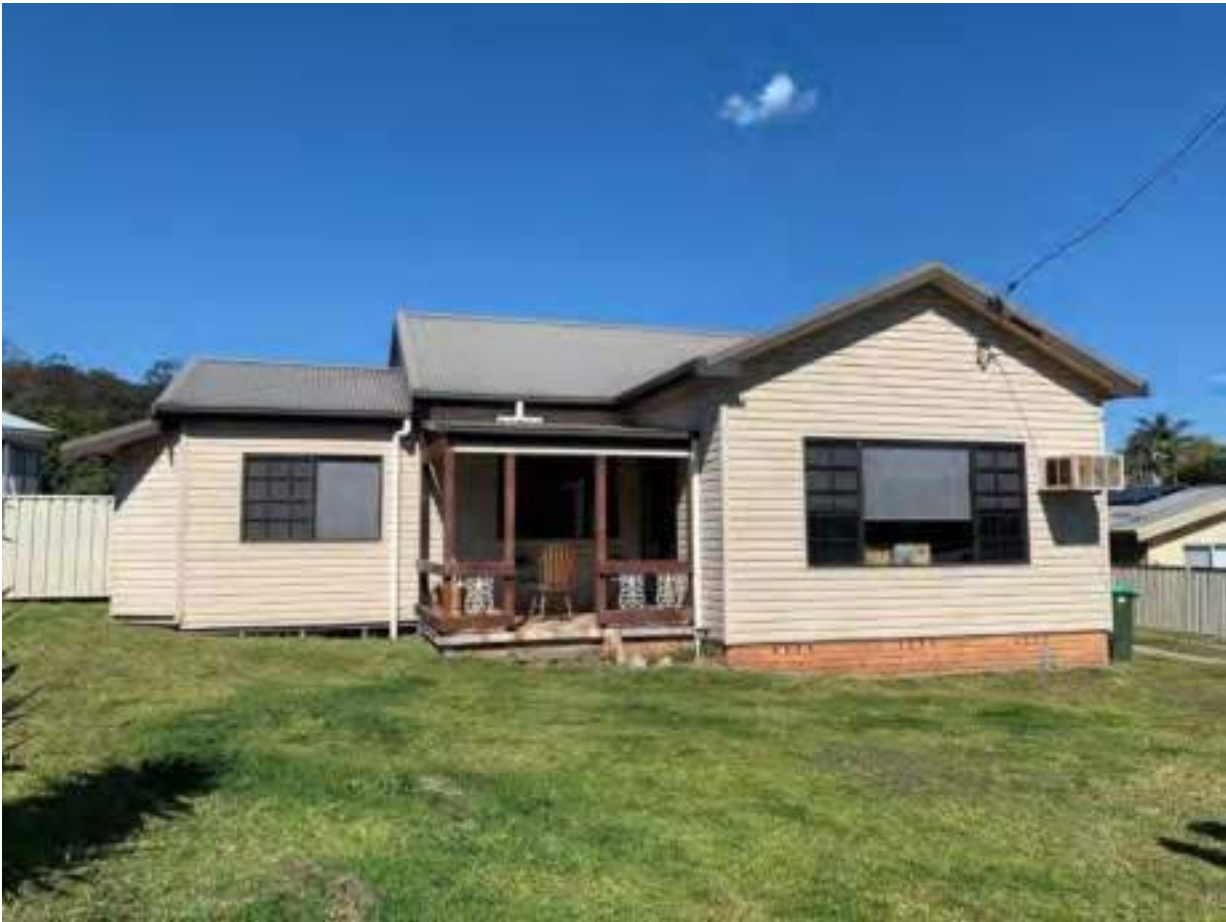
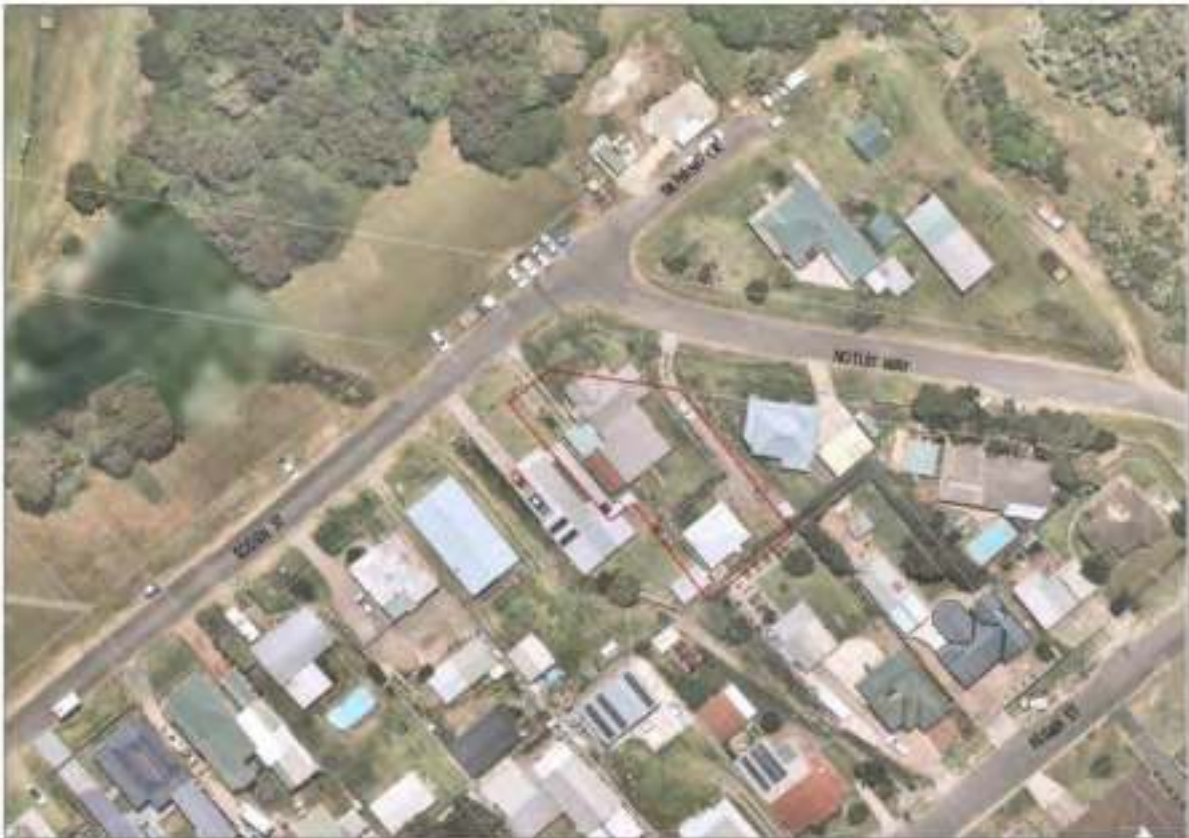
4 EDDEN STREET, WEST WALLSEND 2286

Conservation Area Contribution Level	Est. Construction Date	Previous studies and/or community input
Contributory 2	Early to late 20 th century (broad range)	No prior heritage assessments or research undertaken.
Assessment Text		Observed Modifications
<p>The scale (single-storey) and general style of the dwelling is consistent with that of the streetscape and wider HCA. Dwelling contributes positively to the streetscape and wider HCA, particularly in comparison to Non-Contributory buildings.</p> <p>The dwelling features appropriately proportioned and positioned fenestrations, an appropriate roof form (gabled or hipped) and other features consistent with the architectural character of the area (e.g. front verandah with timber or brick posts, timber detailing, corrugated metal roofing, etc). The contributory value of the dwelling is limited however by either:</p> <ul style="list-style-type: none"> • External modifications that have in some way obscured the style, scale or design intent of the building and have resulted in less physical integrity than Contributory 1 buildings. • Being a later dwelling constructed in an appropriate referential style, but comprising little to no fabric of intrinsic heritage significance. 		<p>It is likely that multiple extensions have been made to the north eastern side of the dwelling.</p> <p>The timber balustrade and support posts of the veranda are contemporary additions.</p>

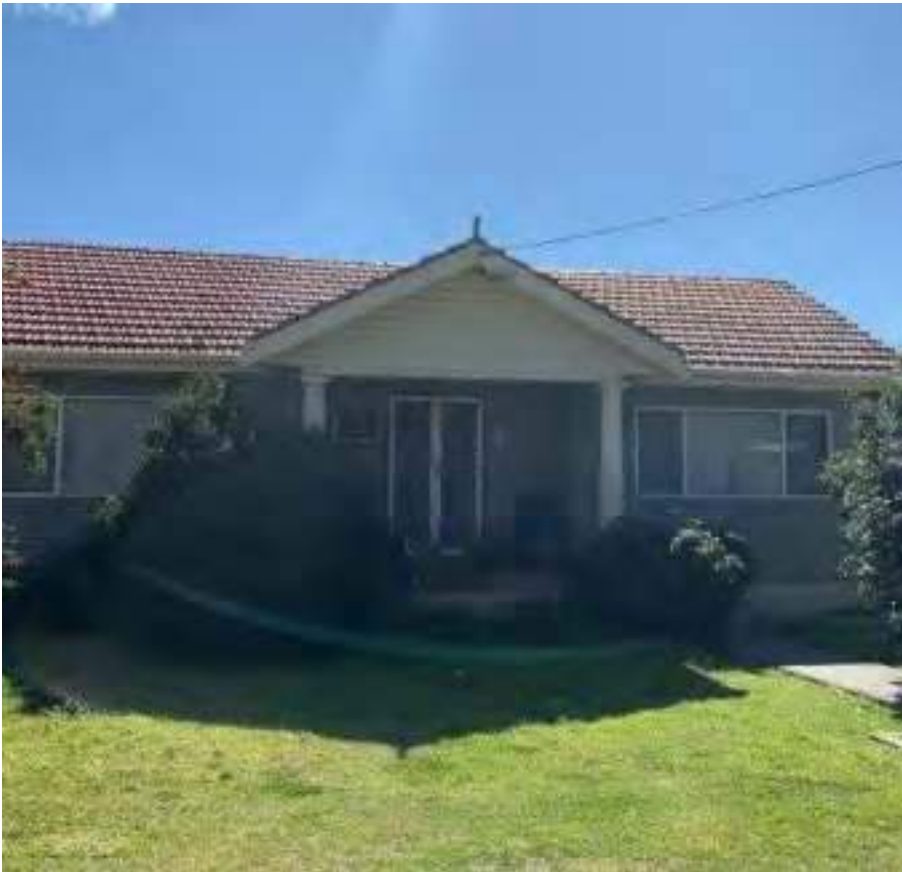
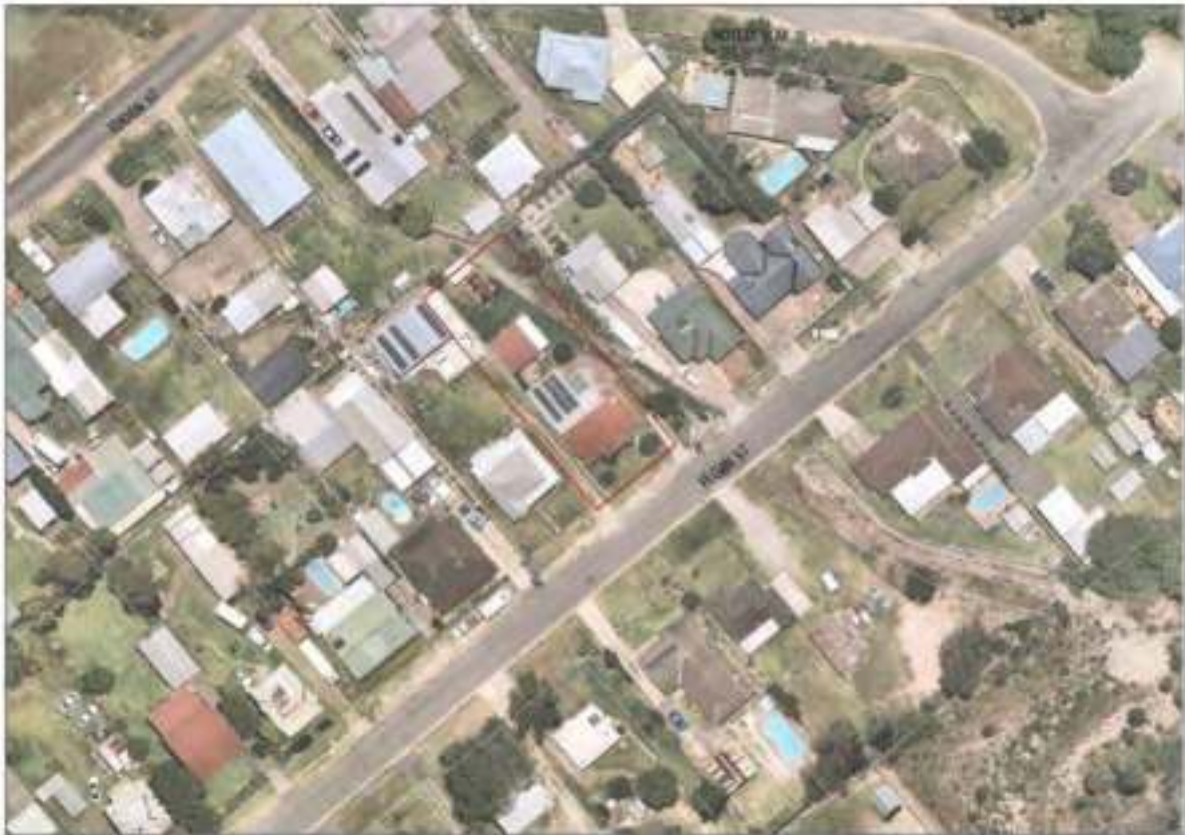
7 FEGAN STREET, WEST WALLSEND 2286

Conservation Area Contribution Level	Est. Construction Date	Previous studies and/or community input
Contributory 2	Early to late 20 th century (broad range)	No prior heritage assessments or research undertaken.
Assessment Text		Observed Modifications
<p>The scale (single-storey) and general style of the dwelling is consistent with that of the streetscape and wider HCA. Dwelling contributes positively to the streetscape and wider HCA, particularly in comparison to Non-Contributory buildings.</p> <p>The dwelling features appropriately proportioned and positioned fenestrations, an appropriate roof form (gabled or hipped) and other features consistent with the architectural character of the area (e.g. front verandah with timber or brick posts, timber detailing, corrugated metal roofing, etc). The contributory value of the dwelling is limited however by either:</p> <ul style="list-style-type: none"> • External modifications that have in some way obscured the style, scale or design intent of the building and have resulted in less physical integrity than Contributory 1 buildings. • Being a later dwelling constructed in an appropriate referential style, but comprising little to no fabric of intrinsic heritage significance. 		<p>The faux European pillars are possibly a contemporary addition to the dwelling.</p>

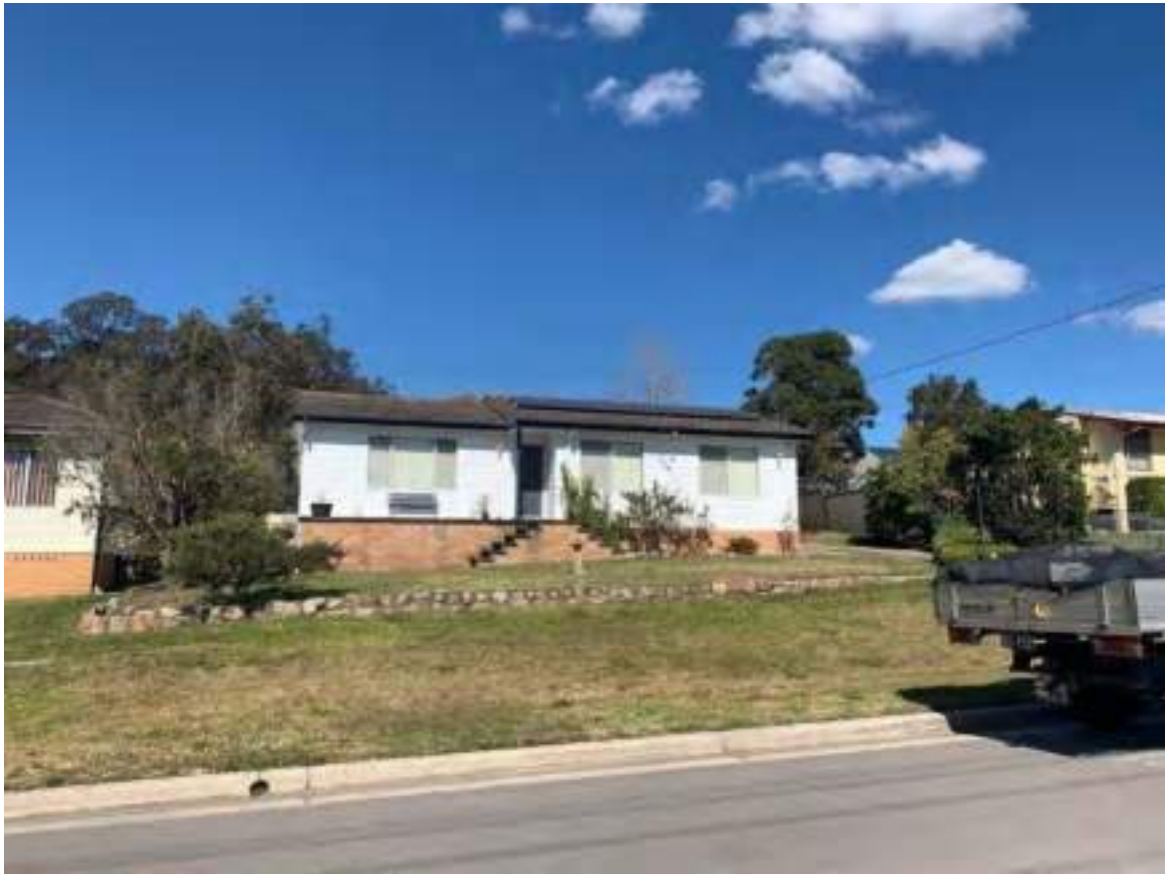
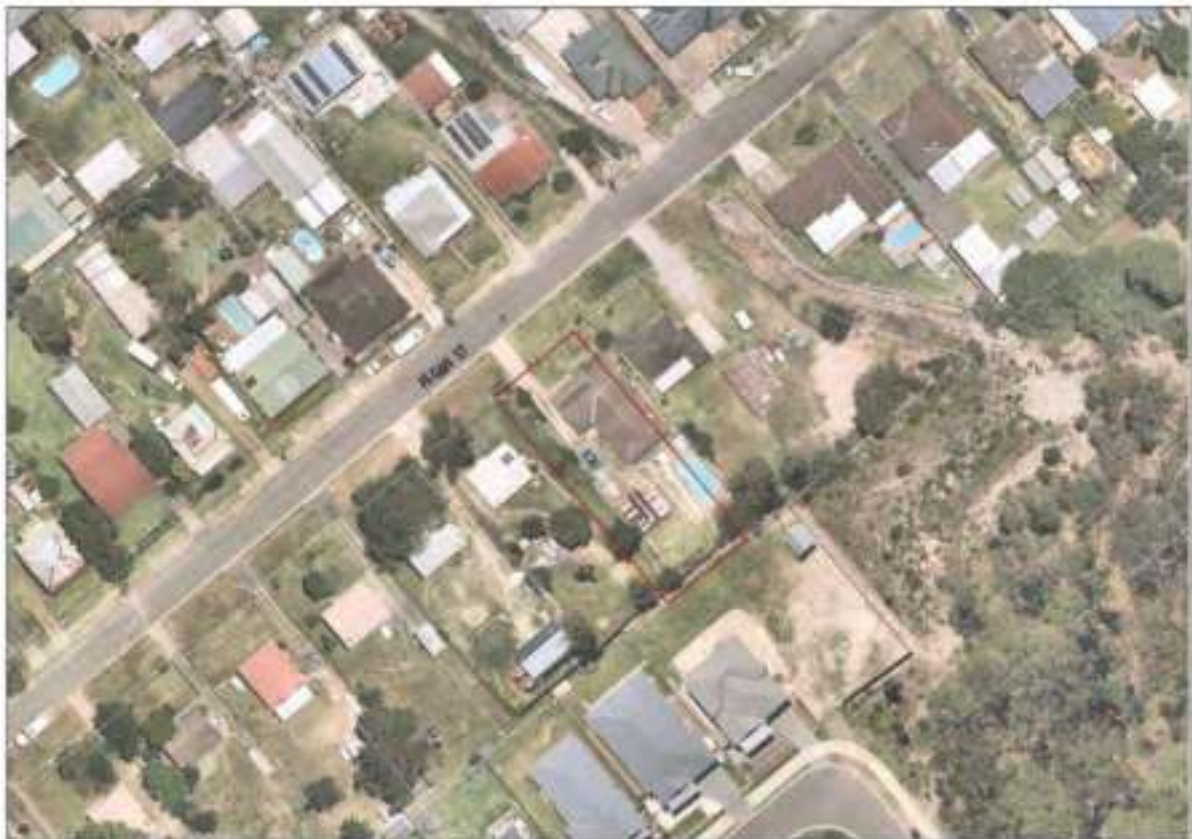
16 FEGAN STREET, WEST WALLSEND 2286

Conservation Area Contribution Level	Est. Construction Date	Previous studies and/or community input
Contributory 2	Early to late 20 th century (broad range)	No prior heritage assessments or research undertaken.
Assessment Text		Observed Modifications
<p>The scale (single-storey) and general style of the dwelling is consistent with that of the streetscape and wider HCA. Dwelling contributes positively to the streetscape and wider HCA, particularly in comparison to Non-Contributory buildings.</p> <p>The dwelling features appropriately proportioned and positioned fenestrations, an appropriate roof form (gabled or hipped) and other features consistent with the architectural character of the area (e.g. front verandah with timber or brick posts, timber detailing, corrugated metal roofing, etc). The contributory value of the dwelling is limited however by either:</p> <ul style="list-style-type: none"> • External modifications that have in some way obscured the style, scale or design intent of the building and have resulted in less physical integrity than Contributory 1 buildings. • Being a later dwelling constructed in an appropriate referential style, but comprising little to no fabric of intrinsic heritage significance. 		Solar panels are visible on the north western portion of the roof.
