APPENDIX 2

Building Assessment Sheets (Inventory Sheets)

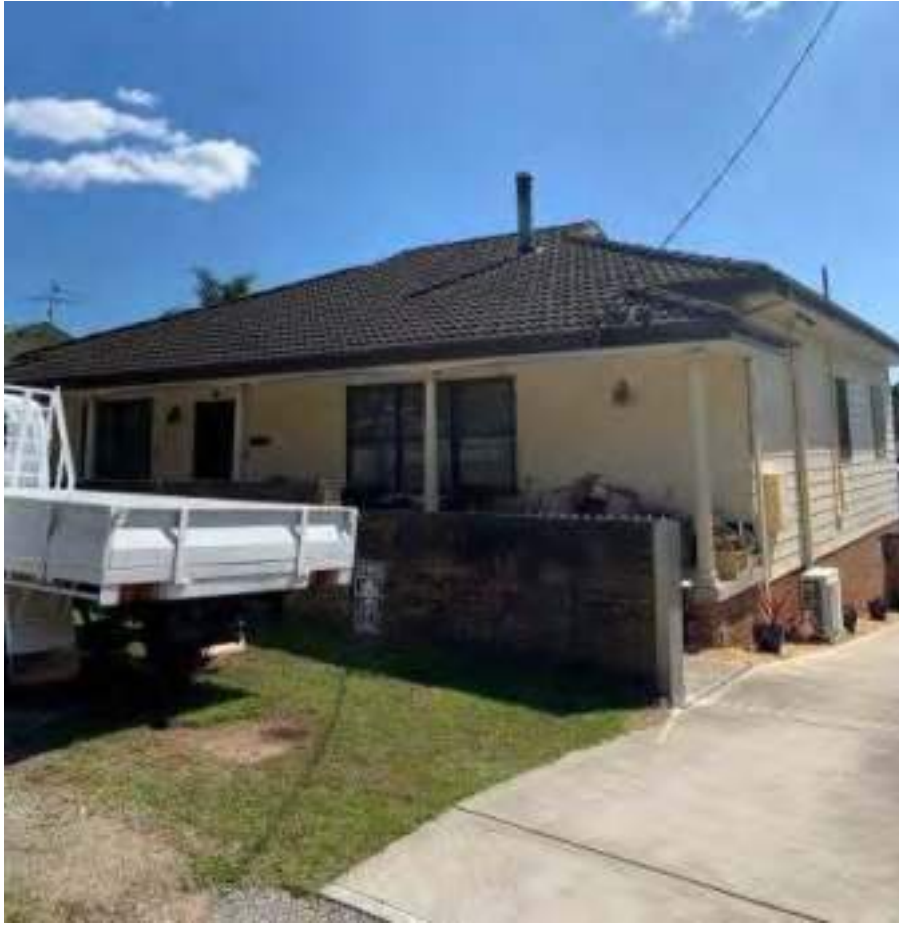
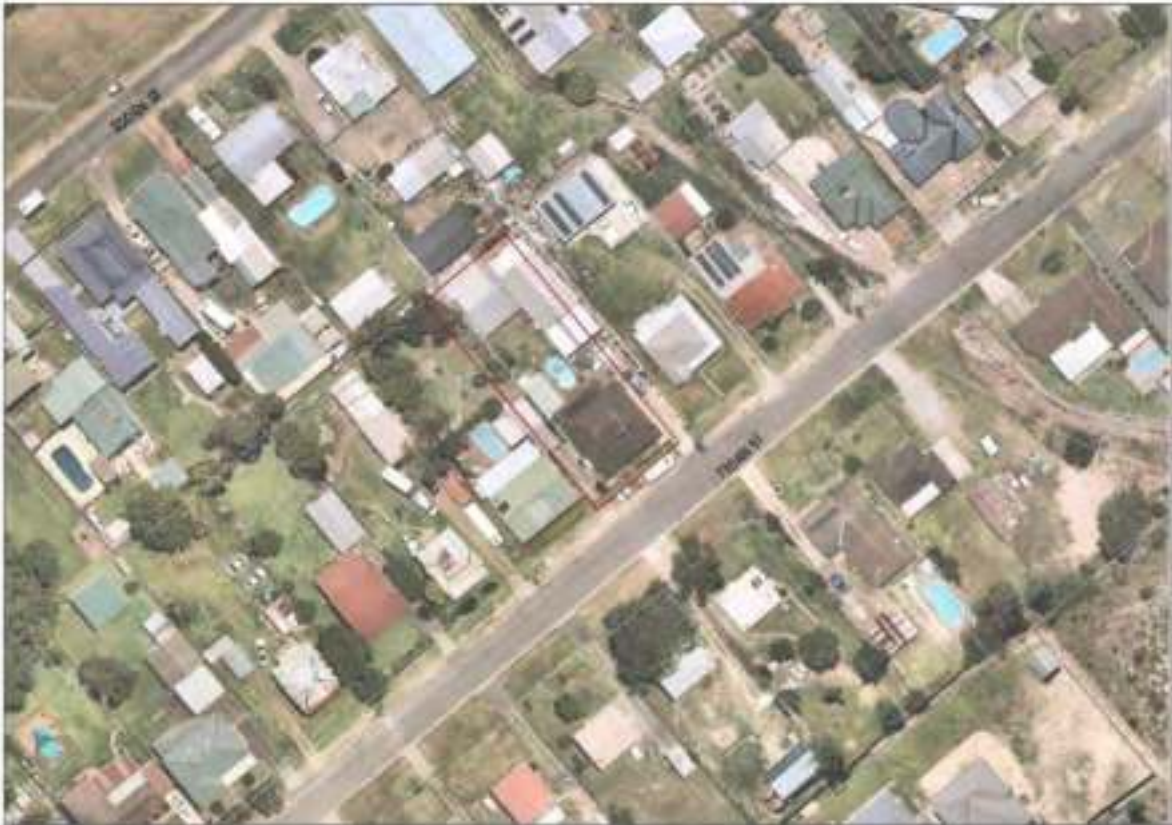
11 FEGAN STREET, WEST WALLSEND 2286

Conservation Area Contribution Level	Est. Construction Date	Previous studies and/or community input
Contributory 2	Early to late 20 th century (broad range)	No prior heritage assessments or research undertaken.
Assessment Text		Observed Modifications
<p>The scale (single-storey) and general style of the dwelling is consistent with that of the streetscape and wider HCA. Dwelling contributes positively to the streetscape and wider HCA, particularly in comparison to Non-Contributory buildings.</p> <p>The dwelling features appropriately proportioned and positioned fenestrations, an appropriate roof form (gabled or hipped) and other features consistent with the architectural character of the area (e.g. front verandah with timber or brick posts, timber detailing, corrugated metal roofing, etc). The contributory value of the dwelling is limited however by either:</p> <ul style="list-style-type: none"> • External modifications that have in some way obscured the style, scale or design intent of the building and have resulted in less physical integrity than Contributory 1 buildings. • Being a later dwelling constructed in an appropriate referential style, but comprising little to no fabric of intrinsic heritage significance. 		<p>The faux European pillars are likely a contemporary addition to the dwelling. This is a common modification in the area.</p>

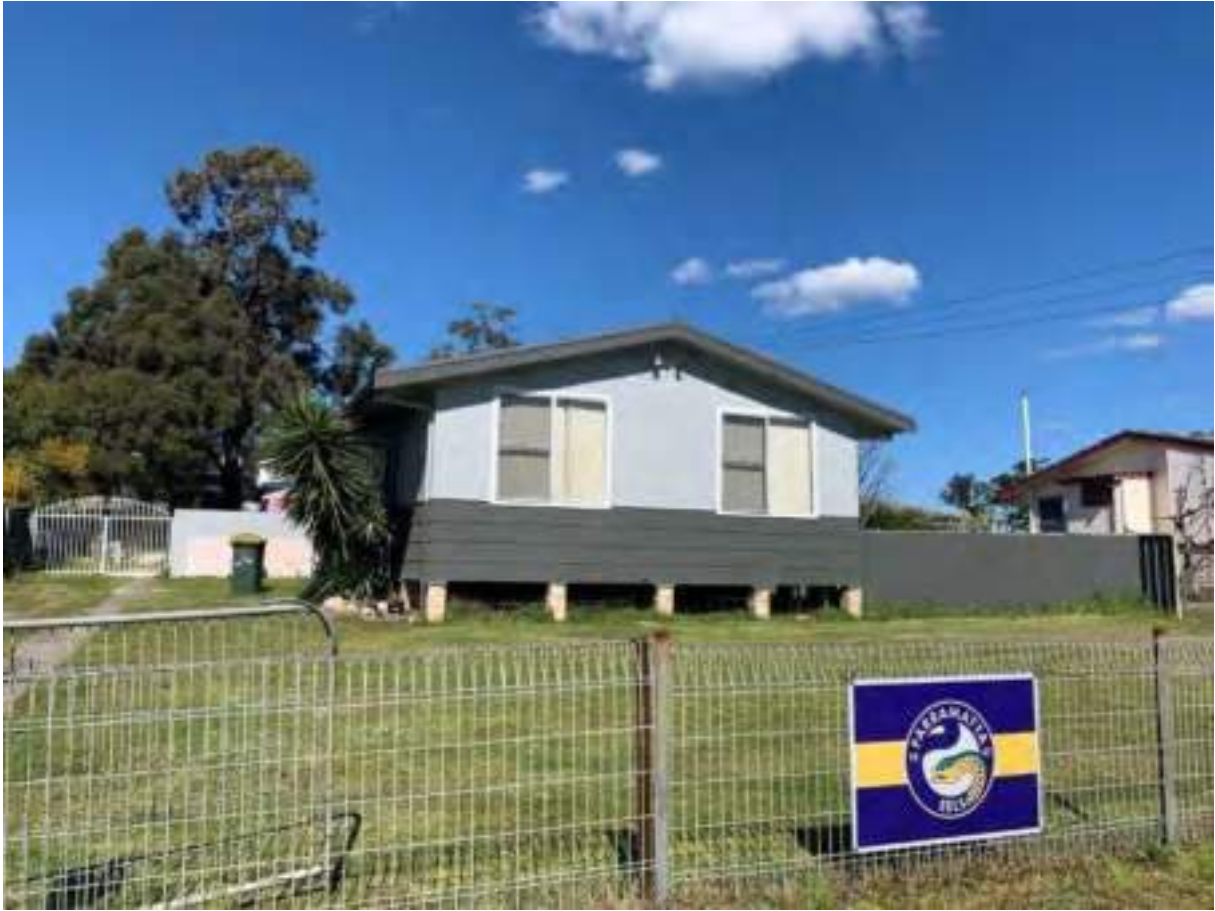
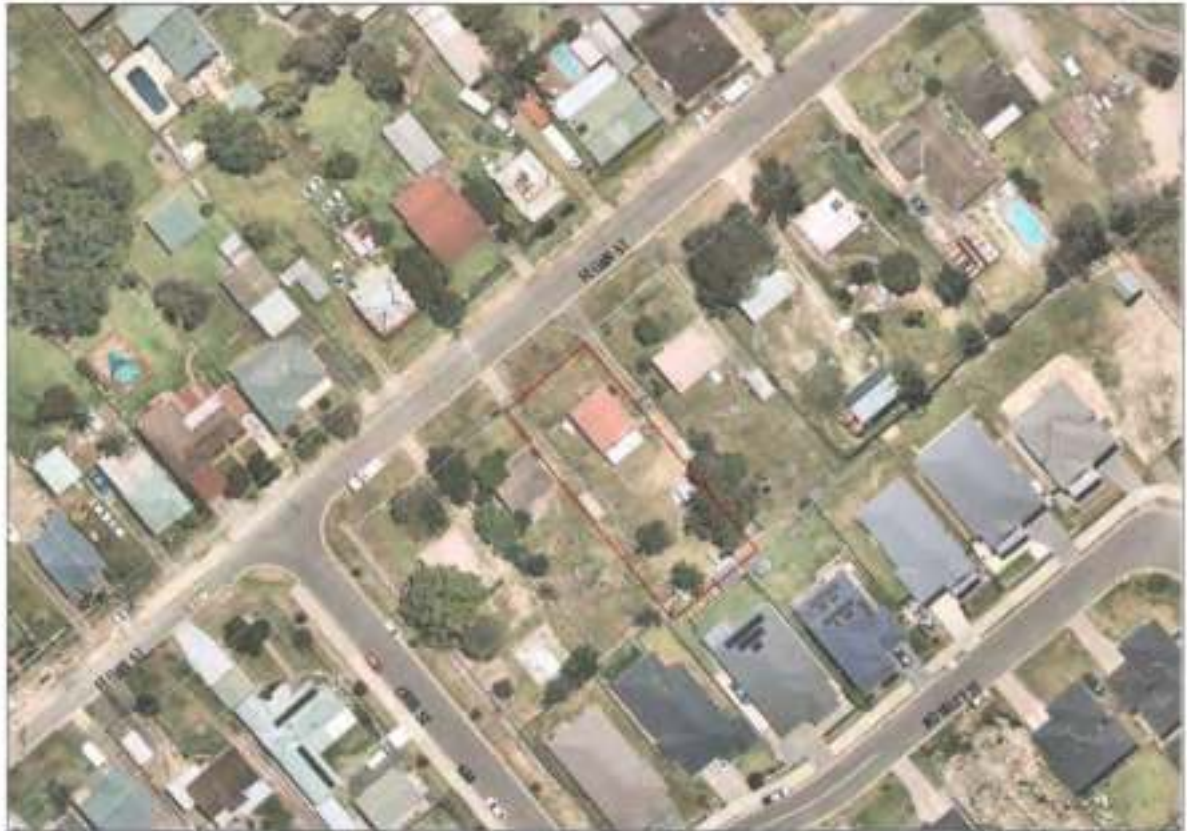
24 FEGAN STREET, WEST WALLSEND 2286

Conservation Area Contribution Level	Est. Construction Date	Previous studies and/or community input
Contributory 2	Early to late 20 th century (broad range)	No prior heritage assessments or research undertaken.
Assessment Text		Observed Modifications
<p>The scale (single-storey) and general style of the dwelling is consistent with that of the streetscape and wider HCA. Dwelling contributes positively to the streetscape and wider HCA, particularly in comparison to Non-Contributory buildings.</p> <p>The dwelling features appropriately proportioned and positioned fenestrations, an appropriate roof form (gabled or hipped) and other features consistent with the architectural character of the area (e.g. front verandah with timber or brick posts, timber detailing, corrugated metal roofing, etc). The contributory value of the dwelling is limited however by either:</p> <ul style="list-style-type: none"> • External modifications that have in some way obscured the style, scale or design intent of the building and have resulted in less physical integrity than Contributory 1 buildings. • Being a later dwelling constructed in an appropriate referential style, but comprising little to no fabric of intrinsic heritage significance. 		<p>The visible windows are contemporary designs.</p>

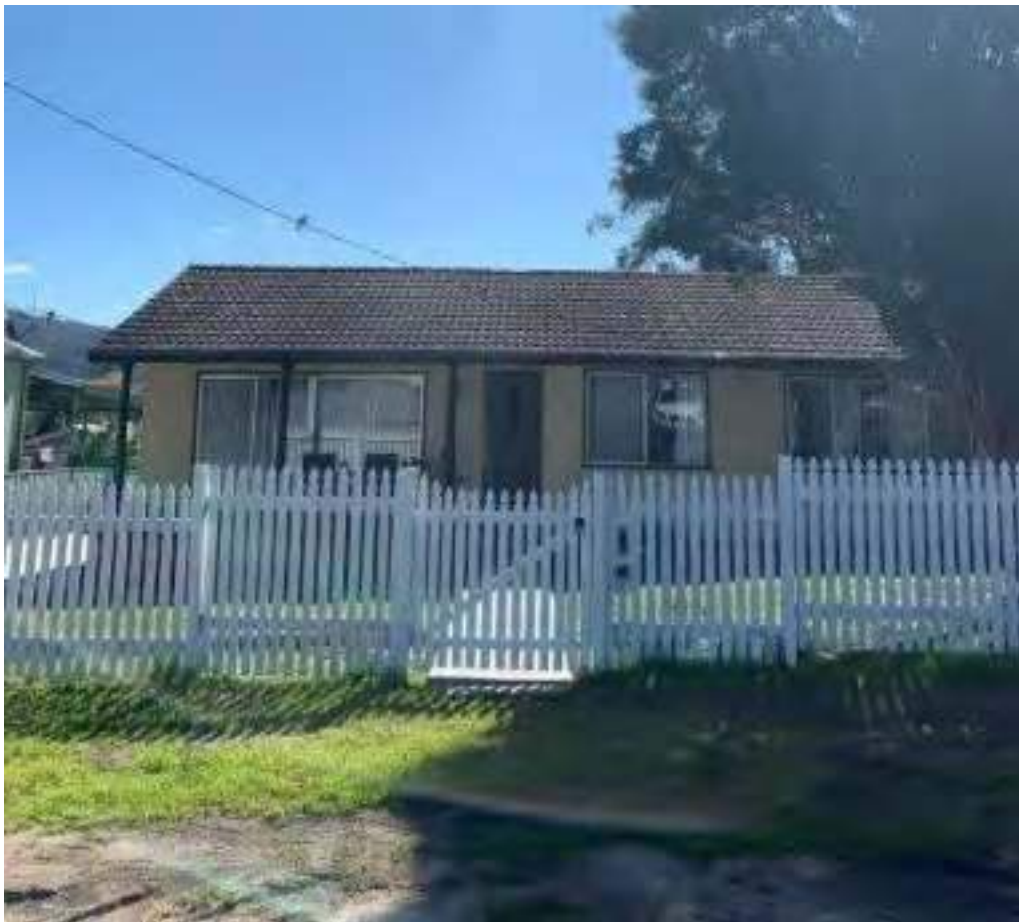
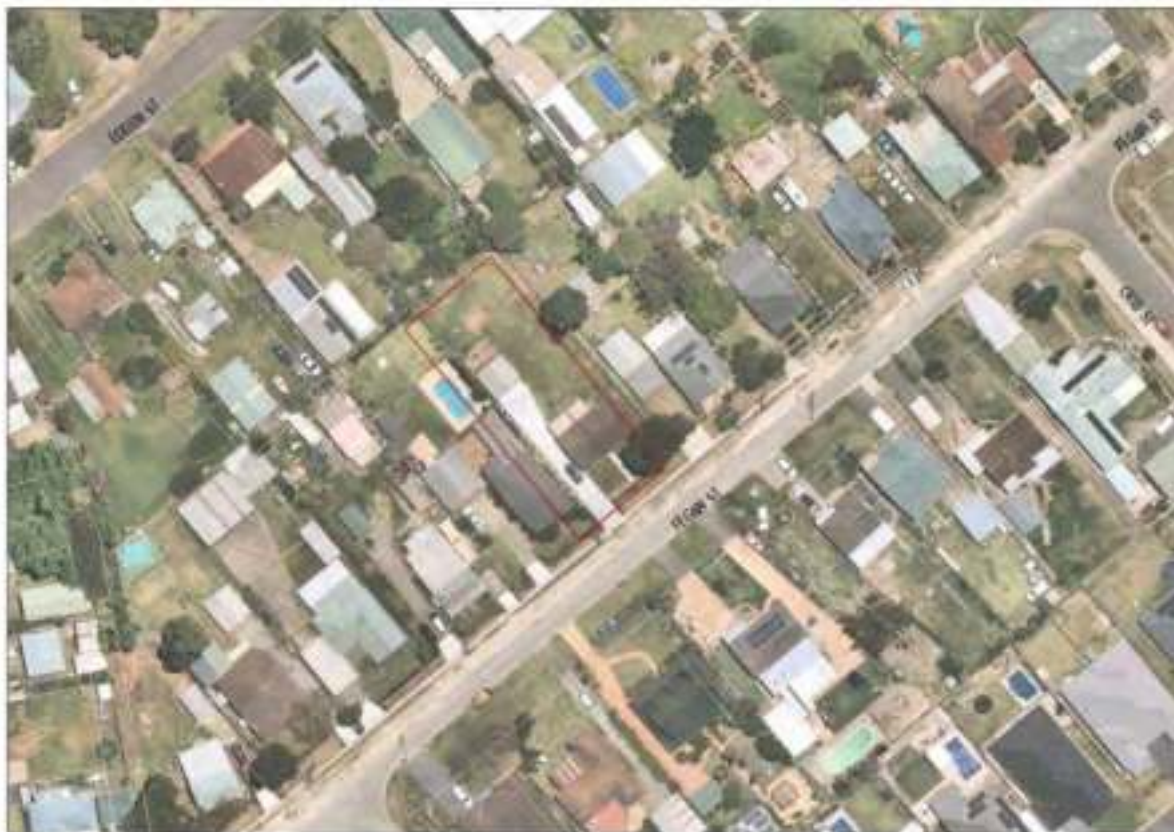
33 FEGAN STREET, WEST WALLESEND 2286

Conservation Area Contribution Level	Est. Construction Date	Previous studies and/or community input
Contributory 2	Early to late 20 th century (broad range)	No prior heritage assessments or research undertaken.
Assessment Text		Observed Modifications
<p>The scale (single-storey) and general style of the dwelling is consistent with that of the streetscape and wider HCA. Dwelling contributes positively to the streetscape and wider HCA, particularly in comparison to Non-Contributory buildings.</p> <p>The dwelling features appropriately proportioned and positioned fenestrations, an appropriate roof form (gabled or hipped) and other features consistent with the architectural character of the area (e.g. front verandah with timber or brick posts, timber detailing, corrugated metal roofing, etc). The contributory value of the dwelling is limited however by either:</p> <ul style="list-style-type: none"> • External modifications that have in some way obscured the style, scale or design intent of the building and have resulted in less physical integrity than Contributory 1 buildings. • Being a later dwelling constructed in an appropriate referential style, but comprising little to no fabric of intrinsic heritage significance. 		No modifications observed.

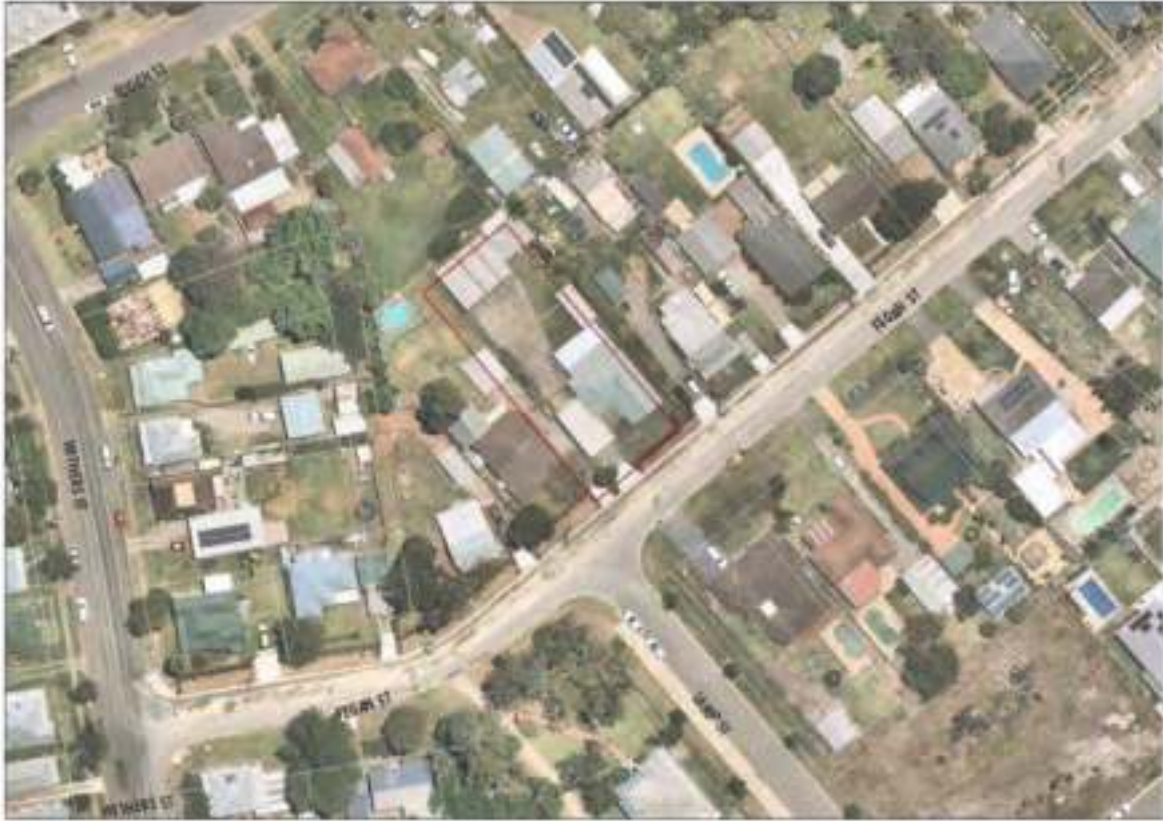
39 FEGAN STREET, WEST WALLSEND 2286

Conservation Area Contribution Level	Est. Construction Date	Previous studies and/or community input
Contributory 2	Early to late 20 th century (broad range)	No prior heritage assessments or research undertaken.
Assessment Text		Observed Modifications
<p>The scale (single-storey) and general style of the dwelling is consistent with that of the streetscape and wider HCA. Dwelling contributes positively to the streetscape and wider HCA, particularly in comparison to Non-Contributory buildings.</p> <p>The dwelling features appropriately proportioned and positioned fenestrations, an appropriate roof form (gabled or hipped) and other features consistent with the architectural character of the area (e.g. front verandah with timber or brick posts, timber detailing, corrugated metal roofing, etc). The contributory value of the dwelling is limited however by either:</p> <ul style="list-style-type: none"> • External modifications that have in some way obscured the style, scale or design intent of the building and have resulted in less physical integrity than Contributory 1 buildings. • Being a later dwelling constructed in an appropriate referential style, but comprising little to no fabric of intrinsic heritage significance. 		No modifications observed.

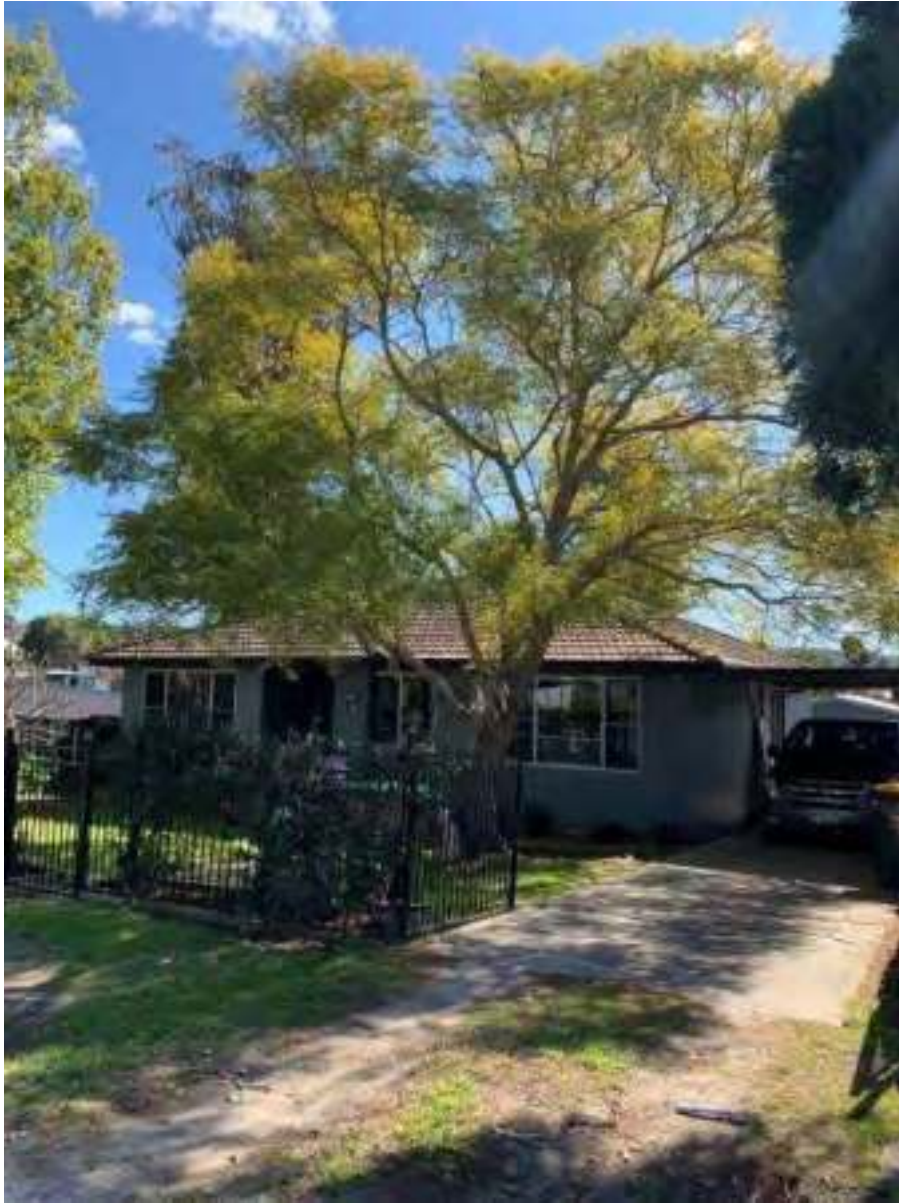
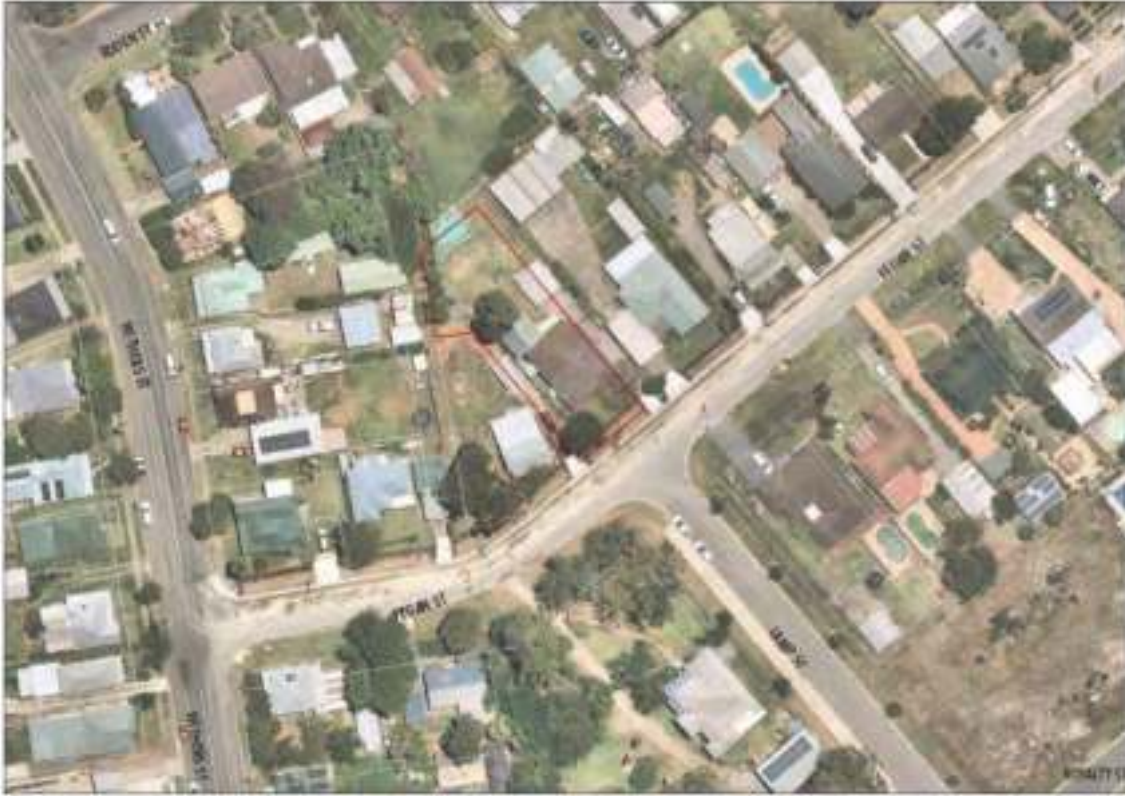
41 FEGAN STREET, WEST WALLSEND 2286

Conservation Area Contribution Level	Est. Construction Date	Previous studies and/or community input
Contributory 2	Early to late 20 th century (broad range)	No prior heritage assessments or research undertaken.
Assessment Text		Observed Modifications
<p>The scale (single-storey) and general style of the dwelling is consistent with that of the streetscape and wider HCA. Dwelling contributes positively to the streetscape and wider HCA, particularly in comparison to Non-Contributory buildings.</p> <p>The dwelling features appropriately proportioned and positioned fenestrations, an appropriate roof form (gabled or hipped) and other features consistent with the architectural character of the area (e.g. front verandah with timber or brick posts, timber detailing, corrugated metal roofing, etc). The contributory value of the dwelling is limited however by either:</p> <ul style="list-style-type: none"> External modifications that have in some way obscured the style, scale or design intent of the building and have resulted in less physical integrity than Contributory 1 buildings. Being a later dwelling constructed in an appropriate referential style, but comprising little to no fabric of intrinsic heritage significance. 		<p>A carport has been constructed to the east of the dwelling.</p>

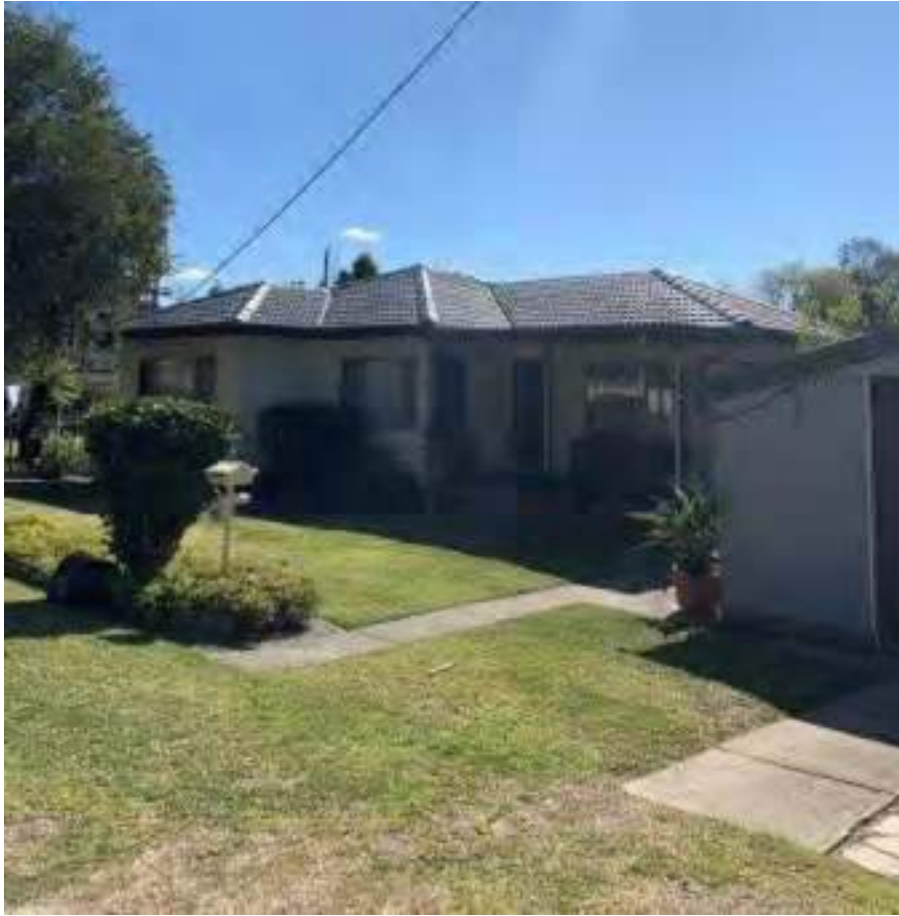
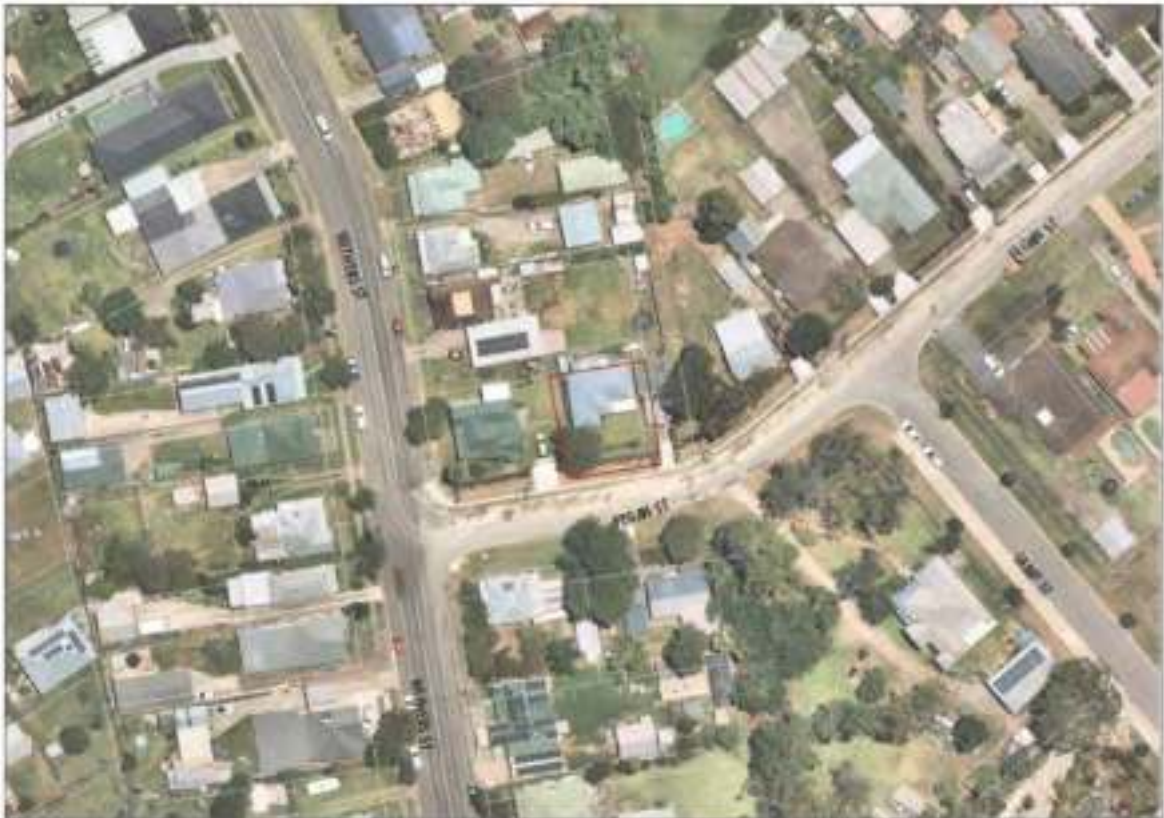
45 FEGAN STREET, WEST WALLSEND 2286

Conservation Area Contribution Level	Est. Construction Date	Previous studies and/or community input
Contributory 2	Early to late 20 th century (broad range)	No prior heritage assessments or research undertaken.
Assessment Text		Observed Modifications
<p>The scale (single-storey) and general style of the dwelling is consistent with that of the streetscape and wider HCA. Dwelling contributes positively to the streetscape and wider HCA, particularly in comparison to Non-Contributory buildings.</p> <p>The dwelling features appropriately proportioned and positioned fenestrations, an appropriate roof form (gabled or hipped) and other features consistent with the architectural character of the area (e.g. front verandah with timber or brick posts, timber detailing, corrugated metal roofing, etc). The contributory value of the dwelling is limited however by either:</p> <ul style="list-style-type: none"> • External modifications that have in some way obscured the style, scale or design intent of the building and have resulted in less physical integrity than Contributory 1 buildings. • Being a later dwelling constructed in an appropriate referential style, but comprising little to no fabric of intrinsic heritage significance. 		No modifications observed.

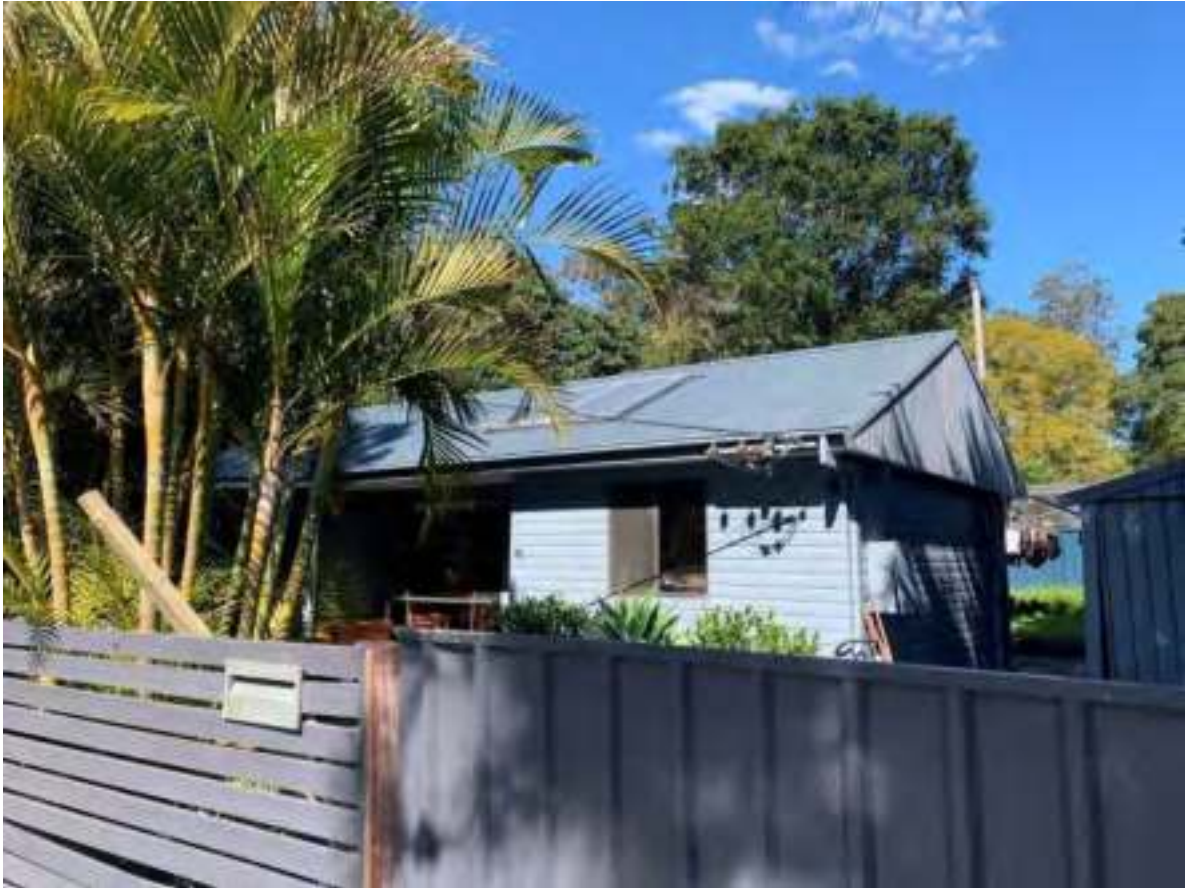
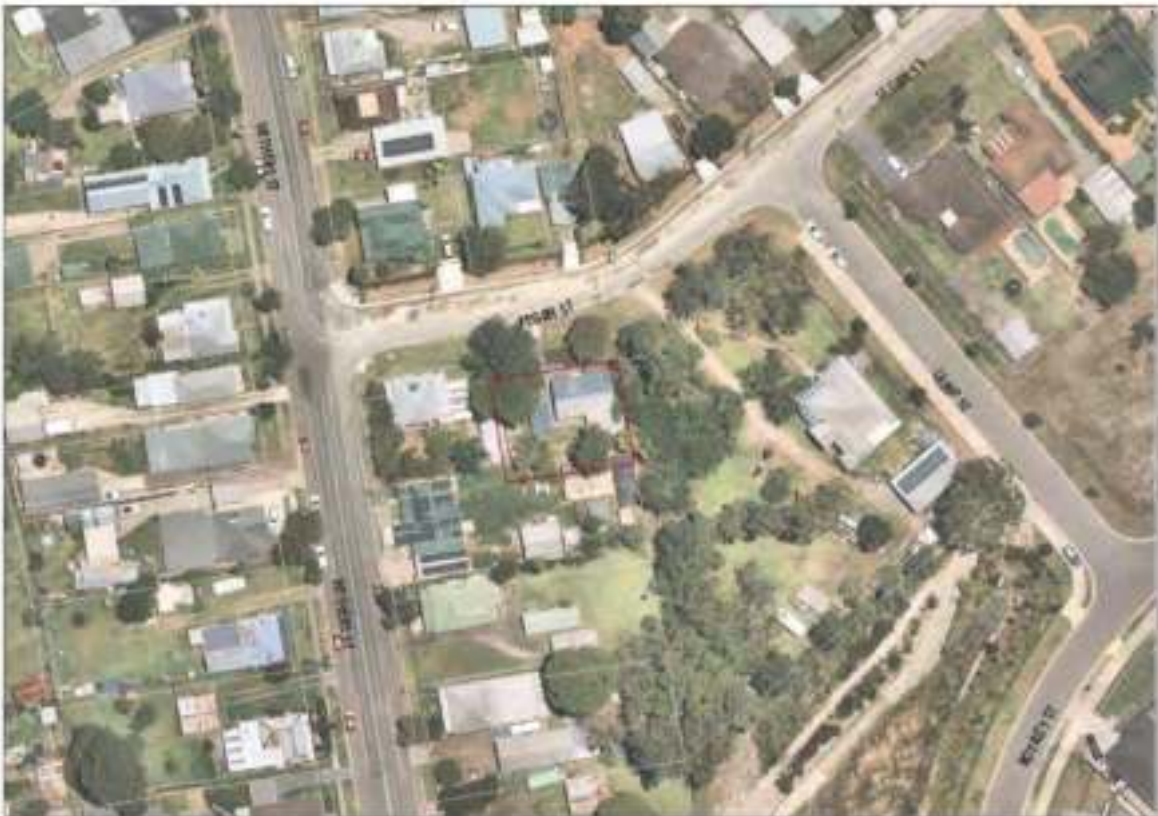
50 FEGAN STREET, WEST WALLESEND 2286

Conservation Area Contribution Level	Est. Construction Date	Previous studies and/or community input
Contributory 2	Early to late 20 th century (broad range)	No prior heritage assessments or research undertaken.
Assessment Text		Observed Modifications
<p>The scale (single-storey) and general style of the dwelling is consistent with that of the streetscape and wider HCA. Dwelling contributes positively to the streetscape and wider HCA, particularly in comparison to Non-Contributory buildings.</p> <p>The dwelling features appropriately proportioned and positioned fenestrations, an appropriate roof form (gabled or hipped) and other features consistent with the architectural character of the area (e.g. front verandah with timber or brick posts, timber detailing, corrugated metal roofing, etc). The contributory value of the dwelling is limited however by either:</p> <ul style="list-style-type: none"> • External modifications that have in some way obscured the style, scale or design intent of the building and have resulted in less physical integrity than Contributory 1 buildings. • Being a later dwelling constructed in an appropriate referential style, but comprising little to no fabric of intrinsic heritage significance. 		No modifications observed.

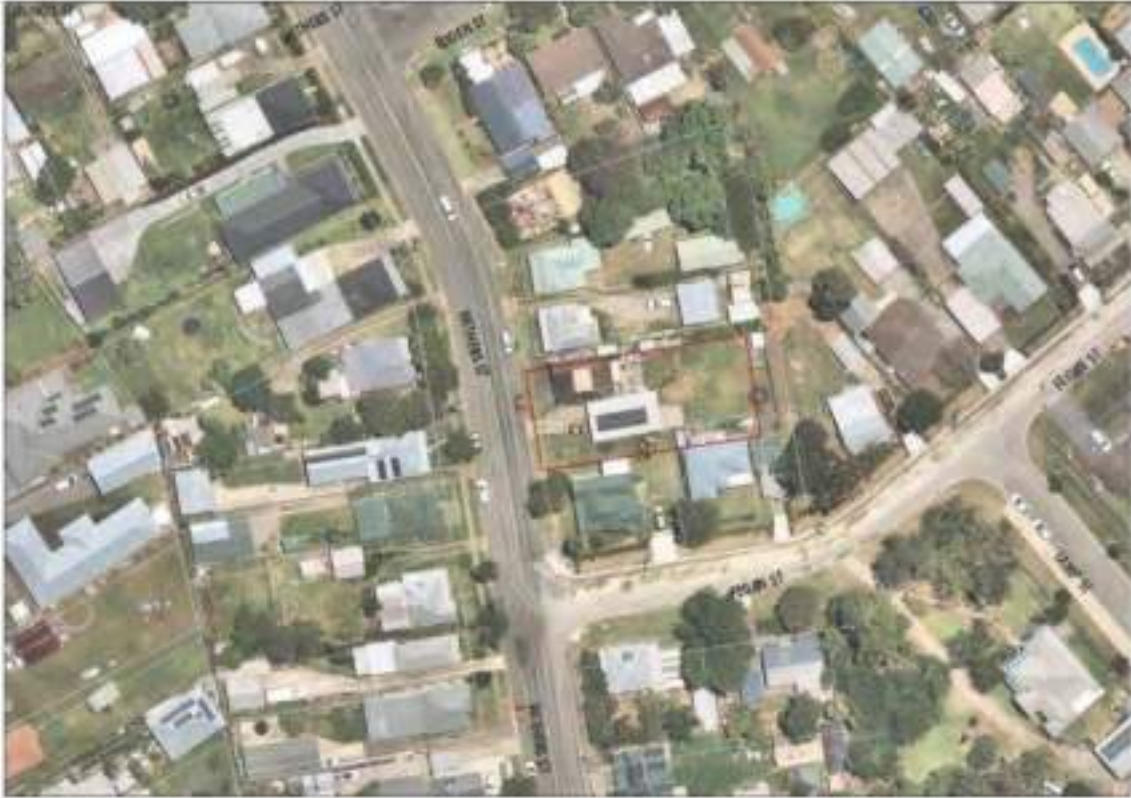
55 WITHERS STREET, WEST WALLSEND 2286

Conservation Area Contribution Level	Est. Construction Date	Previous studies and/or community input
Contributory 2	Early to late 20 th century (broad range)	No prior heritage assessments or research undertaken.
Assessment Text		Observed Modifications
<p>The scale (single-storey) and general style of the dwelling is consistent with that of the streetscape and wider HCA. Dwelling contributes positively to the streetscape and wider HCA, particularly in comparison to Non-Contributory buildings.</p> <p>The dwelling features appropriately proportioned and positioned fenestrations, an appropriate roof form (gabled or hipped) and other features consistent with the architectural character of the area (e.g. front verandah with timber or brick posts, timber detailing, corrugated metal roofing, etc). The contributory value of the dwelling is limited however by either:</p> <ul style="list-style-type: none"> • External modifications that have in some way obscured the style, scale or design intent of the building and have resulted in less physical integrity than Contributory 1 buildings. • Being a later dwelling constructed in an appropriate referential style, but comprising little to no fabric of intrinsic heritage significance. 		<p>A corrugated iron structure has been constructed to the south of the dwelling.</p>

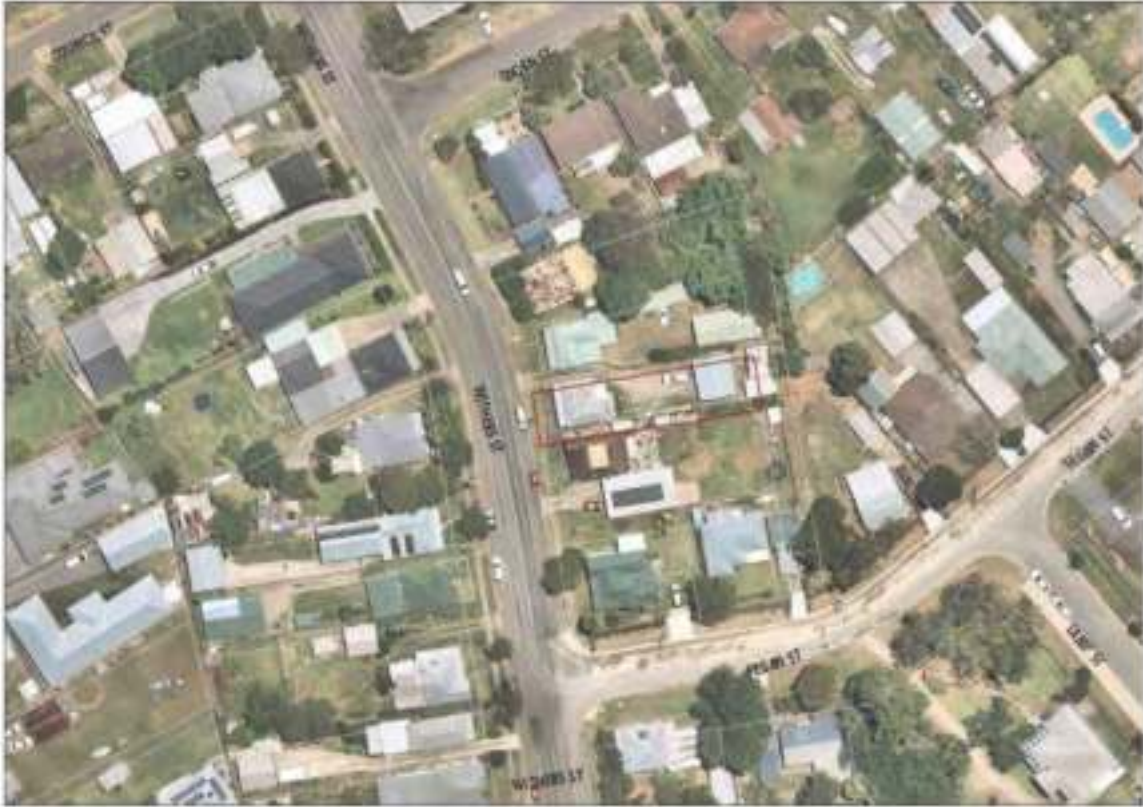
53 WITHERS STREET, WEST WALLSEND 2286

Conservation Area Contribution Level	Est. Construction Date	Previous studies and/or community input
Contributory 2	Early to late 20 th century (broad range)	No prior heritage assessments or research undertaken.
Assessment Text		Observed Modifications
<p>The scale (single-storey) and general style of the dwelling is consistent with that of the streetscape and wider HCA. Dwelling contributes positively to the streetscape and wider HCA, particularly in comparison to Non-Contributory buildings.</p> <p>The dwelling features appropriately proportioned and positioned fenestrations, an appropriate roof form (gabled or hipped) and other features consistent with the architectural character of the area (e.g. front verandah with timber or brick posts, timber detailing, corrugated metal roofing, etc). The contributory value of the dwelling is limited however by either:</p> <ul style="list-style-type: none"> • External modifications that have in some way obscured the style, scale or design intent of the building and have resulted in less physical integrity than Contributory 1 buildings. • Being a later dwelling constructed in an appropriate referential style, but comprising little to no fabric of intrinsic heritage significance. 		<p>The veranda has been fully enclosed to create an additional western living area. The front door has been relocated to a street front location, with contemporary windows either side.</p>

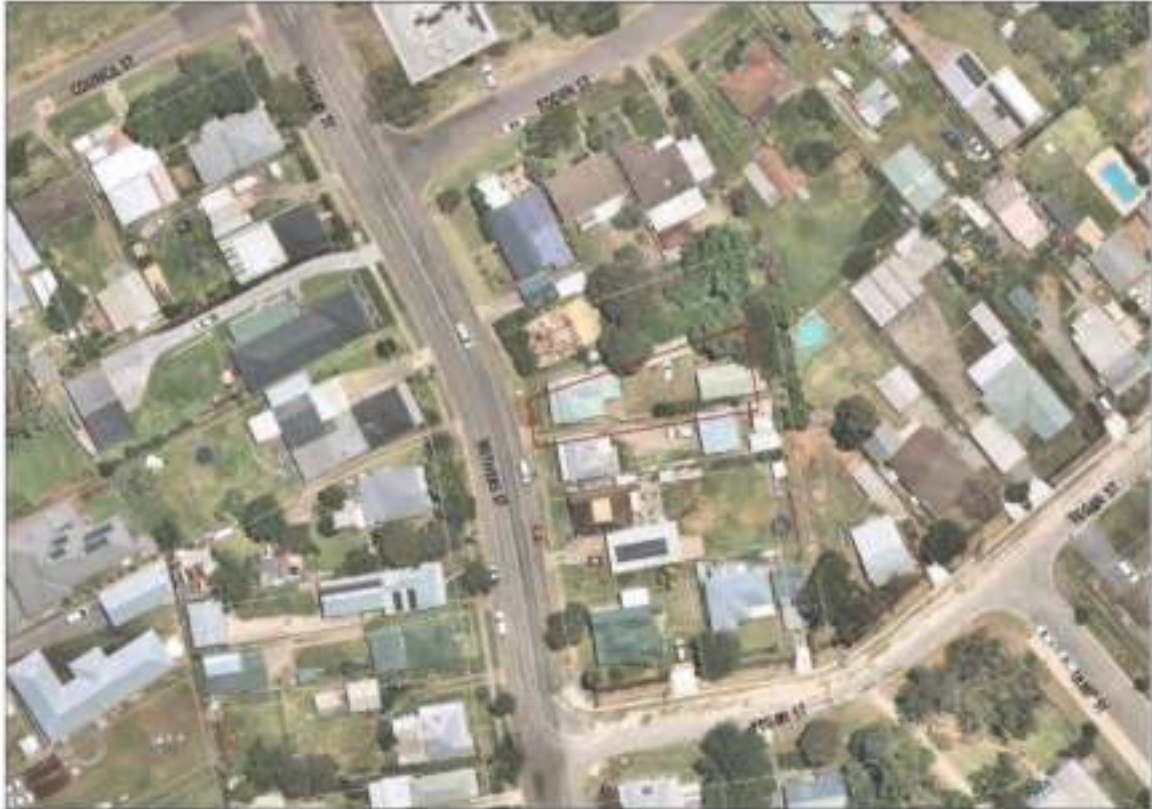
51 WITHERS STREET, WEST WALLSEND 2286

Conservation Area Contribution Level	Est. Construction Date	Previous studies and/or community input
Contributory 2	Early to late 20 th century (broad range)	No prior heritage assessments or research undertaken.
Assessment Text		Observed Modifications
<p>The scale (single-storey) and general style of the dwelling is consistent with that of the streetscape and wider HCA. Dwelling contributes positively to the streetscape and wider HCA, particularly in comparison to Non-Contributory buildings.</p> <p>The dwelling features appropriately proportioned and positioned fenestrations, an appropriate roof form (gabled or hipped) and other features consistent with the architectural character of the area (e.g. front verandah with timber or brick posts, timber detailing, corrugated metal roofing, etc). The contributory value of the dwelling is limited however by either:</p> <ul style="list-style-type: none"> • External modifications that have in some way obscured the style, scale or design intent of the building and have resulted in less physical integrity than Contributory 1 buildings. • Being a later dwelling constructed in an appropriate referential style, but comprising little to no fabric of intrinsic heritage significance. 		<p>The veranda has been enclosed to create an additional western living room. The front door has been relocated to this street front location, with contemporary windows either side. This is a common modification of the area.</p>

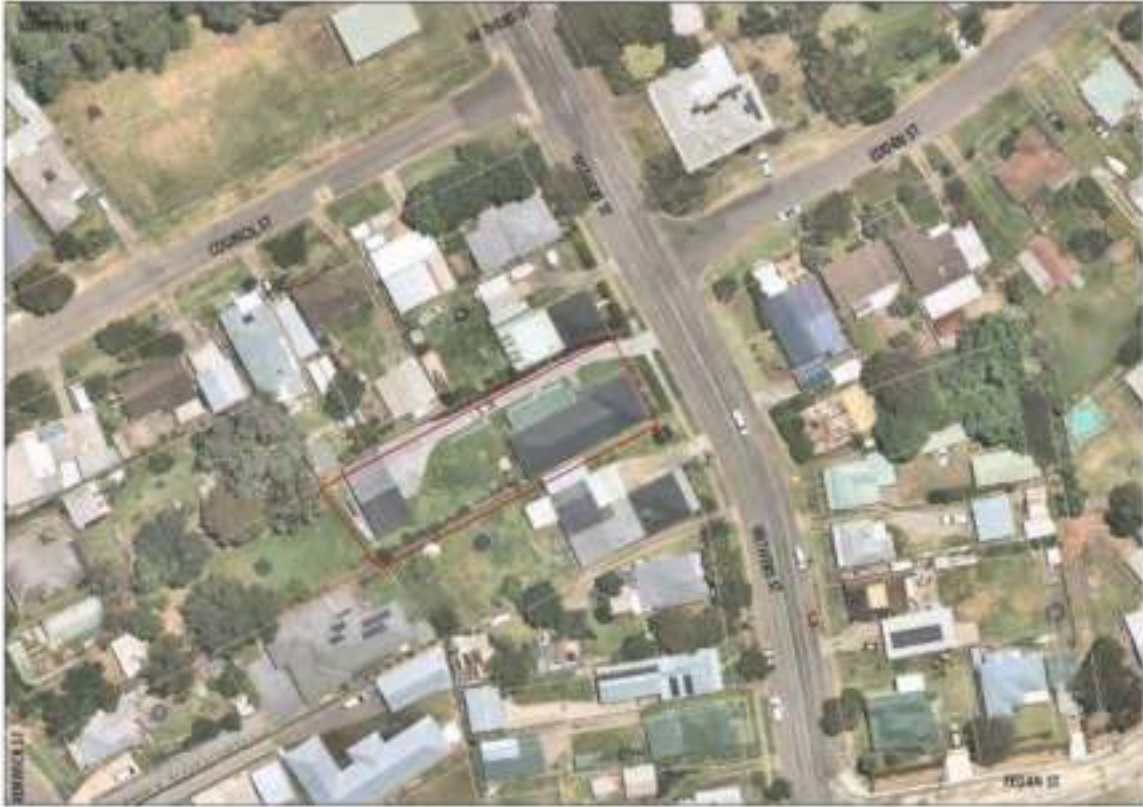
34 WITHERS STREET, WEST WALLSEND 2286

Conservation Area Contribution Level	Est. Construction Date	Previous studies and/or community input
Contributory 2	1910–1930	No prior heritage assessments or research undertaken.
Assessment Text		Observed Modifications
<p>The scale (single-storey) and general style of the dwelling is consistent with that of the streetscape and wider HCA. Dwelling contributes positively to the streetscape and wider HCA, particularly in comparison to Non-Contributory buildings.</p> <p>The dwelling features appropriately proportioned and positioned fenestrations, an appropriate roof form (gabled or hipped) and other features consistent with the architectural character of the area (e.g. front verandah with timber or brick posts, timber detailing, corrugated metal roofing, etc). The contributory value of the dwelling is limited however by either:</p> <ul style="list-style-type: none"> External modifications that have in some way obscured the style, scale or design intent of the building and have resulted in less physical integrity than Contributory 1 buildings. Being a later dwelling constructed in an appropriate referential style, but comprising little to no fabric of intrinsic heritage significance. 		<p>The veranda has been extended to wrap around the eastern and northern sides of the dwelling. the timber posts and ornate brackets supporting the roof are contemporary additions replicating the original timber design. This added decorative bracketing has been undertaken in a heritage style and is sympathetic to the heritage streetscape.</p> <p>The visible windows are contemporary designs.</p> <p>An extension has been constructed at the back western section of the dwelling, connecting with the extended veranda.</p>

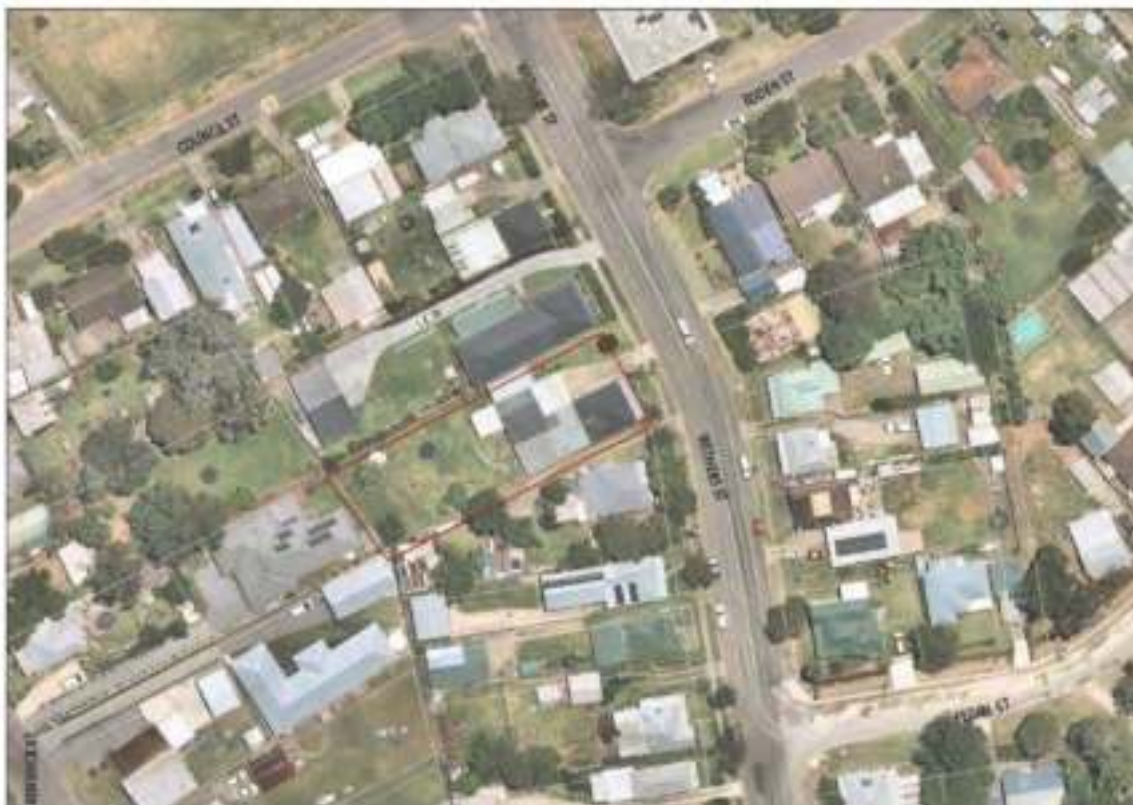
36 WITHERS STREET, WEST WALLSEND 2286

Conservation Area Contribution Level	Est. Construction Date	Previous studies and/or community input
Contributory 2	1900–1930	No prior heritage assessments or research undertaken.
Assessment Text		Observed Modifications
<p>The scale (single-storey) and general style of the dwelling is consistent with that of the streetscape and wider HCA. Dwelling contributes positively to the streetscape and wider HCA, particularly in comparison to Non-Contributory buildings.</p> <p>The dwelling features appropriately proportioned and positioned fenestrations, an appropriate roof form (gabled or hipped) and other features consistent with the architectural character of the area (e.g. front verandah with timber or brick posts, timber detailing, corrugated metal roofing, etc). The contributory value of the dwelling is limited however by either:</p> <ul style="list-style-type: none"> • External modifications that have in some way obscured the style, scale or design intent of the building and have resulted in less physical integrity than Contributory 1 buildings. • Being a later dwelling constructed in an appropriate referential style, but comprising little to no fabric of intrinsic heritage significance. 		<p>The visible windows are contemporary designs.</p> <p>The façade has been painted a bright red and dark blue, a colour scheme which is unsympathetic in choice and detracts from the heritage streetscape.</p> <p>A carport has been constructed on the northern side of the dwelling.</p>
