APPENDIX 2

Building Assessment Sheets (Inventory Sheets)

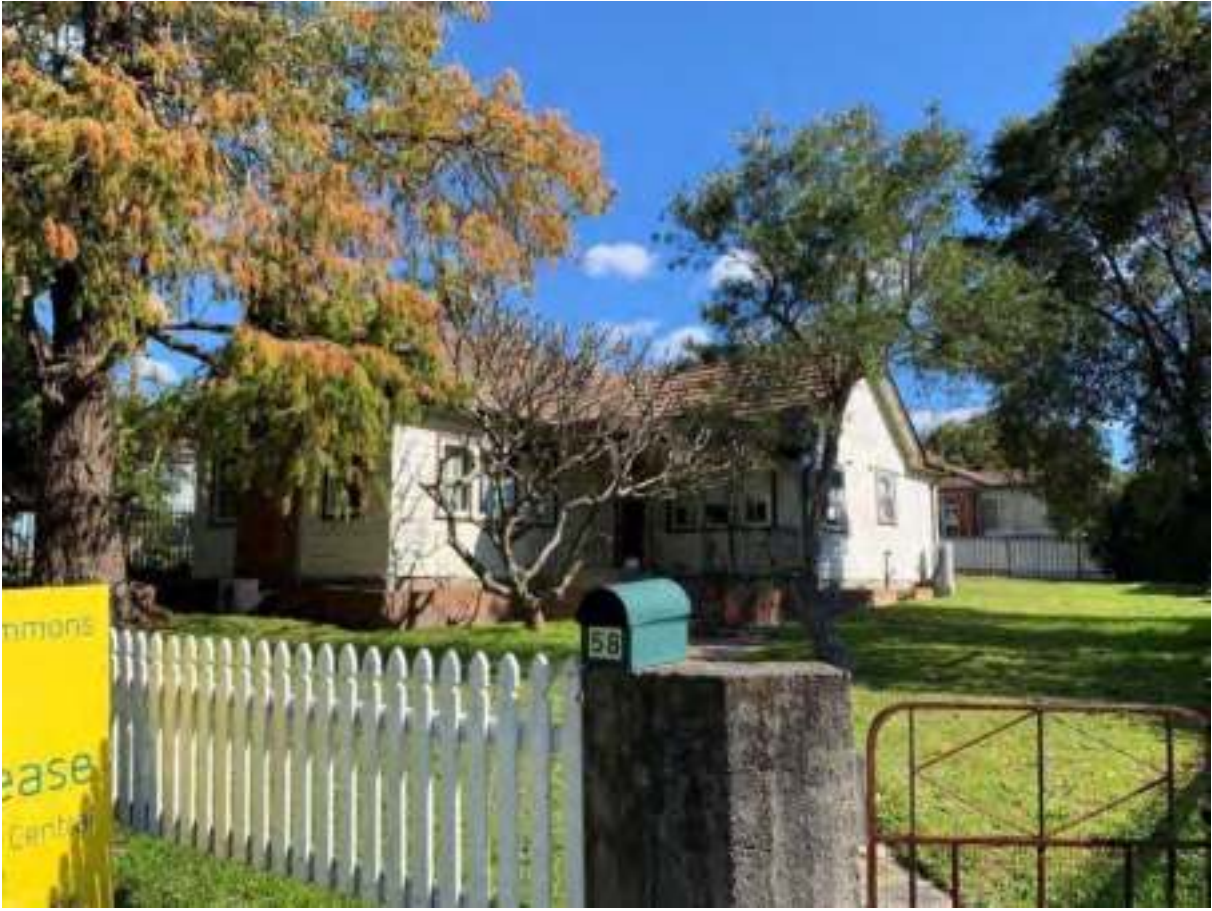
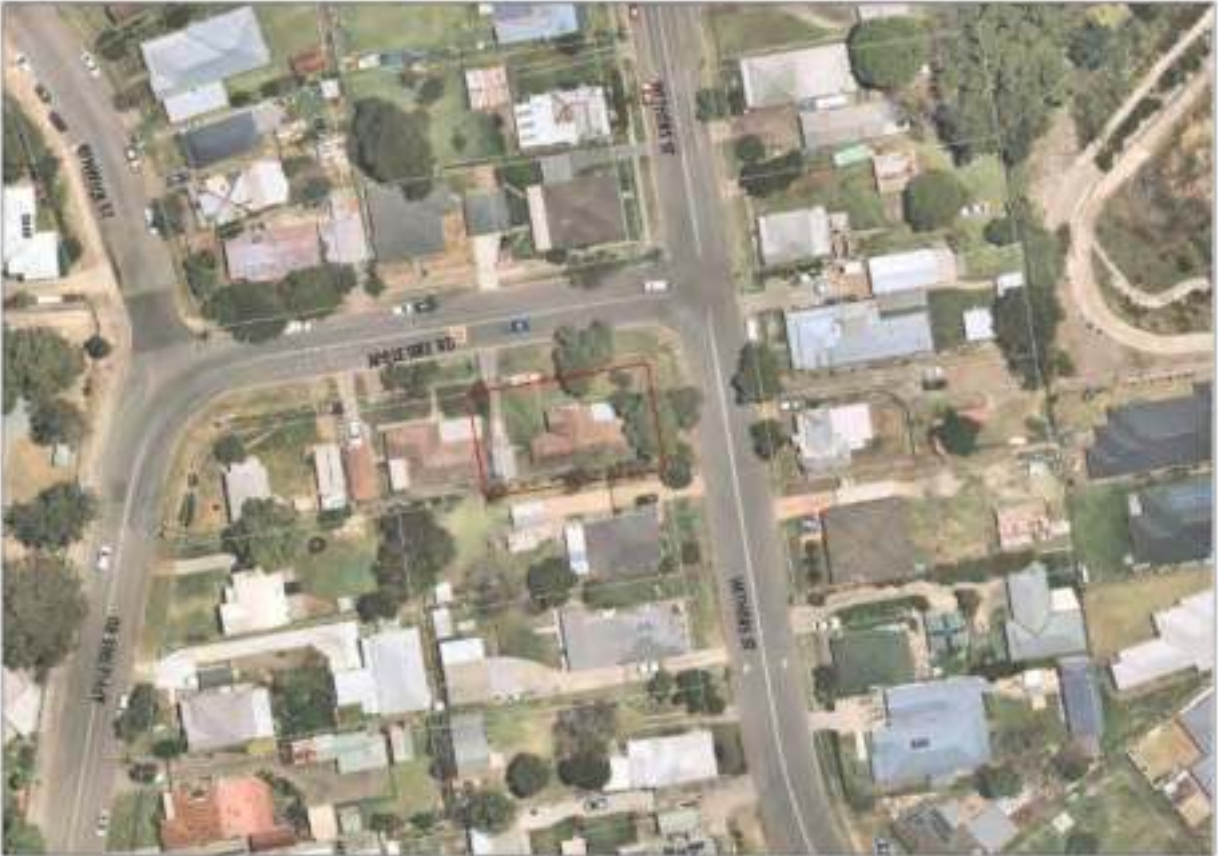
58 WITHERS STREET, WEST WALLSEND 2286

Conservation Area Contribution Level	Est. Construction Date	Previous studies and/or community input
Contributory 2	Early to late 20 th century (broad range)	No prior heritage assessments or research undertaken.
Assessment Text		Observed Modifications
<p>The scale (single-storey) and general style of the dwelling is consistent with that of the streetscape and wider HCA. Dwelling contributes positively to the streetscape and wider HCA, particularly in comparison to Non-Contributory buildings.</p> <p>The dwelling features appropriately proportioned and positioned fenestrations, an appropriate roof form (gabled or hipped) and other features consistent with the architectural character of the area (e.g. front verandah with timber or brick posts, timber detailing, corrugated metal roofing, etc). The contributory value of the dwelling is limited however by either:</p> <ul style="list-style-type: none"> • External modifications that have in some way obscured the style, scale or design intent of the building and have resulted in less physical integrity than Contributory 1 buildings. • Being a later dwelling constructed in an appropriate referential style, but comprising little to no fabric of intrinsic heritage significance. 		No modifications observed.

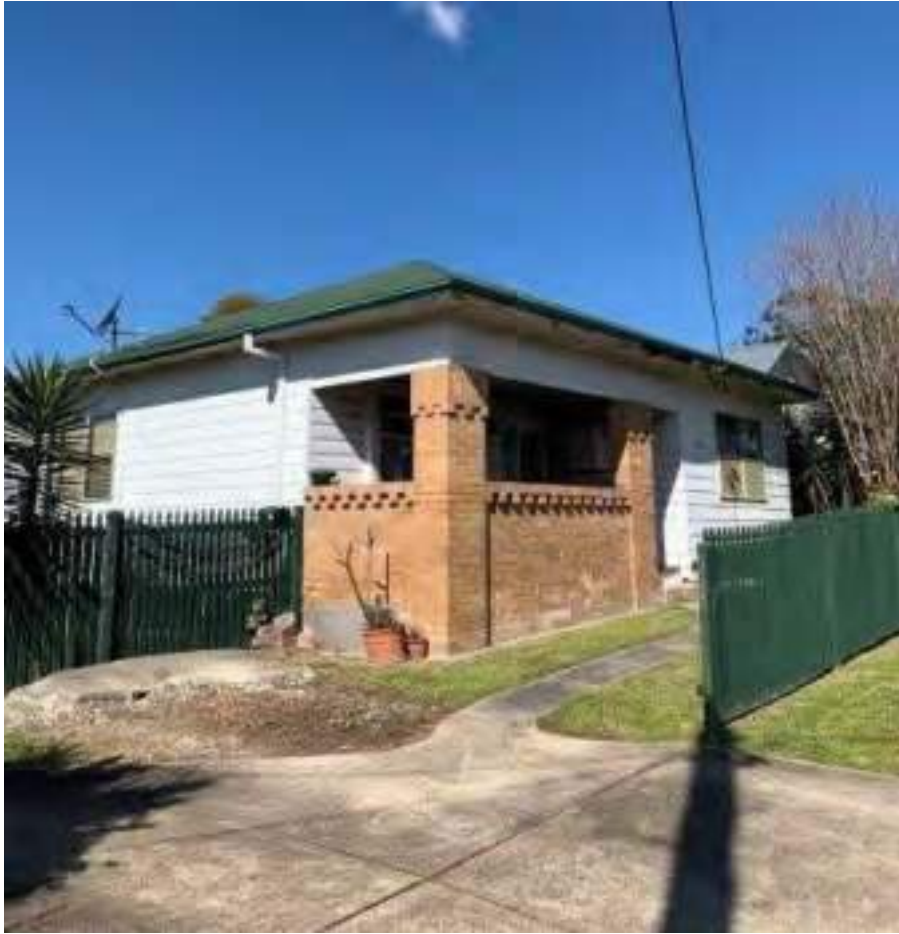
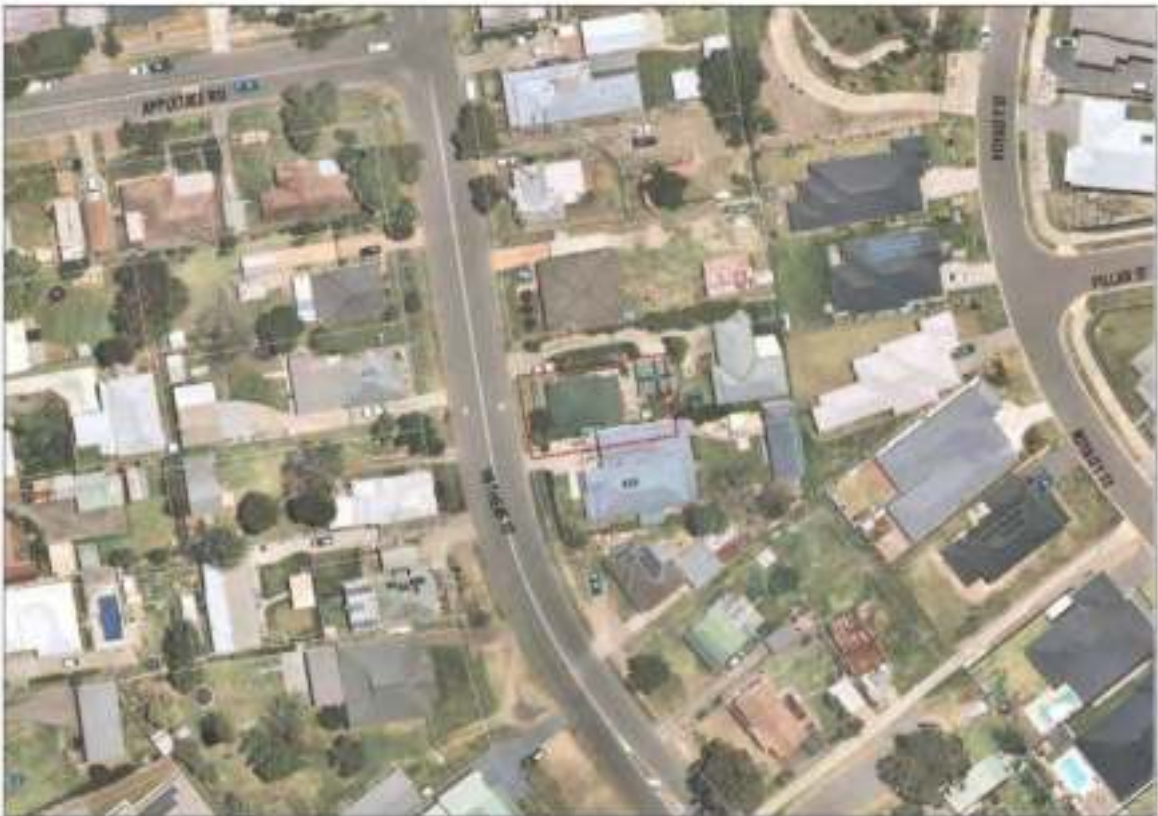
75 WITHERS STREET, WEST WALLSEND 2286

Conservation Area Contribution Level	Est. Construction Date	Previous studies and/or community input
Contributory 2	Early to late 20 th century (broad range)	No prior heritage assessments or research undertaken.
Assessment Text		Observed Modifications
<p>The scale (single-storey) and general style of the dwelling is consistent with that of the streetscape and wider HCA. Dwelling contributes positively to the streetscape and wider HCA, particularly in comparison to Non-Contributory buildings.</p> <p>The dwelling features appropriately proportioned and positioned fenestrations, an appropriate roof form (gabled or hipped) and other features consistent with the architectural character of the area (e.g. front verandah with timber or brick posts, timber detailing, corrugated metal roofing, etc). The contributory value of the dwelling is limited however by either:</p> <ul style="list-style-type: none"> • External modifications that have in some way obscured the style, scale or design intent of the building and have resulted in less physical integrity than Contributory 1 buildings. • Being a later dwelling constructed in an appropriate referential style, but comprising little to no fabric of intrinsic heritage significance. 		No modifications observed.

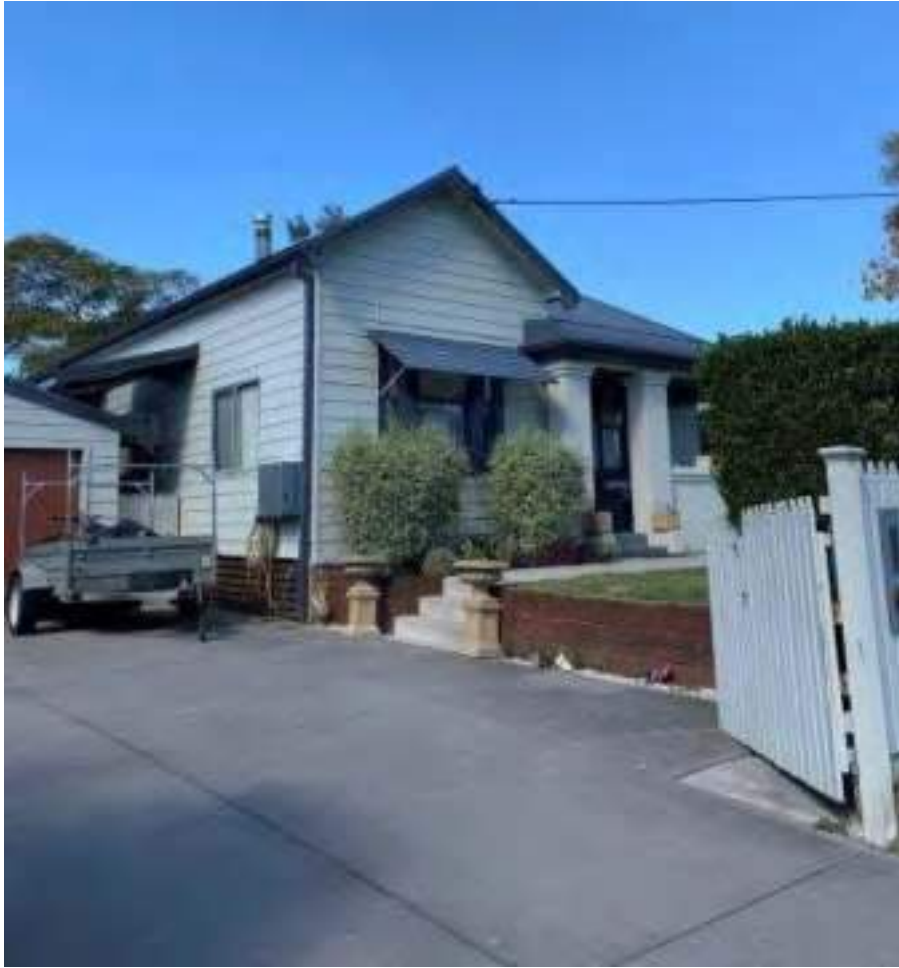
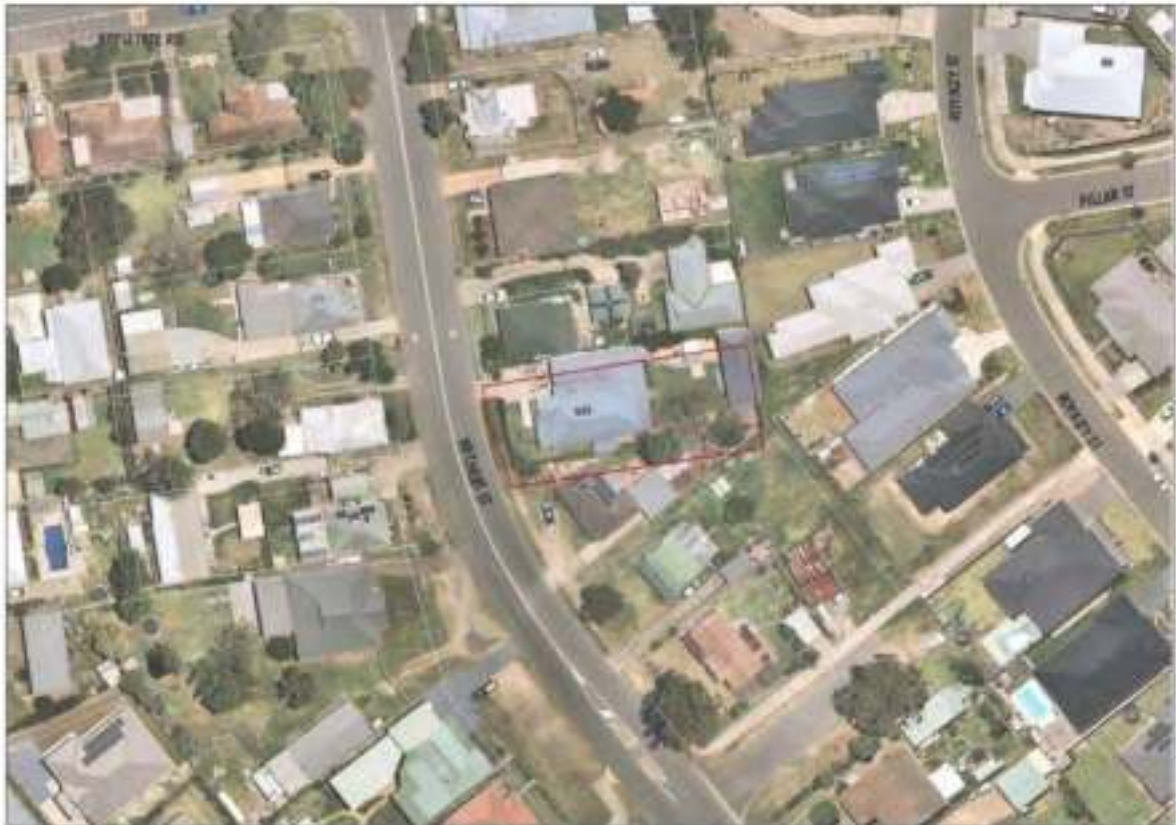
77 WITHERS STREET, WEST WALLSEND 2286

Conservation Area Contribution Level	Est. Construction Date	Previous studies and/or community input
Contributory 2	Early to late 20 th century (broad range)	No prior heritage assessments or research undertaken.
Assessment Text		Observed Modifications
<p>The scale (single-storey) and general style of the dwelling is consistent with that of the streetscape and wider HCA. Dwelling contributes positively to the streetscape and wider HCA, particularly in comparison to Non-Contributory buildings.</p> <p>The dwelling features appropriately proportioned and positioned fenestrations, an appropriate roof form (gabled or hipped) and other features consistent with the architectural character of the area (e.g. front verandah with timber or brick posts, timber detailing, corrugated metal roofing, etc). The contributory value of the dwelling is limited however by either:</p> <ul style="list-style-type: none"> • External modifications that have in some way obscured the style, scale or design intent of the building and have resulted in less physical integrity than Contributory 1 buildings. • Being a later dwelling constructed in an appropriate referential style, but comprising little to no fabric of intrinsic heritage significance. 		<p>The brickwork rendered pillars supporting the verandah are a contemporary addition, likely replacing an original timber design.</p> <p>An extension has been built onto the northern side of the dwelling. A large gable roof garage is built on the northern side of the dwelling.</p>

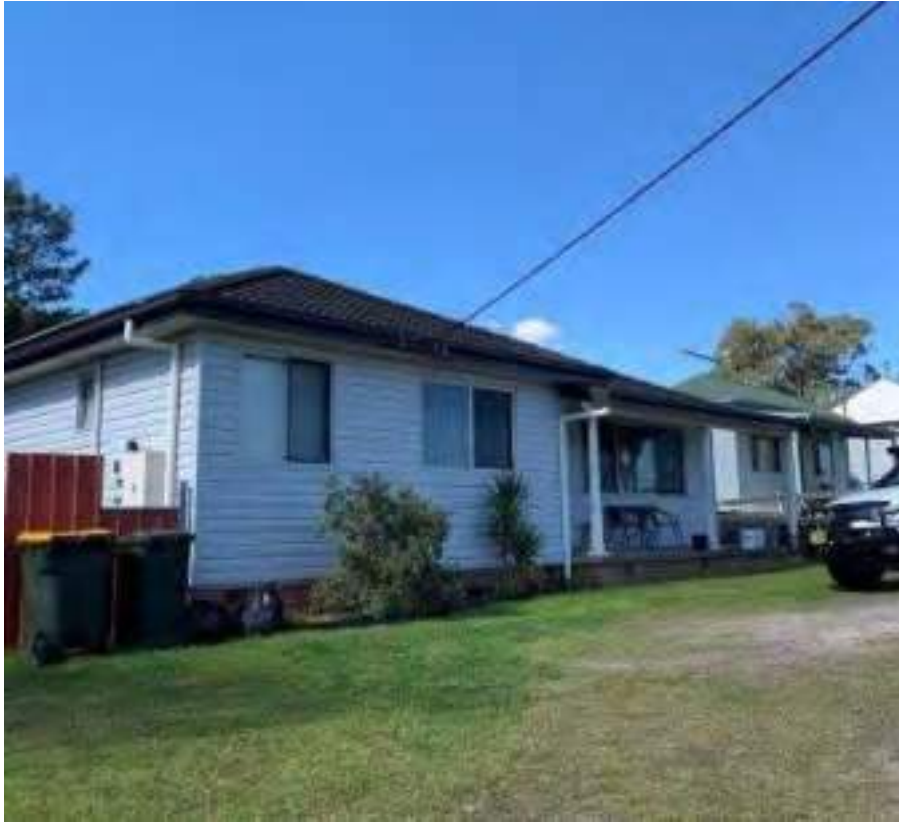
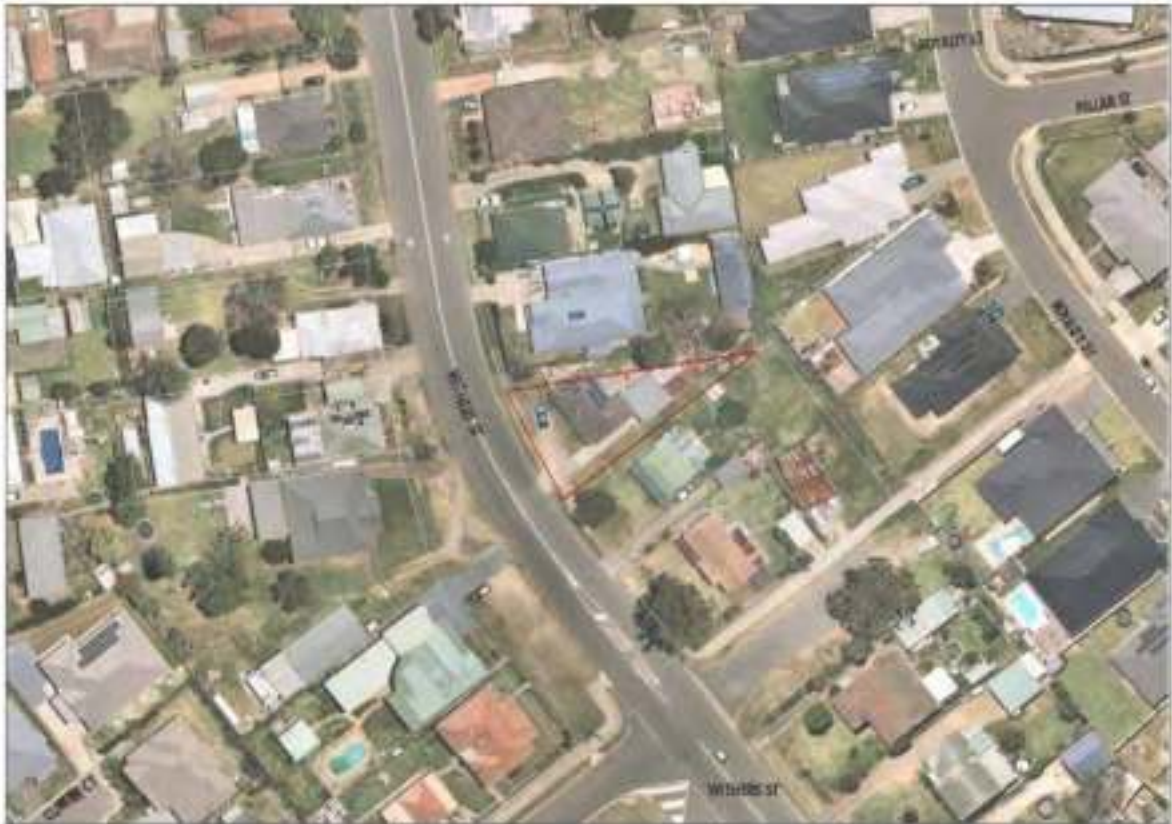
79 WITHERS STREET, WEST WALLSEND 2286

Conservation Area Contribution Level	Est. Construction Date	Previous studies and/or community input
Contributory 2	Early to late 20 th century (broad range)	No prior heritage assessments or research undertaken.
Assessment Text		Observed Modifications
<p>The scale (single-storey) and general style of the dwelling is consistent with that of the streetscape and wider HCA. Dwelling contributes positively to the streetscape and wider HCA, particularly in comparison to Non-Contributory buildings.</p> <p>The dwelling features appropriately proportioned and positioned fenestrations, an appropriate roof form (gabled or hipped) and other features consistent with the architectural character of the area (e.g. front verandah with timber or brick posts, timber detailing, corrugated metal roofing, etc). The contributory value of the dwelling is limited however by either:</p> <ul style="list-style-type: none"> • External modifications that have in some way obscured the style, scale or design intent of the building and have resulted in less physical integrity than Contributory 1 buildings. • Being a later dwelling constructed in an appropriate referential style, but comprising little to no fabric of intrinsic heritage significance. 		<p>The faux European pillars are likely a contemporary addition.</p>

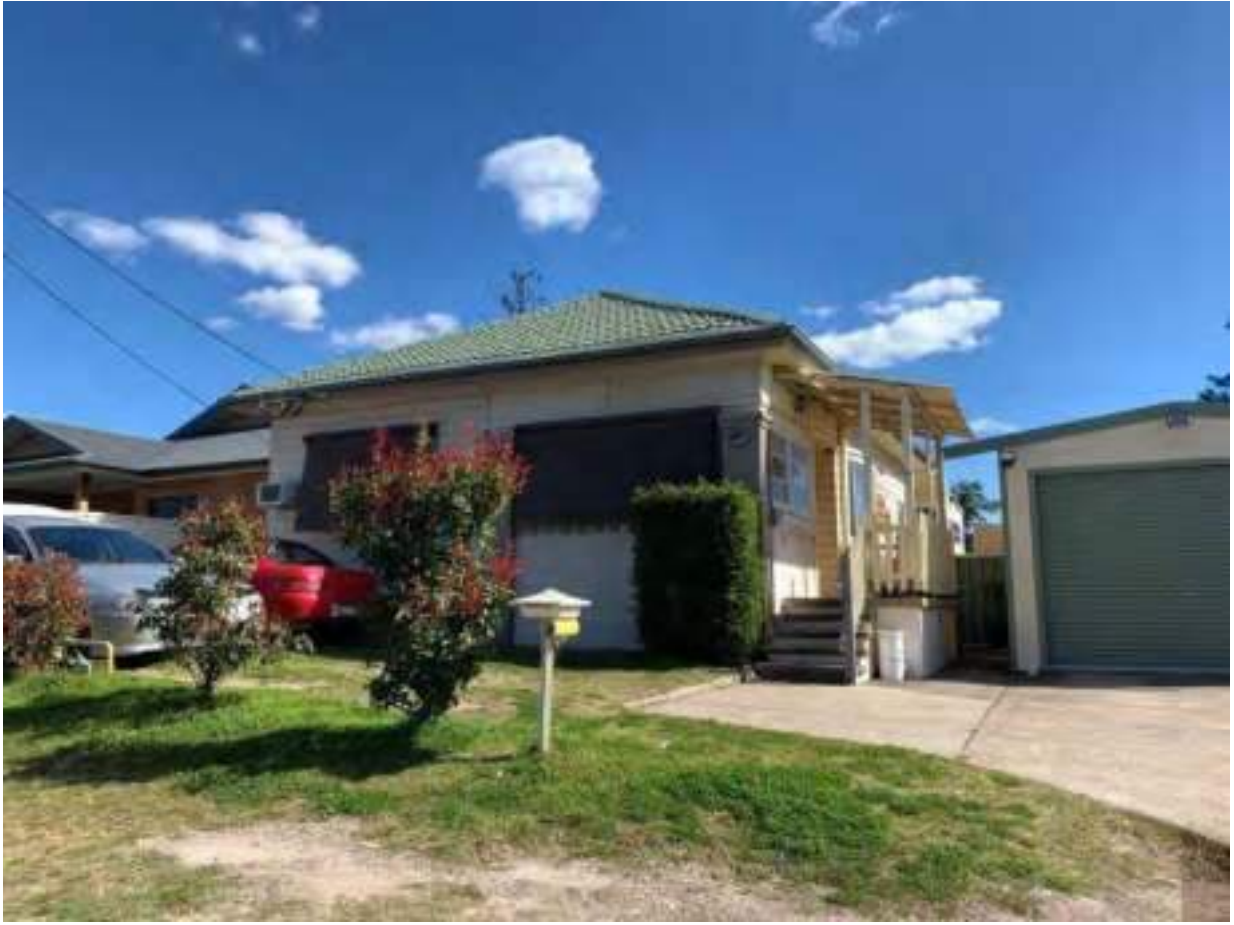
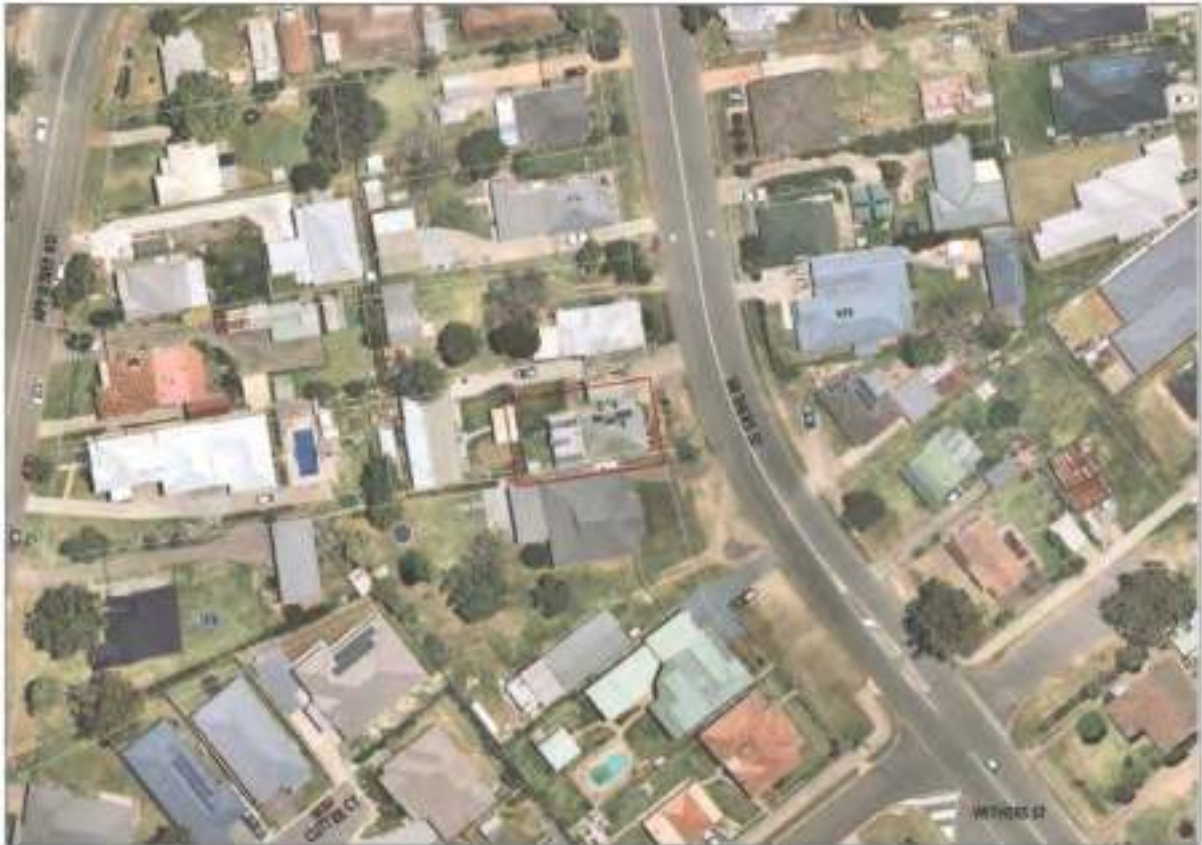
66A WITHERS STREET, WEST WALLSEND 2286

Conservation Area Contribution Level	Est. Construction Date	Previous studies and/or community input
Contributory 2	Early to late 20 th century (broad range)	No prior heritage assessments or research undertaken.
Assessment Text		Observed Modifications
<p>The scale (single-storey) and general style of the dwelling is consistent with that of the streetscape and wider HCA. Dwelling contributes positively to the streetscape and wider HCA, particularly in comparison to Non-Contributory buildings.</p> <p>The dwelling features appropriately proportioned and positioned fenestrations, an appropriate roof form (gabled or hipped) and other features consistent with the architectural character of the area (e.g. front verandah with timber or brick posts, timber detailing, corrugated metal roofing, etc). The contributory value of the dwelling is limited however by either:</p> <ul style="list-style-type: none"> • External modifications that have in some way obscured the style, scale or design intent of the building and have resulted in less physical integrity than Contributory 1 buildings. • Being a later dwelling constructed in an appropriate referential style, but comprising little to no fabric of intrinsic heritage significance. 		<p>A skillion veranda roof has been constructed a top the eastern veranda space. A gable roof garage has been built to the north of the dwelling.</p>

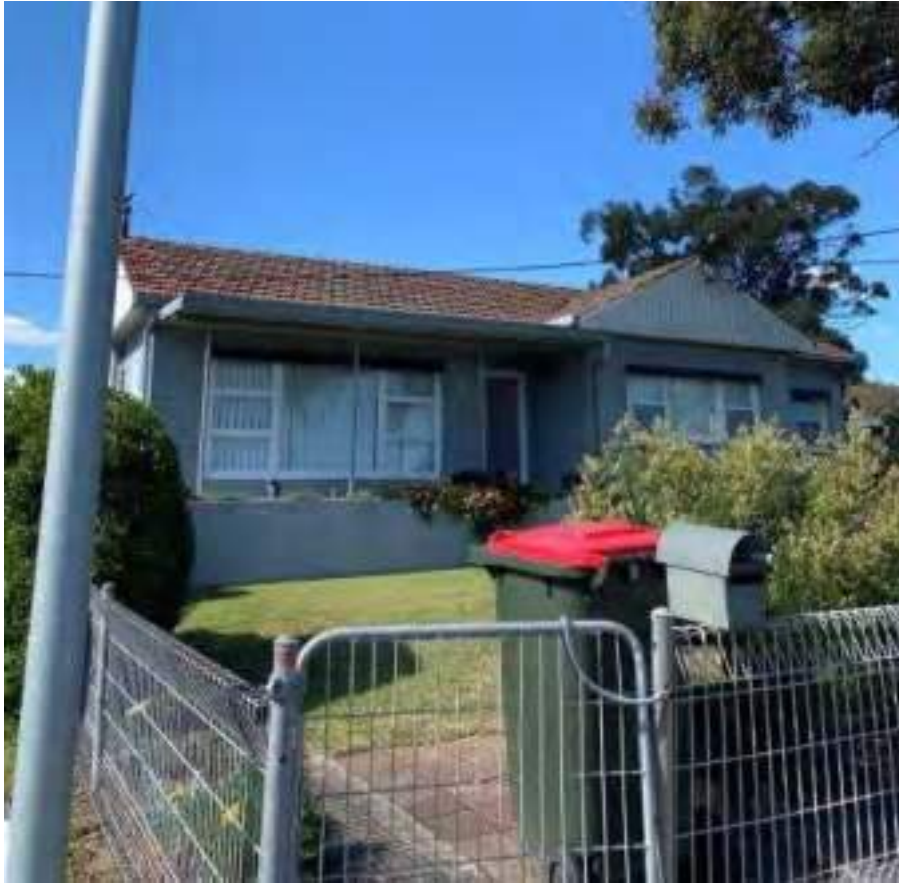
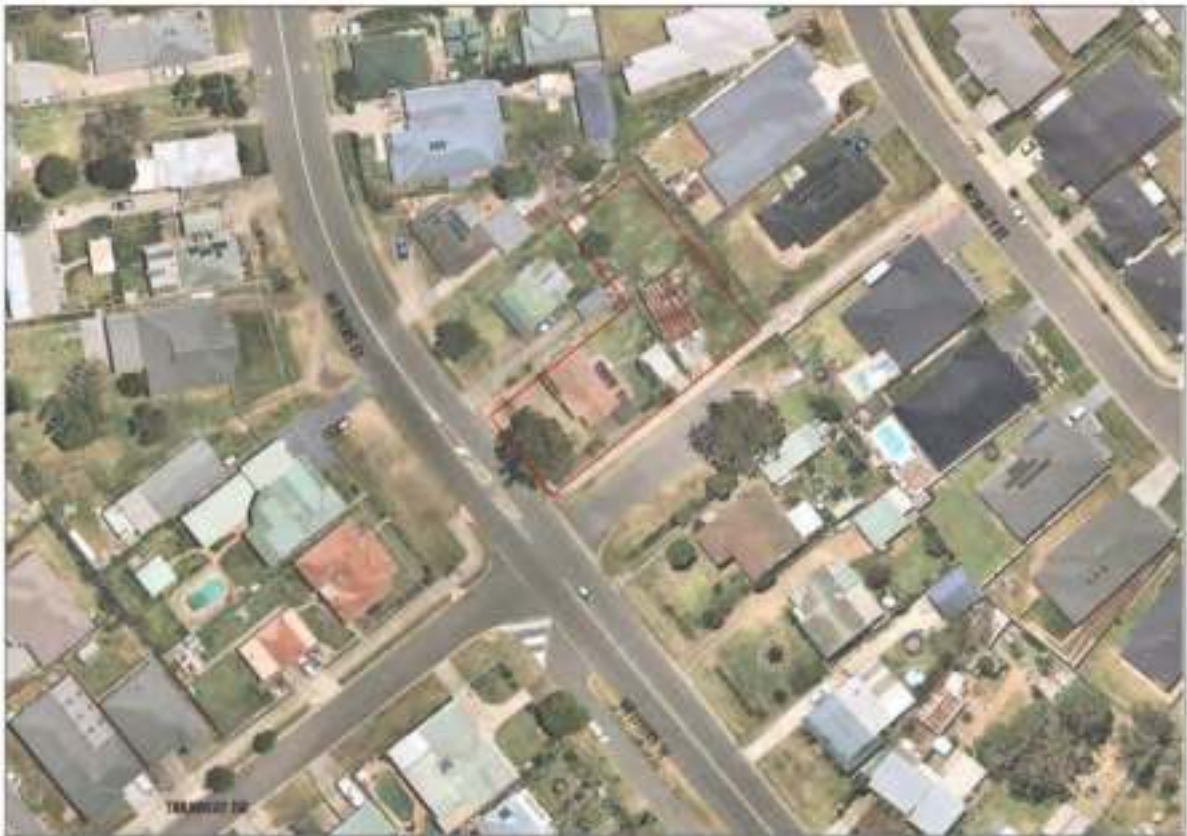
83 WITHERS STREET, WEST WALLSEND 2286

Conservation Area Contribution Level	Est. Construction Date	Previous studies and/or community input
Contributory 2	Early to late 20 th century (broad range)	No prior heritage assessments or research undertaken.
Assessment Text		Observed Modifications
<p>The scale (single-storey) and general style of the dwelling is consistent with that of the streetscape and wider HCA. Dwelling contributes positively to the streetscape and wider HCA, particularly in comparison to Non-Contributory buildings.</p> <p>The dwelling features appropriately proportioned and positioned fenestrations, an appropriate roof form (gabled or hipped) and other features consistent with the architectural character of the area (e.g. front verandah with timber or brick posts, timber detailing, corrugated metal roofing, etc). The contributory value of the dwelling is limited however by either:</p> <ul style="list-style-type: none"> • External modifications that have in some way obscured the style, scale or design intent of the building and have resulted in less physical integrity than Contributory 1 buildings. • Being a later dwelling constructed in an appropriate referential style, but comprising little to no fabric of intrinsic heritage significance. 		<p>Metal security screening has been installed on some of the visible doors and windows.</p>

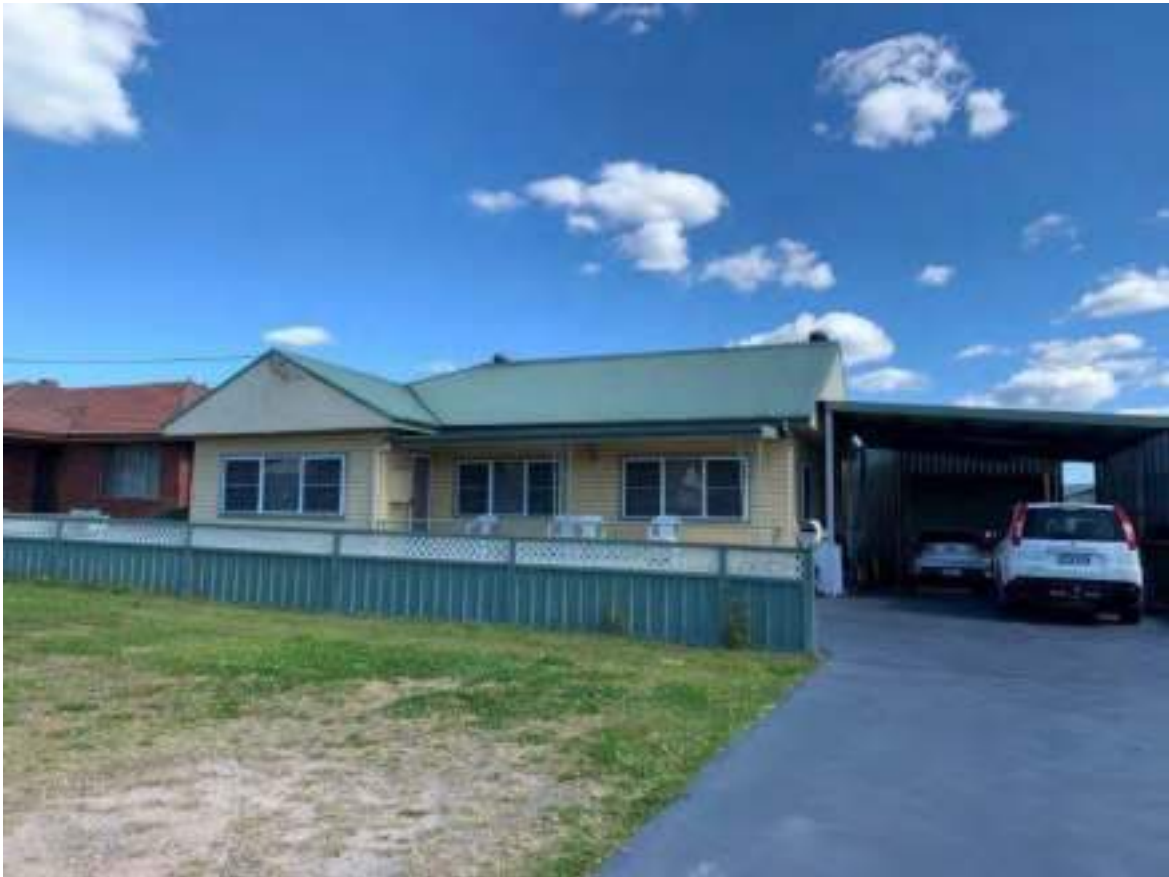
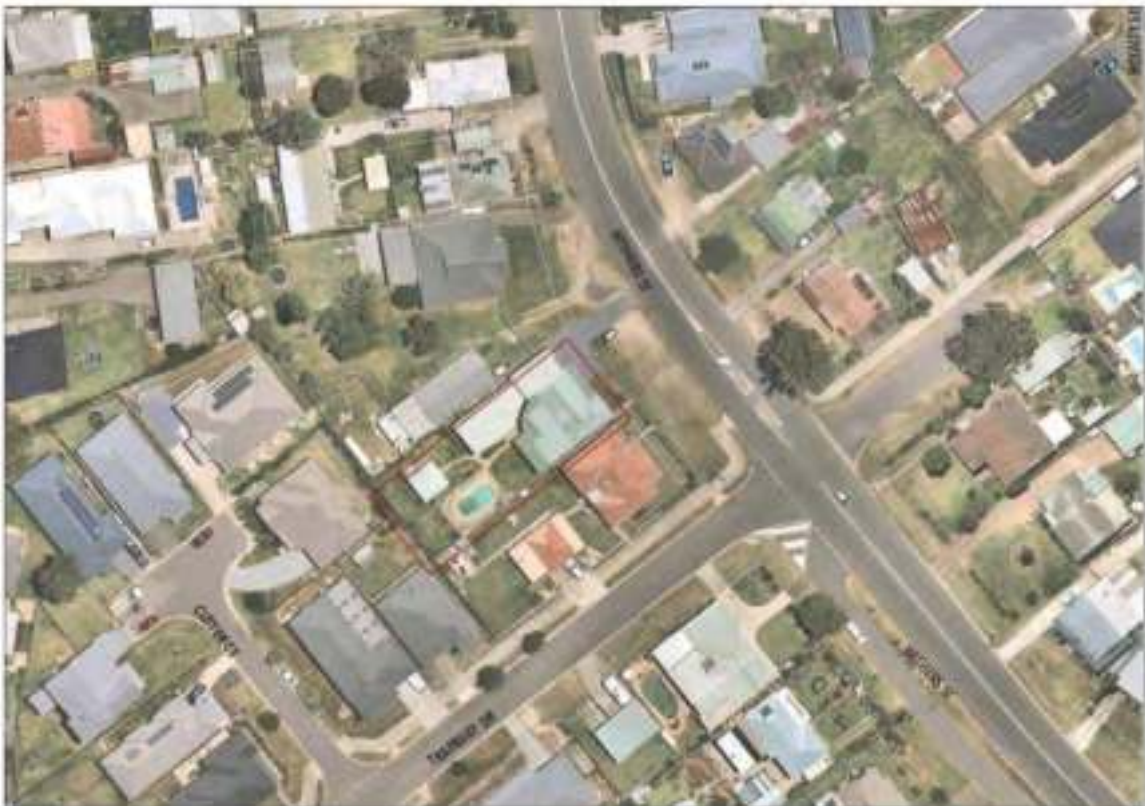
70 WITHERS STREET, WEST WALLSEND 2286

Conservation Area Contribution Level	Est. Construction Date	Previous studies and/or community input
Contributory 2	Early to late 20 th century (broad range)	No prior heritage assessments or research undertaken.
Assessment Text		Observed Modifications
<p>The scale (single-storey) and general style of the dwelling is consistent with that of the streetscape and wider HCA. Dwelling contributes positively to the streetscape and wider HCA, particularly in comparison to Non-Contributory buildings.</p> <p>The dwelling features appropriately proportioned and positioned fenestrations, an appropriate roof form (gabled or hipped) and other features consistent with the architectural character of the area (e.g. front verandah with timber or brick posts, timber detailing, corrugated metal roofing, etc). The contributory value of the dwelling is limited however by either:</p> <ul style="list-style-type: none"> • External modifications that have in some way obscured the style, scale or design intent of the building and have resulted in less physical integrity than Contributory 1 buildings. • Being a later dwelling constructed in an appropriate referential style, but comprising little to no fabric of intrinsic heritage significance. 		<p>The property is enclosed by a Colourbond and lattice fence.</p> <p>A carport has been constructed to the north of the dwelling.</p>

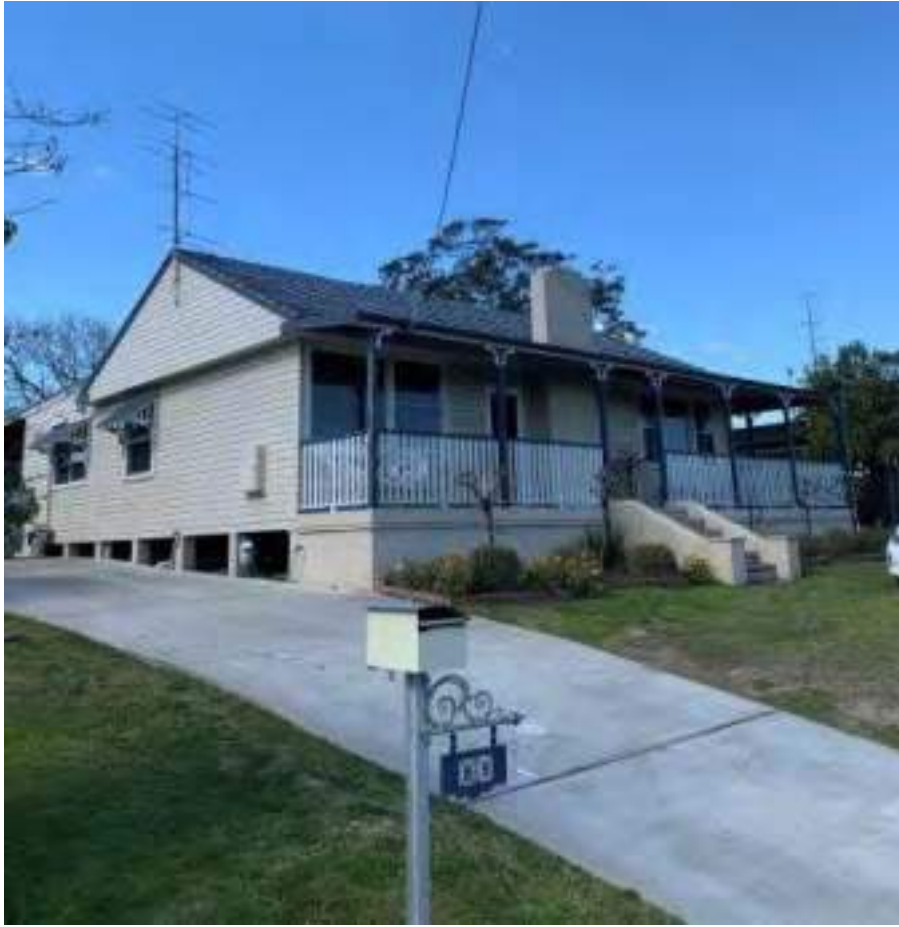
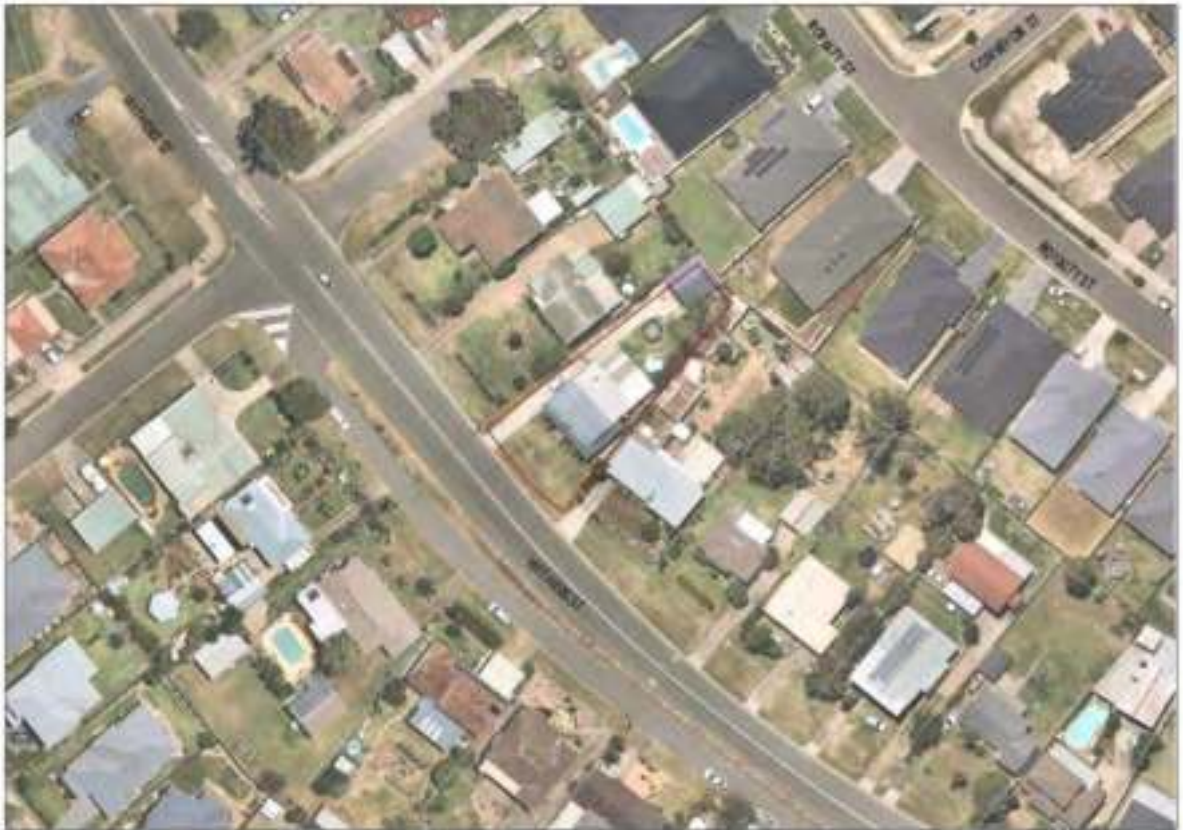
89 WITHERS STREET, WEST WALLSEND 2286

Conservation Area Contribution Level	Est. Construction Date	Previous studies and/or community input
Contributory 2	Early to late 20 th century (broad range)	No prior heritage assessments or research undertaken.
Assessment Text		Observed Modifications
<p>The scale (single-storey) and general style of the dwelling is consistent with that of the streetscape and wider HCA. Dwelling contributes positively to the streetscape and wider HCA, particularly in comparison to Non-Contributory buildings.</p> <p>The dwelling features appropriately proportioned and positioned fenestrations, an appropriate roof form (gabled or hipped) and other features consistent with the architectural character of the area (e.g. front verandah with timber or brick posts, timber detailing, corrugated metal roofing, etc). The contributory value of the dwelling is limited however by either:</p> <ul style="list-style-type: none"> • External modifications that have in some way obscured the style, scale or design intent of the building and have resulted in less physical integrity than Contributory 1 buildings. • Being a later dwelling constructed in an appropriate referential style, but comprising little to no fabric of intrinsic heritage significance. 		<p>The dwelling has undergone multiple modifications, with the central location of the chimney/fire place suggesting a reconfiguration of the front door and/or an extension expanding the dwelling.</p> <p>All visible windows are contemporary designs.</p> <p>The rendered brick stair case leading to the veranda is likely a contemporary replication of an original stair case.</p> <p>The balustrade, timber posts and decorative bracketing of the veranda is a contemporary addition, this has been constructed in a sympathetic manner and does not detract from the heritage streetscape.</p> <p>The veranda has been extended to wrap around the south western and south eastern side of the dwelling.</p>

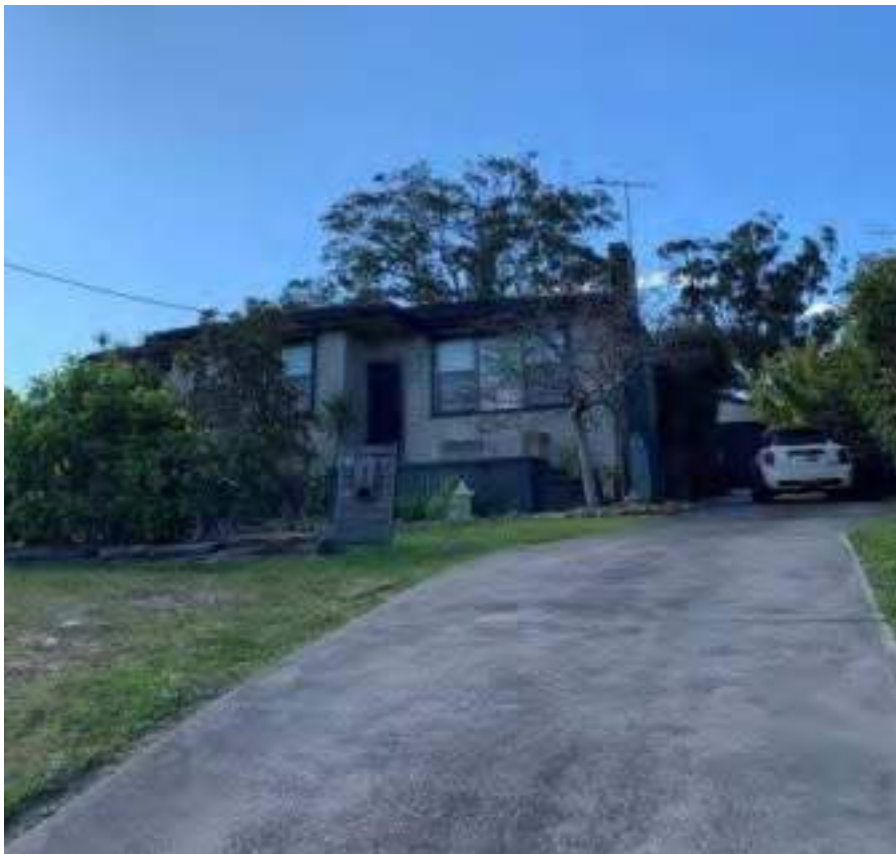
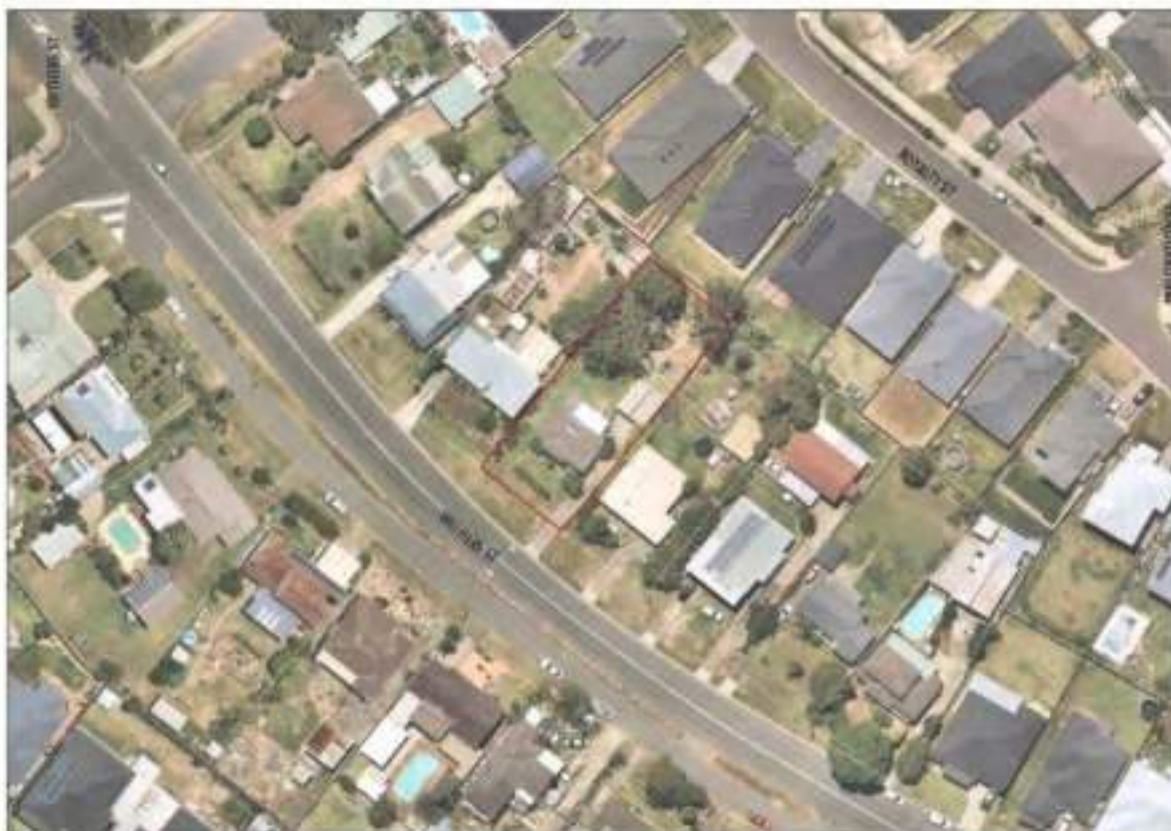
93 WITHERS STREET, WEST WALLSEND 2286

Conservation Area Contribution Level	Est. Construction Date	Previous studies and/or community input
Contributory 2	Early to late 20 th century (broad range)	No prior heritage assessments or research undertaken.
Assessment Text		Observed Modifications
<p>The scale (single-storey) and general style of the dwelling is consistent with that of the streetscape and wider HCA. Dwelling contributes positively to the streetscape and wider HCA, particularly in comparison to Non-Contributory buildings.</p> <p>The dwelling features appropriately proportioned and positioned fenestrations, an appropriate roof form (gabled or hipped) and other features consistent with the architectural character of the area (e.g. front verandah with timber or brick posts, timber detailing, corrugated metal roofing, etc). The contributory value of the dwelling is limited however by either:</p> <ul style="list-style-type: none"> • External modifications that have in some way obscured the style, scale or design intent of the building and have resulted in less physical integrity than Contributory 1 buildings. • Being a later dwelling constructed in an appropriate referential style, but comprising little to no fabric of intrinsic heritage significance. 		<p>The visible windows are contemporary in design.</p>

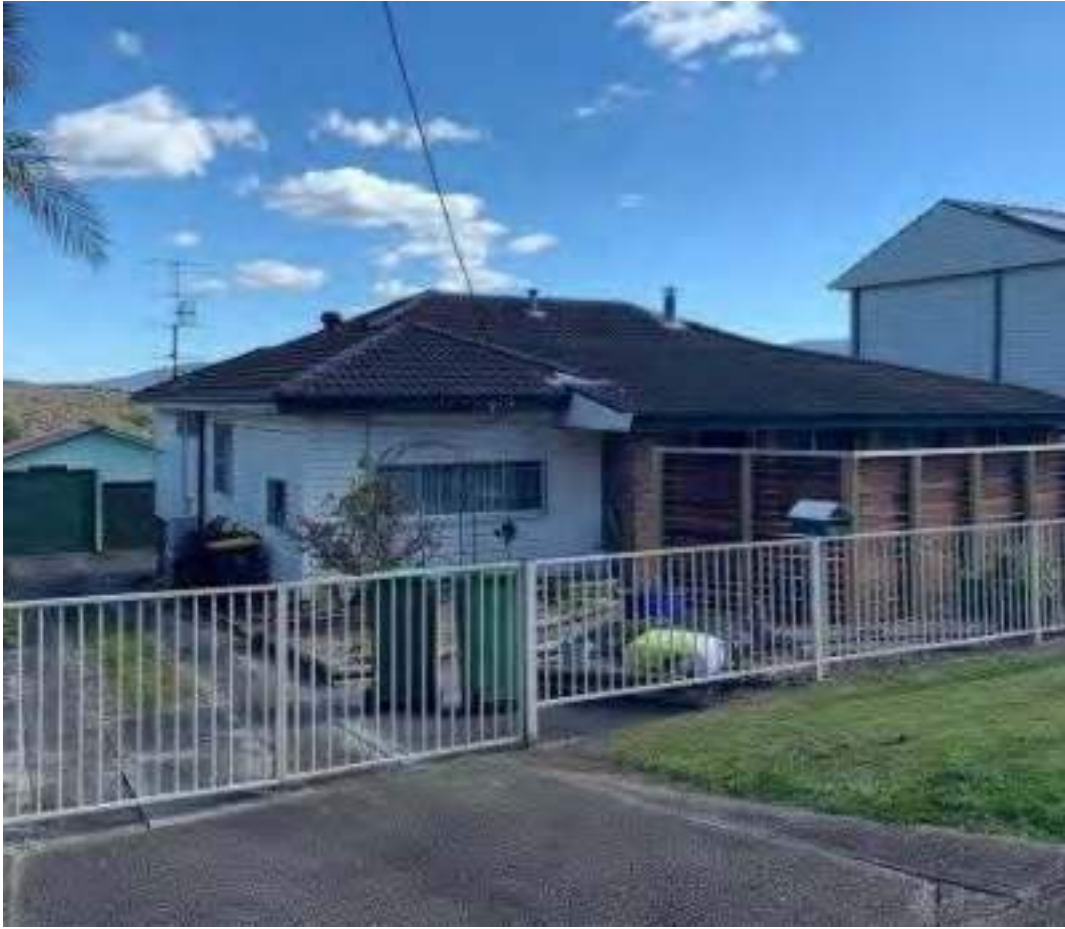
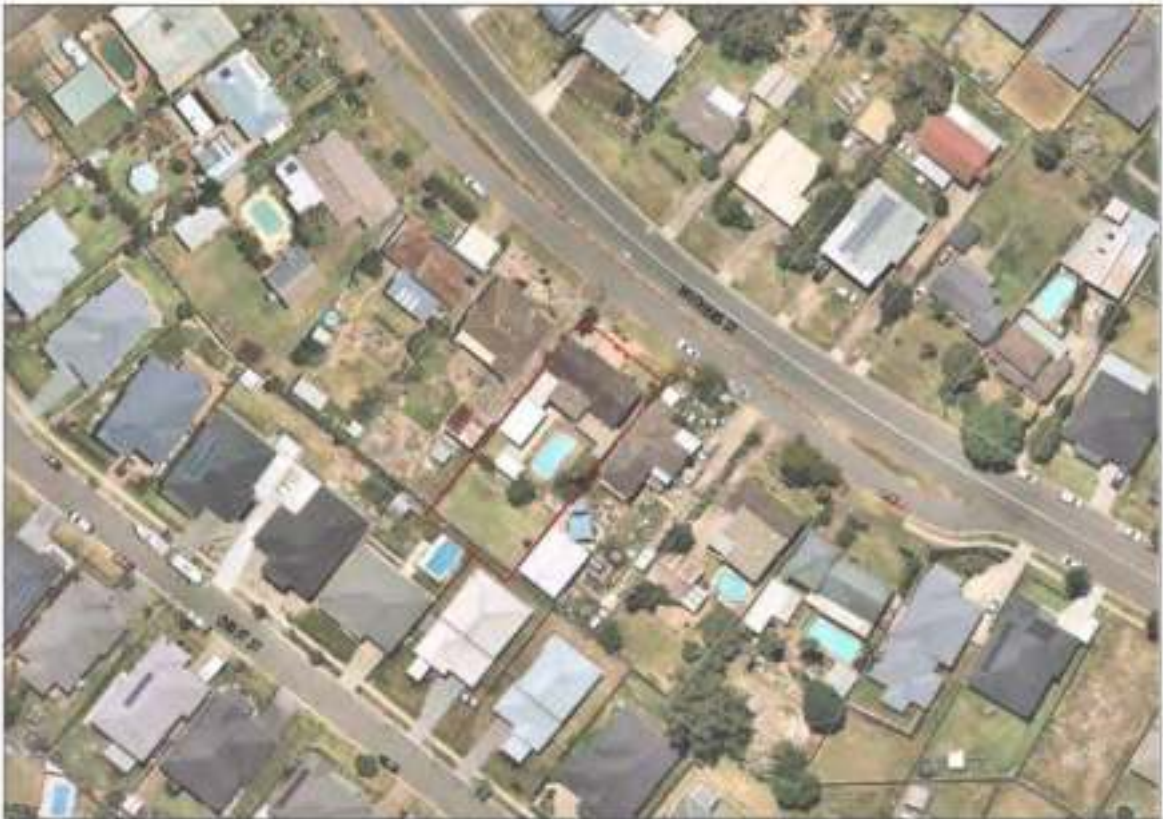
84 WITHERS STREET, WEST WALLSEND 2286

Conservation Area Contribution Level	Est. Construction Date	Previous studies and/or community input
Contributory 2	Early to late 20 th century (broad range)	No prior heritage assessments or research undertaken.
Assessment Text		Observed Modifications
<p>The scale (single-storey) and general style of the dwelling is consistent with that of the streetscape and wider HCA. Dwelling contributes positively to the streetscape and wider HCA, particularly in comparison to Non-Contributory buildings.</p> <p>The dwelling features appropriately proportioned and positioned fenestrations, an appropriate roof form (gabled or hipped) and other features consistent with the architectural character of the area (e.g. front verandah with timber or brick posts, timber detailing, corrugated metal roofing, etc). The contributory value of the dwelling is limited however by either:</p> <ul style="list-style-type: none"> • External modifications that have in some way obscured the style, scale or design intent of the building and have resulted in less physical integrity than Contributory 1 buildings. • Being a later dwelling constructed in an appropriate referential style, but comprising little to no fabric of intrinsic heritage significance. 		<p>An area of enclosed timber panelling has been constructed at the front north eastern side of the dwelling.</p>
